THE RIVER ALYN (aka ALUN)

**MOLD FLY FISHING CLUB
Advisory Visit Report Undertaken
On behalf of the Wild Trout Trust
By Ron Holloway MIF
23rd April 2002-04-28**

The Mold Fly Fishing Club

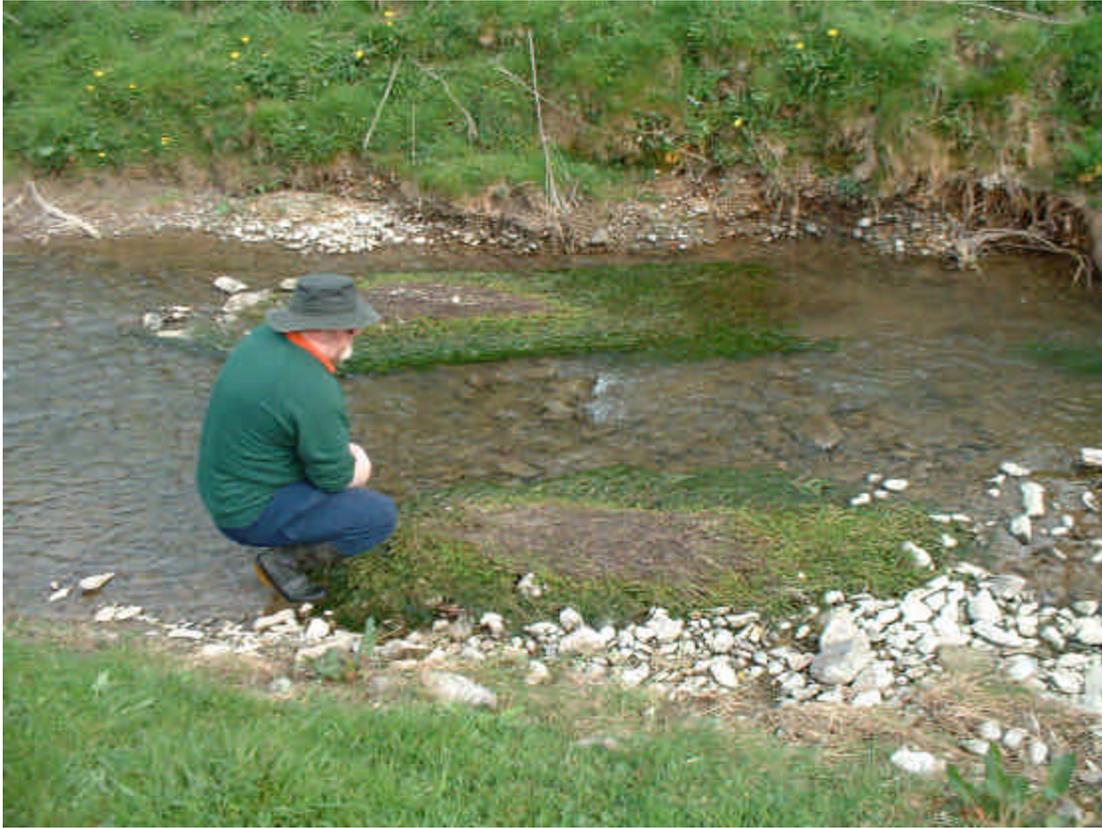
Struggling Rununculus!

Historically, anecdotal evidence states that rununculus was at one time abundant. There is a good and varied population of invertebrates with shrimp, caddis and ephemyoptera present. Given the presence of the diversity of invertebrates - water quality is satisfactory, however there is concern that water temperatures may be a problem at low flows in a hot summer.

3. It is recommended that consideration be given to embarking on a programme of reintroduction of Ranunculus by replanting with plants obtained from within the Alyn catchment. Max Gooch will advise on availability of plants and the methods of planting. Ensure that plants are reintroduced into fast flowing water without shade and suggested sites would be at the heads and tails of fast flowing riffles. The plant is not emergent so requires to be under water at all times. Do not contemplate replanting until all of the instream rock work is completed. Once the plants are established in order to help protect them a programme of Autumn cutting would help by trimming the tresses back to within 6 inches of the roots and this will help protect the plants from being torn out in any high winter flows. Once established the Summer growth will not only provide extra cover for all age groups of trout but also augment the food supply with aquatic insects that will abound within the growths .

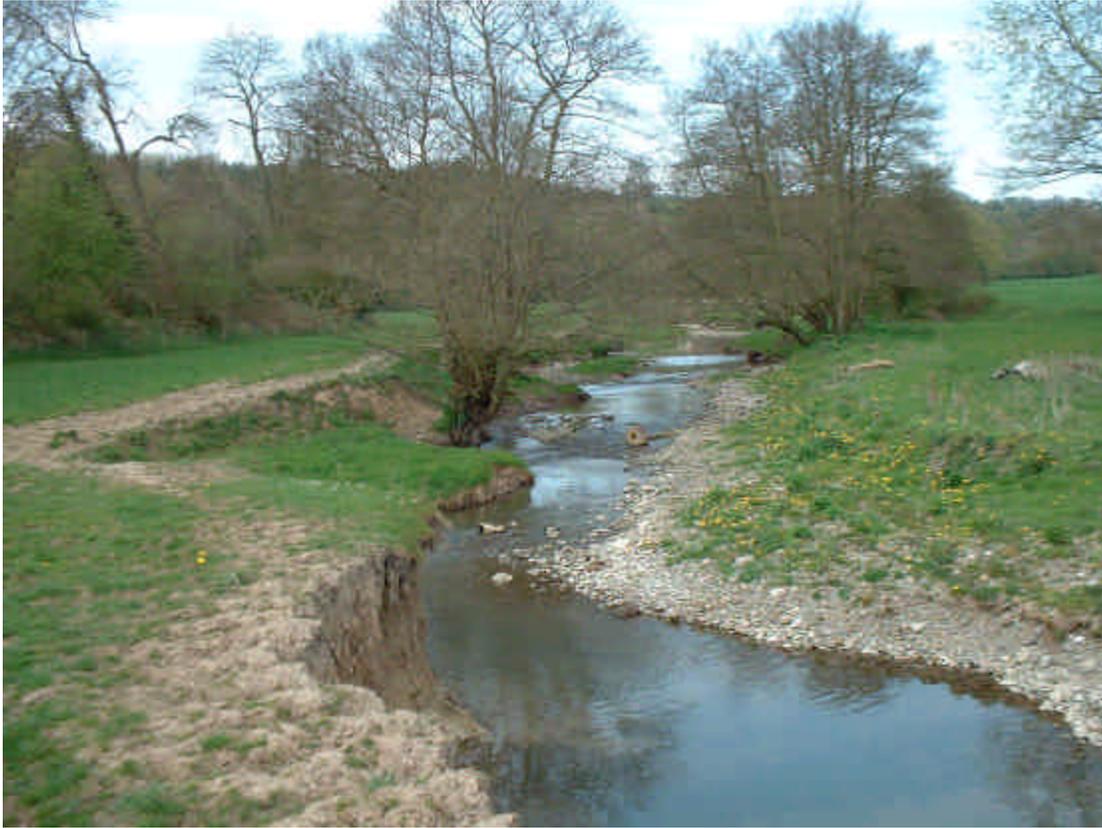
There are adequate spawning areas that hold good size gravel which would be attractive to trout spawners and this is substantiated by the observed presence of a vigorous population of brown trout swim up fry along the stream margins, particularly in the tails of well oxygenated, clean riffles.

Spawning gravel area.

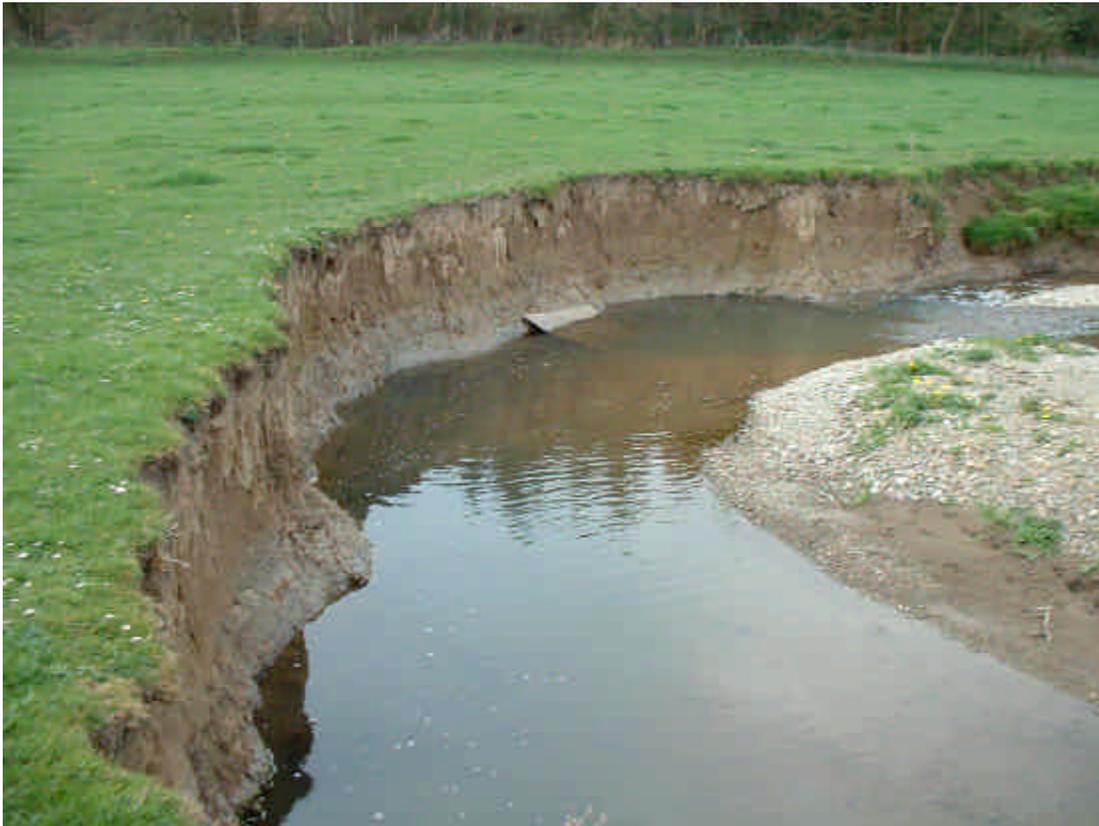
The stream has migrated across the flood plain in places which has created substantial areas of erosion into the aluvial deposits that make up the flood plain. This damage has been exacerbated considerably by a high density of cattle grazing all along the river margins which has removed essential soil stabilising bankside vegetation and, along with the effects of the trampling by many cattle, it has broken down the vulnerable soft river banks. Once overgrazed and trampled, the soil in these banks becomes very susceptible to washout in any high, or bank full, flows.

Erosion!

The areas of major erosion should be addressed, but this could necessitate some civil engineering work. Some suggested courses of action are:-

1. Large rock riprap firmly placed along the foot of the erosion wall and the bank behind re-profiled to slope back from the riprap which is then planted with natural vegetation, willow and alder.
2. A tree trunk wall constructed along the foot of the erosion wall, which is then backfilled with rock, cobble and gravel and also planted up with natural vegetation, willow, alder etc. It is advised that consultation with the EA be sought on both these operations.

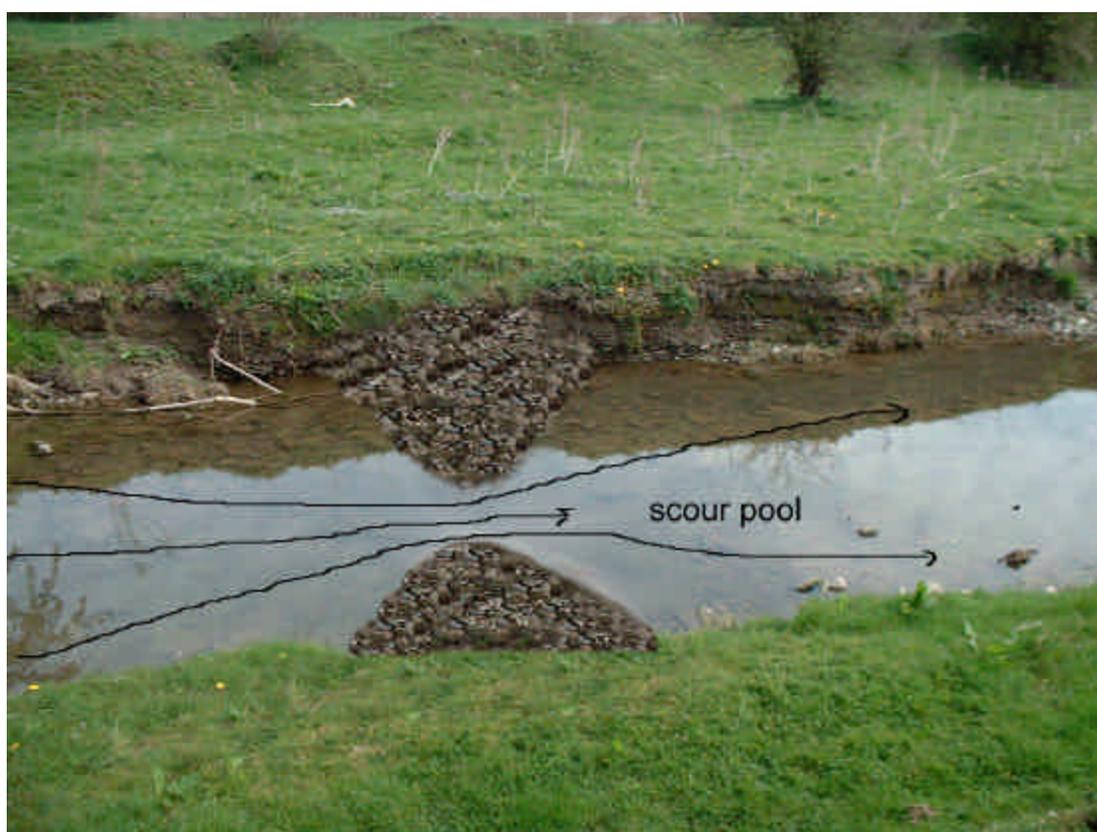
Rock Deflectors.

It is suggested that more substantial sizes rocks be used than illustrated above. No suitable sized rocks were available when this illustration was constructed! When submerged at high water the shape of the construction will ensure the flows will always be directed into the scour hole and therefore reduce bank erosion downstream. The points of the triangular structure to out of water by 6 inches at mean base flow. The concentrated flow will scour a depression in the bed and create a useful holding area for trout. Several of these structures could be strategically placed at numerous

points along the whole beat. Consult with Max Gooch (EA Fisheries) as to the siting and placement of same.

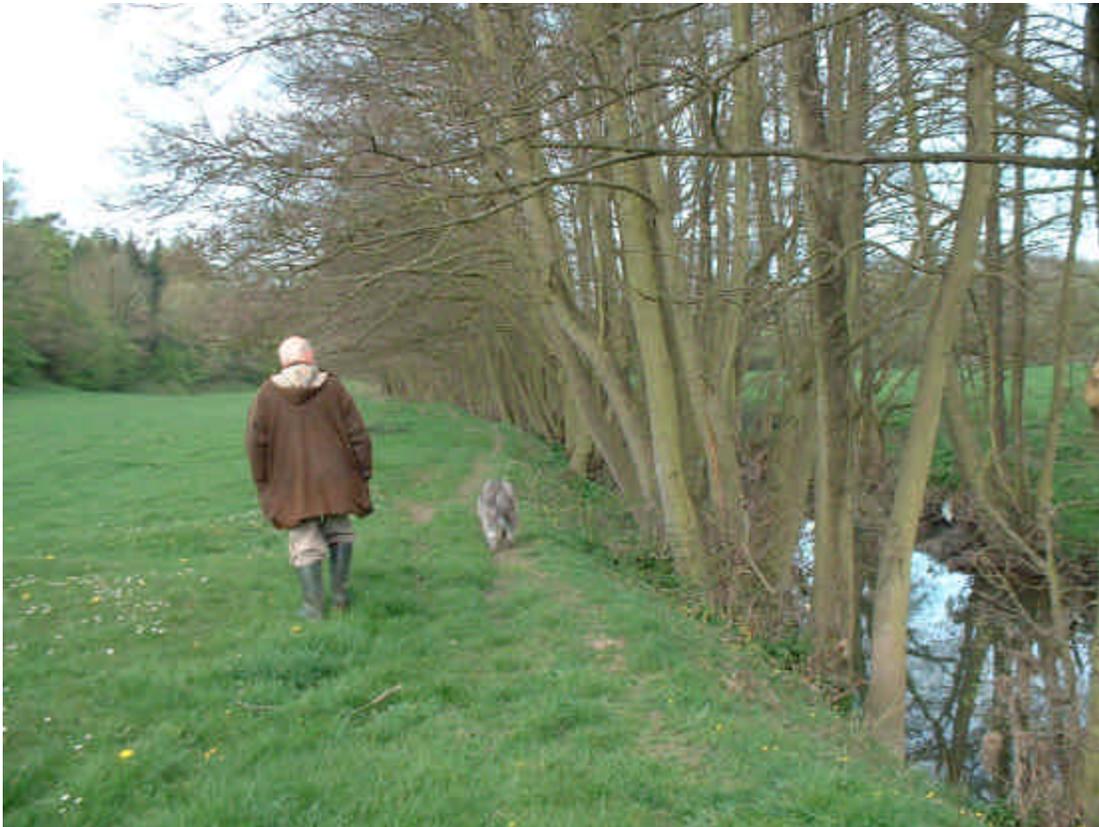
Needs Pollarding

4. Although there is room for some judicious tree planting to provide shading along the open banks there are other areas where some systematic pollarding is required to allow more sunlight to reach the river. In these shaded areas it is suggested that a

that a ratio of 40% shade and 60% sunlight should be achieved.

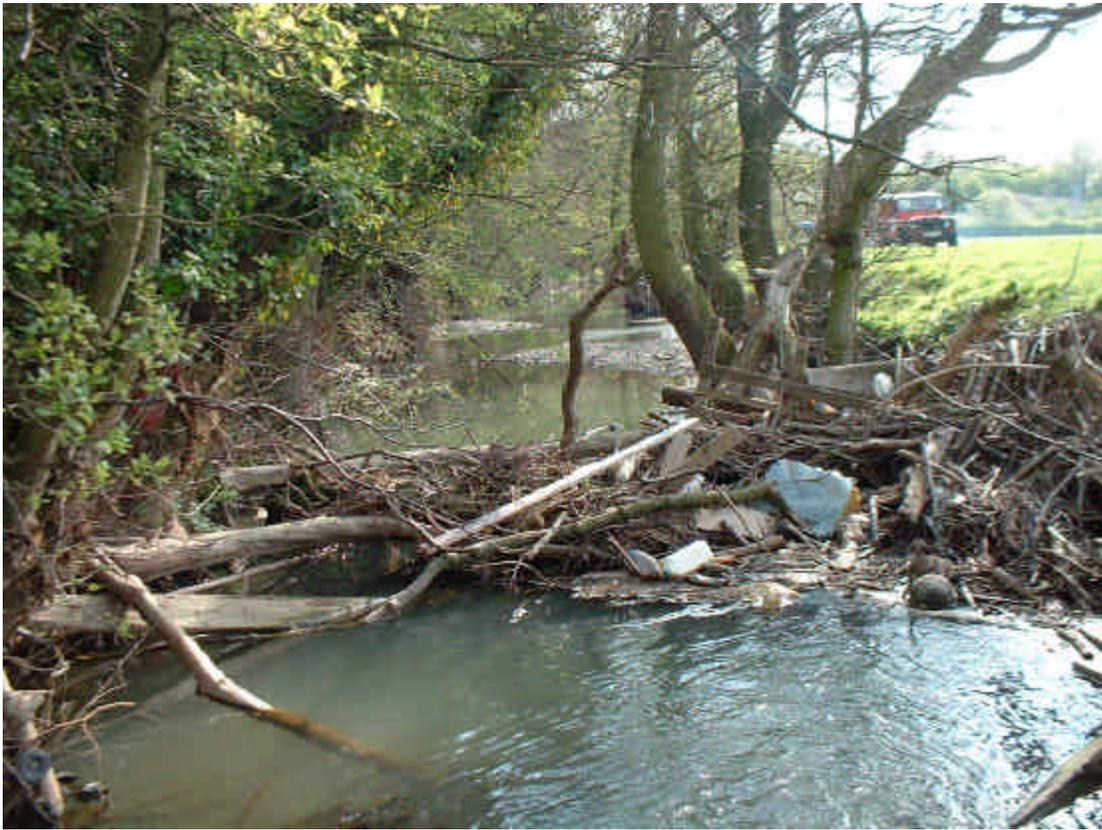
Debris Dam. Pic.1

5. Woody debris can be of benefit in a river as it can not only provide trout cover it also affords good insect habitat as well as assisting in the scouring the river bed of accumulated sediments. However the two substantial debris dams need to be removed as in one (Picture 1) it has done its job of scouring a large hole under and downstream creating an excellent trout holding area, but if left will continue to scour and could start to cause more damage than good .

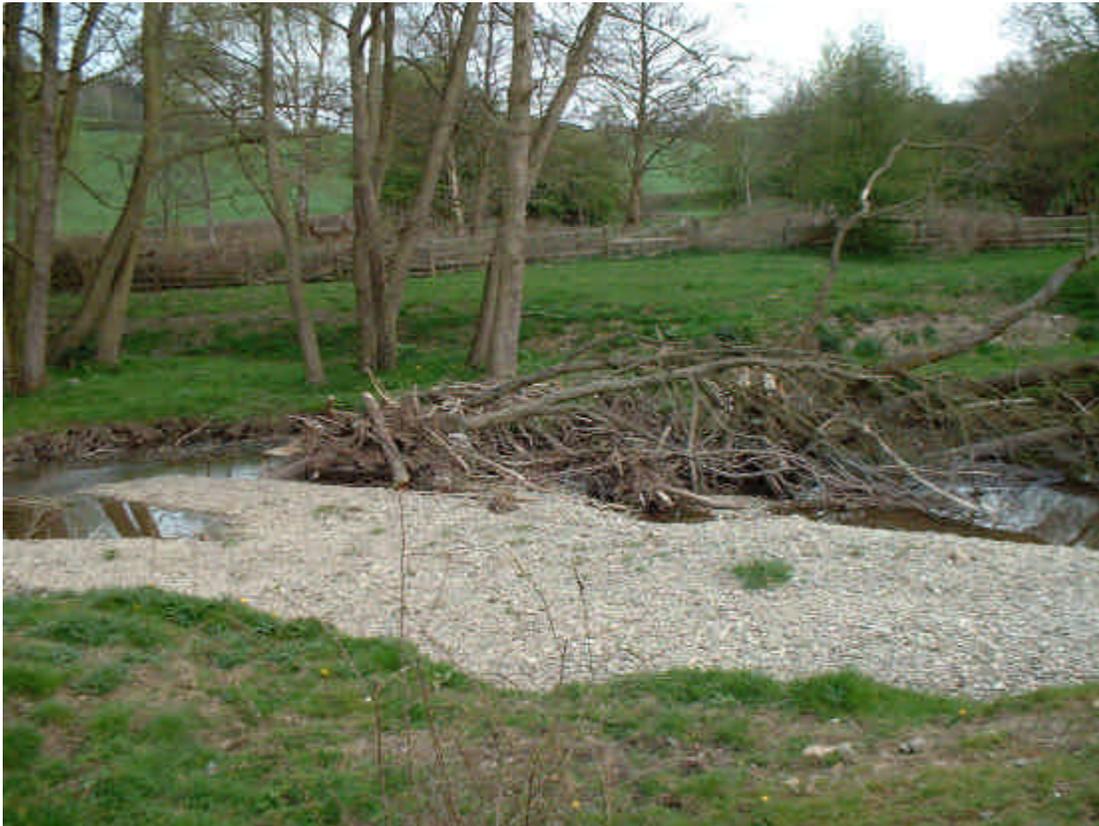
Whereas the second dam (See pic.2) will only collect further debris on the next flood which could further dam the river and encourage it to cut around the obstruction and make a further unwanted channel.

Debris Dam. (Pic.2)
