Habitat Advisory visit to the Beresford  
Fishery, on the River Dove Derbyshire.  
Undertaken by Vaughan Lewis, Windrush  
AEC  
May 2002

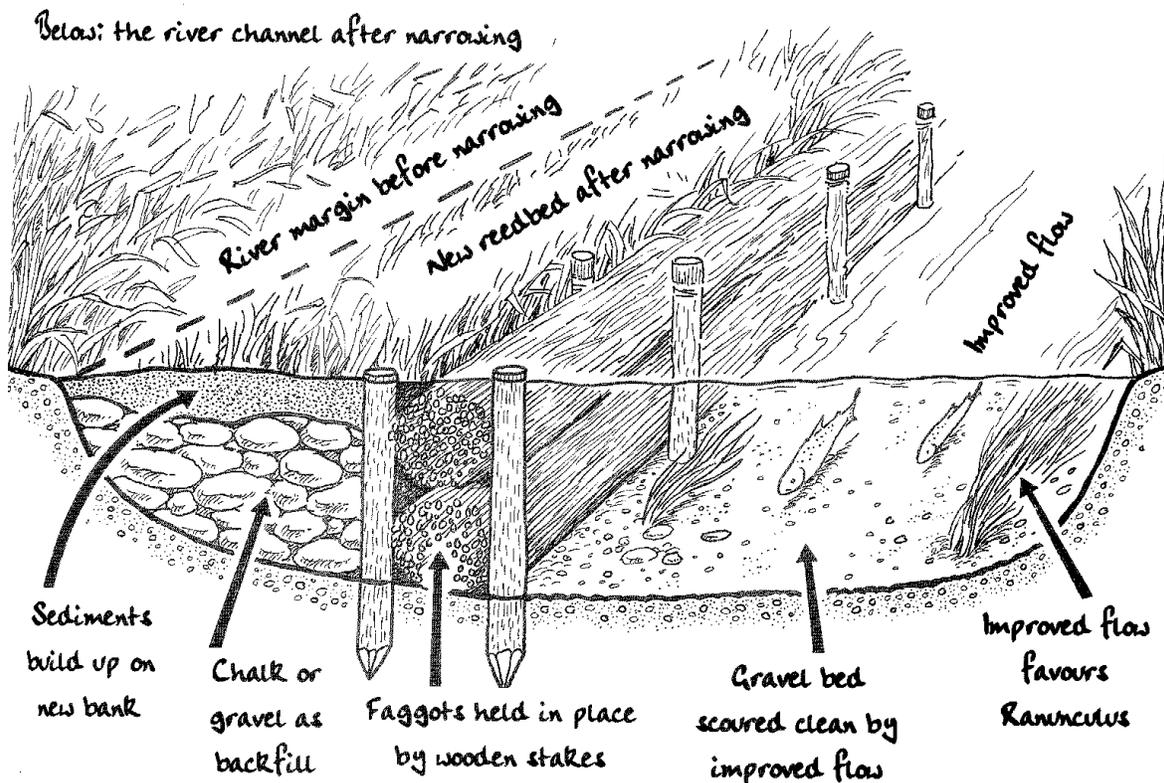
## Narrowing the river channel with hazel and brushwood faggots

- The dense stands of snowberry and dogwood are also shading out valuable marginal vegetation. They should be cut back heavily. Stump treatment with a herbicide approved for use near water such as fosamine ammonium may then be appropriate. Note that this operation requires the written consent of the EA.
- *Phytophthora* infection of alders will mean that many of these will be lost in the next few years. Consideration should be given to replacing them with an alternative suitable species such as ash *Fraxinus excelsior*.
- Once overhanging vegetation has been cut back, marginal growth can be established. This will require the creation of low level planting shelves. These are best constructed using faggot bundles formed from arisings from coppicing (see below).

The shelf created should be no more than 1m in width, with the top of the faggots set at approximately 100mm above summer water level.
