Advisory Visit - 27 September 2002

A report on behalf of Wild Trout Trust

**Etchilhampton Water**  
at  
Old Rectory, All Cannings, Devizes SN10 3PF

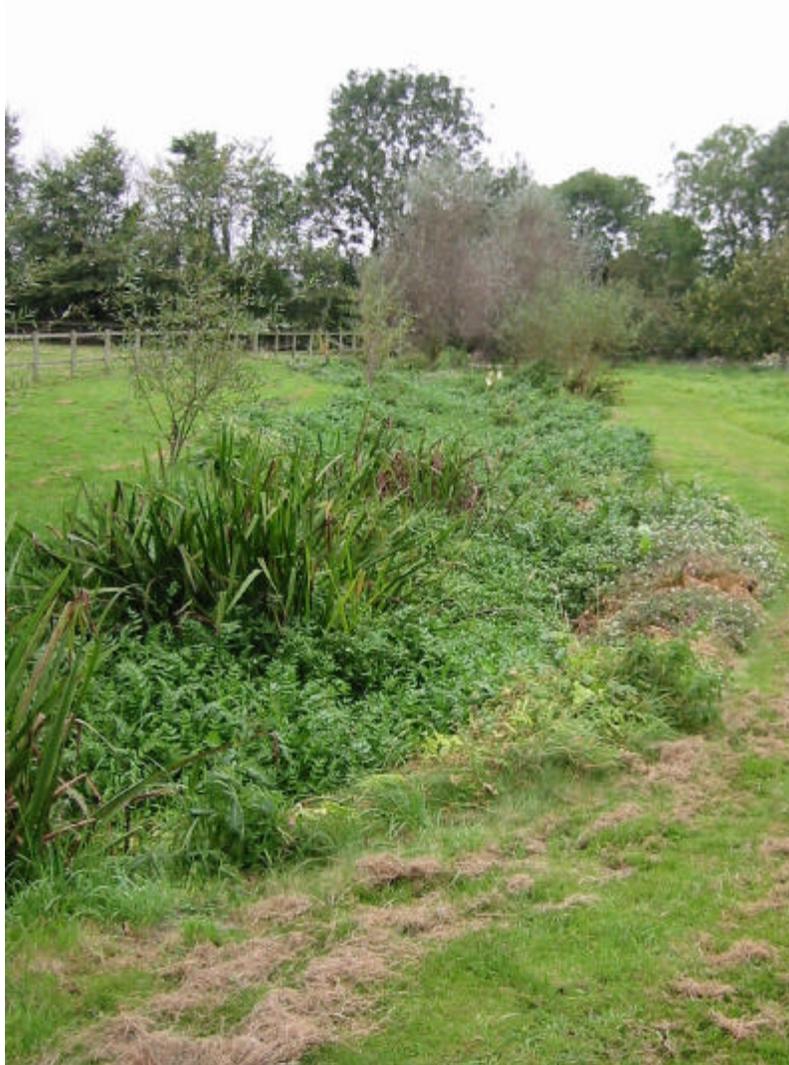
The photograph on the cover of this report shows the main stretch of the stream within the property. The water flow is slow and where the light levels are high, there is extensive weed cover. Beyond the upstream limit of the property, where the stream is overgrown by a thick tree & shrub canopy, the weed is scarce.

The owners have already commenced planting trees along the stream to shade the weed but this will not treat the real issue of slow flow. The conditions downstream of the weir show that the flow rate is the critical factor. Downstream, the flow rate is sufficient to prevent much siltation but is insufficient to prevent dense weed growth. This indicates that it is essential to increase the water flow rate: this seems to be possible only by narrowing the channel significantly. However, wholesale narrowing along the length would not provide an acceptable answer. Creation of a series of shady wider (*i.e.* 1.5 – 2m) stretches alternating with narrowed (*i.e.* <1m) stretches along the stream will tend to keep the weed at bay by either shade or water flow rate.

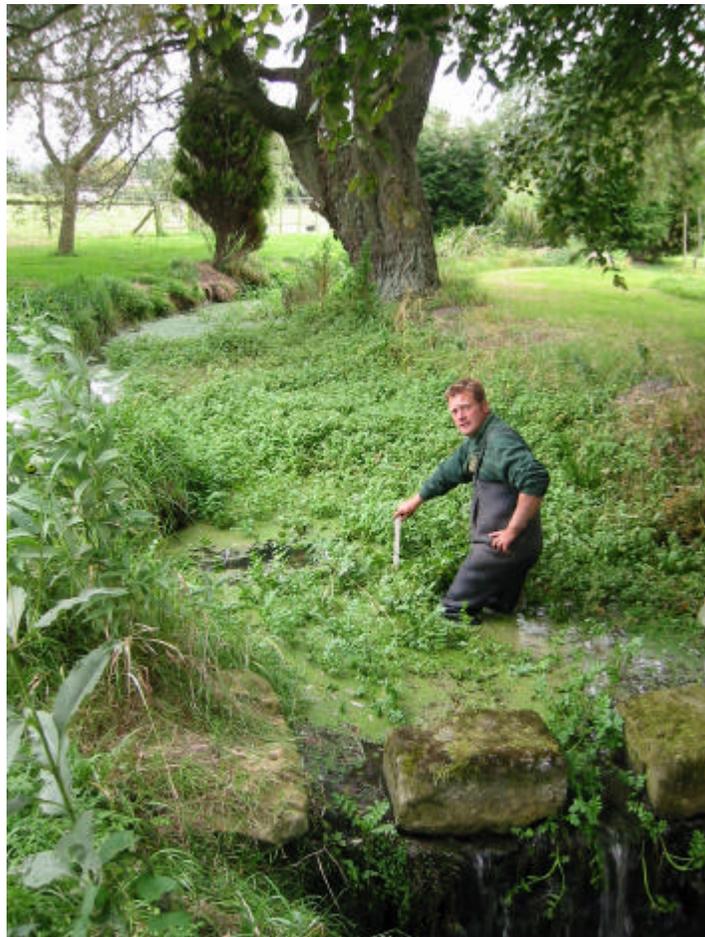
The photograph to the right shows the weir at the downstream end of the property. Below the weir, the bed is gravel, with a water depth of approximately 300mm.

Above the weir, the stream has suffered severe siltation. In broad terms, the whole stretch holds approximately 800-900mm of silt above a gravel bed. Approximately 300mm of water flows above the silt.

Just beyond the view of this photograph there is a brick bridge, the span of which indicates that the original stream would have been approximately 1.8m wide. Testing the silt along the stretch shows similar original widths.

Initially, however, the siltation must be removed. A skilled excavator operator will be able to remove the large quantity of silt with minimal damage to the original profile of the stream banks. This care is extremely important. The depth testing indicated that in places the bank is stepped: retaining the stepped profile may give a narrow channel for low water levels, widening out for higher winter levels. Disposal of the silt will be costly, unless an alternative solution is found, for example the neighbouring farm. After removal of the silt, the entire weir should be dismantled. Use of some filtration medium below the weir should be considered to prevent washing of silt downstream. The two previously separated sections of the stream will then be re-united.

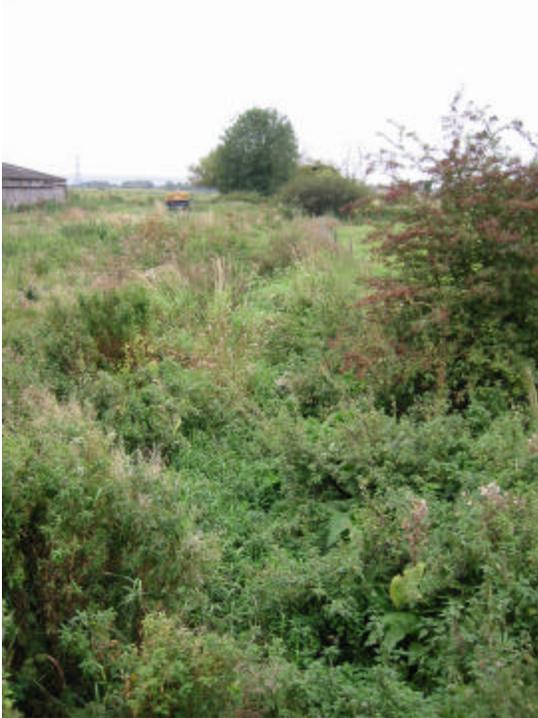
The photograph to the left shows the stream below the Old Rectory. The stream is approximately 2m wide with a gravel bed, and a water depth of approximately 300mm. The flow is slow and high light levels have led to significant quantities of weed.

The present owners report that in winter, the water levels below the weir increase by approximately 500mm.
