DAILY ANGLING CLUB

The River Girvan, Ayrshire

Advisory Visit Report
Undertaken on behalf of the Wild Trout Trust
By Ron Holloway MIFM

30th March 2002-

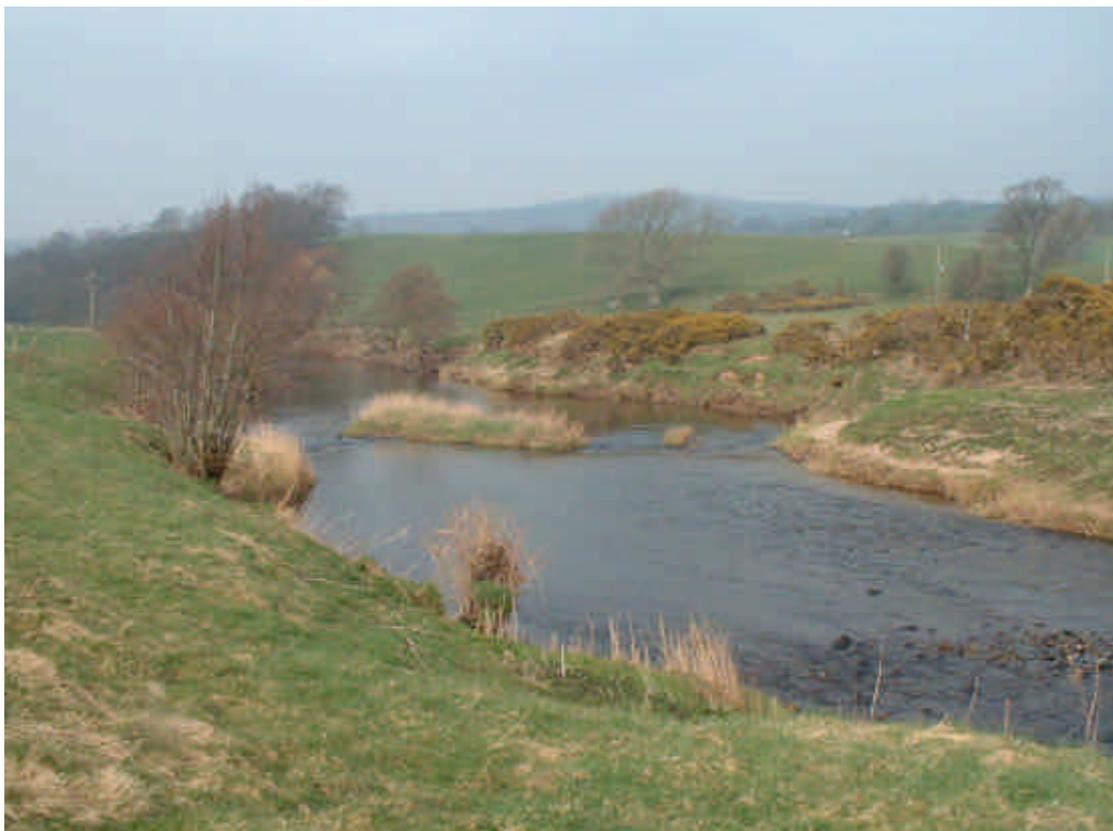
Fig.2.

SITE ONE. (See Fig.2)

The natural island here must not be touched but some holding territory could be enhanced by constructing a rock feature on the gravel riffle at the head of this pool. This construction (see Fig.2) comprising of rocks and boulders would speed up the flow and scour a deeper holding pool below the structure and just upstream of the island. It is essential that this construction is placed so that it is submerged at mid to high water flow – i.e. 1ft above water level as seen on the 30th March 2002 (low water?) The triangular profile of this construction is essential as this will prevent further bank erosion below the structure.

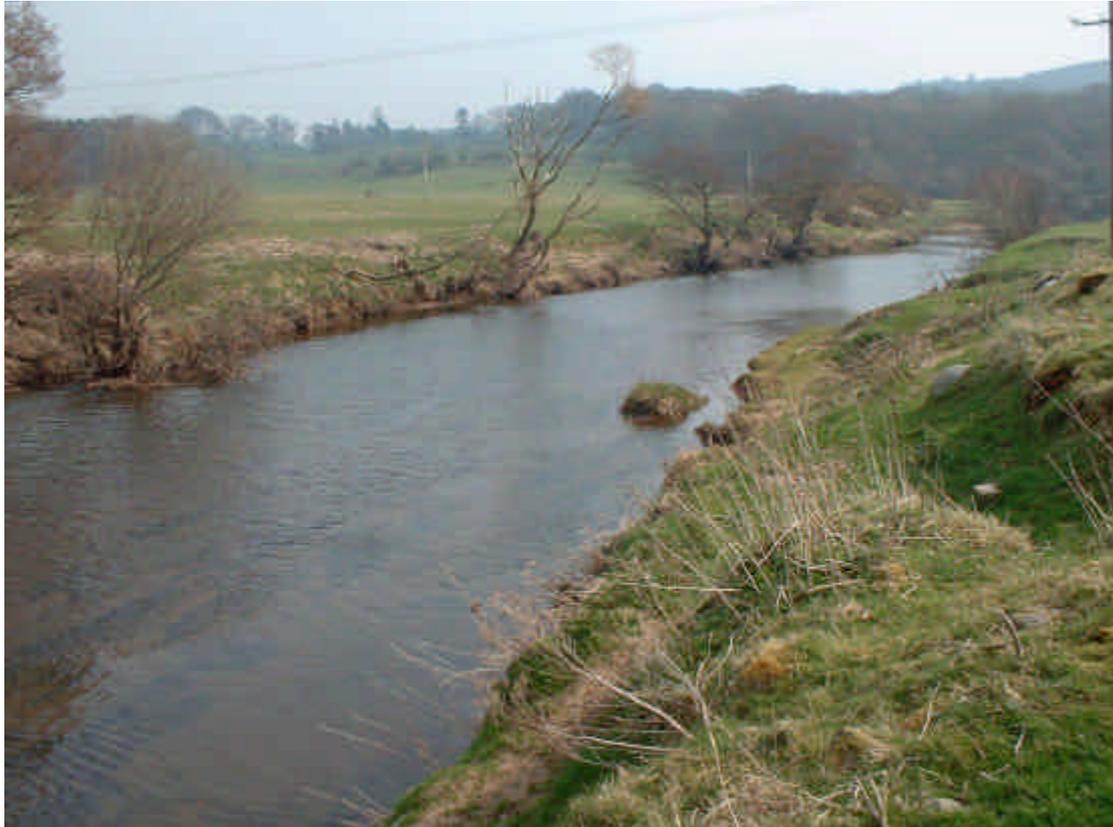
Fig.3

SITE TWO

No major problems here although to create more habitat diversity it is suggested that some single triangular groynes be installed in a series, i.e. alternating one on one bank and one on the other bank, to encourage flow to meander to and fro – (see Fig.3).

These constructions (groynes) should comprise of heavy stone and rock that will be resistant to movement in high flows. Again, these should be positioned one foot above low water mark so they are overtopped during spate flows. The advantages of this are:

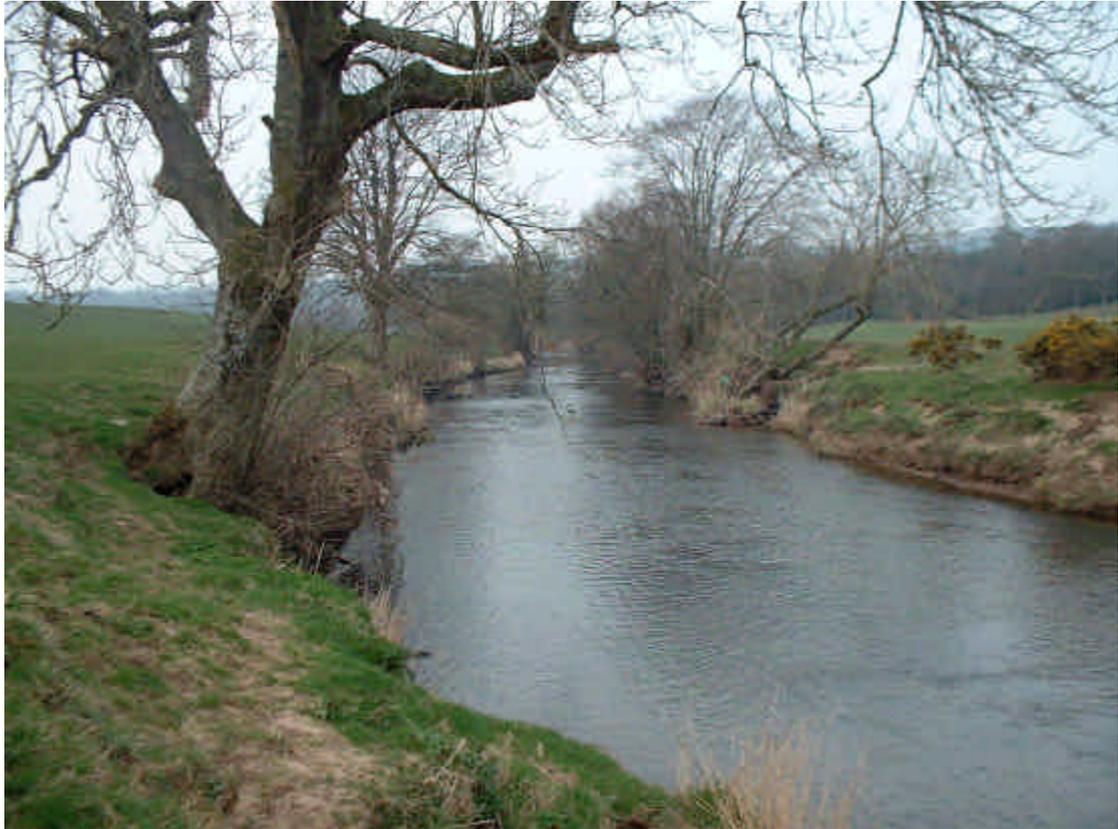
Fig.4.

SITE THREE (See Fig.4)

Improve instream holding potential along this stretch with random placement of large rocks to create more holding lies. A couple of triangular groynes could be placed to further increase holding area and to improve fishing access.

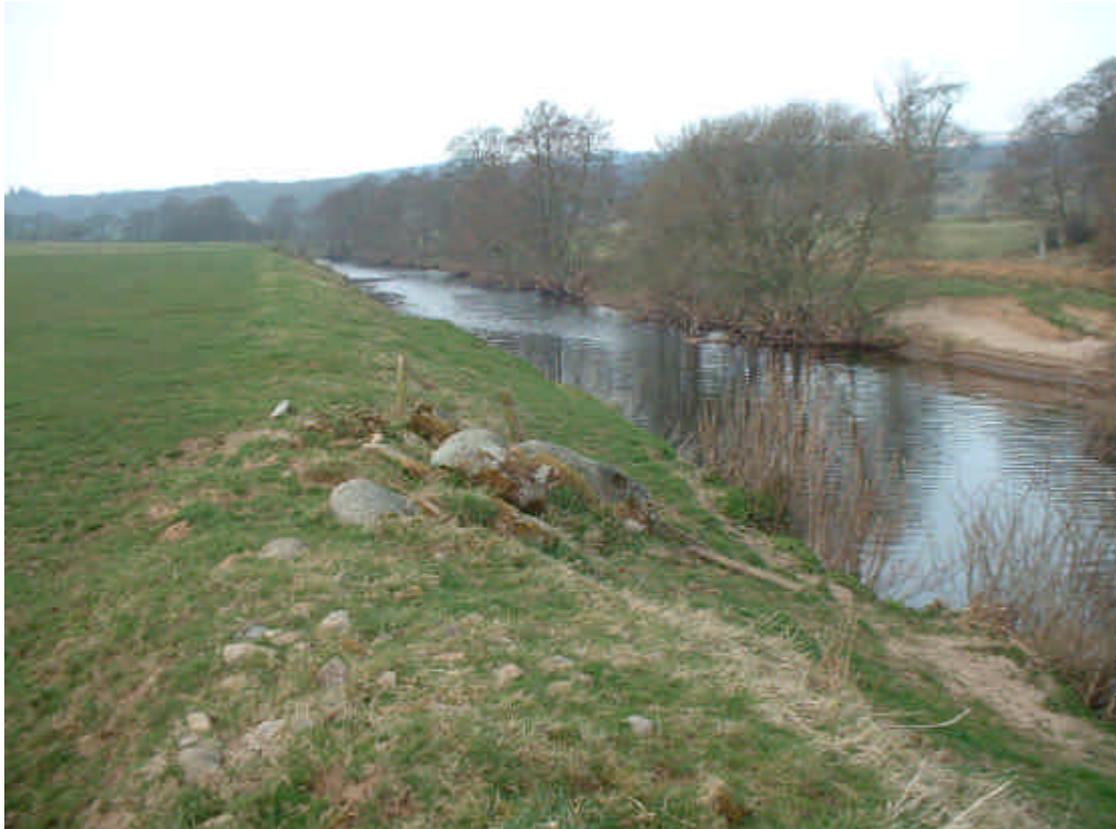
Fig.5

SITE FOUR (See Fig.5)

Return large rocks to river to create holding lies. On the far bank where there is a large bank of sandy silt deposited it is suggested this is planted thickly with willow and alder saplings. This silt/sandbank needs to be stabilised with planting as soon as possible to allow the saplings to root during summer and hopefully stabilise the bank before the next high flows of winter.

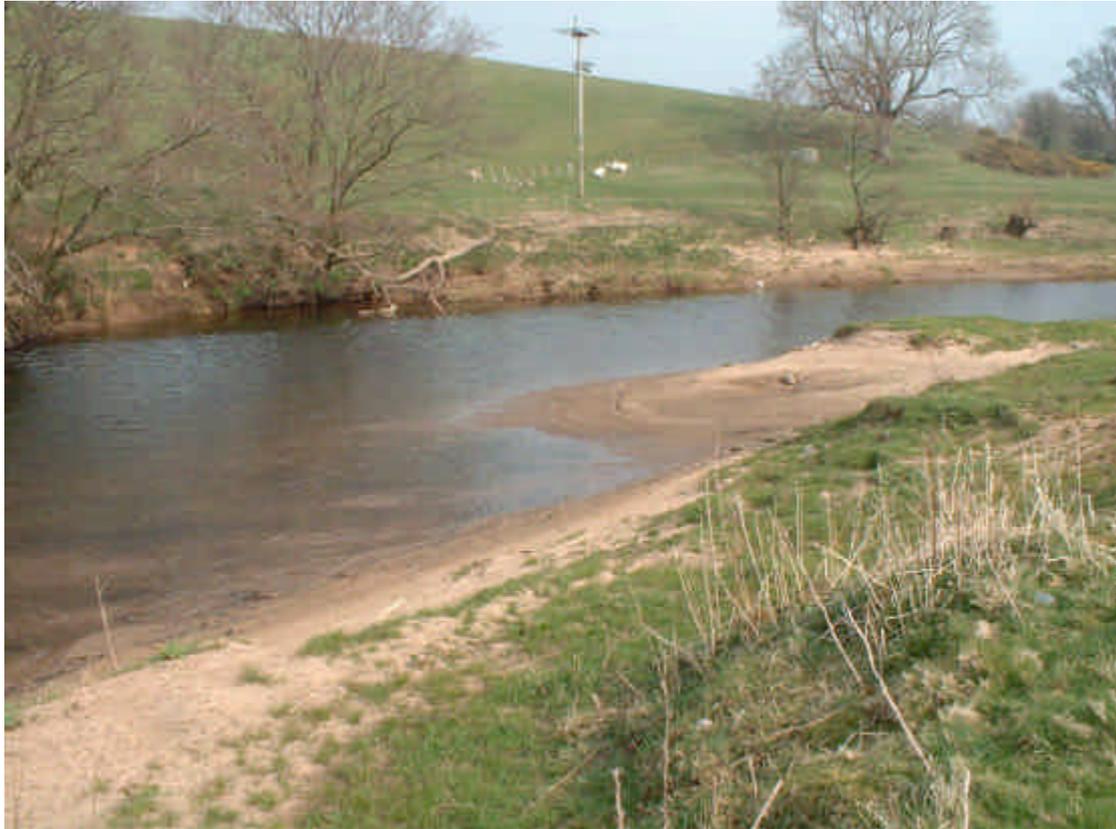
Fig.6

SITE FIVE (See Fig.6)

This silt and sand deposit should be left and, once protected by fencing, natural vegetation should stabilise. This could be assisted by planting a few willow slips and alders.

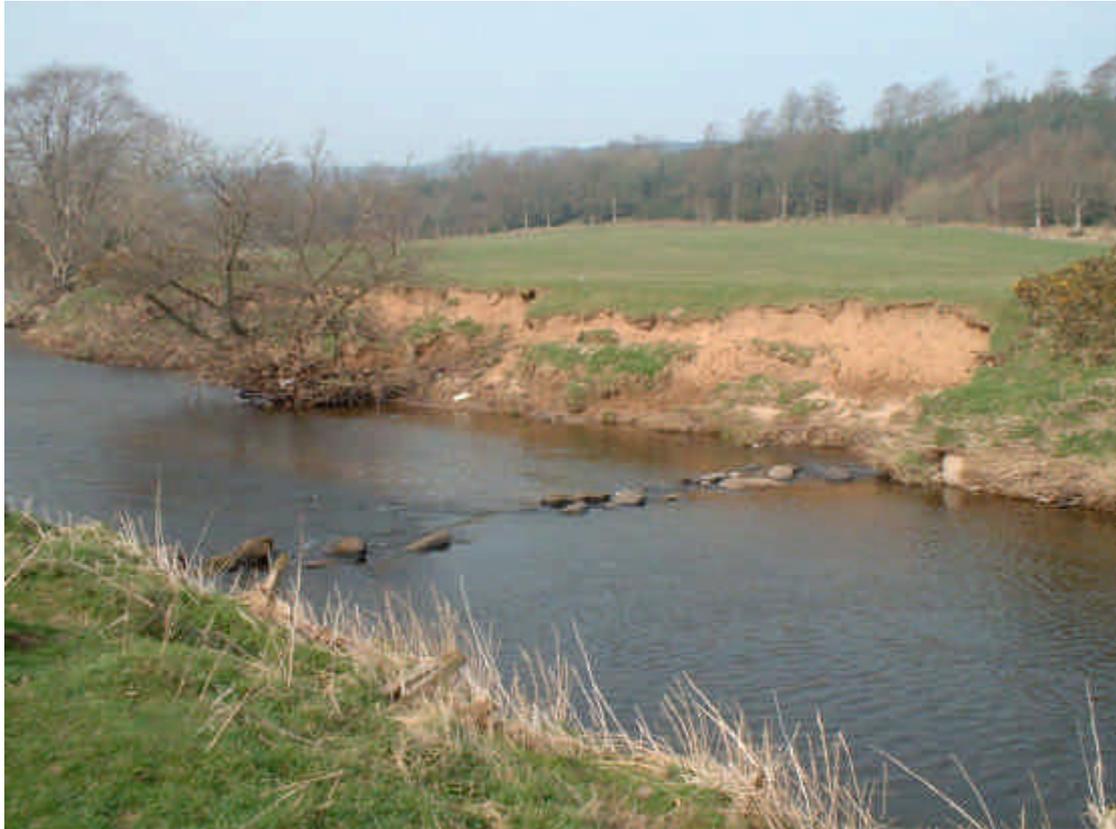
SITE SIX (See Fig.7)

Some work is required here. The present weir has accelerated bank erosion for some distance downstream. This structure needs to be re-profiled to divert high river flows away from the banks, for the suggested profile see Fig.7.

Again, it is essential to keep the structure low, as in the other structures, so that it will be overtopped by high flows but will divert the main flow away from the bank into the centre of the river. To help stabilise the eroded area, plant up with natural vegetation and once fenced off, this growth will help to stabilise the river bank.

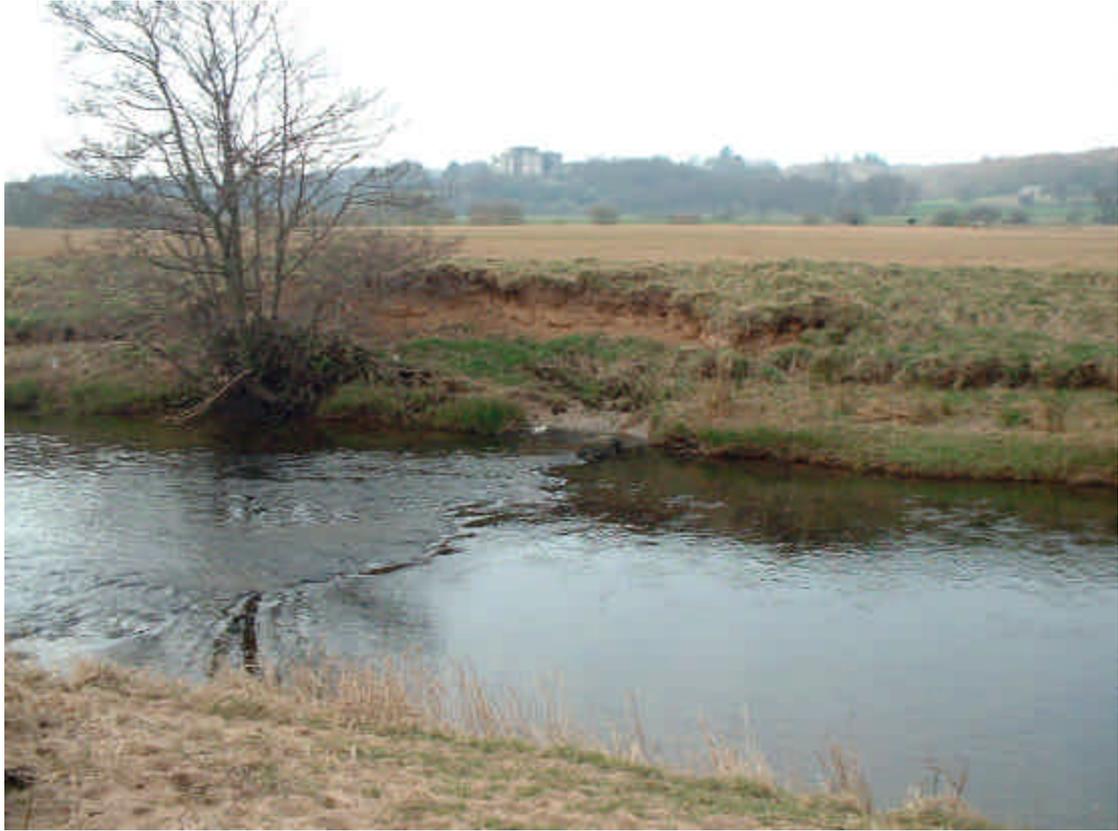
SITE SEVEN (See Fig.8)

This mini weir is encouraging bank erosion on the far bank and if not addressed soon will become worse. A serious “nick point” has already started to form at the far end of the weir and needs urgent protection.

It is suggested that the weir is re-profiled and the nick point infilled with stone and rock (See Fig.8 for suggested re-profiling of weir). Use the existing stone and rock and, again, ensure the construction is only 1ft above low water level.

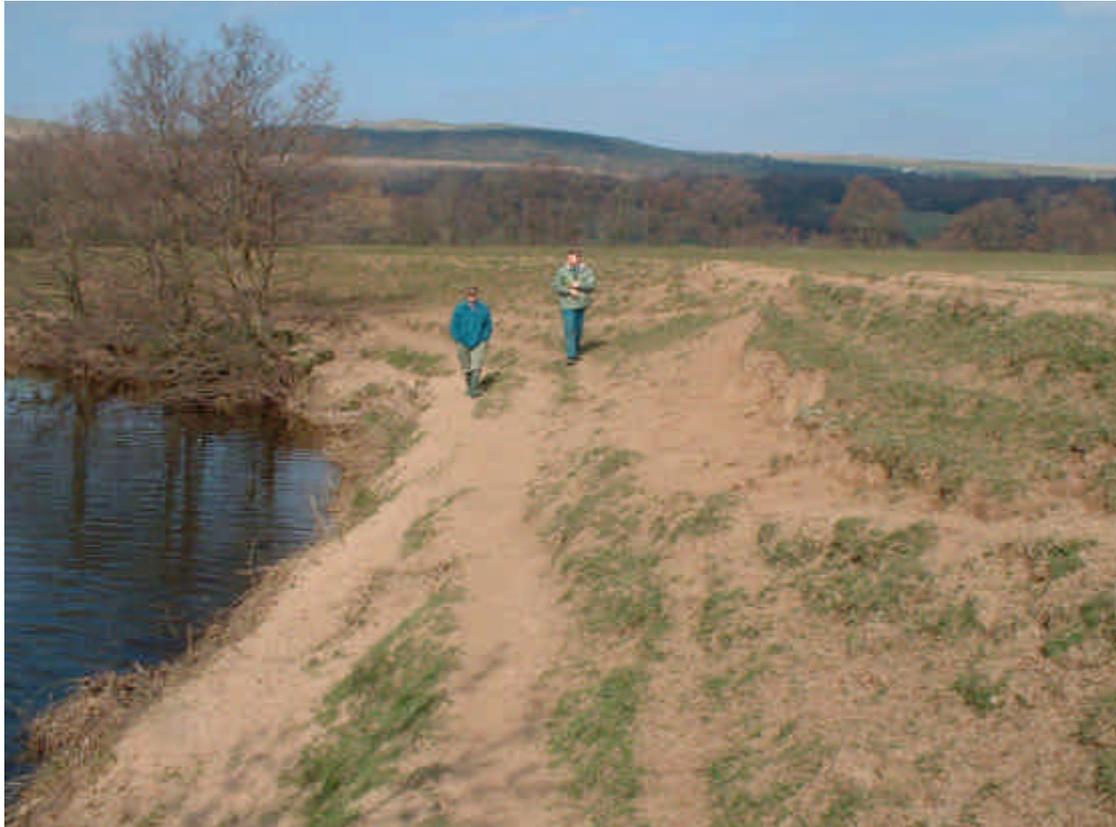
Fig.9

SITE EIGHT (See Fig.9)

This entire bank needs to be protected from grazing animals and once fenced, plant a few willows and allow the natural ground vegetation to grow which should stabilise this boggy bank.

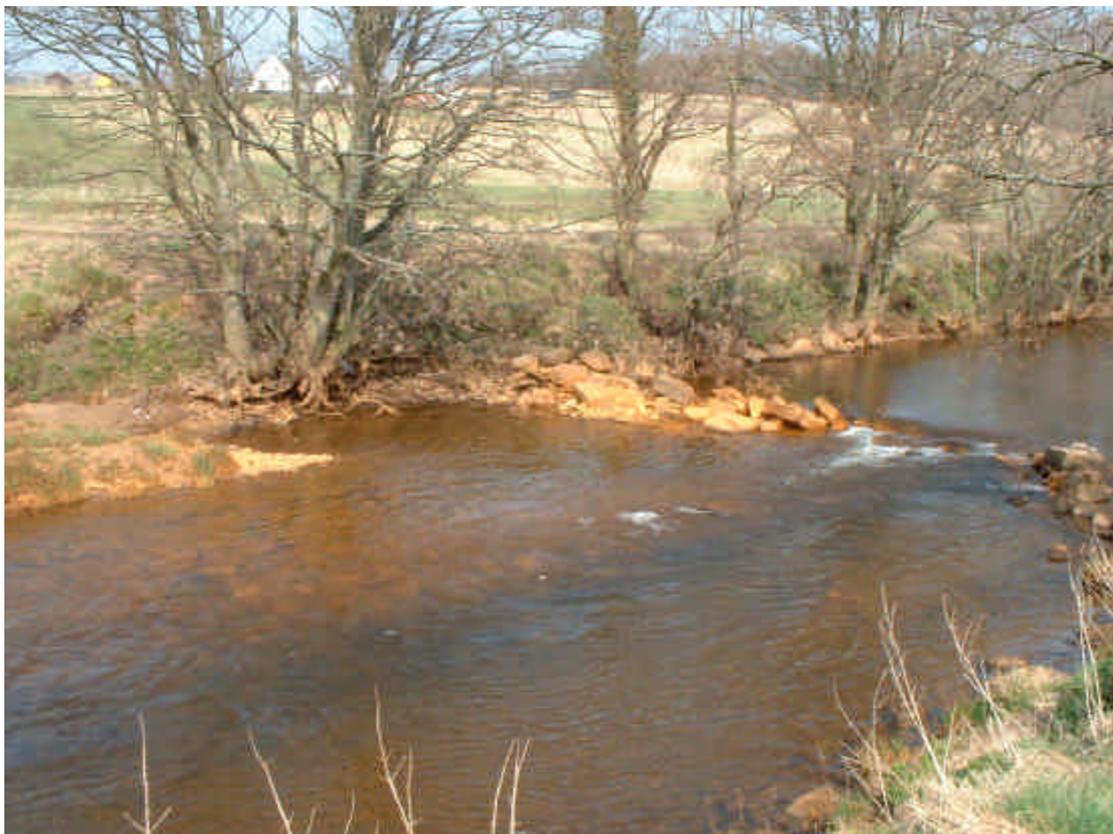
Fig.10

SITE TEN (See Fig.10)

There is severe bank erosion occurring below this ill-profiled weir. It is suggested that the far side of the weir be rebuilt to divert high water flows away from the bank. The undermined tree will then be protected and the high flows directed towards the middle of the river which should also improve the holding pool below the weir. The nearside of this weir is alright.

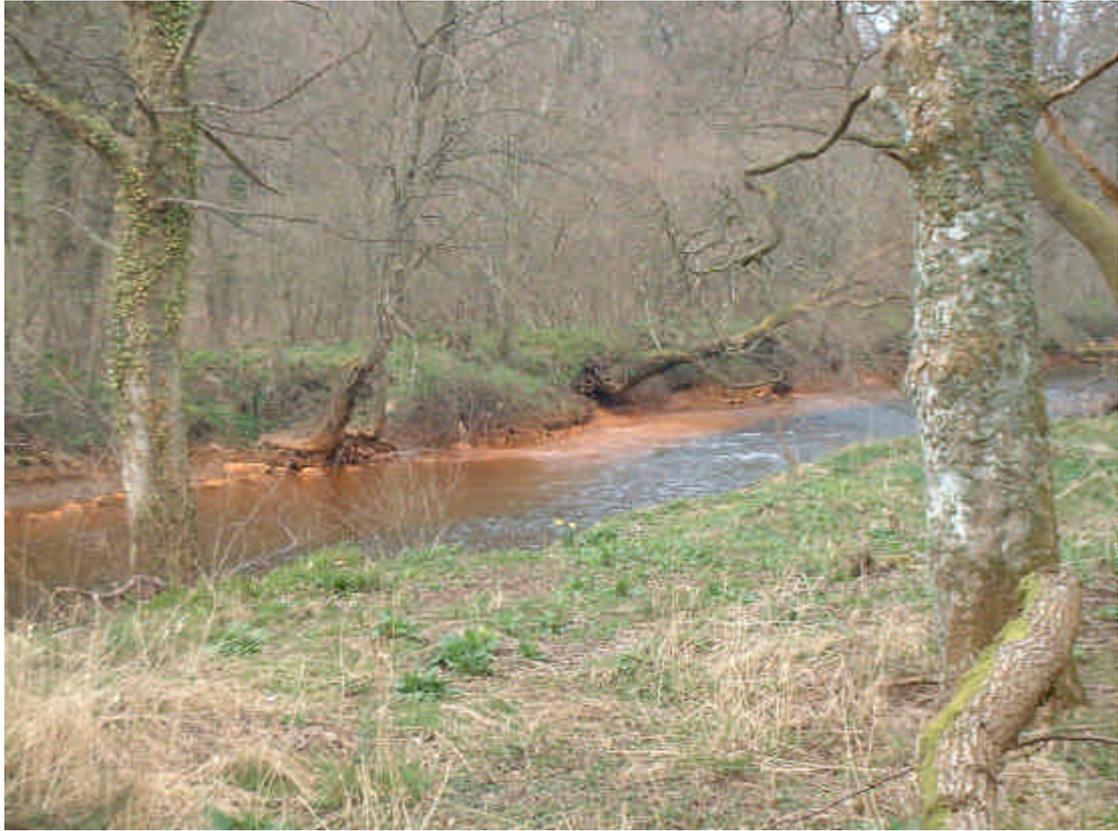
Fig.11

SITE ELEVEN (See Fig.11)

The effluent discharge from the disused coalmine looks very bad but, in my opinion, looks far worse than it is. A brief inspection of the bed of the outfall stream did show evidence of some invertebrate life (mainly caddis). Although sparse, there is life in this effluent outfall. The appearance of the iron oxide deposits could indicate that there has been a recent heavy discharge of iron oxide laden effluent which may have

occurred during some high groundwater run off events. SEPA Water Quality monitoring codes of practice should show the quality and content of this discharge. Whichever authority or agency is responsible for maintaining the water quality should be able to give all necessary information on discharge from this mine. Constant pressure should be kept on the responsible organisations and if the Club is not happy, press for explanations from SEPA and, in the last resort, set out the whole story clearly to your local MSP. It is surprising what a letter from a member of parliament can achieve.
