Advisory Visit - 26 February 2003

A report on behalf of Wild Trout Trust

River Chess

Micklefield Estate, Near Sarratt, Rickmansworth, Herts.

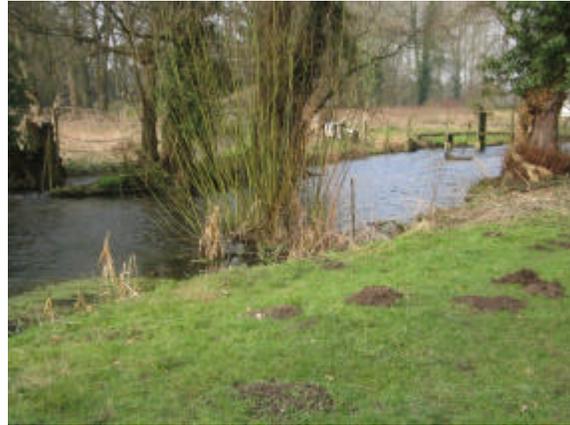
The top photograph shows the riffle at the head of this stretch.

At the top 30m of the river there is a strong flowing riffle, with hard gravels and patchy weed. If permission could be sought to coppice any one of the larger alders, then this would be beneficial.

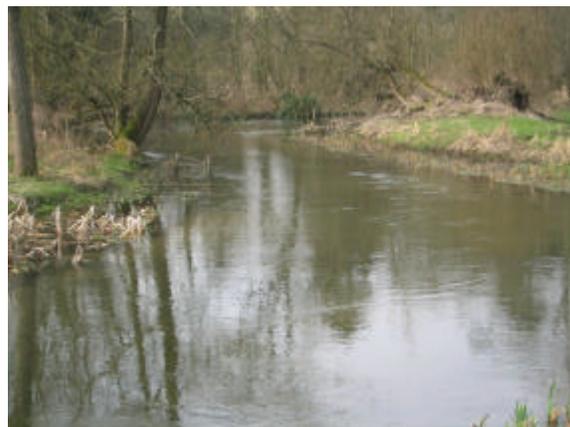
The middle photograph shows the leaning willow at the top right and the two lengths of silty margin to be supported.

From 40m there is the remains of a previous narrowing. This should be repaired and supported along the inside of the bend. At 54m there is a leaning willow across the river. This should be coppiced.

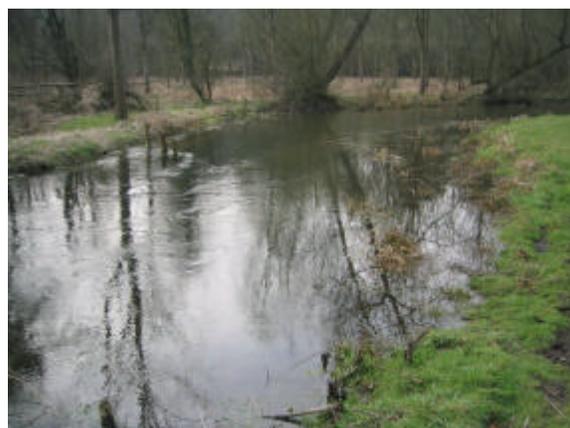
The bottom photograph (taken from the top of Stretch 2) shows where the deflectors are needed: alongside the leaning willows on the far bank. The scrub and willow should be coppiced.

From 101m there are boulders, which have scoured out some pools. These are effective, but below the pools two sandbanks have built up, which are dividing the flow. Revetments or deflectors should be positioned from 105m – 120m on the east bank and another opposite to incorporate the sandbanks. These will single the flow and trap silt.

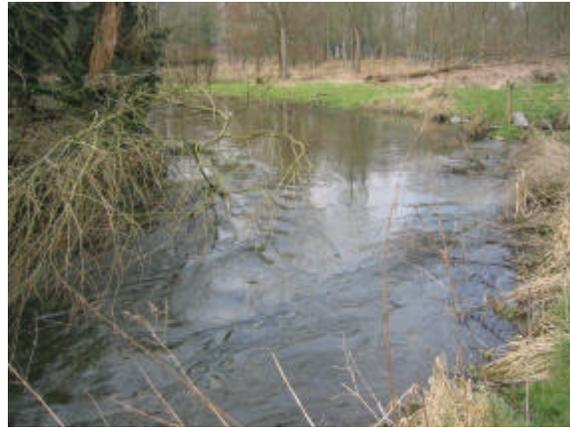
At approximately 138m, two hurdles remain on the south-west bank, leading up to the inside of a bend. These should be supported. The fallen tree at 152m, shown in the photograph to the right, should be retained. This will, in time, build up with silt and the strong flow will continue to scour out a pool.

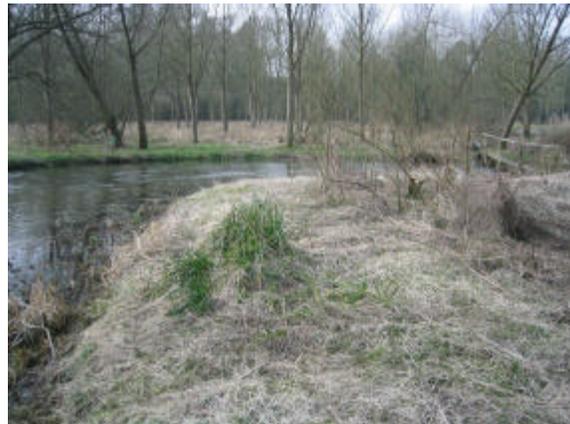
Below the bridge at the beginning of this Stretch, hurdles have helped to build up a sandbank on the inside of the bend. A nice pool has developed on the outside of this bend, shown in the photograph to the right.

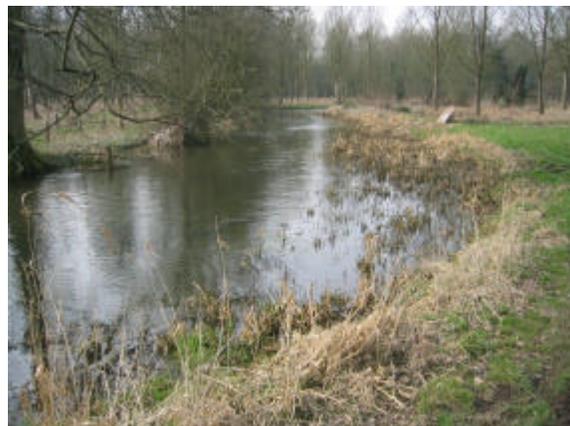
Further downstream, seen in the lower photograph, there are some good flows, but only patchy weed. It is recommended to clear back some of the fallen scrub and cut branches back to give more light.

Between 220m and 250m, there is scope to consider creating a riffle. It would depend on summer water levels, but it is likely that importation of 50-80mm gravel might be necessary. (In some places, the existing gravel is lacking the mid-size range, and so the smaller material is often completely scoured away, to leave the larger stones only.)

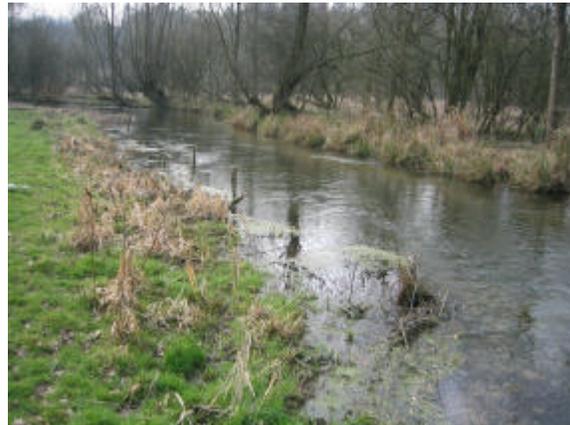
The final view down Stretch 3 is through a narrows created by the NRA. This has worked very well and needs little support. However, the same comments apply. This would make a nice riffle, but perhaps some imported mid-size gravel is necessary, depending on summer water level.

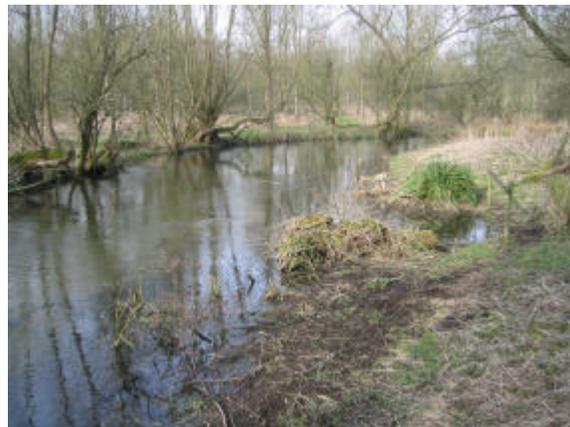
This Stretch is very silted, despite the potentially good riffles from 360m – 412m.

The channel is wide here and so methods to narrow the channel and trap silt are necessary. Looking at the photograph to the right, approx 315m – 335m, either a series of upstream deflectors should be installed, or a low chestnut/hazel revetment. The overhanging scrub willow should be coppiced.

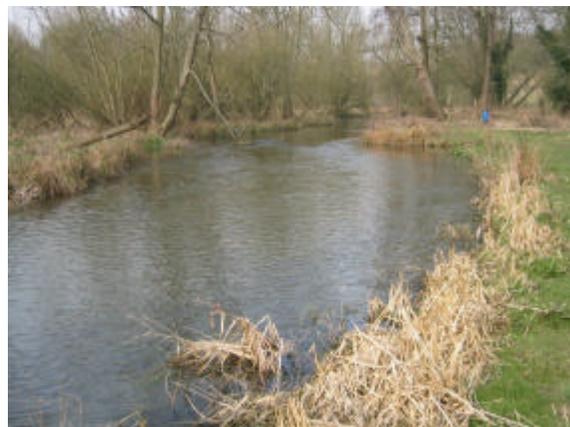
The photograph on the right is looking upstream from 412m, towards the ford. A revetment should be constructed from the foreground in a sinuous line to where the bank comes in from the right. The channel should be narrowed to between 5m and 8m in width.

The gravels are very silty: these should be raked over to break up the silt in the Autumn. In addition, consideration should be given to a shallow (150mm) upstream V weir, positioned a couple of metres below the ford. This should scour out a shallow pool.

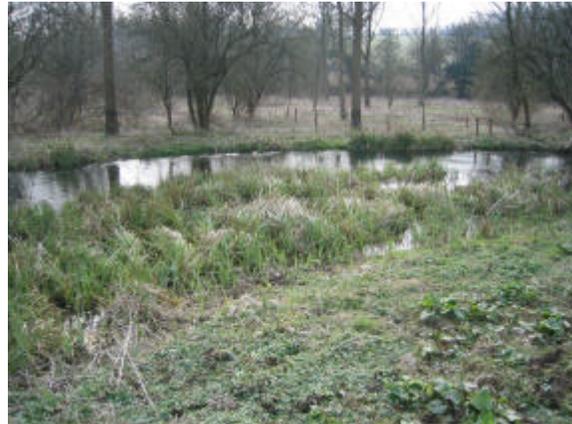
Another successful narrowing leads from the end of Stretch 4. This section needs no attention at the moment. From the narrowing, a wet margin has built up, shown in the photograph on the right, on the inside of the bend. This stretch has good flow and leads to a very nice pool under the horse chestnut, as shown in the lower photograph.

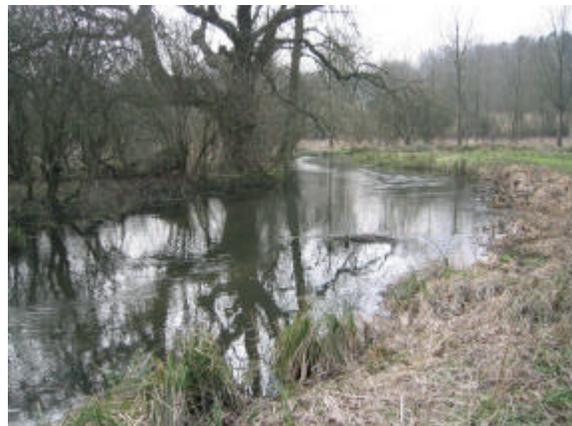
This was reported to have been a good place to fish in the past: it looks as though it still is!

Downstream of the horse chestnut, on the southwest bank, willows should be coppiced to give as much light as possible. The remaining hurdles on the inside bank should be supported or replaced.

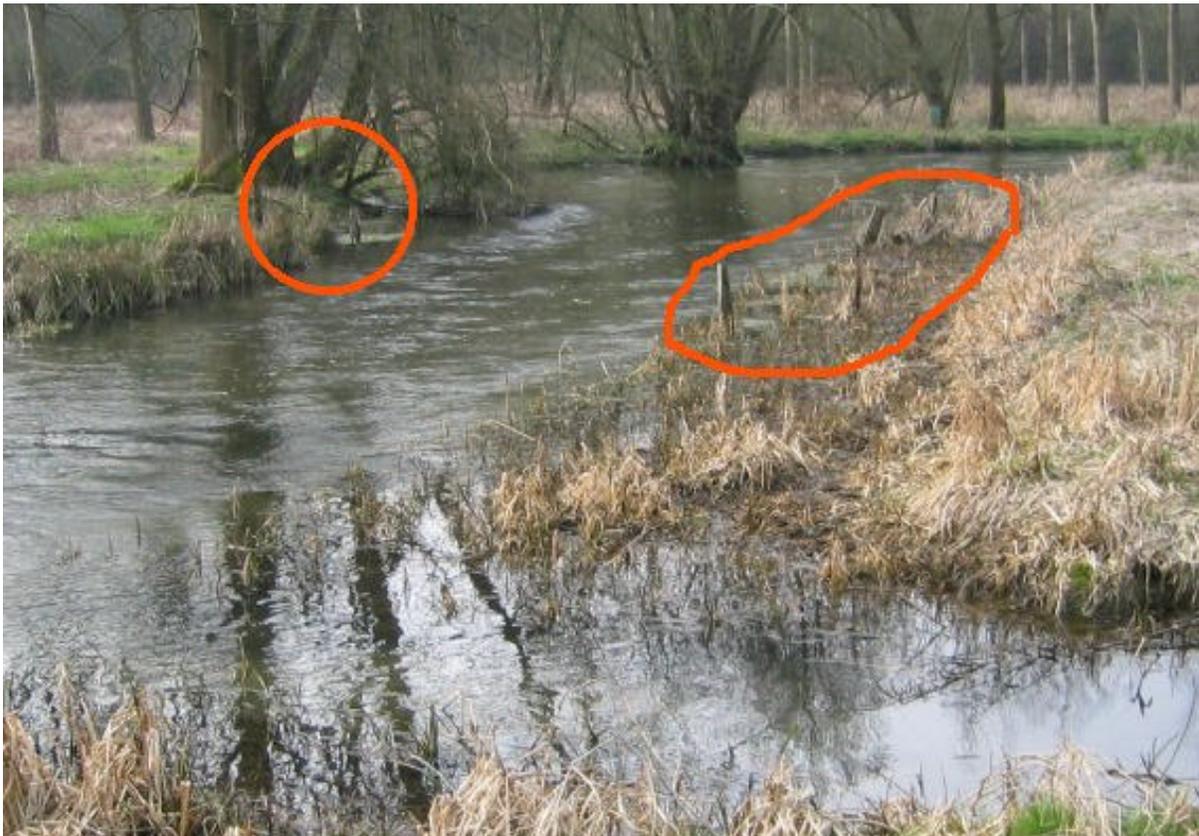
Repair and extend narrowing schemes The original NRA schemes were well planned and have been very successful. The structures are now deteriorating, so repairs and replacement of these should be carried out, to continue the benefits given so far. An example is shown the photograph below.

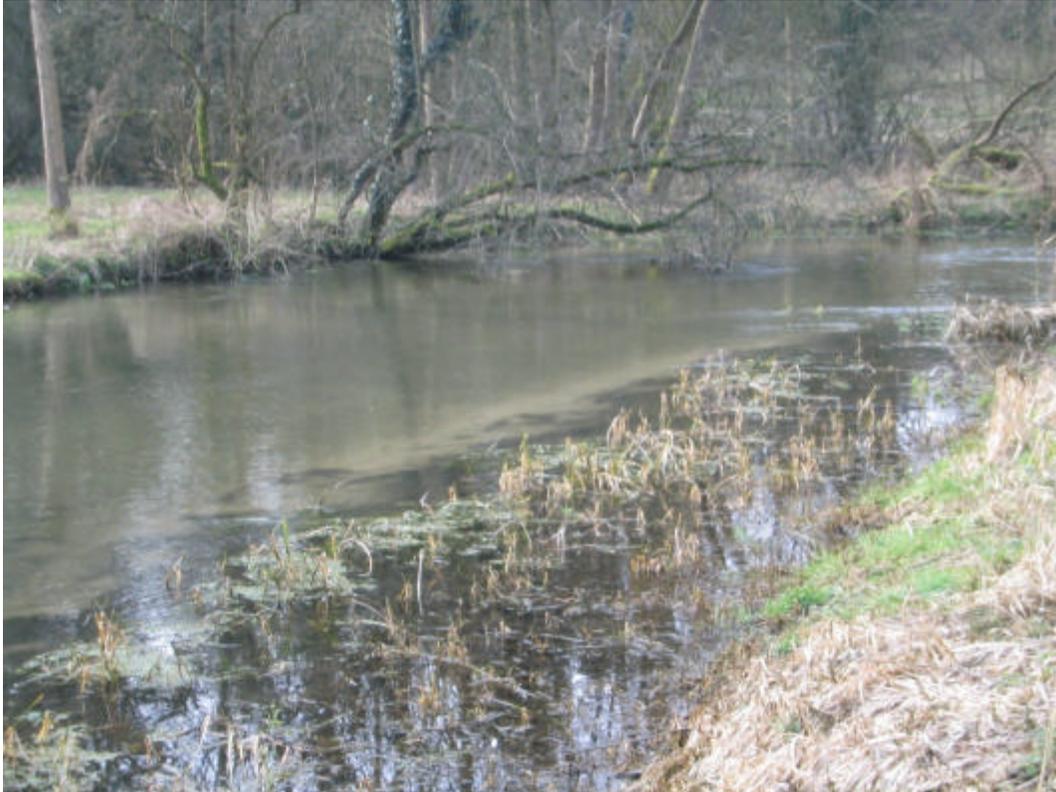
Accretions of silt on the insides of bends should be supported and extended with structures such as chestnut/interwoven hazel revetment. In suitable places, an alternative could be to use stems of trees 30-40cm in diameter, supported at the upstream end by a hurdle or faggot. These alternatives will be less satisfactory but less costly. These structures will accumulate silt further and reduce the tendency for silt to slump back into the channel. A good example of where the margin could be emphasized, and the channel narrowed, is shown in the photograph below.
