Advisory Visit to the Gopsal Fishery,
River Scence, Leicestershire

Undertaken on behalf of the Wild Trout
Trust, by Vaughan Lewis, Windrush
AEC Ltd

June 2004

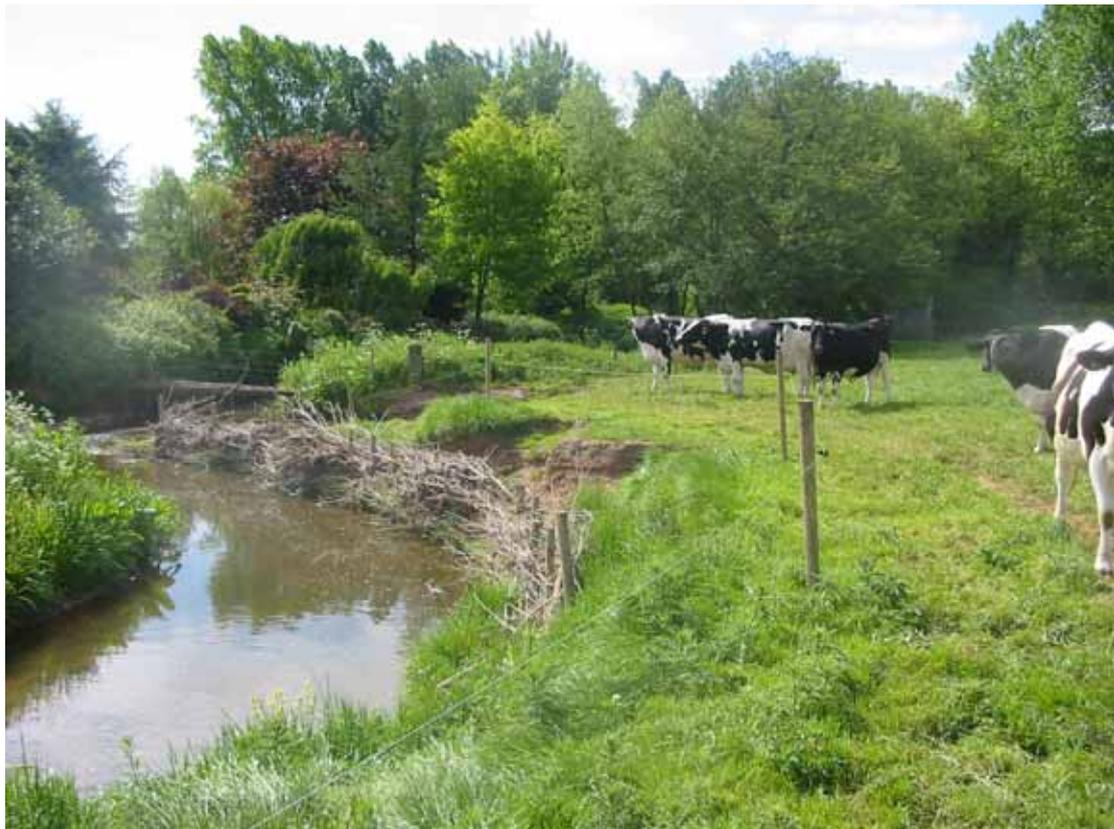
Adjacent to Tivey's Farm, a large dairy herd had caused considerable damage to the banks, grazing riparian vegetation and physically trampling in the margins. The club has electric fenced the majority of the reach upstream of the road bridge in an effort to stop this damage. In addition, they have installed sections of willow spiling and faggoting to repair bank damage already caused. The benefits of the faggoting could be increased by using 'cut and fill to create a wide shallow berm behind the woody revetment.

Fencing to exclude cattle, with faggot revetment installed in order to repair previous bank damage

- Electric fencing of the banks where agricultural stock are present has significantly improved the river's form. Continuation and extension of this practice is recommended, particularly in the Cricket Field. Use can be made of Papa Pumps, (a modern version of a Ram Pump Tel:01288 354454 for details) in order to provide a reliable source of drinking water for stock during periods when the river is fenced.

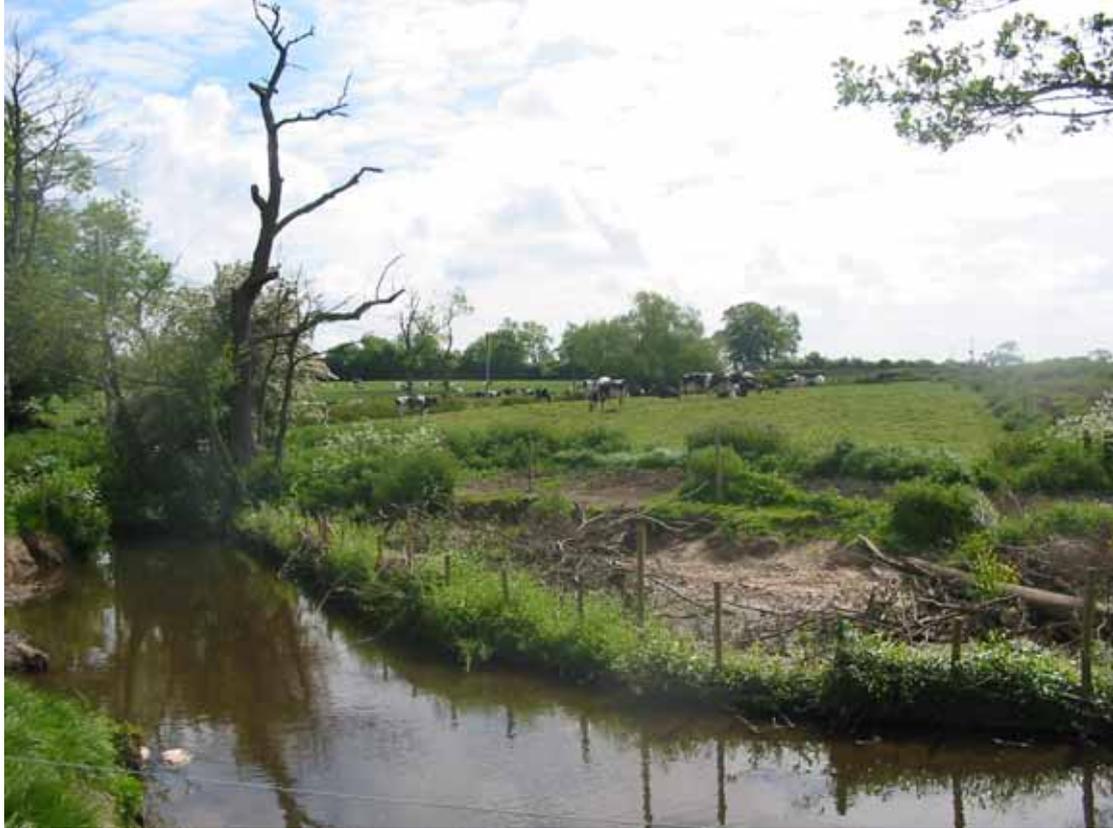
Additional lengths of spiling undertaken further upstream during 2003 had taken very well, with a strong growth of willow visible on both vertical and lateral elements.

Strong growth of willow spiling on inside of bend upstream of Tivey's Farm

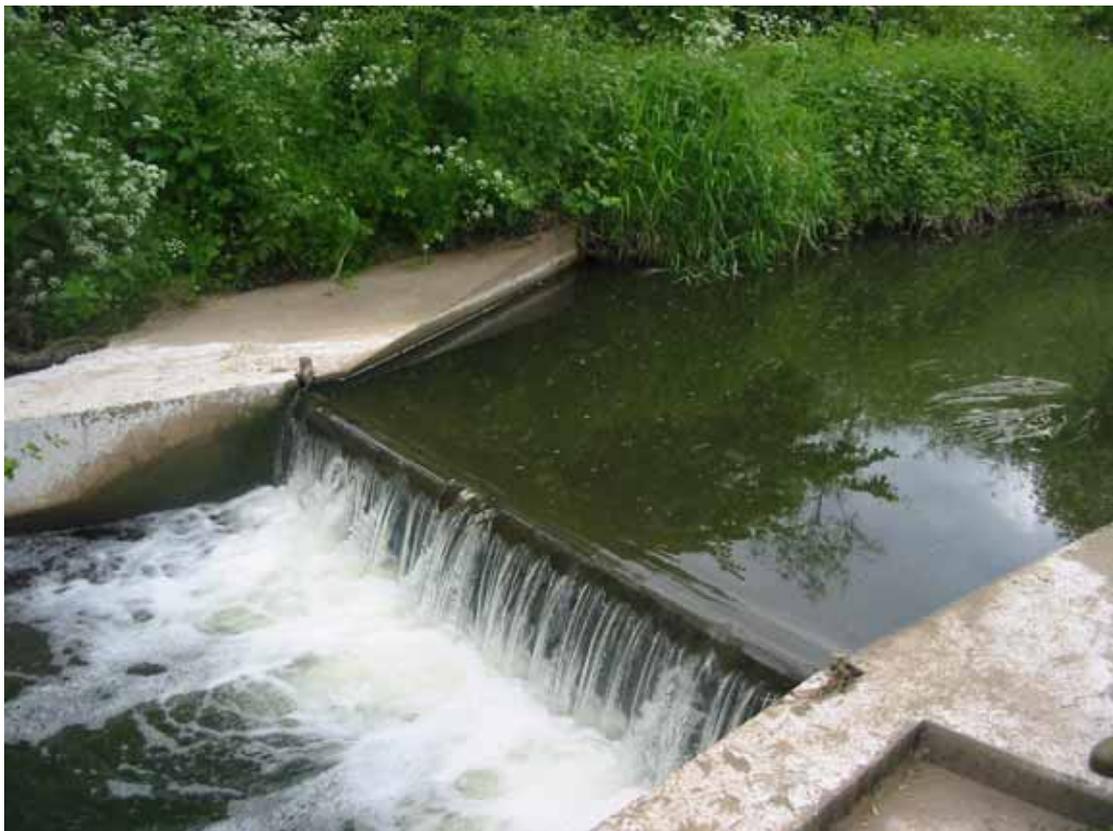
Throughout the fishery, a total of 22 larger, concrete and/or stone weirs was present. These were, in places, quite close together, with for instance 5 weirs present in the Cricket Field (middle beat) alone. The weirs appeared to have been installed in the past in order to retain levels for fishing following extensive dredging. The club has a measure of control on some of the weirs, being able to add and remove stop logs in order to vary the retained head. As a rule, boards are removed during the winter period and replaced during summer.

In general, the weirs had created a large scour pool downstream and a moderate length of impounded, depositing water upstream, with in some cases, a strong growth of emergent vegetation. These sections are much favoured by many in the club as they provide good holding water for stock fish which are then vulnerable to capture by angling. However, the weirs significantly disturb the natural geomorphological processes of the river, interrupting sediment transport, with a consequent loss of shallow, spawning/juvenile habitat.

Typical small concrete weir on the Scence

- The presence of the large number of weirs on the fishery is problematical. They appear to have been installed in an attempt to address another problem, namely the low water levels left post-dredging. Their presence has significantly altered the nature of the river, with impounded, depositing reaches common. To remove them would to some extent restore a more natural geomorphological regime to the river, but at the expense of further incising its profile, increasing access difficulties and reducing its hydrological connectivity to the floodplain.

As a trial, it is recommended that no stop logs are installed into a selection of say 5 weirs after the winter period, and members views gauged. In addition, it is recommended that a single weir downstream of Tivey's Farm bridge, should be deliberately and sequentially lowered over a 2 year period. If this is done in conjunction with the removal of the flood berm detailed above, the relationship of the water and land levels should remain similar to the present.

On a more strategic level, it is recommended that a programme of 'managed obsolescence' should be adopted, with weirs not replaced as they fall into disrepair, unless there are other over-riding factors not connected with the fishery that make this policy unacceptable. In this way, the fishery will gradually adjust over time to the loss of the weirs. Any money saved by the club as a result of not having to repair the structures could be hypothecated for more beneficial habitat restoration work elsewhere on the fishery.

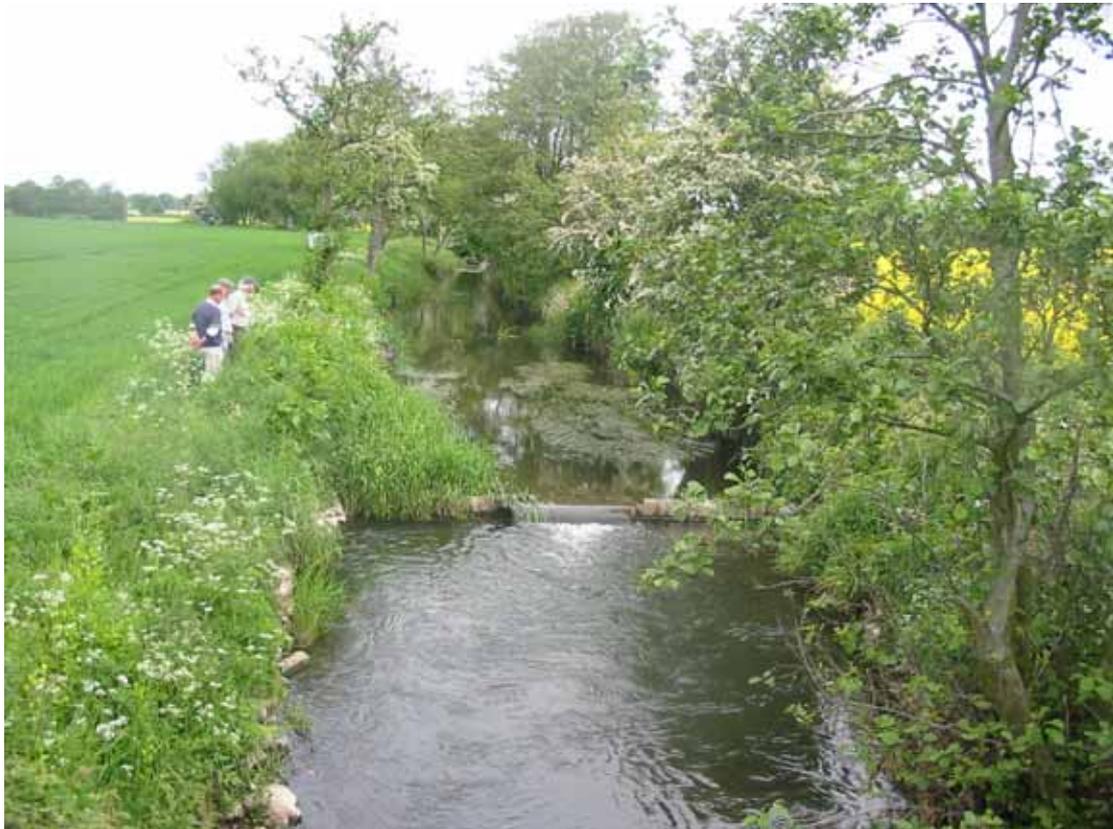
The bottom beat upstream of Harris Bridge Farm was dredged in 1948 as part of a major drainage scheme. As a consequence, the channel was relatively straight and heavily incised (>1.5m), with a series of small sheet piled weirs installed to retain water. Surrounding land use was dominated by arable fields; the banks of the channel were thus not affected by grazing pressure.

Sheet piled weir upstream of Finch's Bridge
