Habitat Advisory visit to the River Aire  
on behalf of Bowland Game Fishing  
Association undertaken by Vaughan  
Lewis, Windrush AEC Ltd  
June 2005

## **1.0 Introduction**

This report forms the output of a site visit to the River Aire, near Kirkby Malham, Yorkshire on 18 June 2005 on behalf of Bowland Game Fishing Association. Information in the report is based on observations on the day of the visit and additional comments provided by club members.

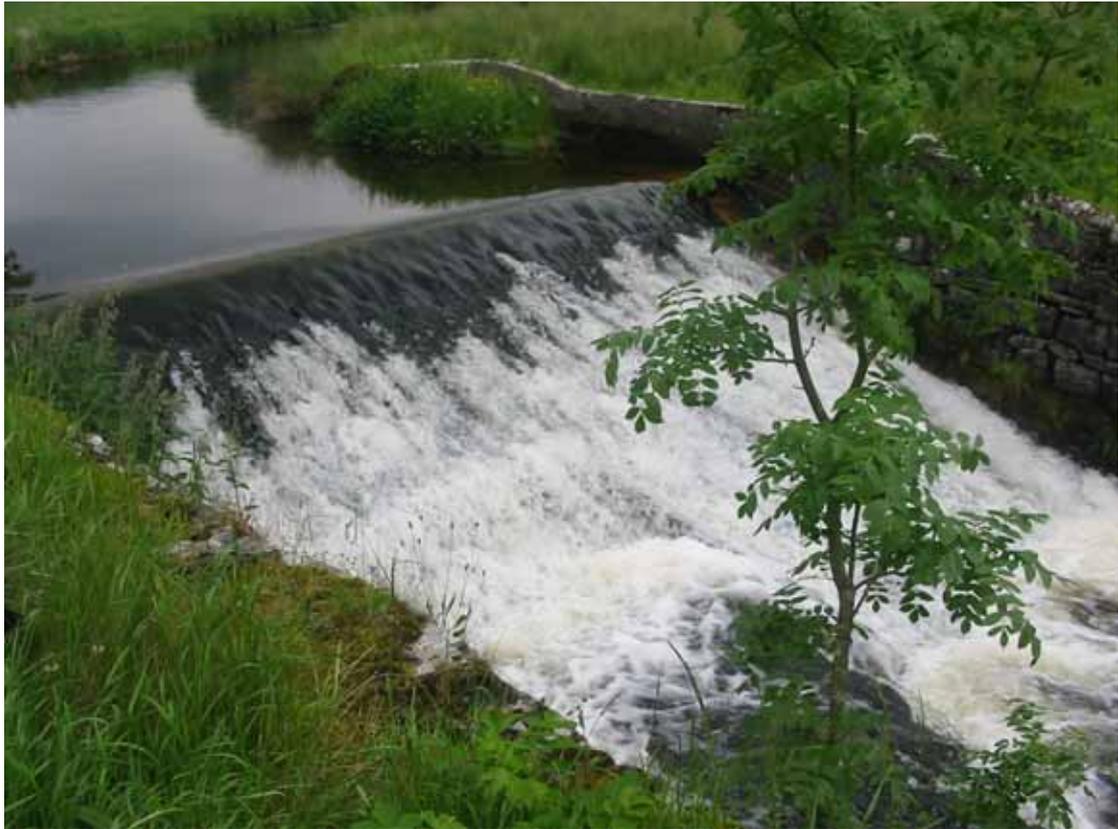
A large (2m+) impoundment had been historically constructed at Aire Head in order to impound a head of water sufficient for the operation of Scalegill Mills. Although club members have seen brown trout *Salmo trutta* ascend the impoundment on occasion in very high water, its height would, in all normal circumstances, make it impassable to upstream migrating fish. Migration of trout parr in a downstream direction would however be possible.

### **Impoundment at Aire Head**

- The impoundment at Aire Head prevents upstream migration of the majority of brown trout over a wide range of discharges, effectively isolating adult trout in the downstream reach. This is likely to have had, and will continue to have, a significant impact on recruitment due to exclusion of adult trout from a significant length of potential upstream spawning. There is also a concern that if the club are correct regarding the decline in quality of the Malham Beck, trout spawning in this reach may be affected, further reducing recruitment to the upper river. The Environment Agency should be asked to carry out an investigation into the status of the Malham Beck, particularly its water quality.

- In addition, the weir reduced downstream migration of coarse sediment, including

gravel of a suitable size for trout spawning. Partly as a consequence of this interruption of geomorphological processes, the reach downstream of Aire Head had limited gravel of a size suitable for trout spawning. It is likely as climatic change increases peak rainfall events, the amount of suitable sized gravel in this reach will decrease further.

- If the hypothesis identifying the paucity of spawning gravel as a habitat bottleneck is correct, it may explain the apparent lack of small fish in this reach. One possible way to overcome this habitat bottleneck is through the use of a deep substrate incubation box.

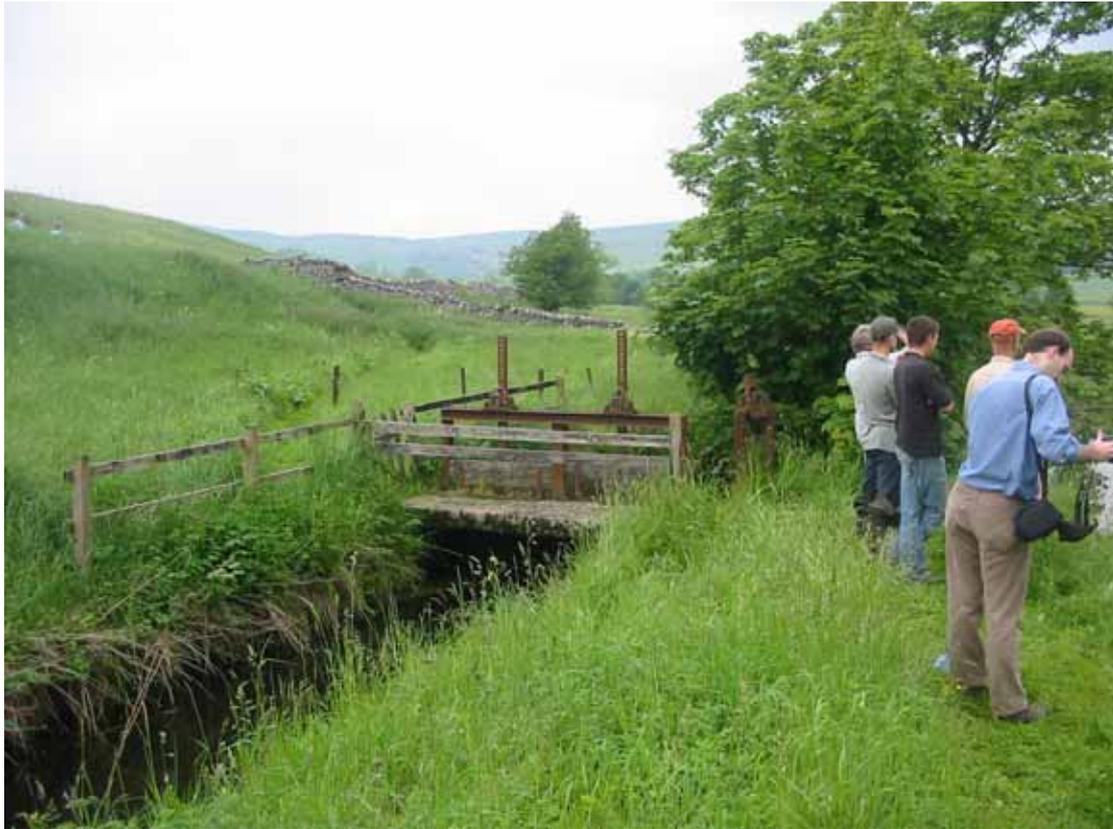
Water flow into the high level Scalegills Mill leat was controlled by two large iron and wood sluices immediately upstream of the impounding weir. Latterly, flows along the mill leat have been restricted by closure of the sluices, with only a 'sweetening flow' allowed to pass along the leat.

### **Controlling sluices at the upstream limit of the mill leat**

- It is recommended that, subject to the requirements of the owners of Scalegill Mill, water flow along the high level mill leat should be minimised. The mill leat is functioning as a level dependent habitat, to which a loss of flow is not likely to prove critical. The prioritisation of flow along the main River Aire will be the benefit of a wide range of species present, particularly during periods of low flow.

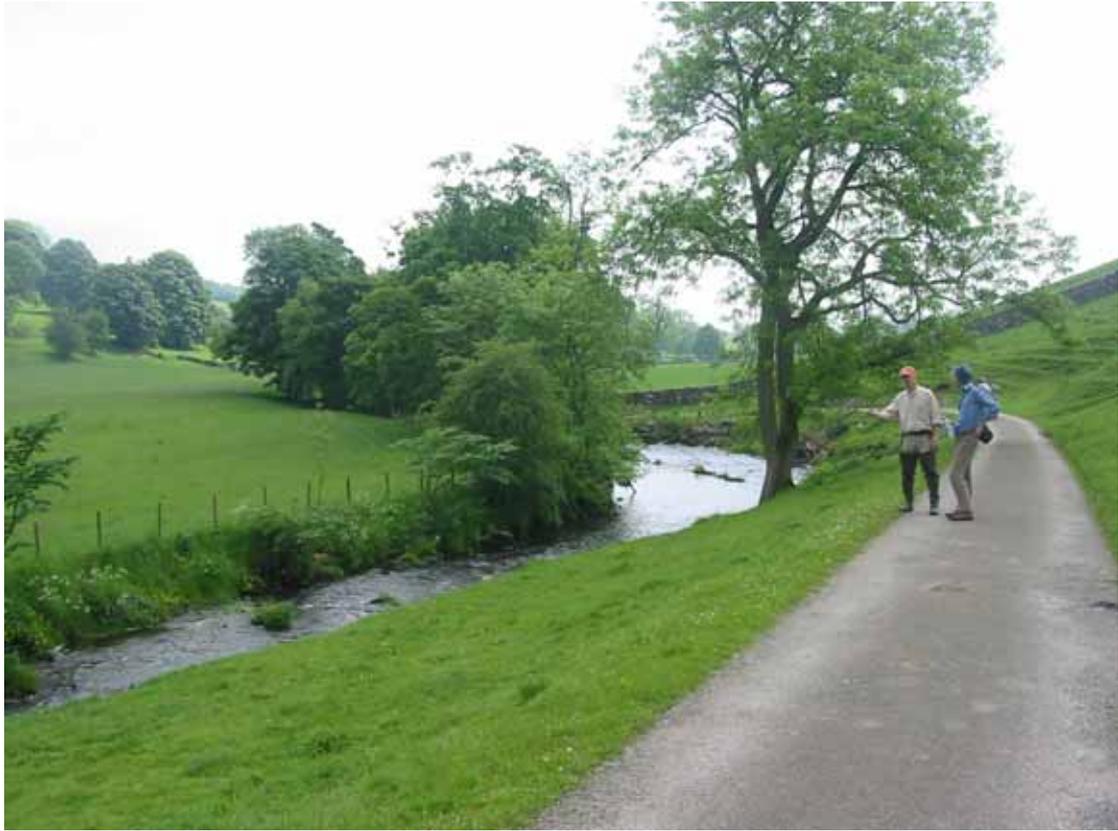
Downstream of the mill, the gradient of the river lessened. The RB land use was dominated by grazing pasture. Shading by riparian trees remained significant in some sections, although there were lengths of less shaded channel present.

**River below Scalegill Mill**

- Lengths of the river were overshadowed by riparian trees. It would be of benefit if a regime of rotational coppicing/pollarding could be established alongside sections of the watercourse. The aim of this should be to produce 'dappled' shading over the water's surface, allowing the growth of vegetation on the banks, whilst retaining valuable tree root systems. The ecological and landscape value of the mature trees

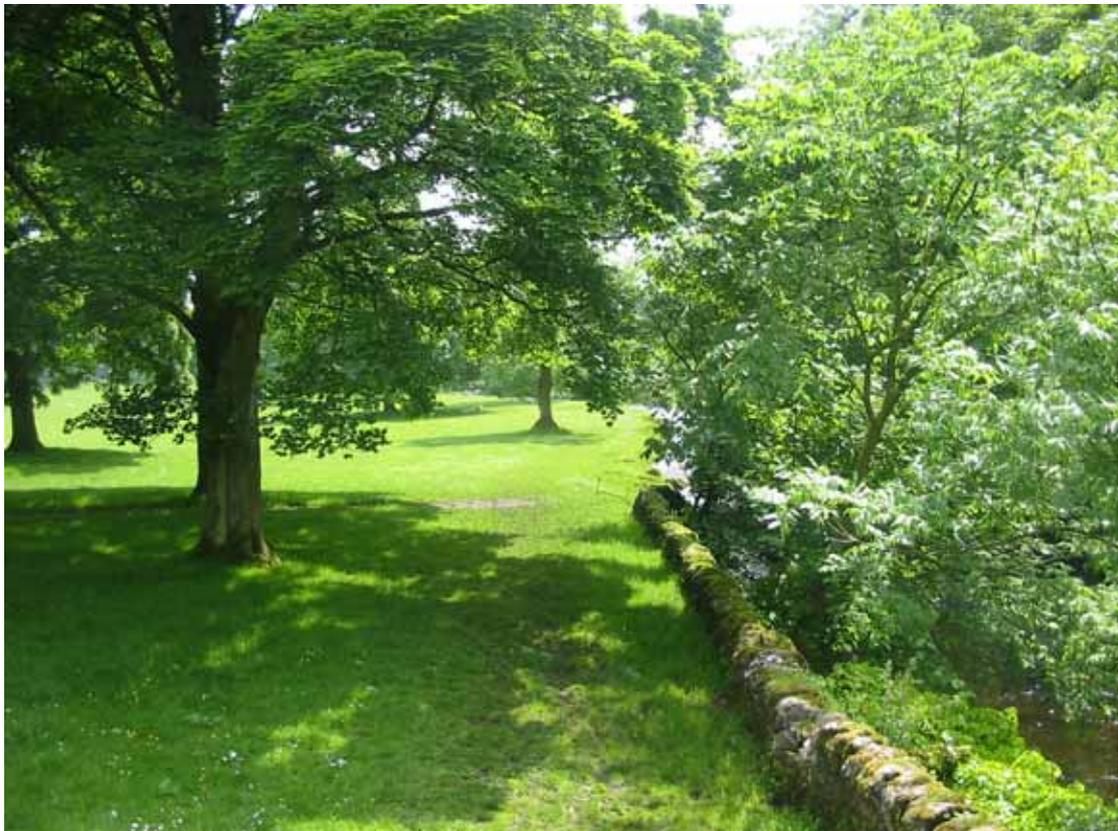
**Parkland with heavy grazing pressure downstream of Hanlith Hall**

Below the minor road bridge adjacent to Hanlith hall, the LB of the river was heavily sheep grazed parkland, with significant loss of marginal vegetation and associated erosion. Mature parkland trees cast significant shade over this section of the river.

- Grazing pressure from sheep was significant, particularly in the lower reaches of the club's fishery. There was a change in grazing in the lower fishery from cattle to sheep following the foot and mouth outbreak in 2001. There is little doubt that the current grazing regime is causing significant damage to the fishery, by over-widening of the channel, removal of over-hanging vegetation, mobilisation of fine sediment and prevention of establishment of riparian trees. The club has attempted to reduce grazing pressure by fencing small sections of river bank and subsequently planting trees within the enclosures created. In order to continue this work, it is recommended that either:

- The club seeks to take control of the grazing rights within the riparian fields and controls grazing pressure in order to minimise bank erosion. This is the preferred option, both in terms of cost, aesthetics (no fencing required) and ecological benefit (careful management of the fields would increase their floristic diversity considerably)

- Fencing is erected along affected reaches in order to prevent stock access to the river bank. It may be necessary to provide drinking areas for the sheep within the fenced area. Management of vegetation growth within the fenced area will be required in order to provide access for anglers fishing the water. The use of temporary electric fencing might be considered to be appropriate in the sensitive landscape of the national park. Willows already established in some of the original fenced areas could be used as 'donors' for future replanting. Rotational coppicing of these well established trees would not only provide an abundance of whips/stakes that could be used to establish trees in newly fenced areas, but would also allow the regrowth of valuable fringing vegetation in the areas of reduced shading.

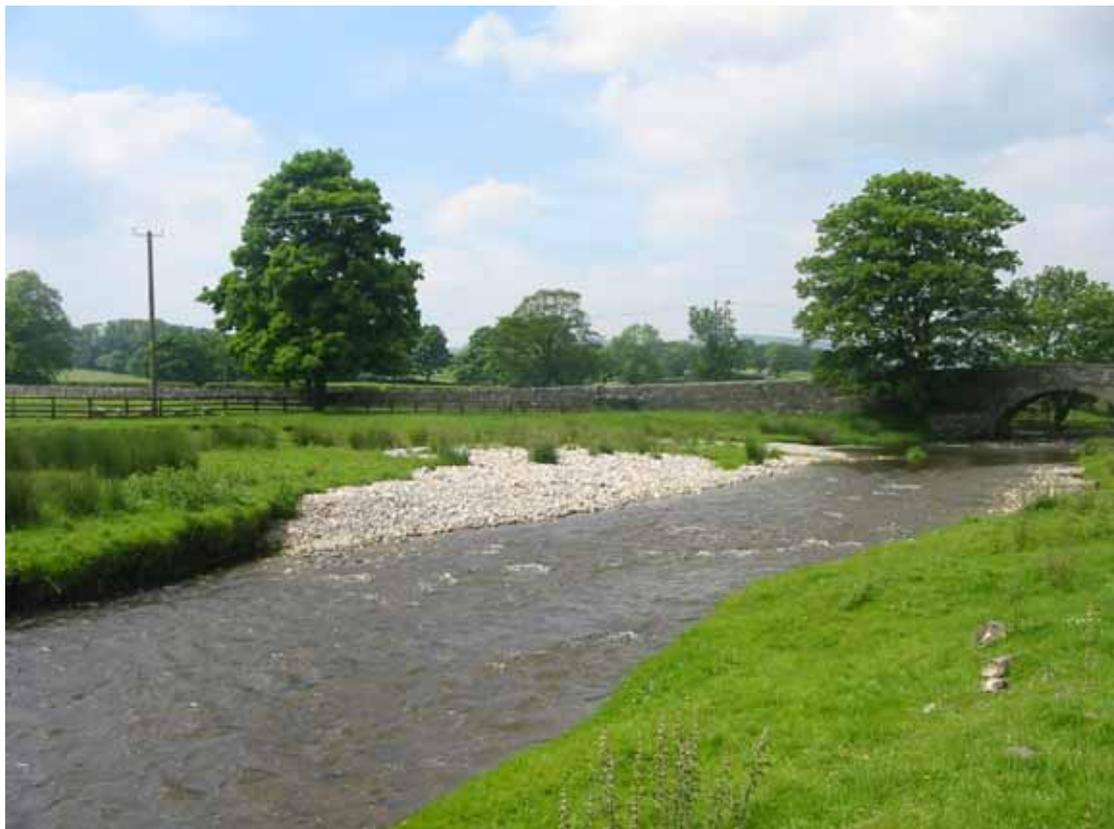
Land use was dominated by intensive sheep grazing on both banks.

### **River Aire downstream of Newfield Bridge. Note heavily grazed banks**

There was a paucity of riparian trees and associated LWD in this reach, reducing the sorting of bed material.

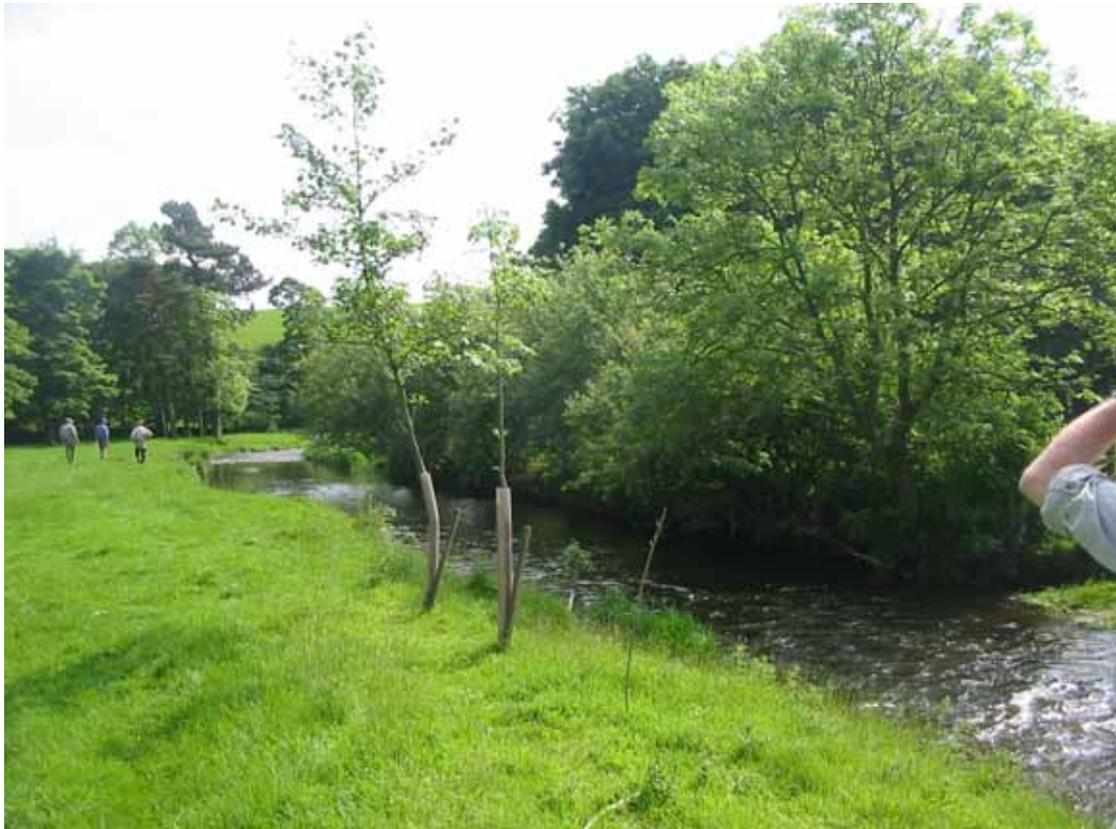
mix of native tree species. Unfortunately, sheep had gained access to some of these, grazing the banks and allowing erosion to continue. As a consequence, fencing had fallen into the river and the enhancement failed. More positively, the sheep proof fencing had remained intact on other enclosures, with the result that both the bankside vegetation and trees had become well established. Riparian habitat in these sections was excellent with clear benefit visible to the channel.

### **Failed (LB) and successful (RB) fencing/tree planting**

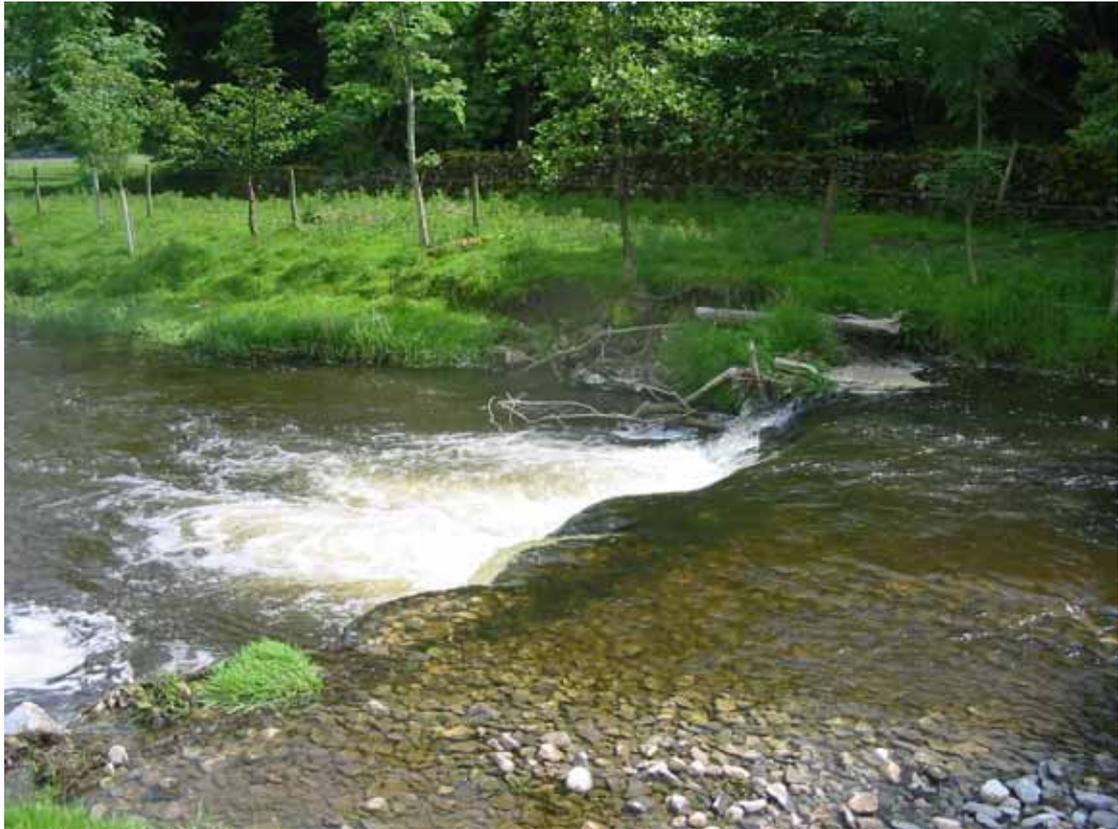
In an attempt to increase instream habitat diversity in the shallow riffle lengths of this reach, the club had constructed a number of small boulder/gabion weirs. These had created some small pools downstream, but in some cases were causing limited lateral erosion of the banks and siltation of upstream areas.

**Constructed boulder weir. Note the erosion on the RB**

- The constructed weirs should be removed or modified so as to prevent upstream impounding. In some cases, lowering of the height of the weir should prove adequate, whilst in other situations, the removal of the central section of the weir will allow free passage of water, whilst protecting the banks from erosion.

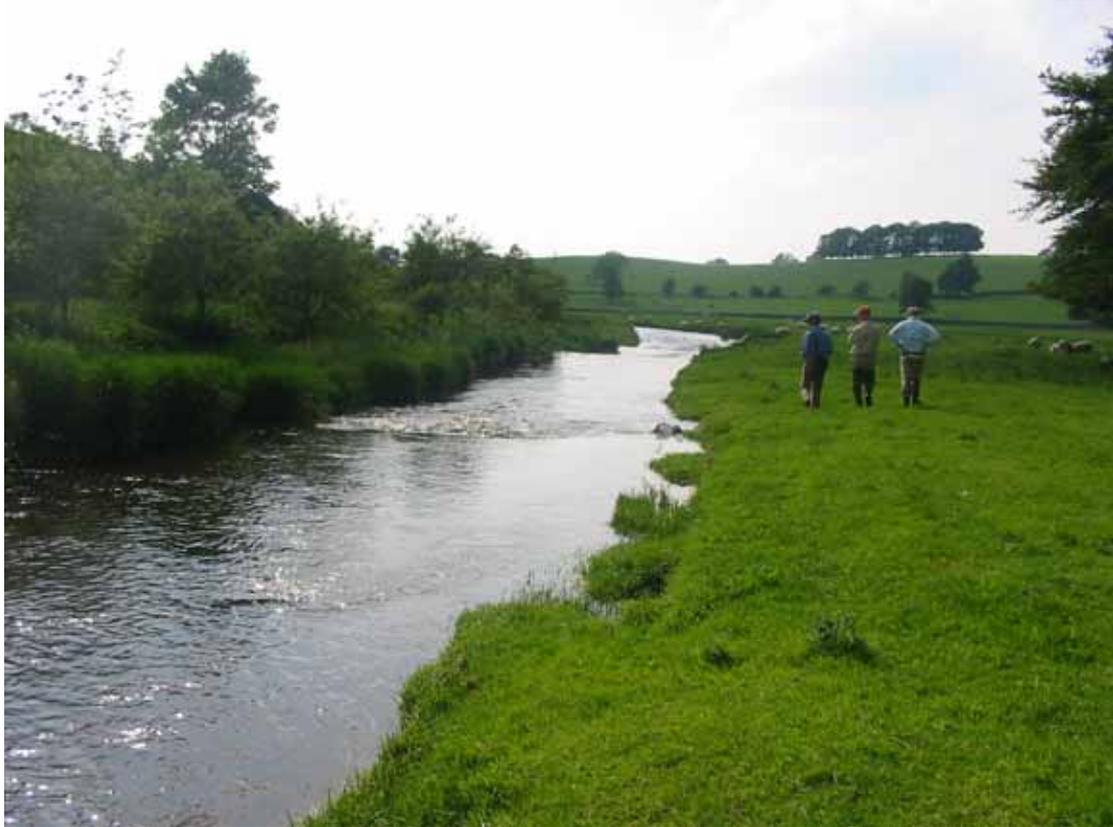
Below the small footbridge, the river was fenced on the LB of the river. The resultant regeneration of vegetation on the bank was excellent, proving the benefit of this type of management. The RB which remained unprotected and grazed had little marginal vegetation.

**Fenced LB and unfenced RB below footbridge. Note contrasting vegetation**

The fenced area downstream of the footbridge offers an exemplar of the benefits to be gained from removal of grazing pressure.
