Advisory Visit

Abbey Brook

20/07/16

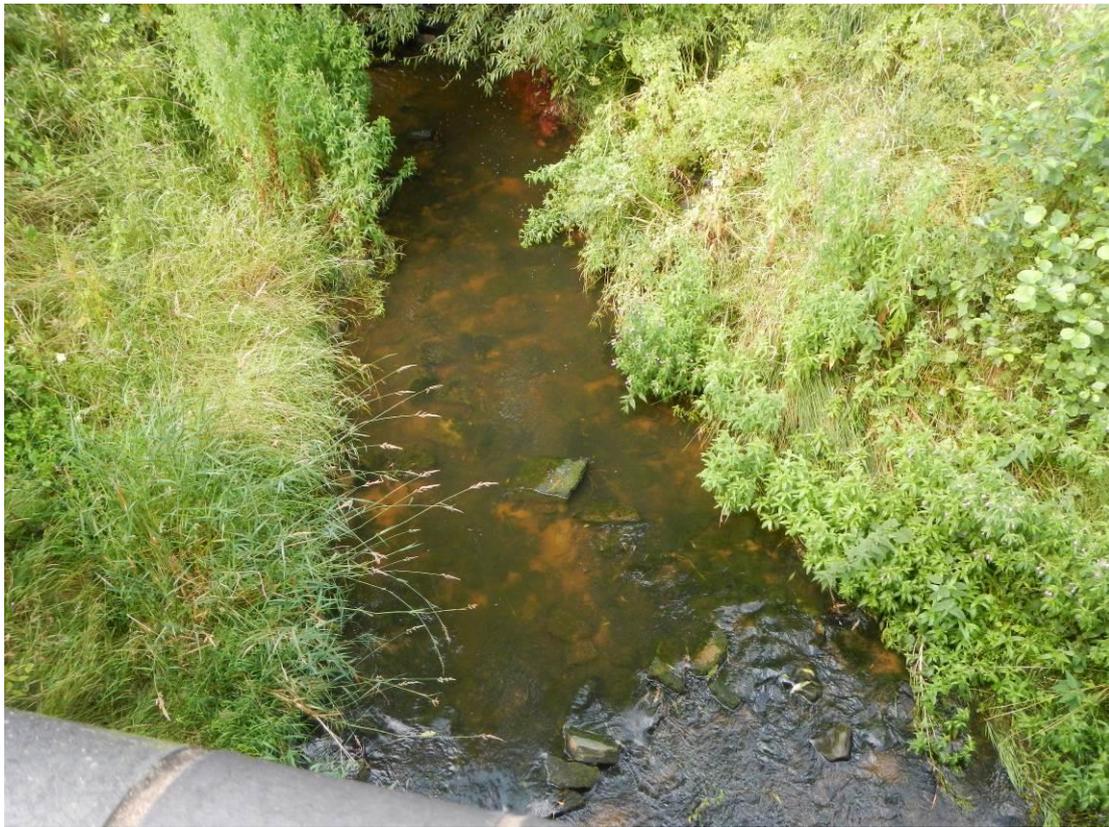
Inspection from the bridge at the upper limit of the site revealed that the Brook is suffering significant inputs of fine sediment and sand, as can be seen by deposition on the bed (Fig. 1). This issue greatly limits the habitat quality in the Brook for many of its native species. Fine sediment entering the Brook, particularly in low and medium flows, fills vital spaces between the gravel and cobbles, greatly reducing the quality and diversity of that habitat. Finer sediments trapped within the riverbed also limit the flow-through of oxygenated water that is required by many invertebrates and any fish eggs that may be laid within the gravel. The fine sediment input is therefore likely to be a key contributor to the 'poor' WFD score for invertebrates.

The Brook has been subjected to straightening in the past and now flows absolutely straight for c.200m u/s of the site (Fig. 1). This has implications for flow conveyance, geomorphology and ecology of that area and the subject area of the visit d/s, which has also been dredged and straightened to a lesser extent.

Figure 1. Looking u/s of the site at a heavily straightened (c.200m) section.

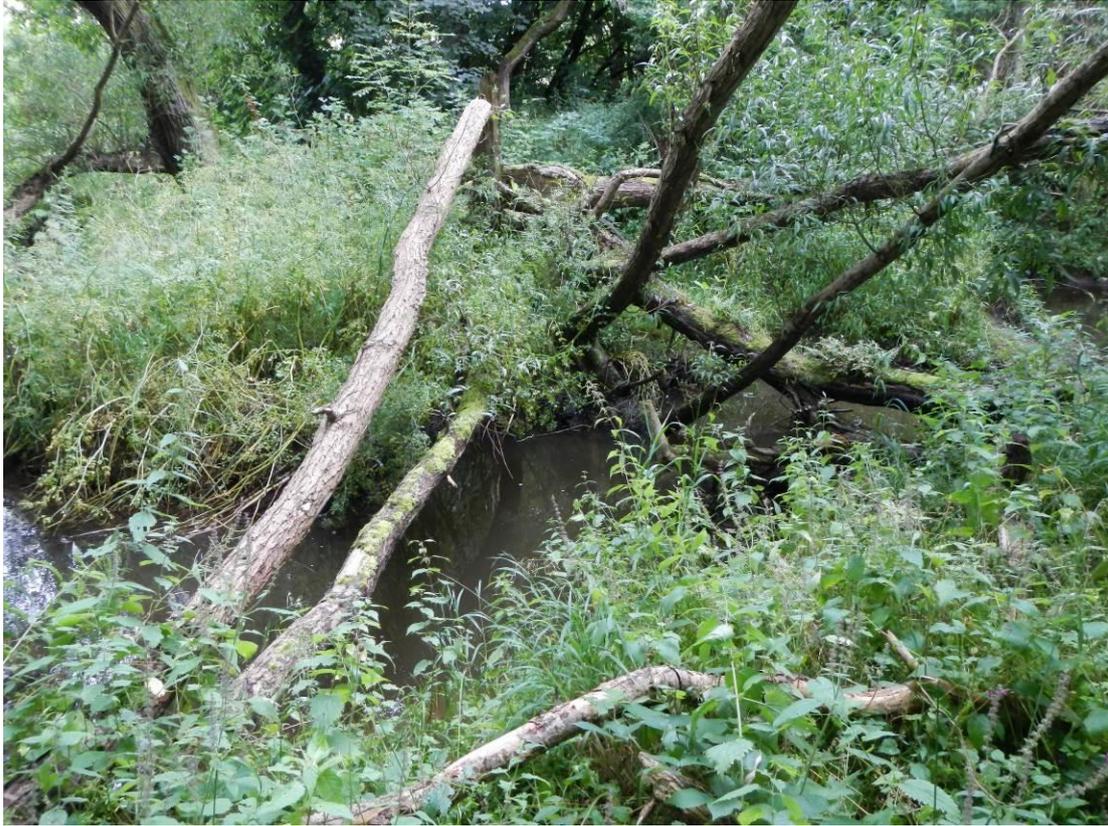
If allowed time and opportunity to adjust, the actual intervention required to achieve a more natural channel is minimal. Figure 2, taken within the woodland site, demonstrates the point perfectly. Over time, trees will naturally grow out into the channel, or fall across it as they move out towards the light or erosion undermines them. Left within the channel, they create increased roughness that slows water transit d/s, helping high flows to spill out of the low-flow channel and onto the floodplain. The restriction within the low-flow channel also diverts and focusses flows, driving them into the bed and banks and developing beneficial in-channel features.

Figure 2. Fallen trees that increase habitat diversity and provide attenuation of flood flows.

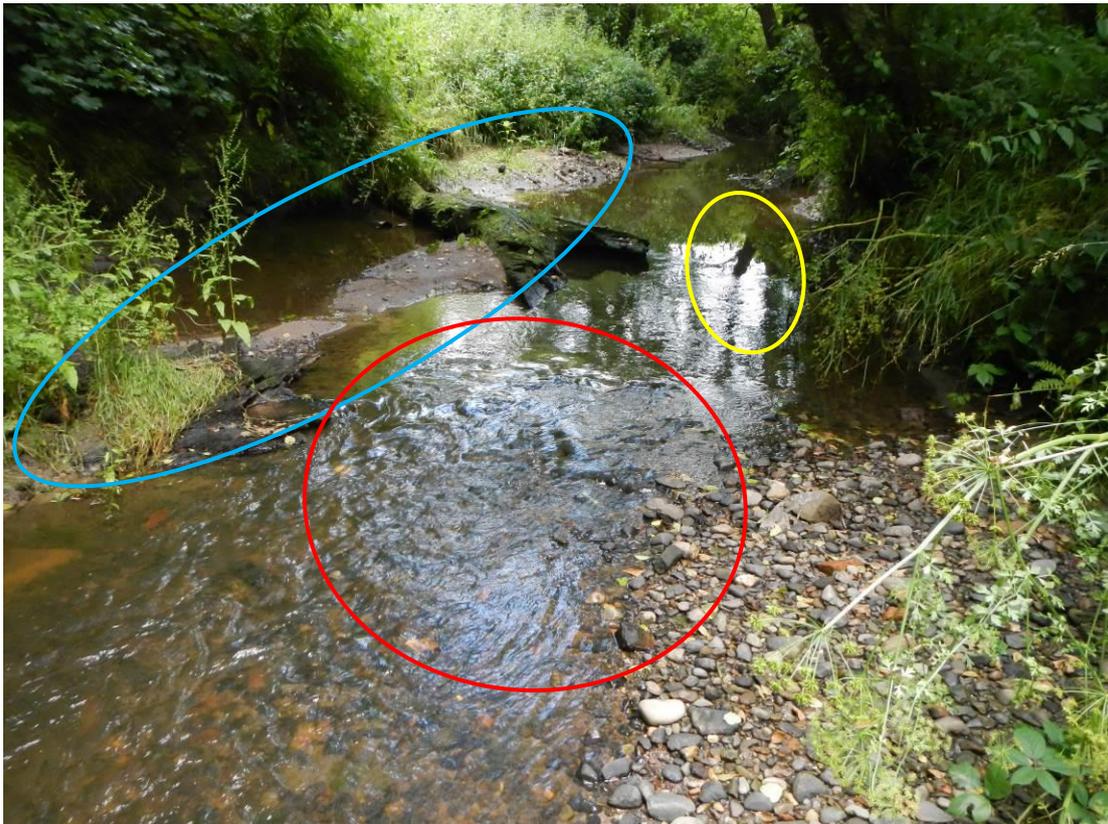
Moving downstream into the woodland, further examples of the benefits of retaining woody material within the channel can be seen. Old, decaying logs provide valuable food and cover for invertebrates but also facilitate the retention and sorting of valuable gravel and cobble substrate that provides further invertebrate refugia and salmonid spawning habitat (Fig. 3).

Figure 3. Valuable dead wood within the channel. Note: fine sediments are retained u/s and d/s within the lee of the log (blue oval); flows are focussed between the log and the tree roots on the LB (right of shot) to scour and maintain deeper pool habitat (yellow oval); and the scoured material which is deposited a short distance d/s is maintained relatively free from fine sediments by the accelerated flows (red circle). However, even in these optimal conditions, the excess sediment inputs from u/s cannot be fully mitigated.

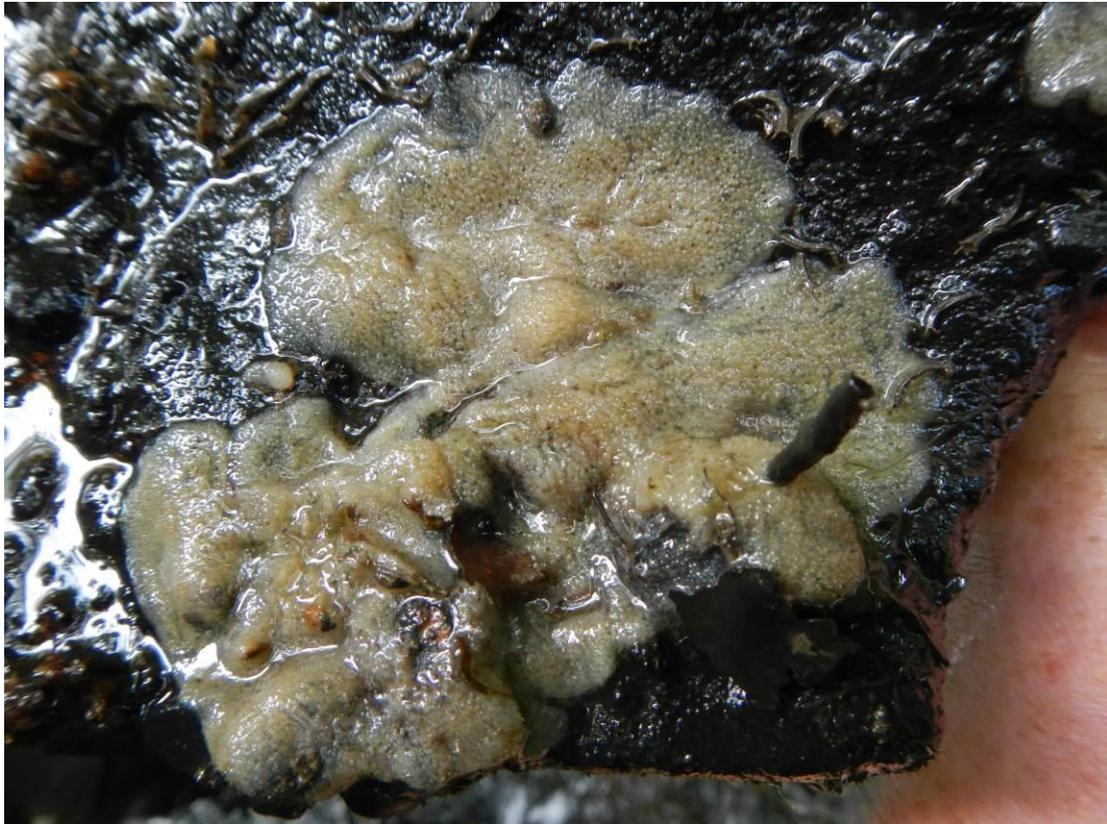
Figure 4. A freshwater sponge inhabiting an area of coarser cobble substrate.

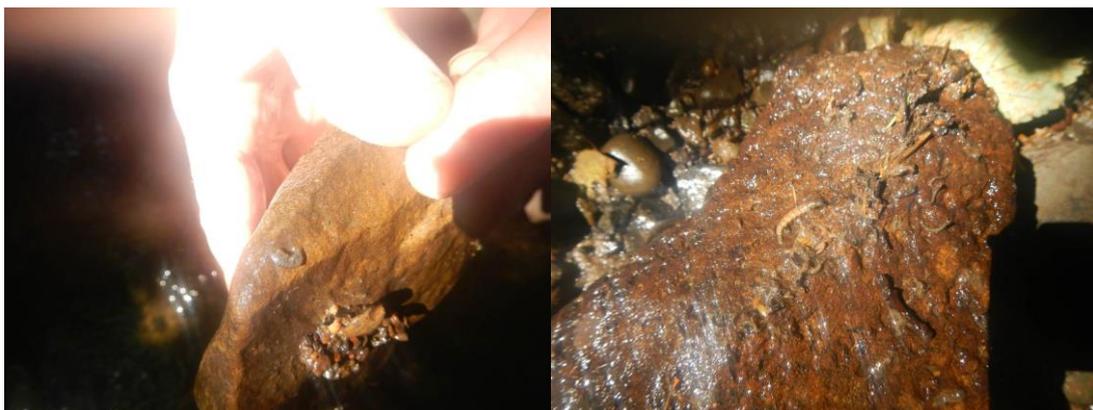
Figure 5a & b. Freshwater shrimp and caseless caddis, respectively.

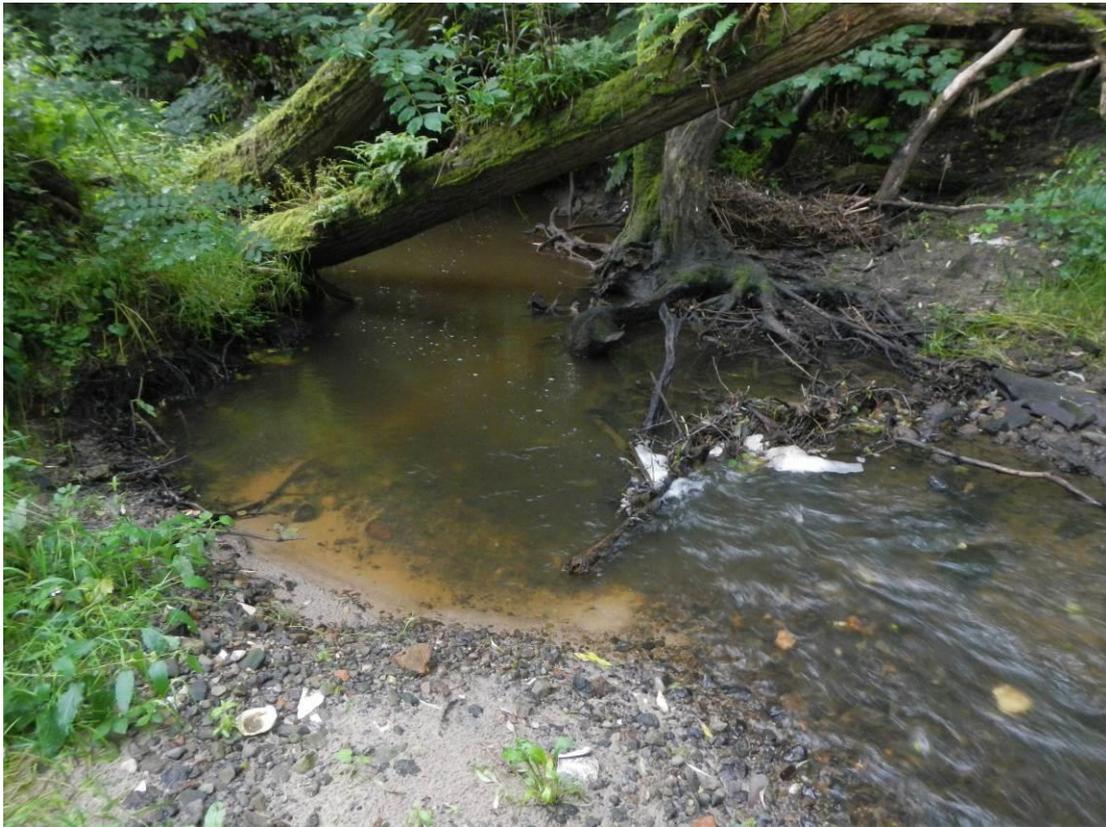
Historically, large woody material was removed from the channel of the Brook by the Environment Agency and its predecessors to reduce the perceived flood risk, to the detriment of vital diverse habitats (like those shown in Figure 6) and natural channel recovery processes.

Figure 6. The type of high quality, natural channel pinch-points that are created by dead and fallen trees – these greatly diversify habitat and create and maintain vital pool features.

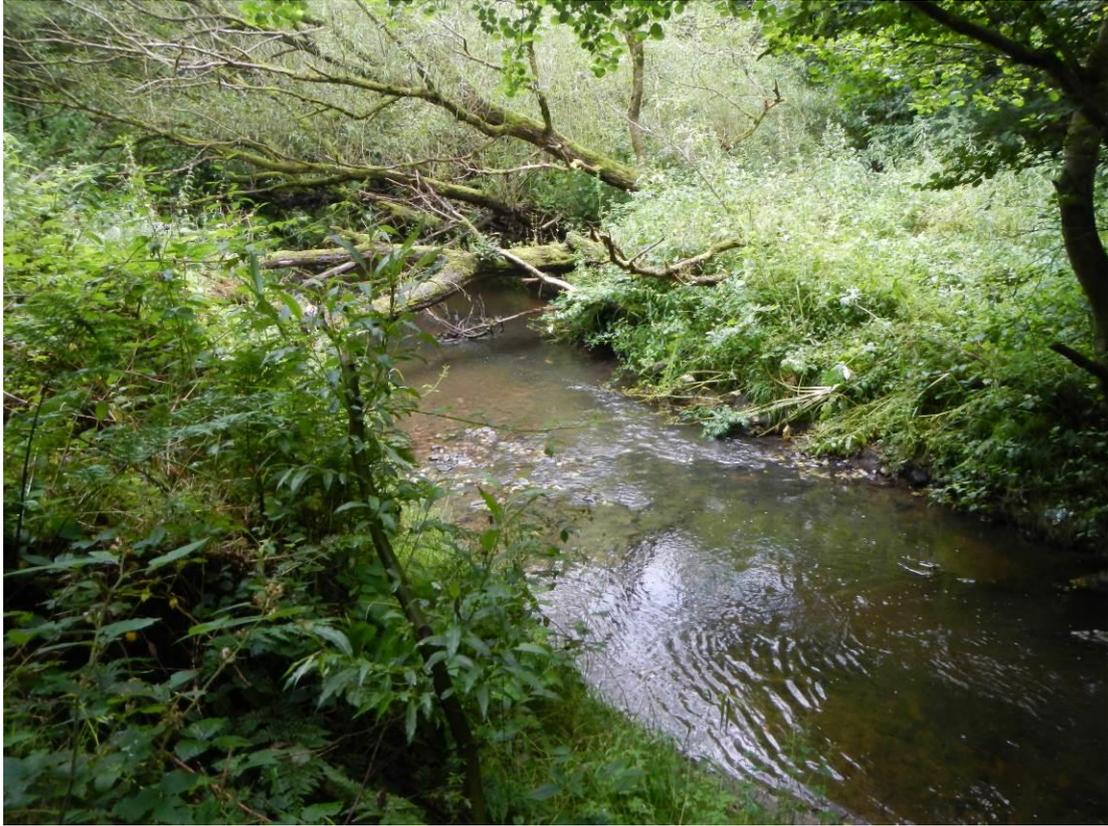
Figure 7. A perfect example of how fallen trees provide natural tree-catchers that prevent the downstream transport of other fallen trees. In this case, the willow that has fallen across the channel is likely to have rooted back into the bank opposite via adventitious roots from its branches, thereby completely securing it and any other woody material in place

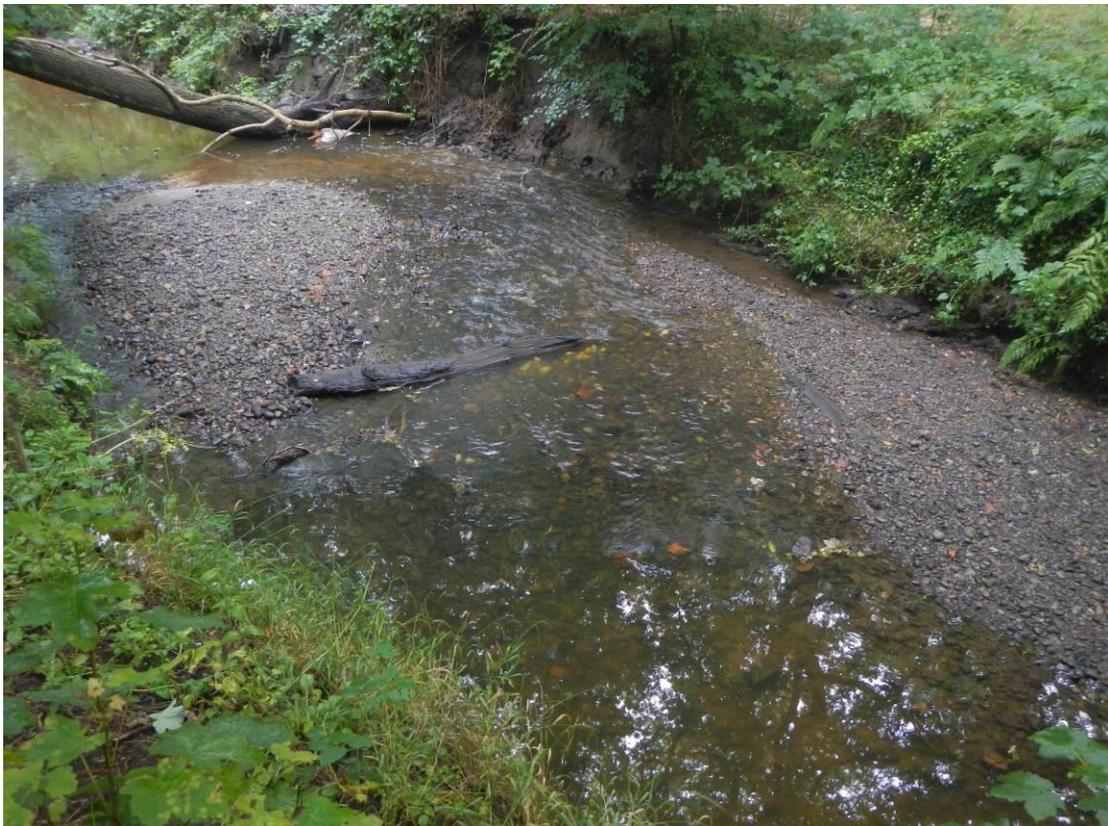
Figure 8. Valuable gravel bar features with a collapsed tree in the background. The tree is currently helping to create and maintain deeper pool habitat around its root-ball and will, over time, facilitate further lateral scour into the RB (right of shot), creating a much needed increase to the channel sinuosity.

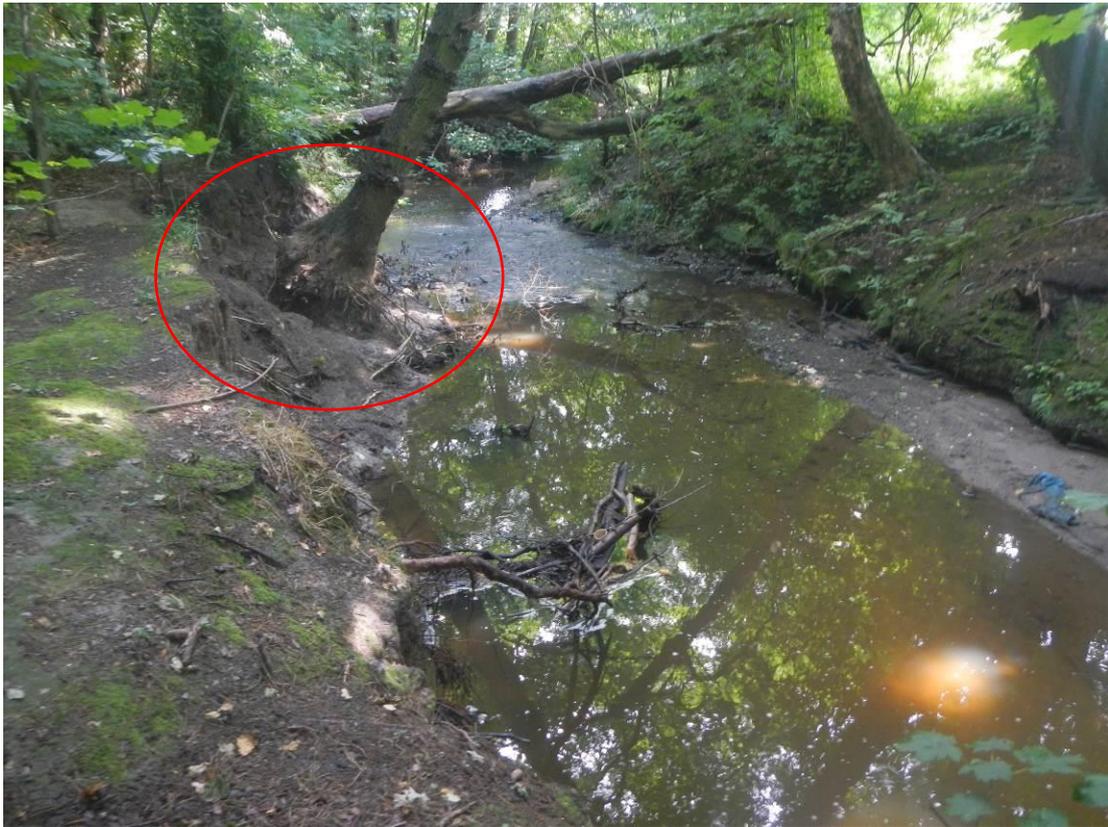
Over time, the straightened channel sections within the woodland are developing natural features, with deposition of substrate diversifying the course and flow patterns and facilitating greater morphological diversity (Fig.s 8 & 9). If left to develop further, these features, aided by natural inputs of woody material (trees etc.) will facilitate the lateral erosion required to further restore the Brook's channel (Fig. 10). For this reason, woody material in the channel and material with the potential to enter the channel should be left. A recent unnecessary attempt to remove a fallen oak tree (*Quercus robur*) from the channel would have only served to denude the habitat and inhibit natural channel adjustment (Fig. 9) - this tree should be left.

Figure 9. Woody material and deposition are part of the channel naturally adjusting and recovering from the past straightening work. Removing fallen trees from the channel (red circle) will only inhibit the recovery.

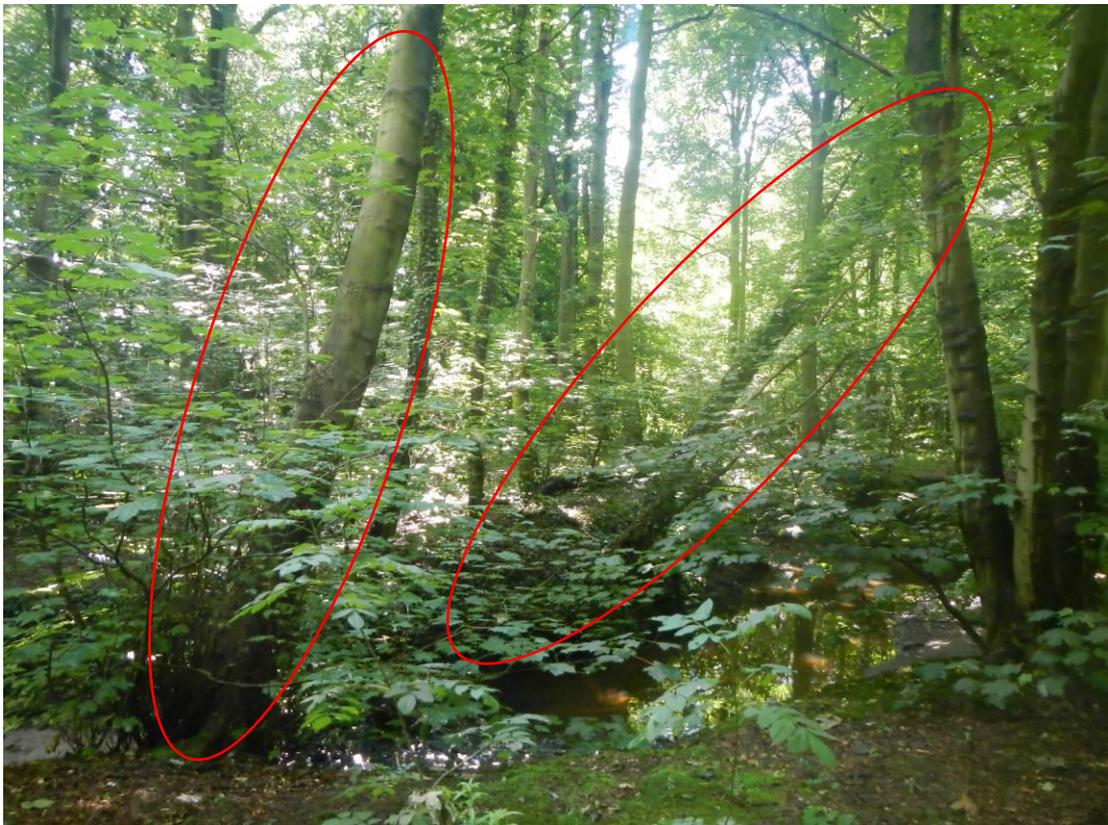
Figure 10. Many trees along the bank have the potential to fall into the channel over time (red ovals) as lateral bank erosion destabilises them. These trees should be left as they will provide valuable in-channel structure and the void created in the banks as they fall is also likely to accelerate channel adjustment/recovery.

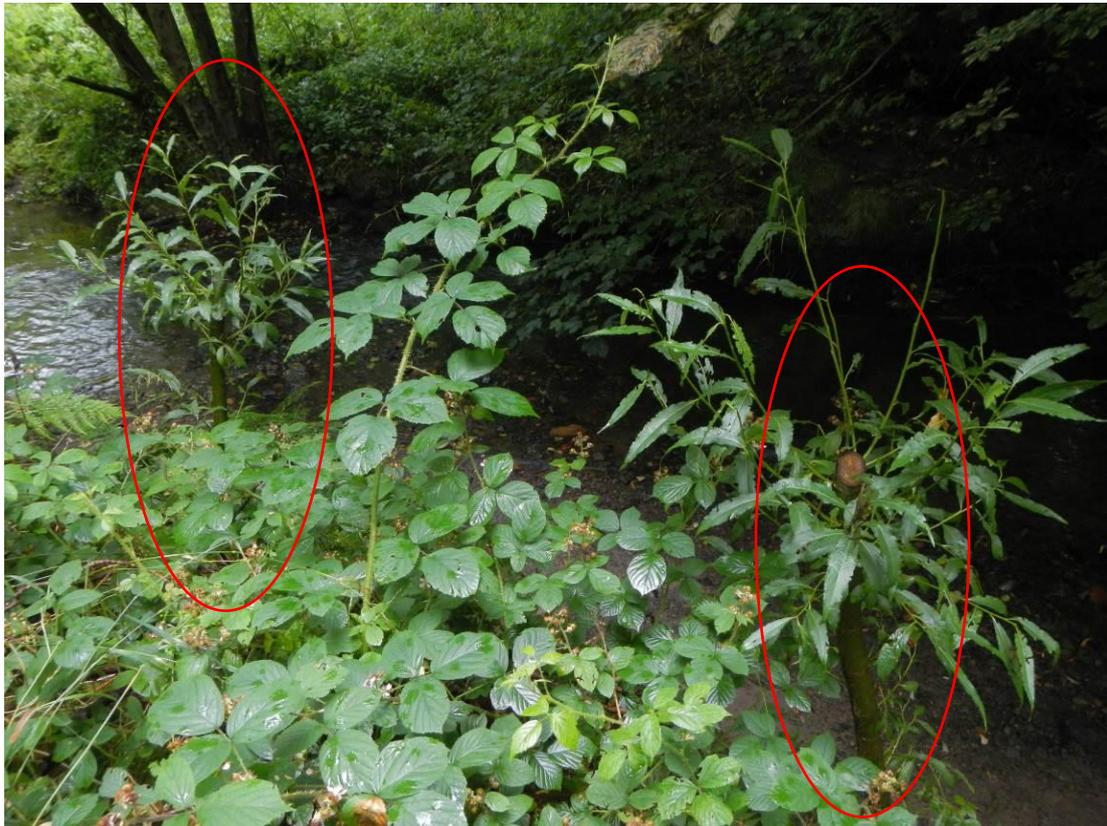
Figure 12. Some of the planted willow whips could be laid down into the channel to increase in-channel cover and structure.

In some circumstances, it may be beneficial to deliberately introduce material to the channel, particularly live willow which can be laid (as you would hawthorn in a hedge). A few of the natural willows along the banks could be laid to simply lower them into the channel, and willows planted from whips (several throughout the site) could be laid over along the bank to provide a valuable increase in low-level cover and future woody material input to the river (Fig. 12).

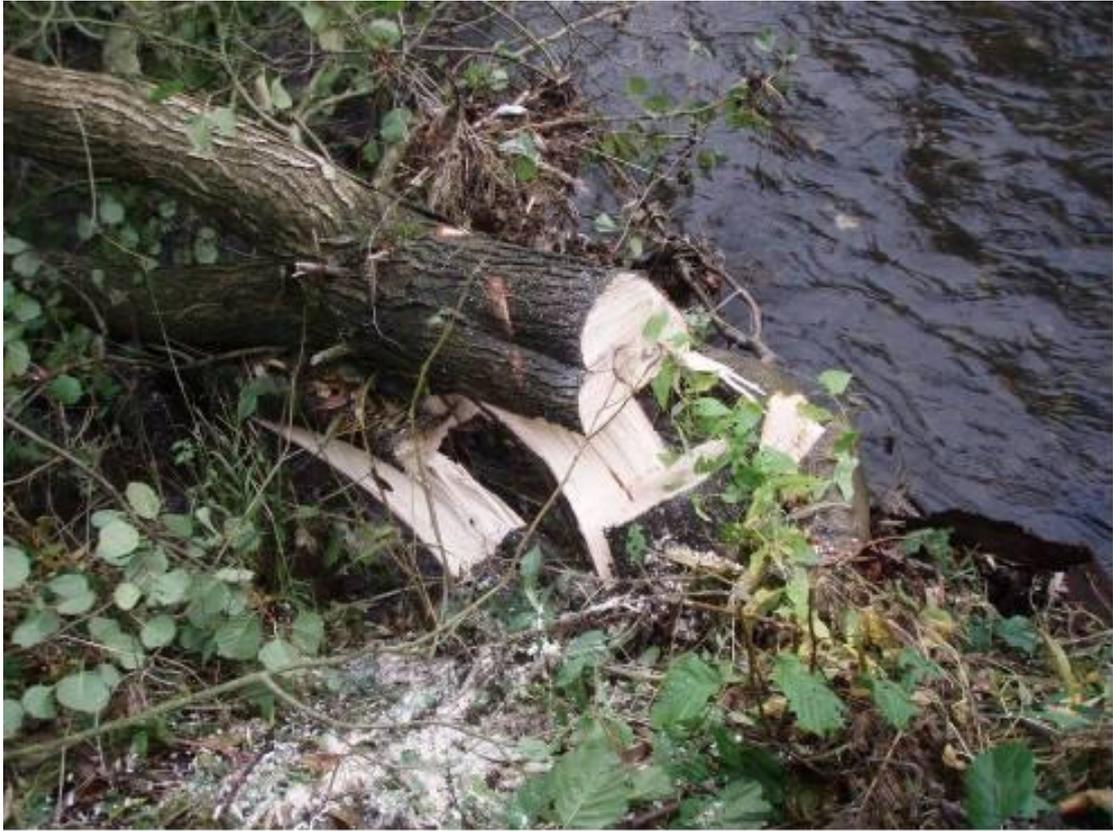
Photograph 13. Hinged willow.

Laying involves cutting part-way through the stem/trunk while downward pressure is applied to the stem (like laying a hawthorn hedge), until it can be forced over into the channel (Photos 13 & 14). The depth of the cut should be limited only to that which is required to bend the limb over, as this will retain maximum strength in the hinge and maintain the health of the tree/shrub. For small shrubs, cutting the stem at a very shallow angle then putting an axe blade into the cut and hitting it with a hammer can also work effectively.

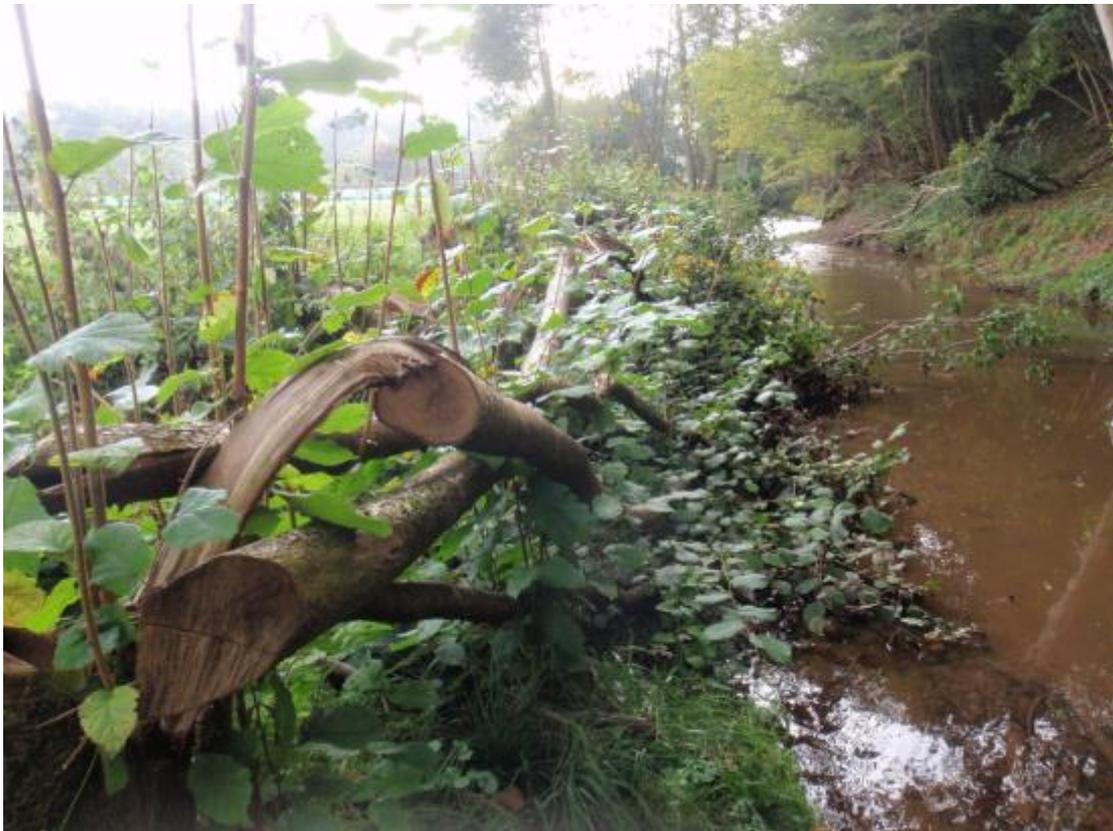
Photograph 14. Hinged hazel.
