Advisory Visit
Upper Wyre, Abbeystead Estate
June/July 2016

1.0 Introduction

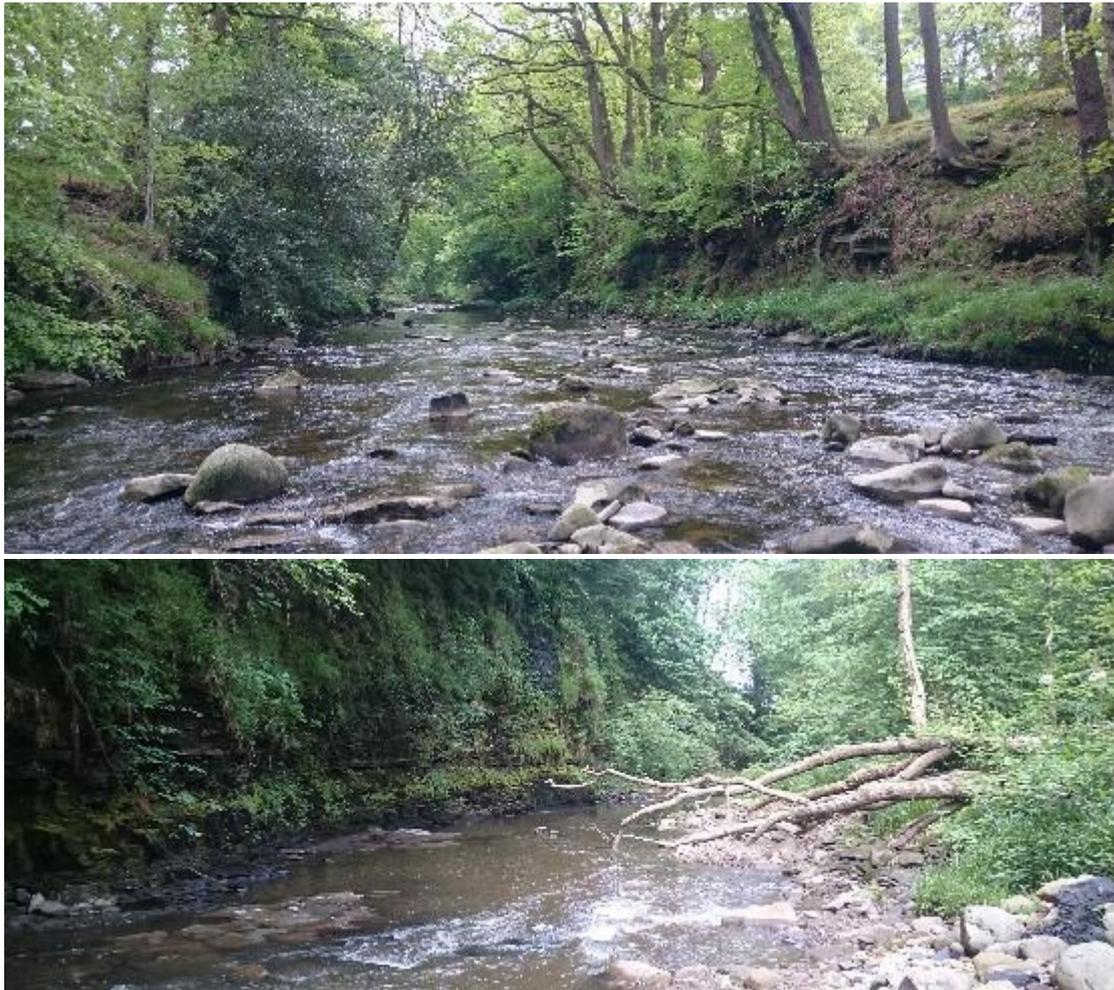
Fig 1. Upper: typical view of lower reach of the Wyre with natural pool-riffle-glide sequences and mature riparian vegetation on both banks providing good quality habitat. Lower: abundant, stabilised, large woody material helps to diversify flow and aids the slowing of flow under spate conditions.

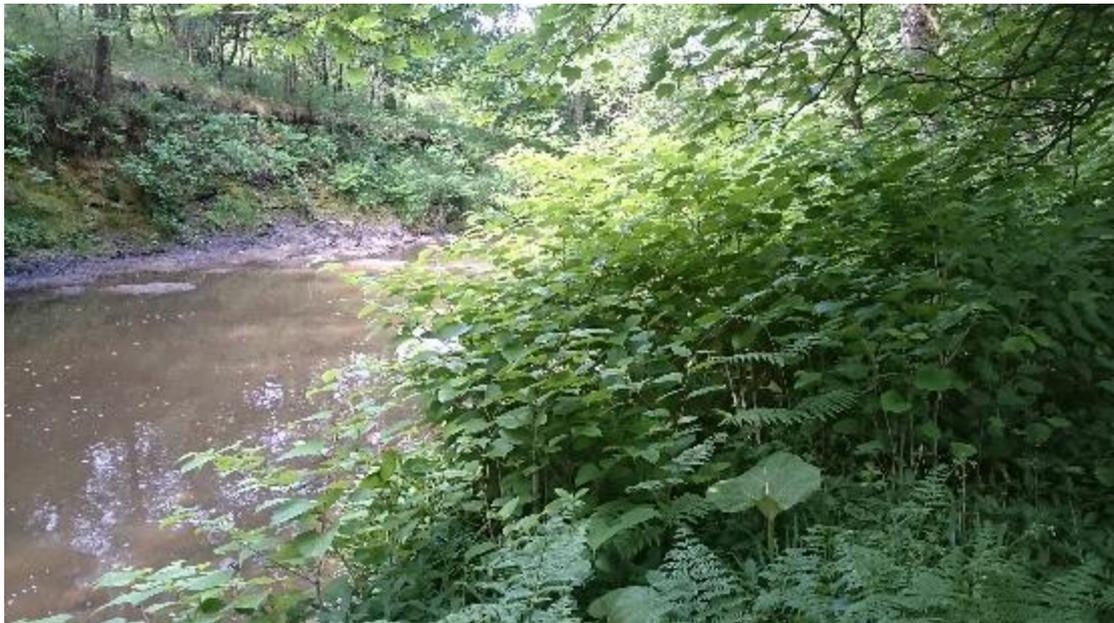
On the RB, ~100m d/s of the footbridge (Long Bridge; SD5448853825), there were two clumps of Japanese knotweed (*Fallopia japonica*) noted (Fig 2). The presence of this invasive, non-native species (INNS) should be addressed as it outcompetes native plants but has little root structure to enhance bank stability. When it dies back completely in winter, it leaves the bank soils entirely exposed to erosion.

Fig 2. On the RB d/s of Long Bridge, a stand of Japanese knotweed has taken hold.

Himalayan balsam and Japanese knotweed were observed at specific sites and should be relatively easy to eradicate as the estate controls the entire upper catchment. All estate workers should be encouraged

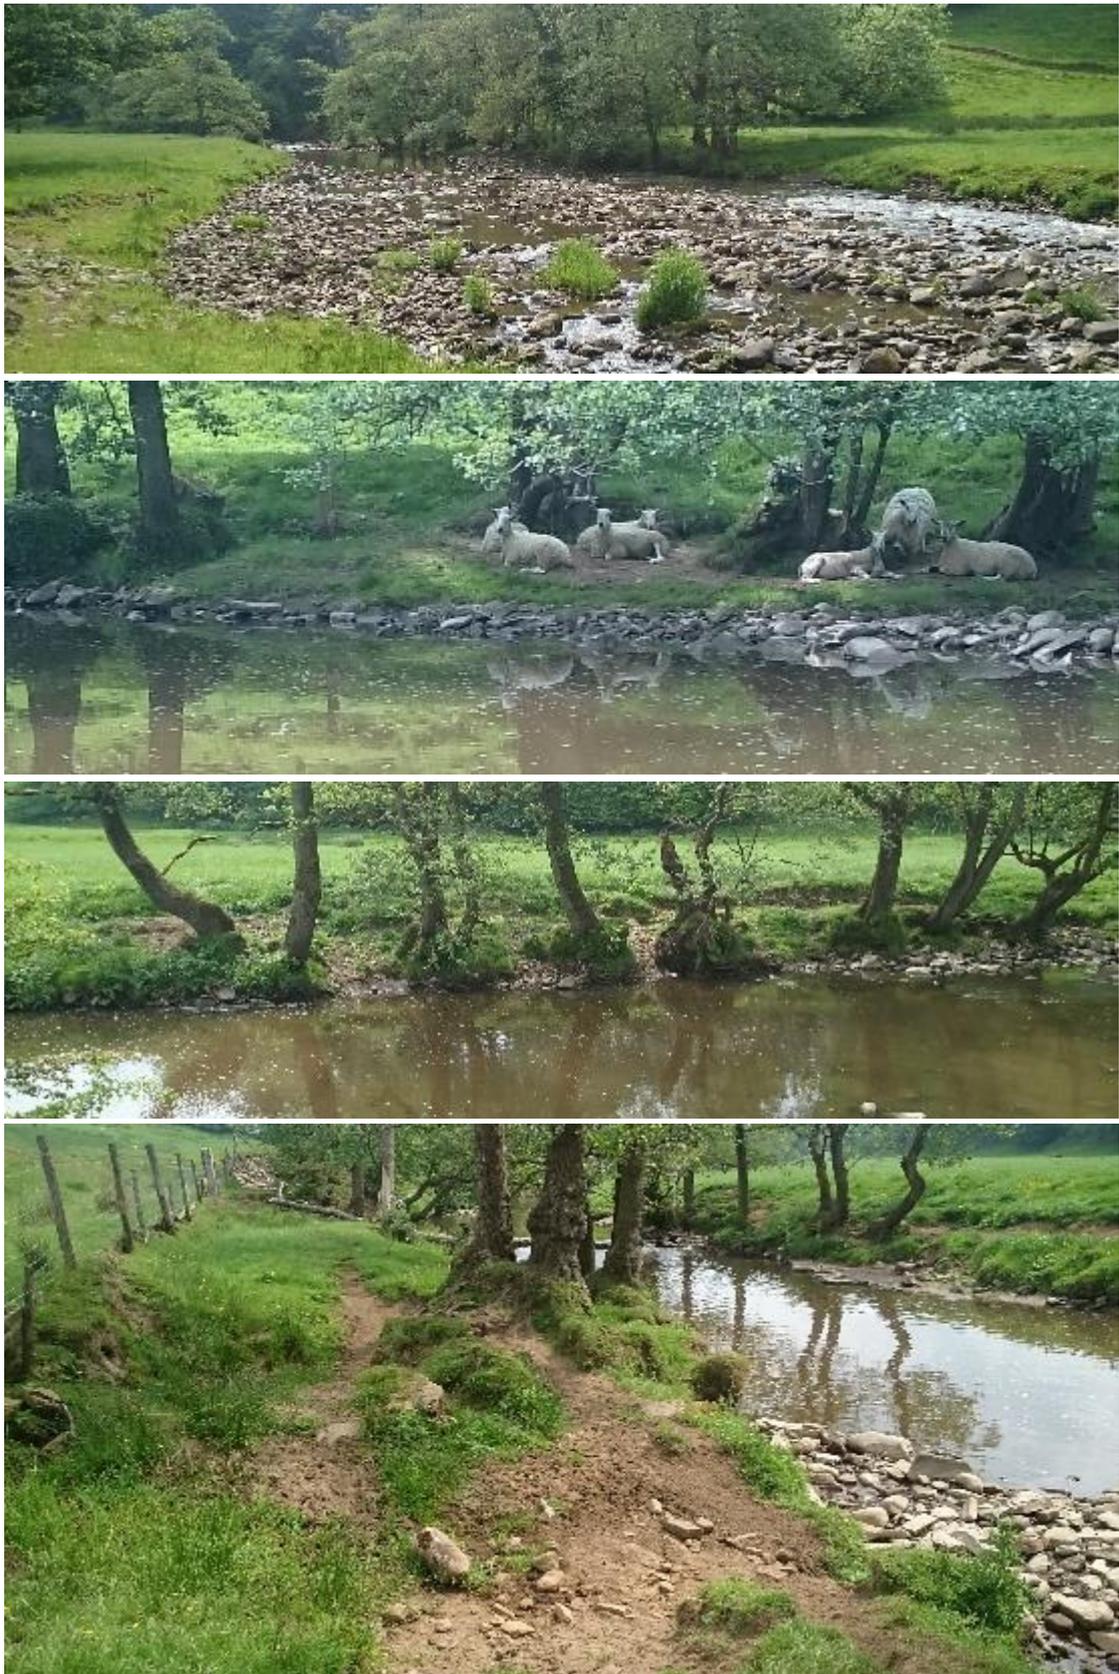
This is most notable around the base of riparian trees (Fig 3) where sheep (in this case) tend to congregate, and their trampling and rubbing at exposed banks and landslips further exacerbates erosion and prevents the natural recolonisation of the exposed soils by plants. The focus of erosion around bankside trees has multiple impacts. It increases sediment ingress to the channel, reducing water and substrate quality. It increases the likelihood of tree loss to spates, further reducing the structural integrity of banks, and removing the shading, refuge, and nutrient benefits of trees. There is also a complete lack of self-set young trees to replace those lost through the processes above; this is because stock preferentially target the more nutritious shoots and saplings. Excessive erosion of both banks leads to over-widening of the river channel, and a consequent uniformity of depth and substrate composition as the flow energy is dissipated over a greater cross-section (Fig 3). The alders at SD5497553867 (Fig 3: lower panel) are particularly vulnerable as they are on the outside of the bend (RB). There is already a fence preventing access from the field to the north and little viable grazing would actually be lost by preventing access along this sliver of bank from the field to the west.

Fig 3. Upper: overly wide section of river where both banks are heavily grazed. Mid upper: sheep maintaining exposed soils around tree roots. Mid lower: typical stock erosion impacts around each tree. Lower: friable soils left exposed after sheep trampling. Note also lack of low branches to provide valuable cover and shade.

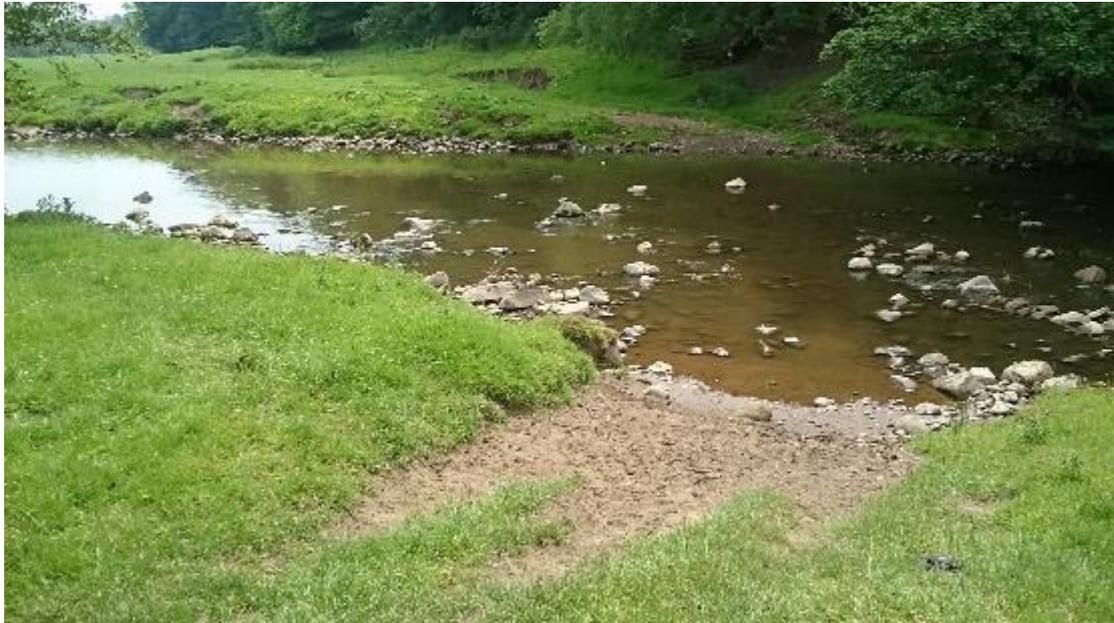
Fords have similar effects to stock poaching on both the river and the banks (Fig 4). If these are necessary, then entrance and exit points should be formalised with some kind of hard-standing or railway sleepers to prevent continual poaching (from stock) or rutting (from tyres) of soils and further fine sediment ingress from the slopes whenever it rains.

Fig 4. A fording point (SD5479053762) which causes erosional over-widening of the channel and ingress of fine sediments if the entrance/exit points are not formalised.

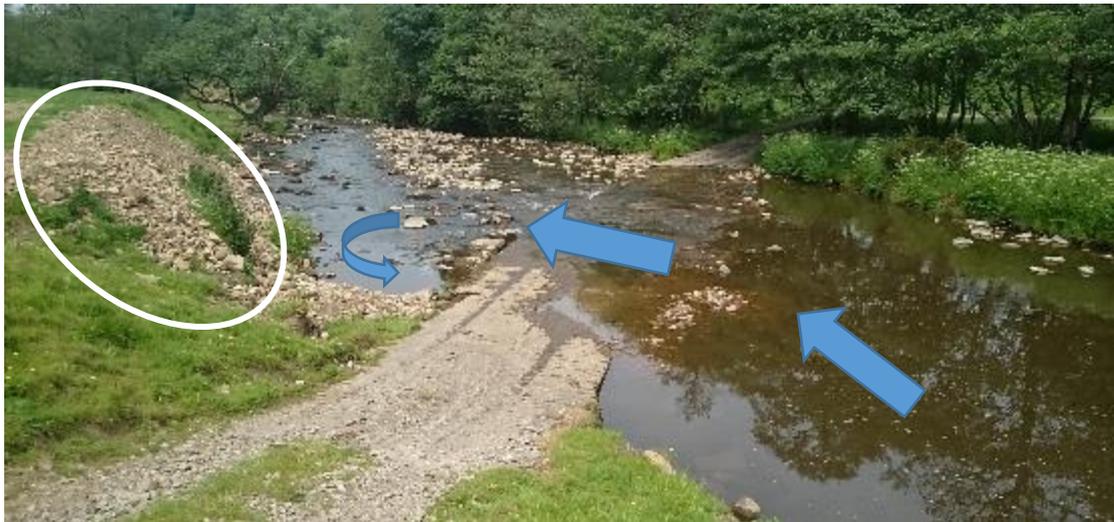
At the formal vehicle crossing point, there was considerable erosion evident on the LB, which had been recently rebuilt and re-profiled (Fig 5). Unfortunately, the concrete ford has been installed at an angle across the river which, at certain flow heights, will divert the flow path of the river directly at the LB and/or cause eddying turbulence (dependent upon gauge height), and hence will continue to cause erosion at that point. The actual structure of the rebuilt section of bank was not visible, but the surface re-profiling was essentially with cobbles and soil. Over the 6 weeks between first and final visit there was virtually no regrowth of plant cover on this bank and further evidence of some slippage, probably because it was not protected from stock access.

At the gauge height depicted in Fig 5, the ford is an obstruction to the free passage of fish and it impedes the free movement of bed substrate; it also impounds the river for ~80-100m u/s creating a relatively featureless section (Fig 6).

Fig 5. Formal concrete ford crossing the Wyre below the dam infrastructure. The angle it is installed will divert flows toward the LB (blue arrow) and consequently continue to cause erosion. The rebuilt section (white ellipse), as with most riverbank, requires stock exclusion to allow a diverse flora to regenerate and cover the exposed soils. Once stock are excluded, the area would benefit from willow whips or stakes driven into the toe of the bank to provide further structural stability.

Existing fencing should be maintained in a state fit-for-purpose. To maximise the benefits of tree planting (above) or bank reparations already undertaken (e.g. Fig 5), it will be necessary to exclude livestock. Key sites to consider are: any that can be set aside for planting to slow the flow; banks that have already succumbed or are susceptible to further land slip; around established vegetation that is in immediate danger of succumbing to further erosion from stock trampling; and along the lower reaches of some of the small spawning tributaries. Examples of all of these are noted earlier in the report.

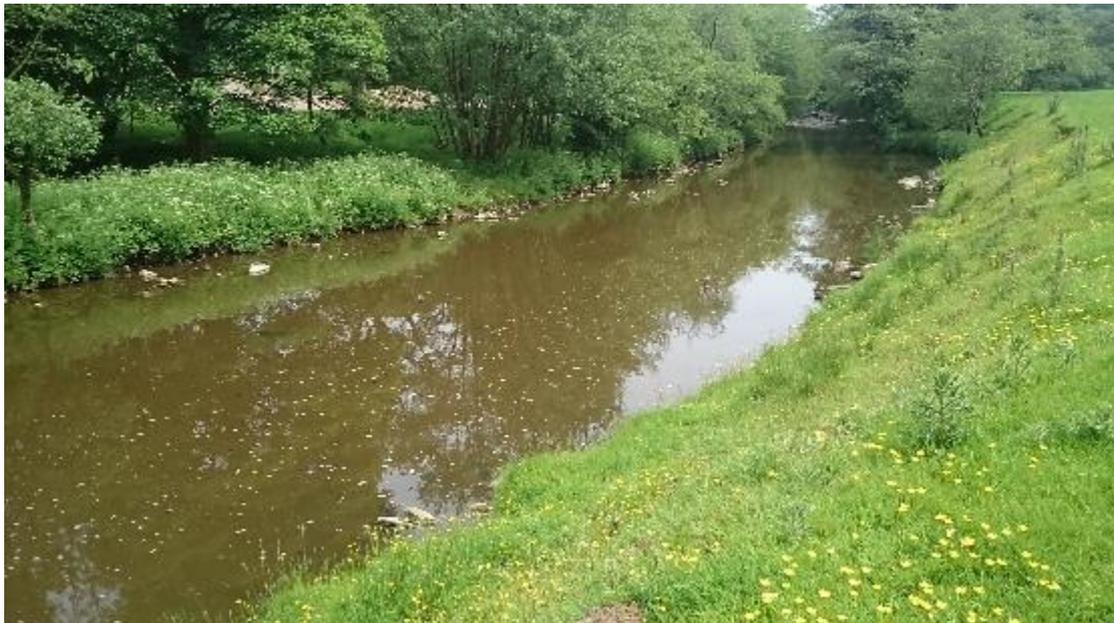
Fig 6. The relatively featureless impounded section of river (immediately u/s of Fig 5).

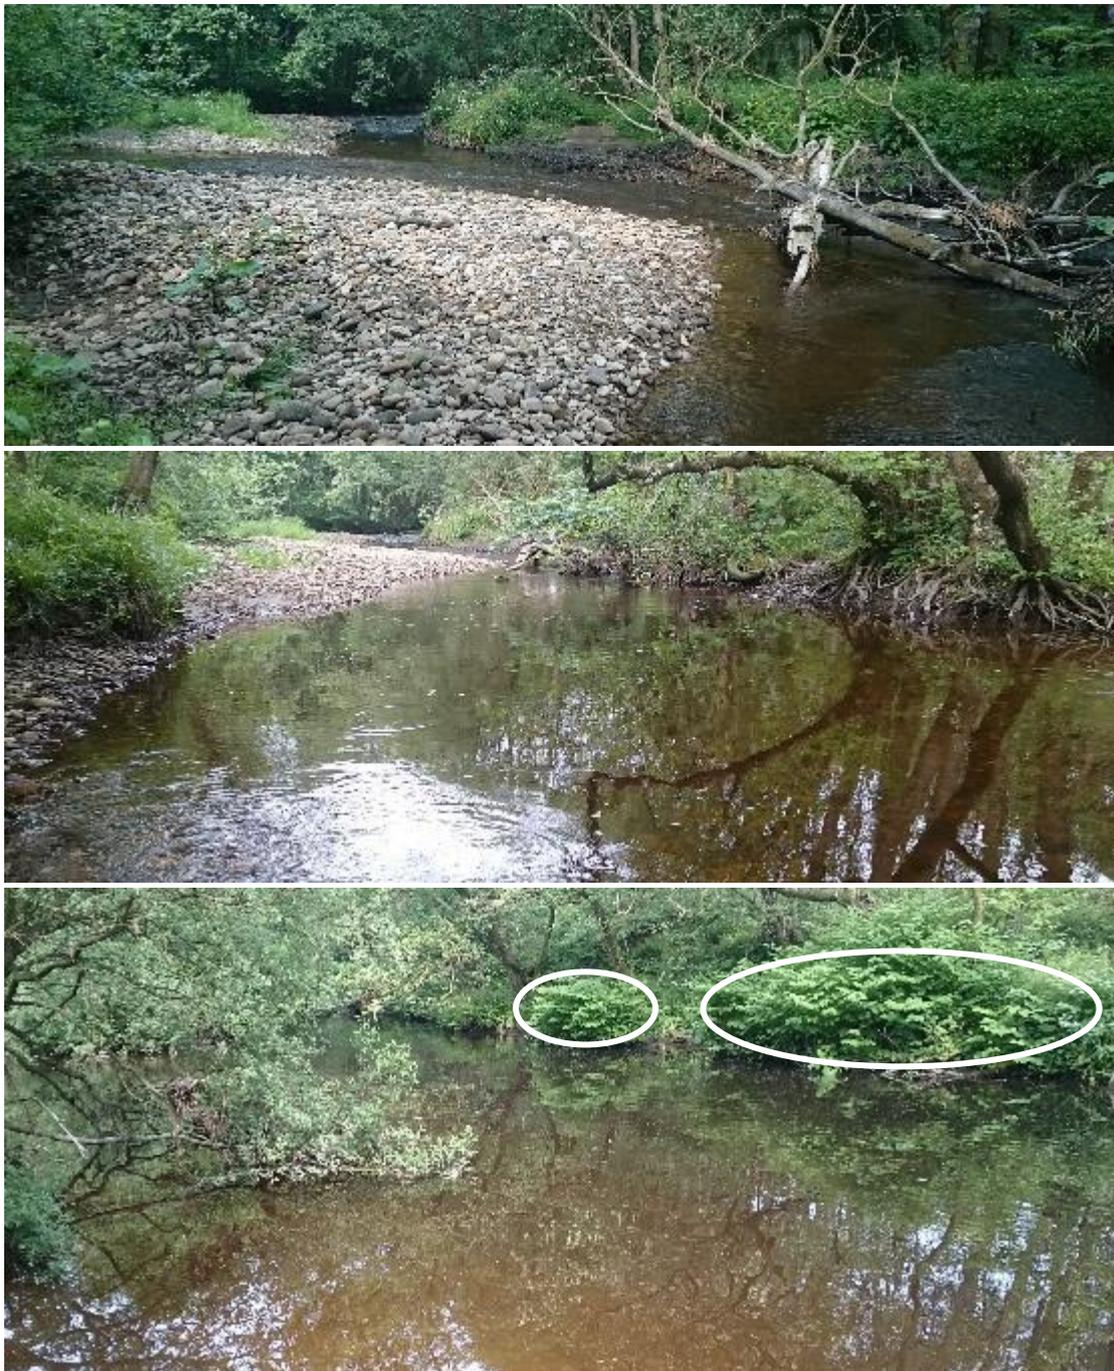
Fig 7. Upper: cobble and gravel bars, meandering planform and large woody material maintain natural geomorphology of the river below the confluence. Mid: pool with excellent quality gravels for spawning habitat and refugia in alder roots; note dimple ring left by rise of small trout. Lower: deeper, slower flowing water as the river forms a delta with the reservoir; note the beneficial trailing branches of the willow but the presence of Japanese knotweed (white ellipses) on the opposite bank (LB).

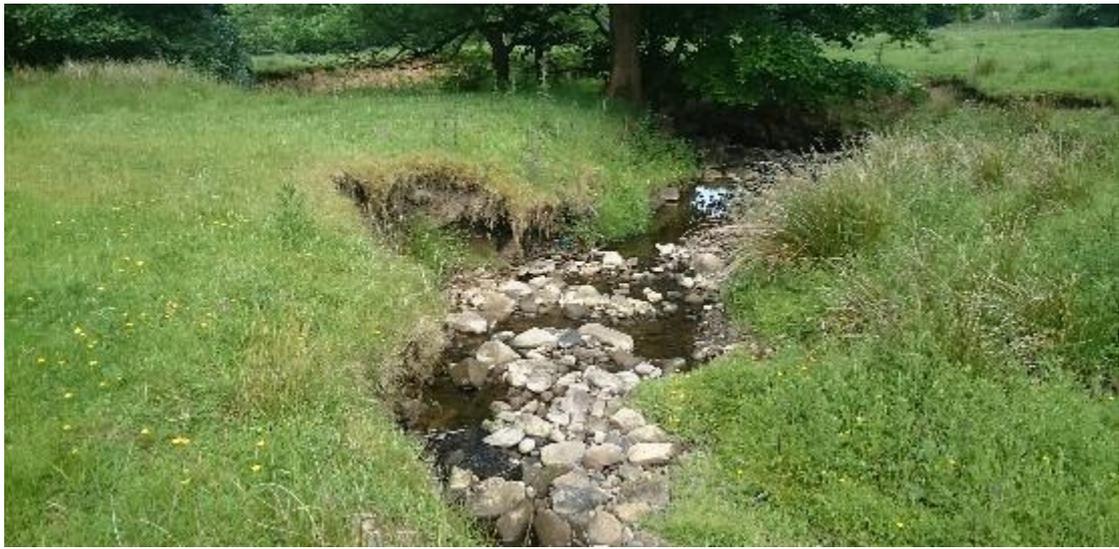
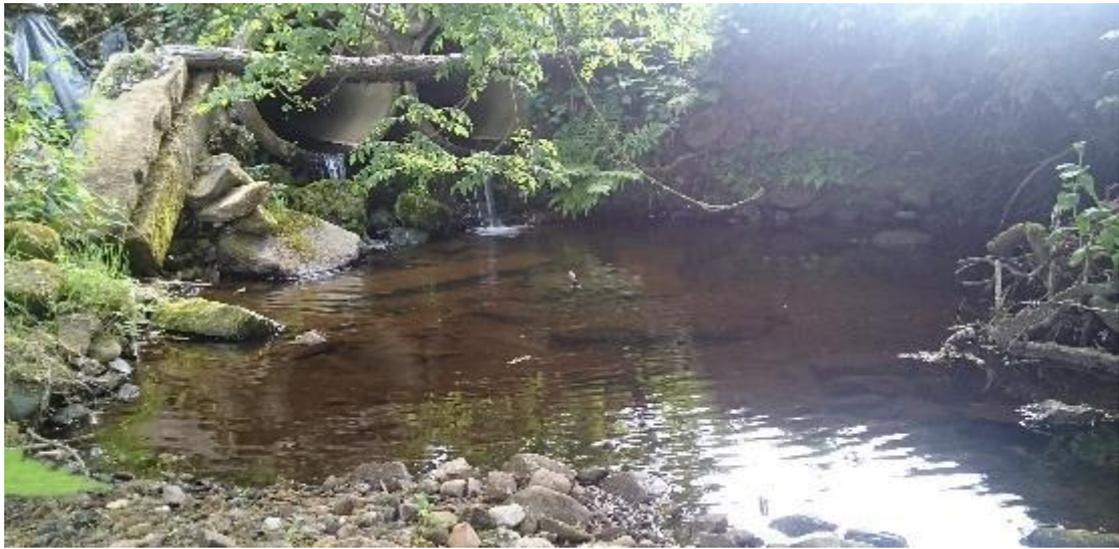
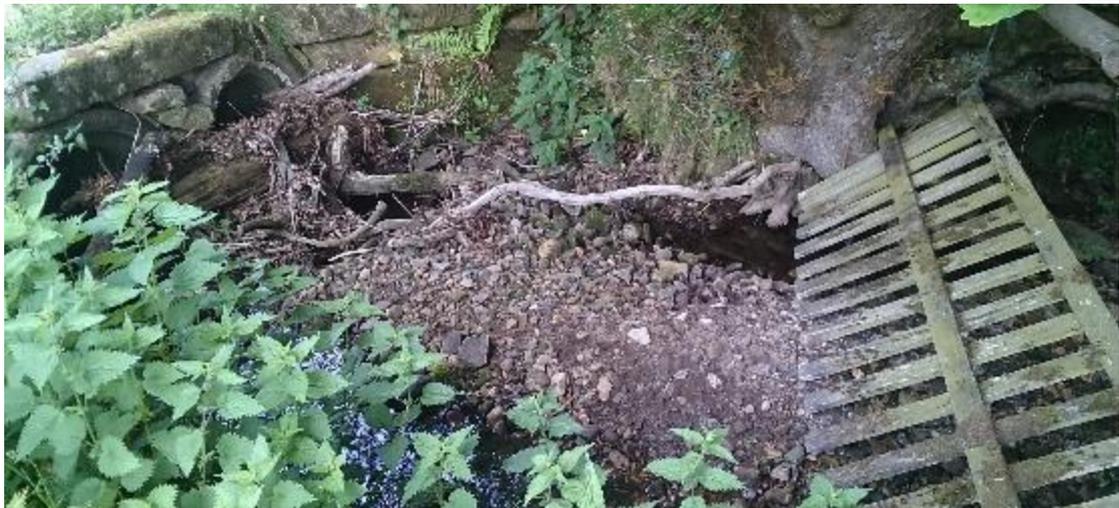
The tributary descending from Gallows Clough enters the Wyre on the RB near to the mill at SD5405753939. It was assessed to the first estate track crossing point, ~150m from the confluence with the Wyre. For most of that distance, it was devoid of much beneficial vegetative cover as it is exposed to stock grazing on both banks (Fig 8). As a consequence, the banks have been subject to considerable erosion over the last winter and the majority of the bed substrate comprises overly large boulders and cobbles relative to the cross sectional area and 'normal' flow observed. However, in the one deeper pool, beneath a mature tree and immediately d/s of the track culvert, there were several small trout indicating the potential of the beck for spawning and juvenile recruitment to the wider Wyre population. The double culvert pipes are perched, i.e. ~25cm above the pool surface, and the depth of water flow through the culvert was insufficient for fish passage (Fig 8 mid panel). Combined with accumulation of debris immediately u/s of the culvert pipes, these factors create a considerable barrier to fish movement both up and downstream. Single, large culverts always present a better option than multiple smaller ones and should be sunken at least one third of their depth below the bed of the watercourse to allow free movement of sediment and prevent them from becoming perched.

Fig 8. Upper: beck descending from Gallows Clough showing lack of bankside cover and oversized substrate. Mid: pool below perched culvert pipes at the track crossing. Lower: debris and water gate immediately u/s of culvert pipes; note deposit bar of appropriately sized spawning gravels cobble and gravel bars prevented from moving d/s by debris blockage.

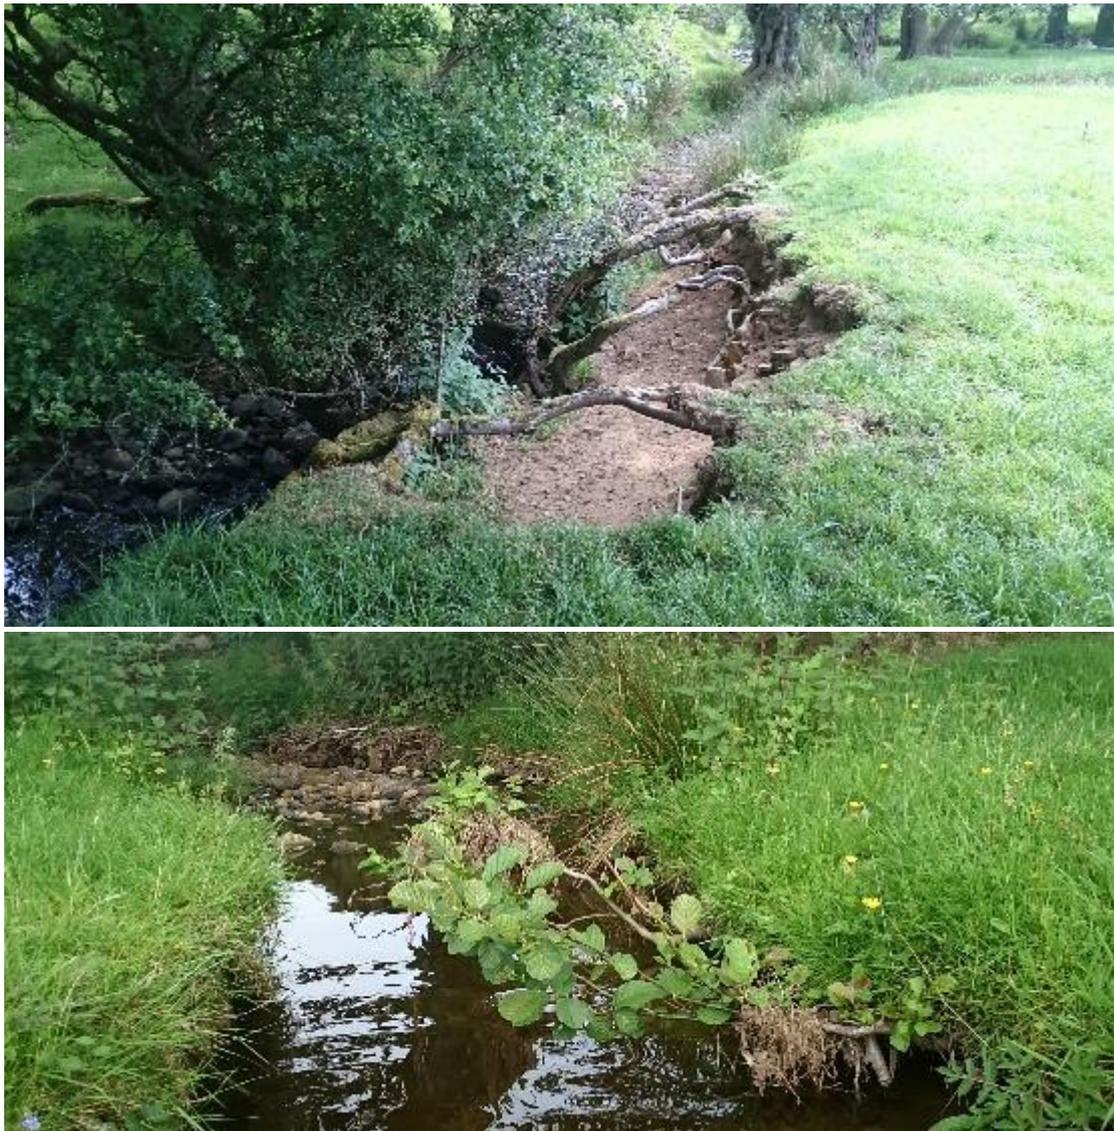
The joint flow of Parson's Brook and Joshua's Beck enters the Wyre on the RB at SD5509253828. Both watercourses were walked for their lowest 20m to confirm the presence of trout. However, the following focuses on the 150m between the confluence with the Wyre and the estate track ~150m u/s, where there is some intriguing man-made infrastructure installed. The culvert under the track is perched (~15cm) and so constitutes a barrier to free fish passage; the pool immediately d/s contained >10 trout. Sheep grazing and trampling has impacted upon bank integrity and the flora (Fig 9).

Fig 9. Impacts of sheep: undermining the root structure of hawthorne bushes (upper); and (lower) browsing of this small alder, effectively forcing it grow horizontally over the channel so that now it can be accessed from the opposite bank.

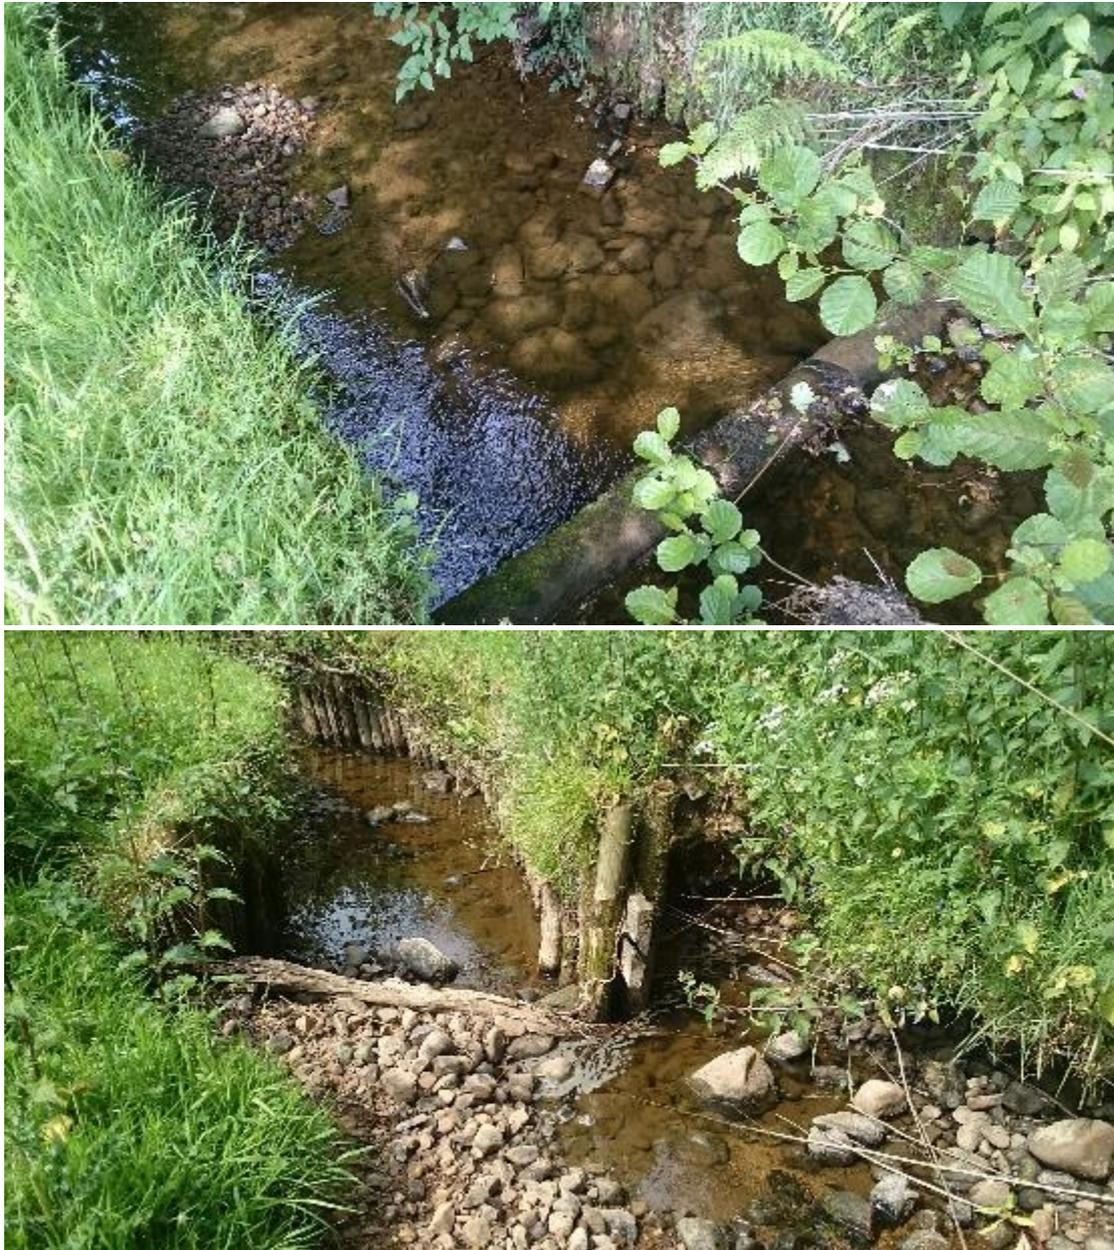
Fig 10. Wooden pilings and weirs introduced into the small tributary.

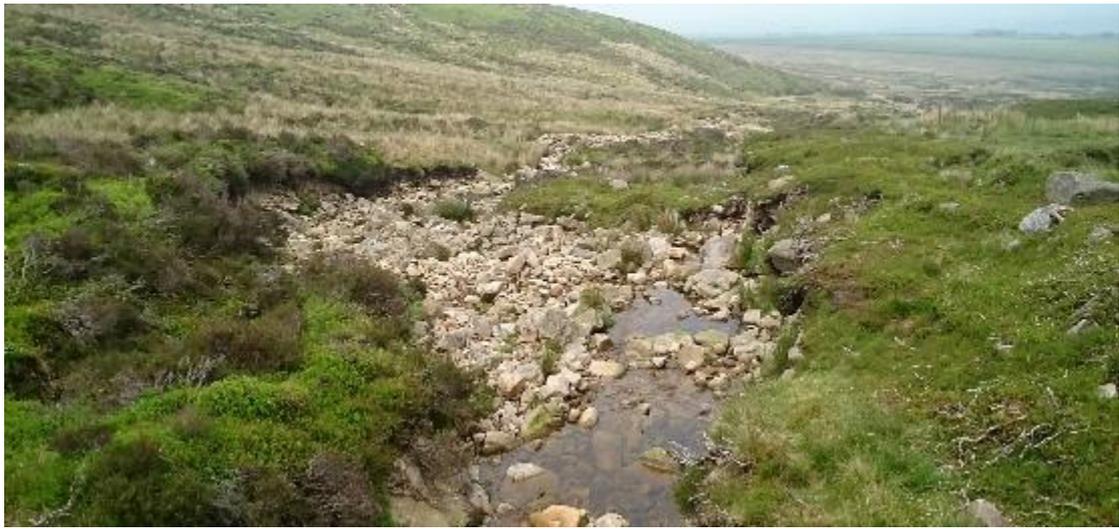
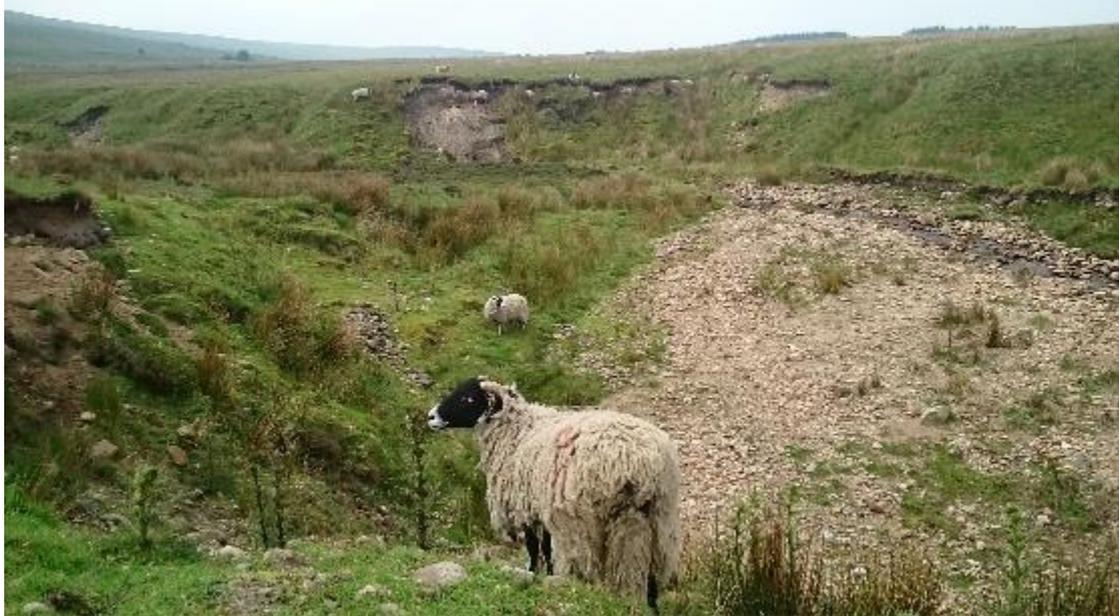
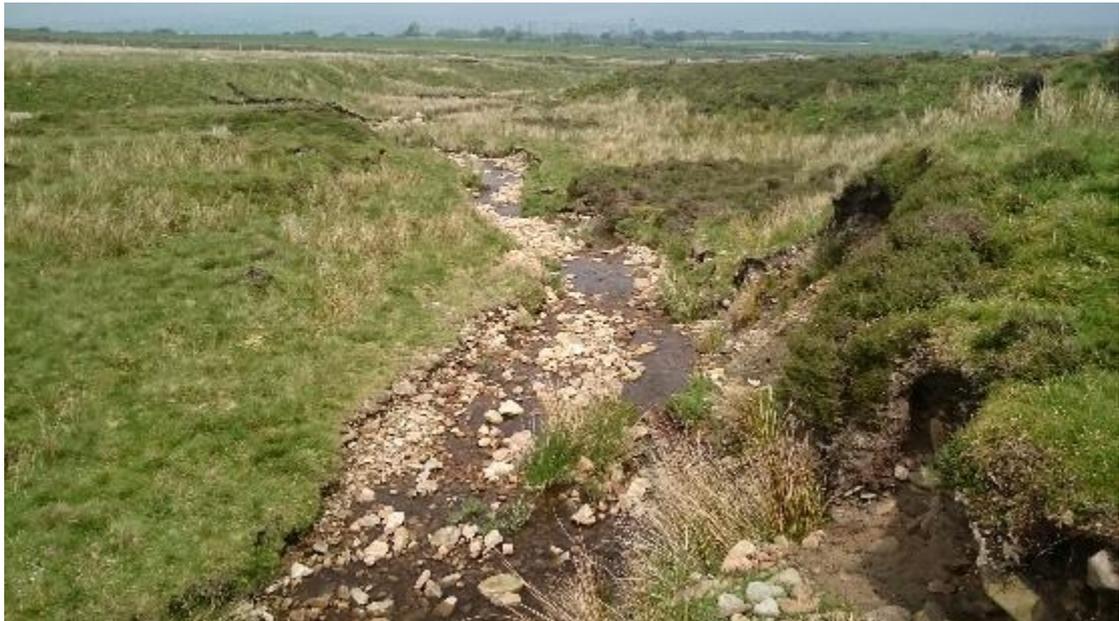
Fig 11. Upper: Cam Brook ~700m u/s of the road; evidence of severe flooding. Mid: sheep using the scours and landslips. Lower: a few trout were observed here, despite the exposed nature of the environment.

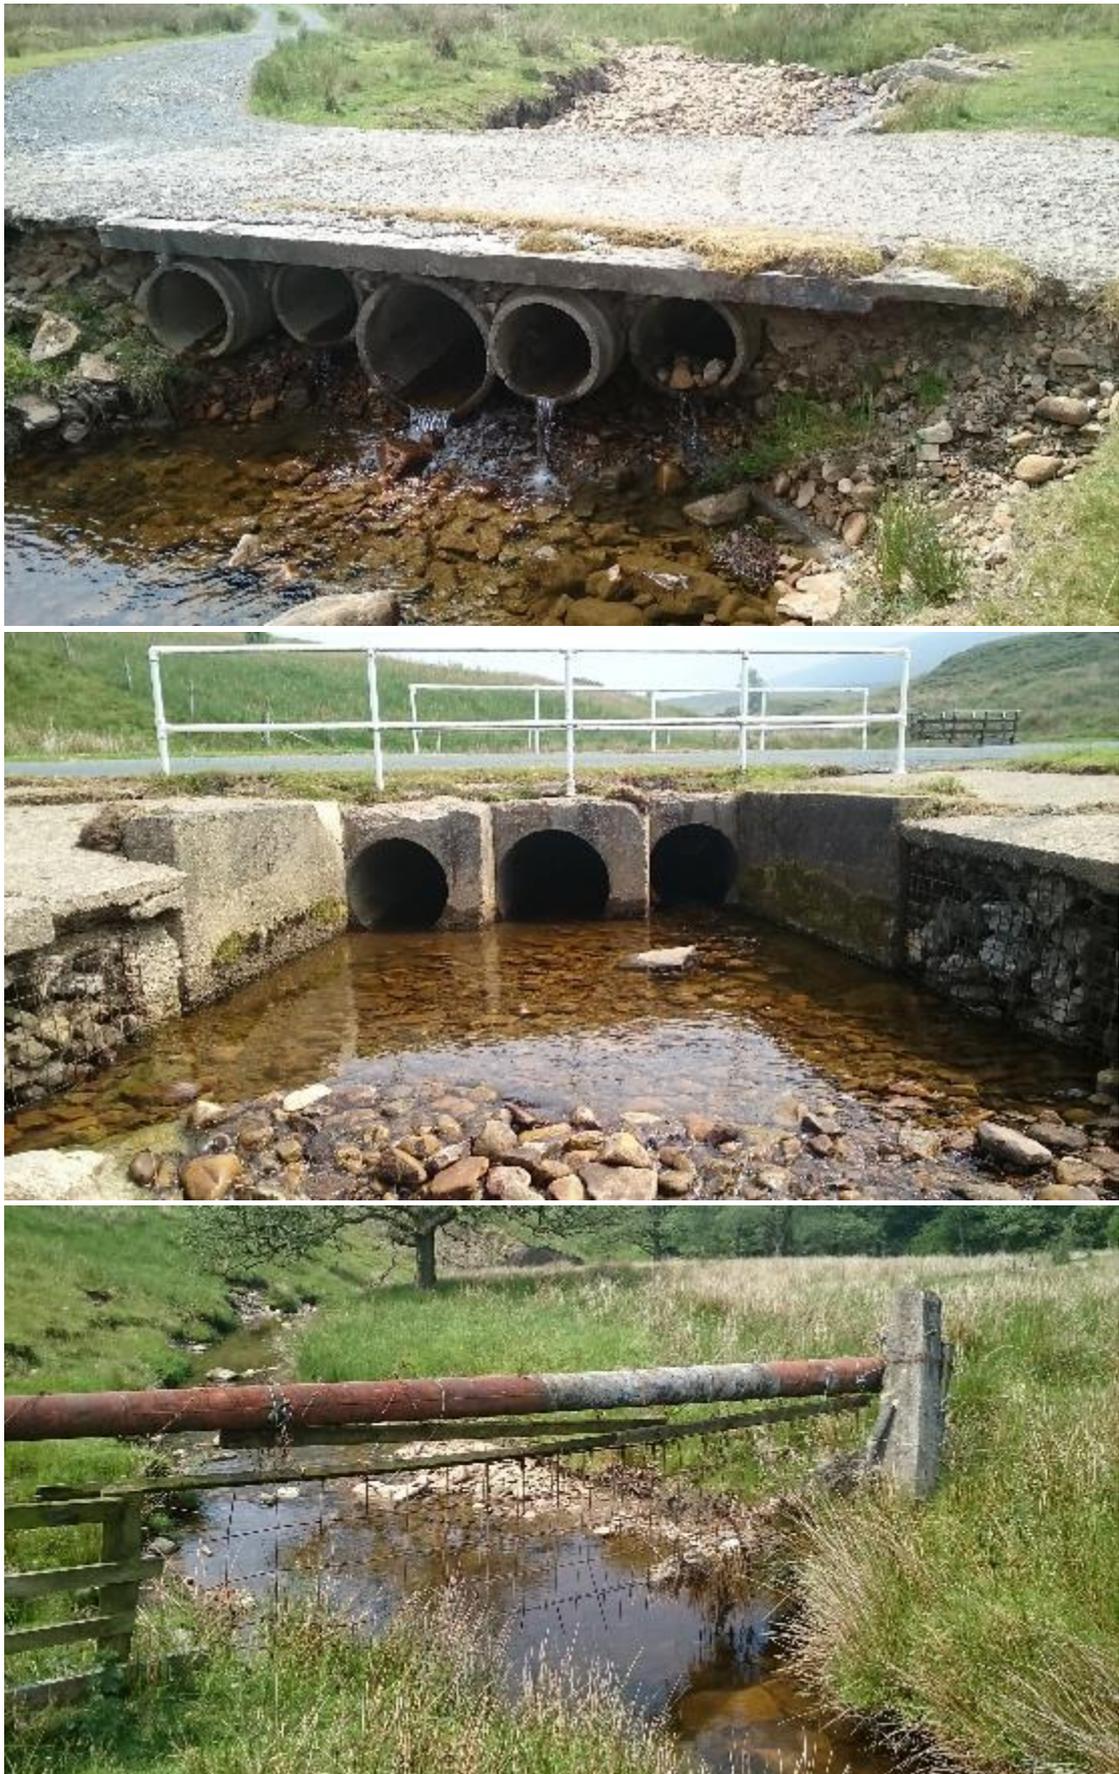
Fig 12. Upper: perched culvert pipes at the lower end of Catshaw Greave; note the interruption of sediment transport and cobble deposits u/s. Mid: more appropriate culverting with at least some water depth maintained throughout, under the road at Cam Brow. Lower: pool at the watergate immediately d/s of the road culvert containing >10 trout.

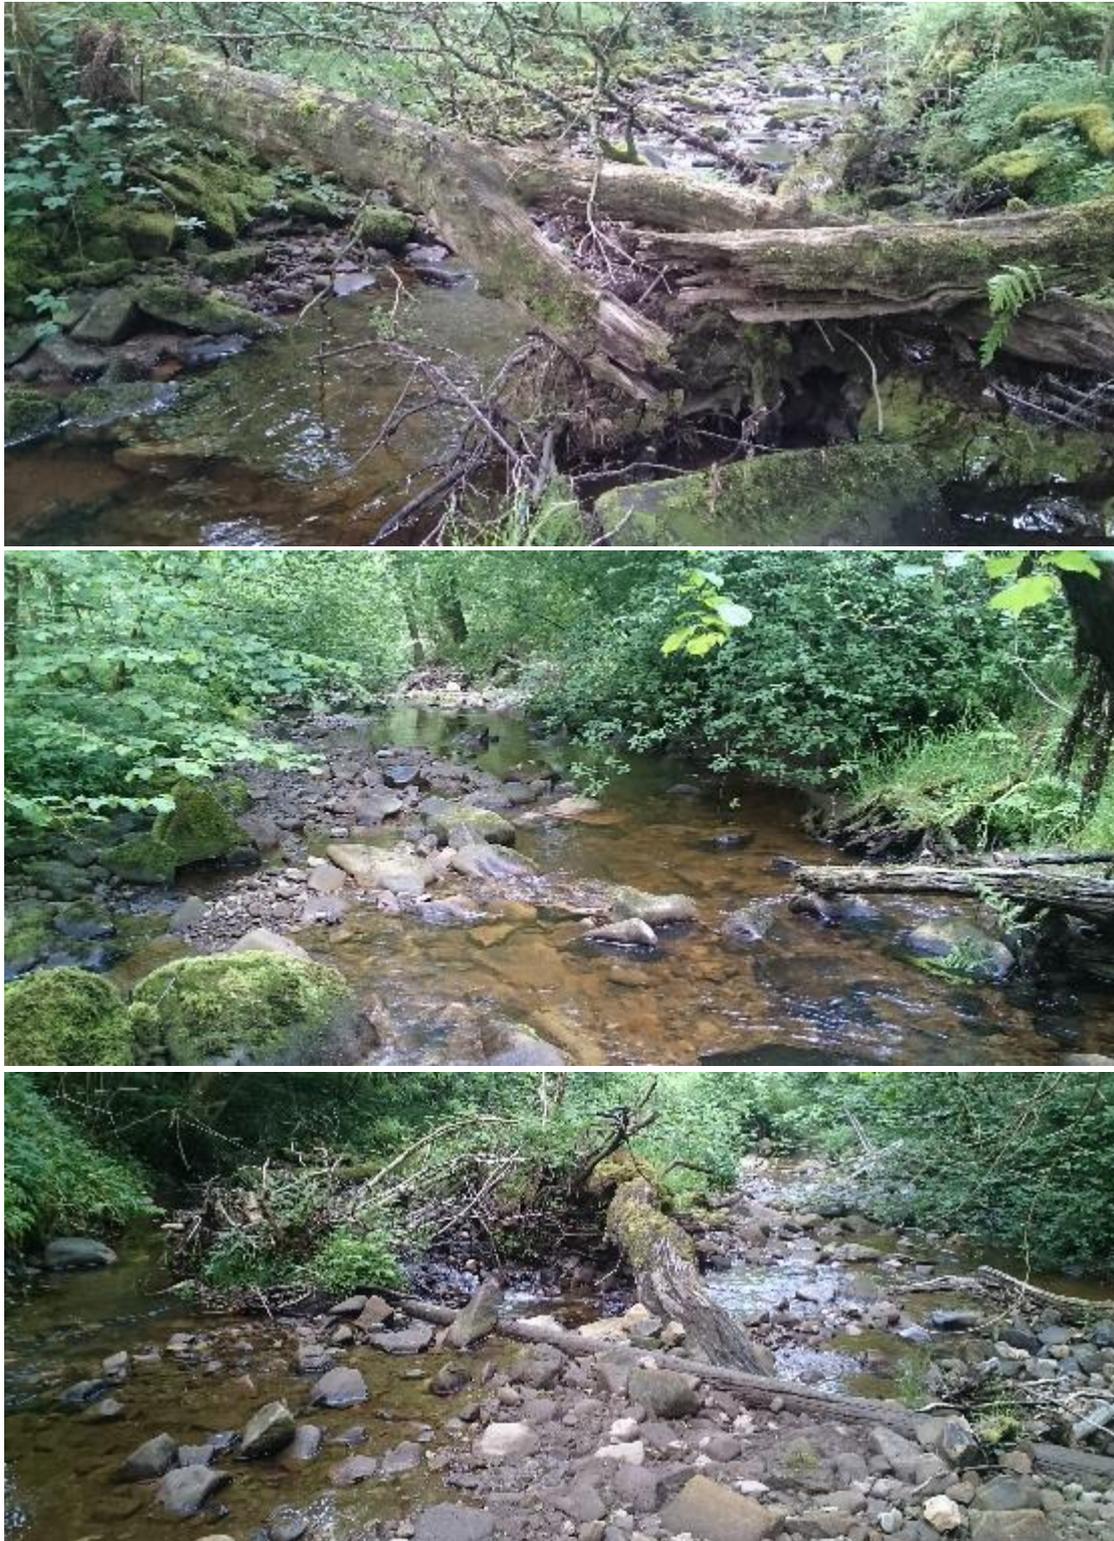
Fig 13. Examples of excellent quality juvenile salmonid habitat induced by woody material, naturally introduced and retained in channel, which also retained ramps of finer gravels for spawning.

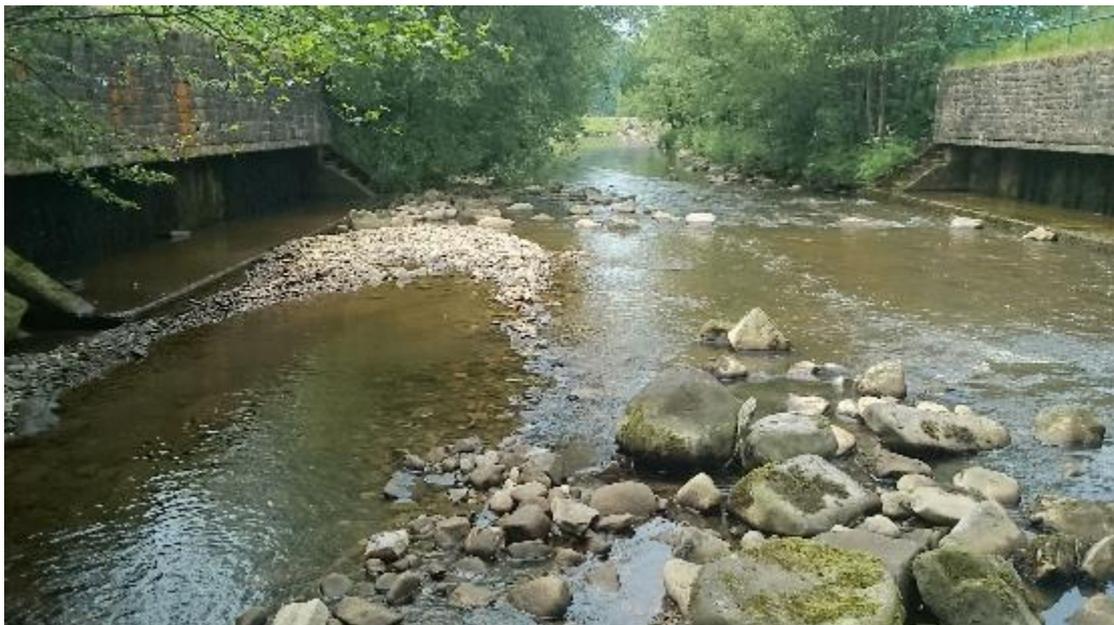
Cam Brook discharges into the Wyre immediately u/s of the concrete Lune-Wyre Transfer infrastructure which spans the entire channel of the Wyre (Fig 14). As such, it will be important to maintain as much natural riparian cover and ensure that access to the brook is of sufficient depth to encourage use during spawning.

Fig 14. Looking d/s between the Lune-Wyre Transfer ducts. The Wyre flows past toward the RB; the Cam Brook enters from the LB (bottom left of shot) and the deposition arc ramp of gravel can be clearly seen. Access and attraction flow are limited at this water level, especially as the bed of the Wyre between the ducts is a concrete slab.

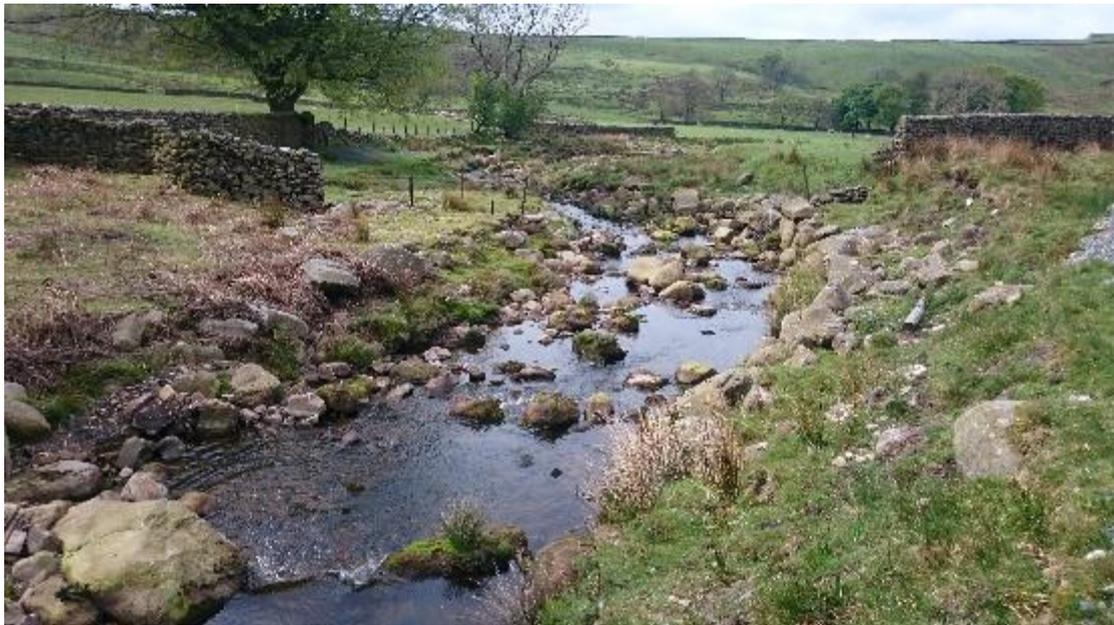
At Pea Carr Barn (SD5980955643), the Tarnbrook Wyre already shows signs of flashy, spate flows (Fig 15), with the substrate dominated by large boulders and very little retention of fine gravels. The riparian vegetation is restricted to closely grazed grasses, *Juncus* rushes and some bracken.

Fig 15. The Tarnbrook Wyre at Pea Carr Barn.

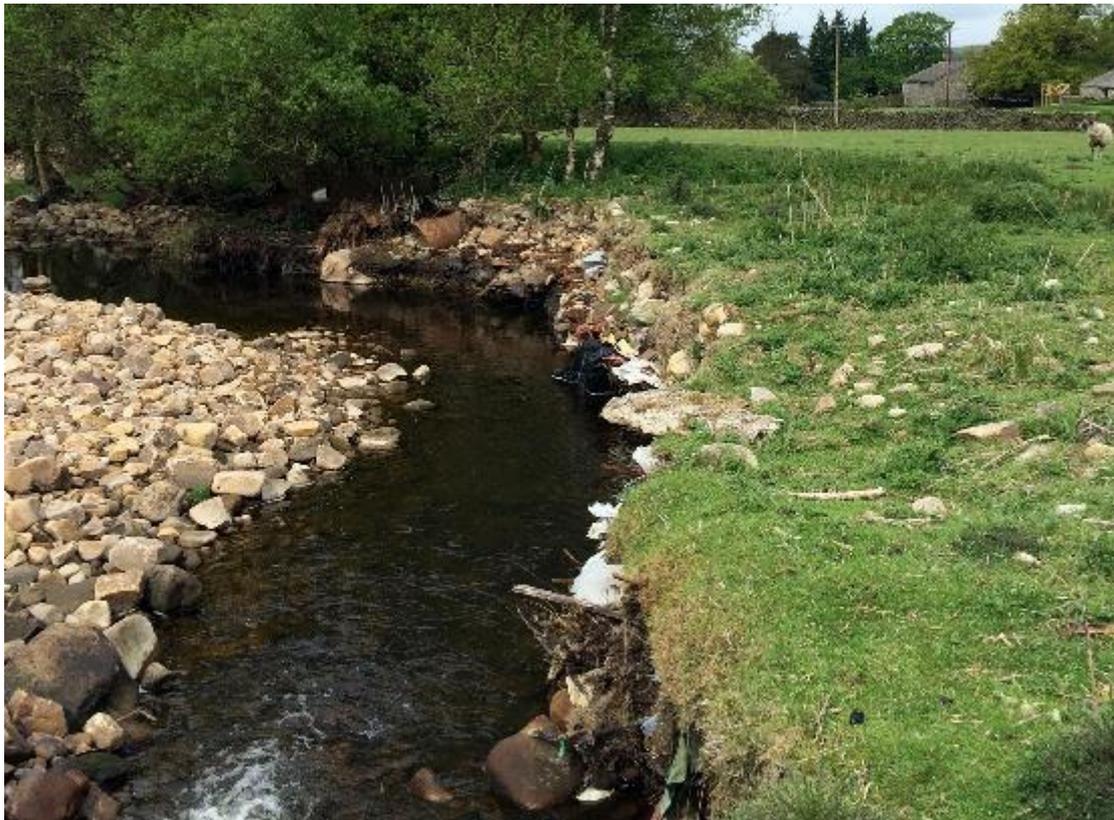
Fig 16. Erosion into the 'midden' at the Tarnbrook farm exposing some relatively modern rubbish which is being liberally distributed downstream. Photo: Tom Myerscough
