Advisory Visit
Upper Wyre, Abbeystead Estate
June/July 2016

1.0 Introduction

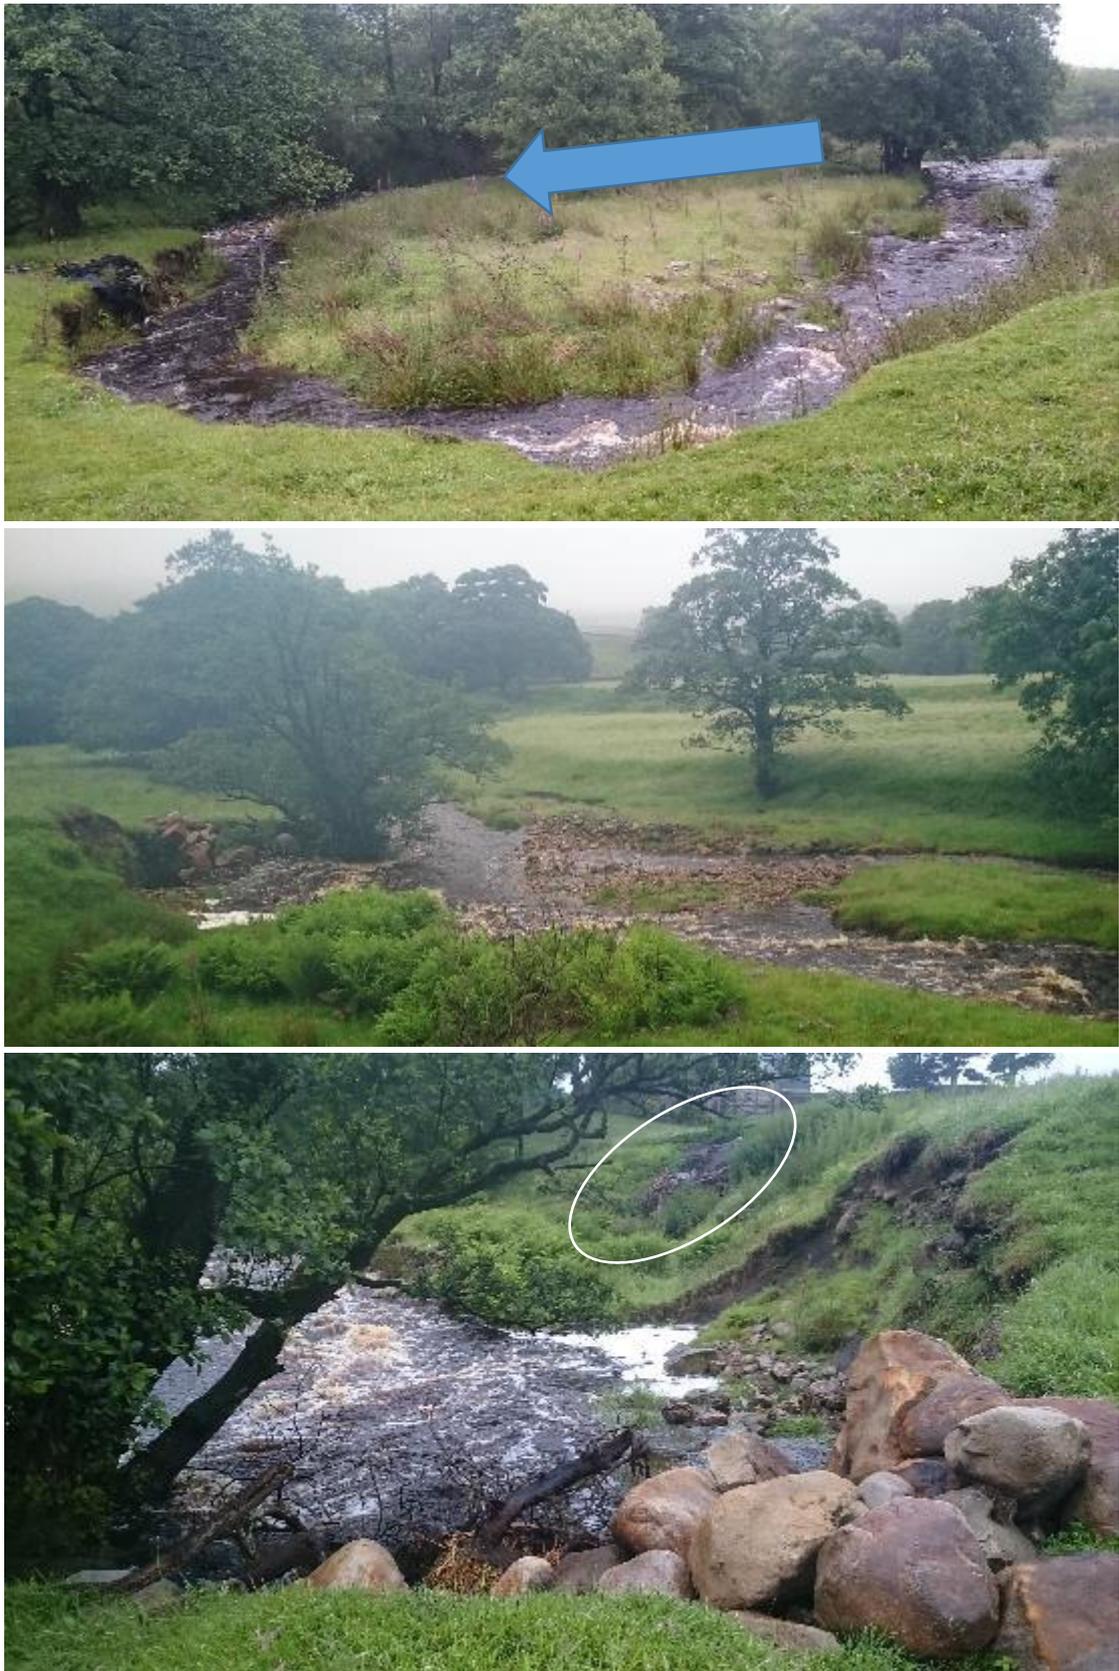
Fig 17. Upper: the river has braided and cut an entirely new channel (foreground) which loops back into the main channel (blue arrow). Mid: Excessive erosion on the grazed LB is cutting behind an established tree. Lower: boulders have been tipped in to try and alleviate the erosion; note the tipping of waste in the background (white ellipse).

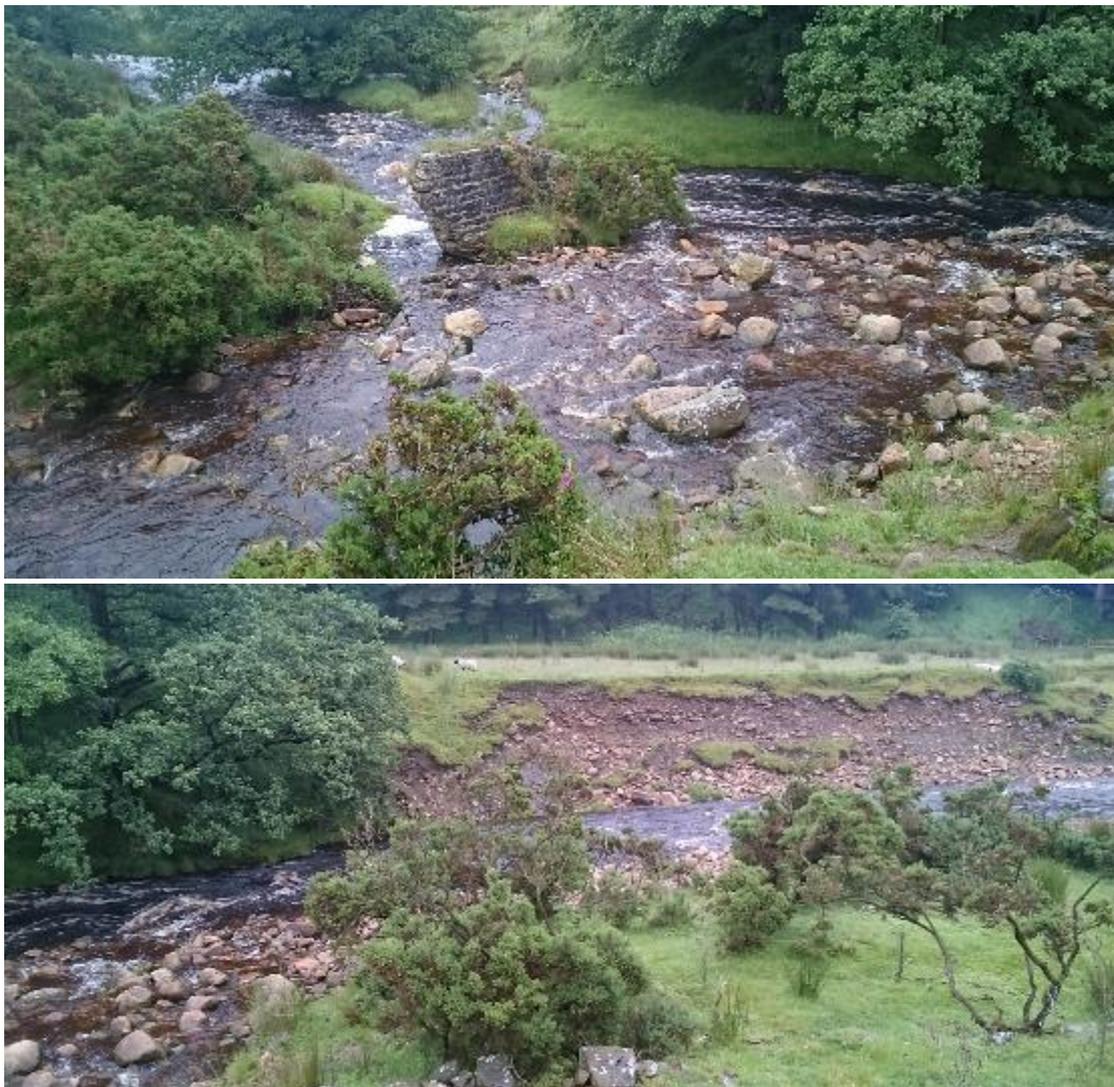
Downstream from Lee Bridge (itself a barrier to free passage: flume effect), the R. Grizedale enters from the RB, and the brook wends for ~1km to the estate office. Spate flow from the Grizedale has clearly deposited a considerable amount of boulder substrate at the confluence, as well as contributing to erosion on the LB of the Tarnbrook Wyre d/s which would otherwise be protected by riparian trees (Fig 18).

Fig 18. Upper: the Tarnbrook Wyre (flowing from top left to right) is joined by the R Grizedale (bottom left). Considerable deposition of large boulders has occurred. Lower: immediately d/s on the Tarnbrook Wyre LB there is considerable erosion caused by spate flow from the Grizedale (confluence, bottom left).

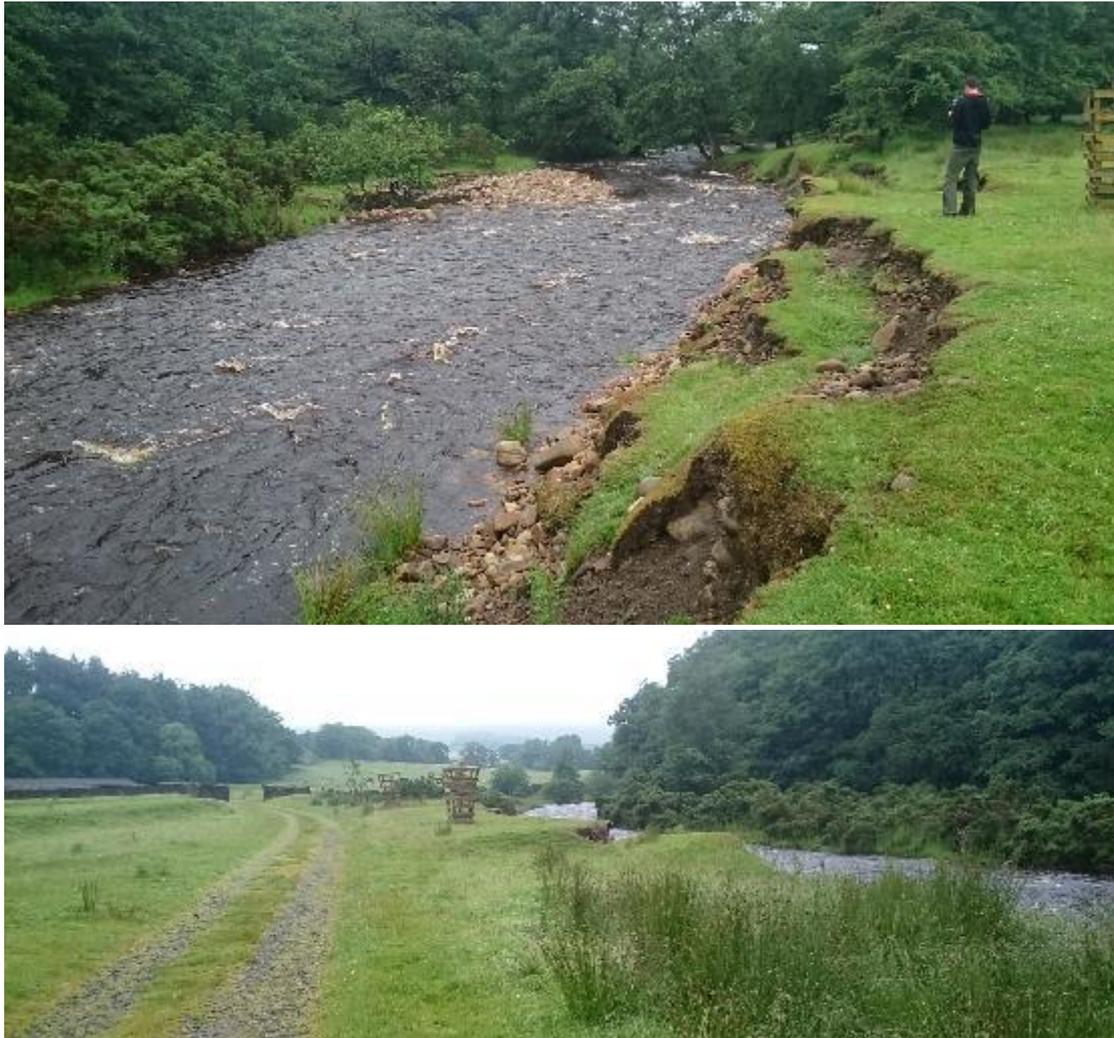
Fig 19. Upper: looking d/s at erosion exacerbated by livestock. Lower: looking back u/s to demonstrate proximity of track and presence of wooden protectors around ornamental trees.

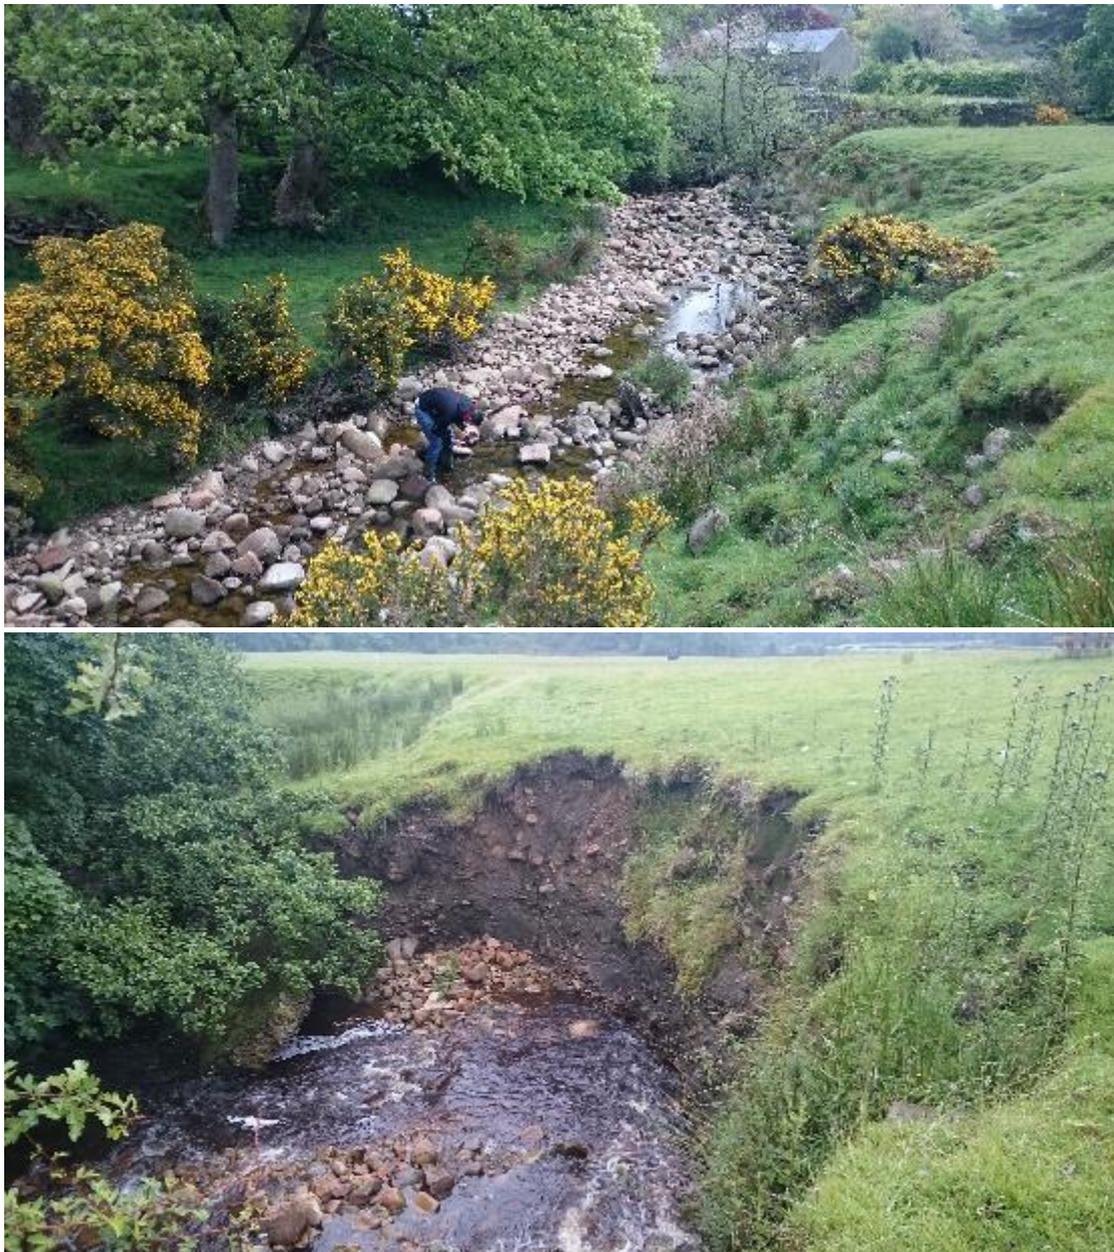
draining the steeper cloughs, the substrate size (and lack of retention of smaller particles) indicates a very flashy hydrograph which places un-natural erosional stress on the banks, especially where these are also grazed by livestock (Fig 20).

Fig 20. Upper: the Grizedale under low flow ('full-take' abstracted) during the first visit; and Lower: erosion particularly on the grazed banks. Note the lack of species diversity growing along the bank top (due to grazing) and the associated lack of root structure within the bank.

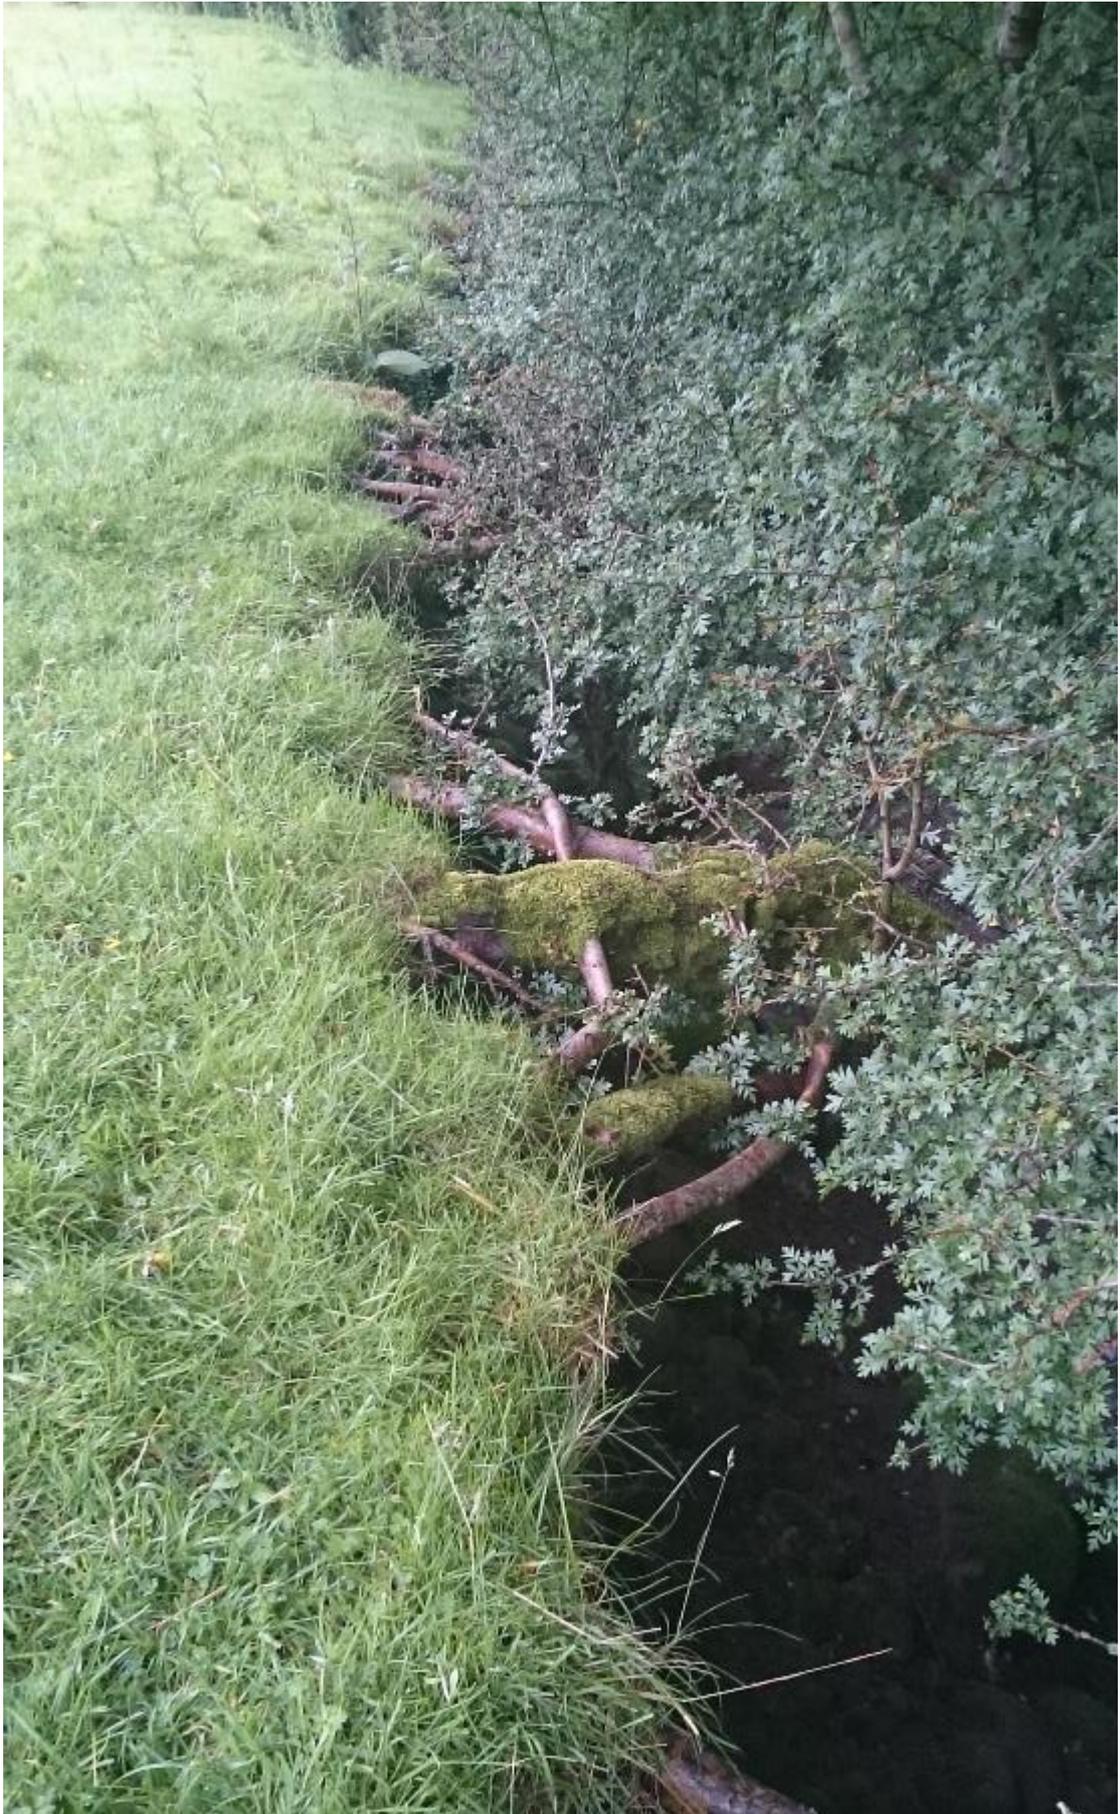
Fig 21. Horizontal roots protecting these mature hawthorns from erosion by the river, but sheep grazing and trampling of these roots will eventually weaken them and a large area of bank and all the fine soil associated with it will be swept into the Tarnbrook Wyre and eventually to the reservoir.

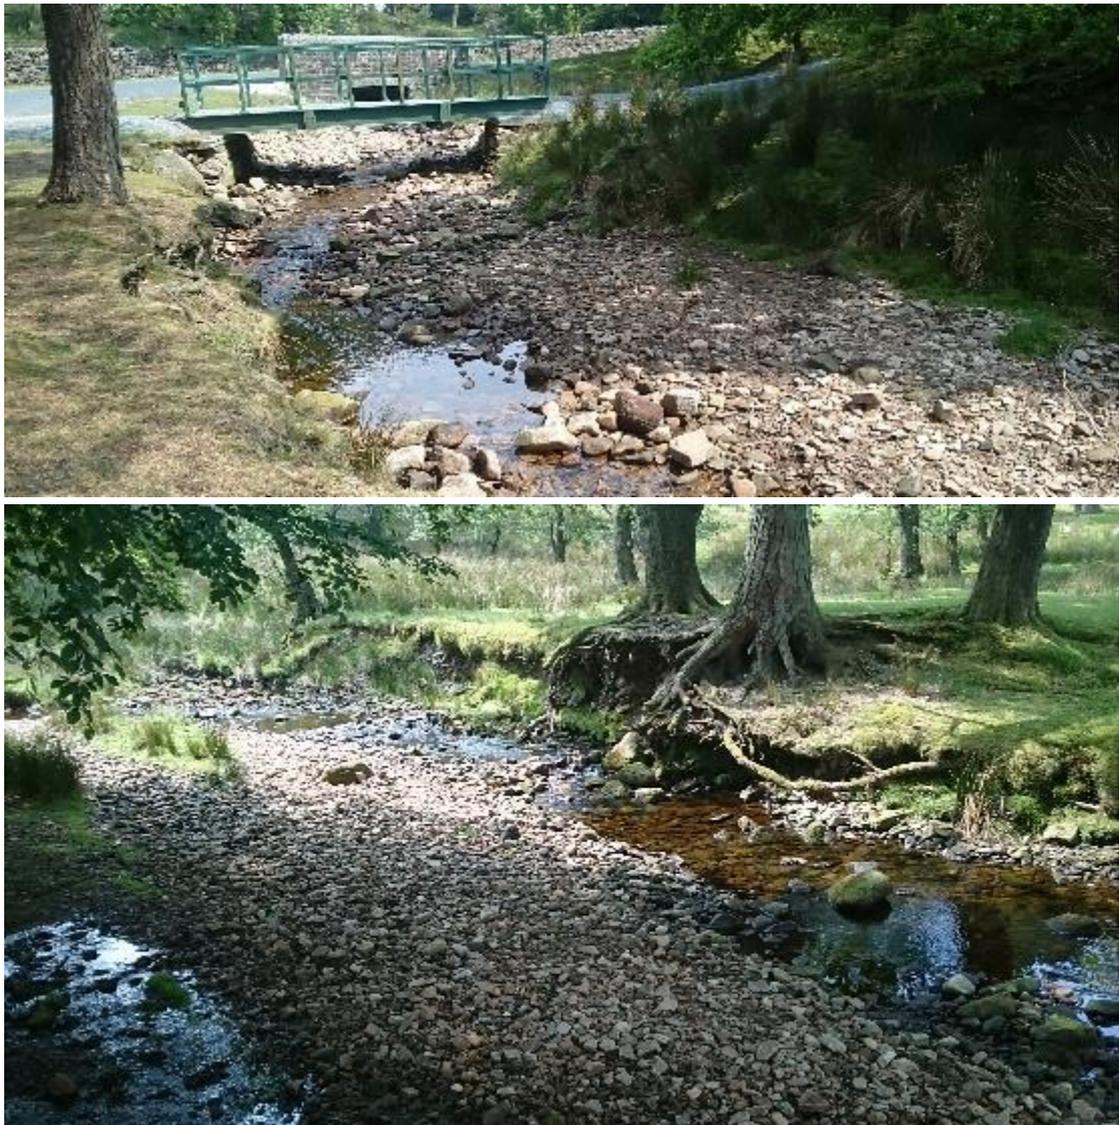
Various sections of the Marshaw Wyre were assessed on different days but for consistency the report will proceed from the uppermost site (SD6126653868) in a d/s direction. At this point it encounters and then runs parallel to the Trough Road (on the RB), and the surrounding land changes from open heather moorland to a sparse mixture of native coniferous and deciduous trees. Small trout were observed as far up as the estate track bridge (Fig 22). Already, the channel form and substrate suggests extremes of flow are experienced; it is wide with relatively large substrate and little evidence of particle size sorting except on the inside of sharper bends. The banks are heavily cropped by sheep (in some places degraded by picnickers) and numerous mature trees on the outside of bends are being undermined by erosion (Fig 22).

Fig 22. The Marshaw Wyre exhibiting an already overly wide channel and evidence of high spate flows leading to an over-supply of cobble substrate. Note the undermining of mature trees and closely grazed understory.

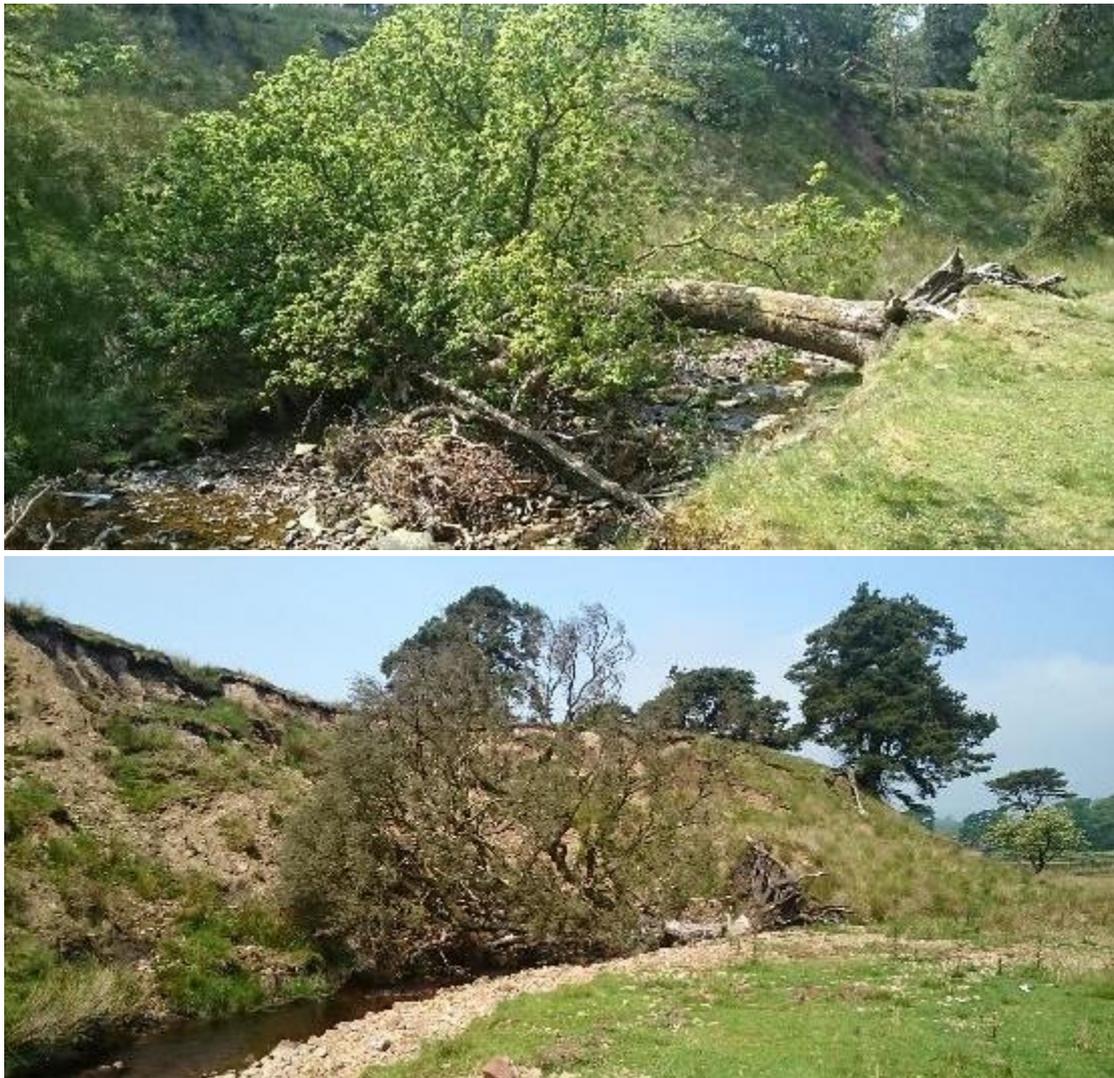
Fig 23. Fantastic tree fall (large woody material) in the channel. The beneficial functions of these trees should be retained whenever and wherever possible; by creating more bank resistance, large woody material produces bed scour rather than bank scour.

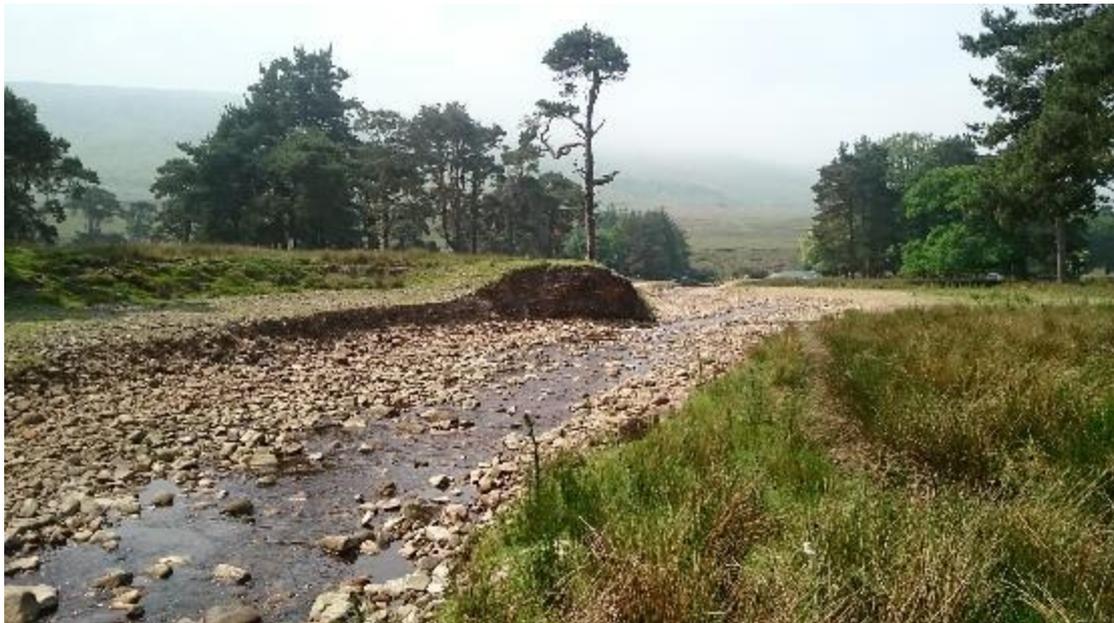
Fig 24. Extremely exposed channel above the Black Clough track bridge. The LB has been re-profiled using deposited material.

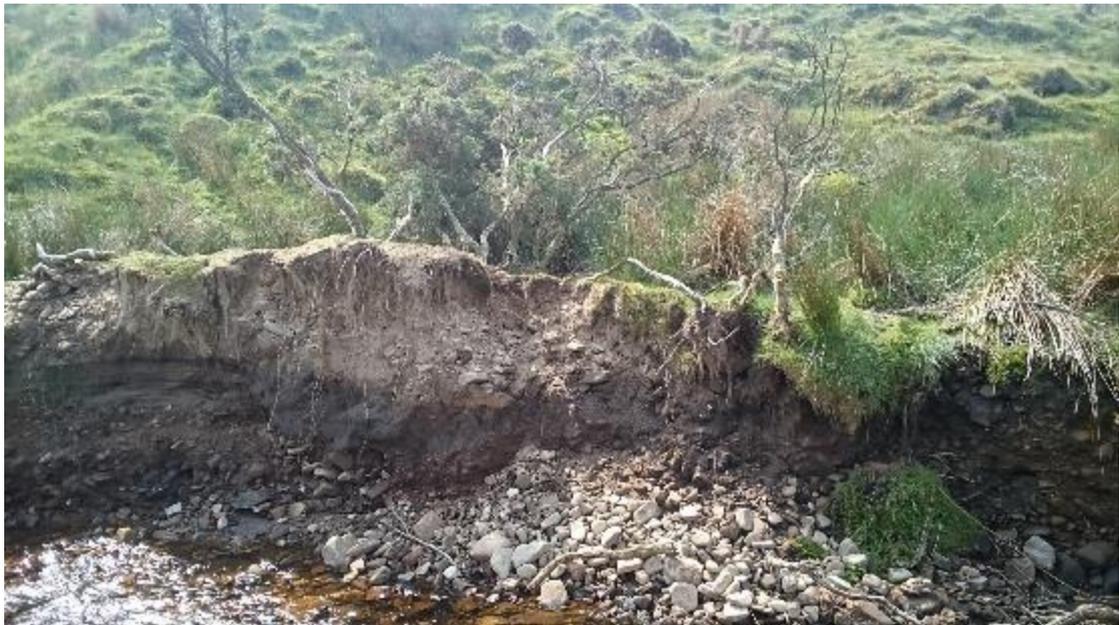
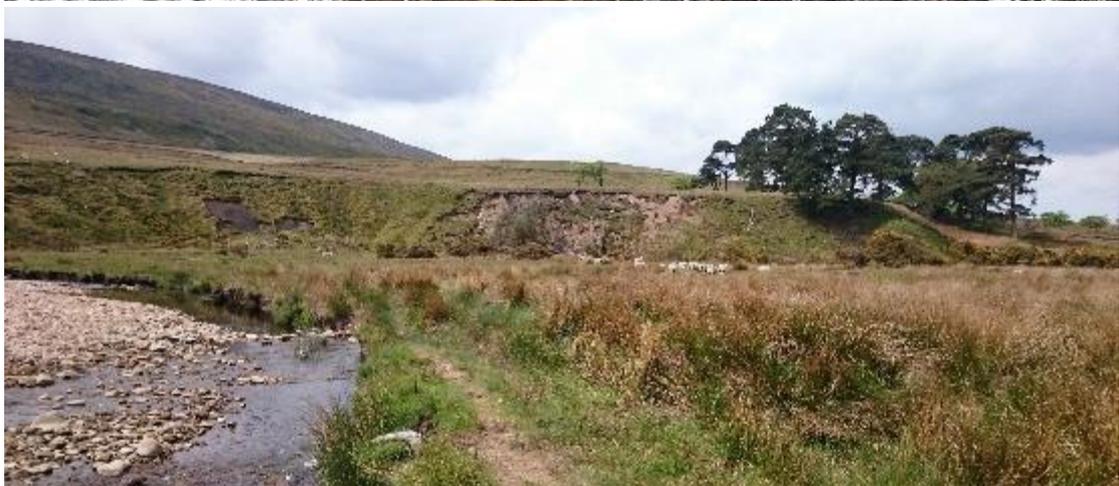
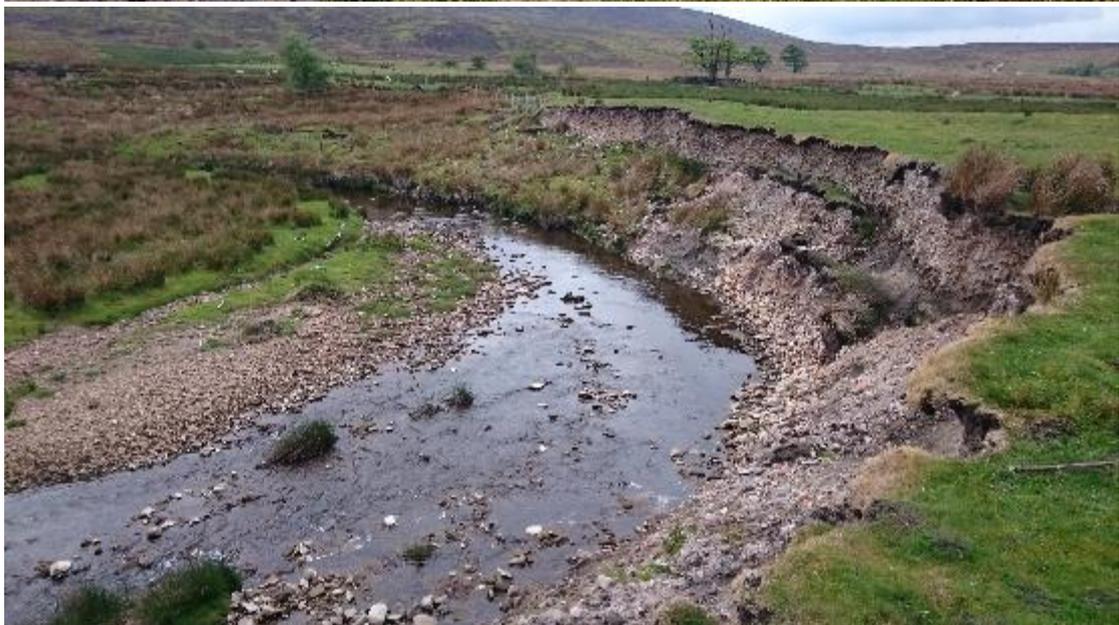
Immediately below the confluence with the Black Clough tributary, the Marshaw Wyre sweeps around a broad right hand bend and the combined spate flow of the two watercourses at that point seems to have worsened the erosion on the grazed LB (Fig 25). There are several bends from here to Well Brook where poor vegetative structure on the bank has allowed severe slippage to occur. The banks comprise former alluvial deposits which are now being cut back into, a natural process but operating at an excessive rate caused by accelerated conveyance from the moors and grazing pressure. Fascines, low, staked bundles of material aligned to the contours would help to reduce further erosion – see Recommendations.

Fig 25. Excessive bank erosion. Upper: immediately d/s with the confluence of Black Clough on the LB. Mid: landslips on the bend d/s of the confluence. Lower: further slippage not far u/s from Well Brook. Large areas like these would benefit from installation of fascines.

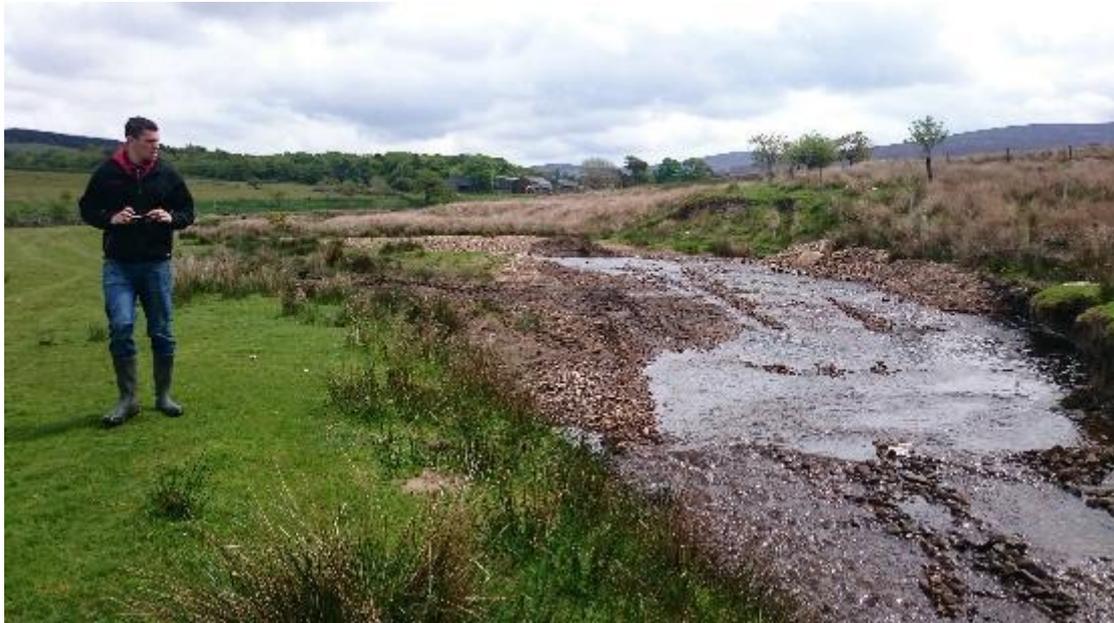
Fig 26. Very recent evidence of vehicles in the beck and use of unconsolidated gravels to shore up eroded banks.

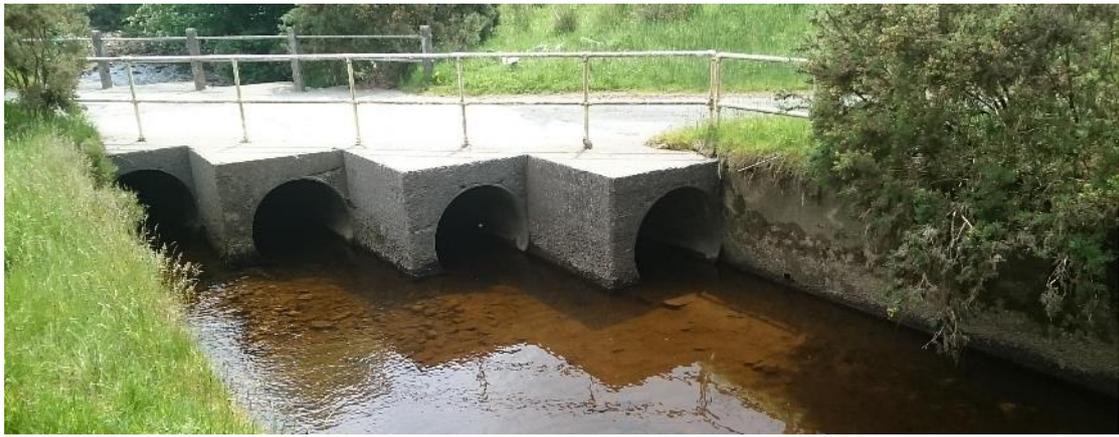
Fig 27. Adequate culverting under the road at Well Brook. Trout were observed swimming freely from the pool into the culvert pipes, and there were no passage issues at the u/s end.

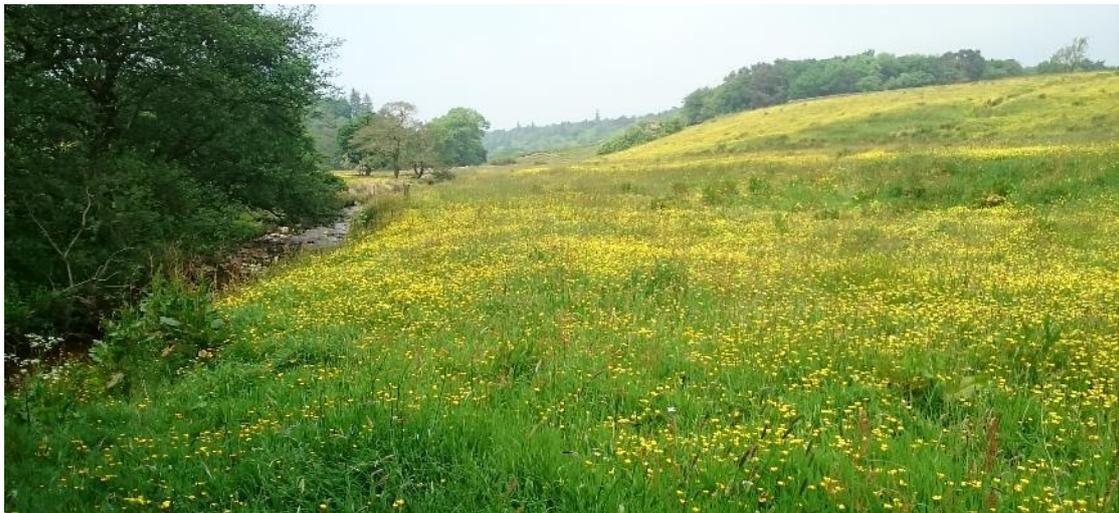
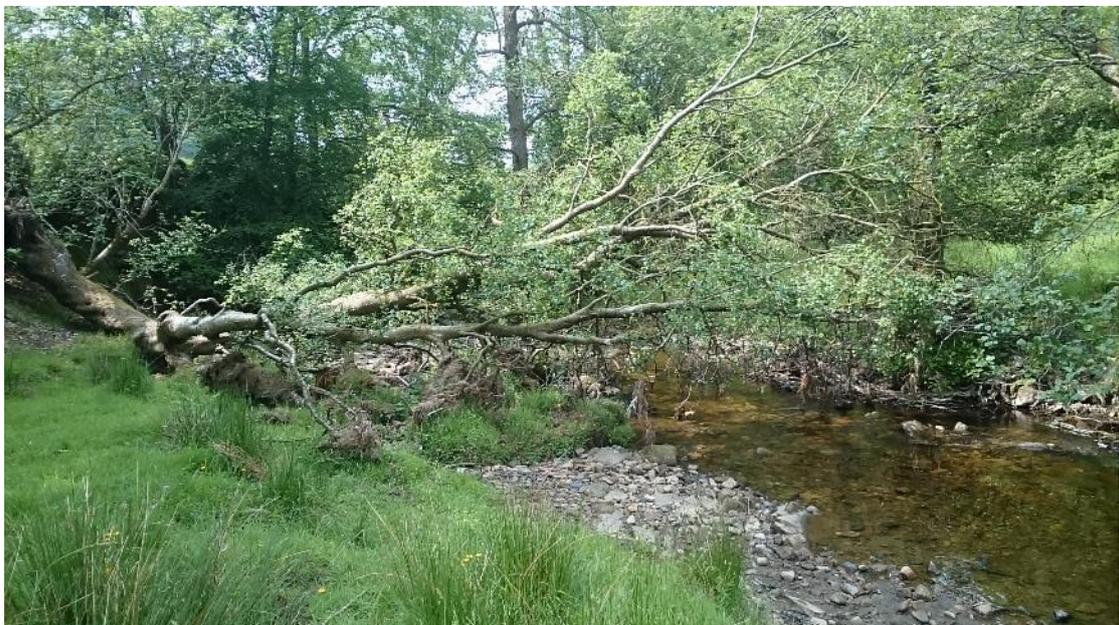
Fig 28. Upper: low intensity pasture / meadow below Well Brook but note the lack of self-set tree saplings / tree regeneration. Lower: where woodland replaced pasture, the quality of riparian and instream habitat improved.

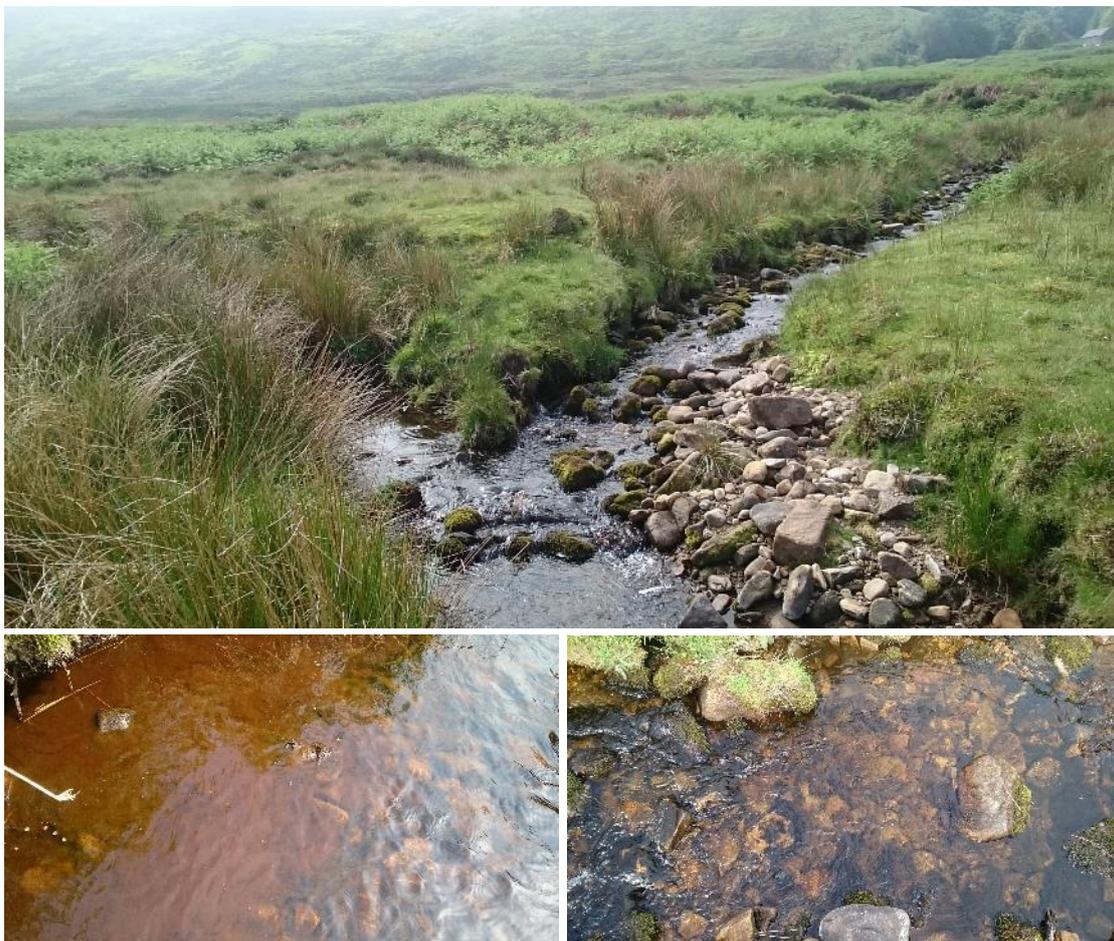
Fig 29. The confluence of small becks from Tail Clough (left) and Black Clough (right) and the difference in substrate quality evident in each

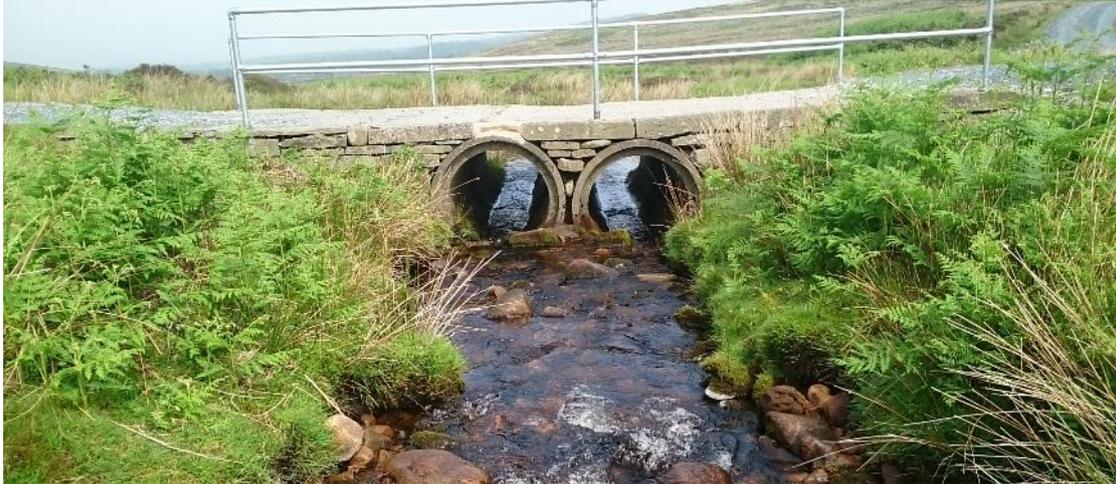
Fig 30. The culverted track bridge at the bottom of Black Clough is partially blocked at the u/s side and requires monitoring for maintenance of fish passage

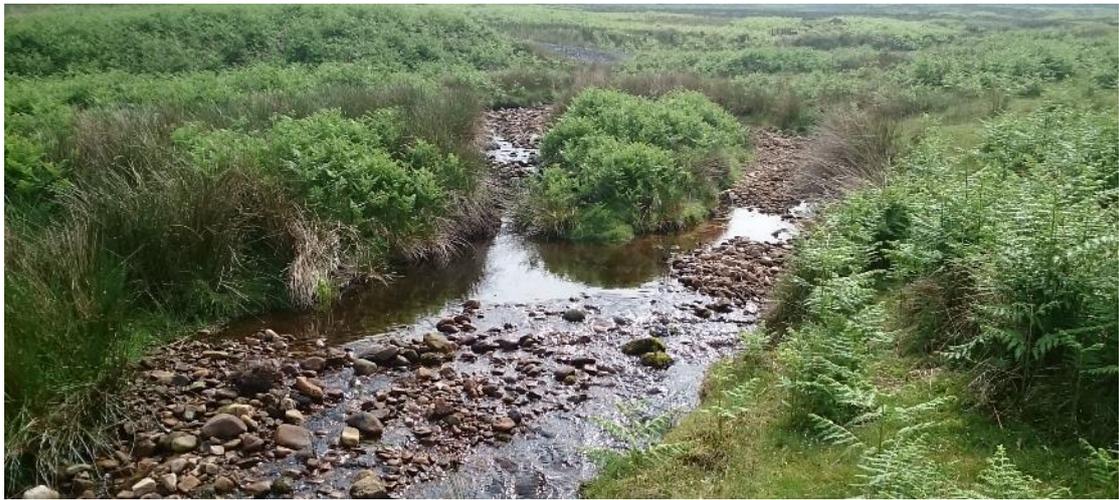
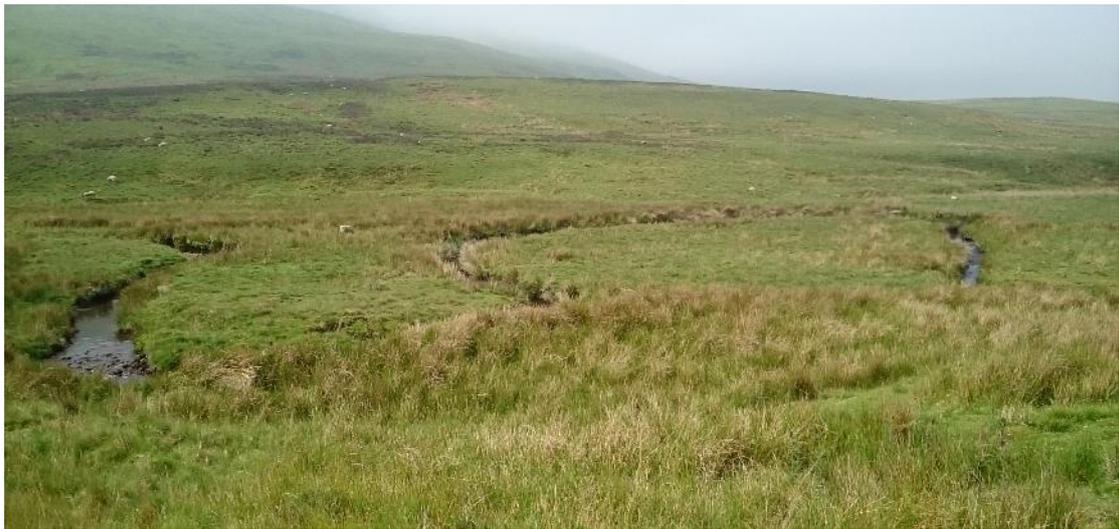
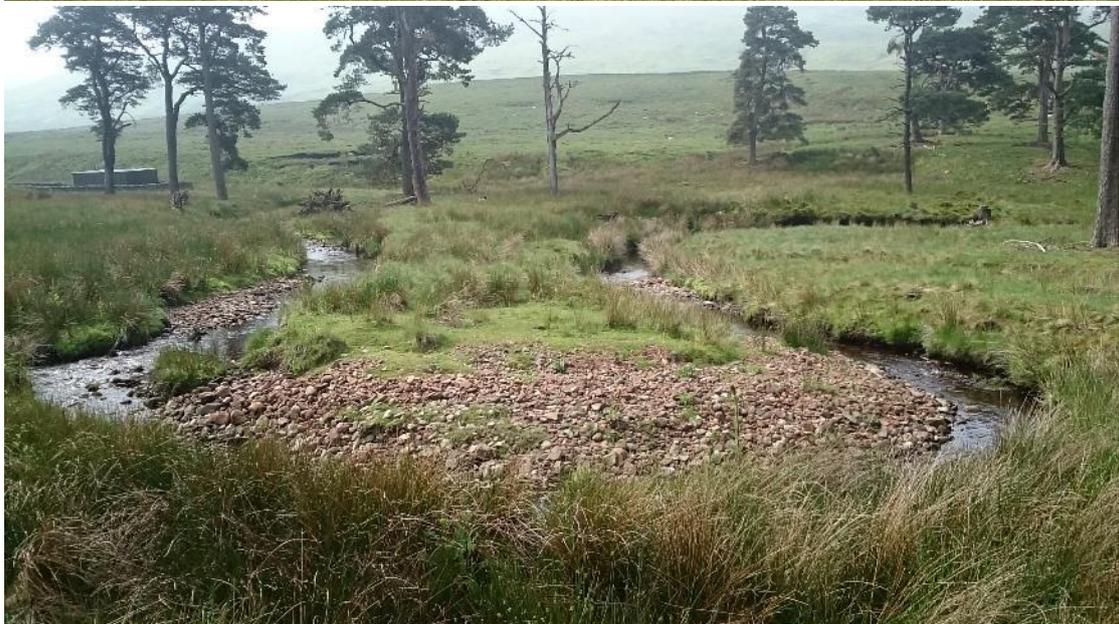
Fig 31. In the valley bottom, the tributary starts to braid (upper panel) and meander (lower panels) which will increase conveyance time to the Marshaw Wyre considerably.
