Advisory Visit

Town Beck and Back Beck, R. Wharfe, Addingham

13/12/2016

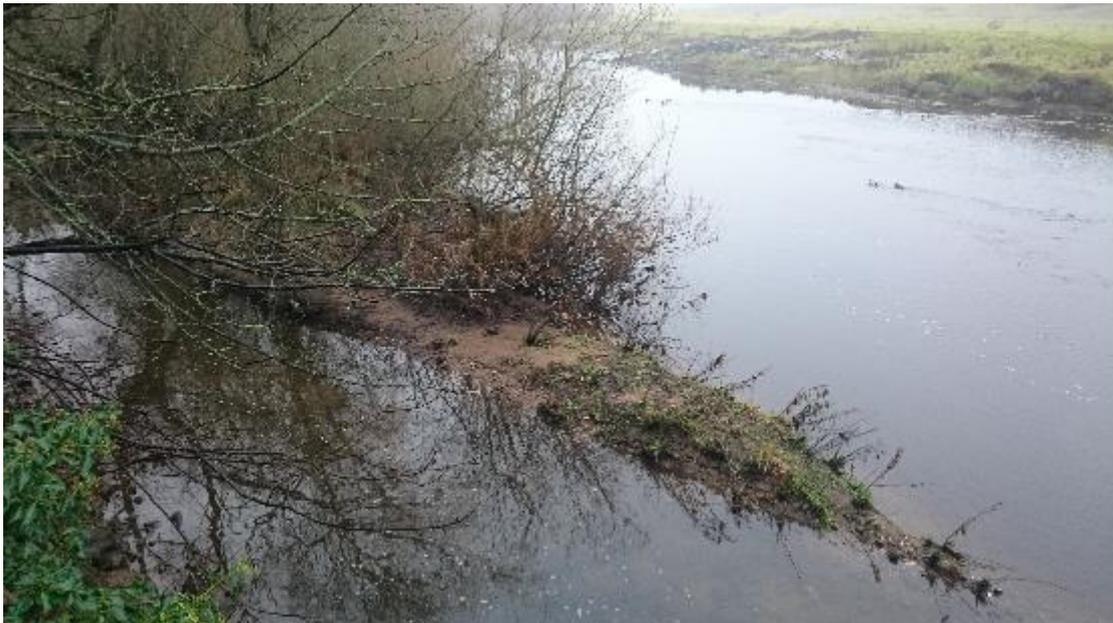
The starting point of the walked section was at the confluence with the River Wharfe at Low Mill (SE 09003 49460) at the d/s end of a low-lying island (Fig 1). As is typical for confluences of this type, the tributary channel is overly wide and hence flow from the beck is barely discernible. During high rainfall, spate flows from the beck tend to be overwhelmed by that within the main river and cause the deposition of substrate homogenously across the bed, creating a uniform, trapezoidal channel mouth (see also Fig 2 lower panel). The RB of Town Beck is walled but there are numerous native trees providing shade and cover, and the LB (island) appeared mostly native vegetation although some bare areas hint at Himalayan balsam issues. Certainly the riparian vegetation on the RB of the mainstem Wharfe (at the confluence) is better quality than that on the LB where it has been heavily grazed and is consequently eroding (Fig 1), and so fish are more likely to be using the cover near to the tributary mouth.

Fig 1. Mouth of Town Beck as it enters from the RB of the River Wharfe at Low Mill. The confluence was accessible, but at lower flows access could be compromised by the uniform depth profile of the tributary channel

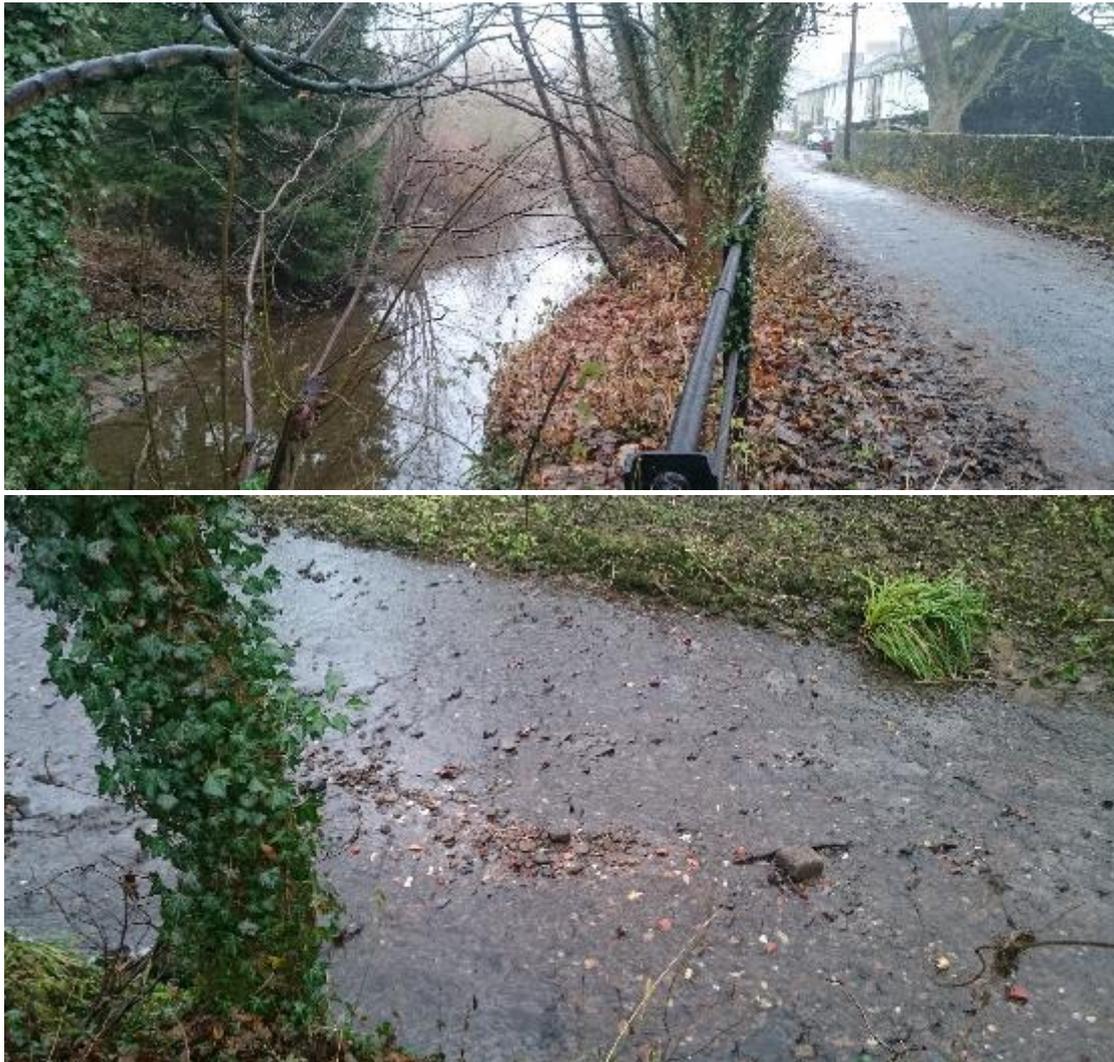
Immediately u/s, several landowners have introduced stepping-stones across to the island which have created several impounded sections and contributed to further deposition of bed material (Fig 2a&b). Impounded sections of slow water with little underwater habitat complexity provide easier conditions for fish predators (such as herons, goosanders and mink) to hunt.

Fig 2. Upper: looking d/s at an impounded section caused by stepping stones from the properties on the RB. Lower: uniform deposition of sediments caused as the beck spate flow backs up against mainstem river flow. Note the straightened channel maintained by the walled RB protecting the road.

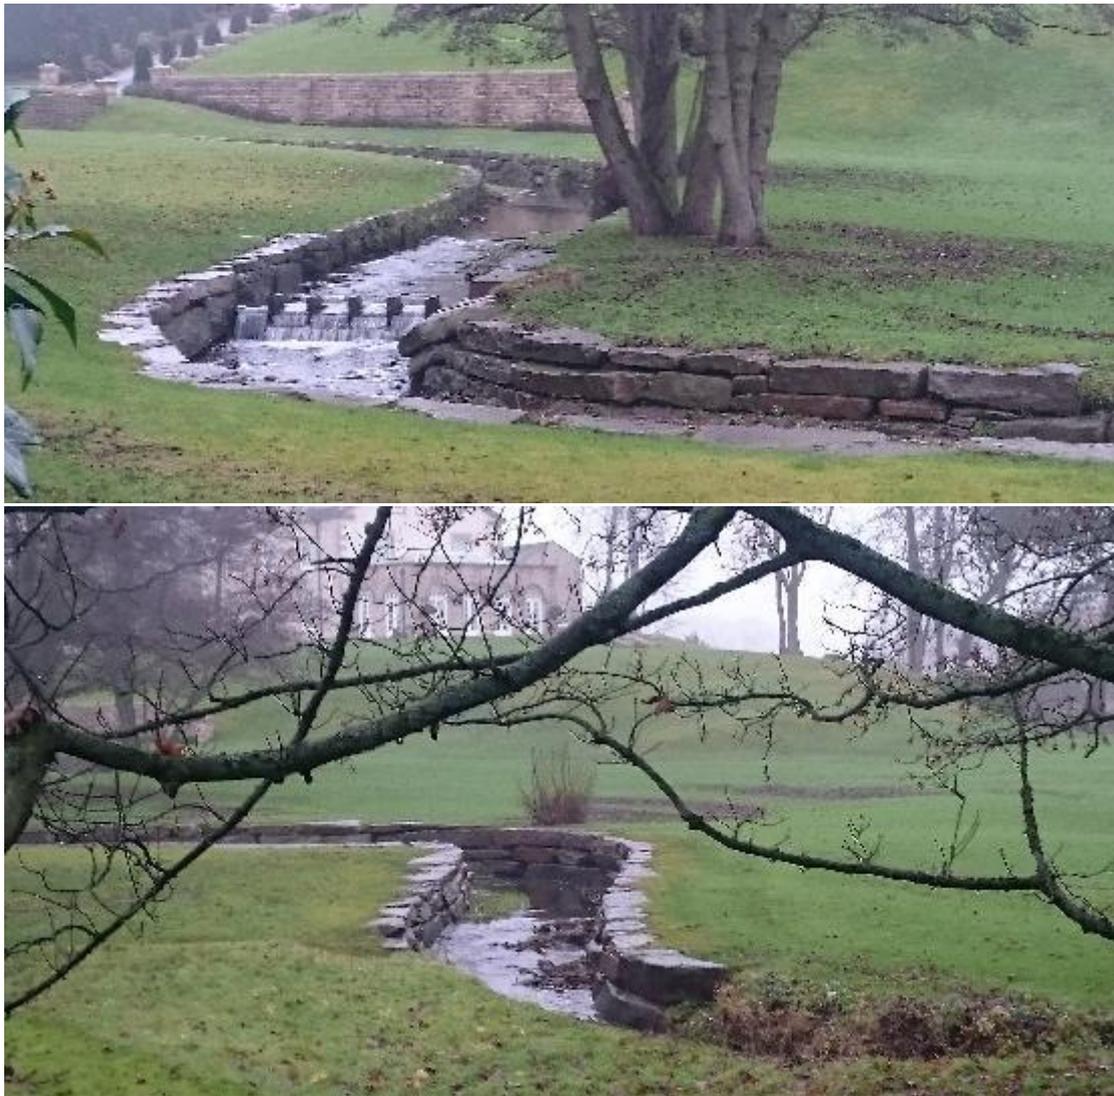
Town Beck flows through the grounds of a large private house, and the channel and path have been heavily modified for aesthetic purposes and presumably to restrict flooding across the manicured lawns. The work will have required consent from the Environment Agency. The banks have been replaced by stone walls in places, there is a formal weir which may cover a service pipe or may simply be to introduce the sound of a burbling stream, and the bankside vegetation is primarily mown grass (Fig 3). One slight saving grace is that the path of the beck has been created to meander relatively naturally through the grounds. While a close look was not possible, deposition was clearly occurring on the inside of bends (Fig 3 lower panel) and natural recreation of a channel form of more appropriate proportions was evident (two-stage channel meanders within the artificial channel).

Fig 3. The (mostly) walled channel made to meander through the private gardens. Upper: the weir is a barrier to fish passage and geomorphology and may just be aesthetic. Lower: deposition processes reclaiming a more natural meandering channel morphology within the walls. Note the distinct lack of riparian cover.

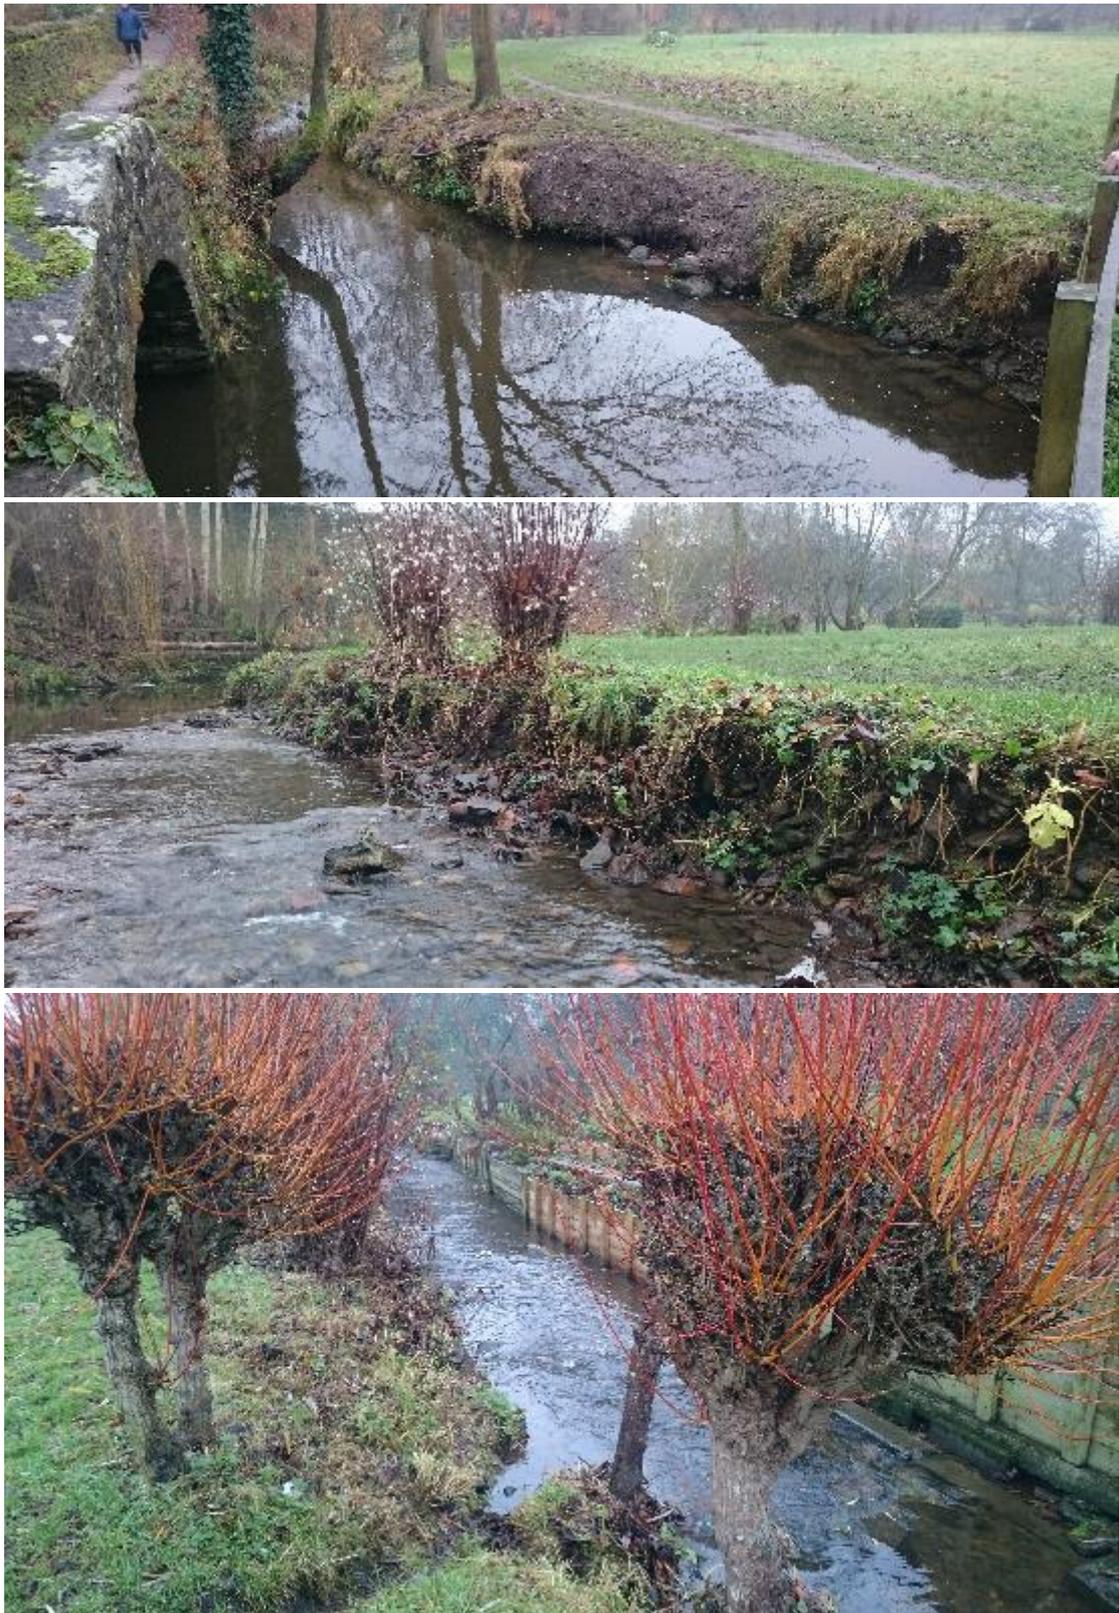
Fig 4. Various images from the church meadow. Upper: compacted soils from footfall, and a mudslide of eroded bank where dogs access the beck. Mid: mown vegetation to the bank edge. Lower: exotic vegetation planted along the banks and evidence of heavy pruning of overhanging scrub.

Wherever there is public access, there is the added pressure of excessive footfall compacting soils and trampling vegetation, and a requirement for access points to the beck, e.g. for dogs. The erosive scouring of dogs entering and exiting the beck can be clearly seen in

Fig 4 upper panel; it also introduces unwanted fine sediments that clog the interstices between gravels, a demand for oxygen as the organic content is mineralised, and prolonged activity at one site can lead to guttering of rainwater from overland flow. However, an accessible and popular point on the beck such as this could also be used to good effect as an engagement and education site.

Various exotic trees and shrubs have been planted along the bank edges while native flora has been mown or pruned right back. Heavy pruning of overhanging scrub (Fig 4 lower panel) is probably to alleviate perceived flood risk. However, by removing the fringing vegetation, it is not only habitat being degraded but elements of natural flood management (slowing the flow as water works through and around trailing branches) are removed as well. Removal of the natural vegetation exposes the bank soils to more erosive force during spates and reduces their resilience to future events. It is clear from the lower panel in Fig 4 that the RB and indeed the LB in places (around a step-weir) had been reinforced with wooden hoarding, and some sections very recently. Any work of this nature must be approved by the Environment Agency.

More riparian growth could be promoted in open areas, especially to protect the banks from block failure and erosion from footfall (and dogs entering and exiting the water) around, for example, Church meadow (Fig 4). Grass should not be mown to the bank edge, but a buffer strip of natural vegetation left uncut. It is not intended that the buffer strip ultimately blocks the view of the beck, nor prevents access, but it will require some sensitive management to achieve the desired results, i.e. a more stable bank and a buffer that provides a) shelter and food for riparian animals, and b) protects the beck from soil ingress.

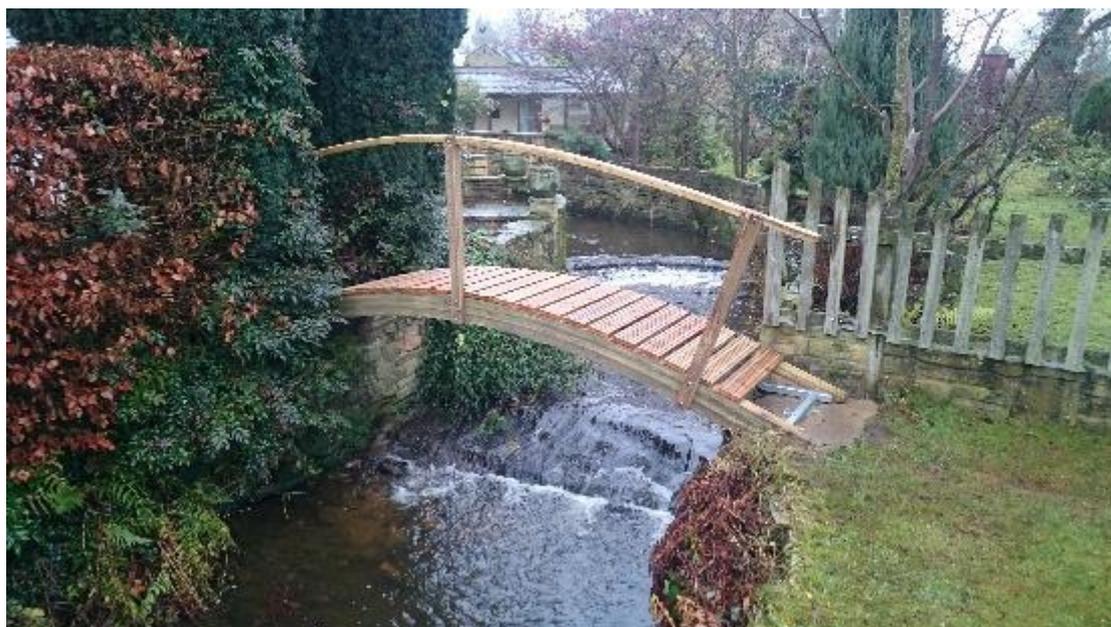
Fig 5. The lowest extent of the beck where it was walled and with housing on both banks. Note the angle of the two weirs to change the course of the beck and reduce erosive power on the outside of the bend.

There are numerous bed-check weirs and weirs to divert the flow path and reduce the erosive force on the outside of bends where the channel has been forced to make sharp turns (Fig 5). Each of these is a barrier to free fish passage, with numerous other insidious effects, as well as interrupting the natural movement of substrate downstream. The bed-check weirs have probably been installed to counter the intensive straightening of the channel, which has considerably shortened the natural (meandering) path and hence increased the gradient and increased the flow velocity; this can be seen as long continuous riffles in the straightened sections (e.g. Fig 6). The impounded sections above each weir are relatively short, primarily because of the gradient issues mentioned above. The impoundments are also shallow because substrate has deposited over time and built up to the crest of each weir.

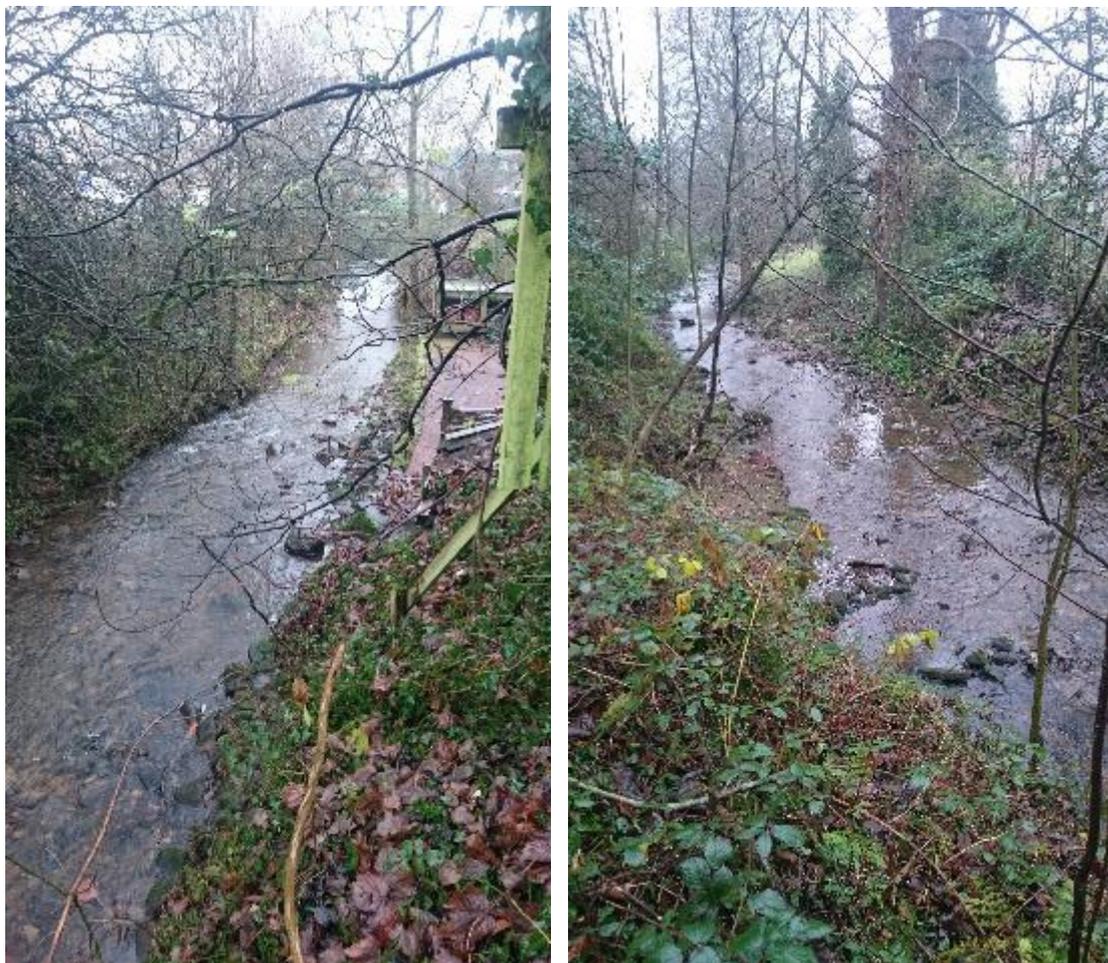
Fig 6. Looking d/s (left) and u/s (right) from the footpath running beside the sawmill pond (SE 08017 49878). The beck is one continuous riffle, a function of it having been straightened. The bed is a heterogeneous mix of substrate sizes offering little in terms of holding habitat for larger fish. However, the native riparian vegetation is one small bonus.

The straightened section running parallel to the sawmill pond and d/s for ~100m (Fig 6) does have natural riparian vegetation and where the root boles of trees are at the waterline, there is evidence of downward scouring and the development of some variation in depth profile. Seemingly inconsequential features such as this will be of benefit to fish and can be replicated very easily without increasing flood risk.

<http://www.wildtrout.org/content/how-videos#log>). Arranging these in an alternating, staggered fashion will promote meandering flow, whilst arranging in a matching pair on opposing banks will achieve a degree of channel pinching or narrowing. Both alterations to the flow are desirable and should be considered in locations such as Church Meadow (Fig 4) and d/s of the sawmill pond (Fig 6) on Town Beck, or near to the school on Back Beck.

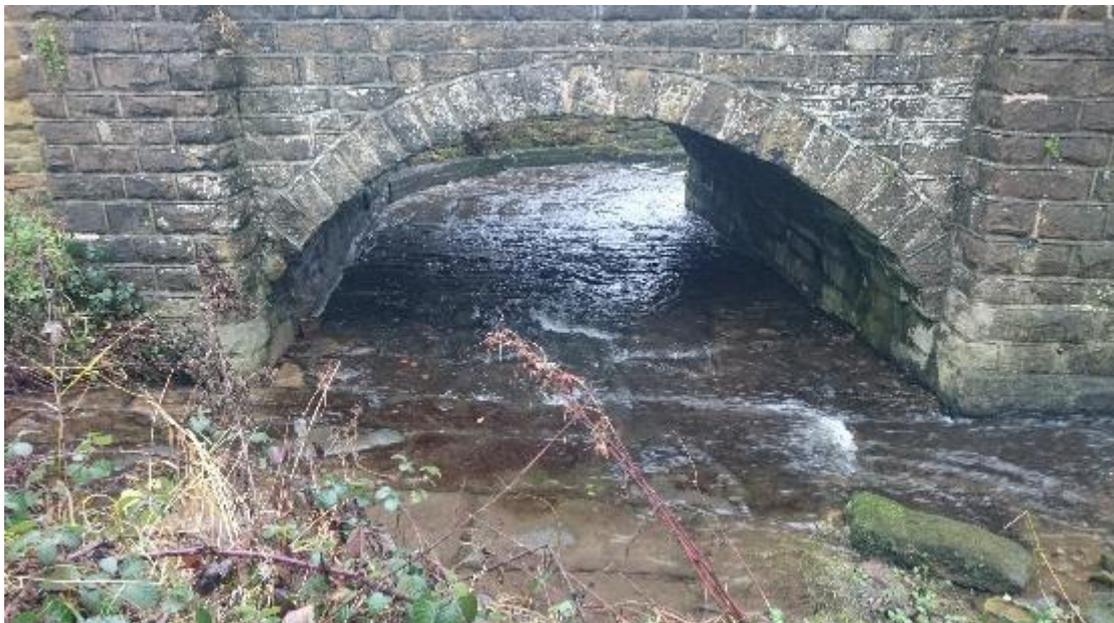
Fig 7. Back Beck (left) meets Town Beck (right) head on and flow under the Bolton Road bridge at SE 07898 49921. The flat concrete apron spanning the bridge culvert and extending d/s is an issue for fish passage.

A short distance upstream from the sawmill pond, the Town Beck flows under Bolton Road where it is joined by Back Beck; the confluence occurs immediately u/s of the bridge. The bridge culvert consists of a flat concrete apron and presents a considerable barrier to fish passage because of the shallow depth and fluming nature of the flow (Fig 7).

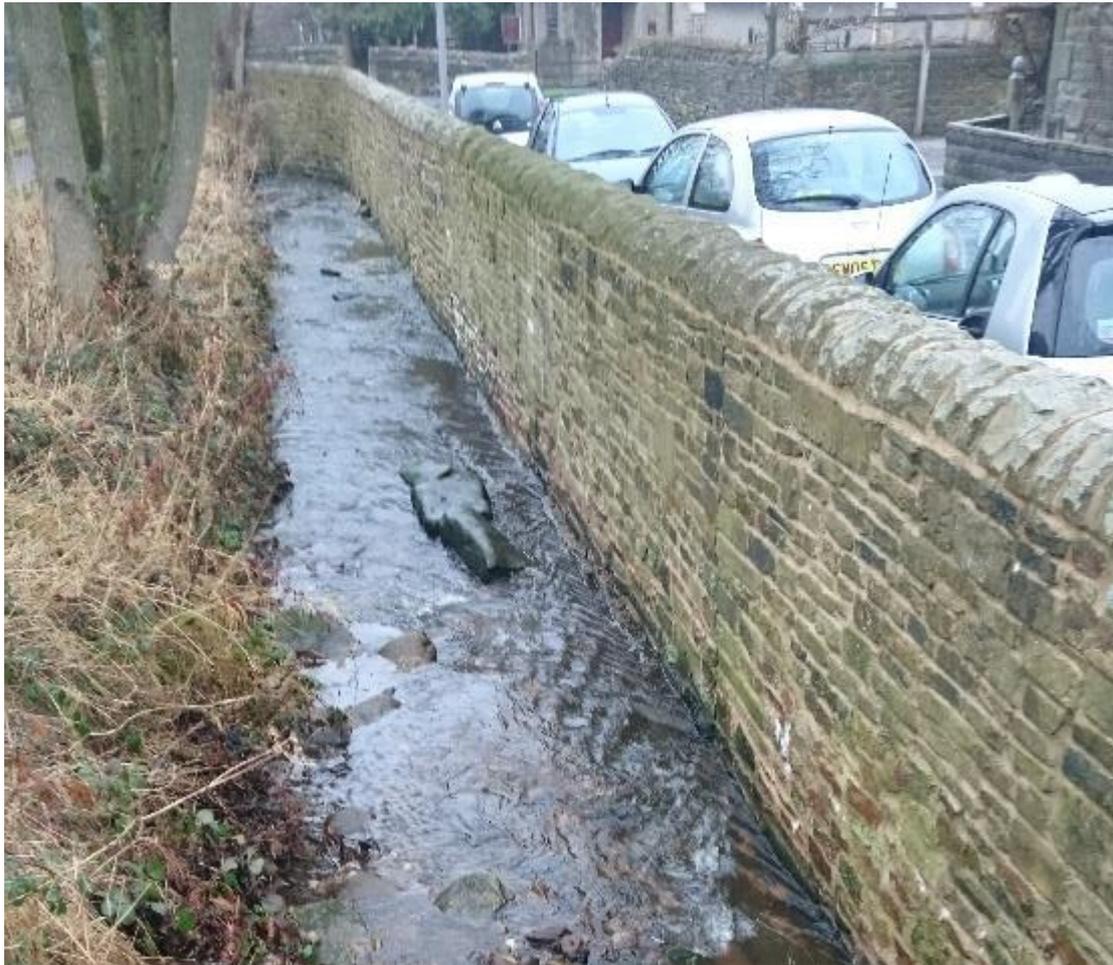
Town Beck then follows Bolton Road and Main Street through Addingham, generally tightly constrained by walling (Fig 8) and through several long culverts where it is crossed by roads and beneath several residential and commercial properties. Where the beck does have room to wiggle slightly, and where vegetation has been allowed to grow within the confines of the walled banks, there is actually some reasonable habitat: retention of small pockets of

Fig 8. Town Beck tightly constrained by the B6160 Bolton Road.

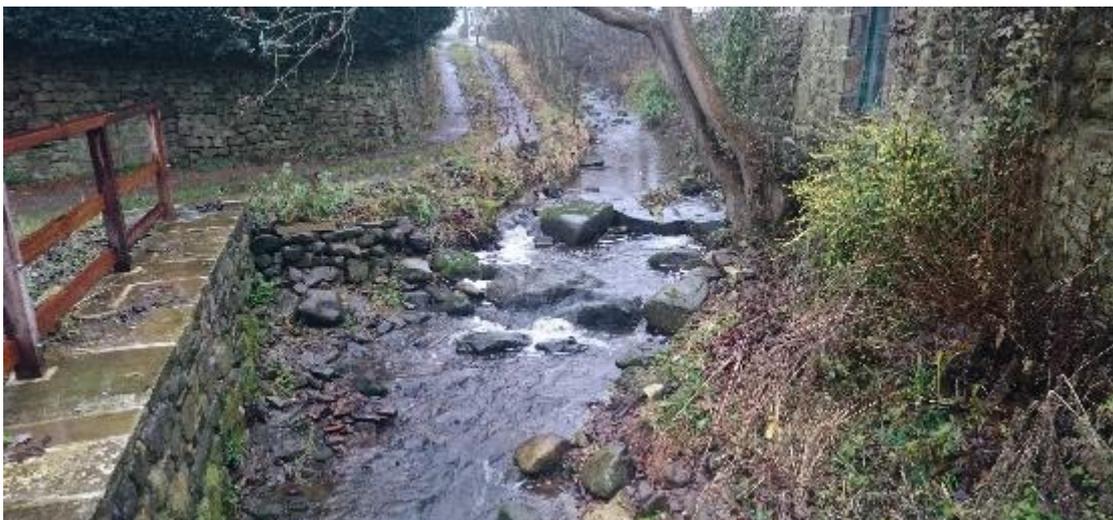
gravels instream, trailing bankside vegetation providing low cover, and pockets of deeper water between larger boulders (Fig 9).

Fig 9. A historic ford. Whilst straightened and hence operating over a steeper gradient, the larger boulders and unkempt vegetation (further u/s) provide deeper pockets of water, and refugia from flow and predators.

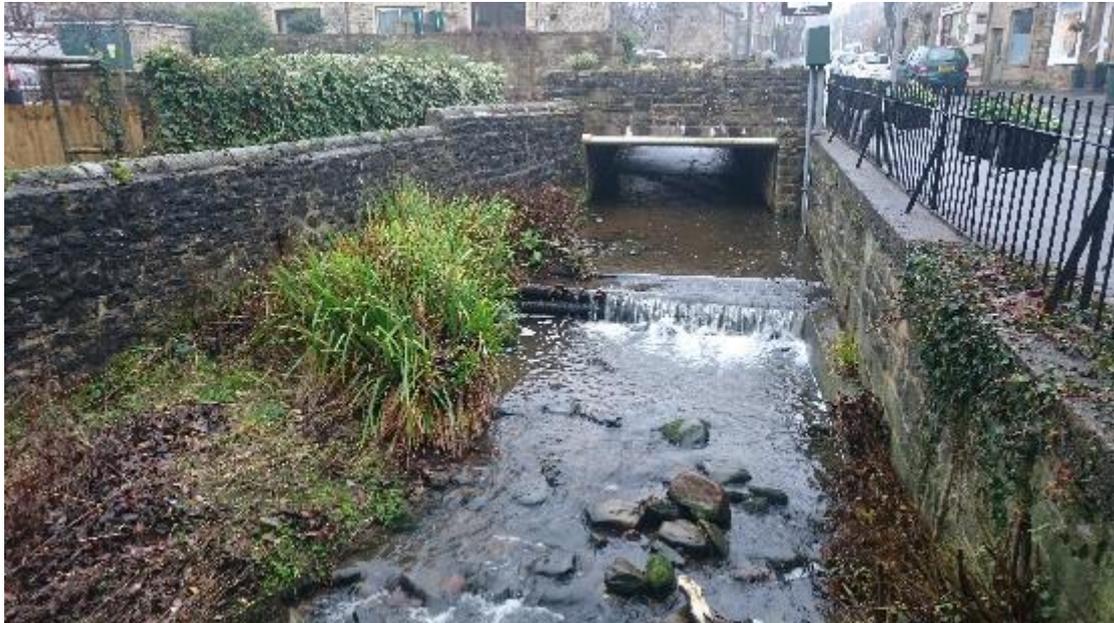
Culverted bed sections (concrete and laid stone) and small step weirs (protecting service pipework and used to change the beck direction) are numerous (eg Figs 10 & 11) but not impossible to improve for fish passage. Anecdotally, the bridge in Fig 10 above the pipes/weir, is the highest point that trout have been seen by the AV attendees.

Fig 10. The Environment Agency gauge situated immediately u/s of a series of metal pipes spanning the channel. Deposition of sediment on the RB has allowed native and non-native vegetation to flourish and provide some much needed cover.

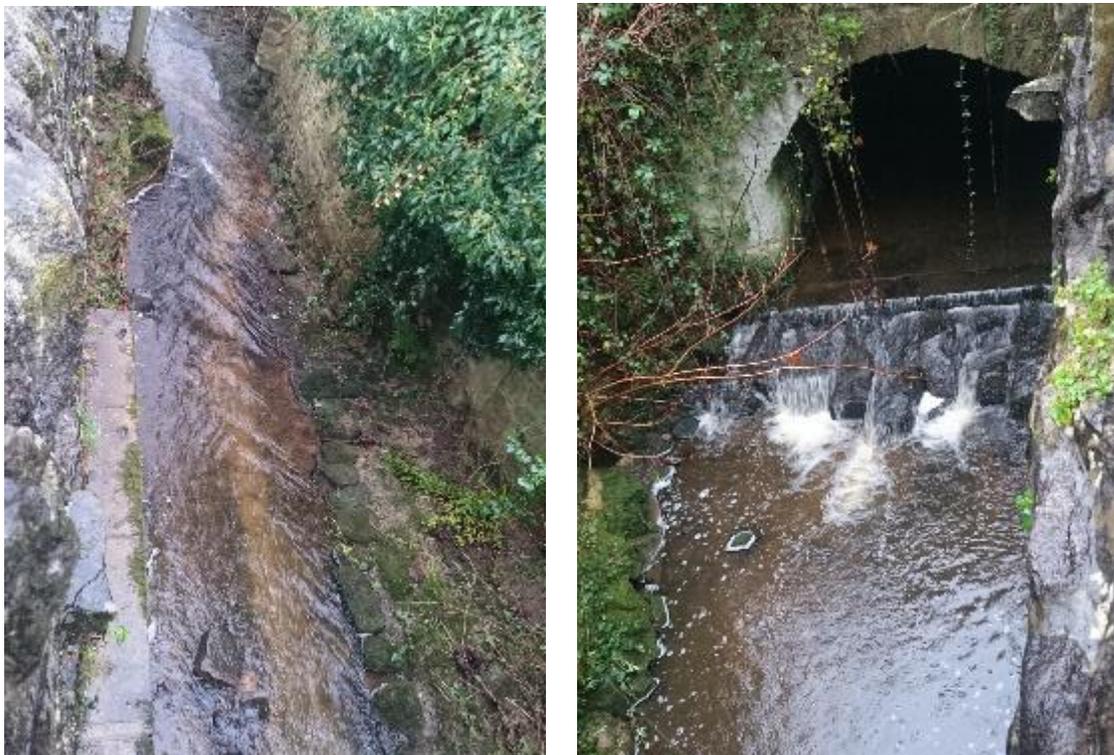
Fig 11. Concrete on stone culverting of the beck bed (left) and a check weir immediately d/s of another long culverted section of Town Beck (right) at SE 07303 49859.

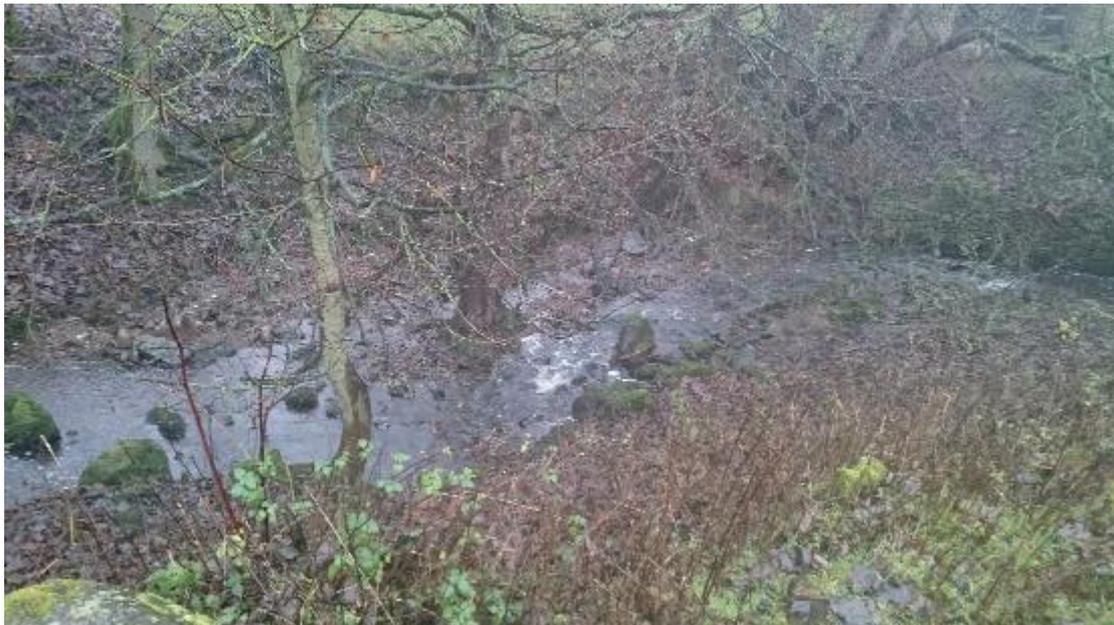
Fig 12. Much more natural channel morphology, substrate heterogeneity and riparian vegetation u/s of the business park.

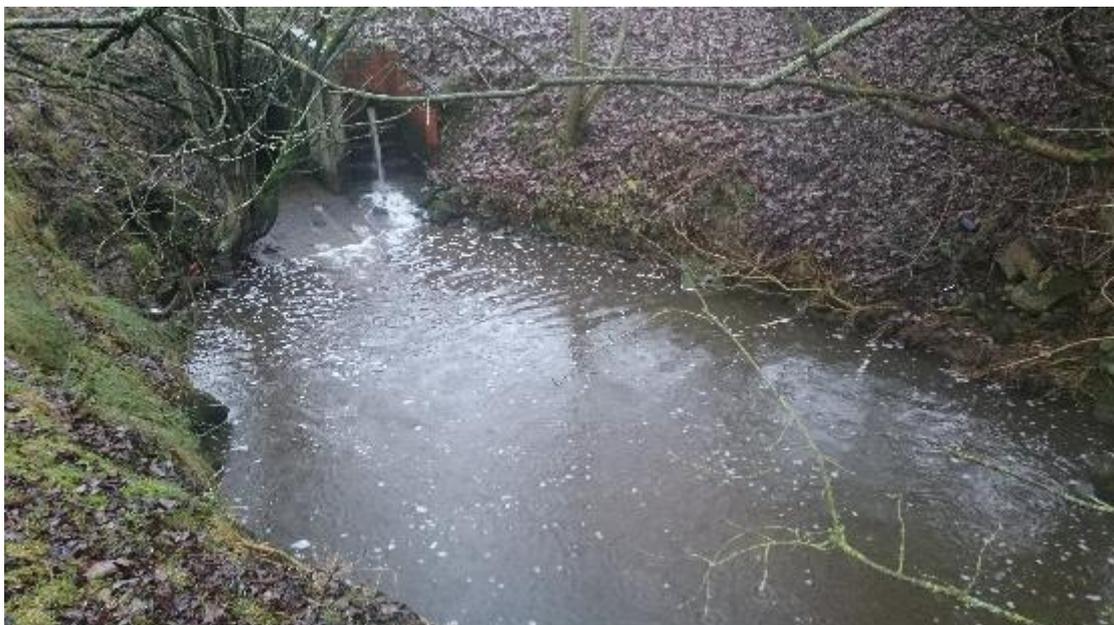
Fig 13. The large scour pool immediately d/s of a box culvert and a perched pipe (seen to the right) which pass beneath Big Meadow Drive. The ramp up to the culvert is clearly an issue for fish passage. The water emanating from the pipe had a distinct organic smell and should be investigated.

This less impacted section lasts for ~250m until the valley has been effectively dammed for the construction of Big Meadow Drive, and the beck is constrained to a box culvert for ~40m (Fig 13). It would be interesting to investigate the rationale / design for this structure; it looks like it should act as a choke on the beck during high flows and the valley above the culvert has potential to hold back a considerable volume of water, yet no attendees could recall it operating as such. Erosion scour from the beck exiting the culvert had caused the formation of a relatively deep pool (Fig 13); the ramp up to the culvert mouth and the length of the culvert itself present considerable issues to fish passage, but could be lessened by the installation of a pre-barrage to increase the depth of the pool and drown out the ramp and mouth of the culvert (see *Recommendations*). The pipe delivering water next to the culvert in Fig 13 had a distinctly organic odour and should be investigated.

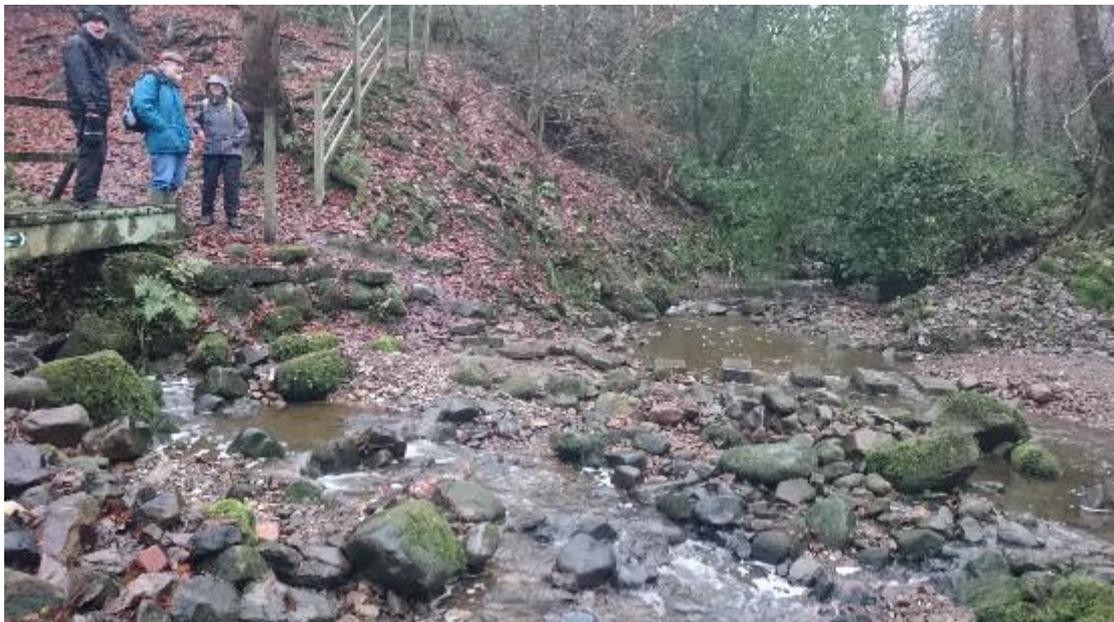
Fig 14. The confluence of Marchup Beck to the right of shot and an un-named beck from Addingham Middle Moor (under the bridge to left) to form Town Beck.

The habitat potential remained reasonably good (as below the culvert) until the confluence of Marchup Beck and an un-named beck (which together form Town Beck; Fig 14), ~300m u/s of the culvert. A quick spot-check of invertebrates by stone turning here revealed several species of cased and caseless caddis (Trichoptera), stone-clinger mayfly (Heptageniidae) and freshwater shrimp (Gammaridae) indicating reasonable water quality and food availability for fish. Immediately u/s on the LB of Marchup Beck is where the village tip spoil enters, so the presence of the invertebrates at least suggest nothing noxious is leaking from that site.

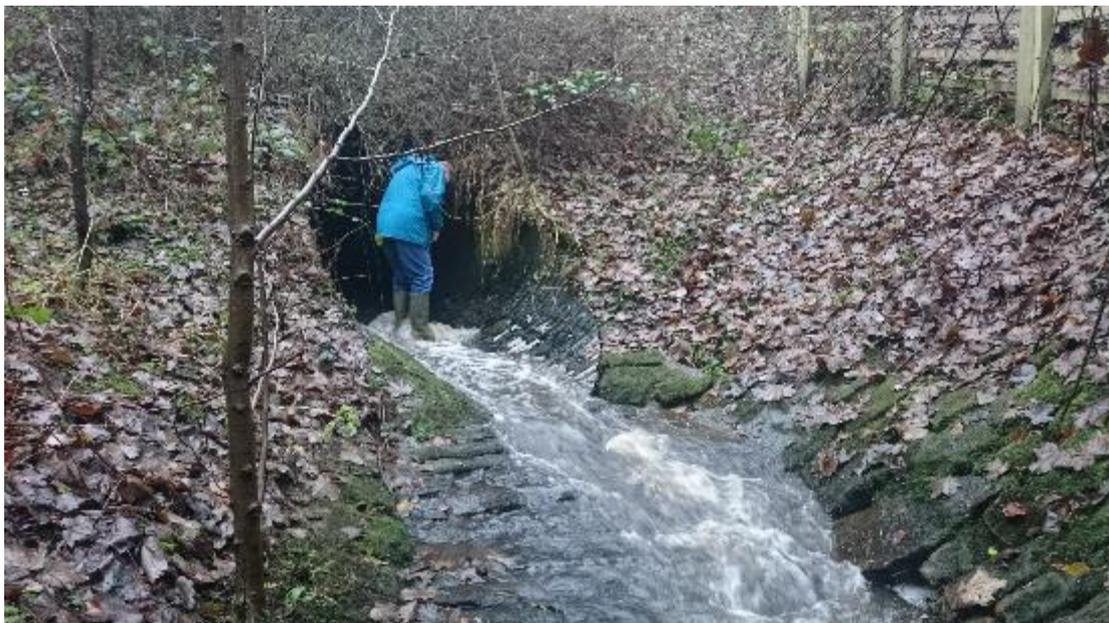
Fig 15. The d/s end of the long, corrugated culvert beneath the A65.

Two spot checks were made at either end of the culvert which transports Marchup Beck below the A65, and u/s for a further ~300m but then there was a natural barrier, a waterfall over bedrock. Hence, it is of little value to consider options for this culvert.

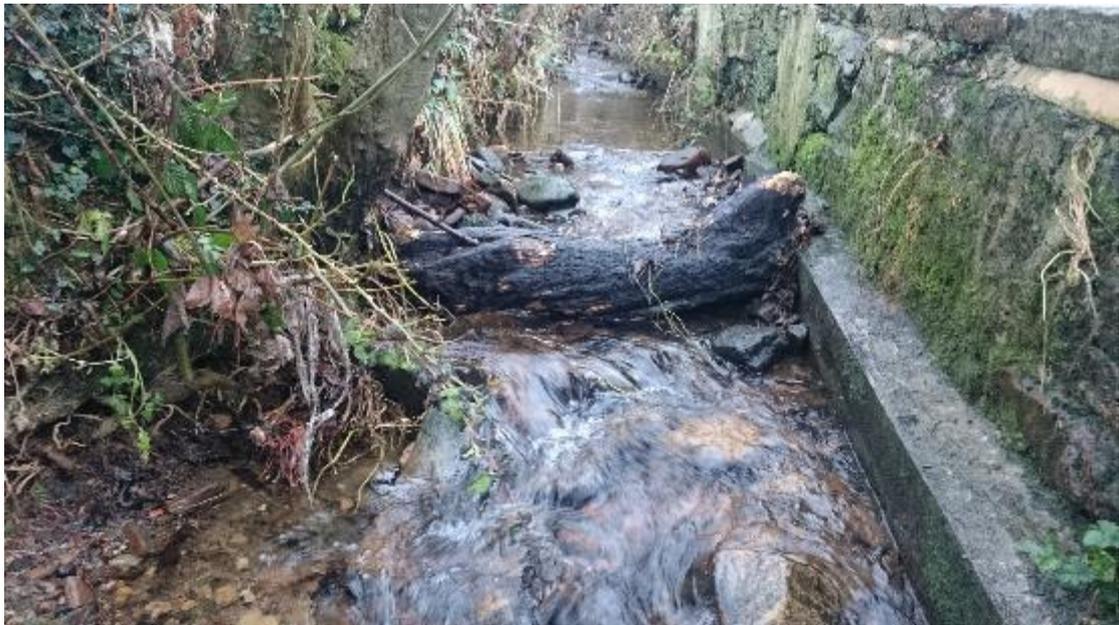
The walled banks have been colonised by native trees, and retention of root masses near the toes of the bank and the introduction of woody material (Fig 16) have allowed pockets of gravels of a suitable size to be used for spawning to be retained. The beck flows past the primary school and the natural vegetation at that point provides good quality riparian habitat, shade, and better protection from disturbance by passers-by. This is an ideal spot for engagement with the local school-children.

Fig 16. Woody material and tree roots within the walled channel of Back Beck actually help to sort the gravel substrate and provide some limited refugia.

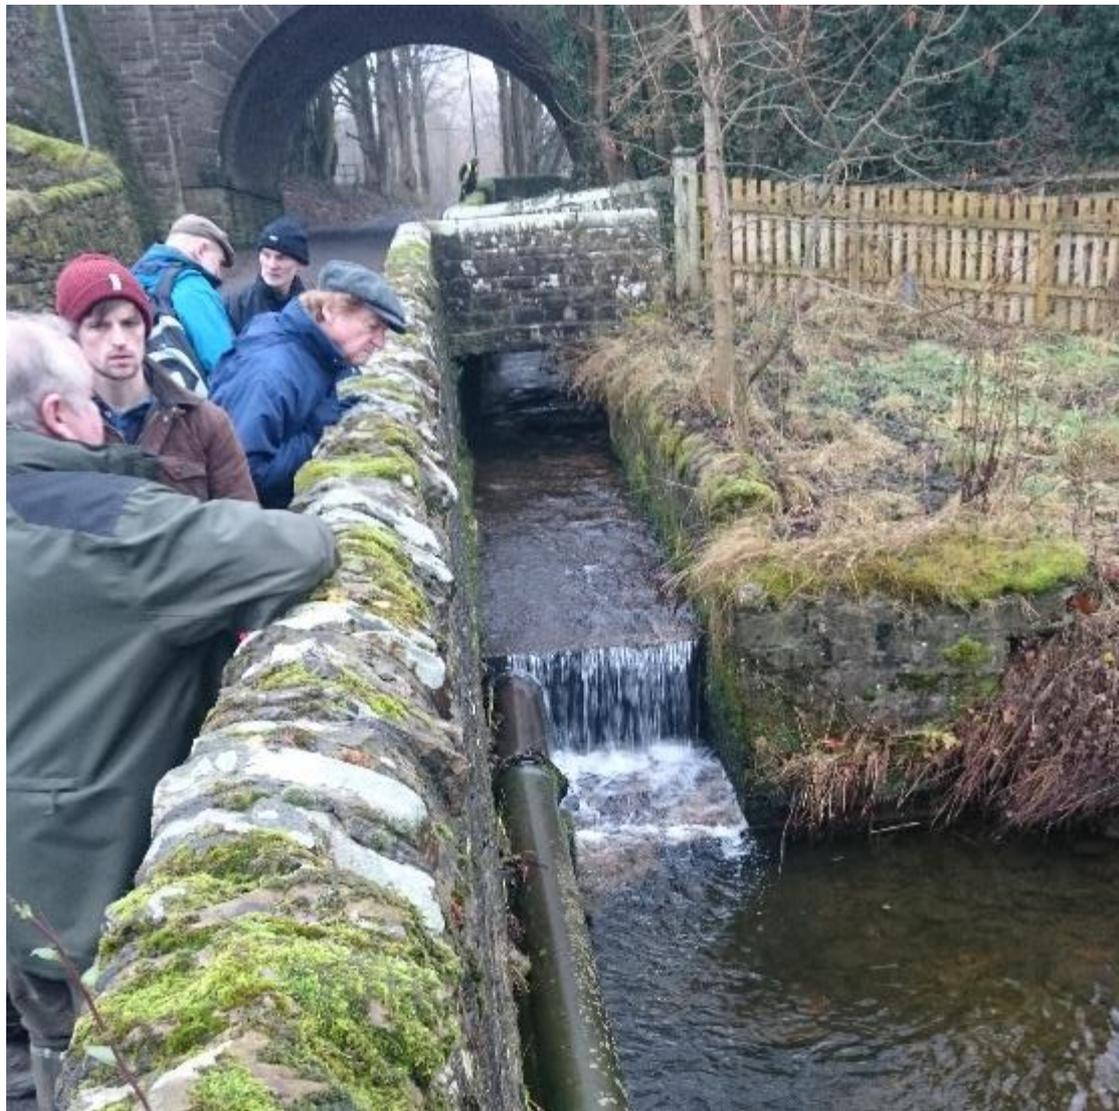
Just upstream from the school, is a scour pool formed at the exit of a long straight culvert which forces Back Beck beneath Bridge 55 (Fig 17). The extra depth and rocky substrate provide good cover for fish and it is little surprise that this is considered the upstream extent of the trout population; the step weir is impassable. It would be interesting to consider electrofishing Back Beck above the village (not seen during the visit) as the potential for a remnant population up there is high given the quality of habitat observed at a distance.

Fig 17. The pool below 'Bridge 55' and the upstream limit of trout (anecdotal evidence provided by attendees). The step weir is $\sim 1\text{m}$ high, and the channel upstream is concrete / stone-lined extending for $\sim 40\text{m}$.

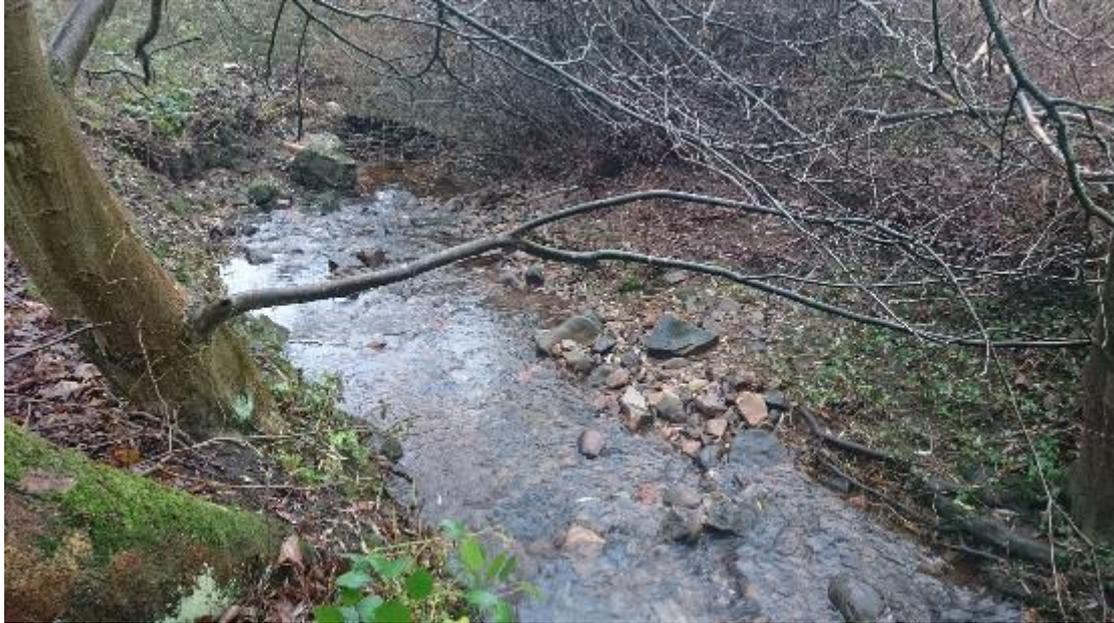
Above the Bridge 55 culvert, the gradient and habitat are better, as the beck is allowed to meander and is bordered by more natural riparian vegetation (Fig 18). The highest point up this tributary seen was at the remnants of the old school site.

Fig 18. Back Beck near to the site of the old school. More unkempt bankside vegetation and meandering form present better quality habitat.
