Advisory Visit

River Ivel Navigation, Bedfordshire

March 2019

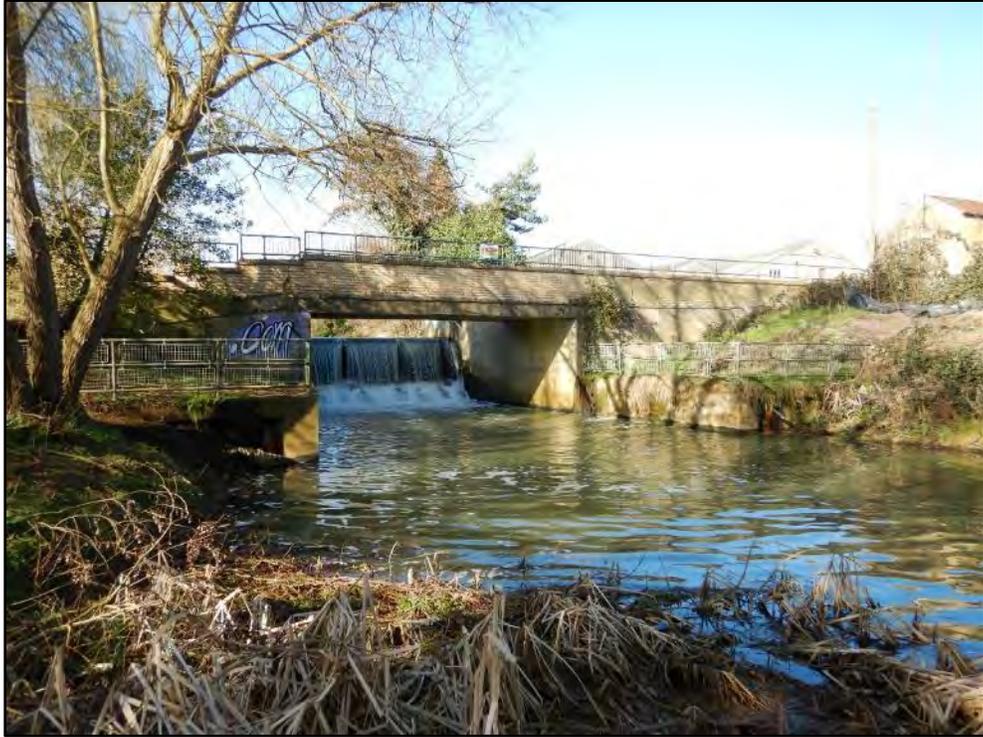
The visit started downstream of the Shefford Mill Sluice (pic 1). The sluice held back a head of water ~1.8m and is impassable to fish. The presence of a bristle-brush elver pass was noted.

Pic 1 – The Shefford Mill Sluice, a barrier to fish passage.

Wherever possible, the first approach should be to remove a weir in order to reinstate natural river processes, which in turn will govern the development of riverine habitats.

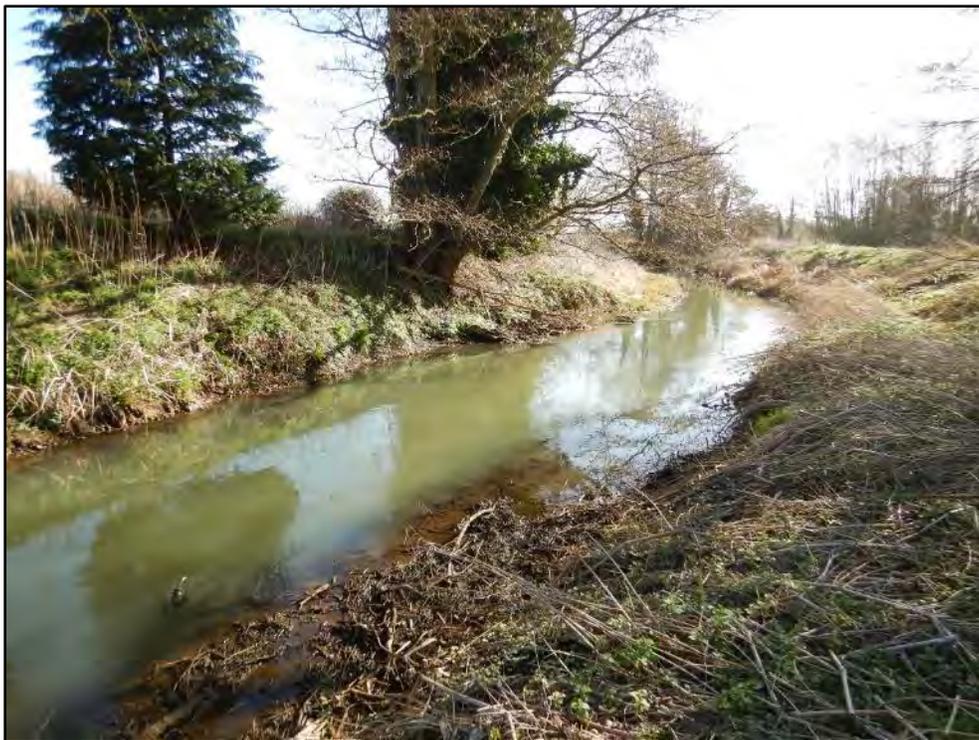
The river had gently sloping banks (pic 2) with marginal vegetation dominated by the invasive non-native Himalayan balsam **and nettles**. **At the water's edge** there were extensive deposits of sand which had not been consolidated by vegetation and were considered to be mobile. The adjacent land use was amenity grassland (RB) and fallow land (LB). At the edge of the amenity grassland was a large pile of grass cuttings. The leachate from the cuttings had the potential to enter the water. The pile should be located away from the river. Between the river and the grass pile was a heavily silted backwater (pic 3). The backwater appeared to receive drainage from the amenity land.

Pic 2 – The Ivel Navigation downstream of the Shefford Mill Sluice. Extensive margins of fine sediment (mainly sand) were present.

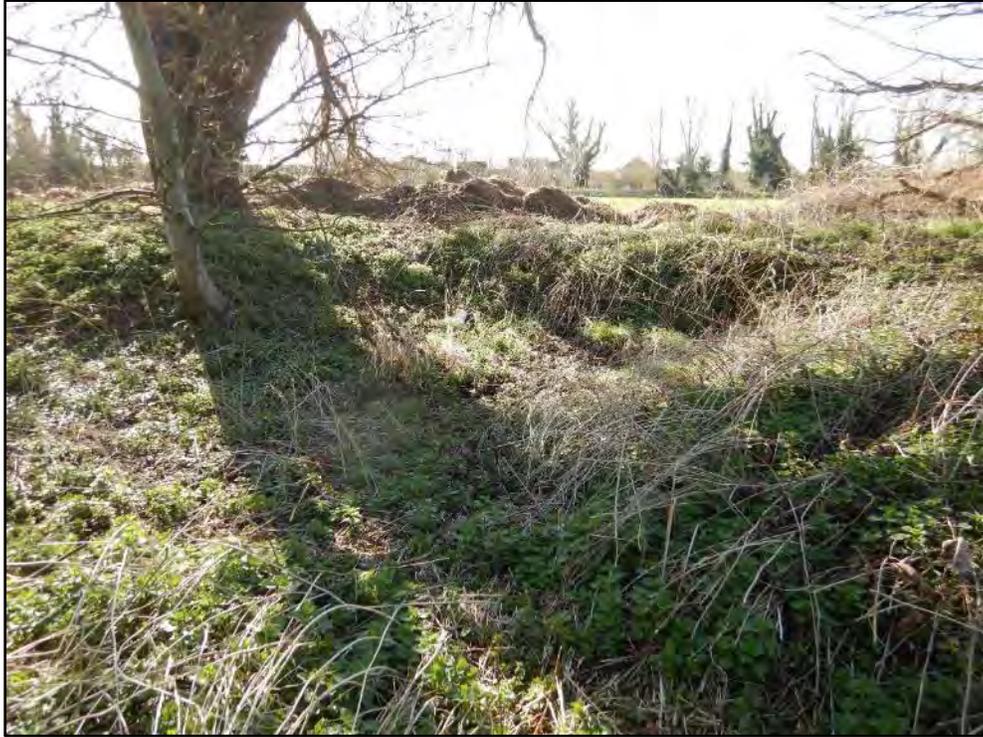
Pic 3 – This silted-up inlet could be desilted to form a backwater to benefit coarse fish. Note the large pile of grass cuttings which should be moved.

The large grass cutting pile should be located away from the river (such as on the other side of the field).

A number of silted back-channels were found which could be desilted to provide refuge areas for fish during high flow, and warmer habitats for juvenile coarse fish to grow within.

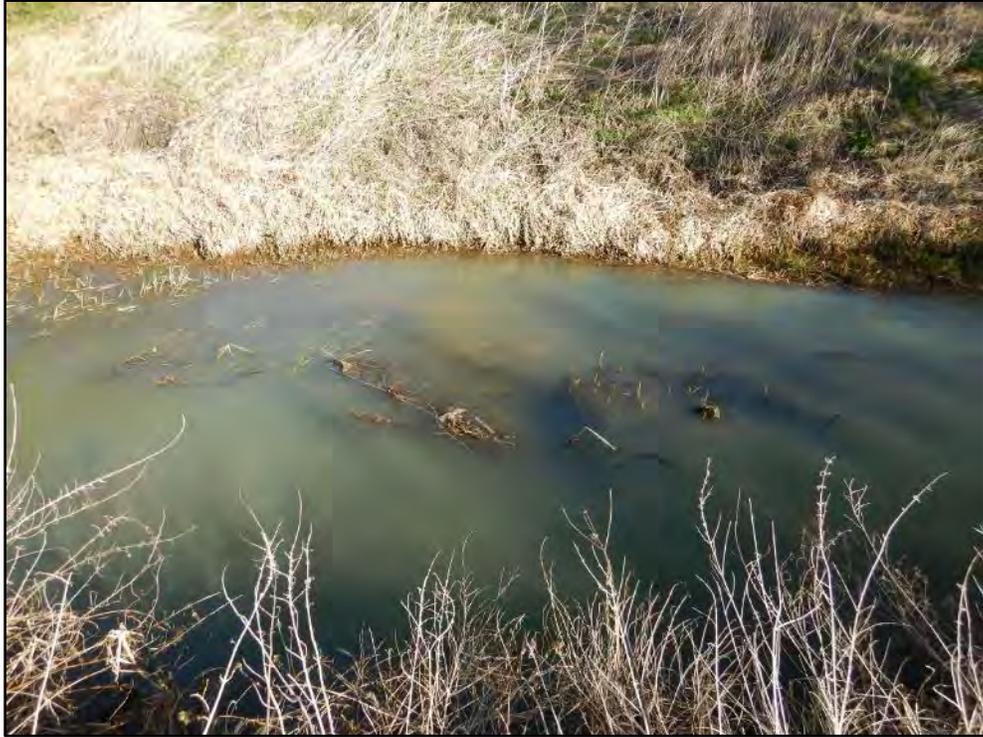
The river contained stands of branched bur reed (pic 4) which had not been scoured from the river by winter flow. The presence of bur reed mid-channel is indicative of a high sediment load and an inability of the river to scour fine material from the bed. Bur reed can often dominate artificial channels and rivers that have been dredged. Extensive bur reed growth can often give the appearance of a river choked by vegetation. But in reality, the plant dies-back following frosts and does not impede winter flow. However, bur reed can impact on the summer conveyance of channels. Therefore, **sustainable measures that work to reduce the channel's suitability for the plant (such as increasing water velocity and bed scour)** will bring about a better long-term control of bur reed resulting in increased flood conveyance through the reach.

Pic 4 – The channel contained stands of branched bur reed which were reported to be very dense come mid-summer. The winter flow has not cleansed them from the channel.

Removal (or re-adjustment) of the stones beneath the Horsebridge would reduce upstream water levels initiating bed scour, which in turn would control the growth of bur reed.

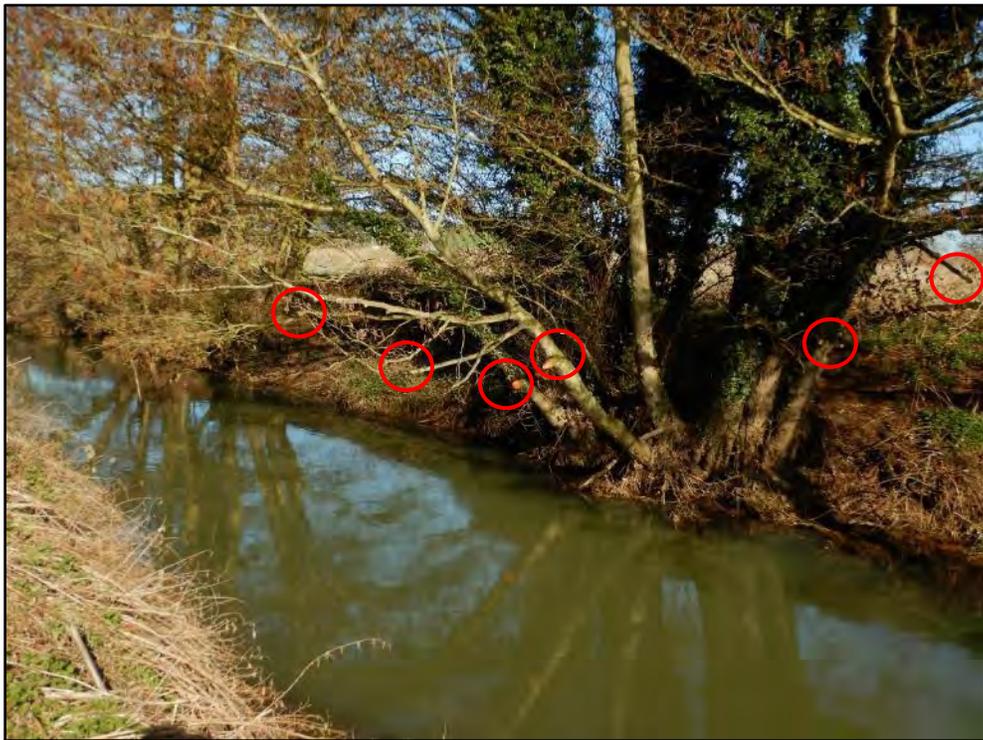
Alder and willow were the dominant riparian trees. Many trees had been subject to recent work by the EA's **FCRM team**, this had resulted in the majority of trailing branches being removed from water level. It is not known whether the branches were collecting flood debris, or were holding back any water, but given the relatively small size of branches removed (pics 5 & 6) the capacity to hold back *any* flood water is very doubtful. By lifting the lower canopy of the trees, but retaining high cover, the tree work has encouraged a tree-tunnel to establish along the river. That approach it not going to be beneficial to the river in the long-term as it will limit marginal growth which aids bank stability, provides cover and reduces opportunities for large woody material (LWM) to fall into the river.

Pic 5 – Riparian alder trees with their lower branches removed (red circles).

Some stands of willow must be allowed to re-grow in order to control excessive emergent vegetation and to aid water cooling. A tree management plan should be produced by SDAA, and agreed by the EA, to ensure that important trees are retained in future, and so that a tree-tunnel is not grown to the detriment of marginal plants.

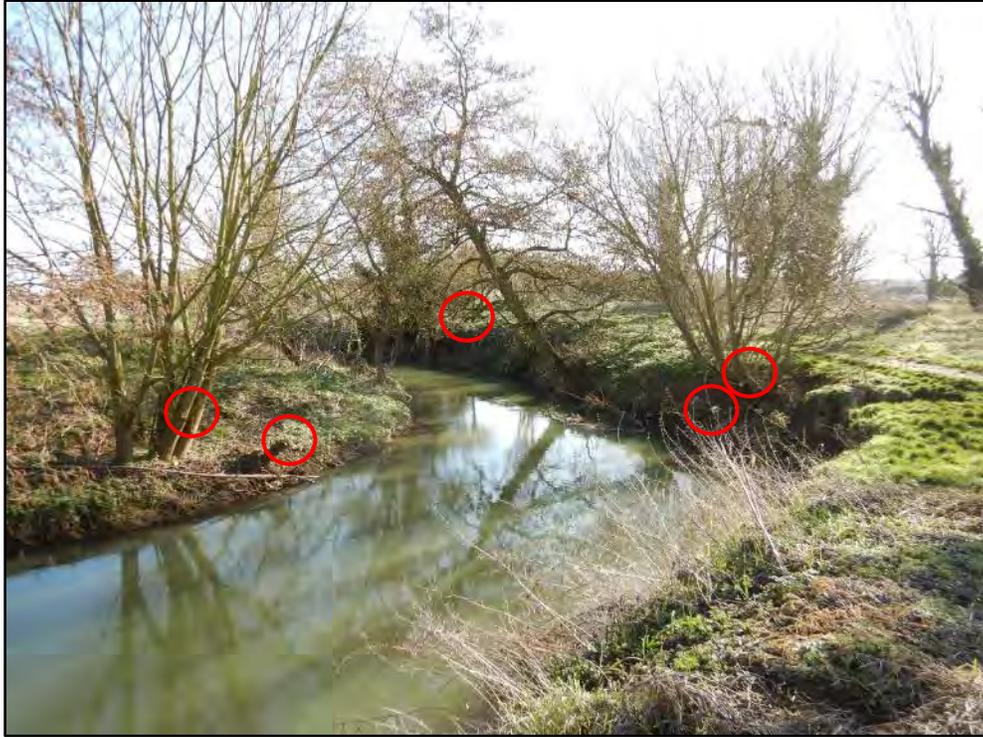
Pic 6 – Riparian sycamore, willow and alder trees with their lower branches removed (red circles).

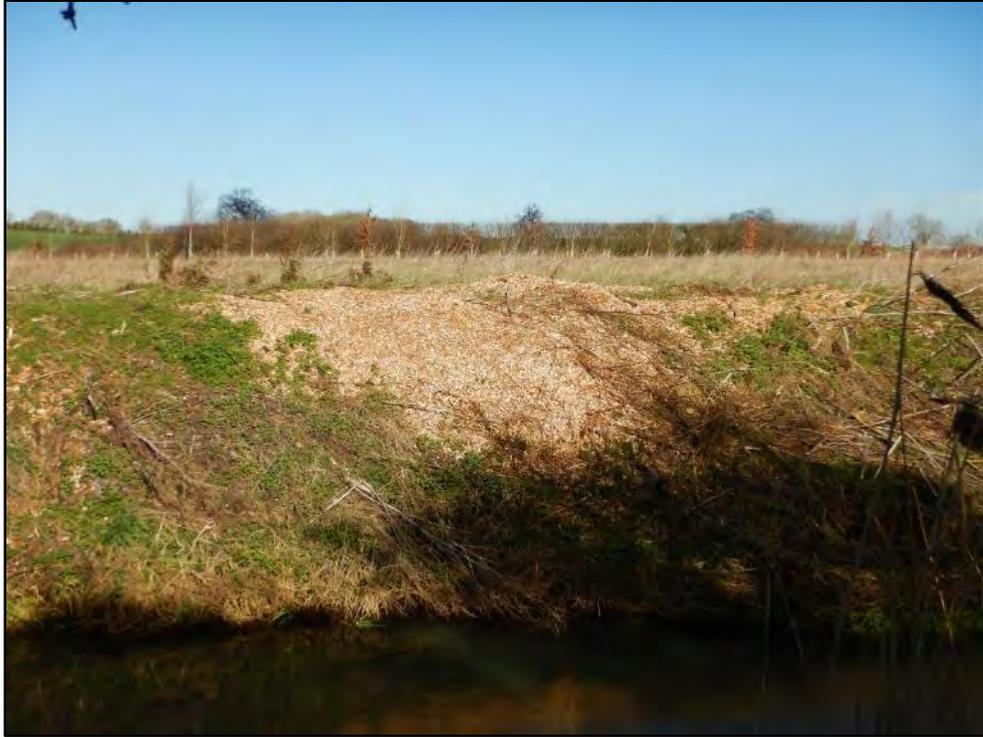
The vast majority of cut wood had been chipped. All chipping piles were at the top of bank, with many piles spilling down into the channel (pic 7). That is not acceptable. All chipping piles should have been sited well-back from the river so their leachate presents no risk to water quality, and so the material is not at any risk of being swept into the river during high flows.

Pic 7 – Chippings should not be allowed to spill down the bank.

All chipping piles should be relocated away from the bank top.

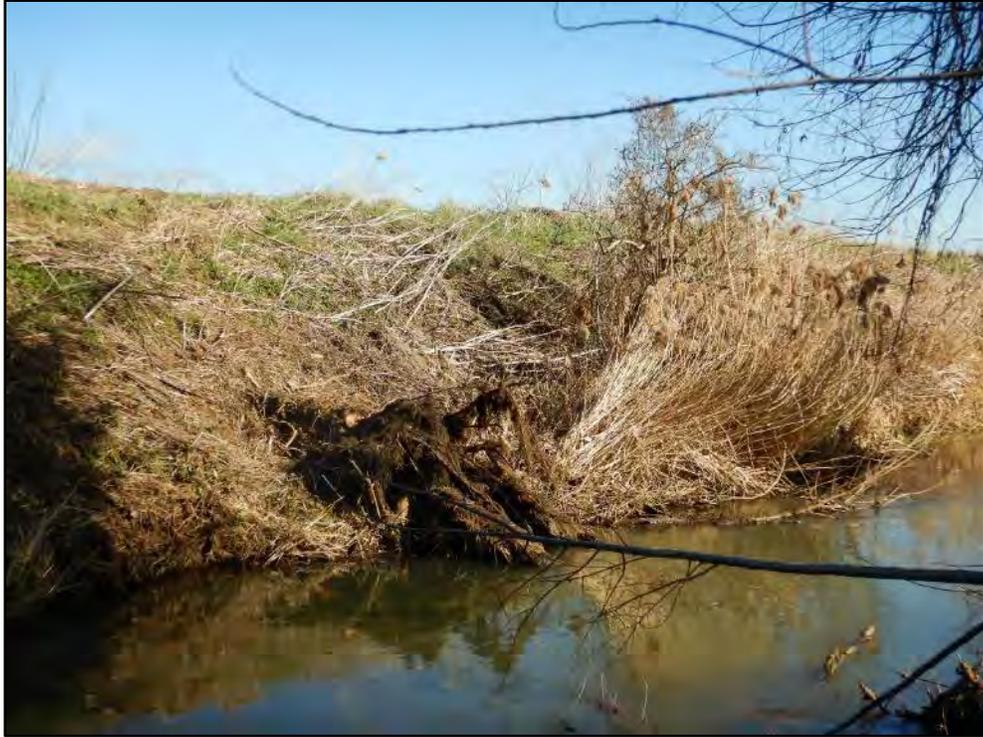
Stands of common reed were observed (pic 8 & 9). Common reed has the ability to significantly encroach into slow-flowing rivers. It will continue to colonise more of the slow-flowing reach if scouring flow is not present and there is no shade to check its spread.

Pic 8 – Willow roots removed from the channel alongside fringing common reed. With the loss of the willow the reed will colonise more open water habitat.

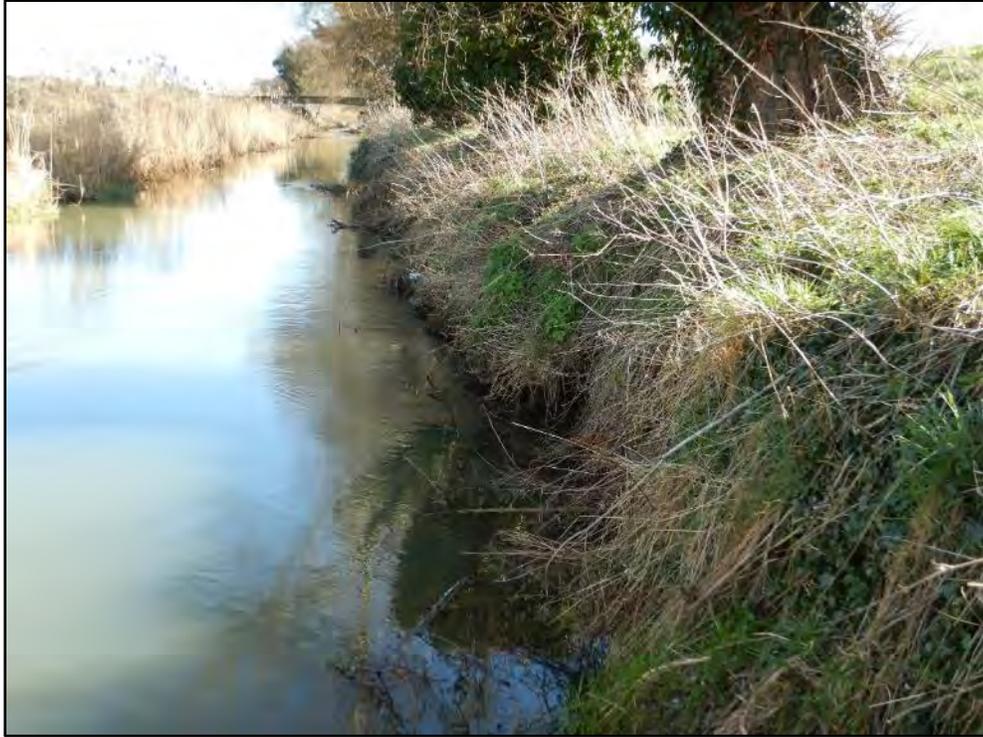
It was reported that the river contained a significant population of American signal crayfish. Whilst no extensive bank failure was observed, it was noted that the RB was becoming steeper due to its partial shading and lack of fringing vegetation which would have trapped sediment (pic 9). The cut woody material could have been used to sensitively reinforce the RB but due to material being chipped that opportunity has been lost.

Pic 9 – The RB has become undercut with the situation reported to be made worse by extensive signal crayfish burrows (not seen). The opposite bank is stable due to a gentle grade from land to water aided by common reed.

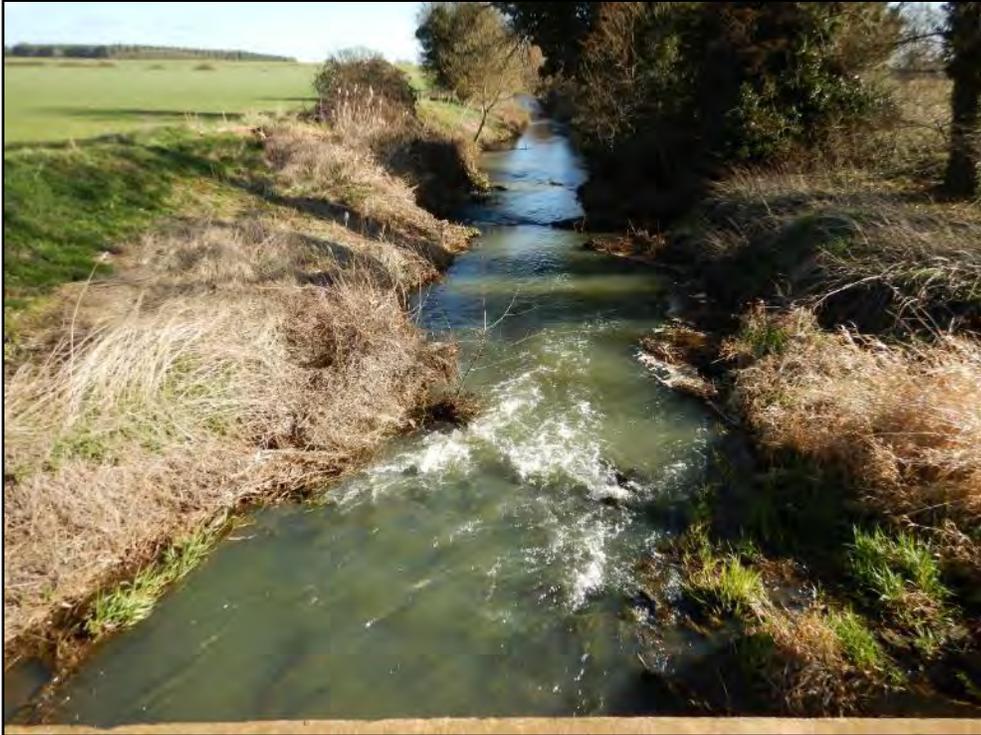
At the Horsebridge there was a change of gradient (pic 10). The change had been brought about by the collapse of the Clifton overspill weir in November 2008. The reduced downstream water level resulted in the energising of the entire reach up to the bridge. Levels above the bridge are still impounded by stone rubble (pic 11) resultant from a former bridge having been demolished and left in the river. Redistribution of the stones would bring about a lowering of the upstream water level, which would increase water velocity, thus initiating bed scour and promoting sediment transfer. This simple action would **increase the river's ability** to scour bur reed from the channel and to potentially form ecologically important riverine features such as gravel shoals and riffles. Rearrangement of the stones would also allow the flow energy to be directed further down-channel rather than being dissipated immediately below the bridge.

Pic 10 – The reach is effectively divided in two; the upper reach is still impounded above the Horsebridge but downstream it flows more freely due to the failed overspill weir.

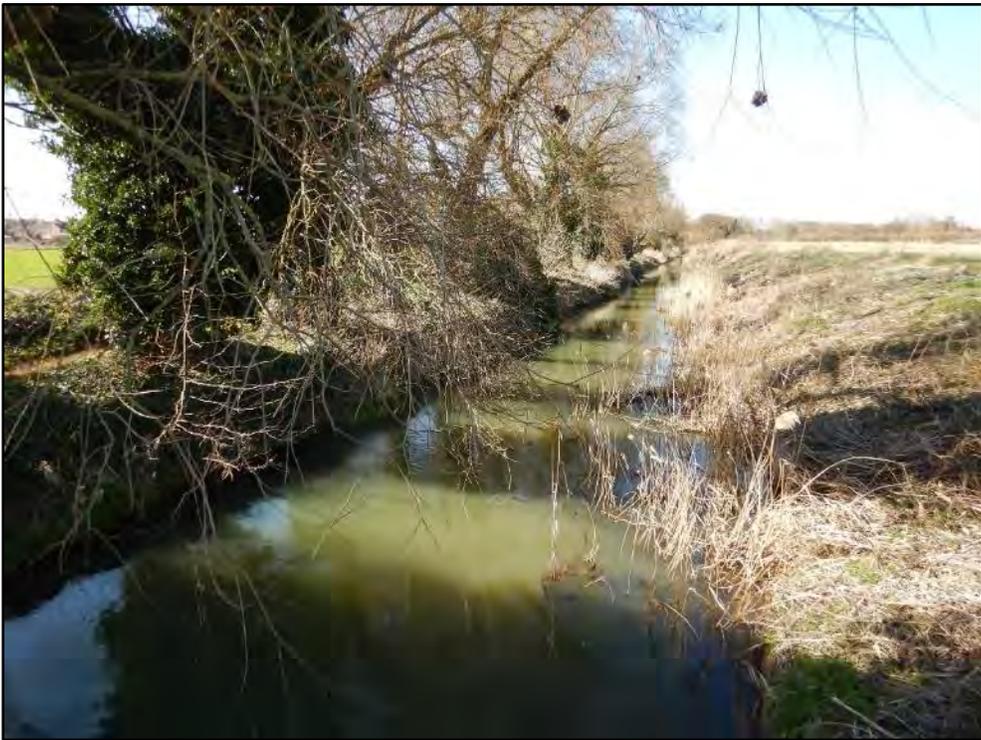
Pic 11 – The reach above the overspill weir still retains the feel of a drain or navigation.

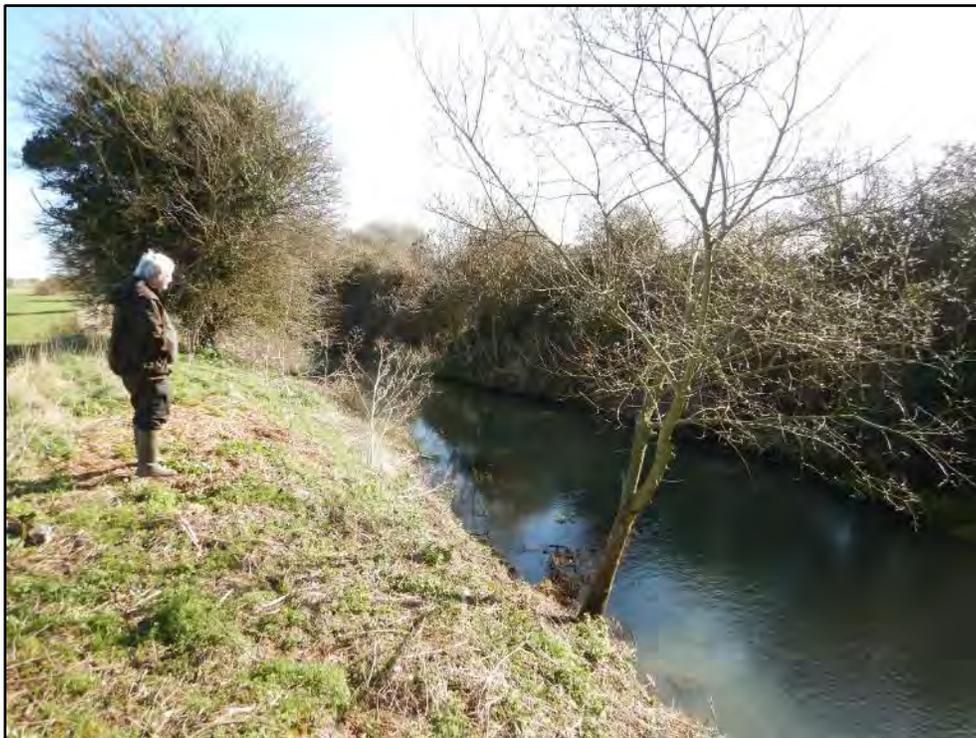
Pic 12 – A number of single trees have been retained at the toe of bank, these trees could be used for tree-hinging.

A technique favoured by the Wild Trout Trust for delivering instant woody cover at water level is tree-hinging. Trees (large or small) are cut to produce an effect similar to hedge laying. Some species such as willow and hazel respond particularly well. Laying retains a living hinge that secures the cut stem to the tree stump so structural strength is retained. With the tree-top laid at water level, it provides excellent over-head cover, flow deflection and, if beneath the surface, a potential spawning substrate for coarse fish. Unfortunately, many of the trees that would have been suitable for hinging have been removed, and others have been sided-up and crown-lifted reducing the number of side branches that would provide cover at, and below, water level. However, some suitable trees still remain (pic 12).

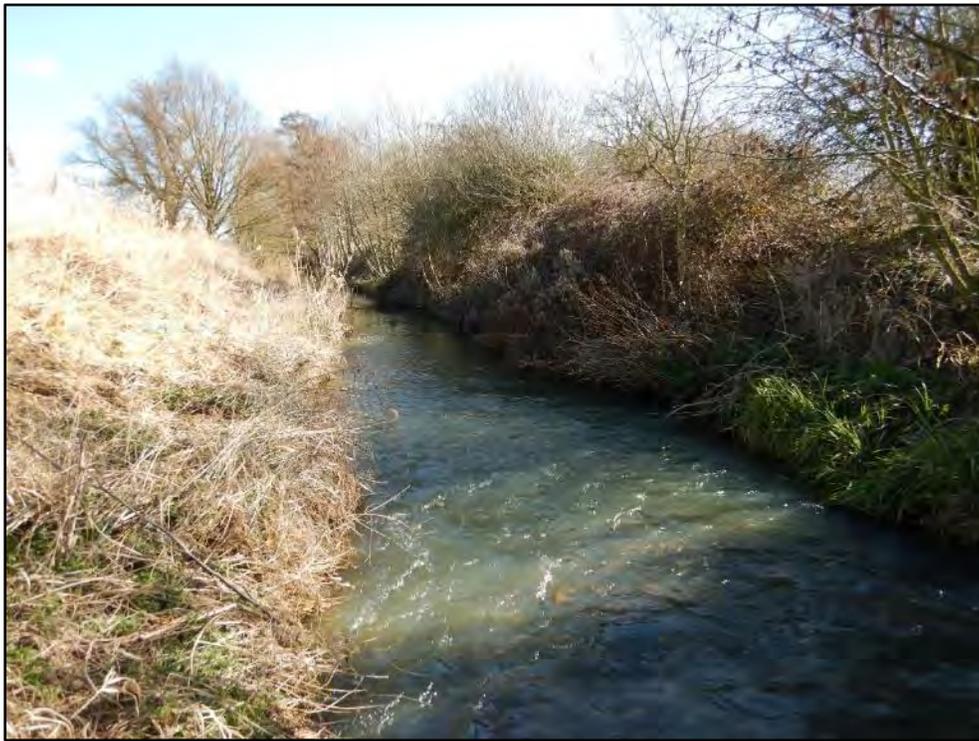
The flow rate remained rapid for a length of ~240m with a clean gravel bed, flow diversity and plants of water crowfoot (pic 12). Water crowfoot is important for retaining a head of water, increasing in-channel cover, providing shade, and a spawning substrate for many coarse fish species. The plant is typical of clean swift-flowing rivers. This reach looked particularly suitable for wild brown trout. Trout require habitat diversity for feeding, spawning and nursery areas, in addition to good water quality. Trout will spawn on well-sorted gravels (particularly in the range 15-40mm).

Pic 13 – The river flowed swiftly with a clean gravel and cobble bed exposed.

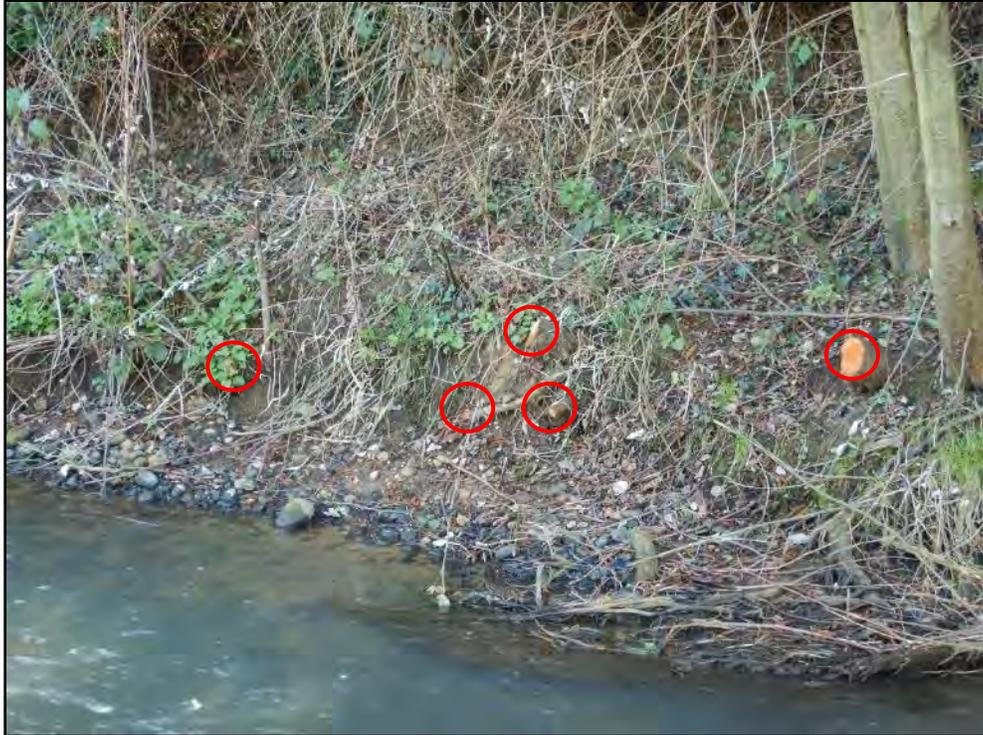
Disturbing the bed by foot revealed the coarse sediment to be relatively loose yet it contained a high sand content. It is possible that recent FCRM work had mobilised the sand. The **river's margins showed (pic 14)** there to be a gravel seam which if subject to scour could supply further coarse sediment to the channel. Increasing in-channel sinuosity through the use of flow deflectors would assist the evolution of a sinuous channel, which would be better able to sort its bedload. Fine material (especially sand) could then become deposited in the slower moving margins, thus aiding the development of marginal habitats and sediment entrainment. Furthermore, the creation of some deeper **pool habitat (using of flow deflectors) within what it's a relatively shallow run** for this fishery could increase angling opportunities, as well as providing resting habitat for pre and post-spawning fish.

Pic 14 – A gravel seam was present just above the waterline, lateral scour could result in this material being supplied to the river which would aid the development of habitats. Note the tree stumps (red circles)

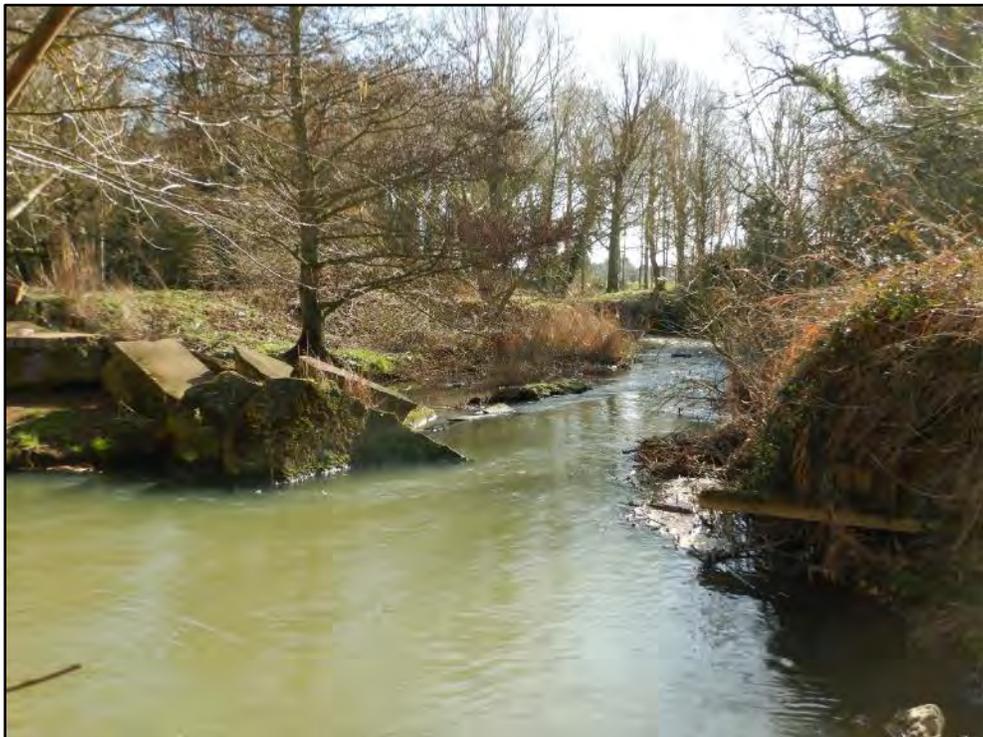
Pic 15 – The collapsed Clifton overspill weir. The head-loss has allowed the river to become energised up to the Horsebridge.

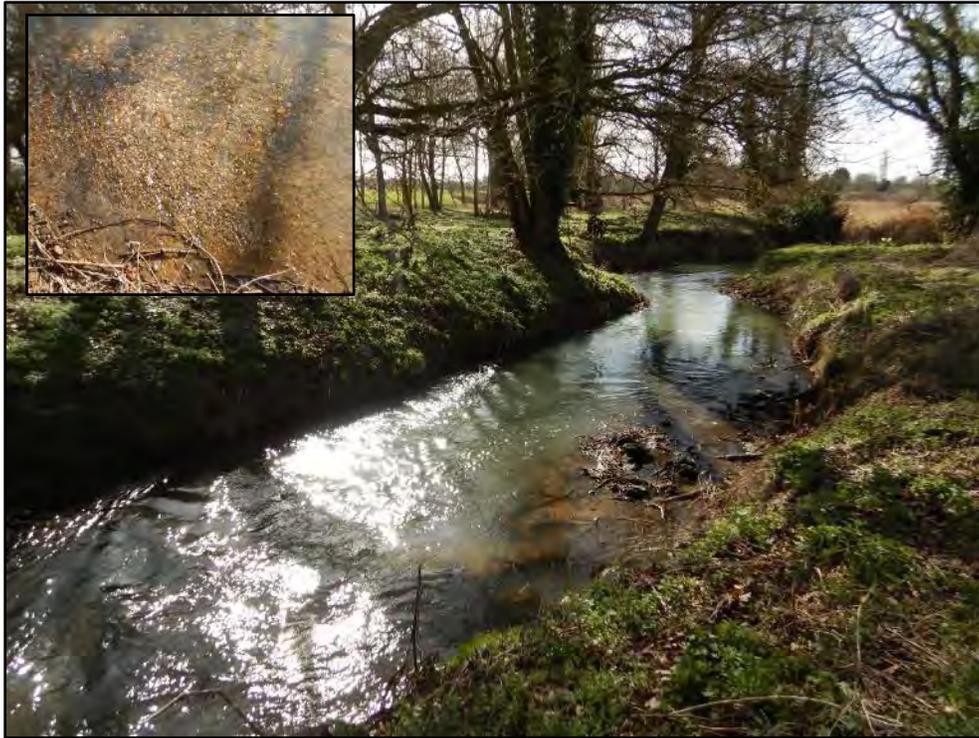
Downstream of the failed Clifton overspill weir the river had returned to what was believed to be the natural channel of the River Ivel. The channel form exhibited far greater bed variation, flow diversity and in-channel sinuosity (pic 16). The sinuous channel was clearly aiding sediment transfer and sorting, as gradation of particle size could be seen in the margins.

Pic 16 – Following the weir, the river has returned to flow once again in its natural channel. This short length of river exhibited many natural features which would be attractive to brown trout and gravel spawning coarse fish (depth variation, flow diversity, undercut banks, accumulation of graded sediment and mature tree cover).

The EA's FCRM team should be asked to clarify their objectives for the work in this reach. If it was for flood conveyance then the removal of LWM, riparian trees and trailing branches would have a negligible impact given the impounding structures still present. If it was to increase flood attenuation, then re-connecting the river to its floodplain is the ultimate position.

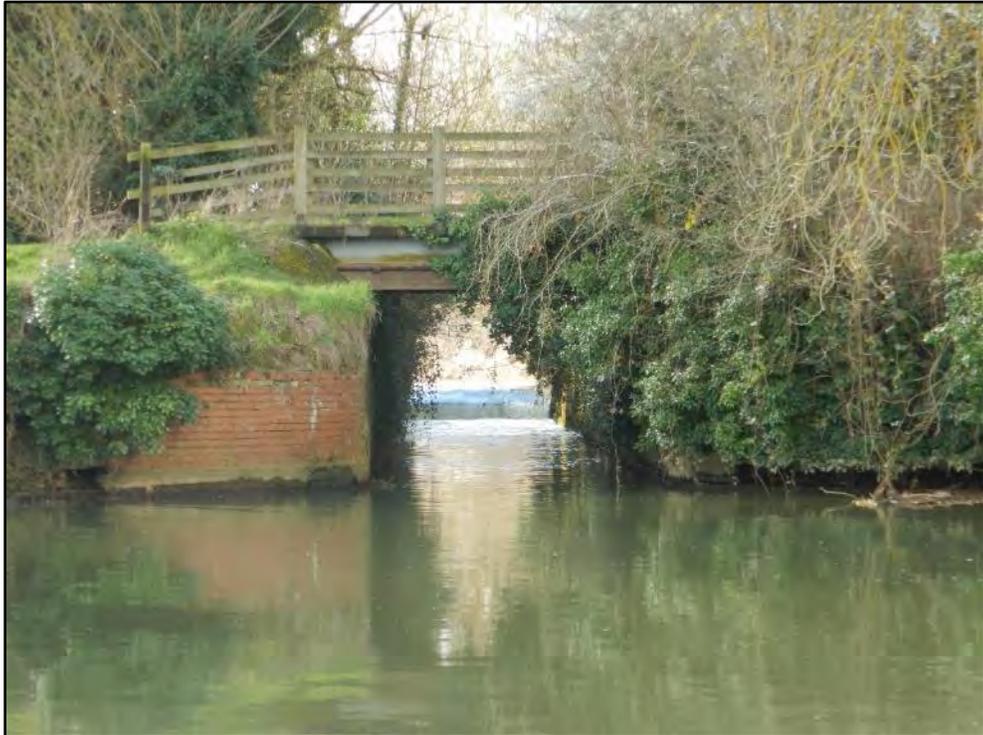
The start of this reach was immediately downstream of a redundant lock (pic 17). It is important to note that the navigation is no longer operational and as such there is no need for the lock to be present. The lock was causing upstream water levels to be impounded (and thus increasing flood risk to that area) and acts as sediment trap for coarse material. Furthermore, the lock dissipated **the river's** energy with cascading water centred entirely within it.

There was little scour downstream of **the lock**. **Options for the lock's removal** should be explored. If that cannot be achieved then fish passage through a rock ramp should be considered.

Pic 17 – A redundant lock on the navigation. Note the ~0.6m fall of water within it which presents a barrier to the movement of fish.

The defunct lock near Stanford should be removed or be subject to a rock ramp fish pass.

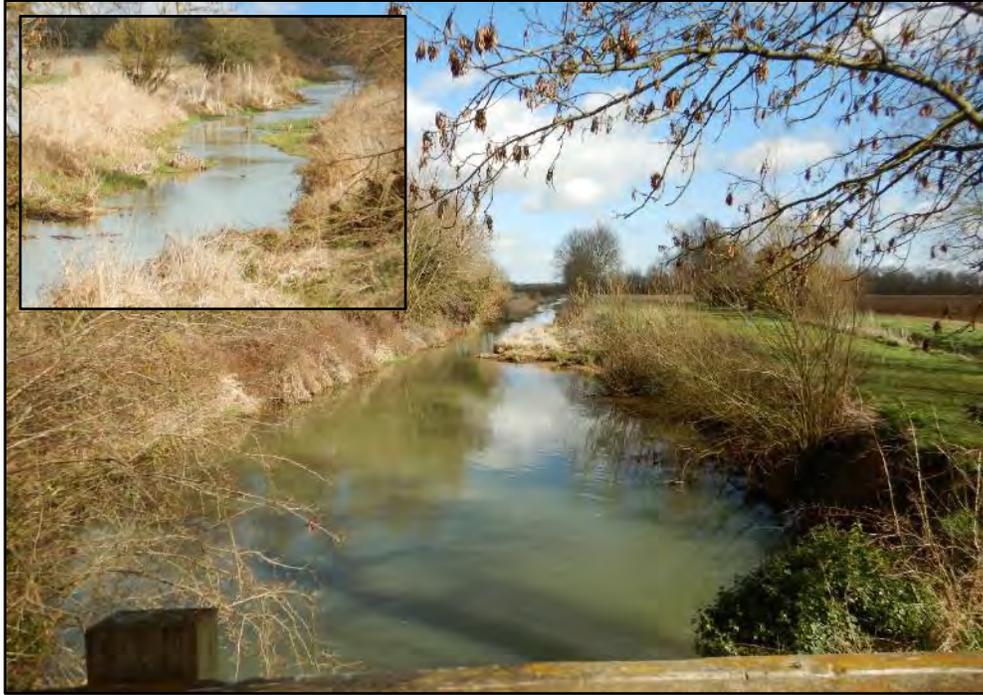
The pool downstream of the lock was ~20m wide with no flow diversity (pic 18). It was not possible to assess the depth within this reach. The margins had fine sediment forming mud bars beneath the willow trees of the RB. The bed was covered in fine sand and silt.

Pic 18 – The navigation downstream of the lock was wide and slow flowing, but downstream marginal vegetation had narrowed the channel resulting in the evolution of a sinuous pathway (inset).

On emerging from the lock pool, the river had been able to narrow itself due to marginal encroachment (pic 18) and willow roots. Unfortunately, an excavator had been used to remove many willow trees from the margins. This had compromised the stability of many silt bars and it is possible that many will wash-out over the coming months resulting in an impoverished habitat at source, and degraded habitat where the silt settles. It may take many years for the river to evolve the same extent of stable silt bars, marginal growth and riparian trees to that which were removed.

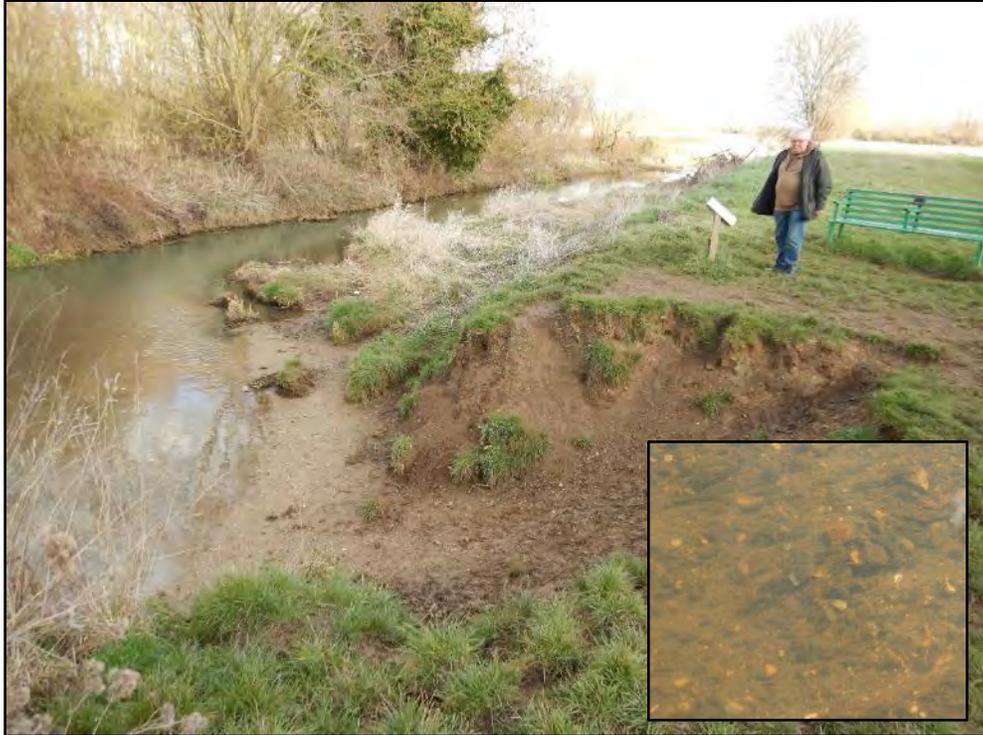
A significant dog slide was seen, and it had caused severe bank erosion. It was a significant source of fine sediment input (pic 19).

Pic 19 – An extensive dog slide resulted in fine sediment smothering the gravel bed (inset).

The dog slides could be reinforced with logs to create a stepped profile and the bank-toe topped with cobble/gravel mix to reduce the down-washing of fine sediment. The largest slide could be re-shaped to create a bay-like habitat to aid the growth of coarse fish fry.

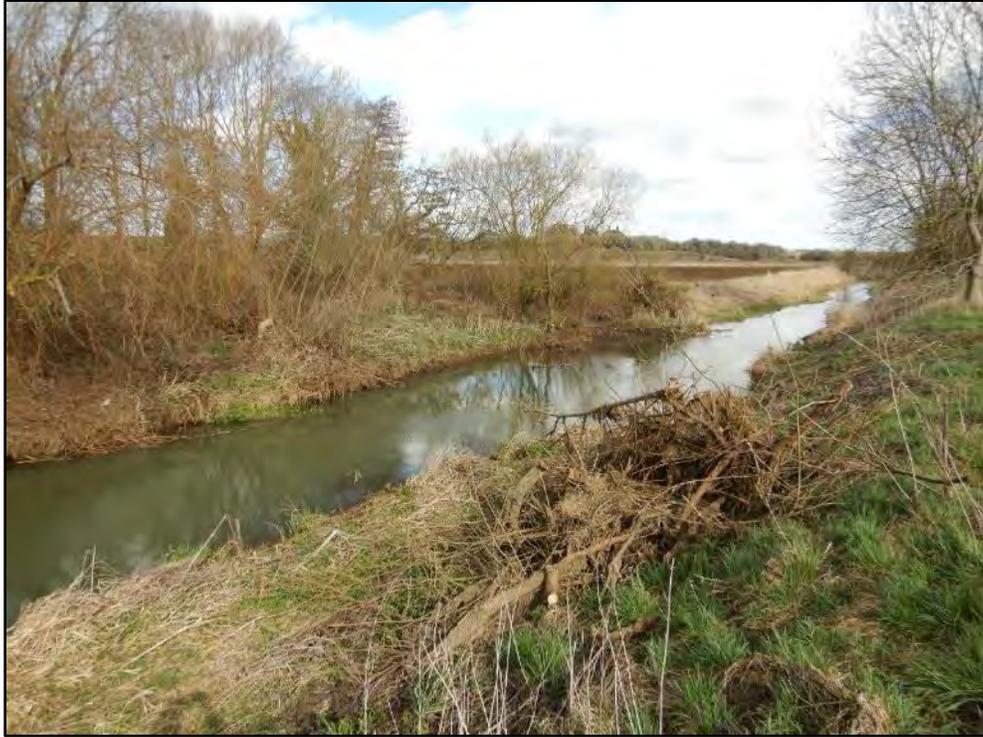
Pic 20 – The removal of willow trees will have mobilised fine sediment and eliminated their ability to suppress excessive marginal vegetation.

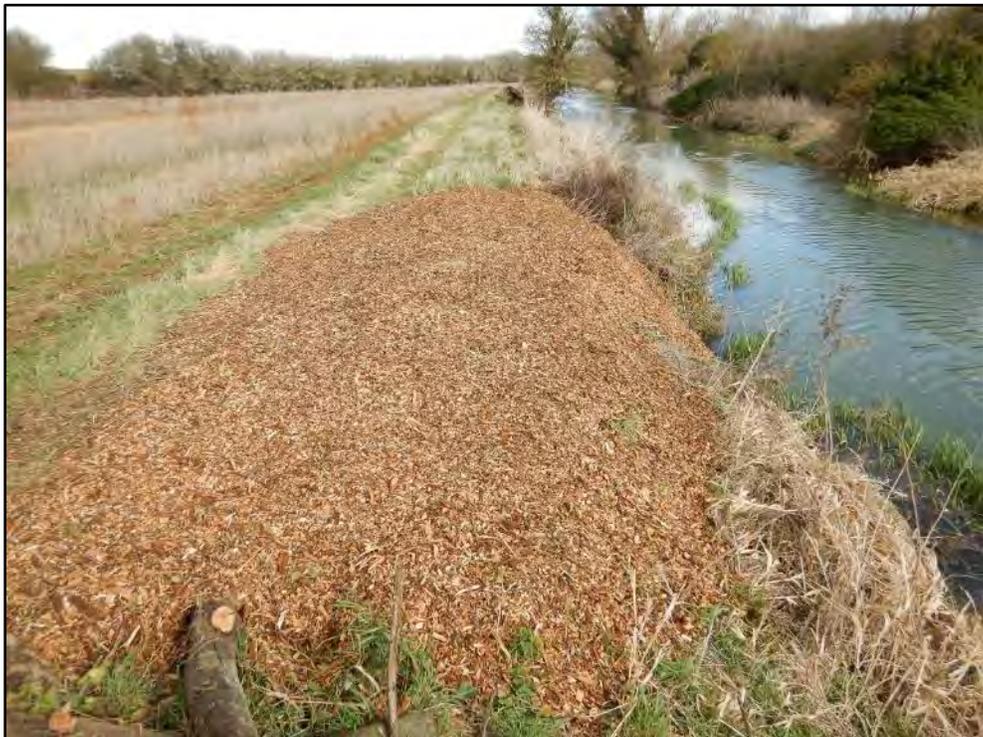
Pic 21 – An extensive chipping pile left on the bank-top and side.

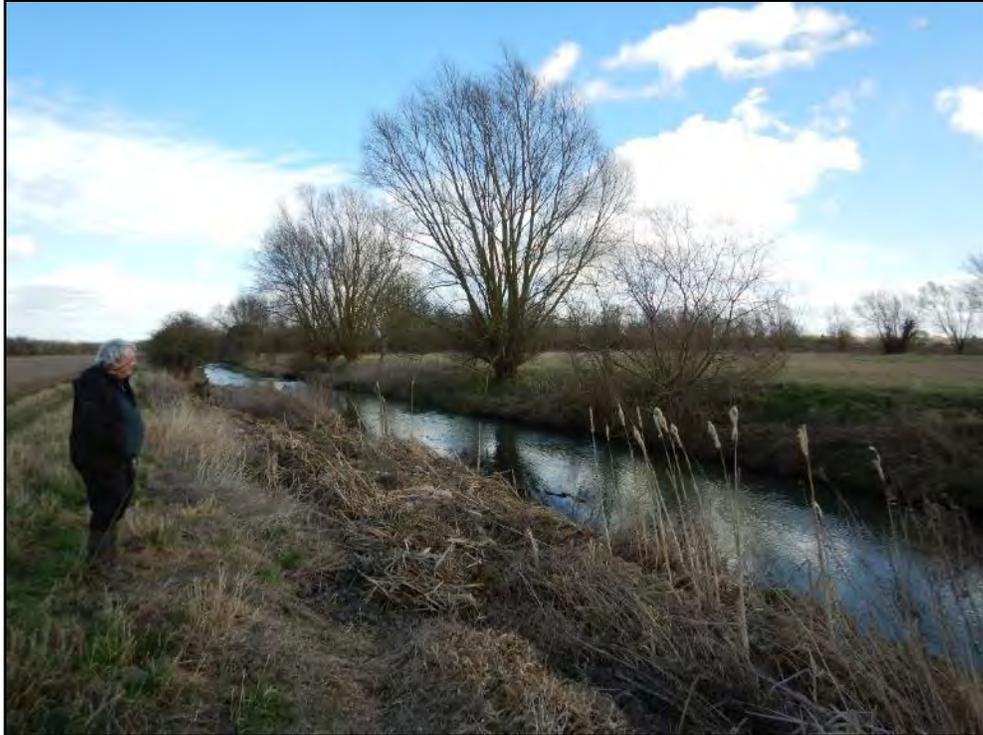
Pic 22 – Stands of marginal reedmace had been pulled back and placed on the existing berm.

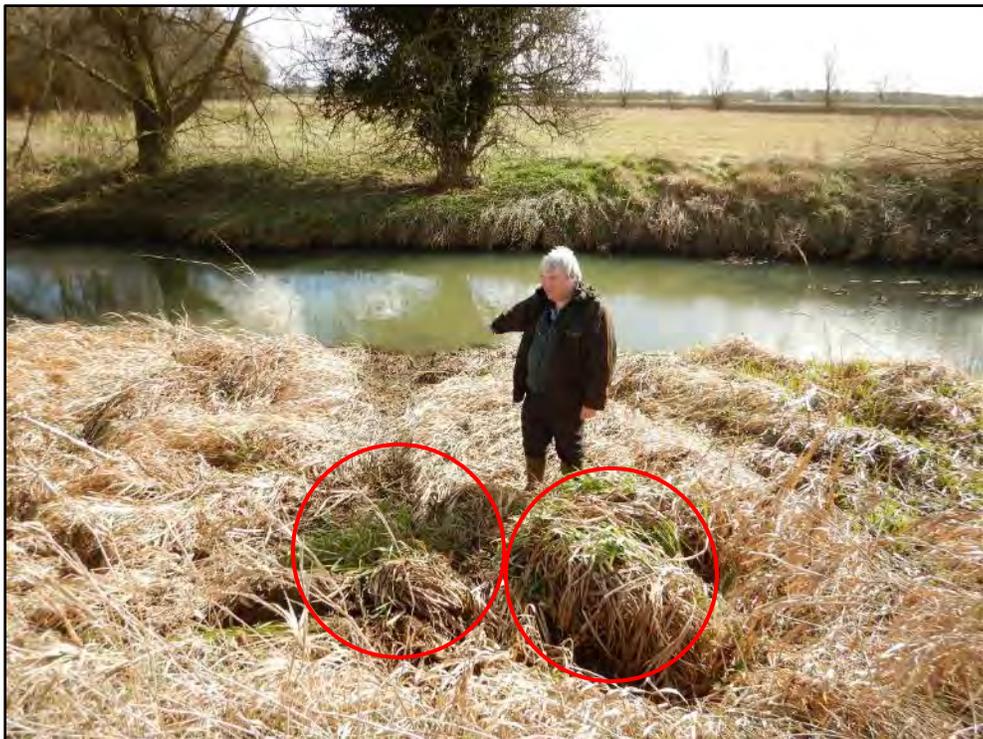
Pic 23 – Marginal vegetation has been pulled from the water's edge and placed upon the berm (red circles).

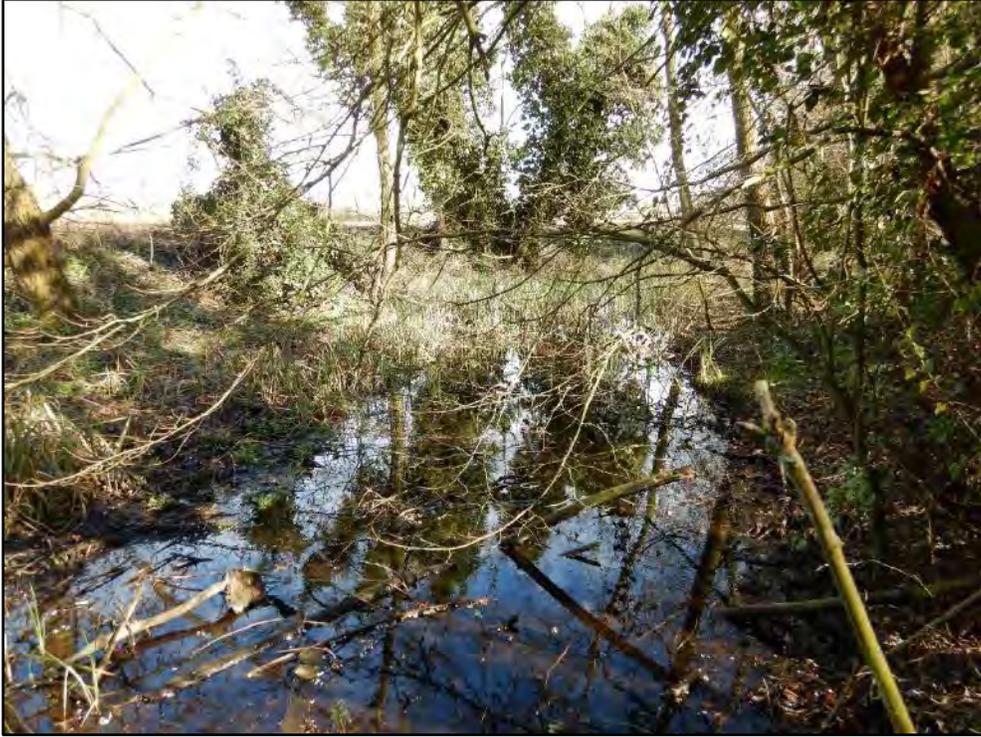
Prior to the river's realignment to create the navigation a mill existed near to Stanford. The mill channel is now heavily silted (pic 24) and shaded. It is barely visible where it meets with the navigation (pic 25). The mill channel could be opened-up and desilted to provide a substantial backwater to benefit juvenile fish.

Pic 24 – The former mill channel above the navigation. It could be desilted to create a backwater habitat.

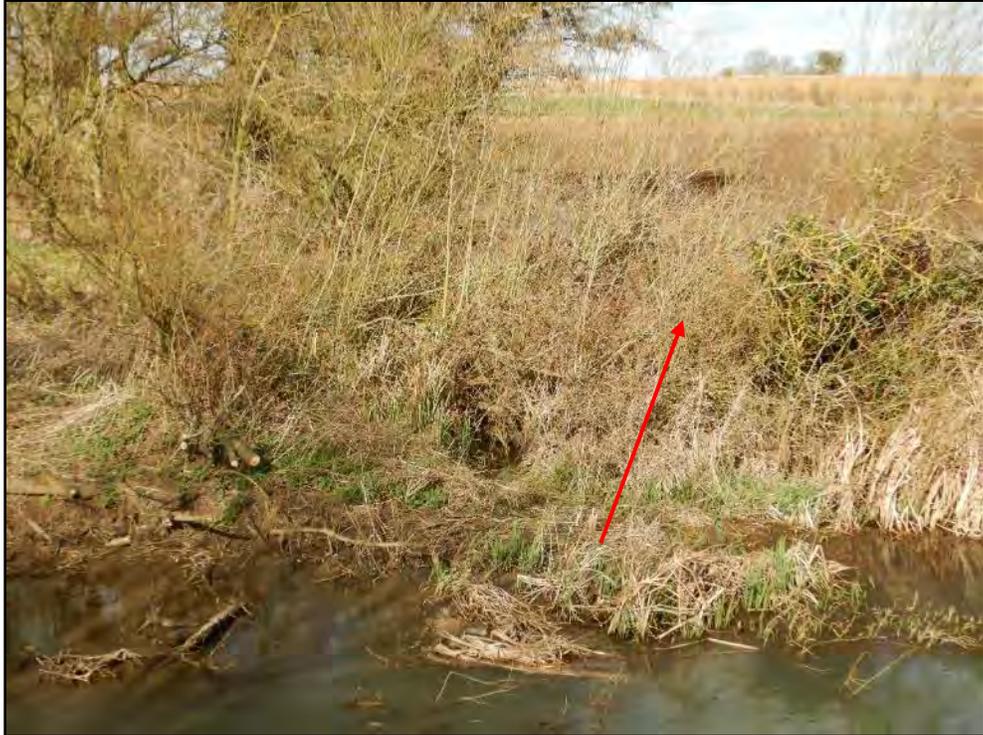
Pic 25 – The removal of willow that would have provided marginal cover for juvenile fish. This location (red arrow) is the point where the former mill channel once entered the navigation.

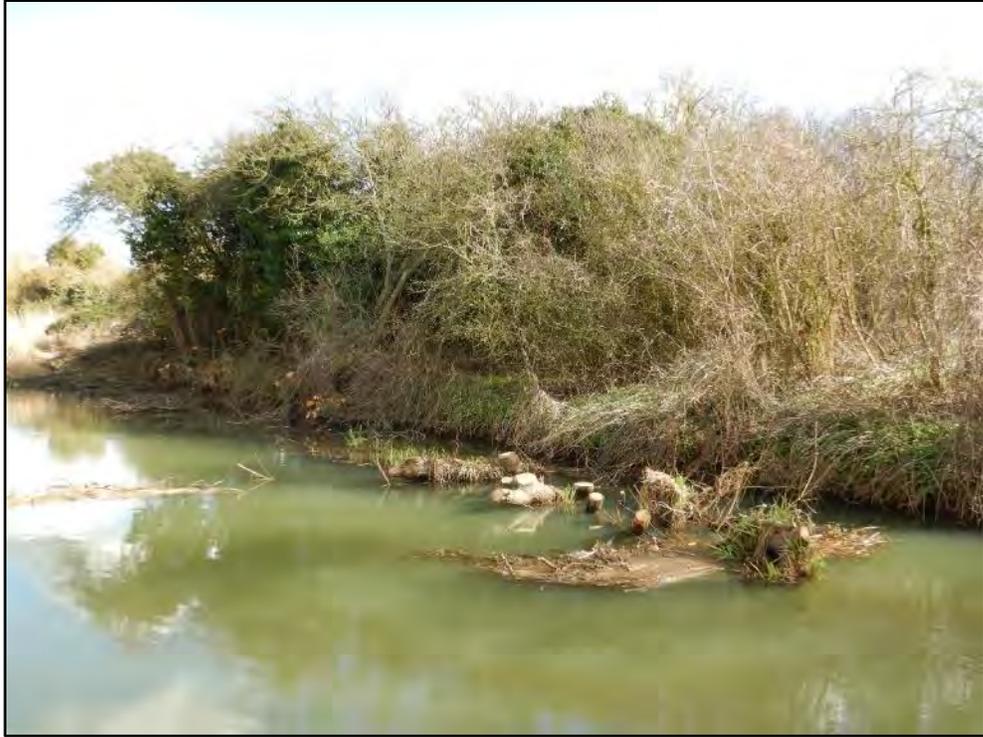
Pic 26 – Riparian willows have been completely cut back.
