Advisory Visit

River Ivel Navigation, Bedfordshire

March 2019

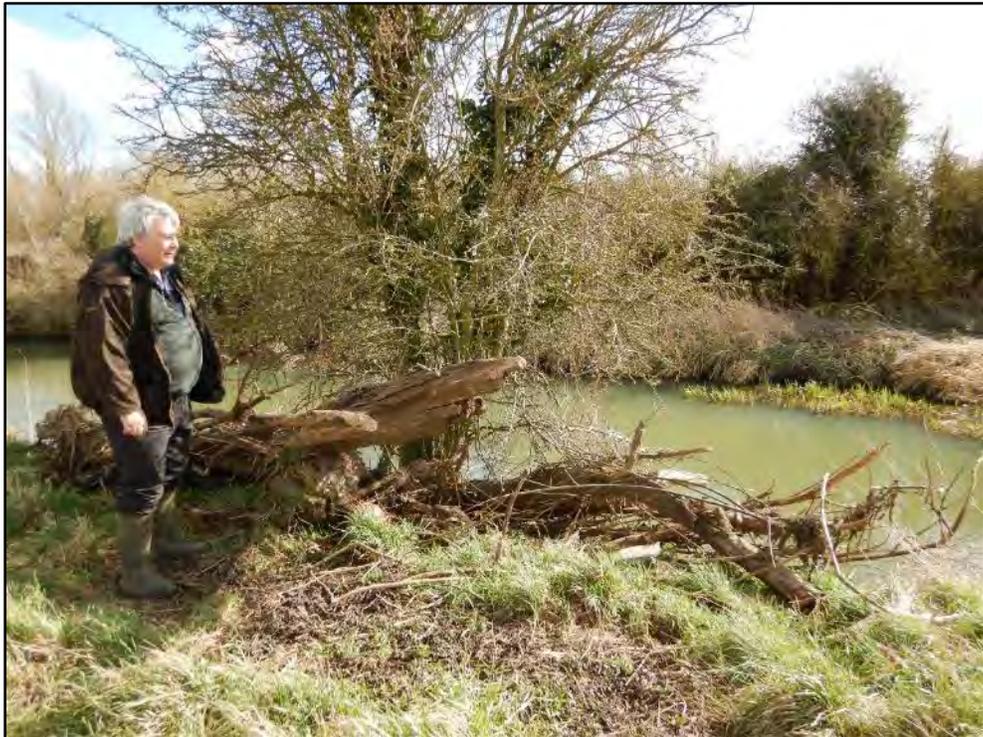
Pic 27 – LWM had been removed from the channel. Much of this material was completely saturated and is likely to have been in the river for many years.

Large woody material should be returned to the channel, particularly downstream of the Horsebridge, to enhance in-river habitat. The WTT could work with SDAA to conceive a project proposal. Tree-hinging would be a simple first approach to managing the existing tree stock whilst providing cover at water level. The introduction of simple flow deflectors to initiate scour and sediment transfer would be beneficial, especially if combined with brushwood ledge creation to encourage the retention of fine sediment within the margins.

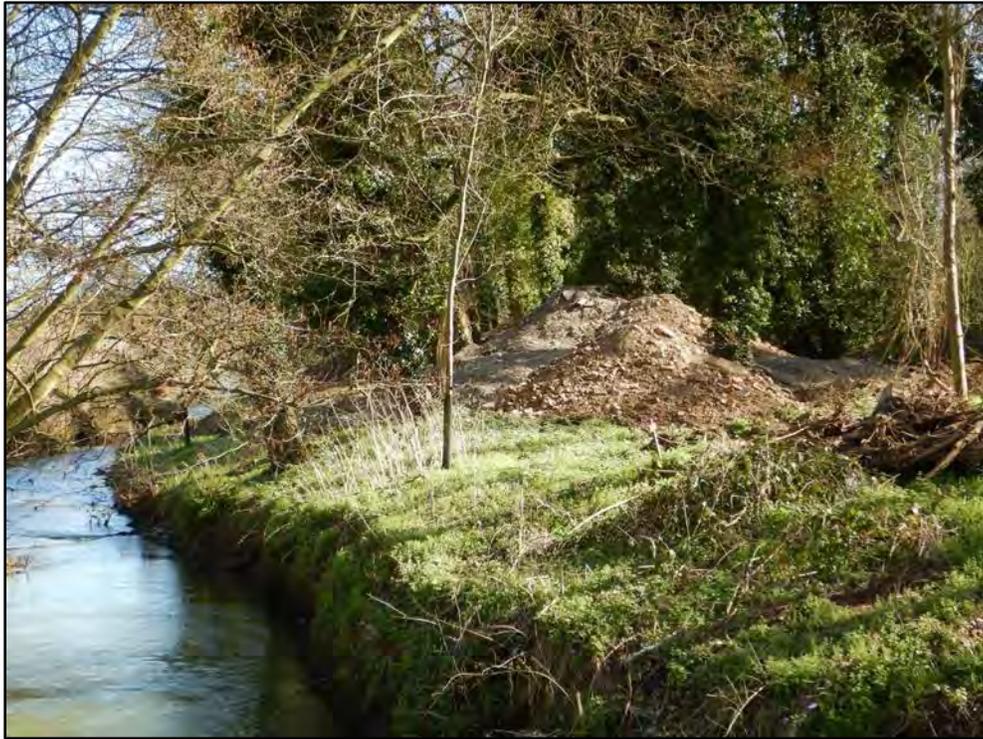
During the visit an extensive length of spoil deposition was noted on the RB downstream of the Clifton overspill weir (not on Shefford and District Angling Association controlled land). The matter has been reported to the EA via its incident line. The reduction of floodplain capacity and alteration of floodplain flow poses a much greater flood risk than marginal vegetation, trailing branches and some large woody material. Photographs of the deposited spoil are presented in the appendix.

Pic 28 – Spoil deposited on the flood plain reduces water storage.

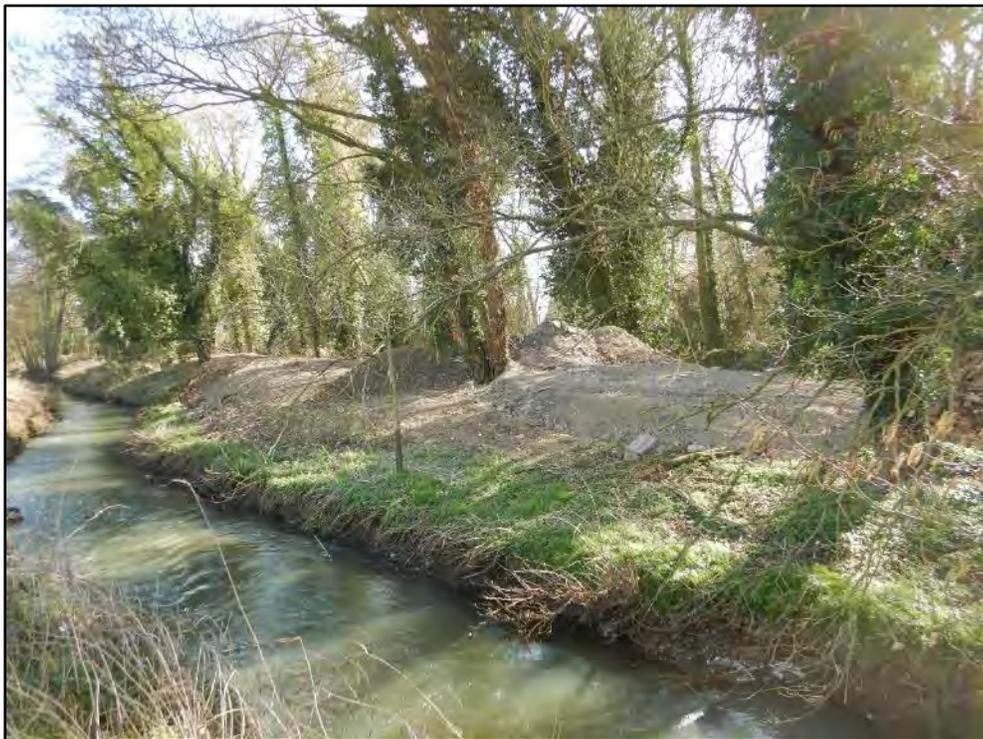
Pic 29 – The length of deposited spoil extended for over 100m.

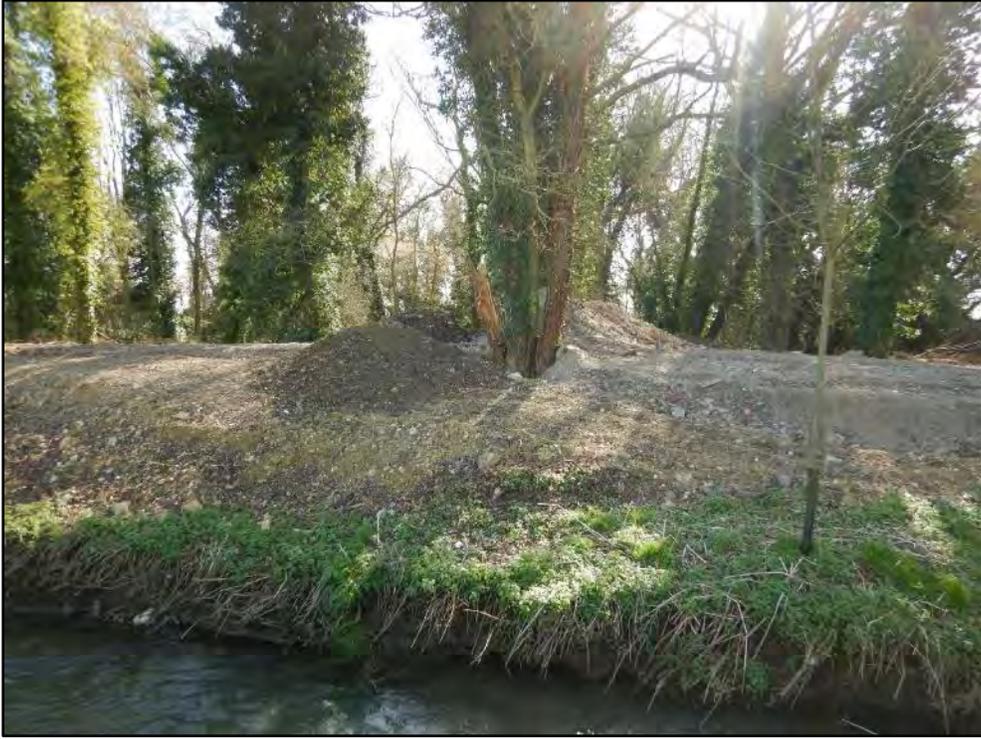
Pic 30 – The burying of tree stems by deposited spoil is unacceptable and is unlikely to have been consented by the appropriate authority.
