Advisory Visit  
Little Ouse River, Thetford  
June 2018

Undertaken by Rob Mungovan

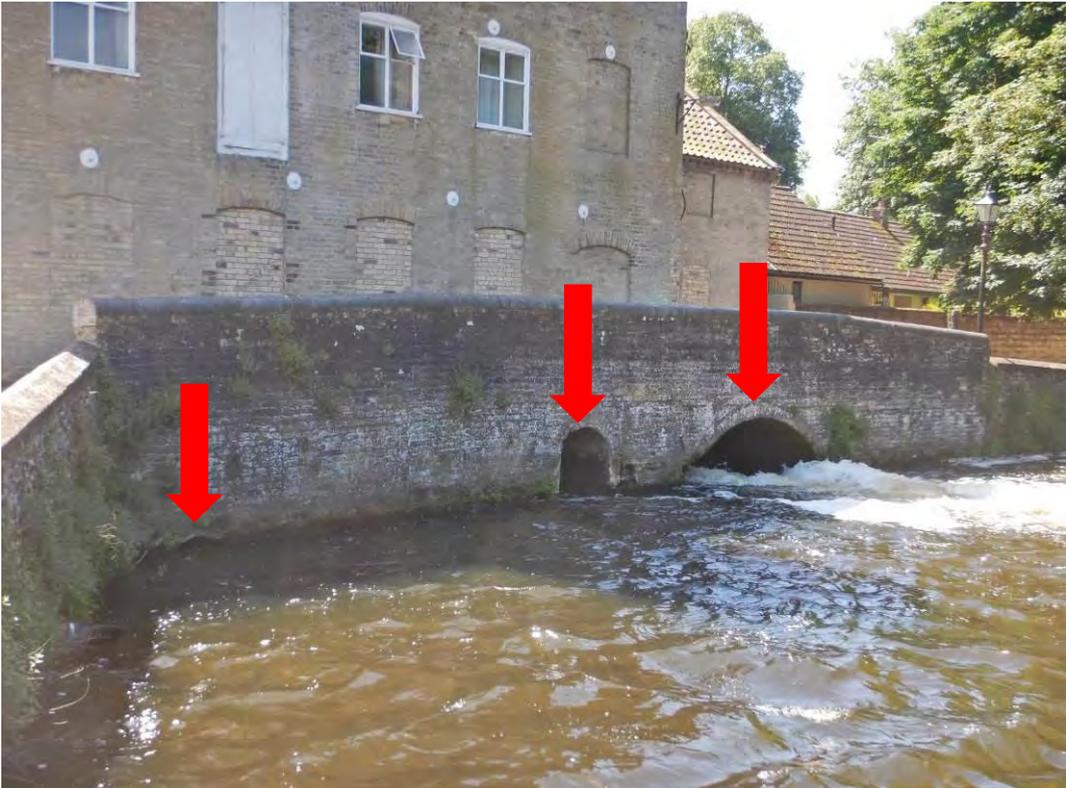
The visit commenced in the town of Thetford immediately downstream of the Coffee Mill, and focussed on the two main channels that run around the town parks and open spaces. The Coffee Mill presents a significant barrier to the movement of all fish species. It is reported that a feasibility study for improvements to fish passage may be funded through the Water and Environment Grant (if successful). The front of the mill presents at least three pathways for flow and each of these should be investigated as potential routes for fish to traverse the mill.

Pic 1 – The Coffee Mill in Thetford town centre presents a barrier to the movement of fish. Three arches marked by red arrows represent potential flow pathways that should be investigated.

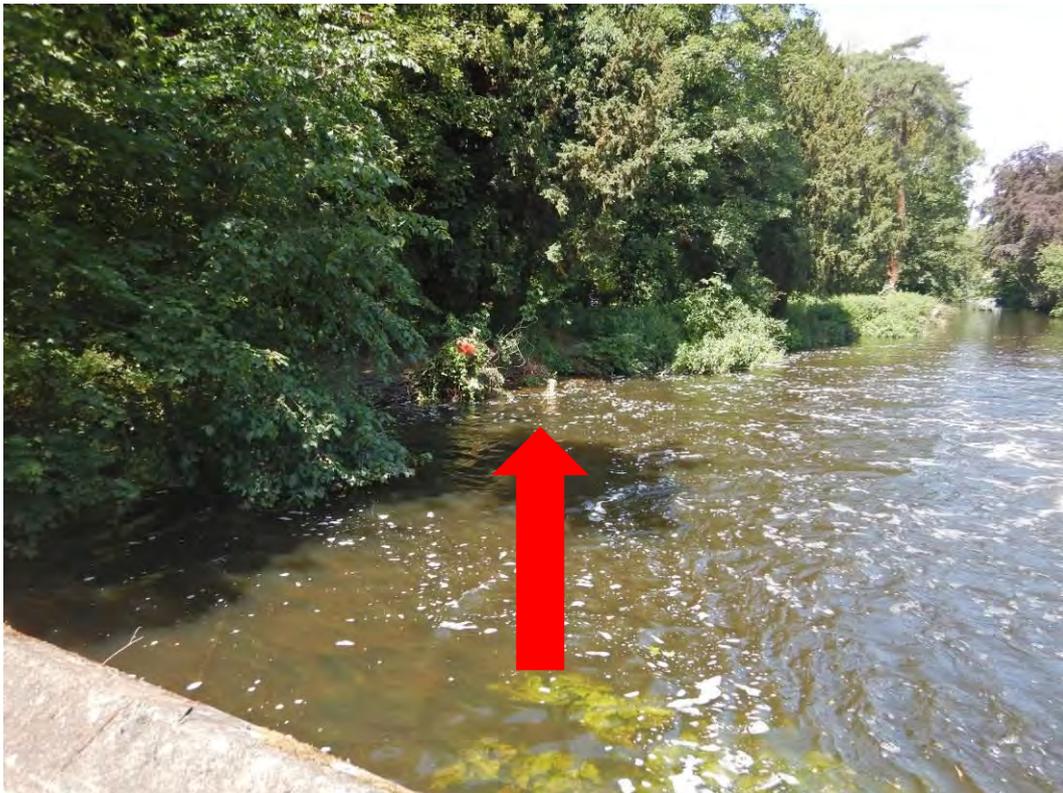
Downstream of the mill recent clearance work has resulted in the total removal of fallen trees from the river (pic 2). The remaining stumps have been treated with herbicide to prevent their re-growth (pic 3). Removal of fallen trees and their subsequent killing is highly detrimental to the river. Fallen trees, large branches and stems are collectively referred to as large woody material (LWM); the presence of which is extremely important within a river. It increases the available surface area onto which algae will grow and undertake photosynthesis thus initiating nutrient cycling. Algae then provides a source of food for invertebrates, thus increasing the total biomass that a river can support. LWM can also provide underwater cover, offering protection for fish against high flows, otters and fish-eating birds. LWM is also a key element in kick-starting geomorphic processes such as bed and bank scour, leading to the development of natural river features such as pool and riffle sequences (where gradient allows). Furthermore, the sorting of bed material can encourage marginal deposition of fine sediment or allowing it to be deposited upon the floodplain in out-of-channel flow.

Pic 2 - Tree removal (red arrow) has resulted in the removal of LWM from the river which would have otherwise provided valuable cover at water level.

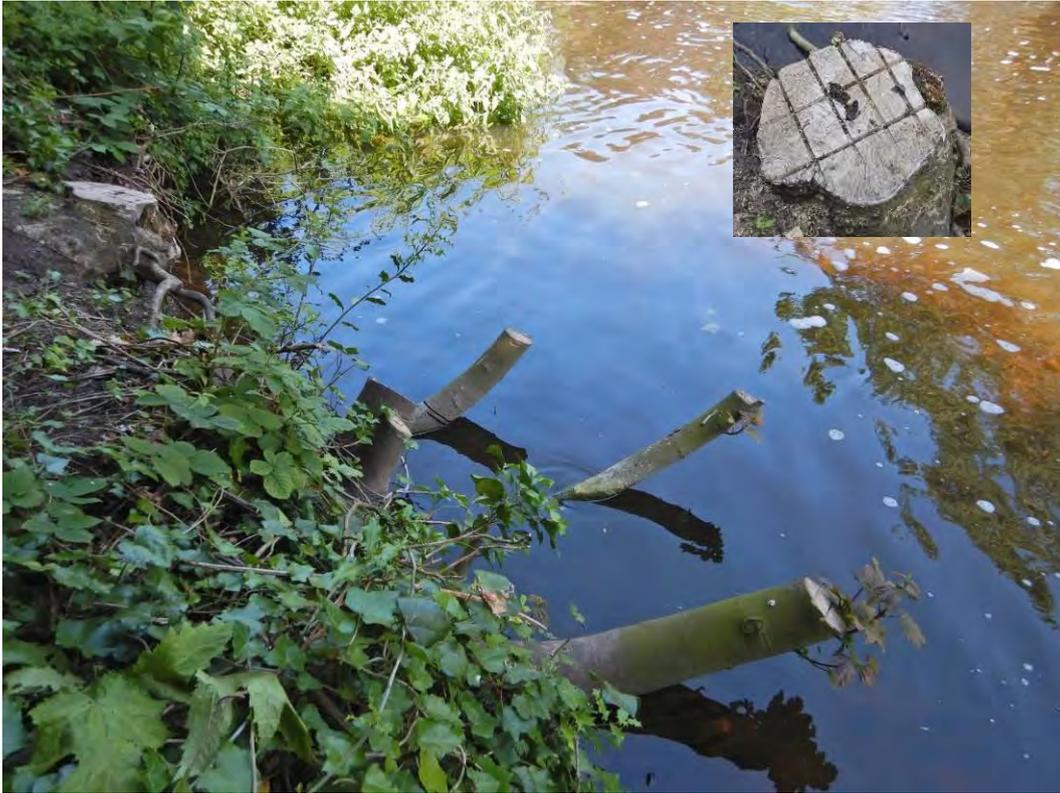
Pic 3 – These sycamore trees have been cut-back and killed off as indicated by the cross-cutting to hold herbicide. Note an otter spraint present on the stump (inset picture).

The removal and killing of trees has left the bank prone to erosion. Fallen trees within a river can be managed to retain their habitat value by winching them to a secure bankside position and securing them with stakes and/or cable rope. Where riparian trees require thinning and their habitat potential as fallen LWM would otherwise be removed, a technique known as tree-hinging can be used. Tree-hinging is similar to hedge laying in that it retains a living hinge that secures the cut stem to the tree stump. The hinge continues to allow the tree to live so structural strength is retained. For additional security, the tree can be secured using cable rope. Laying the tree canopy down to water level (or below) provides excellent over-head cover, flow deflection and a spawning substrate for coarse fish species. These two approaches would be suitable for many of the trees within Thetford town where trees may otherwise be removed on safety grounds (pic 15).

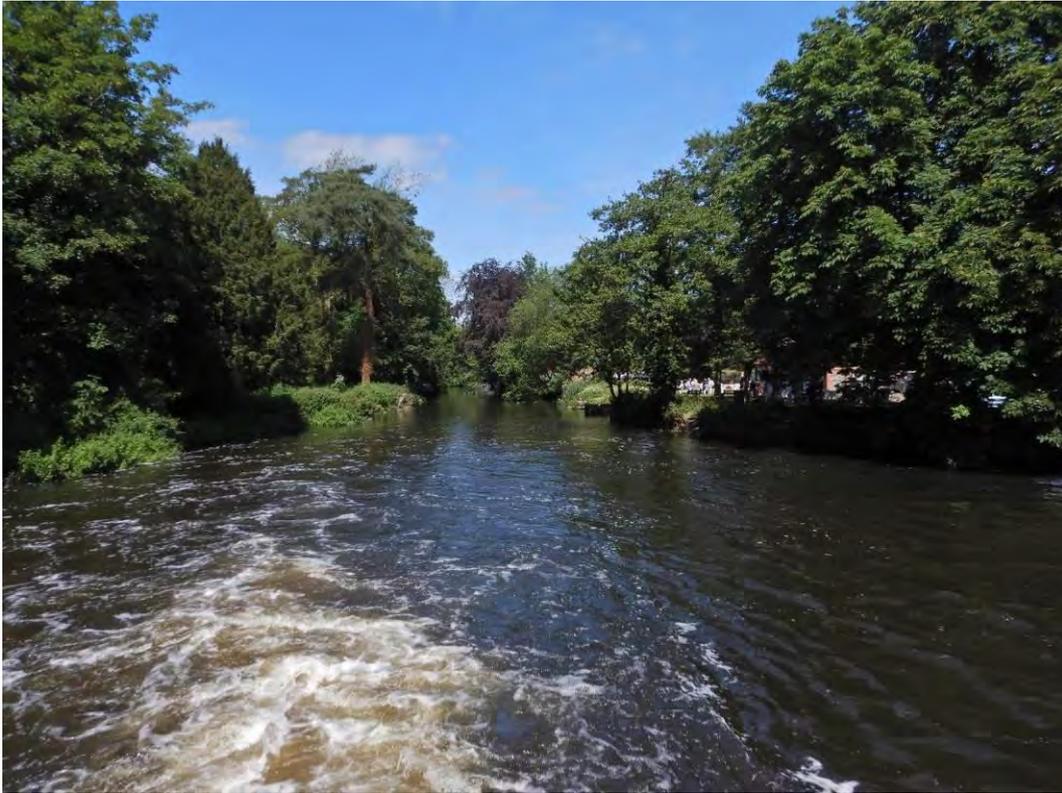
This pool provides some good cover, but only along the LB that has branches trailing from it, and many of them were relatively small. It would be beneficial to provide further cover at the edges of this pool to protect adult fish during spawning periods. Nearby cover is important as spawning fish often become exhausted making them prone to predation. Cover also protects fish from wash-out during flood flows. Similarly, as young fish emerge they too need to find cover from strong flow in order to maintain a feeding station and to prevent them from being washed downstream.

Pic 5 – The river immediately downstream of the Coffee Mill, with turbulent flow keeping the pool cleansed of silt and the gravel well-sorted. Cover at water level is found on the LB but it is limited.

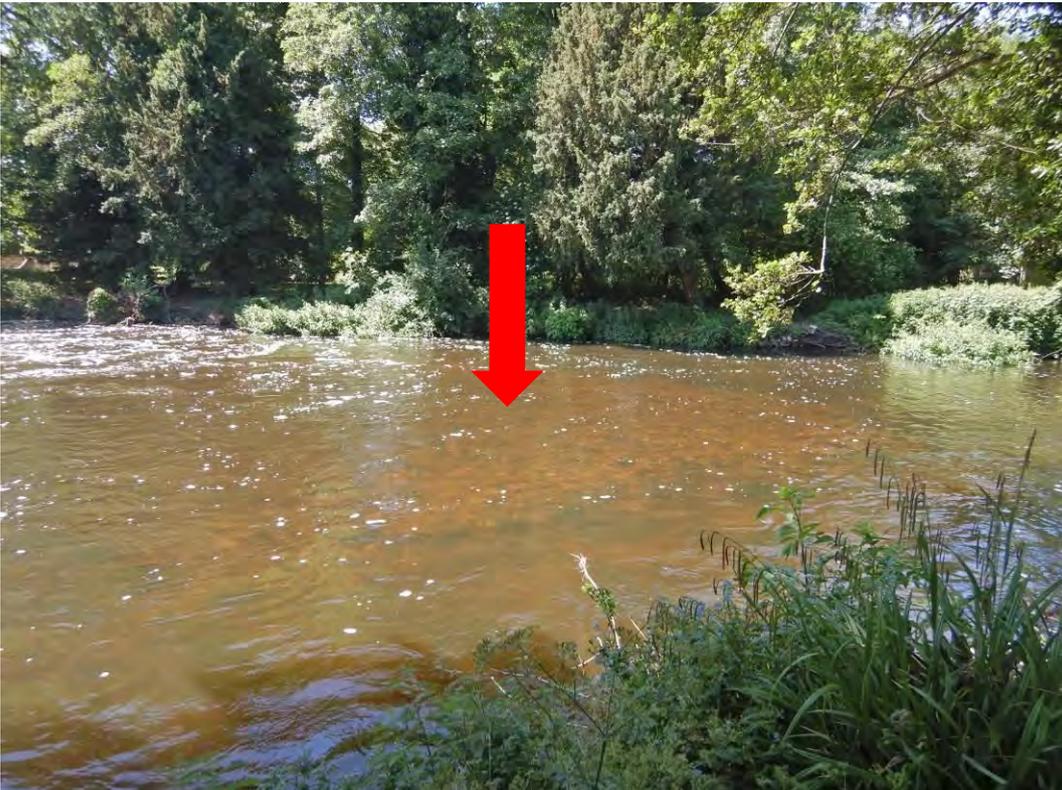
Rapid flow of water emerging from the Coffee Mill aerates the pool and maintains high flow velocities keeping the gravel free from silt. An extensive gravel bar at the tail of the pool (pic 6) provides valuable increased flow velocity and habitat diversity. This gravel bar is likely to present a locally important spawning area for many fish species (especially brown trout during the winter and chub and dace in the spring and early summer) and its presence and form should not be altered (such as by dredging). If sea trout run up the Lt Ouse and are prevented from moving further upstream by the mill then this type of feature would present a valuable spawning site.

Pic 6 – The gravel bar (red arrow) at the end of the mill pool provides a valuable spawning site for a range of fish species including sea trout if they cannot pass the mill.

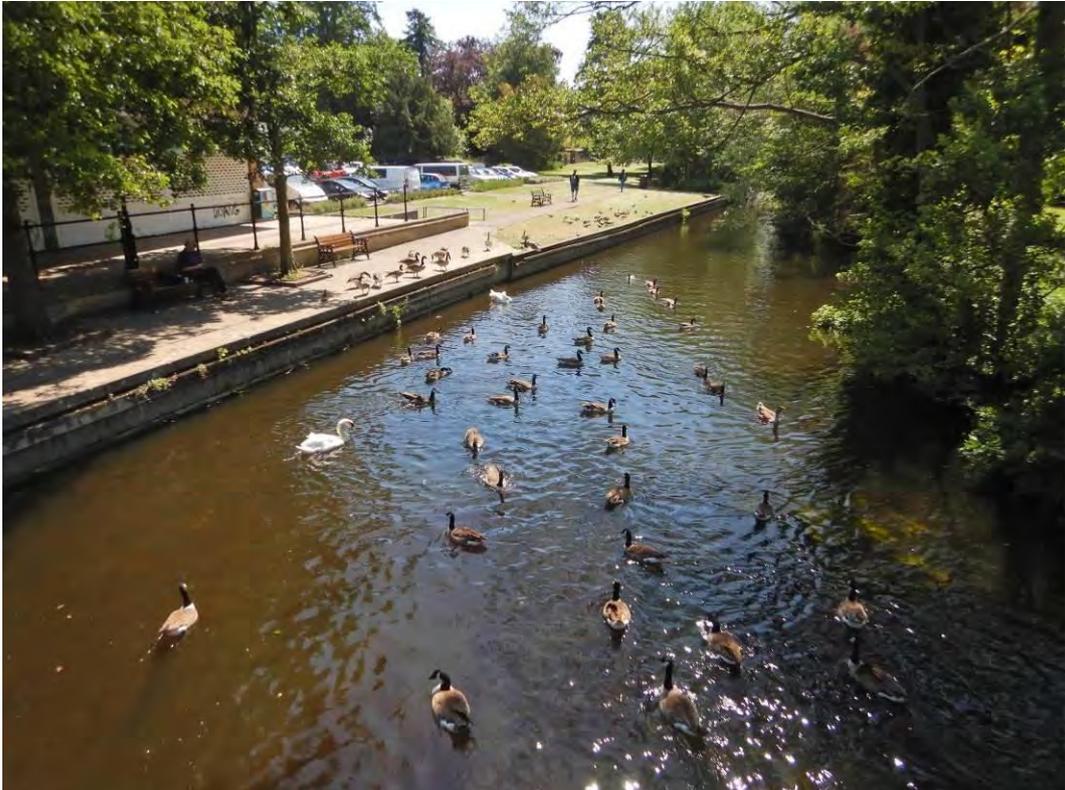
The parks and open spaces are typical of most urban parks with close-mown grass bordering the river. The bank was often formed from hard brick or stone revetments with no gradual transition to water level (pics 8 and 9).

Pic 8 – The hard stone revetment provides no marginal habitat for the river. Extensive lengths of walling prevent plants that would otherwise support invertebrates and small animals from finding a niche.

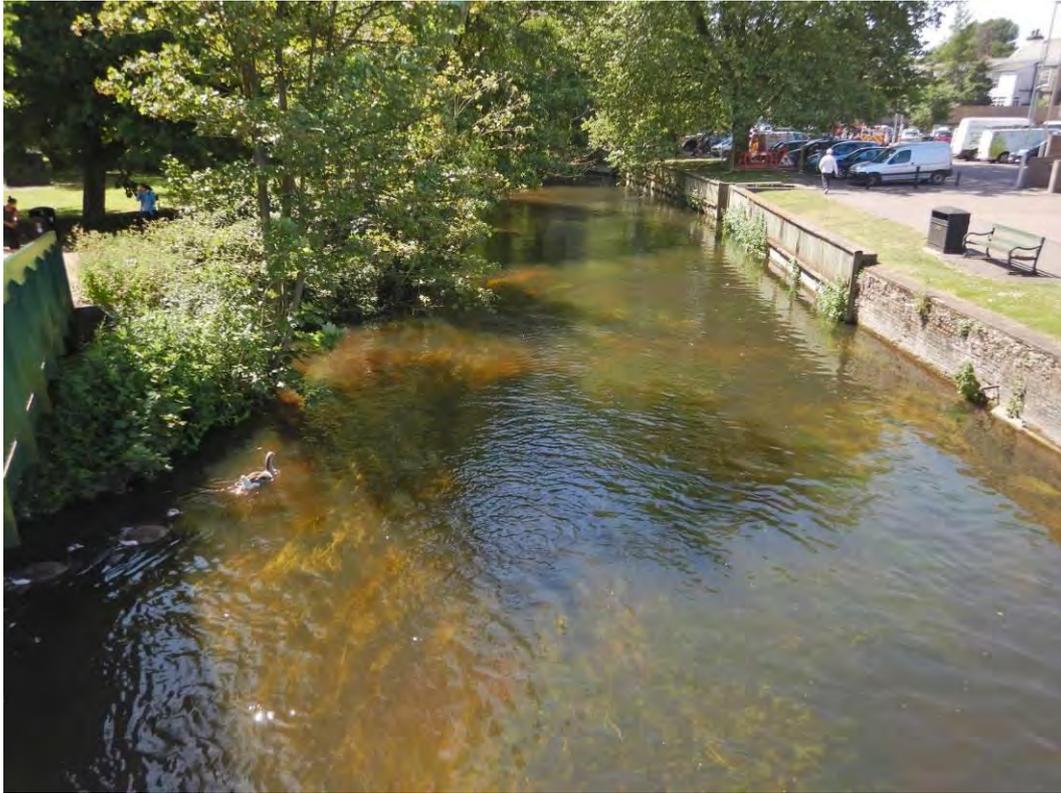
Pic 9 – The contrast in habitat quality between a tree-lined bank and a hard revetment is very apparent at this location. The stone walled right bank has been colonised by a very limited number of plants. In contrast, the opposite bank has marginal vegetation which trails to the water, and trees provide bank stability and cover.

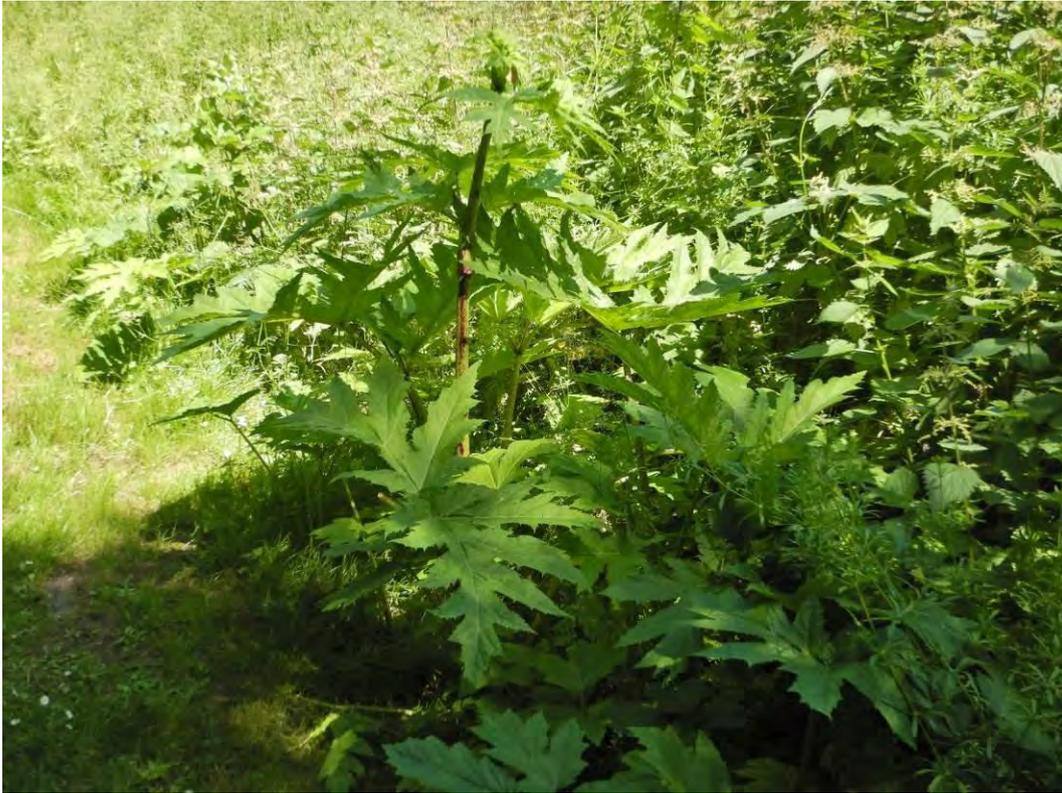
During the visit the only non-native invasive species observed was one stand of giant hogweed. Giant hogweed presents a serious threat to any waterway due to its ability to rapidly colonise habitats through mass seed production. The plant can then out-compete other species due to its tall growth allowing it to form dense monocultures. In addition to being a threat to native biodiversity through direct competition, the plant poses a serious threat to human health. Hogweed contains a photoactive sap that, following contact with skin, reacts when exposed to sunlight, causing potentially serious chemical burns. There is often a lag time between exposure to the sap and its photoactivity period so anyone that comes into contact with the plant may not realise until it is too late. All giant hogweed plants should be controlled through appropriately certified personnel, using herbicide if necessary. No flower heads should be allowed to set seed.

Pic 11 – A small number of giant hogweed plants were found growing on the right bank of the Island at TL 87017 82864. All hogweed plants should be eradicated as a matter of health and safety.

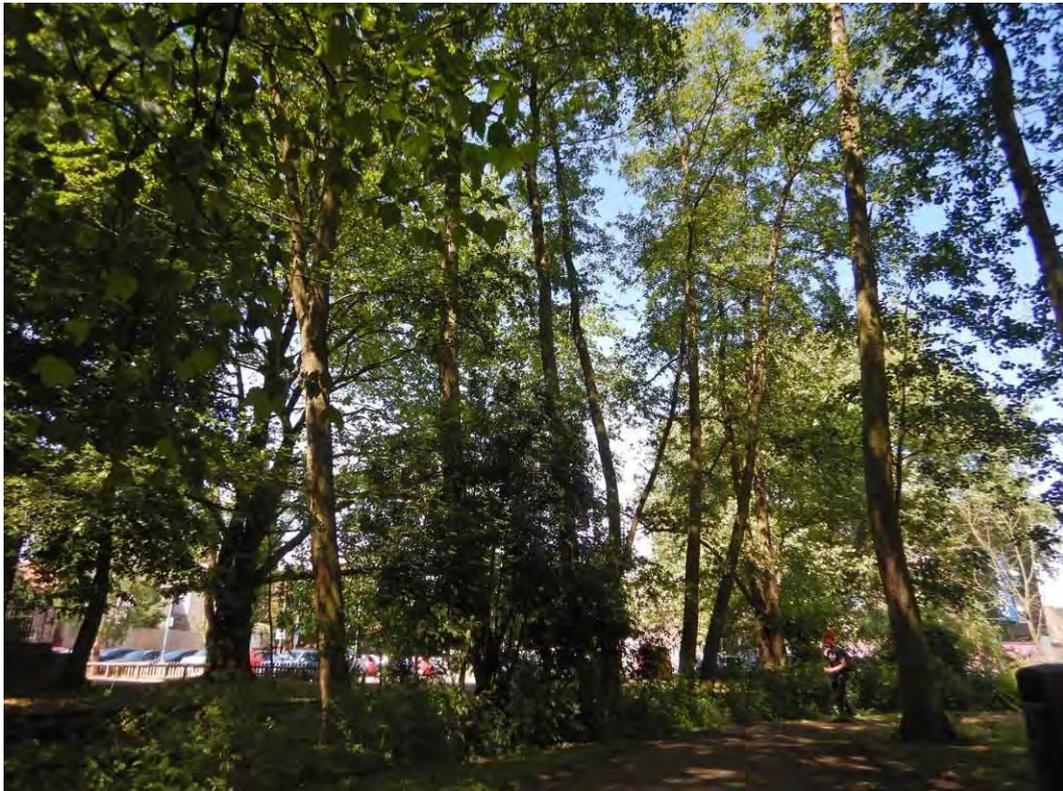
It appeared that the effect of shade was starting to impact upon in-channel plant growth. Selective tree work to let light onto parts of the channels would be advantageous. The techniques of coppicing and/or pollarding might be appropriate. However, tree-hinging would be of greater benefit to the river. This approach would allow a reduction in the shade cast whilst still utilising the fallen (but still fixed) timber to create habitat features such as flow deflectors and LWM at water level as cover. There were many tall trees, and some standing dead trees, which could be utilised for in-river habitat enhancement work.

Pic 15 – Tall alder trees are casting shade on the river and reduce both marginal and aquatic vegetation growth.

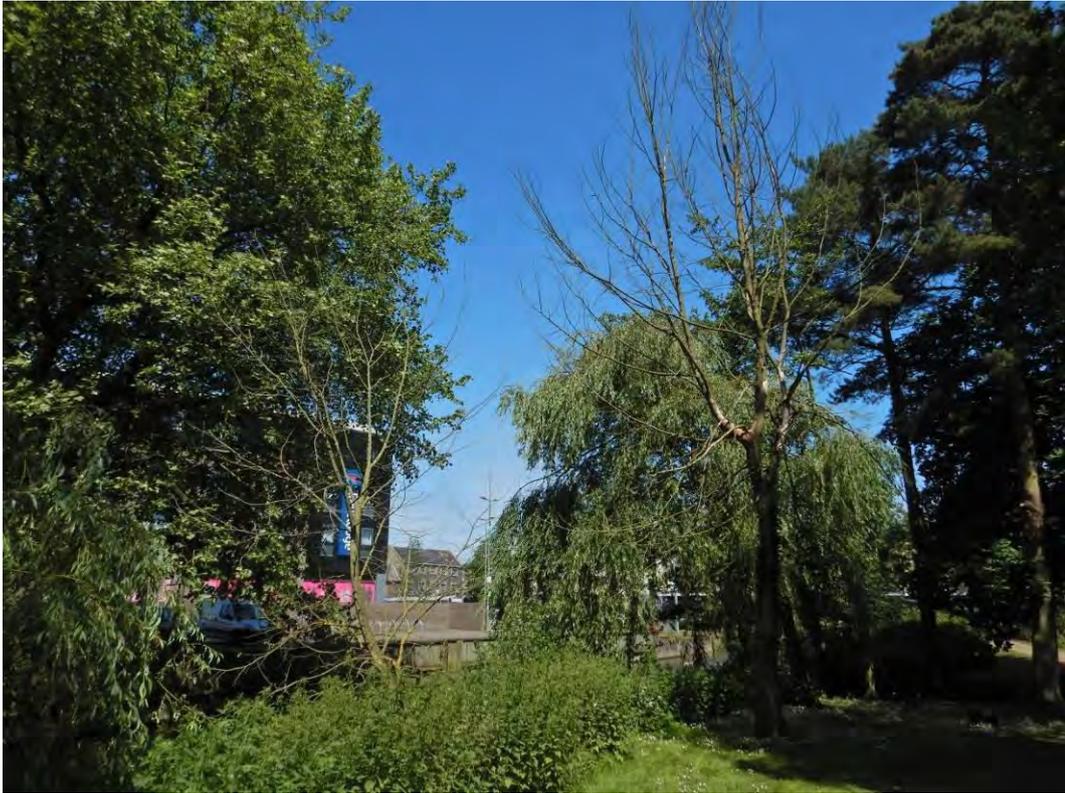
Pic 16 – A limited number of standing dead trees were observed. Presumably these trees will have to be taken down given their location in a public park. These trees provide a ready source of LWM for undertaking habitat enhancement work.

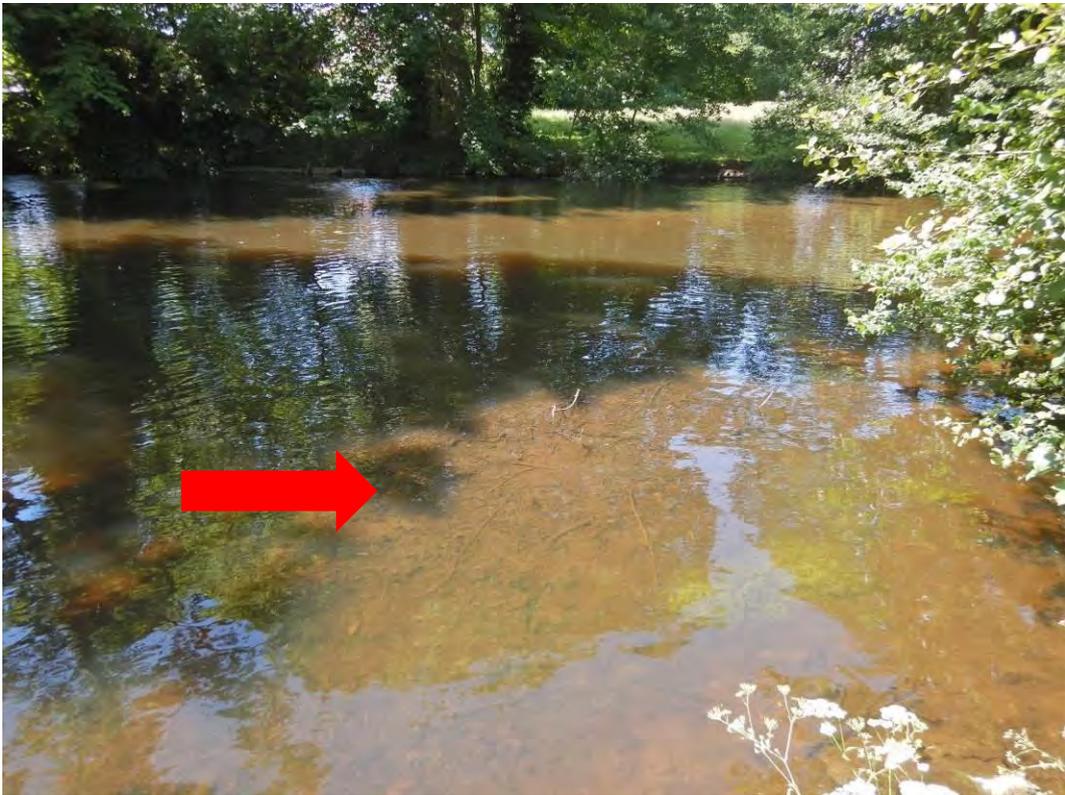
Extensive fine sediment is being deposited in the slack water around the confluence of the two side-channels. The use of LWM in the form of brushwood mattresses could help to speed up this deposition and help to consolidate it. Stable silt bars then provide an opportunity for colonisation by vegetation and provide further marginal habitat for invertebrates.

Pic 19 – Deposition of fine sediment in margins shows that the river has the ability to sort and transport its load. If this sediment remains stable it will become vegetated.

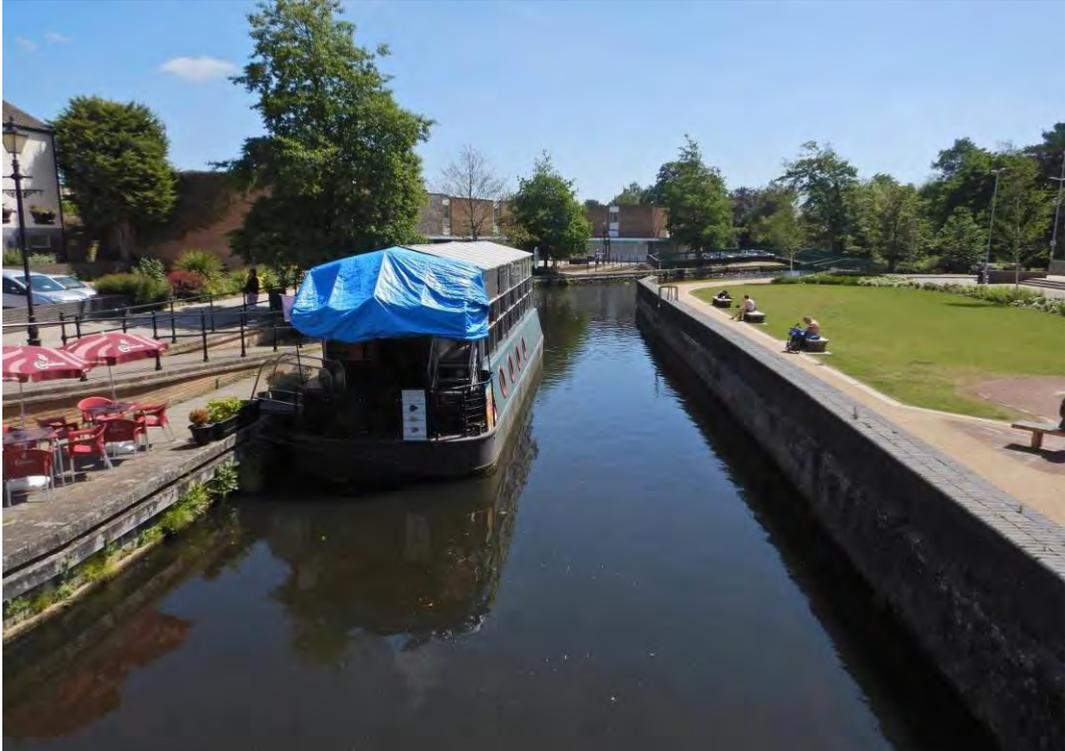
Downstream of Thetford town centre the river flowed in one channel. The channel is relatively narrow and constrained by hard revetments. This reach offers little habitat potential and, given the requirement for boating traffic

into the centre of the town, the option of providing habitat in the narrow channel is not easily achievable. If/when the existing walls require significant repair, or replacement, a holistic scheme could be put forward which retains the required strength of the walls whilst providing planting opportunities at water level.

Pic 20 – Where boat traffic is important, there is very minimal opportunity to provide habitat gain unless significant re-engineering of the retaining walls is required.

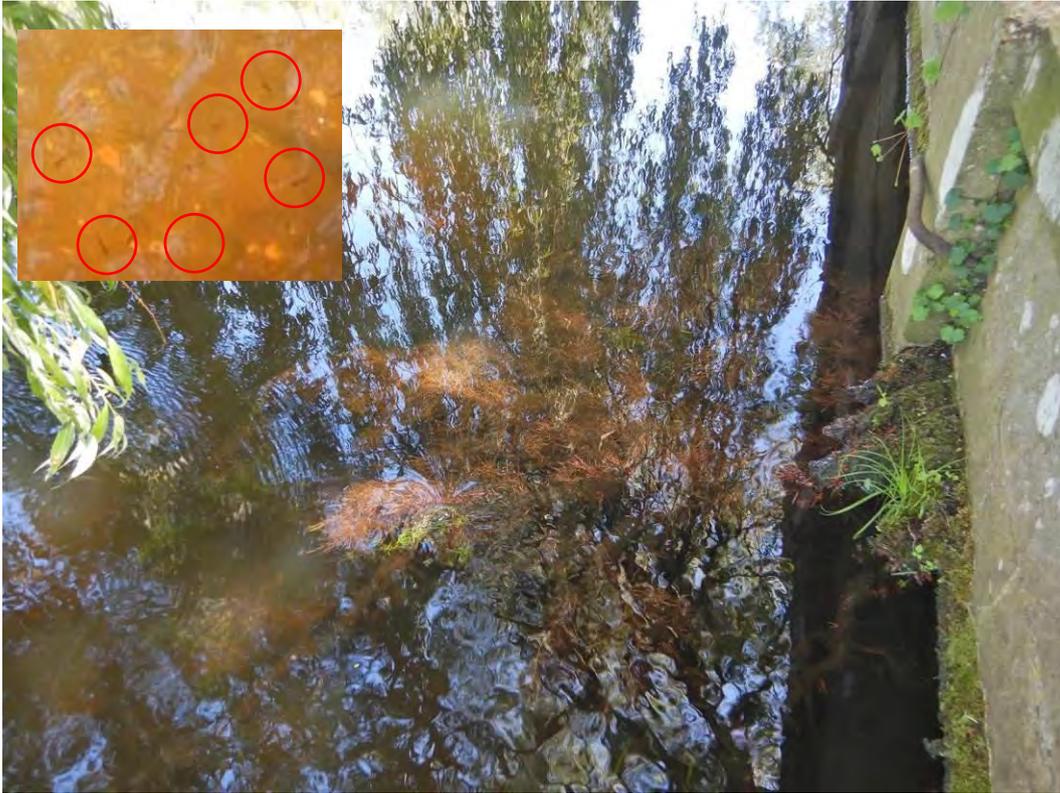
Where willow roots were growing out of the hard revetments there were 100s of small fry taking cover (pic 26). The provision of similar additional structure (such as hazel faggots or pinned tree stems) could vastly increase the holding capacity of the river for juvenile fish.

Pic 26 – Tree roots provide cover for 100s of small fry (red circles).

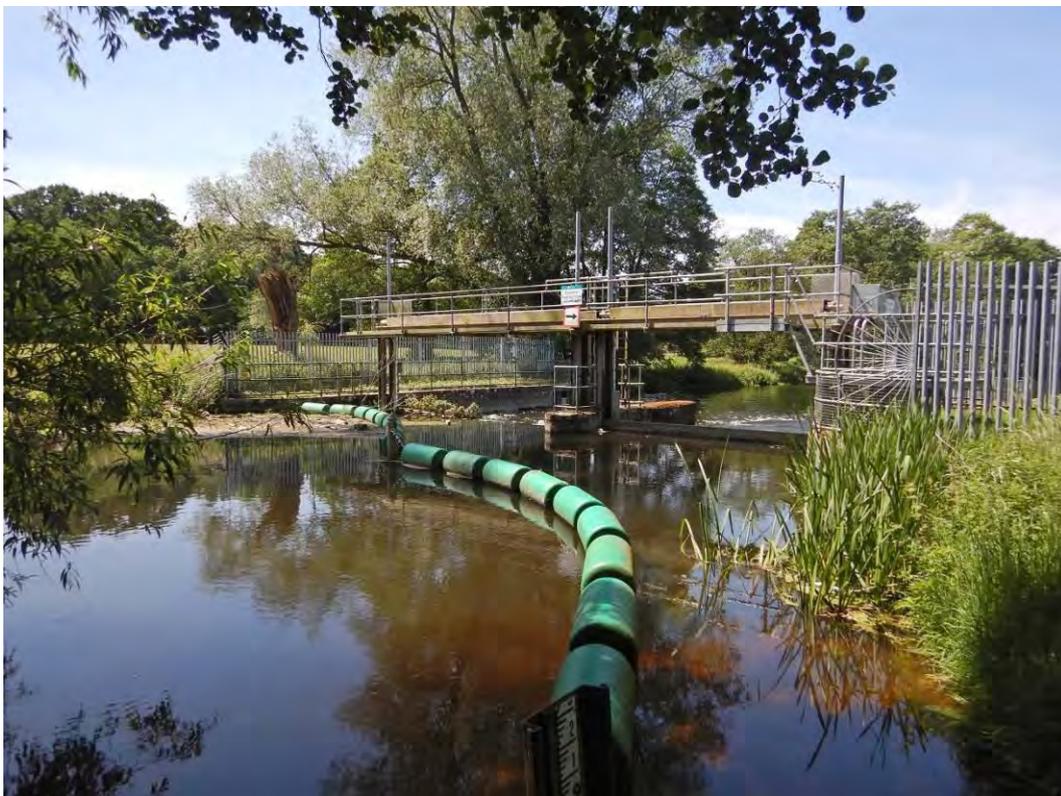
It is presumed that the Thetford no.1 staunch's purpose is to retain an upstream water level to aid navigation. If navigation was not required it might be possible to remove this structure, reducing upstream flood risk and allowing the river to develop a more natural form.

Pic 32 - A staunch on the river still controls upstream levels back to Thetford.

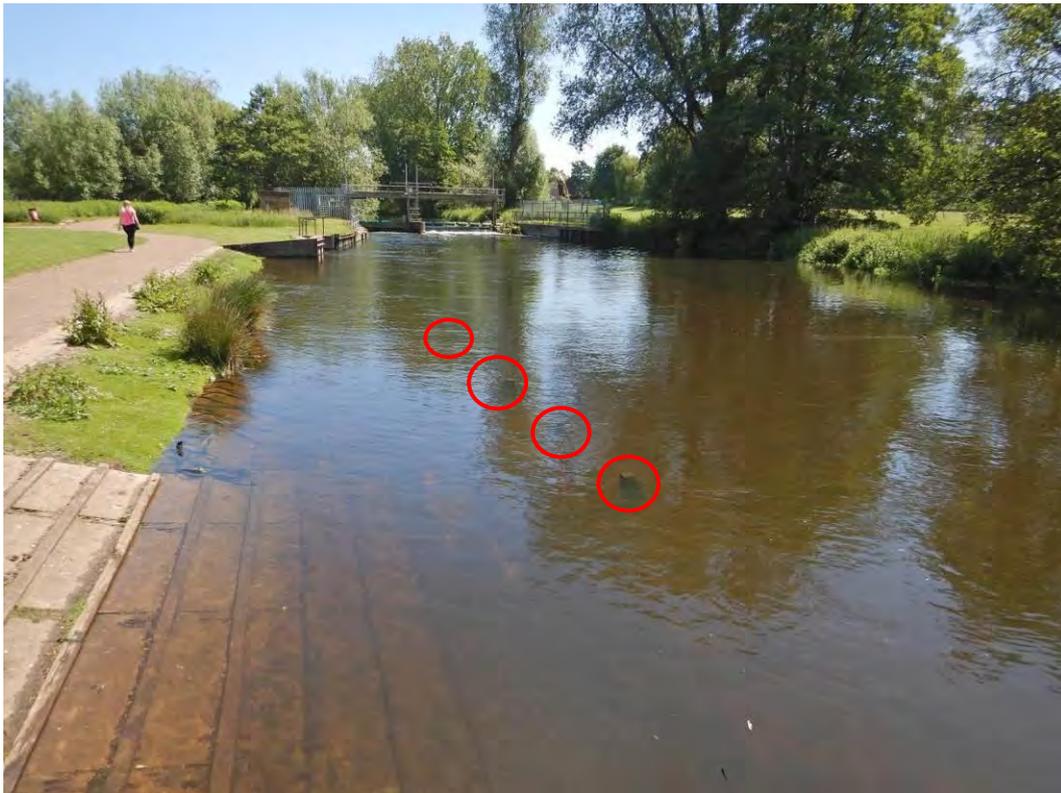
Downstream of the staunch the river bank appears to have been modified for boat launching, with a consequential degradation of marginal habitat. This area could be reshaped and planted to create a reed bed in the shallow margins if boat access is no longer a priority. It should be noted that there were a number of large underwater posts that present a hazard to boaters and swimmers (pic 34).

Pic 34 – The banks have been strengthened to facilitate boat traffic with a consequential degradation of biodiversity. Red circles show underwater posts which presents a hazard to boats and swimmers.

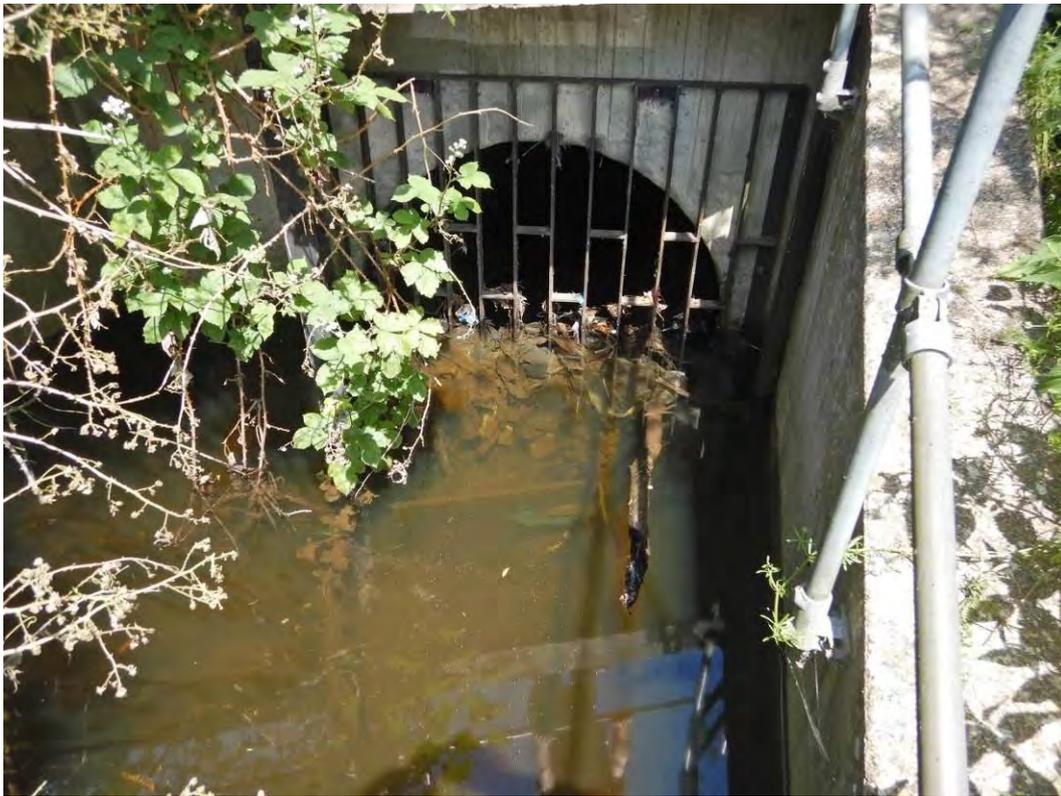
Pic 37– This culvert (TL 8584083335) releases storm flow to the river. It is a source of plastic rubbish to the river and had traces of oil residue emerging from it.

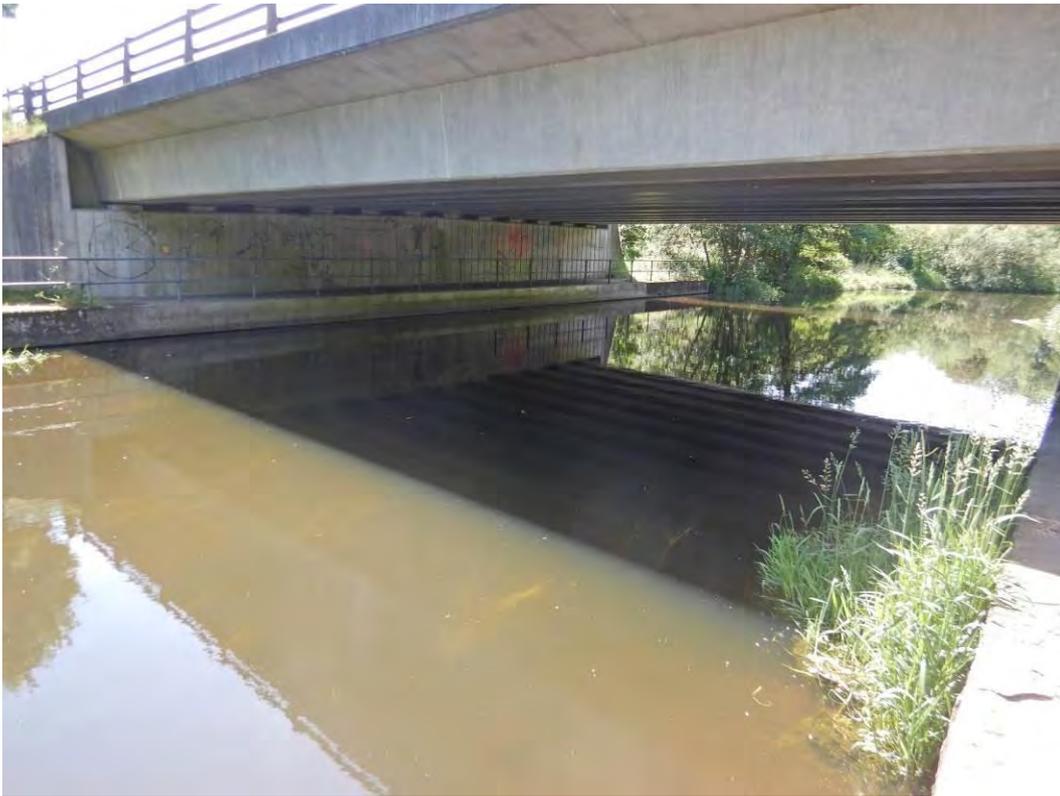
**Pic 43 – The A11 crossing has resulted in degradation of river habitat beneath due to shading and the hard edges provided by the walkway.**

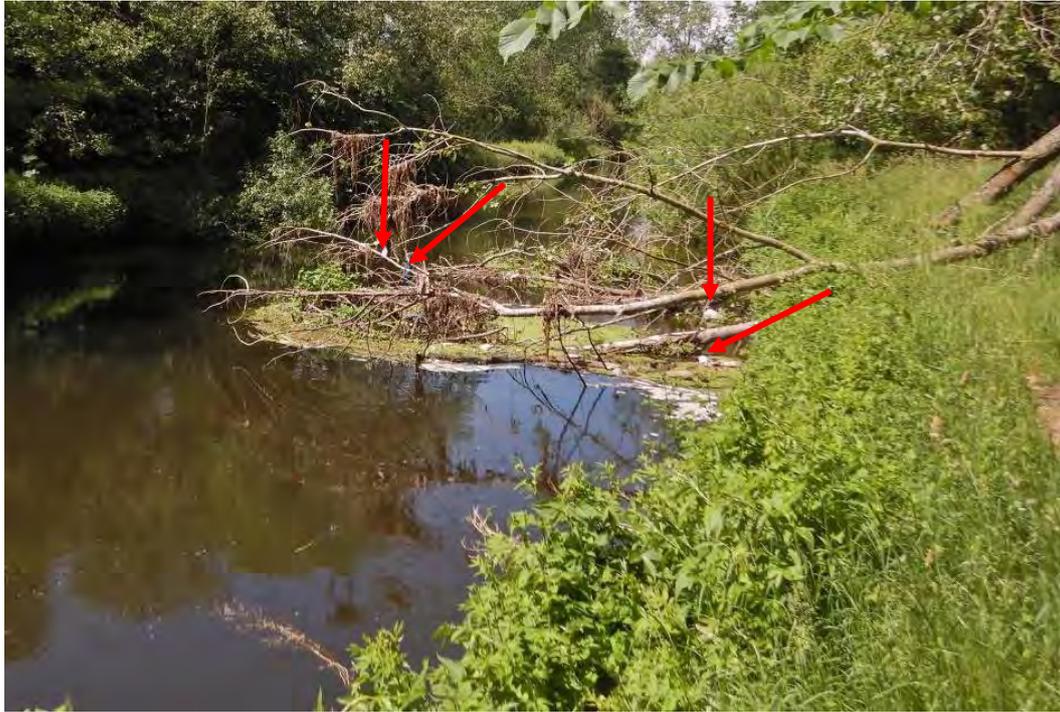
Pic 44 – One of the concerns at leaving fallen trees is that they collect litter (red arrows). However, that it is a human action . Whilst litter is unsightly and potentially hazardous to wildlife, the Lt Ouse does not have a significant litter problem, especially when compared to many reaches of urban river elsewhere.

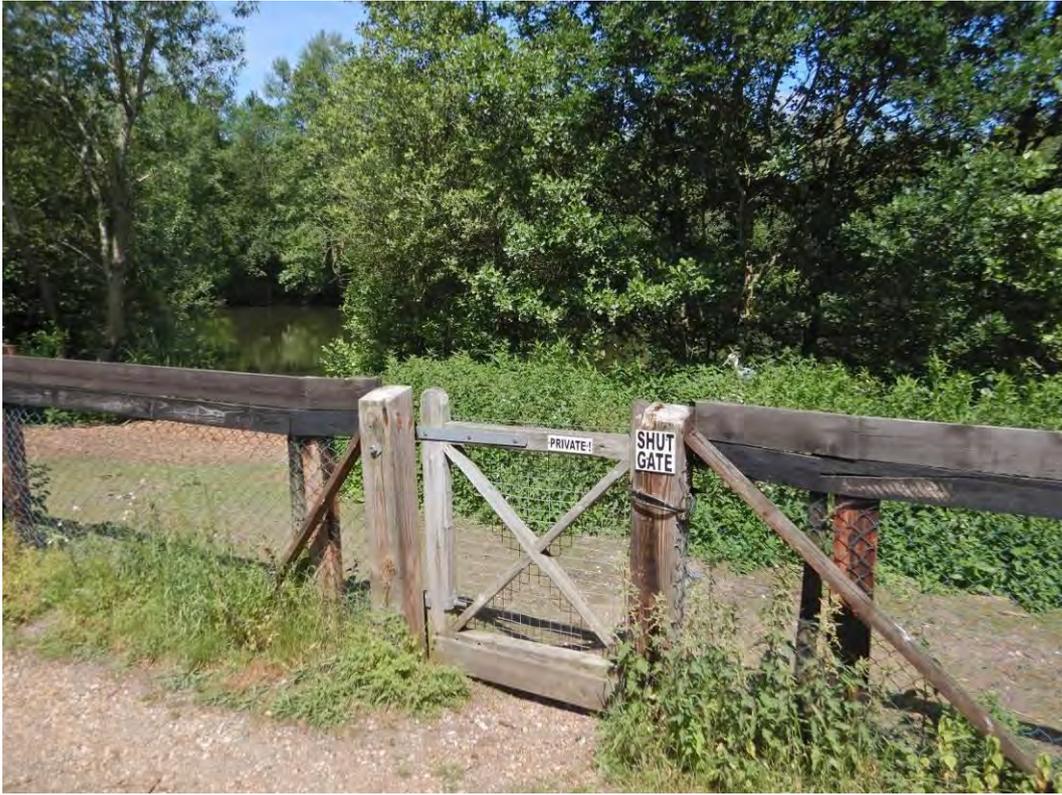
Pic 46 – Otter fencing protects a fishery within a lake. However, the gates don't extend fully to the ground so otters will still be able to access the lakes.

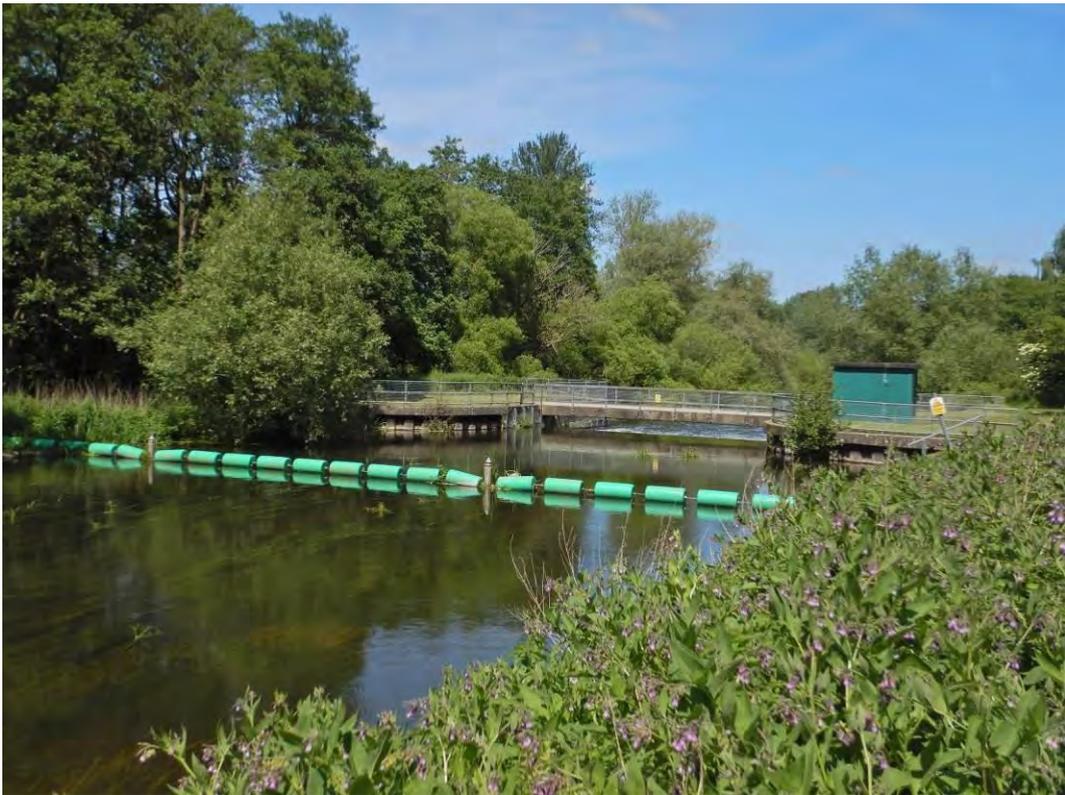
The approach to the Abbey Heath gauging station was clear of fallen trees and trailing branches resulting in an impoverished habitat. However, these smooth flow conditions (laminar flow) are necessary for accurate monitoring. The open nature of the river has allowed the growth of extensive beds of reed sweet grass which provide important marginal habitat.

Pic 50 - The upstream view of the EA's Abbey Heath gauging station.

Alternatively, an ambitious target could be to replace the current gauging station's weir with less intrusive gauging technology. This would remove the need to maintain an upstream impoundment and would allow a natural channel to establish.

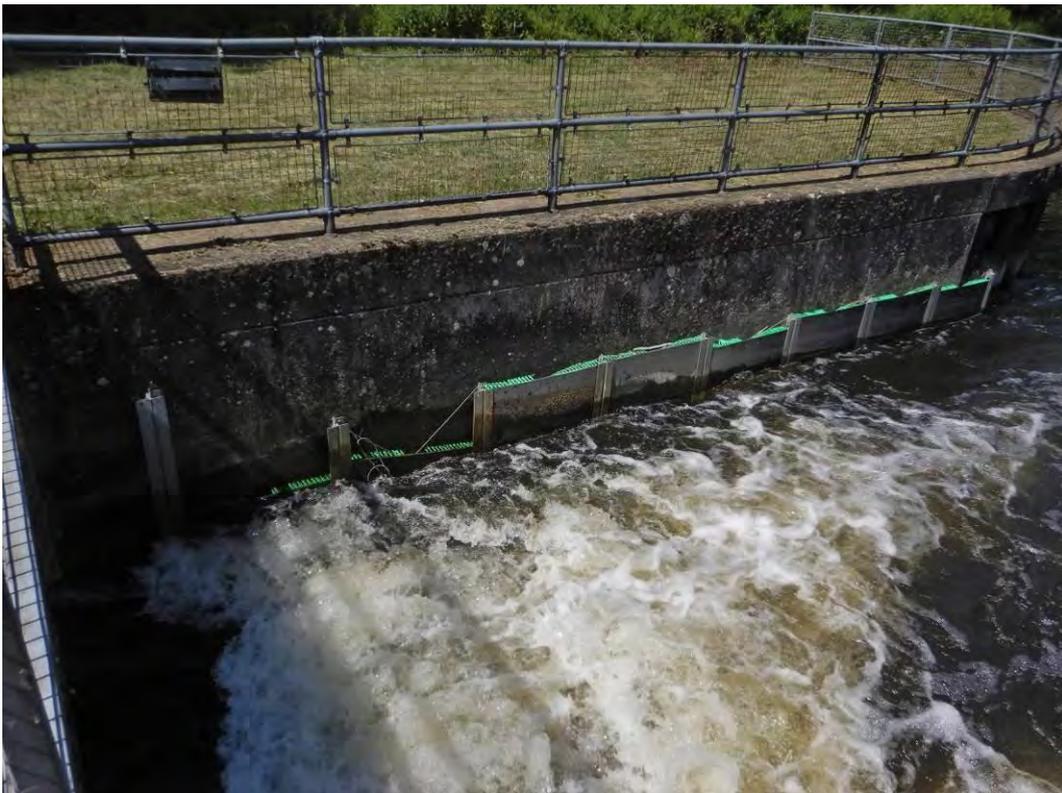
Pic 53 – There is an eel pass in the form of brush baffles that should allow eels to ascend the structure. However, it looks as if it requires some maintenance due to missing covers.

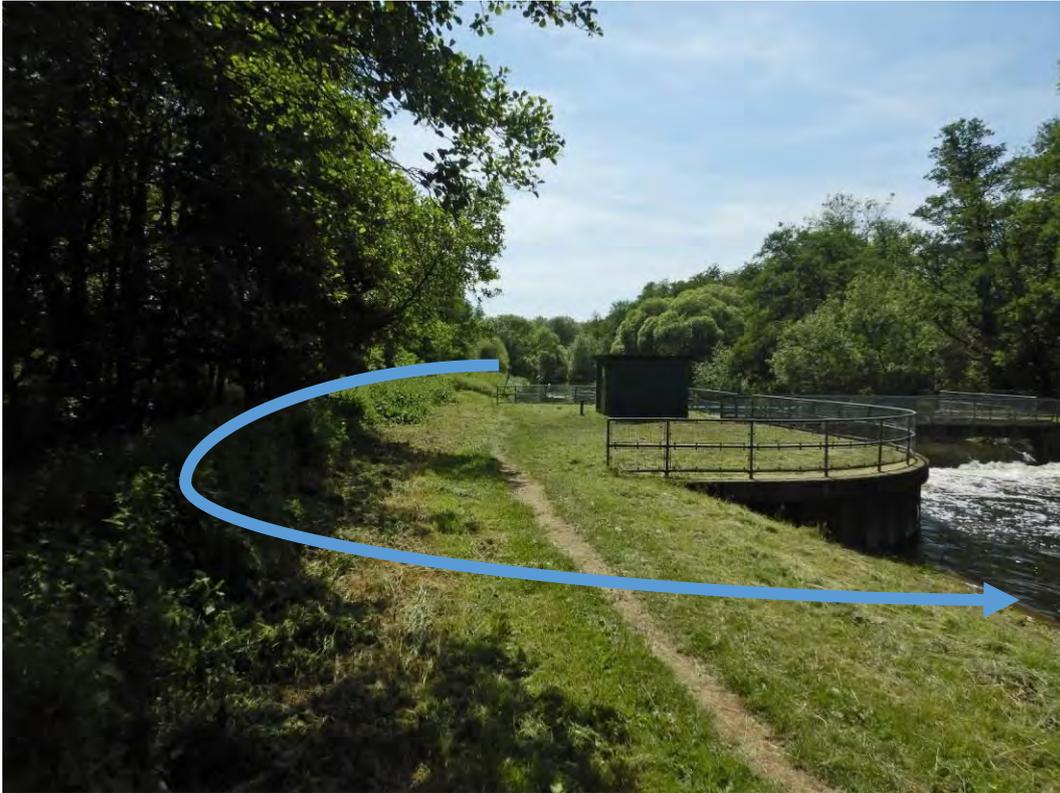
Pic 54 – A possible route for a by-pass channel around the gauging station. Any new channel would have to carry a known volume of water at all times so as not to affect the performance of the gauging station.
