Grayling Society

**Advisory Visit
Afon Cain, Powys
January, 2011**

This report is the output of a site visit undertaken by Tim Jacklin of the Wild Trout Trust to the Afon Cain, Powys, on 28th January, 2011. Comments in this report are based on observations on the day of the site visit and discussions with Tony Bostock of the Severn Rivers Trust (SRT) and Richard Dearing, Catchment Officer with the Environment Agency (EA).

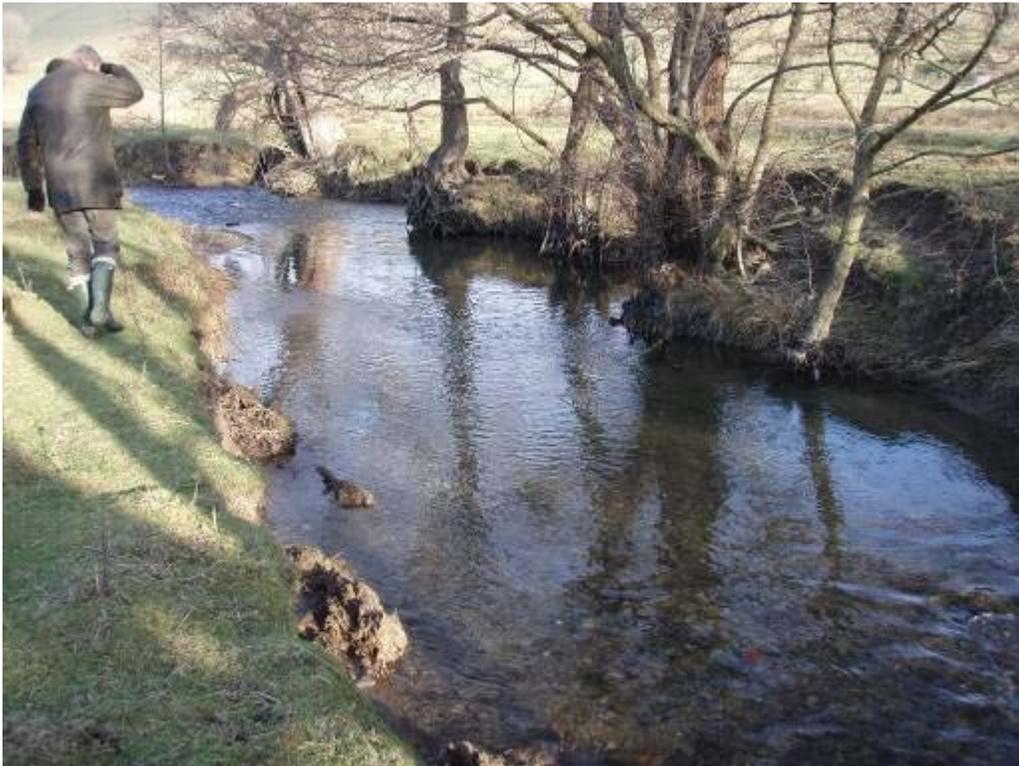
This section of river has a meandering plan-form with a pool and riffle sequence which provides a variety of depths and flow velocities – the basic building blocks of good habitat. This is a predominantly gravel substrate which is good for trout, grayling and salmon spawning. Some mature trees are present (mostly alder) and the root masses of these trees provide good bank stability and excellent cover for adult fish (Photo 1).

Photo 1 Good in-stream habitat – pool and riffle sequence, tree roots in the water and a gravel bed.

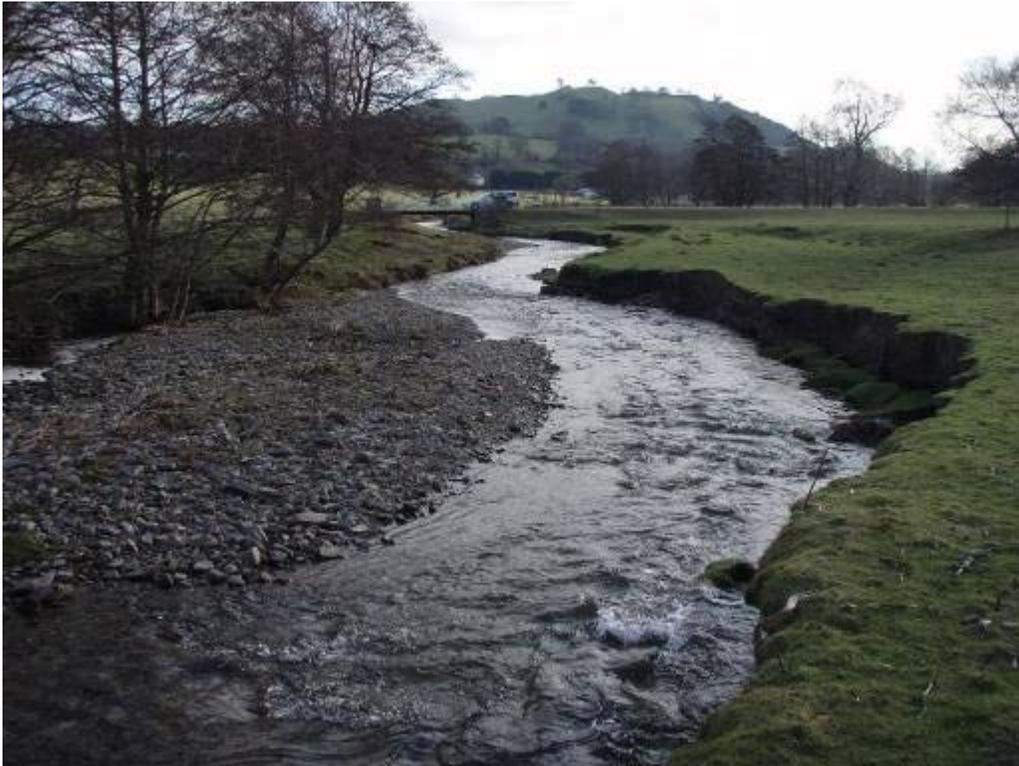
Unfortunately the in-stream habitat is compromised by highly accelerated rates of bank erosion (Photos 2, 3). The outsides of meanders in many locations are being rapidly eroded by the process of block failure, where the river cuts away the toe of the bank and gravity causes the overhanging block of earth to collapse into the river. Although erosion (on the outside of bends) and deposition (on the inside) is a natural process which promotes the desirable natural pool-riffle sequence, accelerated rates of erosion cause poor in-stream habitat for fish.

- Over-grazing by high densities of sheep. The banks are closely cropped which removes bank-stabilising vegetation; this includes coarse grasses, sedges and reeds and also tree succession is prevented. As mature trees are lost (a process exacerbated by the increase erosion) none are coming through to replace them and provide much needed bank stability, shade and source of terrestrial invertebrates for fish food.

- Increased coarse sediment supply. When the supply of cobble to pebble-sized sediment is increased within an upland catchment, this often leads to a "traffic jam" of sediment as the gradient of the river lessens; the supply of coarse sediment starts to exceed the rate the river can transport it downstream. The result is the deposition of large gravel shoals, and the river's response is to find pathways around these, leading to accelerated rates of bank erosion. Some clear-felling of steep slopes in the Nant Alan valley was carried out in 2008 and may have resulted in increased coarse sediment supply; however the site was inspected during this visit and appears to be stable and being re-planted with native tree species.

Photo 2 Block failure erosion on the right bank, possibly caused by a combination of over-grazing and increased coarse sediment supply from the upper catchment.

1. As a priority, grazing pressure should be reduced alongside the river. This could be achieved by changing the emphasis of the land use from livestock production to conservation grazing, for example by using low densities of traditional breed cattle. Alternatively, fencing out a generous buffer zone alongside the river would be required (5 metres minimum, preferably 10 m). Reduced grazing pressure is essential if any of the bank revetment techniques described below are to be successful.
2. Protect the rapidly eroding sections of river bank with soft revetment techniques, using materials like logs, brushwood, Christmas trees and

root wads. Advice and demonstrations of techniques are available from the Wild Trout Trust. For longer term protection of the outside of meanders it is recommended that fenced, ungrazed headlands are created and planted with native tree species.

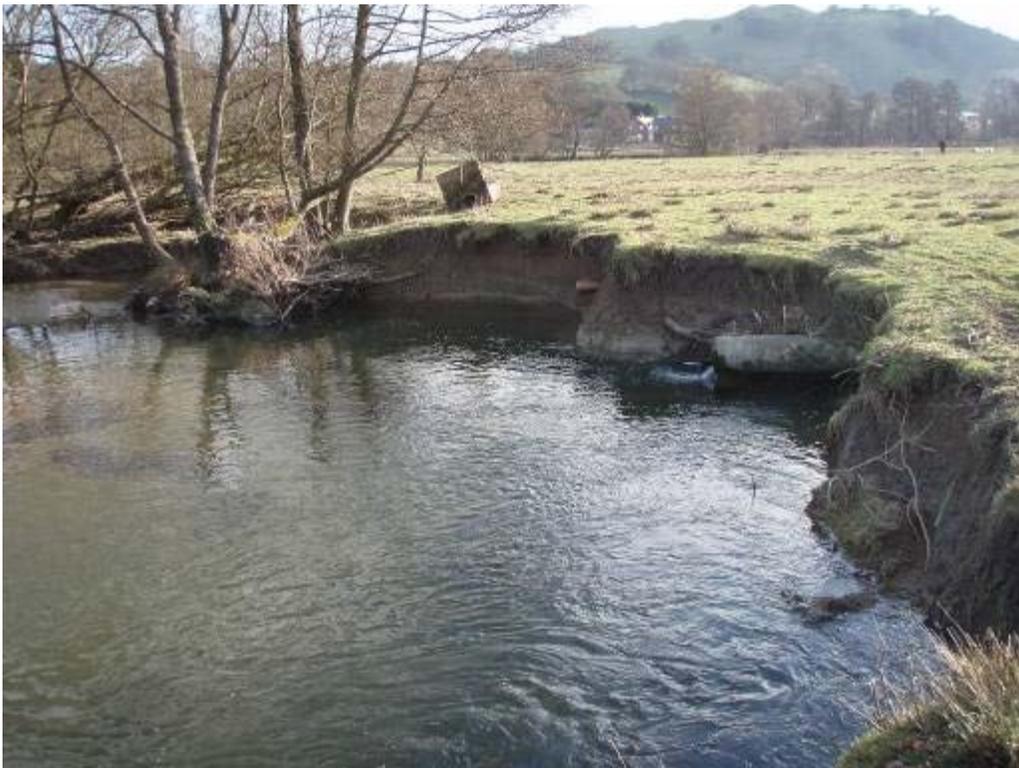
Photo 3 Accelerated erosion – there are two sections of the concrete pipe (right bank) lying on the river bed here indicting the extent or recent bank loss.

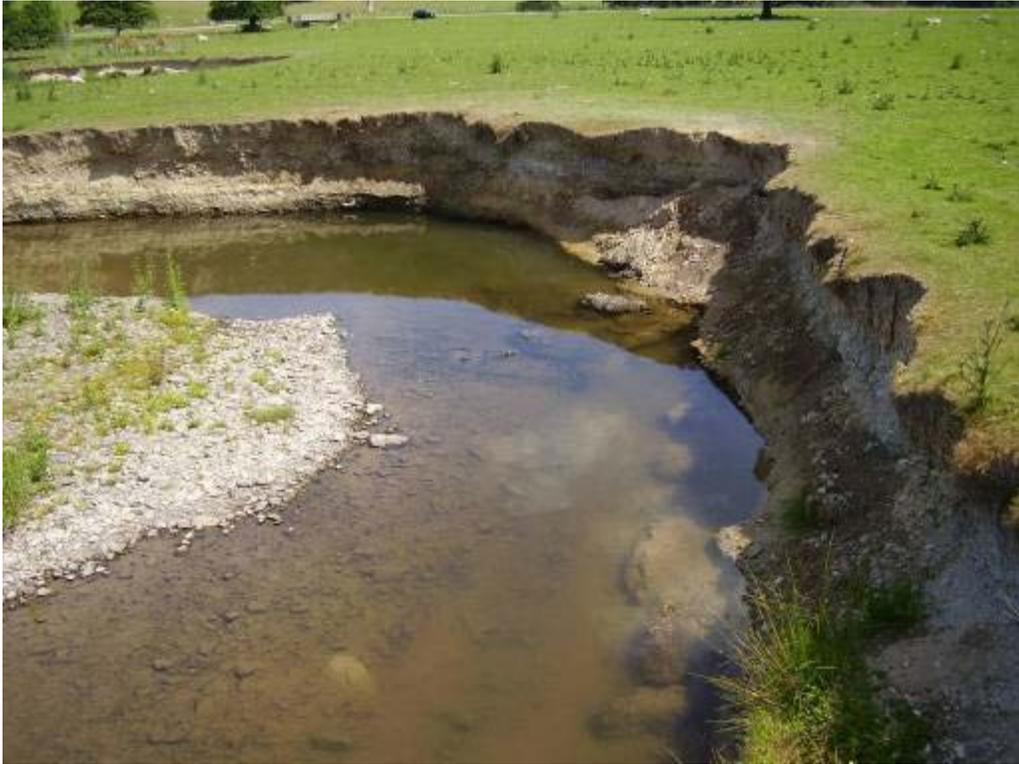
Resultant over-widening and shallowing of the river channel promotes the settling of fine sediments which compromise fish spawning and invertebrate

diversity (Photo 4). Also, the erosion is a significant source of fine sediment entering the watercourse and affecting downstream areas. Rapid loss of the important riparian (marginal) zone compromises habitat for fish, birds (including kingfishers and sand martins which nest in earth cliffs), mammals and invertebrates.

Photo 4 Summer, low flow conditions – note the fine sediment accumulating on the gravel bed. (Photo: Tony Bostock)

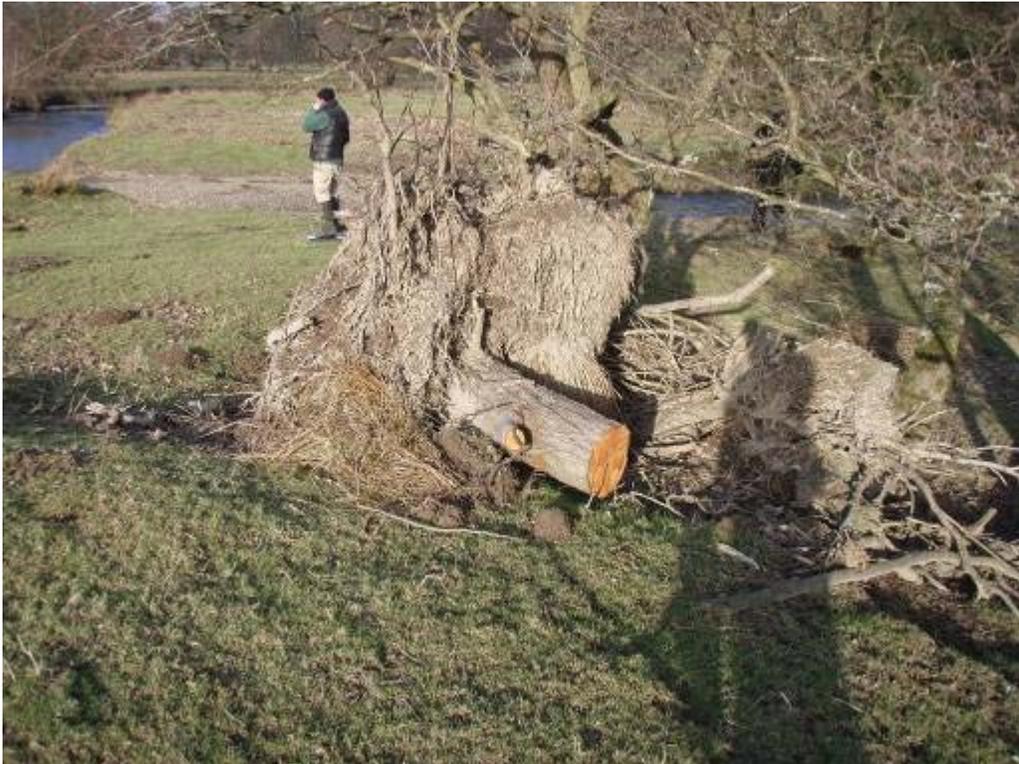
Photo 5 Some materials suitable for bank revetment are available on site.

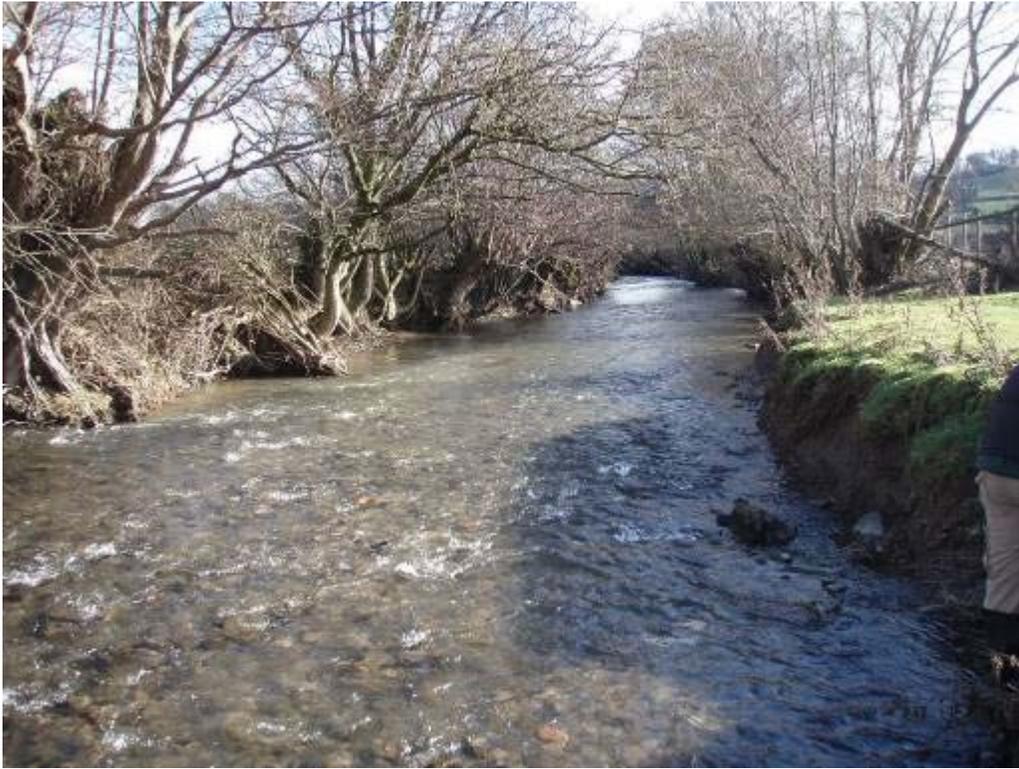
This section was walked upstream from Green Hall Farm (Figure 2). The plan-form of the river here is straighter than the previous section and there are fewer meanders and less of a pool-riffle sequence. It is likely that this section of river has been previously straightened (Photo 8).

Because of the straightened nature of the channel here, deeper pool habitat which could hold adult fish is lacking which will restrict the value for angling. This could be improved by the retention of naturally occurring large woody debris within the channel, or by deliberate introduction of flow deflectors to create bed scour and deepen the channel in selected areas; the tree-laying technique could easily be adapted to achieve this by positioning the tops of the trees in the river channel. This provides excellent cover for all life stages of fish, improves invertebrate abundance and diversity and helps moderate water temperatures in hot weather.

Photo 8 The tree-lined banks provide good stability but the straightened channel is dominated by shallow riffle and glide habitat and lacks deeper holding pools for adult fish

1. Introduced large woody debris to the river channel by hinging trees using the same technique as already carried out in places (Photo 9). Where trees will not hinge, tethering with steel cable to create “tree kickers” is an alternative option. Logs could also be introduced to promote bed scour; these can be fixed to the river bed by drilling and pinning with rebar.

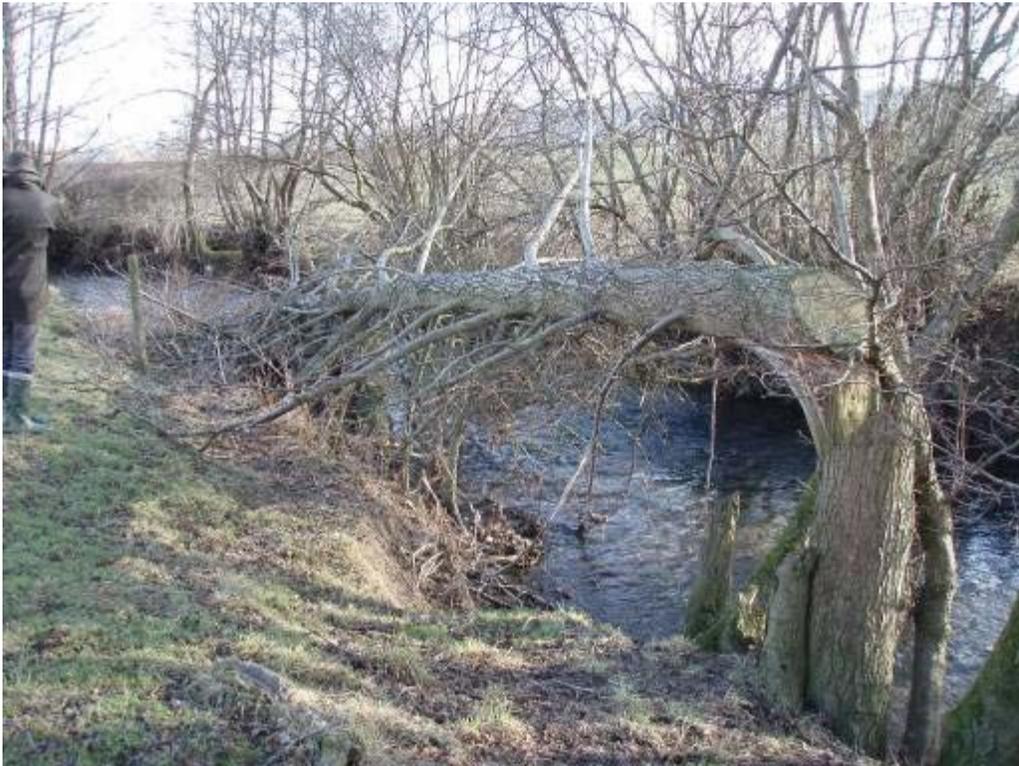
Photo 9 An alder which has been “laid” along the bank. Positioning the top of the tree within the river channel itself would greatly improve in-stream habitat for fish.

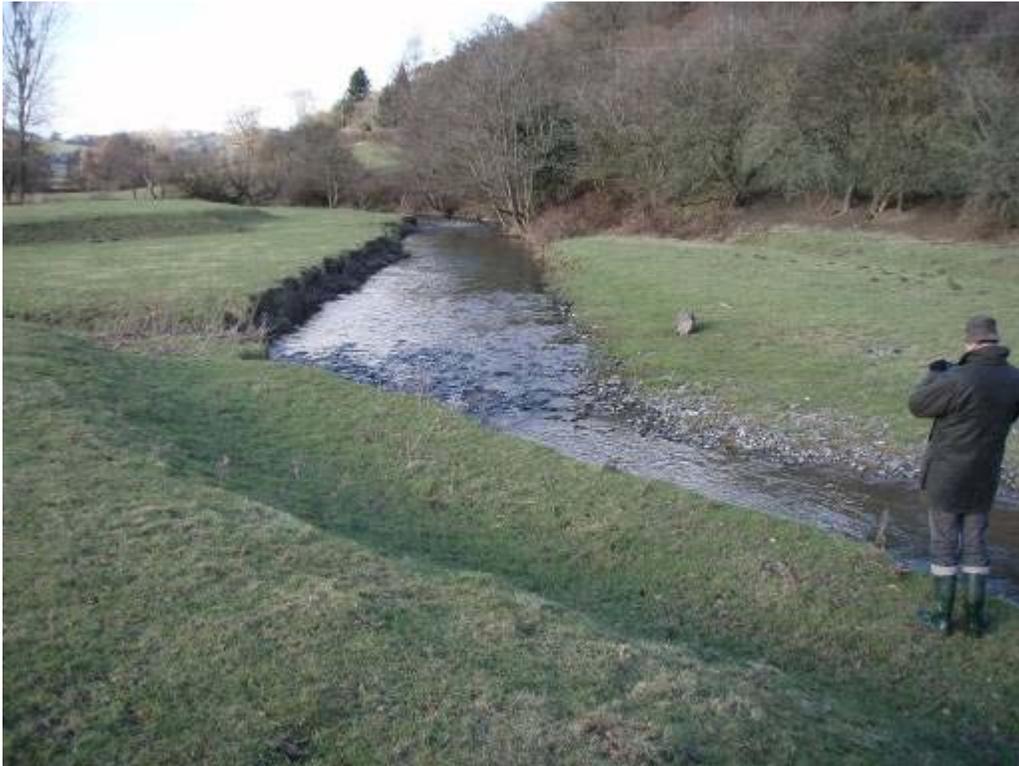
The upstream section of this beat is more open (Photo 10). Cut-off meanders and embankments here indicate that past straightening and bed lowering may have taken place. The effect on in-stream habitat is a wide, shallow channel with little adult fish habitat; also grazing and erosion of the banks has removed good marginal habitat greatly reducing the amount of juvenile fish habitat, particularly for trout. Occasional areas of more suitable habitat occur, usually where deeper water occurs on the outside of bends and in the vicinity of large woody debris which has been retained within the river channel (Photo 11).

Photo 10 More open section towards the upstream end of the Green Hall Farm beat

2. On the open sections near the upper end of the beat, consider using brushwood revetment along the open banks to reduce erosion and provide in-stream cover for juvenile fish (see Photo 7 above). Stock fencing of these areas should also be carried out to allow a healthy riparian zone to develop. Careful design and positioning of the fence is required (e.g. including ‘sacrificial’ panels in areas vulnerable to flooding and debris accumulation, for ease of repair).

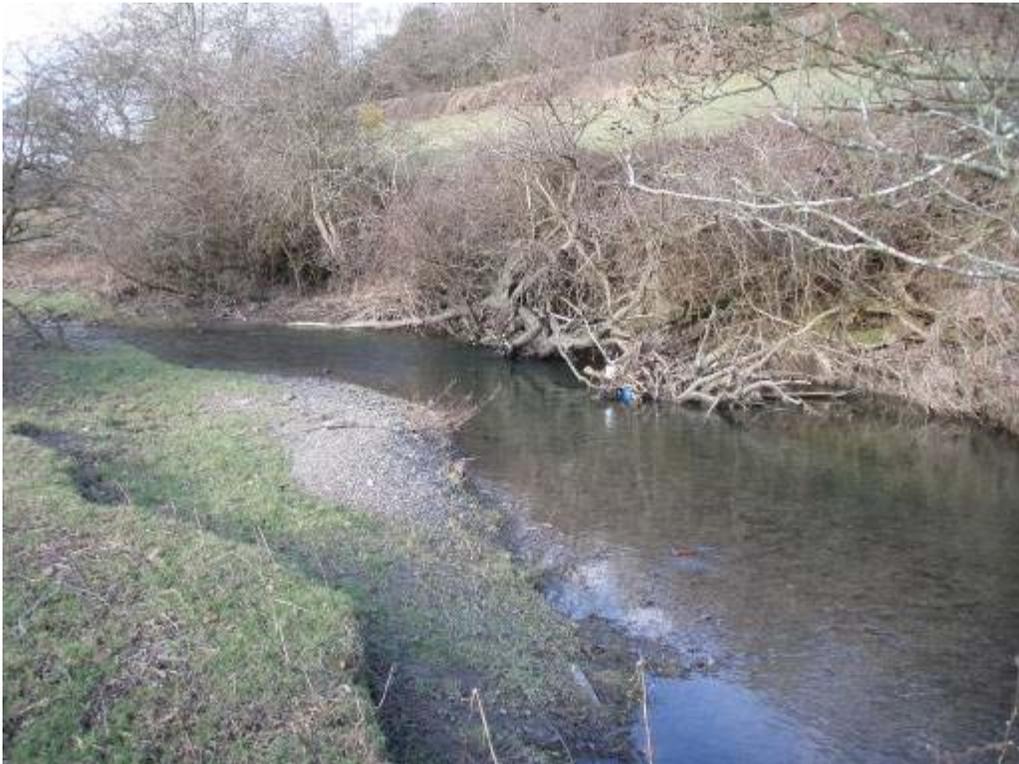
Photo 11 Retention of large woody debris creates good fish-holding habitat.

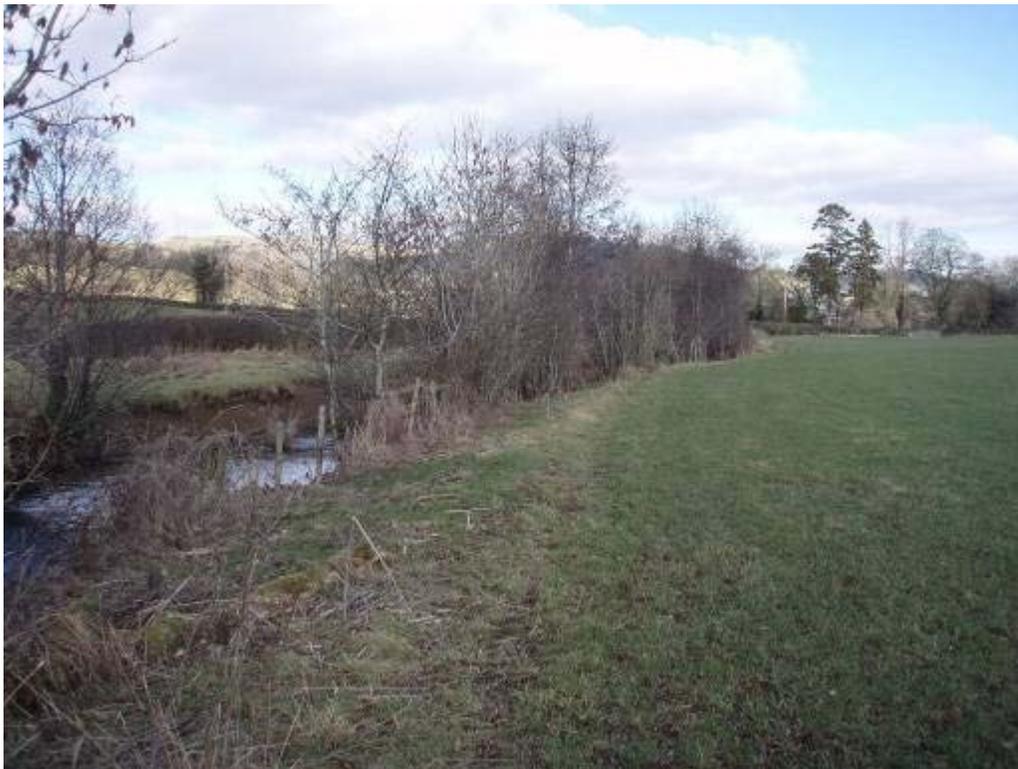
Upstream of Pont Talwrn bridge there is a straightened section of river up to Talwrn Mill lined by alders, ash and willow that have been coppiced and form almost a hedge alongside the river (Photo 12). There are occasional areas of accelerated bank erosion, which could be addressed by bundling the arisings from coppicing and staking these in the eroding areas (Photo 13). Some tree-laying has taken place, as described above; the pros of this are the exclusion of livestock from the river and maintenance of bank stability, but the cons are heavy shading of the river and difficult access for people (e.g. anglers) through the dense hedge that is formed.

Photo 12 Straight section below Talwrn Mill with dense tree cover

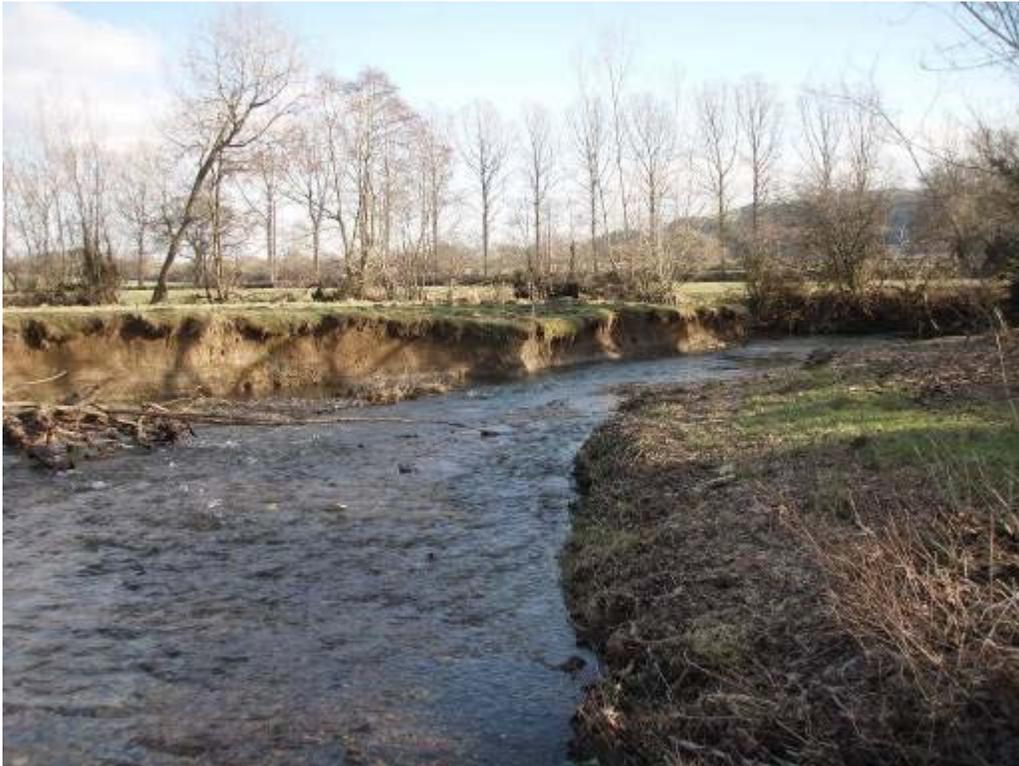
Photo 13 Excessive erosion occurs on some exposed banks

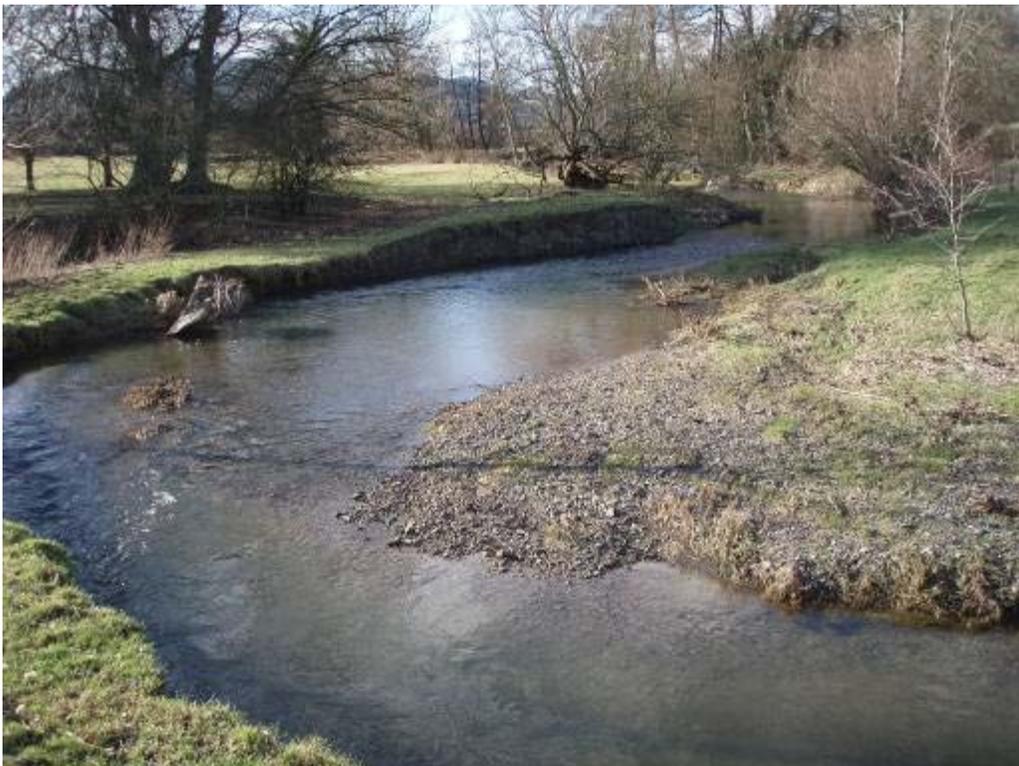
Above Talwrn Mill the river has a natural plan-form with meanders and a pool-riffle sequence, providing some good in-stream habitat (Photo 14). There are some areas of excessive erosion, but also a good balance of trees which provide bank stability. Some erosion control attempts may have been made previously (Photo 15).

Photo 14 Meandering river with a pool-riffle sequence – good in-stream habitat

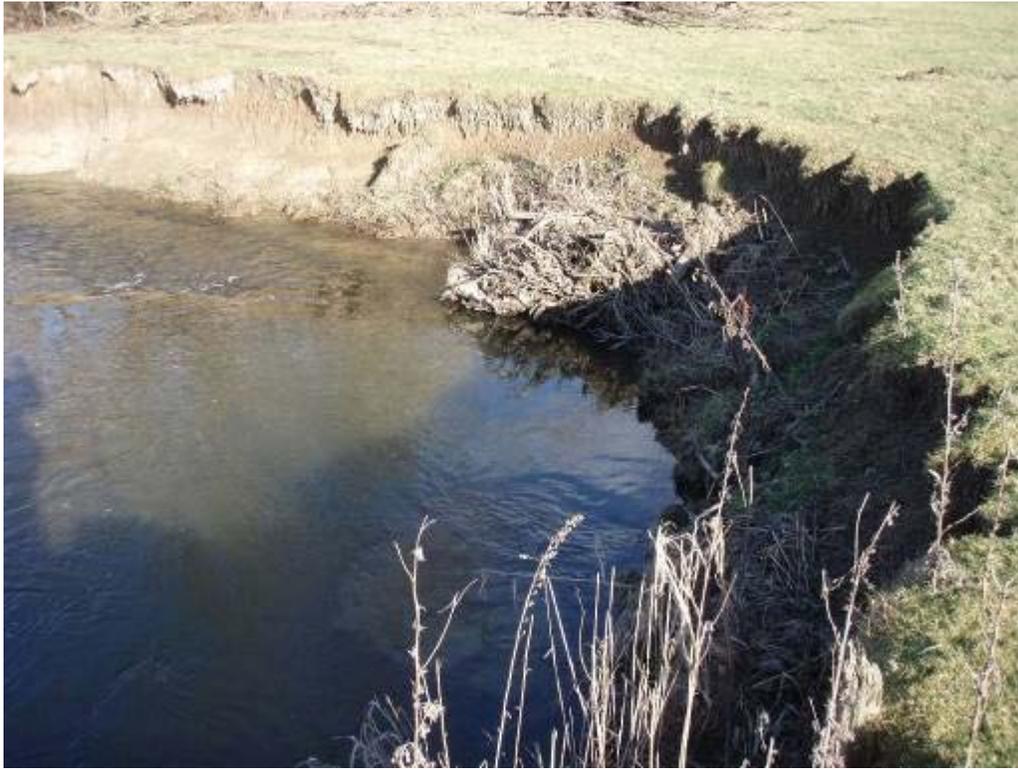
Photo 15 Some attempts at erosion control with woody debris have been made previously, possibly by EA Operations Delivery team, with some success. Establishing trees is required to provide long-term bank stability.

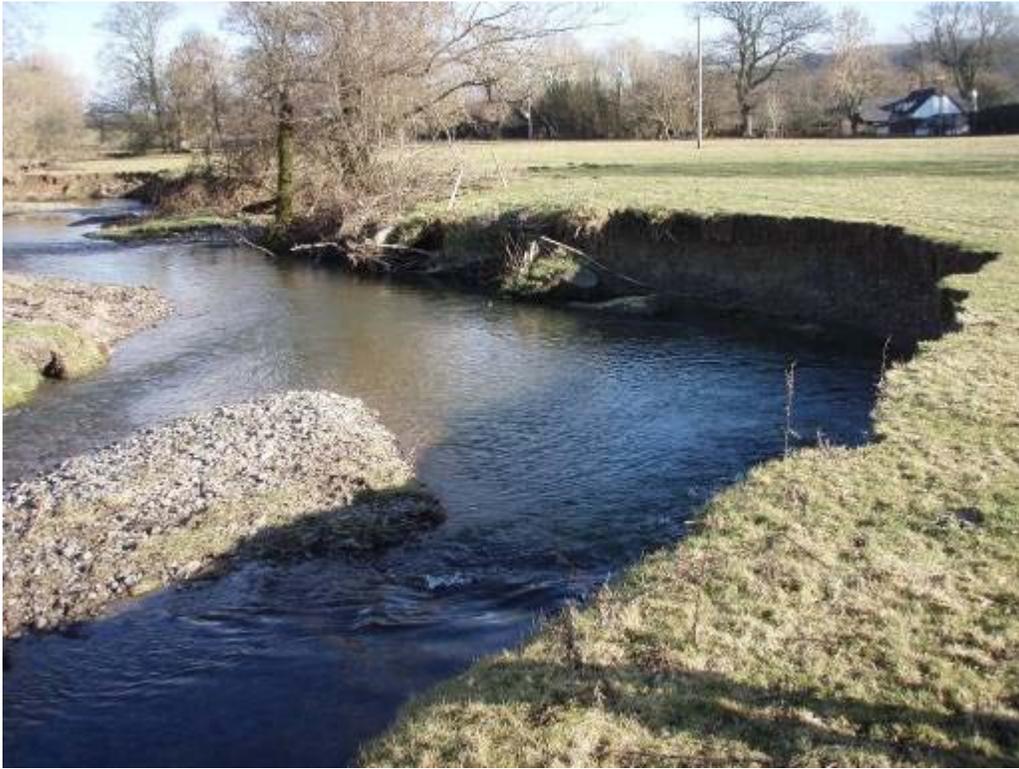
Downstream of Pont Talwrn, the river has an excellent meandering plan-form and pool-riffle sequence giving broadly good in-stream habitat. Unfortunately this is marred by accelerated rates of bank erosion in numerous areas. Such problems often begin with the loss of trees with their bank-stabilising root systems, then persist because of a lack of succession of trees because of grazing right up to the bank edge. It is interesting to contrast the situation in Photos 16 and 17; both are on the outside of bends, yet the situation where there is a headland of trees means the bank remains stable and excessive erosion cannot get a hold.

Photo 16 Lack of a stable, well-vegetated margin leads to rapid erosion

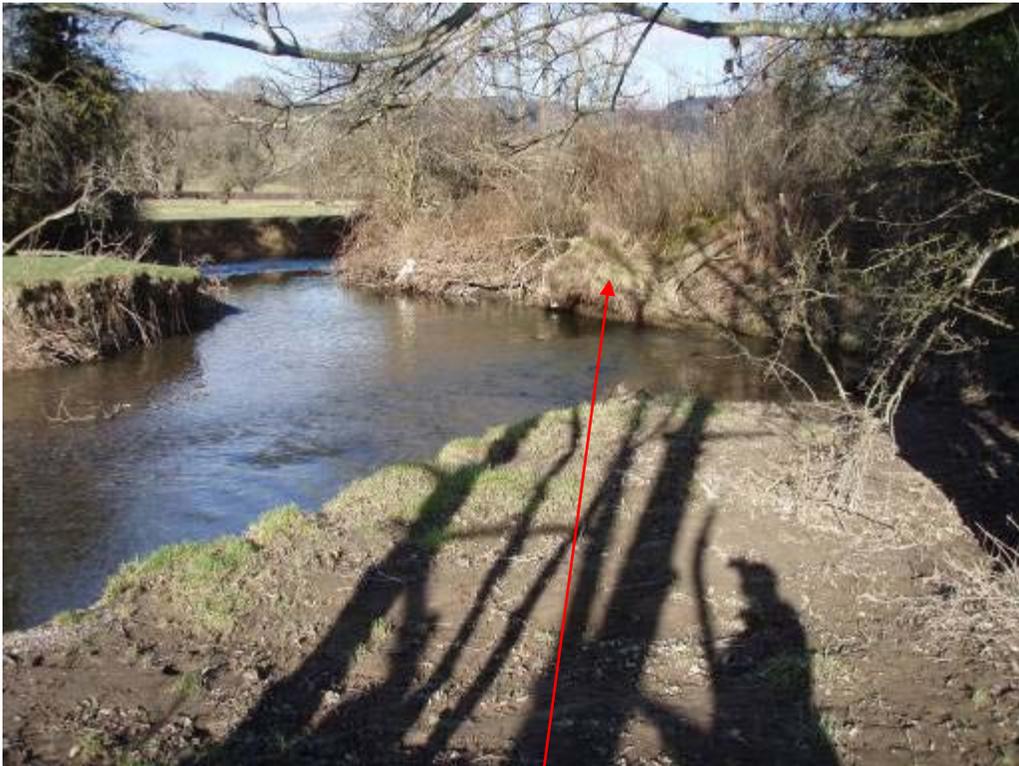
Photo 17 Well-vegetated margins on the outside of a bend providing good erosion resistance

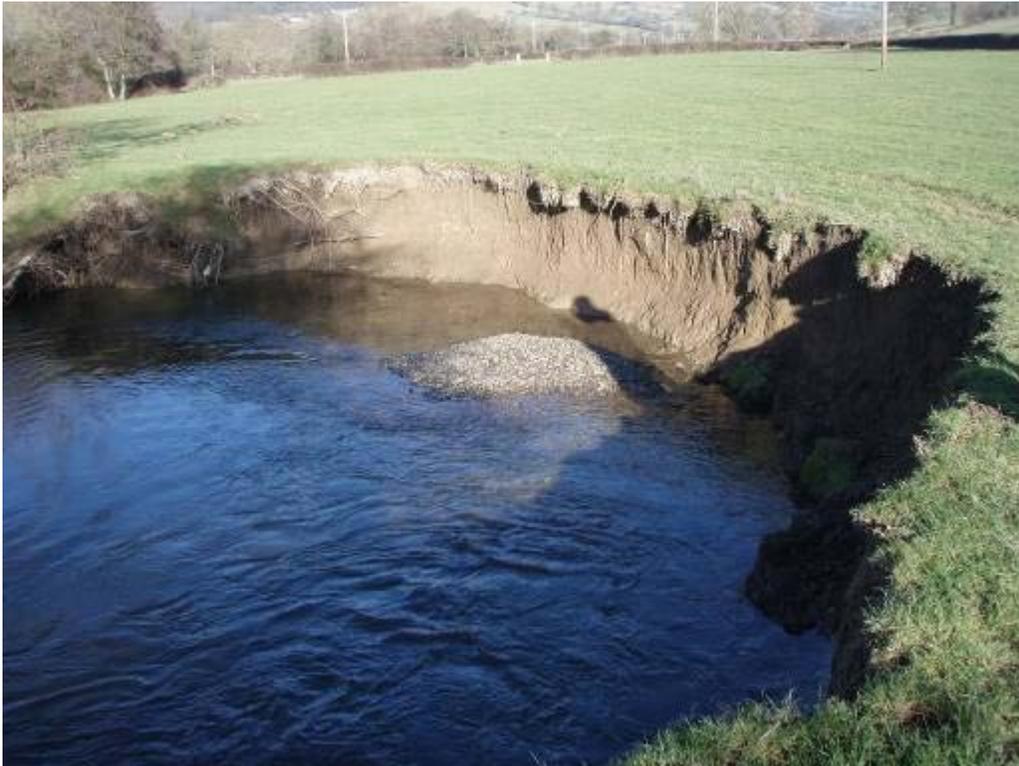
At one point a tree has been lost, bank erosion has ensued and the tree has ended up as a stable woody debris log jam in the channel just downstream. The landowner is particularly concerned about this location and possible ways of tackling the situation were discussed. As a compromise between retaining the valuable in-stream woody debris and protecting the bank, it is suggested that the trunks of the log jam are cut a few feet above normal water level, leaving the stable in-stream structure in place. The arisings could then be used to tackle the scalloped bank upstream to stabilise the

Photo 18 Eroding area of particular concern to the landowner

excessive erosion; an engineered log-jam log-Christmas tree revetment approach could be used here.

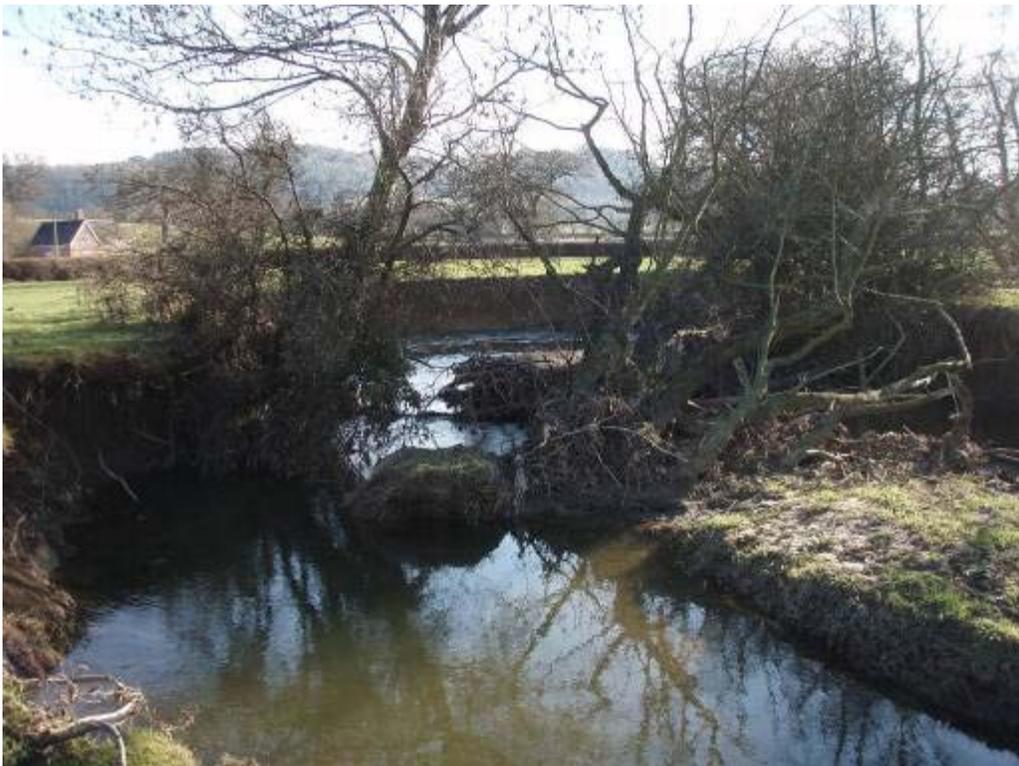
Photo 19 Woody debris jam downstream of area shown in Photo 18.

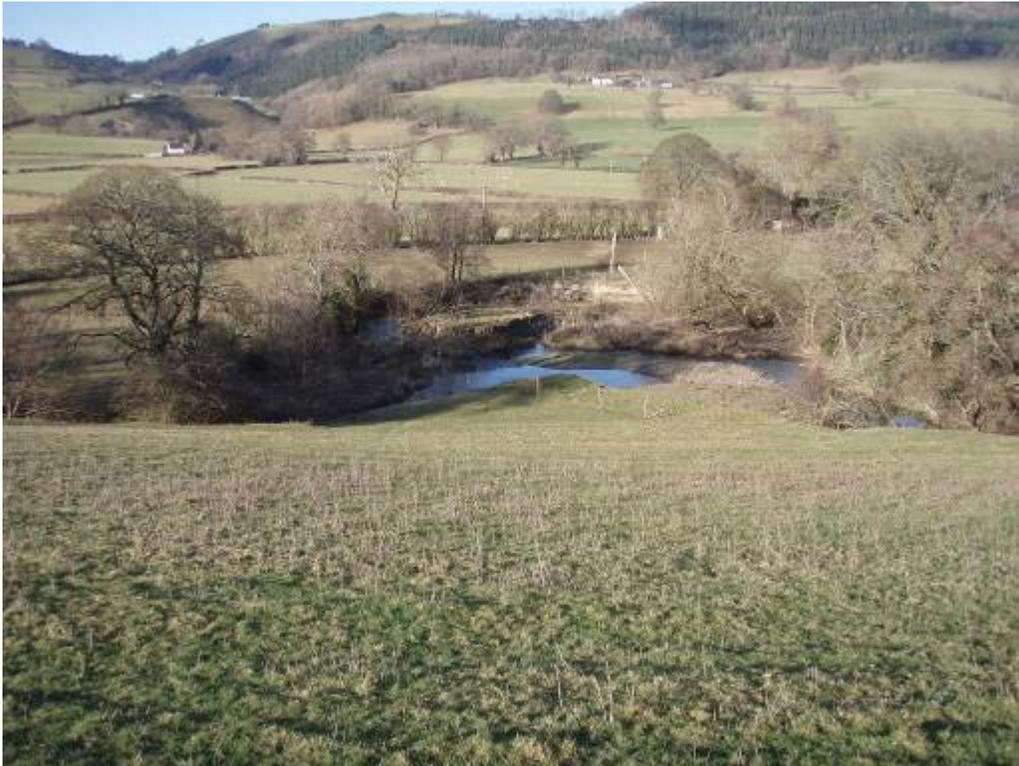
At Domen Gastell, the river is similar to the section above: a meandering plan-form, pool-riffle sequence and generally good in-stream habitat, but with some very rapidly eroding areas. The active erosion was demonstrated by a large cut-off meander which had occurred in a matter of months according to the landowner, Mr. Richard Ellis (Photo 20). A bedrock check is present, above which the river was impounded for a short length. Fine sediment has accumulated in this stilled section, showing the problem with the source of sediment from the eroding banks (Photo 21).

Photo 20 Recent cut-off meander

1. Intervention to control excessive erosion should be a priority on this section using soft revetment techniques such as log and Christmas tree, brushwood packing and engineered log/rootwad jams. Some examples are illustrated below. The considerable lengths of river affected by the accelerated rates of erosion mean that tackling these in one go is impractical. Probably the best approach would be to undertake a demonstration project with the relevant landowners, and then encourage and facilitate further works. There may also be the possibility of using volunteers co-ordinated through SRT.

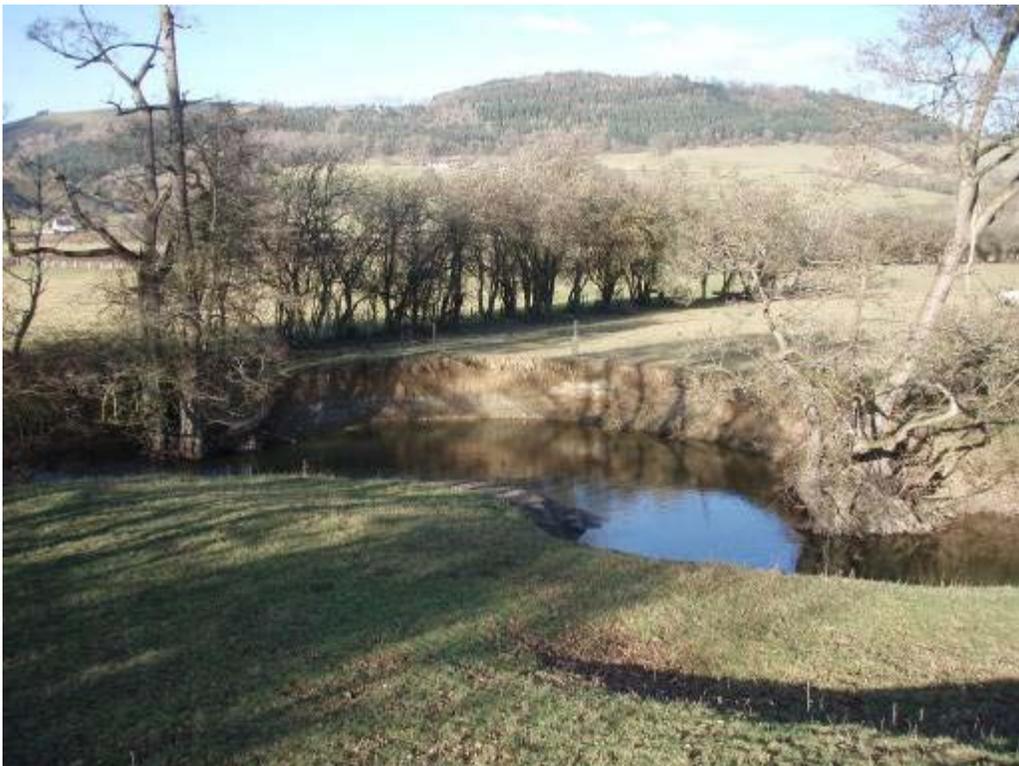
Photo 21 Eroding banks

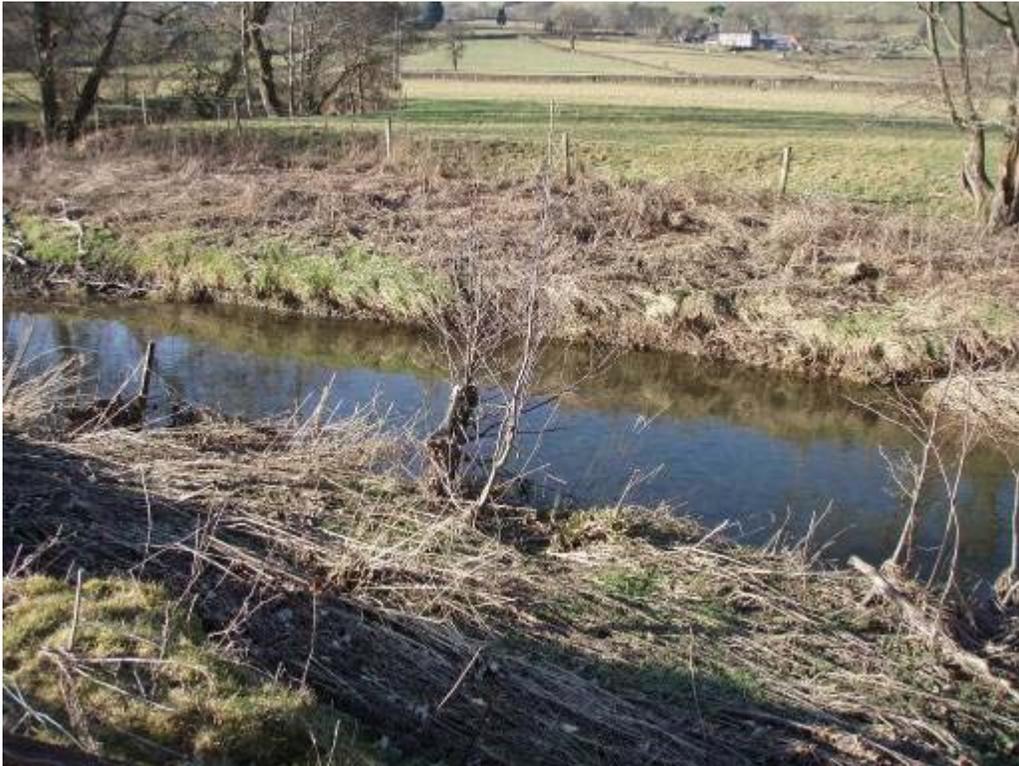
Some lengths of bank are fenced and are more stable, with well-vegetated banks and even some trees starting to recolonise (Photo 22). There are also some excellent examples of large woody debris in the river channel, creating excellent habitat (Photo 24).

Photo 22 Fenced margins with coarse vegetation and tree regeneration – contributing to greater bank stability

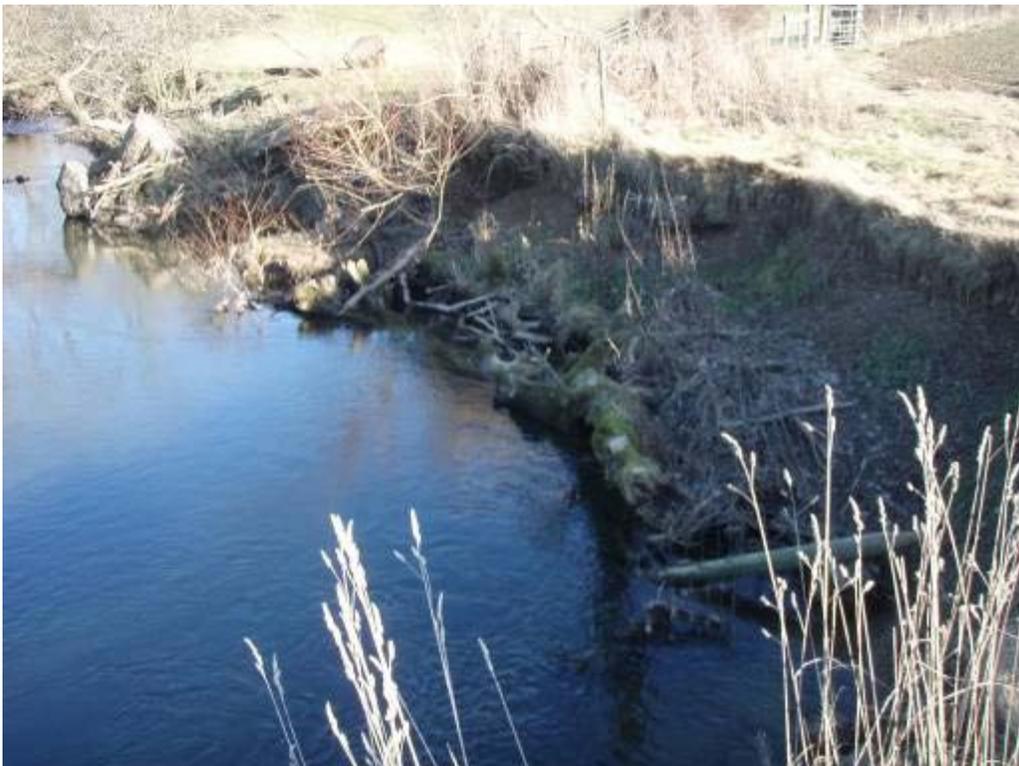
Some areas of bank erosion have been tackled with hardcore rubble tipped down the bank (not very successful) or with placed tree trunks at the toe of the bank (much more successful); the latter is understood to have been carried out by EA river maintenance team some years ago (Photo 23). Tackling the eroding areas with engineered log jams and soft revetment, backed up with the establishment of wooded headlands and generous buffer strips (as already implemented in an arable field on this section – Photo 25) would create a much better in-stream environment and reduce the amount of land being lost to erosion.

Photo 23 Log bank revetment successfully protecting the toe of the bank

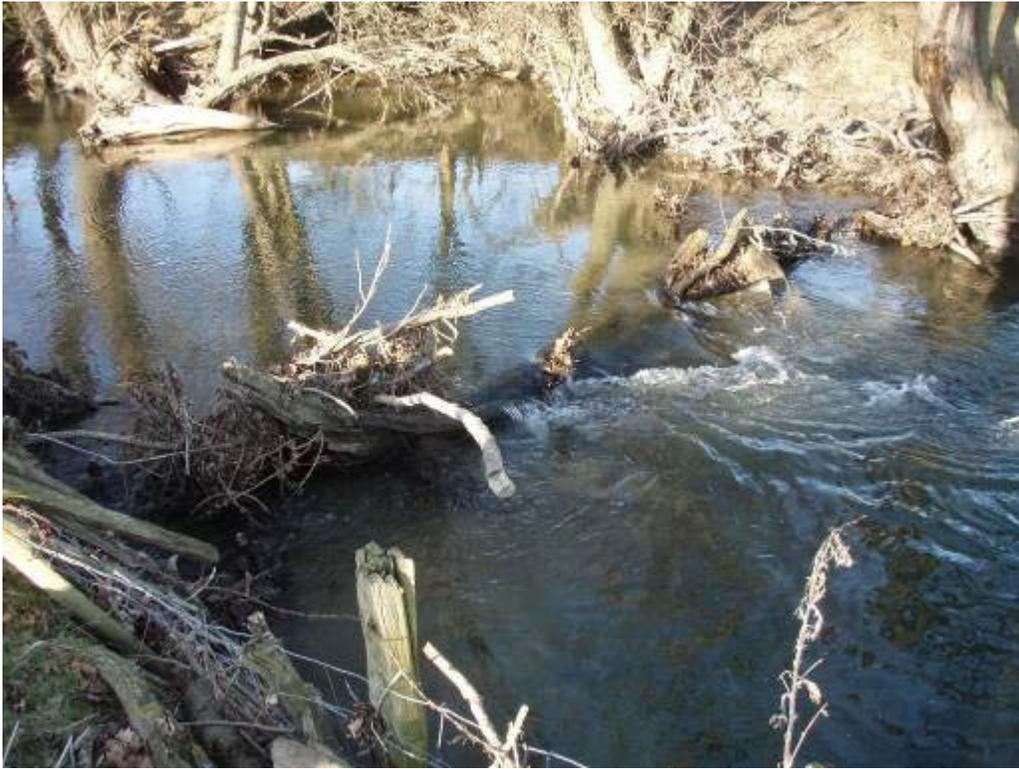
Photo 24 Large woody debris creating localised bed scour

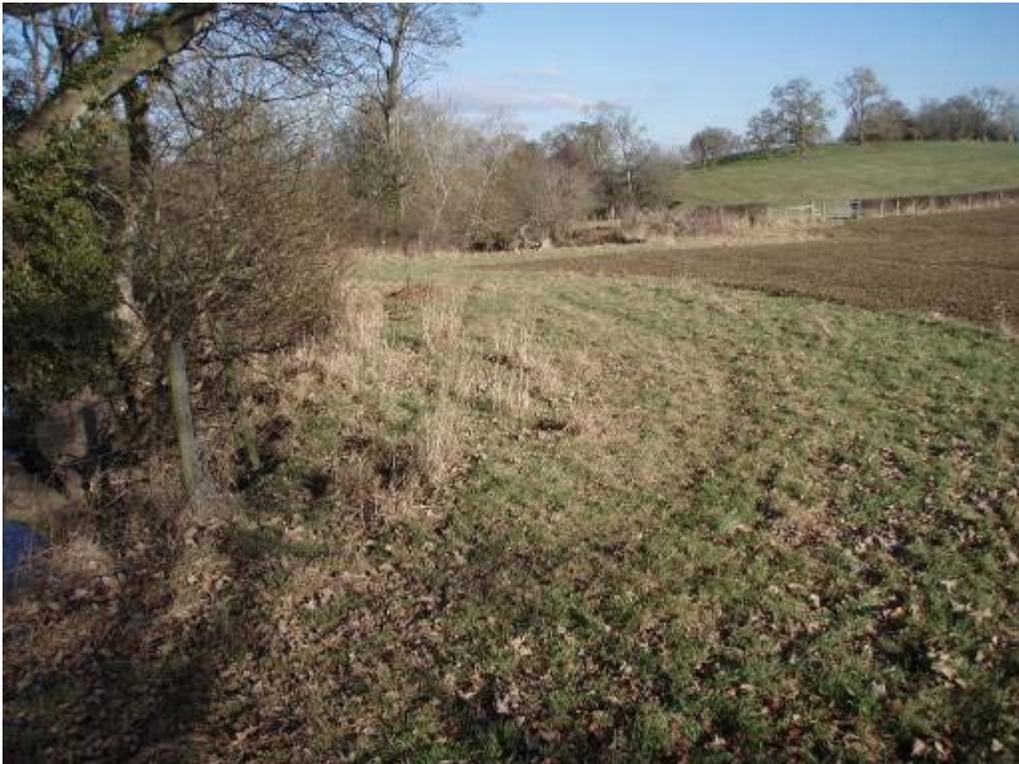
Photo 25 Buffer zone between river and arable cultivation – good agricultural practice.

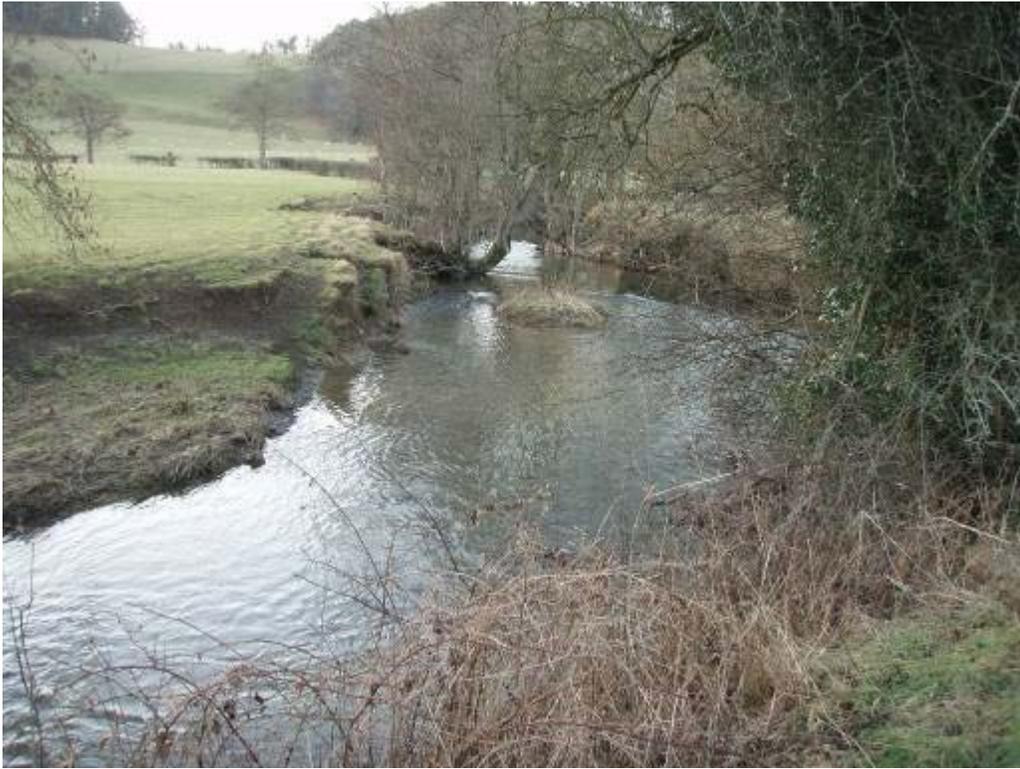
Photo 28

Some recent fencing has been completed on the left bank here in the field below the bridge; it is very close to the fall of the bank, hence unlikely to provide any meaningful bank protection through vegetation regeneration and at risk of being undermined by the river. The right bank is more open than the left, and there are several areas where rubble hardcore has been tipped down the bank in an attempt to reduce erosion.
