Grayling Society

**Advisory Visit
Afon Cain, Powys
January, 2011**

This report is the output of a site visit undertaken by Tim Jacklin of the Wild Trout Trust to the Afon Cain, Powys, on 28th January, 2011. Comments in this report are based on observations on the day of the site visit and discussions with Tony Bostock of the Severn Rivers Trust (SRT) and Richard Dearing, Catchment Officer with the Environment Agency (EA).

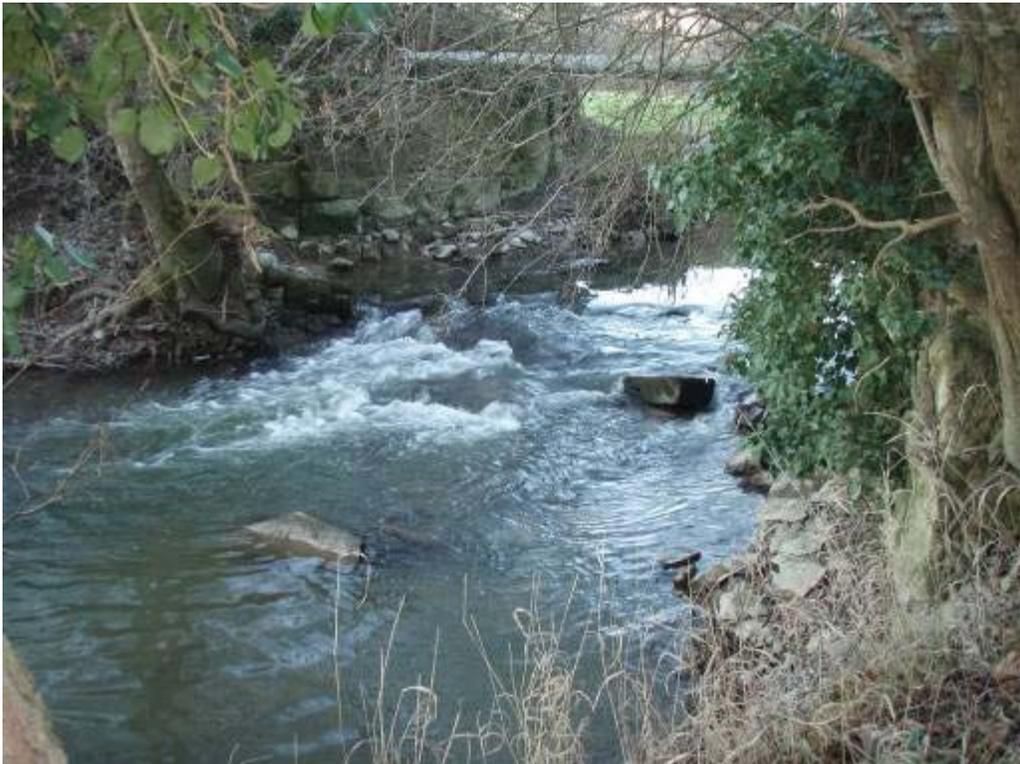
Where the old railway crosses the river, the remains of the bridge culvert create a bed check which could be a barrier (particularly at lower flows) to upstream migrating fish; this could be relevant for species with less ability or inclination to cross such barriers (e.g. grayling), rather than trout or salmon.

Photo 29 Old railway bridge culvert
