Alder Brook, Crowborough, East Sussex.

Advisory Visit April 2017

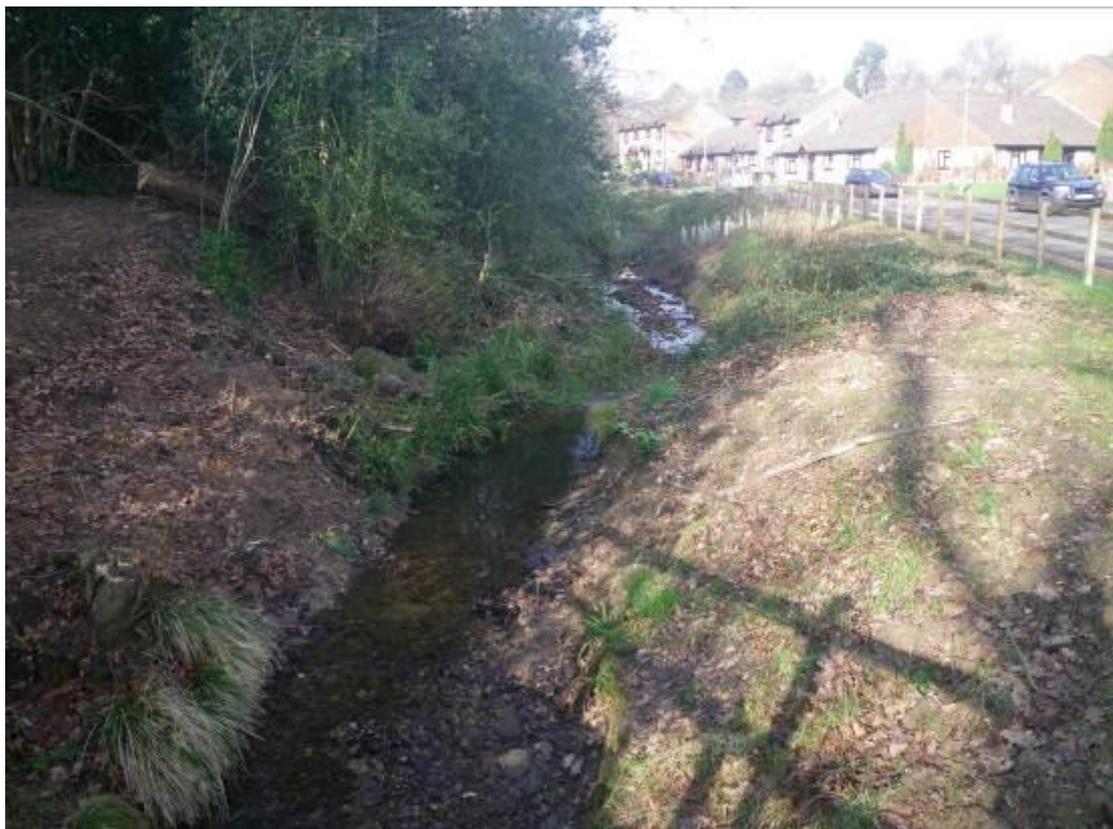
This particular upper section of the stream benefits from a relatively steep gradient and mainly takes the form of shallow riffle habitat, flowing over a gravel-rich bed. Outcrops of eroded sandstone and ironstone can be seen, as well as flint gravels. The river bed here also contains cobbles and brick fragments, which presumably were discarded during past local building projects. The stone-rich bottom, whether natural, or introduced, provides some potentially useful habitat for gravel spawning fish species such as brown trout *Salmo trutta*, bullhead *Cottus gobio* and brook lamprey *Lampetra planeri*. Unfortunately there is little information available regarding local fish communities but it is possible the stream also supports other gravel spawning species.

Photo 1. Shallow riffle flowing over a mainly gravel bed at the top end of the reach

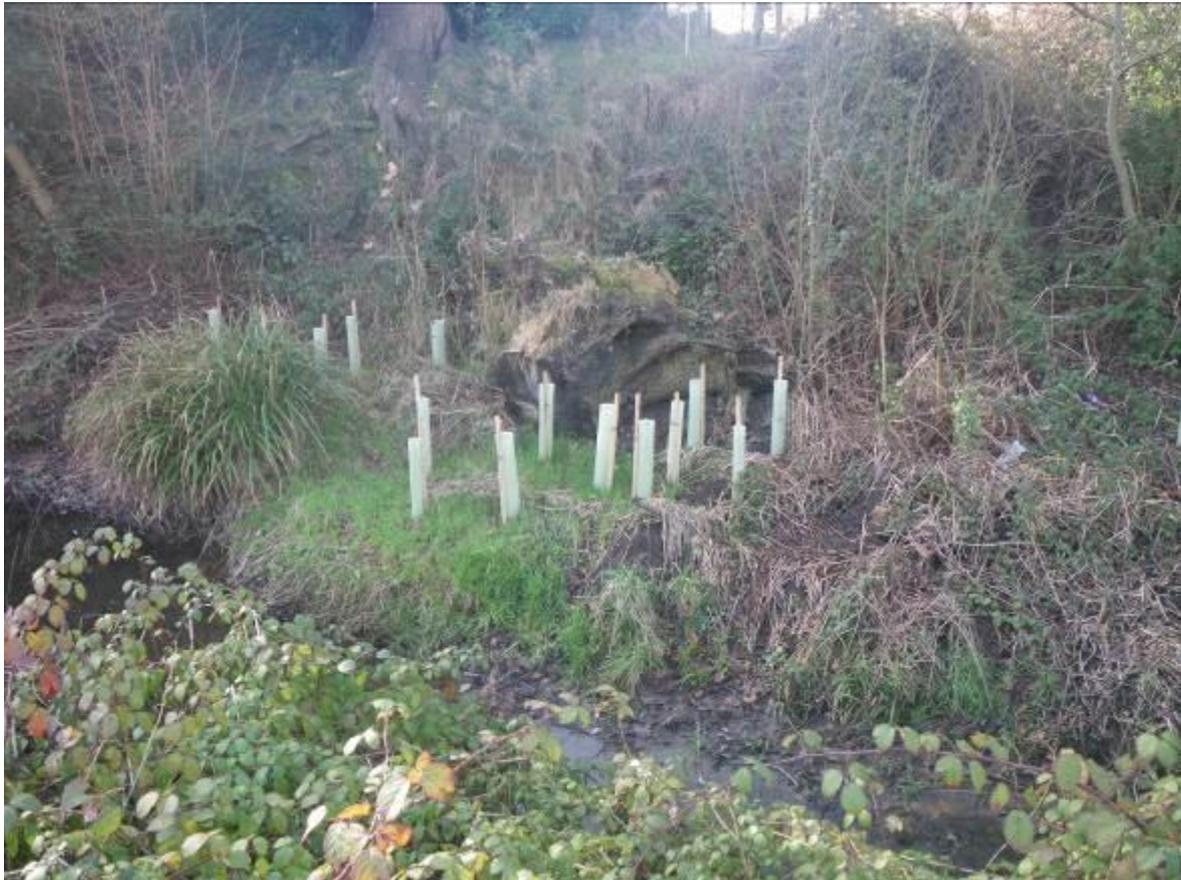
Efforts to plant up the margins were evident with some tree species having been planted on a low section of RB (photo 2). This low section of bank will be subject to inundation following a heavy rainfall event and the success of the planting will very much depend on which tree species have been selected. On a slumped bank or berm, which is potentially located in a relatively high flow energy

environment, only certain species will flourish, with willow *Salix spp* being the most-well adapted and resilient.

Photo 2 Recent tree planting on a section of slumped bank. Clumps of Pendulous sedge were also evident.

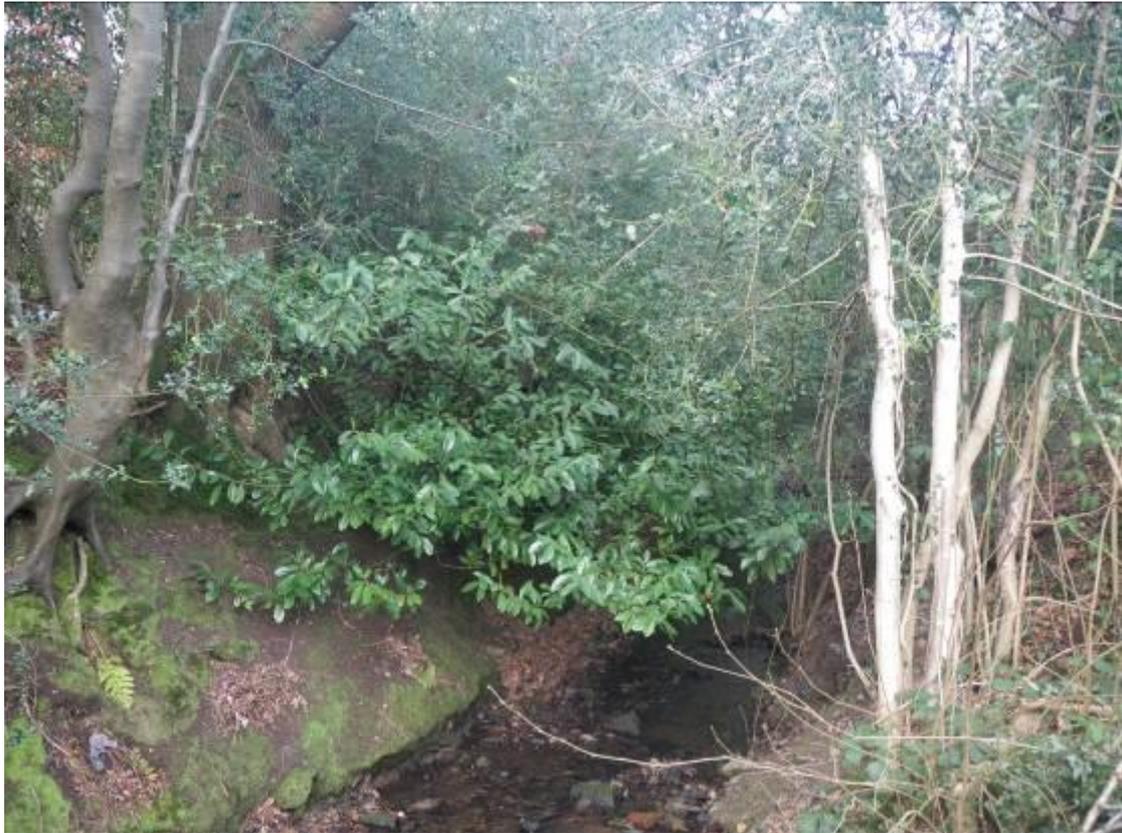
Towards the upper boundary there were clumps of either rhododendron or cherry laurel present (Photo 3). Both of these species are considered to be undesirable river-side plants, due to their propensity for intense shading. The leaves from both of these plants also contain toxins and are highly acidic in nature. This combination of factors usually result in bare banks which are then vulnerable to erosion.

Photo 3. Laurel or Rhododendron result in intense channel shading and bare banks.

- Control and if possible eradicate non-native plants. Plants that throw heavy shade and produce toxic leaves such as laurel and rhododendron should be removed.

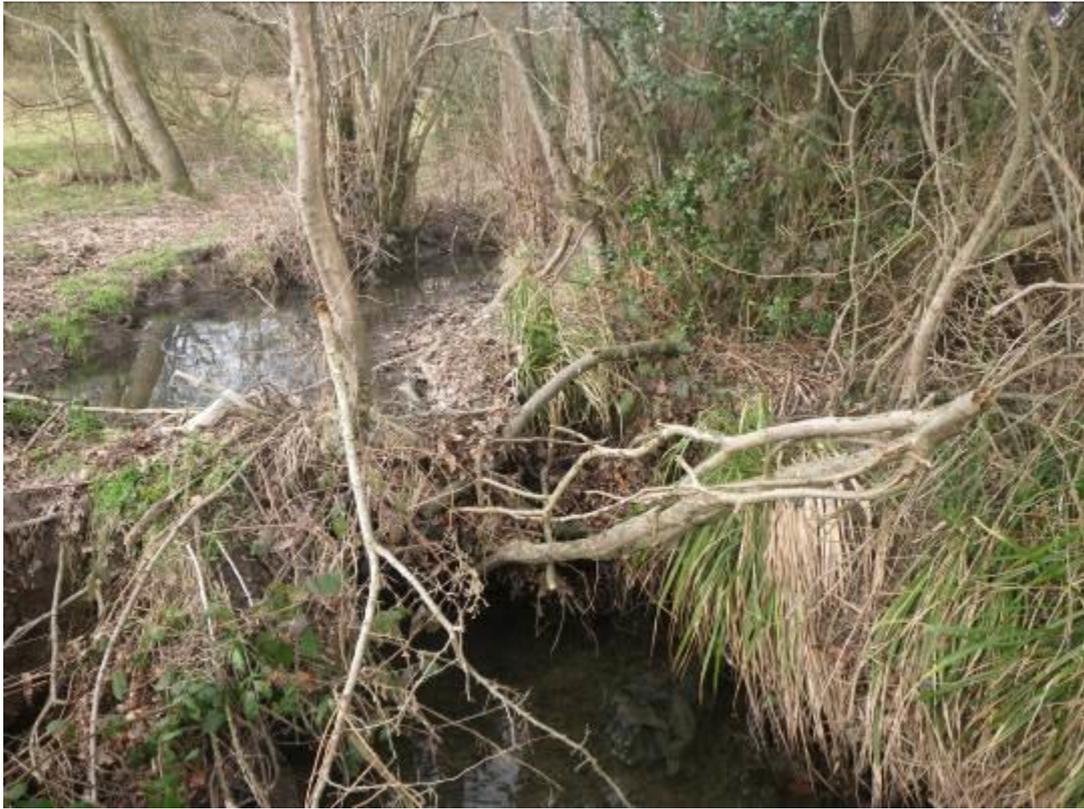
Photo 4. Established debris dam completely blocking the channel forcing the water to cut a new course.

Fallen woody material is a critical component of habitat in streams like this and should, whenever possible, be left in situ. Some monitoring of natural woody debris dams is recommended because in extreme cases the small undershot gaps that usually occur in debris dams can become blocked with fine material, resulting in a sealed, full channel-width weir or dam developing. In such cases it is not unusual for the upstream bed levels to rapidly rise as increasing amounts of bed material are trapped on the upstream side. Occasionally this might result in large steps forming in the river bed, which then block access for fish species wishing to migrate up and down the system. One such debris dam is depicted in photo 4. In this particular case the blocked channel isn't causing a problem as a new channel has formed under high flow conditions, potentially facilitating fish migration around this naturally formed impoundment. Where there is sensitive infrastructure present, such as bridges or footpaths, it is sometimes advisable to ease out small sections of the debris dam to help any undershot flow develop and reduce the risks of damaging infrastructure. If there is room for the channel to migrate either side of the debris dam then the best outcome is simply allow the river to carve out a new route.

- Move but do not remove woody material that is deemed to be causing a local issue.
- If debris dams form and subsequently the upstream bed level rises to more than 300mm above the downstream bed level then consider light intervention to ease fish migration.

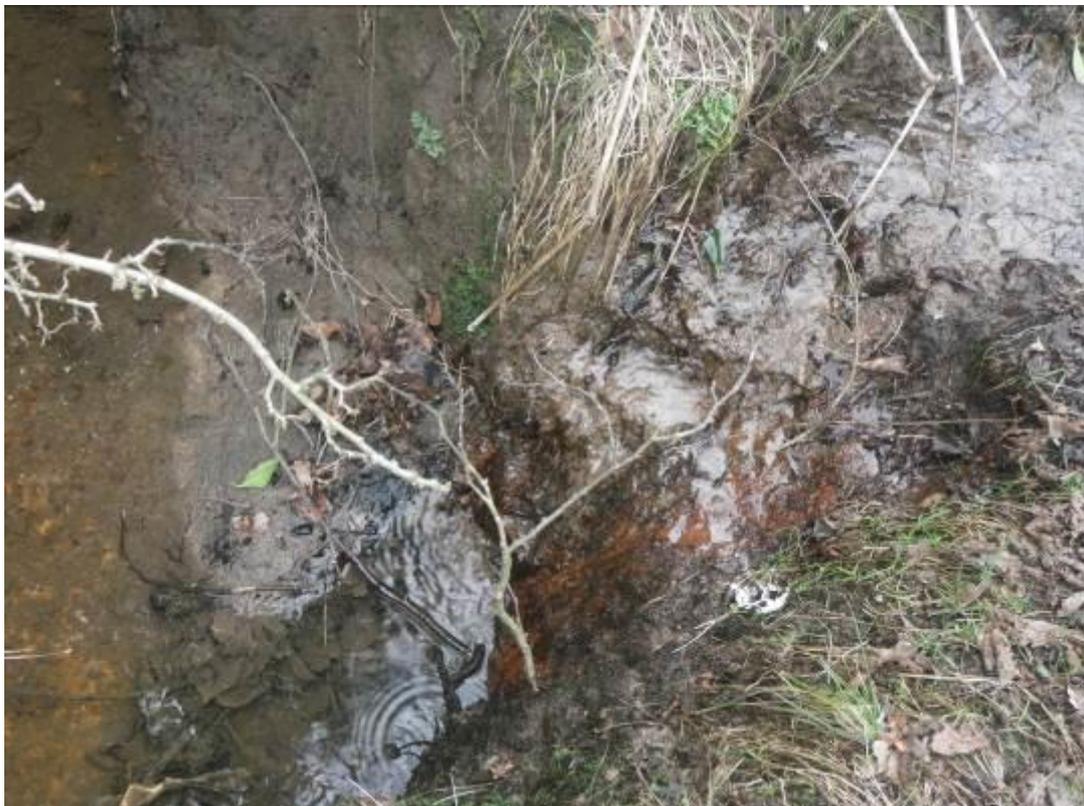
Photo 5. Iron rich ground water entering the stream, highlighting why this area was so important for medieval iron smelting.

Evidence of iron-rich ground water (Photo 5) was seen in this reach, which gives the stream a strong “tea” colouration. Although iron-rich streams are usually less productive than more alkaline streams, they are nonetheless natural and valuable, often supporting specialised invertebrate communities.

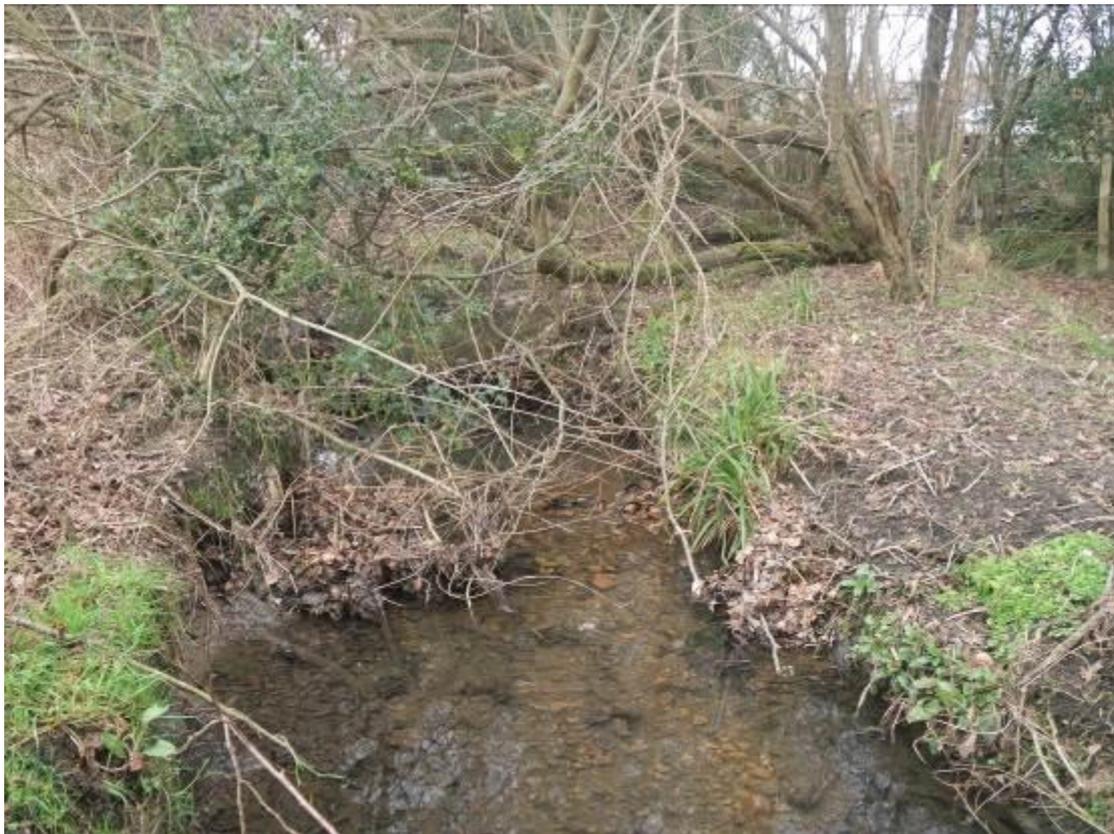
There were numerous examples of high quality stream habitats where either large woody material had helped to create pool habitat, or where coarse woody material had fallen, creating a primary source of food for grazing invertebrates and excellent cover for juvenile fish species. Photos 6 and 7 are typical examples of good quality habitat that should be retained in any management plan.

Photo 6. Coarse woody material in the channel providing food for bugs and cover for juvenile fish

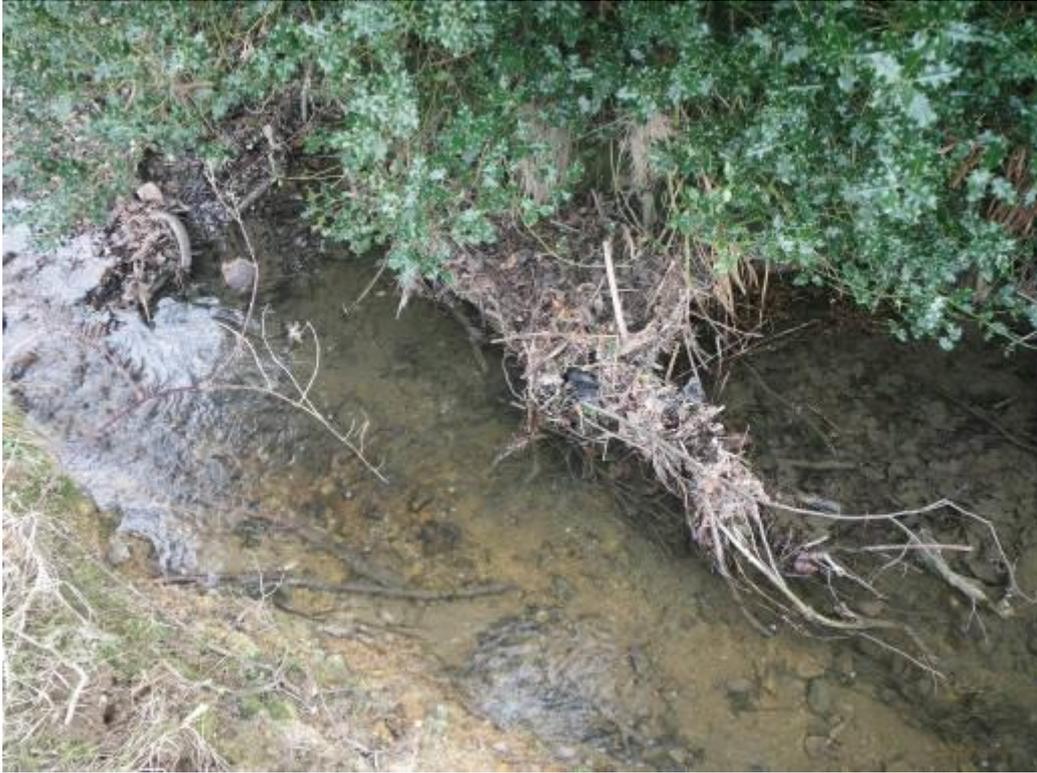
Photo 7. A further example of a holly root system trapping coarse woody material and providing good quality cover.

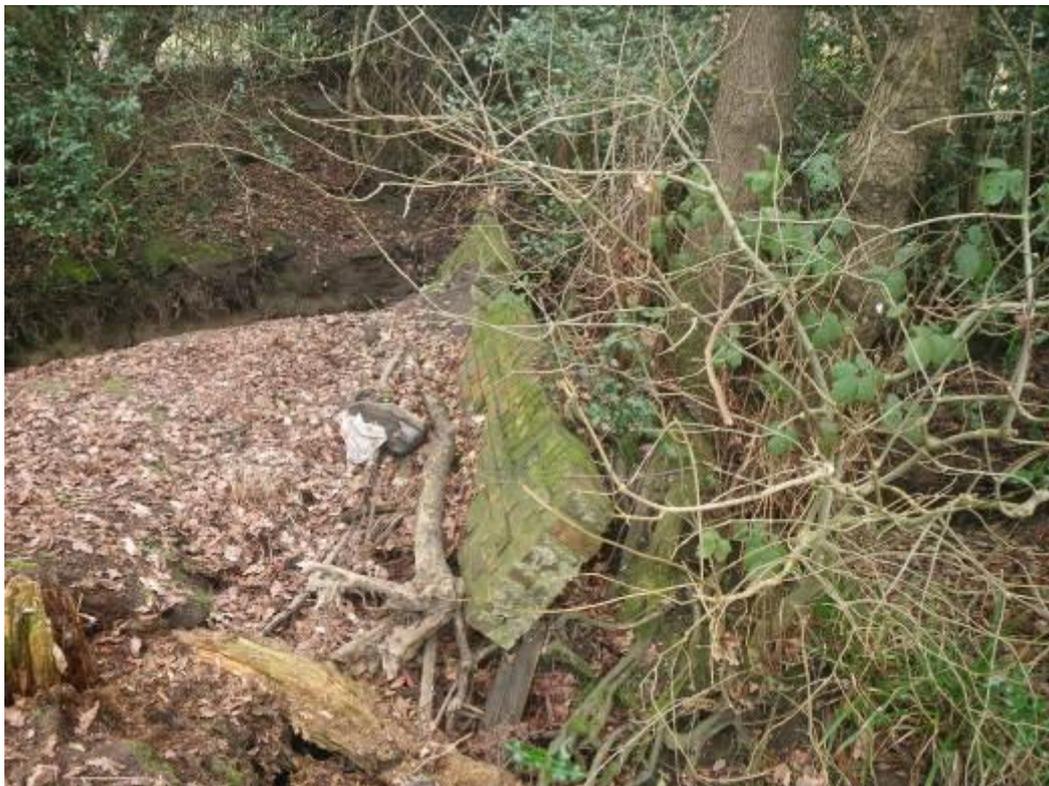
Photo 8. A large section of brick wall is evidence of how much power this stream can generate under spate conditions.

Evidence of the streams power in spate conditions were also evident, with the remains of a brick wall, which appeared to form part of a bridge wing and which now has been moved by the stream.
