WILD TROUT TRUST
wildtrout.org

Advisory Visit
River Arrow, Alcester, Warwickshire
August 2023

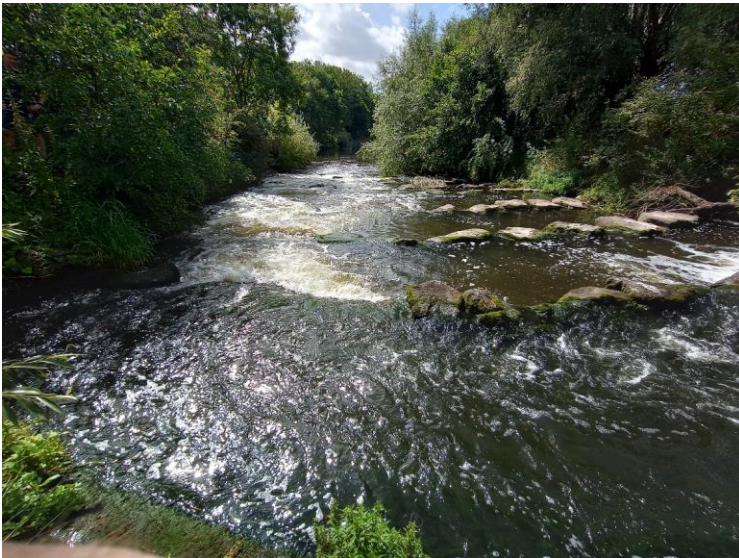
Photo 2 Rock-ramp fish pass at Arrow Mill weir, constructed in 2012 (see [Appendix](#)).

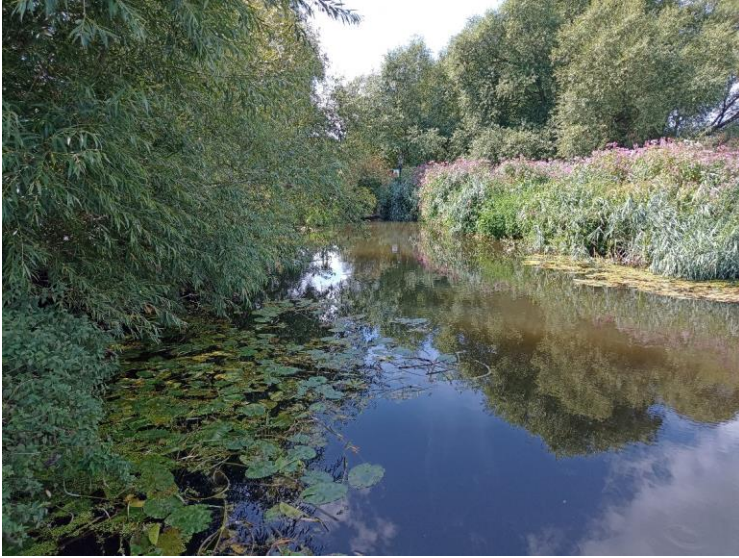
The overriding influence on river habitat quality here is the impoundment of water by the weir at Arrow Mill at the downstream extent of the reach (Photo 1 - Photo 3). The water level difference across the weir is approximately 2.2m (from LiDAR levels); the stilling effect is visible throughout the reach to the upstream point inspected and the habitat is more akin to a canal than a river.

Photo 3 Immediately upstream of Arrow Mill weir.

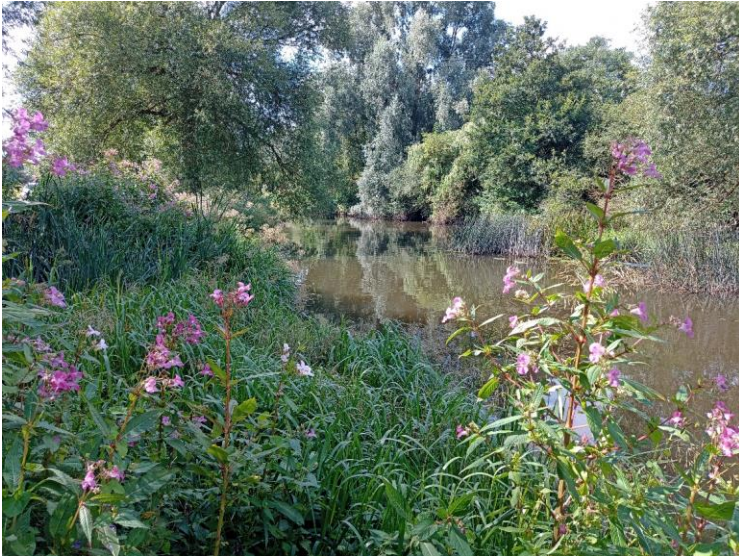
The connection between the Back Brook and main river channel is very silted and overgrown and it appears the exchange of water is limited; it would benefit from clearance and regular maintenance to keep the connection open. The former river channel on the right (NW) bank may provide a similar benefit, subject to the levels being suitable.

Photo 4 The connection between the river and Back Brook backwater (foreground) is blocked by silt and vegetation.

- Thin the trees alongside the Back Brook and introduce and secure the thinnings to the margins as cover. Improve the connection between the main river channel and the Back Brook backwater; keep the connection open through regular maintenance.
- Investigate the opportunity to connect the former river channel on the right bank. Check the relative water and bed levels between the old and new channels.
- Retain fallen trees, submerged and overhanging branches and weedbeds within and alongside the river channel as vital cover for fish from predation.
- Control the non-native invasive plant Himalayan balsam by hand-pulling before it sets seed.

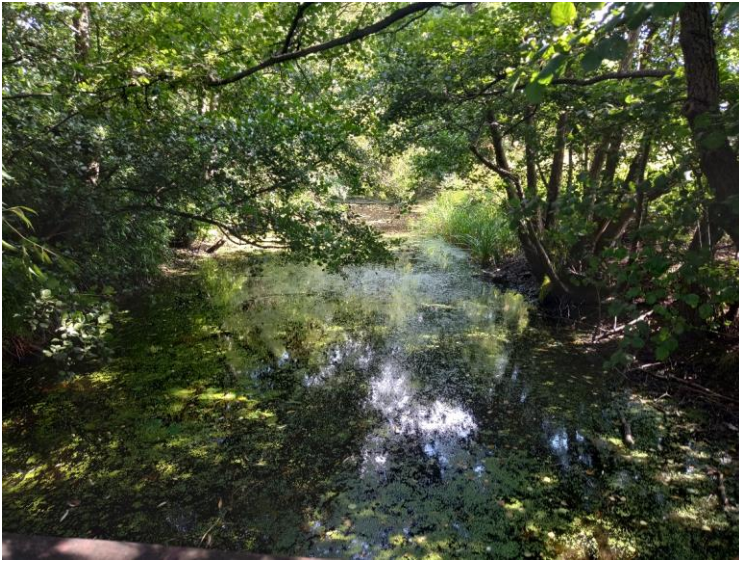
The Back Brook (former tailrace of Oversley Mill) provides backwater habitat alongside the main channel which could be valuable for the recruitment of juvenile fish (Photo 4 - Photo 5). Shallow backwaters warm-up early in spring and generate vital planktonic food for fish fry in their early development. Backwaters also provide refuge for fish from flood 'washout' and predation.

Back Brook is currently heavily shaded by trees; in many contexts, tree shading is valuable to keep rivers cool, but here it would be beneficial to reduce the shading (particularly on the southern aspect); this would promote warming of the backwater benefiting the production of plankton and fish fry. The brash from tree trimming could be laid in the margins of the backwater and secured with stakes and fencing wire to provide cover for fish fry. ATLAC are planning a similar initiative to the [Avon Roach Project](#) and the Back Brook has potential as a rearing area for roach eggs harvested from elsewhere in the river.

Photo 5 Back Brook backwater.

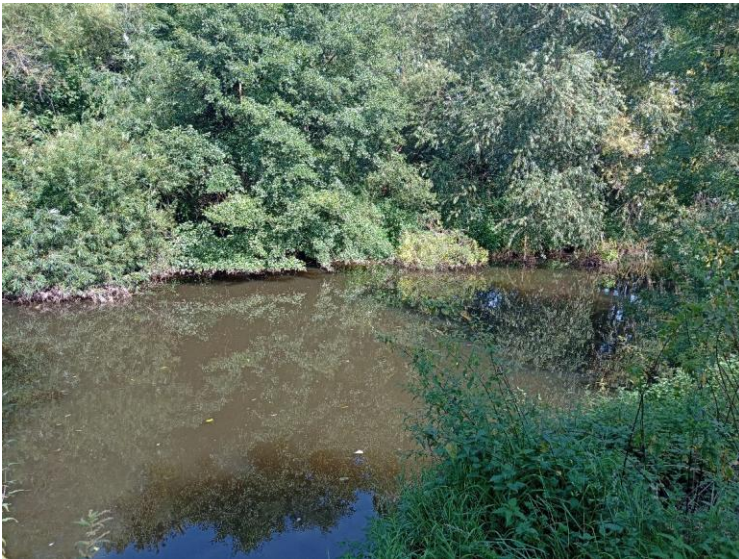
The downstream sections are reported to be deep, with scour holes below pinch points such as the former railway bridge. With progress upstream, the river becomes shallower and beds of common club-rush (*Schoenoplectus lacustris*) are prolific, pinching the channel in places and creating some discernible flow (Photo 7). Other aquatic vegetation includes water lilies, reed sweet-grass (*Glyceria* sp.), reedmace (*Typha latifolia*) and common reed (*Phragmites* sp.); along with abundant overhanging bankside willows, these provide good cover for fish from predation (Photo 3, Photo 6).

Photo 6 River channel upstream of A435 – still impounded, but with good cover on the far bank which should be retained.

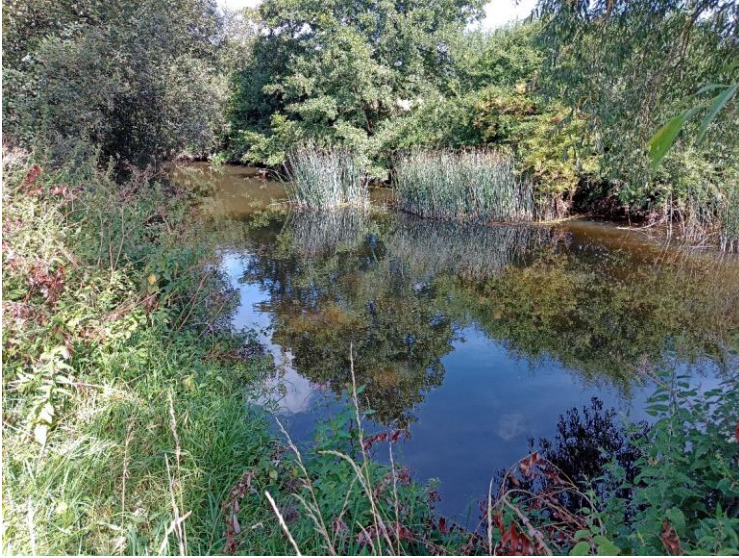
Photo 7 Towards the upstream end of the reach, the river becomes shallower and is pinched in places by beds of club-rush.

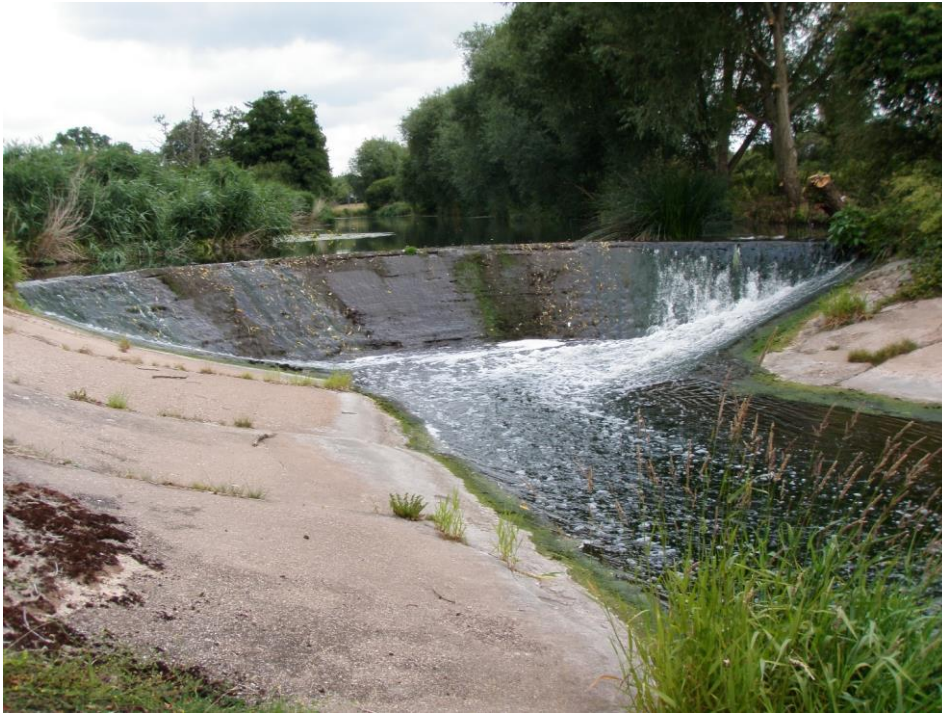
Photo 8 Weir above Arrow Mill before fish pass construction.

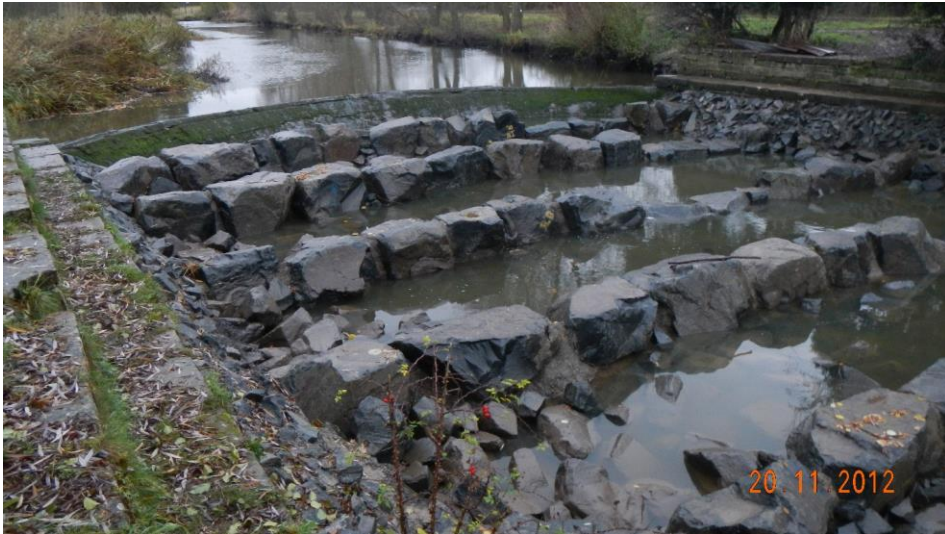
Photo 9 Rock ramp fish pass construction.
