**Advisory Visit**  
**River Arrow, Warwickshire**  
**May 2012**

## 1.0 Introduction

This report is the output of a site visit undertaken by Tim Jacklin of the Wild Trout Trust to the River Arrow, Ragley Hall Estate, Warwickshire on 8<sup>th</sup> May, 2012. Comments in this report are based on observations on the day of the site visit and discussions with Steve Lyon (Property Manager, Ragley Hall Estate), Giles Matthews (Environment Agency Biodiversity Officer) and Melissa Hoskins (Severn Rivers Trust).

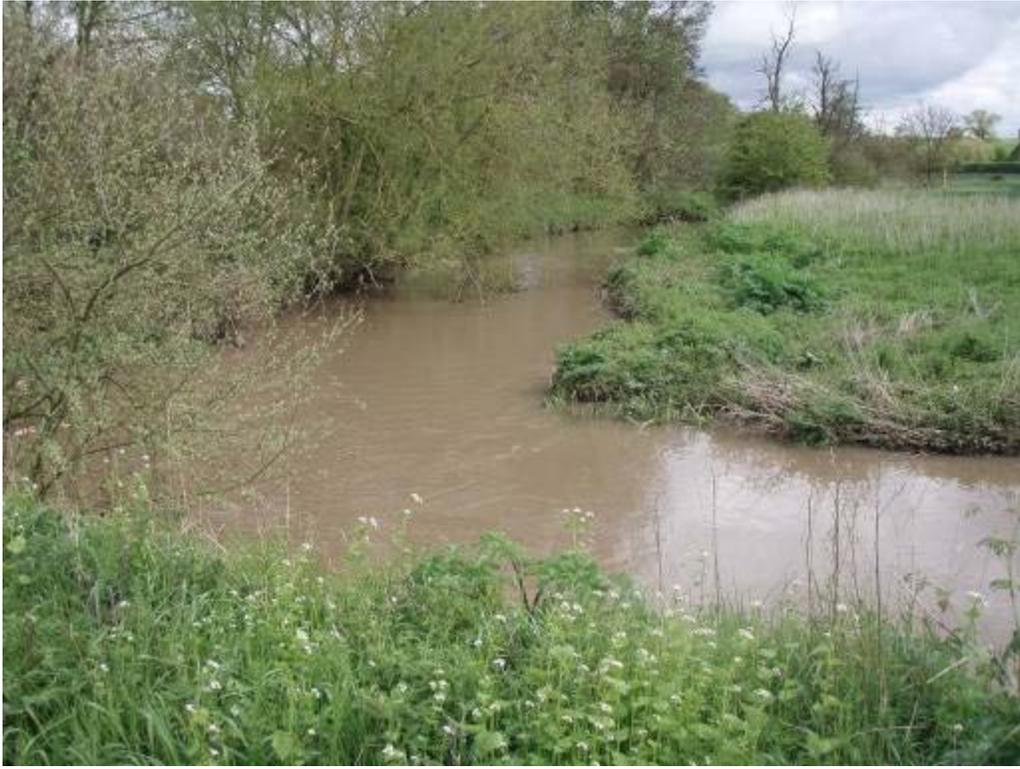
**Photo 1**

The rate of erosion of some banks appears to be accelerated because of adjacent land use. Arable agriculture is the predominant land use and where this occurs immediately adjacent to the river, the banks have less stability and are prone to increased erosion rates (Photo 1). By contrast, where woodland or a wide riparian zone with trees is present, the banks are more resistant (Photo 2).

- Consider land use changes adjacent to the river, namely woodland creation in order to increase bank stability and reduce rates of erosion.
- Retain large woody debris within the channel wherever possible.
- Create backwater areas connected to the river and within the floodplain to provide refuge areas and juvenile habitat for coarse fish species.

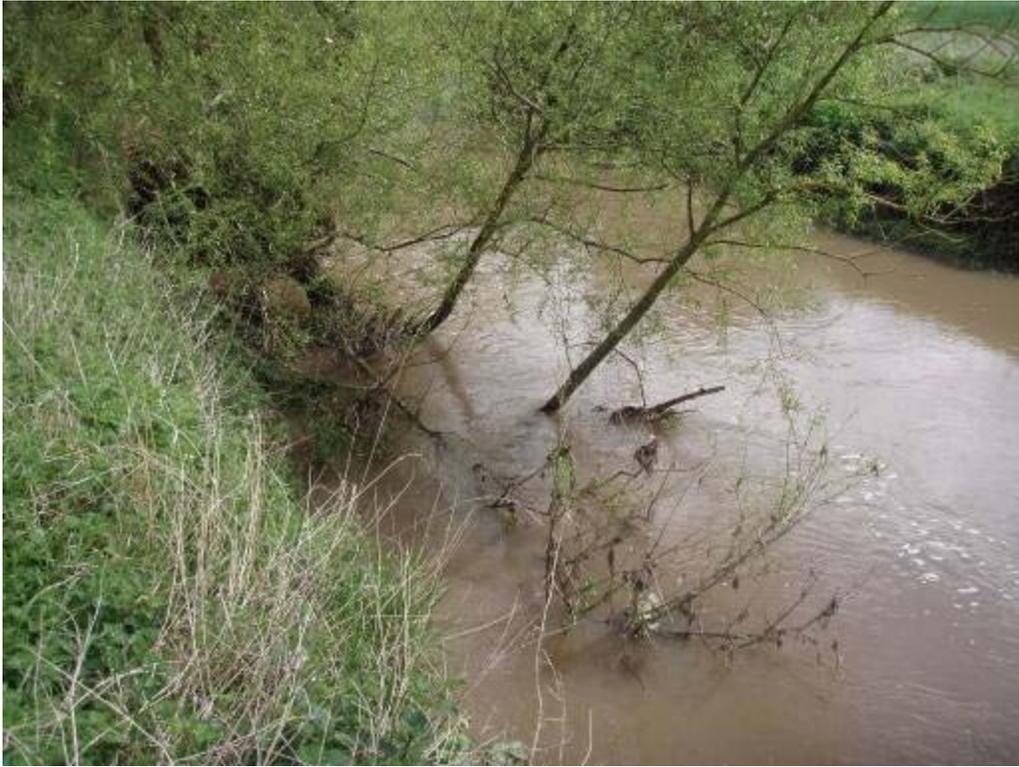
**Photo 3 Trailing branches provide valuable low cover for fish**

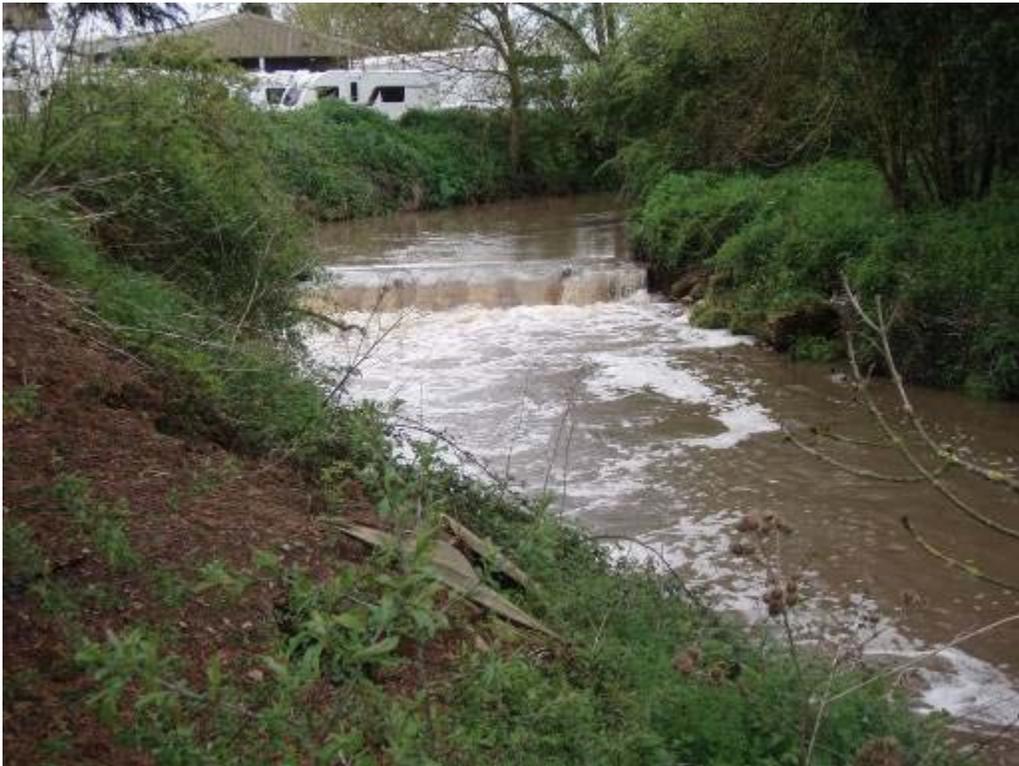
A sheet-piling weir is present (Photo 4) near the industrial site on the left bank and a similar structure appears to be present (on aerial photography) a short distance upstream at SP086593. These were probably installed as bed level checks to stabilise the river following engineering works. They present obstacles to fish movement and fragment river habitat. Ideally, they should be removed, or if this is not possible, improved for fish passage, for example by installing a low-gradient rock ramp. A thorough assessment of the potential impact of weir removal on re-grading of the river bed, bank erosion

and the risk to upstream properties should be carried out by a suitably qualified person before the structures are removed.

**Photo 4 Sheet piling weir, approximate NGR SP085591**

- Remove or modify the weirs present to improve fish passage, habitat connectivity and sediment transport. Consult with the Environment Agency and ensure proper consideration of the risks of removal.

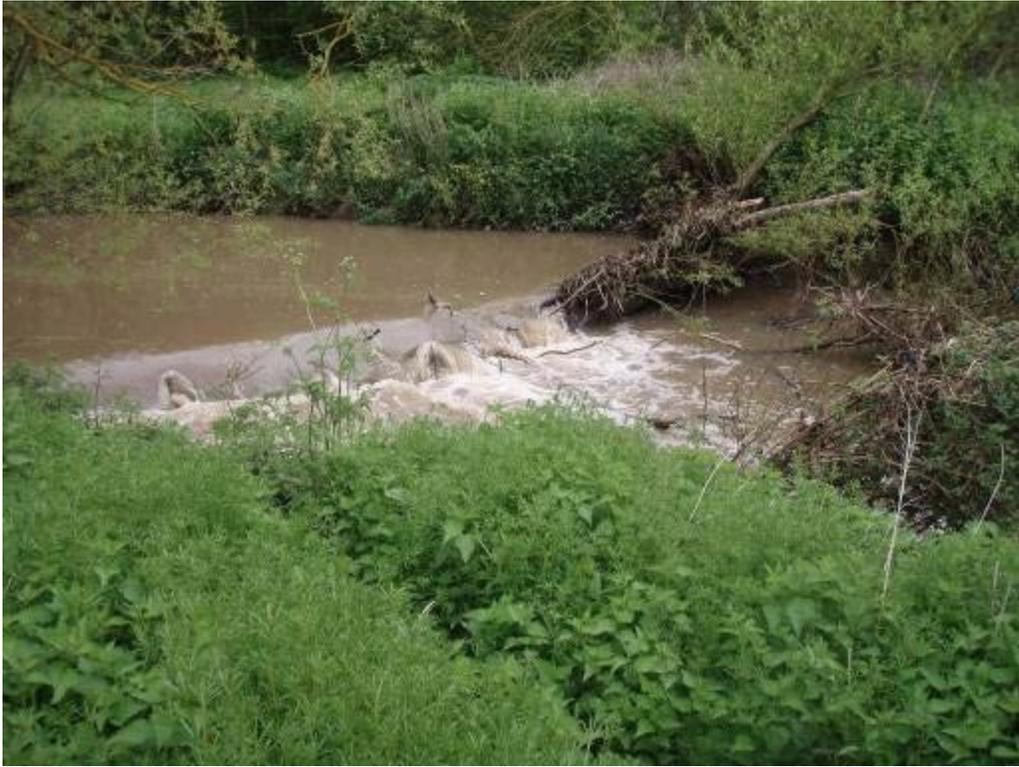
Some large woody debris (LWD) was present in the river channel (Photo 5) where a willow tree had fallen across the channel. LWD has been shown to be extremely important in several respects:

**Photo 5 A fallen willow creating some valuable large woody debris within the river channel.**

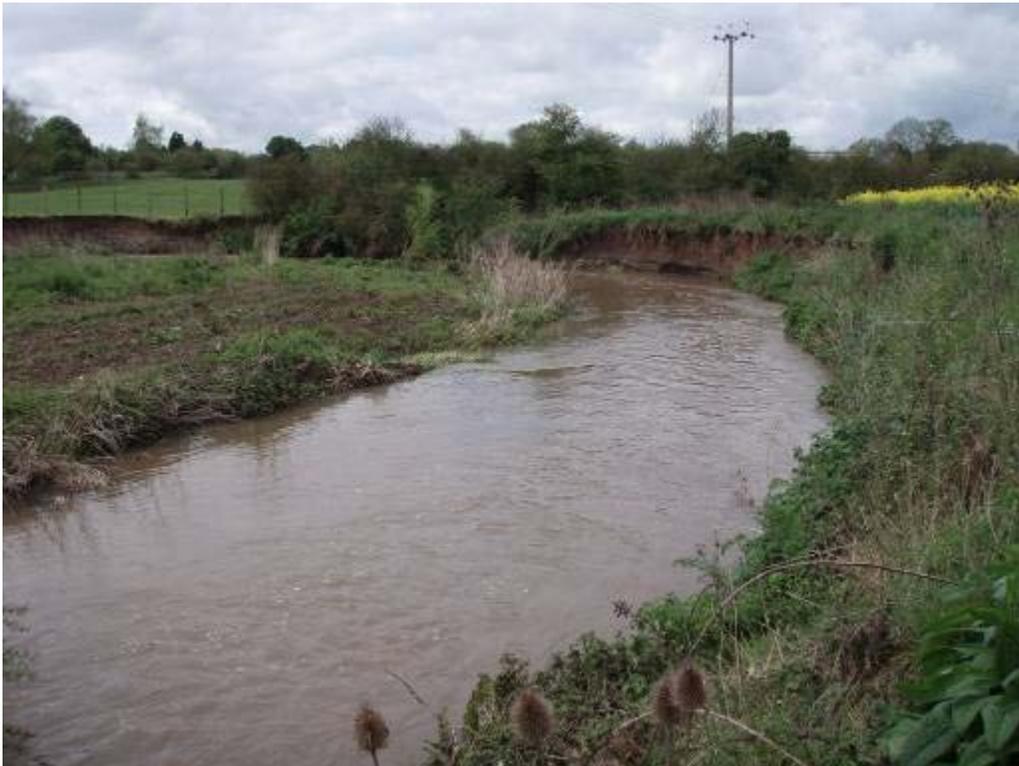
At the downstream end of Site 1, the right bank is eroding at an accelerated rate (Photo 6). Methods of bank protection were discussed, including pinning live willow trunks and brushwood bundles at the toe of the bank. This would reduce the rate of erosion in the short term, but for a more permanent reduction, the land use on the right bank needs to be changed to allow mature trees to develop.

**Photo 6 Downstream limit of Site 1. The eroding bank could be protected here, maybe by reveting the toe of the bank with willow logs or brushwood, but changing the land use on the right bank to woodland to increase bank resilience would be required for a longer term solution.**

The Estate should consider the possibility of woodland creation in this vicinity under existing stewardship agreements or under woodland creation schemes. Strategically located blocks of woodland alongside the river could greatly assist in reducing erosion rates and loss of land.

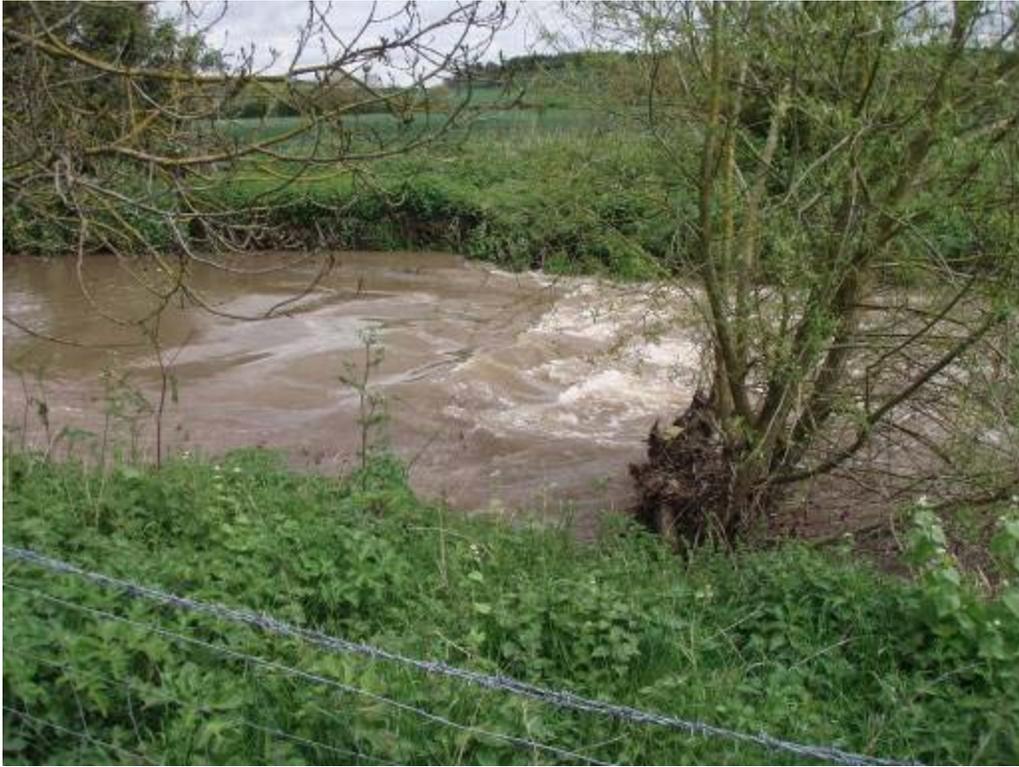
**Photo 7 Site 2 – sheet pile weir**

The River Arrow here is a bigger river, having been joined by the River Alne in Alcester. A sheet-piling weir is present (Photo 7) although it was drowned by the high water levels at the time of the visit. Two similar weirs are located on this reach, upstream of the A46 (SP084550). As stated above, these structures were probably installed as bed level checks during river re-grading works. The same recommendations apply to these structures – remove in consultation with the EA and following an appropriate impact assessment, or improve fish passage.

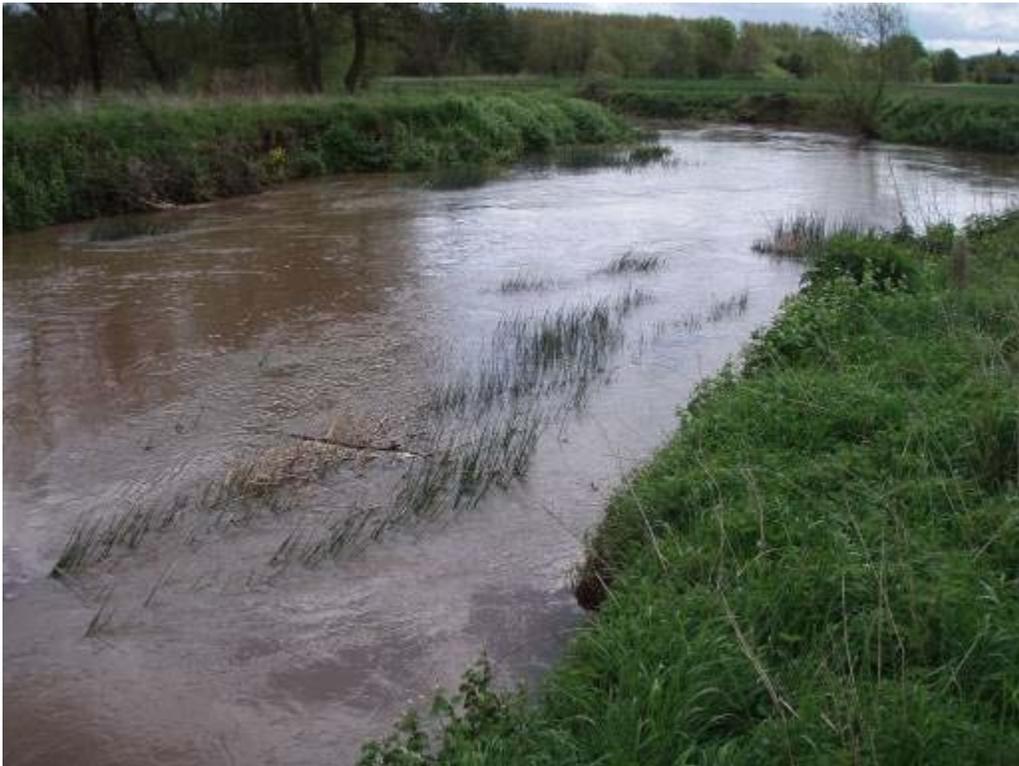
**Photo 8 Site 2 – view downstream towards A46 bridge**
