## **Hampshire Avon, Countess, Wiltshire**

**An Advisory Visit by the Wild Trout Trust November 2017**

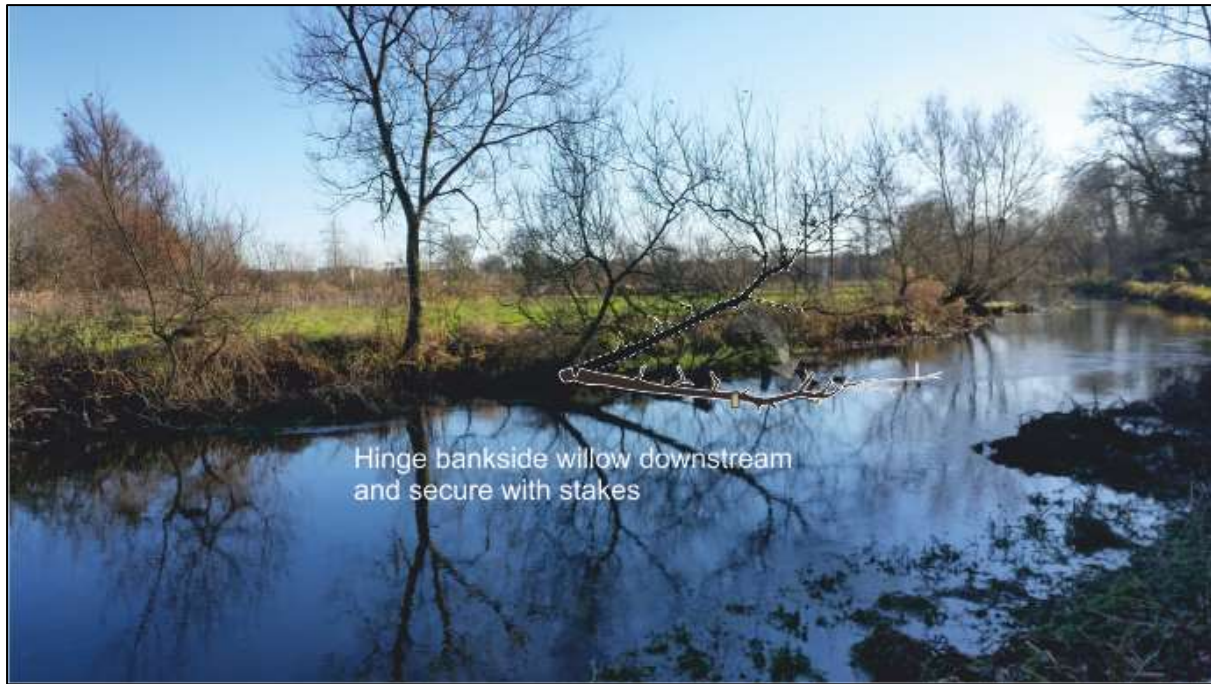
At the upstream extent of the water visited, SADAC shares a half-water with the Snake Bend fishing syndicate. The river is relatively uniform in width but there are several opportunities to introduce some flow-deflecting habitat features that would significantly improve habitat diversity and potentially create some new feeding lies which would provide good sport for anglers. Hinging bankside willow limbs into the river and securing with wooden (ideally untreated sweet-chestnut) stakes will provide excellent cover habitat as well as pockets of slack water alongside runs of faster flow – ideal conditions for trout to hold up and snap up passing prey (Figure 2).

Figure 2: An illustration showing where a bankside willow could be hinged and secured

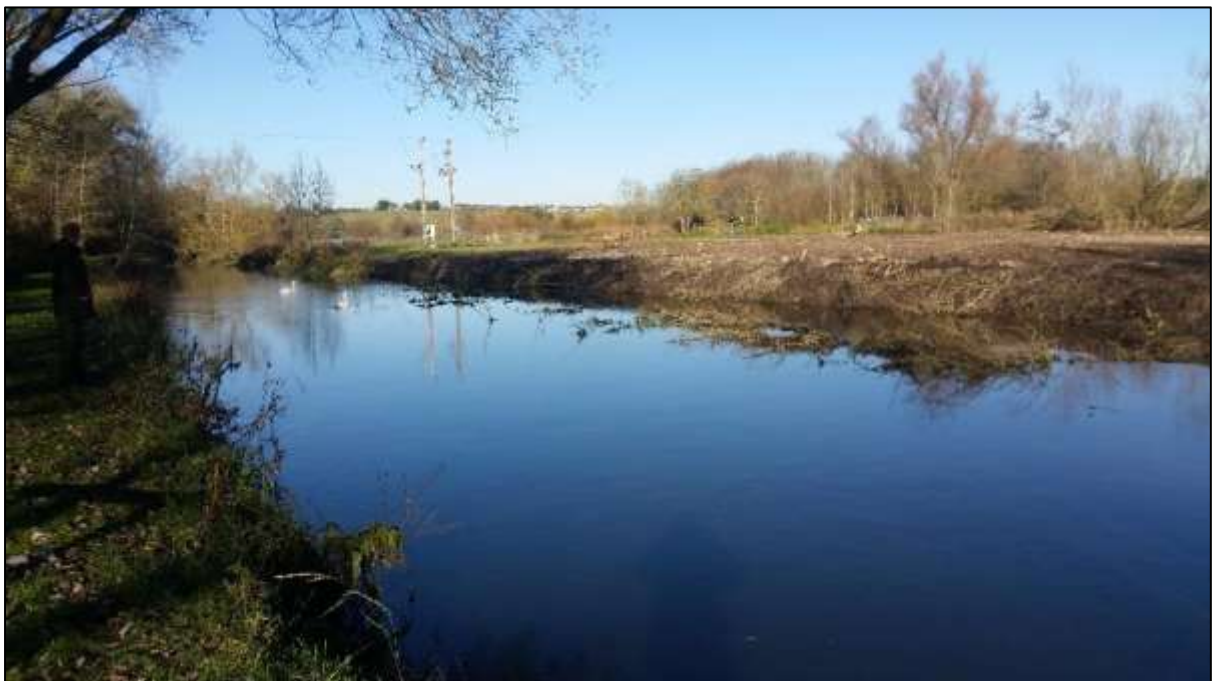
Towards the downstream extent of the water shared with Snake Bend, next to the southernmost of the fishing lakes, some extremely insensitive bank clearance has almost completely denuded all marginal habitat from the LB (Figure 5). Some engagement with the land owner is advised before implementing further habitat improvements at this location.

Figure 5: This extremely insensitive bank clearance work is detrimental to river ecology and is unlikely to have been consented.

- 1.** Engage with the Snake Bend syndicate and the land owner at the upstream extent of the fishery and plan a project involving the introduction of naturalistic, flow-deflecting woody habitat features. Also discuss more sensitive approaches to bank management.

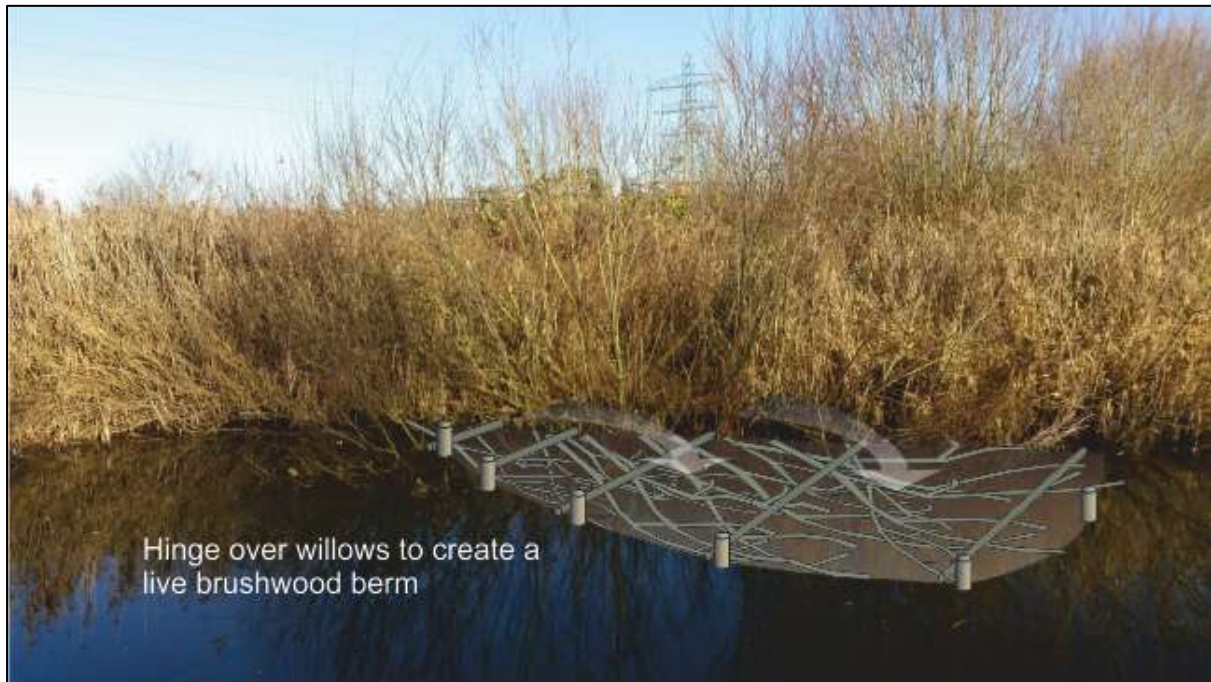
cover on the LB is initially dense and consists mostly of shrubby goat willows (*Salix caprea*). Hinging occasional clusters of branches (as opposed to single, large limbs) into the river would introduce some much needed diversity and flow deflection (Figure 6). Doing so will also help break up the canopy which is currently at a relatively uniform height and density and casts uniform shade over the river margin.

Figure 6: An illustration showing how clusters of branches could be hinged and secured to create a living brushwood berm

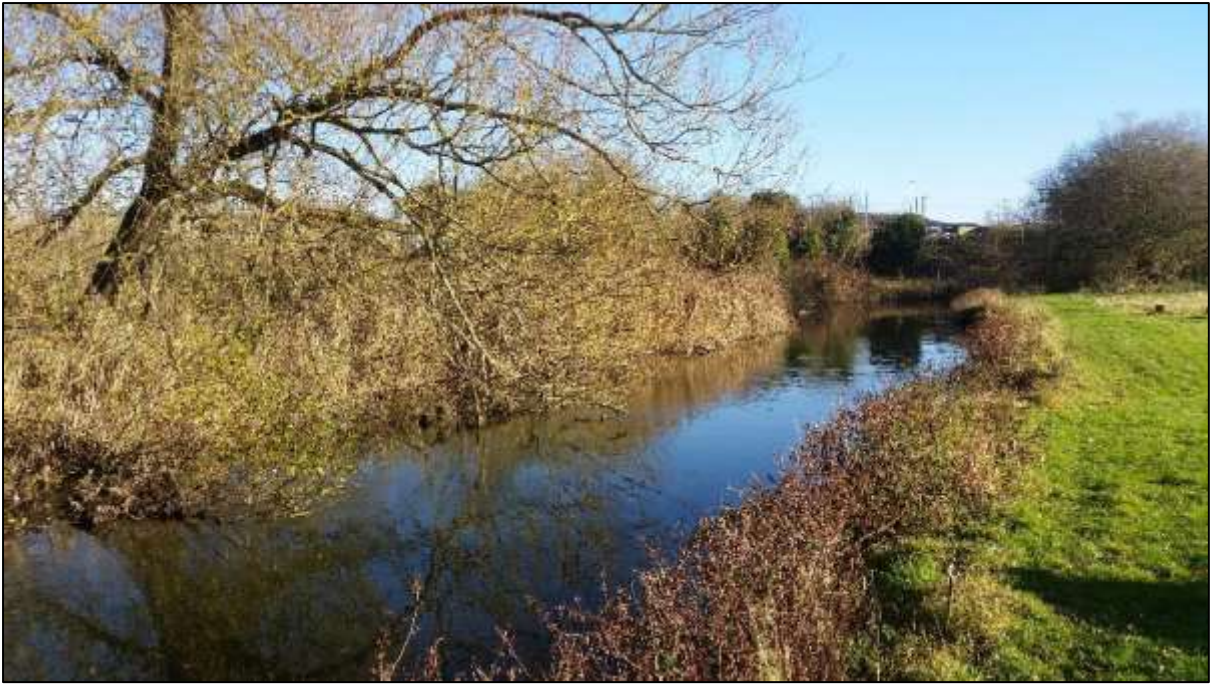
The RB along this reach is steep, almost vertical in places (Figure 7). Fortunately there is ample space and access on the upper bank for some bank re-grading works. Creating a new bank toe from logs or brushwood and then grading the bank down to the toe with an excavator will better connect the river with its floodplain, provide a transitional habitat for a succession of marginal plants and also create some low-level angler access. Such works would also be an opportunity to slightly narrow the channel and create a more sinuous bank edge, diversifying flow patterns and boosting biodiversity (Figures 8 and 9).

Figure 7: The right-hand bank is steep, almost vertical in places

- 2.** Identify and capitalise on other opportunities for habitat enhancement such as hinging stands of live willow into the river.
- 3.** Consider re-grading sections of bank to provide low, bankside angler access, and opportunities for a succession of different marginal plant species to establish and thrive. NB – Surveys and appropriate mitigation measures for water vole (*Arvicola amphibius*) will almost certainly be required.

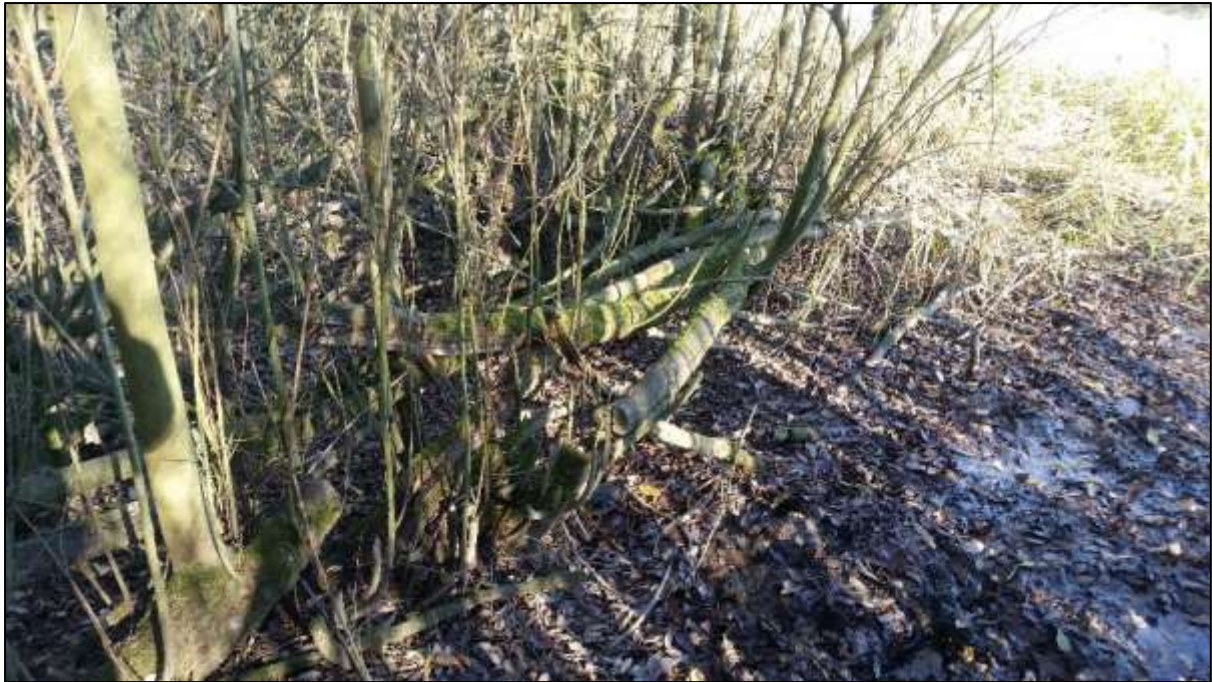
The bank around the hinged willow consists of consolidated fine sediment trapped by the hinged limbs over time. The willow limbs were initially hinged into the river margin. This increased friction and the rate of deposition, resulting in a soft berm on the inside of the bend, accentuating the meander and narrowing the river. This is an excellent example of a simple management practice working with natural processes to instate change over time. As new shoots growing from the hinged limbs have now grown tall, there is an opportunity to pinch the river yet further by cutting additional hinges and again laying them down into the wet margin.

Figure 10: Hinged willows were initially laid into the river. The resulting deposition means they are now on solid bank

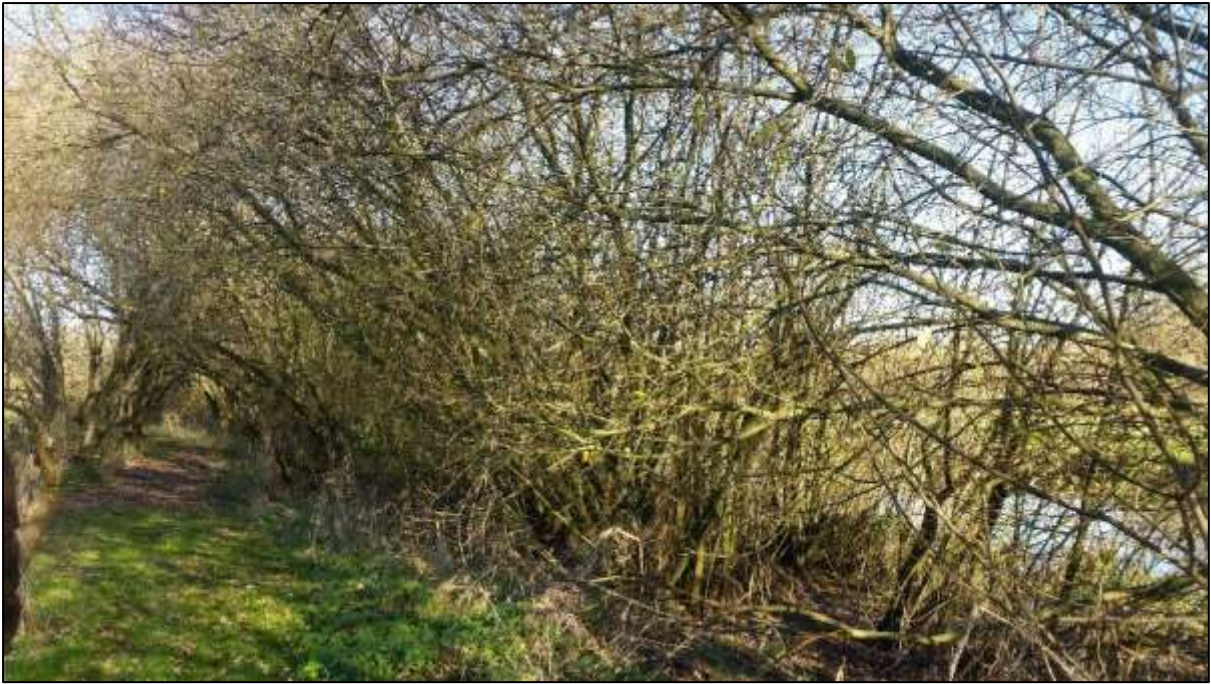
As these willows were cut at approximately the same time, the resulting re-growth has formed a thicket of uniform canopy height and density, casting uniform shade over the river margin (Figure 11). Undertaking some selective coppicing will diversify light conditions, benefitting biodiversity and also giving rise to live willow brushwood that could be used to create some live willow berms. Strategically placed, these berms could help to pinch the river, deflect flows and provide additional marginal habitat. The river is relatively shallow at this location (compared to much of the water visited) and was probably the site of the bed raising element of the project (Figure 12). Some additional flow deflection could help clean and sort what gravel is available, improving it as a spawning site for flow loving fish such as brook lamprey (*Lampetra planeri*), chub (*Squalius cephalus*) and dace (*Leuciscus leuciscus*) and possibly providing clean enough gravel to provide some spawning habitat for salmonids.

Figure 11: Willows growing to uniform height and density. Selective tree works will diversify habitat and provide material for habitat enhancements elsewhere.

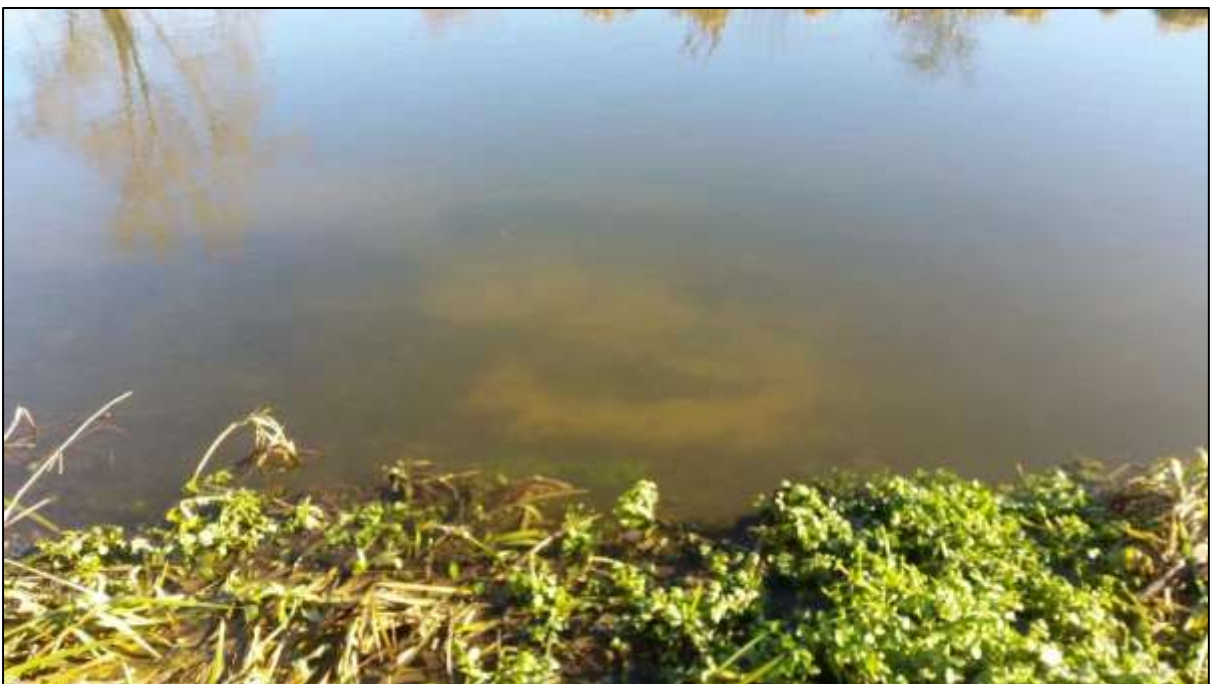
Figure 12: A section of shallower water is probably the site of bed raising works undertaken as part of the STREAM project.

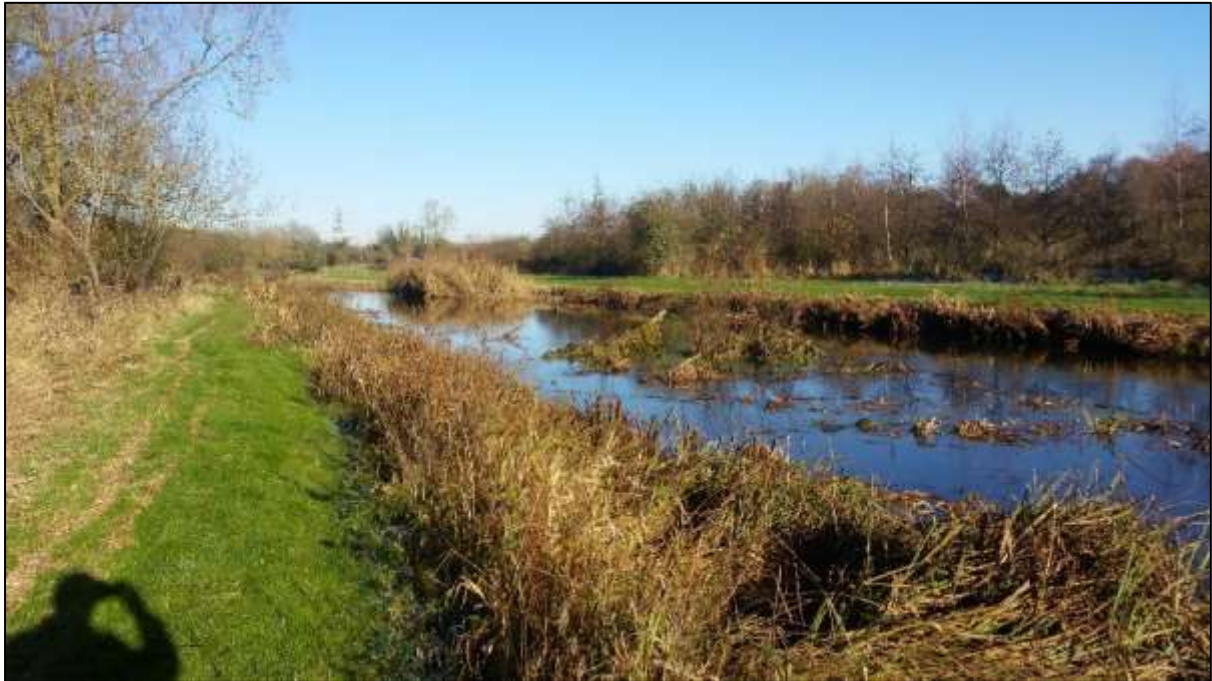
Downstream the river becomes straight, uniformly wide and very deep as it flows toward the A303 bridge. There is also a paucity of bankside tree cover. As part of the STREAM project, LWD flow deflectors were introduced alternating along the banks. This part of the project has had some limited success in providing cover and marginal habitat (where fine sediment has deposited in the lee of the structures and promoted emergent vegetation). However, the rate of deposition has not been sufficient to consolidate into a firm bank and as such the river margins are inaccessible to anglers and flows remain sluggish and laminar (Figure 13). Recent

electrofishing surveys (Pers. Comm. Russell Spencer, Avon Catchment Co-ordinator) seem to confirm angler accounts (Pers. Comm. John Stoddart and Paul Clancy) that the reach is lacking in juvenile and small wild trout and is dominated by a small number of large (probably stocked) trout which are probably making use of the deep water and cover to prey on smaller fish.

Figure 13: LWD has increased the rate of deposition but this has not been sufficient to consolidate new banks. As a result the river is difficult to access for anglers and remains straight and wide.

The river is deep and slow at this location because it is impounded by weirs at Bowles Hatches on the outskirts of Amesbury and has also probably been dredged in the past. Maps dating as far back as 1870 show the river upstream of the A303 was already straightened before the road was created. However, before the A303 was constructed the river used to meander sharply to the right at the approximate location of the bridge, then bend left and right again before Lord's Walk. In the 1970s when the A303 was built, a short section of the river was moved into the gentle right-hand bend now situated downstream of the bridge. This did not necessarily shorten the river but did remove some bends that would have probably provided some diversity of flow and depth conditions. The existence of the A303 also limits the number of options available for restoring the river. The fact that the river must flow under the road at the specific location of the bridge (Figure 14) and exerting minimal erosive force, could make the option of excavating a new, shallower and more sinuous channel unfeasible.

- 4.** Build on the work undertaken as part of the STREAM project, introducing additional woody material to speed up the rate of deposition and consolidate berms into new riverbank.

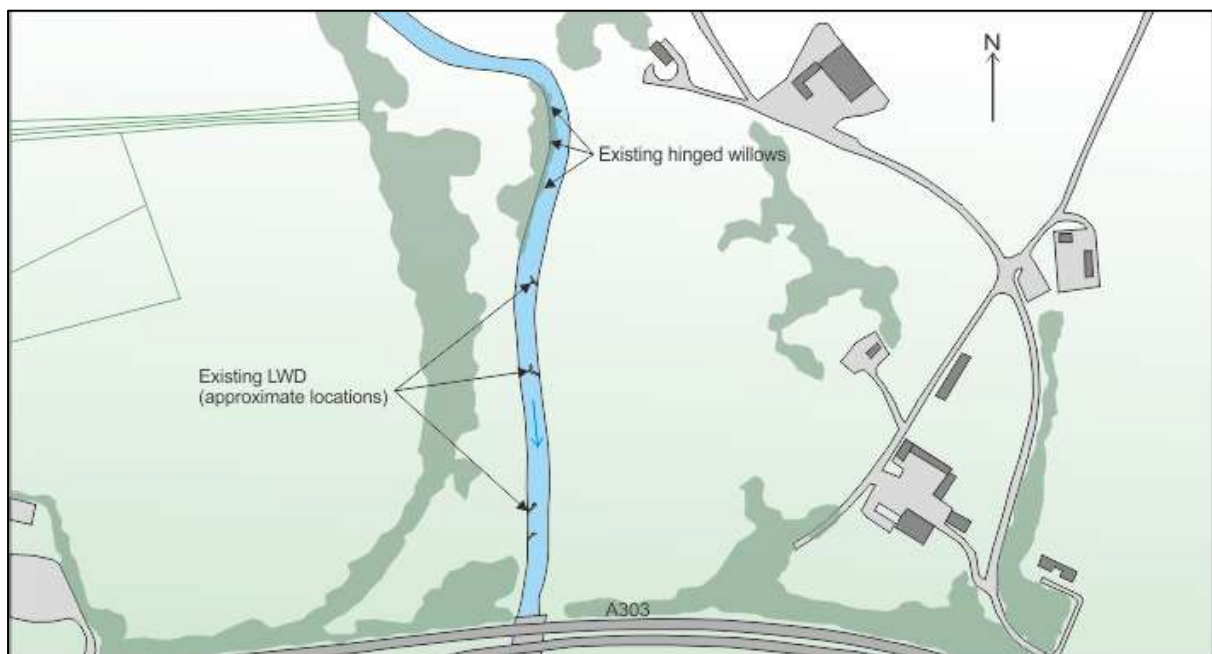
Figure 15: An illustration showing the locations of structures installed as part of the STREAM project

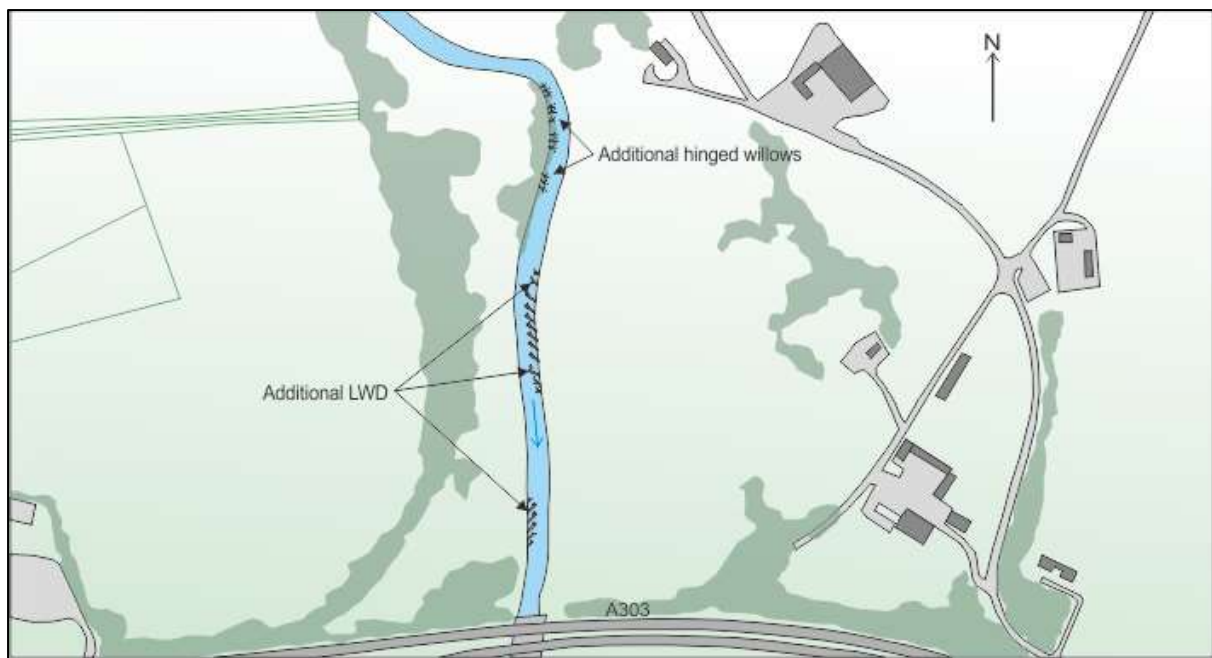
Figure 16: An illustration proposing the introduction of additional woody material building on the morphological changes started by the STREAM project

Applying the principles observed upstream at the hinged willows, to the deeper reach downstream, a project involving the introduction of additional LWD (whole tree sized pieces) installed around the existing features could increase the rate of deposition and consolidate the fine sediment. If a great enough effect can be achieved, this should create berms that over time will become solid enough to walk on, improving angler access and increasing channel sinuosity (Figures 15 and 16). Of course, this alone will not address the problems associated with the uniformly deep water, but it will provide a more natural channel form which will mean that rather than a wholesale bed raising requiring thousands of tonnes of aggregate, short sections of bed raising could be undertaken to compliment the more sinuous channel. Reducing the amount of required bed raising to two or three glides could also allow for other additional works (such as bank re-grading) to be included in a capital project (Figure 17).

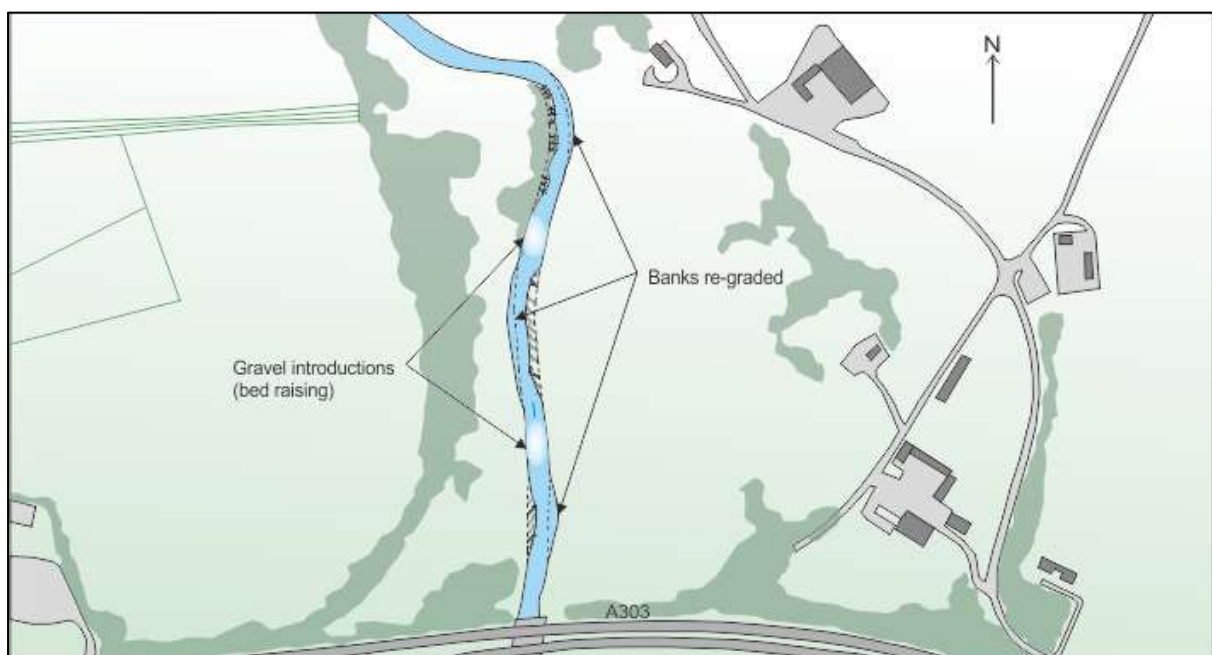
Figure 17: An illustration proposing possible 'phase 2' works (bed raising and bank re-grading) following consolidation of the berms and once funds become available
