Advisory Visit

River Aire, Bradford City Angling Association

04/02/2016

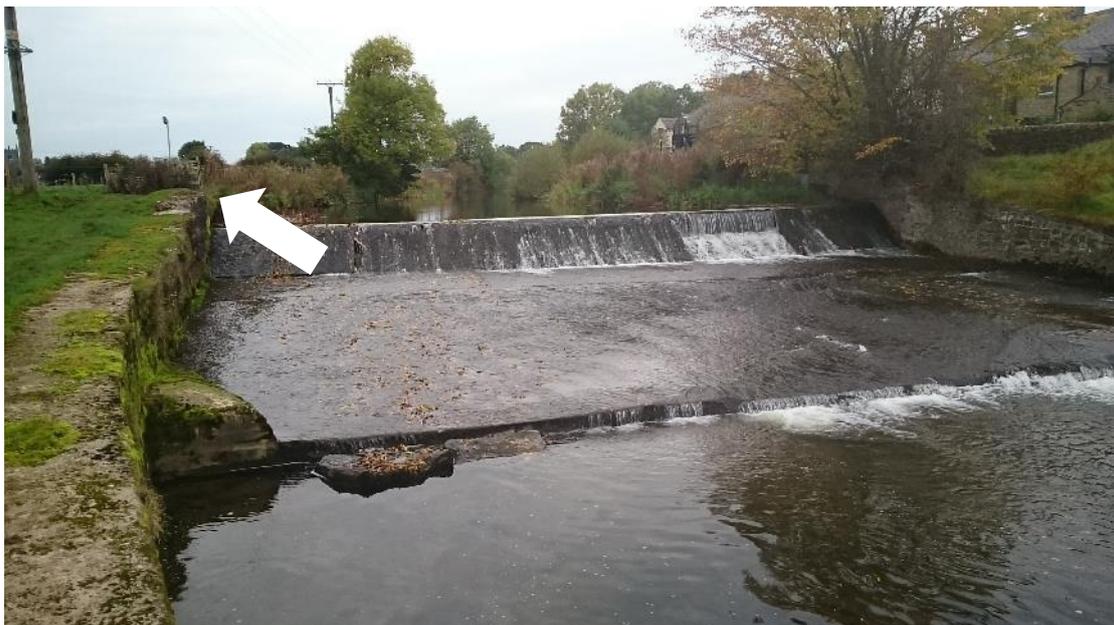
The starting point for the walkover was BCAA's upper fishing limit at the weir in Gargrave at SD9374253945 (Fig 1). The weir was installed to impound water for a leat into the factory site on the LB; the head-loss generated by the structure is $\sim 3\text{m}$. It is a considerable obstacle to fish passage (a function of the head-loss combined with the shallow gradient concrete apron $>10\text{m}$ in length, which is also perched), alters the free flowing character of the river u/s by impoundment for $\sim 100\text{m}$ and prevents free transport of substrate, thereby impacting upon geomorphology d/s. See a WTT video outlining key impacts, here: <https://youtu.be/ILofBcLiDts>

Fig 1. The weir marking the u/s fishing limit of BCAA waters at Gargrave. Major fish passage issues arising from the head-loss ($\sim 3\text{m}$) and perched apron ($>10\text{m}$ length). Note riparian vegetation protected by fencing immediately u/s on the RB (white arrow).

Obviously the weir forming the u/s fishing limit is a considerable obstruction (Fig 1). It is unlikely that it will be removed in the short/medium term because of housing foundation issues u/s but there should be the requirement from the Environment Agency to consider an obstruction of this size for fish passage easement, i.e. a pass. There is plenty of space to do so on either bank. While this will not reinstate the geomorphological connectivity, it will hopefully improve passage for both game and coarse fish alike. Pete Turner (EA) will be able to advise on potential plans for this structure.

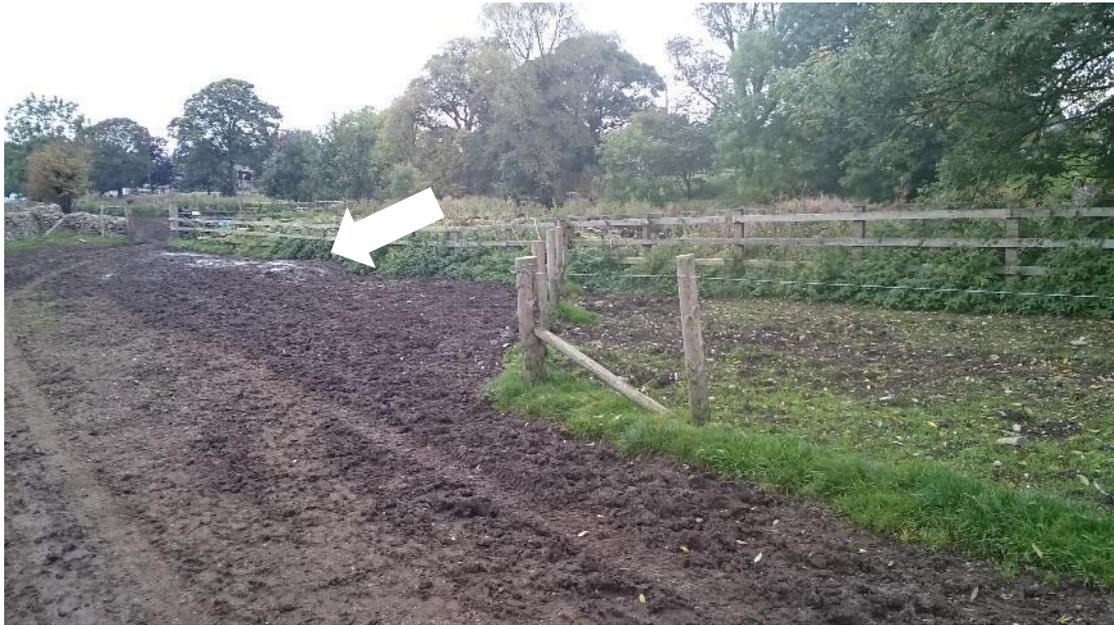
Recent remedial work using single-strand, breast-height fencing to protect the RB immediately u/s of the weir from livestock (primarily cattle) poaching has worked, and the riparian (bankside) vegetation is recovering. However, cattle still gather to be milked at a gate precariously close to the river u/s; it acts as a focal point for faecal material and it appears that a gully is regularly cut to the river from this low-lying point to clean the gateway thereby introducing fine silts and nutrients directly to the watercourse (Fig 2).

Fig 2. Focal point for cattle to gather at gateway to farm. White arrow depicts lowest point where there was evidence of a drain cut to the river. Note single-strand breast-height fencing allowing recovery of vegetation to right of shot

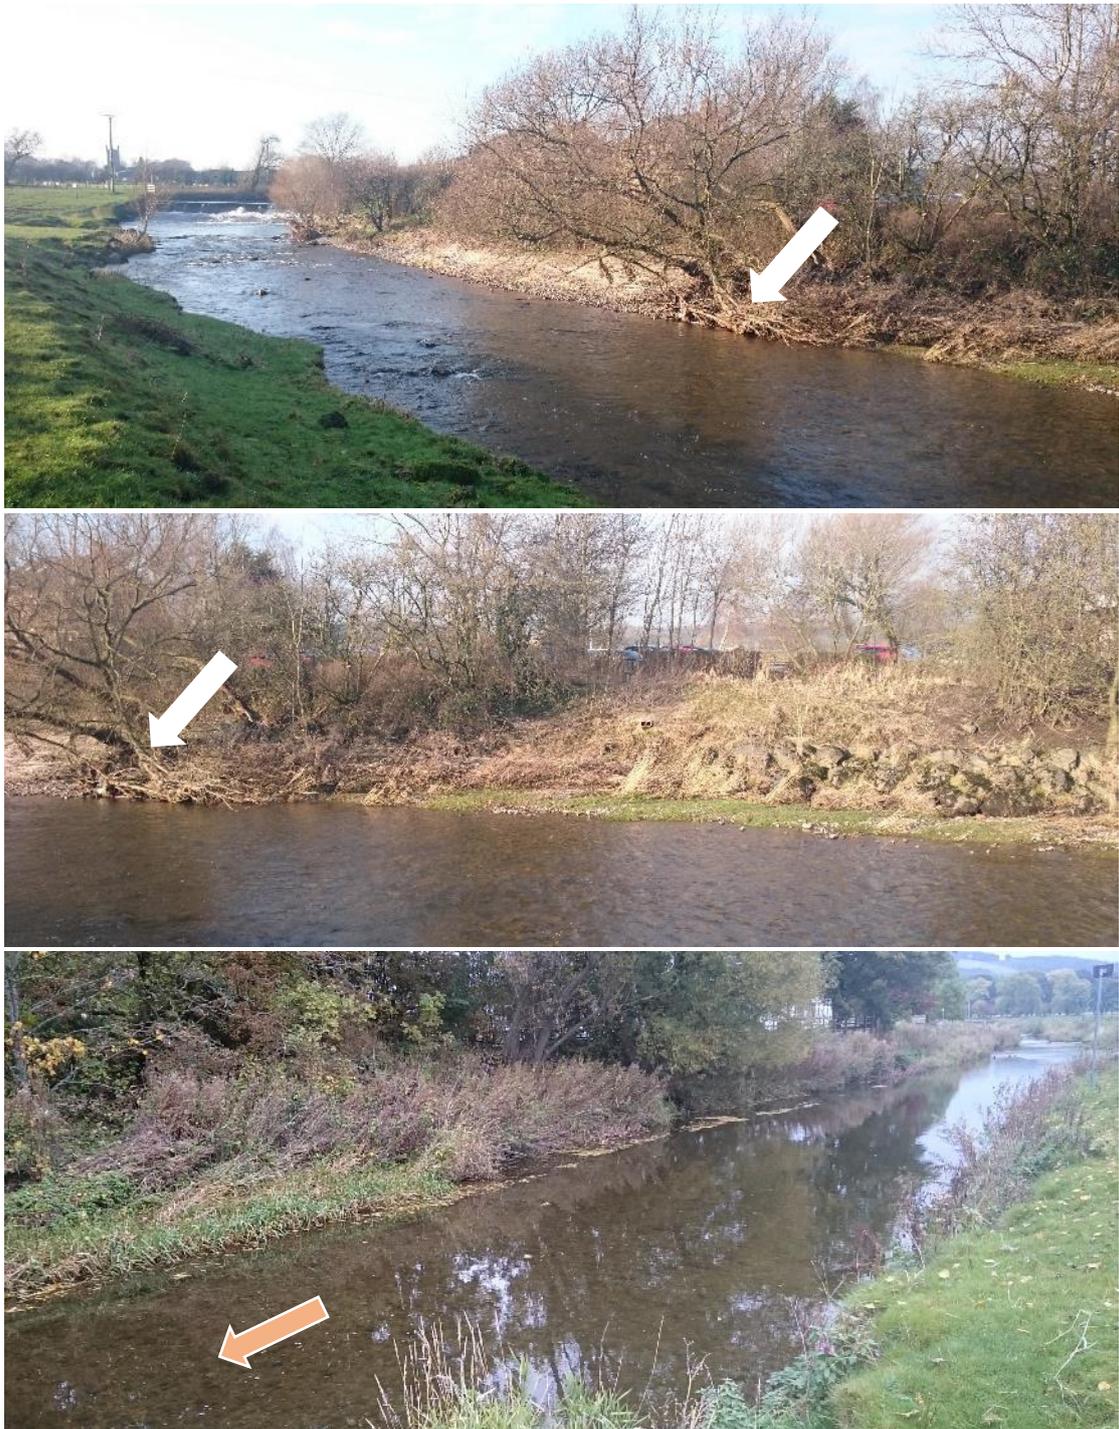
It is clear that immediately d/s of the weir, the channel has been dredged and straightened. It is heavily incised and the spoil from historic dredging can be seen piled along the bank top. During low flows, the channel is over-wide and uniform in depth, there is no focussing of flow energy and hence, fine sediments uniformly coat the bed (Fig 3); the weir u/s intercepts coarse sediments that may otherwise have been supplied to replace the removed material and re-establish the inherent dimensions and form of the pre-dredged channel. The LB has been heavily modified with large boulders to protect the leat. However, little management on that bank has meant that several willow species (*Salix capraea* and *S. fragilis* – goat and crack willow, respectively) have established and where they are close to the water line, provide some low cover for fish refuge, some trailing and broken branches to create small but vital flow diversions, and introduce leaf litter and woody debris for aquatic invertebrates (as well as foraging and nesting / roosting sites for terrestrial organisms). In contrast, the RB is open to cattle grazing and is virtually devoid of anything other than short-sward grasses (see Fig 3).

Fig 3. Upper panel: beginning of straightened section. Note difference in plant cover on ungrazed (LB) *versus* grazed (RB) banks. One 'cracked', still living branch from the willow (shown in both Upper & Mid panels by white arrow) is playing a vital role in causing scour (underneath the branch) and deposition (immediately d/s) thereby creating diversity in channel-form and hence habitat for fish. Mid panel: Vegetation on the deposited gravels (protected in the lee of that branch) was still evident despite the unprecedented floods. Lower panel: impounded, straightened section alongside factory leat; brown arrow points to silty deposition across the bed.

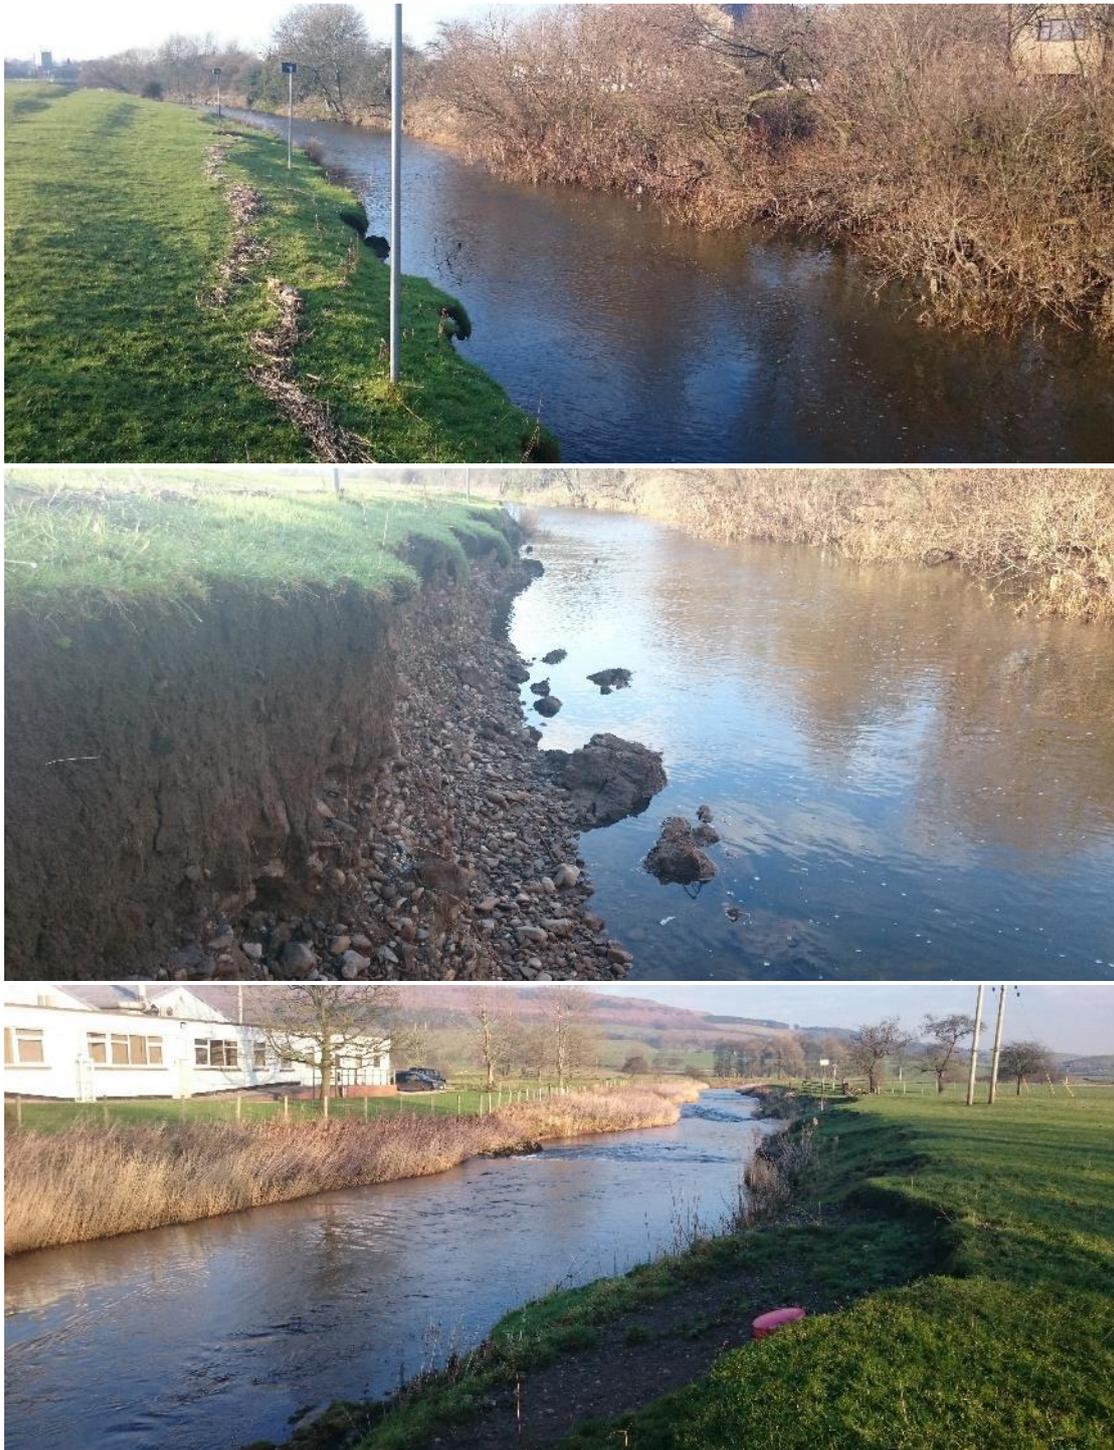
As a consequence, the RB has suffered considerable erosion by block-failure (in which the bank toe erodes, temporarily leaving a hanging cliff-face which then collapses and washes away) over the winter 2015-16 period (Fig 4). While erosion is a natural and vital source of spawning gravels for example, in this particular location it is causing over-widening of the channel at an unnatural rate, exacerbated by the livestock pressures.

Fig 4. Upper panel: looking u/s, note the strandline of debris following the highest ever levels recorded on the Aire, and the shadows cause by historical dredging spoil deposition on the heavily grazed RB. Mid panel: fresh erosion of the RB by block-failure; note the undercutting of the turf and the negligible root structure. Lower panel: looking d/s at scalloping erosion caused by livestock from above and the river subsequently acting upon weakened soils; again, note difference in vegetation cover on opposing banks.

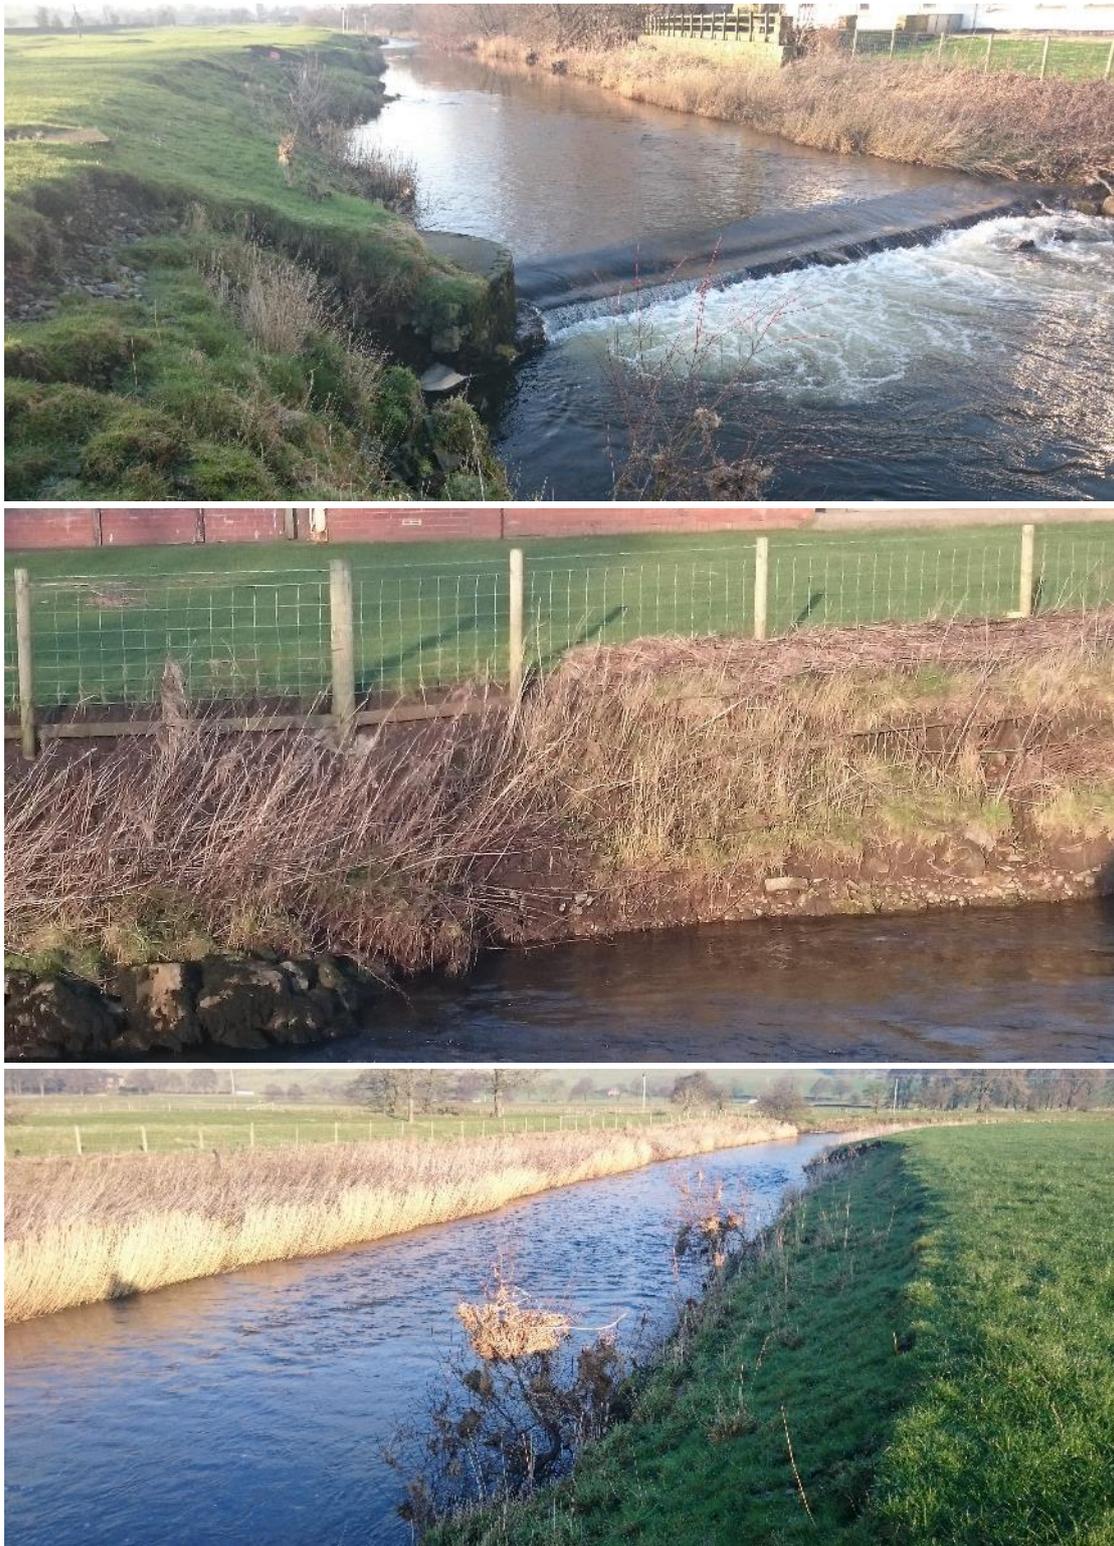
There is another fish passage issue at SD9412953955 where a pipe (presumably from the factory to the Sewage Treatment Works; STW) crosses the river with a 'weiring' effect (Fig 5). The impoundment effect u/s is clear for ~100m and while the weir pool does introduce some much needed variety in channel form, the lack of riparian vegetation means that: a) the pool is exposed; and b) the banks d/s are vulnerable to eddy erosion stemming from the hard weir structures (Fig 5: mid panel).

Fig 5. Upper panel: pipe and concrete / stone structures causing impounding u/s. Mid panel: the fence-line becoming vulnerable to erosion, even on the ungrazed LB because of the eddy erosion from the weir structures and insufficient vegetative buffer zone; behind the fence, the lawn is mown. Lower panel: looking d/s at the straightened channel which is essentially one long glide with little riparian cover; two goat willows have managed to establish out of reach of livestock grazing.

The stone weirs installed by the Club ~100 years ago should definitely not be repaired. Indeed, existing weaknesses should be exploited to 'notch' them further, so their impounding effect u/s is reduced, but the focussing effect on flow and hence scouring to create deeper pools and runs is maintained under low flows. Material won back from here could usefully be applied to the solution for the small weir (Fig 5; above).

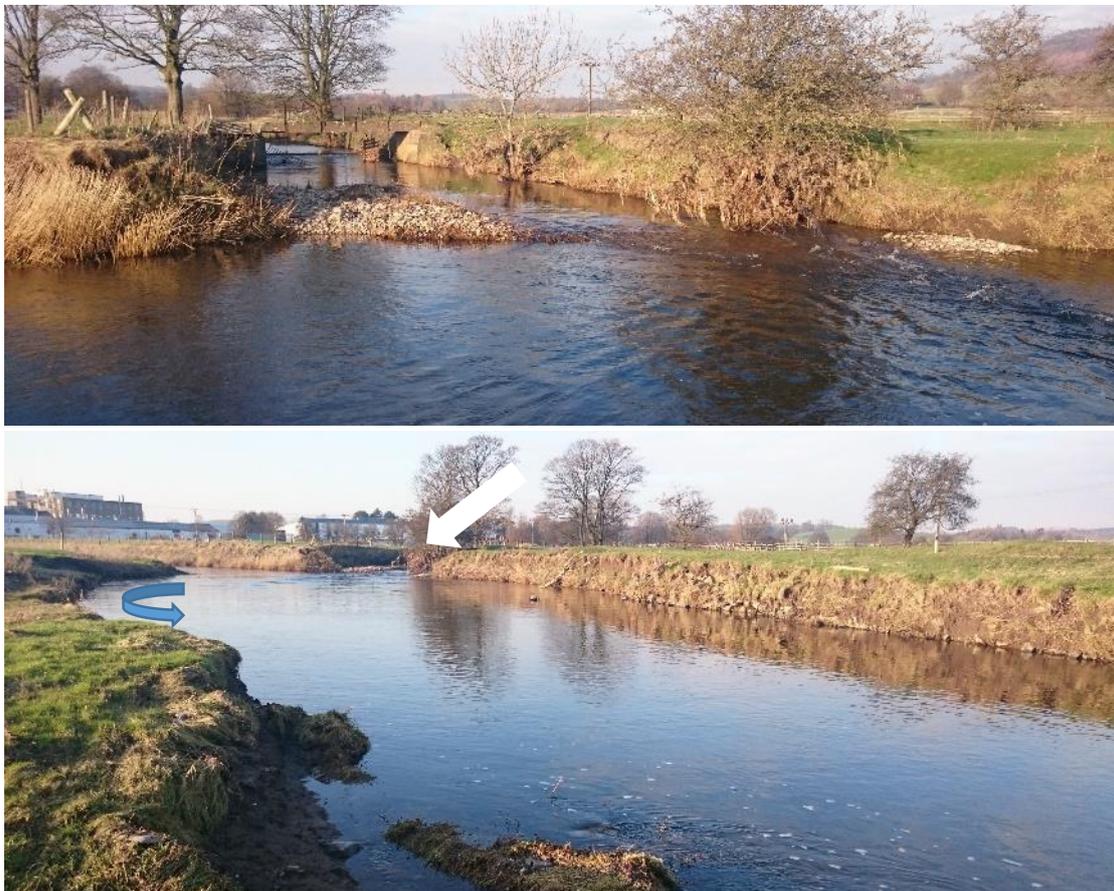
Fig 6. Upper panel: The confluence of Eshton Beck where it joins the LB of the R Aire; note the deposition of gravels and diversity of flow paths. Lower panel: looking u/s to the confluence with Eshton Beck (white arrow). Note the widening caused by the flow from Eshton (blue arrow), and also the vulnerability of both banks to erosion (especially the vertical face of the LB).

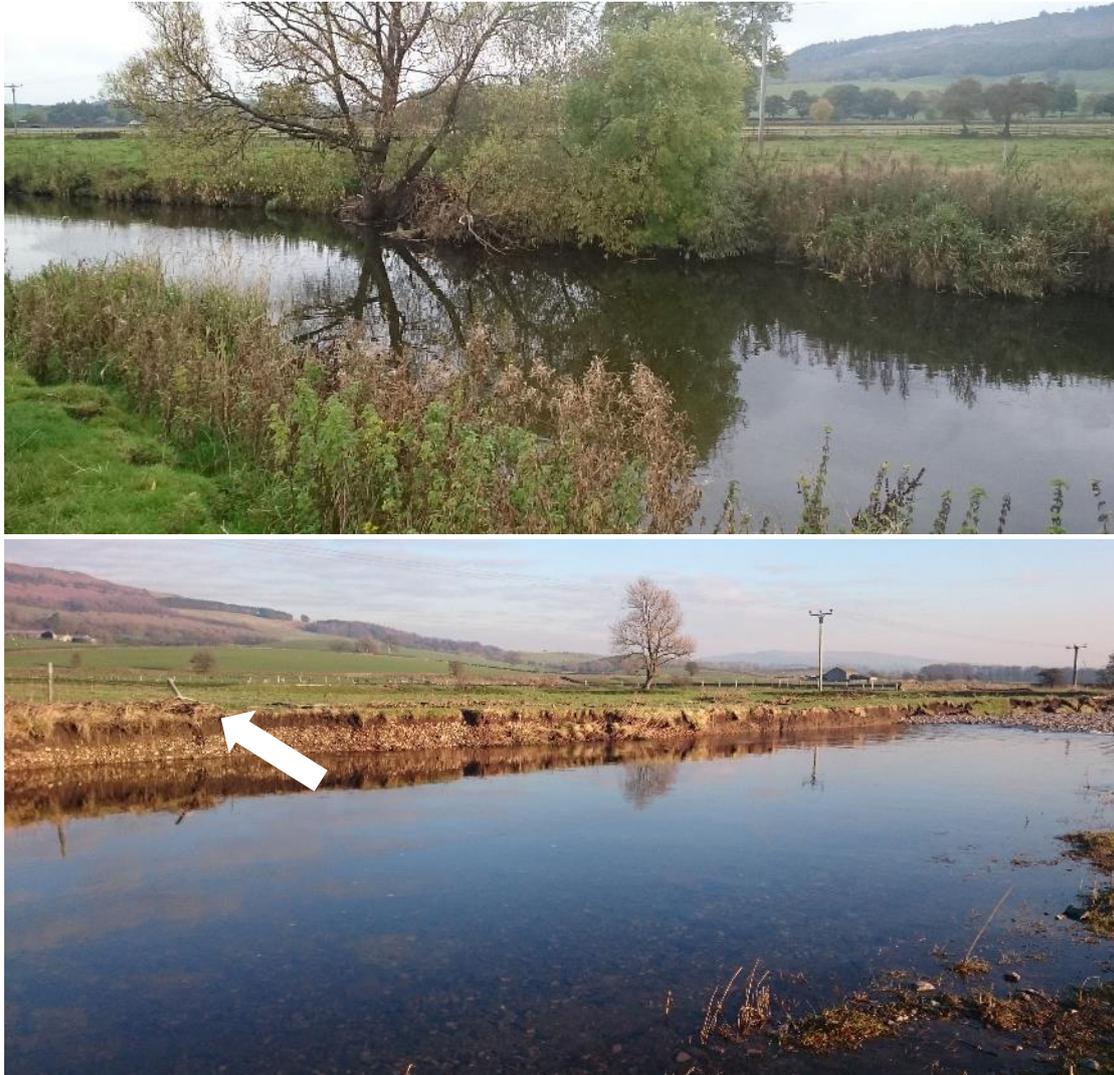
The channel is very wide and uniform below the pool with few obvious features to hold fish and little in the way of riparian vegetation as both banks are now open to grazing (Fig 7). The LB has short sections

of livestock fencing in place but this needs to be maintained and extended to realise the benefits (see *Recommendations*). Already, in the lower panel of Fig 7, some of that fencing is teetering on the brink as the bank threatens to collapse beneath it. This is most likely because livestock have had access behind the fence (it is poorly maintained) preventing the natural regeneration of shrubby vegetation, and/or the riparian strip was too narrow in the first place.

Fig 7. Upper panel: almost canal-like flow below the confluence with Eshton Beck. The crack (larger) and goat (smaller & greener) willows are the only trees of note along this straightened section (photo taken in October). Lower panel: just d/s from the willows in the upper panel, the overly wide, uniform flow continues (photo in January); note the imminent loss of a section of ill-maintained fencing on the LB (white arrow).

3	Fig 7 – 10	RB: possibly from lone crack willow (Fig 7) to STW inspection and down to bend at Fig 10. This is mostly former gravel bars and hence poor grazing. Increase stability of these bars, increase resilience to erosion around STW infrastructure and prevent further bank collapse eg in Fig 9. Although low-lying, mostly on inside of bend and hence should be low flood risk. Yorkshire Water should be approached to see if they will contribute to this as it may mitigate some of the damage to their infrastructure. ~500m.
4	Fig 12	LB: Repair of existing fence.
5	Fig 13	LB: Install short section to prevent loss of trees. Sited on top of high bank, parallel to flow and hence low flood risk. ~100m
6	Fig 17 & 18	LB: prevent cattle access. Two short sections to tie in to rock armouring and high bank. 2x ~30m

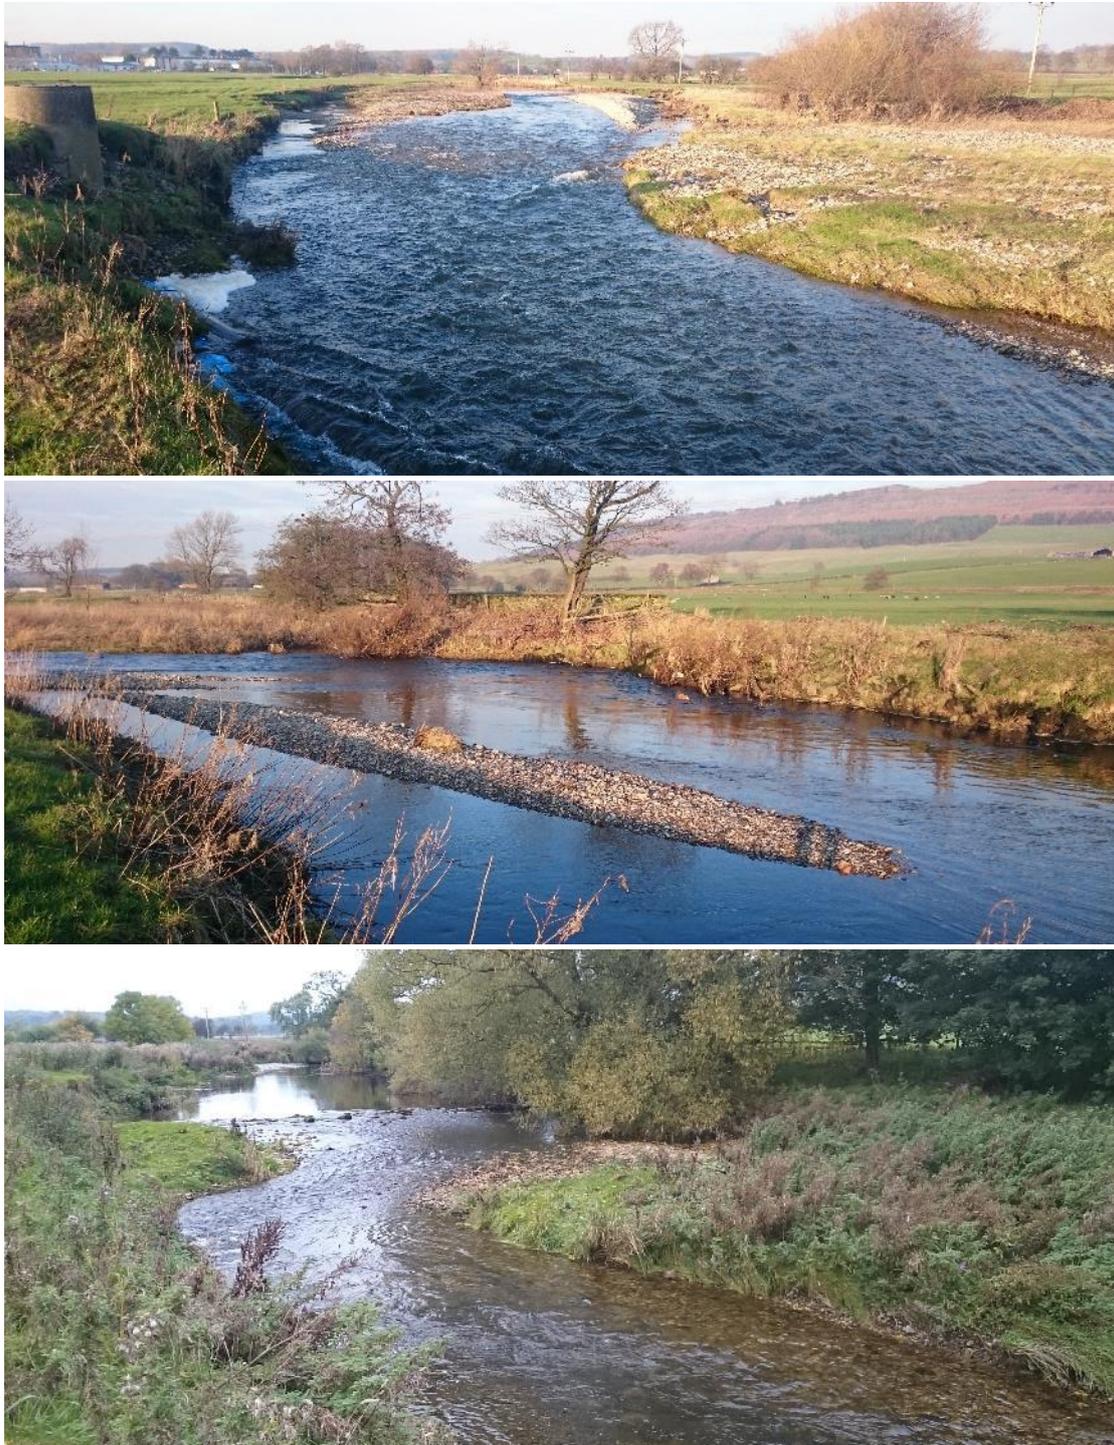
been considerable deposition of gravels, both historically and from recent spates, diverting and constricting the flow into a narrower channel more appropriate for the median discharge for the river, and the resultant meandering has also led to a much more natural geomorphological regime of riffles, pools and glides (Fig 8).

Fig 8. Upper panel: Copious gravel deposition and increased sinuosity of the channel only constrained by the STW infrastructure and pipes on the RB. Mid panel: just d/s of the STW pipes a turn to the right has resulted in more gravel deposition and channel form diversity. Lower panel: reinstatement of more natural pool, riffle and glide sequences, and valuable lateral scour causing varied depth and velocity profile in cross-section; note the channel width compared to Fig 7.

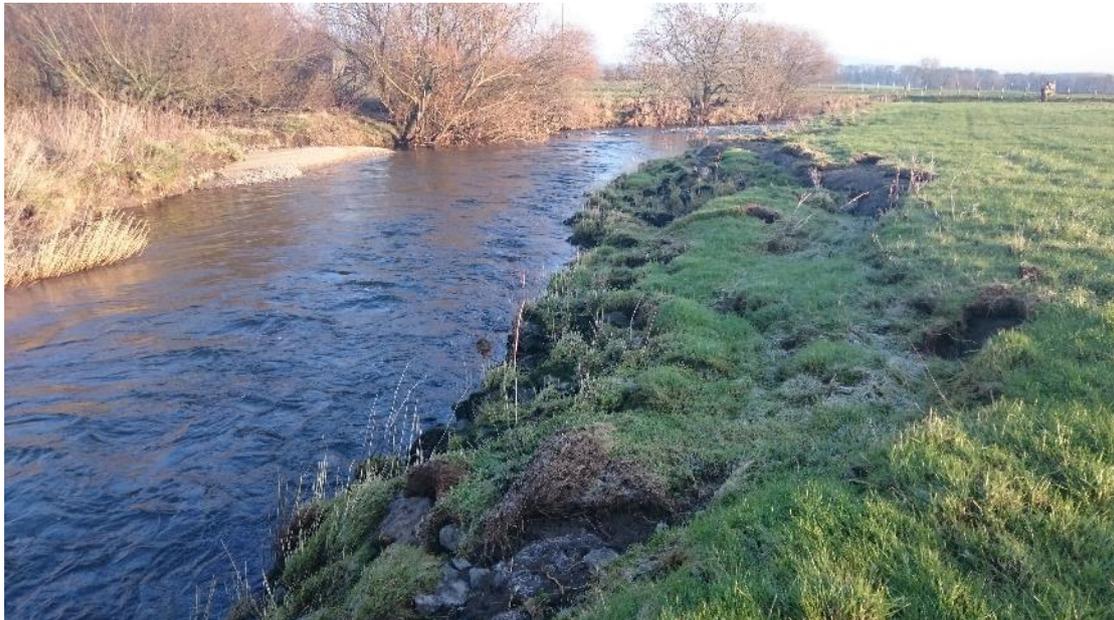
The RB is still very susceptible to erosion as trampling, poaching and grazing continue unabated (Fig 9). Indeed, the winter floods have lifted large swathes of shallow-rooted grass turves and overturned them in various locations. The slumps caused by livestock in Fig 9 have actually re-profiled the bank to a more natural form; provided they receive some protection now by excluding stock and introducing some willow whips to stabilise and reinforce the structure, it will create good quality habitat in the future.

Fig 9. While the LB comprises shaggy low scrub and plenty of willows and ash providing much needed protection from erosion and low cover for fish, the RB is still notably exposed to weakening by livestock pressures and subsequent erosion during spates. However, the re-profiling of the bank to a more natural form can be capitalised upon if protected moving forward.

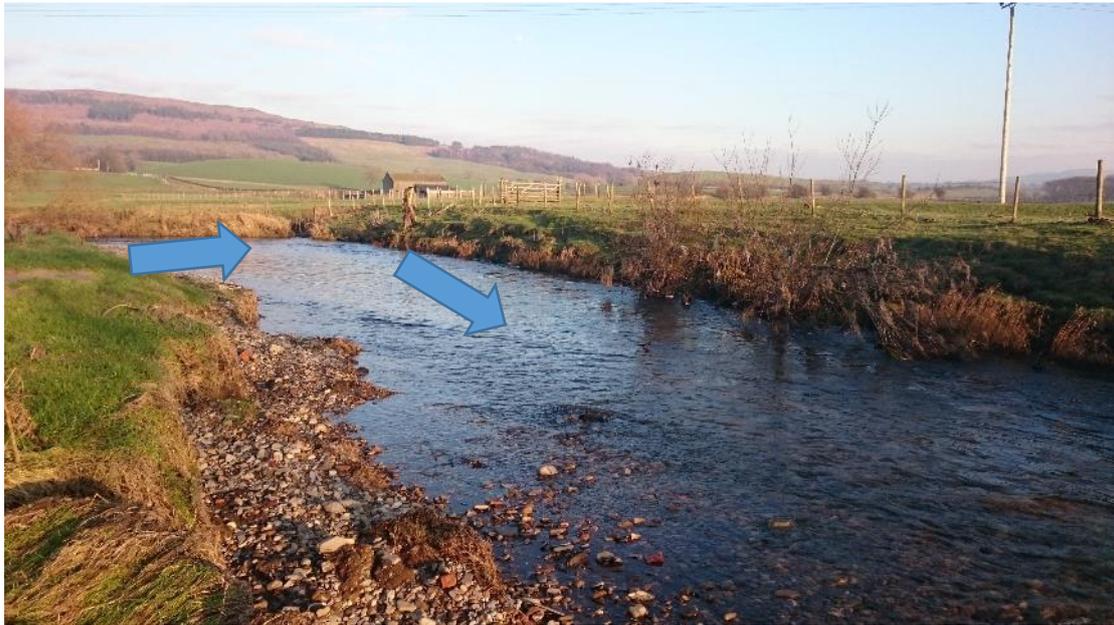
Fig 10. A notable diversion of the flow by rock armouring of the LB to force the river to the right. The LB is protected by livestock exclusion fencing here although it requires maintenance. Aside from the scrubby goat willow, this potential holding pool is very exposed.

Immediately d/s of the tributary confluence, the Aire is forced to the right by rock armouring to the LB (Fig 10). This creates deeper water at the erosional face (outside of bend) and consequent deposition on the inside of the bend, but the exposed nature of the pool means that it is probably holding fewer fish than it could. Introduction of some low cover along the rock armouring to the existent goat willows (see Fig 10) will be beneficial.

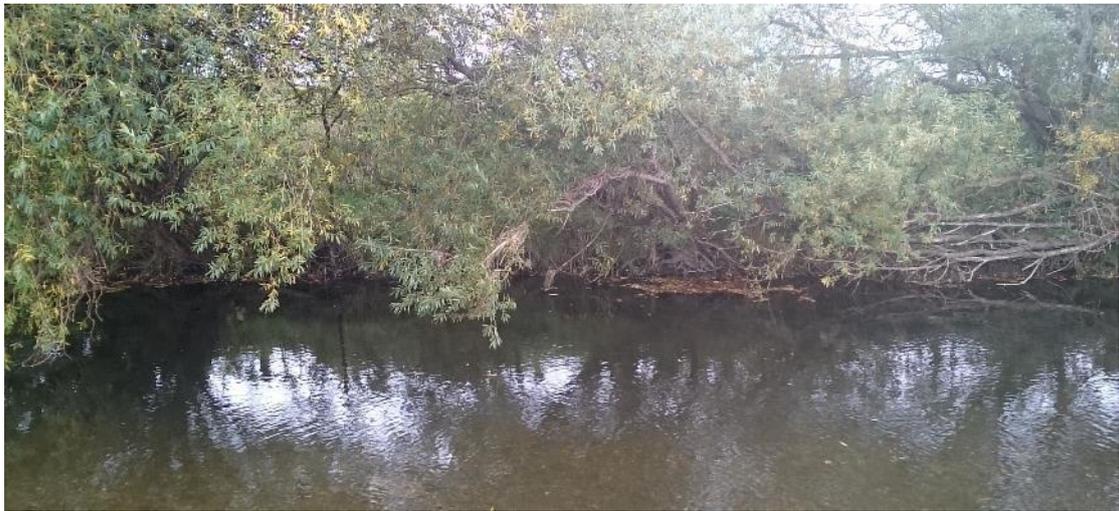
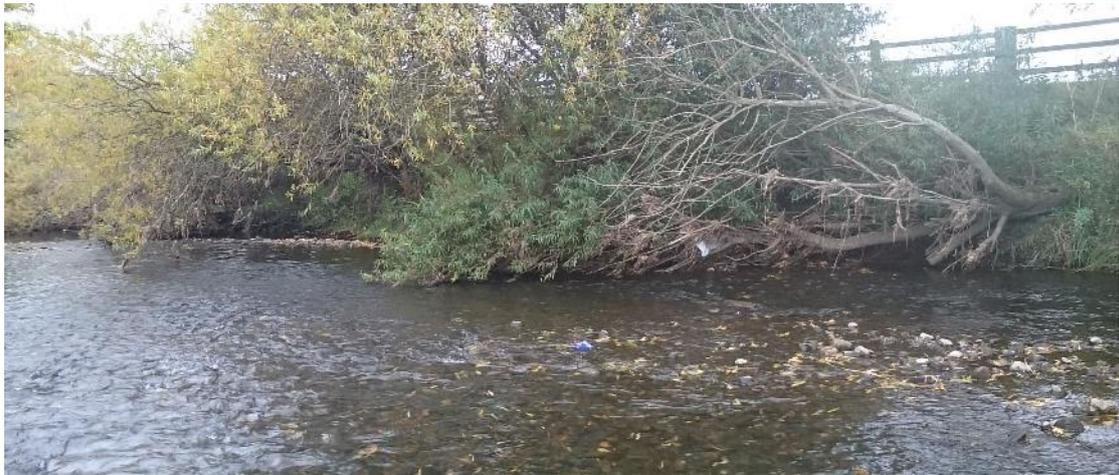
Fig 11. Scrubby goat willow cover not only protects the bank from erosion but provides low cover and causes localised scour and deposition thereby diversifying channel form where trailing branches divert water.

The dense line of goat willows on the RB, d/s of the crossing point, could be managed to create even more diverse habitat benefits for both aquatic and terrestrial fauna (see *Recommendations*).

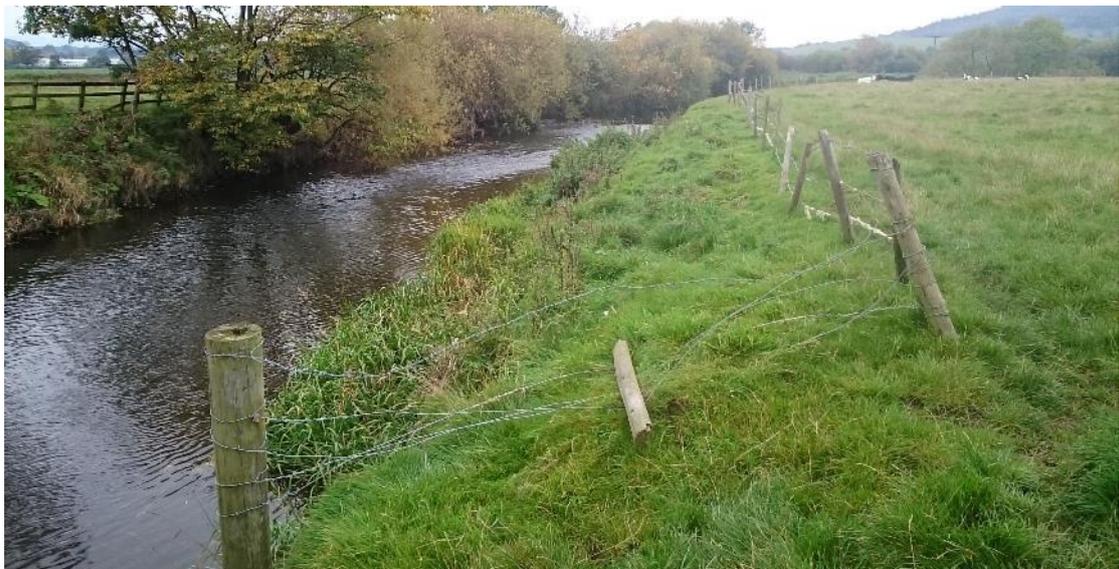
Fig 12. A short section of fencing could be protecting the LB below the 'crossing point' but in its current condition is being compromised; sheep are entering the area to browse preventing regeneration of woody plants.

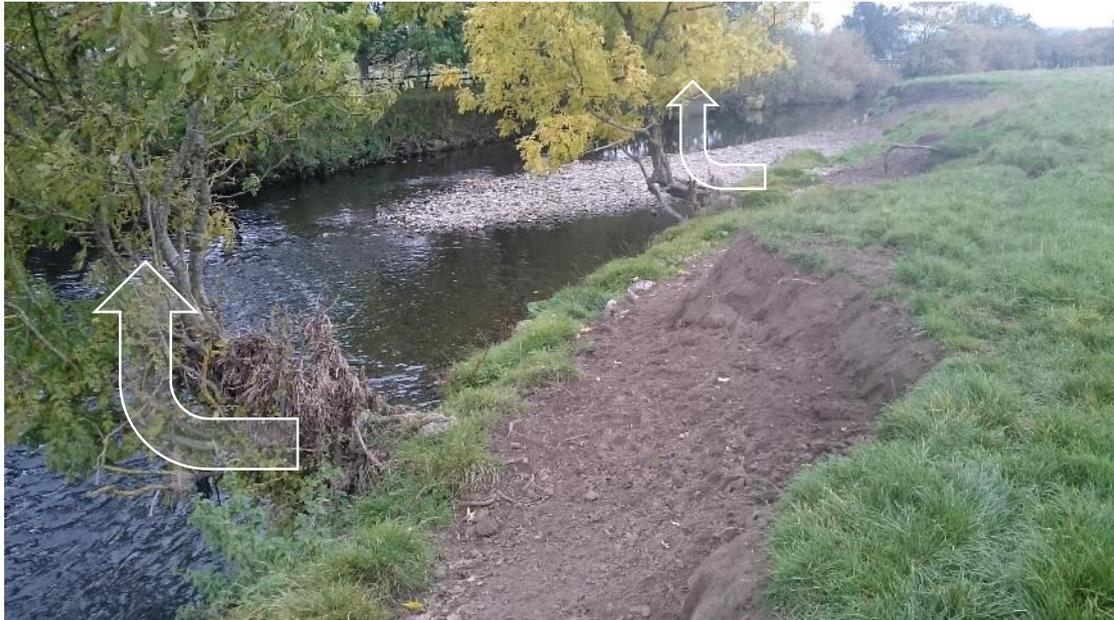
Fig 13. Frequent and severe erosion scallops in the LB, often occurring where livestock are trying to browse the few remaining riparian trees, or shelter next to them. Note the outward 'lean' of both the trees caused by consistent browsing from the bank.

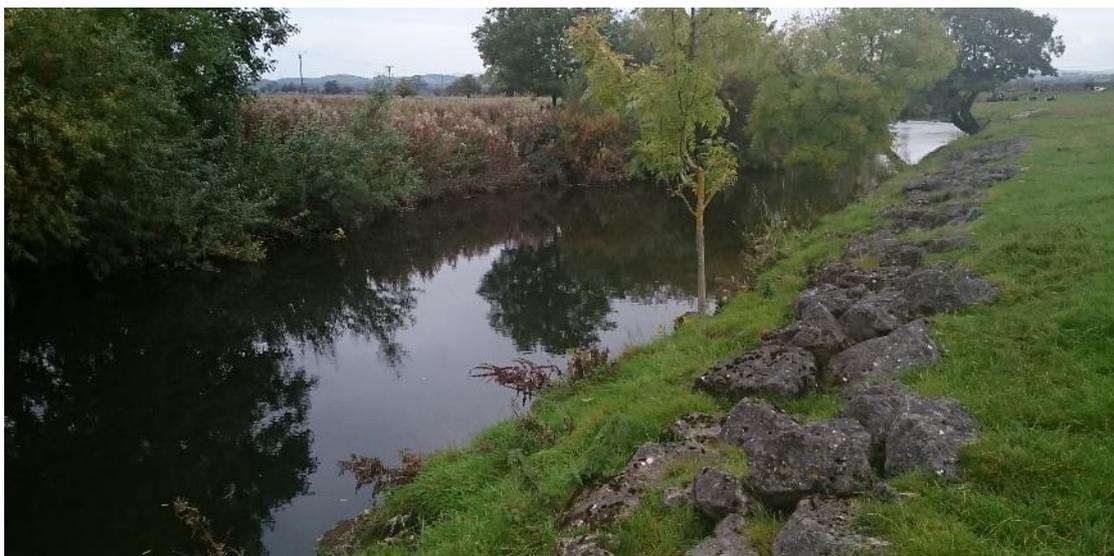
Fig 14. Rock armoring is apparent in many locations, including some straightened sections like this, presumably to prevent the river cutting toward the enormous flood relief bund that has been built on the LB.

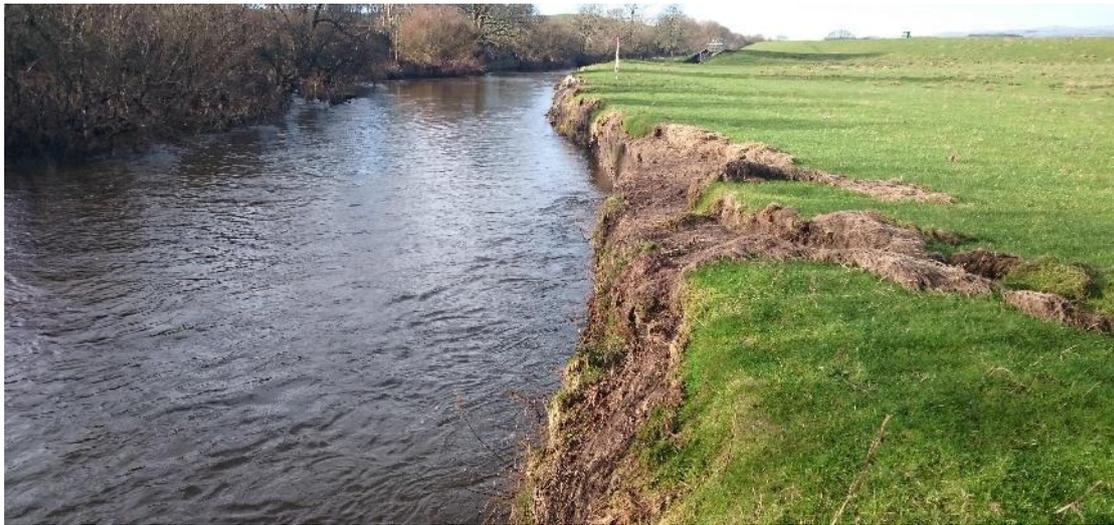
Fig 15. Vertical incised banks which are prone to erosive block-failure because there is insufficient root structure within. The grass sward is cropped to almost bowling green length by sheep. Note the flayed turves cut and overturned by recent spates exemplifying the lack of root structure.

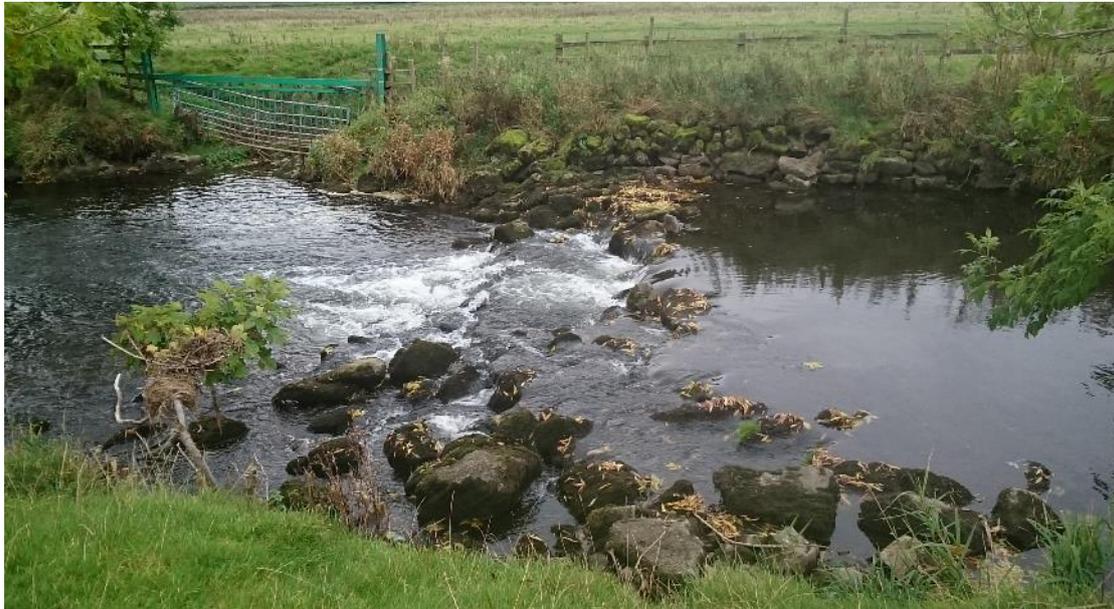
From SD9469153213 down to the Railway Bridge at SD9588852085, there are numerous dilapidated stone weirs (e.g. Fig 16), the majority of which were v-shaped with the point u/s to focus over-topping flow toward the centre of the channel. They were apparently introduced historically (~100 y ago) by the Club to create pools for fishing. They are currently in such a state of disrepair that they constitute little barrier to fish passage although there is little doubt that they still

Fig 16. The uppermost weir introduced by the Club. All are in a poor state of repair and even under relatively low flow conditions (here in October) this should be easily passable by fish of most sizes and in both directions (but with delay & possible predation issues), due to the plethora of water channels and flow between the rocks. Note the confluence of a small tributary on the RB beneath the debris gate.

Immediately d/s of the first of these weirs (Fig 16), a small tributary joins from the RB. Again, it is probably of limited use as a spawning tributary, but its water quality and habitat should be maintained as a refuge for fry and invertebrate life. It also offers a potential means of escaping any pollution incidents on the main-stem for a small, but vital, proportion of wild fish breeding populations.

have some impounding effect. Exploiting some of the weaknesses to notch them further effectively creates a pinch point which will retain scour through the pool whilst facilitating natural morphology and easing fish passage further. Those stones removed could be used to create further in-stream structure toward the tail of the pool, or used elsewhere in the river.

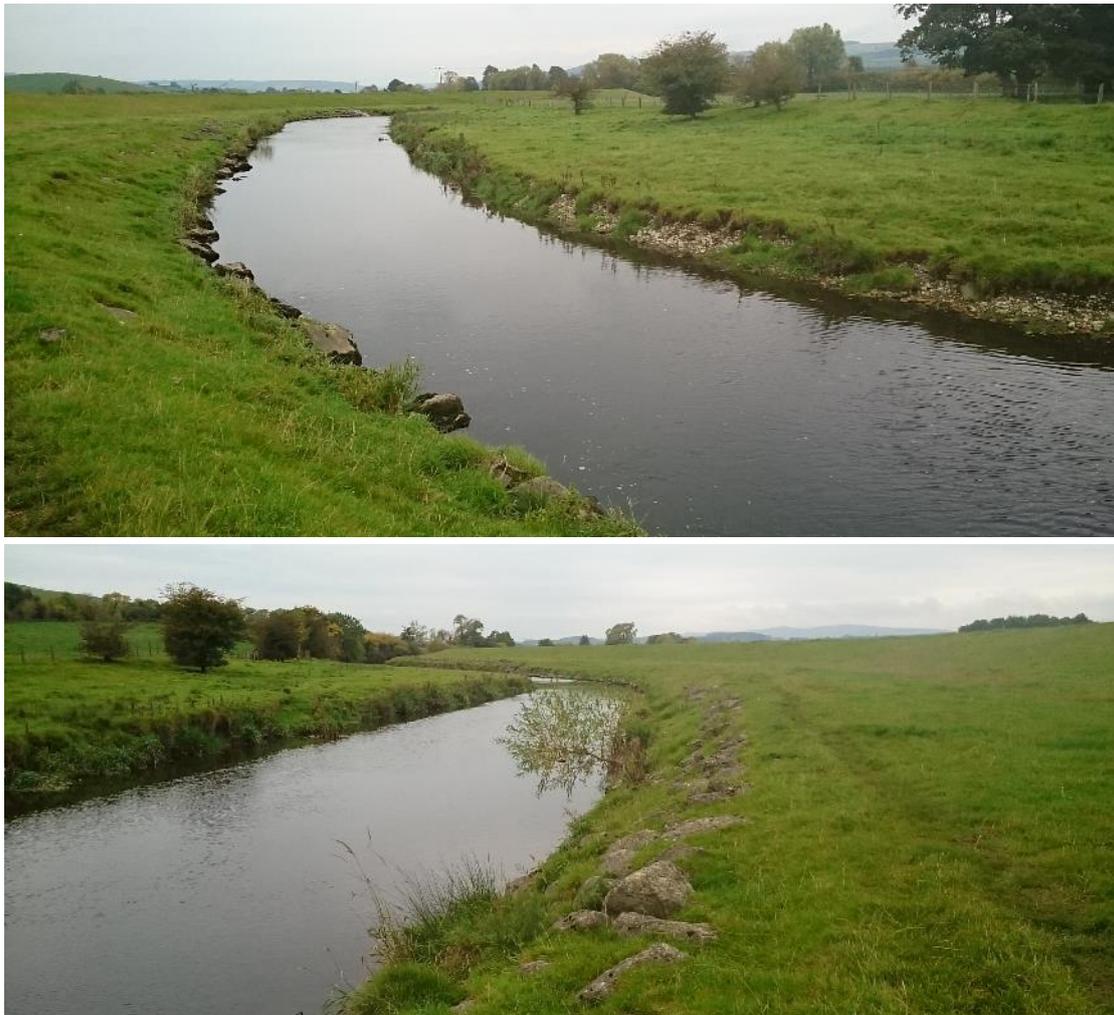
Channel modifications have led to rather long sections of glide between the sparse riffles and pools. Some of these are quite deep with overhanging willows and trailing branches trapping rafts of flotsam. While not classic lies for trout (and a relatively difficult to cast to), such areas provide good spate refuge, especially for grayling, and only require some light maintenance work on the willows to encourage continued low cover. Other glides are completely devoid of any natural cover on the banks, although limited weed growth and boulders instream provide sporadic cover and certainly diversify the channel form (see Fig 17).

Fig 17. Two views of the same continuous glide habitat (upper panel – looking d/s; lower panel – looking u/s). Cattle access both banks at riffles up & downstream of this particular stretch, and hence there is no natural riparian cover. The lone, self-set willow (lower panel) has established because cattle cannot access it across the rock armouring.

The glide in Fig 17 holds a considerable number of fish, yet they are vulnerable to piscivorous birds in such a simplified habitat and it could potentially hold more with better cover (refugia) provided by more diverse vegetation on the banks; this would also benefit the fly-life which would in turn supplement fish diet. Livestock access is the major problem as they can access both banks. At either end of this long glide are riffles where cattle are actively encouraged to enter the river. Indeed, a formalised area of hard-standing was created at the d/s end but this has been destroyed in the winter spates (Fig 18). Ideally, these two access points should be removed. It would prevent cattle entering the river, where they have caused extensive erosion of the banks via trampling and poaching and subsequently overwidened the channel; these areas also are a focal point for nutrient and sediment pollution. It would also prevent them gaining access to the RB which should recover to a more diverse vegetative cover quite naturally, although tree regeneration could be augmented to realise

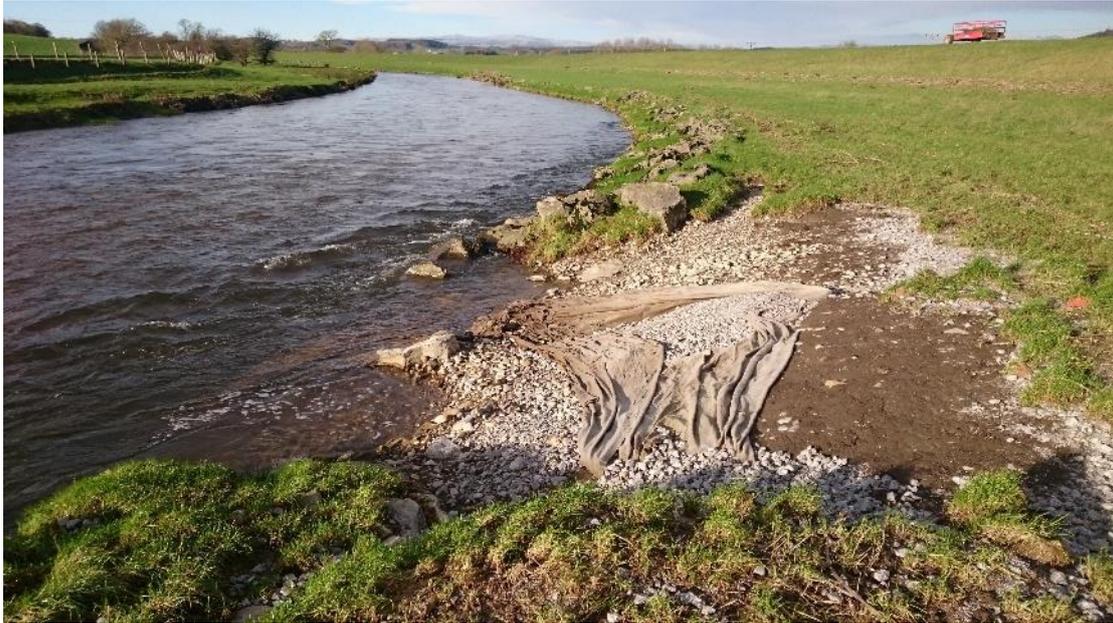
Fig 18. A formalised cattle drink at the d/s end of the glide in Fig 17 has been severely damaged in the recent winter spates. Note the ~3-4m bunding allegedly for flood water storage on the LB (trailer parked on the top).
