Advisory Visit

River Aire, Bradford City Angling Association

04/02/2016

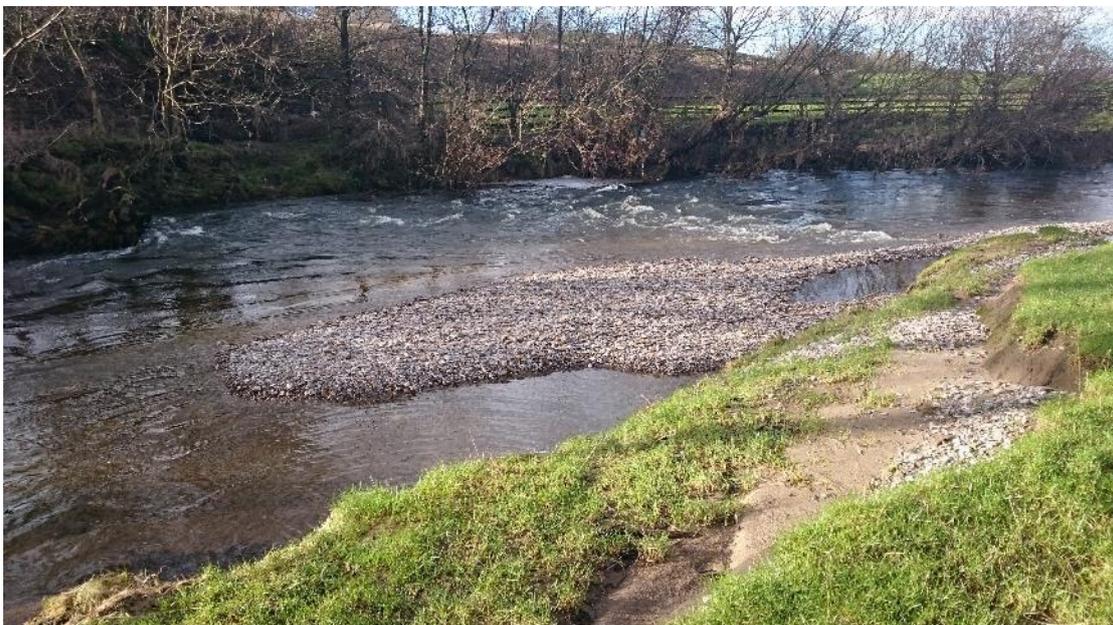
Fig 19. A left-hand bend forced by the railway line. The inside of the bend here is a natural area of deposition with an already degraded bank; it could be sacrificed as a cattle access point to substitute for that destroyed in Fig 18, and it is only 150m d/s.

An alternative access point for cattle could be encouraged at the inside of the bend at 'railway corner', as the river cannot move much here; it is constrained by the railway line on the opposing bank (Fig 19). Cattle already access the water here, it is an area of deposition, and because of deep water immediately u/s and d/s, they would be

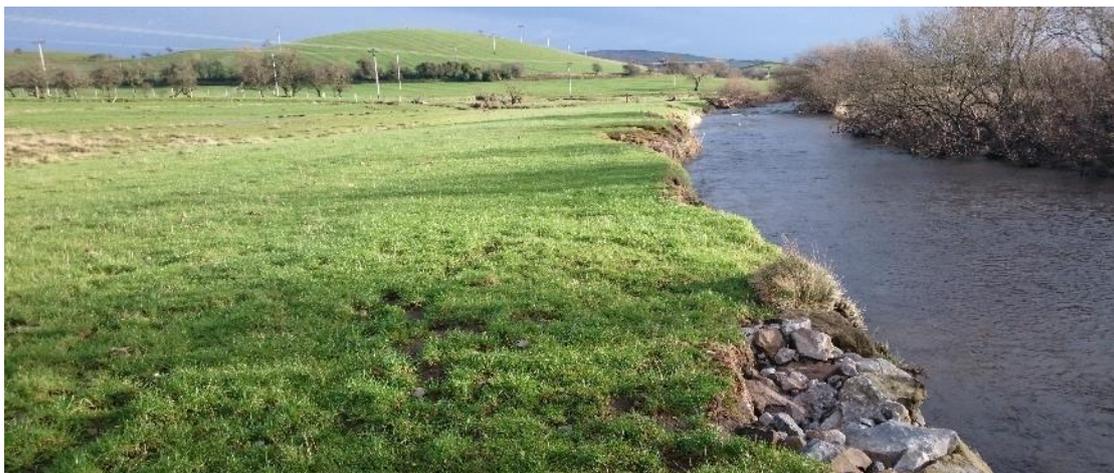
Ideally, the LB should have some similar tree cover encouraged, perhaps off-set in clumps to that on the RB which might initiate some slight sinuosity in channel path, but unfettered access by sheep and cattle prevents any natural regeneration via self-setting. The lack of diversity in vegetation and livestock trampling to the very edge of the bank contributes to the constant erosion and results in the vertical banks (Fig 20).

Fig 20. Grazing and trampling on the LB, plus some rock armouring, contributes to the maintenance of the vertical bank face as erosion cuts it back, making access to the water difficult. Note difference in cover on opposing banks.

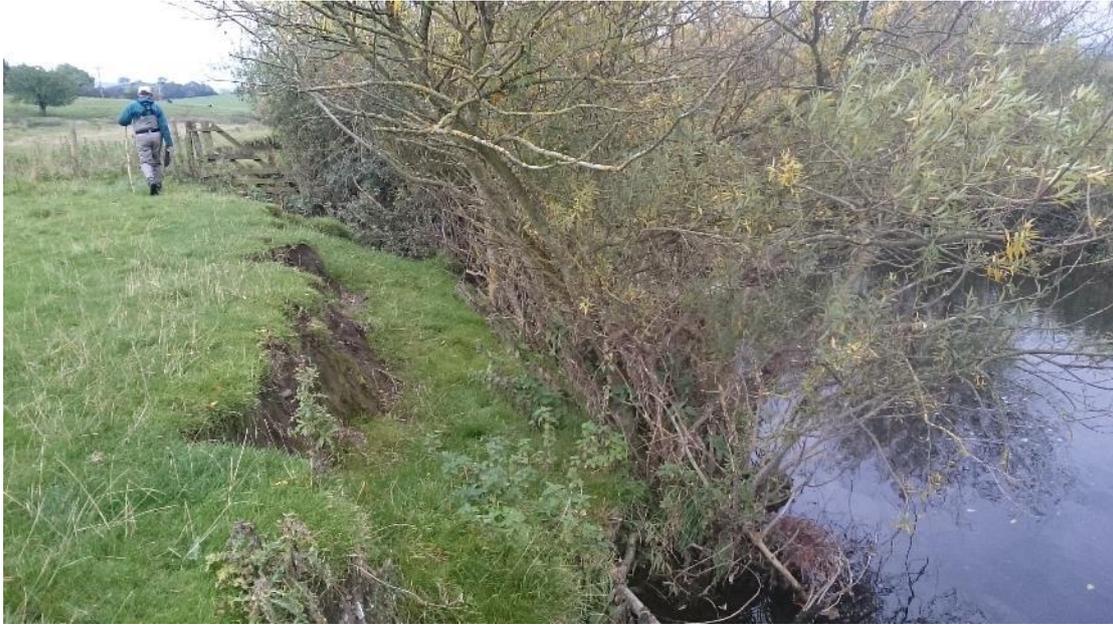
There is one short section of very valuable willow growth on the LB (Fig 21) which is at risk of loss because of livestock access. It should be protected as a matter of priority.

Fig 21. As in Fig 13, livestock access to browse on these willows is causing erosion behind them, and will eventually lead to their demise in a future spate.

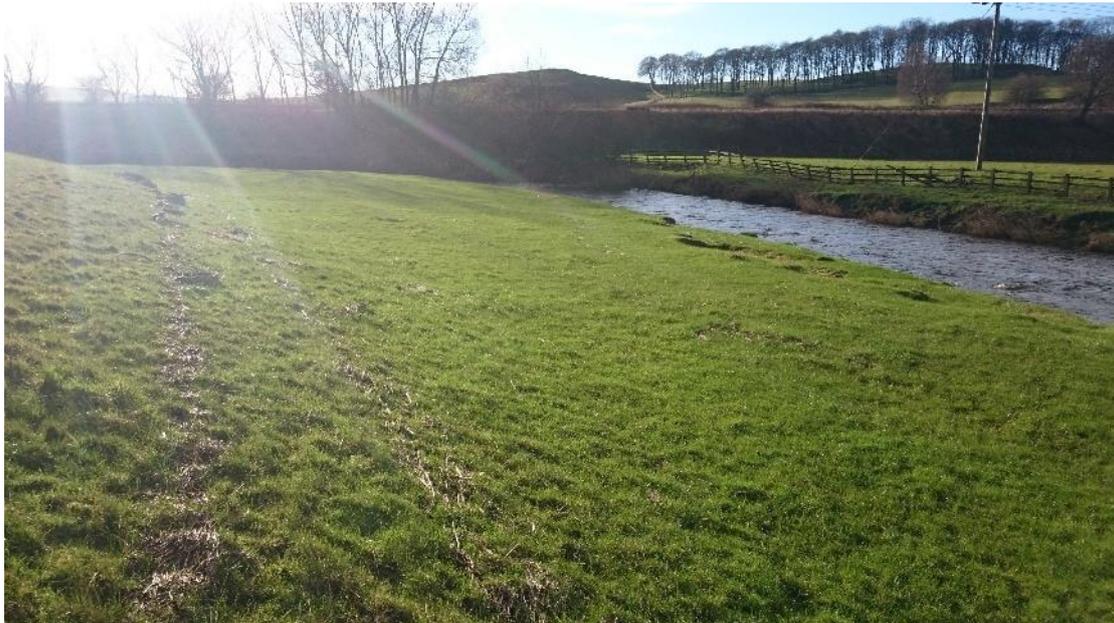
Fig 22. The spate strandline on the LB bund, some 30m from the channel and ~3m above the water level.
