Project Proposal
Backstone Beck, River Wharfe, Ilkley
September 2015

1.0 Introduction

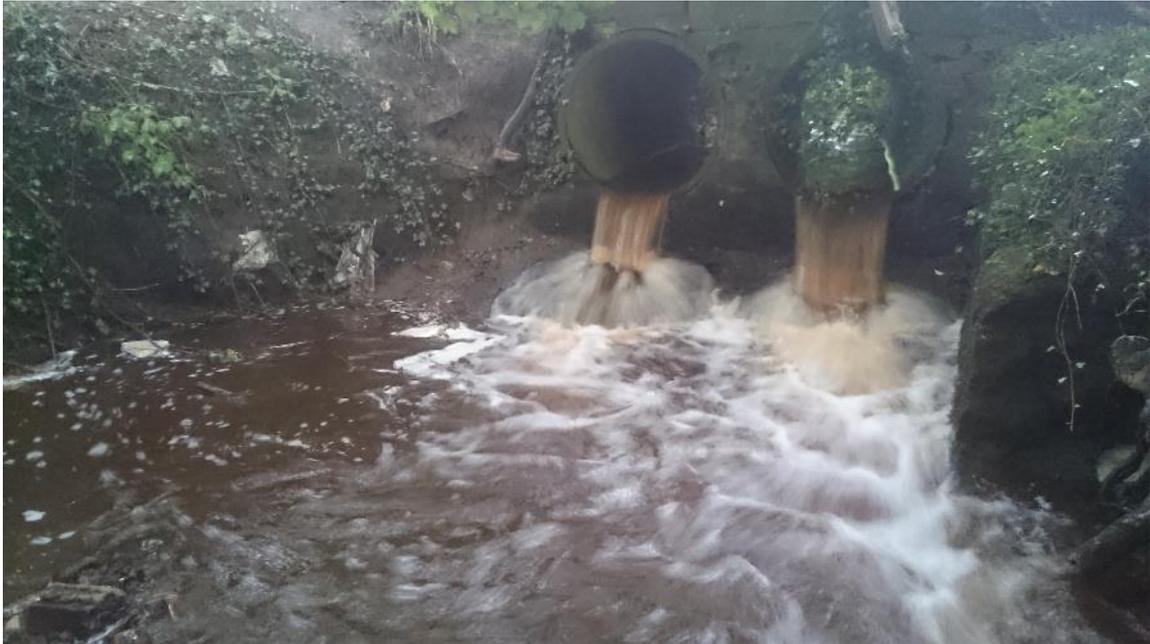
potential. A major obstacle to fish passage in and out of the Beck is found immediately at the confluence with the Wharfe (SE1279348244): a double culvert of concrete pipe which is perched above a sloping apron of concrete (Figs 1&2). The purpose of the visits was to ascertain potential for spawning within the Beck and propose remedial action for better fish passage at the culvert.

Figure 1. The perched culvert at the mouth of Backstone Beck as it enters the R Wharfe. High flows cascade onto a sloping apron.

The best solution is clearly complete removal of the culvert and replacement with a clear-span bridge or a single, over-sized, sunken culvert. This will alleviate any potential problems with raised bed level and blockage that small diameter (currently $\sim 0.9\text{m}$) pipes are susceptible to, so should actually reduce flood risk. Removal of the current structure (with an estimated headloss of $\sim 1.3\text{m}$; Fig 7) would result in some bed level adjustment over time (as substrate would move naturally under reinstated geomorphological process). To ameliorate any incision u/s, the remnants of the structure should be left *in situ* immediately d/s to partially infill the scour pool that has developed from the perched culvert and create a roughened bed to help trap the mobilised material.

Location	Recommendations
Perched culvert	<ol style="list-style-type: none">1. Contact the Council to discuss the state of the culvert and seek assistance in replacing the structure with a clear-span bridge or sunken culvert (or alternative). Lodge request with Council for consultation prior to any repairs / works on the culvert. This is likely to be from a maintenance perspective of the Dales Way.2. Monitor for deterioration of structure by fixed point photography3. Investigate potential for infilling of the scour pool to essentially raise the bed d/s and overcome the 'perch'.
Ephemeral side channel	<ol style="list-style-type: none">1. Create more structured two-stage channel to cater for Beck only flows, and Wharfe & Beck flows, by creating pinch points and low-level obstructions on alternate sides of the channel (for sinuosity).2. Lay existing willows to provide low cover as well as creating obstructions in 1, above.

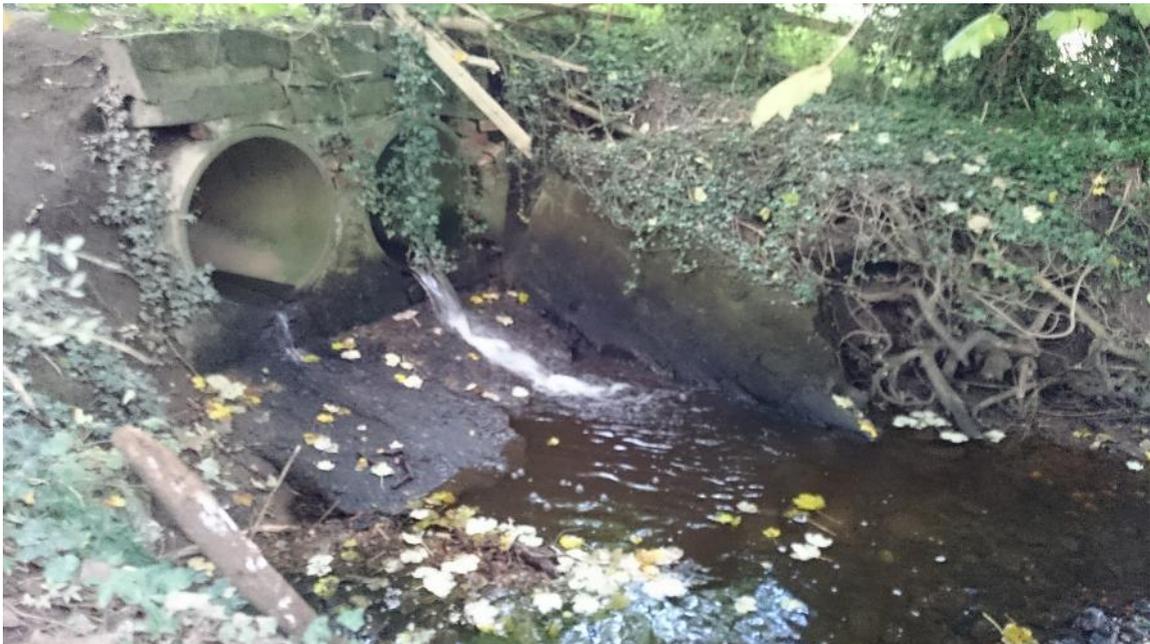
Figure 2. The perched culvert under low flow conditions showing the extent of the degrading sloping apron, and generally poor state of repair of the whole structure. Note the walling on the LB has been undermined by flood waters and is near to collapse.

The culvert is in a considerable state of disrepair. Brickwork on the d/s face of the structure, surrounding the two concrete pipes, is failing. The sloping concrete apron is degrading and breaking away. There is considerable erosion on both banks, and as noted in the legend of Fig 2, the stone wall on the LB has been completely undermined, exposing the roots of the riparian trees; this will eventually lead to the loss of the trees and further associated damage to the bank during future spates. The two pipes each consist of 2x ~3m sections, and the d/s sections have tipped at a greater angle, again likely due to the disrepair of the whole structure. Unfettered access to the edges of the structure from the Dales Way footpath is causing erosion of the soils surrounding the stone and brickwork.

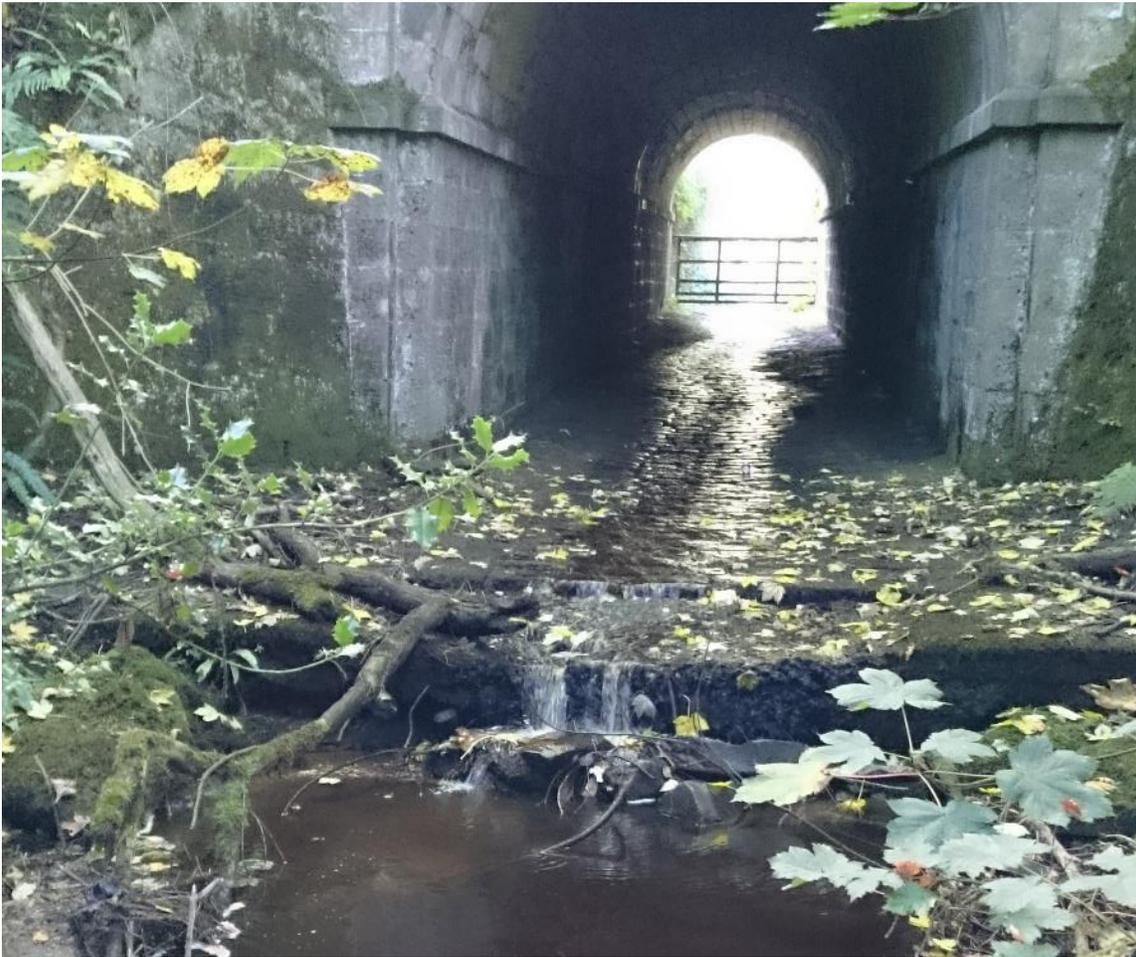
immediately u/s of the culvert (Fig. 3; red arrow) was also examined. At arrow 1, the Beck is of such a high natural gradient that it was deemed impassable to trout, and so it was not assessed any further u/s. Three impassable, man-made obstacles were noted between arrows 1&2: The culverts allowing Hangingstone Rd (Fig 4) and Ben Rhydding Rd (Fig 5) to pass over the Beck; and a vertical walled waterfall of approximately 4m at arrow 2 (Fig 6).

Figure 4. The stone-floored culvert under Hangingstone Rd. The head loss over the entire length of the stone-flooring (which extended approximately 25m u/s of the culvert), and including the step at the d/s side was estimated at ~5m.

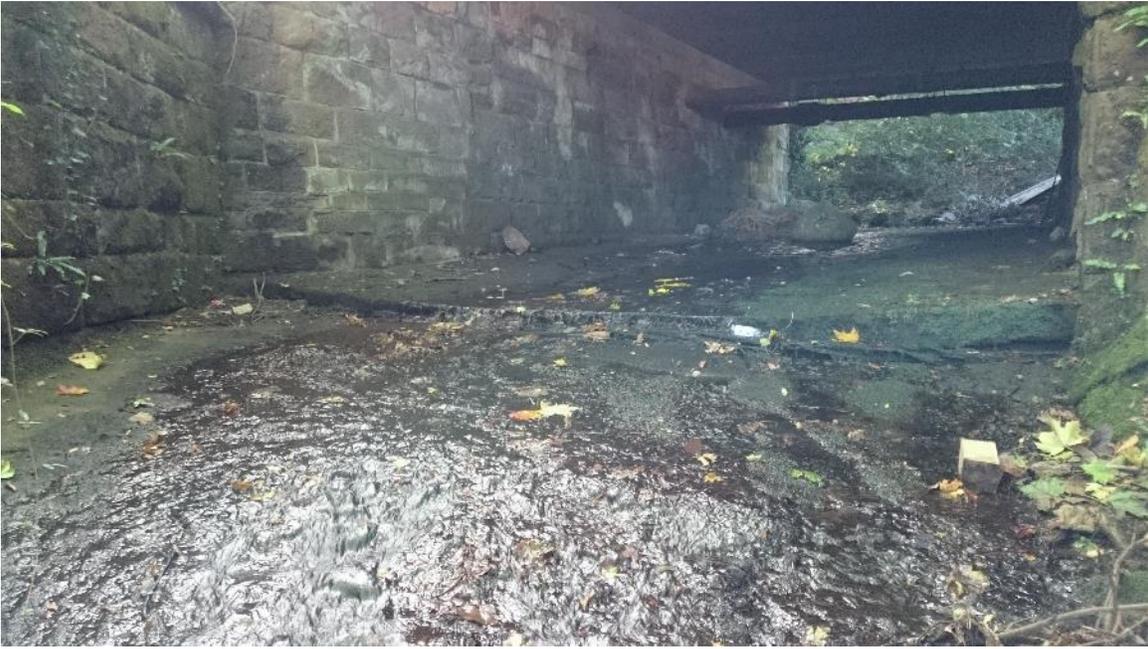
Figure 5. The concrete-floored culvert under Ben Rhydding Rd. Headloss estimated at $\sim 1.8\text{m}$.

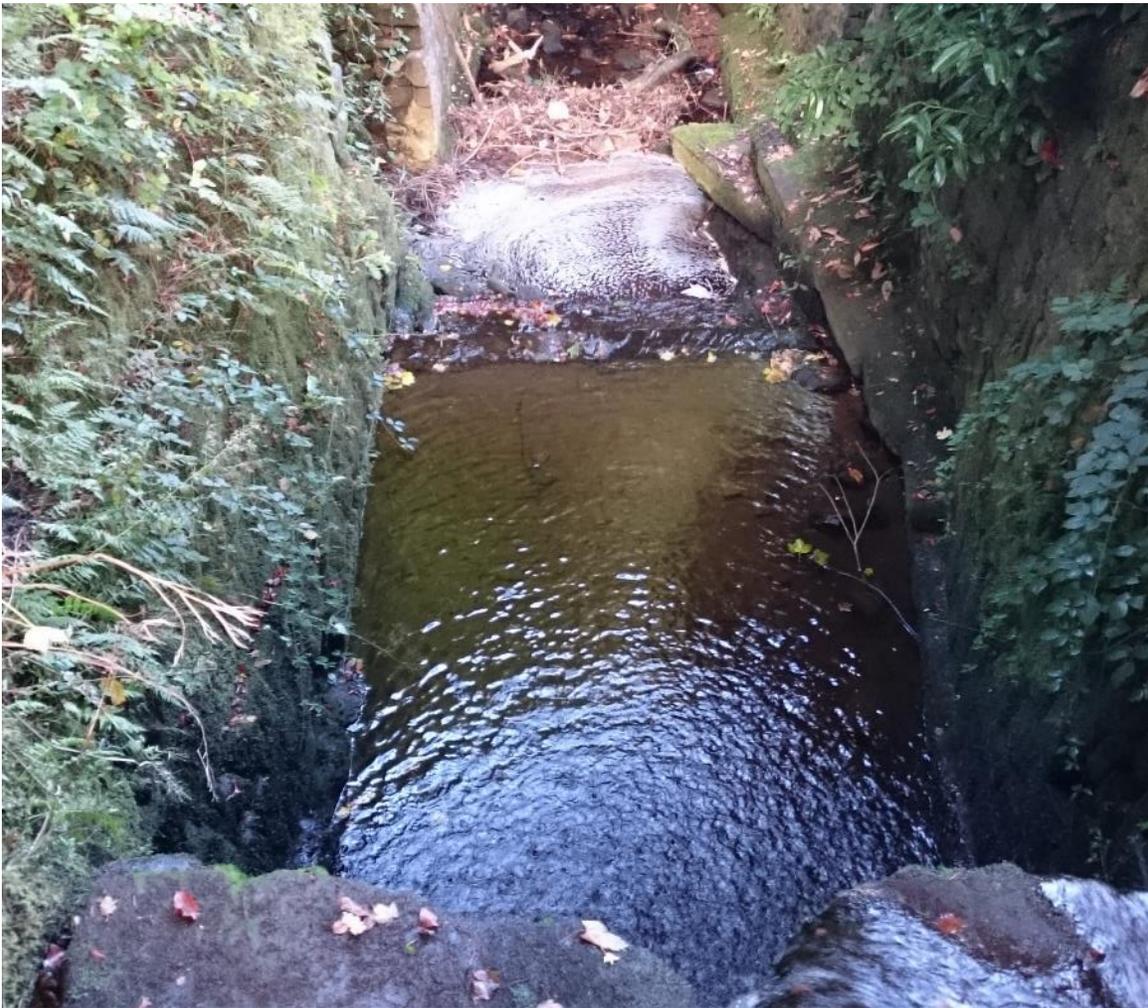
Figure 6. Looking d/s over the walled waterfall, with an estimated headloss of $\sim 4\text{m}$.

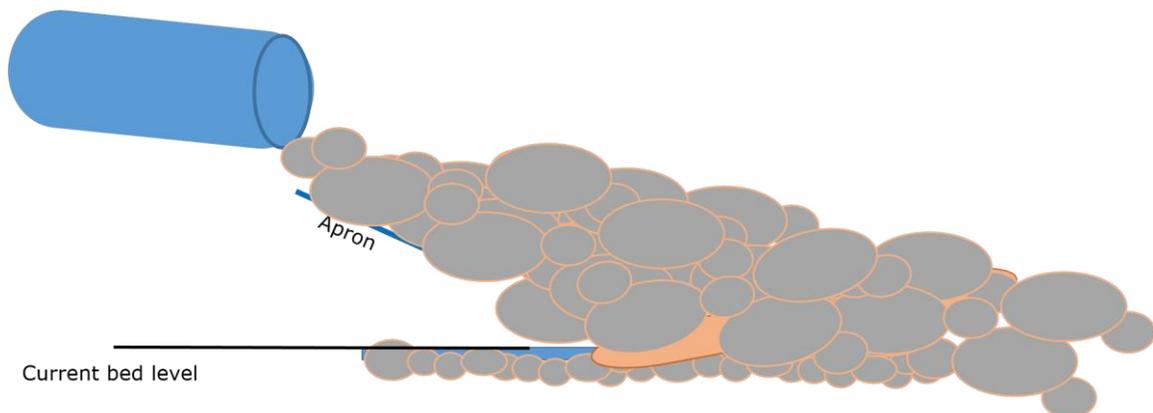
The scour pool is ~3.5m wide by 4.5m long and so judicious use of a matrix infilled with the degraded wall (Fig 2), and boulders (as large as possible that can be 'man-handled') from the Wharfe could form a 'rock ramp' to the culvert. However, this design is difficult to execute so that it works at low flows; it may act as a colander as the water percolates down rather than flows across the top in the desired manner.

Figure 8. Schematic of debris infill to current scour pool below culvert: a mix of large wood to form a secure matrix infilled with locally won boulders. The gaps will fill in naturally over time with supply of material from Backstone Beck.

A cheaper solution could be to infill the scour pool d/s of the culvert with a simple rock ramp (a range of substrate from gravel to large boulders) to reduce the current headloss (Fig 8). The depth required, from the current bed level to the d/s lip of the culvert pipes, is 1.1m. Ideally, the new bed level should be sufficiently high to slow the flow through the pipes, thereby increasing the depth within the pipes (one pipe more than the other to increase the range of passable flows); this could be achieved by installing the u/s end of the ramp to a greater elevation than the bed of the culverts or creating a notched baffle at the mouth of the pipes.

The second solution (Fig 8) will need consent from either the local Environment Agency office or the Council, depending upon whether the scour pool is classified as part of the 'main river' Wharfe or 'ordinary watercourse' Backstone Beck.

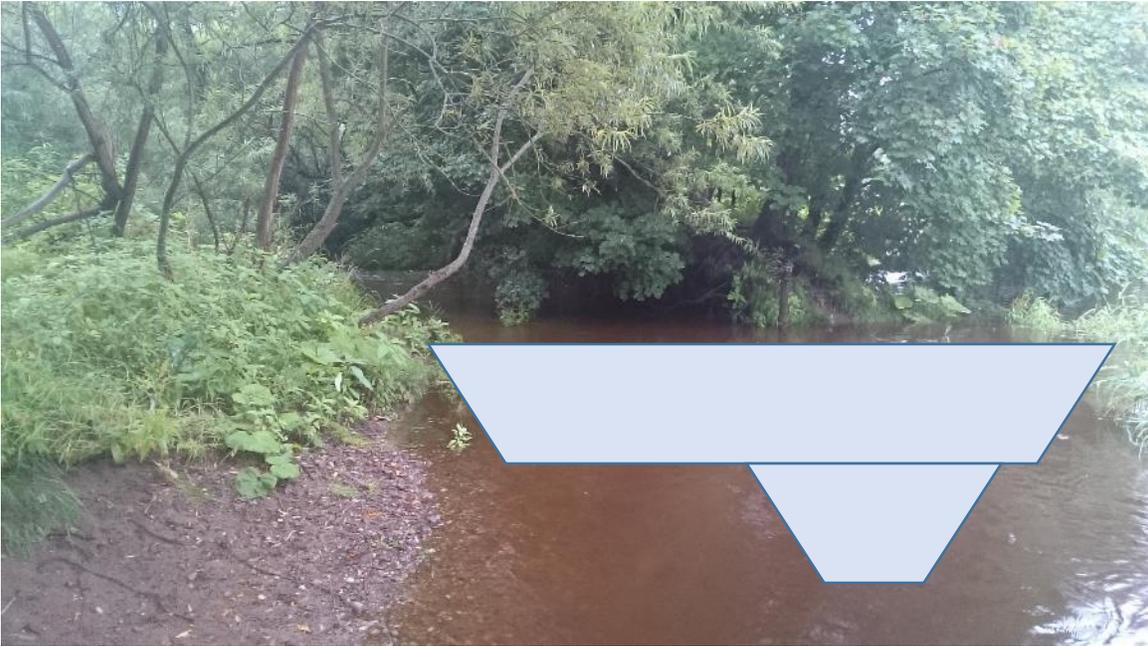
However, more could be done to improve and maintain the quality of this habitat, certainly as juvenile refugia, and even potential spawning habitat (given that it is likely to be flowing consistently with Wharfe water during the spawning period). Currently, it is overly wide for the flow provided by Backstone Beck alone, and would benefit from the introduction of a more structured two-stage channel; low flows are catered for in a narrower channel while high flows take up the full cross sectional area (Fig 9).

Figure 9. The ephemeral side channel (in high flow) as it re-joins the Wharfe d/s of Beanlands Island. Overlaid is a schematic of a two-stage channel. As seen, the water fills the complete cross-sectional area, but in low flows, is focussed into the more appropriate, smaller dimensioned channel. Here, being on a bend, the deeper channel should be encouraged towards the outside bank as would naturally occur.

In places, the flow is meandering around natural wood and debris obstructions despite being within the over-capacity channel. This needs to be emulated throughout the length to focus flow at low water levels to keep potential spawning substrates free from finer sediments. Rearranging some of the boulders found *in situ* or installing low brush berms to create pinch points (narrowing the channel but easily overtopped in high flows), and laying (hinging) some of abundant willow at a shallow angle $<30^\circ$ into and along the sides of the channel will provide further low cover and focus the flow of water. The simple solutions above could be easily achieved with dedicated man-power; laying of material into the watercourse should be discussed with the Environment Agency, but there is an abundance of material naturally *in situ* already which can be used as a supporting argument.
