River Barle, Dulverton, Somerset

An Advisory Visit by the Wild Trout Trust August 2016

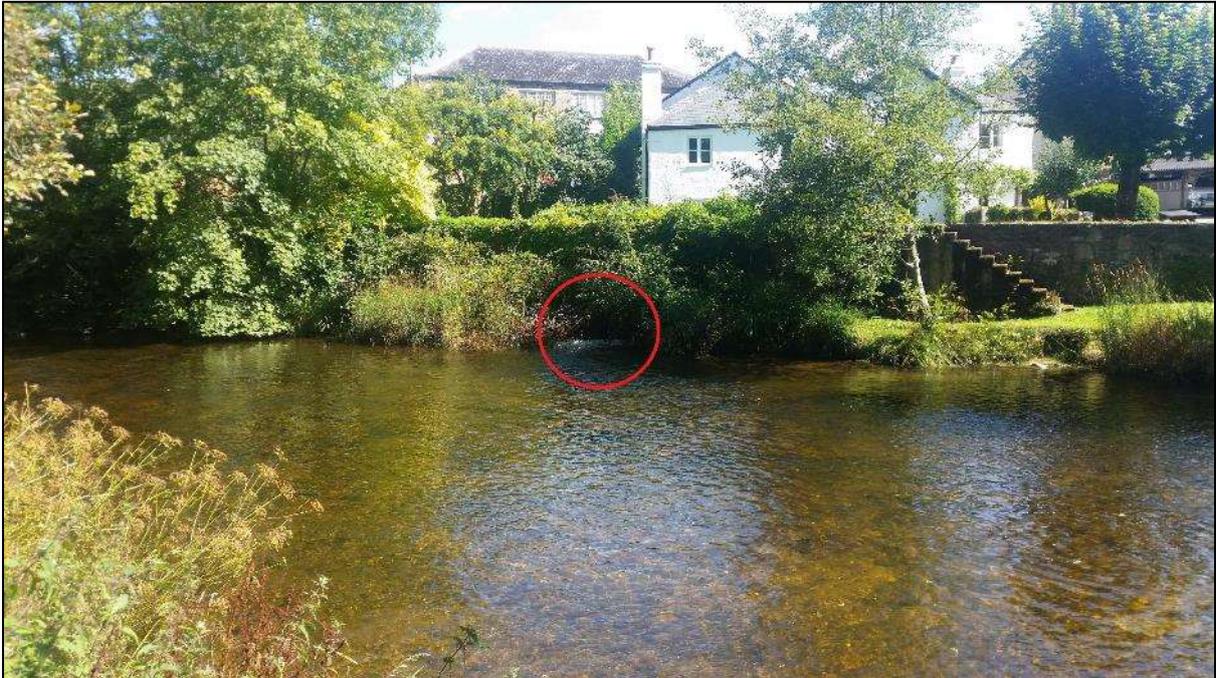
At SS 91245 27734 Dulverton leat discharges back into the main Barle via a small culvert. (Figures 2 and 3).

Figure 2: The outfall of the mill leat (circled in red) where it discharges back into the main Barle

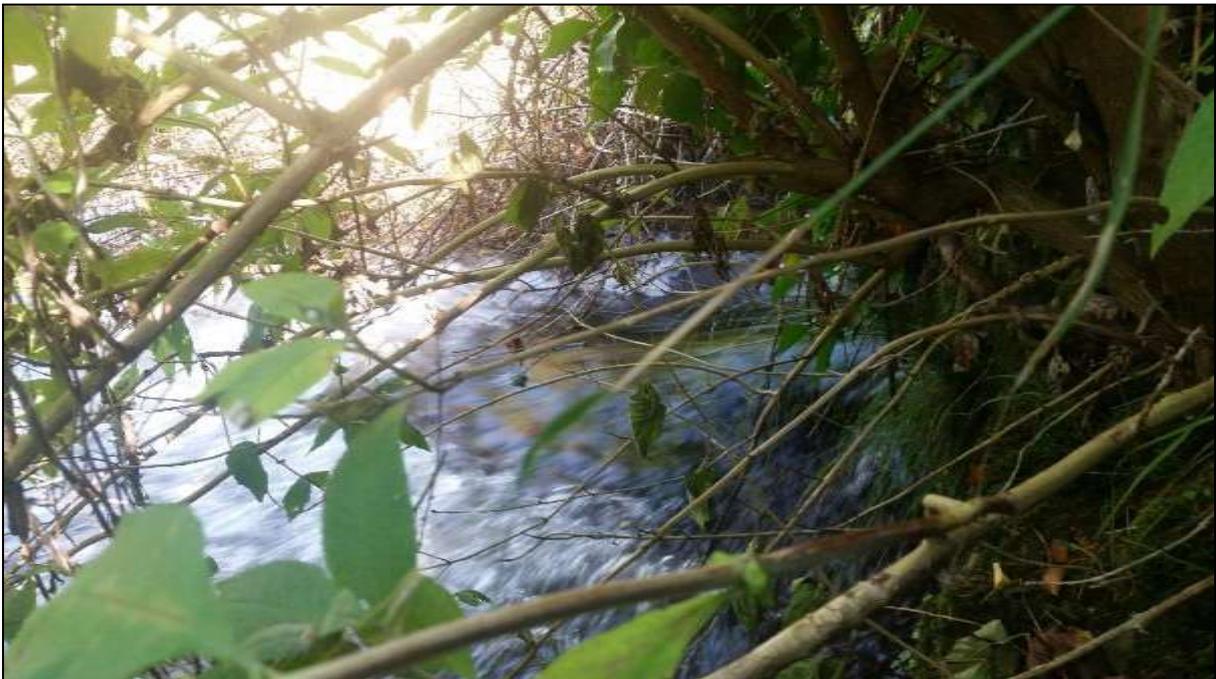
Figure 3: The culvert discharges over a shallow concrete apron

The culvert is relatively narrow and discharges over a concrete apron to prevent the bed from undercutting the hard-engineered bank revetment. Due to the

narrow diameter of the culvert, the flow speed through it is accelerated. Under the flow conditions observed on the day of the visit, the culvert represents a complete barrier to fish passage. Even a strong-swimming adult salmonid would be extremely unlikely to successfully leap into the culvert and maintain a sufficient burst of exertion to then traverse it. When water level in the main Barle is higher, it may be that the culvert is more accessible, however, under such circumstances, it is almost certain that the volume of water discharging through the culvert will also be higher, potentially negating any easing of fish passage.

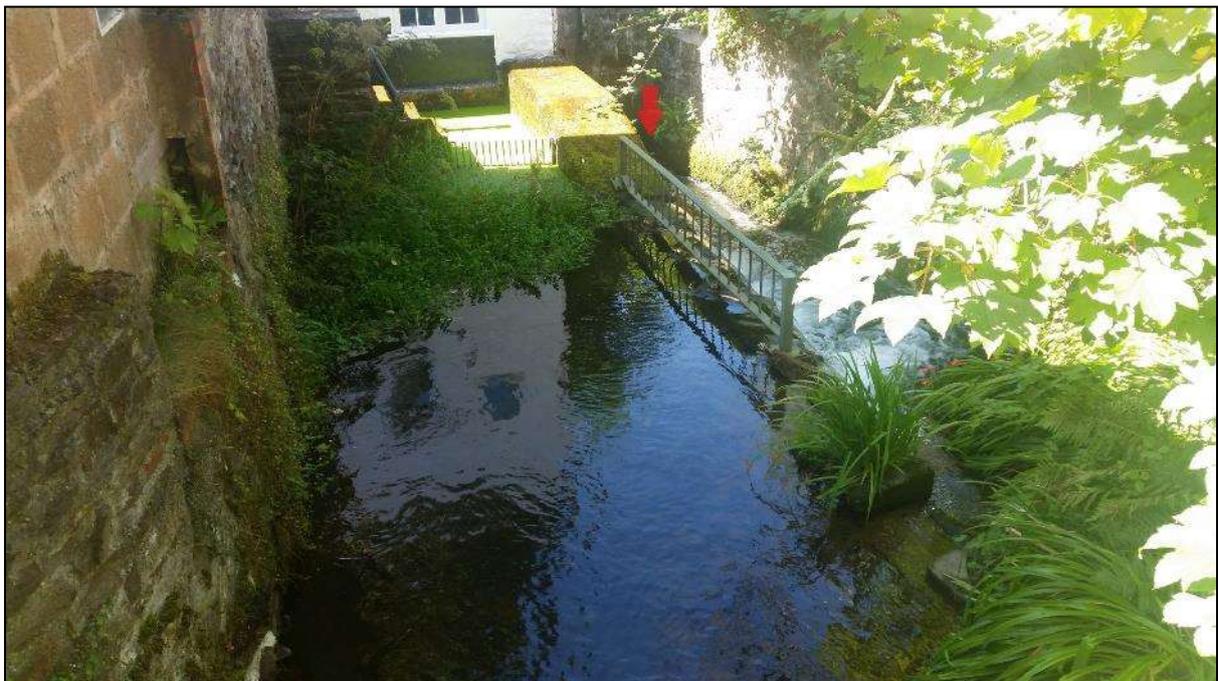
Even if fish are able to traverse the culvert, they are immediately met with another obstacle to overcome, at the remnants of the lowest mill on the leat (now Dulverton Laundry, Figure 4).

To successfully continue upstream, any fish that make it through the culvert will have to pass over the weir and through or around the trash screen affixed on its crest. As with the culvert itself, the weir may be more passable under higher flow conditions when the head drop (the difference in water level above the weir compared to below it) is reduced.

Figure 4: The entrance to the culvert (red arrow) is below an old mill weir

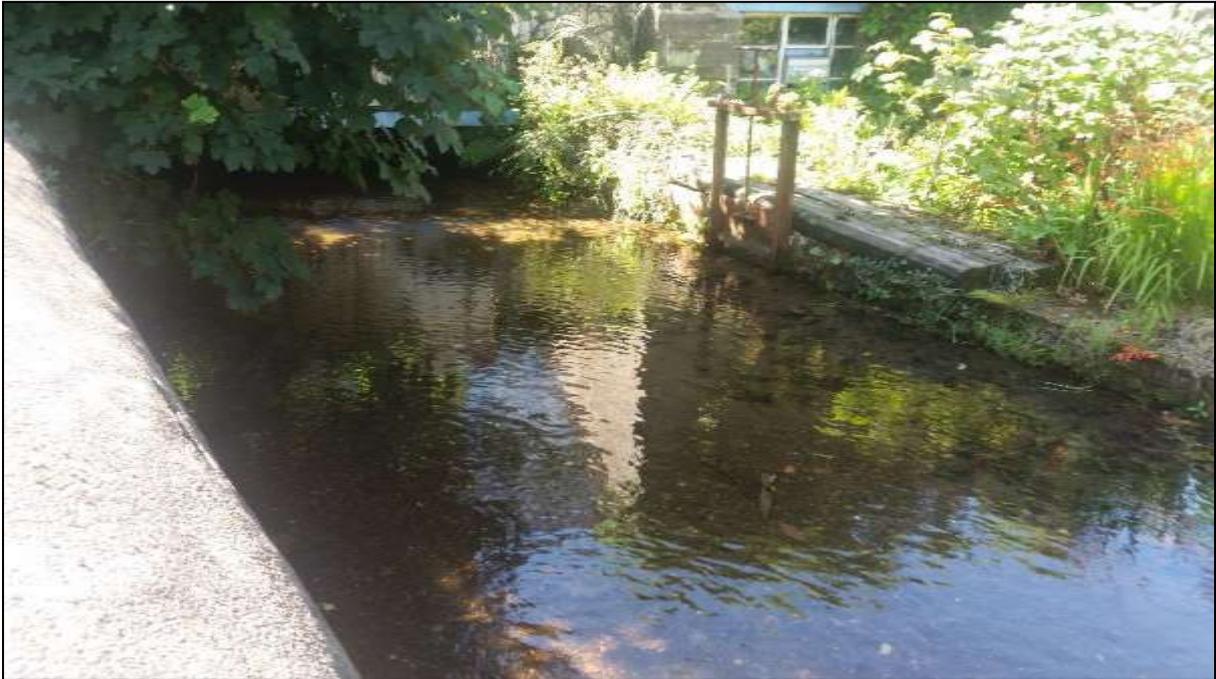
The river upstream is impounded (held up and ponded) by the weir and the bed has reportedly risen over the past few decades (Pers. Comm. Peter Romain). A sluice gate (closed) controls flow through a secondary culvert (dry) that was presumably part of the operation of the mill. The closed sluice and dry culvert are probably what has caused the bed to rise at this location as sediment carried through the mill has steadily dropped out of suspension in the slow, impounded flow above the weir. The interruption of sediment transport caused by impounding structures such as weirs causes fine sediment to drop out of suspension and smother the bed. The result is a uniform, flat and silty riverbed with a significantly

reduced habitat diversity and quality. As in all environments, biodiversity in rivers is directly linked to physical diversity. In short, the greater the diversity of different habitat niches, the greater the potential diversity of organisms filling them.

Figure 5: The riverbed above the weir has risen as sediment has accumulated. When the mill was in operation the sluice pictured would have regularly diverted flow through a secondary culvert and flushed the channel

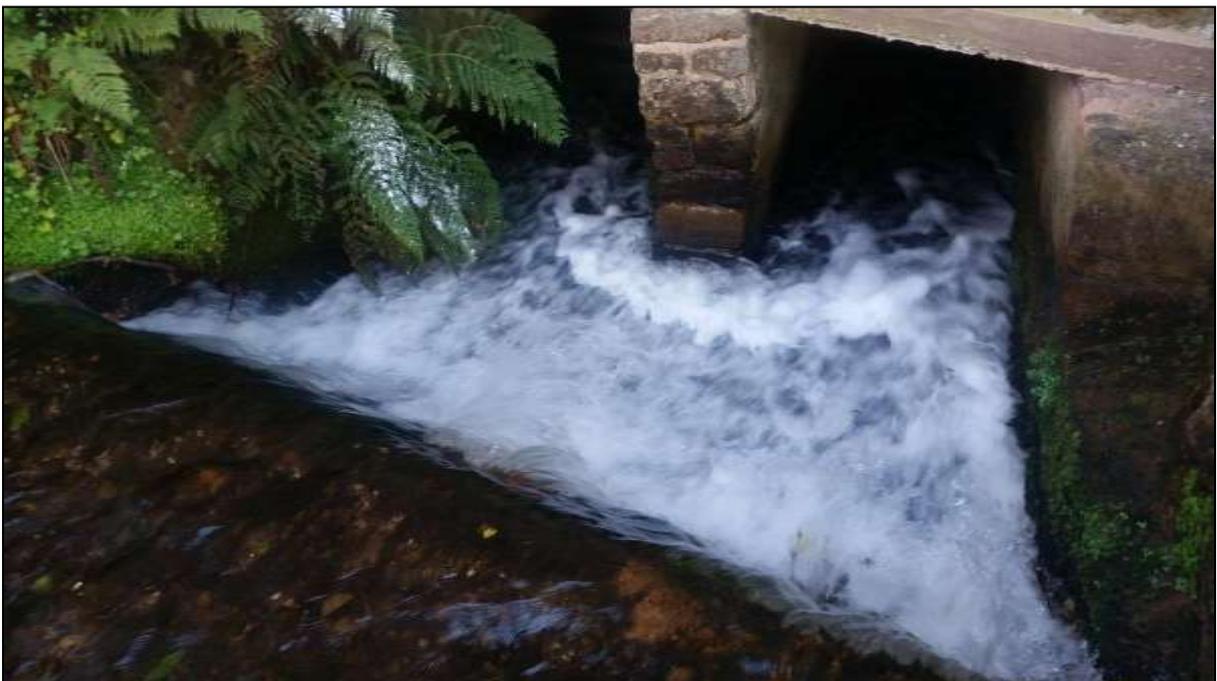
The next mill is just a few metres upstream (Town Mills). Here the leat flows directly under the old mill building. As with the mill downstream, flow above Town Mills was originally split into two channels and controlled by a sluice. This was common practice with many water mills, granting millers the ability control the rate of flow through the mill works. The sluice is now derelict and the majority (but not all) of the flow is carried under the old mill. The culvert under the mill is broad with a natural bed (which is generally good news for fish passage). However, the weir immediately above the culvert is a major barrier to fish passage (Figure 7).

Figure 7: The weir immediately upstream of Town Mills

The fact that the weir is so close to the mill building and culvert also means that it would be extremely difficult to improve fish passage at this location. The weir could be notched to create a low area to ease fish passage but this would require an assessment by a structural engineer to ensure that doing so would not compromise the mill building. Easing fish passage through the other culvert would also be a very difficult undertaking. This culvert has a steep gradient and curves sharply, making working in such a confined space (an already risky option), almost impossible. Other common options, such as de-culverting (excavating), are also unlikely to be feasible at such a historic, and almost certainly listed location.

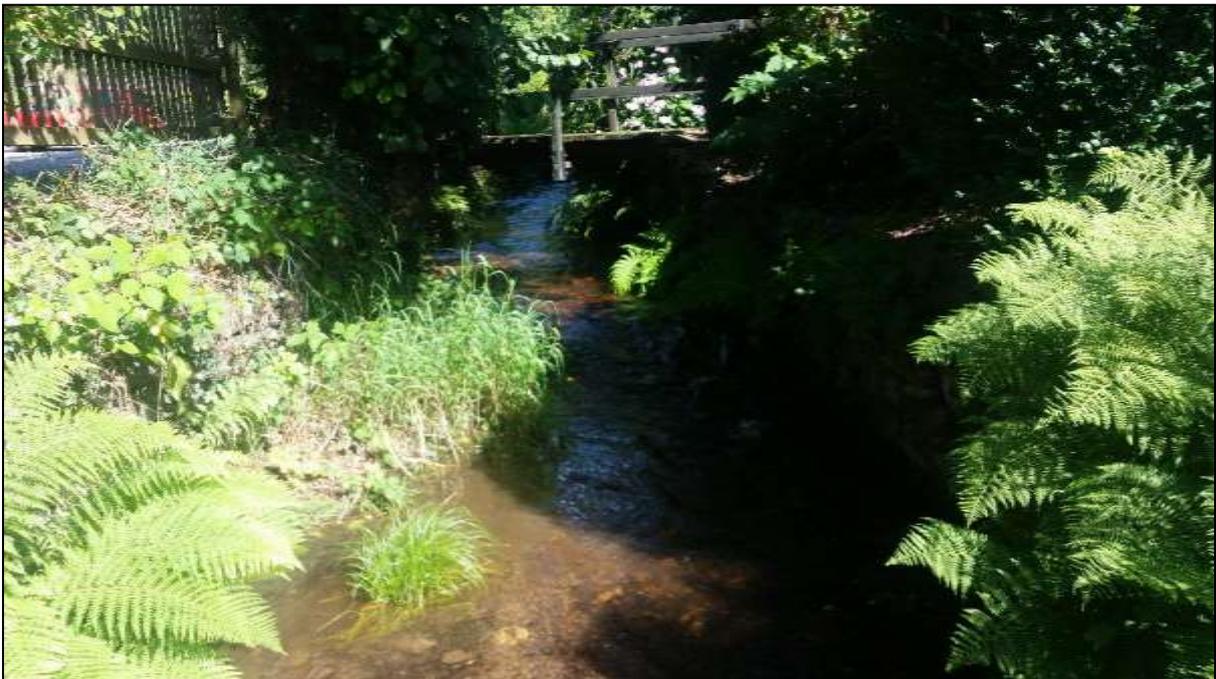
Figure 8: Some good natural features observed between the Heritage Centre and Police Station

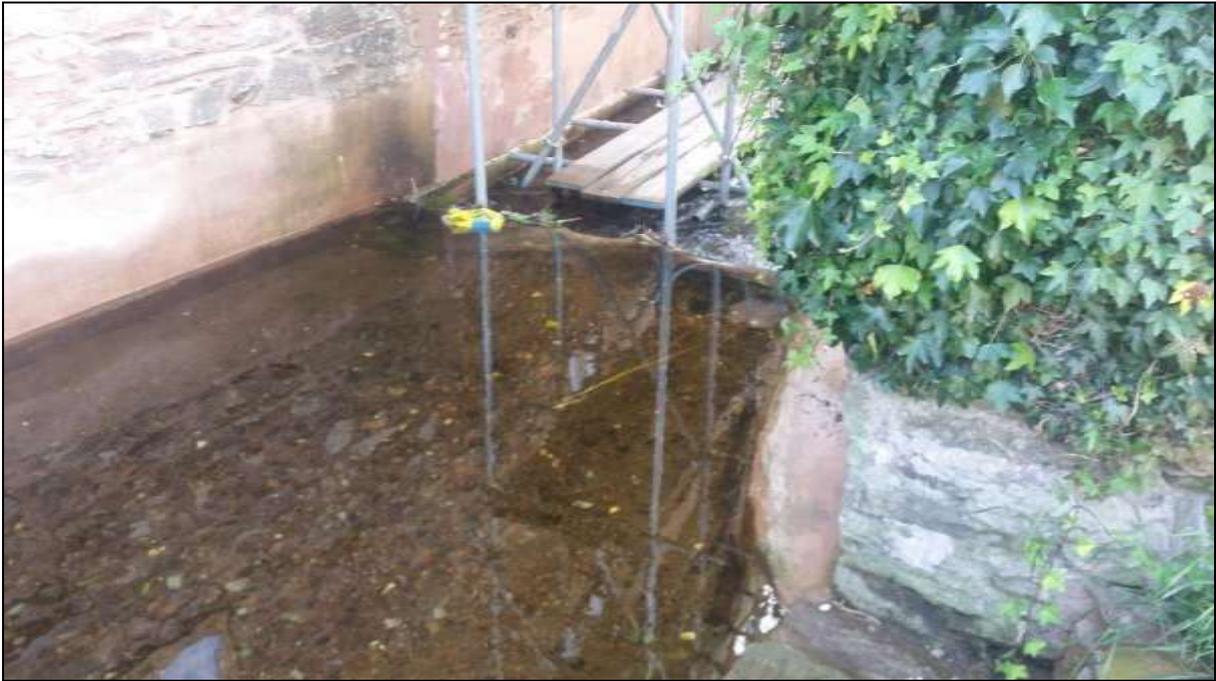
Figure 9: A small stoplog in the river should be removed

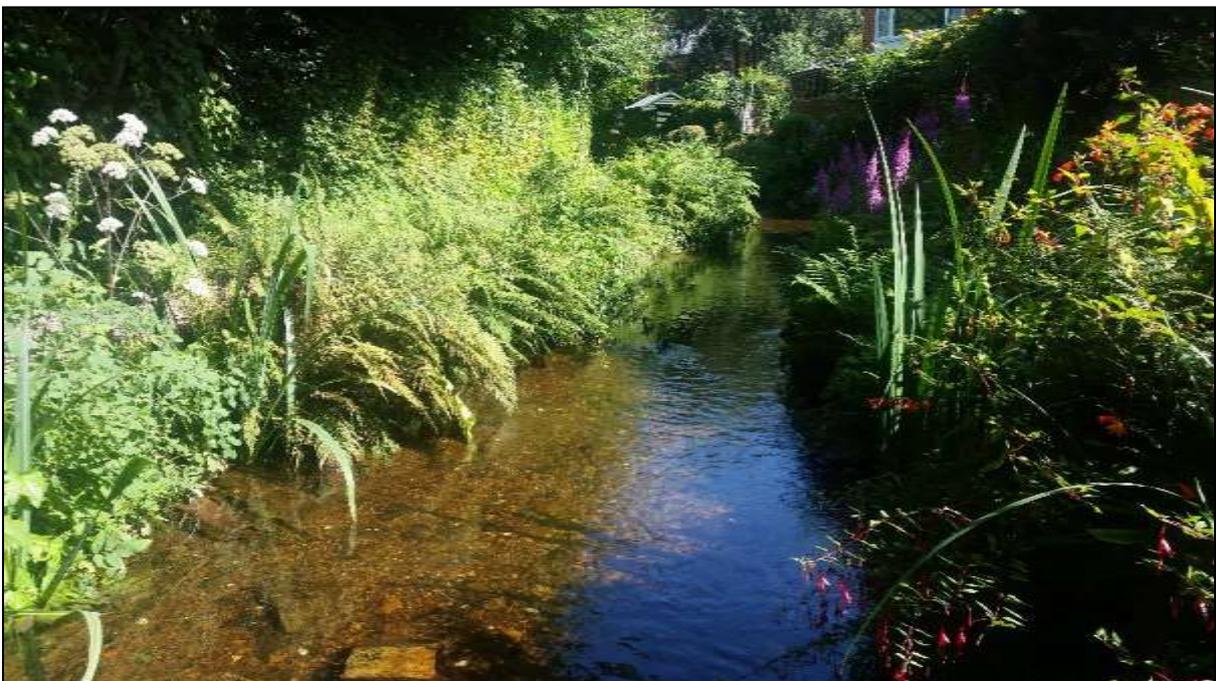
The reach flowing along the back of the properties on Lady Street down to the Heritage Centre is followed by a public footpath on the RB. In places the stream margins have been colonised by ferns, true wetland species, or otherwise planted with garden cultivars (Figure 10). This affords some good marginal cover habitat that is beneficial to fish and other aquatic/amphibious fauna.

Figure 10: Marginal plants, even if not necessarily true marginal wetland species, provide good cover habitat

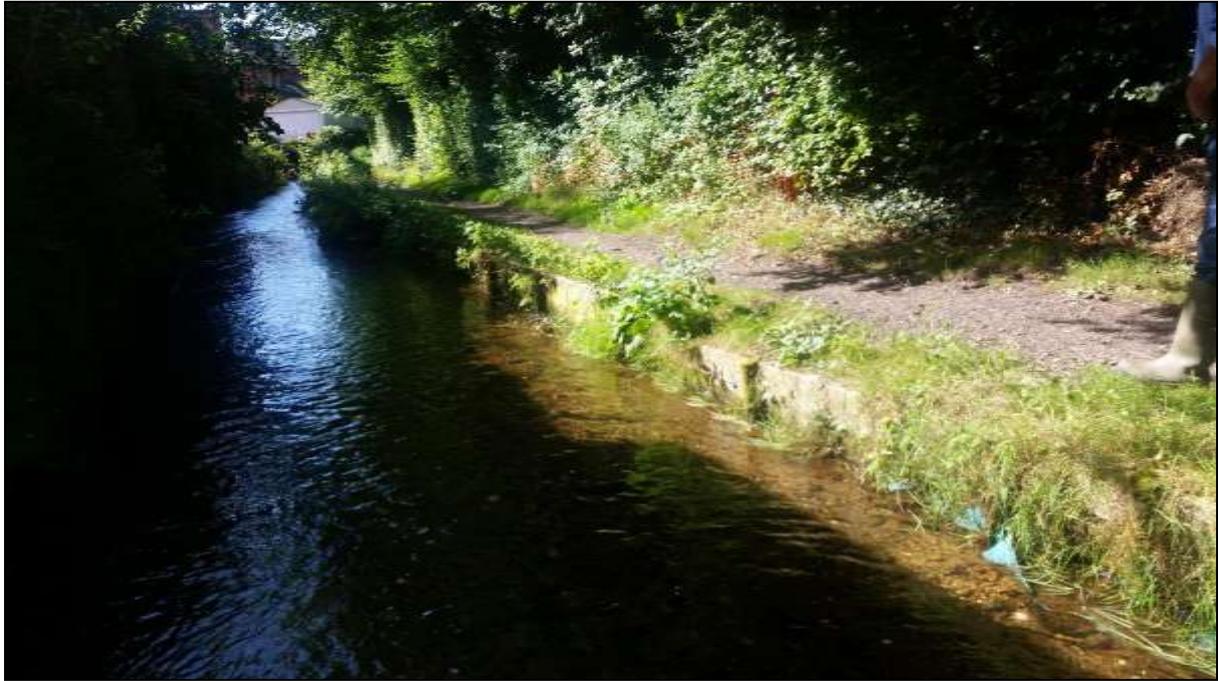
However, for most of this reach the RB consists of vertical timber shuttering (Figure 11) which denudes the stream of marginal habitat and significantly limits biodiversity. Occasionally, a clump of vegetation has established in front of the

shuttering, which helps to soften the hard edge and provide some degree of marginal cover but the reach could be significantly improved by replacing the shuttering with a softer medium in which a greater diversity of marginal plant species could establish and thrive.

Figure 11: Wooden shuttering inhibits marginal habitat

1. Replace the toe board shuttering along the public footpath between Lady Street and the Heritage Centre with a soft-engineered and diverse margin of true marginal wetland plant species. There are a number of techniques that could be employed to achieve this and a number of specialist soft-engineering/river restoration companies that can supply and install such features. Perhaps the most cost-effective option is to make use of locally-won brushwood arising from 'skylighting' tree works to create a narrow brushwood shelf (Figure 24 and as described on page 13). These features act as silt traps, slowing flow through them and encouraging fine sediment to drop out of suspension. Given sufficient time and afforded sufficient sunlight, the silt-laden brushwood will

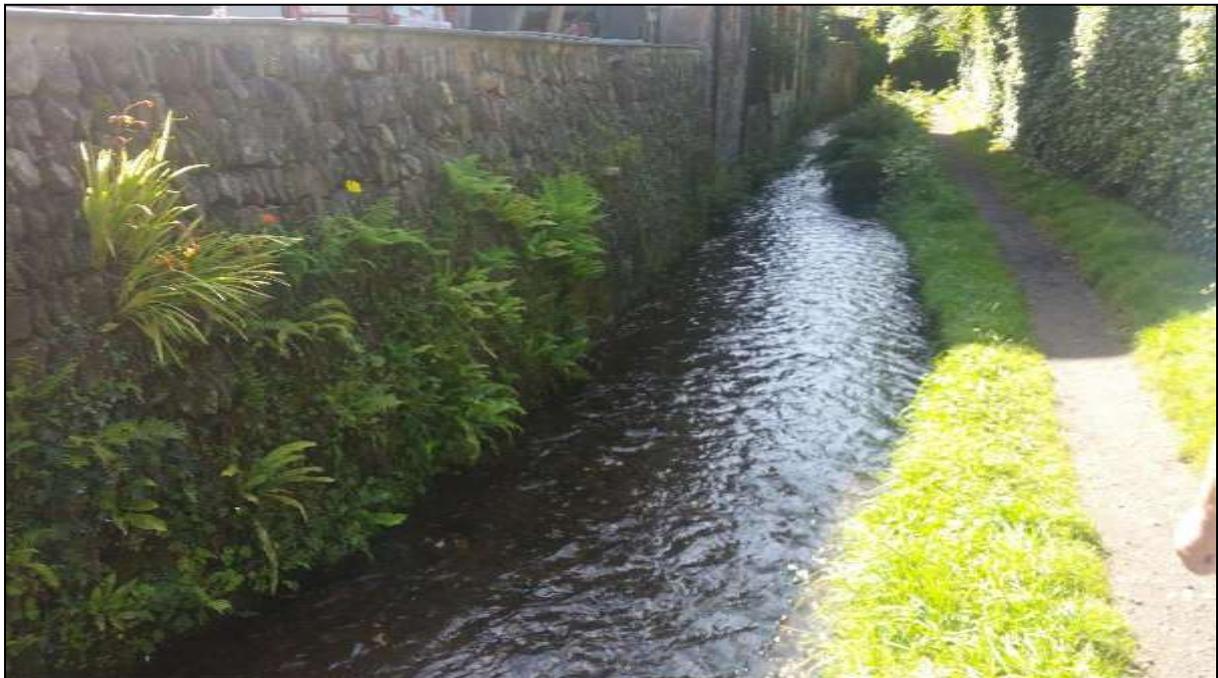
The LB throughout this reach consists mainly of a tall, vertical stone revetment at the rear of the Lady Street properties (Figure 12).

Figure 12: The tall wall on the LB colonised by a few ferns but otherwise providing very little habitat

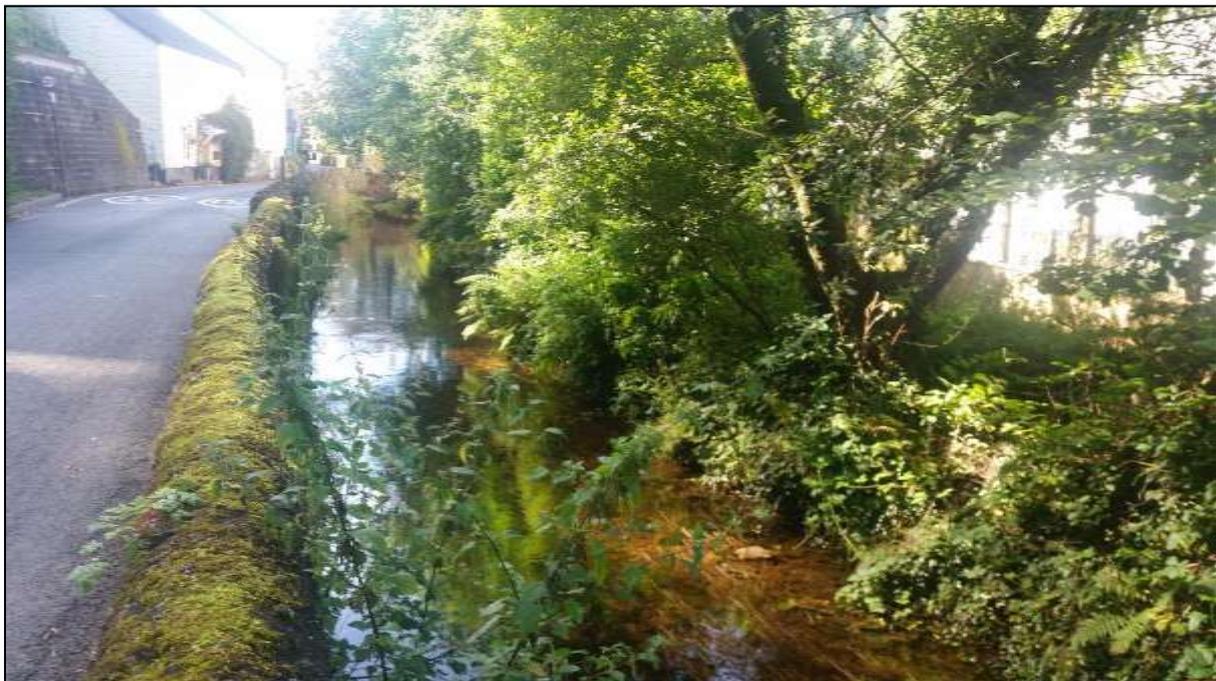
Upstream of the reach with the footpath, the leat flows alongside Northmoor Road. Both banks of the leat are hard-engineered vertical revetments offering very little refuge habitat. Some low cover habitat is provided by small trees, shrubs and ferns that overhang the river from the RB (Figure 13).

Figure 13: Low overhanging vegetation provides cover and softens the hard-engineered channel

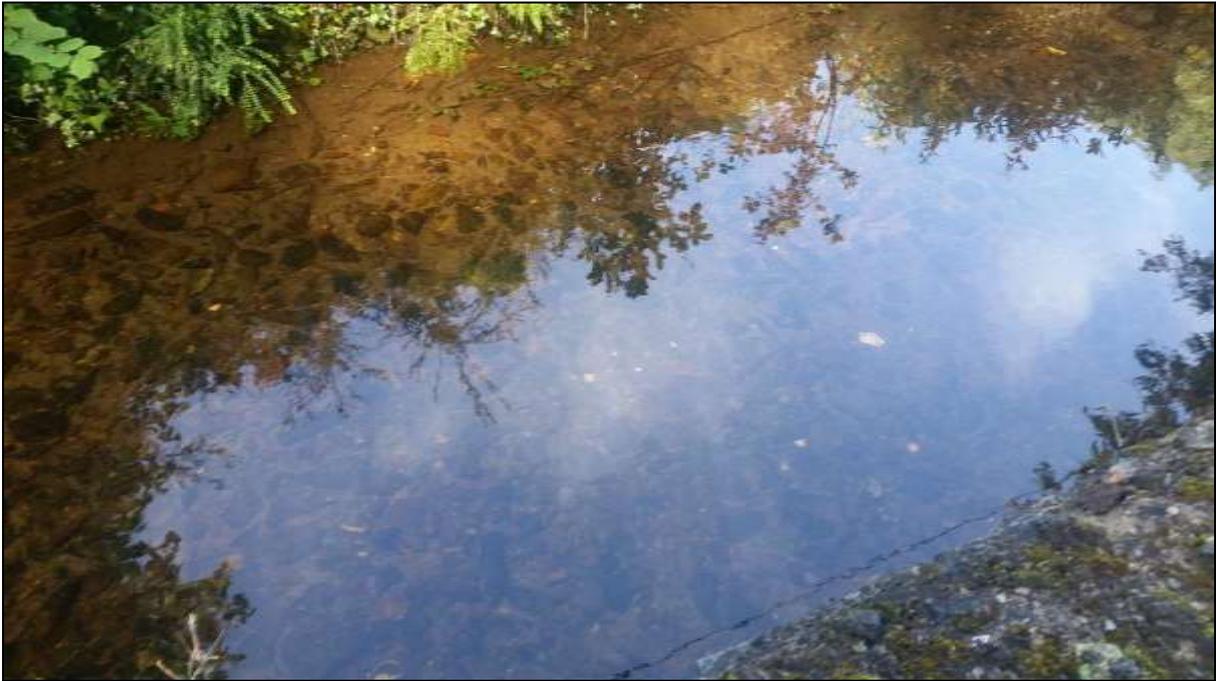
The leat appears to have a more-or-less natural bed but is cobbled in places. It is also possible that it is hard-engineered below some of the natural substrate. The riverbed that is present is compacted and 'armoured' (i.e. consists of a coarse surface layer of large stones over finer material, Figure 14). This occurs as smaller gravel grains are transported away, leaving larger material behind.

Figure 14: The riverbed is cobbled or otherwise armoured in many places.

This armoured and compacted bed is unsuitable spawning habitat for gravel spawning fish like trout, grayling and salmon. Even if fish were able to cut a redd (nest) in the hard bed, the eggs they deposited would almost certainly become smothered in fine sediment and suffocate. The lack of space between the gravels/cobbles, owing to inundation with finer material, also greatly degrades it as invertebrate habitat.

An absence of finer gravels in the leat here is in a large part due to the lack of in-channel structure. The straight and smooth hard banks provide very little friction and no opportunities for finer gravel to deposit. The installation of a few, small flow deflecting features could allow a more diverse bed profile to develop over time and perhaps lead to some viable spawning habitat developing. The Barle carries a substantial loading of gravel during spate flows and providing even some very minor opportunities for deposition could yield valuable habitat improvements.

3. Where the bed of the leat is cobbled, armoured or otherwise too hard to penetrate with stakes or rebar, consider improving marginal habitat by introducing stone berms back-filled with gravel and soil. This technique has proved successful elsewhere in the county (Figure 26). Depending on the flow speeds and shear forces experienced in the leat during spate conditions, it may be prudent to fix every third or fourth stone to the bed by drilling into the stone, chemi-fixing a short section of threaded bar into the hole and then drilling another hole in the bed and placing the bar into it. This technique has been used in a concrete channel on a spate-prone section of the River Meon in Hampshire.

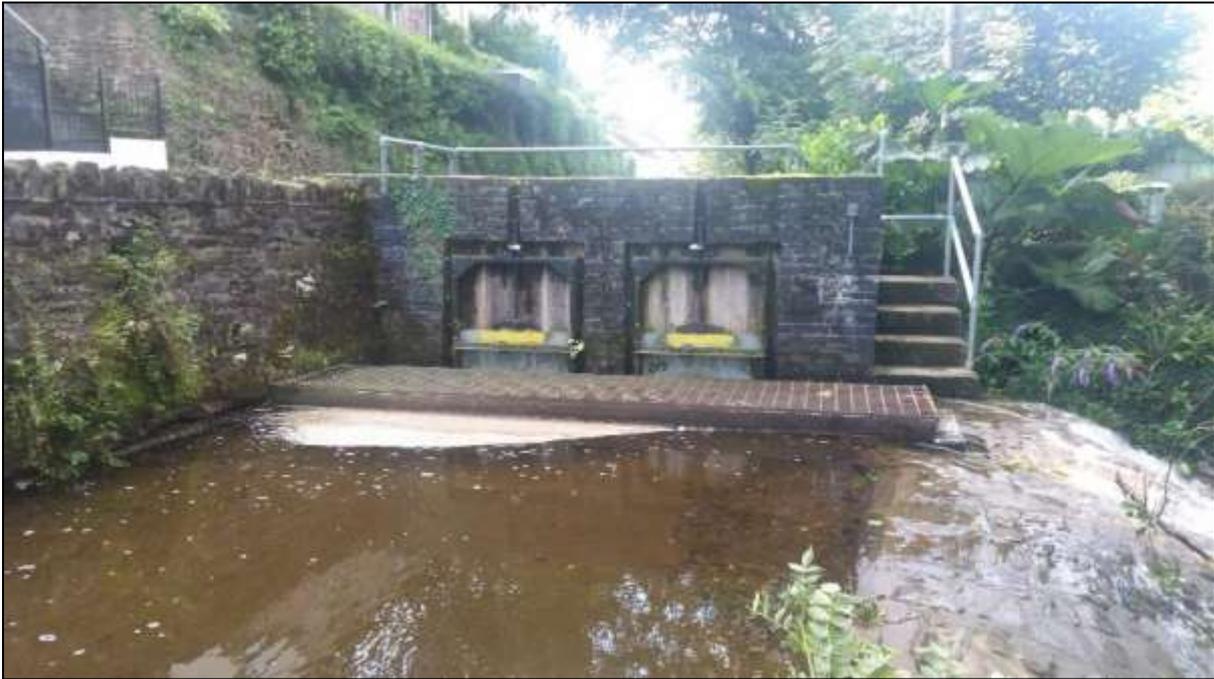
At the head of the leat is a relatively modern undershot sluice (Figure 15). This structure controls what proportion of the available flow is diverted through the leat and what proportion of flow instead flows over the weir. Undershot sluice gates (where water flows beneath the sluice) are better for habitat both in terms of connectivity and quality than overshot sluices (where water flows over the sluice). Fish, invertebrates and other aquatic wildlife can easily pass through the sluice except under very high (and therefore fast) flow conditions. The sluice also allows for relatively natural sediment transport.

Figure 15: An view from upstream of the undershot sluices

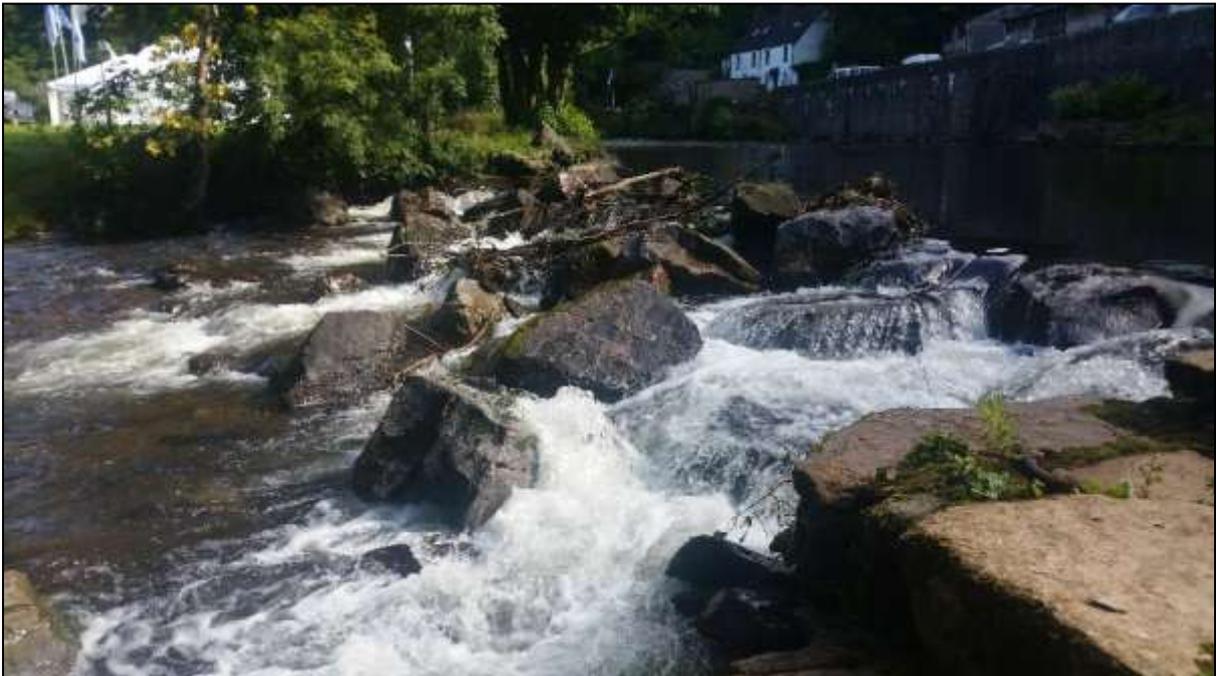
Dulverton Weir itself is an enormous structure approximately 120m in length that spans the river diagonally (Figure 16). The structure has undergone temporary repairs after breaching in the high flows and flooding of winter 2012/13.

At the RB end of the weir is a 16m long boulder ramp that serves as a 'rock ramp' type fish easement (Figure 16). This type of easement mimics the structural variety of natural rocky 'rapid' features usually found in high energy rivers. These features are relatively passable to fish as the roughness and randomised arrangement of boulders baffle flows and provide an abundance of small 'pockets' where fish can rest. The complexity, diversity and roughness of such features can ease passage for a broad range of fish species including eels. Rock ramp fish easements can reduce problems with attraction flow that hinders the performance of some technical passes but they are often less passable by adult fish at lower flows.

Figure 16: The nature-like fish pass on Dulverton Weir.

5. The existing nature-like fish pass on Dulverton Weir eases passage for a range of species and sizes of fish. This structure should be retained and enhanced if possible. If the restoration of the weir requires a new fish pass to be created, a number of key factors need to be considered

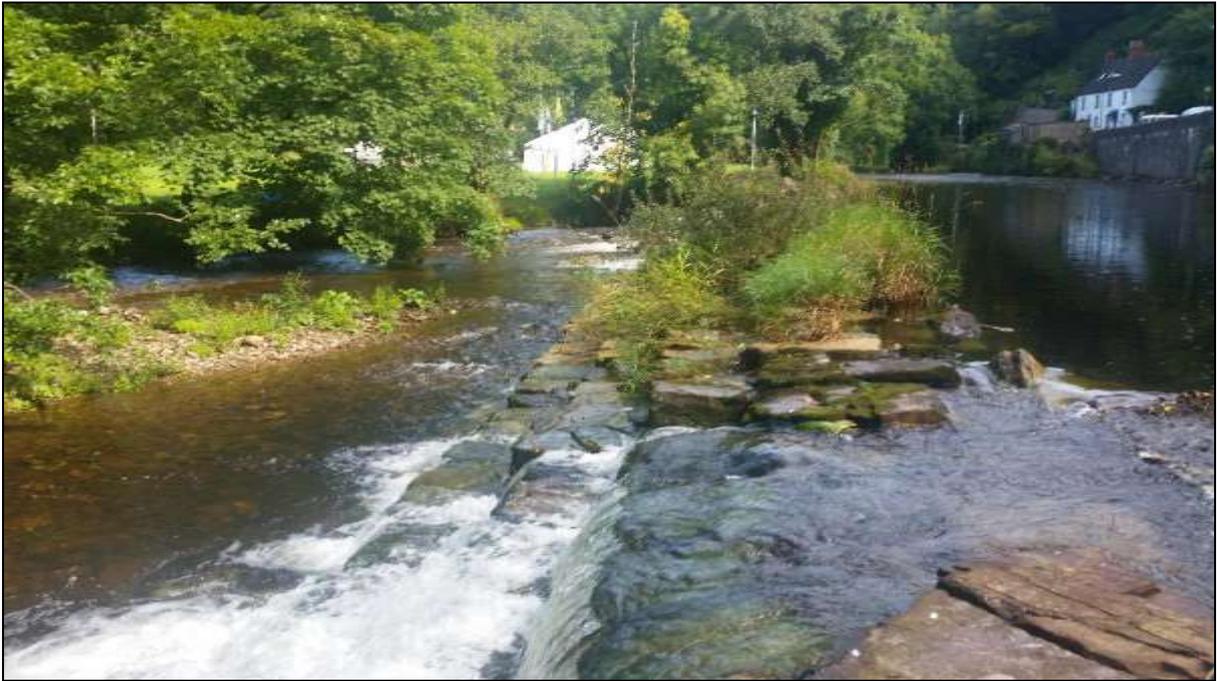
The middle-right 22m section of the weir consists of a modern block stone repair undertaken in 1993 and 2000 (Figure 17). This section is not passable for fish under normal flow conditions but is probably passable to strong-swimming fish under high flow conditions.

Figure 17: The blockstone (middle) section of the weir

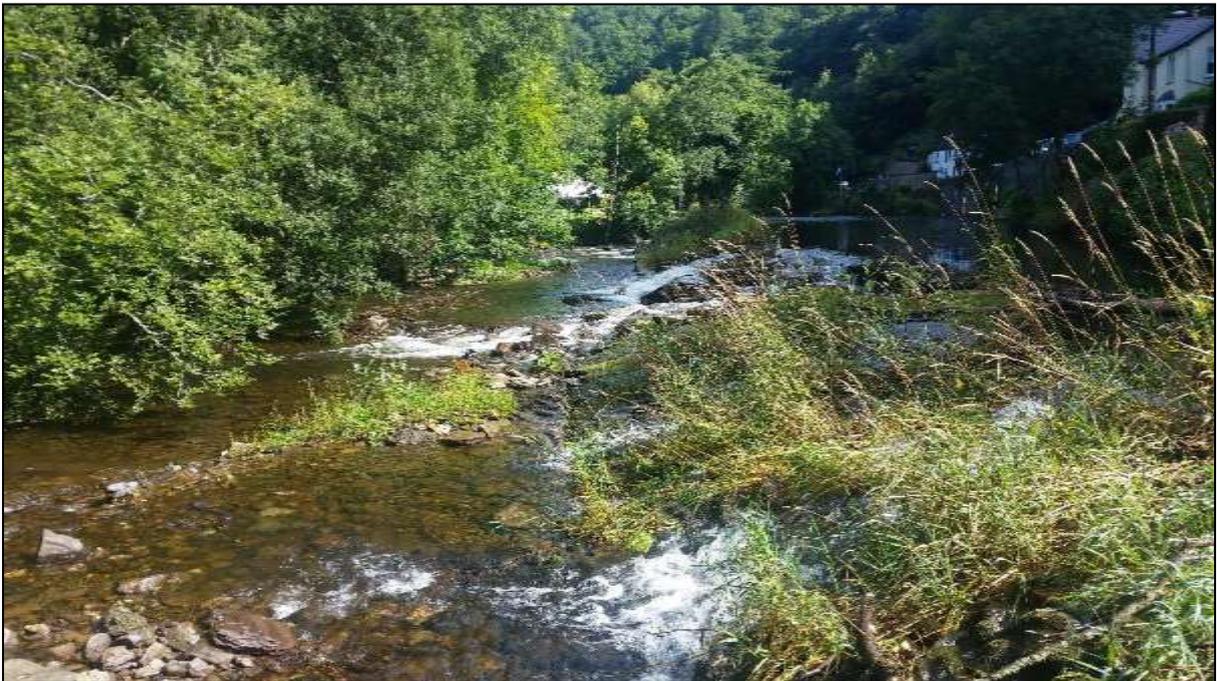
The middle-left 27 metres of the weir consist of the surviving ancient structure constructed from wooden stakes and large, rounded stones (Figure 18). The upper part of the ancient weir is protected by a row of gabions.

Figure 18: The oldest part of the weir constructed from wooden stakes and hand-placed stones.

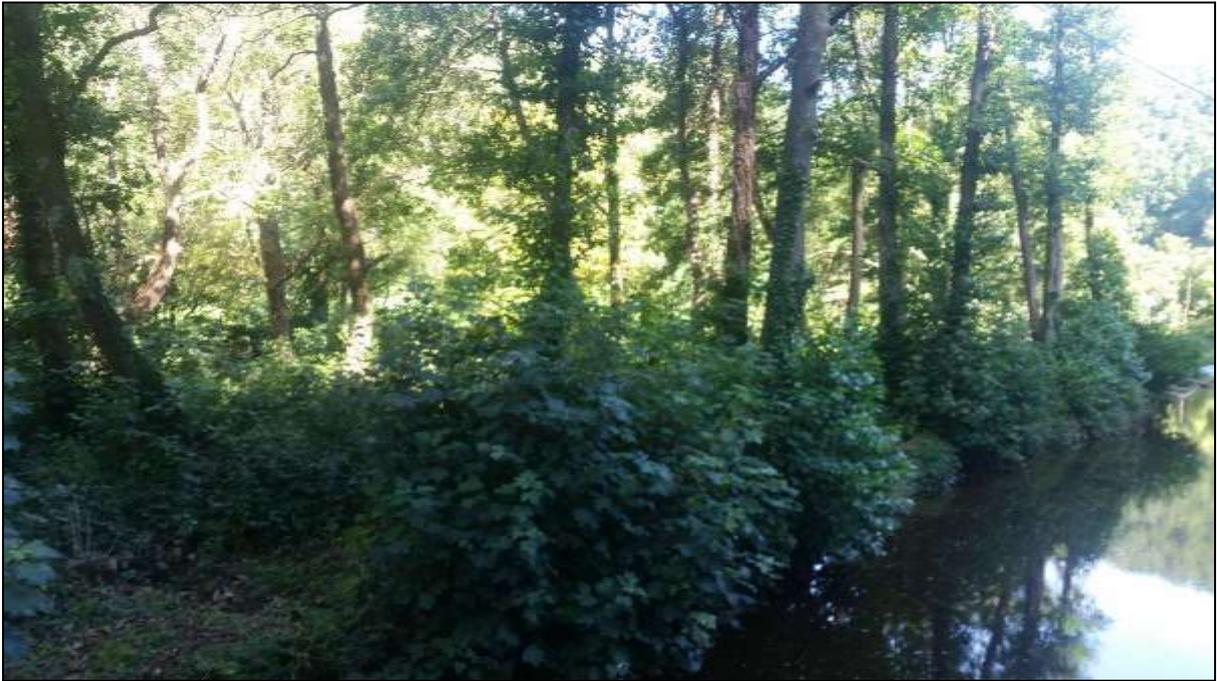
The weir then continues a further 48m in the form of a stone revetment along the left-hand side of an island. This island is densely wooded (Figure 19) and is bisected by a small channel which is dry under normal summer flows (Figure 20).

Figure 19: The heavily wooded island

6. Try to maintain the island on the weir as a wildlife refuge and resist the temptation to 'garden' it too heavily. Reducing disturbance will make the island more attractive to birds and mammals such as otters (*Lutra lutra*), particularly as there is a hidden channel through the island's centre (see Figure 20).

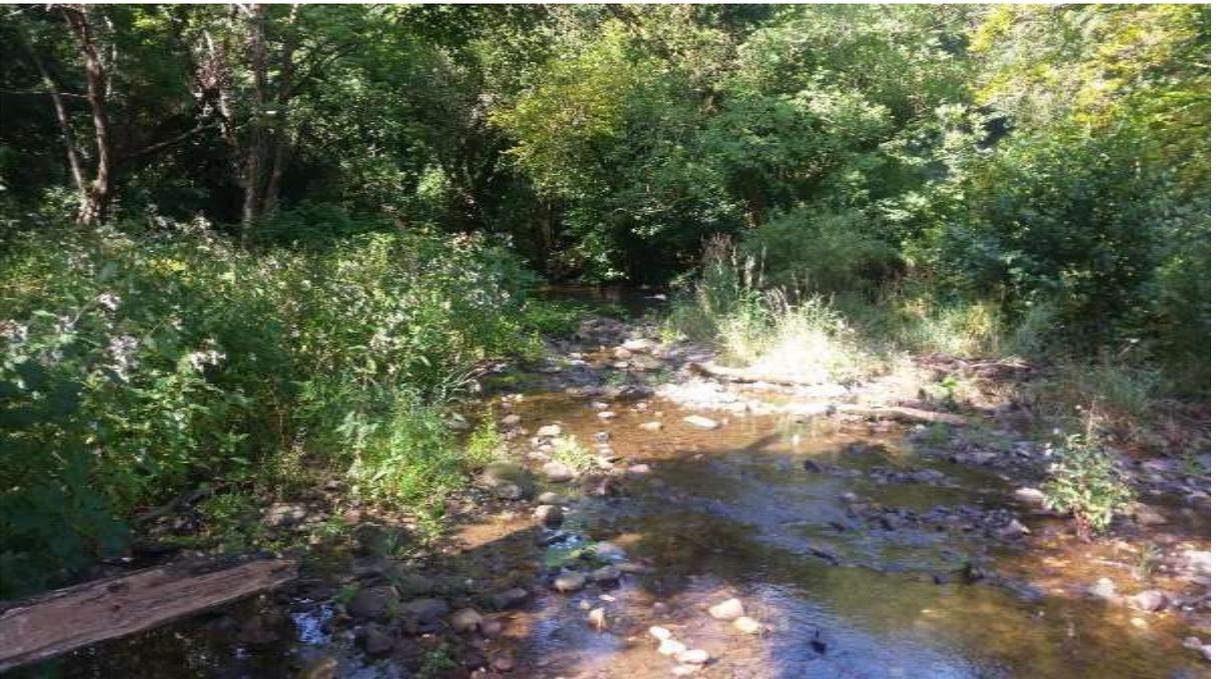
The island is undoubtedly a small wildlife haven and should be managed as such. The alien invasive species Himalayan balsam (*Impatiens glandulifera*) is present on the island. Himalayan balsam (HB for short) is prolific both in its rate of growth and its reproduction. It can rapidly out-compete native wetland species and disperse seeds by means of exploding seed pods. Not only can HB fire seeds over 7m in any direction, these seeds also float, making them particularly invasive within river corridors. HB is particularly shallow rooted and dies back during the winter leaving riverbanks exposed and vulnerable to erosion. Annual eradication efforts should be included in the ongoing management of the island.

Figure 20: A hidden channel in the middle of the island (note Himalayan balsam on the left).

However, Himalayan balsam will need to be managed. This is best done with volunteer work parties hand-pulling the plants in late spring before the seed pods develop. A secondary pull later in the summer, to eradicate any later sprouting plants may also be beneficial. The nature of HB is such that only a concerted joined-up source-to-sea effort will effectively eradicate the species from a river. However, blitzing it annually at a local level will minimise its impact and safeguard biodiversity (e.g. http://www.sciencecodex.com/global_plant_diversity_hinges_on_local_battles_against_invasive_species-105553).

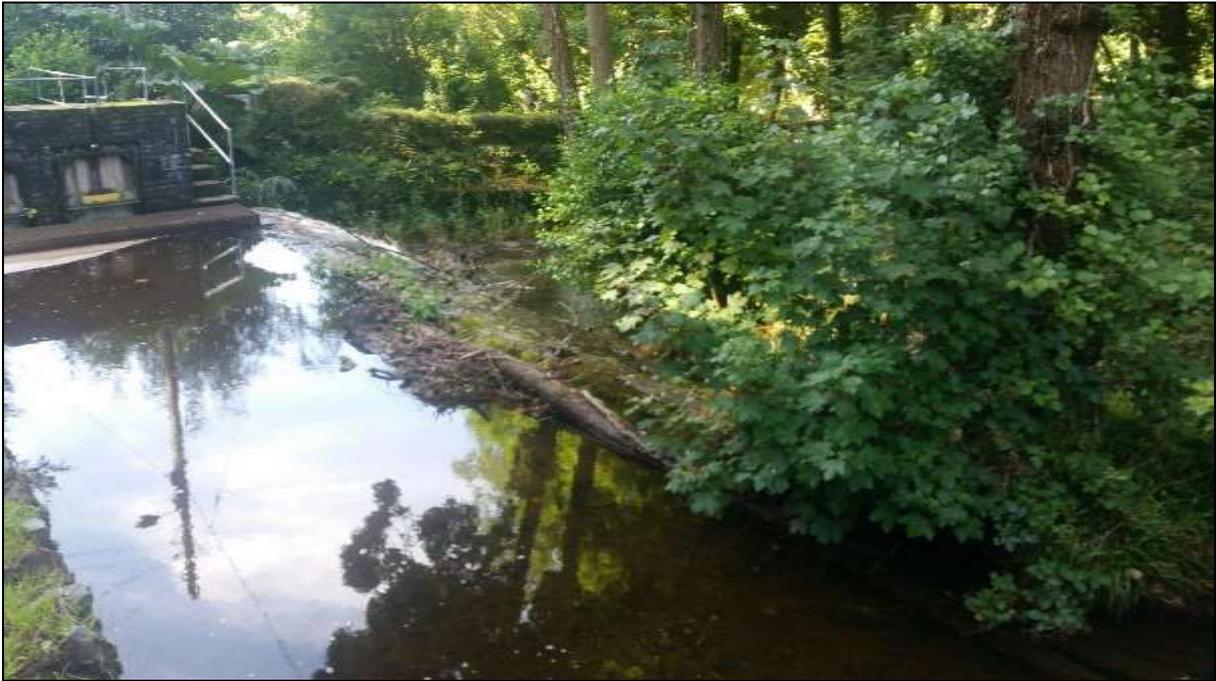
Adjacent to the sluices is a further 7m wide section of stone weir (Figure 21) that carries flow along the back of the island to re-join the main Barle.

Figure 21: The 7m section of weir next to the sluice diverts excess flow around the island
