**Walkover Assessment
Beechburn Beck
(River Wear Catchment)
County Durham
05/03/2019**

Undertaken by Gareth Pedley

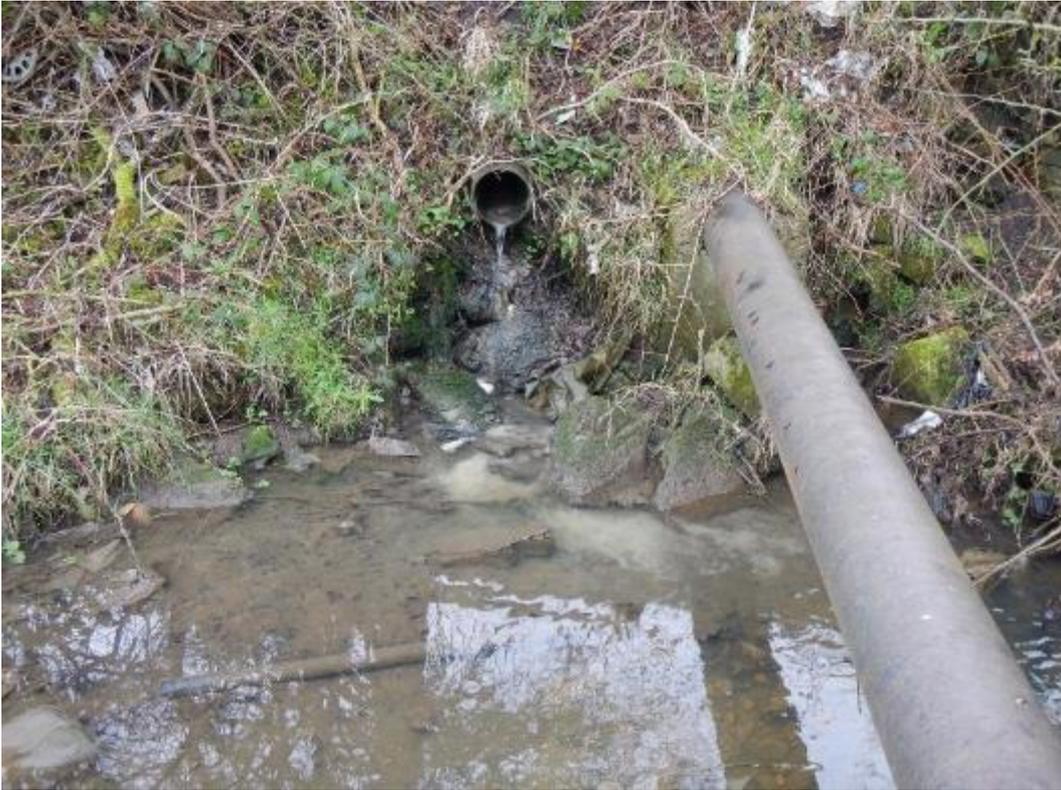
Photo DSCN0171. Point source pollution 1 (NZ 15760 37104): at the u/s limit inspected, obvious water quality issues were identified in association with a pipe discharging from the bank. The watercourse would benefit from buffer fencing at this location but is not a high priority site.

1	NZ 15760 37104	Report to EA incident hotline (believed to have already been completed by WRT)
Obstruction A. (blockage at u/s end of culvert).

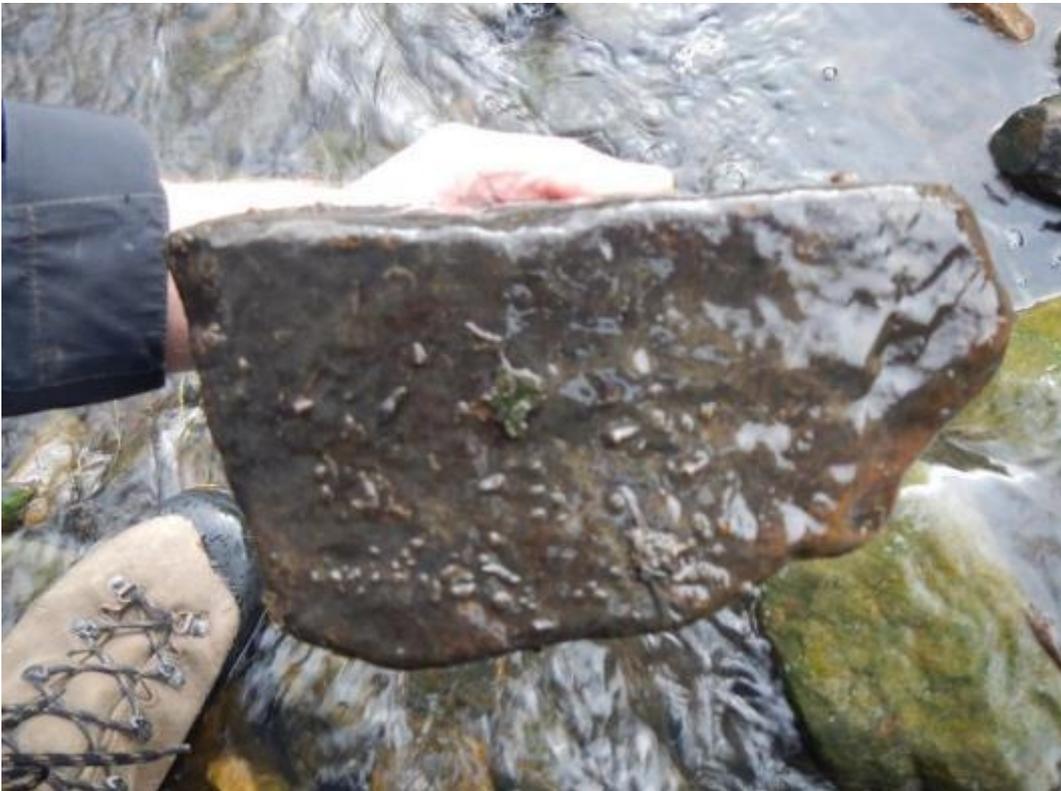
Photo DSCN0170. Brief inspection of the bed revealed only species tolerant of poor water quality (hog lice, snails and midge larvae), also suggesting issues in a watercourse that should be supporting more sensitive species (mayflies, stoneflies and caddisflies).

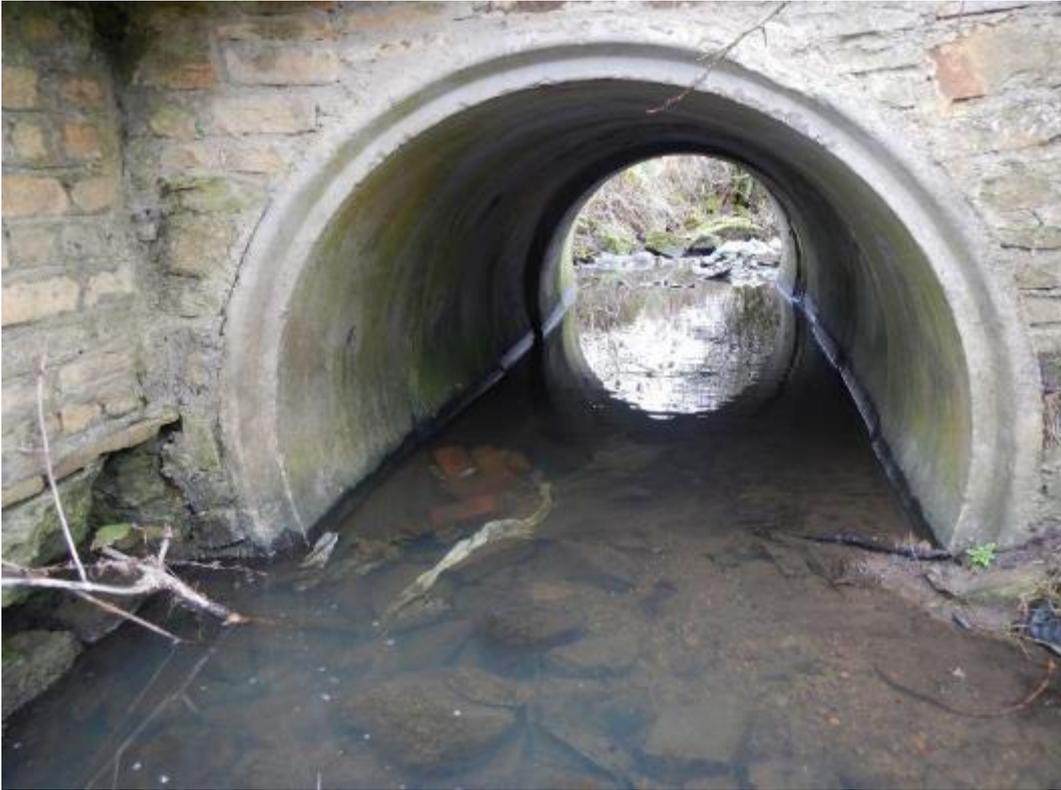
Photo DSCN0168. The first culvert observed was appropriately sunken and poses no issues (NZ 15856 37065).

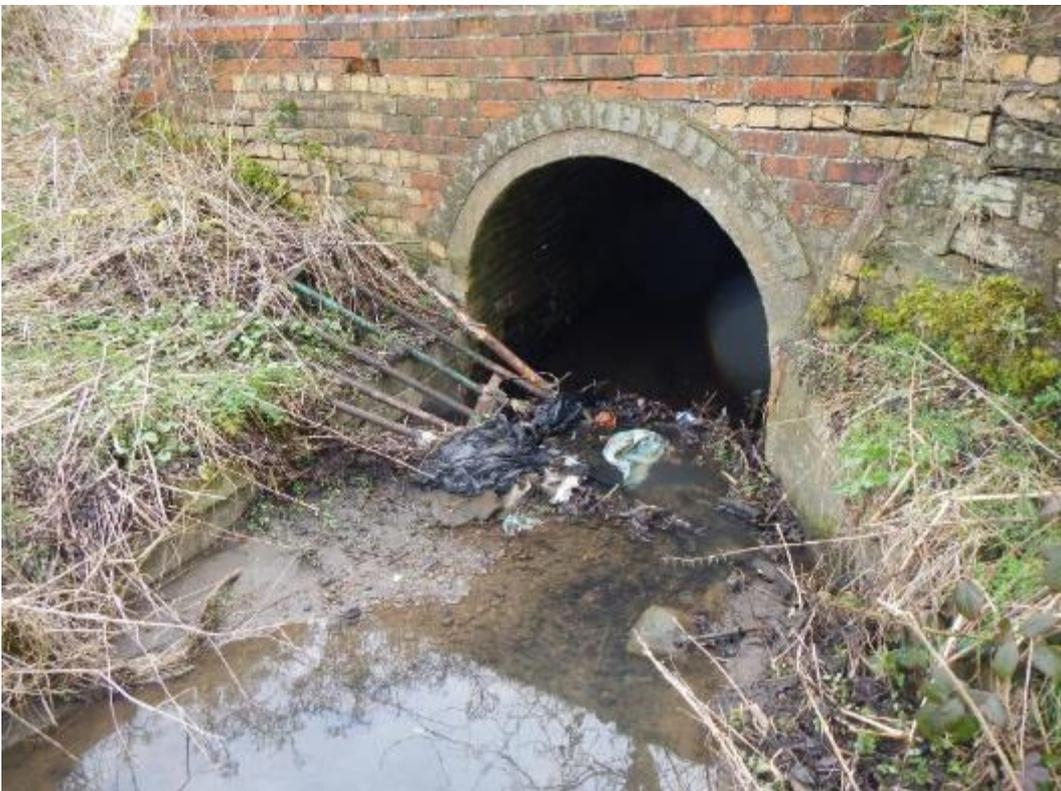
Photo DSCN0172. Obstruction A (NZ 15864 37047): a longer (c. 30m), older culvert creates potential fish passage issues through an inappropriately placed gate at the u/s end which had blocked with debris; all should be removed. Himalayan balsam was also noted at this location.

2	NZ 15864 37047	Medium priority owing to ease of solution by simply removing gate/blockage with volunteers. This would improve fish passage if any are present.
Obstruction Ai (shallow water within culvert).

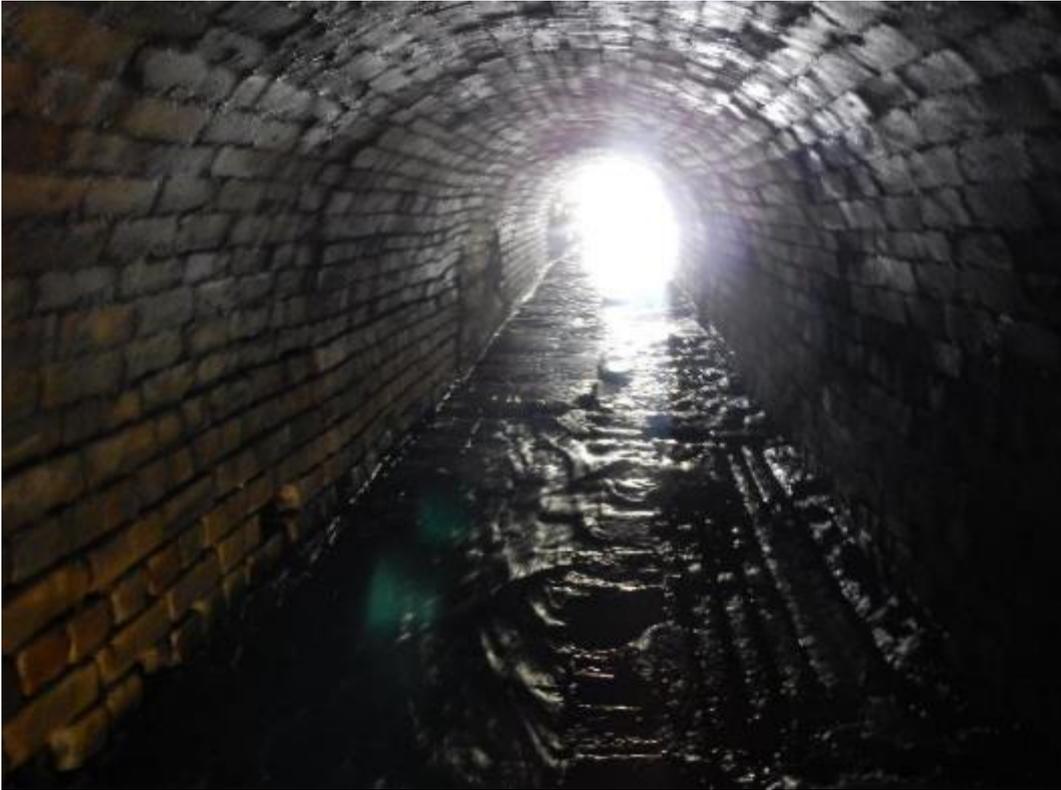
Photo DSCN0174. Obstruction Ai: inside the culvert, the uneven bed (focussing flows to one side) will aid fish passage by providing increased depth,

2	NZ 15864 37047	A single partial width baffle could be installed at the d/s end of the culvert to concentrate flow and increase depth within culvert. Low priority owing to location in catchment and significant issues d/s.
Obstruction Aii (step at d/s end of culvert).

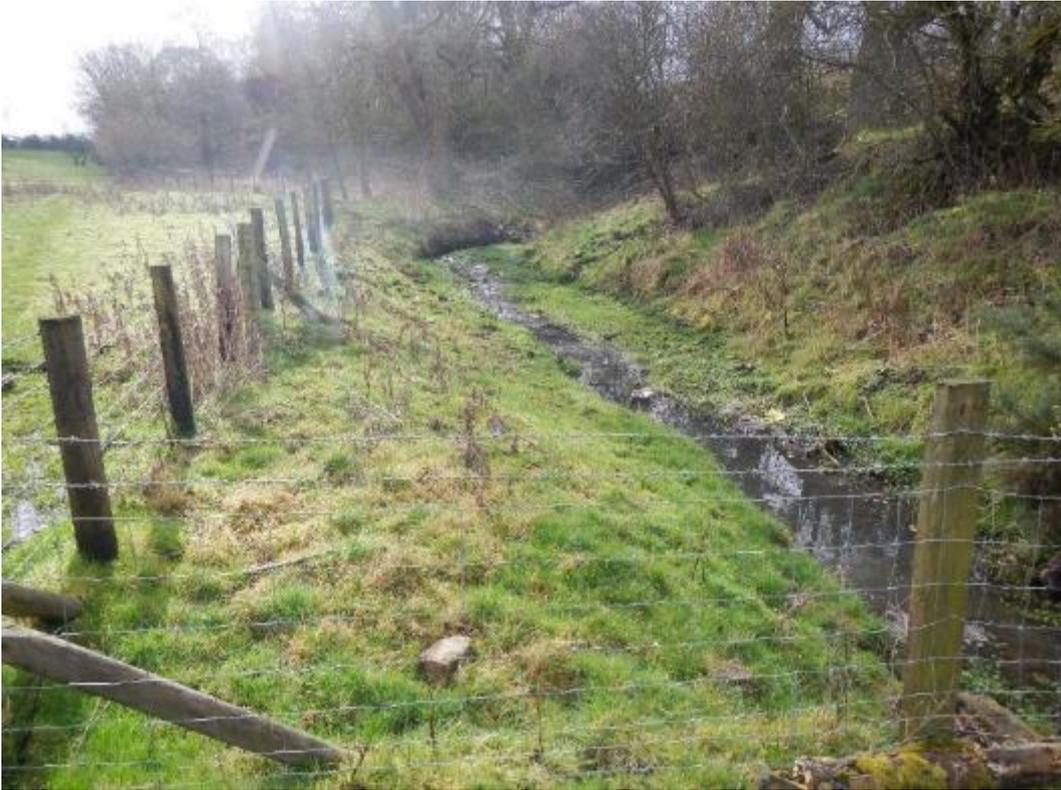
Photo DSCN0179. There is a small drinking area immediately d/s of the culvert, but the rest of the field is buffer fenced down to a wooded section. It should be noted that once the gate that is currently blocking the culvert upstream is removed, this fence could become the next debris catcher.

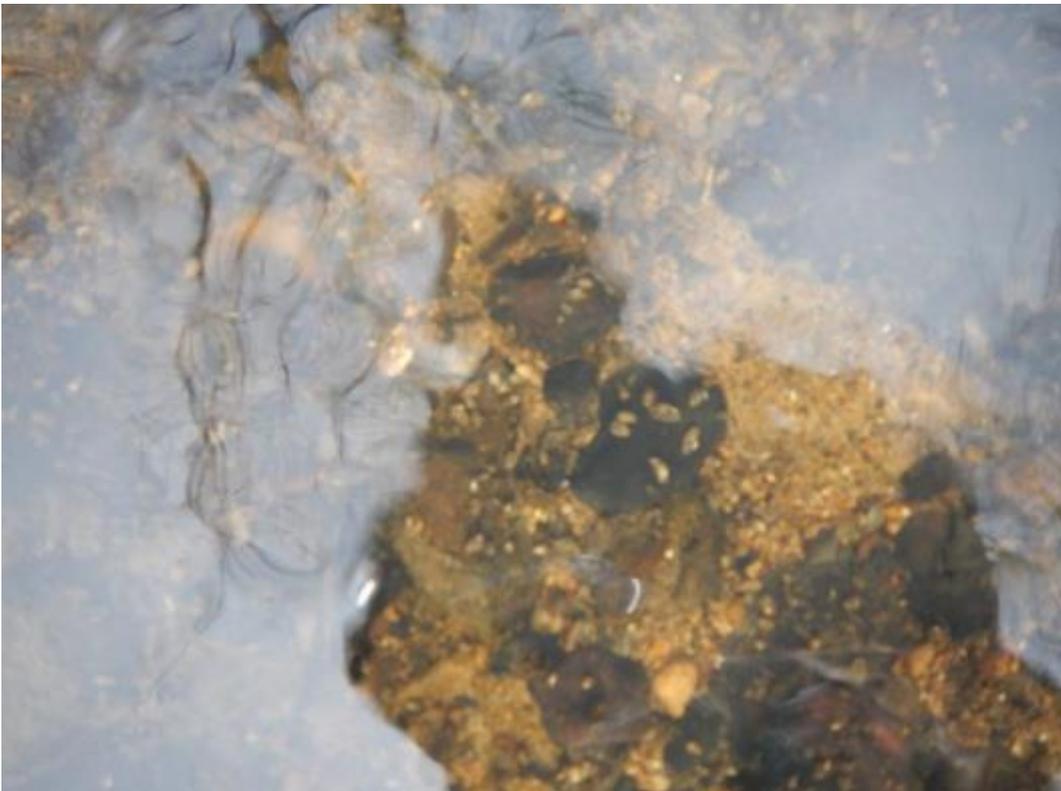
Photo DSCN0180. Within the wooded section, stone turning revealed some cased caddis and stoneflies, suggesting an improvement in water quality away from the point source pollution identified upstream.

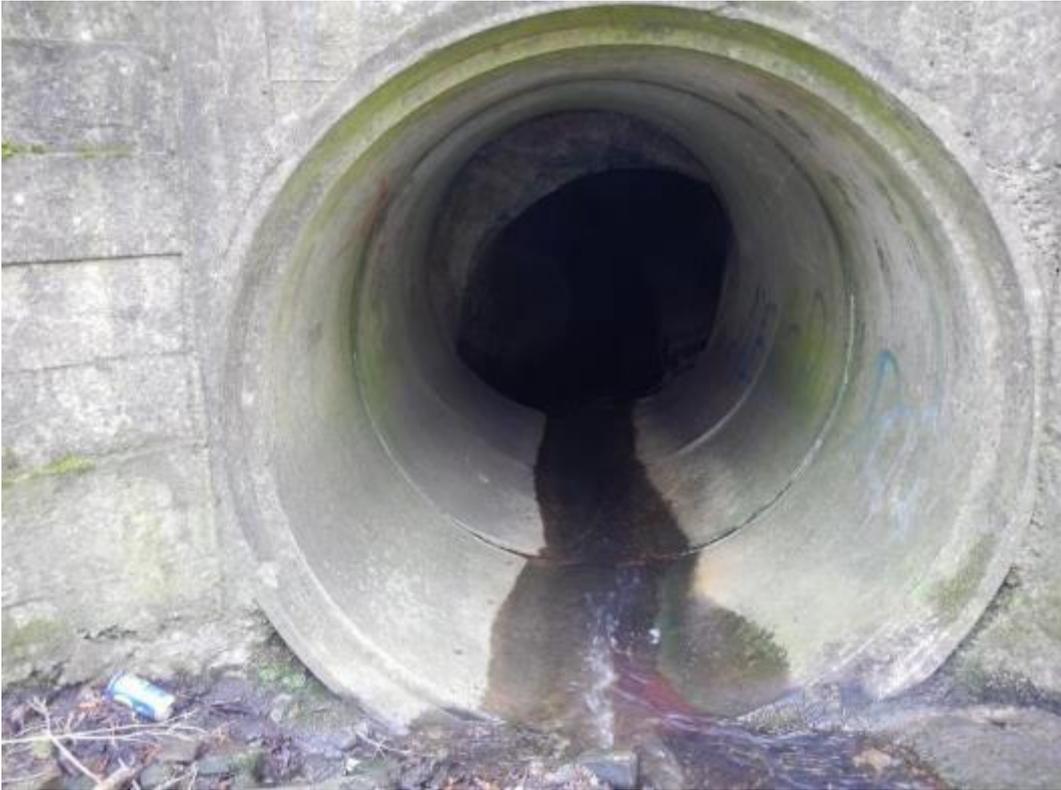
Photo DSCN0183. Obstruction B (NZ 15999 36780): a long culvert within the wood creates another obstruction to fish movement.

2	NZ 15999 36780	Shallow water in culvert could be improved with baffles but low priority owing to location in the catchment. The ideal solution would be full restoration to remove the culverts and reinstate a high quality surface channel.
Obstruction Bi (shallow water within culvert).

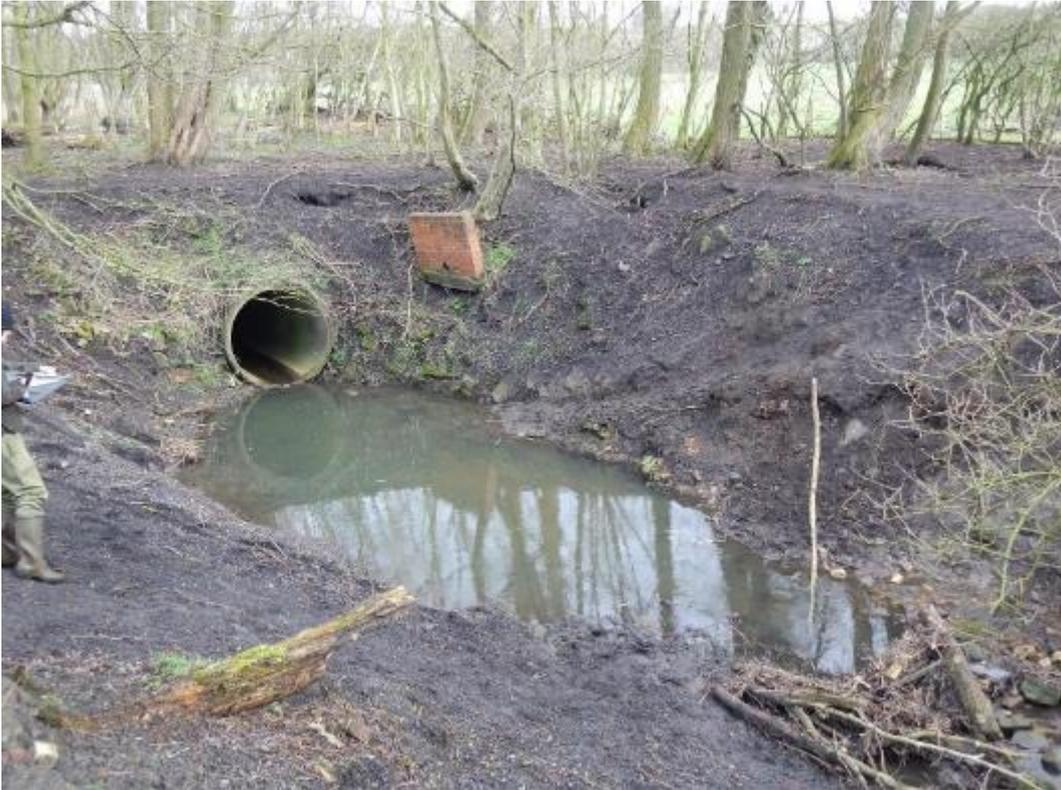
Photo DSCN0194. Obstruction Bii (NZ 16002 36701): the d/s of the culvert creates a minor step but the shallow flows within pose a greater issue to fish passage. By this point in the woodland, livestock (horses) have access to the banks, creating significant erosion and sediment input.

<p>2</p>	<p>NZ 15999 36780</p>	<p>Shallow water in culvert could be improved with baffles but low priority owing to location in the catchment.</p> <p>The ideal solution would be full restoration to remove the culverts and reinstate a high quality surface channel.</p>
<p>Obstruction C – ~1m high concrete weir.</p>

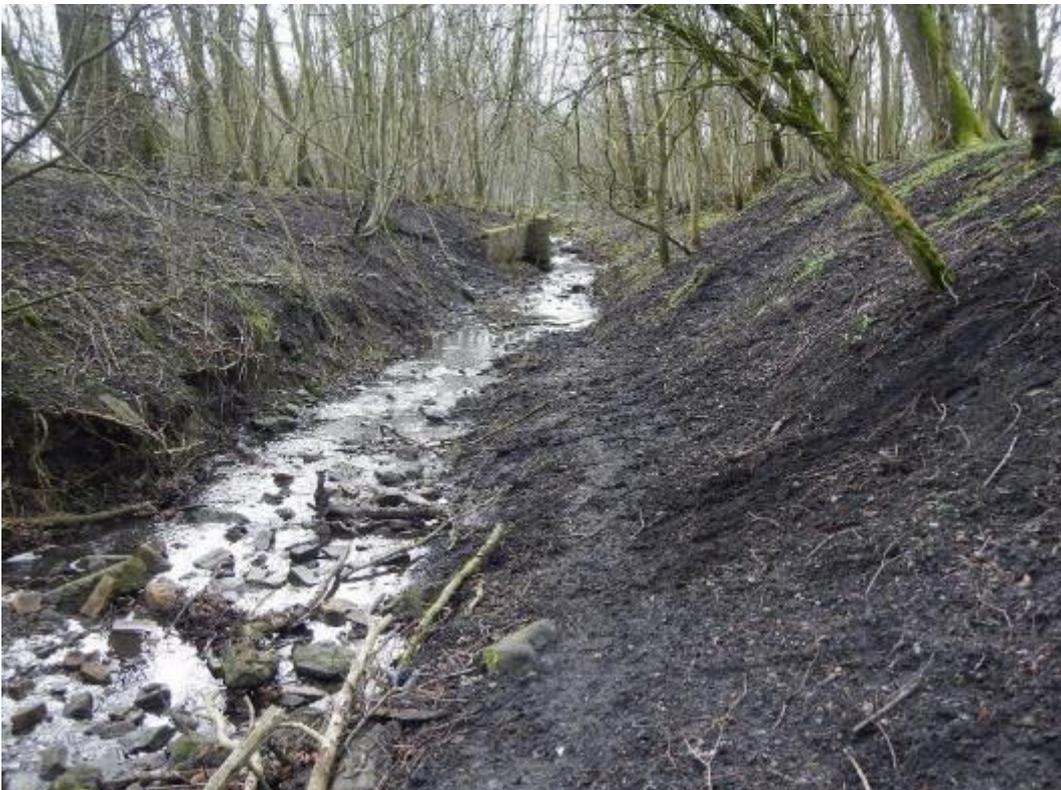
Photo DSCN0193. D/s of the culvert the channel appears to bisect reinstated ground (historic maps suggest a legacy of coal mining). Channel restoration and realignment to a more naturally sinuous course would be beneficial here, potentially incorporating removal of the culvert, but contaminated land is likely to be an issue. A strong chemical/tar-like odour was noted in this area and may indicate pollutants associated with the past mining.

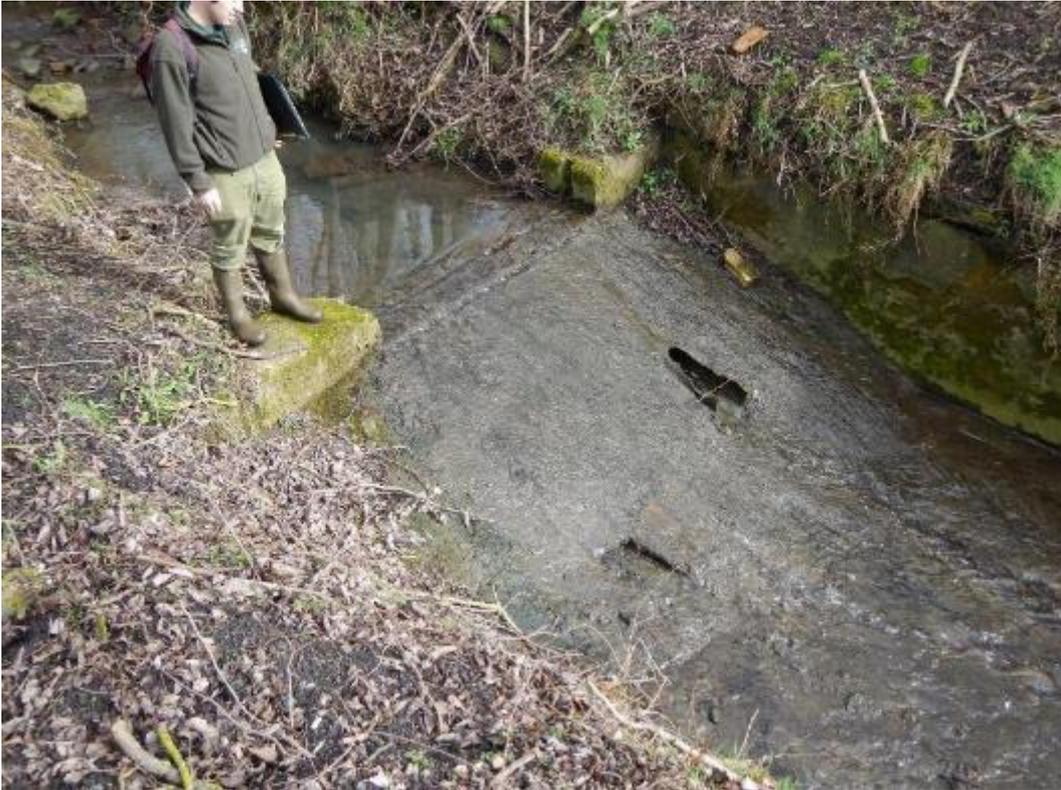
Photo DSCN0196. Obstruction C (NZ 15994 36625): a smooth-faced concrete weir creates a major barrier to fish passage and marks the start of a long section of straightened, concrete-lined channel.

<p>2</p>	<p>NZ 15994 36625</p>	<p>This weir should be removed, ideally as part of a reach-scale scheme to restore the channel of the beck.</p>
<p>Obstruction D – concrete block weirs.</p>

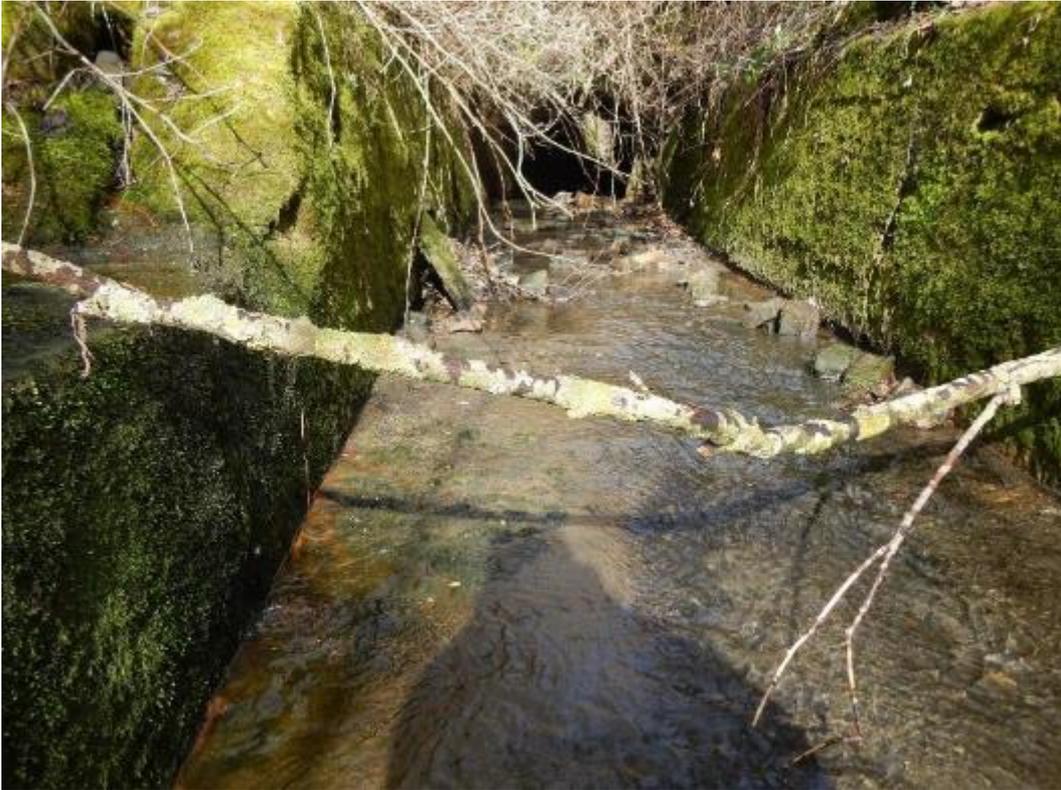
Photo DSCN0202. The concrete-lined and walled channel d/s of the culvert. Also note the perched tributary channel (left of shot).

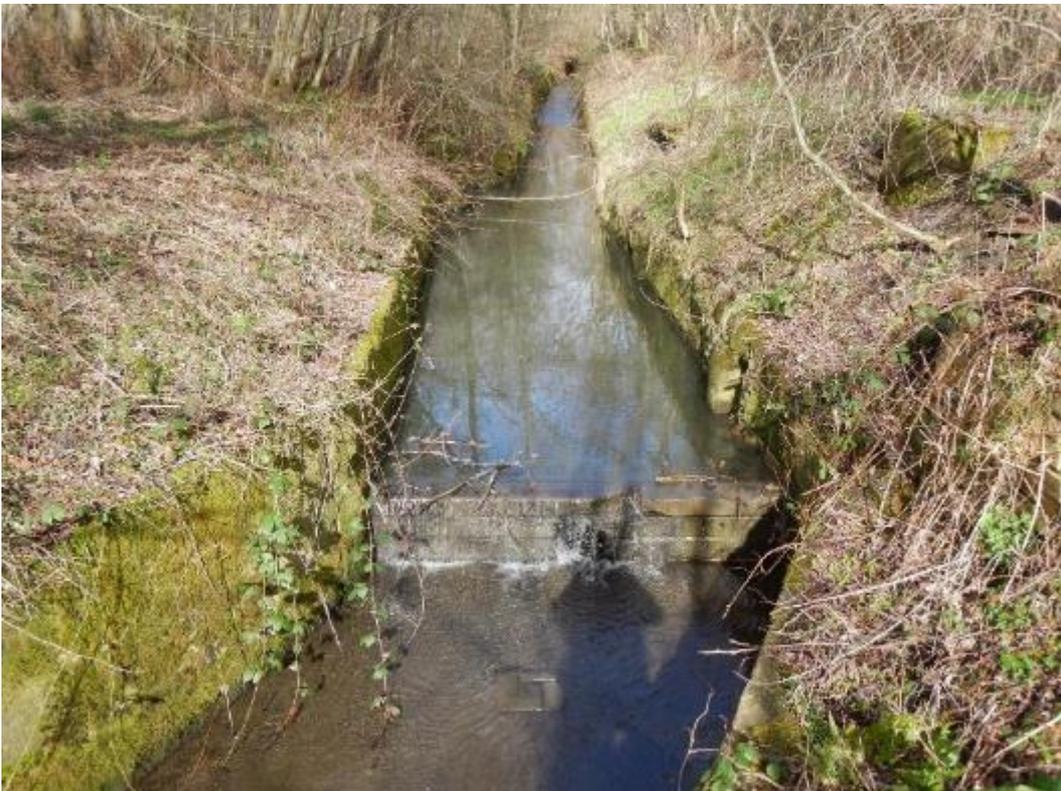
Photo DSCN0206. Obstruction D (NZ 16023 36548): a concrete-block weir creates a major barrier to fish passage. However, this structure also provides the only real potential for water depth via impoundment within the over-wide, artificial channel.

<p>2</p>	<p>NZ 16023 36548</p>	<p>The weir could be easily removed by volunteer work parties to reinstate fish passage. However, if fish are not present, they may be better retained as pool features for other wildlife in what would otherwise be a bare concrete channel.</p>
<p>Obstruction E – step in concrete- lined bed.</p>

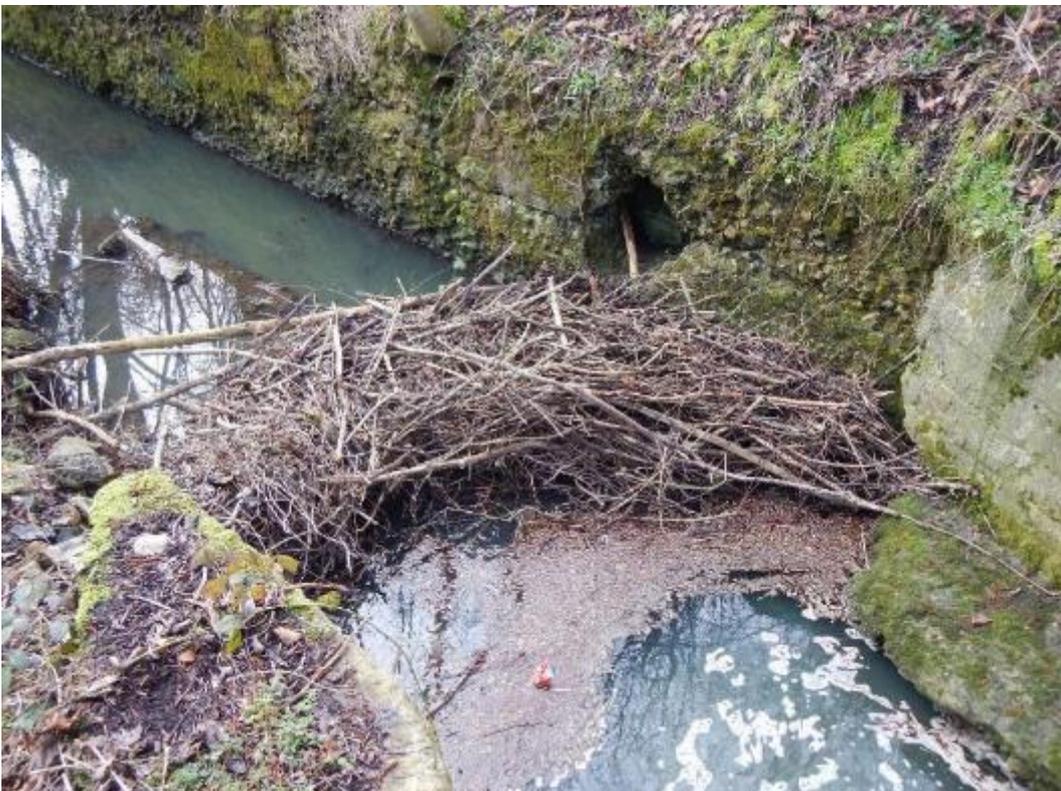
Photo DSCN0211. The incised, narrow, walled channel increased suffers an increased potential for blockage through natural woody material input that would otherwise be a valuable addition within a natural channel. By this point, the water clarity and surface scum give a strong suggestion of water quality issues.

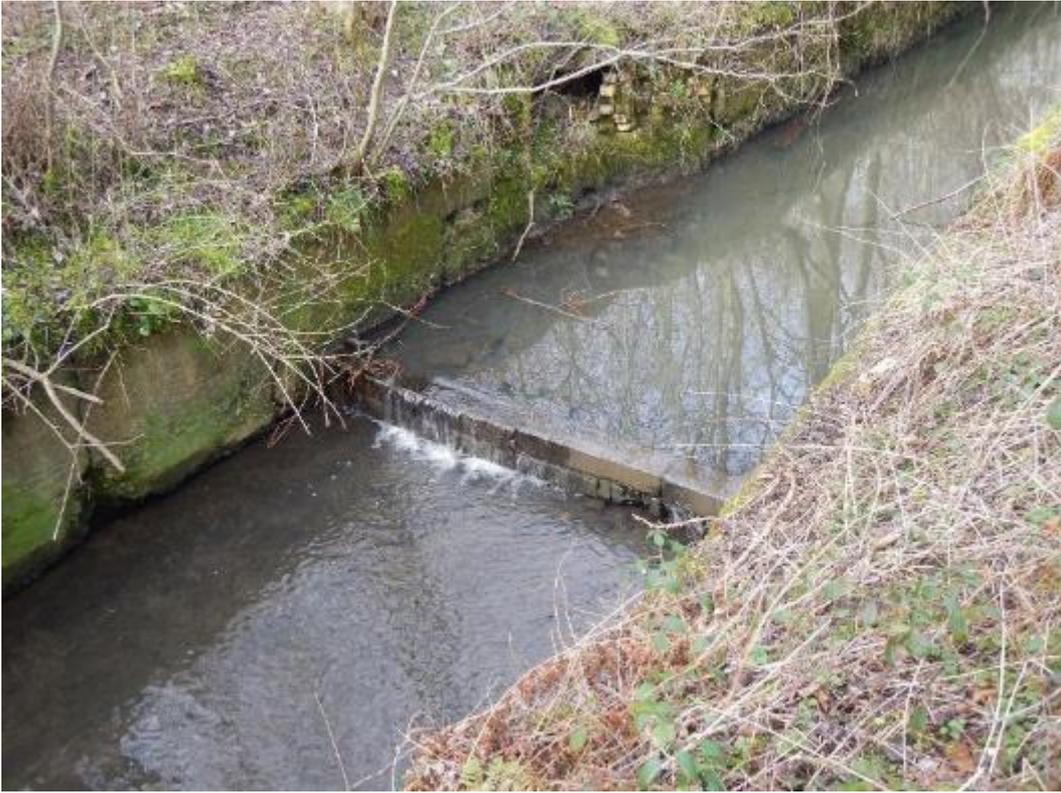
Photo DSCN0214. Obstruction F (NZ 16039 36506): a second concrete-block structure with the same cons and pro as the one u/s.

<p>2</p>	<p>NZ 16039 36506</p>	<p>The weir could be easily removed by volunteer work parties to reinstate fish passage. However, if fish are not present, they may be better retained as pool features for other wildlife in what would otherwise be a bare concrete channel.</p>
<p>Obstruction G – collapse culvert section.</p>

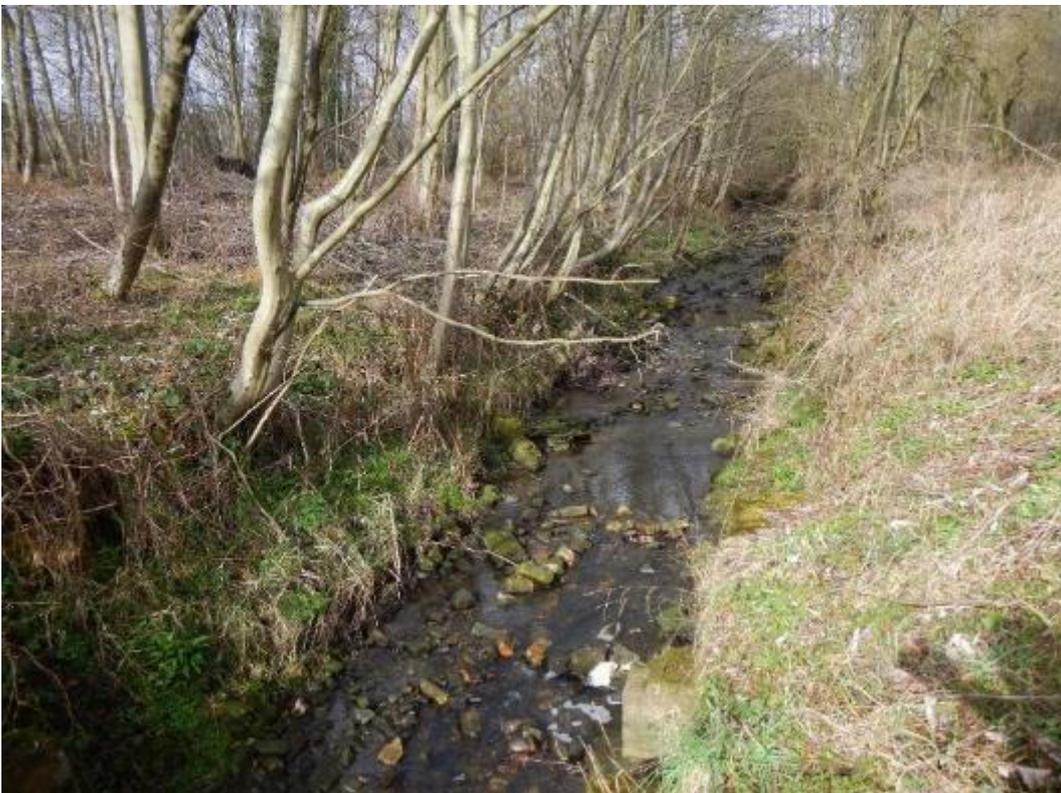
Photo DSCN0220. A short distance d/s of the second concrete-block weir the channel regains a natural bed and habitat quality increases; however, the straightened channel is a far more uniform depth than would occur naturally through scour and deposition if it were sinuous.

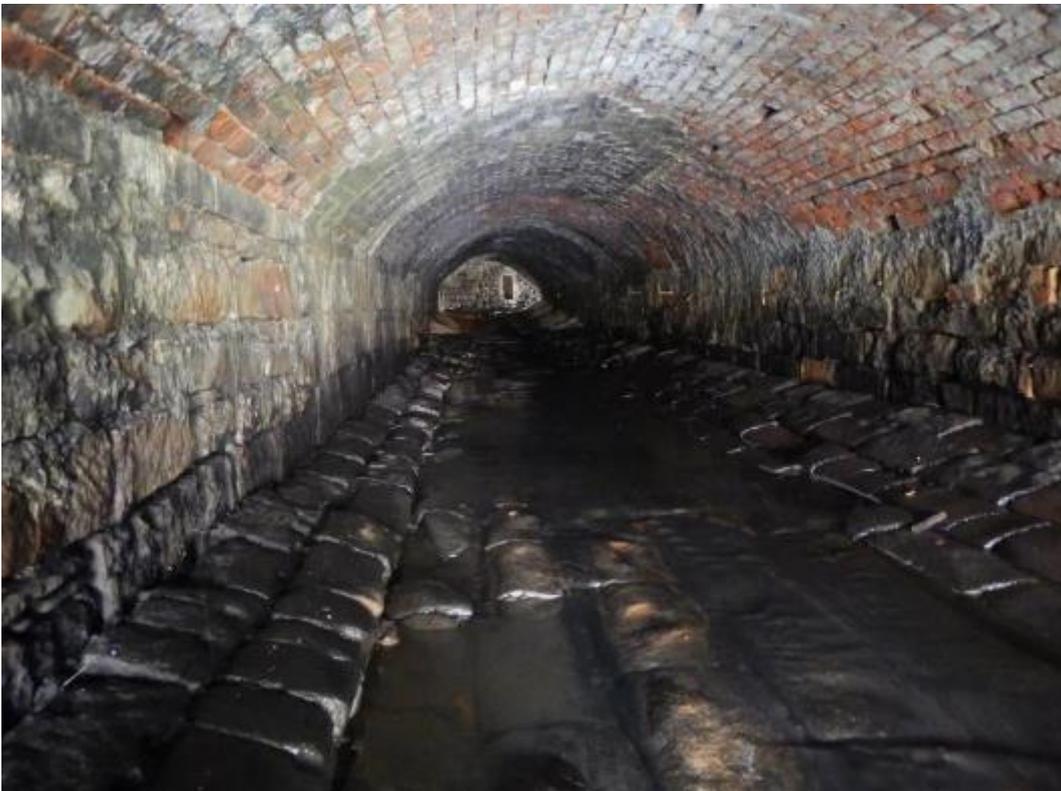
Photo DSCN226. Obstruction Gi: within the culvert, the scoured bricks of the invert allow some water depth and would ease fish passage but an increase in gradient toward the u/s 1/3 of the culvert reduces its passability.

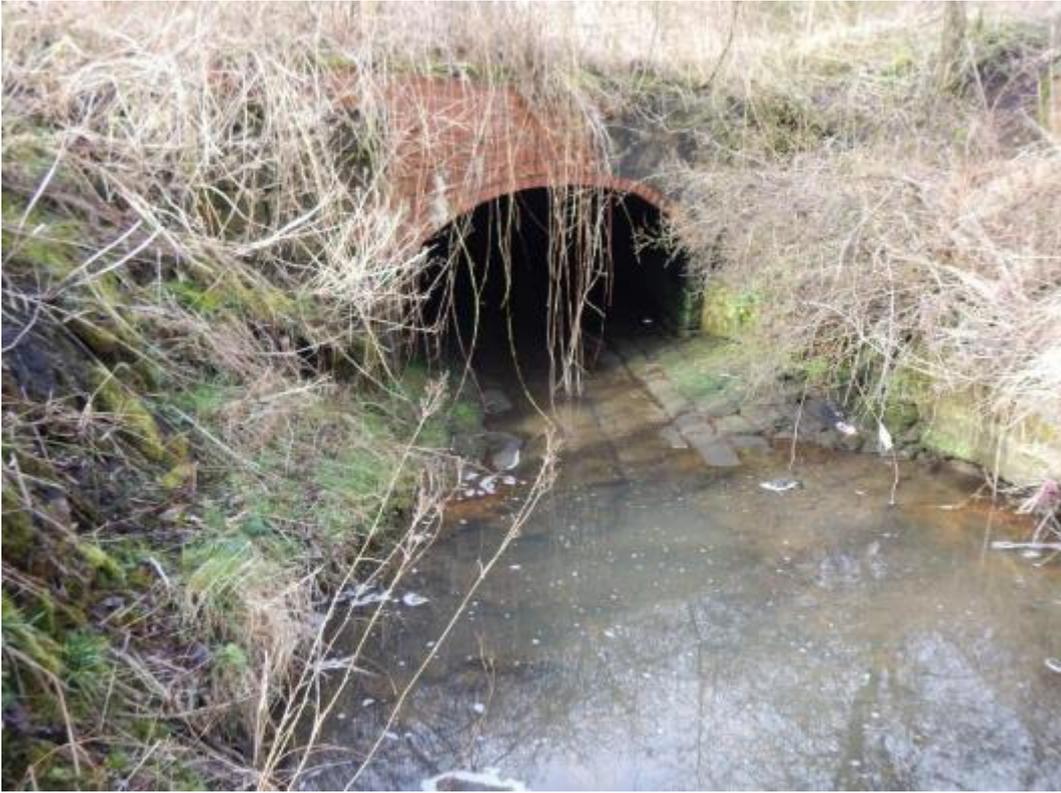
Photo DSCN222. Obstruction Gii: the d/s end of the culvert is sunken and access is possible but the shallow water impedes passability.

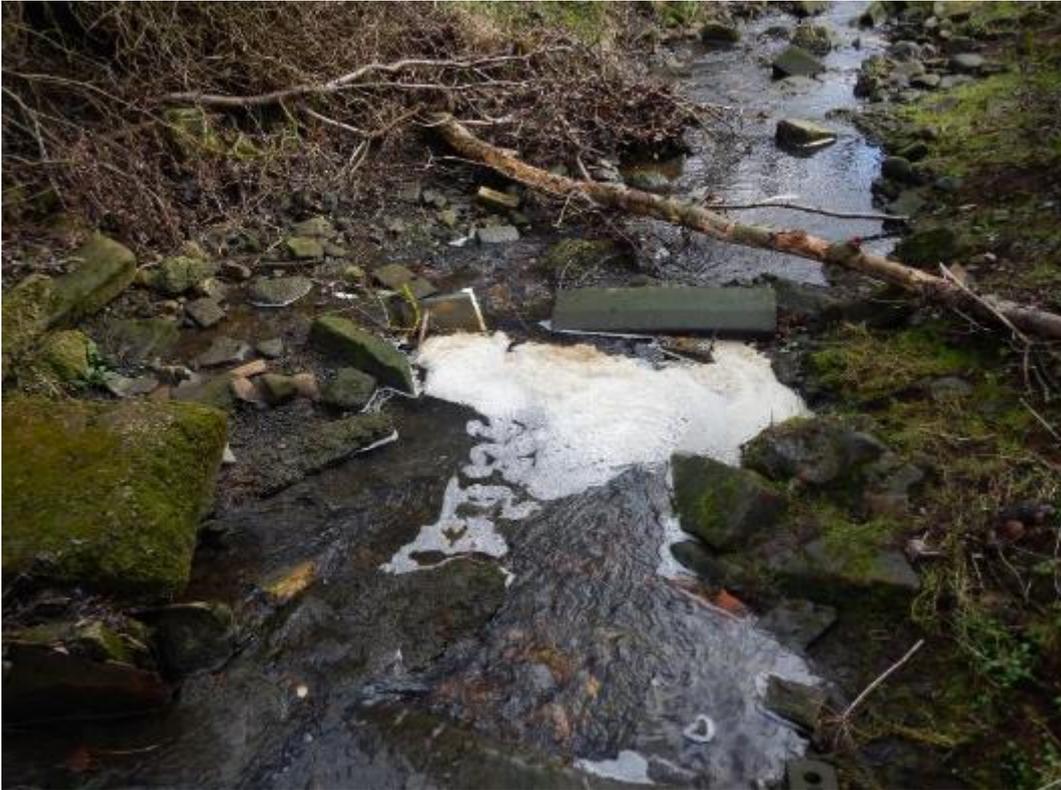
Photo DSCN0232. Although foam on the water surface does not always signify man-made pollution, in this instance it is suspected to be symptomatic of the range of water quality issues observed along the watercourse.

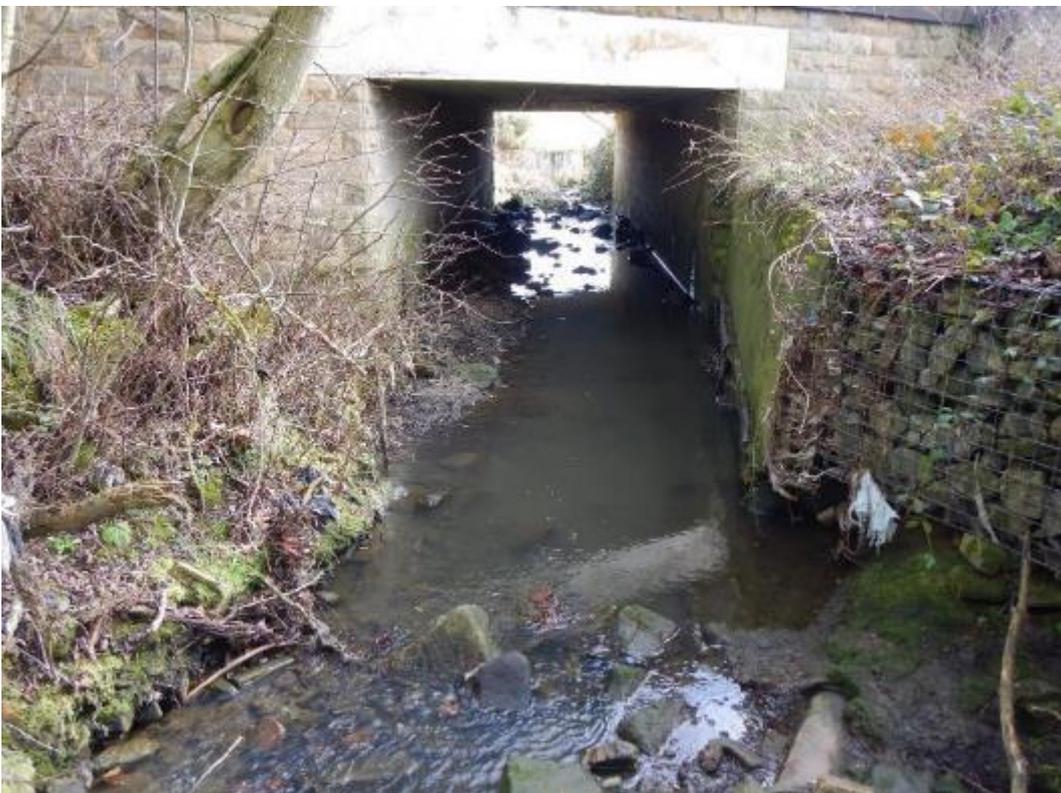
Photo DSCN0233. The B6298 road crossing poses no real issues but the bank upstream is suffering from erosion that is likely to ultimately threaten the road (see below). This could be used as further support for a scheme to address the channel modification issues with river restoration throughout the reach upstream.

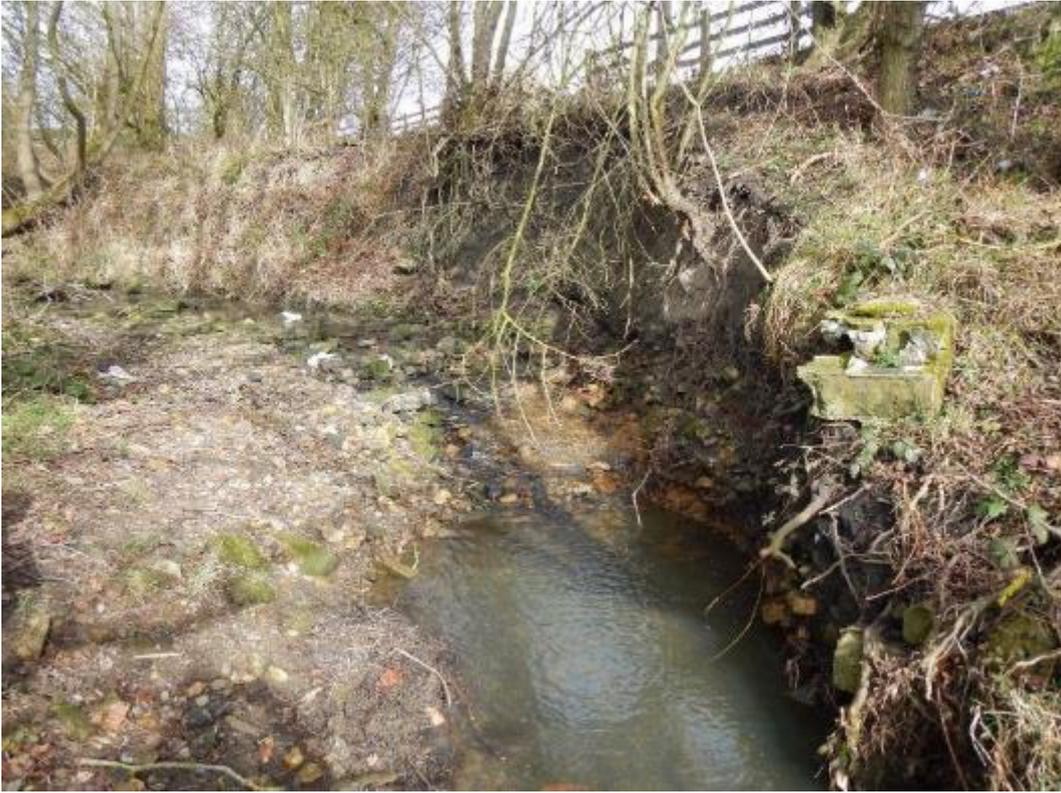
Photo DSCN0234. Erosion upstream/alongside the B6298.

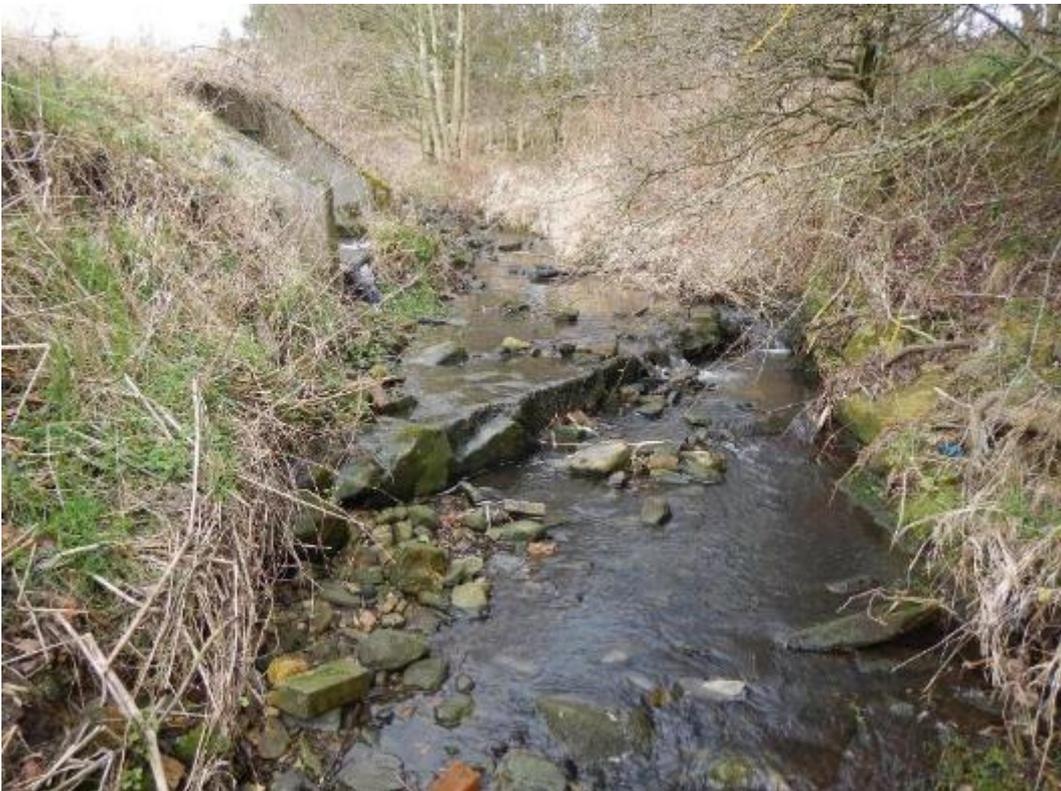
Photo DSCN0238. Obstruction H (NZ 16321 36244): a concrete step in the bed creates a minor fish passage issue. The angle has facilitated some sediment retention in the u/s corner and aids passage somewhat.

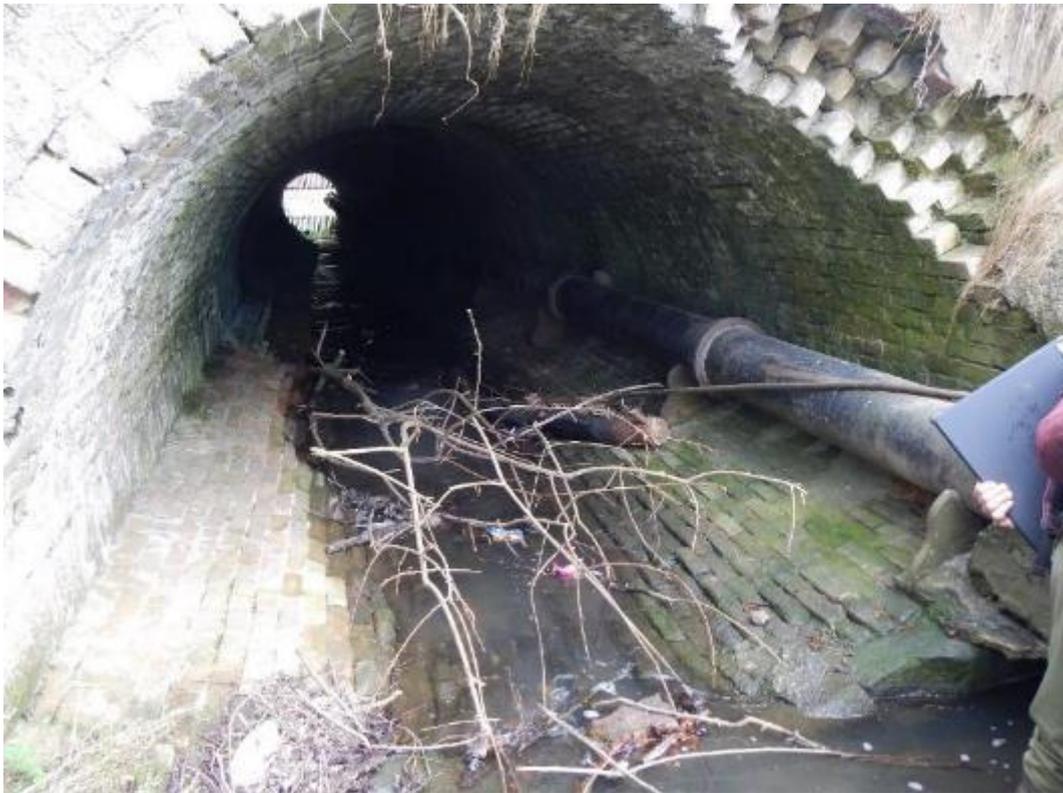
Photo DSCN02339. Obstruction I (NZ 16329 36239): the culvert under the disused railway u/s of Crook allows relatively free fish passage.

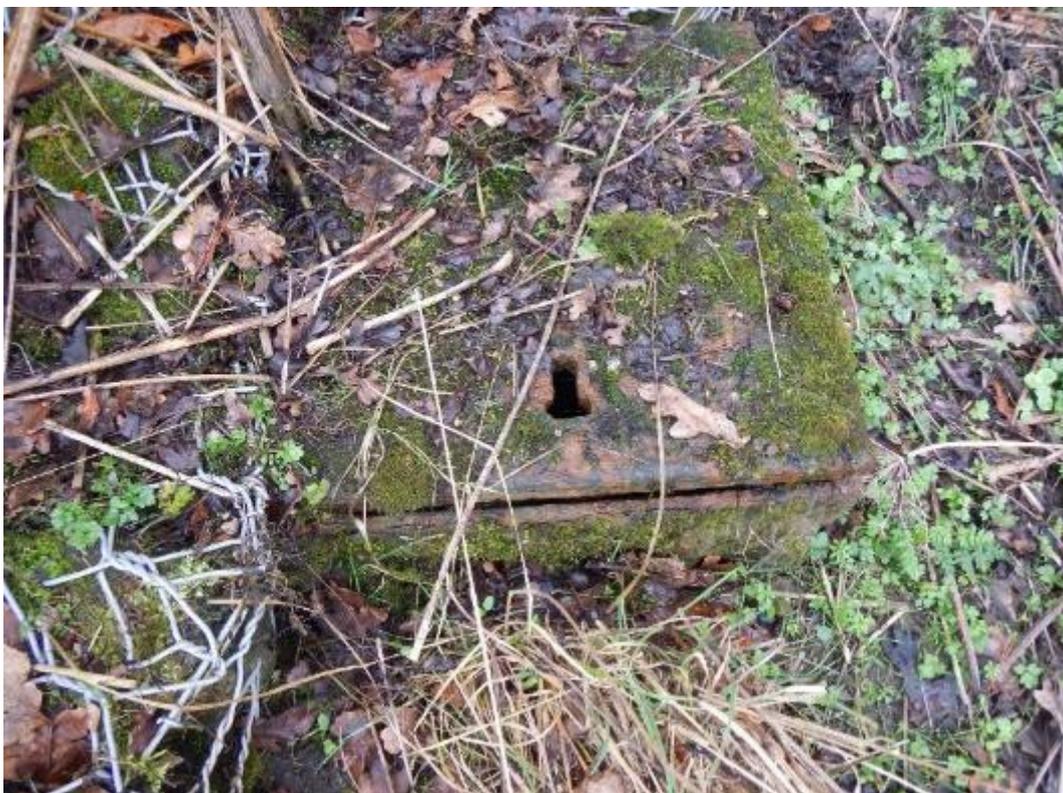
Photo DSCN0240. A strong sewage odour was emanating from a poorly sealed inspection chamber immediately d/s of the culvert (NZ 16384 36223). This is not necessarily an issue but may highlight outdated infrastructure with a potential for issues in the future.

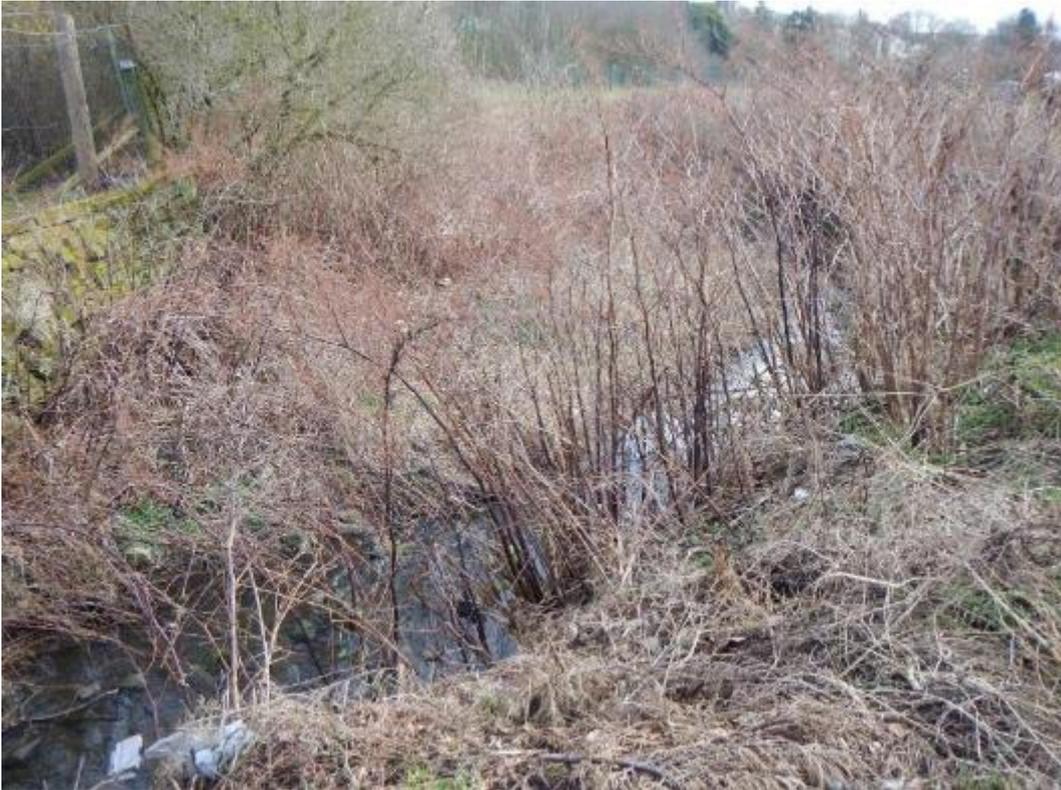
Photo DSCN0245. The first area where large stands of Japanese knotweed were noted around NZ 16510 35946. This area should form the starting point for investigations back u/s to confirm its extent; from which the infestation can start to be addressed on the catchment.
