**Walkover Assessment
Beechburn Beck
(River Wear Catchment)
County Durham
05/03/2019**

Undertaken by Gareth Pedley

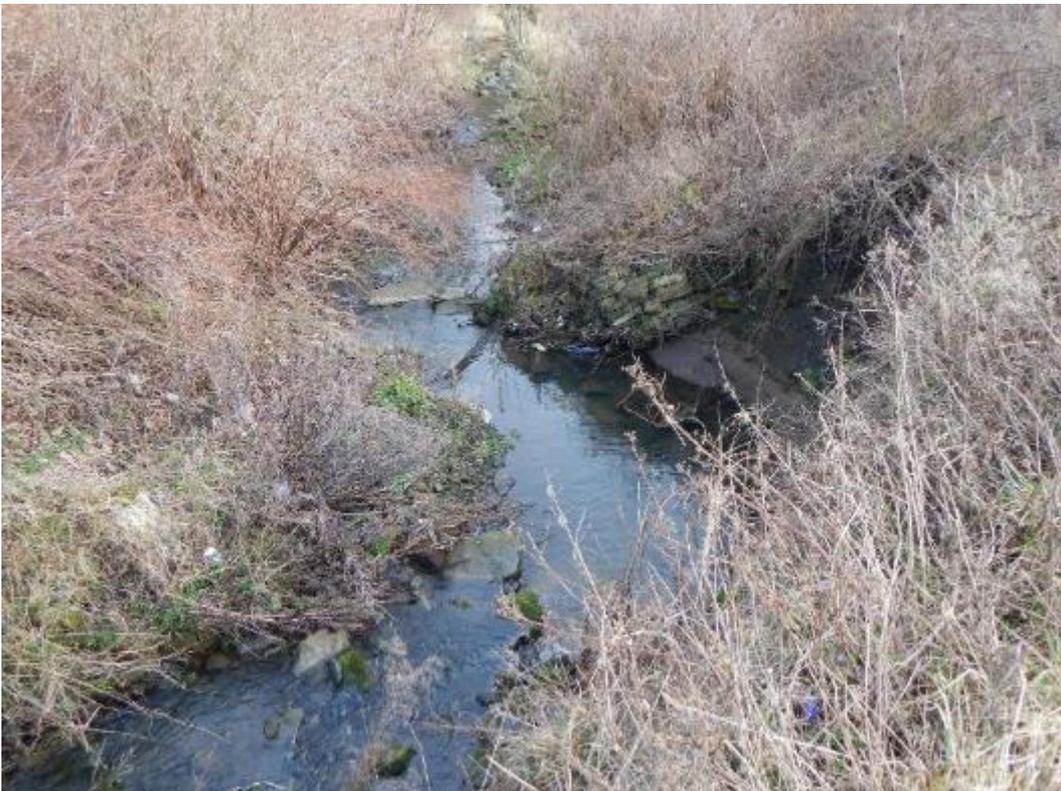
Photo DSCN0246. Obstruction J (NZ 16526 35937): a small raised bed cross-section creates a minor obstruction. Nonetheless, it should be removed if there is no dependent infrastructure.

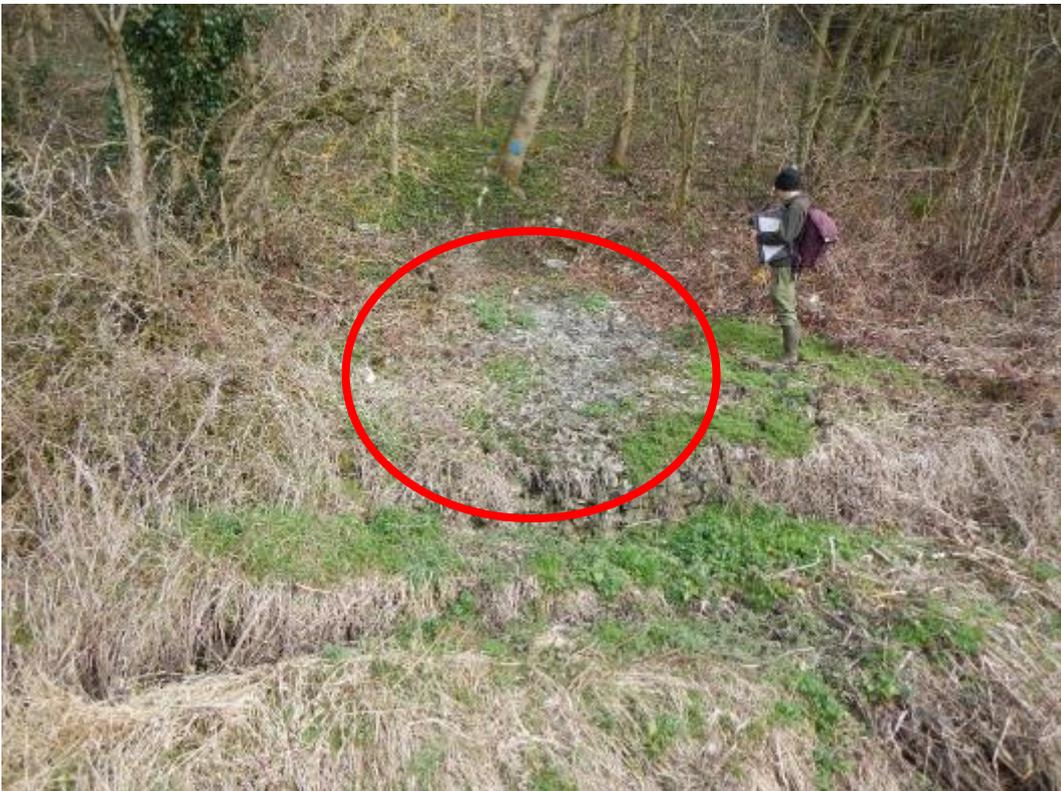
Photo DSCN0249. Point source pollution 2 (NZ 16612 35882; LB): raw sewage and litter have clearly been emanating from a pipe along the LB side of the beck.

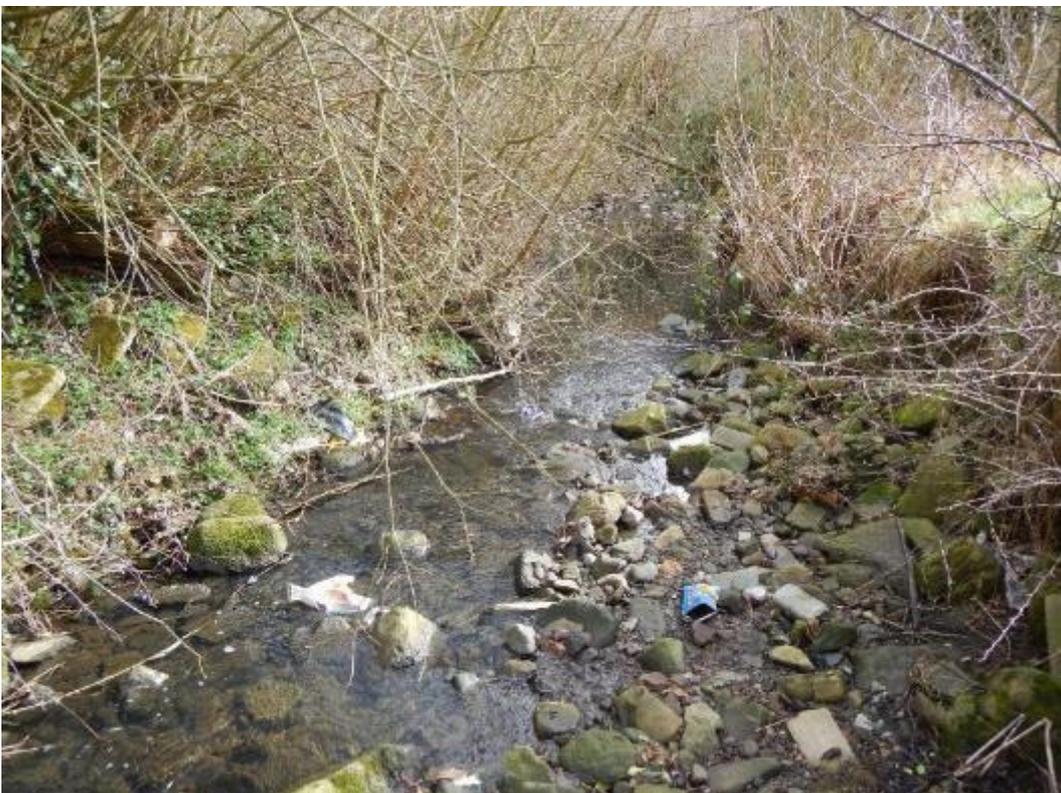
Photo DSCN0257. Downstream of the concrete channel, the habitat quality improves with good habitat potential for fish and invertebrates. Progressing d/s from the concrete-lined channel, which could well be a barrier (physical and/or behavioural) to fish colonisation/recolonisation, the potential of the watercourse to support fish populations increases.

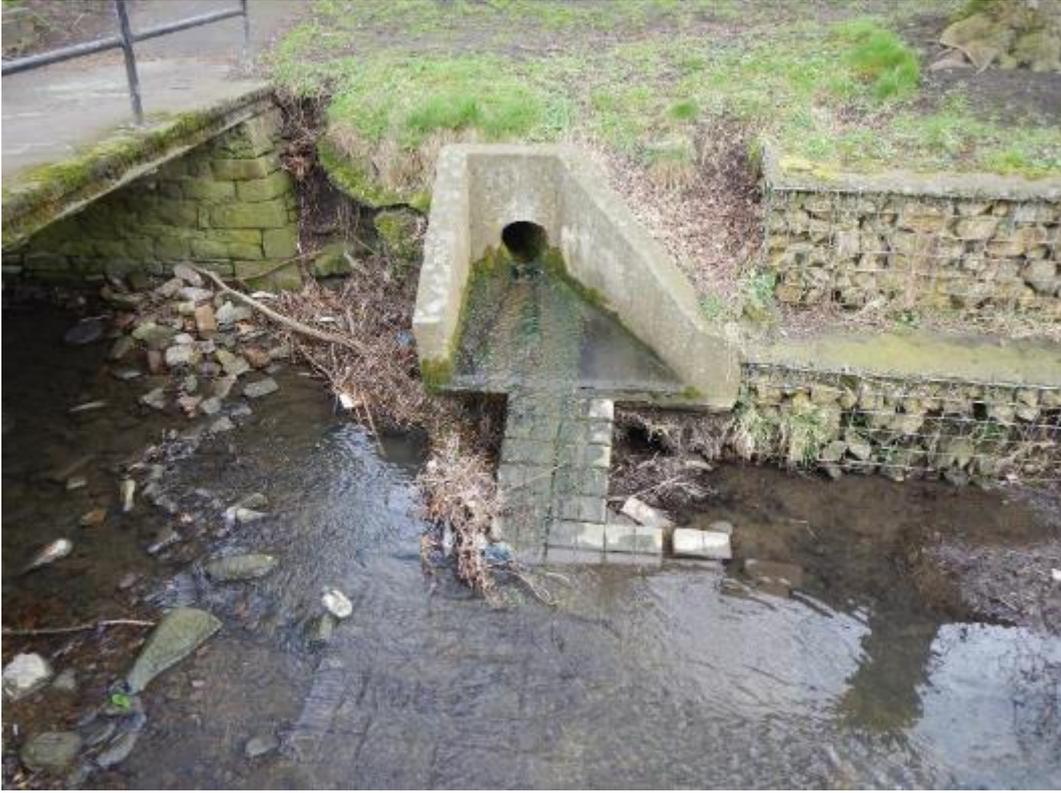
Photo DSCN0258. Point source pollution 3 (NZ 16802 35397): suspected high nutrient discharge, as evident by increased algal growth on the outfall structure.

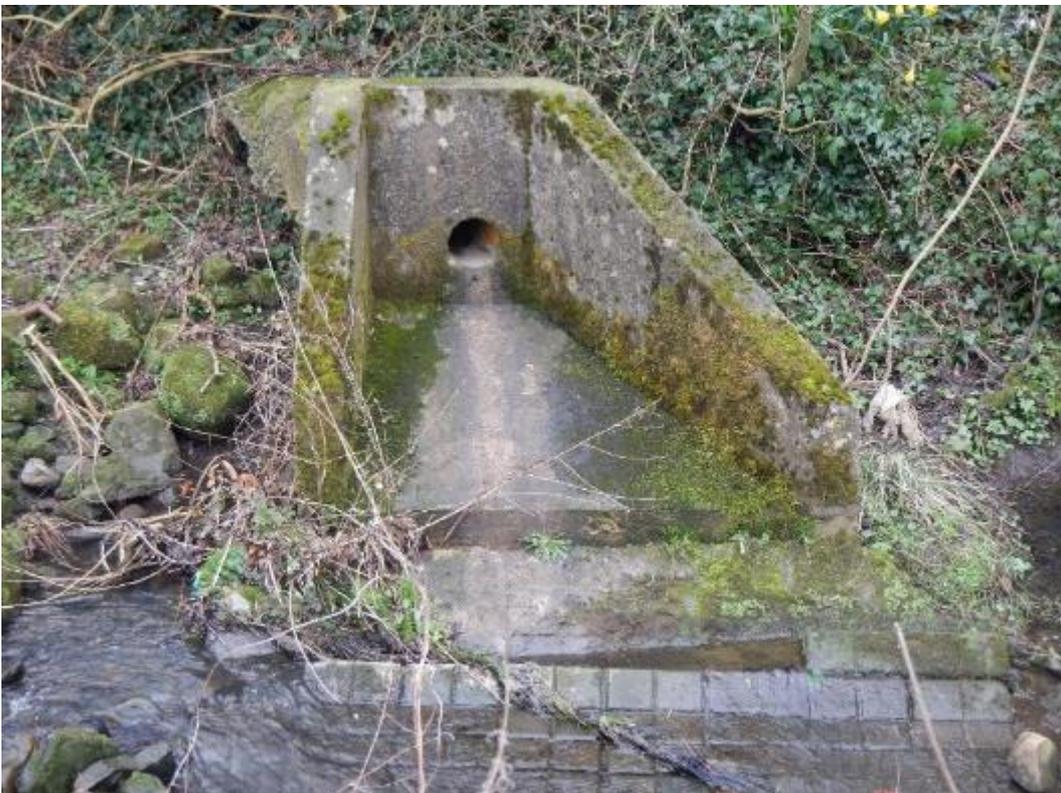
Photo DSCN0260. Point source pollution 4 (NZ 16785 35345): a lack of algae and moss at this discharge suggests it receives regular flow (but it is of low nutrient). The grey staining suggests that it does supply elevated levels of fine sediment, potentially from road runoff.

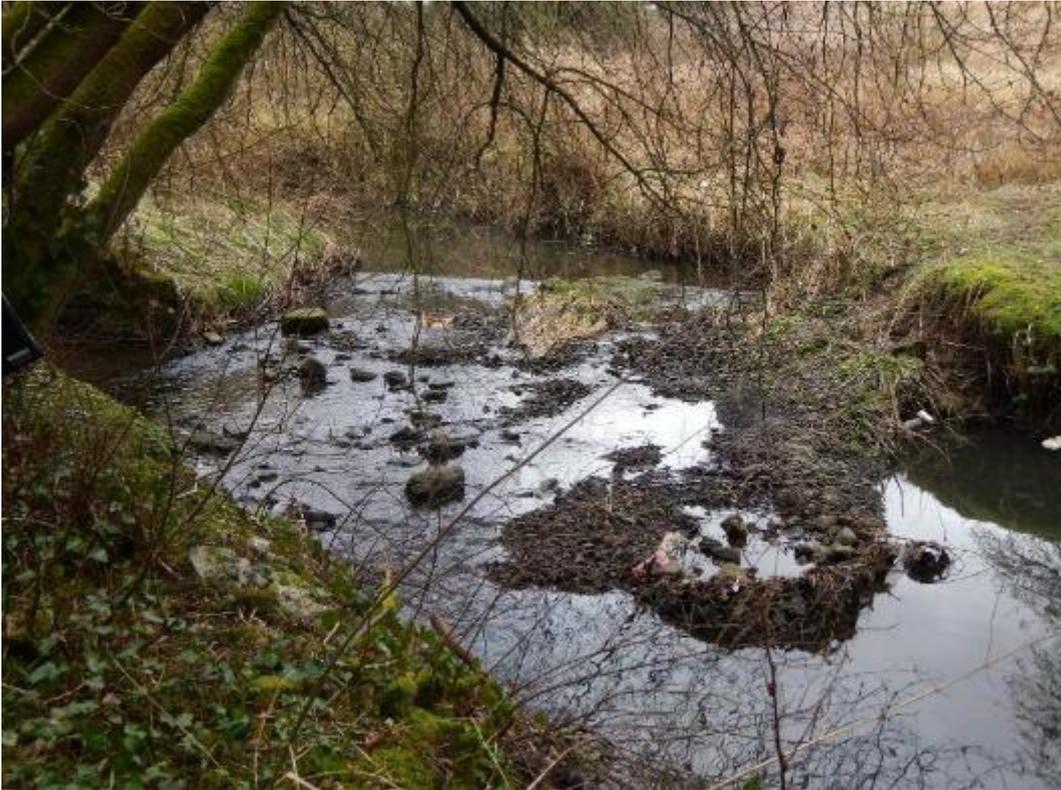
Photo DSCN0262. Obstruction M (NZ 16752 35330): bed scour protection at a combined sewer overflow and a raised pipe crossing create a small obstruction – both aspects are very poor practice.

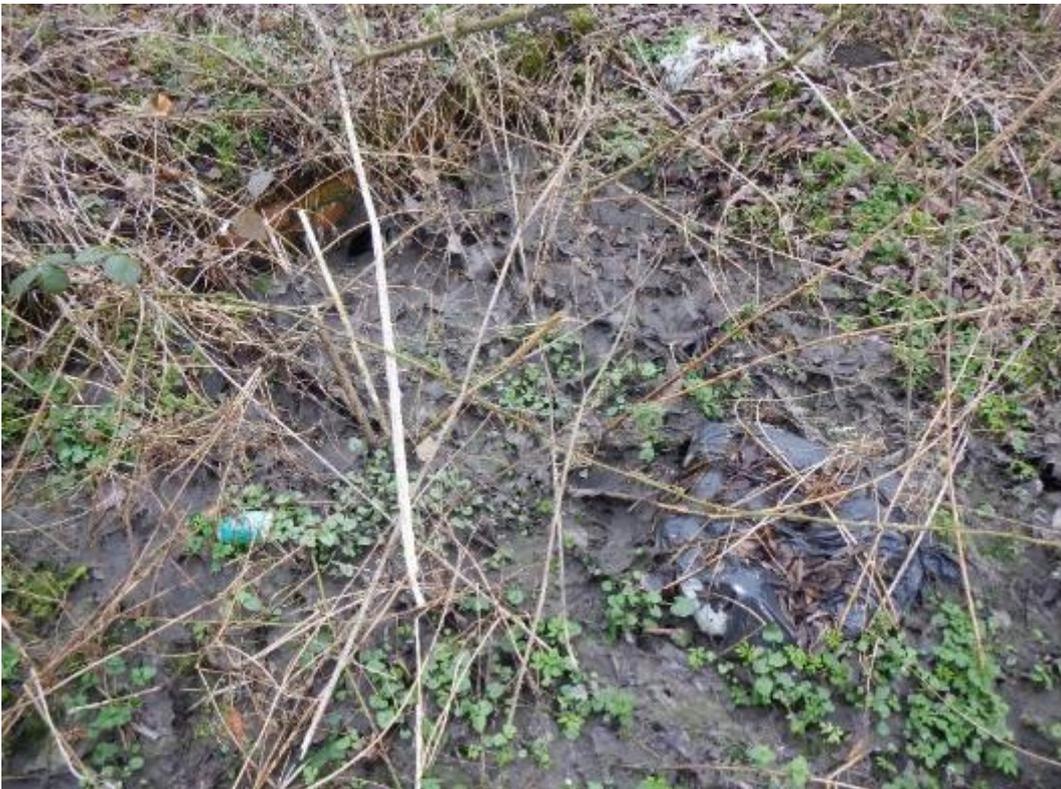
Photo DSCN0267. Point source pollution 5 (NZ 16741 35315): in the vicinity of the overflow, another poor water quality discharge was observed.

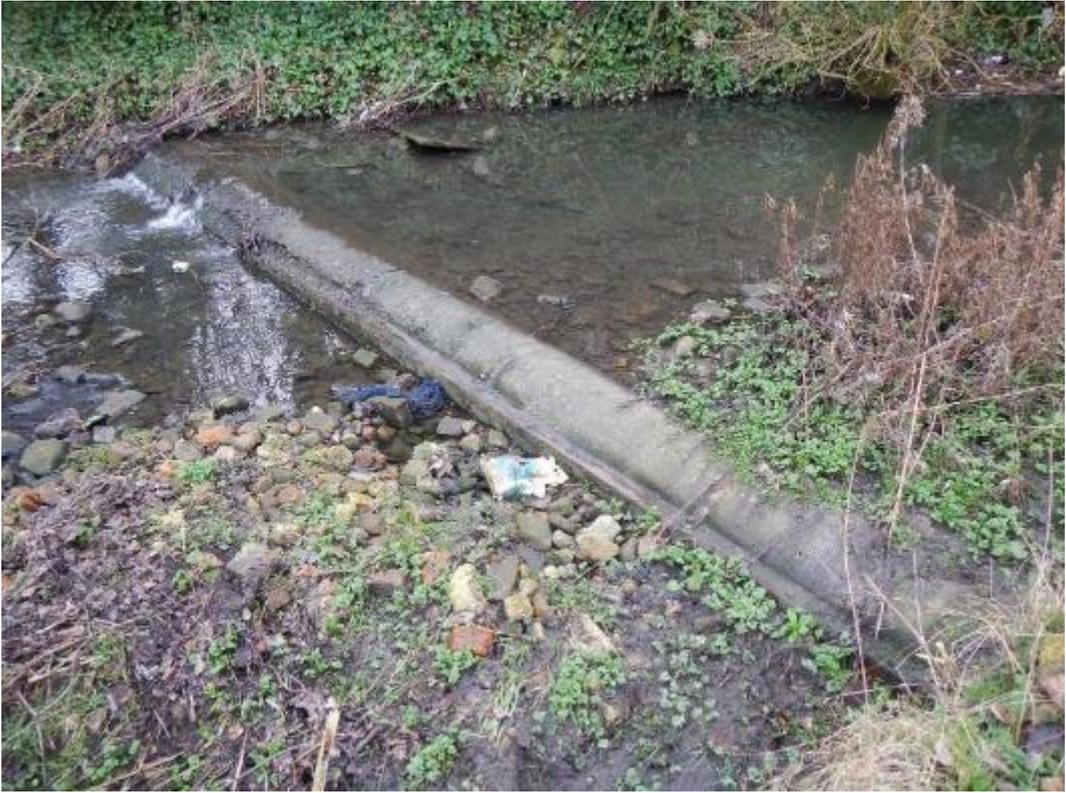
Photo DSCN0268. Obstruction N (NZ 16736 35307): the raised pipe crosses the channel again a short distance d/s.

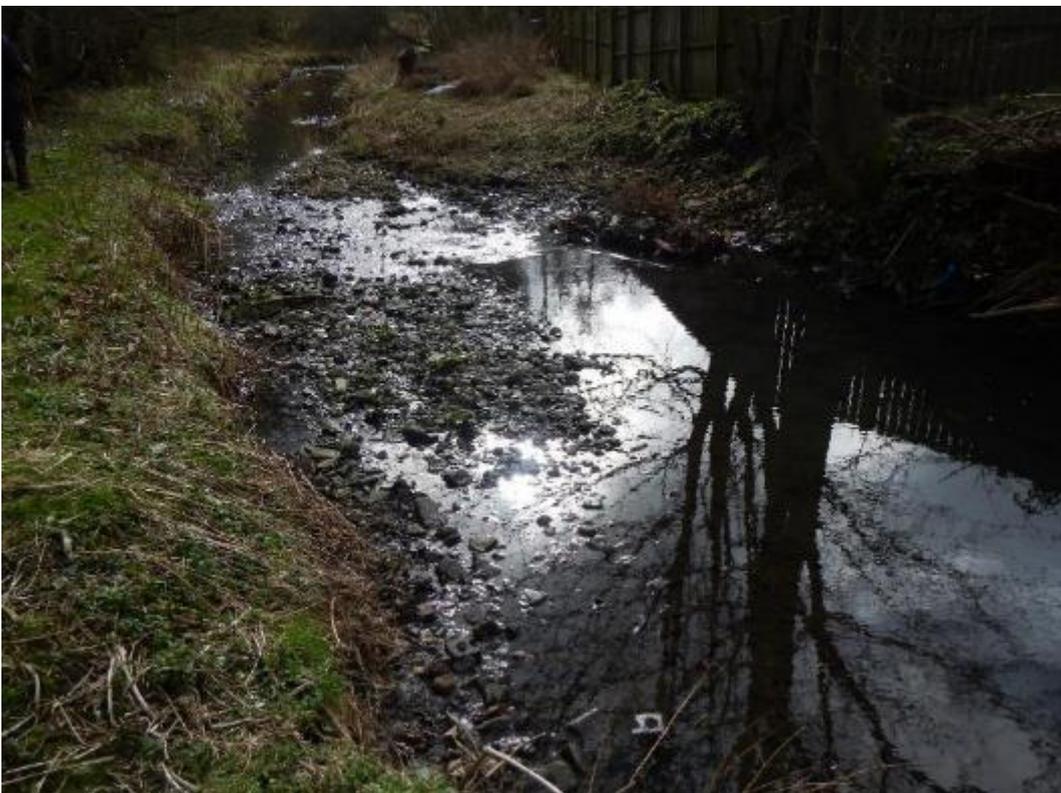
Photo DSCN0293. In areas where the channel has more freedom and allowed more natural width variability, valuable depositional features are present.

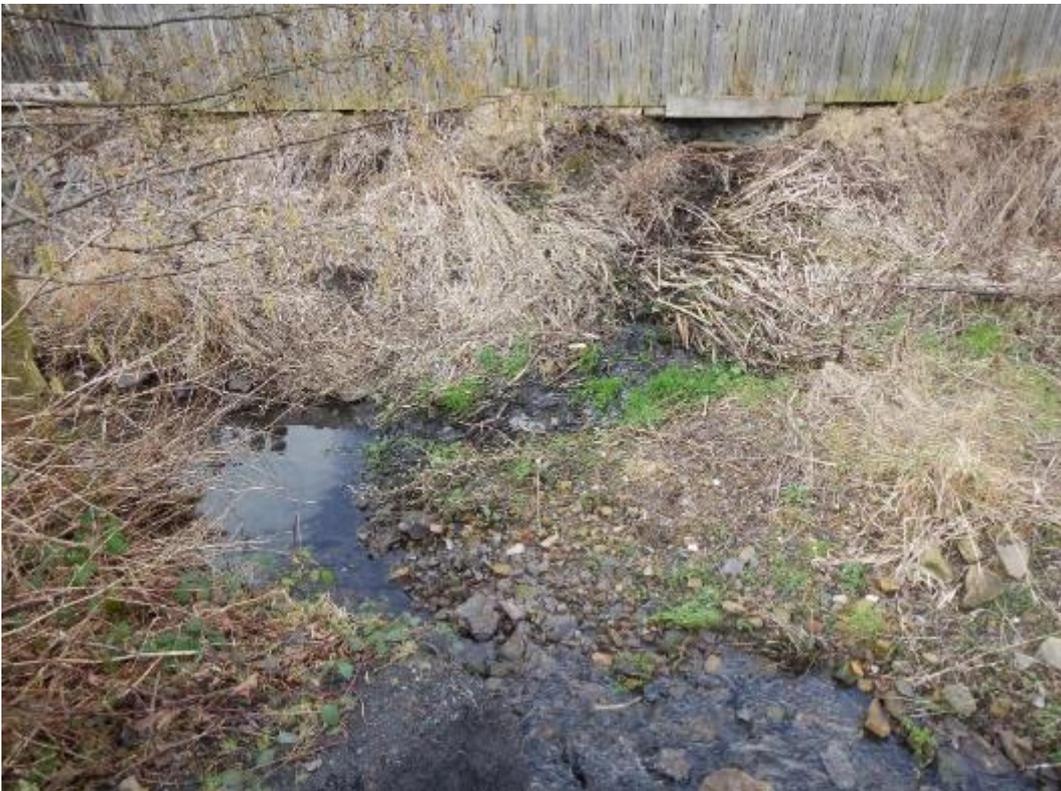
Photo DSCN0294. At NZ 16478 34513, the signs of a coal mining heritage are again evident where eroded material from a large mound of slag is entering the watercourse.

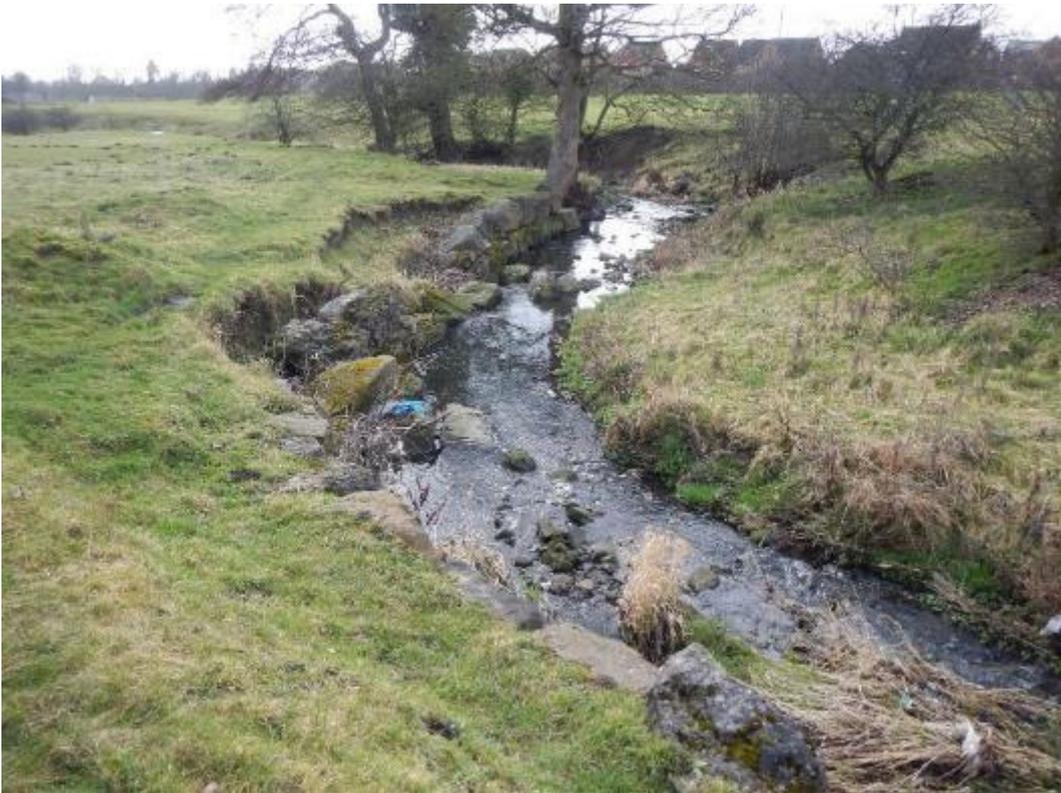
Photo DSCN0295. Point source pollution 8 (NZ 16478 34513): opposite the slag heap, a small discharge enters the beck. This appeared to be of slightly elevated nutrient content but less significant than many of the previous.

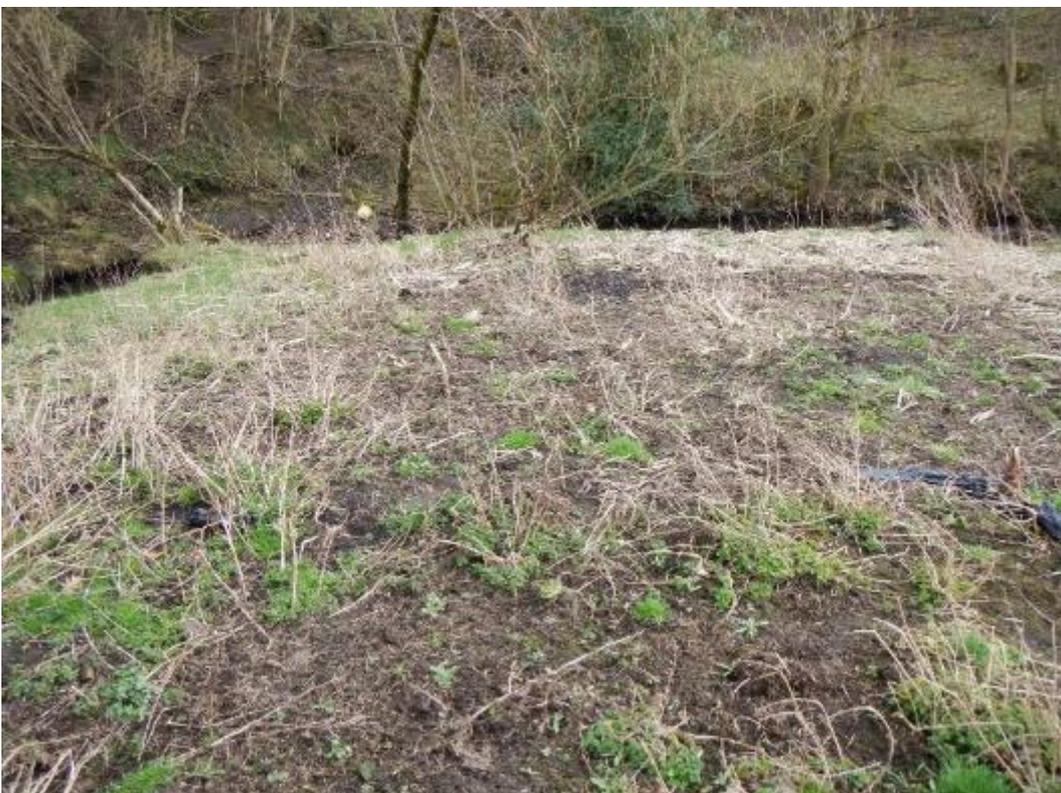
Photo DSCN0297. Erosion within a grazed field (NZ 16410 34448 - NZ 16421 34170) contributes to the poor water quality of the beck.

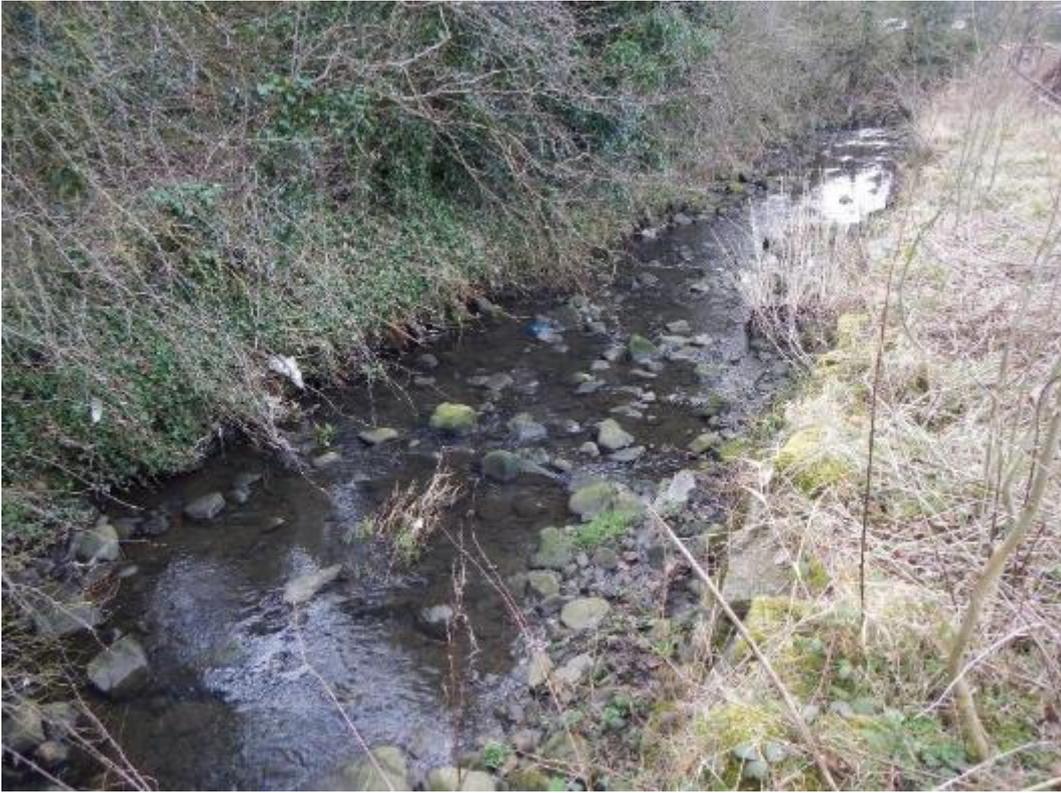
Photo DSCN0300. Livestock feeding/storing of potentially pollution organic material appears to have been occurring within 10m of the watercourse (NZ 16490 34218), although the issue was not occurring during the walkover. This is an offence under the Farming Rules for Water (April 2018) and should be raised with the owner/tenant.

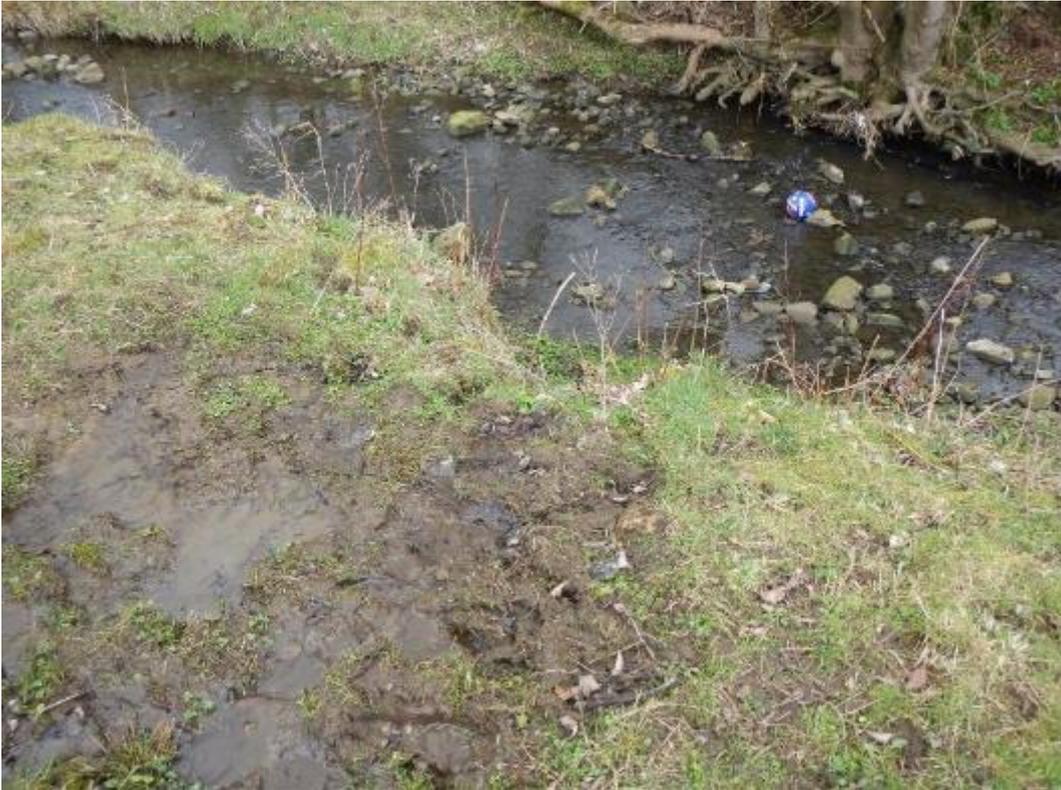
Photo DSCN0308. Unrestricted grazing within a single field at NZ 16271 33902 greatly degrades the riparian habitat/vegetation.

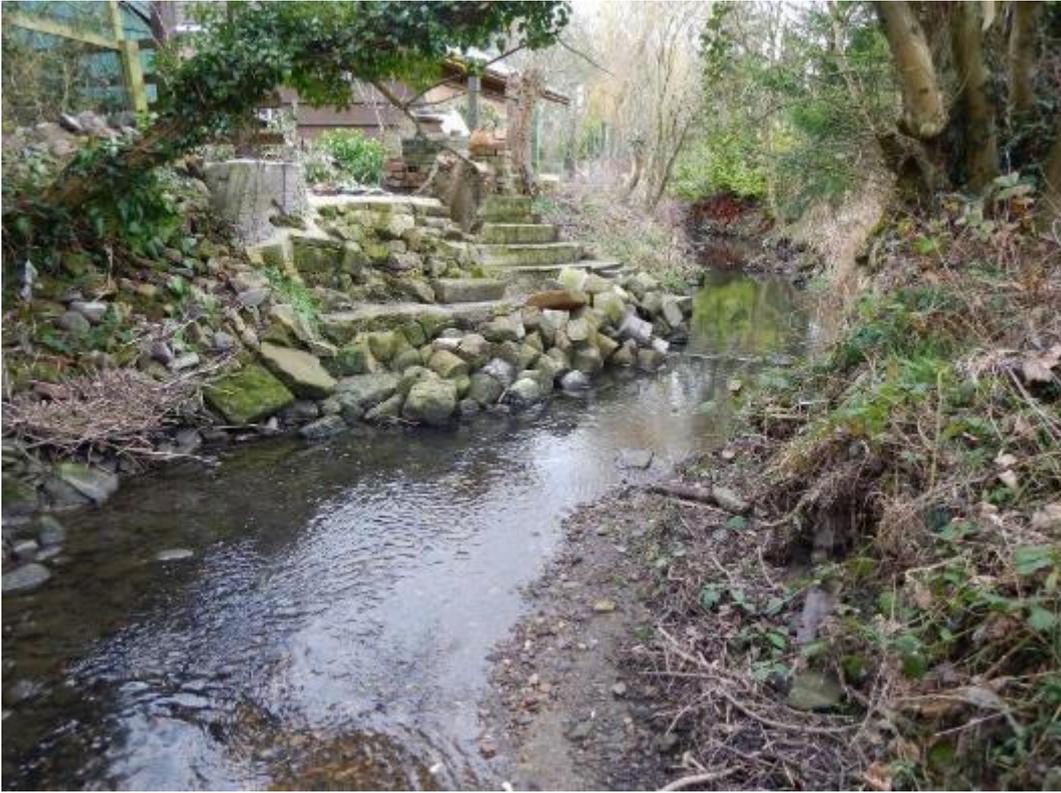
Photo DSCN0310. Wooded areas provide natural riparian habitat conditions although there is potential for greater trailing and low-level cover and woody material input.

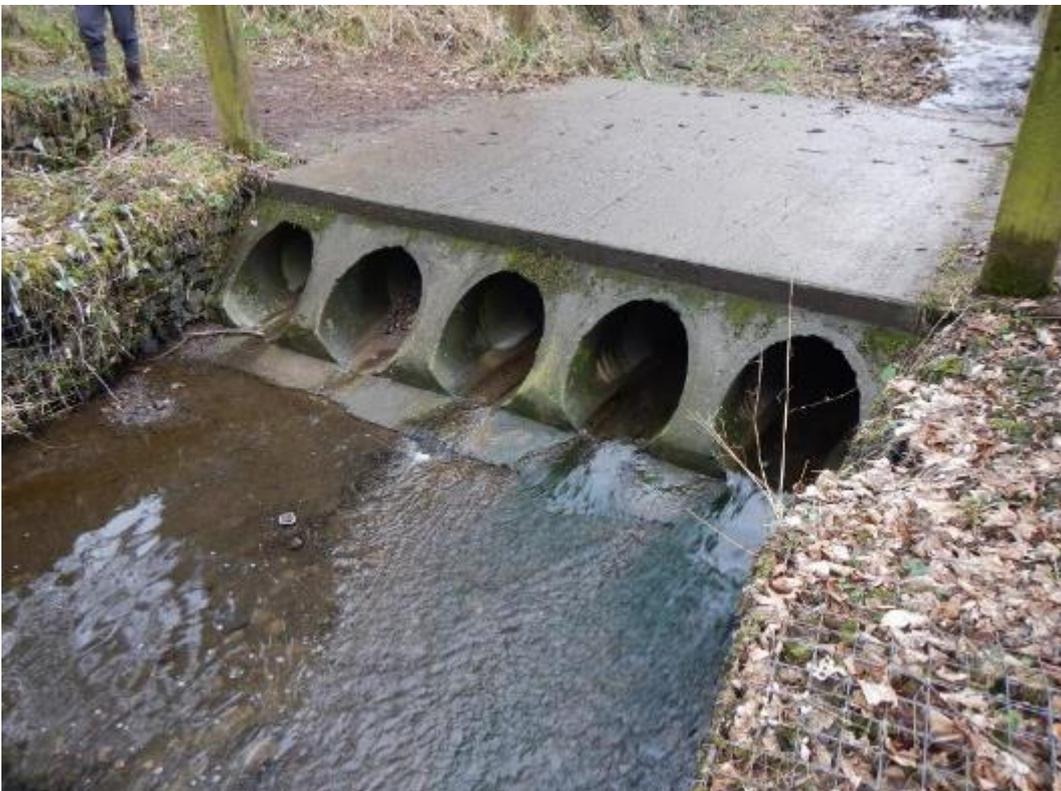
Photo DSCN0330. Obstruction R (NZ 16571 32697): a pipe culvert/bridge creates an issue for sediment transport and fish passage. Note two of the five pipes are already blocked, with one no longer even visible from the u/s side.

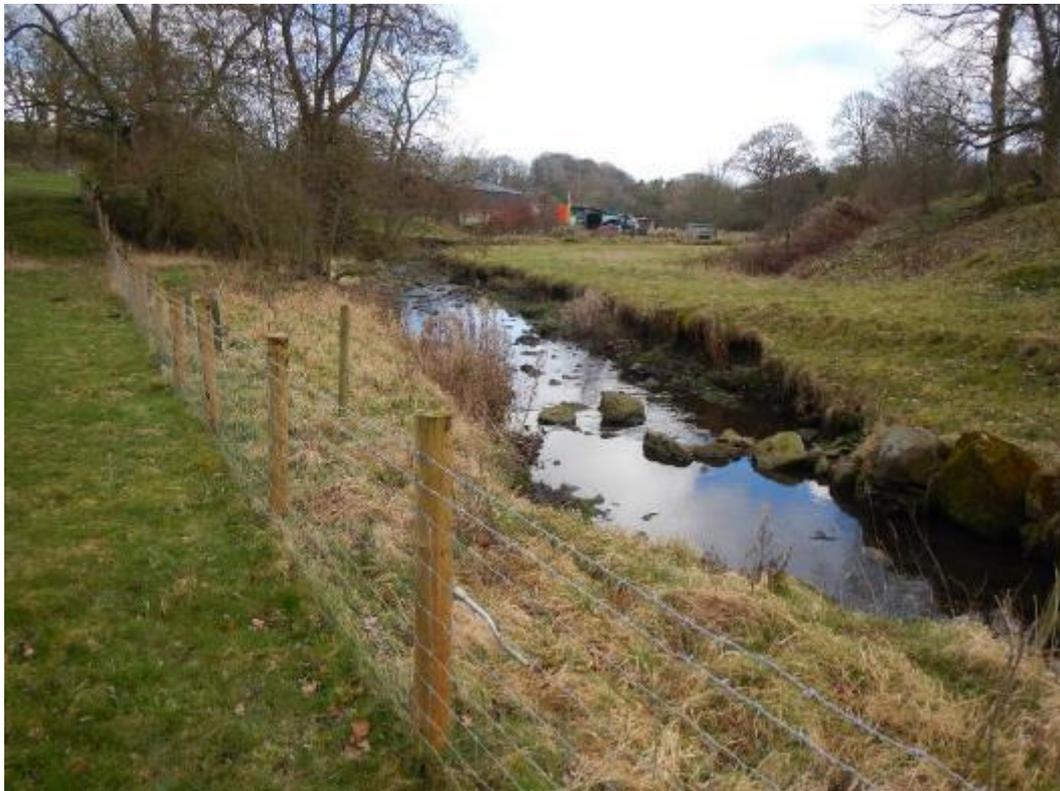
Photo DSCN0342. In the first field d/s of the wood, an area of bank has been elevated with hardcore and soil, then reseeded (NZ 16773 32289). The area is open to livestock.

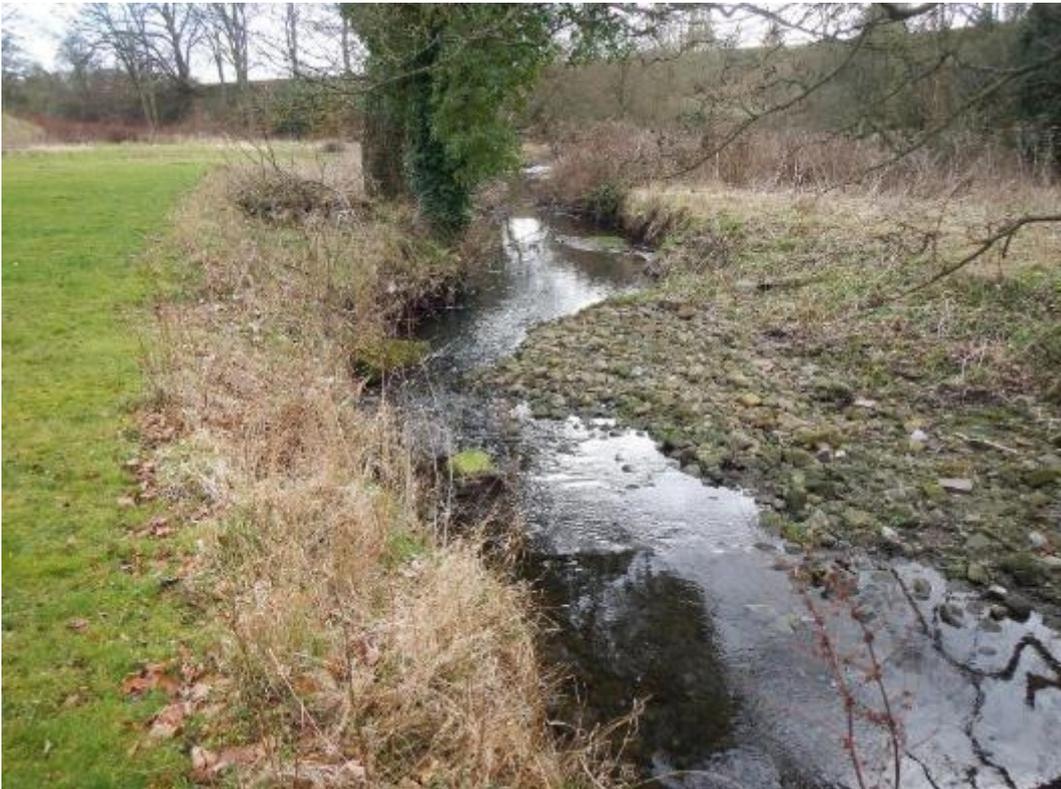
Photo DSCN0345. Several areas of raised embankment have been installed around Mill Farm (NZ 16933 32032).

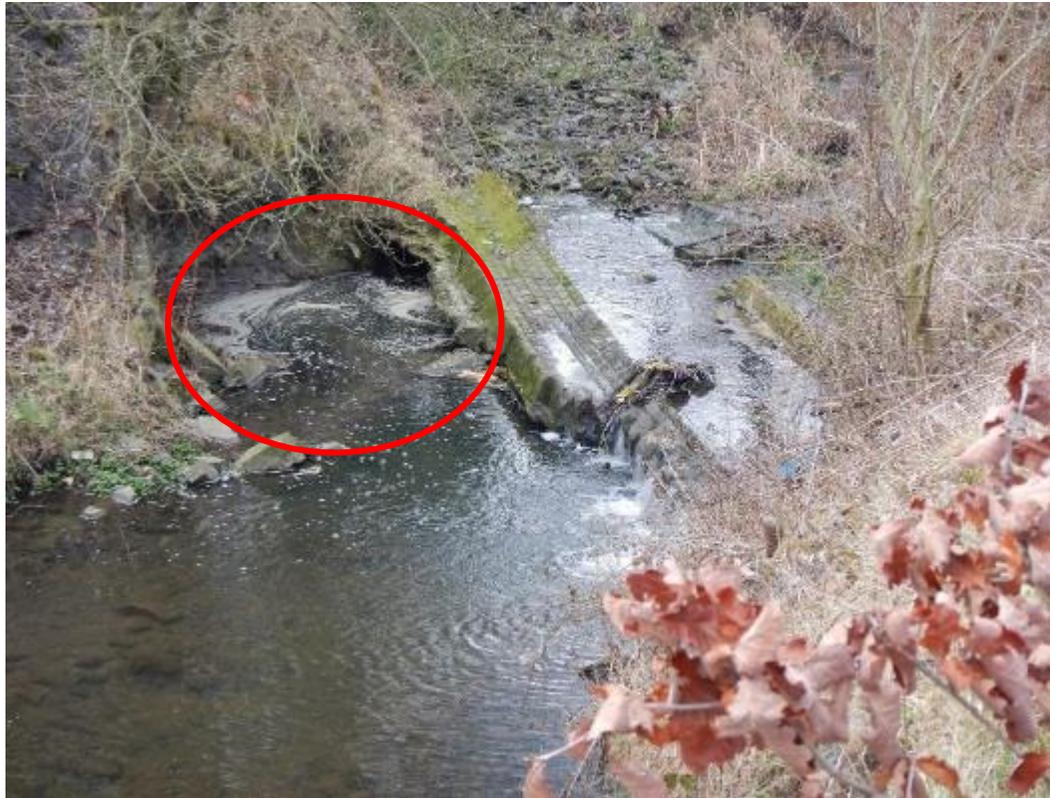
2. Obstruction S – NZ 16699 32581

This appears to be the remains of an old brick lined culvert/channel section that is now completely superfluous and creates a major obstruction for fish in the lower reaches of the beck. It is important to consider that recolonisation of the beck from the lower reaches or the River Wear may occur through the upstream migration and dispersal of juvenile salmonids, not just adults, providing that they are afforded the opportunity to do so. As such, this completely unnecessary obstruction should be removed from the watercourse. Alternatively, being constructed of relatively inert bricks and mortar, the material could be broken up on site and used to fill the scour hole in the RB that the structure has created (red circle).

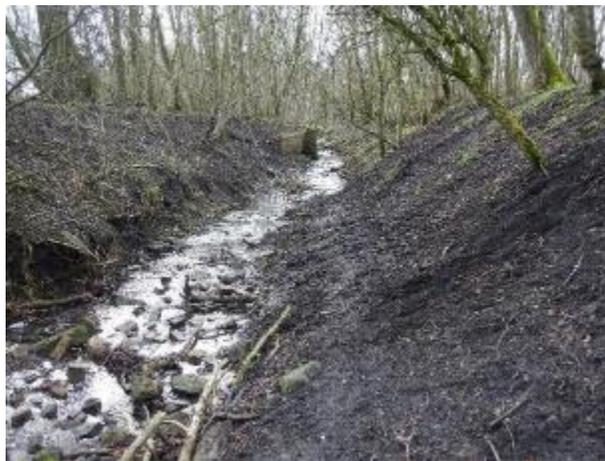
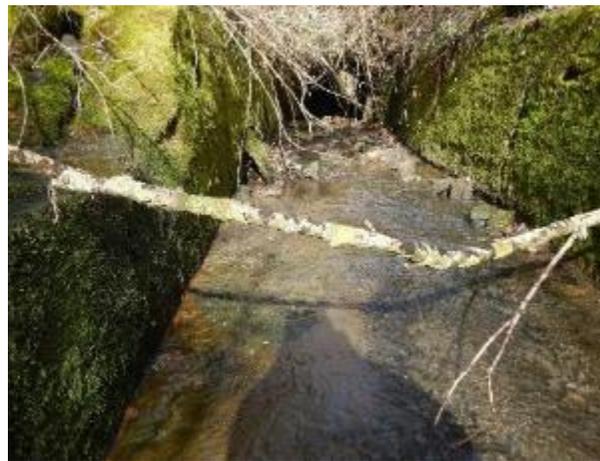
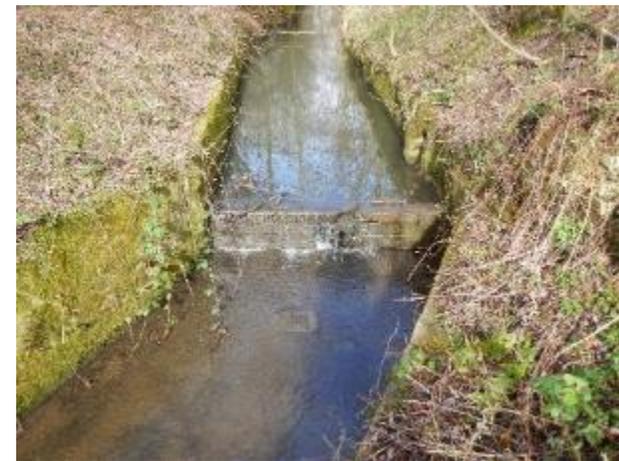
This site requires full restoration to a natural gradient, meandering channel following past mining operations which have left it in a heavily degraded state. Restoration would also address the physical obstructions to fish recolonisation (Obstructions B - Gii), thereby providing multiple benefits. This would be a far better utilisation of funding than attempting to simply mitigate barriers within the heavily modified, incredibly degraded channel.

Further investigation into the contamination status of the land and potential leaching of pollutants to watercourse (suspected to already be occurring and impacting upon water quality) is required. The presence of contaminated land should not be used as an excuse to avoid full channel restoration here as addressing the input of pollutants to the watercourse, along with improving the physical habitat quality of the channel, will be fundamental in restoring its ecology. Further site-specific investigations are recommended.
