Walkover Assessment
Black Beck
(River Ehen Catchment)
20/11/2018

Undertaken by Gareth Pedley

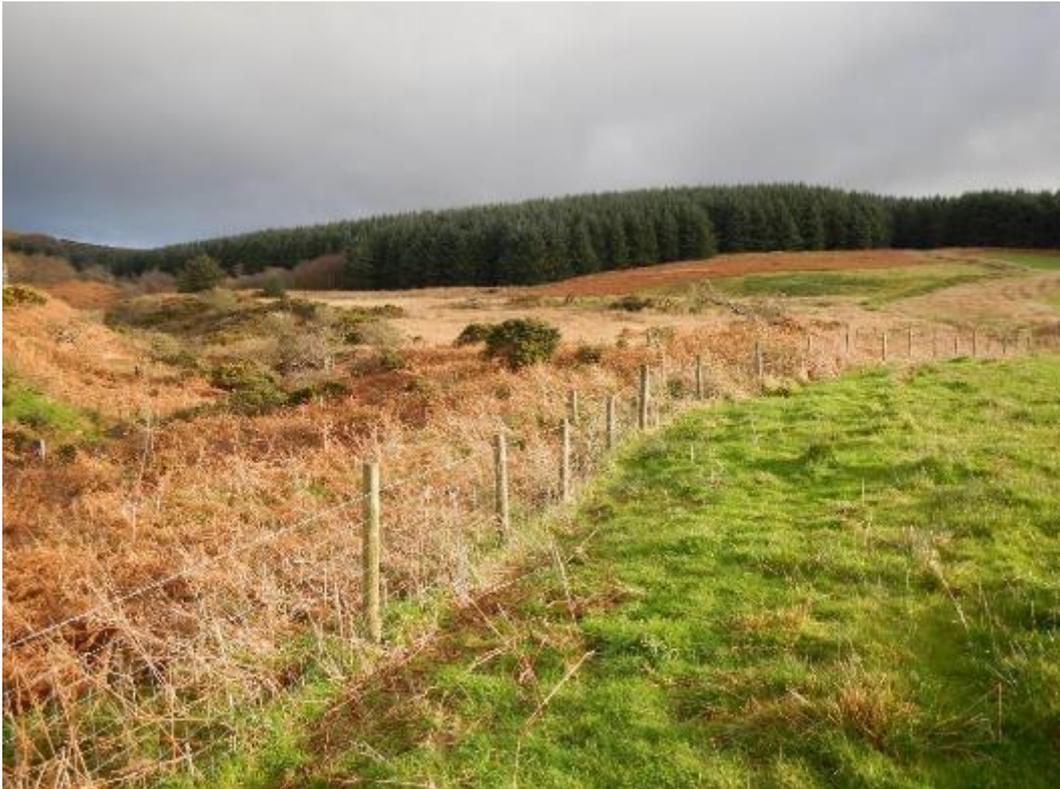
Photo DSCN5119. The watercourse was walked from the point where adjacent land use changes from forestry and rough heathland to pastoral agriculture. This area is initially well buffer fenced, protecting a section of scrub and heathland along the river (NY 02814 12001 - NY 02394 11814).

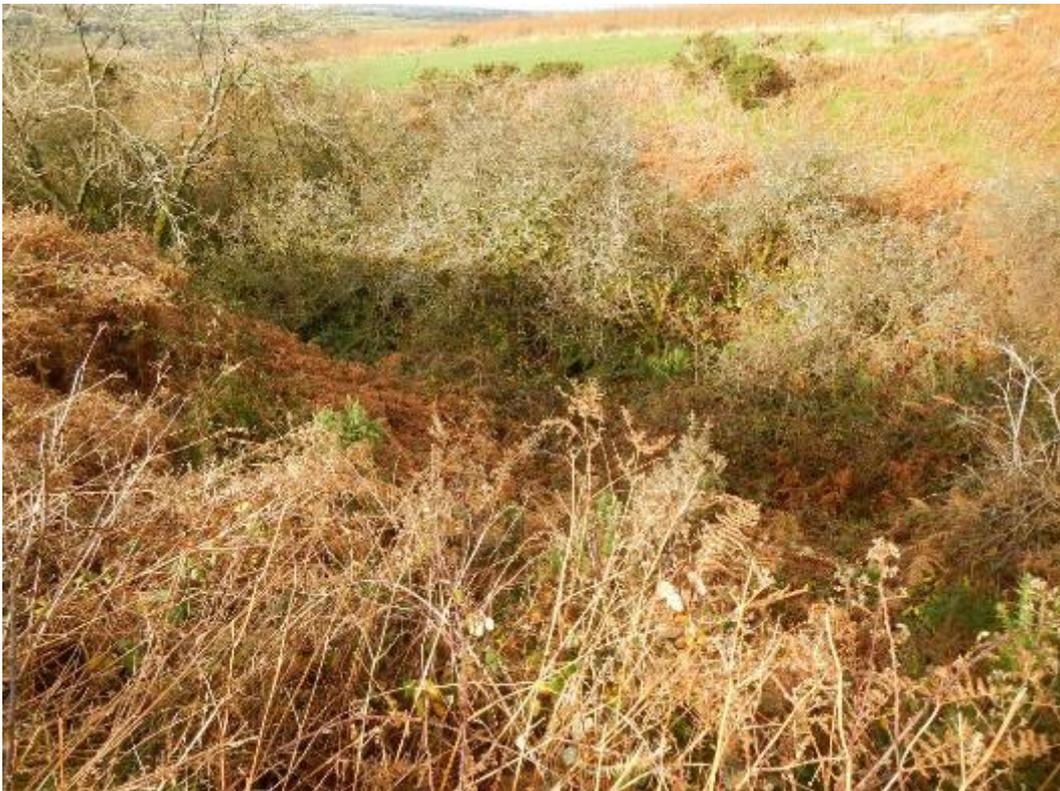
Photo DSCN5125. The dense matrix of trees, shrubs and herbaceous vegetation provide good quality riparian habitat and will contribute towards stable banks and naturally controlled fine sediment input.

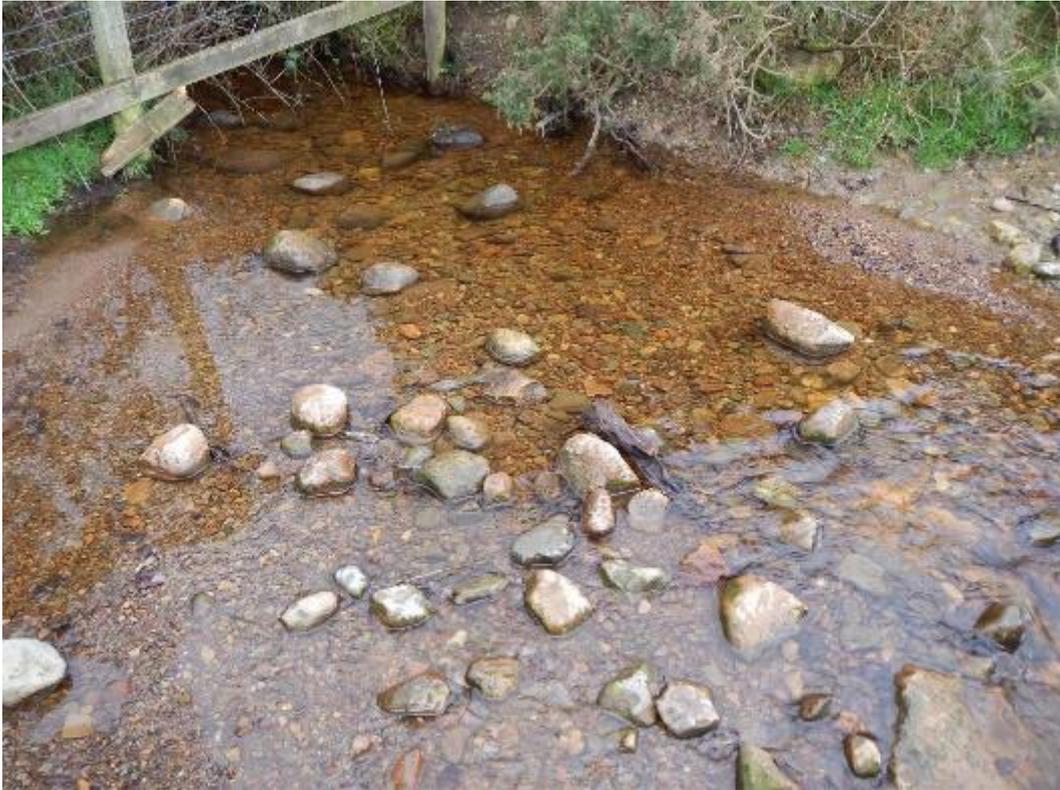
Photo DSCN5128. Despite the coniferous forestry upstream (which can often elevate fine sediment input), inspection of the bed revealed unusually high quality, naturally coarse substrate, undoubtedly aided by the generous buffer strips upstream.

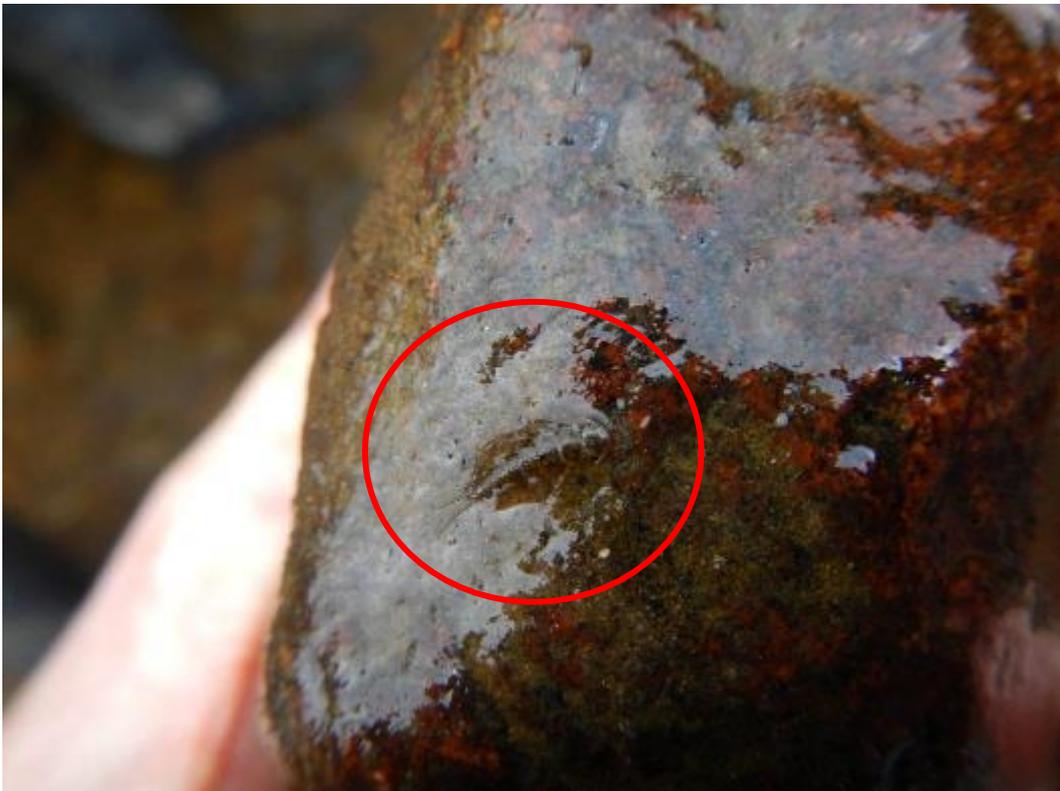
Photo DSCN5130. Turning some of the larger cobbles identified mainly stoneflies, which supports the scenario of a naturally low sediment/low productivity watercourse, as would be expected for this area and geology.

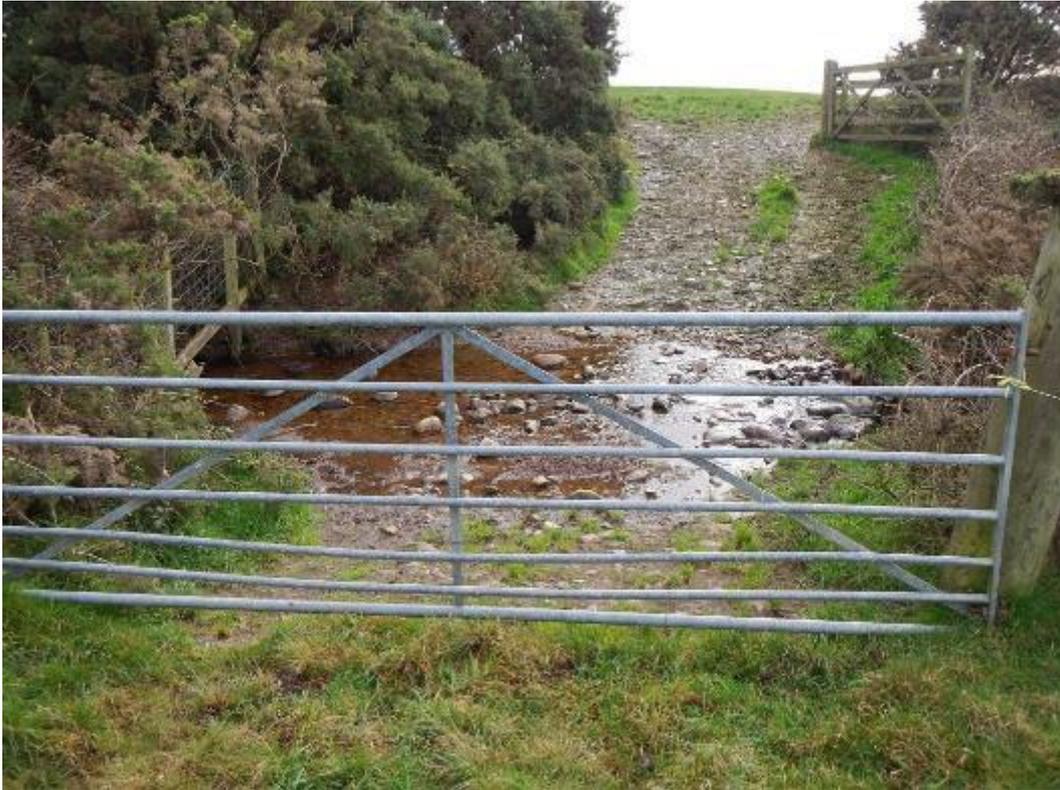
Photo DSCN5133. The crossing fording point inspected does create the first potential location for fine sediment input observed (NY 02549 11905). Ideally, the gates at either side would be kept closed when fording is not occurring, to maintain healthy vegetation cover on the banks. However, it is likely that the area is being used for livestock watering, so an alternative water source is likely to be required.

2	NY 02549 11905	<p>The crossing point should be closed when not in use and alternative stock watering provided.</p> <p>The step at the ford should also be alleviated by either an appropriately sized sunken culvert or lower level ford.</p>
Perched (at the d/s end), undersized culvert that will restrict fish passage.

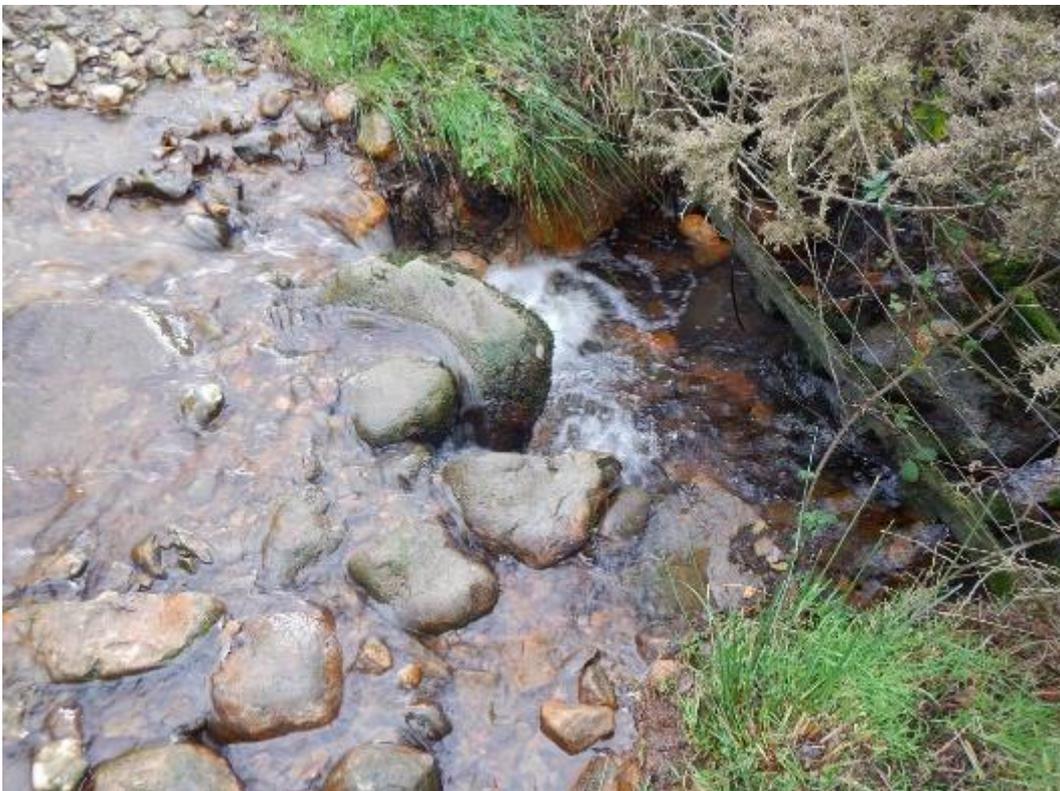
Photo DSCN5126. The ford itself creates a step in the bed that will be a small obstacle to fish passage. The step could be as a result of the widening at the ford increasing sediment deposition in that area or the result of a small bed-check weir to stabilise the crossing point.

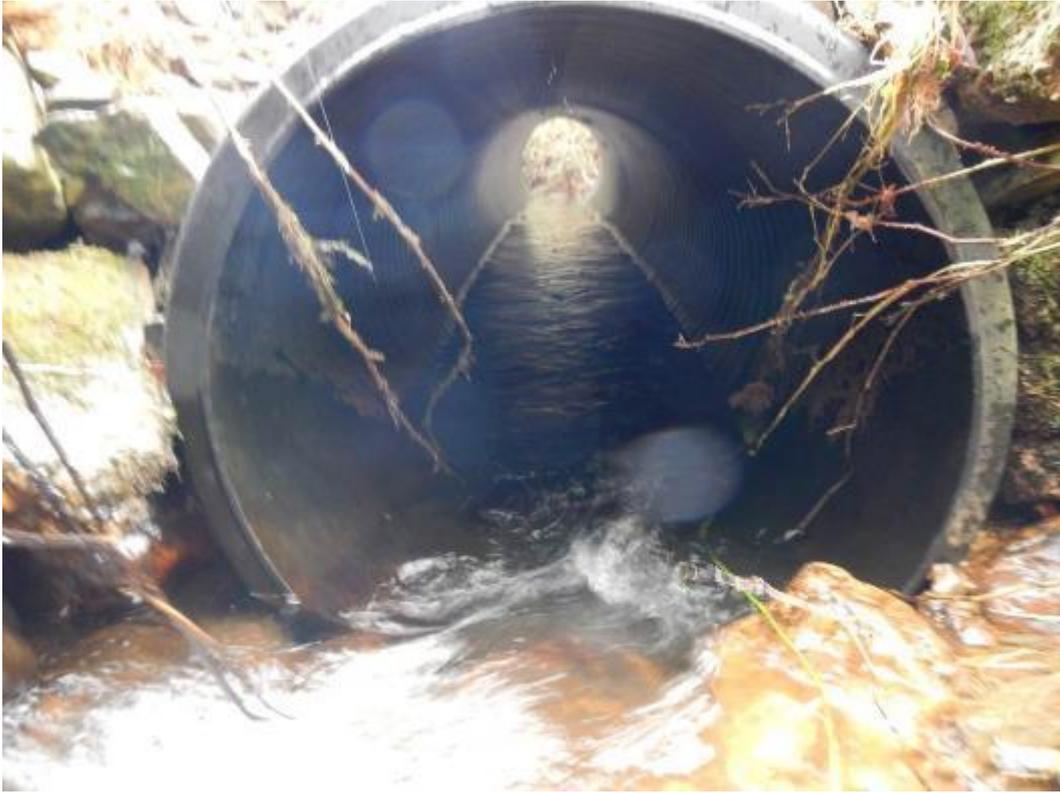
Photo DSCN5137. The d/s end of the next track crossing culvert is perched (NY 02394 11814). This, combined with the narrow gauge of the pipe, create high flow velocities making the structure an issue for fish passage, thereby unnecessarily restricting movement to certain flows (and times).

2	NY 02394 11814	<p>Culverts should be set be of sufficient capacity with c.1/3 set below the bed level and accommodate high flows and sediment transport. This will also reduce the issues of erosion at the d/s end and the potential for them becoming perched.</p>
Incomplete field drainage system.

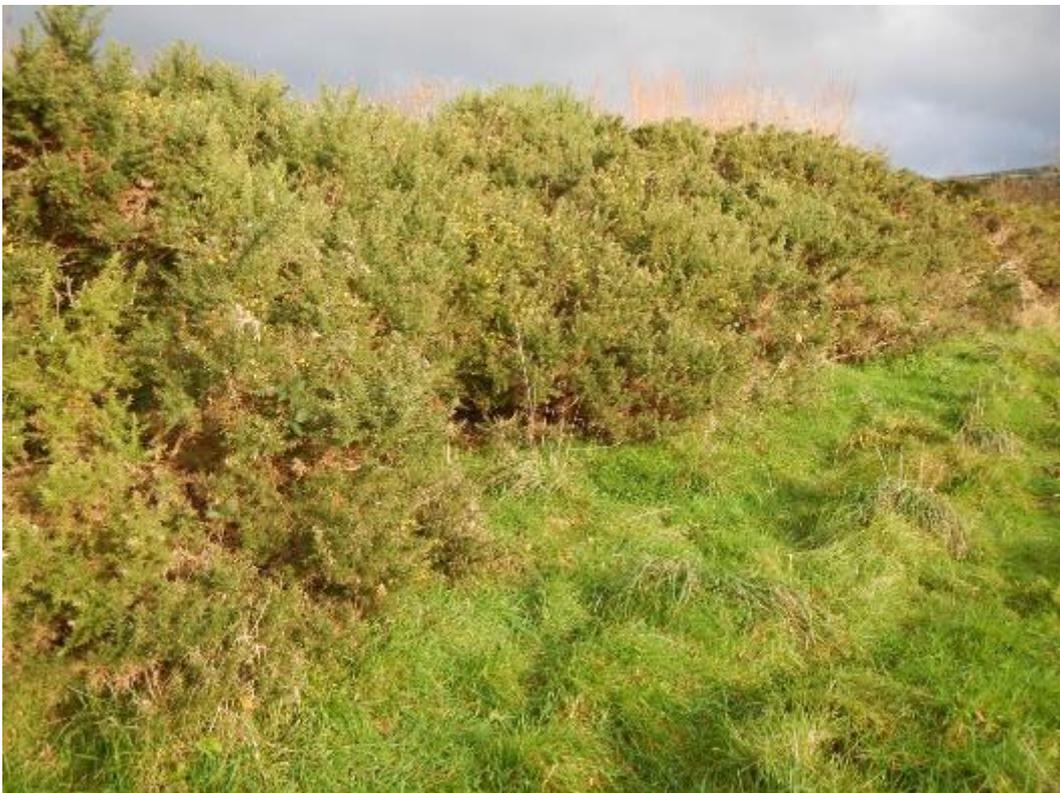
Photo DSCN5139. The watercourse is buffer fenced in next field d/s (NY 02394 11814 - NY 02251 11583). The initial section of watercourse appears to be enclosed with gorse and other rank vegetation but where access to the watercourse could be achieved, the riparian habitat observed was good quality.

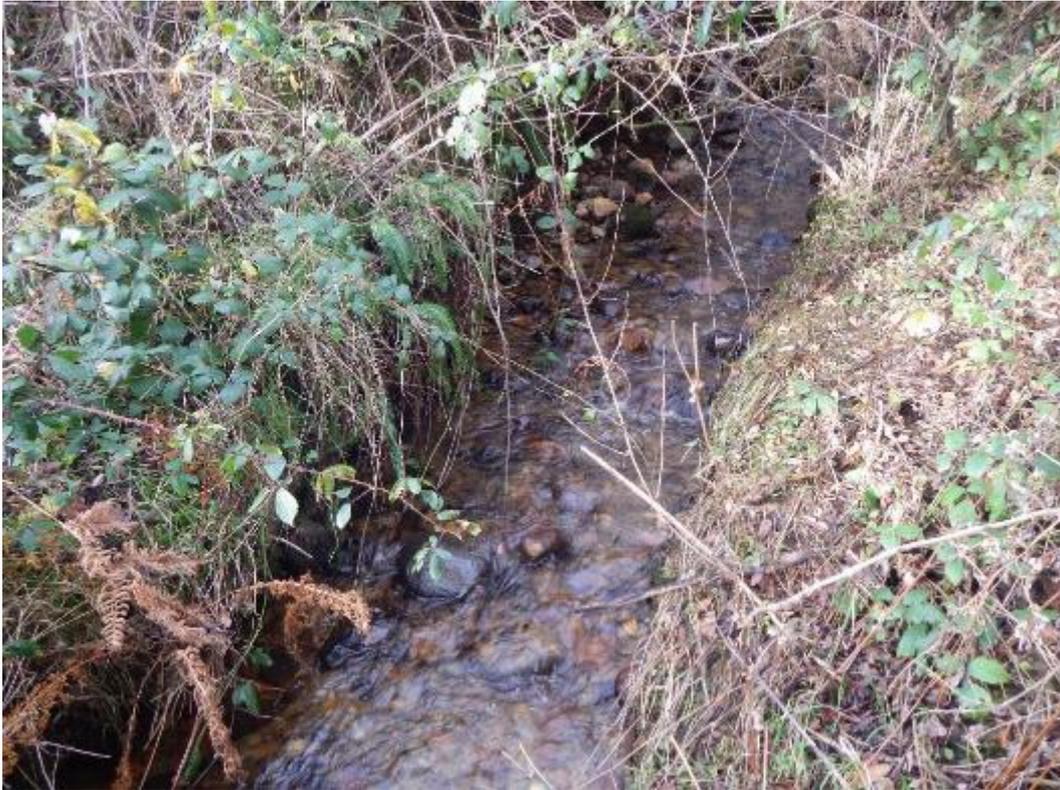
Photo DSCN5141. The channel does appear to have been straightened which greatly limits the flow diversity and bed morphology but active sediment supply, coupled with good riparian cover, help to enhance the area.

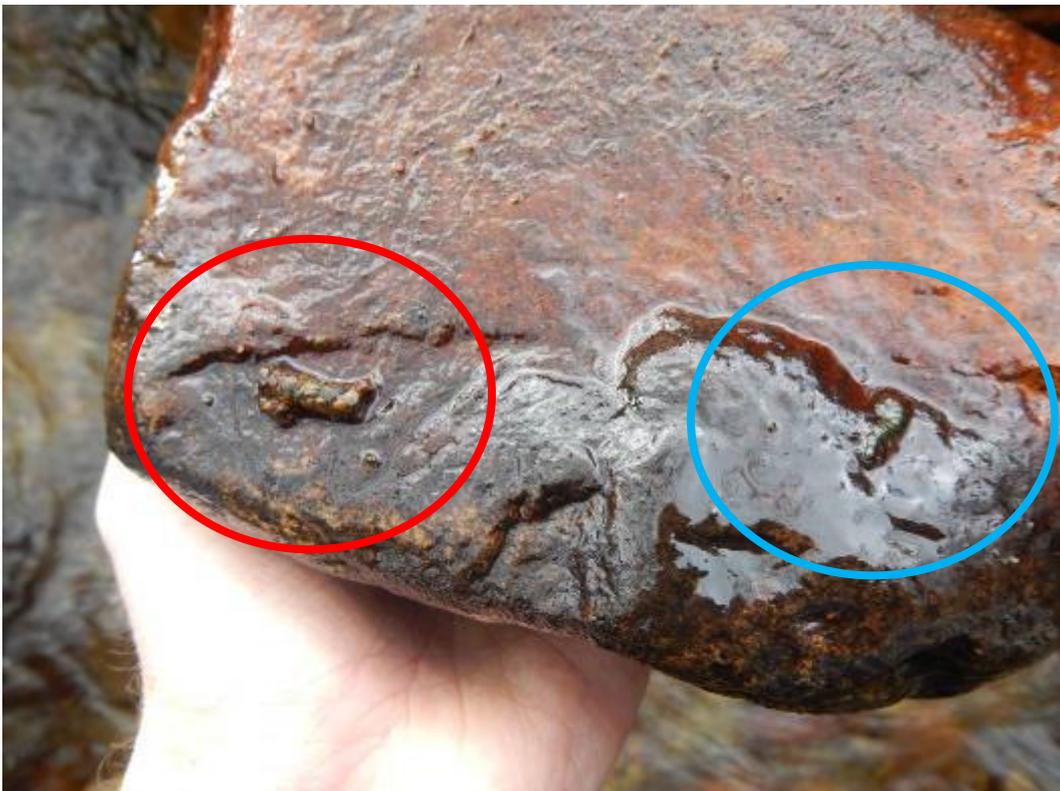
Photo DSCN5142. Cased (red) and caseless (*Rhyacophila* sp.) caddis (blue) were observed through stone turning, along with stoneflies.

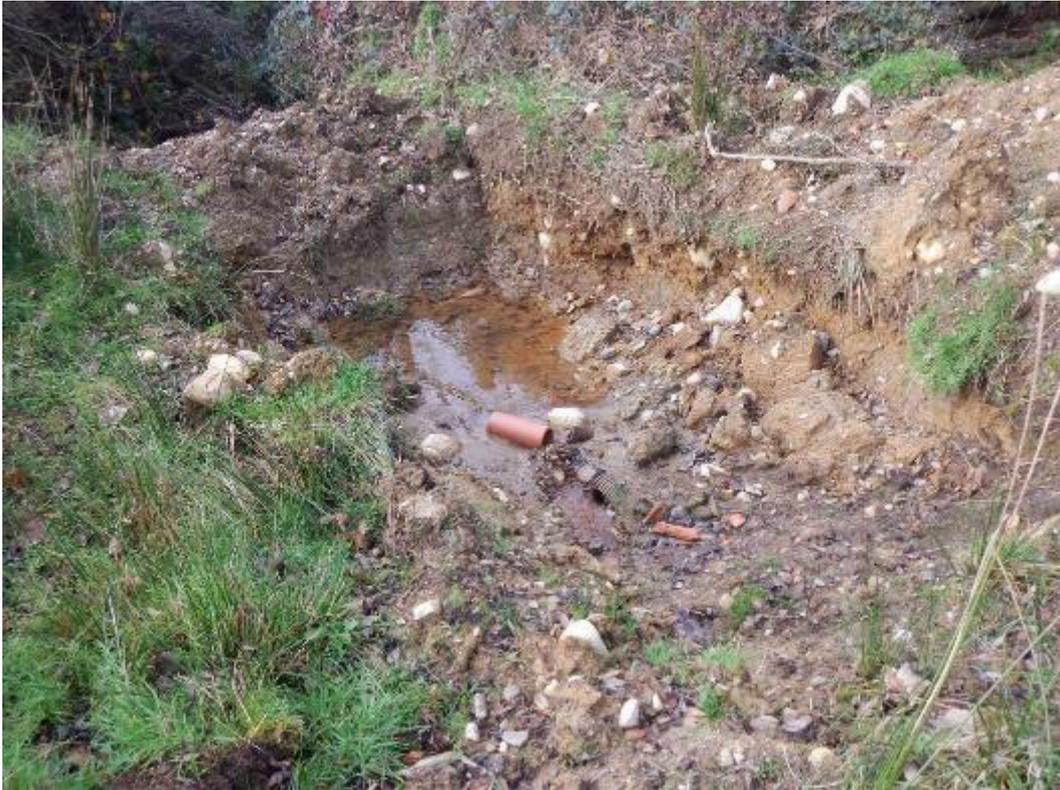
Photo DSCN5144. At NY 02266 11588 a series of field drains discharge to the beak. These are to be expected on land of this type but the open/incomplete nature of the setup and potential for erosion and fine sediment following heavy rain are a concern here.

2	NY 02266 11588	<p>Contact the landowner to make them aware of the potential pollution issues, with reference to the new Farming Rules for Water.</p>

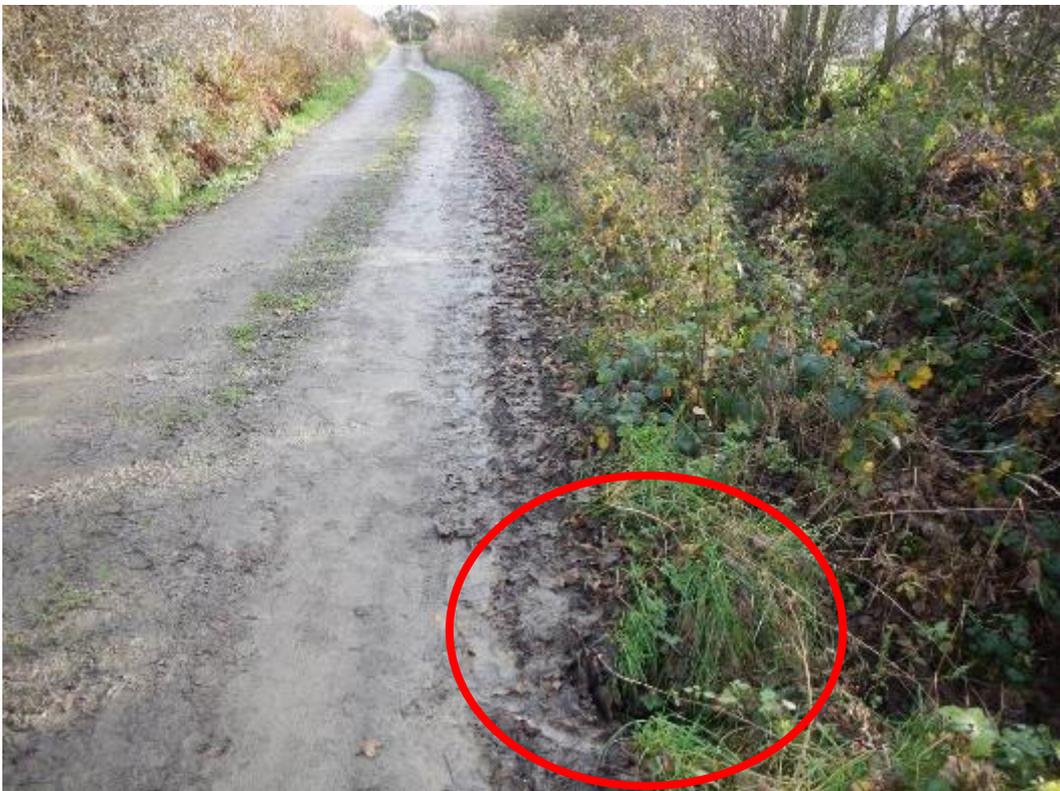
Photo DSCN5145. Problems from surface runoff were observed at the track crossing d/s. The problem and potential solution are complicated by the fact that the ditches running alongside the track also discharge directly to the beak, which is very poor practice (NY 02251 11583).

2	NY 02251 11583	Install cross drains and prevent direct discharge from any surface water conduits to the beck.
Small culvert.

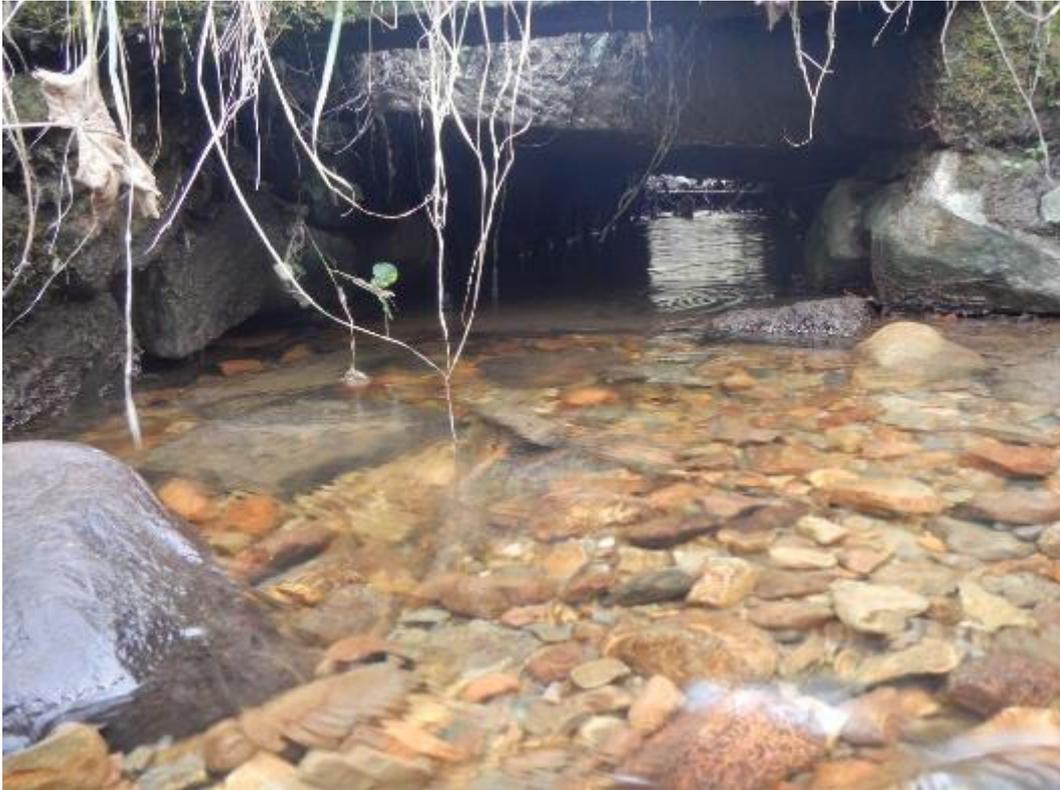
Photo DSCN5147. The culvert beneath the track is of limited size but was relatively free from debris at the time of the visit (NY 02251 11583). The structure is suitably installed to allow the movement of fish and sediment (if maintained free from debris). It may be an obstruction at higher flows, due to fluming, but is less of an issue than many of the other culverts observed.

3	NY 02251 11583	Ensure the culvert is kept free from blockages.
Major poaching and fine sediment input to the watercourse.

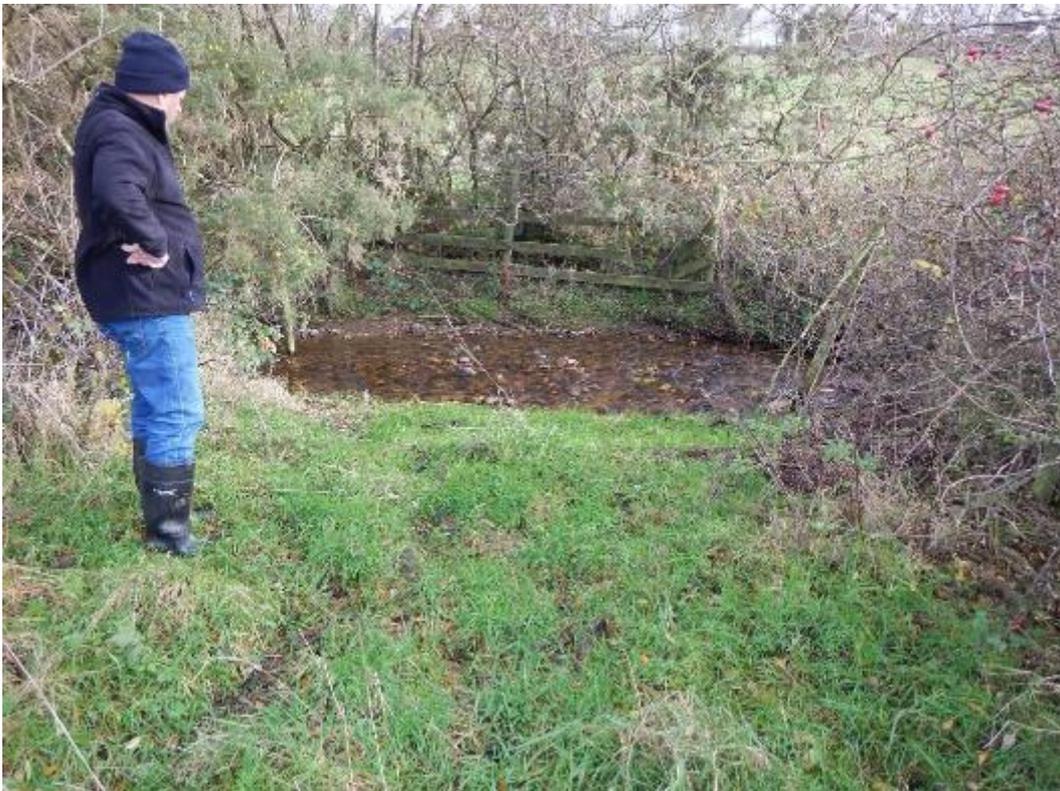
Photo DSCN5149. The watercourse is initially buffer fenced d/s of the track, with an open drinking point (NY 02209 11536) that would ideally be replaced by an offline watering system.

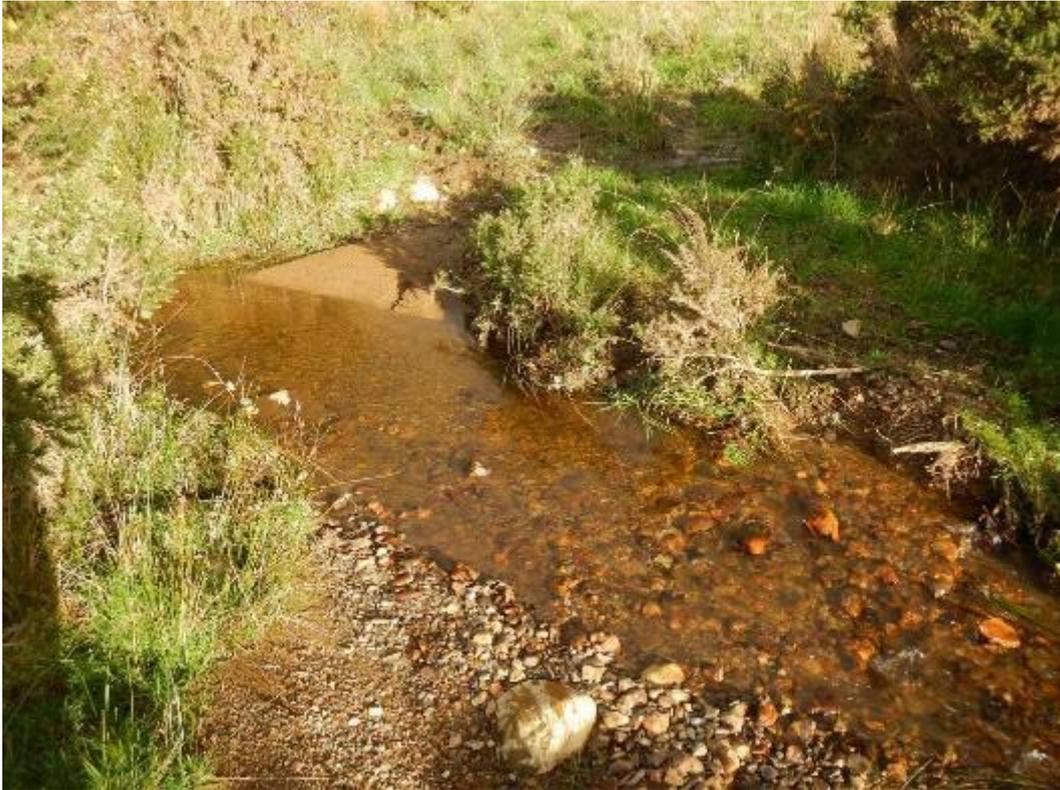
Photo DSCN5154. The next field d/s has unrestricted livestock access and suffers from poaching (NY 02202 11521 - NY 02198 11372). The substrate in this section is still of a reasonably high quality but the impact of fine sediment inputs upstream is already becoming apparent.

2	NY 02202 11521 - NY 02198 11372 (C. 160m)	Install buffer fencing. N.B. This area could have potential for channel restoration.
Buffer fencing.

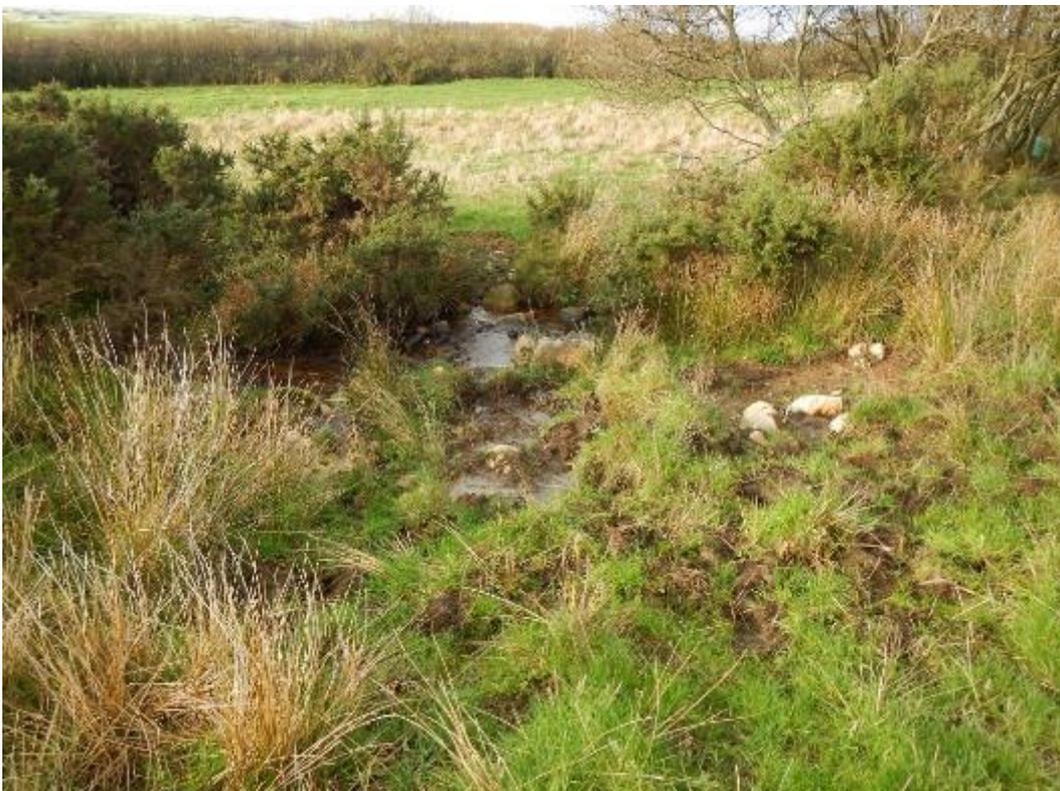
Photo DSCN5157. Some areas of the field are particularly poached and the boggy nature of the adjacent land means that transport of fine sediment across the field to the watercourse is highly likely following rain. The watercourse also appears to have been realigned in this field, although it is recovering. Reinstating a more natural sinuosity to the course would be beneficial.

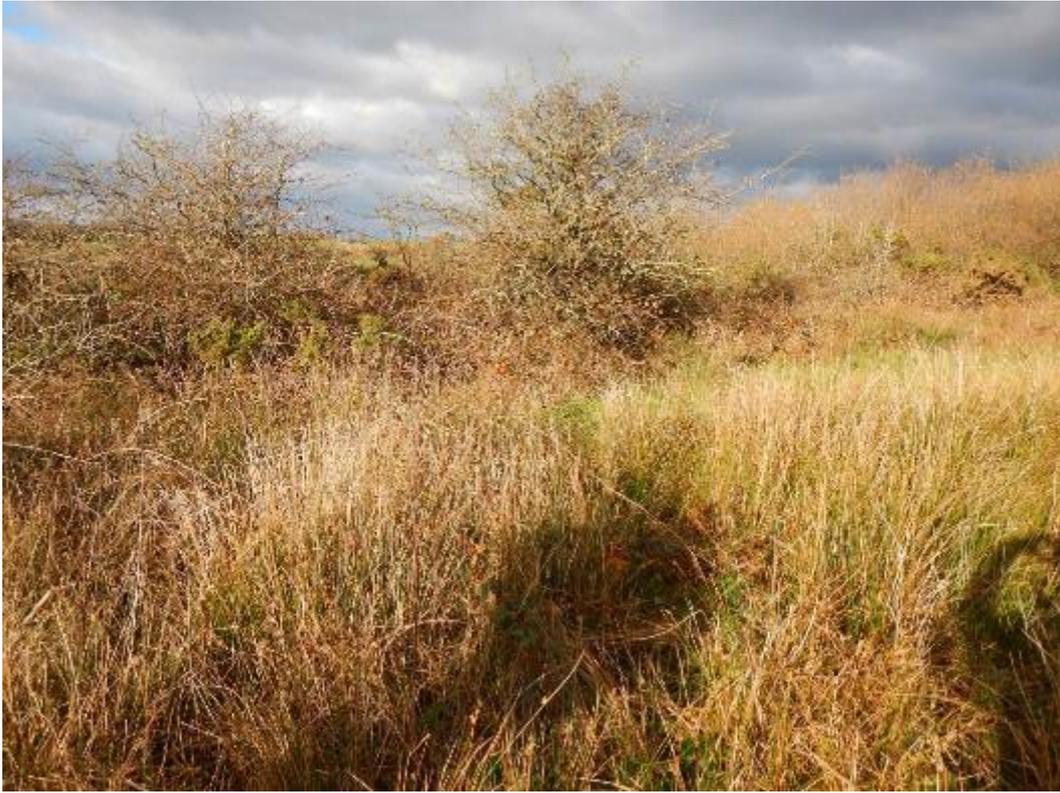
Photo DSCN5161. Livestock appear to be excluded from the next section d/s, which has developed into an area of rough scrub and rank vegetation and, providing habitat for a range of wildlife (NY 02157 11311 - NY 02198 11372).

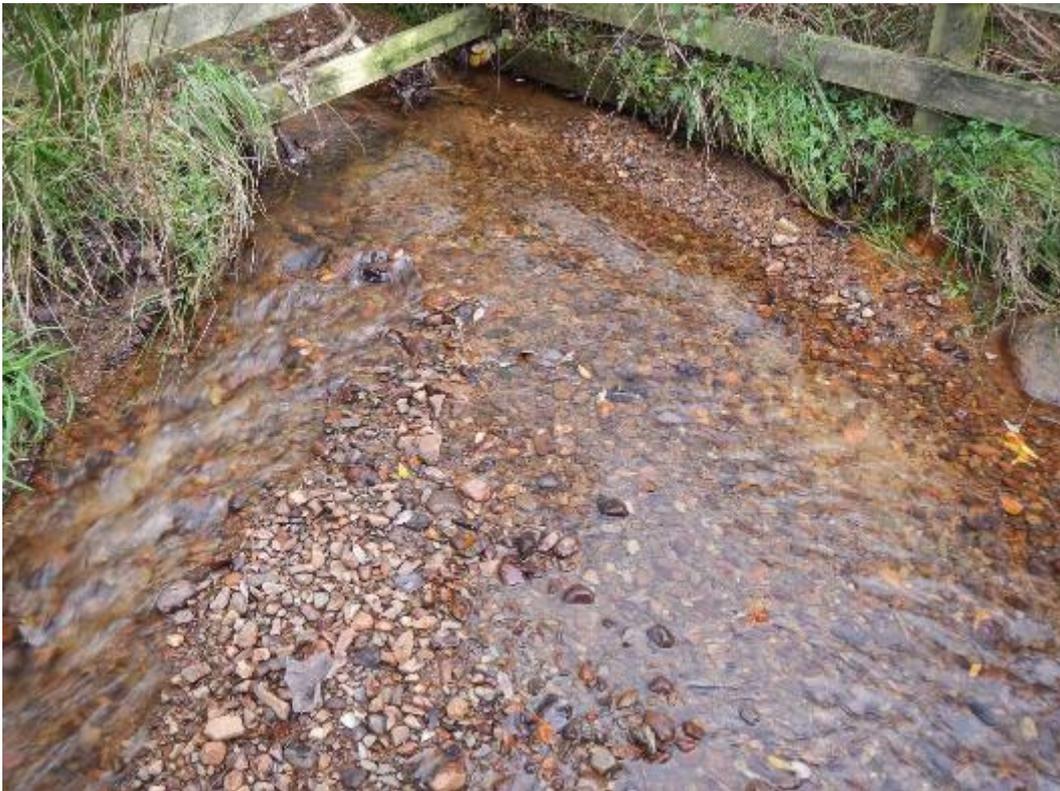
Photo DSCN5168. At a drinking point d/s of the scrub, gravel deposition provides potential salmonid spawning habitat (NY 02157 11311). However, the quality is reduced by the fine sediment component. These occasional depositional areas of gravel are symptomatic of the issues occurring on straightened watercourses; the gravel portion is not retained in the straight sections but deposits at the few remaining bends or wider areas. This often contributes to a general lack of gravel and salmonid spawning habitat on straightened watercourses.

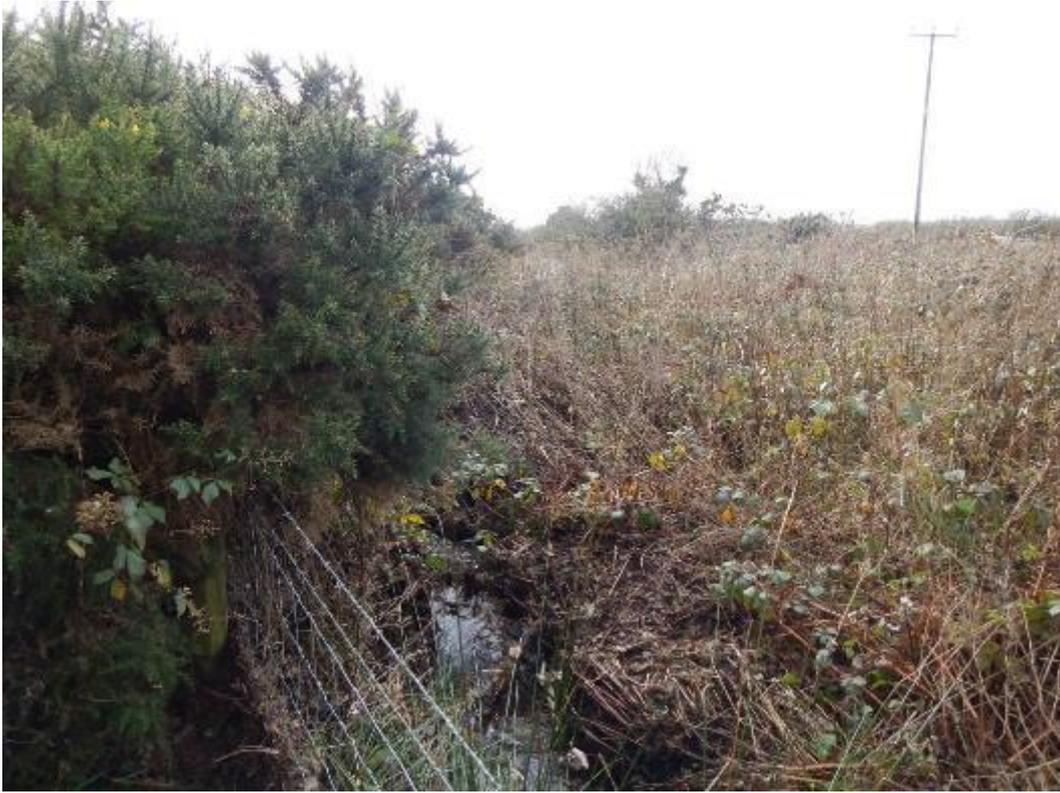
Photo DSCN5169. The next section is buffered with reasonably good riparian cover (NY 02198 11372 - NY 02123 11268).

3	NY 02198 11372 - NY 02123 11268	Ensure existing fencing is maintained to preserve the benefit it provides.

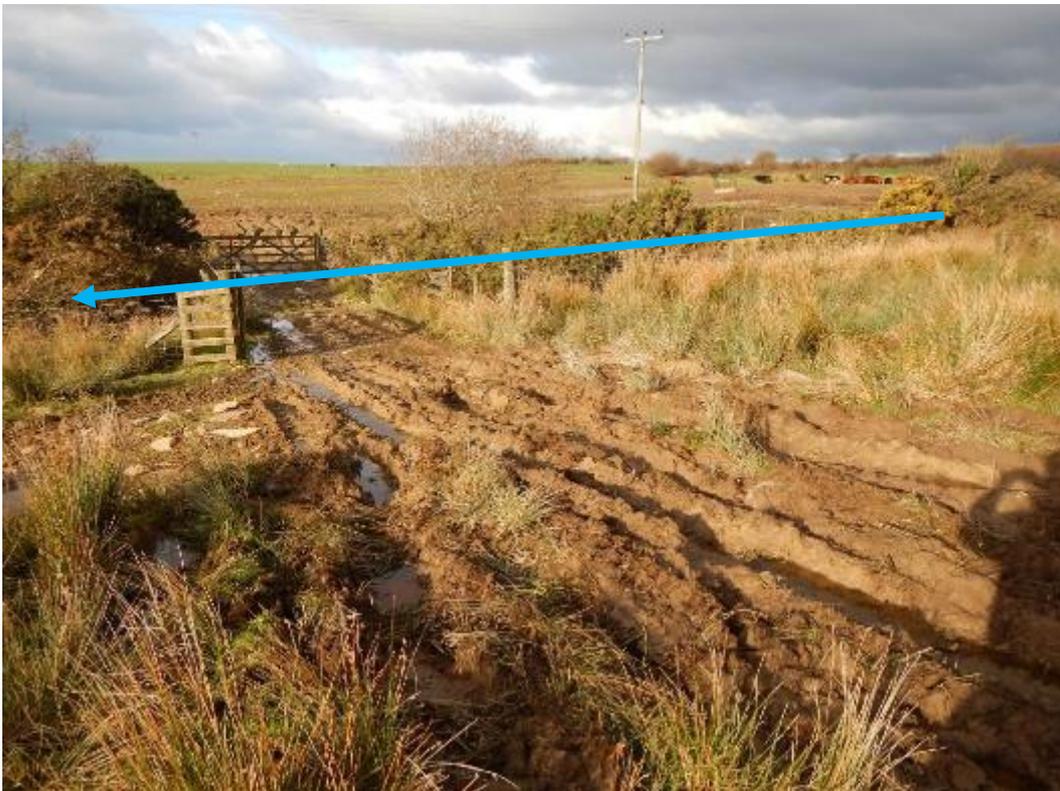
Photo DSCN5170. By far the worst fine sediment input on the watercourse occurs around NY 02123 11268. The track crossing and severely poached and rutted land is clearly liberating large volumes of fine sediment to the watercourse (blue line). This is a major contravention of the Farming Rules for Water and a significant pollution issue that should be addressed quickly.

1	NY 02123 11268	The farmer should be approached and made aware of the Framing Riles for Water and encouraged to rectify the problem. If no action is taken, the issue should be raised on the Environment Agency National Incident Reporting System (NIRS).
Culvert and obstruction to fish passage.

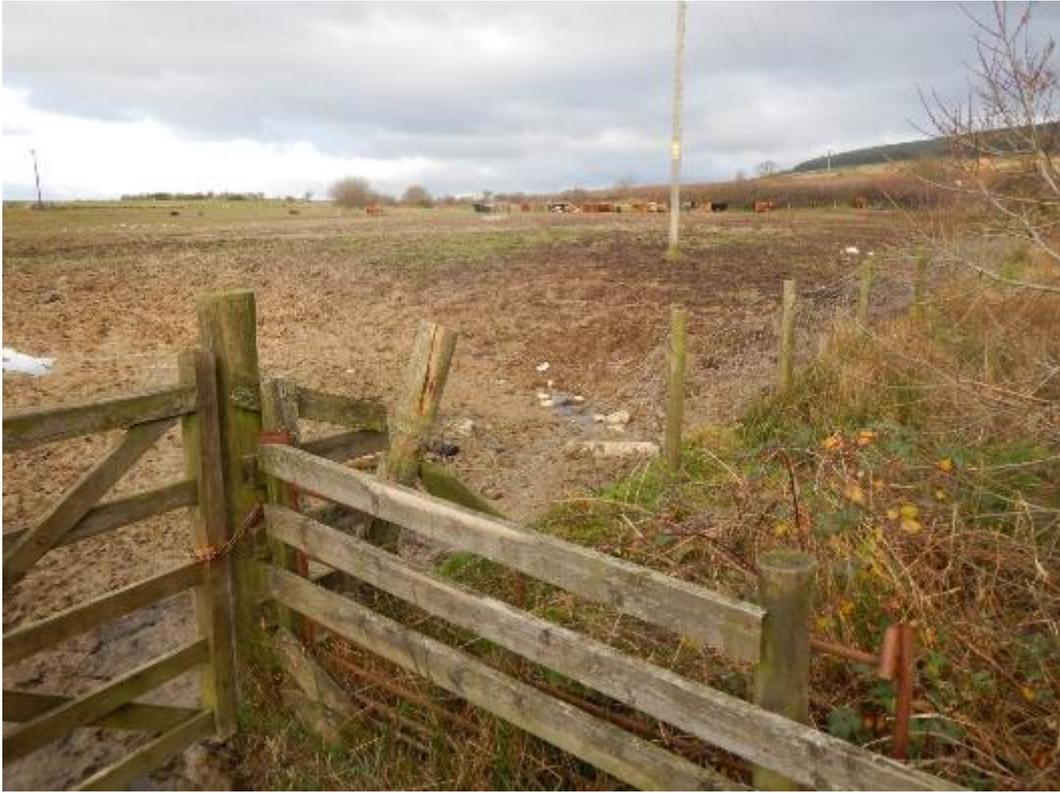
Photo DSCN5172. The sediment issues are further exacerbated by a broken drain in the opposite RB field (NY 02119 11280). This should also be addressed as matter of urgency.

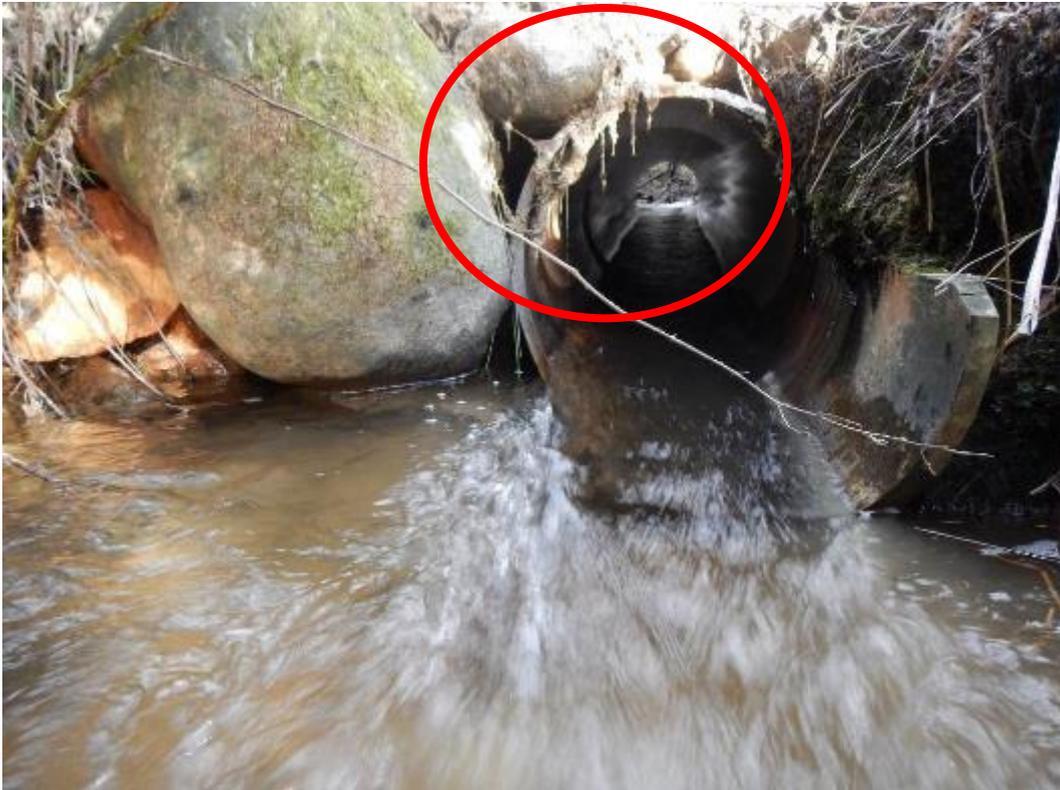
Photo DSCN5176. The culvert beneath the track crossing is also very small and is an obstruction to fish passage although, being set at around the bed level, fish should be able to pass in some flows (NY 02123 11268). Also note the trail of mud and fine sediment from the track above (red circle).

1	NY 02123 11268	Culverts should be set be of sufficient capacity with c.1/3 set below the bed level and accommodate high flows and sediment transport. This will also reduce the issues of erosion at the d/s end and the potential for them becoming perched.

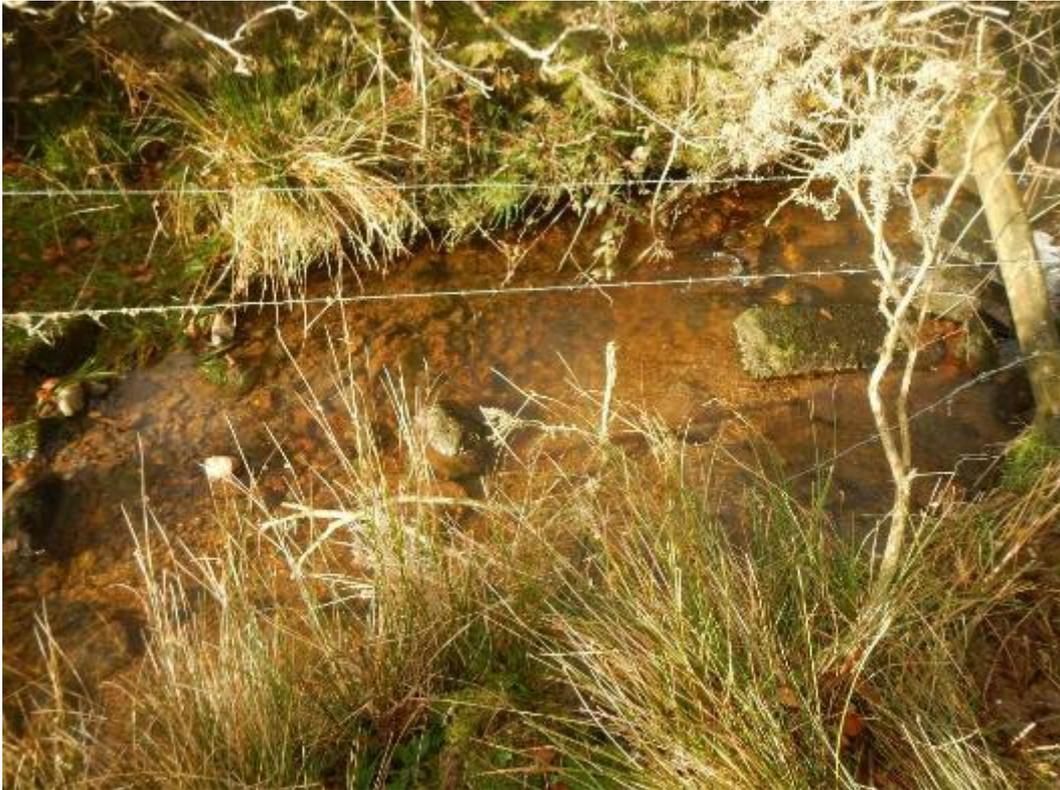
Photo DSCN5181. Some of the fields d/s are fenced, but the beck traverses the field boundary and livestock gain access in other areas. Replacement buffer fencing is required on one or both banks for an extended reach (NY 02123 11268 - NY 02059 11130).

2	NY 02123 11268 - NY 02059 11130 (c. 150m)	Install buffer fencing. N.B This should encompass the boggy area at the d/s end of the field.
Lack of buffer fencing on either the LB or RB between grid refs.

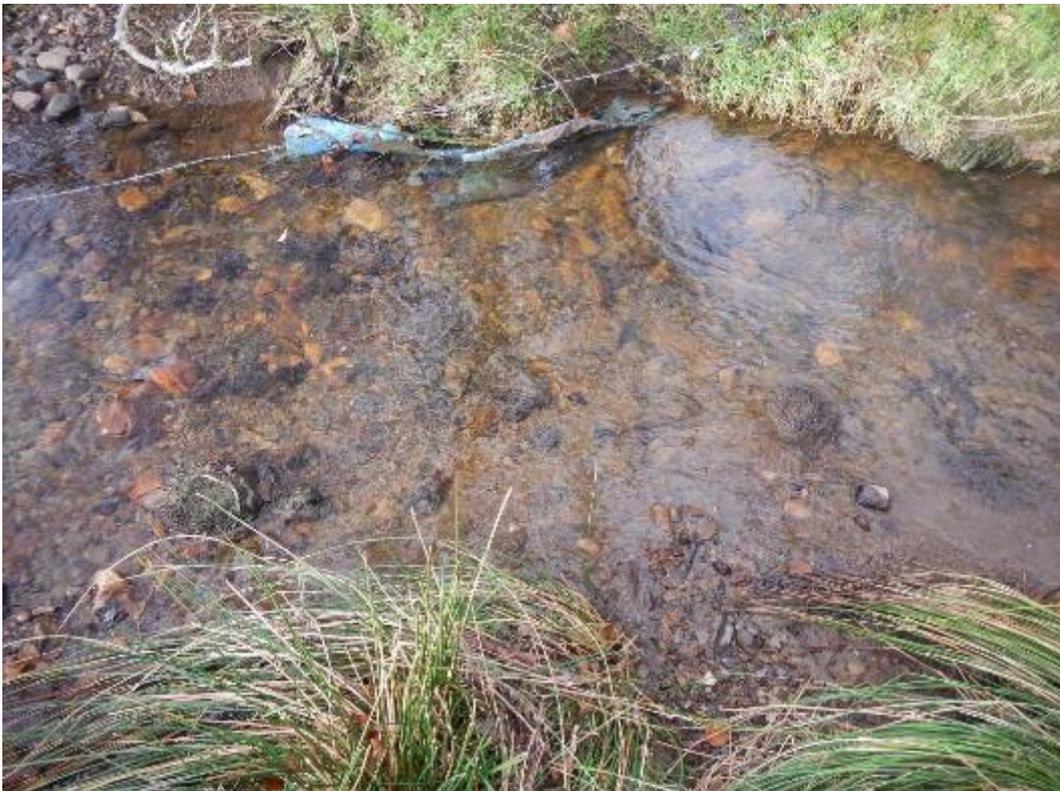
Photo DSCN5184. The cumulative impact of the fine sediment inputs along the beck, exacerbated by the poor land management u/s, has severely degraded the substrate quality by this point.
