Walkover Assessment
Black Beck
(River Ehen Catchment)
20/11/2018

Undertaken by Gareth Pedley

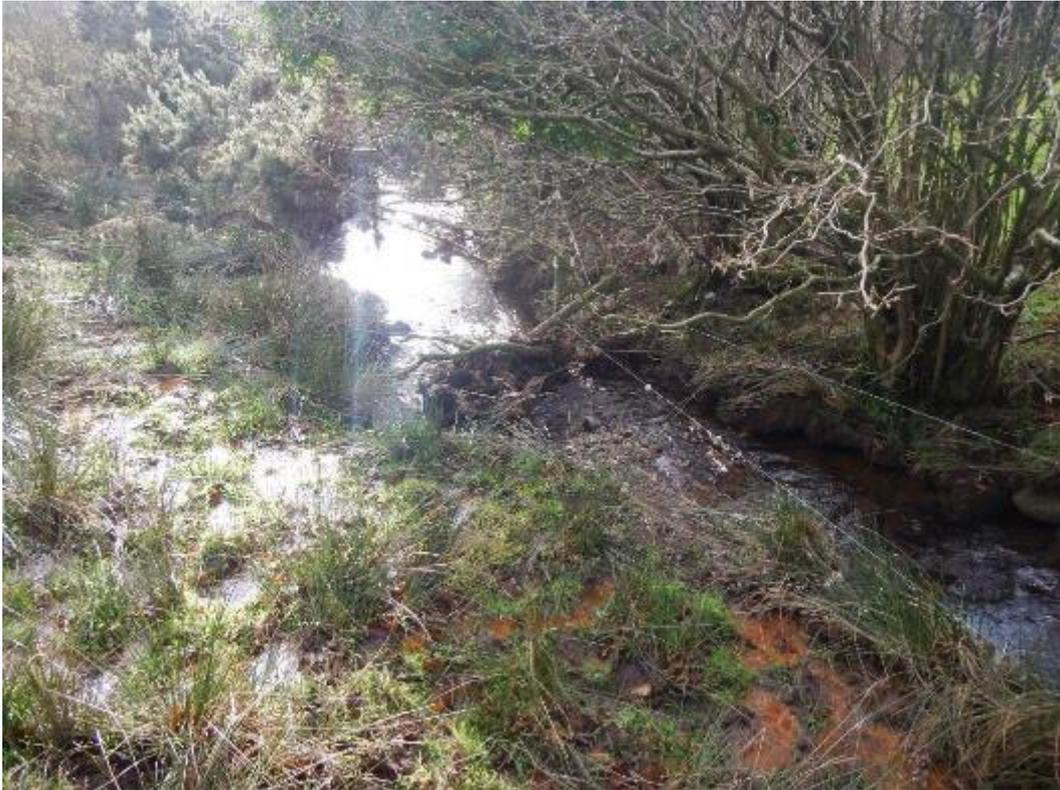
Photo DSCN5185. Towards the d/s end of the field, a particularly boggy area provides little grazing and would ideally be excluded from the adjacent field within a watercourse buffer strip. The ochreous iron precipitation looks striking but in the relatively low volumes observed is unlikely to be an issue.

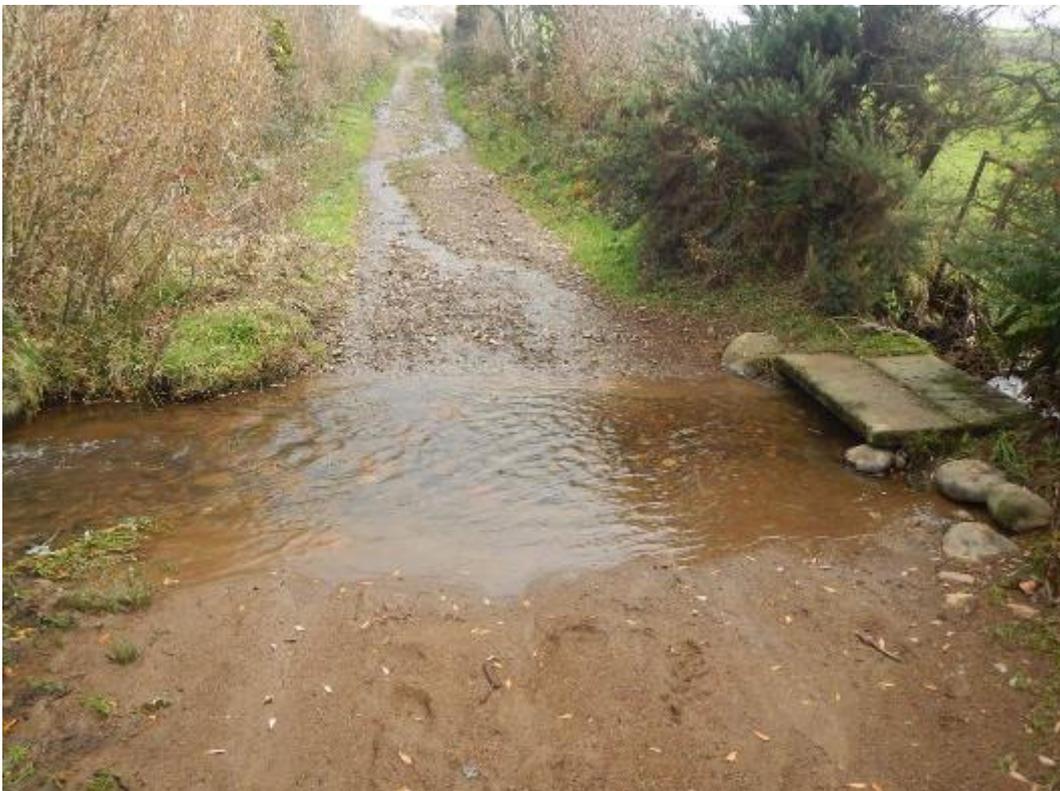
Photo DSCN5188. The access track at NY 02059 11130 creates no fish passage issues but is again a notable conduit for surface runoff and associated fine sediment. Installing cross drains that discharge to rough ground soakaways rather than directly to the watercourse would be greatly beneficial.

2	NY 02059 11130	Install cross drains and prevent direct discharge from any surface water conduits to the beck.
Fording/drinking points.

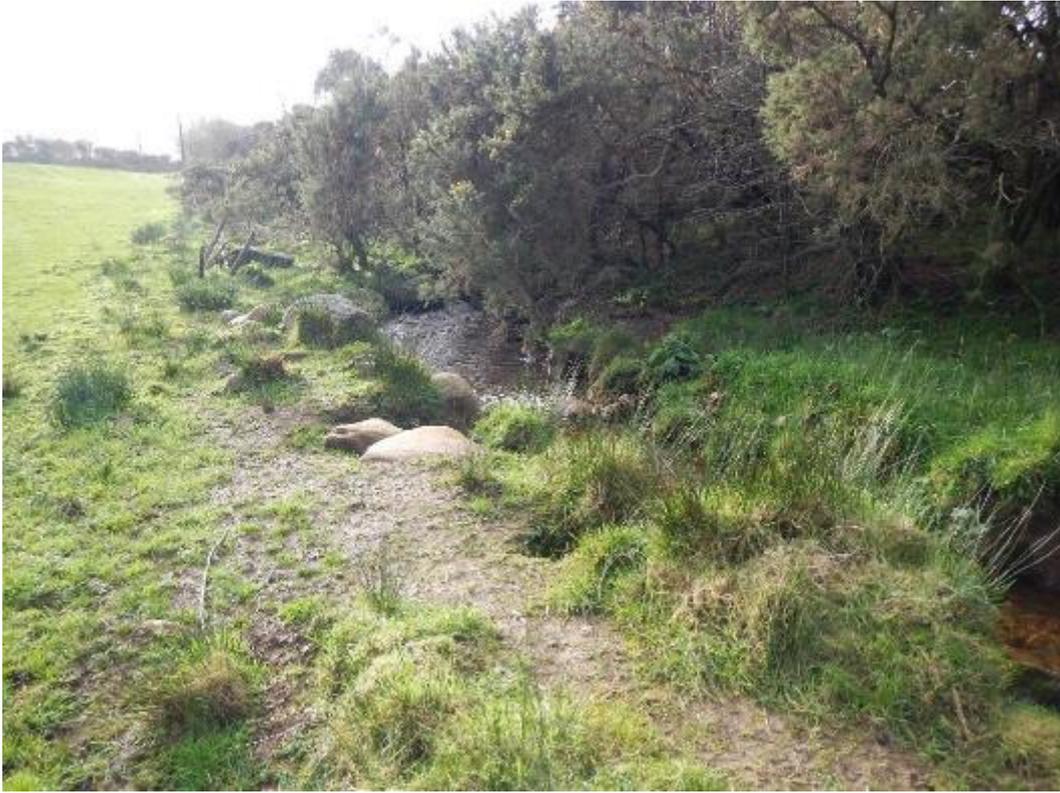
Photo DSCN5193. In the next field d/s the watercourse traverses the field boundary, with areas of higher intensity sheep in the fields grazing on both bank sides (NY 02059 11130 - NY 01998 10942).

2	NY 02059 11130 - NY 01998 10942 (c. 200m)	Install buffer fencing.
Lack of buffer fencing on either the LB or RB between grid refs.

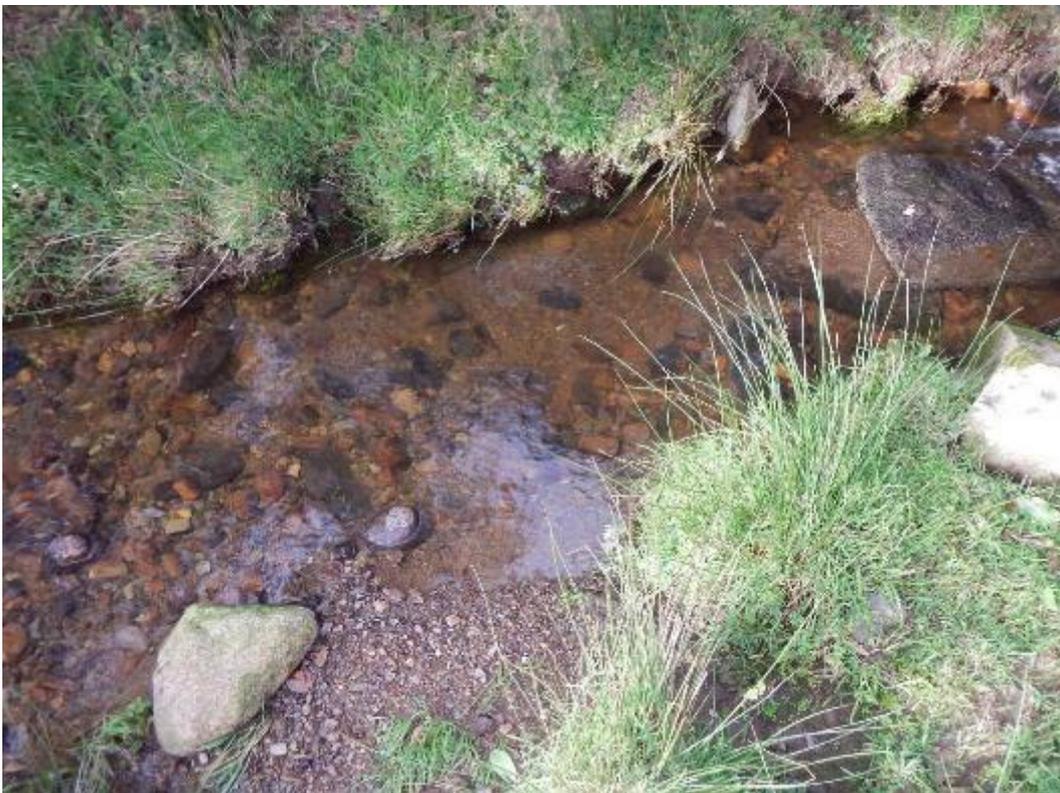
Photo DSCN5194. Further evidence of the impact upon substrate quality. Straightening of the watercourse throughout much of the length limits the retention of gravels in peak flows but large inputs of fine sediment during peak flows and during subsequent lower flows is clearly infiltrating the bed with large volumes of silt. Also note the lack of vegetation diversity owing to grazing pressure.

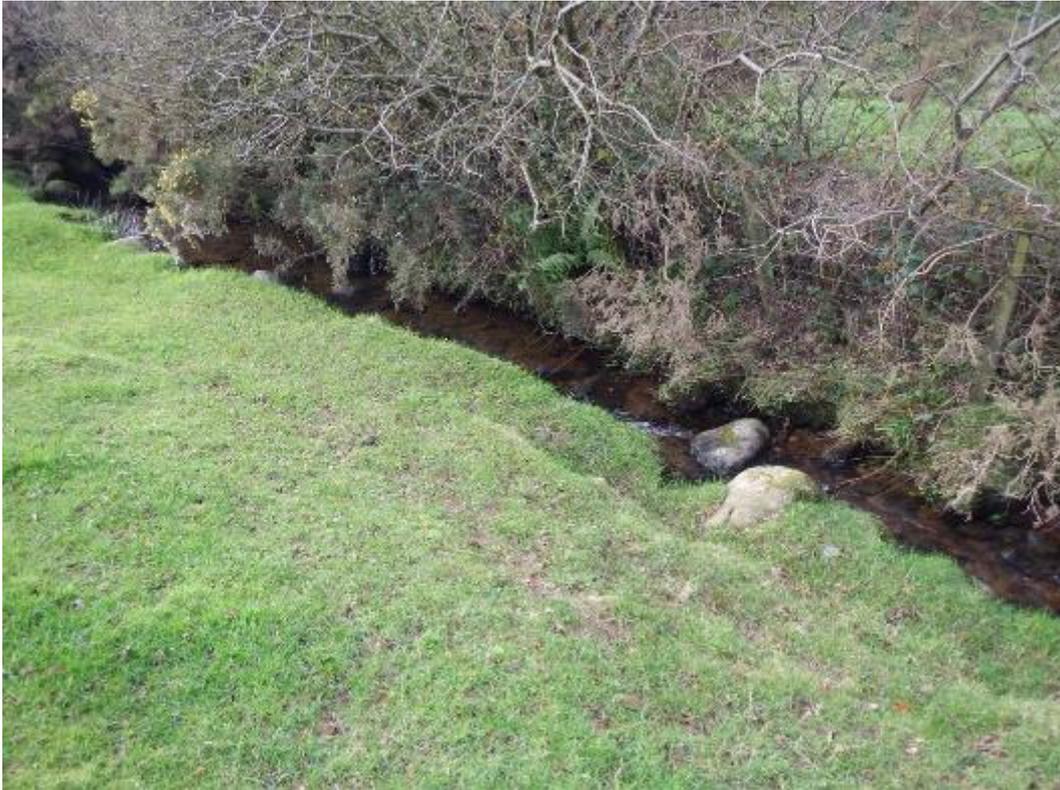
Photo DSCN5198. Progressing d/s, the watercourse continues to traverse the field boundary (so livestock access to the beck is allowed from one or other bank sides), with very high intensity grazing on the LB (NY 01998 10942 - NY 01969 10875) and a particularly badly poached area on the (RB NY 01974 10909).

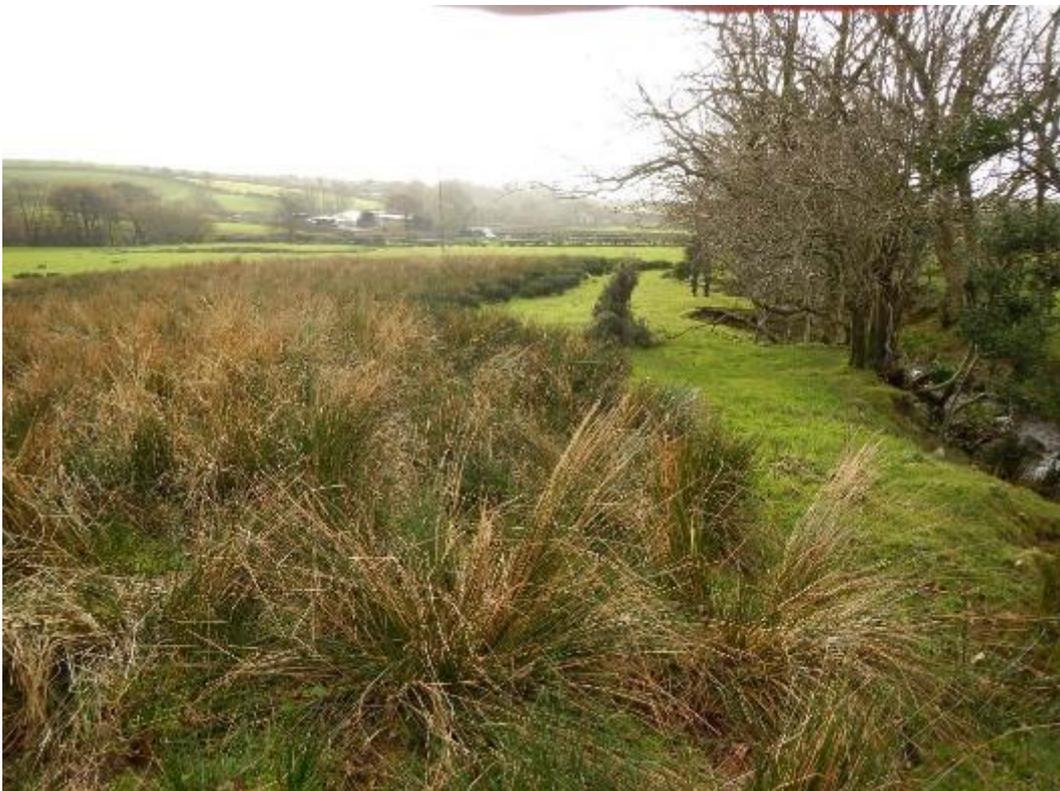
Photo DSCN5206. High intensity sheep grazing continues on both sides of the river d/s, where there is either a lack of buffer fencing or the fence is not stock proof on one bank or the other (NY 01969 10875 - NY 01880 10742). The paleo-channel of the now straightened and incised watercourse remains as a wet area in the field where *Juncus* sp. is able to outcompete the grass.

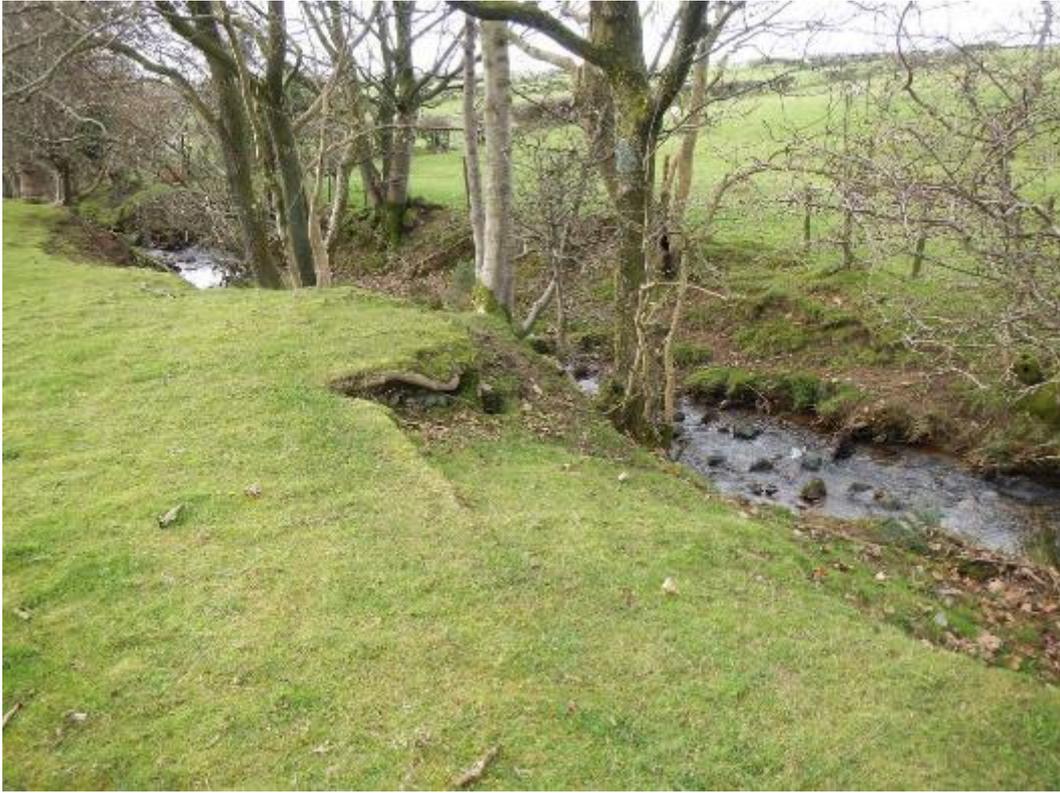
Photo DSCN5207. The intensity of the sheep grazing continues d/s, leaving nothing but a very thin covering of grass and banks susceptible to erosion. The extent of channel incision here is particularly evident.

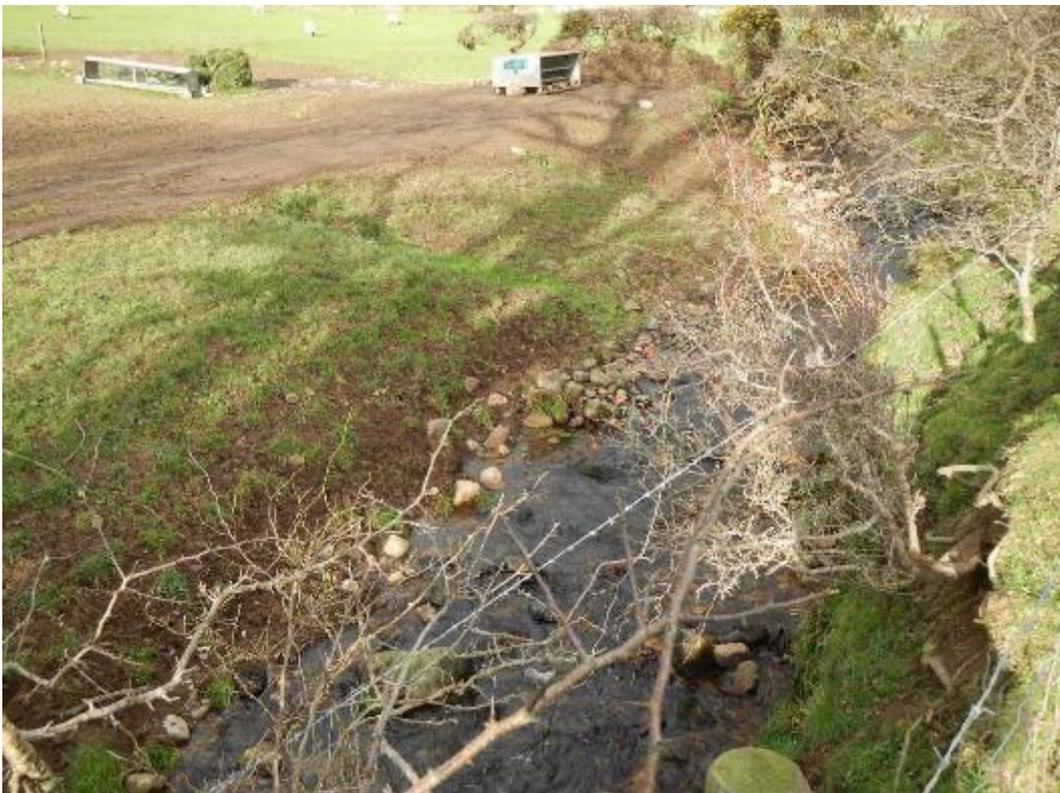
Photo DSCN5217. On the RB at NY 01887 10774, sheep trampling and overgrazing around a feeder (located too close to the watercourse) creates further issues from surface runoff and bank erosion. Attempt appears to have been made to clear the area, with muck and waste having been scraped up into a small midden, but this too is a potential pollution source to the watercourse.

2	NY 01969 10875 - NY 01880 10742 (c. 165m)	Install buffer fencing. There is a particularly poached area on the RB at NY 01887 10774, where a feeder has been located too close to the watercourse.

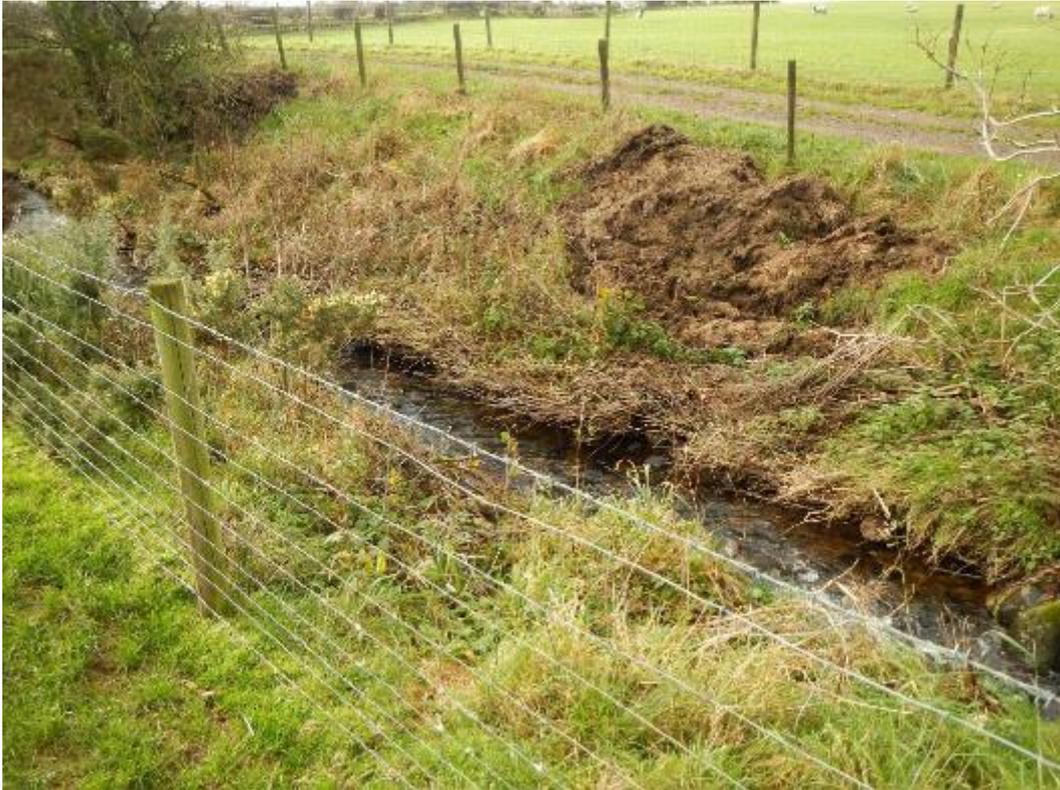
Photo DSCN5222. The watercourse is buffer fenced from NY 01880 10742 - NY 01844 10663. Note the greatly improved diversity of bankside vegetation. Also note that more scrapings appear to have just been dumped over the fence into the buffer. These are likely to leach nutrients to the watercourse and potentially wash into the watercourse at higher flows.

3	NY 01880 10742 - NY 01844 10663	Ensure existing fencing is maintained to preserve the benefit it provides.
Buffer fencing.

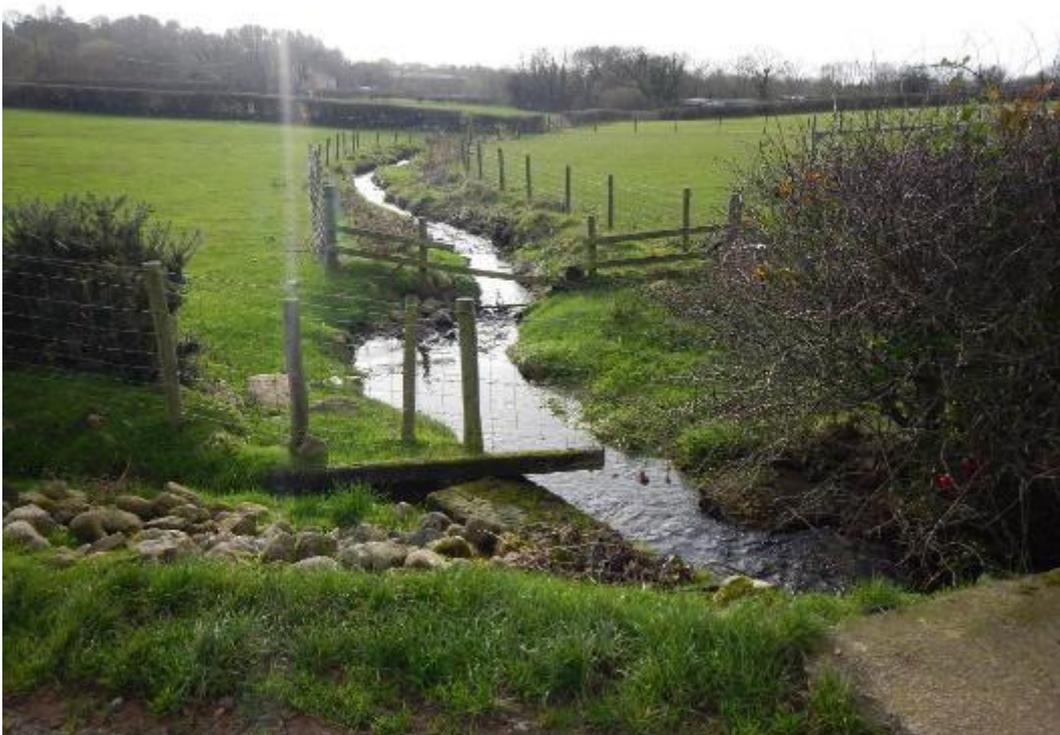
Photo DSCN5224. Drinking points/livestock access to the watercourse at NY 01844 10663 currently denude habitat but are not currently causing major pollution. However, it would still be better to completely exclude livestock and provide alternative watering.

3	NY 01844 10663	Ideally exclude livestock and provide offline watering.
Weir – an obstacle to fish passage.

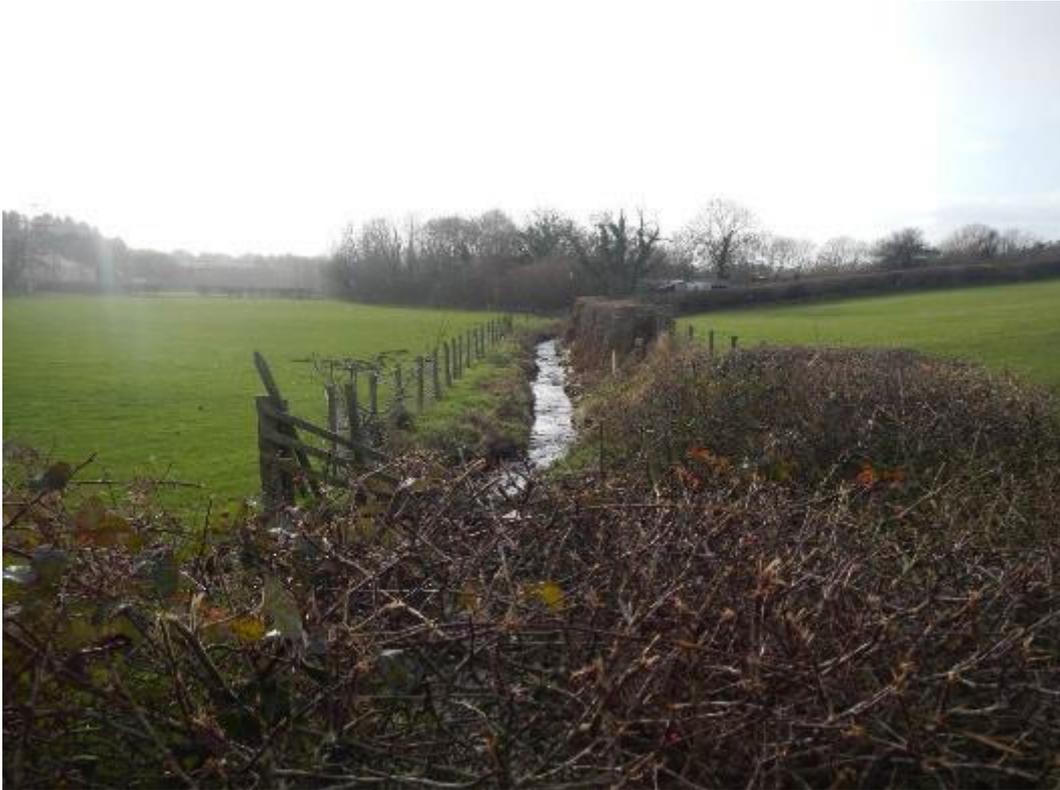
Photo DSCN5227. The remainder of the watercourse is either buffer fenced (NY 01844 10663 - NY 01747 10494) or un-grazed downstream to the last field along the river Ehen. The general lack of trees suggests a long history of grazing, before more recent buffer fencing. Judicious tree planting along the reach would be beneficial but restoration of these straightened sections to a more natural, sinuous course will be required to reinstate truly high-quality habitat.

3	NY 01844 10663 - NY 01747 10494	Ensure existing fencing is maintained to preserve the benefit it provides. Additional tree planting would also be beneficial.
Buffer fencing.

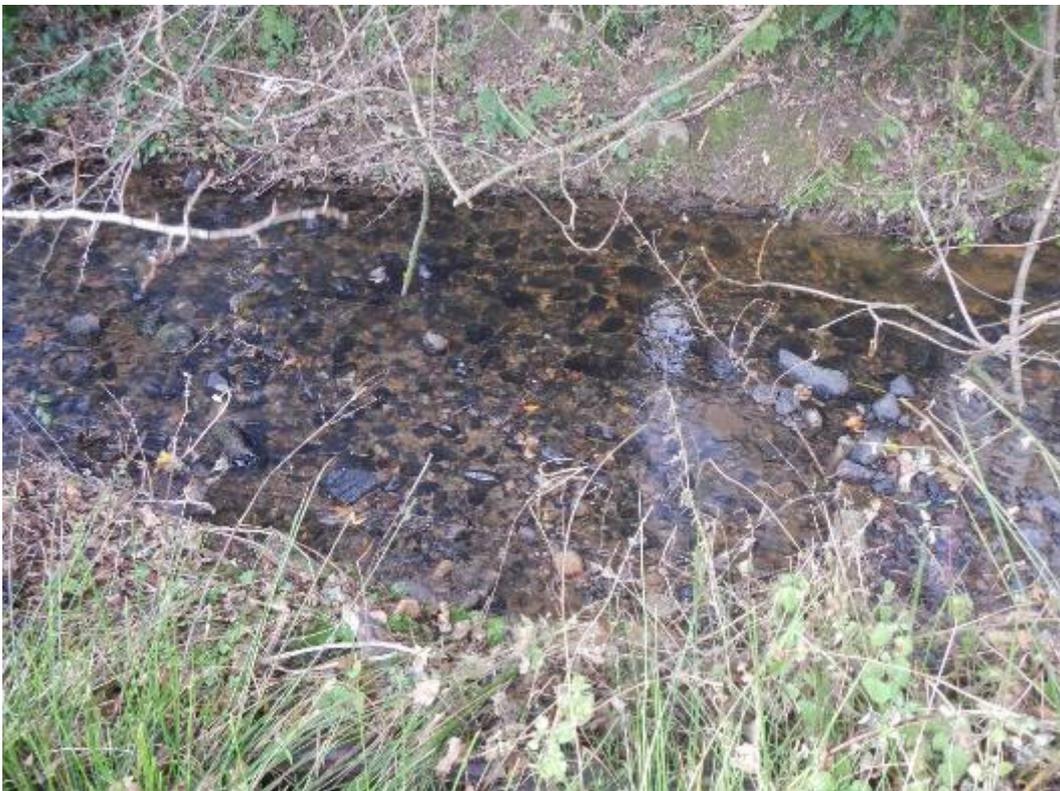
Photo DSCN5228. In areas where the channel widens and retains gravel and small cobbles, the fine sediment component severely degrades potential salmonid spawning habitat. A lack of in-channel structure/woody material also limits the potential for natural bed scouring and sorting.

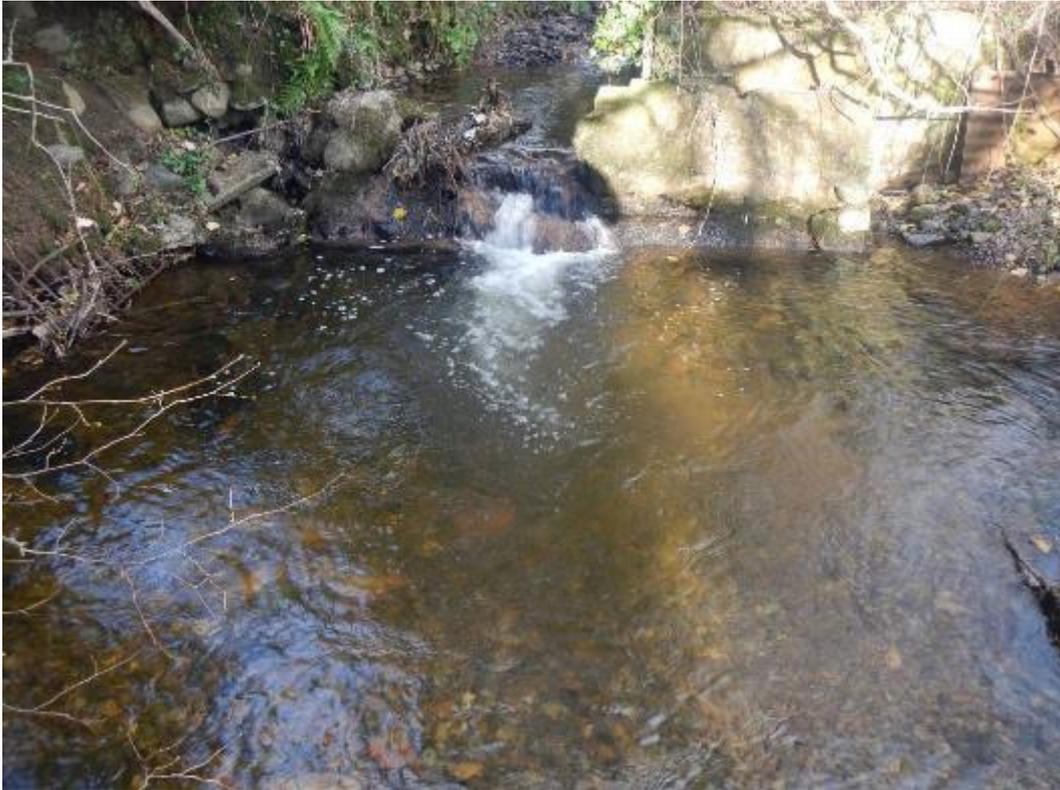
Photo DSCN5229. A weir at NY 01746 10511, associated with the old fish hatchery has been eased but still creates an obstruction to fish passage. It is important to consider that even small fish need easy access around the catchment to accommodate their changing habitat requirements as they grow. Preventing them from dispersing to utilise new habitat can increase competition and limit the potential production of a watercourse, particularly one with a scarcity of gravel and spawning opportunities.

1	NY 01746 10511	As the weir is now obsolete it should be completely removed to reinstate natural sediment transport and fish passage.
Culvert - an obstacle to fish passage.

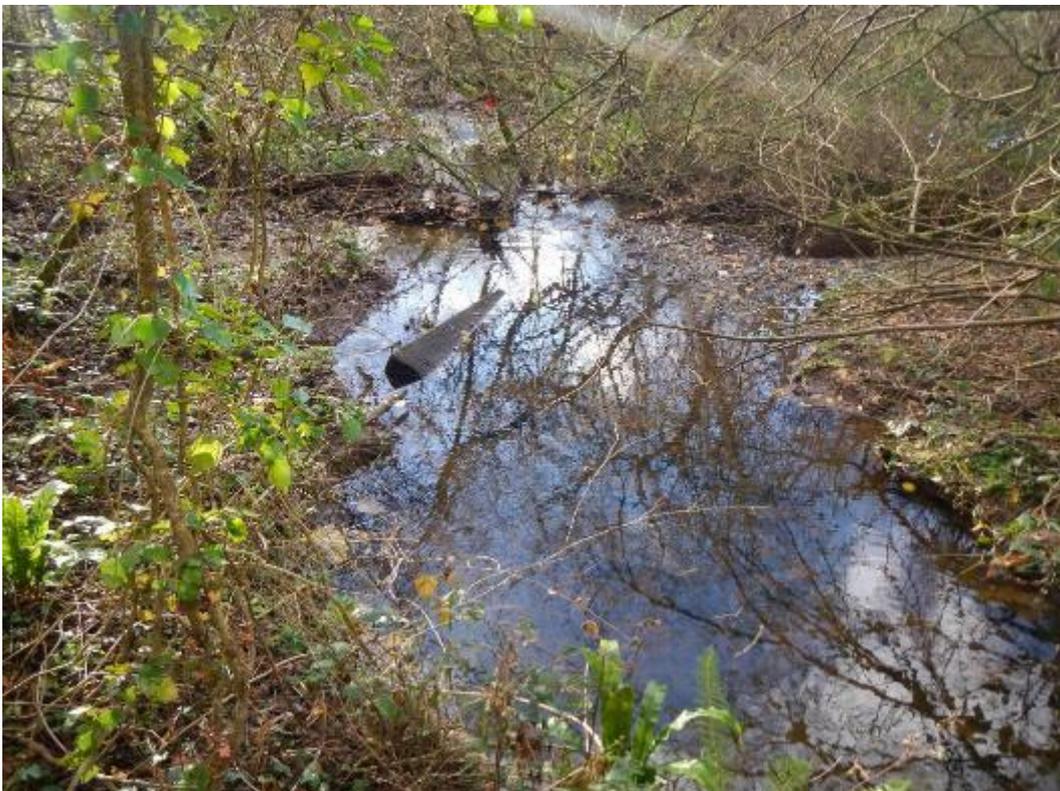
Photo DSCN5233. Around the location of the old hatchery, an area of valuable wet woodland has developed, greatly diversifying the generally degraded and uniform beck channel. This creates high quality juvenile habitat through the diversity of in-channel structure and protection.

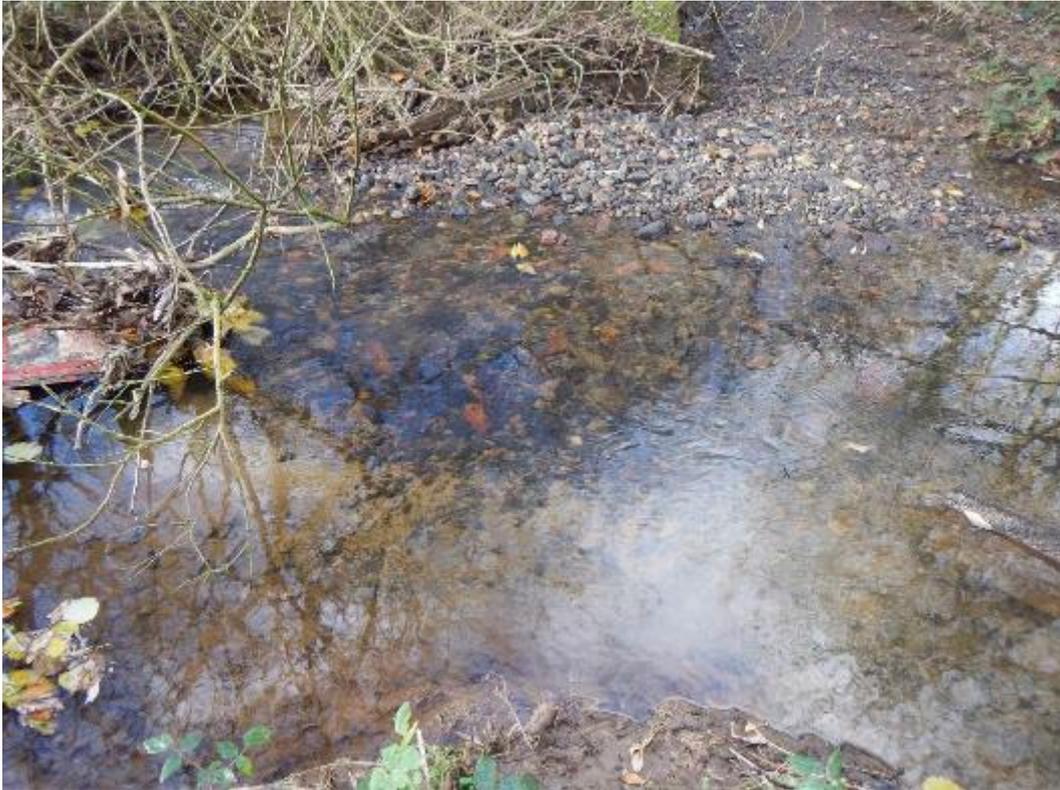
Photo DSCN5235. Structure within the channel also retains valuable potential spawning substrate. For this reason, these overgrown areas should be retained, with efforts directed at improving poorer quality areas and the major fine sediment issues occurring upstream.

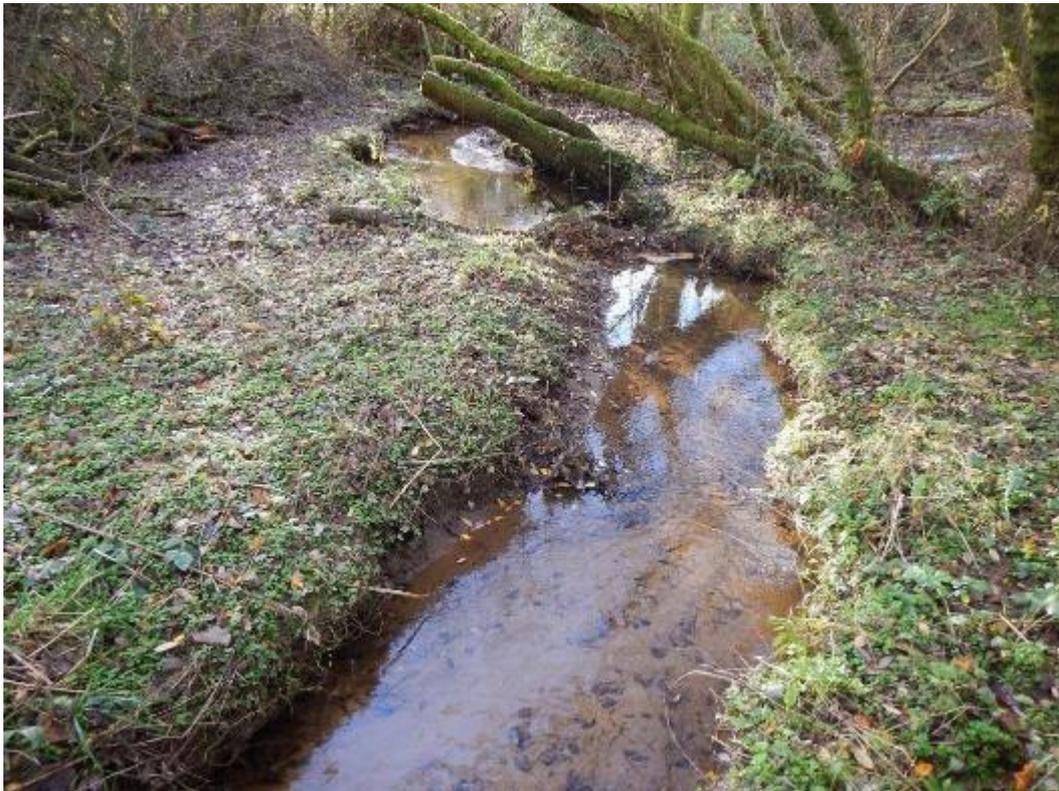
Photo DSCN5235. There is a common misconception that all rivers require extensive tree management to let light in. This is not the case. On many upland rivers, particularly where weed growth is unlikely (due to low nutrients and coarse, mobile substrate), removing branches and trees just denudes what habitat there is. Providing there is enough light for primary production (algae/biofilms on the bed), which there invariably is, the natural food web should be supported. Equally importantly, tree management is an intensive, ongoing task; pruning once then walking away usually just leads to worse shading in the long term.

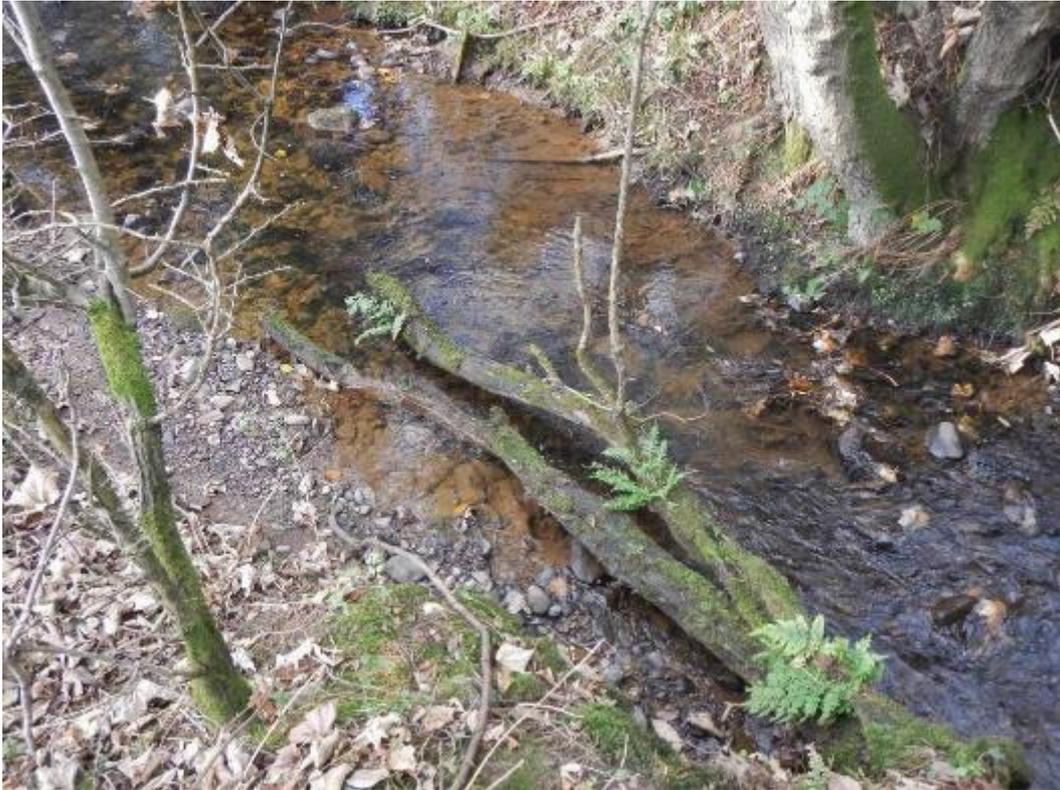
Photo DSCN5248. Note the major impact of fine sediment deposition over the bed, even in the relatively fast-flowing sections. The bed in this shot should naturally appear black, rather than brown. This smothering of the bed with fine silt will inhibit the natural productivity of the watercourse for invertebrates, and the algae upon which many of them feed, far more than any amount of tree shading.

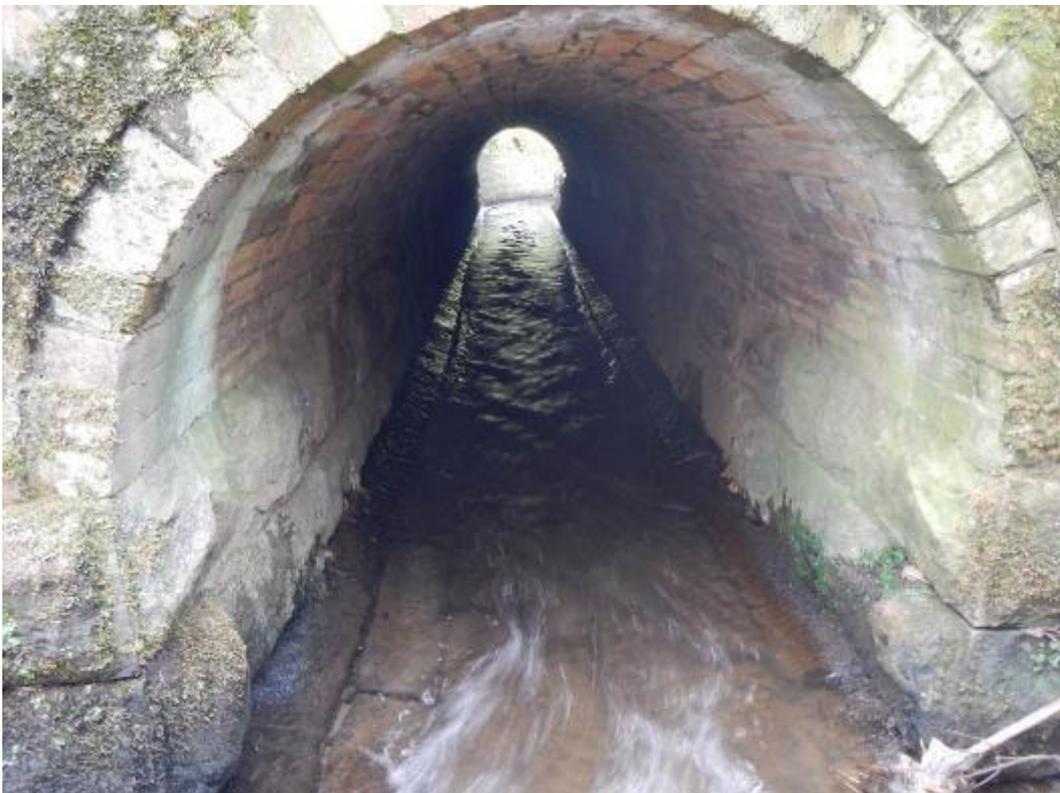
Photo DSCN5248. At NY 01615 10382, the first of two more significant culverts create a small obstruction to fish, owing to the shallow water depth and relatively smooth bed. Although fish will pass the structure, it is just one more unnecessary challenge and a behavioural barrier which should ideally be improved with baffles to increase the water depth and slow the flow.

2	NY 01615 10382	Install alternating baffles to retain greater water depth at all flows and aid fish passage. It may also be possible to partially drown out the culvert with a structure installed at the d/s end.

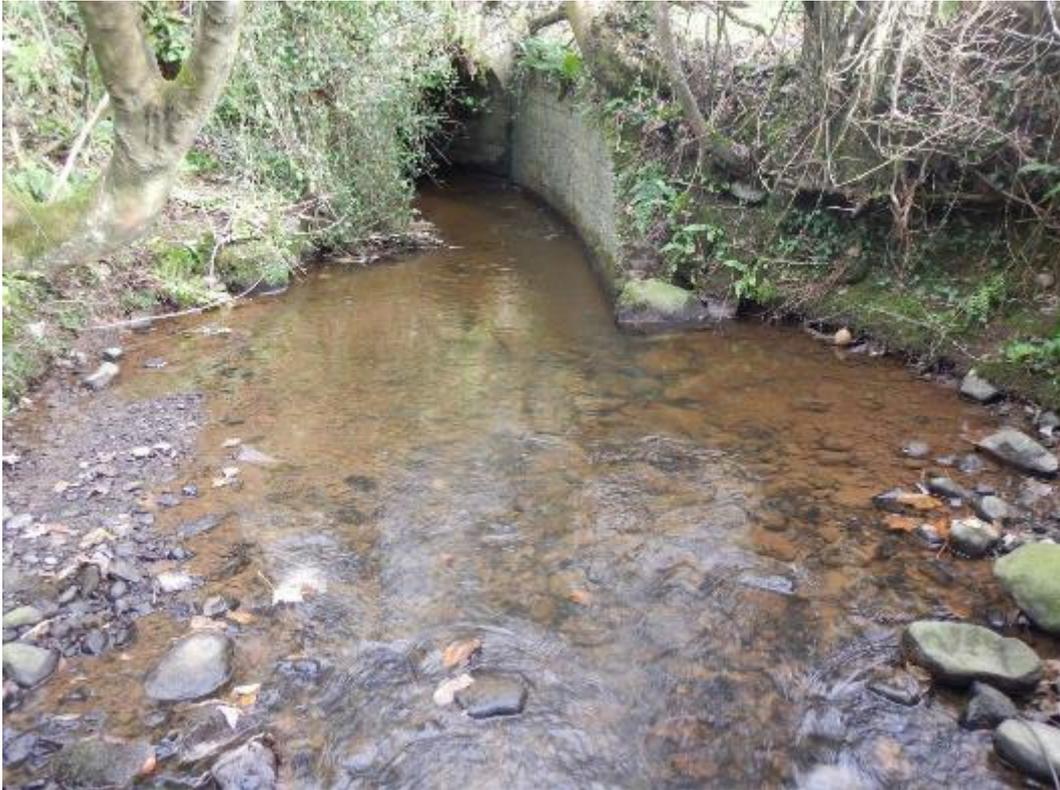
Photo DSCN5255. Access into the culvert from the d/s end is reasonably good, with a resting pool and no major step. Note the fine sediment smothering the bed in this wider area. A little fine sediment might be expected but this is excessive and symptomatic of the chronic and acute fine sediment issues u/s.

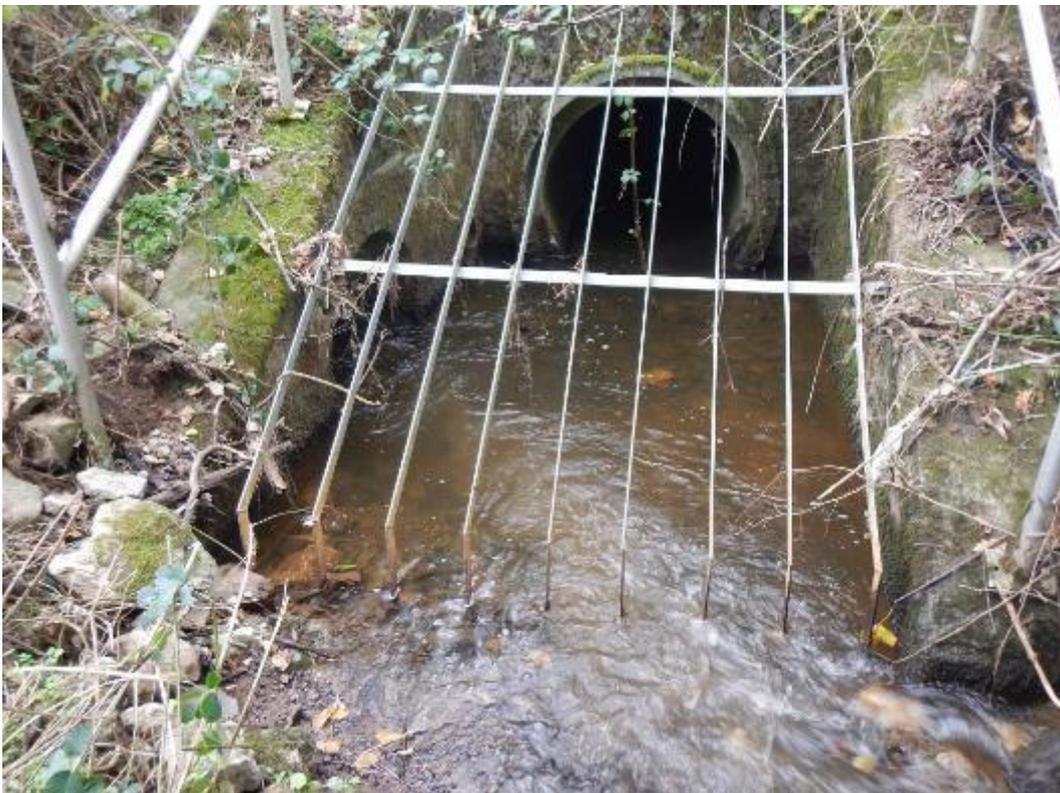
Photo DSCN5256. The A595 road culvert d/s (NY 01582 10371) appears to provide similar flow and water depth but is smaller diameter, so creating greater issues from fluming of high flows. The dimensions of the culvert may also make it harder/infeasible to install baffles throughout much of its length, although there may at least be an option to improve the area around the d/s end. Note the tributary joining the beck to the left of shot.

2	NY 01582 10371	Install baffles where possible. It may also be possible to partially drown out the culvert with a structure installed at the d/s end.
Composting on the bank.

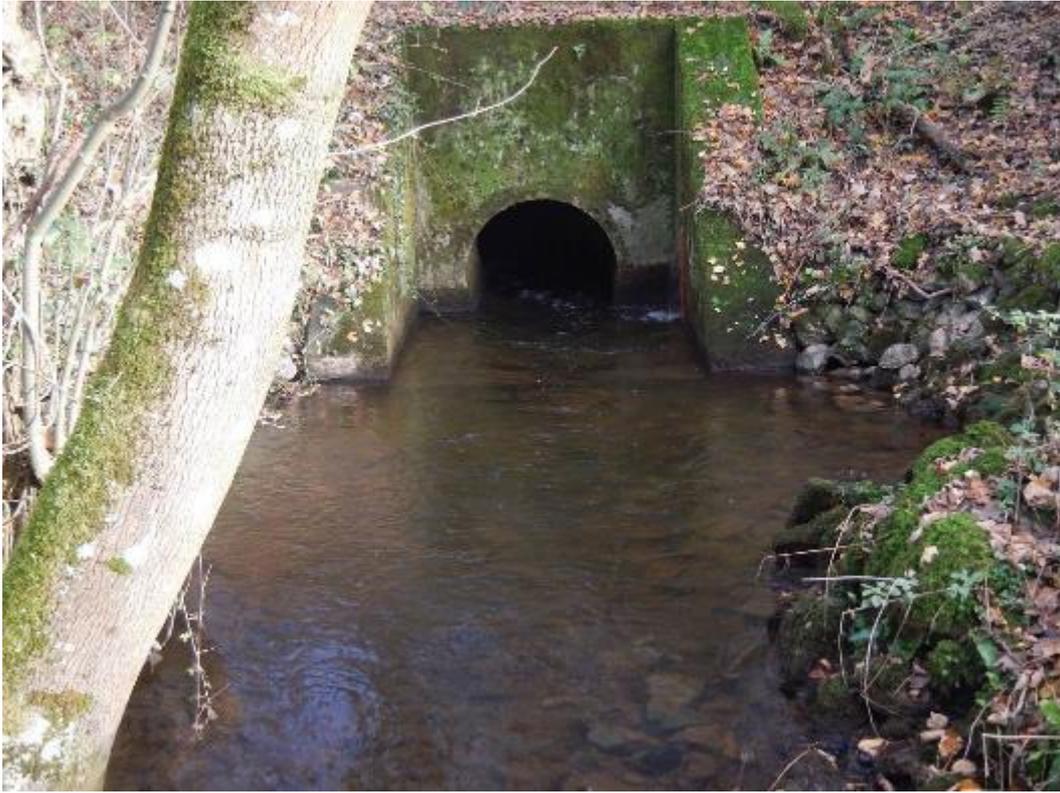
Photo DSCN5259. The d/s end of the A595 culvert. It may be possible to increase water depth and flow dissipation within the culvert by baffling towards the d/s end or even with a notched impoundment in the channel d/s.

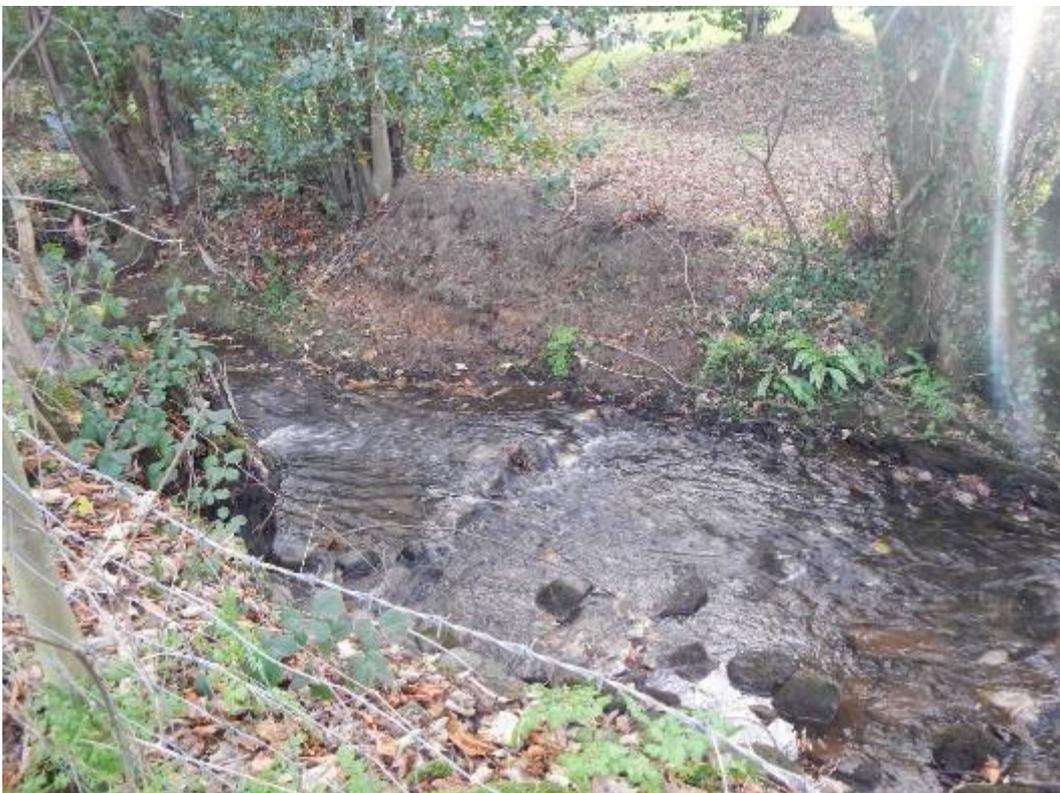
Photo DSCN5262. Towards the d/s limit of the beck (NY 01457 10338), garden waste is being composted right on the bank. This should be stopped as the composting process will be leaching nutrients into the watercourse. Composting should always be undertaken well away from any watercourses to avoid pollution.

3	NY 01457 10338	The owner should be encouraged to compost well away from any watercourses.

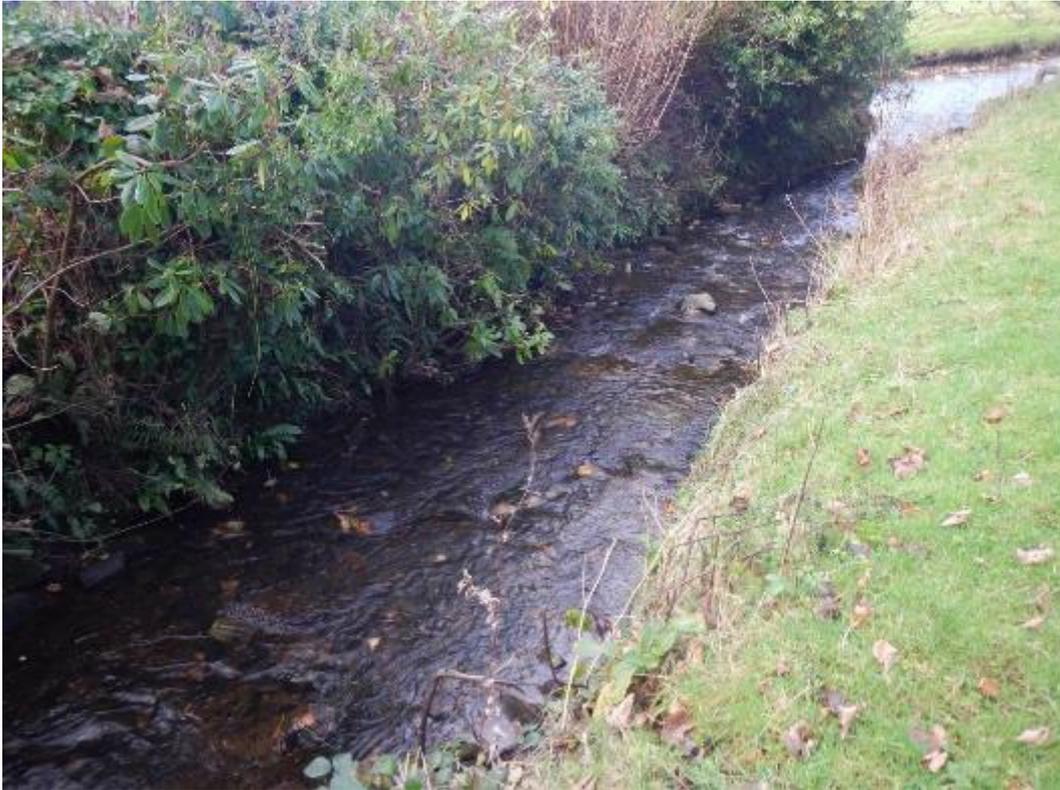
Photo DSCN5265. Pruning of the overhanging and trailing branches has been greatly reduced habitat quality in the straightened, walled section of the beck around the confluence with the River Ehen. Although several of the shrubs are non-native, in the absence of replacing them with native species, they should be allowed to grow over the channel to reinstate the valuable shade and cover that has been removed. It is always advisable to seek professional guidance before undertaking tree pruning and maintenance. The field at the confluence with the Ehen would benefit from buffer fencing (NY 01449 10386).

3	NY 01449 10386 (c. 90m)	Install buffer fencing. Also ensure that valuable trailing and aerial cover is not removed.

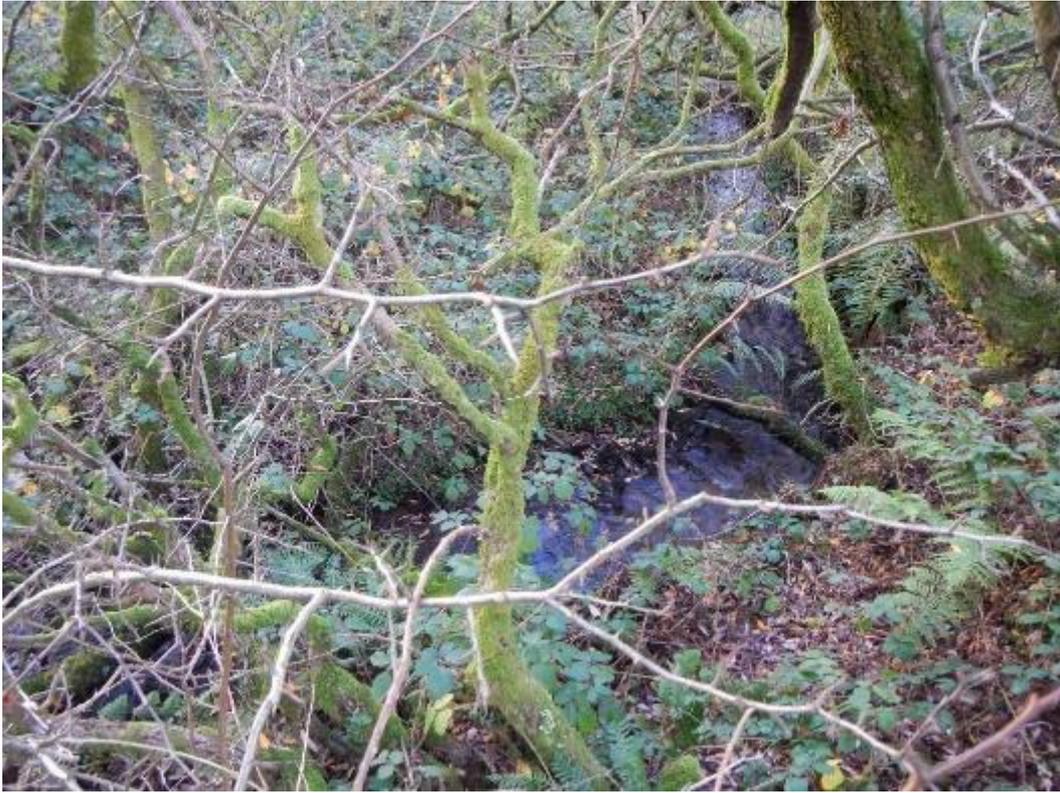
Photo DSCN5100. At farthest upstream point inspected on the tributary there is good availability of cover and structure, with good quality physical habitat for juvenile salmonids.
