Walkover Assessment
Black Beck
(River Ehen Catchment)
20/11/2018

Undertaken by Gareth Pedley

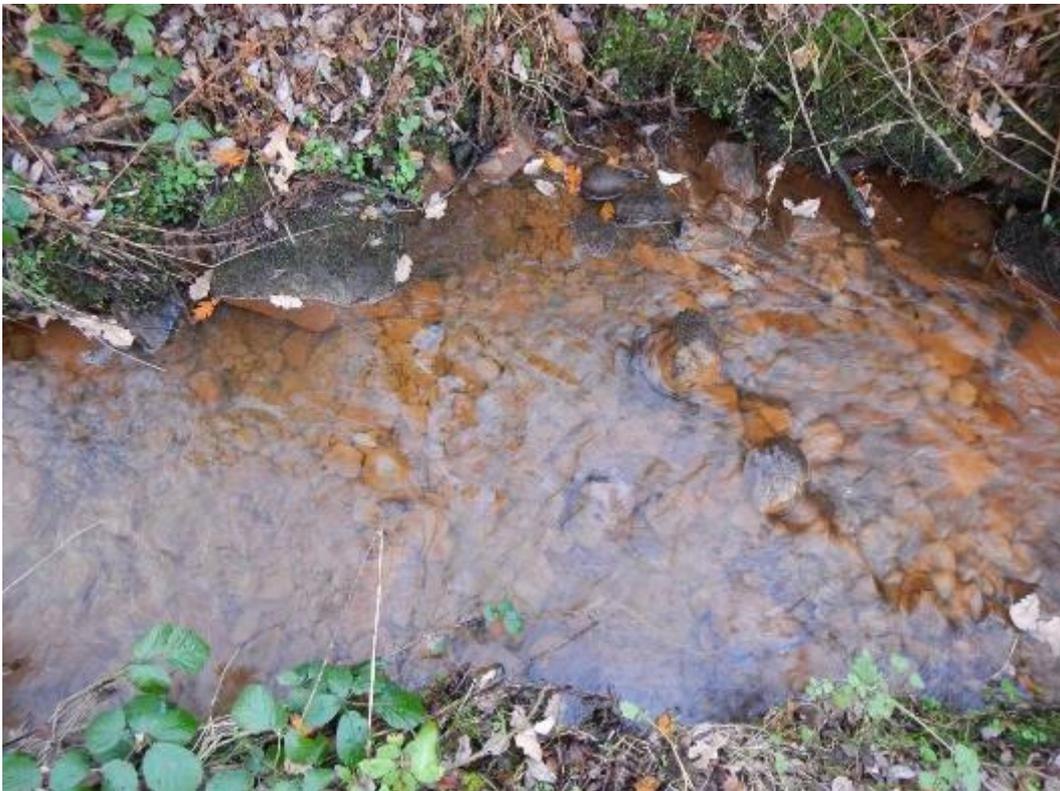
Photo DSCN5100. Chemically, the water in this area appears to have a high iron content, as evident by the ochreous staining of the bed, resulting from oxidation of the iron which forms a rust-like precipitate on the bed.

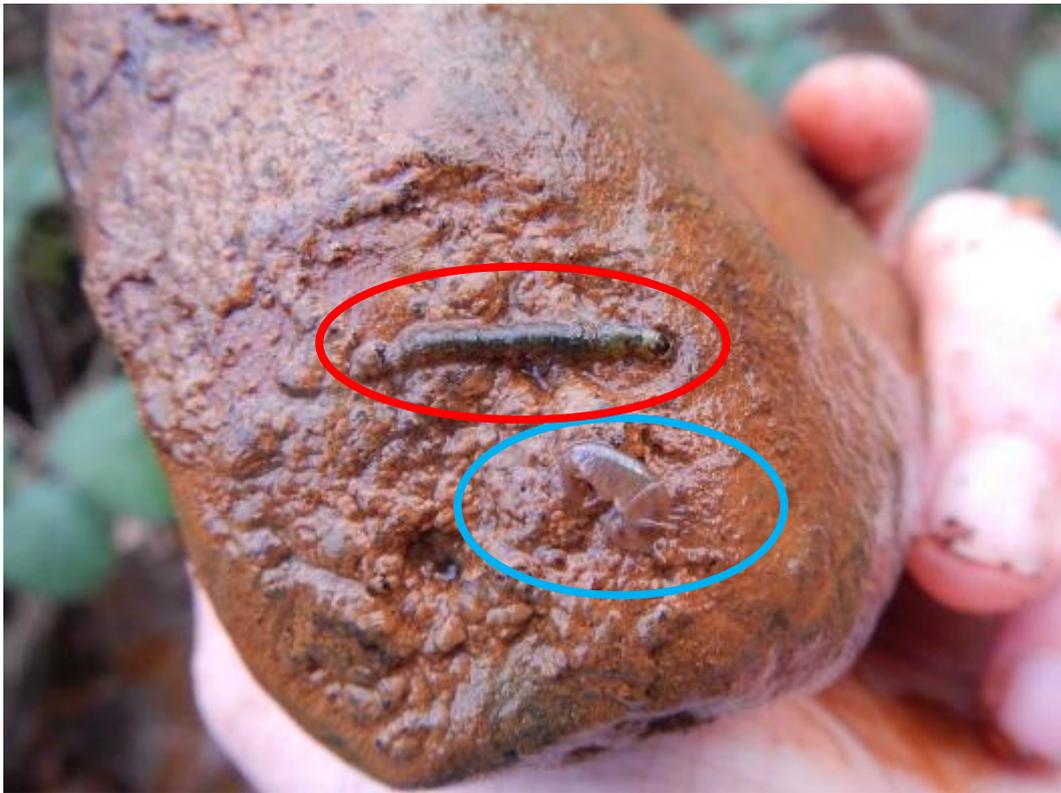
Photo DSCN5115. Despite the iron precipitate and likely locally reduced pH, invertebrates were present in low densities, with small stoneflies, caseless caddis (*Rhyacophila* sp: red ellipse)) and freshwater shrimps (*Gammarus pulex*: blue ellipse) observed.

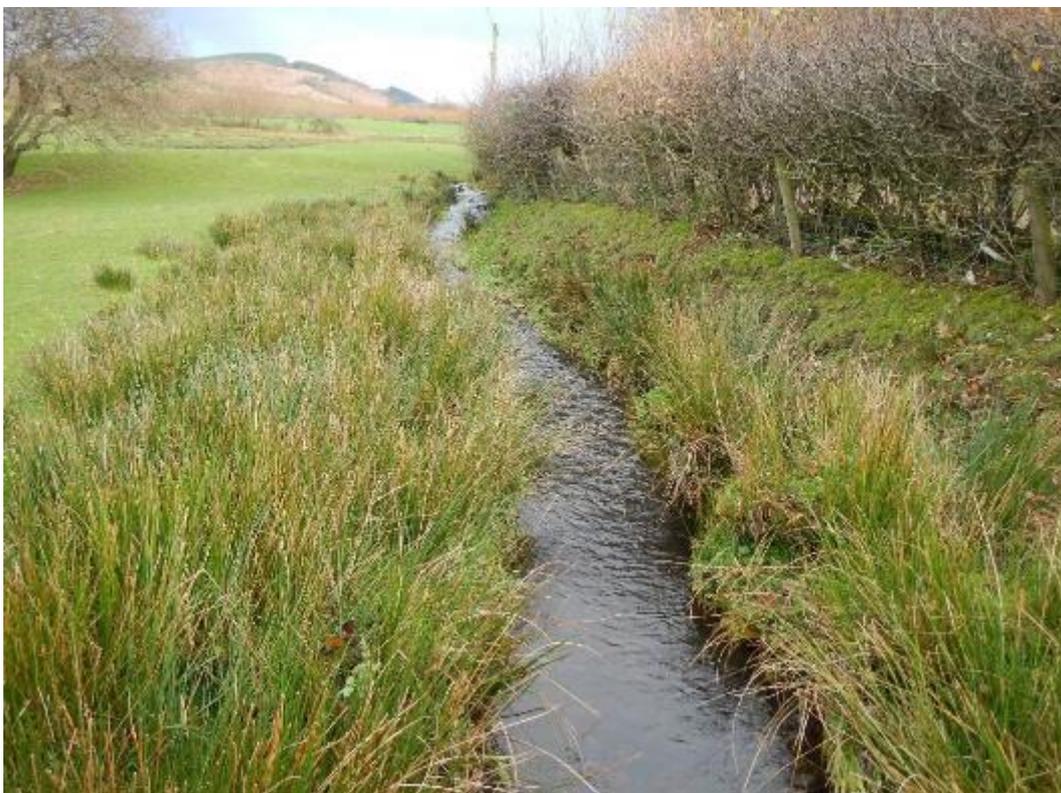
Photo DSCN5211. Progressing d/s, the elevated levels of iron abate and the watercourse taken on a more normal appearance. The channel shape is unnatural, and particularly straight and uniform, but appears to have reasonable potential for juvenile salmonids. Diversification of the channel to a more sinuous course would be greatly beneficial but if this is not feasible, at least buffer fencing the watercourse would allow species diversification and provide habitat improvements (NY 02039 10710 - NY 01946 10666).

2	NY 02039 10710 - NY 01946 10666 (c. 200m)	Install buffer fencing.

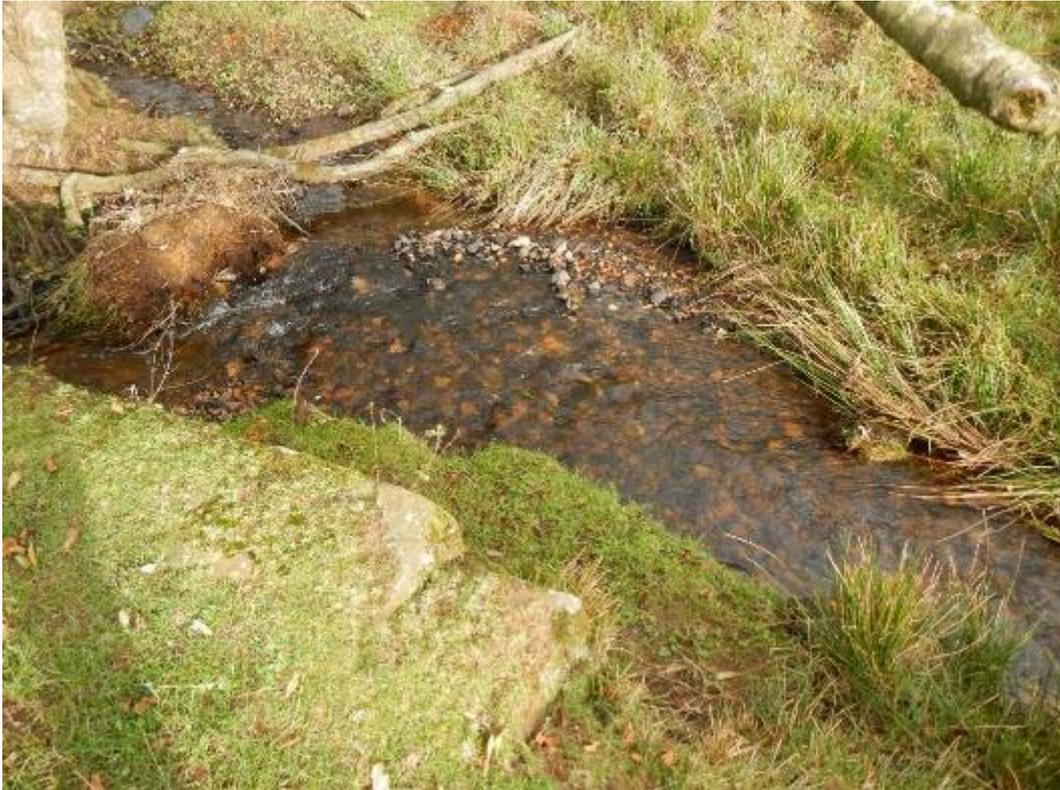
Photo DSCN5213. At the remains of an old weir, a kink in the channel is sufficient to retain higher quality, potential salmonid spawning habitat, again demonstrating the importance of reinstating more natural sinuosity of these watercourses.

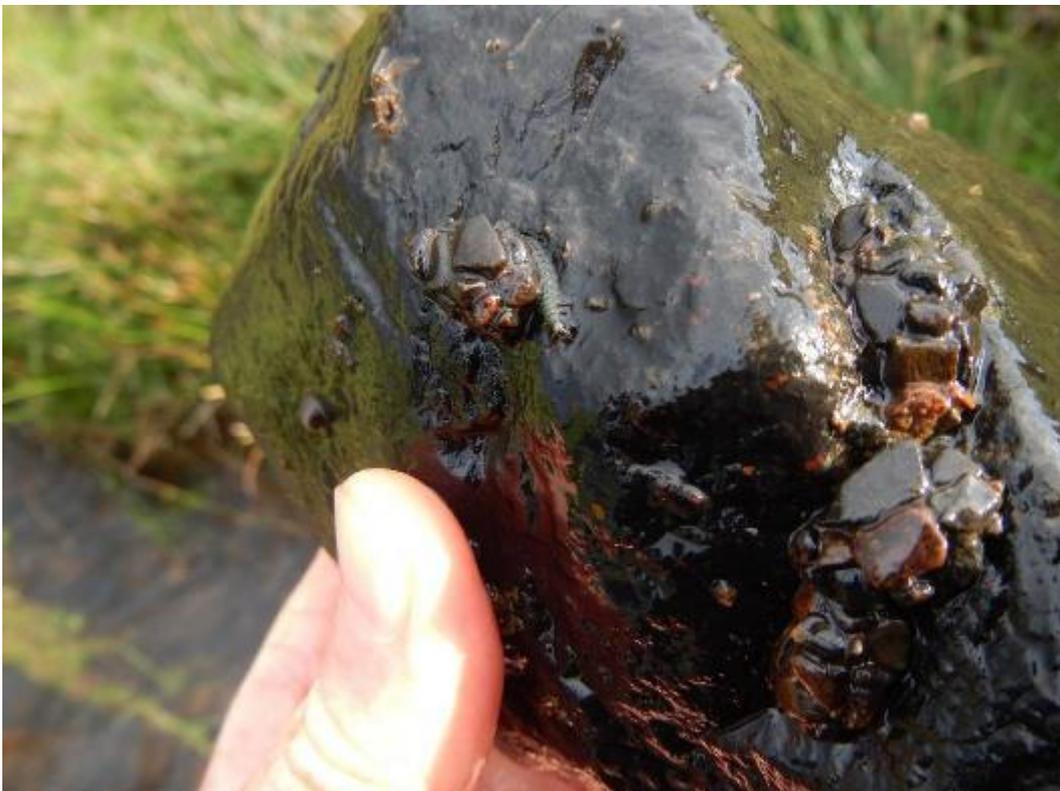
Photo DSCN5215. Stone turning in the middle reaches of the watercourse identified a much greater abundance of cased and caseless caddis and stoneflies. Somewhat surprisingly, no mayfly nymphs were observed; however, that is no confirmation that they are absent from the site.

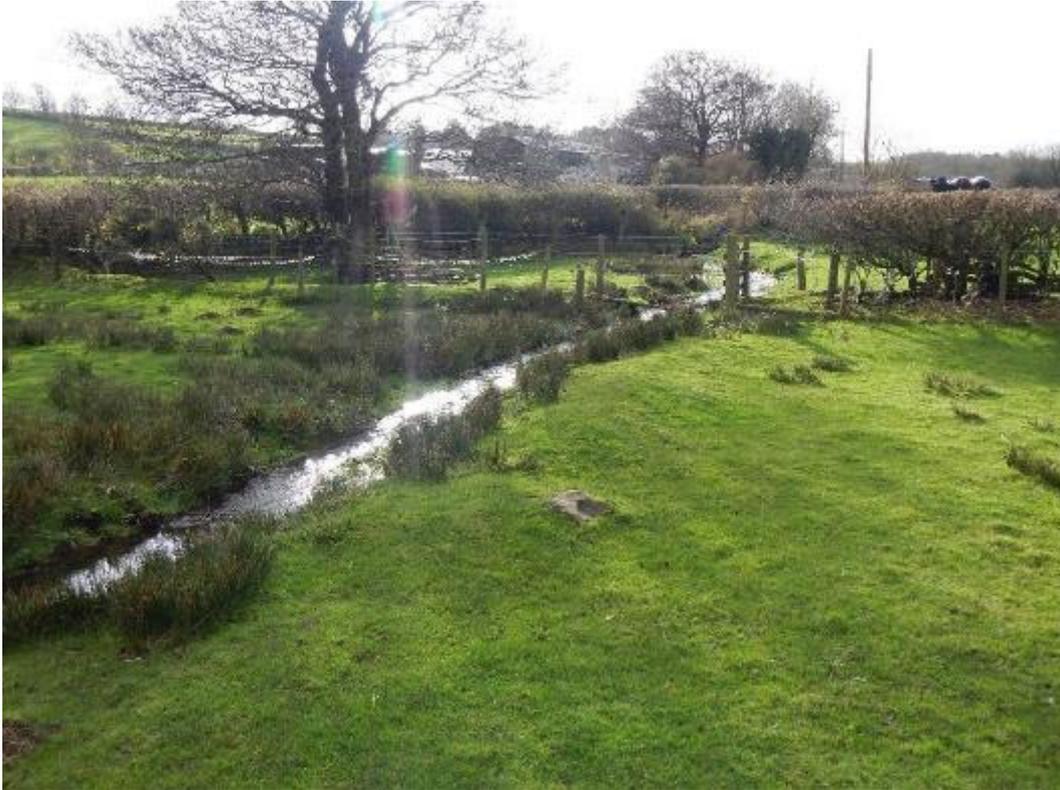
Photo DSCN5216. The straight and heavily grazed channel could be improved through the installation of fencing, but more extensive channel improvements would be beneficial.

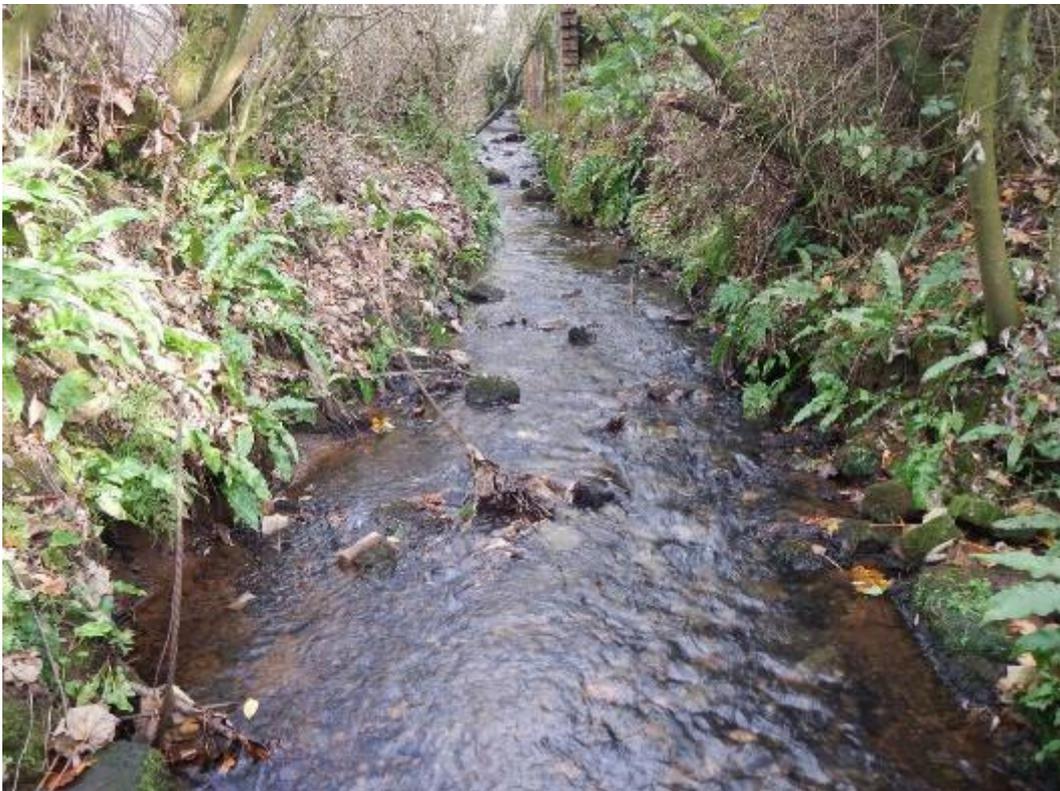
Photo DSCN5258. Away from the grazed areas, past straightening/modification of the channel still limits its potential to maintain deeper holding pools and sort and retain gravel, but the bankside vegetation does enhance what habitat features there are. Pruning of the bankside trees and shrubs should be avoided to optimise the habitat potential.

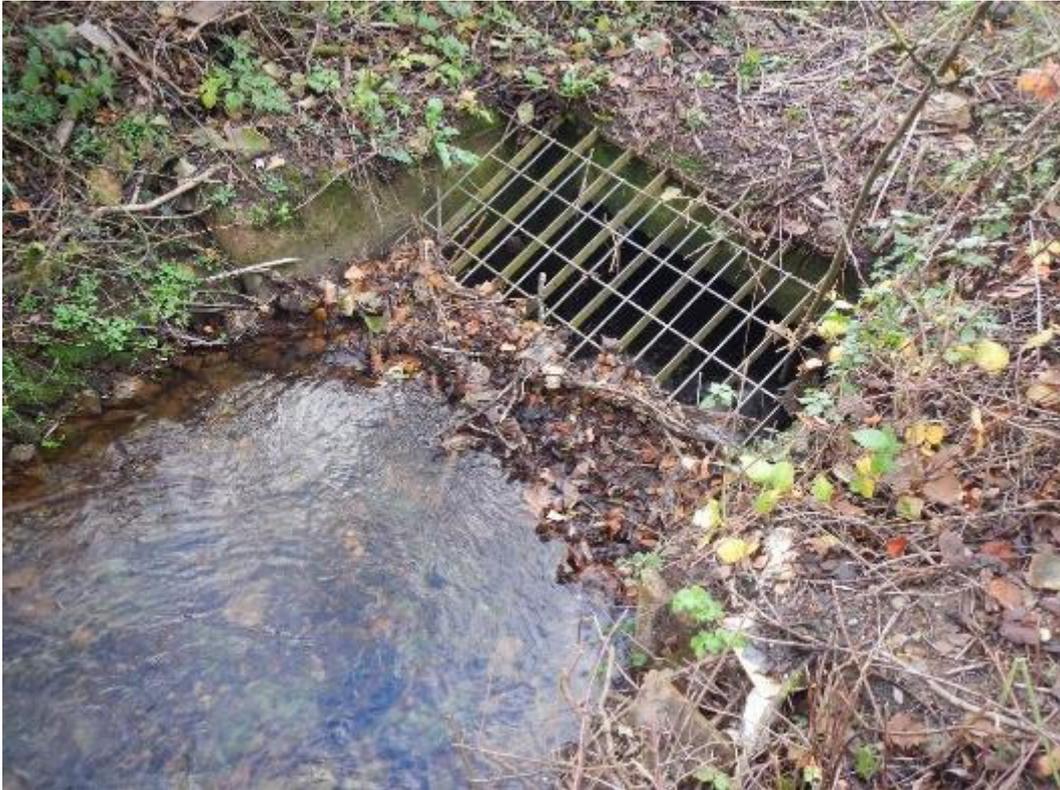
Photo DSCN5257. An concrete step and overly restrictive grid, on top of a trash screen, at the entrance to a long, culverted section of the watercourse has created a complete barrier to fish movement and constitutes a clear offence under the Salmon and freshwater fisheries Act 1975 (NY 01650 10306). Removing the step and additional mesh is likely to reinstate substrate transport at the site and greatly reduce the fish passage issue.

1		Investigate options to remove the culvert and reinstate the tributary as a surface watercourse. As a bare minimum, notch/remove step and additional screen at the u/s end of the culvert and ideally modify the original screen.

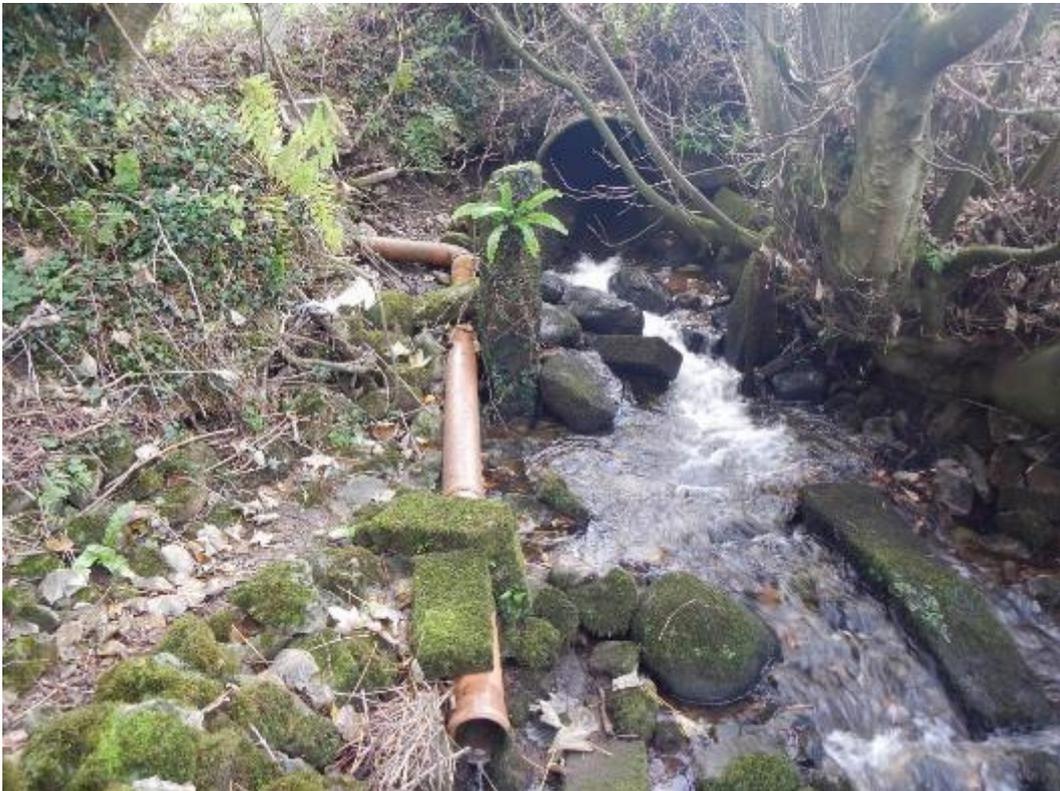
Photo DSCN5253. The culverted section is steep and is already an obstruction to fish passage, but anecdotal evidence suggests that fish did manage to ascend it in certain flows (prior to the mesh obstruction). The ability of fish to pass the culvert should be reinstated as a priority and legal obligation. Note the brown pipe discharging high nutrient water (possibly domestic drains or septic tank), which should be investigated further as pollution.

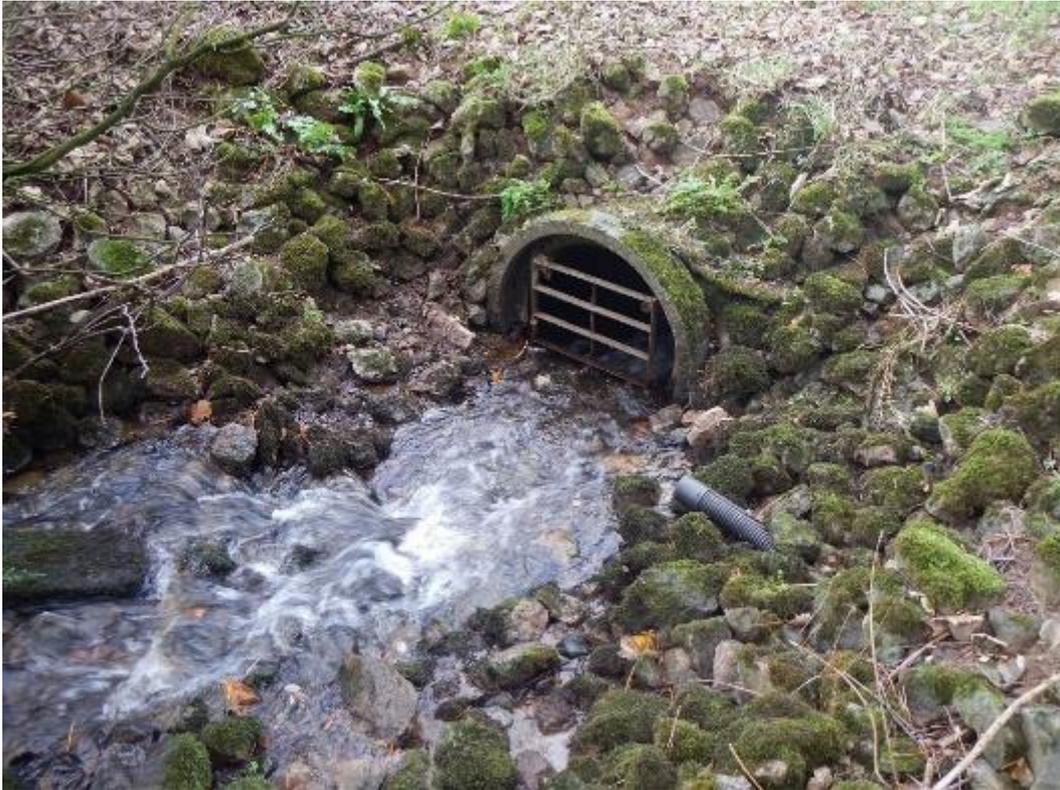
Photo DSCN5252. The watercourse then enters another culverted section down to Black Beck (NY 01620 10344); this is also screened, and modification of that screening could certainly improve fish passage there. The actual requirement for such a fine screen is questionable. Bearing in mind the rough nature of much of the ground under which they pass, the ideal solution for this and the culvert u/s could simply be to break them out, to reinstate more aesthetically pleasing surface watercourses - the main limiting factor probably being the cost.

Investigate at options to remove the culvert and reinstate the tributary as a surface watercourse.
