## **Black Brook (West Vale)**

### **Advisory Visit**

<b>Black Brook (A tributary of the River Calder)</b>
<b>River</b>	Black Brook
<b>Waterbody Name</b>	Black Brook from Source to River Calder
<b>Waterbody ID</b>	<b>GB104027062570</b>
<b>Management Catchment</b>	Humber AWB
<b>River Basin District</b>	Humber
<b>Current Ecological Quality</b>	Moderate
<b>U/S Grid Ref inspected</b>	SE 07878 20613
<b>D/S Grid Ref inspected</b>	SE 09833 21432
<b>Length of river inspected</b>	2.6 km

**Wild Trout Trust Report – Following a Site Visit on 29/04/2019**

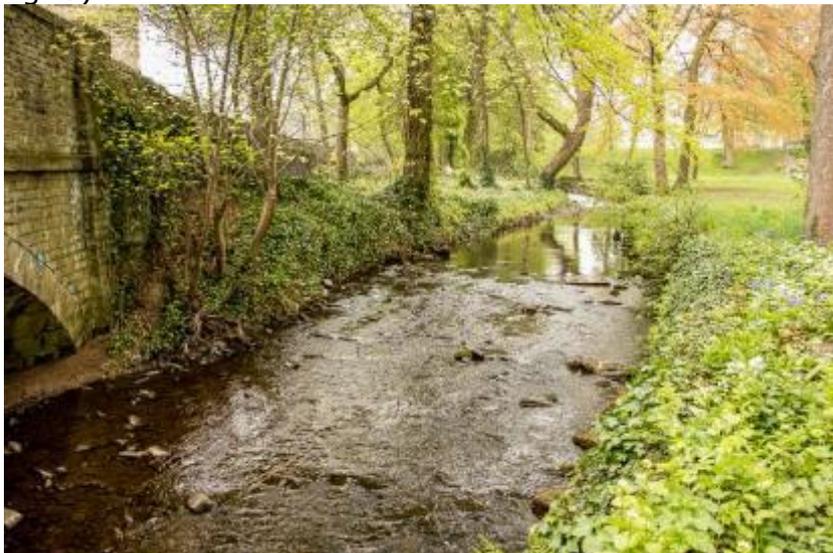
The downstream limit of this visit was the B6112 road bridge at Clayhouse Park, where a diverse riparian understory plant community indicates the benefit of efforts to control Himalayan Balsam infestations that dominate much of the Calder catchment (Fig. 5).

**Figure 5: Looking upstream from the bridge at the Downstream Limit of the visit**

- Continue with (and extend if appropriate) control of Himalayan balsam
- Don't change the current practices that allow overhanging vegetation to develop and persist! (including the selective pollarding practices noted during the visit)

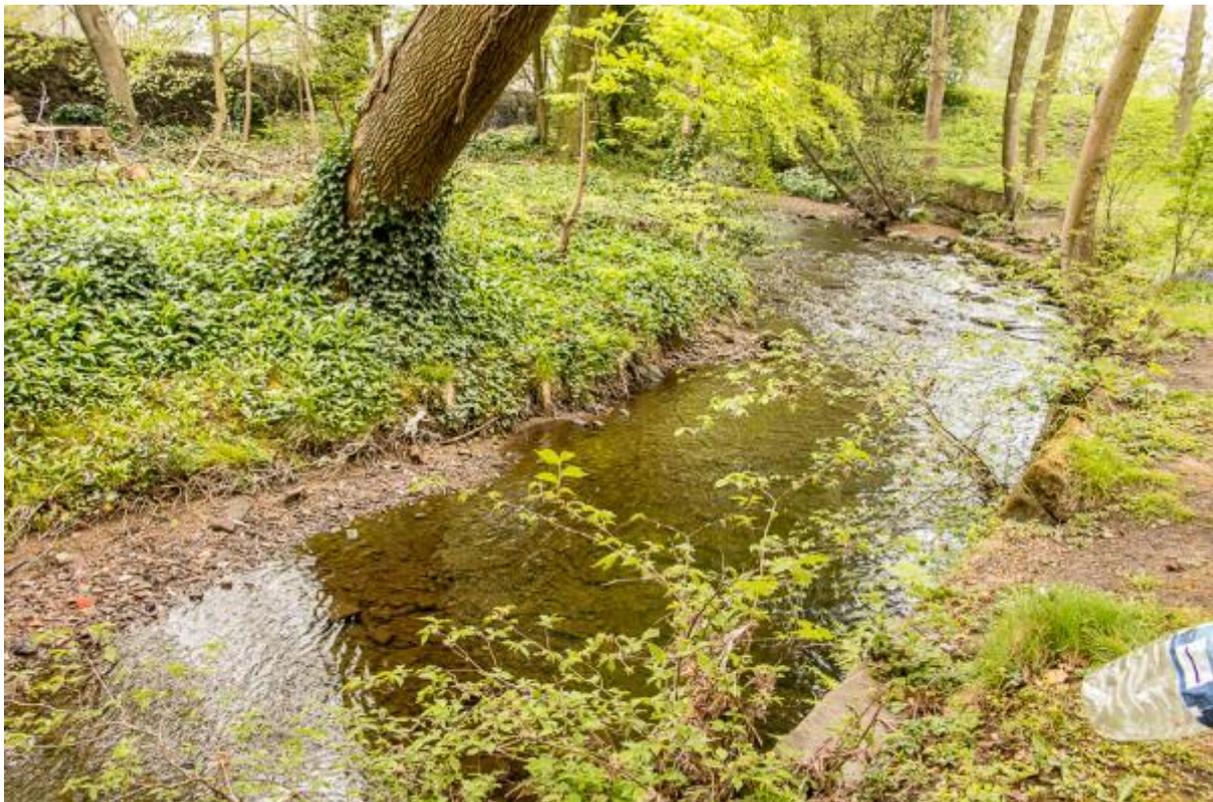
The relatively steep longitudinal bed-slope is allowing some recovery of in-channel riverbed morphology within the confines of the straightened channel (Fig. 6).

**Figure 6: Stone bank revetments on the near bank (LB) contrasting with the deposited gravel, cobble and sand "point bar" on the opposite bank (RB). This is a result of the channel having enough gradient so that, during spate conditions, there is sufficient energy to redistribute relatively large cobbles and small boulders**

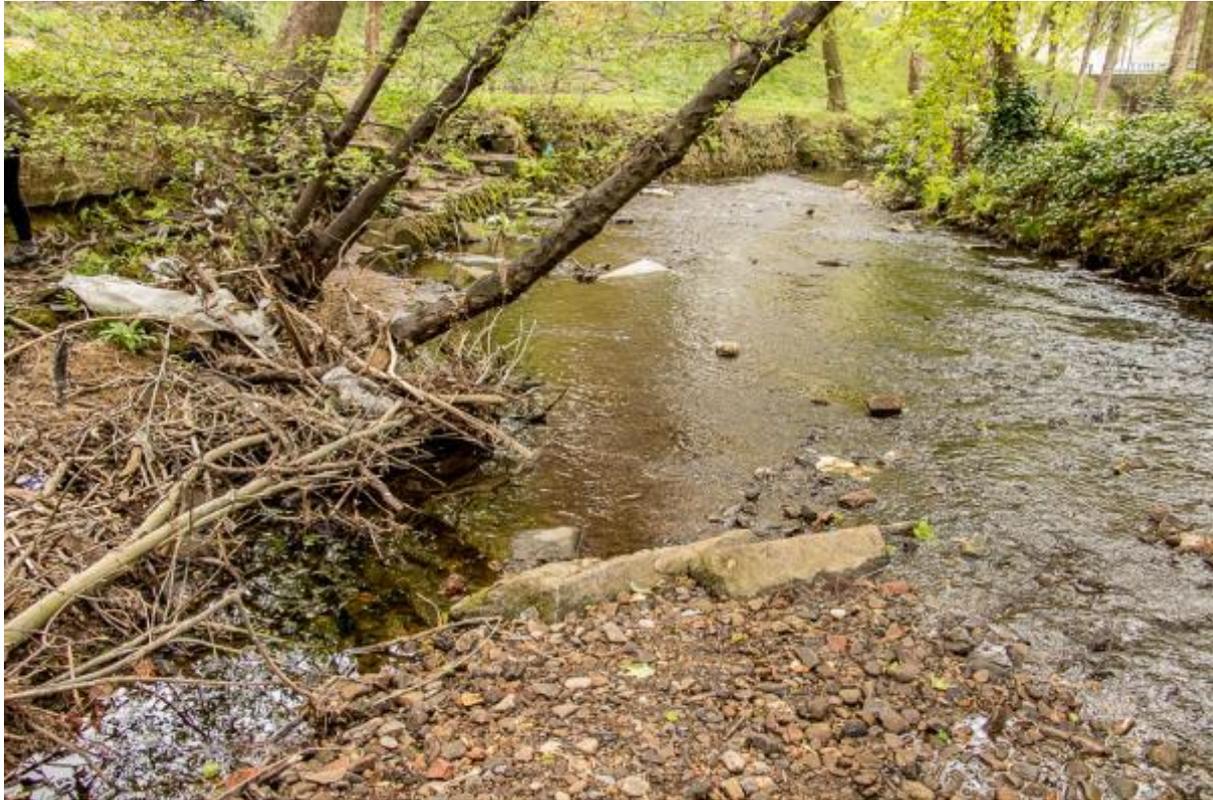
Some of the habitat-value of natural structures that create greater “hydrological roughness” (i.e. structures that “scramble” and slow down strong spate flows) can be seen in Fig. 7.

**Figure 7: The tree roots and leaning stem at SE 09972 21382 have created a dense, complex matrix of coarse woody material - as well as promoting deposition of a gravel bar.**

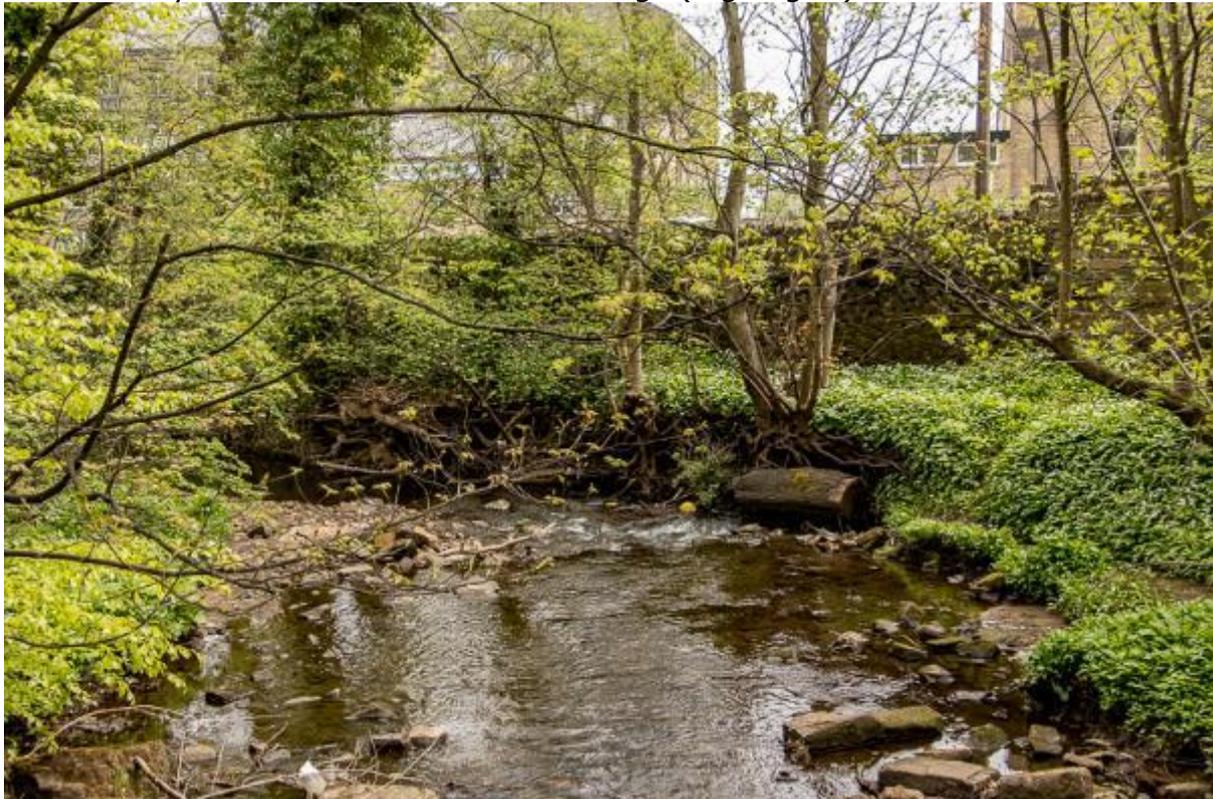
As well as refuge-habitat and leaf-litter retention benefits, tree roots are also important in shaping river channels by creating differences in the susceptibility of banks to erosion. Where only shallow-rooting plants grow, the banks are more easily eroded (important in the formation of meanders). Deeper roots associated with mature trees have a comparable effect on riverbank soils to the function of steel rebar in concrete. The reinforcement and resistance to breakdown of tree roots on the outside of river bends are an important factor that encourages a river to dig downwards and create pool habitat. That reinforcement can also be an important factor in the protection of surrounding infrastructure in developed areas such as Clayhouse Park and its surroundings (e.g. Fig. 8).

**Figure 8: Refuge habitat and bank reinforcement that is protecting stone-walls and the built environment behind is created by the tree roots visible in the centre/background of this image at SE 09714 21323**

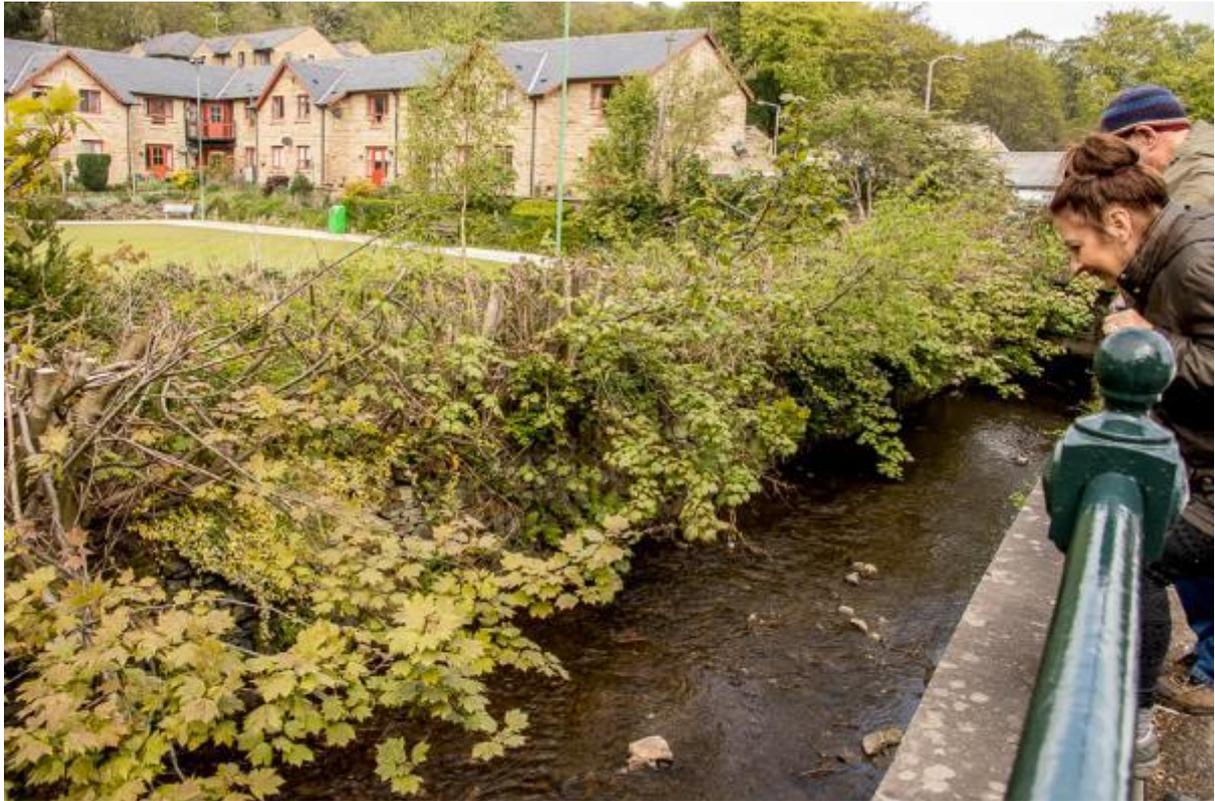
Heading upstream, across the road, some tree maintenance works (pollarding) was evident at SE 09625 21264. It is notable (and to be encouraged in future) that the tree limbs that extend laterally over the river have been left intact (Fig. 9). As well as continuing to supply “subsidies” of terrestrial invertebrates and leaf litter to aquatic foodwebs, the shade and refuge from predation are also important functions of those overhanging branches.

**Figure 9: Low, overhanging branches left behind - good practice for pollarding trees adjacent to watercourses**

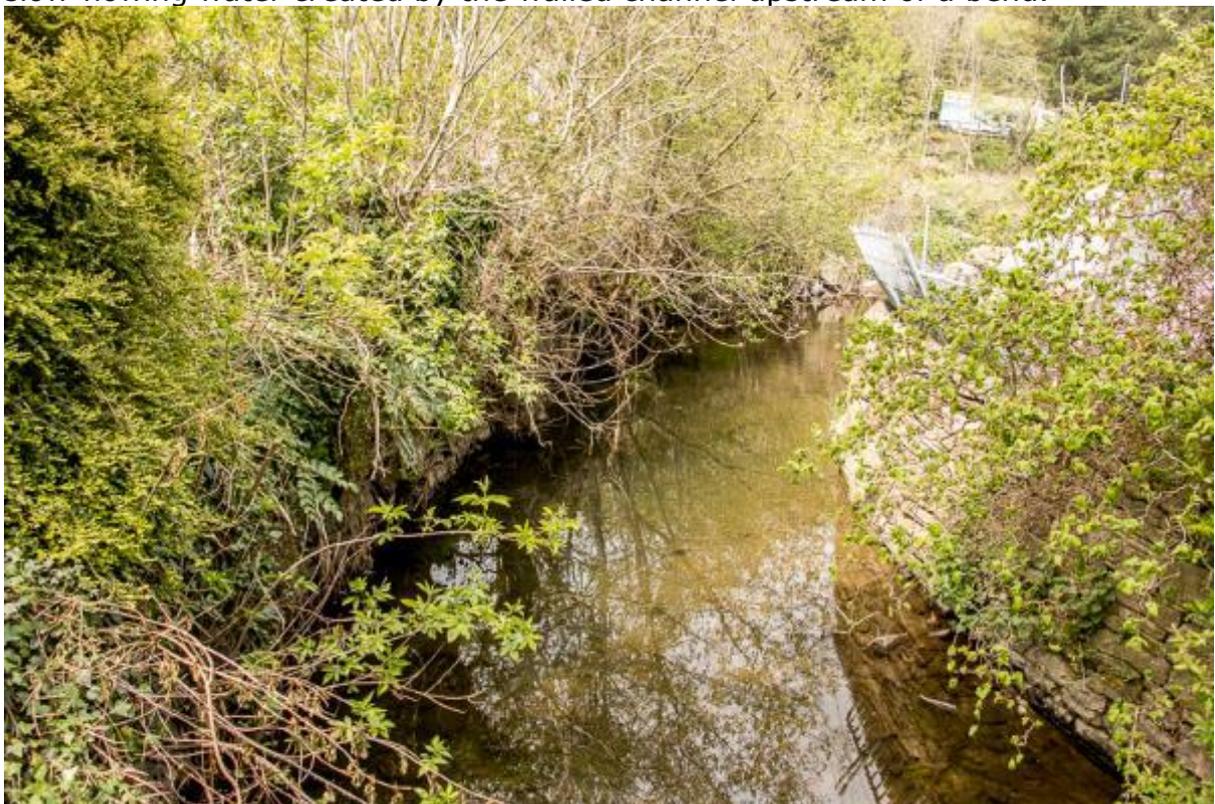
Good tree cover was also evident around the channel where it is crossed by a small footbridge at SE 09581 21222 – albeit in one of the most extensively modified and constrained sections (Fig. 10). Fish were observed in the deeper, slow-flowing water created by the walled channel upstream of a bend.

**Figure 10: Good riparian cover but heavily modified and impounded flow.**

The channel modification has artificially slowed the flow in this section, and the high loading of sand and silt was notable. In areas with faster flow, the relatively high levels of fine sediment packed into the gaps between gravels on the riverbed also indicated elevated inputs of sand and silt (a point that is picked up later in this report).

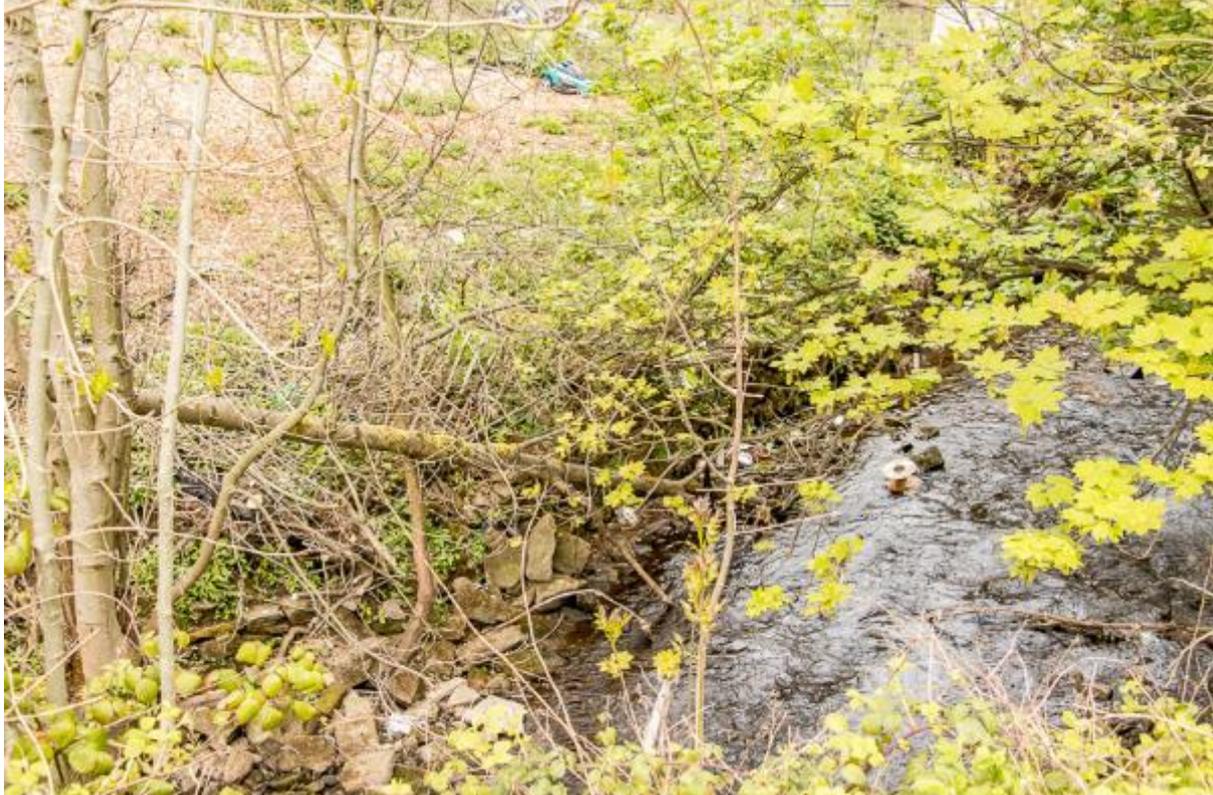
Another good example of naturally-occurring refuge habitat was noted at SE 09444 21140 – where a split tree-trunk had resulted in some nice, trailing and submerged cover (Fig. 11). These features, and the benefits they provide, are what we seek to mimic when we install structures such as “tree kickers” – which are deliberately placed and secured versions of natural processes.

**Figure 11: A naturally-occurring “tree kicker” feature on the LB (left and centre of frame)**

Upon a revisit to this location, it was noted that on the LB just below the bridge there was a patch of sewage fungus (which actually consists of bacterial colonies e.g. [https://en.wikipedia.org/wiki/Sphaerotilus\\_natans](https://en.wikipedia.org/wiki/Sphaerotilus_natans)). This is an indication of localised organic pollution that may be coming from a nearby outfall (possibly under the bridge) or may reflect organic waste derived from the adjacent land-use (e.g. pigeon lofts).

- Investigate and tackle (with the involvement of the Environment Agency) the source of sewage fungus at SE 09444 21140 (including investigations

of Combined Sewer Outfall performance (via utilities company), potential for misconnections to surface water drainage system, surrounding land-use)

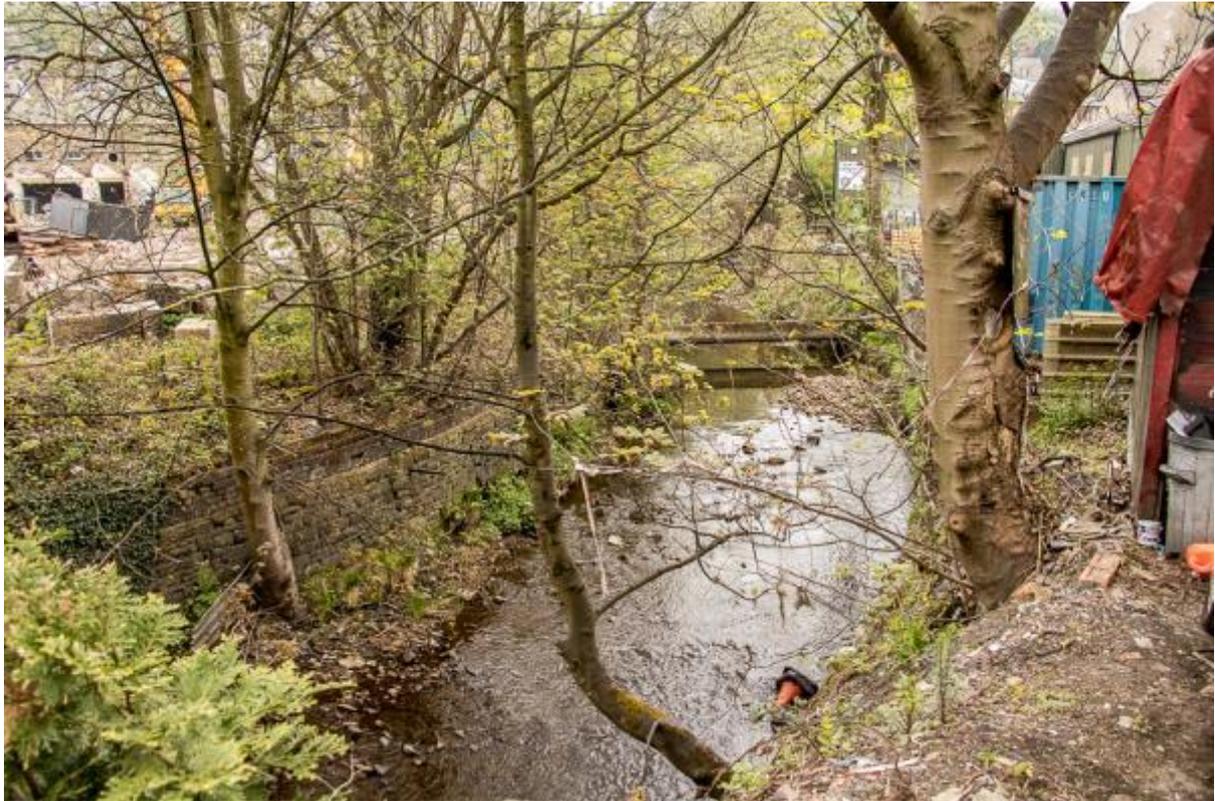
Continuing upstream to an industrial yard at SE 09422 21127, the river sits within a steeper-sided valley – and is flanked by industrial land on both the LB and RB. Here a service pipe crosses the river (Fig. 12) and several trout were noted to be rising in the pool at this location. Their size appeared to be relatively small – which is obviously an indication of breeding within the stream (a positive sign). Further investigation into the fish population structure within these reaches may indicate the extent to which episodic pollution and fish-kills may occur. In conjunction, monitoring of the invertebrate populations would also broadly indicate what the “day to day” water quality is - as well as picking up the influence of any episodic pollution.

**Figure 12: The river at SE 9422 21127 is flanked on both sides by industrial land – which can pose increased threats of accidental pollution/sediment inputs. The self-set riparian trees and vegetation are benefitting this reach by creating diverse habitat in both terrestrial and aquatic zones of the river corridor**

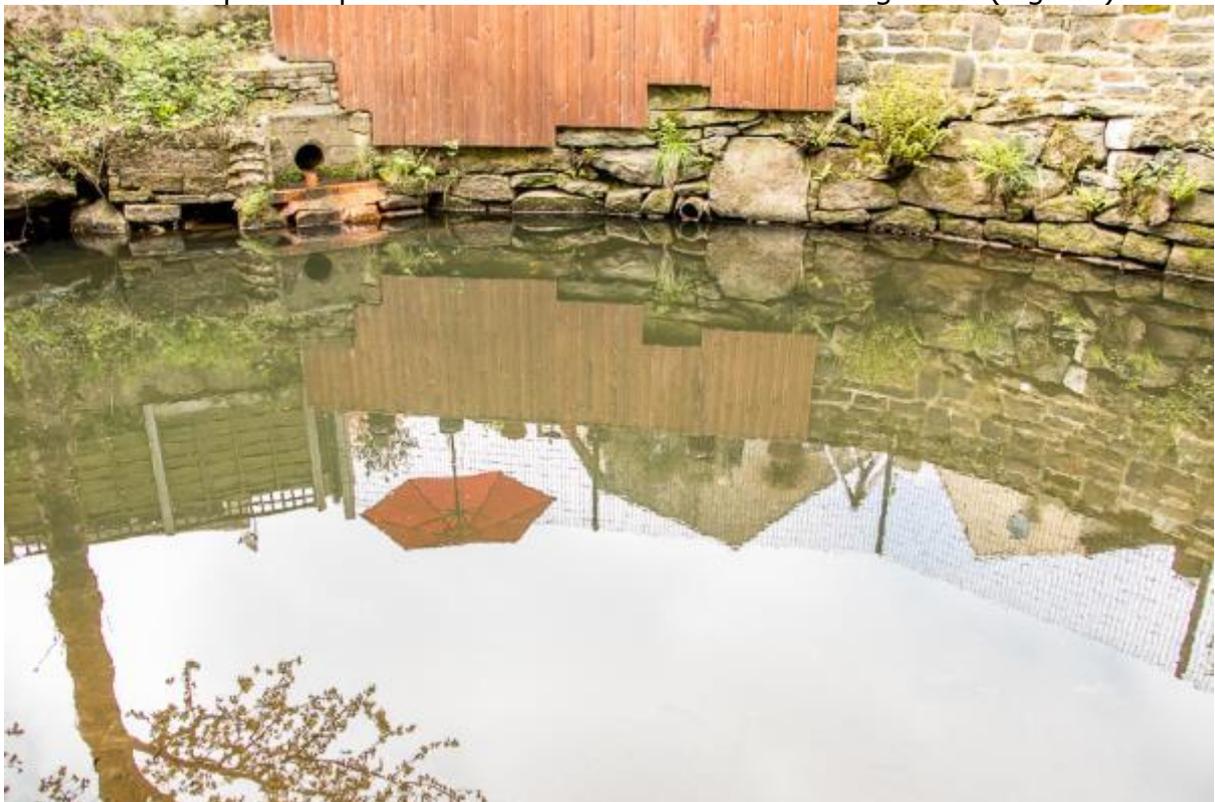
A short drive upstream to the next reach to be investigated at SE09081 20958 revealed a deep bend-pool at the foot of a local resident's garden (Fig. 13).

**Figure 13: Deep bend-pool**

While the pool shown in Fig. 13 has significant depth (and is therefore likely to be of potential value to adult trout), there is very little submerged or overhanging cover to protect against predation.

- Seek to remove the weir at SE 08609 20800 (Fig. 18) e.g. <https://youtu.be/3Io6yqMgMT4>
- Explore the development/installation of submerged and trailing cover in the bend pool (Fig. 13) via:

- Planted (perhaps via wall-mounted basket) trailing sedge grasses or riverside plants of comparable trailing habit at the normal waterline height
  - Anchored and completely submerged tree crown cover (perhaps using one or more discarded Christmas trees)

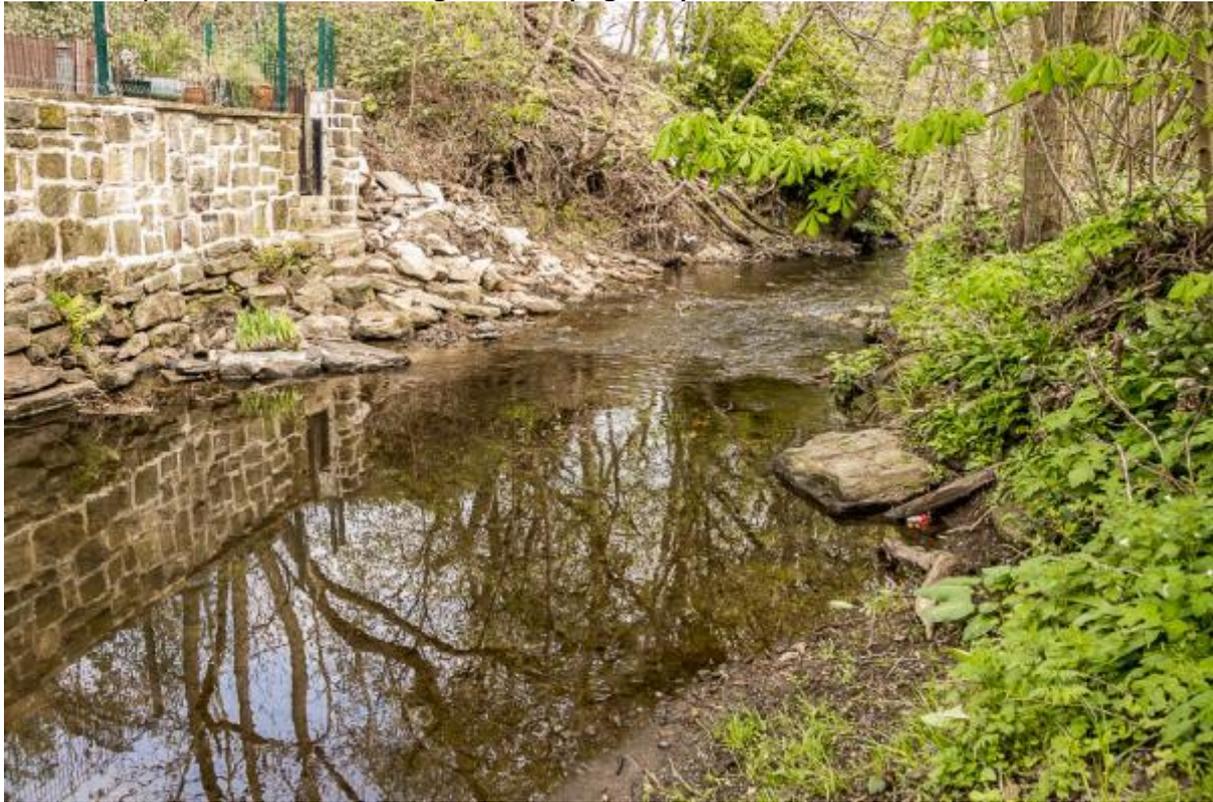
**Figure 14: Good habitat immediately downstream of the pool pictured in Fig. 13**

The greater habitat complexity and availability of more cover in the downstream reach illustrated in Fig. 14 is of significant value in protecting and maintaining more diverse floral and faunal communities.

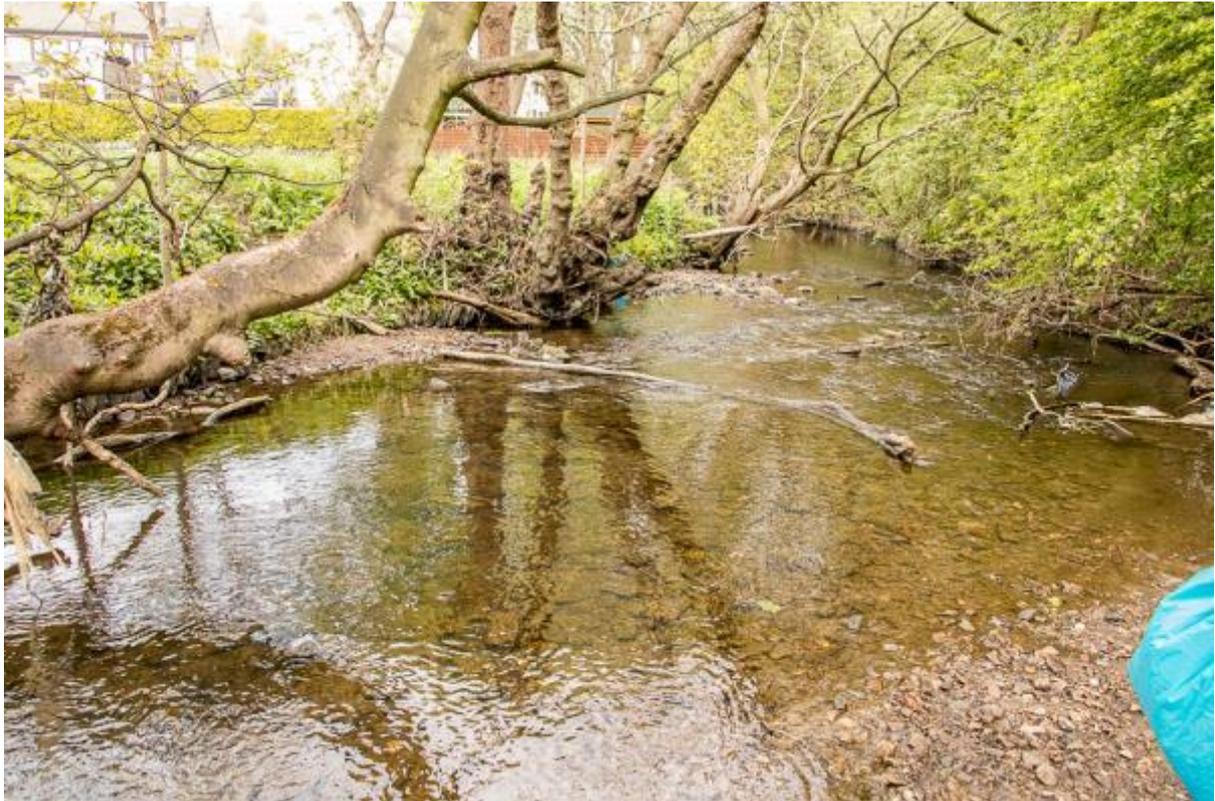
Continuing upriver to SE 09083 20884, some good tree root and tree cover habitat was noted (Fig. 15). The localised shaping of the riverbed created by “undershot scour” – where water is squeezed underneath a curved tree trunk and root-system – is clearly evident in Fig. 16.

**Figure 15: Low overhanging marginal cover on the RB and a series of mature trees/root systems on the LB.**

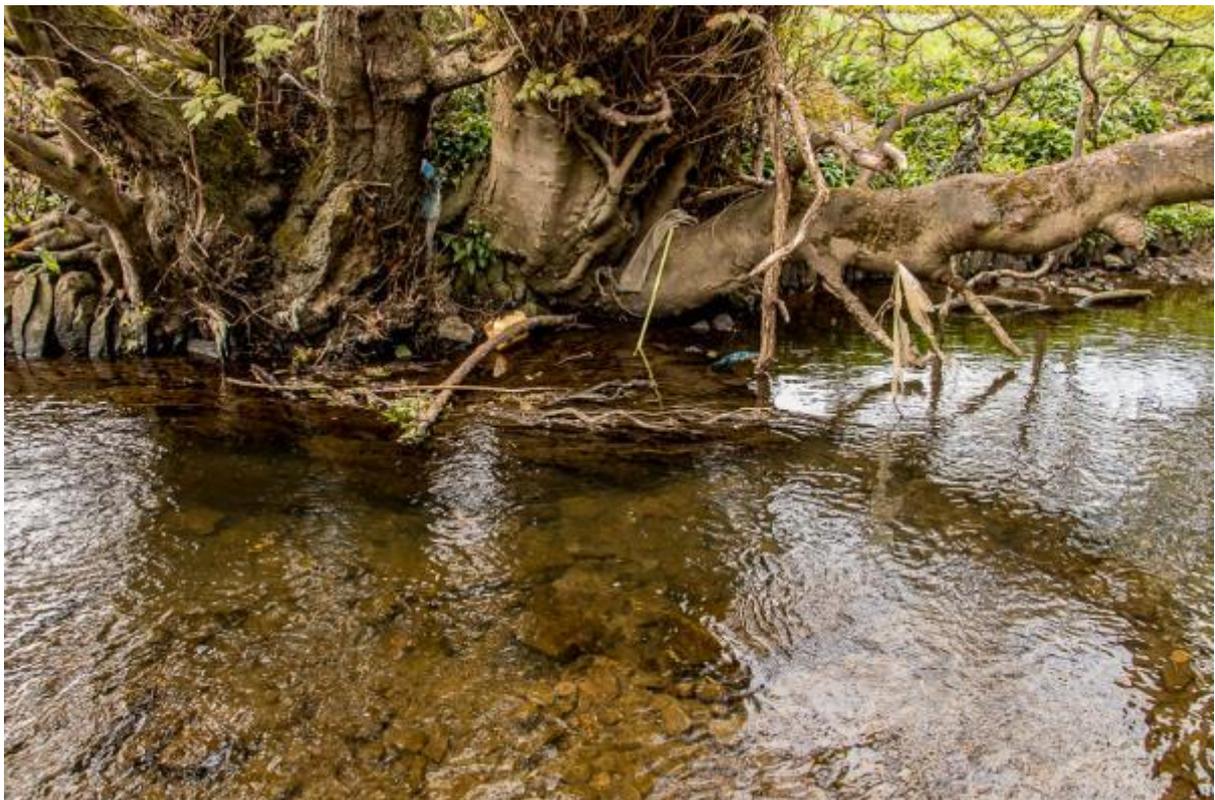
That scouring effect not only creates diversity in the depth and velocity of the river – but it also helps to flush out fine sediments from between the gravel particles at that location. Mounds of silt-free gravel result in much higher egg survival for gravel-spawning species such as trout – so the action of localised-bed scour is very important to their survival prospects.

**Figure 16: Undershot scour creating a pool within a shallow section of the brook N.B. the associated high quality refuge habitat created by the submerged tree roots in the centre of the frame**

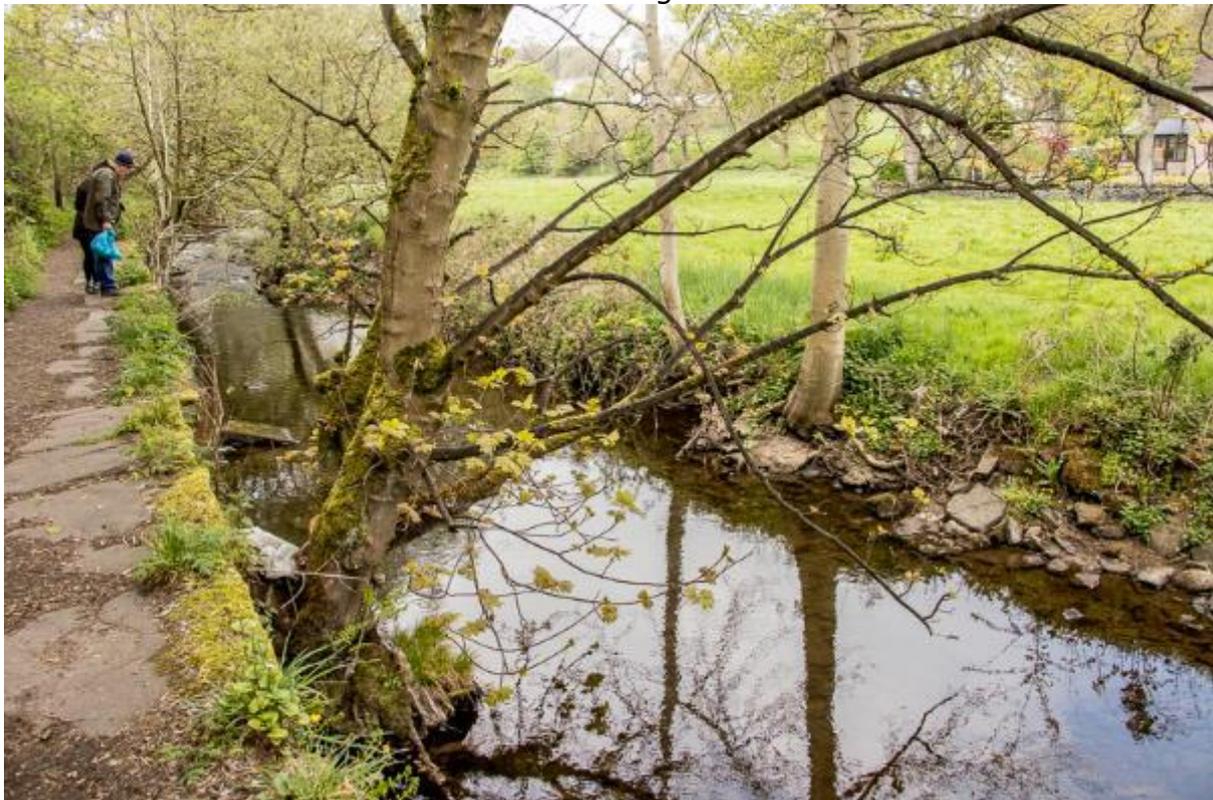
The LB in this section has previously been grazed by cattle (though the future of grazing at this site is currently uncertain). There is a degree of fragility associated with the lack of succession of trees along that LB – which consists of a single line

of veteran trees. The grazing of seedlings would prevent the replacement of those older trees once they reach the end of their lives. That would also remove the variation in bank-resistance to erosion (and the localised undershot bed-scour) that currently generate varied habitat. Allowing cattle to browse right down to the riverside also promotes increased fine sediment and faecal matter inputs into the watercourse.

**Figure 17: Previously-grazed land on the LB (far bank) and footpath on the RB (near side). Note also the artificial straightening of the channel to conform to land-use**

If grazing were to be resumed, therefore, it would be advisable to create a fenced buffer strip to promote the formation of a varied stream-side understory and woodland vegetation. The increased porosity of the soil would provide a dual function of intercepting fine sediment/faecal matter inputs during rainfall events – as well as increasing the soakaway effect of rainfall which can help to reduce flash flooding (e.g. [https://youtu.be/00tcTY\\_UEk4](https://youtu.be/00tcTY_UEk4)).

- Consider establishing grazing exclusion (or cessation of mowing if grazing is not to be reinstated) to create a vegetated buffer strip on the previously-grazed fields

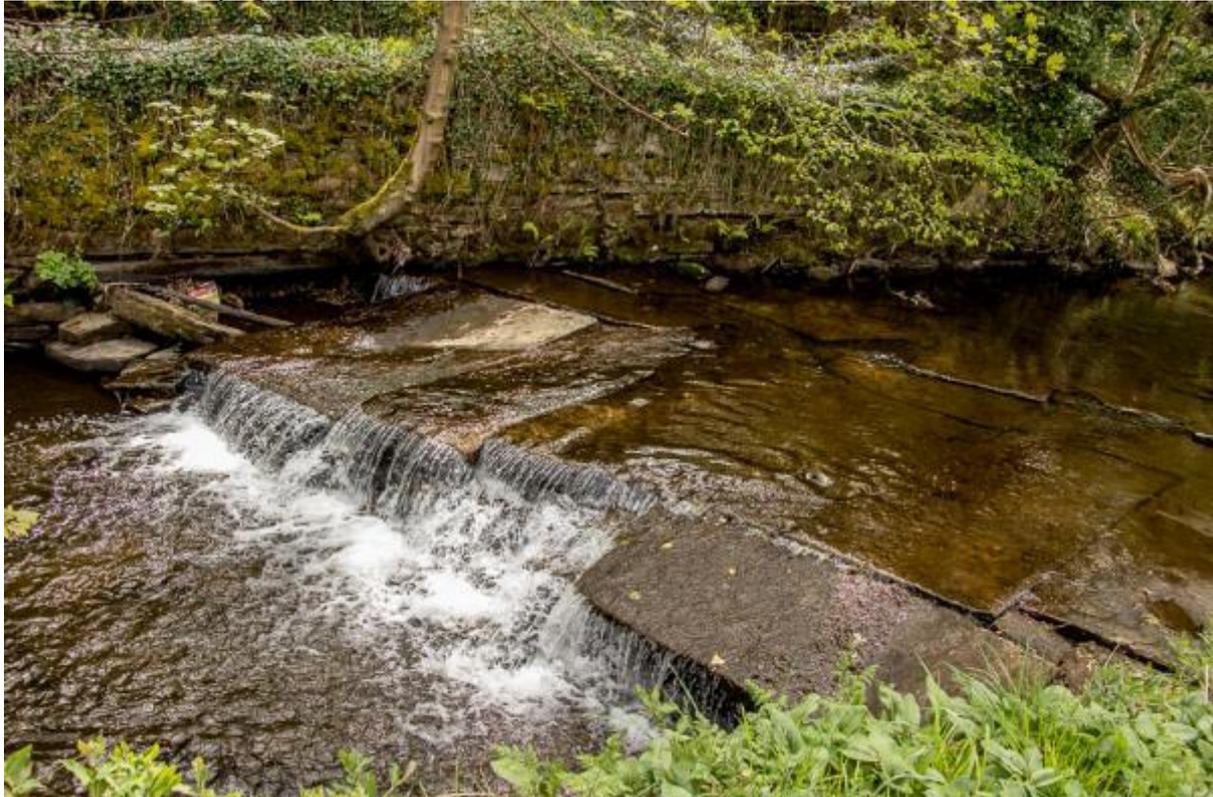
A significant barrier to both upstream/downstream movement of fish – as well as the essential downstream transport of riverbed material – was recorded at SE 08609 20800 (Fig. 18).

**Figure 18: The weir at SE 08609 20800 represents a complete barrier to upstream fish migration under almost all flow conditions. Many fish, including trout, need to migrate from their adult habitat to reach suitable spawning habitats**

Restricting the potential flow of genes between different parts of what should be one, large breeding population carries increased risk of genetic impacts on the resilience of future generations of offspring.

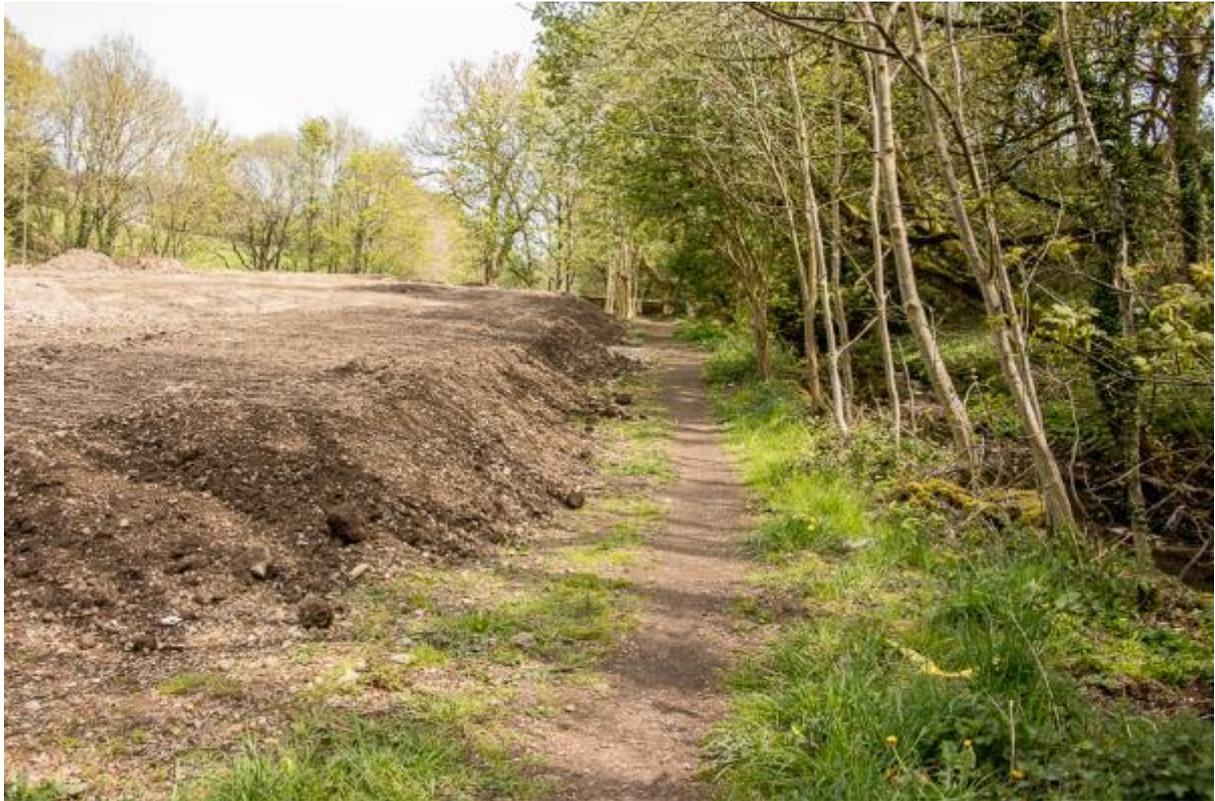
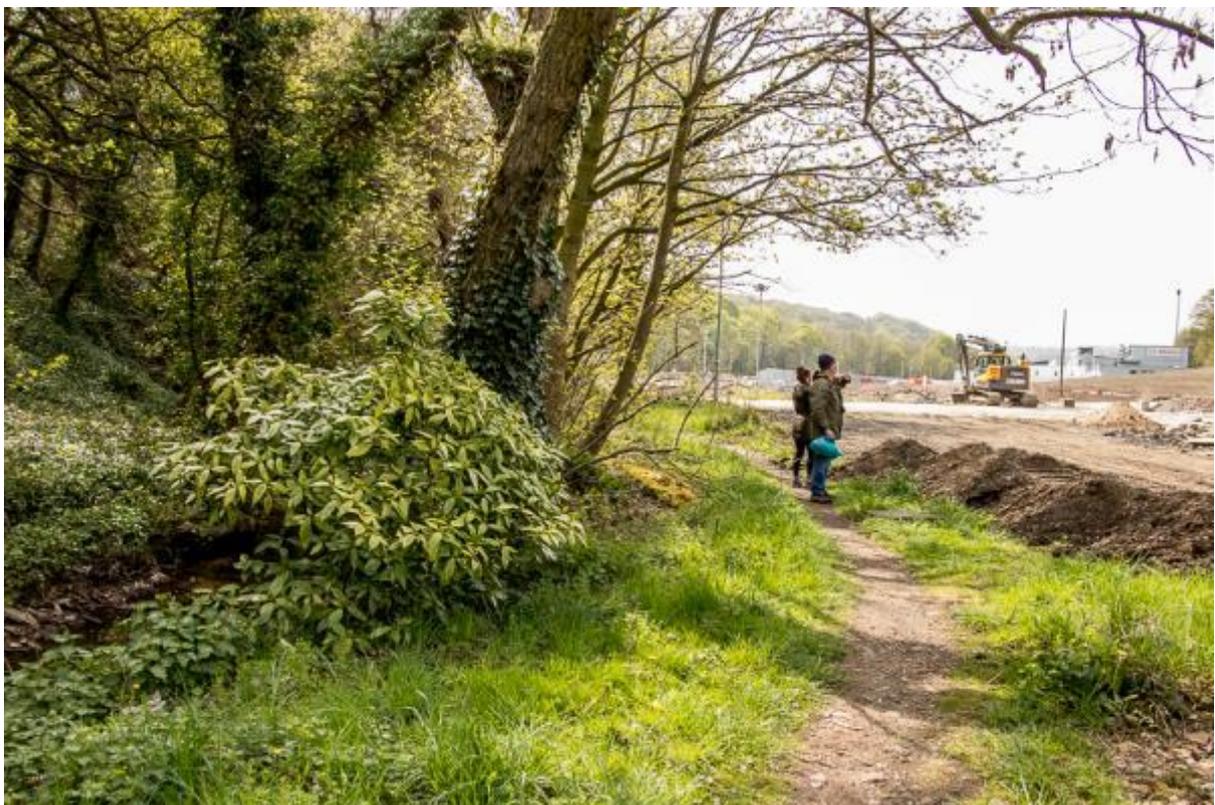
In line with comments made earlier in this report, the potential for large inputs of fine sediment exists at new development sites such as the one at SE 08474 20752 (Figs. 19 and 20). The potential for runoff pathways for sediment in surface water during rainfall should be investigated – and appropriate controls put in place where necessary.

**Figure 19: Part of the development site where topsoil runoff is likely to cause a problem for the Black Brook**

**Figure 20: Development site, photographed facing upstream**

- Consider undertaking Mayfly in the Classroom projects with the local school
- Both before and after heavy rainfall – examine the potential pathways for fine sediment to enter the watercourse from adjacent developments and existing industrial yards (and control/mitigate/remove any input routes so identified) for example:

- Interception of runoff using “silt wattles” (see image on this link <https://www.constructionwashout.com/75-gator-guard/product>)
  - Be aware of the use of “fascines” (and the importance of proper track/path location) in this guide produced by Treesponsibility: <http://www.treesponsibility.com/wp-content/uploads/2013/09/Understanding-the-Hebden-Water-Catchment-LOW-RES.pdf>

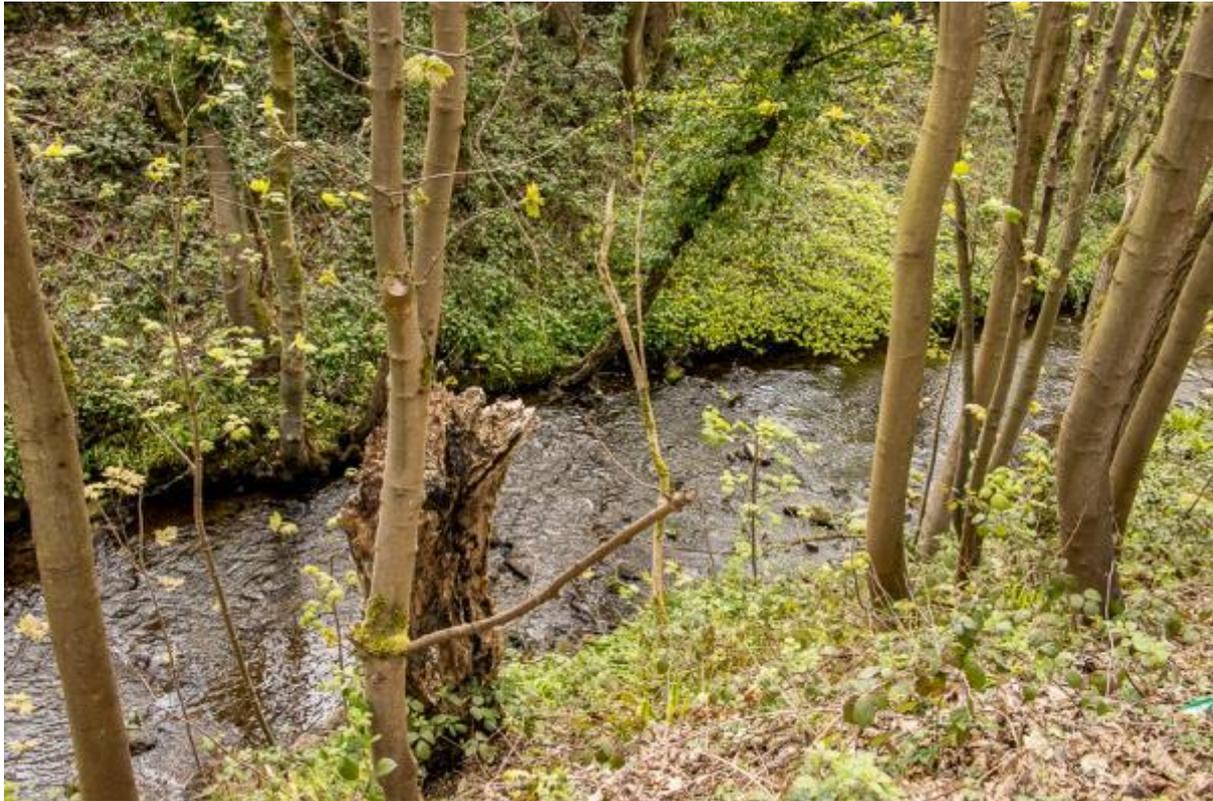
The natural steepness of the valley sides at SE 08116 20639 have allowed an extensive woodland corridor to develop (Fig. 21).

**Figure 21: Steep-sided valley with more limited potential for development or farmland - allowing mature woodland to persist for a greater width on both sides of the channel than is typical for the Black Brook**

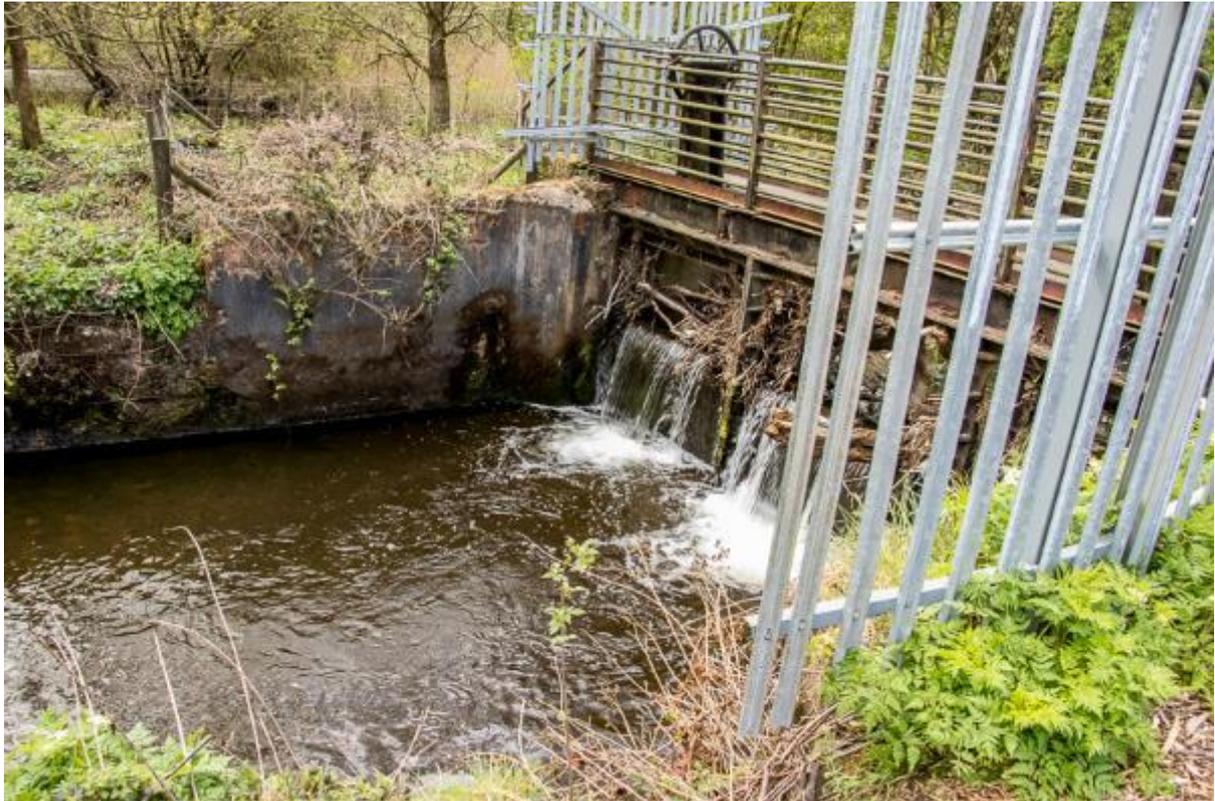
**Figure 22: Sluice at SE 07901 20598**

The second major barrier and impoundment noted during the visit was the sluice gate at SE 07901 20598 (Fig. 22) which serves and controls the pond associated with the adjacent industrial plant (Fig. 23).

Unlike the previous barrier, this sluice appears to still be performing a function in providing a controlled supply of water to the pond. Whether the water-level in the pond could be maintained and regulated by an alternative means (and which does not rely on impounding the river) would be worth investigating.

- Investigate whether the pond at SE 07901 20598 is still a required asset (and if so):
  - Investigate whether there is an alternative water source to feed the pond other than the current sluice

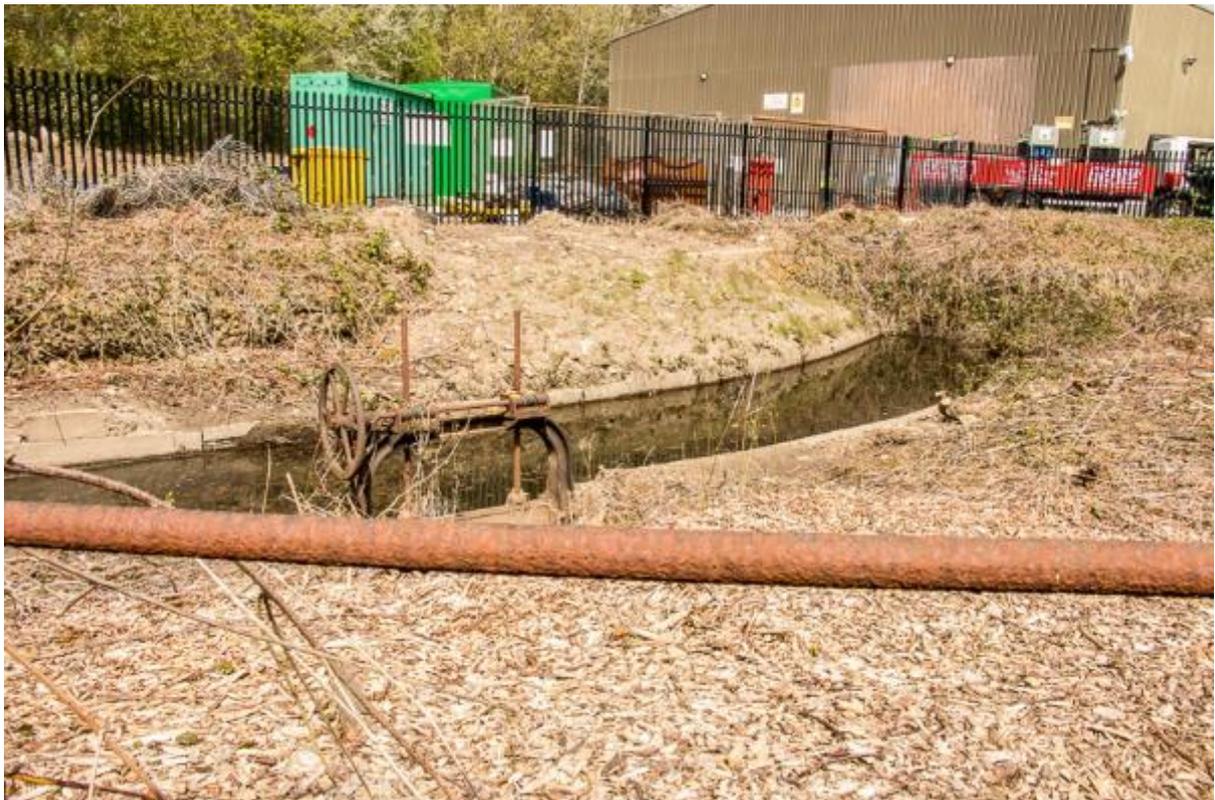
Similarly, establishing whether the pond is critical to the functioning of the industrial plant – or whether alternative means may exist of meeting its required function – are also important enquiries to make.

**Figure 23: Pond served by the impoundment created by the sluice in Fig. 22**

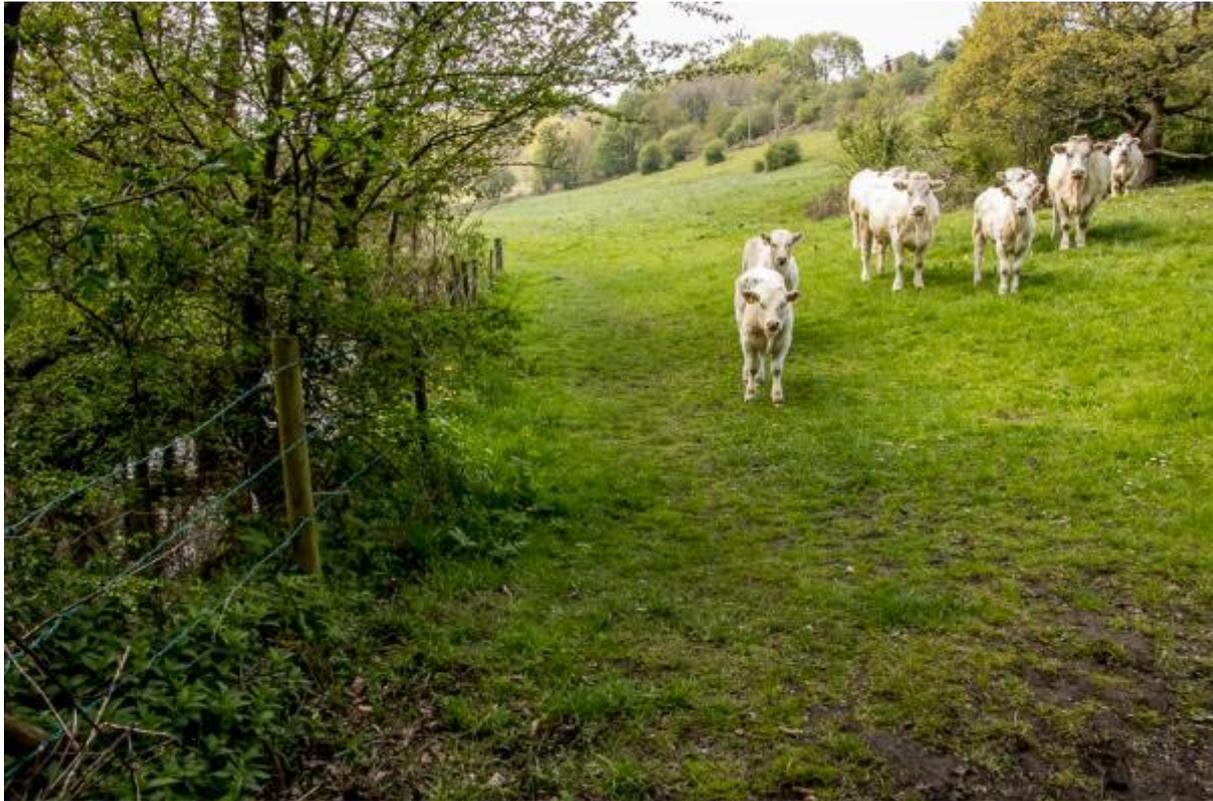
The upstream limit of the visit was at SE 07878 20613 and consisted of cow pasture at the bank-top with a livestock fence to prevent access to the brook (Fig. 24).

**Figure 24: Cattle and bank-top fenceline at the upstream limit of this visit**
