Advisory Visit

River Blackwater, Kells Angling Association

Co. Meath, Eire

17-20th November, 2008

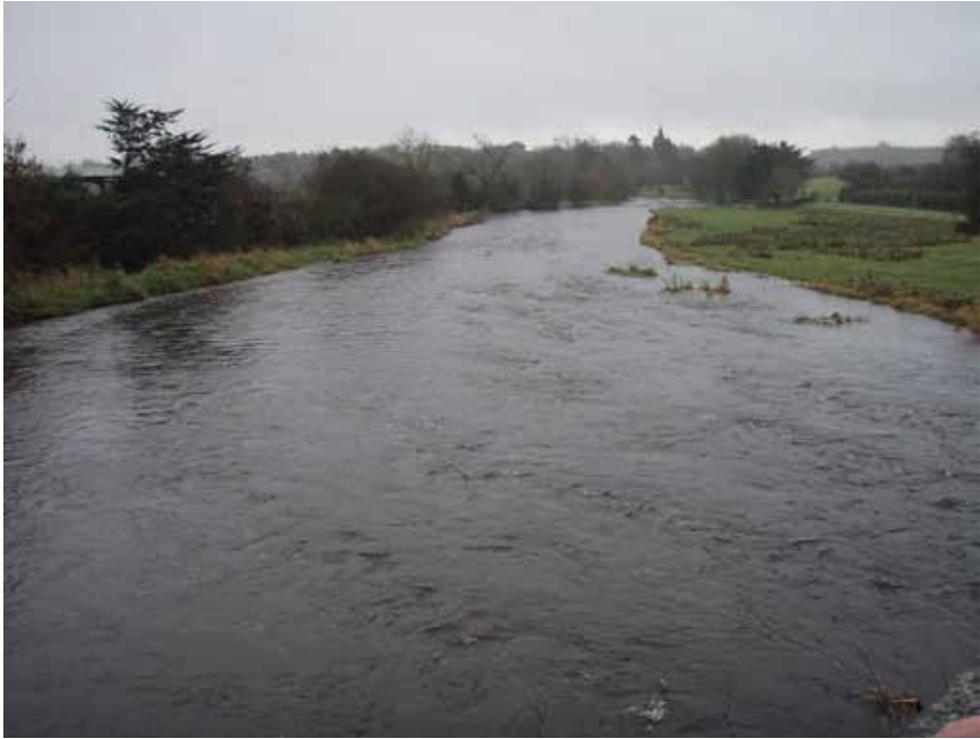
Photo 1 View downstream from Maudlin Bridge

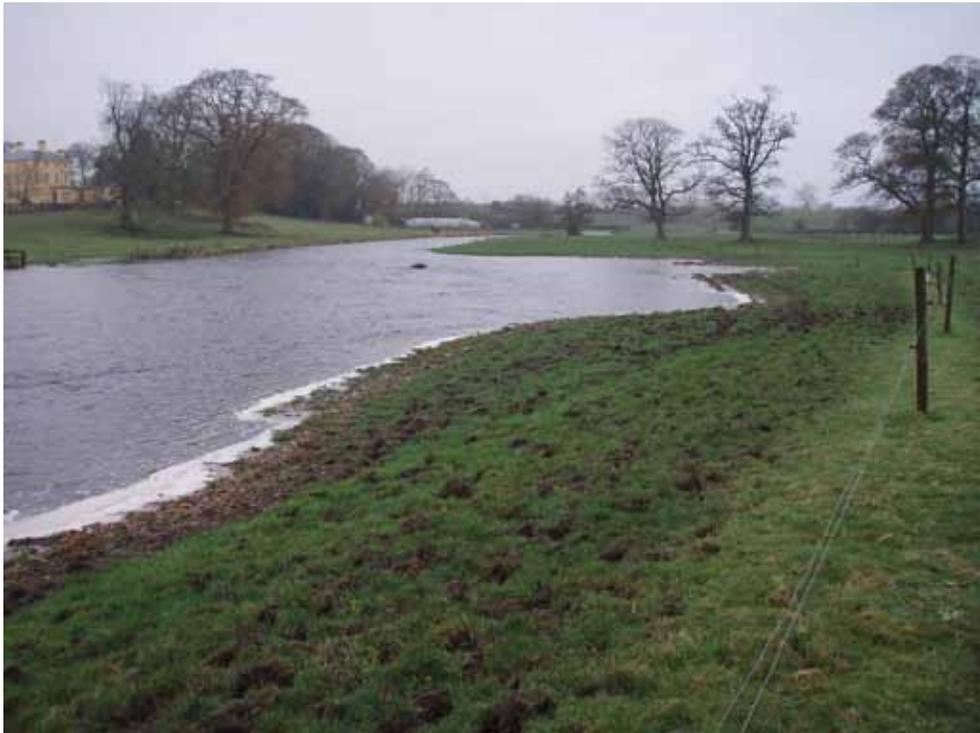
The visit began at Maudlin Bridge (Grid Ref. SA 79065 37617) progressing upstream (Photo 1). The river was carrying approximately 2 ft of extra water. The river here has a good structure with a pool and riffle sequence, and a gravel and cobble substrate. Water crowfoot *Ranunculus* sp. was present. Both banks were grazed, the RHB by horses and the LHB by cattle. The LHB was fenced (electric), although this had not prevented grazing right up to the river, where the bank was quite heavily trampled (Photo 2).

Photo 2 Trampled LHB upstream of Maudlin Bridge

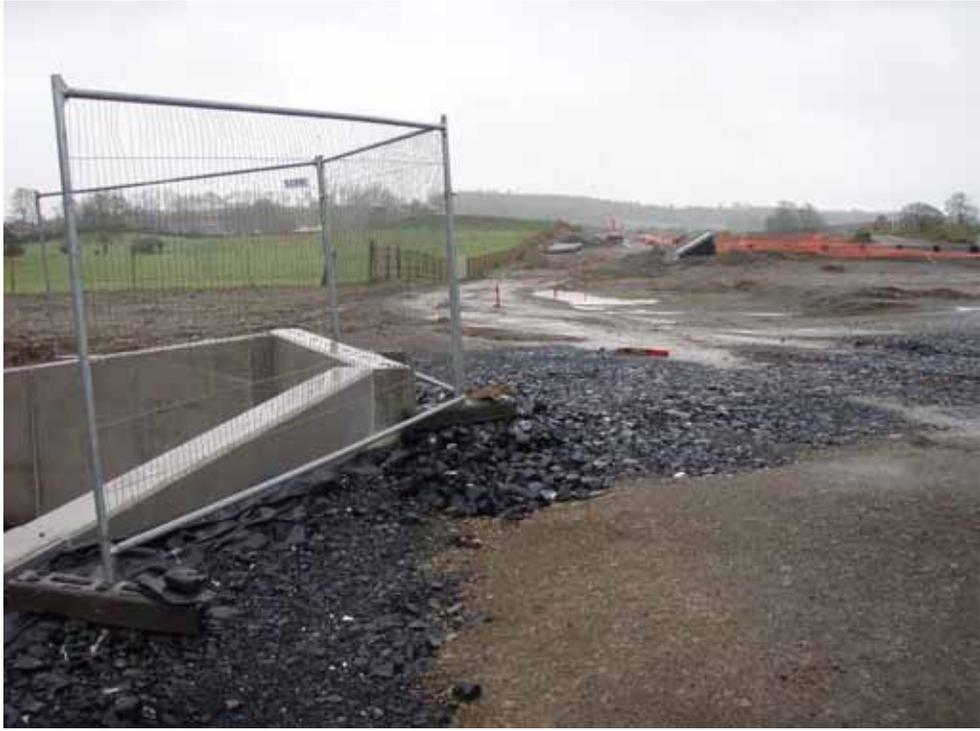
A stream (McCormac’s Stream) joined the river on the LHB (SA 78686 38061). This stream was dredged in about 1980 as part of a land drainage scheme by the Office of Public Works (OPW). The stream has recently been culverted under a new road which is under construction (the M3 Kells by-pass; Photo 3). Upstream of the culvert the RHB was lined with trees (alder, holly, and willow), many of which were leaning over the stream; the LHB was grazed and unfenced. Despite the extra water in the stream, it was slow flowing and had a uniform width and depth (Photo 4). The substrate was largely silt overlaying some gravel, with some starwort *Callitriche* sp. and forget-me-not *Mysotis* sp. present. Prior to the dredging the stream had a gravel bed, abundant water crowfoot *Ranunculus* sp. and abundant juvenile trout (KAA members, pers. comm.). The stream was also inspected further upstream (by about 1 mile) where a minor road crosses; here the habitat was better and a gravel substrate was present indicating land drainage works had not carried on up to this point.

Photo 3 Road construction and culvert crossing McCormac's stream

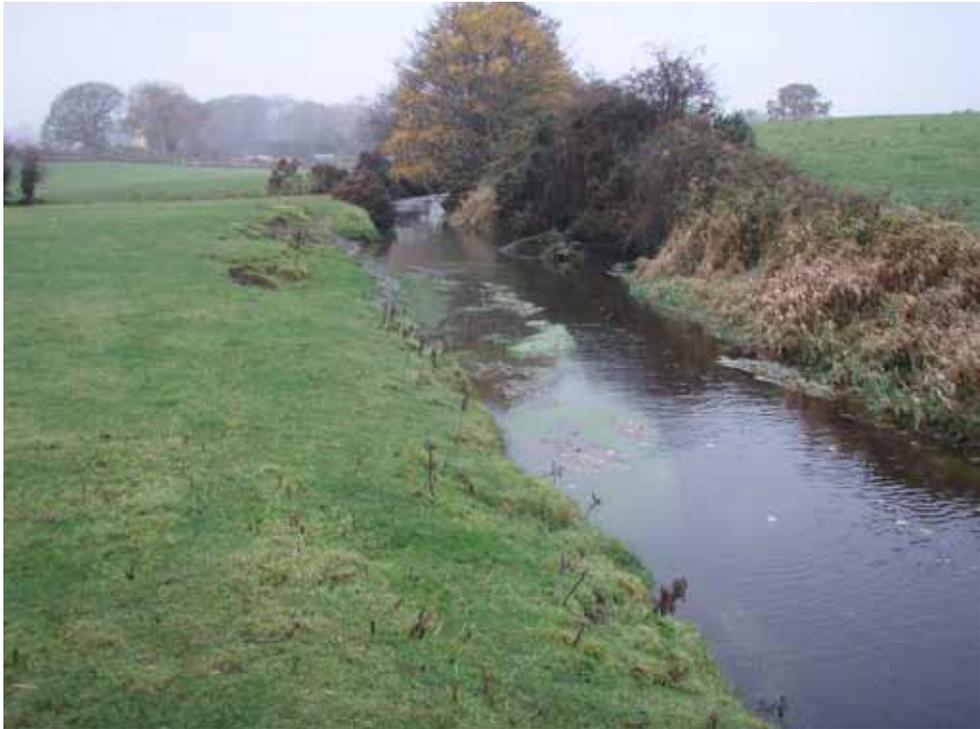
Photo 4 McCormac's stream upstream of the new road

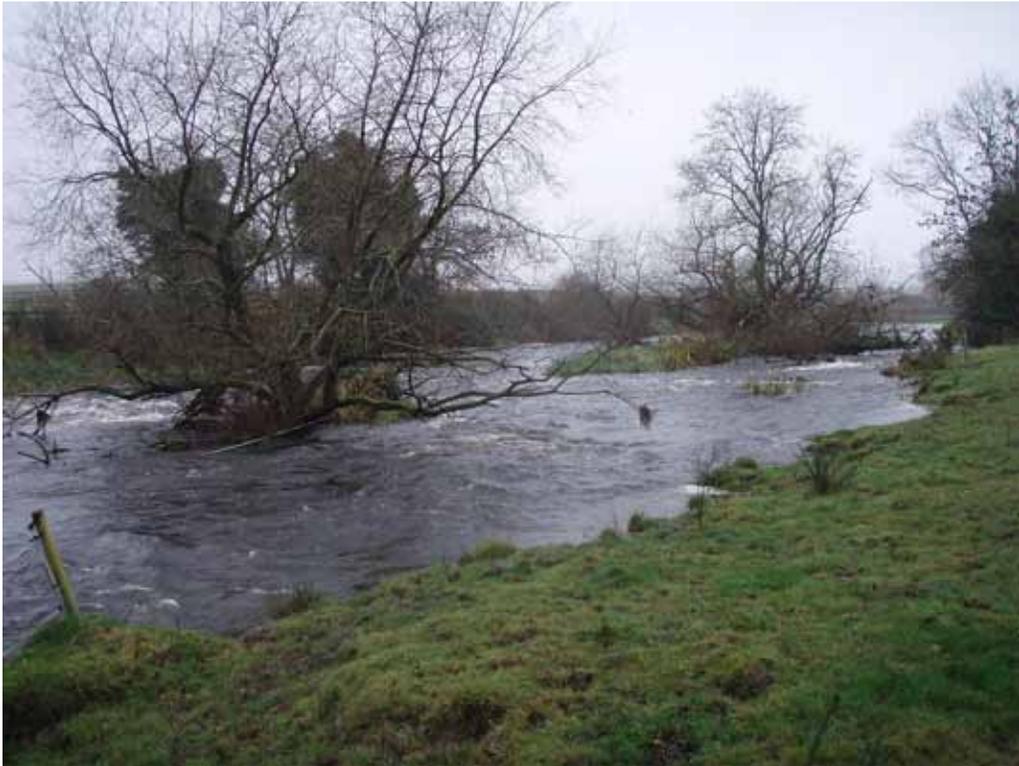
Back on the main river, upstream of the confluence with McCormac’s Stream, there was an area of good instream habitat leading up towards Mabes Bridge. There is a steeper gradient to the river at a bedrock outcrop, and two vegetated islands in the channel. Some instream islands and shoals have been removed from the river in this section, although it has not been subject to arterial drainage (Photo 5).

Photo 5 Midstream islands between Maudlin and Mages Bridges

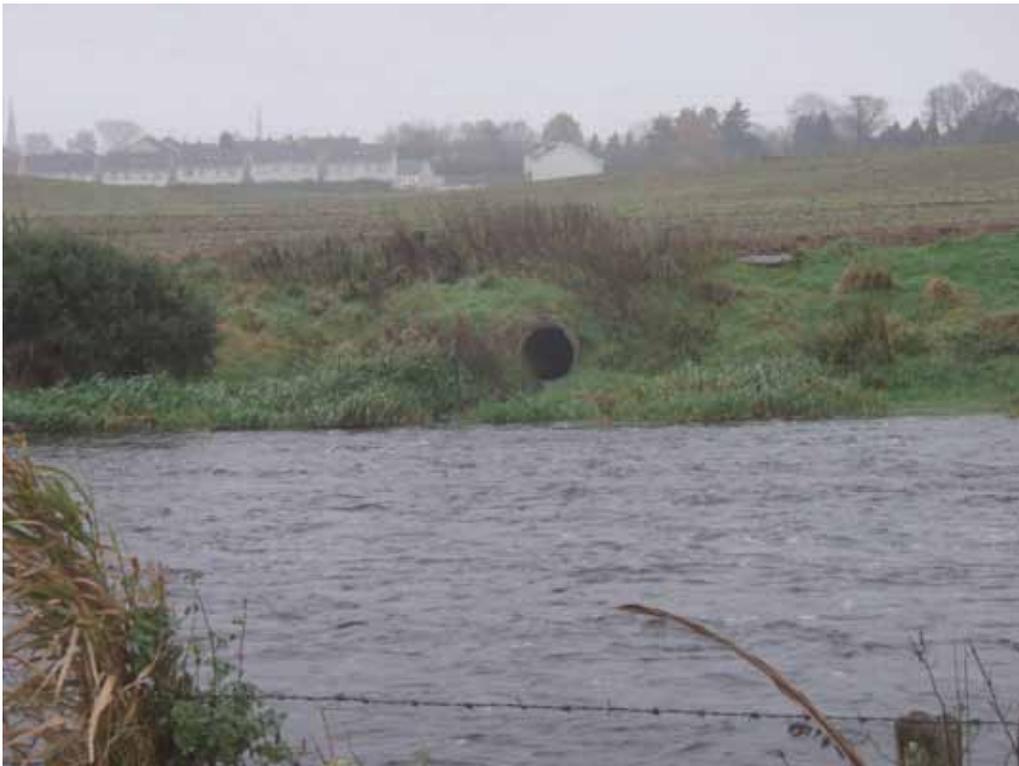
Photo 6 New housing development and surface water drainage

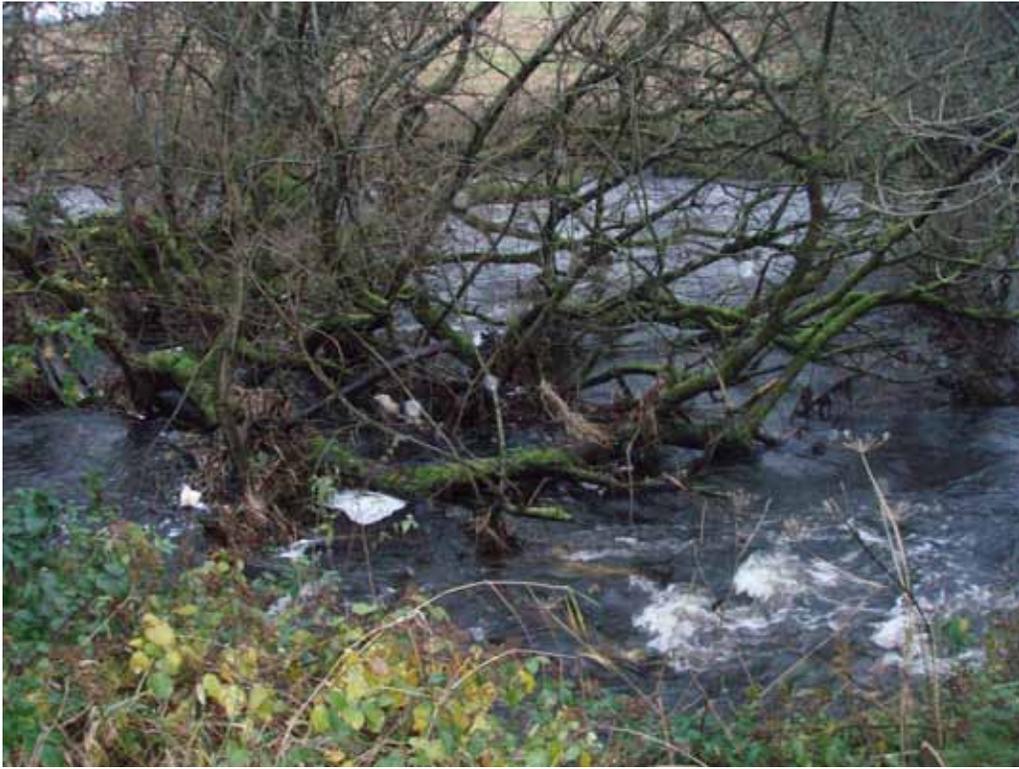
Between Mables Bridge and Claven's Bridge (SA 75995 38393) the instream habitat is very good (Photos 7 & 8). There is a pool and riffle sequence, and some excellent examples of stable large woody debris (LWD). The river has wide, wet margins colonised by reeds and rushes, and there are vegetated islands present. KAA feel the river has narrowed considerably in this reach, with the rushes encroaching on the channel; it is felt this is due to a flashier flow regime following arterial drainage further upstream – i.e. a less sustained flow of water to maintain the channel width.

Photo 7 Stable LWD in the channel – excellent habitat

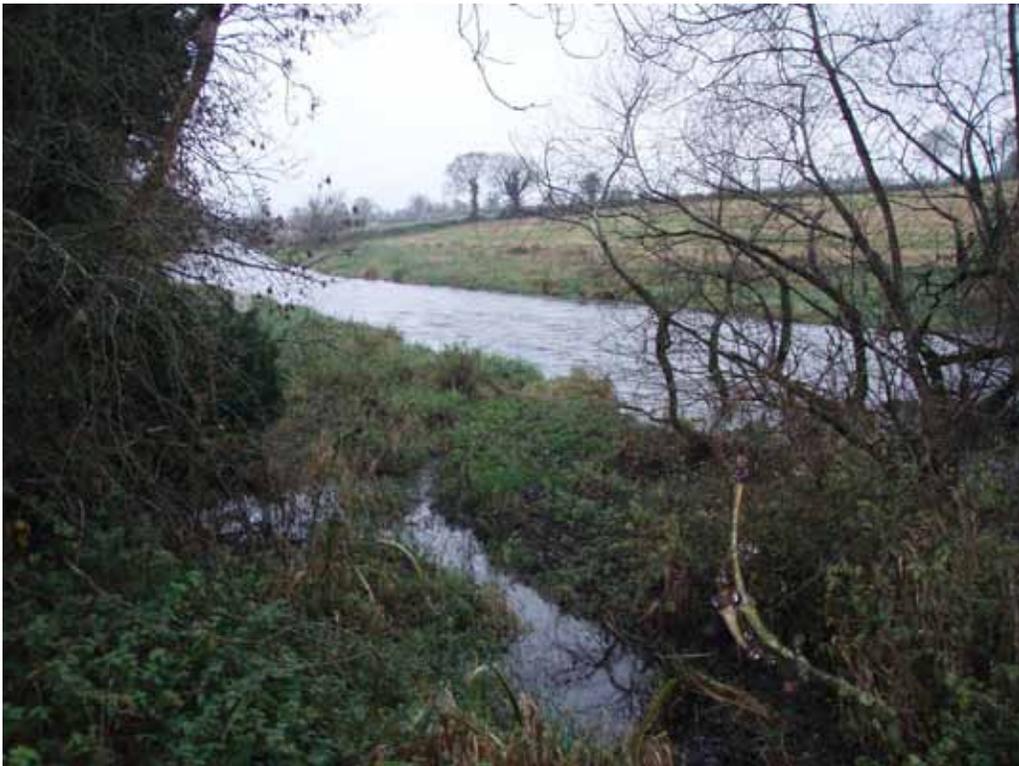
Photo 8 Good habitat upstream of Maves Bridge – low banks and wet margins.

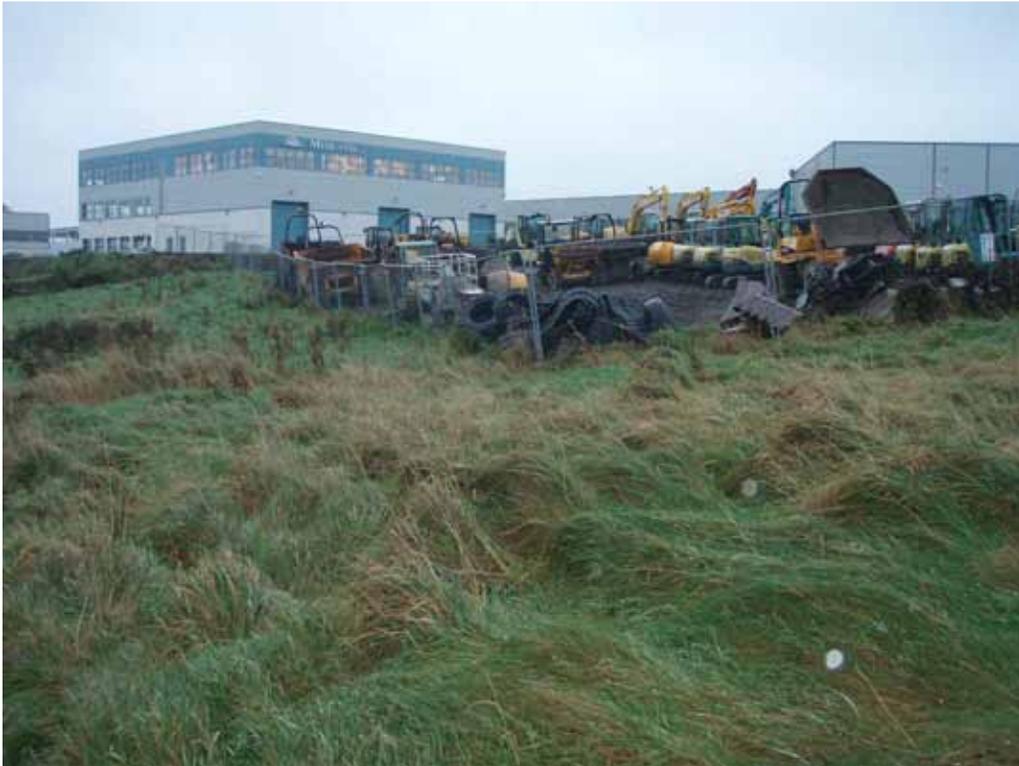
On the RHB for much of this section there is an Industrial Estate. A number of minor but undesirable pollutions were seen along this stretch including:

- A small brook entering the river through this estate was found to have a grey tinge to the water and evidence of sewage debris in it. Turning a few stones revealed some freshwater shrimp and a caseless caddis (species moderately tolerant of organic pollution). This may be the discharge from the sewage treatment facility for the business park referred to in the documents pertaining to the plans to improve Kells sewage works (see page 28).
- Oil leaching from some stored plant in a compound (Photo 9)
- A surface water drain with silt and debris; this had recently been the subject of a pollution that had been investigated by the EPA and resolved.

Photo 9 Industrial estate on RHB upstream of Mages Bridge. Oil was leaching towards the river from the plant in the compound, and poorly treated sewage effluent was entering the river from this estate.

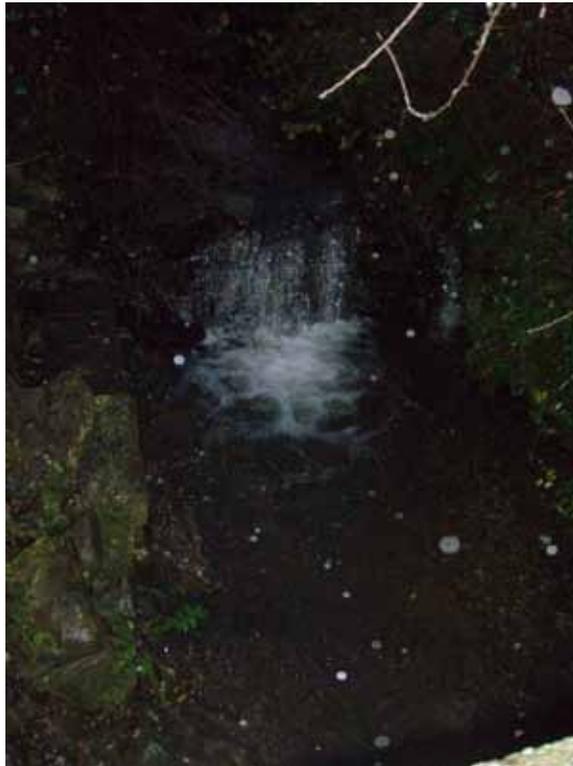
Just downstream of Claven's Bridge a small tributary enters the river on the LHB. The mouth of the stream is masked with rushes and reeds and this would benefit from clearing to give free access for fish. The stream was inspected further upstream next to Sean McGee's house, where two trout were disturbed just below the road culvert. There is a small weir upstream of the road, alongside house, which presents an obstacle to fish moving upstream to spawn at this time of the year (Photo 10).

Photo 10 Weir on a small tributary – an obstacle to spawning fish

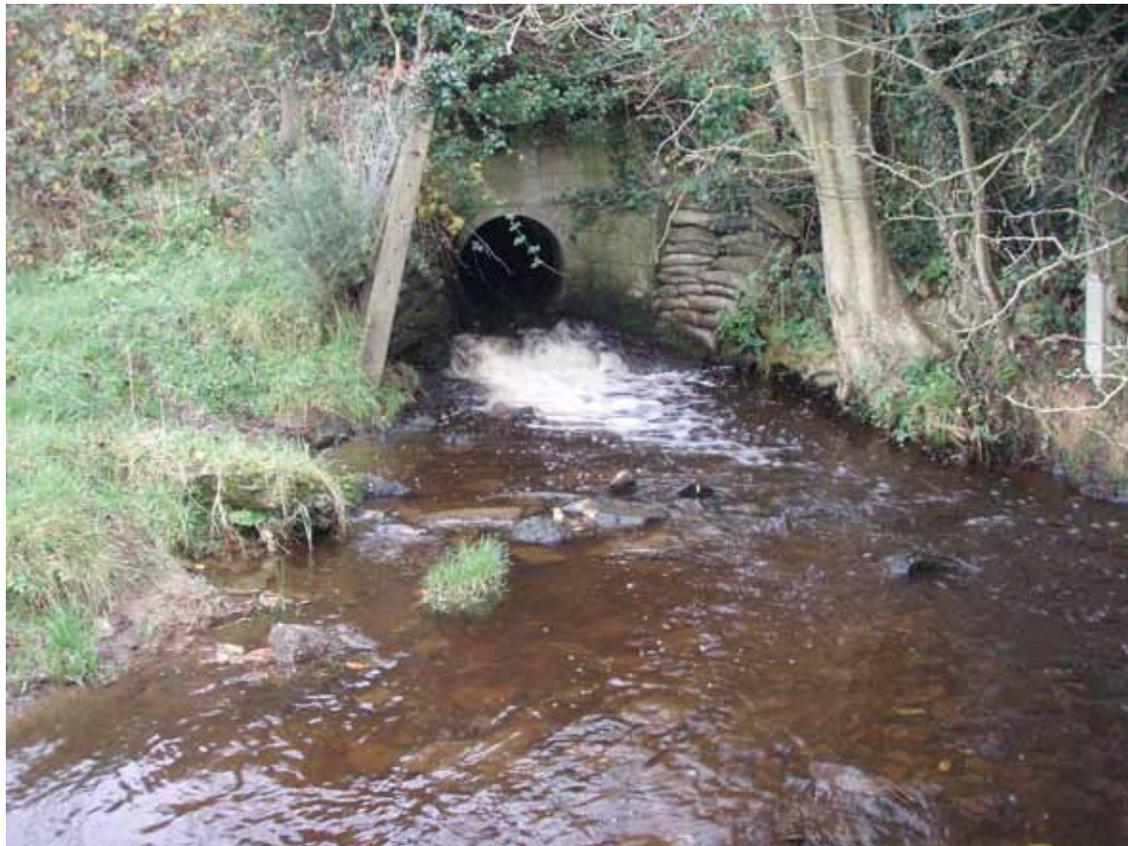
Rathbrack's Stream, a small tributary stream culverted under the N3 road (SA 74227 39336), was inspected. It would be difficult for fish to pass under the road because of the perched culvert pipe (Photo 11). This point is only two or three fields away from the confluence with the main river. The stream looks organically polluted, having brown algal growths on the stones; a brief hand search for invertebrates revealed only freshwater shrimp *Gammarus pulex*. A hedge line follows the stream and it is quite overgrown and shaded. The stream has quite a steep gradient and a good gravel bed. A couple of small bridges created from concrete pipes were observed; these were passable by fish but could become perched in time.

Photo 11 Culvert carrying Rathbrack's stream under the N3 road – an obstacle to fish passage

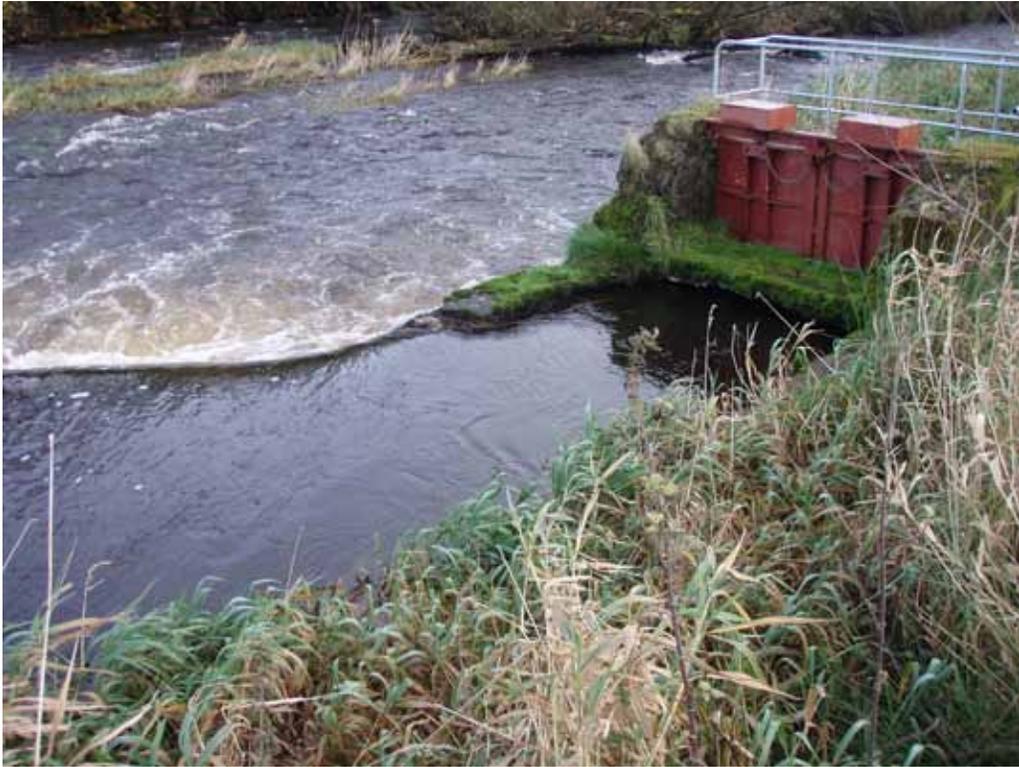
There is no screen at the water intake to prevent entrainment of downstream migrating fish (such as salmon smolts) into the water intake flume (Photo 12); this is surprising given that salmon are one of the species listed on Annex II (Habitats Directive) for which this site is designated a SAC.

Photo 12 Potable water intake – a screen should be installed here to prevent salmon smolt entrainment

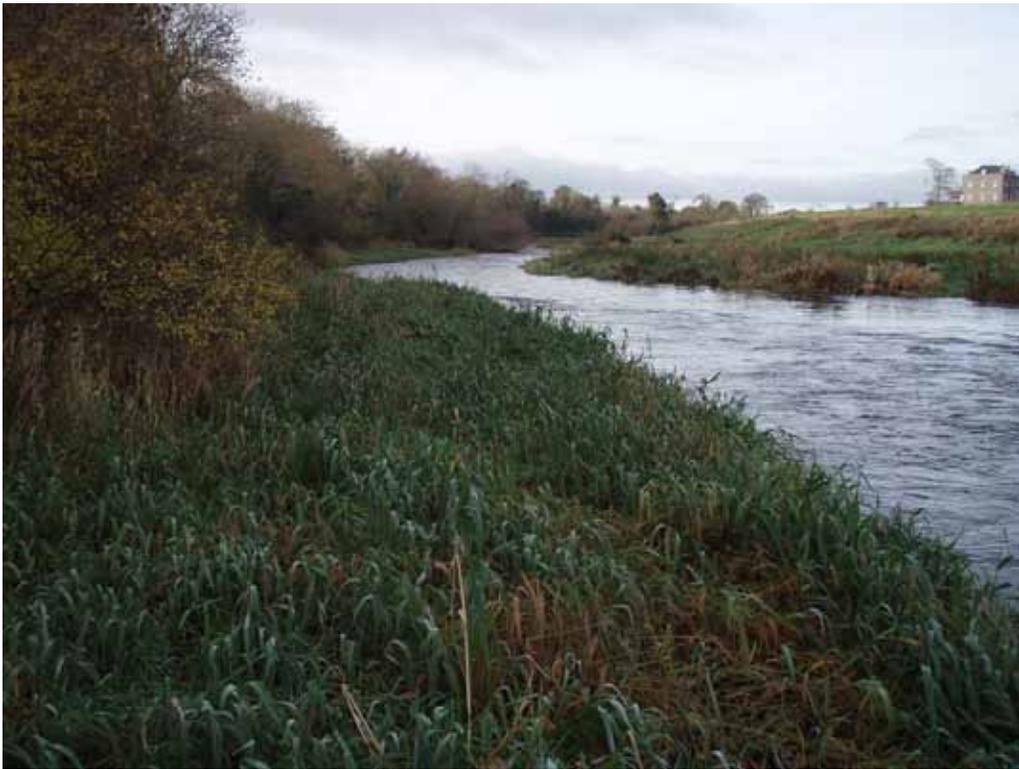
Photo 13 Wet vegetated river margins

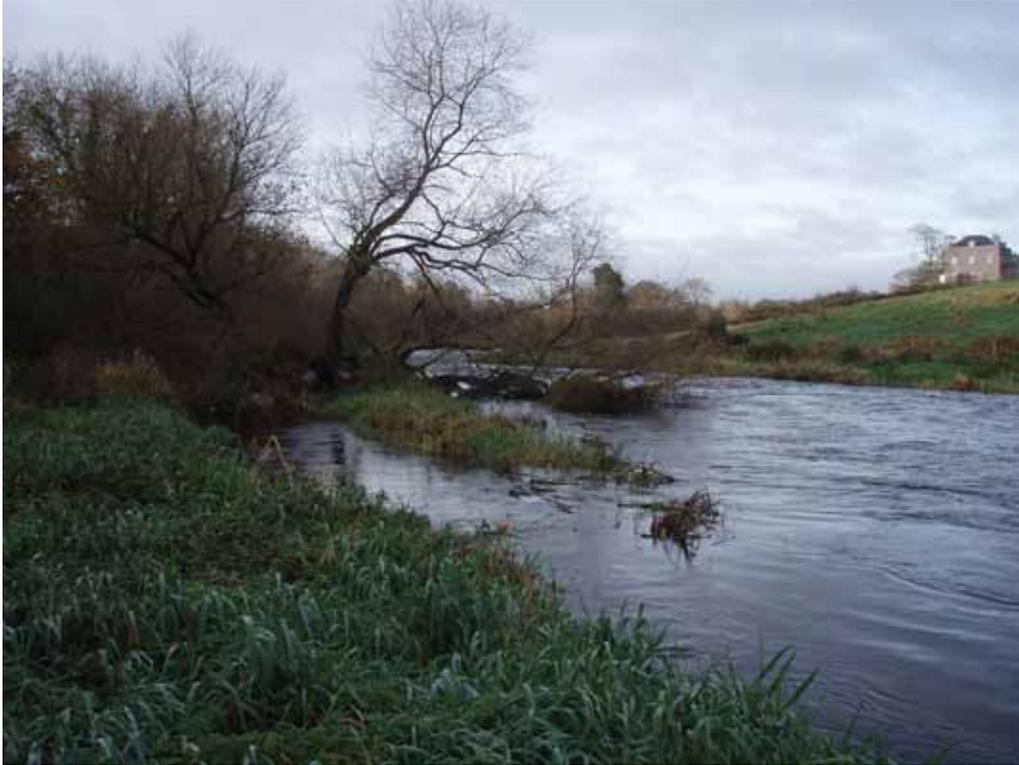
Photo 14 Large Woody Debris creating valuable habitat diversity

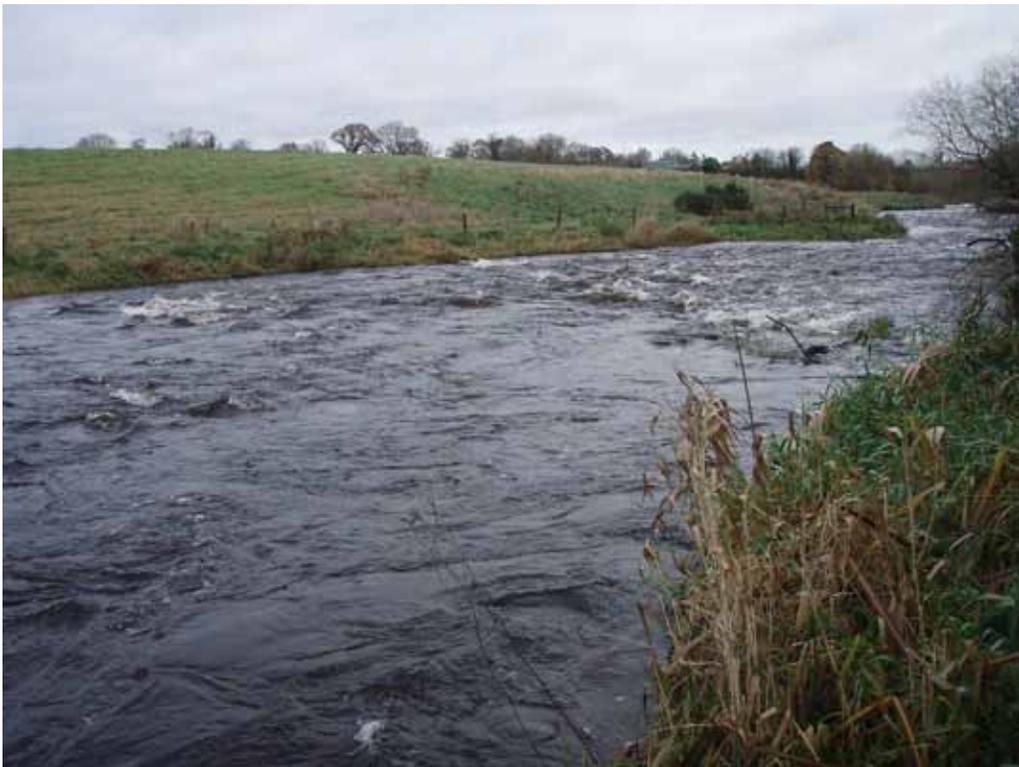
Photo 15 Faster water cascading over bedrock outcrops

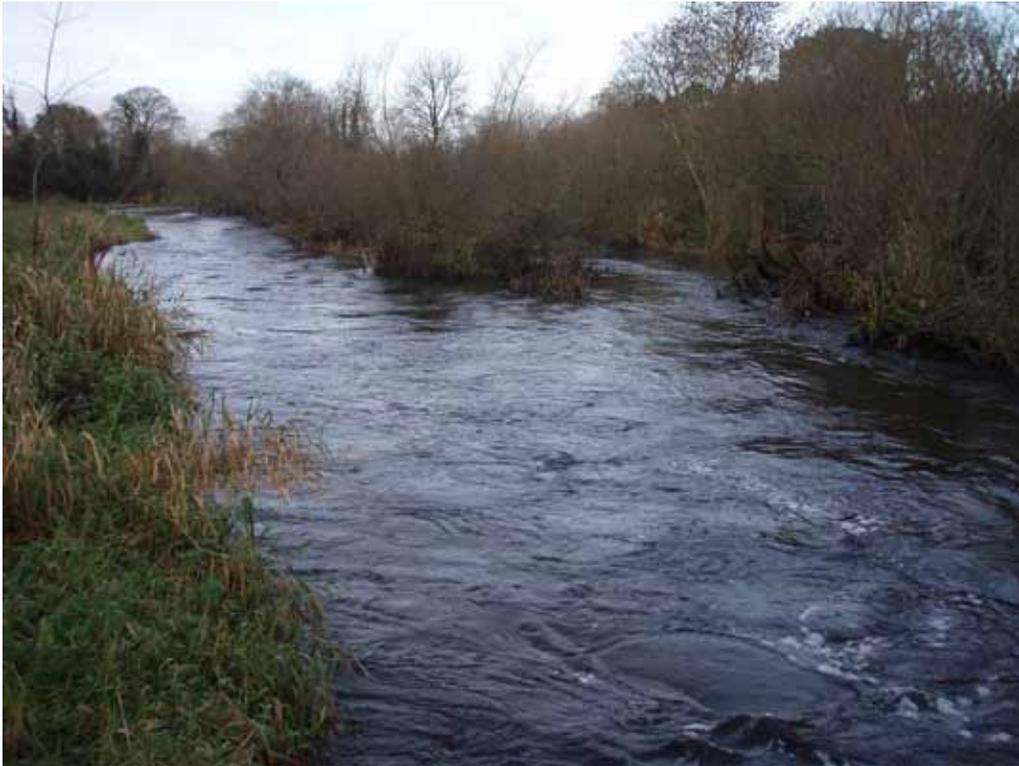
Upstream of the water works is a stretch of good habitat containing the Sheep Pool (a deep, salmon-holding pool). The stretch is characterised by wide, wet river margins colonised by reed canary grass *Phalaris* sp. and reed sweet grass *Glyceria* sp.; there is some good stable LWD in the river channel, and a variable depth profile with high riffle areas caused by bedrock outcrops, and deeper pool areas (Photos 13-15). Near the large house being constructed on the LHB is an area designated a sanctuary for juvenile fish by the club; no fishing is permitted here and there is excellent in-stream habitat in the form of willow scrub growing alongside and in the river channel on vegetated gravel shoals and side bars (Photo 16).

Photo 16 Vegetated gravel shoals and side bars

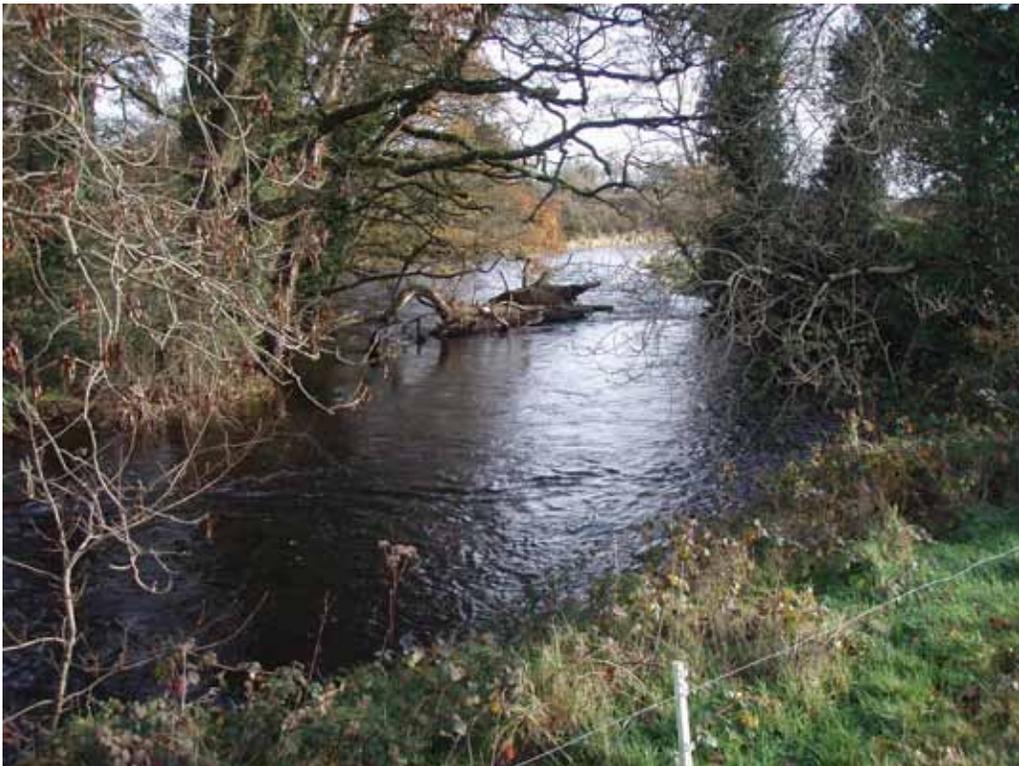
Further upstream is an area known as Lugawooly. Here the banks are wooded and there is some nice juvenile salmonid habitat with shallow water and LWD (Photo 17); this gives way to a deep pot where the river hits a bedrock cliff on the RHB and makes a sharp right turn. This is a deep area known for holding salmon and large trout. Upstream of here the river widens into a broad riffle with good spawning gravel; salmon have been observed spawning here (Photo 18).

Photo 17 Good habitat around Lugawooly

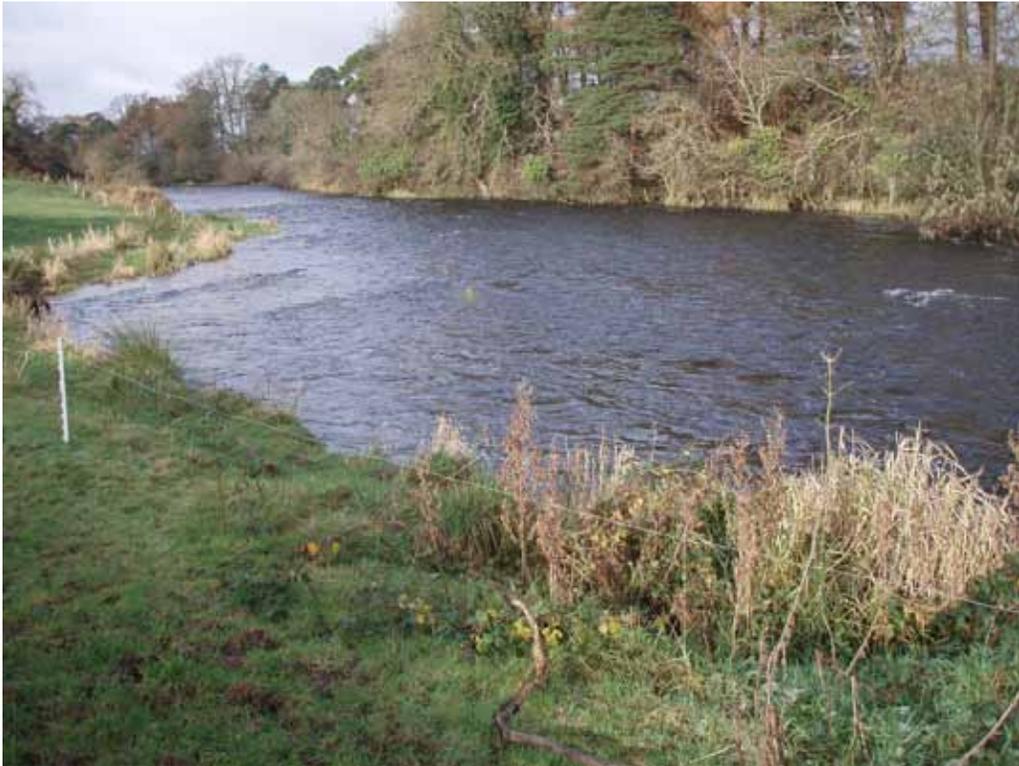
Photo 18 A known salmon spawning area at Lugawooly

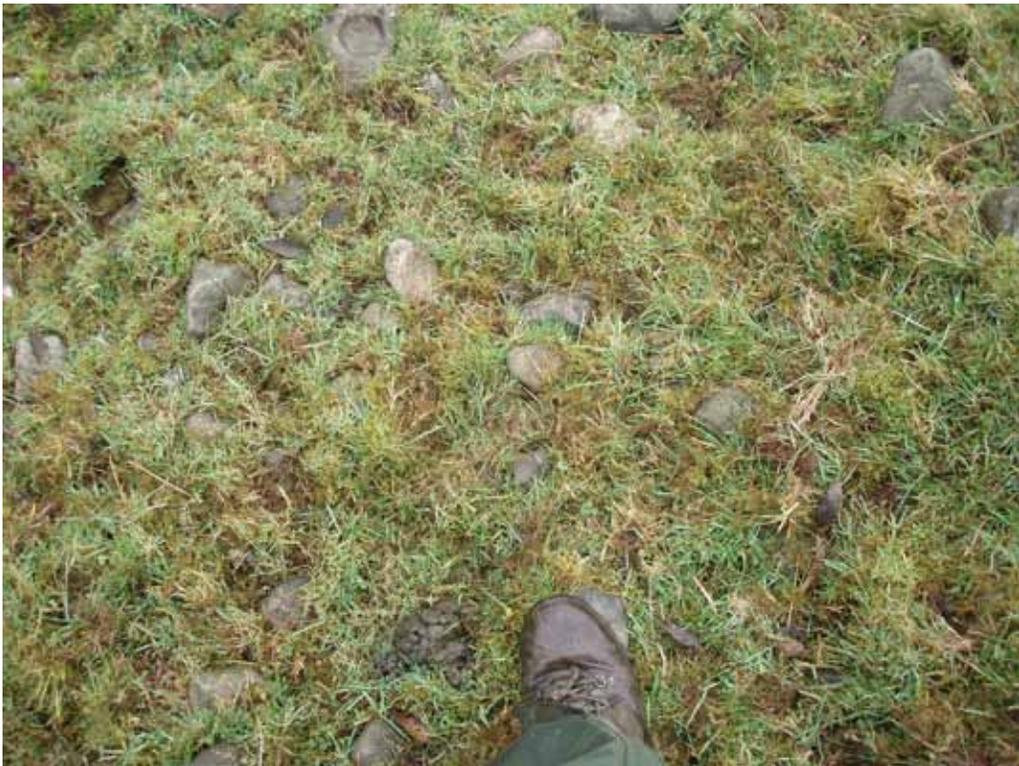
Photo 19 The former river bed now part of the bank as a result of dredging

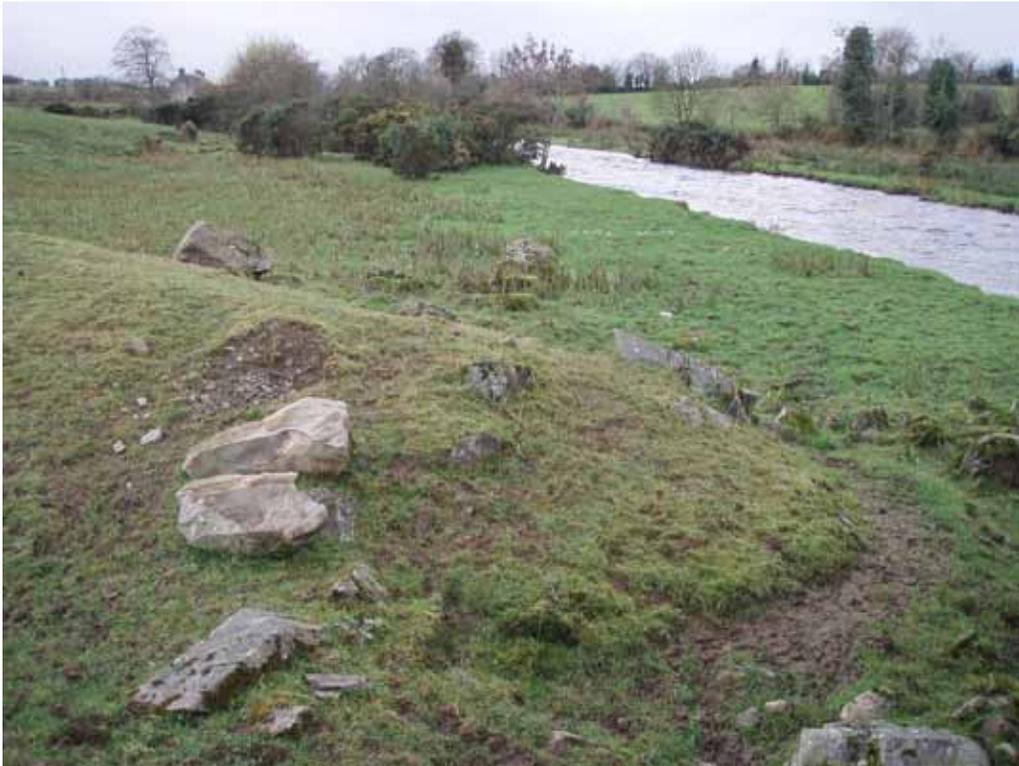
Photo 20 Boulders on the bank from arterial drainage operations

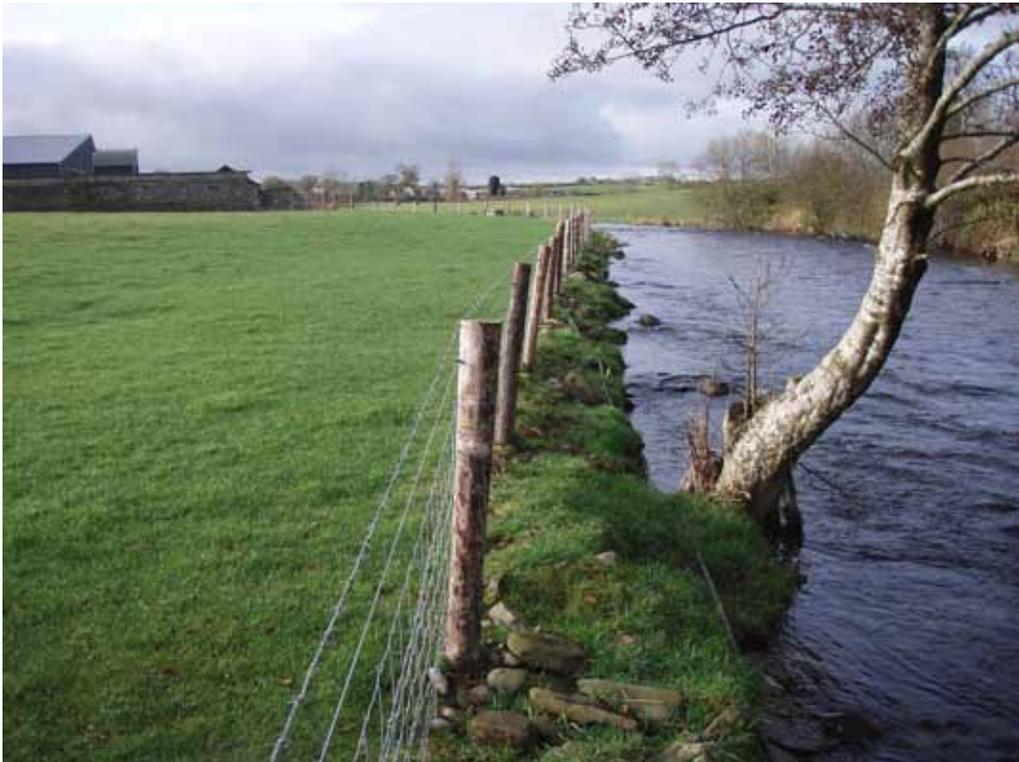
Photo 21 Fencing very close to the river edge

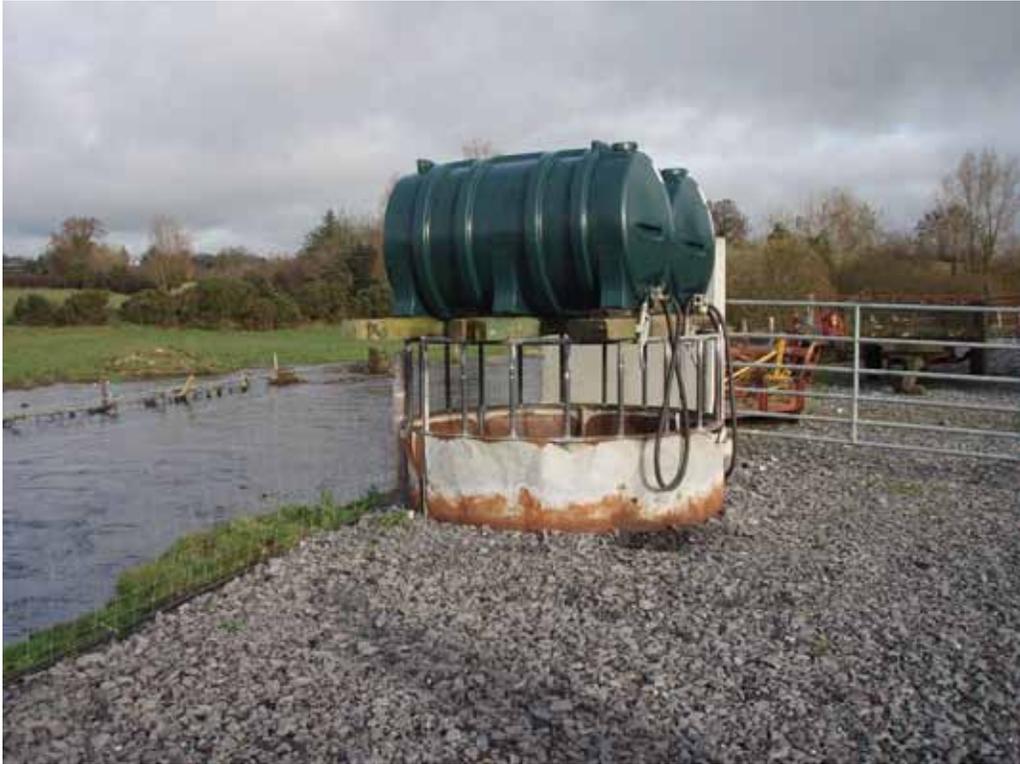
Further upstream at Jack Brady's farm, some new stock fencing and water drinking troughs have been erected alongside the river, possibly under a REPS (Rural Environmental Protection Scheme - http://www.agriculture.gov.ie/schemes/REPS4/REPS4FarmersHandbook_LowRes.pdf). The fencing is located very close to the top of the bank (Photo 21), certainly within the minimum 1.5 metres specified under measure 3 of REPS. Within the farmyard there are some fuel tanks sited very close to the river, with no bund around them, posing a risk of pollution should there be a leak or spillage (Photo 22).

Photo 22 Poorly sited fuel storage tanks

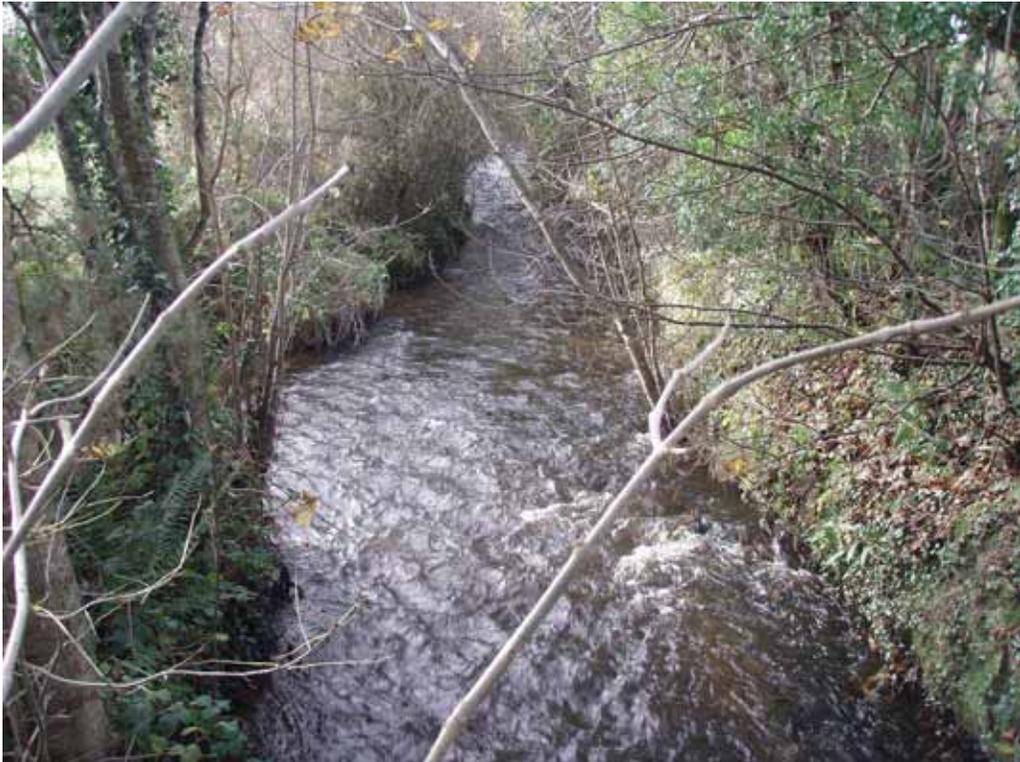
A tributary, the Sheeny River enters on the RHB upstream of Jack Brady's. Twenty years ago a serious pollution resulted from a farmer washing out spraying tanks in the Sheeny River and a large number of fish were killed. The Sheeny River has a gravel bed and a good gradient and flow, providing good trout and salmon spawning habitat (Photo 23)

Photo 23 Sheeny River

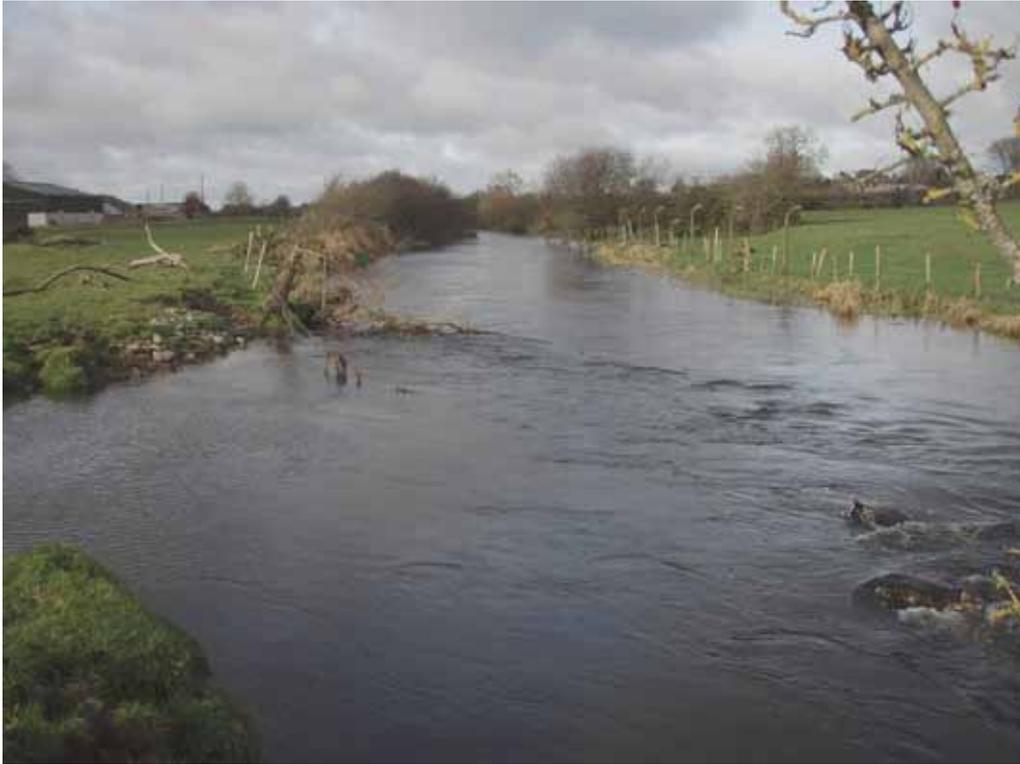
On the main river downstream of Carnaross Bridge there are willows growing out over the river from the RHB providing good low cover (Photo 24); these have recolonised since the drainage scheme. Downstream of this the river is deep and slow down towards Jack Brady's farm, and is known salmon holding water. There are no low weirs/groynes in this section, and the river has a gravel bed. Two or three cormorants were observed feeding on the river here.

Photo 24 Downstream of Carnaross Bridge

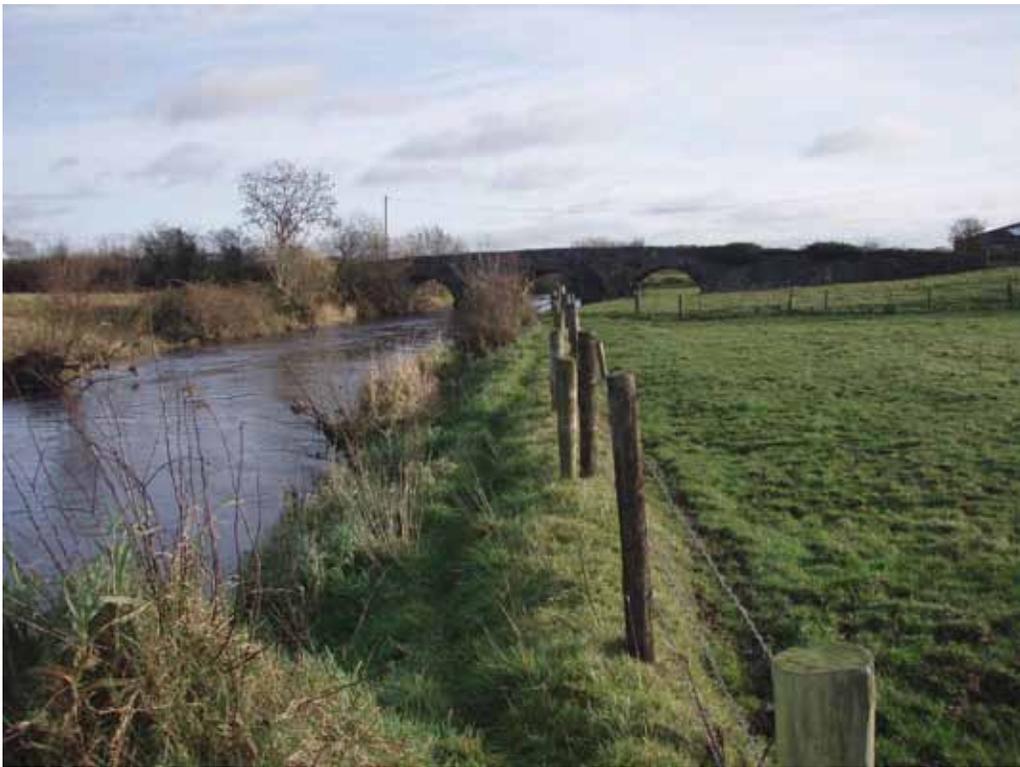
Photo 25 Carnaross Bridge with dry arch (RHB) as a result of drainage scheme

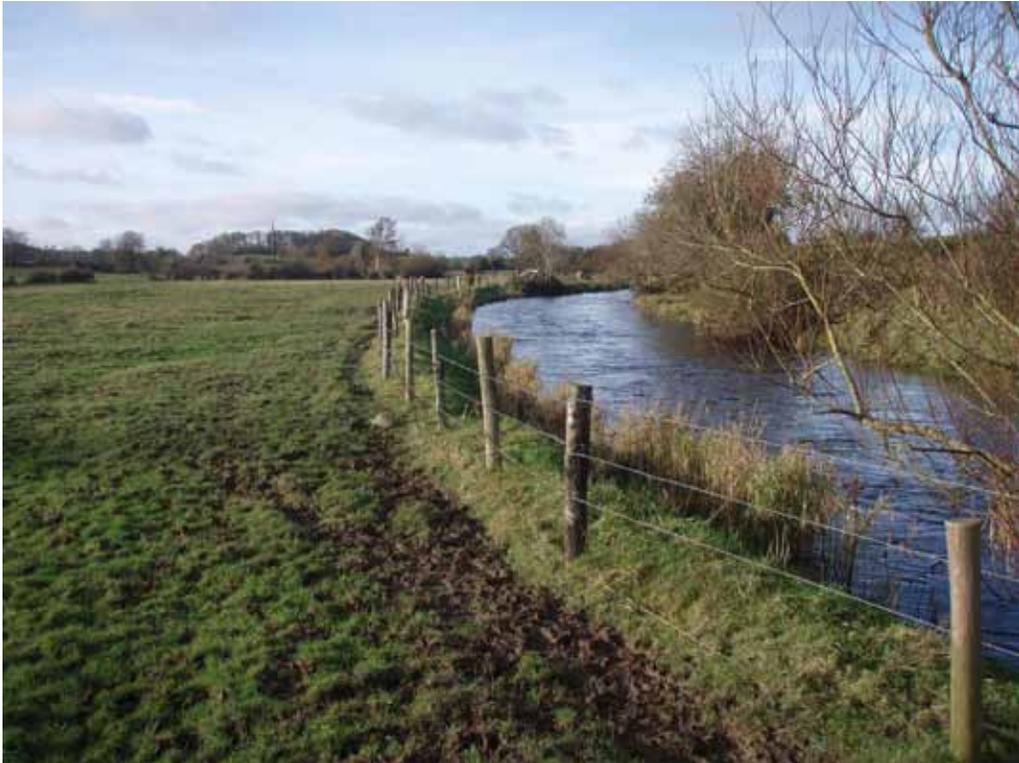
Photo 26 Uniform width, trapezoidal channel.
