Advisory Visit

River Blackwater, Kells Angling Association

Co. Meath, Eire

17-20th November, 2008

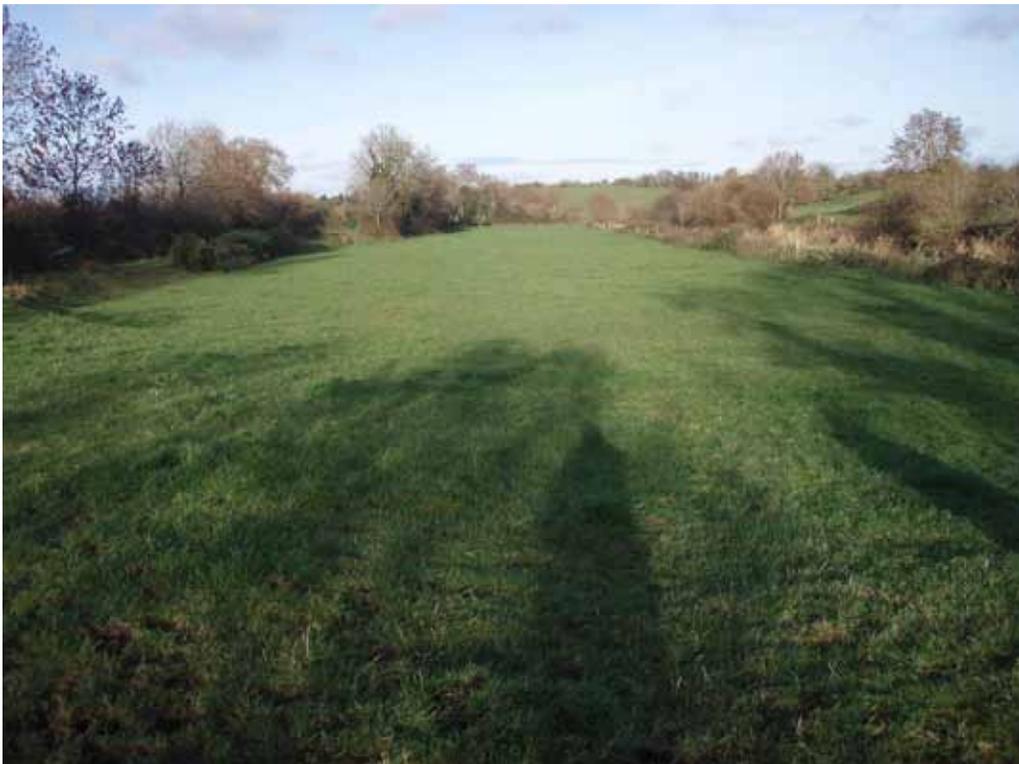
The next field upstream of the fallen willow used to be wide, wet berm pre-drainage, and gives some indication of the level by which the river bed has been lowered (Photo 27). The river is deep along this stretch (un-wadeable at summer level). Ash trees have been planted along LHB which is fenced. At the upstream end of this section, near Harton's Bridge is a cascade where there is a bedrock outcrop (Photo 28); other such areas in this reach were removed with explosives during the drainage programme.

Photo 27 This meadow was a wet margin adjacent to the river (at the right of the picture) prior to land drainage

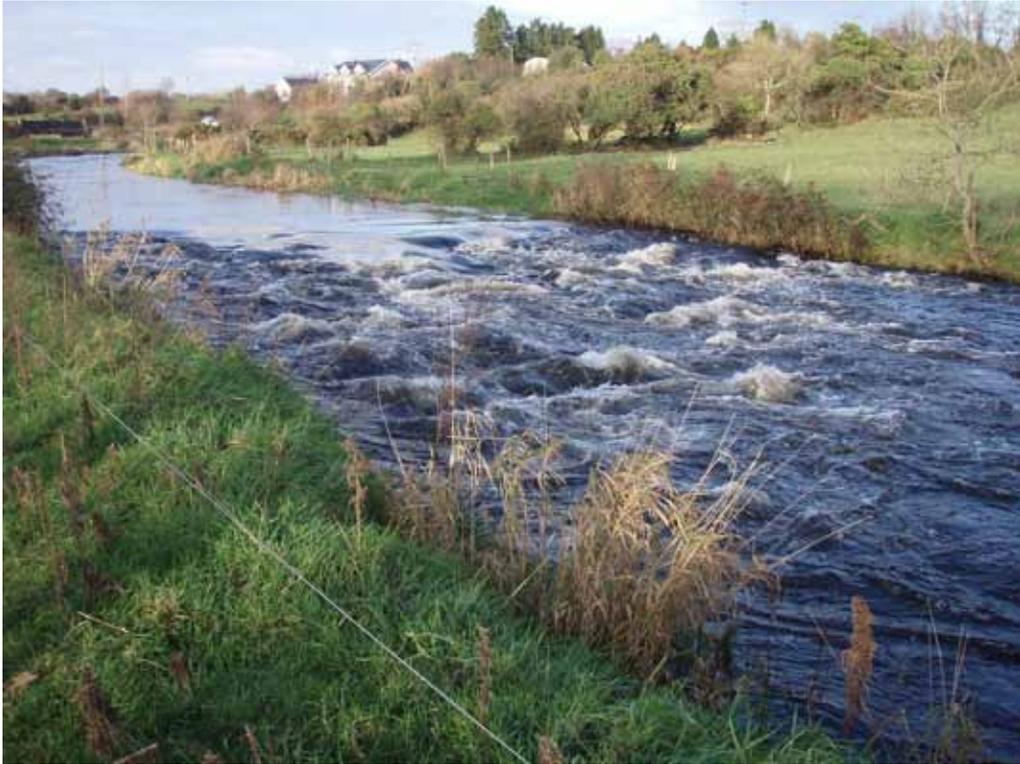
Photo 28 Bedrock cascade downstream of Harton's Bridge

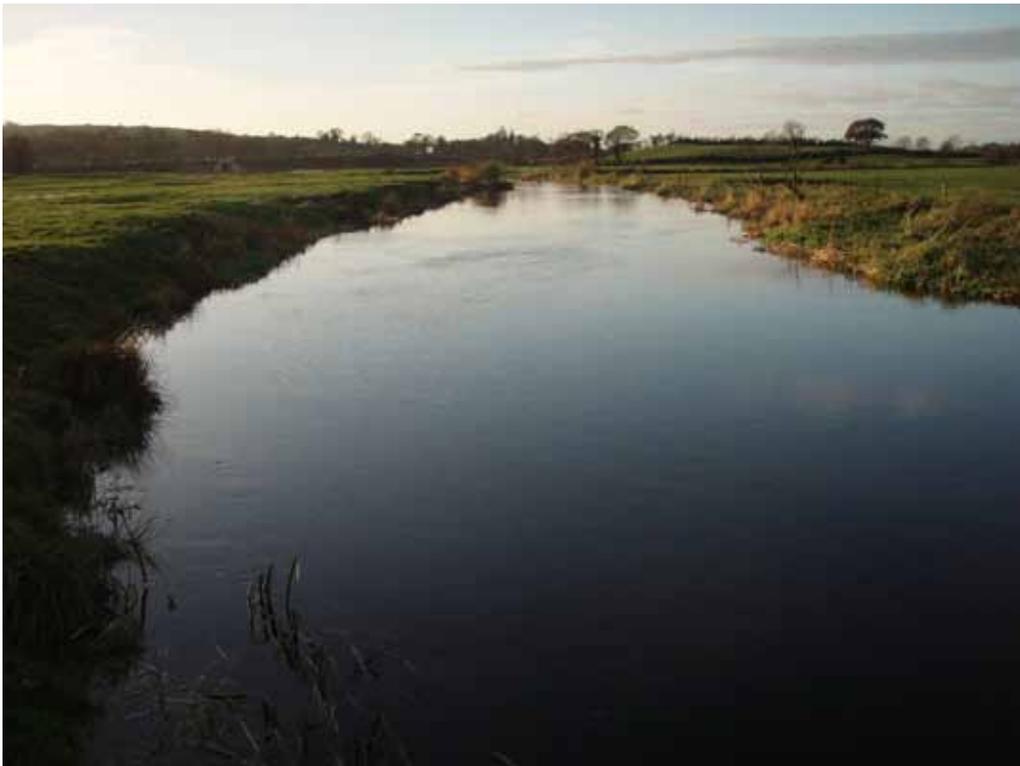
Upstream of Harton's Bridge the river is slow and deep. The river had a similar character pre-drainage, but previously the banks were wet and spongy, and floodplain contained extensive areas of flooded grassland during the winter. There is still some wet grassland evident and lapwing, whooper swan and snipe were observed. The club report few trout in this section, (but big ones). Coarse fish are plentiful and lilies grow here; there is a sandy bed and a depth of 10-12ft deep with some areas deeper. The river retains this character upstream to new M3 road crossing (Photo 29).

Photo 29 Slow, deep section above Harton's Bridge

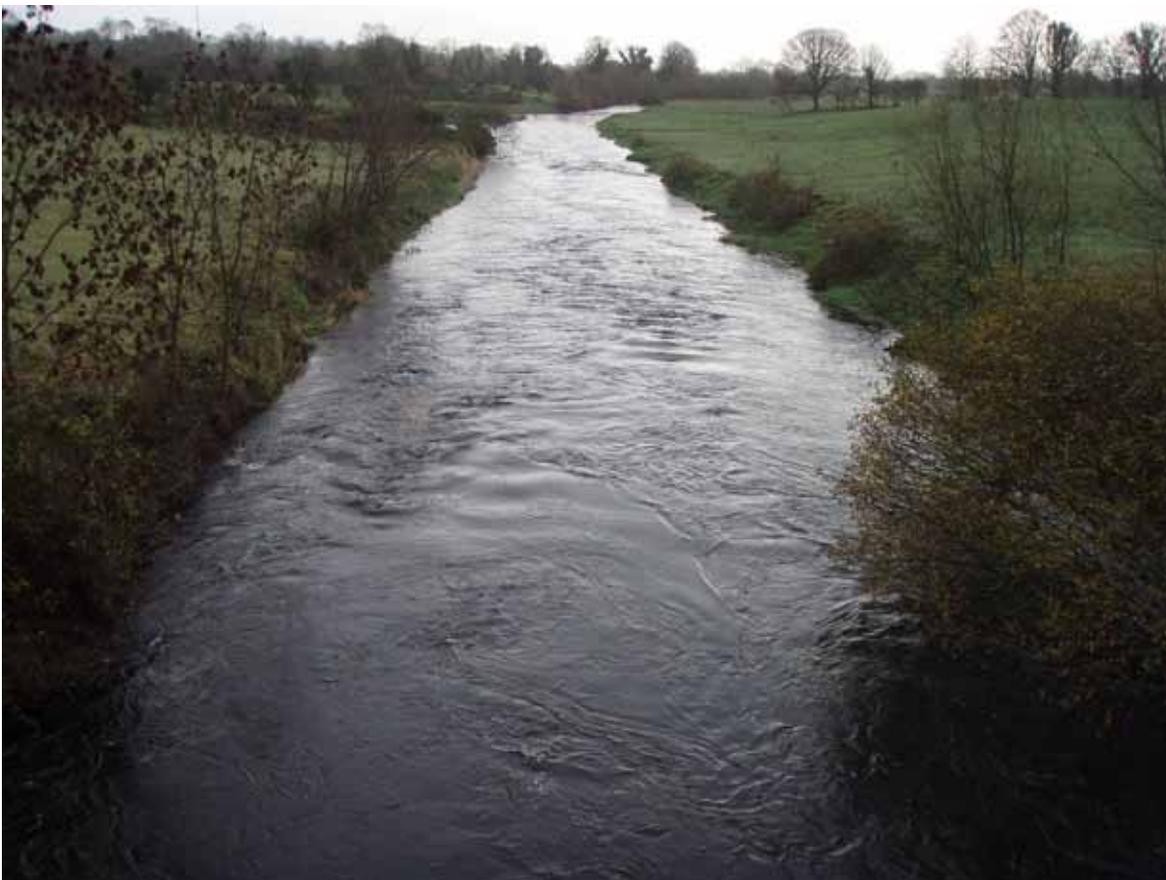
Photo 30 View downstream from Daly's Bridge

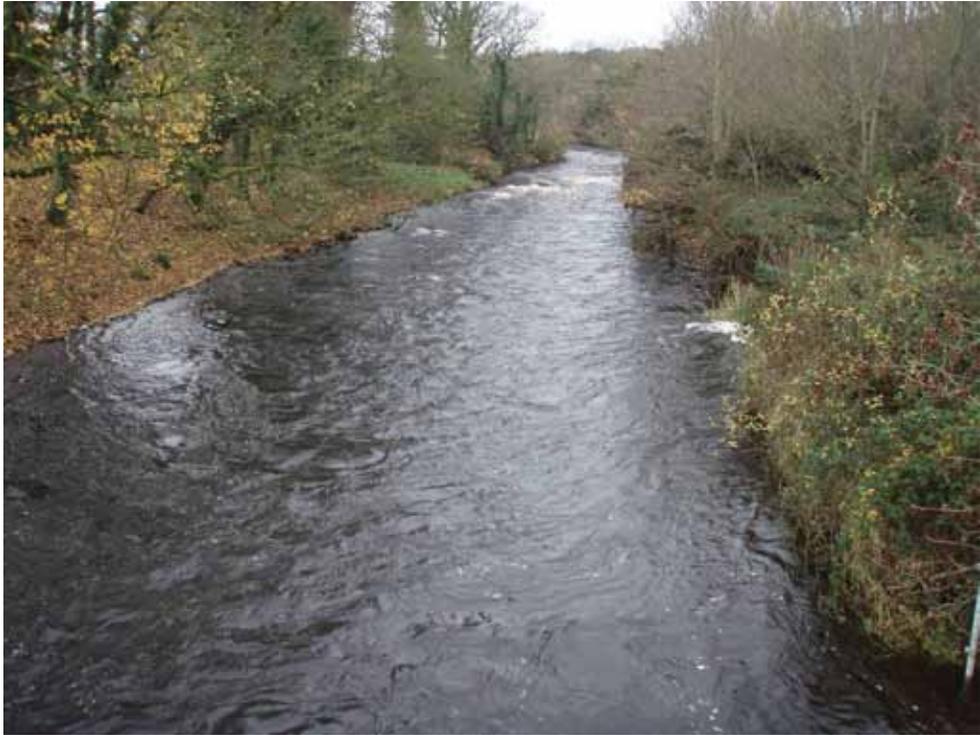
Photo 31 View upstream from Daly's Bridge

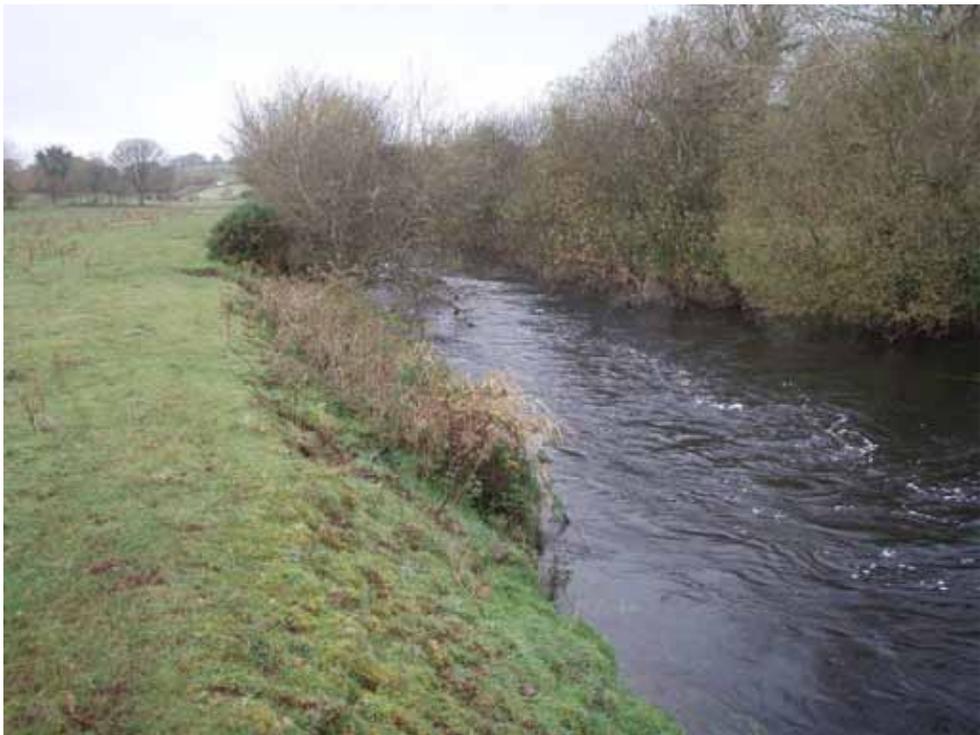
Photo 32 Steep, high banks, with willow and sallow, downstream of Daly's Bridge

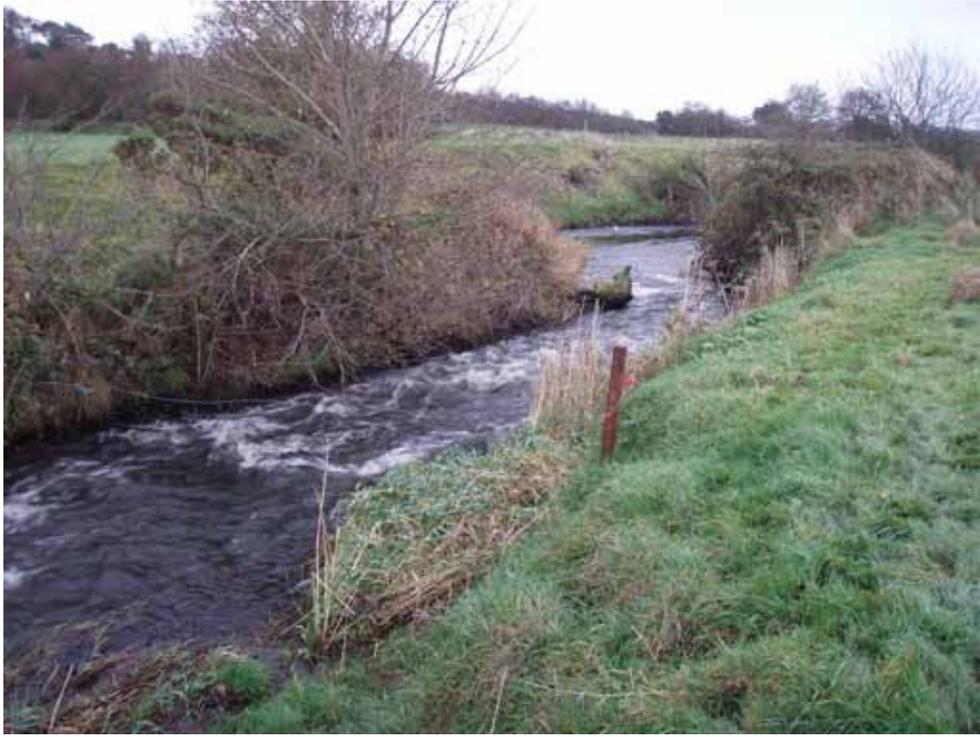
Upstream of Daly's Bridge the river is generally slow and canal-like, with just the odd faster run. The banks are very steep and high. At the Crosswater River confluence (SA 68854 42507) on the RHB a drop of approximately 2 metres can be seen over the last 30m of the tributary; this indicates the level by which the main river bed was lowered (Photo 33).

Photo 33 Steep gradient of the last few metres of the Crosswater due to the lowered bed of the Blackwater

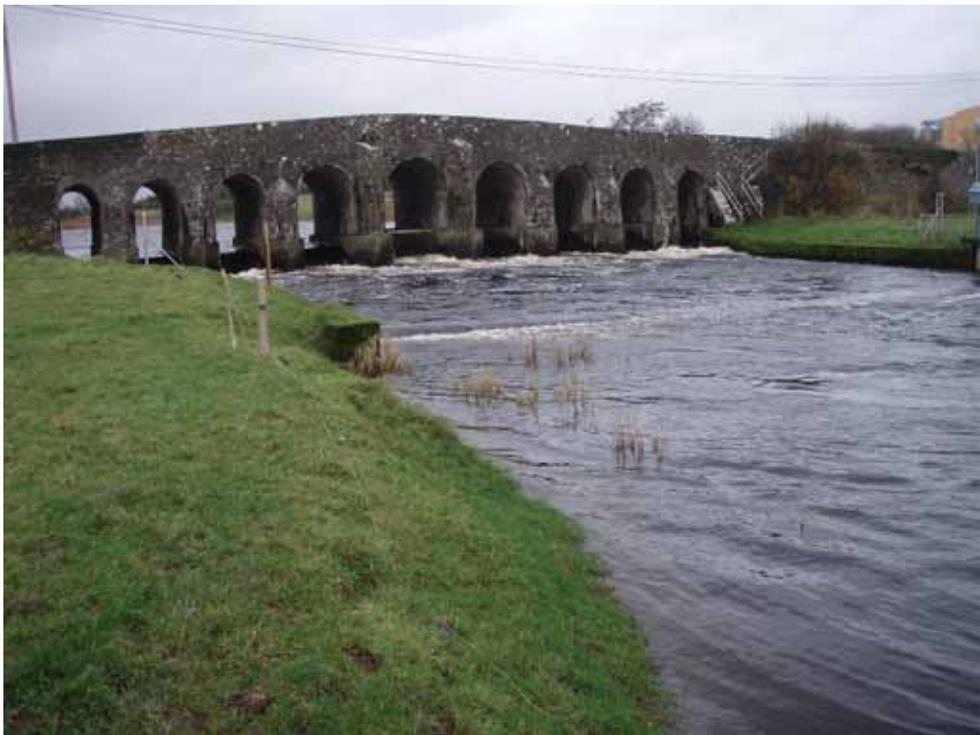
Above the Crosswater confluence, the Blackwater is slow, deep and wide for about a mile up to Nine-eyed Bridge (Photo 34), the outflow from Lough Ramor. Stillwater plant species such as Canadian pondweed *Elodea Canadensis* and broad-leaved pondweed *Potamogeton natans* are present here, and freshwater mussel shells *Anadonta* sp. were found on the bank. Immediately downstream of the bridge is a crump weir flow gauging station.

Photo 34 Nine-Eyed Bridge and the flow gauging weir

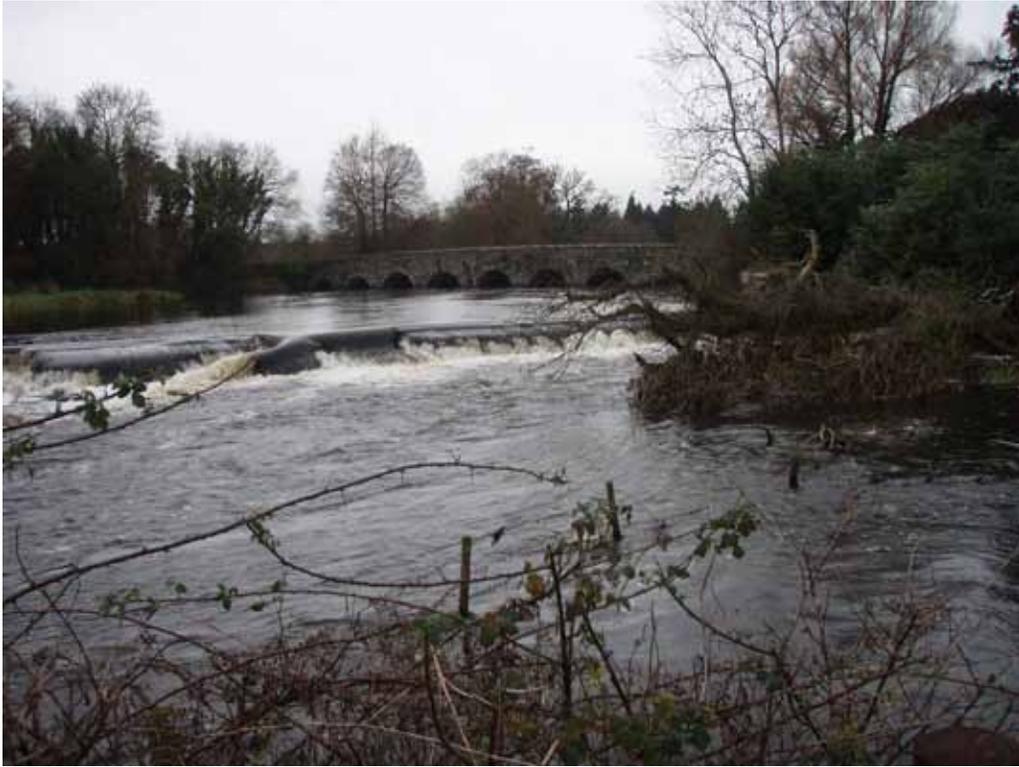
Photo 35 Weir below Headfort Bridge, with blocked fish pass on right of picture

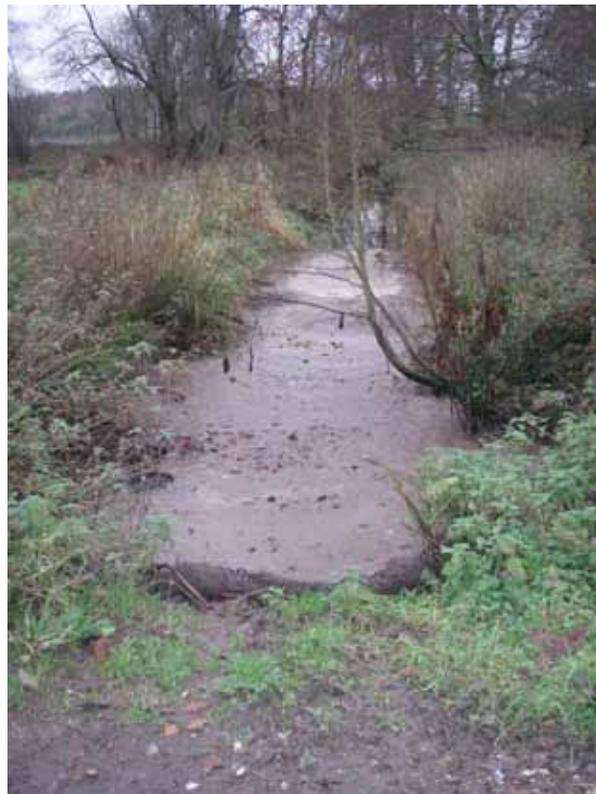
The discharge from Kells Waste Water Treatment Works (WWTW) was inspected on Headfort Estate Golf Club accompanied by the course superintendent. The WWTW discharges into a small stream close to its confluence with the river. There are obvious problems with the volume of the discharge into the stream and with storm overflow capacity at the works. The stream at the river confluence (where there is a short culvert) was covered in floating scum and the adjacent banks were strewn with sewage debris (Photo 35).

Photo 36 Floating scum on the tributary receiving the outflow from Kells WWTW (the stream is culverted under the earth bund in the foreground into the river behind the photographer)

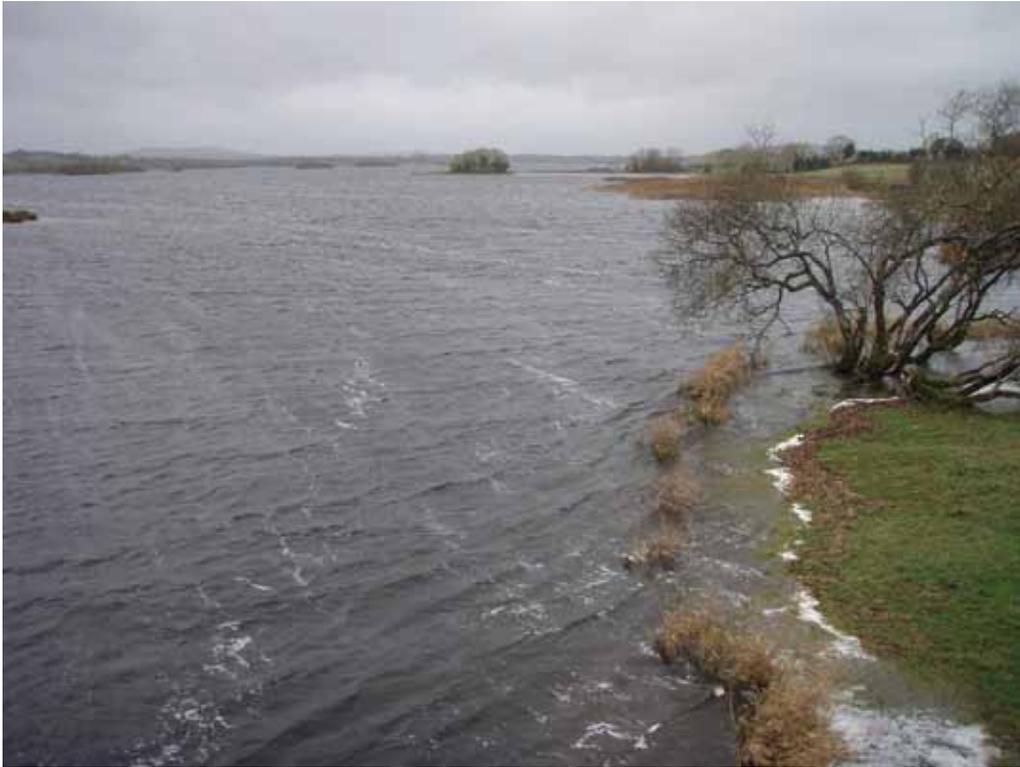
As mentioned above, Lough Ramor (Photo 37) has been classified as hypertrophic since the late 1970s. Nutrient inputs from municipal and industrial discharges and from agriculture is the main source of pollution, leading to excessive growth of phytoplankton and blue-green algae (cyanobacteria) (EPA 2008). The concentration of pig farming in County Cavan and associated slurry spreading is of particular concern as a source of nutrient input to the Lough.

Photo 37 Lough Ramor

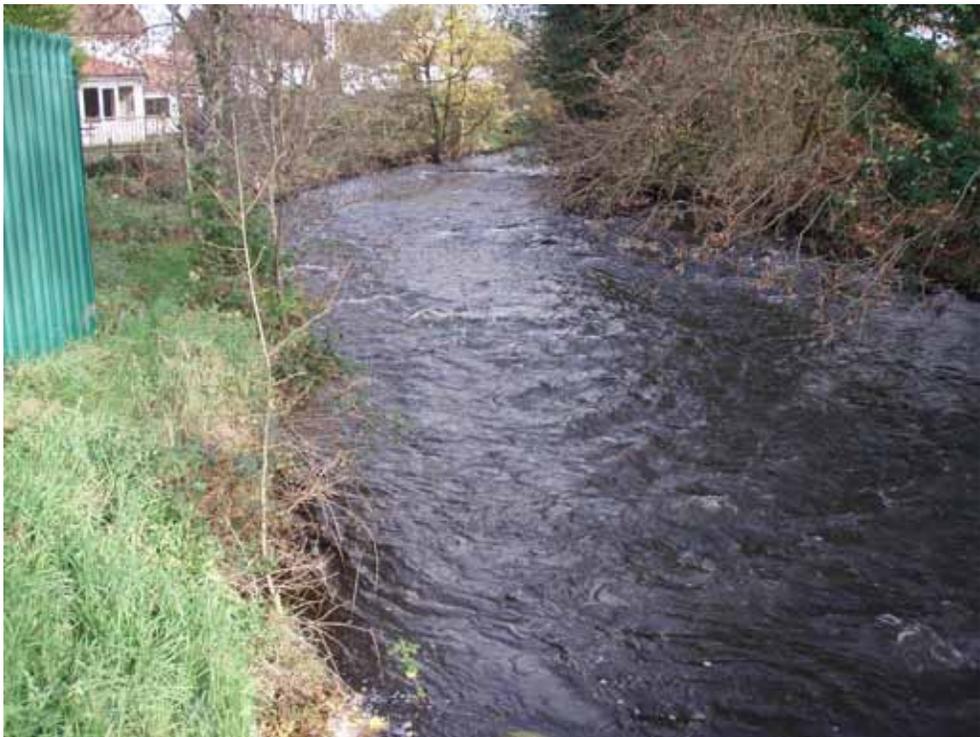
A number of tributaries of the Lough were inspected, the largest of which was the River Lear which drains the area around Bailieborough. The river has a history of poor water quality because of organic pollution of agricultural origin. The section of river from the Lough up into the town of Virginia appeared to have excellent instream habitat, including a gravel bed, pool-and-riffle sequence, instream macrophytes and a diversity of depths and flow patterns (Photo 38).

Photo 38 Lear River, Virginia

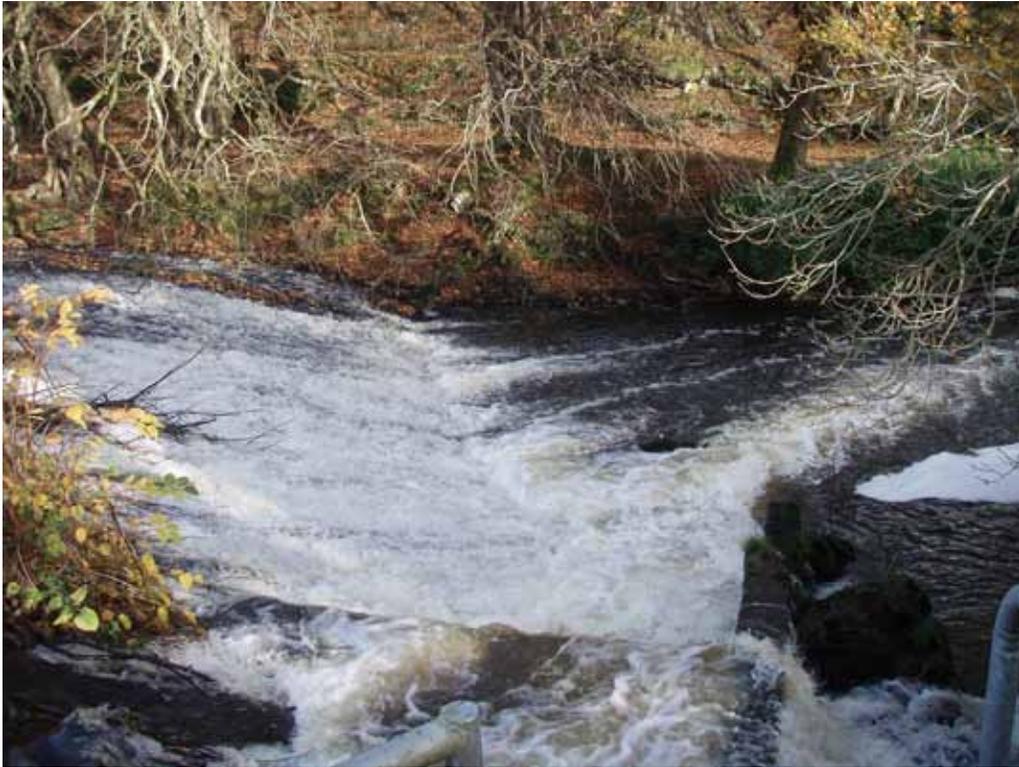
The Eastern Regional Fishery Board (ERFB) have a hatchery alongside the Lear in Virginia and the staff based there kindly provided access to the weir (Photo 39) upstream of the hatchery (which was currently not being used for fish propagation). Unfortunately this weir is a very large structure, impounding the river for a considerable distance upstream, and forming a major obstacle to fish moving upstream. There is a rudimentary fish pass on the weir (in a state of disrepair), and salmon have been recorded passing the weir, but there is no doubt this structure severely limits the Lear's value as a spawning tributary of the Lough. The weir was constructed many decades ago for milling, but the head of water is now used solely to supply the ERFB hatchery. ERFB staff said the river had been subject to arterial drainage further upstream.

Photo 39 Weir on the Lear River at Virginia

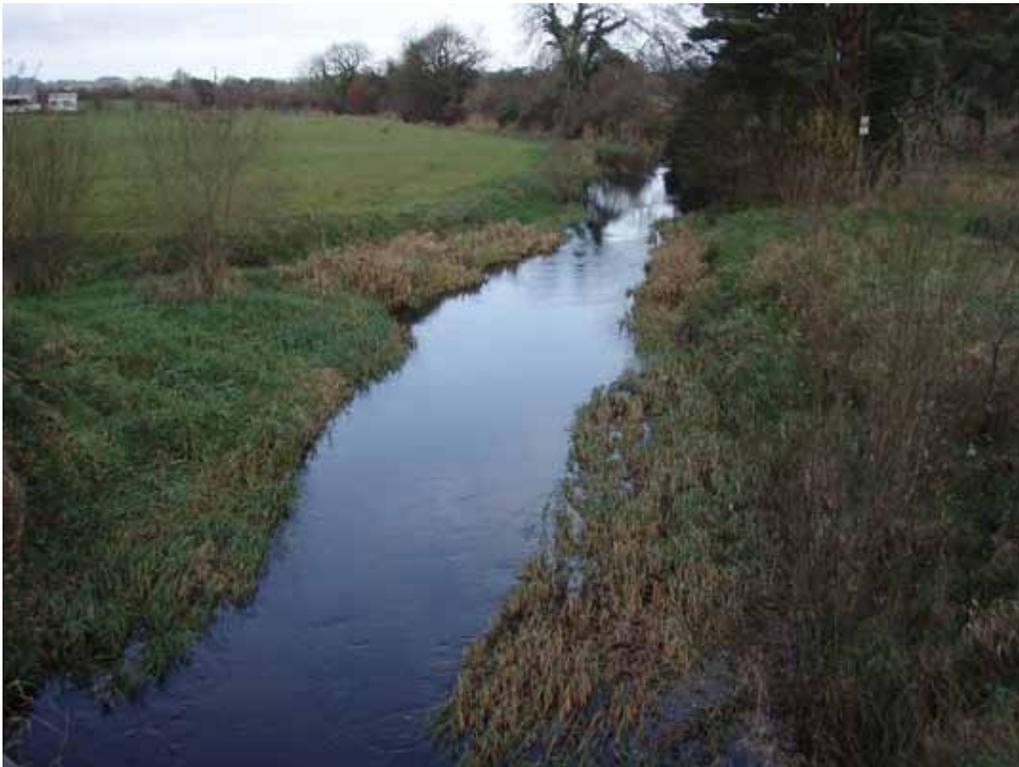
The Killinkere River was inspected on the western edge of Virginia (Photo 40). This river appeared slower and deeper than the Lear, possibly as a result of drainage, although staff at the ERFB said there were some good trout populations in this river and its tributaries. Kells AA members were aware of pollution incidents on this river arising from wrong connections of foul water sewers to surface water drains on new housing developments.

Photo 40 Killinkere River
