**Advisory Visit**

**River Blithe, Staffordshire**

**May 2011**

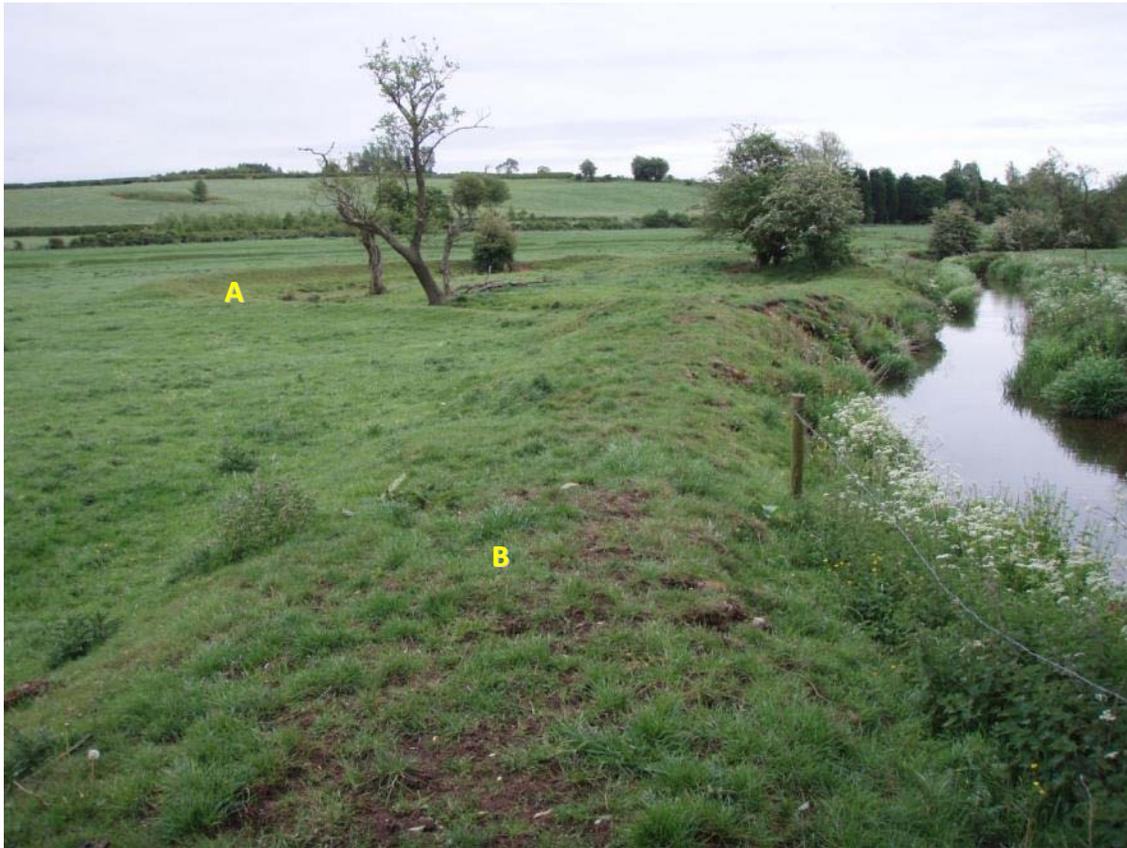
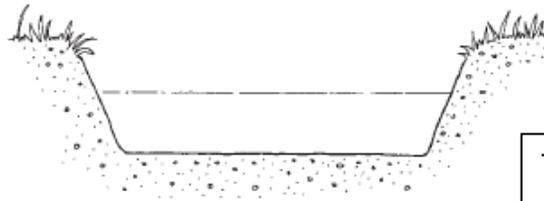
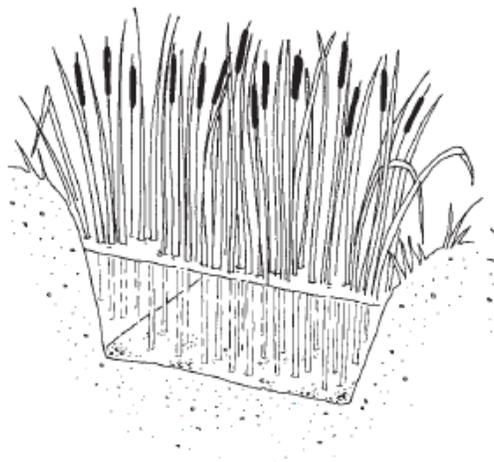
A typical example of a section of river which has been straightened and dredged is shown in Photo 1. A meander has been cut off and a spoil bank created on the left bank from the dredgings from the river. The result is a river channel with a trapezoidal cross-section which tends to be over-wide (immediately after the works) and have a uniform depth; this promotes the deposition of fine bed material (sand and silt) which colonises with rushes and reeds. The spoil bank may prevent inundation of the fields in this

specific location, but it could contribute to increased retention of water on the fields if the river overtops the bank further upstream.

Photo 1 A section of the Blithe which has been previously straightened and dredged. Note the former meander (A) and spoil embankment alongside the river (B). The trapezoidal channel cross-section (below) resulting from this work lacks variety and is very poor for the fishery and conservation value of the river; it is also prone to silting and excessive emergent vegetation growth which can impede drainage.

- Re-profile the river banks on the sections of river which have been previously straightened and dredged. On straight sections, the aim should be to create a two-stage channel which leaves the existing channel intact, but creates a low berm alongside the river which will accommodate higher flows (Figure 1). On meandering sections which have a trapezoidal cross-section, the aim should be to remove material from the inside of bends to restore a more natural cross-section which will also improve flood conveyance (Figure 2).

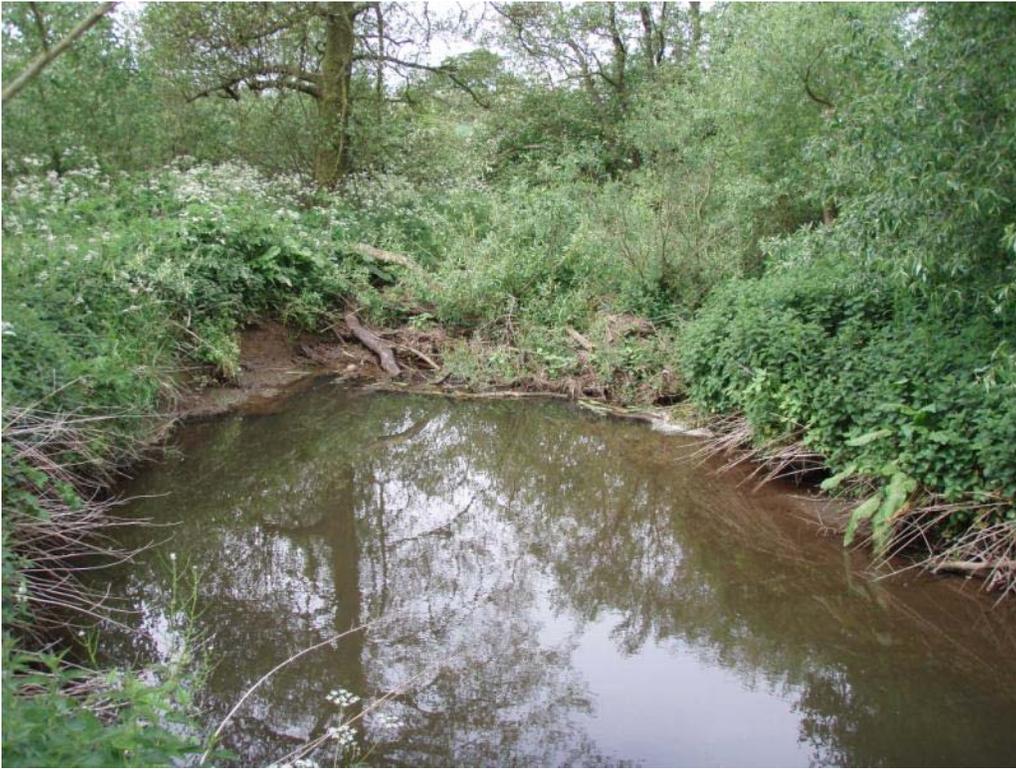
Two woody debris dams were observed during the visit and these filled the entire width of the river channel. Features like this are valuable in-stream habitats for fish, invertebrates and other wildlife; they also promote the formation of natural channel features like pools and riffles. The preferred option from a conservation standpoint is to retain woody debris; however the extent of these particular dams and their colonisation with live willow does represent an impediment to conveyance of high flows.

Photo 2 Woody debris dam

- Manage the willow trees and woody debris dams on the lower part of the upper beat to improve conveyance. It is recommended that this is undertaken by the angling club with Wild Trout Trust assistance. The reduction in the amount of willow on the inside of meanders in this location should be complemented by establishment of blocks of native trees on the opposite bank to assist with erosion control; this would require fencing of a headland or buffer strip alongside the river to allow the trees to establish.

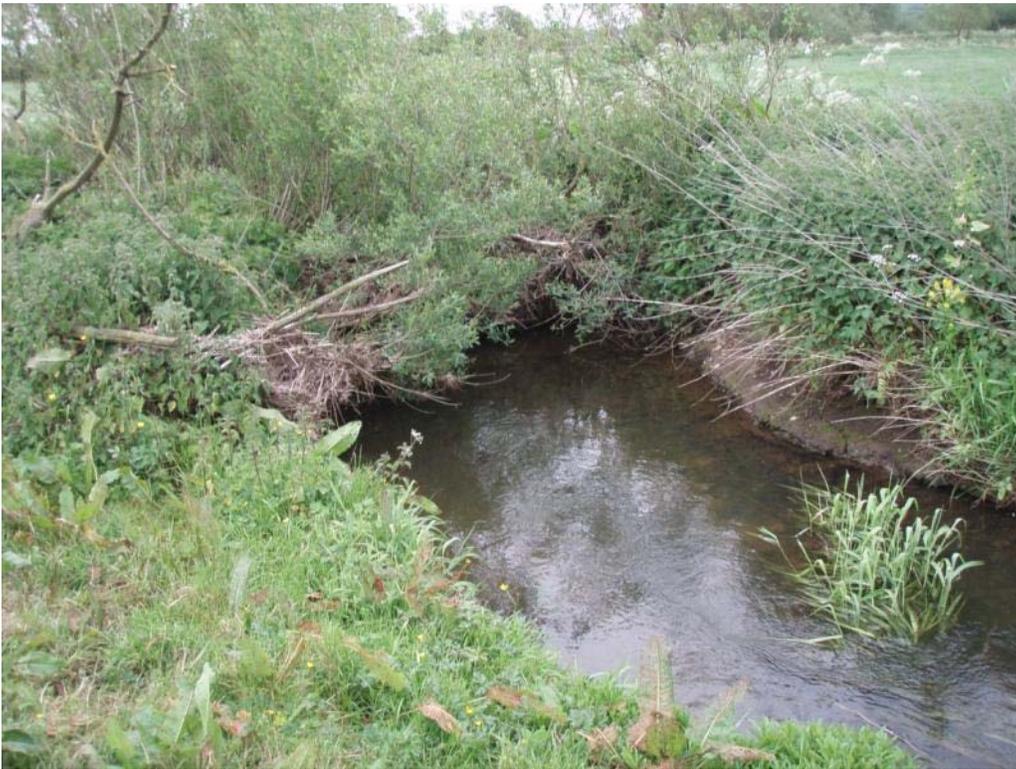
On the middle to lower part of the upstream beat there are sections where willow (sallow) trees have grown out across the channel in dense stands. These are causing heavy shading of the channel and also make angling access very difficult; flood conveyance will also be impeded by the dense growth. Many of the willows are growing on the inside of bends (generally on the left bank) and the opposite outside banks are treeless; this is increasing the rate of bank erosion on the right bank. Ideally, the blocks of trees should be on the outside of the bends to increase bank stability and resistance to erosion.

Photo 3 Willow (sallow) growing on the inside of a bend

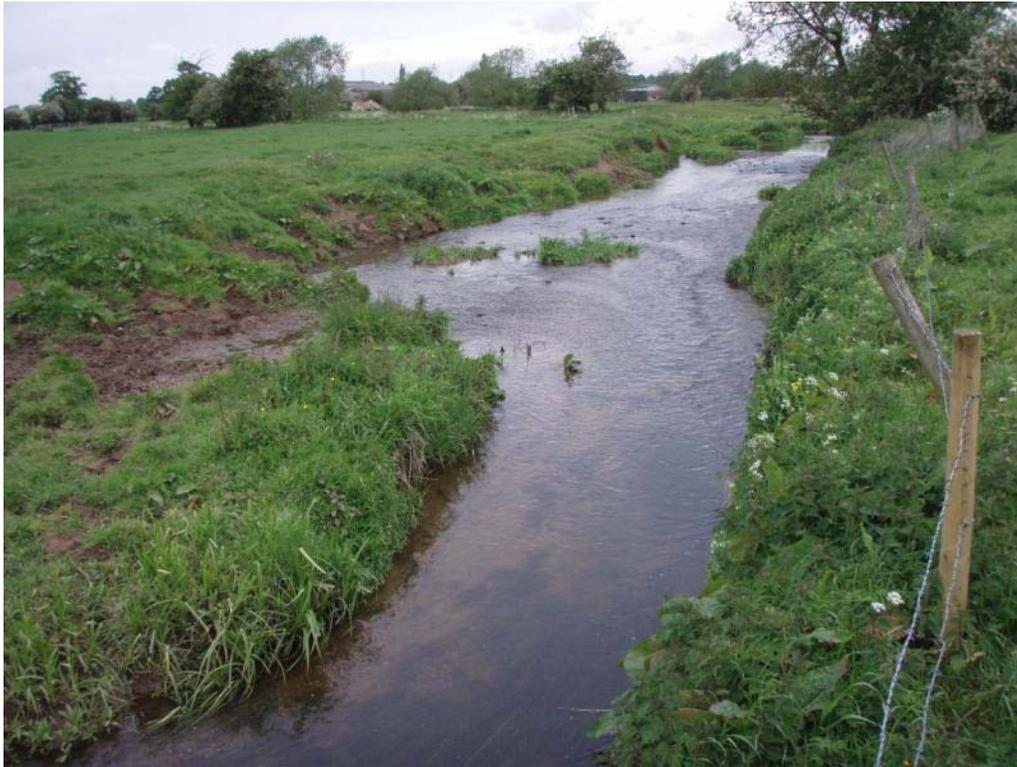
Photo 4 Sections of river with cattle access tend to be wide and shallow because of bank poaching and subsequent erosion: not good for habitat or angling.

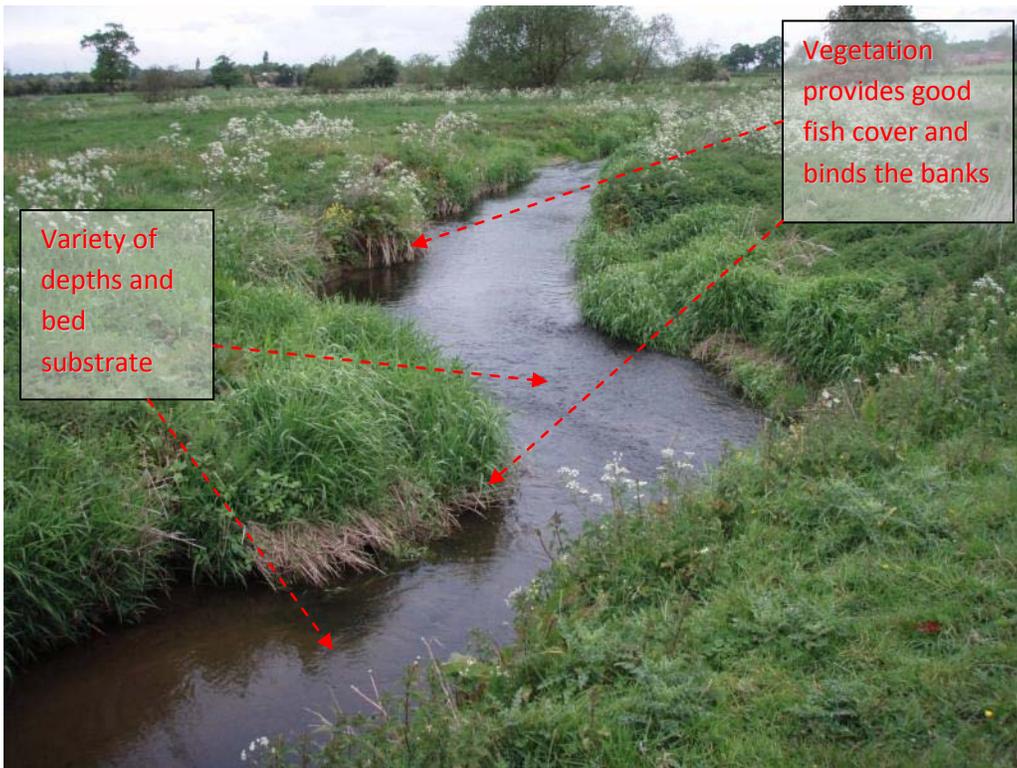
Photo 5 Sections with restricted livestock access have much better habitat and are vastly better for angling.

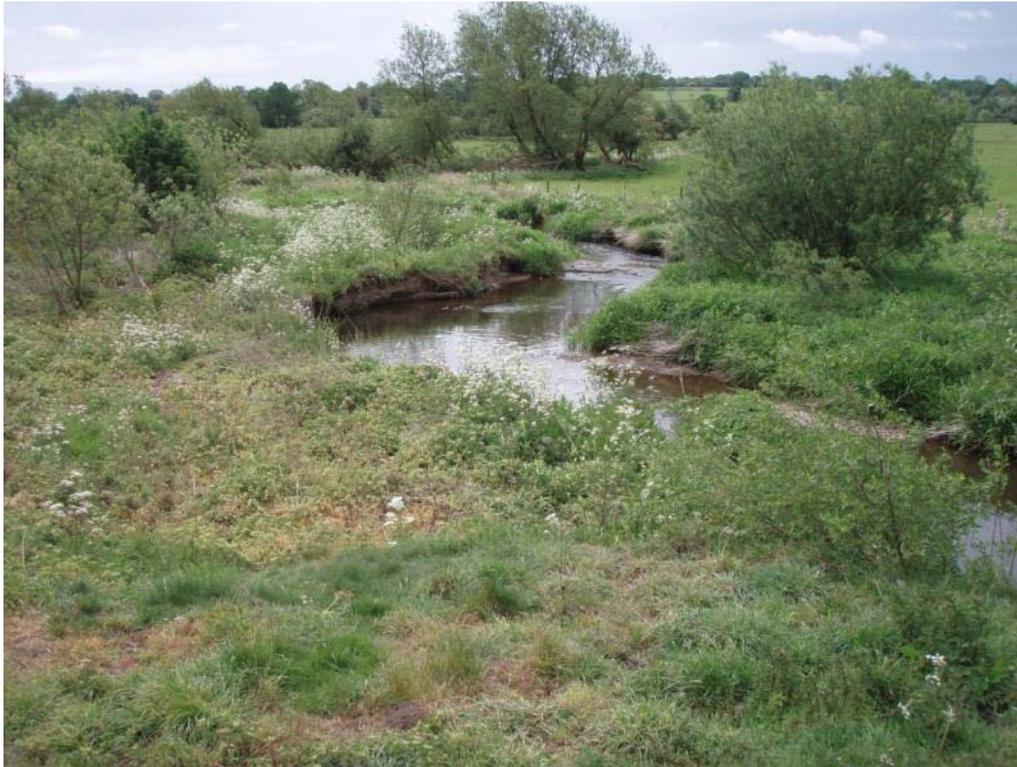
**Photo 6** A section of river with fenced banks, headlands and recently established tree plantations. This is an ideal situation for river management for the fishery and conservation: the river has room for the natural processes of erosion and deposition to take place at acceptable rates, without impinging upon adjacent land use.

- The river should be fenced and formal livestock drinking areas created. Ideally, the fencing should be set back to create a wide buffer zone between fields and the river (Photo 6, Figure 3) and the recently established woodland areas on Mr. Atkin's land are ideal in this respect.

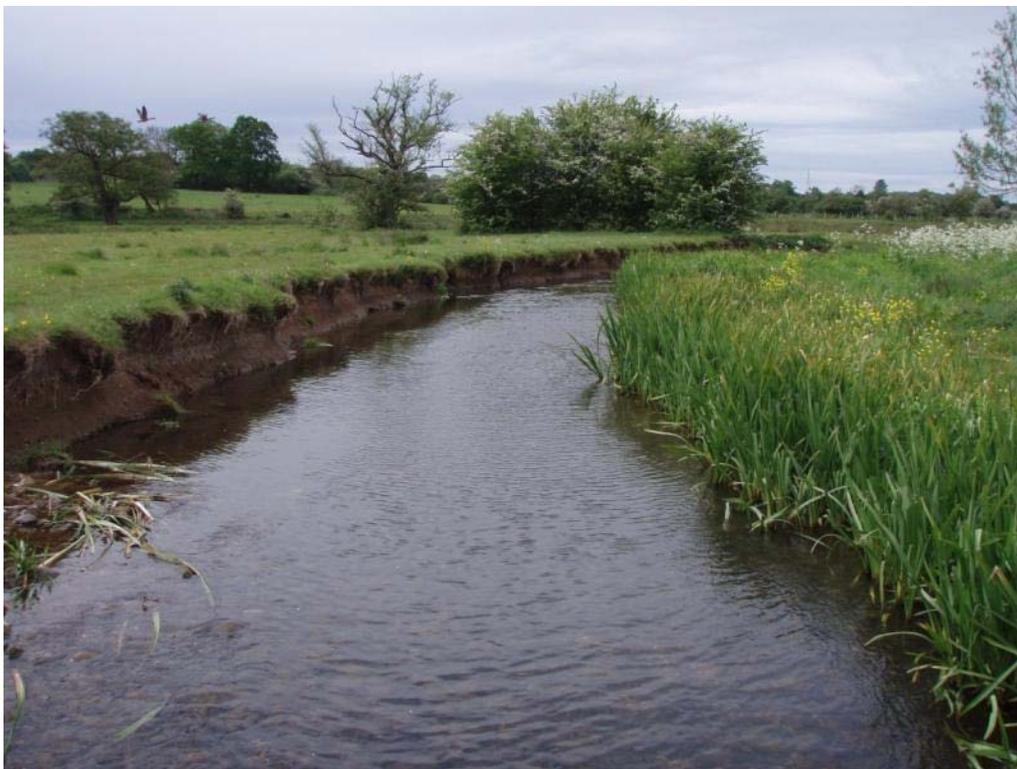
**Photo 7** Not so good...grazing to the edge of the river exacerbates the rate of bank erosion leading to an over-wide, shallow channel.

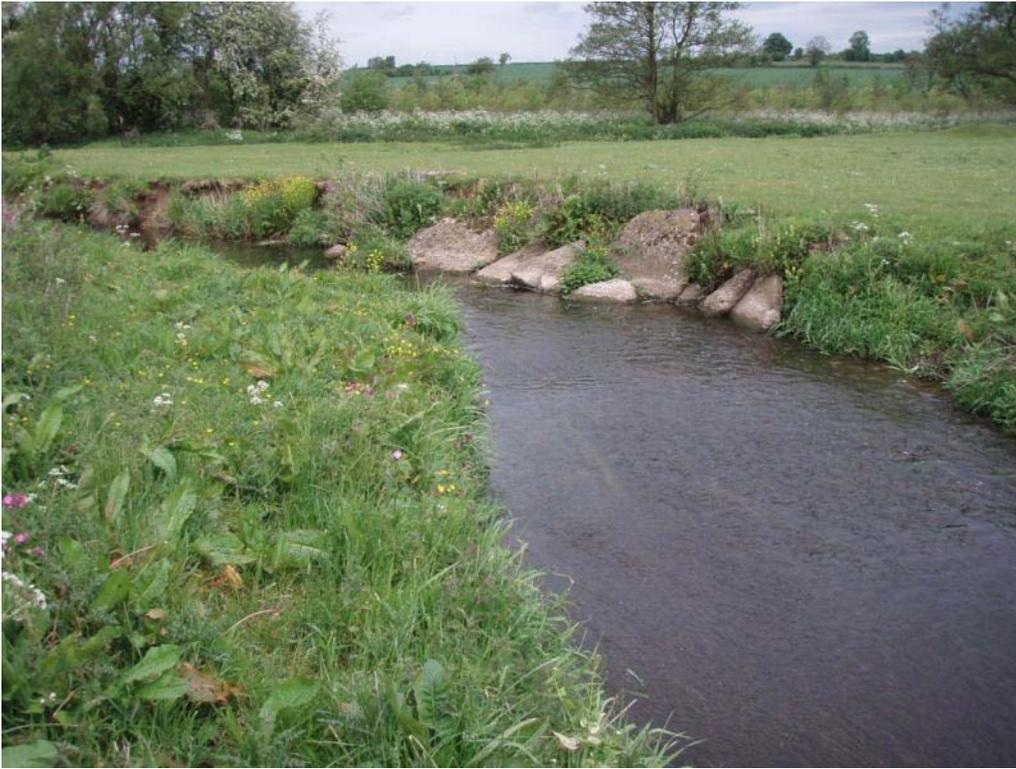
**Photo 8** Some areas of eroding bank have been reinforced with concrete rip-rap. A more lasting and river-friendly solution would be to use soft revetments and protect the bank from grazing (see recommendations).

- Soft revetment using brushwood bundles should be used to protect banks which are eroding at an accelerated rate (Photo 8). This technique requires banks to be fenced off from grazing to be successful but has numerous advantages over hard revetment like concrete blocks. The bundles cause water velocities to slow and deposit sediment amongst the brushwood; this then vegetates and consolidates the bank (Photos 10, 11). In contrast, hard surfaces like concrete do not slow the water but tend to pass the problem

downstream, causing erosion at the boundaries between the hard surface and the bank.

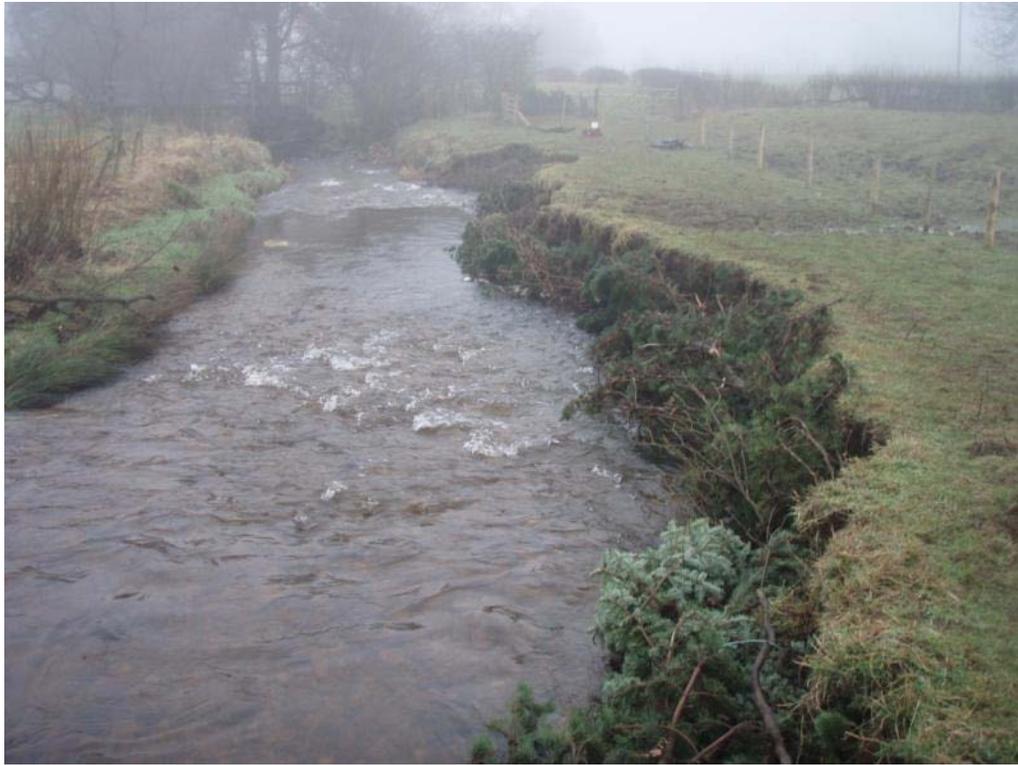
**Photo 10** Newly installed brushwood bank revetments and stock fencing (River Manifold, Staffordshire)

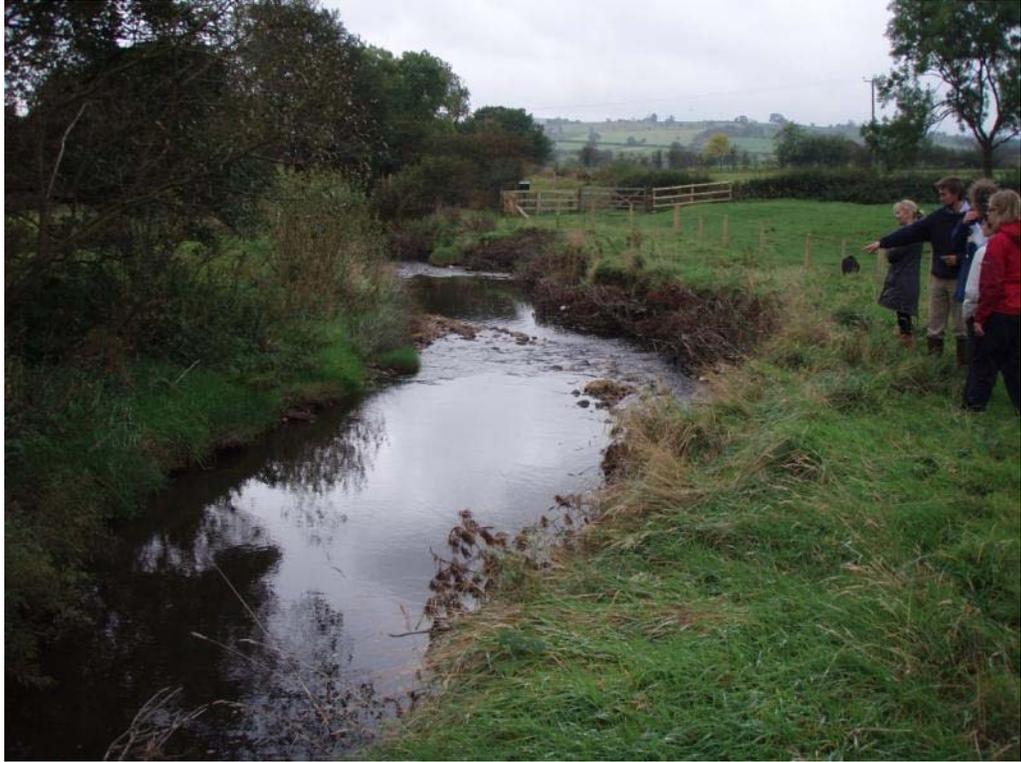
Photo 11 The same area as Photo 10 a year later.
