Advisory Visit
Bodorgan Estate, Anglesey
April 2012

1.0 Introduction

This report is the output of a site visit undertaken by Tim Jacklin of the Wild Trout Trust to the Bodorgan Estate, Anglesey on, 12th April, 2012.

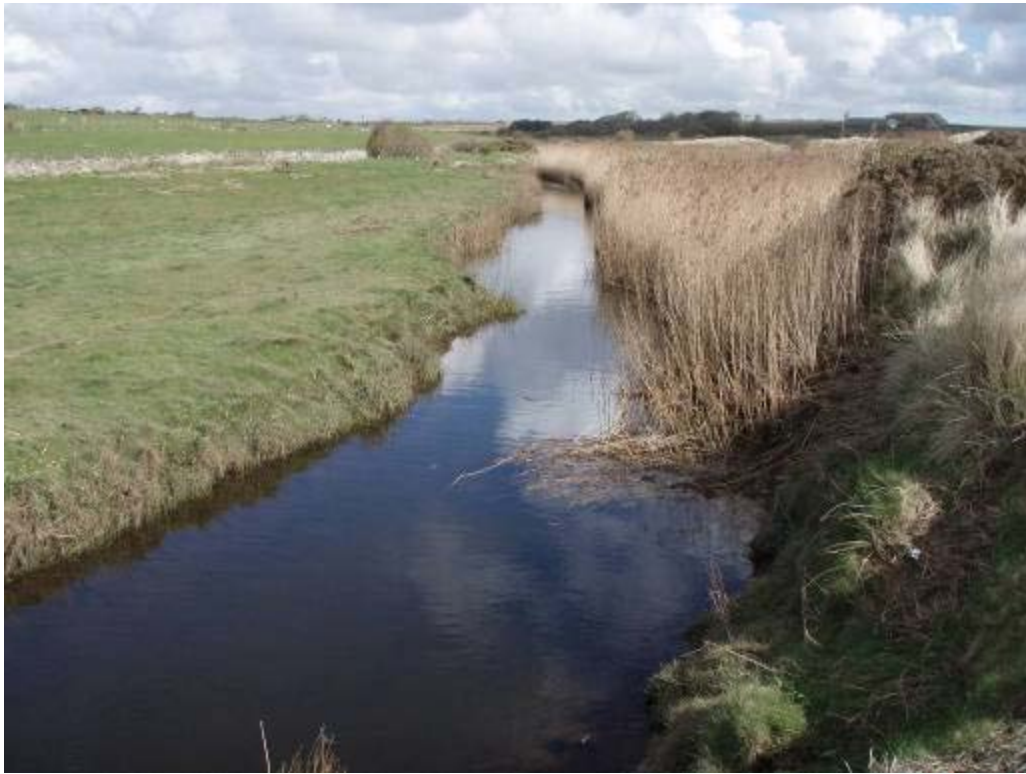
Photo 1 Lower Afon Ffraw a short distance above the estuary at Aberffraw

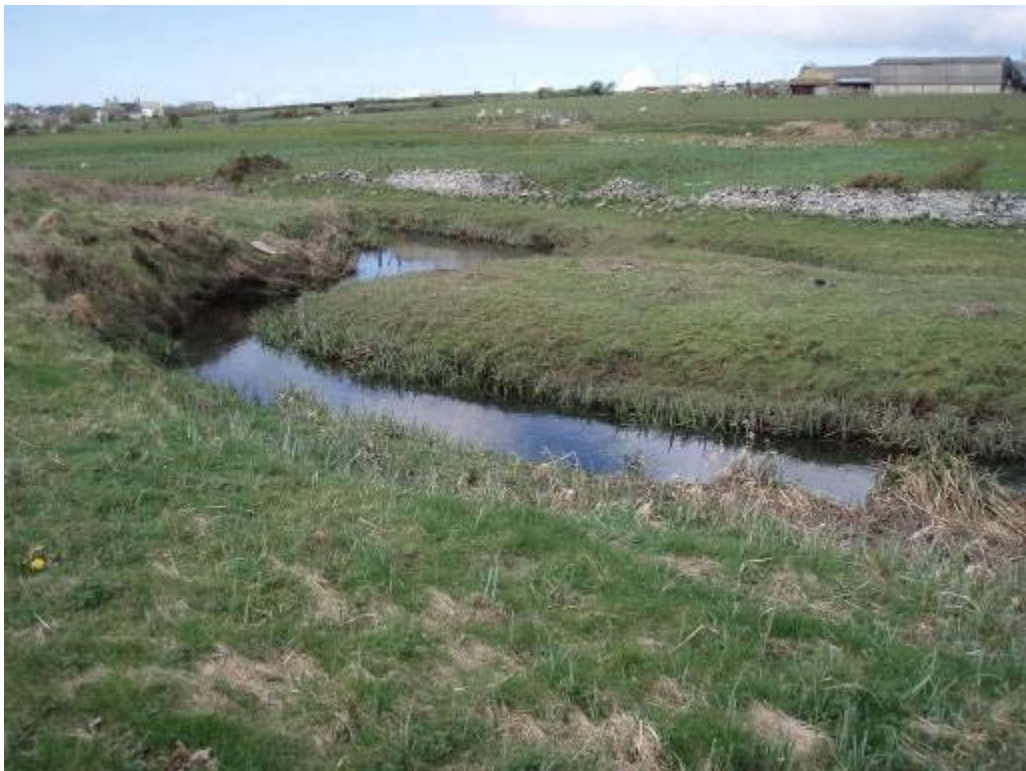
Downstream of Pont Ganel and the confluence of a tributary, the Ffraw has some deep pools that have historically produced large sea trout (Photo 2). When in rivers, adult sea trout seek out deep pool habitat and overhead cover to lie up during daylight hours. Such habitat is generally lacking on the lower Ffraw. Planting low-growing, spreading tree species (e.g. willow species) immediately adjacent to the channel (particularly on the outside of bends) would create more overhead cover and shade and increase the habitat value for sea trout.

Photo 2 Afon Ffraw downstream of Pont Ganol. Deep holding pools that have historically produced sea trout over 15lbs.

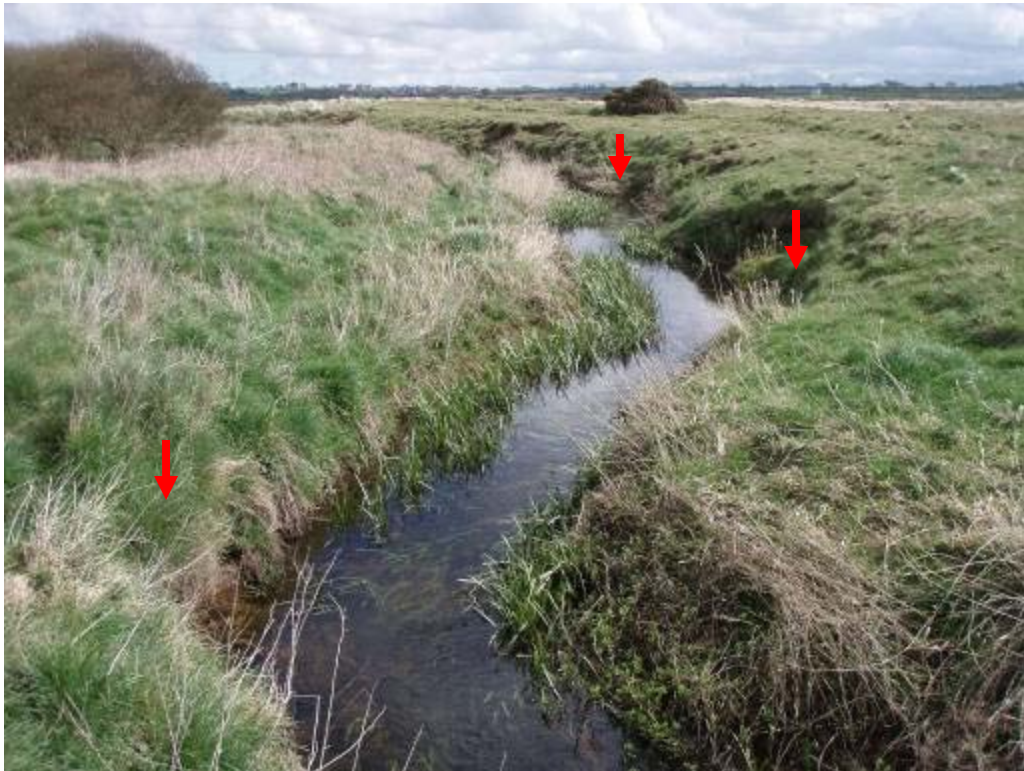
Flowing through an area of dunes, the river here has a low gradient and sandy bed which is naturally suited to the growth of emergent plants (Photo 3). This section of river was reportedly dredged using a hydraulic excavator about 15+ years ago by the then National Rivers Authority; this may have made the river more prone to excessive growth of emergent vegetation by widening the channel and promoting the deposition of fine material on the river bed. A more sustainable way of managing the channel would be to remove a narrow strip of emergent vegetation from the centre of the channel, promoting the development of consolidated berms of fine sediment and vegetation in the margins and creating a narrower, deeper channel.

Photo 3 Afon Ffraw downstream of Llyn Coron showing the dune landscape. The presence of low-growing, bushy willow species in areas like those arrowed would improve the holding capacity for fish and reduce emergent plant growth by shading.

CCW and EAW should be consulted on any activities here to ensure they do not affect the features of interest of the SSSI and SAC. Ideally the willows planted should be of local origin. The best way to get them established would be to make bundles of willow cuttings from native trees elsewhere along the river; these could then be staked in the margins of the river where they can strike root (Photo 3). This is more likely to succeed than using individual whips which would be vulnerable to grazing.

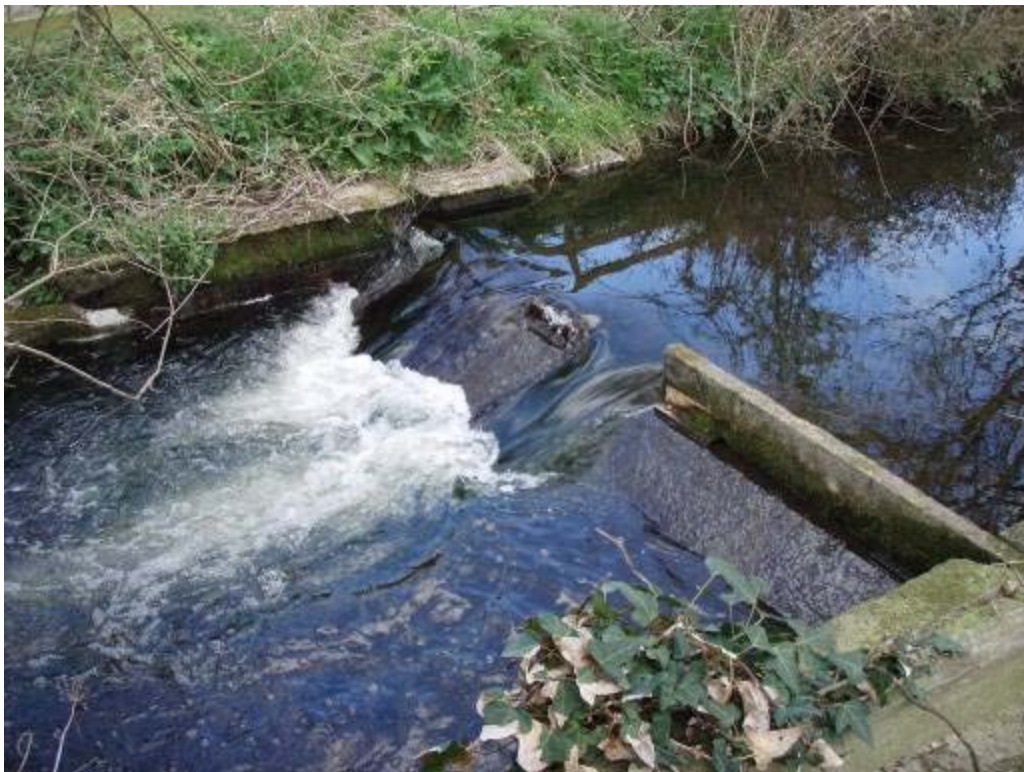
Photo 4 Outflow from Llyn Coron into the Afon Ffraw. The weir and boards were intended to raise lake water levels in an attempt to combat algae blooms.

At the outflow of Llyn Coron there is a concrete crump weir with slots for boards to increase the crest height (Photo 4); this was installed in an attempt to reduce the problem of blue-green algae on the lake by varying water levels. Whilst the structure is not an absolute barrier to fish migration it may influence fish behaviour and delay movements. At present there is one board in place concentrating flows to the right of the channel; this is better than having a shallow flow across the whole crest. It may be worth fitting another board partially across the right side of the crest to concentrate flows through a central notch. A smooth, deep flow of water over a smooth nappe in such a notch would be easier for fish to ascend. One board could be removed in high flows if necessary.

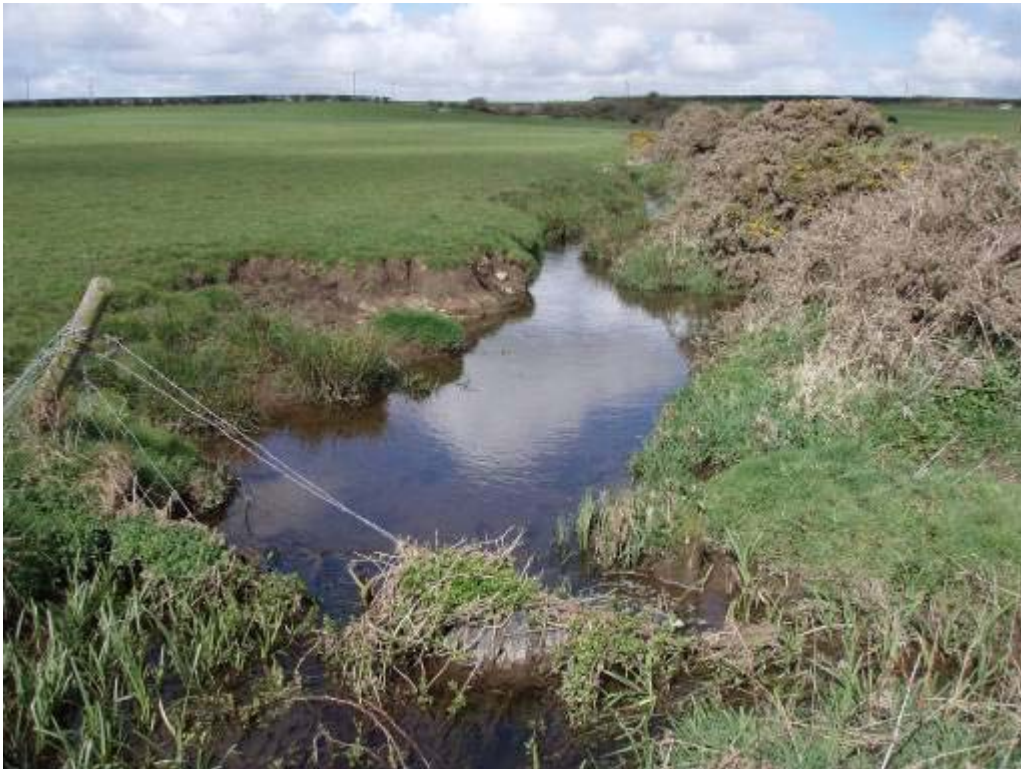
Immediately above the confluence of the two arms the watercourse runs through improved pasture (Photo 5) and is accessible to livestock, especially on the true right bank. In contrast upstream of Pont Glan-felin the river is fenced on the right bank and has an un-cultivated buffer strip on the left bank (Photo 6) greatly improving the in-stream habitat for juvenile trout.

Photo 5 Henllys-fawr arm at confluence with Cae-mawr arm

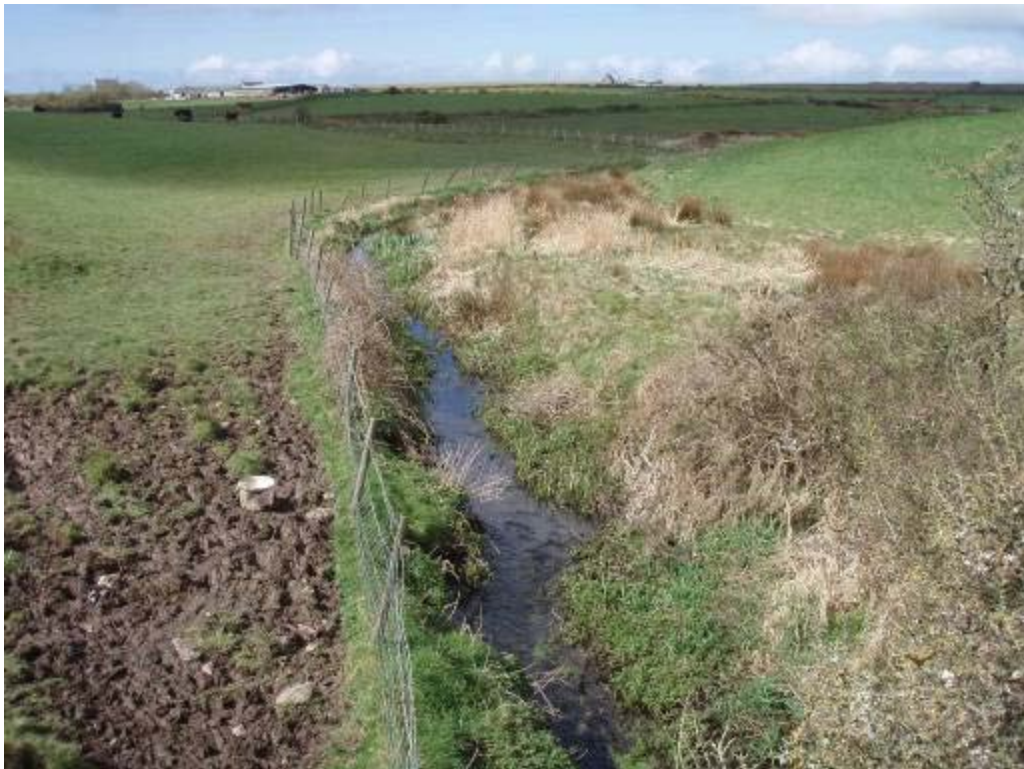
Photo 6 Henllys-fawr arm at Pont Glan-felin. Fencing and an uncultivated buffer strip represent good practice here, but a pathway for fine sediment remains via the stock watering point (Photo 7)

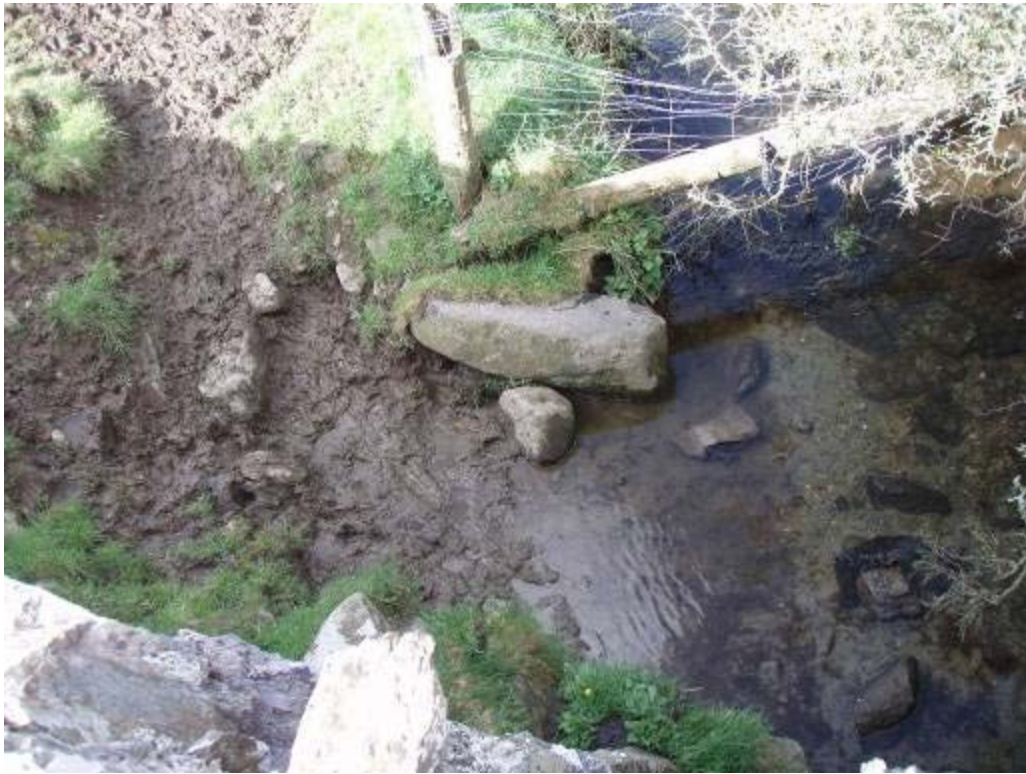
Photo 7 View immediately downstream of Photo 6 – stock watering point and pathway for ingress of fine sediment

However, there is still a pathway for fine sediment ingress at a stock watering point (Photo 7); alternative drinking facilities (mains supplied trough) or a hard standing area alongside the watercourse would improve this situation.

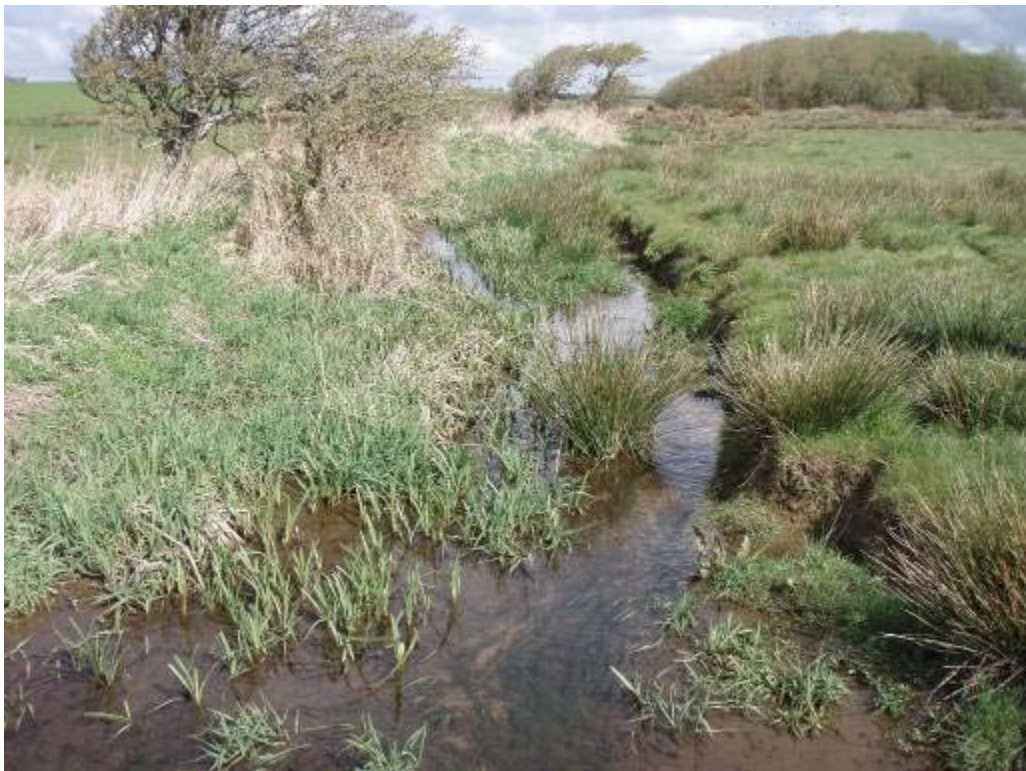
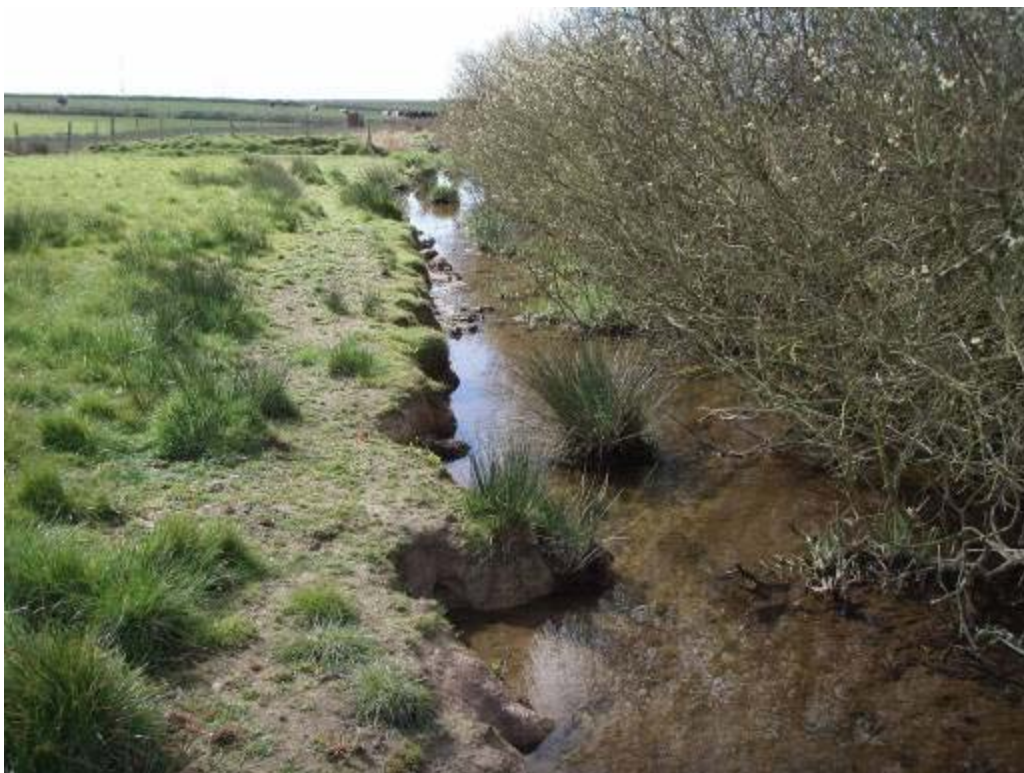
Further upstream at Henllys-fawr (Photos 8 and 9), the watercourse flows through a low-lying, boggy area which is prone to flooding and often under water in winter. The natural situation here limits the value of the watercourse as trout habitat (there are no suitable spawning gravels), but this has been greatly exacerbated by previous dredging of the channel. The channel is straight and wide and parallel ditches take some of the stream flow; this has created a shallow, silty stream, in parts encroached by vegetation, in parts kept over-wide by bank poaching by stock. There is no value here as a trout nursery area and even the successful passage of adult fish through to better habitat upstream is doubtful.

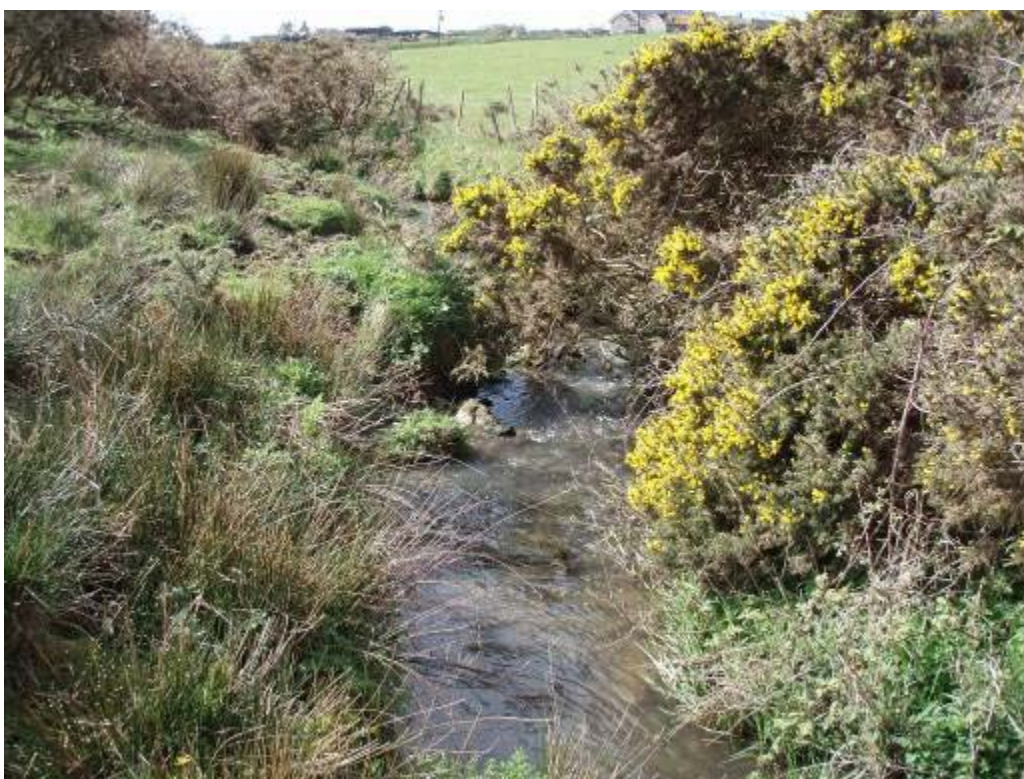
Photo 10 Henllys-fawr arm (SH358712)

Further upstream, the in-stream habitat is a complete contrast (Photo 10), with the stream in a narrow channel with a gravel bed and good marginal habitat provided by overhanging bushes, long grass and reeds. There was some evidence here of recent bank poaching by cattle which could change this situation if left unchecked.

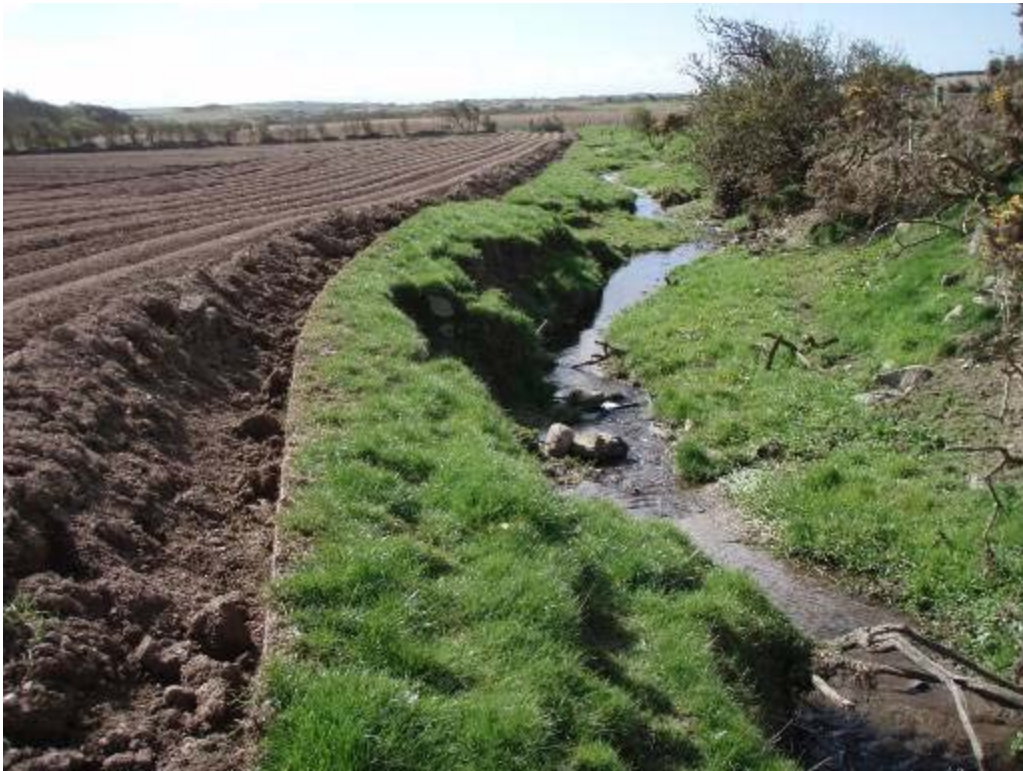
The area where Ian Ferrier has previously seen spawning sea trout was inspected (SH359701). The fields on the left bank here have recently been turned over to potato cultivation, following many years of use for grazing, stockholding for a nearby abattoir and silage growing. One field has been cultivated very close to the watercourse (Photo 11) and is an example of very poor practice; there is no doubt that this will be a major source of fine sediment and nutrient input, reducing the quality of river-bed gravels (Photo 12) for fish spawning and invertebrates and promoting growth of algae.

Photo 11 Cultivation too close to the watercourse, with no buffer strip

In contrast, the next field upstream has a wide margin of uncultivated land between the potato field and the watercourse, providing a buffer for field run-off. Ideally potatoes should not be grown in fields adjacent to watercourses, or at the very least adequate buffer strips (10 metres plus) provided, with no alternative pathways for run-off (tracks, mole drains, etc.).

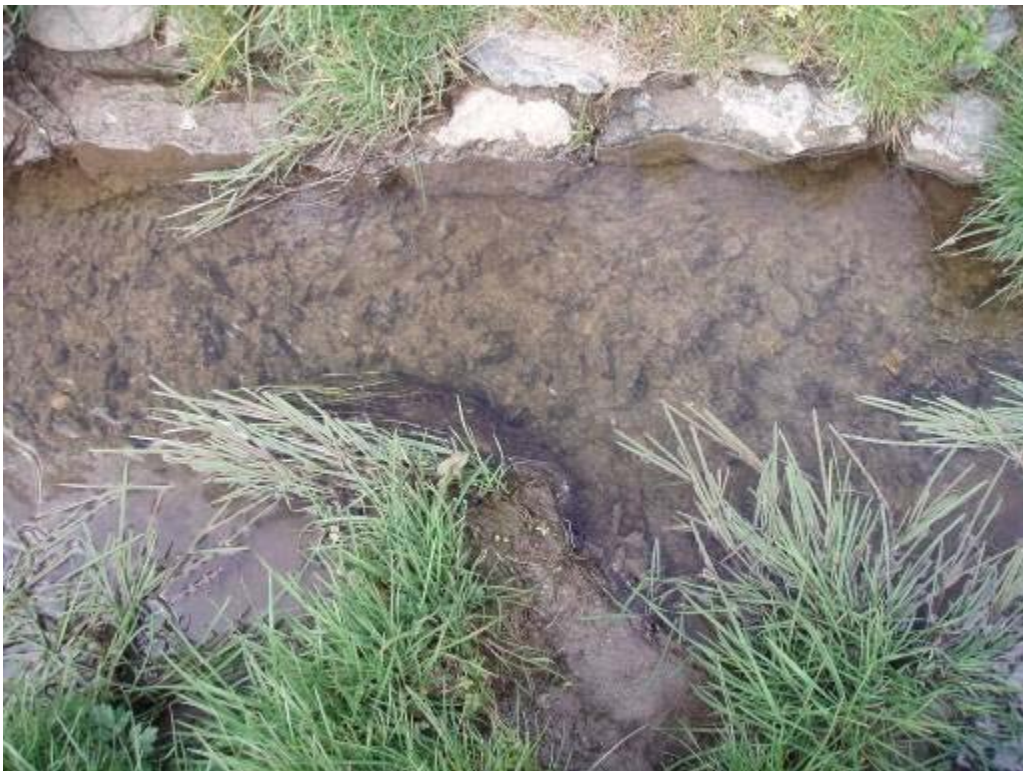
Photo 12 Gravel is present, but with a high loading of fine sediment

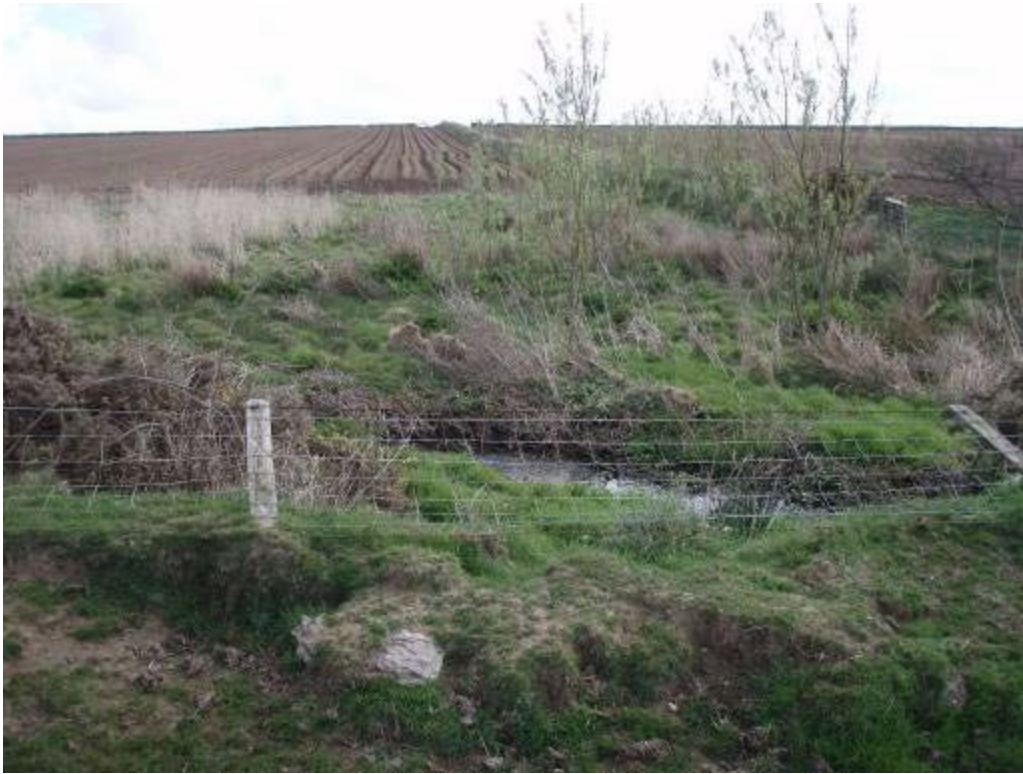
Photo 13 A wide buffer zone between cultivated fields and the stream provides much better protection for the watercourse

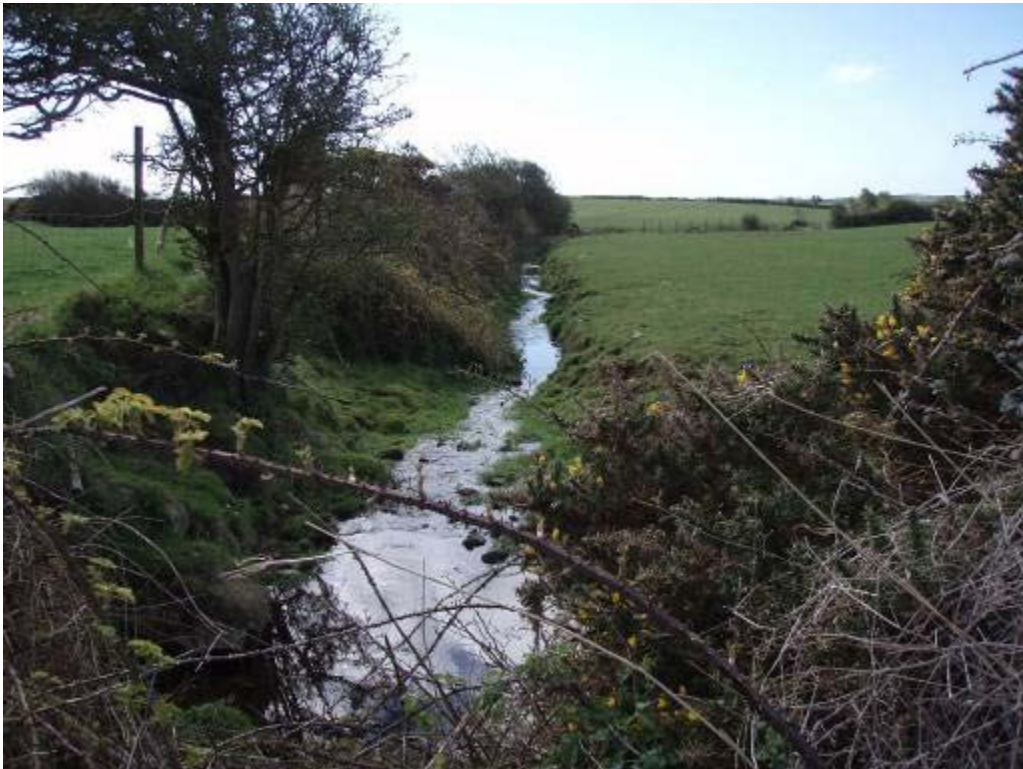
Photo 14 The straightened, ditched nature of the stream makes very poor habitat for juvenile trout

Adjacent land use returns to grazing further upstream (Photo 14) but the channel remains artificially straight and generally very poor habitat for trout. There is scope to improve in-stream habitat (see Recommendations), but this stream is probably not the highest priority given its small size and location.

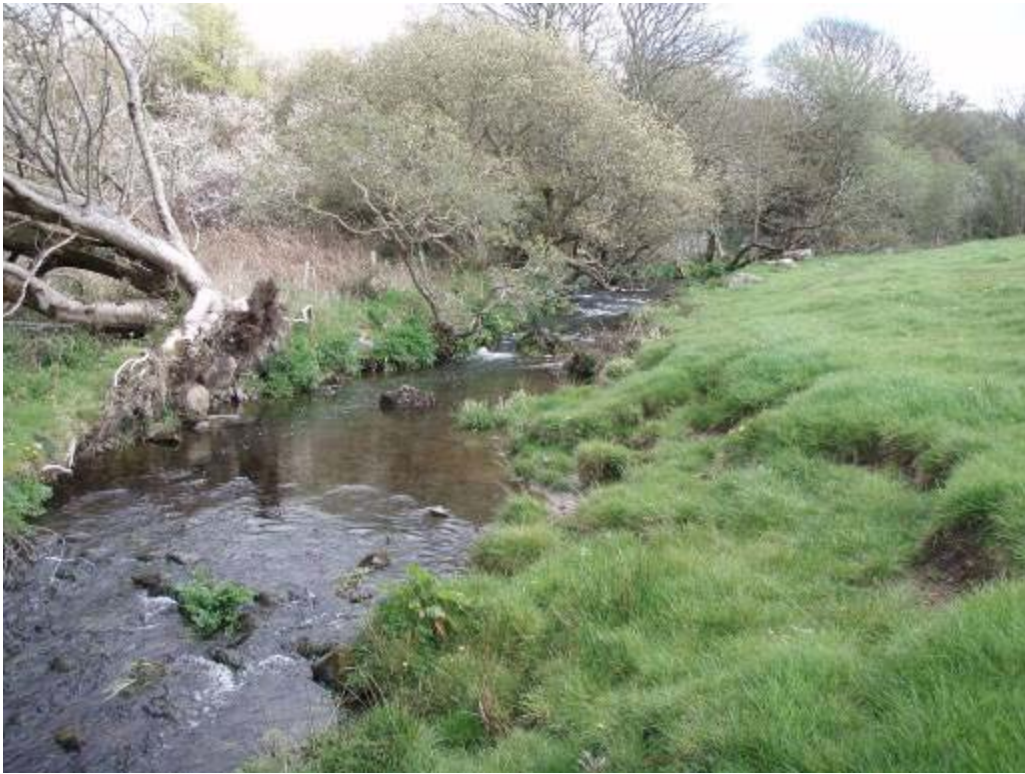
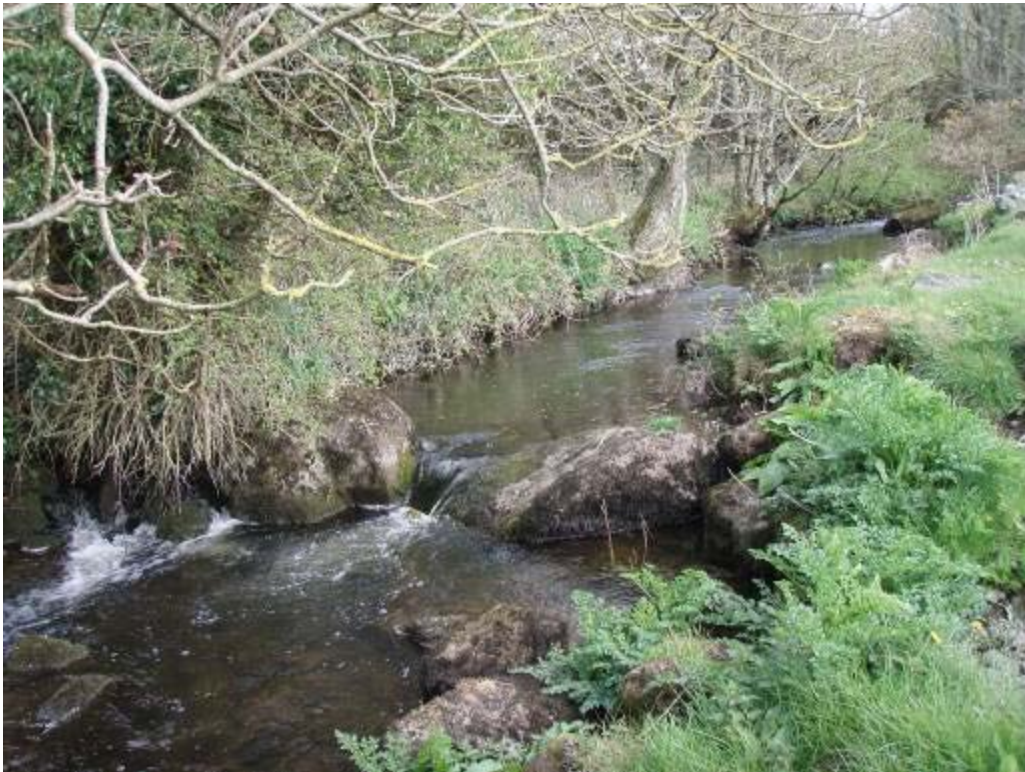
The Afon Gwna is the main tributary of Llyn Coron and is therefore important in providing a spawning and nursery area for brown trout from the lake and for sea trout. The section of river between the lake and the railway bridge was inspected. Ian Ferrier reported catching 21 trout from a single pool as a boy, 40 years ago. The in-stream habitat here is very good (Photos 15 and 16), with features including:

Photo 15 Good habitat on the Gwna: a variety of depth; cover and bank stability provided by trees, bushes and scrubby vegetation; well-sorted river bed substrate and an unaltered channel form.

Photo 16 As per Photo 15 – a template for good habitat

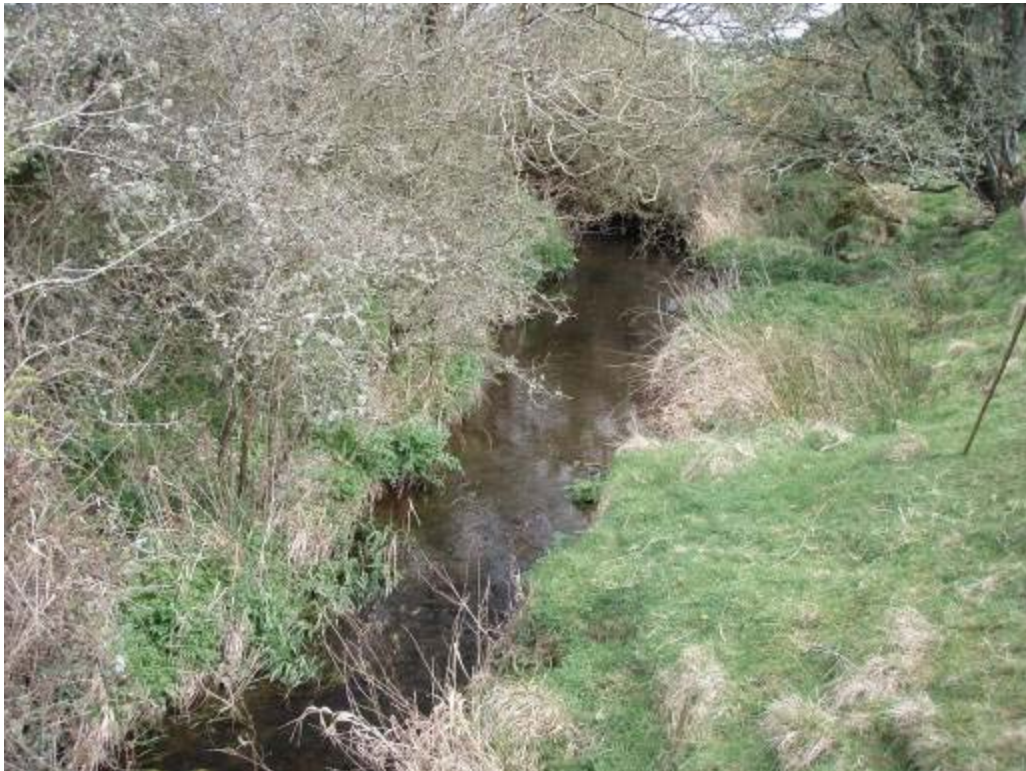
Photo 17 Din Dryfol SH399725

Above the railway bridge the river is not part of the Bodorgan Estate until Din Dryfol (Photo 17). The watercourse is much smaller here, but habitat remains generally good with a gravel bed, good cover from bankside vegetation and low intensity land use. It was not possible to inspect downstream of this point, but it is recommended that the section between Din Dryfol and SH395715 is checked; this appears on the map to be straightened compared with the sinuous section further downstream and could be a good area for habitat improvement works (particularly given its proximity to the lake).

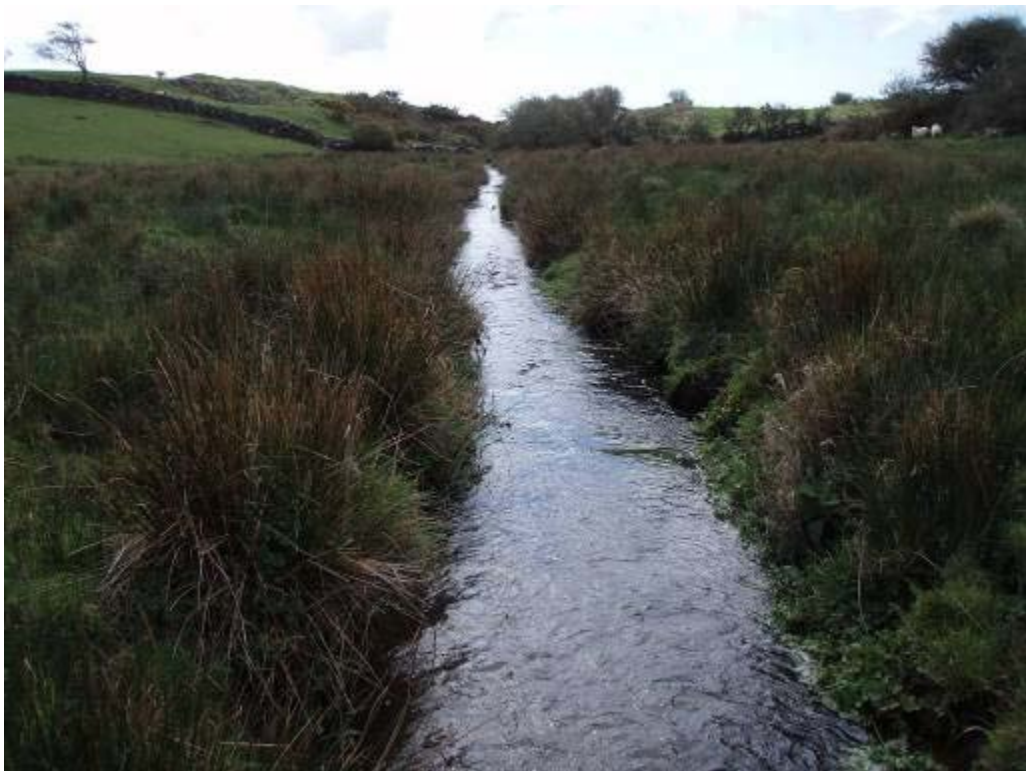
Photo 18 Cerrig Engan SH407733 – a straightened channel

At Cerrig Engan the in-stream habitat quality was poorer. The watercourse was more open and artificially straight, with little variation in depth (shallow) or flow pattern (Photo 18). This would be a good site for enhancement, using the techniques described in the Recommendations section.

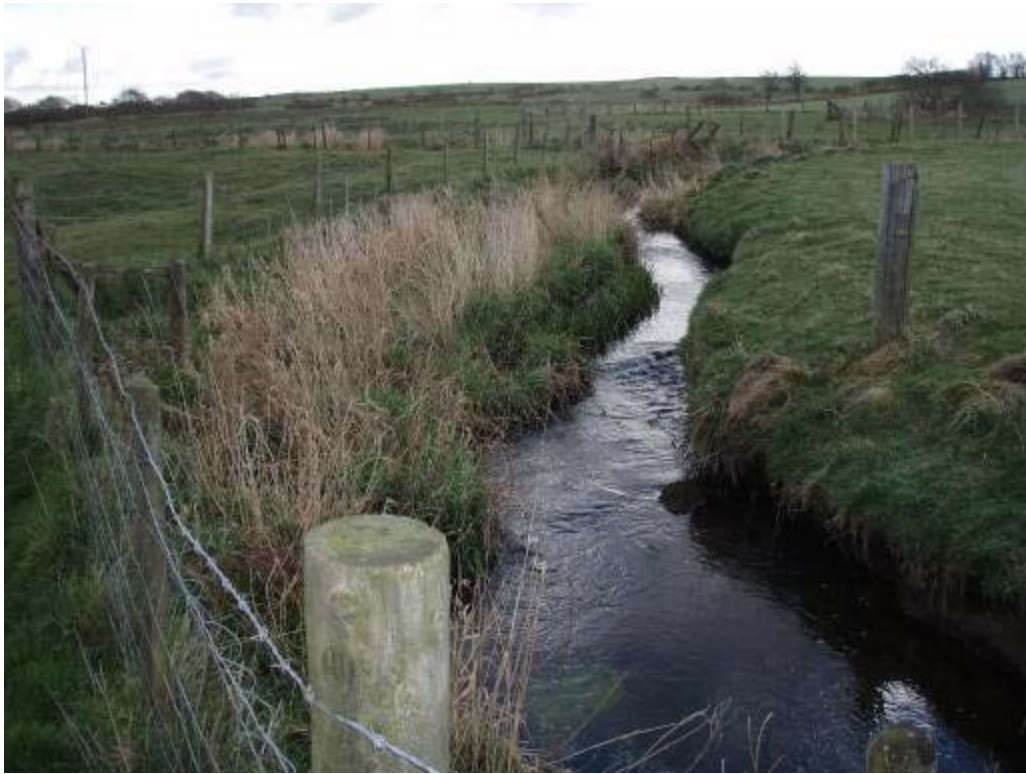
Photo 19 Fencing out livestock has improved in-stream habitat on one bank here.

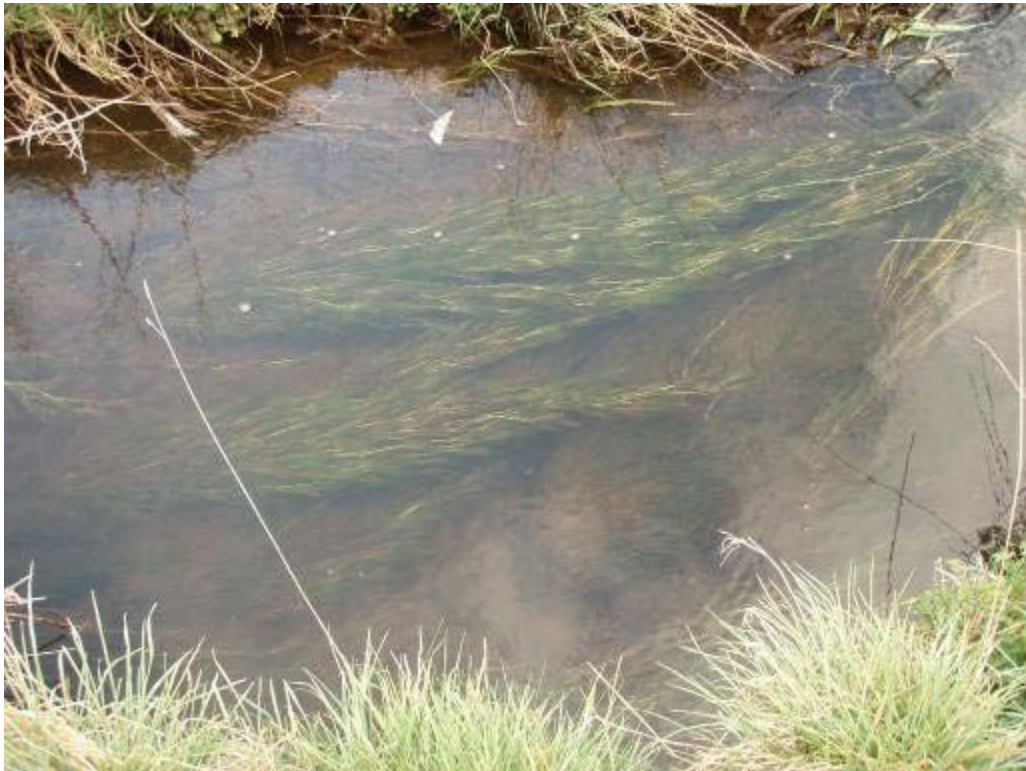
At Y Werthyr the river is located in fields of improved pasture grazed by cattle and sheep. The channel has been modified for land drainage in the past, having a generally trapezoidal cross-sectional profile, steep banks and a general lack of variation in flow pattern and depth. Despite this, in-stream habitat is reasonably good in some sections; where the banks are fenced the river has narrowed off and there is good marginal cover provided by the vegetation (Photo 19). In these narrower areas, the bed comprises large gravel and cobbles and beds of water crowfoot (*Ranunculus* sp.) and starwort (*Callitriche* sp.) are present (Photo 20).

Photo 20 Water crowfoot *Ranunculus* sp.

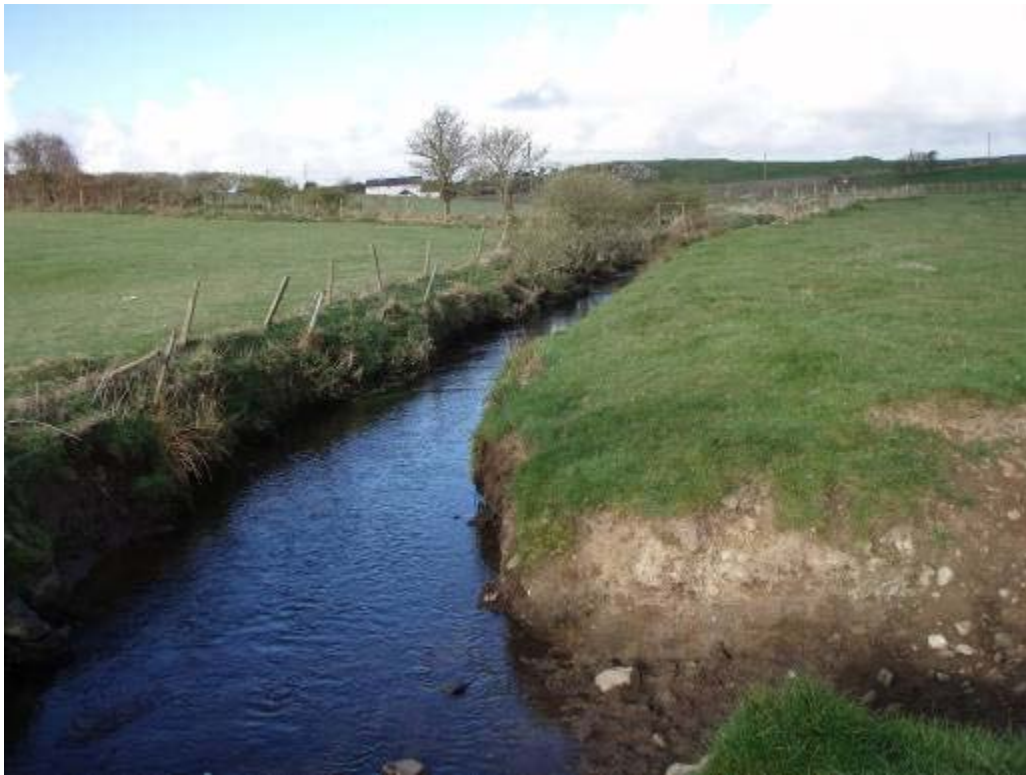
In other sections, the stream was over-wide and shallow with a bed comprised of fine sediment (Photo 21) – poor habitat for trout. This contrasted with a section immediately upstream (Photo 22) which was less agriculturally improved and more lightly grazed; this has resulted in marginal habitat of shaggy grasses and bushes and a narrower, deeper channel – much better trout habitat.

Photo 21 A section of over-wide, shallow, poor quality stream habitat

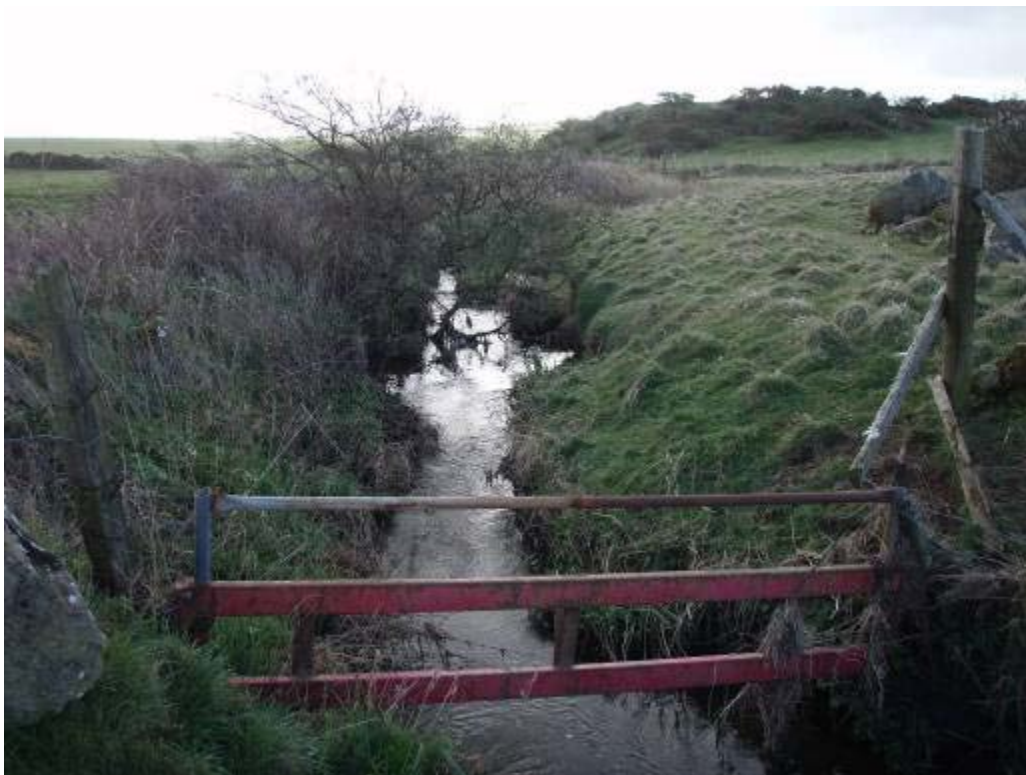
Photo 22 Much better habitat resulting from less intensive land use alongside the watercourse

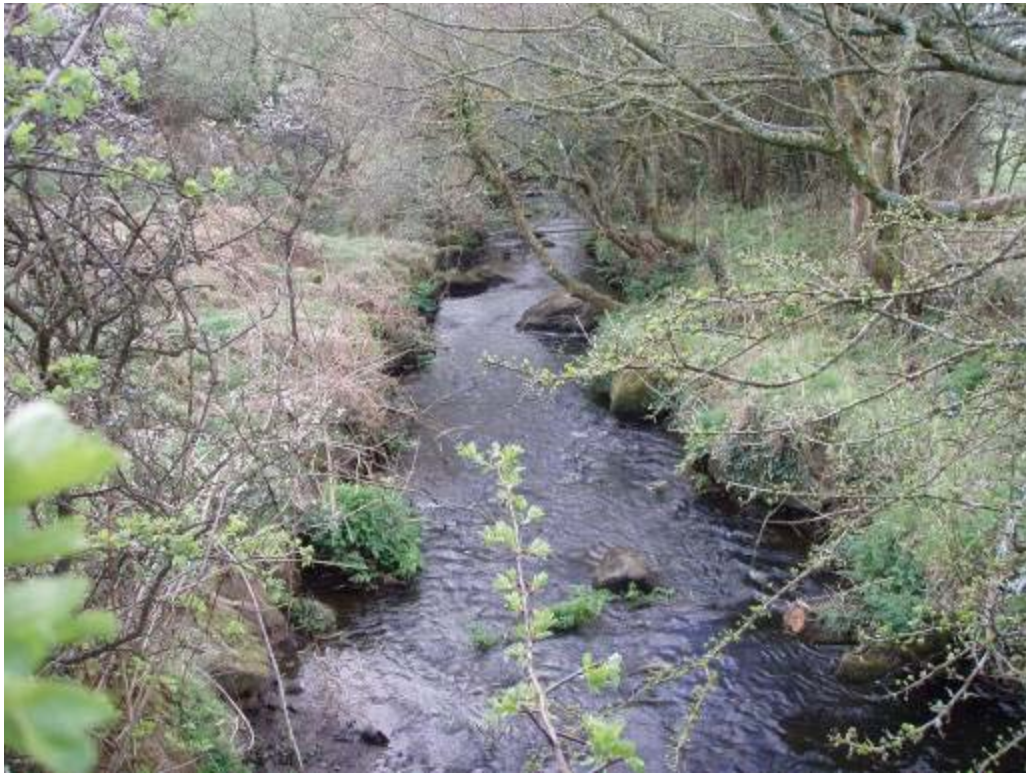
Photo 23 Good in-stream habitat at Bryn Glas, although the channel may have been straightened many years ago, resulting in a lack of pool habitat.

At Bryn Glas (Photos 23-24) the in-stream habitat was reasonably good. There was some evidence of past channel modification in the form of old spoil heaps on the banks, but these may only be associated with a short section where a bridge has been constructed. Also the channel was straight in places and lacking pool habitat, suggesting modification at some point in the past. There is more tree cover in this section providing shade and bank stability, and the opportunity to introduce some large woody debris to promote scour and pool formation (Appendix 1).

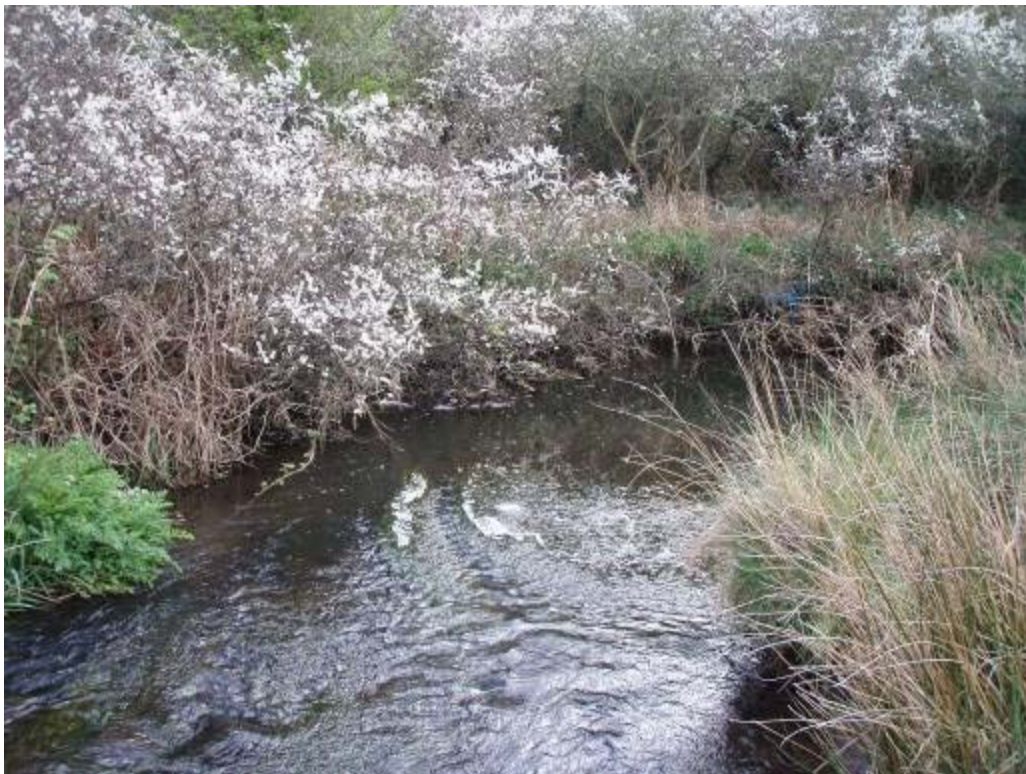
Photo 24 A deep lateral scour pool with abundant cover low over the water – superb adult fish habitat.

There are some deep pools located on the outside of bends (lateral scour pools) with excellent overhead cover provided by overhanging bushes (Photo 24). The combination of a sinuous channel (creating scour on the outside of bends) and good bank stability provided by tree roots is unbeatable in creating deep holding pools which persist for many years; this kind of habitat greatly increases the carrying capacity of fish in a stream.
