Advisory Visit
Bog Burn (Bathgate Water)
River Forth Catchment
Stirlingshire

Undertaken by Gareth Pedley

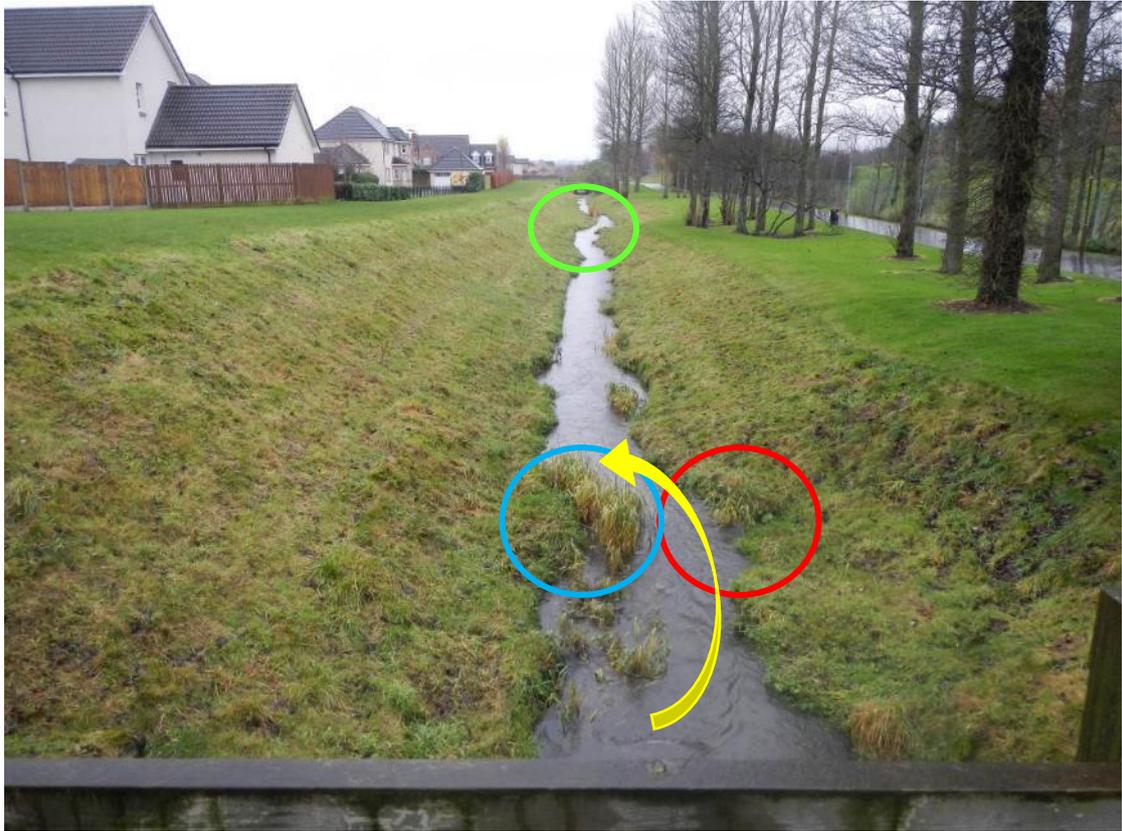
Two years on from a previous WTT visit and report (www.wildtrout.org/sites/default/files/private/Forth%20Fisheries%20Trust%20report_0.pdf), it can be seen that the channel alongside the golf course has changed little (Figs 1a and 1b). Emergent vegetation provides some in-channel diversity but the overall change and improvement in habitat quality is negligible. Unsympathetic cutting and maintenance of vegetation is likely to be inhibiting natural improvements but more active intervention is required to significantly improve the habitat. Confirming whether invertebrate and fish populations are present within the reach could add further weight to the value of any proposed scheme. The availability of a natural sediment supply to the reach is likely to influence the habitat quality of any restored channel sections but improvements could be made through gravel introduction, providing that installed structure or channel diversity and the flow diversity that is created is sufficient to retain it.

Figure 1a. Looking d/s at Bog Burn in 2017 - Little change when compared to the state observed in 2015 (below – Fig. 1b). There is possibly some slight scour/erosion in areas (red circle), driven by the emergent vegetation constricting the channel (blue circle) and diverting flow into the RB (yellow arrow indicating flow path and direction). However, the channel remains straight and lacking variation.

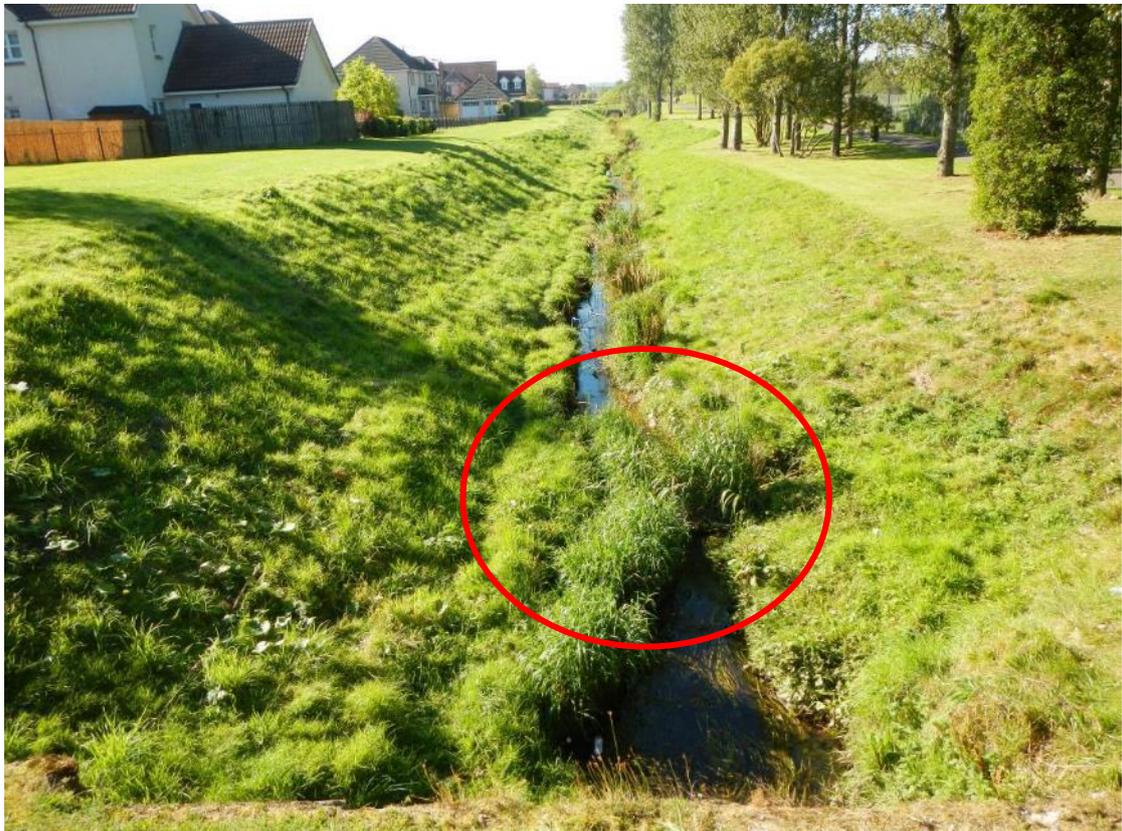
Figure 1b. Bog Burn alongside the golf course during the previous, 2015 WTT visit. The red circle indicates the area highlighted in Fig. 1b.

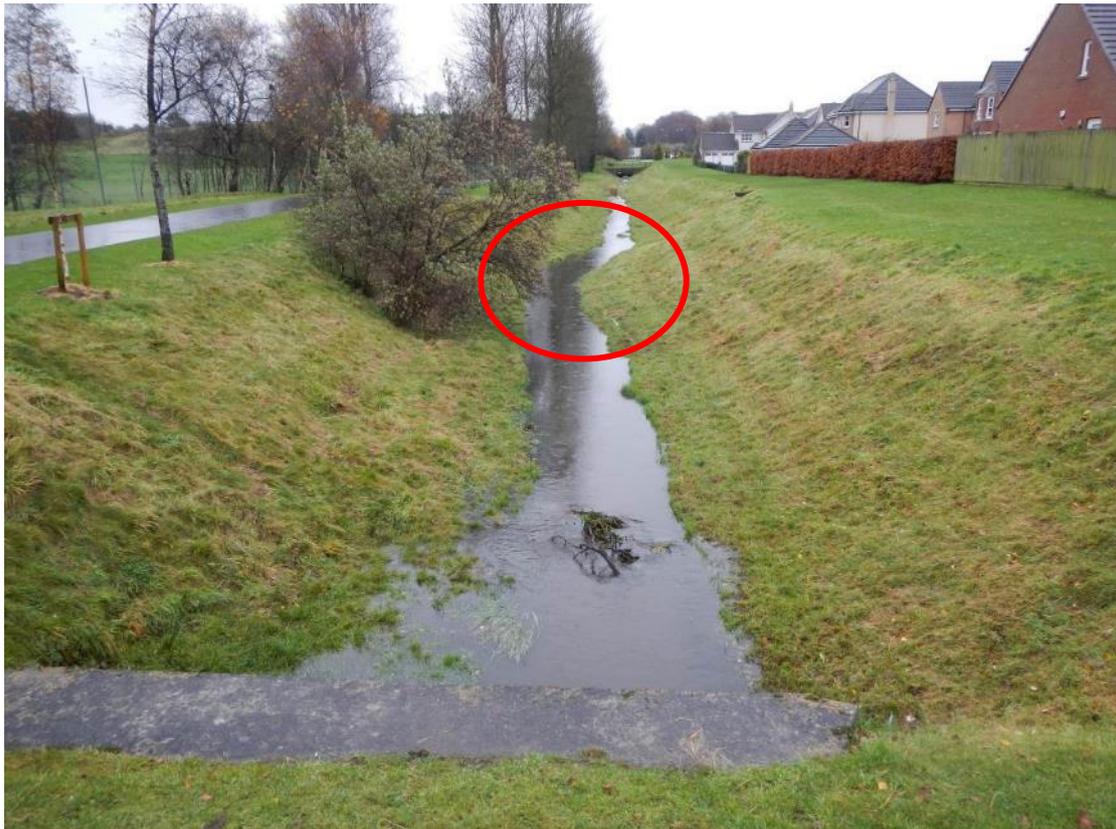
Towards the d/s end of the section depicted in Figure 1, a subtle right and left hand bend in the channel (Fig. 1a – green circle) provides improved habitat, a feature that could be replicated throughout the reach (see section **4.0 Recommendations**). The ultimate quality of the habitat provided here will always remain limited if the vegetation mowing continues. A 1-2m buffer of unmanaged land should be provided adjacent to the watercourse. Doing so would allow habitat improvement even if no further work is undertaken and could create ideal habitat for water voles (known to be present) which is currently scarce.

Figure 3. Photo taken looking back u/s, standing on top of the culvert. A subtle right and left bend (red circle) already present within the channel that could be replicated in other areas too improve the form and function of the channel.

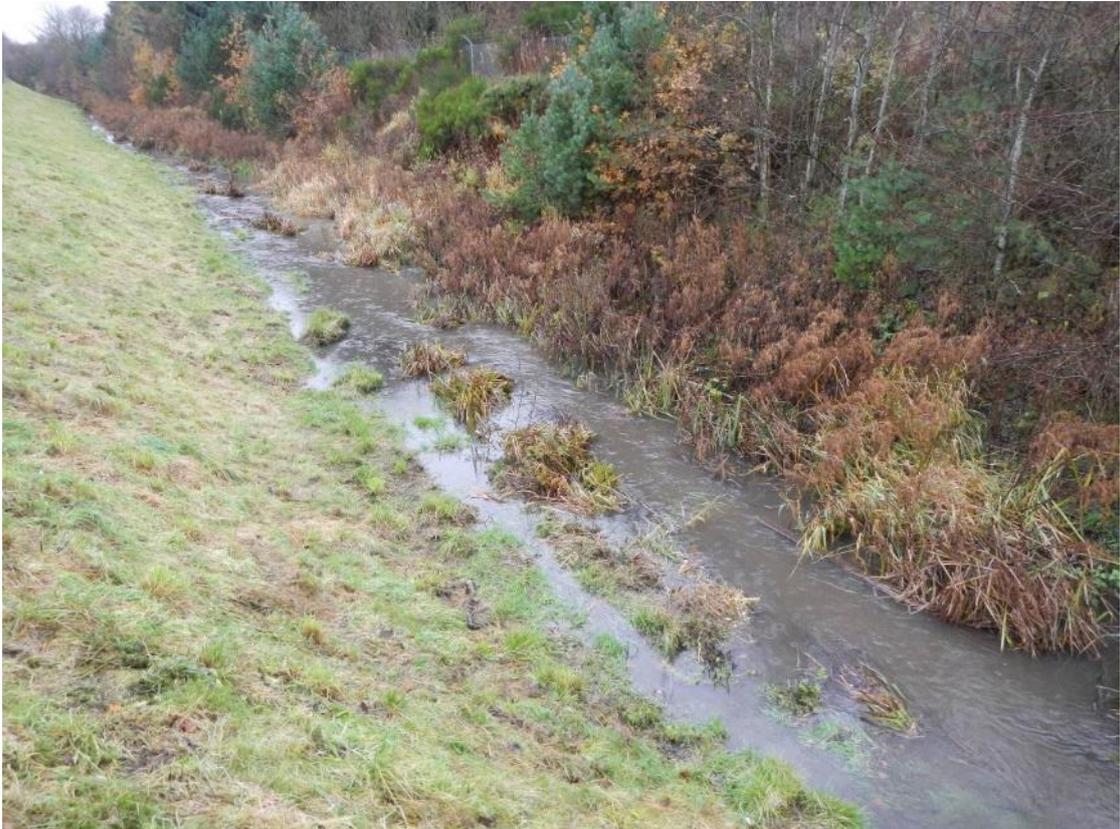
Downstream of the culvert, emergent vegetation has been allowed to develop from the RB side. On over-capacity/dredged channels, emergent vegetation can encroach across the entire width if low flows are insufficient to prevent their growth. It is therefore beneficial to create or encourage a sinuous channel with a more natural capacity which will be 'self-cleansing'. As with u/s, an unmanaged buffer should be left along both banks. Diverse vegetation provided along unmaintained banks (as depicted in Fig. 4, on the RB) is prime water vole habitat but could be improved further for all wildlife with a habitat restoration project.

Figure 4. Encroachment of emergent vegetation, primarily from the unmanaged RB side. Allowing vegetation growth on and from both banks would be beneficial. Alternatively, or in addition, in channel structure could be installed to help divert the flow from one bank to the other. Note the much higher quality water vole habitat provided by the unmanaged RB.

In-channel structures/flow deflectors could be installed to move the dominant flow pathway from one bank side to the other, to scour and maintain a sinuous channel. Deflecting the flow more acutely into the

emergent vegetation on the RB, possibly in conjunction with some light cutting, could help to develop bends towards the RB. If funding were available, the more aspirational dig and dump channel restoration would be ideal, coupled with the input of gravel to reinstate a more varied bed.

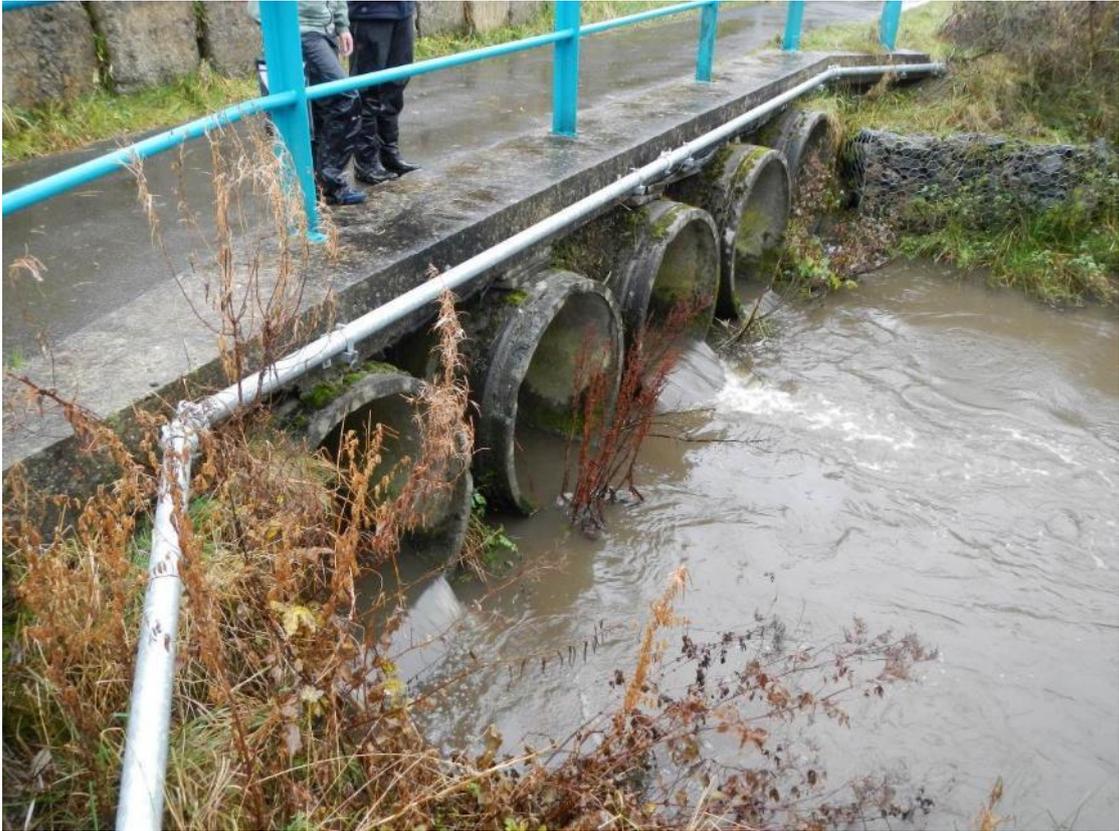
A pipe bridge at NS 97458 67691 appears to pose a small obstacle to fish passage but is not suspected to prevent fish access from d/s. The u/s end was not inspected, which should also be undertaken, ideally looking through the entire culvert to check for steps and ascertain its full passability. Its installation is far from best practice, which would be clear-span (ideally) or a single, 1/3-sunken structure.

Figure 5. An inappropriately installed pipe crossing. Any watercourse crossing should be clear-span or a single sunken structure that allows the free passage of bed material and hence development of a natural bed within it.

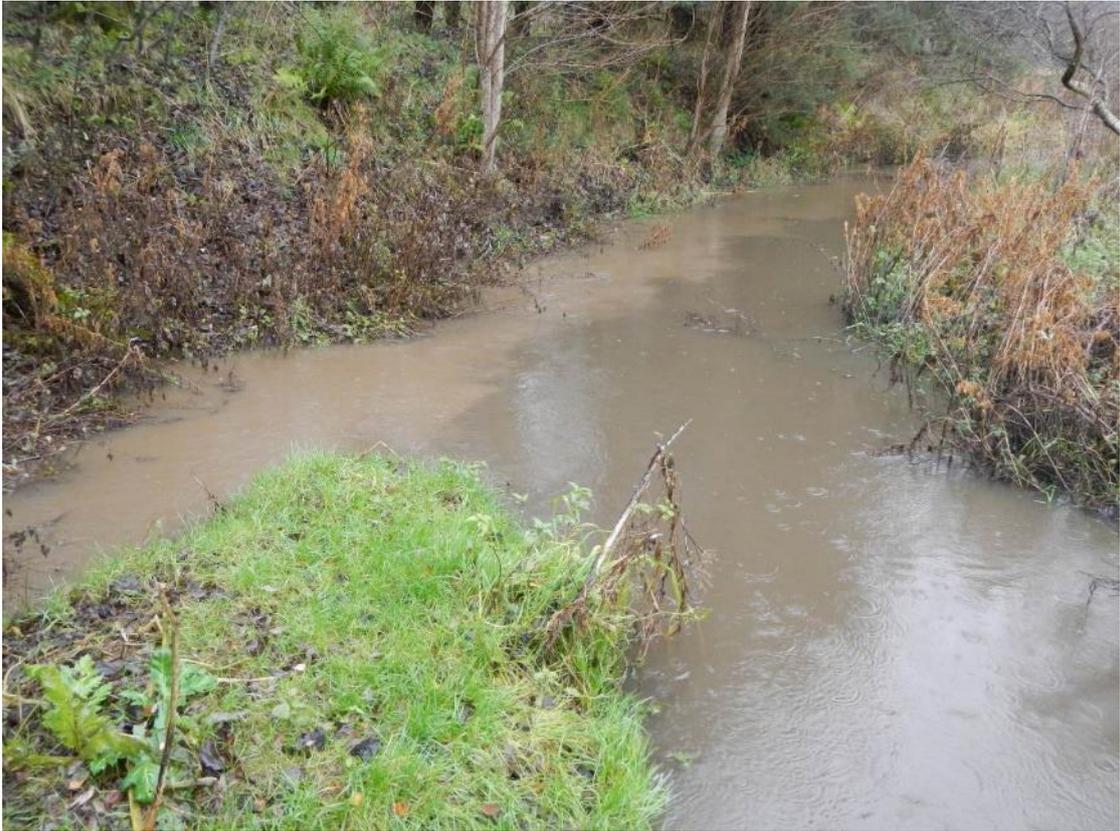
Where the Boghead Burn joins Bog Burn, additional fine sediment input (possibly runoff from construction work visible further u/s) was clearly evident and should be investigated (Fig. 6). In addition to the potential of the broader area, the straightened sections of Boghead Burn and Bog Burn around the confluence provide good potential for a small channel restoration scheme within the areas of rough land adjacent, which may have less potential contamination risk (Fig. 7).

Figure 6. The Boghead Burn (NS 97399 67736) appears to be a source of poor water quality/fine sediment and requires further investigation.

The section d/s of the golf course offers great potential for a full restoration scheme and is definitely worth further investigation. Around the confluence the Bog Burn and Boghead Burn (and u/s and d/s), there is, alternatively, the potential for a smaller restoration and realignment project. The ground in that area is rough/un-managed, so an impact upon the adjacent land use is unlikely. The main pitfall with this course of action is the potential for encountering contaminated land or buried services, but this option should definitely be pursued. The source of the fine sediment input on the Boghead Burn also requires further investigation.

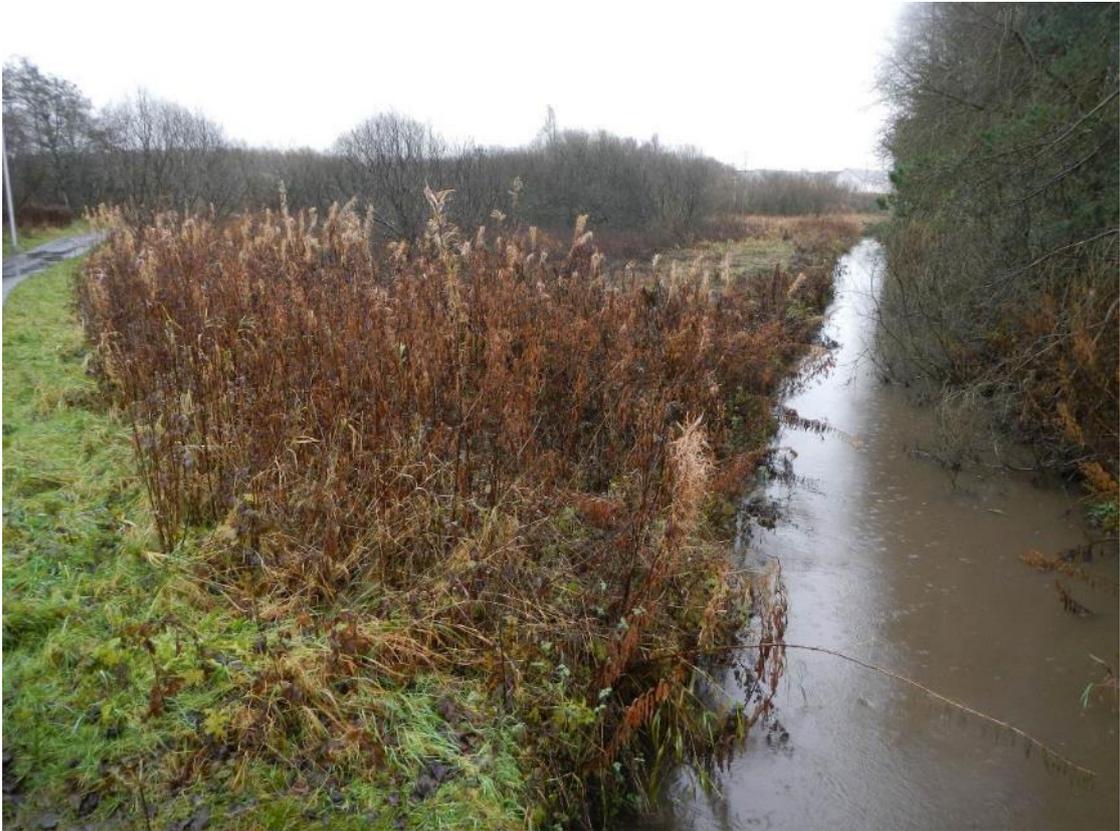
Figure 7. The areas of rough ground around the Boghead Burn and Bog Burn confluence may offer an opportunity for channel restoration.

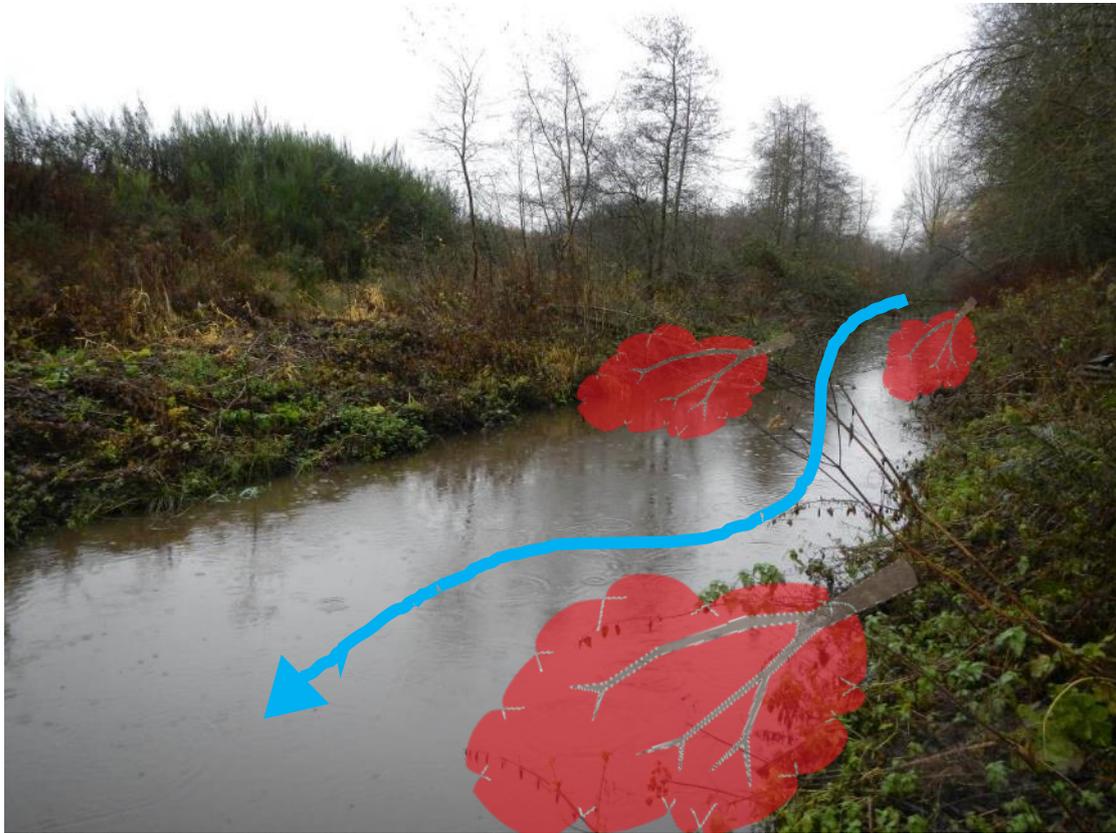
A short distance further d/s, around the footbridge, the channel becomes further over-capacity with a lowered bed level, slow, deep water and silty substrate. The channel proportions and shading from LB trees appear to be limiting the growth of emergent vegetation (Fig. 8), which could potentially be improved by selective tree thinning. However, to achieve a notable improvement, areas of the channel will require a significant reduction in capacity, ideally bed raising/reinstatement. Areas like this are likely to remain overly deep and lacking in coarse substrate for the foreseeable future unless that material is reintroduced to the system, as a supply u/s and/or locally. Channel capacity could be reduced in discrete areas by securing tree tops (canopies), obtained through tree thinning, within alternating margins. These would create areas of narrowing to encourage a more sinuous flow pathway and scour and deposition.

Figure 8. The further over-capacity channel d/s of the Boghead Burn requires narrowing in discrete areas (possibly as depicted with red tree outlines) to diversify the flow (blue arrows) and encourage scour and deposition.

Installing alternating tree deflectors is the quickest, easiest and cheapest way to re-energise and diversify flow within the overcapacity channel (as annotated in Fig. 8). There may even be the possibility of laying occasional suitable (pliable) trees into the channel (Fig. 16), although flood risk could be a concern, so ensuring that the structures are anchored securely would be vital.

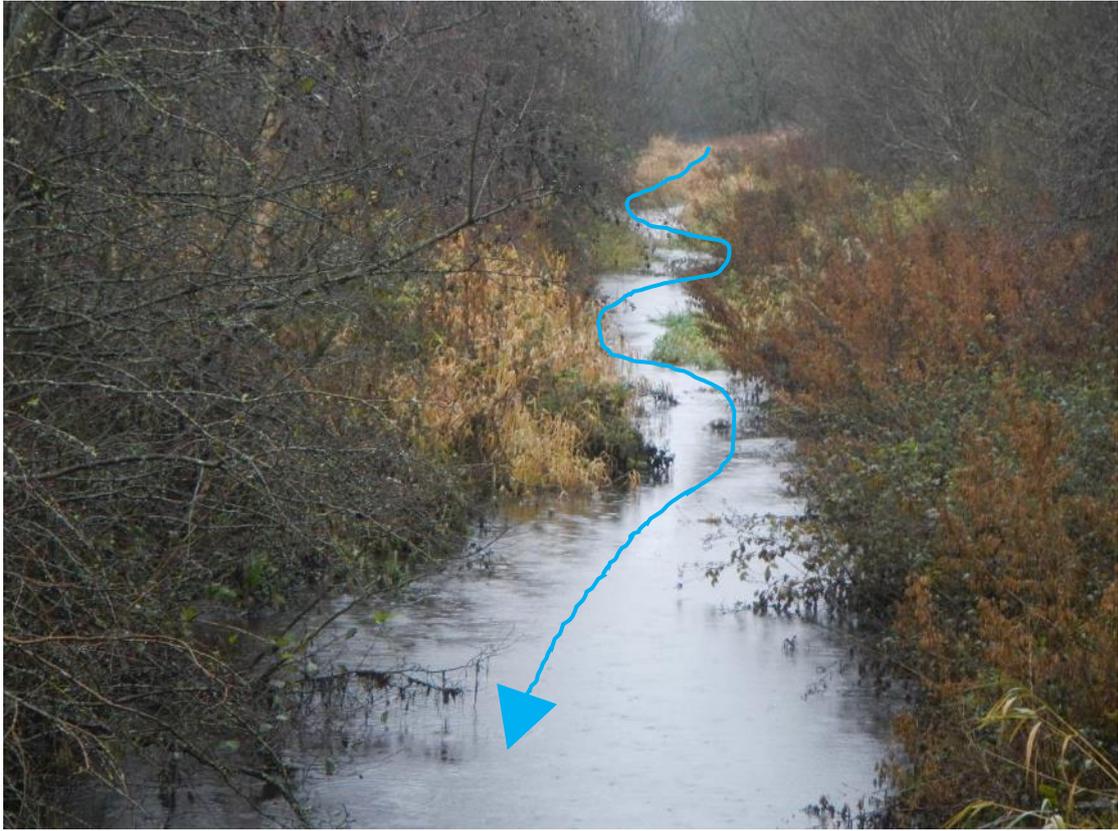
Alongside Morrison's supermarket the improvement of a wider but shallower (less dredged) channel with natural vegetation encroachment is clear, where the burn is now naturally developing a more sinuous course (Fig. 8). This process could be enhanced with in-channel structures but as it is currently developing well unassisted, it may be better to simply monitor the recovery and only intervene if the recovery stalls.

Figure 9. With natural vegetation growth and encroachment, many channels will begin to recover over time. The rate is often dependent upon the extent of modification, flows received and sediment supply, along with light penetration to facilitate the growth off marginal and emergent vegetation.

Where the channel is already actively recovering alongside Morrison's, the recommendation is to simply monitor the natural adjustment which is already delivering habitat improvements (as shown in Fig. 9). Basic monitoring of the channel development could be undertaken with fixed point photography. This can be achieved automatically with a trail-cam to create a time-lapse series or more simply by marking a location (a tree or installed post) from which photos can be taken at regular (c. 3 to 6-monthly) intervals. Installing additional marker points (coloured pegs or posts) within the channel and depositional features could be another effective way of accurately monitoring changes to the channel and vegetation, if required, but the basic photography is possibly sufficient. As with all sections, the introduction of more-natural substrate would be beneficial.

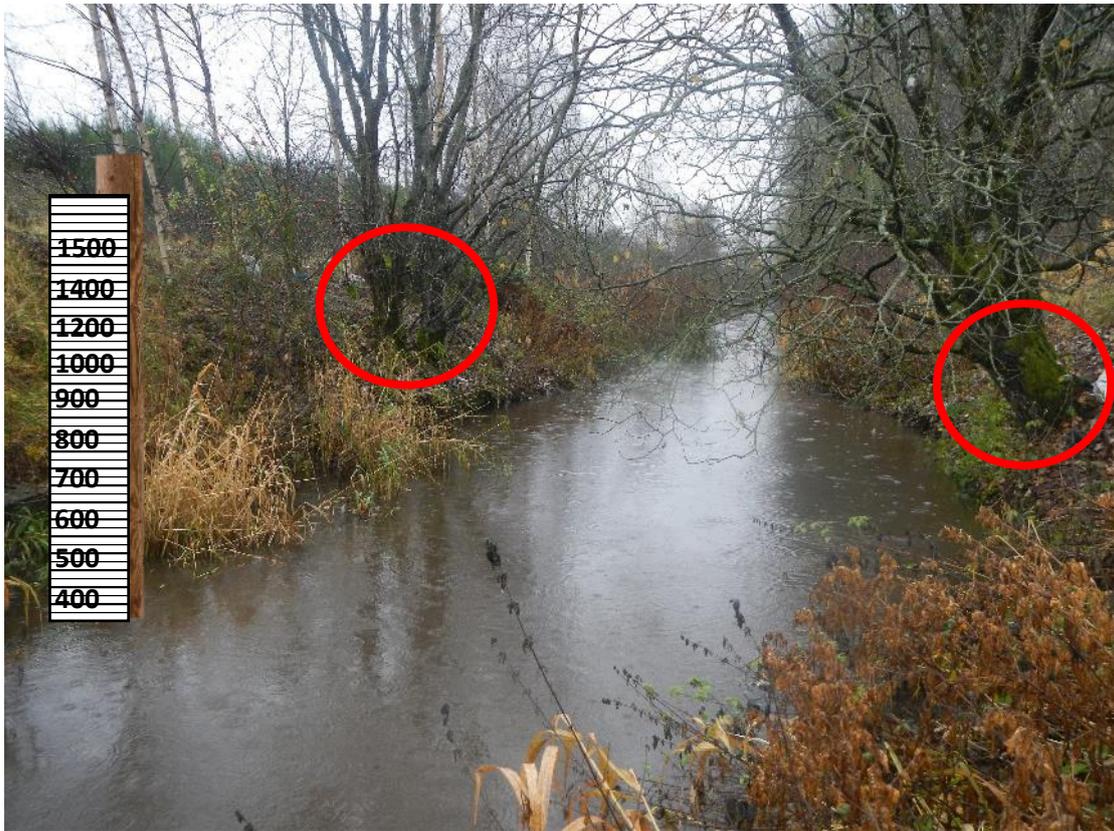
Figure 16. Where pliable species of tree are present (red circle), there may be opportunity to lay branches into the water as pinned brush/deflectors. A trail cam trained on a water level board (red circle) could be used to monitor flows (potential flood levels) before undertaking any work.

Ascertaining the flows/water levels of the burn in flood conditions would inform suitability of in-channel structures. In the absence of local flow gauging, fixed point photography of a water level board (Fig. 16) installed somewhere in the reach coupled with a trail cam set to take pictures at 15 minute intervals could provide valuable flow monitoring that could be compared to local gauge data to ascertain peak flows. This technique could be used as a guide to the range of water height fluctuation on all sections and help determine the requirement for more detailed flow/flood modelling.
