Advisory Visit

Bradshaw Brook, Lancashire

August 2010

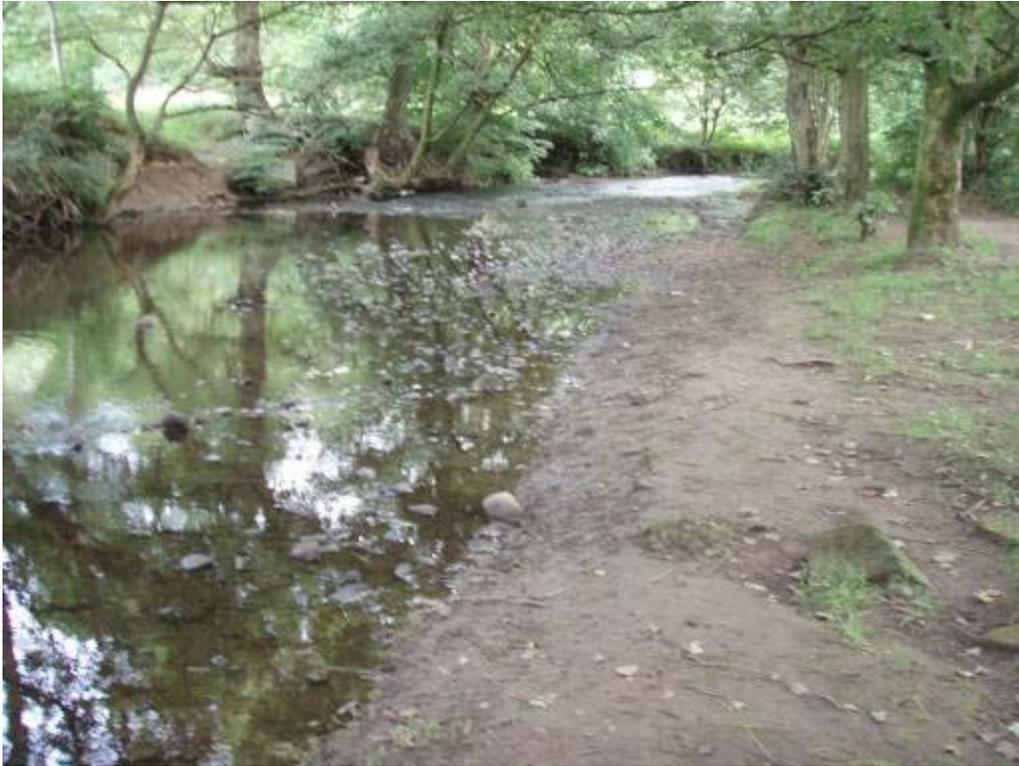
Some sections of the brook are wide and shallow. In some cases this is a result of natural variation in the shape and form of the channel; in other cases it is because of bank erosion (Photo 1). The naturally occurring shallow areas are desirable because of their contribution to the natural diversity of the channel, which could be enhanced further by the addition of some large woody debris (LWD – see later comments). The bank erosion evident in Photo 1 appears to be occurring largely through human activity (footfall), leading to loss of binding vegetation and hence soil erosion; a potential solution is to install brushwood groynes and live willow along the inside of the bend to encourage the deposition of sediment and narrowing of the channel. Figure 1 illustrates the principle of this and is taken from WTT Upland Rivers Habitat Manual (Section 5, page 22). More detail is available in the manual which can be found at www.wildtrout.org/index.php?option=com_content&task=view&id=384&Itemid=327).

Photo 1 Overwide channel because of bank erosion through human activity

The installation of the groynes could be combined with opening the canopy along the right bank to encourage growth of bankside vegetation and the installation of a visual barrier to encourage walkers to stick to the footpath alongside the river. This could be in the form of a low guide rail (e.g. www.snh.org.uk/publications/on-line/accessguide/downloads/5_11%20Single%20Barrier%20Fence.pdf). Once sediment starts to accumulate and consolidate along the right bank, the channel will narrow and deepen.

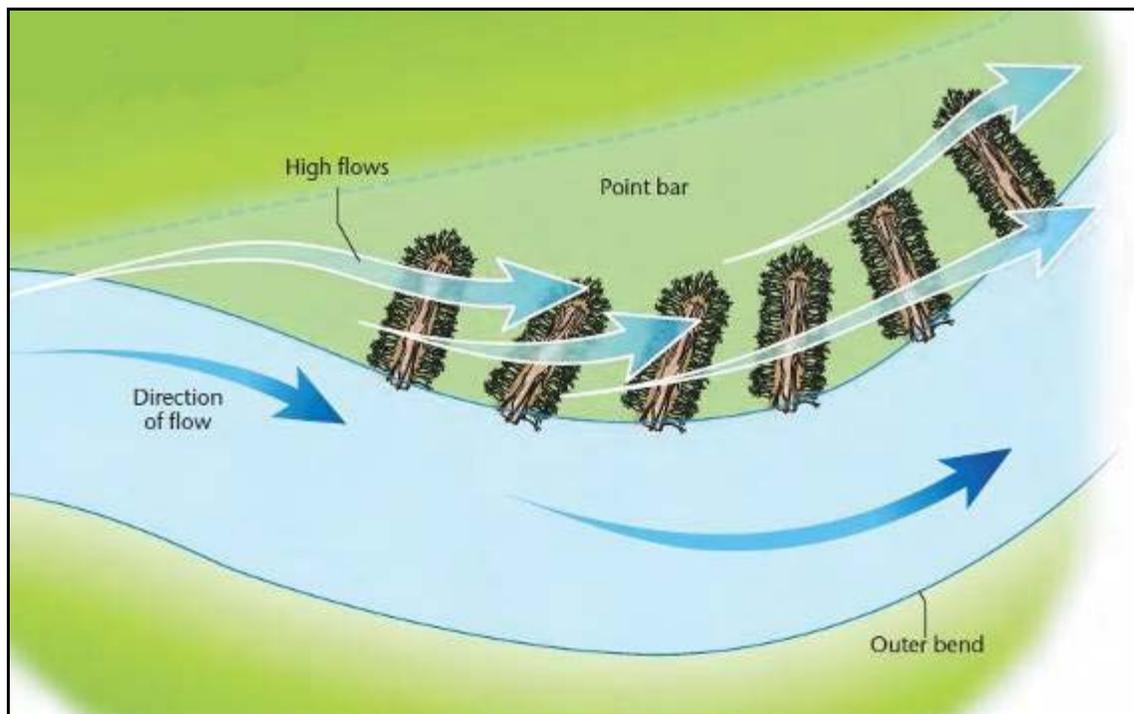
Figure 1 Groynes to trap sediment on the inside of a bend

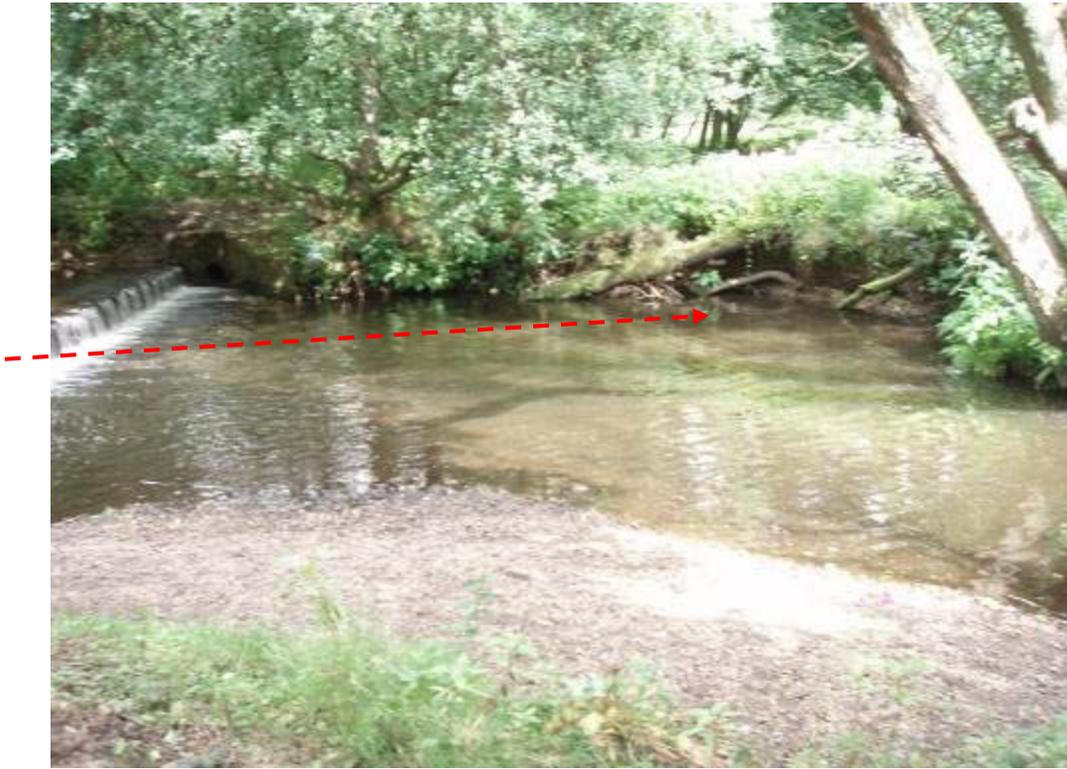
There is an area of accelerated bank erosion occurring downstream of a low weir formed by a sewer pipe crossing the river (Photo 2). The reason for the erosion occurring here is the angle of the weir across the river which is directing high flows against the eroding bank. Ideally the weir should be modified to direct flows more towards the centre of the channel; however this may be an expensive and difficult exercise, complicated by the presence of a surface water outfall on the left bank immediately downstream of the weir. There may be scope to tackle this and improve fish passage over the structure (see later comments).

Photo 2 High flows are directed against the eroding bank by the pipe weir

The effects of the bank erosion could be reduced here by reinforcing the toe of the eroding bank using a suitable method (e.g. log and Christmas tree revetment, or brush-packing – see Upland Rivers Habitat Manual). It may also be possible to use a “belt and braces” approach and install a tree kicker to sit in the gap left by the erosion, if a suitable anchor point can be found (Figure 2).

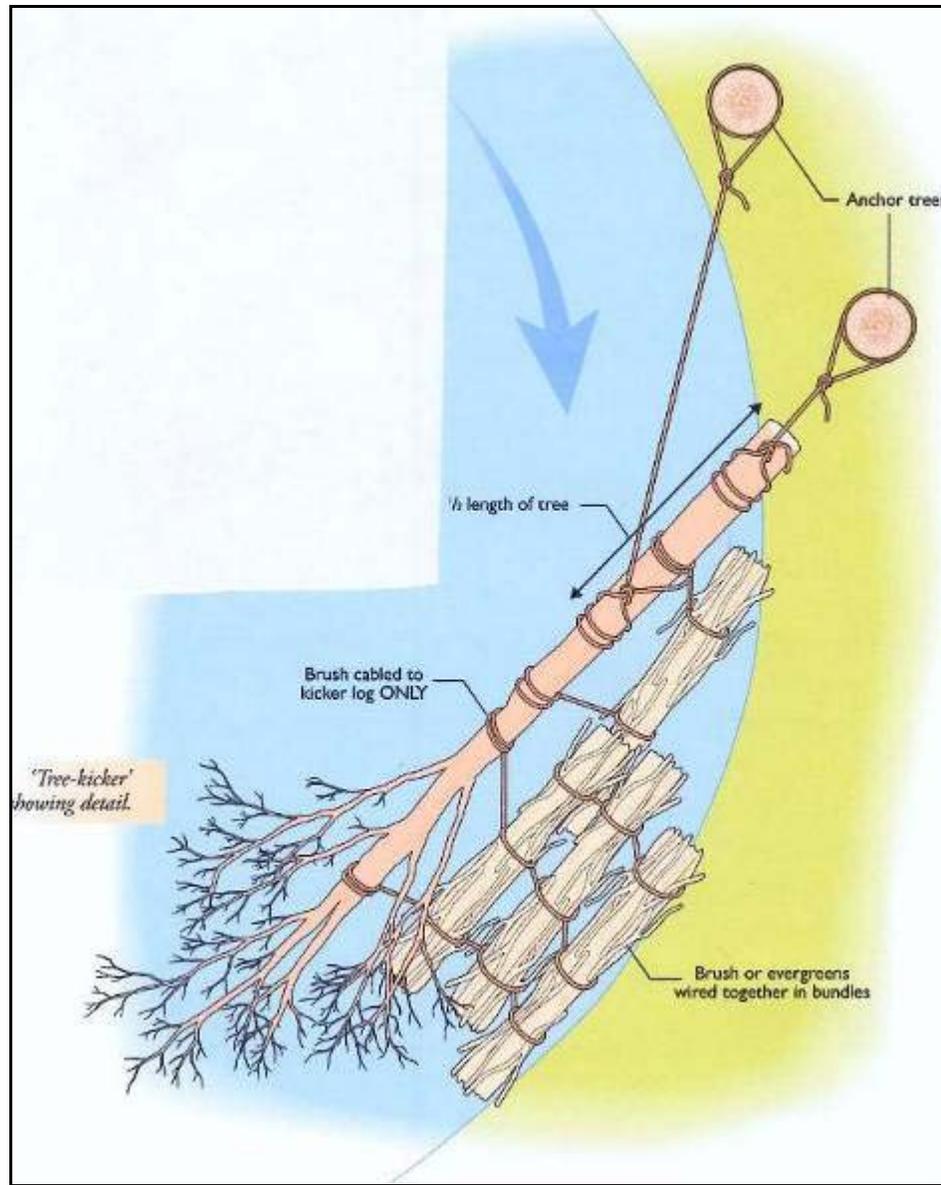
Figure 2 Tree kicker – these structures are anchored so they can float within the gap on an eroding bank, stilling the flow and providing erosion protection at all river levels.

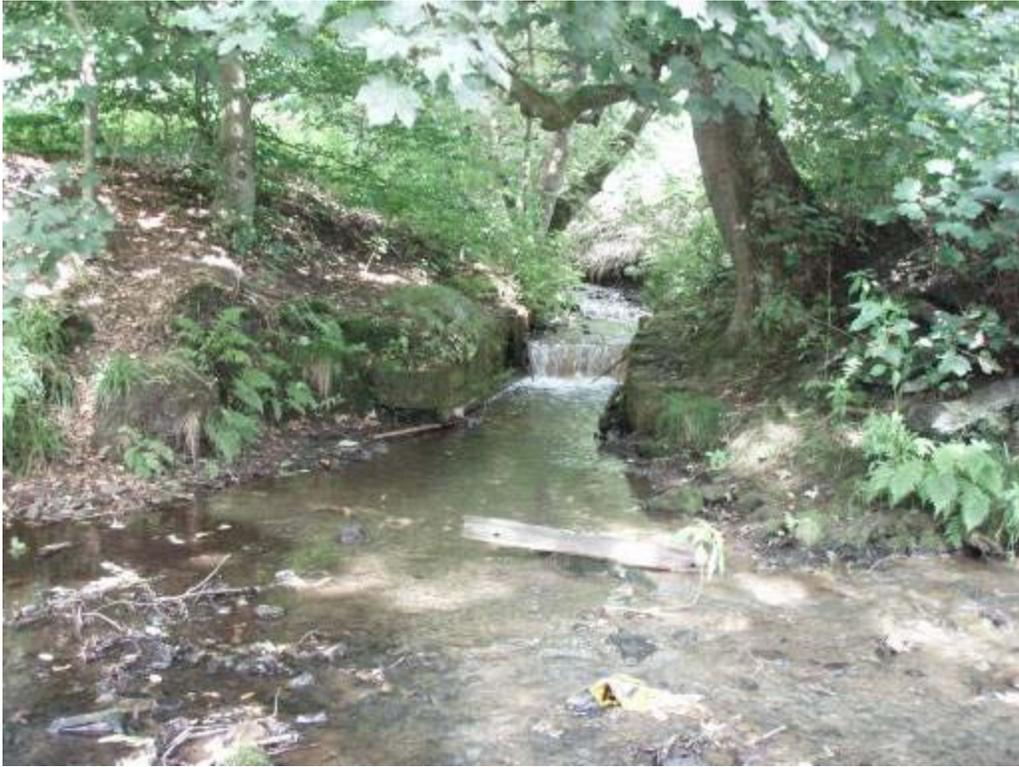
Photo 4 This easily removed obstacle would open up a potential spawning tributary

There are a number of obstacles to free movement of fish within this section of brook, including the pipe-weir described above, a low weir installed by BFF at the confluence of a small tributary on the left bank (Photo 4) and the large weir under the access road to the cricket field (Photo 5). The obstruction in the tributary can and should be easily removed to restore access for trout to a potential spawning area.

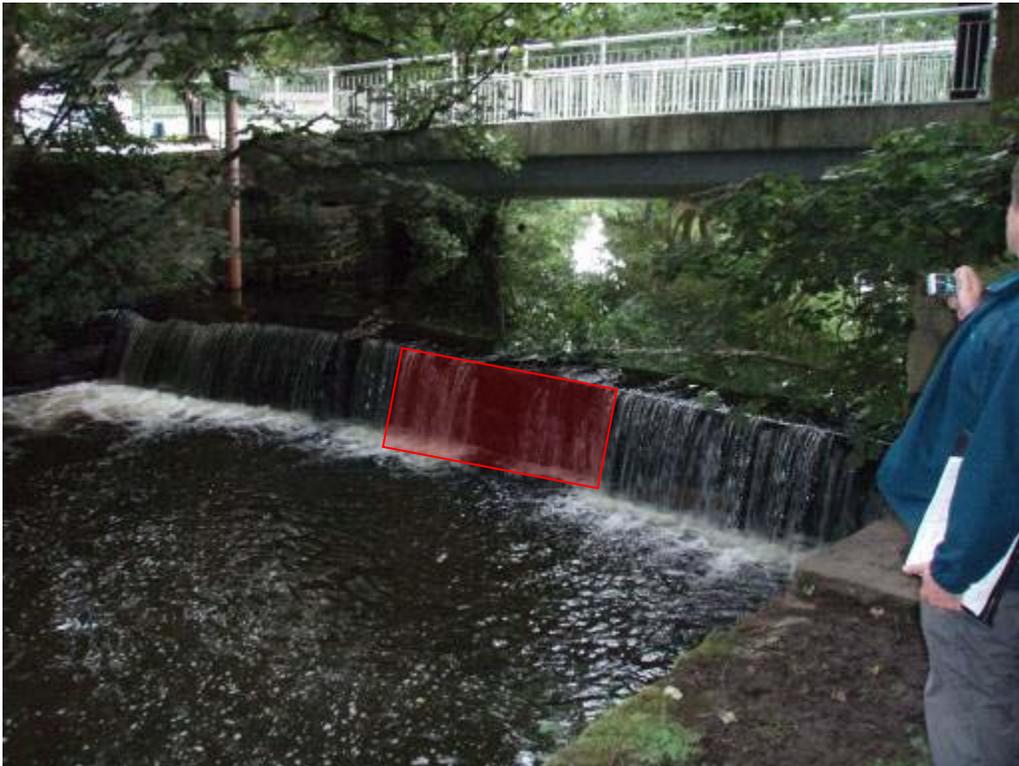
Photo 5 The large weir near the cricket pitch. The simplest solution to improve fish passage and upstream river habitat would be to remove a central section (as indicated). Entire removal of the weir should be considered as well.

It was mentioned on the visit that BFF had plans for a fish pass at the cricket field weir. The EA are looking at the feasibility of reducing or removing obstacles on the River Croal (a target for achieving Good Ecological Status on this watercourse under the Water Framework Directive). The possibility of working collaboratively with the EA, and maybe the Irwell Rivers Trust, to achieve these common goals should be explored.

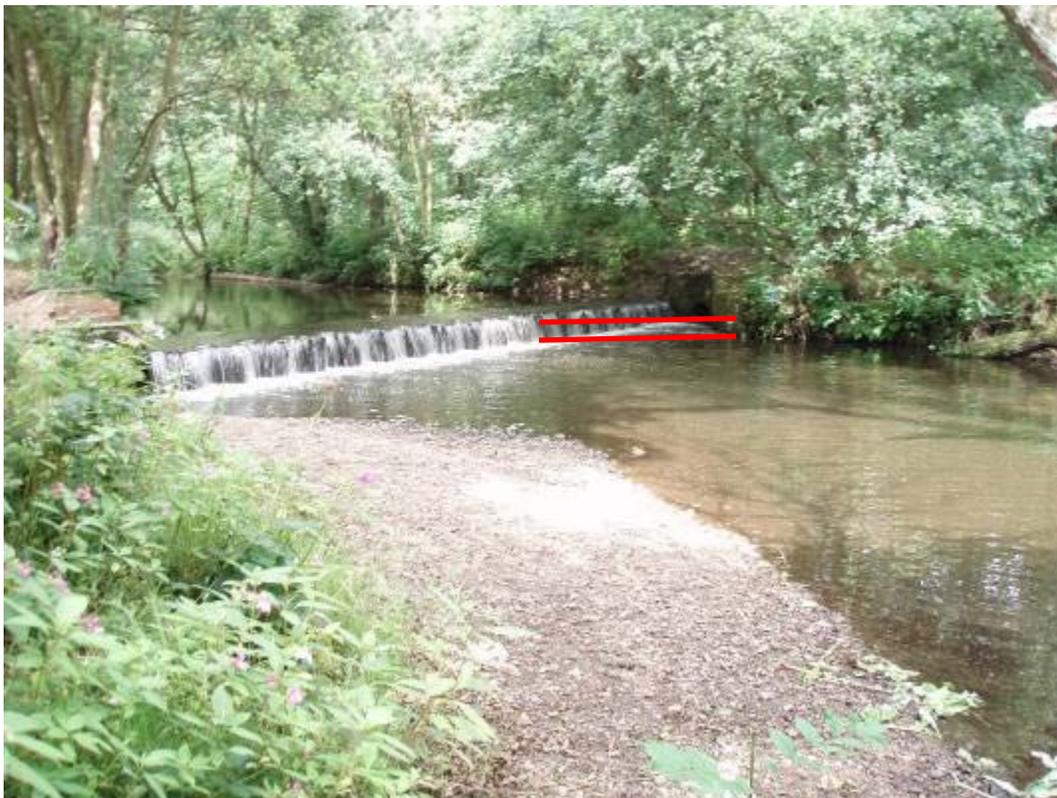
Photo 6 Pipe weir with potential location of pre-barrage

Fish passage could potentially be improved at the pipe-weir by the construction of a simple pre-barrage in the corner against the left bank (Photo 6, Figure 3). This would probably require the extension of the surface water outfall to prevent water backing up it. These works may also take some of the pressure off the eroding bank downstream by diverting flows more to the centre of the channel. Careful planning would be required when working so close to a sewer pipe.

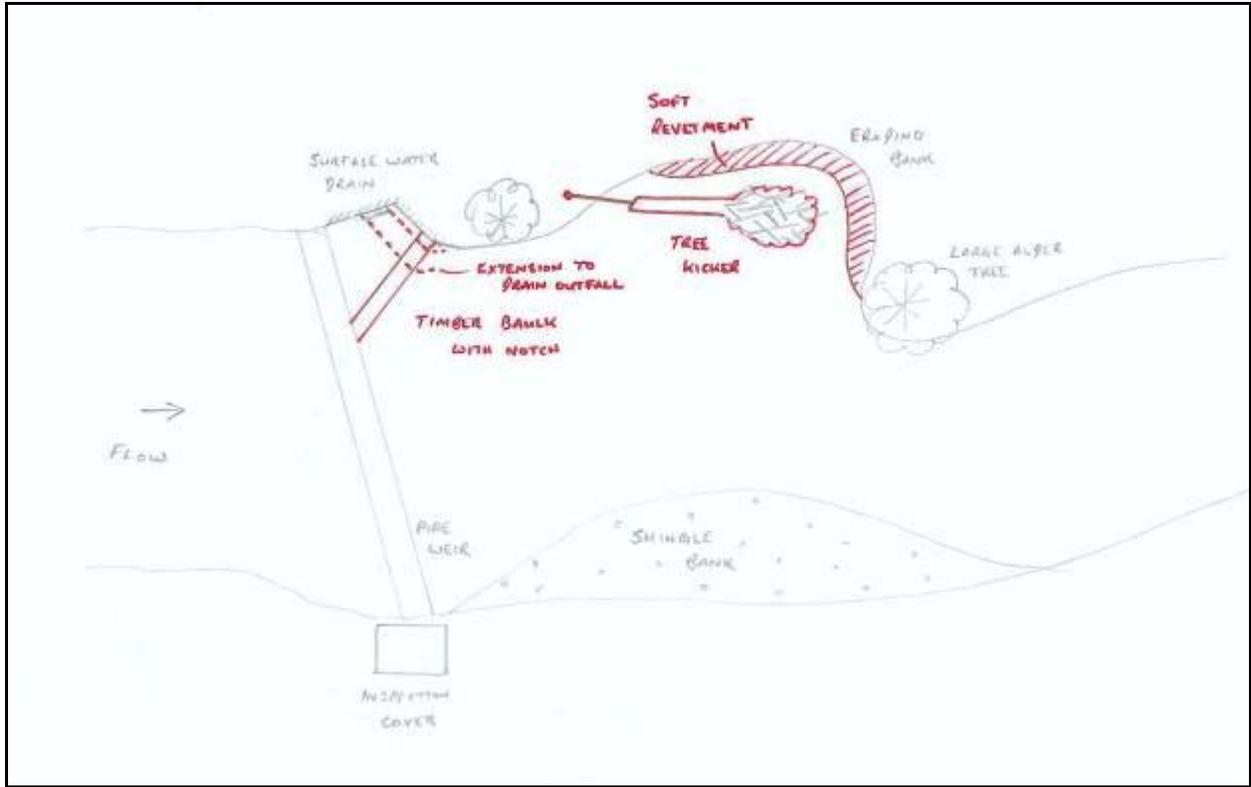
Figure 3 Potential works in the vicinity of the pipe weir. Additions to existing features shown in red.
