Advisory Visit

Brailsford Brook, Derbyshire

July 2015

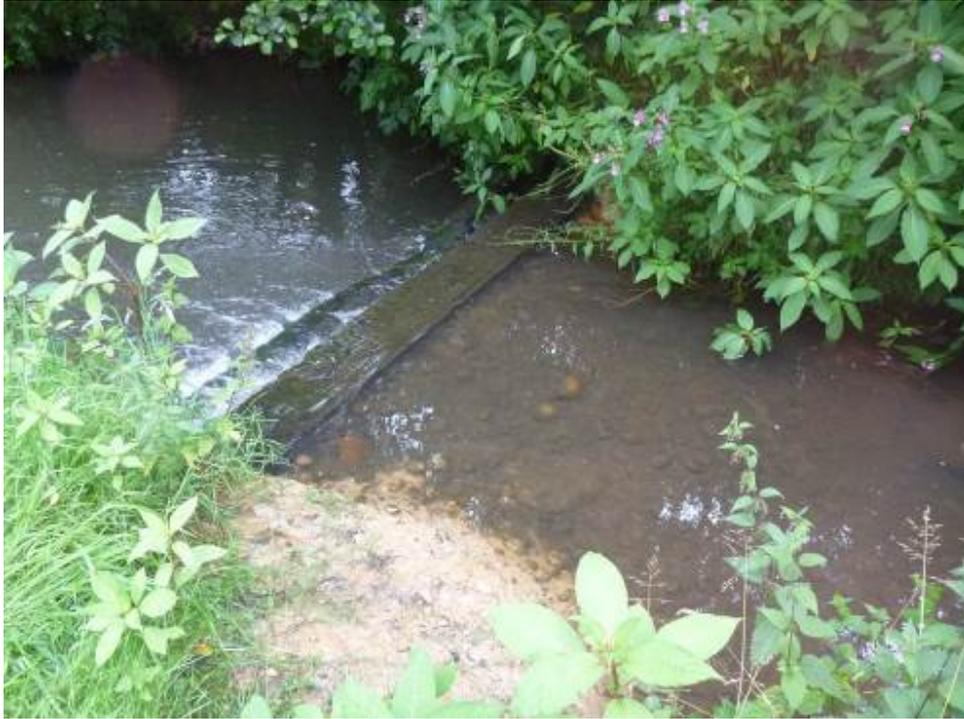
Figure 1 and Photo 1 show how gravels which would normally be transported, graded and deposited by the brook are trapped behind the weir structure. The slower, stilled water immediately upstream of weirs also promotes the settling out of finer sediments (sand and silt), uniformly across the full width of the channel, filling the spaces between the gravels, making them unsuitable for trout spawning and flow-loving invertebrates.

Photo 1 Accumulation of gravel upstream of a weir, trapping suitably-sized trout spawning medium in an unsuitable area for spawning. Also note the accumulation of silt amongst the gravel.

It is recommended that a number of weirs are removed to restore a degree of natural sediment transport and to improve habitat conditions for trout spawning and juveniles. Preferably blocks of weirs should be removed, rather than, for example, alternate ones; this is to give a reasonable length of river over which natural river processes can re-establish.

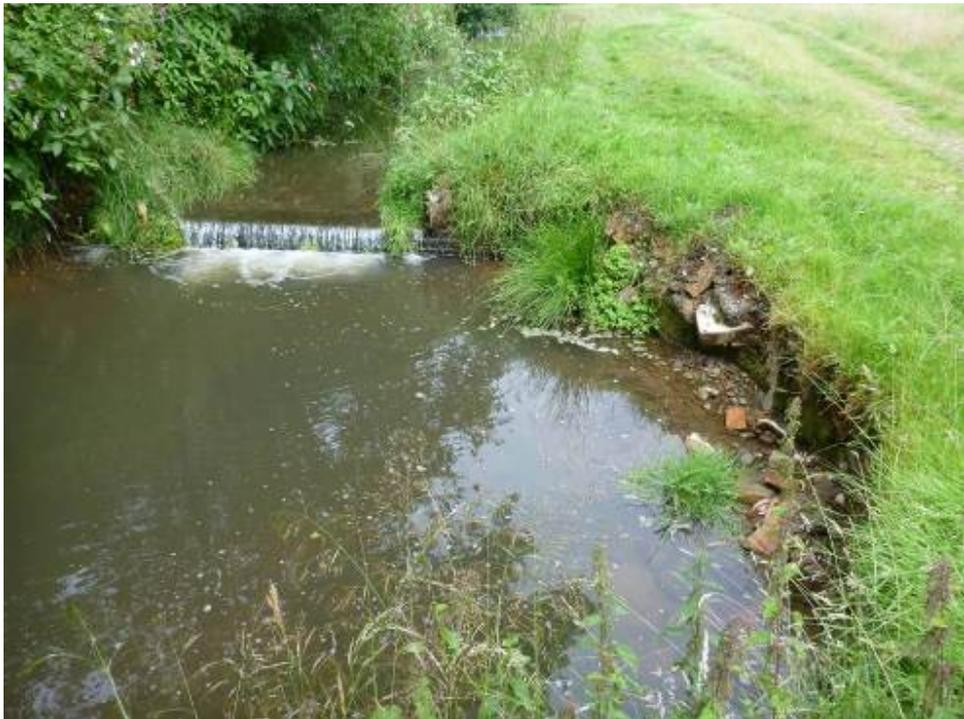
Linked to the disruption of sediment transport and impoundment of flows, weirs also change the natural shape (morphology) of the river channel, reducing bed scouring and preventing the formation of the natural pool-riffle sequence. This reduces the availability of trout spawning and juvenile habitat (Figure 2). Increased rates of bank erosion can also take place downstream of weirs where back eddies occur, leading eventually to the river bypassing the weir structure (Photo 2).

Photo 2 Bank erosion and channel widening caused by flow patterns generated by the weir in high flow events.

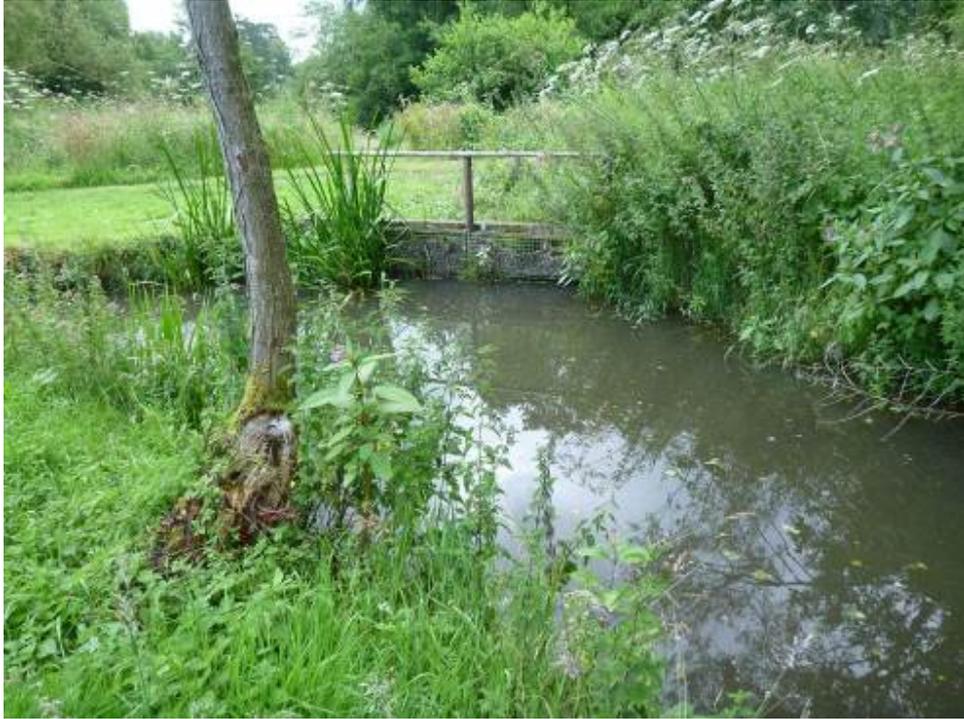
- Secret Lake, Sandy’s Lake and the hatchery ponds are fed from the brook and each abstraction point relies on the water level being maintained by the weir immediately downstream (Photos 3 - 6). Removal of these weirs would lower upstream water levels and prevent abstraction of water into the lakes.

Photo 3 Water off-take feeding into the hatchery ponds, which relies on the water level maintained by the weir downstream of this picture (NGR SK2433143031).

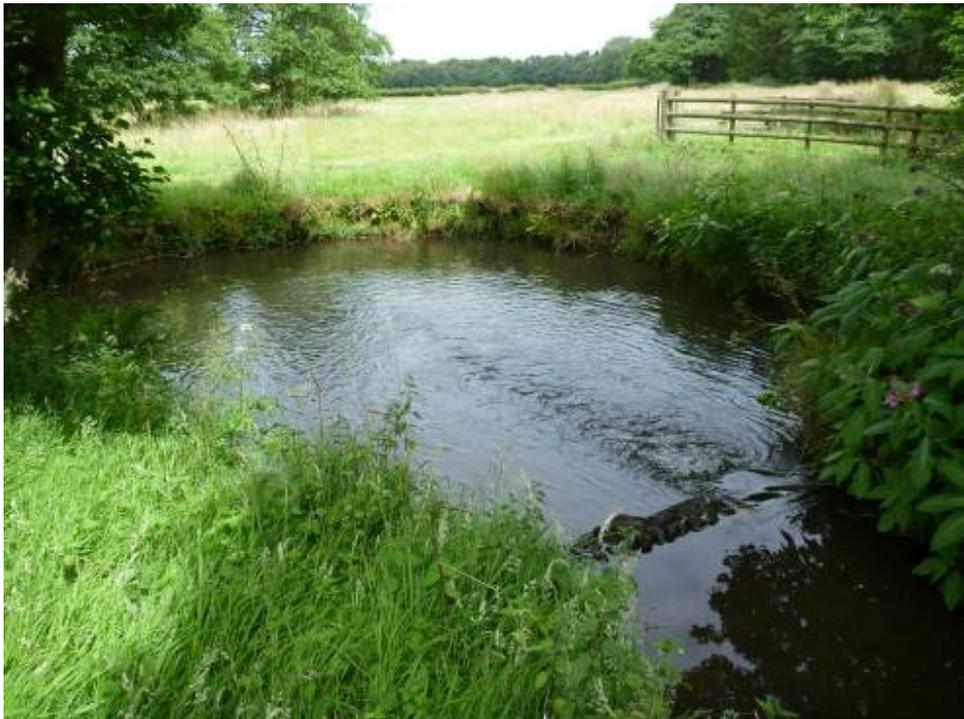
Photo 4 Weir at NGR SK2443643403 which maintains upstream water levels to feed the off-take into Sandy's Lake (Photo 5).

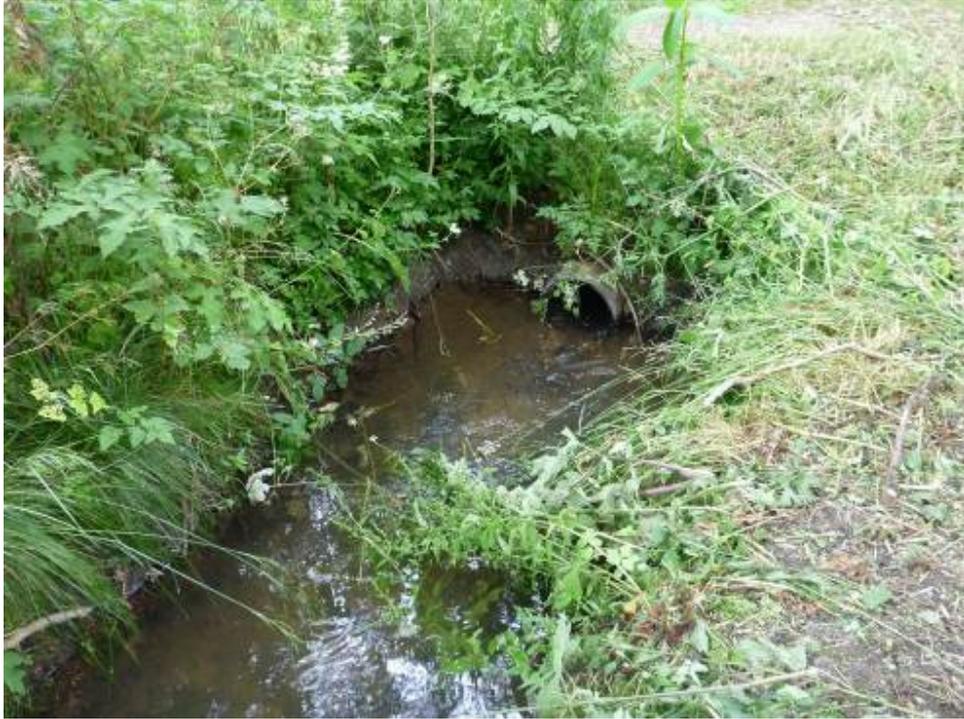
Photo 5 Off-take from the brook feeding into Sandy's Lake

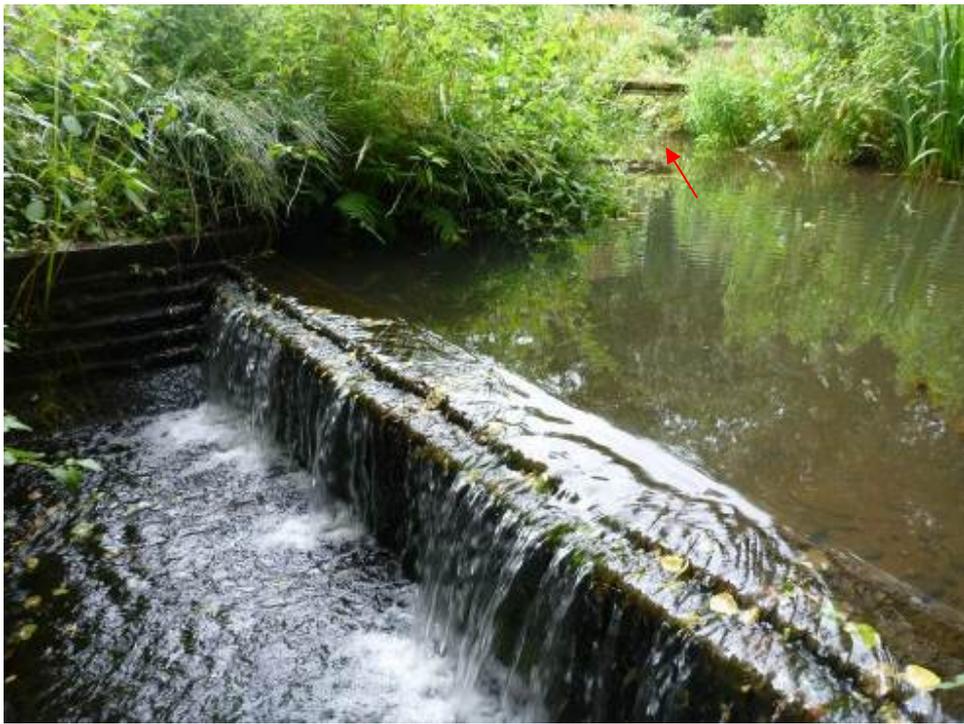
Photo 6 Weir at NGR SK2457044159 with off-take into Secret Lake in the background (arrow).

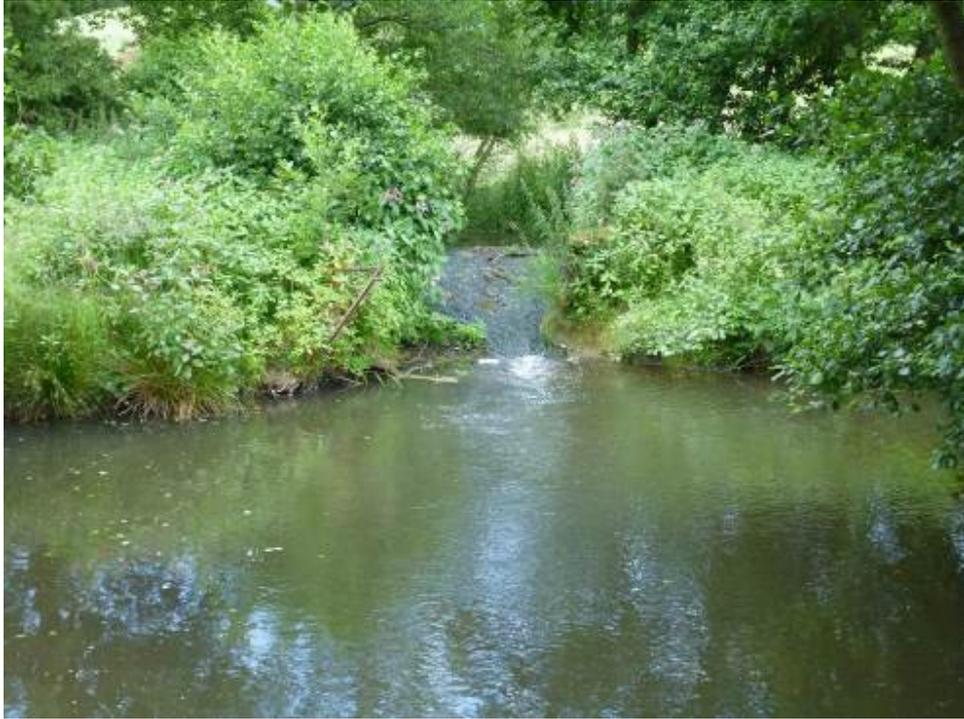
- The large weir at NGR SK2436142611 (Photo 7), downstream of the footbridge below Dam Farm, appears to maintain water levels supplying the mill leat leading to Brailsford Mill (Slack Lane, NGR SK2433542040). This was not inspected during the visit and further investigation is required.

Photo 7 Weir downstream of the footbridge below Dam Farm (NGR SK2436142611) which maintains water levels for the mill leat to Brailsford Mill (requires further investigation).

- Between the weir at Secret Lake off-take and Sandy's Lake off-take. Both the weirs maintaining water levels for these abstractions and the weir below each should be retained.
- Downstream of the large weir at the mill leat off-take (Photo 7). There are four or five weirs here which could easily be removed, plus maybe some more in the wood downstream (not inspected on this visit).

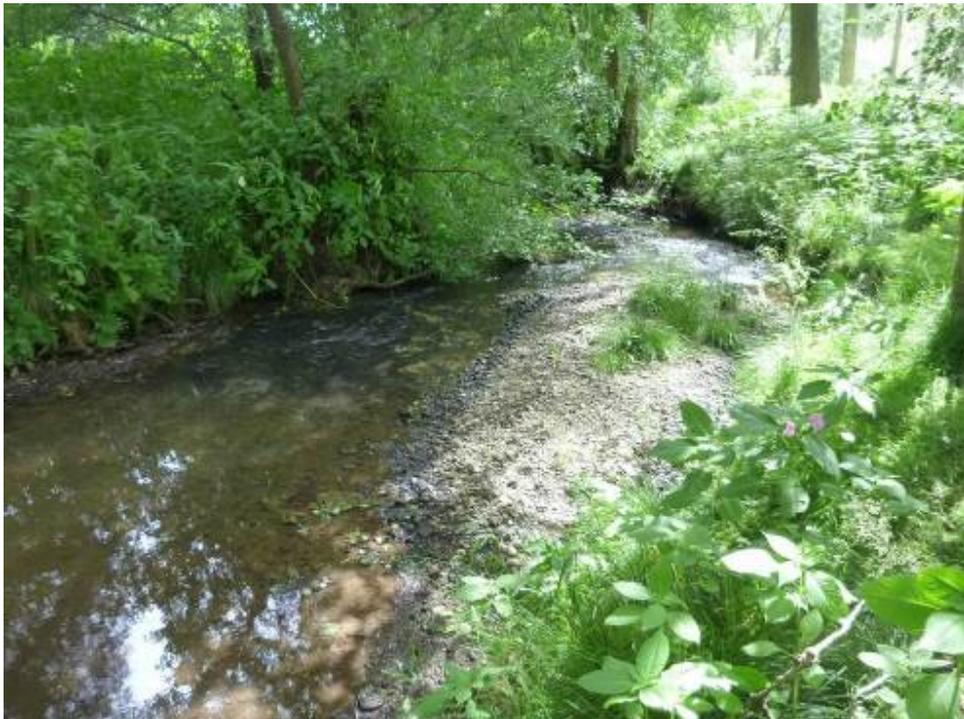
weirs is visible in the short section adjacent to the inflow from Monk's Pond (Photos 8 - 9) at NGR SK2424742427.

Photo 8 Un-impounded (no weirs) section of brook near Monk's Pond outflow (NGR SK2424742427). Note the gravel side bars, riffles and shallow water.

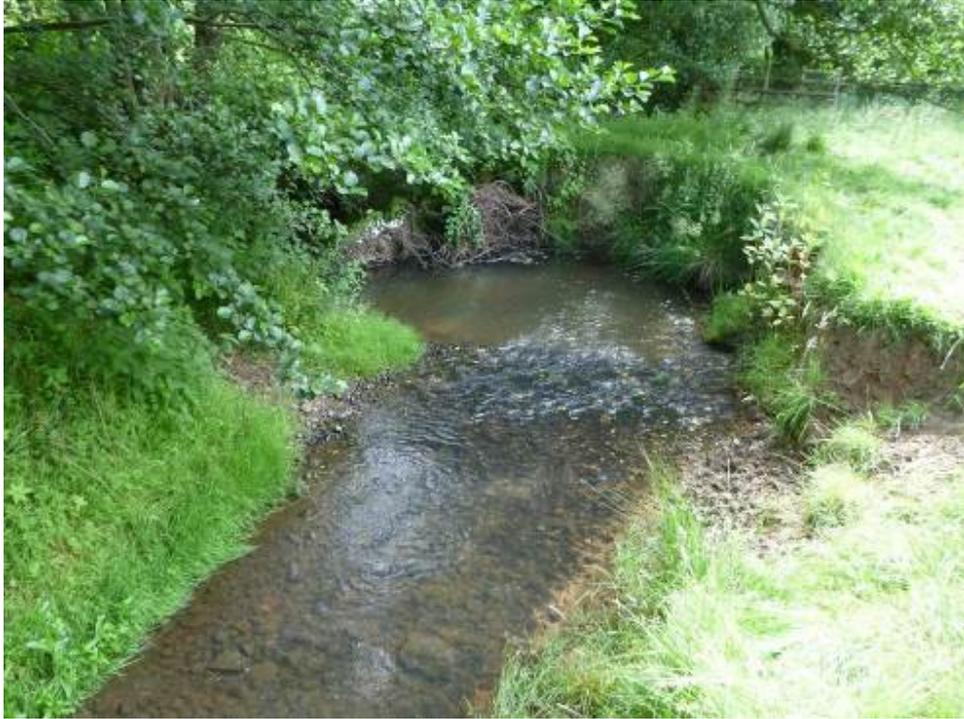
Photo 9 As above, showing a gravel riffle and a deeper pool on the meander bend (lateral scour pool).

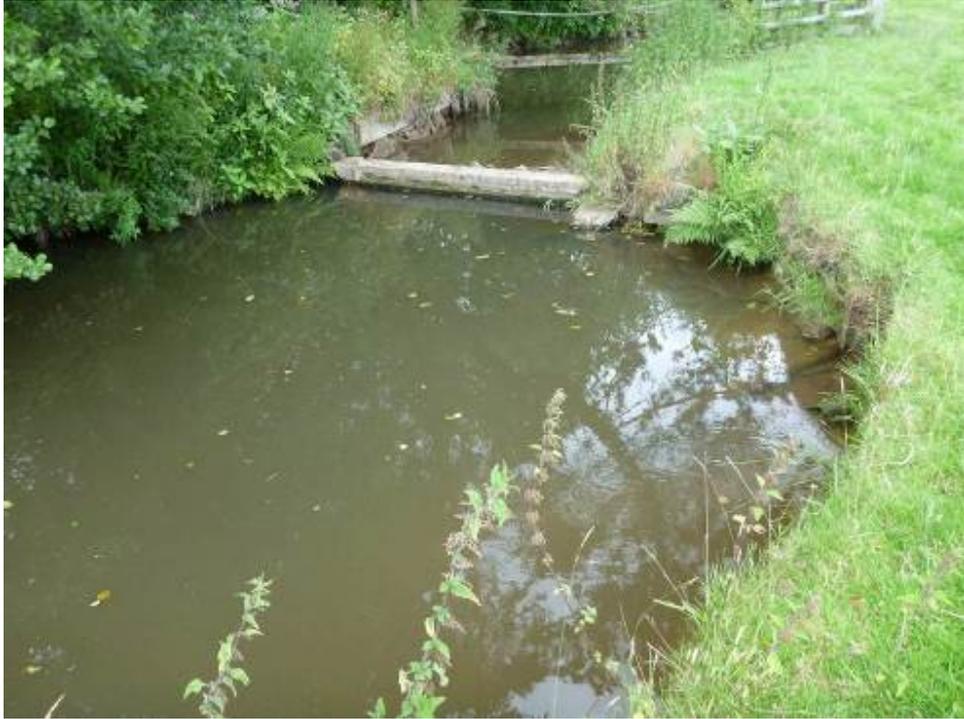
Reducing the flow into the lakes and ponds to the minimum required would also benefit the ecology of the brook. It was evident during the visit that the sections of brook between the inlets and outlets for Sandy's Lake and for the hatchery ponds had very little residual flow (for example, Photo 10 showing no flow over the weir).

Photo 10 Plastic drainage pipes discharge water to the brook from the true left bank (right of picture) – the outflow from Sandy's Lake? Note the lack of flow over the weir upstream, resulting from the diversion of flow through the hatchery ponds which lie on the true right bank adjacent to this area.

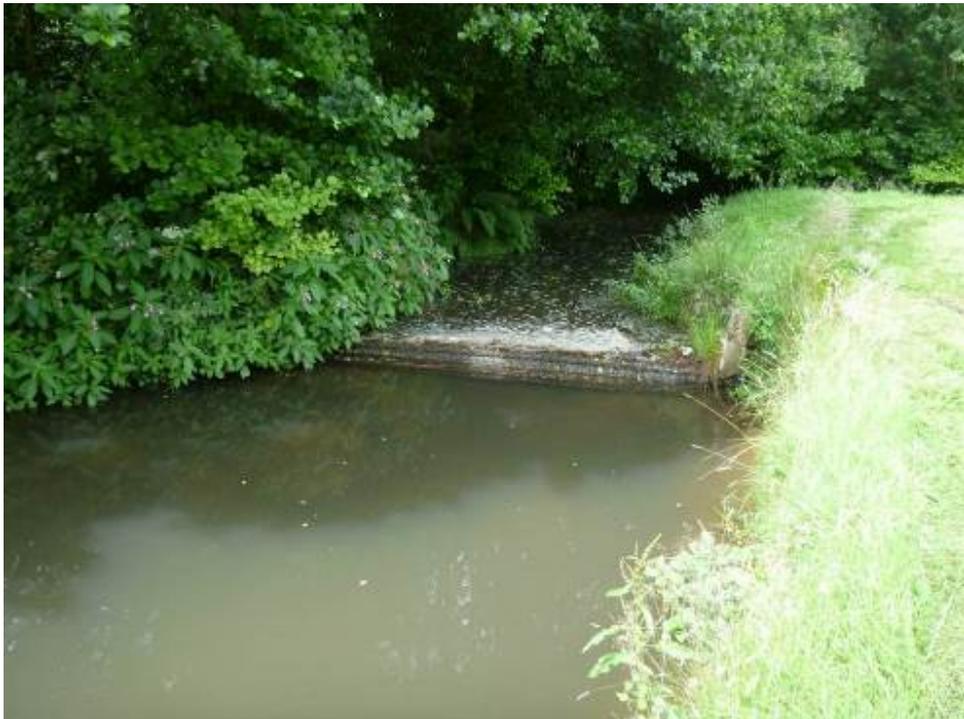
Sandy's Lake and Bradley Lake do not appear on maps until 1978 (absent in 1955) indicating relatively recent construction. The smaller pond (right bank) between the two aforementioned lakes also appears at this time. It was not clear during the visit where the outflow from Sandy's Lake re-entered the brook. Some drainage pipes were discharging to the river on the left bank (NGR SK2437343031, Photo 10) but this requires clarification. In addition, there appeared to be an interruption to the flow of the brook in the vicinity of the smaller pond, where no water was passing over a weir despite good flows over the ones immediately upstream and downstream; this requires further investigation to clarify the flow pathway (Photo 11).

Photo 11 No flow over the weir near the Bradley Brook confluence – further investigation is required to clarify the flow pathway here.

There is also scope for weir removal between Sandy's off-take and the hatchery ponds off-take, but it is recommended that the further investigation is carried out to clarify the exact flow pathway and discharge route from Sandy's lake before considering this. Also, the results of weir removal elsewhere will inform further work.

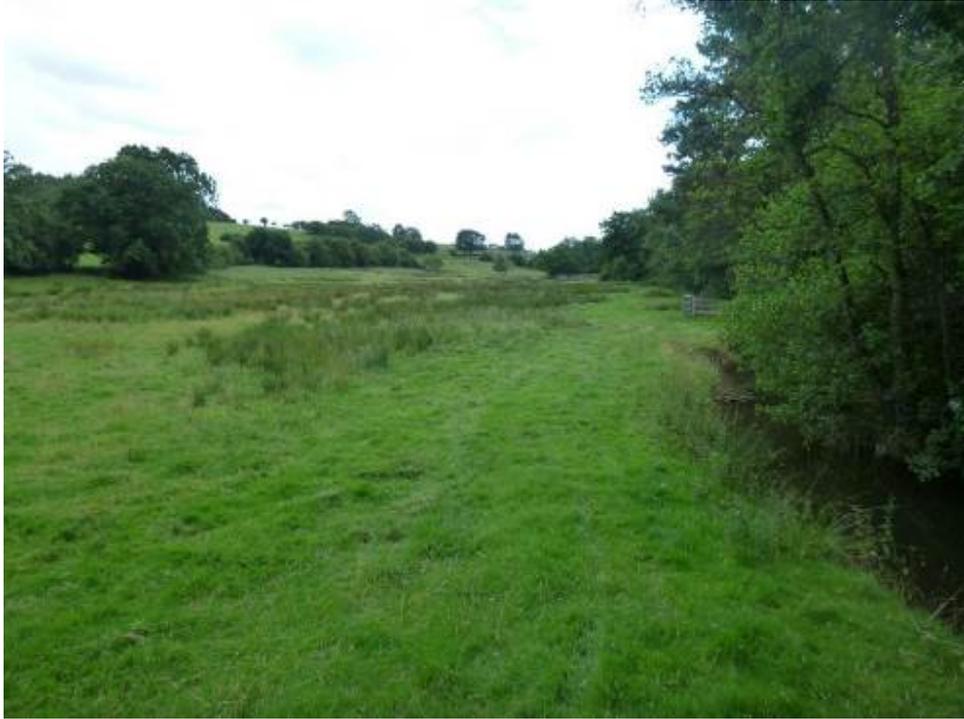
Despite the river following the same course as in 1880, it is highly likely that the course adjacent to the current hatchery ponds was moved to the west from its original course. This section of the brook appears to be in a perched channel (higher than the adjacent land) and it was common practice to move river courses to higher levels on valley sides to provide a head of water for milling (the diversion of the brook into the mill leat is a short distance downstream, at the weir in Photo 7). The original course probably flowed through the field in Photo 12, which still shows a linear wet area marked by rushes.

Photo 12 Field on the true left bank of the brook which is in a perched channel to the right of the picture. The original brook course probably flowed through the lowest part of the field.
