**Advisory Visit**

**Branston Beck, Lincolnshire**

**August 2016**

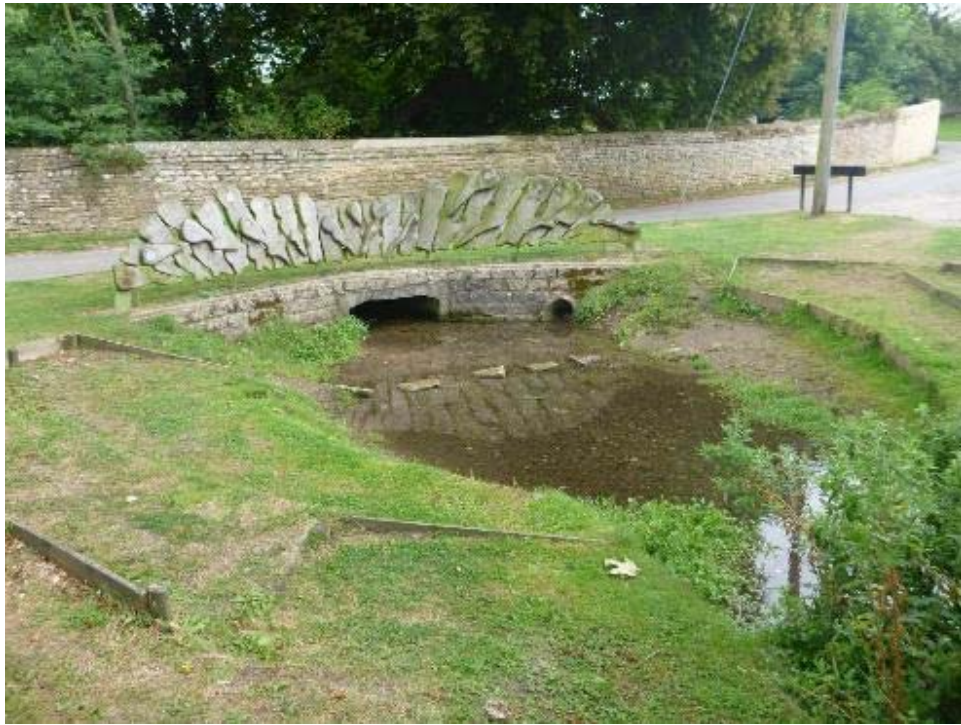
**Photo 1 Hall Lane, Branston**

At the upstream end of the village (Hall Lane) there is an area where the brook has been made accessible, with terraced banks (with toe-boarding), stepping stones and a sculptured handrail on the bridge (Photo 1). Upstream of this area is a riverside footpath and footbridge, creating a short, circular walk. This appears to be an area where a community-led project has created a pleasant space for people to enjoy the brook and its surroundings. The area upstream of Hall Lane is densely shaded with previously coppiced alder and willow trees (Photo 2).

There is opportunity in this area to build on the previous works, including:

- selective coppicing on a 3 – 5 year rotation

- introduction of brushwood mattresses to the brook to create some channel sinuosity and improve in-stream habitat (using material arising from the coppicing)
- Removal of the toe-boards and re-grading of the bank.

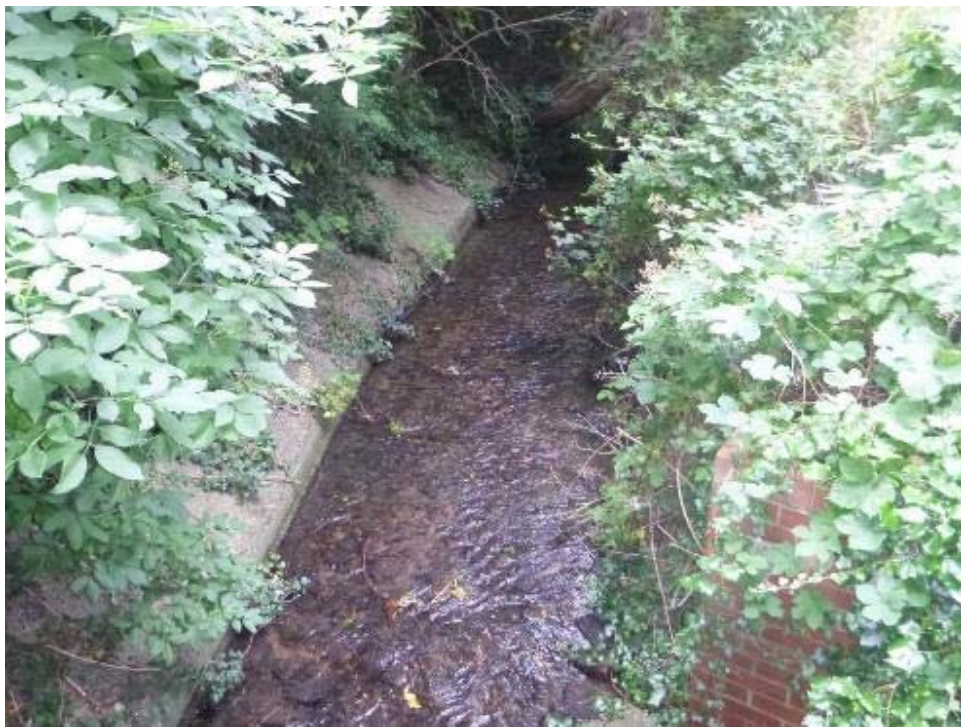
**Photo 4 Alongside Paddock Lane, Branston**

Downstream of Hall Lane, the brook flows through the grounds of Branston Hall Hotel and behind some private residences (not inspected), then alongside a pub car park at the site of a former sheepwash. The brook here is confined within a walled channel and there is an interpretation board describing the old sheepwash and its archaeological investigation (Photo 3). The brook is then culverted under the B1188 High Street and flows through the gardens of a number of private residences on Paddock Lane. Downstream of the gardens, the brook flows within a concrete-edged channel, deeply incised and uniformly shallow (Photo 4).

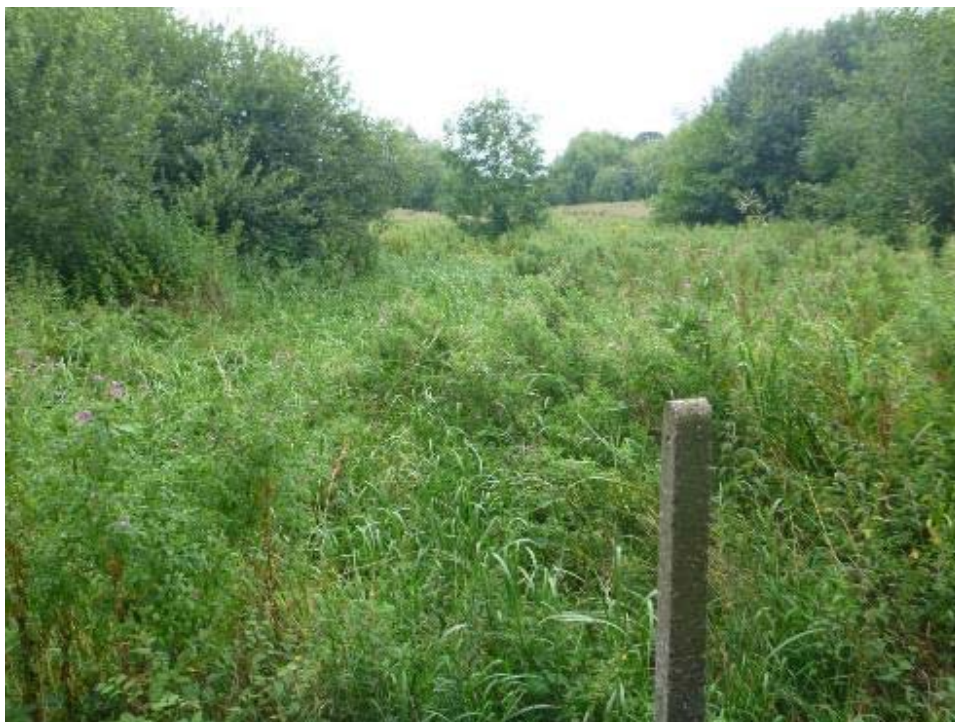
Throughout the sections described so far, the brook is confined within a built environment, limiting the scope for habitat improvement through channel restoration (e.g. re-meandering). However, downstream of Paddock Lane, the brook enters a wide, green corridor between residential areas (Photos 5 – 7). Presently this corridor appears to be maintained as a nature reserve and public open space, with areas of trees, bushes, wetland, mown grass, footpaths and walkways. The brook channel remains very straight along the eastern side of this area and is perched above the natural valley floor; this is particularly evident downstream of the footpath which runs perpendicularly across the valley just upstream of Laburnum Close (Photos 7 and 8). There are pipe connections (with inverts above normal water level) between the brook channel and the floodplain area, along with areas where the brook appears to overspill its left bank at high water.

**Photo 7 Open valley/floodplain area looking downstream from the path crossing the valley close to Laburnum Close. This appears to be the lowest point of the floodplain, but the brook channel is perched, off camera to the right of this picture.**

There is considerable scope here for restoring the in-stream habitat of the brook by re-aligning the channel along the valley floor and re-creating a meandering channel with a pool-riffle sequence. The channel was not inspected downstream towards Dye House Farm on this visit; this is recommended, to check whether the channel is perched to provide a head of water and where a realigned channel could potentially be re-joined to the existing channel.

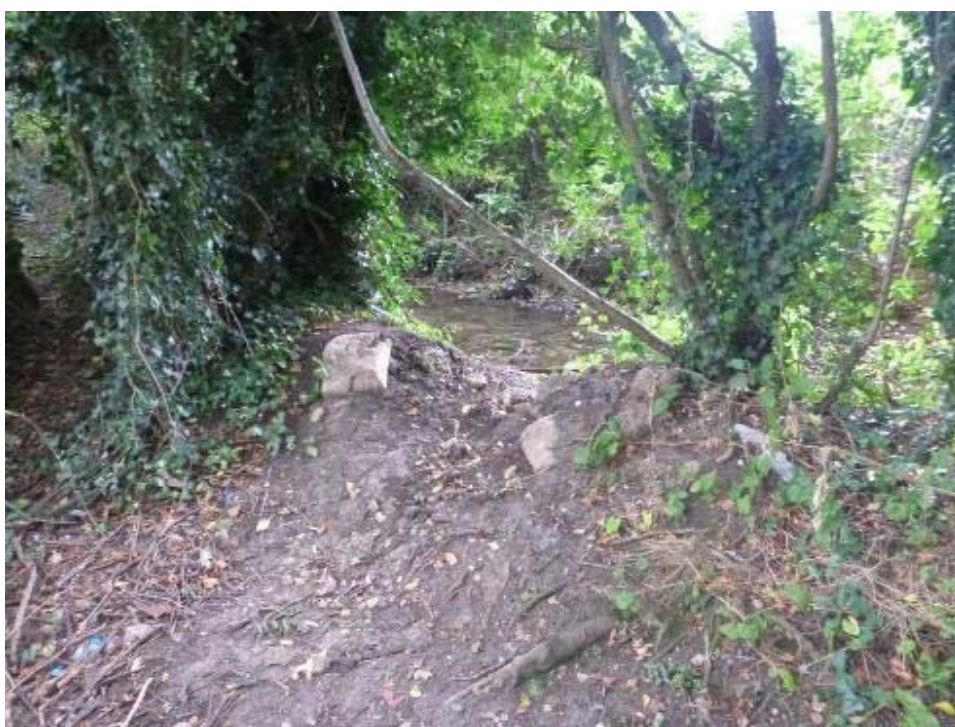
**Photo 8 Perched channel of the Beck, elevated on the east side of the floodplain.**

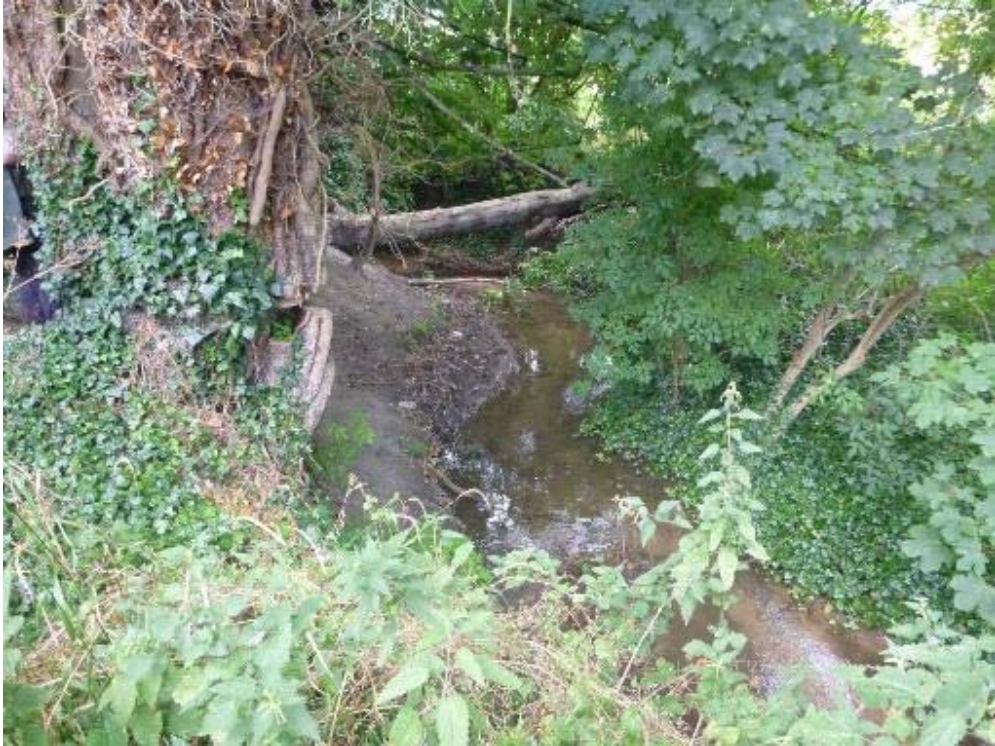
Downstream of Branston village, the brook is joined by a tributary on the left bank (Photo 9), a short section of which was inspected close to Sycamore Drive. The channel was more meandering than the Branston Beck and had good riparian habitat, bordered by trees and including large woody material within the channel; however, the channel was also incised and the bed substrate dominated by unsorted, fine sediment.

**Photo 9 Tributary stream which joins Branston Beck on the left bank downstream of the village.**

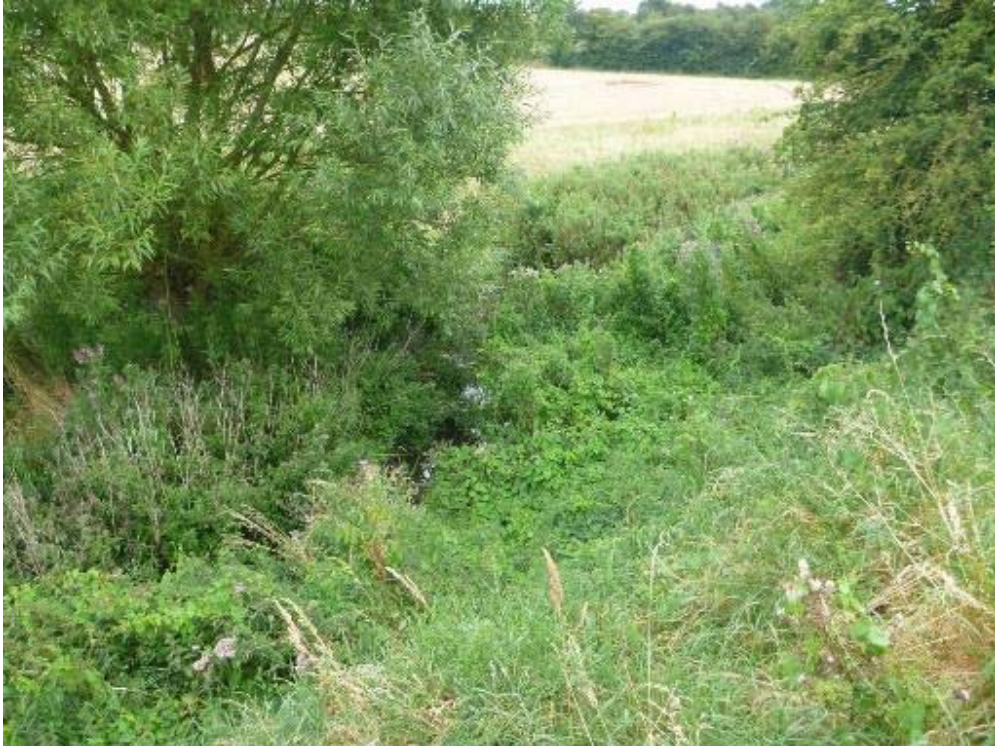
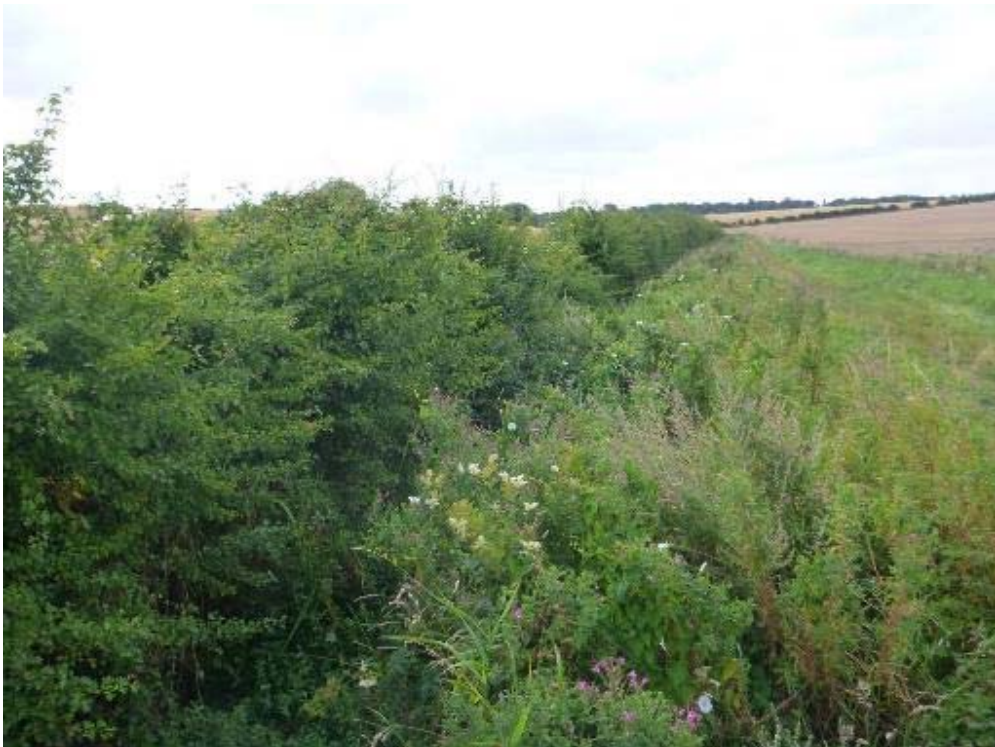
Similar habitat is present on the Branston Beck downstream of the confluence, with the channel shaded by trees and bushes, occasional coarse woody material within the channel and a bed of fine sediment (Photo 10). Downstream of the footbridge at TF 01882 68343, the stream channel is less shaded by trees, resulting in a bankside dominated by tall, herbaceous vegetation with the occasional willow and hawthorn bush. This corridor between arable fields continues downstream to Cliff Farm and as the latter is approached, the right bank of the beck is shaded by a hawthorn hedge (Photos 11 and 12).

**Photo 11 Downstream of the footbridge at TF0188268343**

**Photo 12 Upstream of Cliff Farm (TF0187768935)**

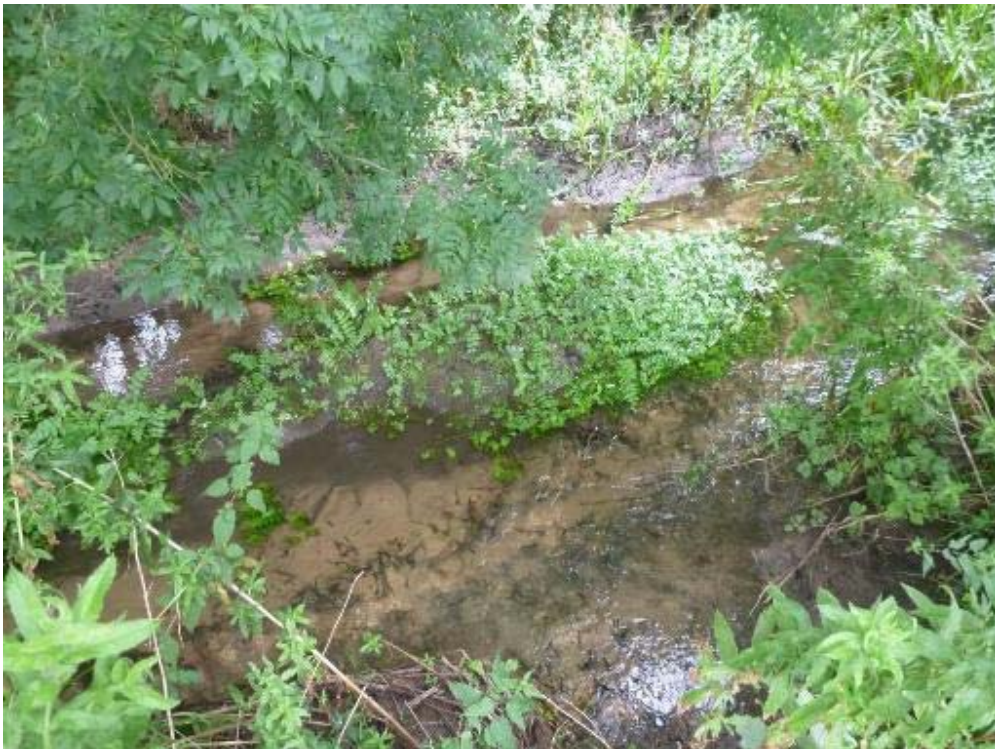
**Photo 16 Fine sediment dominated the bed downstream of Cliff Farm.**

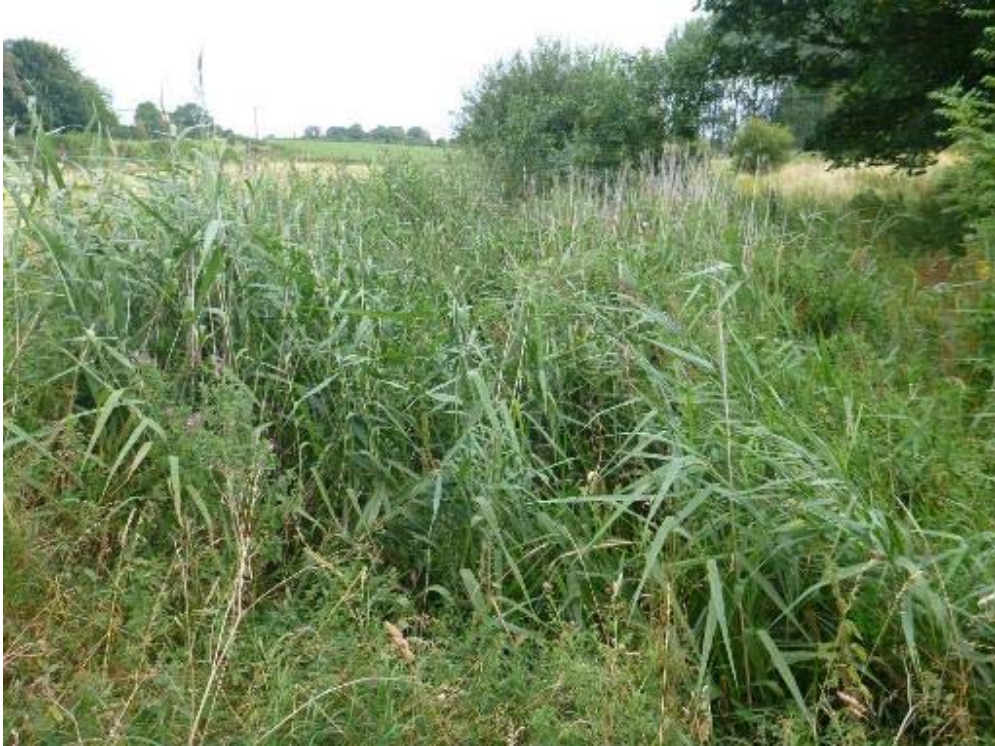
**Photo 17 Dense stands of common reed (*Phragmites australis*) in the channel.**

With progress downstream the brook enters an open area with few trees. Land use is pasture, with a wide, fenced margin along the banks. The channel here is completely overgrown with common reed (Photo 17) and it was not possible to see the brook, except at a couple of crossing points where dog scrambles are keeping the channel relatively clear. At these areas it is clear that the brook bed is dominated by fine sediment (Photos 18 and 19). Excessive inputs of fine sediment are damaging to stream habitat because it deposits on the river bed, filling in the spaces between gravel particles; this suffocates fish eggs and reduces the diversity and abundance of invertebrates.

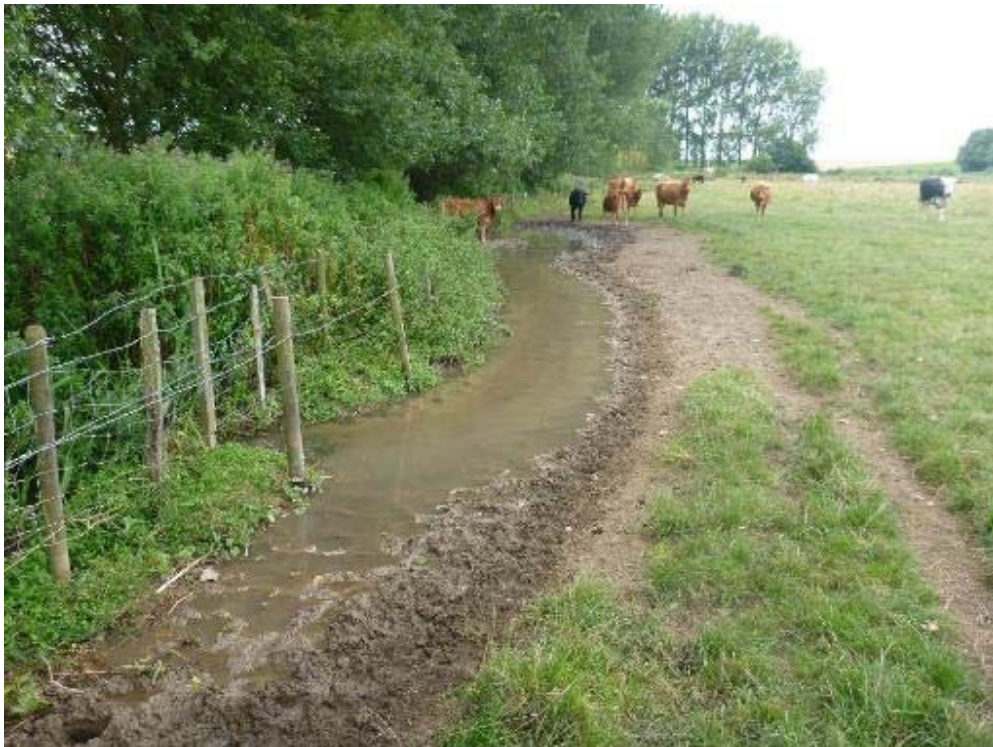
**Photo 20 Cattle drinking area which is creating an input of fine sediment into the beck (TF 02065 69390).**

The last field before reaching Sheepwash Lane had pasture on the left bank (cattle grazing) with a public footpath; the brook is fenced preventing livestock access apart from in one area at a cattle drink where considerable amounts of fine sediment were being mobilised and entering the brook at the time of the visit (Photos 20 and 21). On the right bank there is arable land use with a very wide grassed margin and permissive footpath. The right bank is lined with poplar trees immediately alongside the brook. A number of trout were observed in this reach down to Sheepwash Lane.

Similar improvements could be implemented on the Welton Beck upstream of Sheepwash Lane (Photo 20).

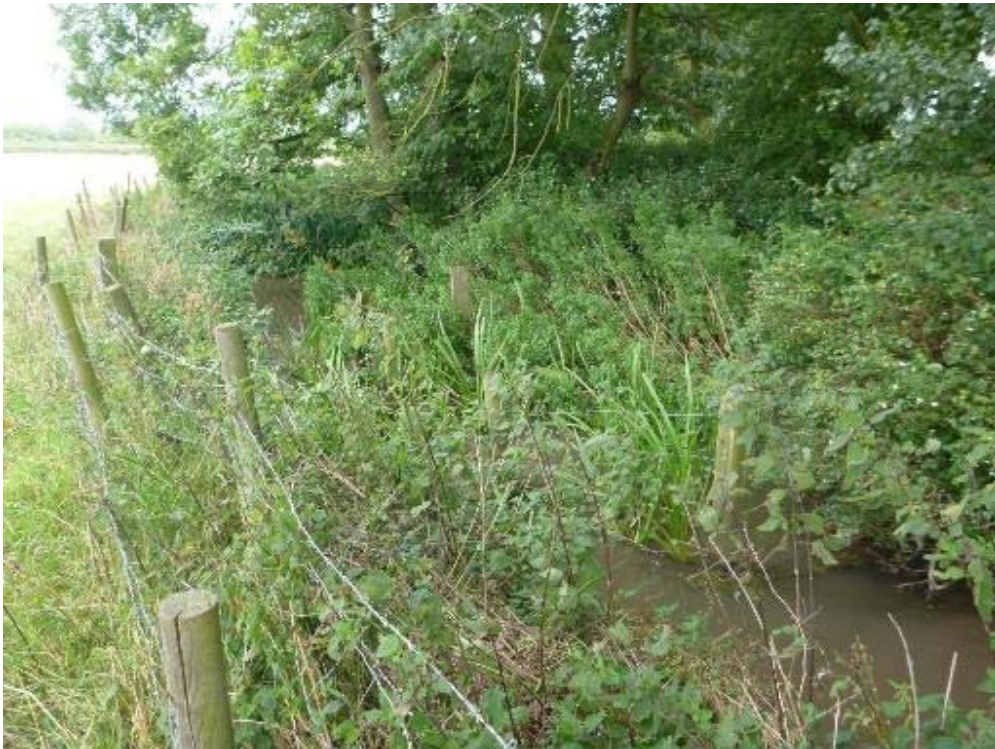
**Photo 21 Good riparian habitat upstream of Sheepwash Lane on the Spires and Steeples Trail. In-stream habitat on this reach could be improved by re-meandering the beck and improving the cattle drink (above).**

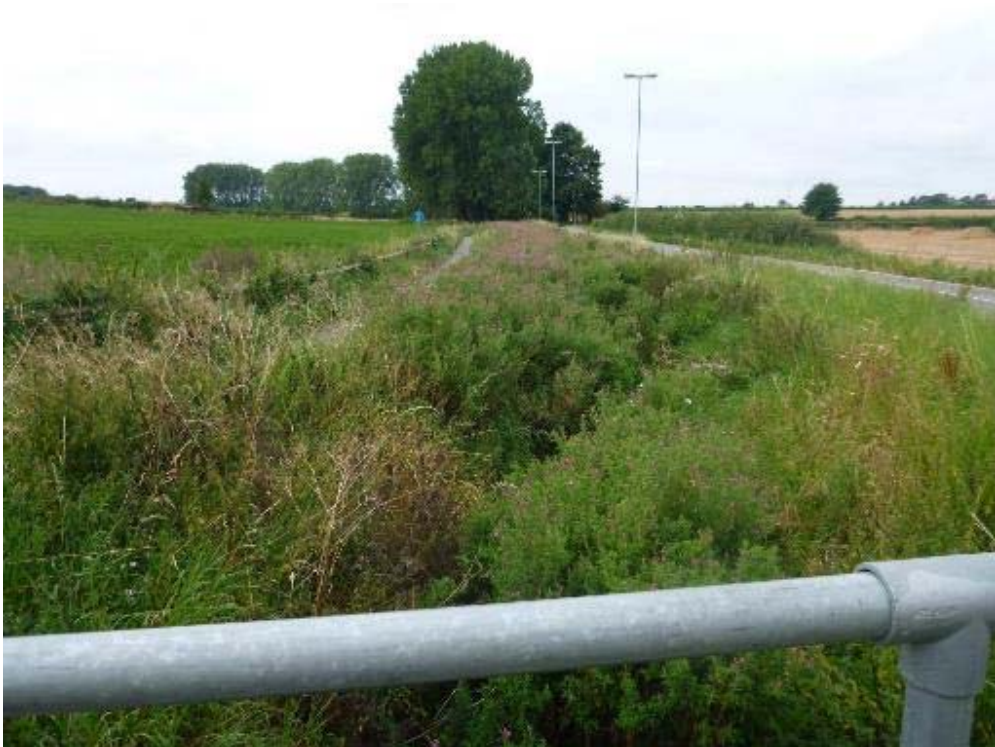
**Photo 22 Section alongside Sheepwash Lane – straightened and deepened for drainage.**

Below Sheepwash Lane, the brook is open and runs alongside the road and cycle path down to the culvert under the railway line. The channel is deeply incised, straight and lined with tall herbaceous vegetation (Photo 22).

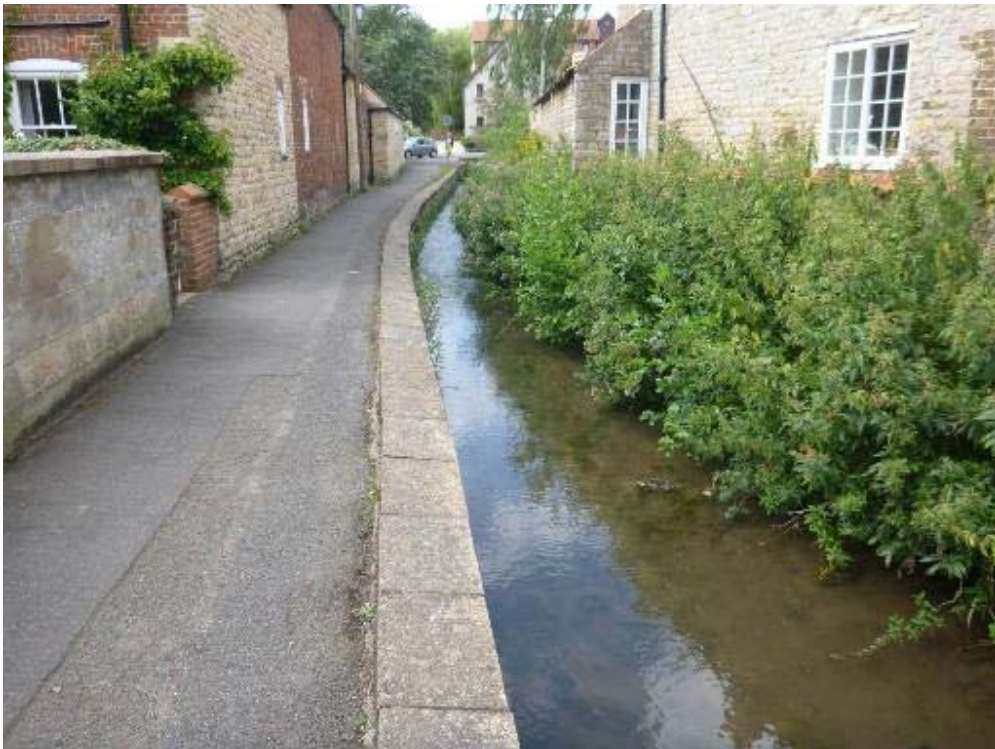
**Photo 26 Hard edging within the village.**

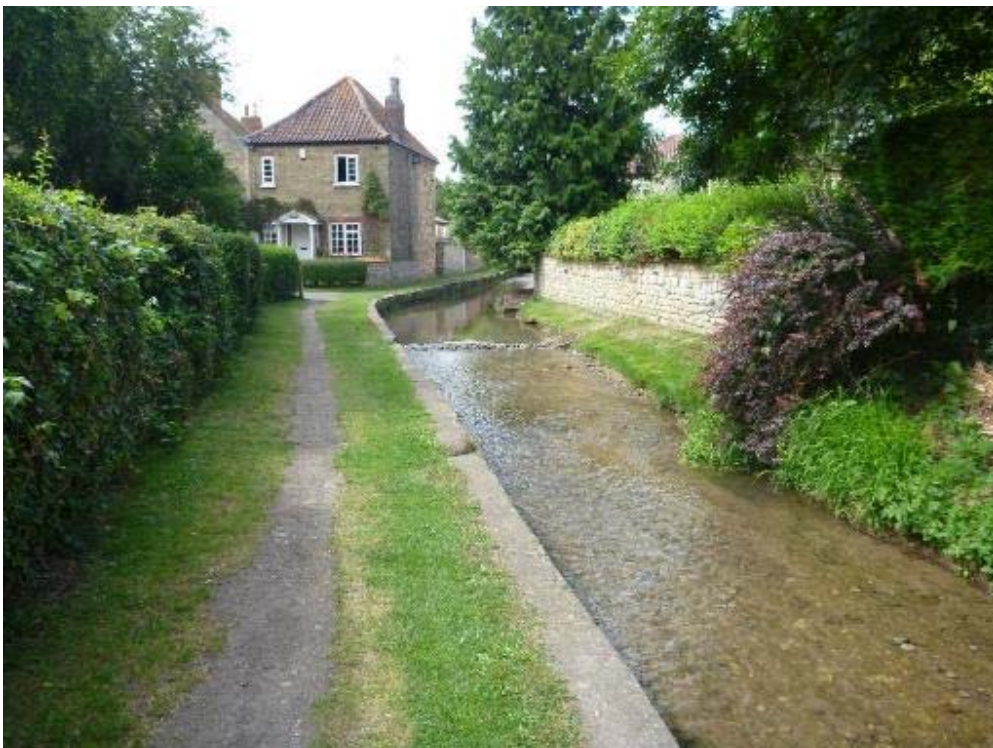
does increase in this vicinity according to the Environment Agency Flood Map. In addition, it was evident that the bed substrate in this area comprised a thin layer of gravel over bedrock, so the extent of bed scour created by any enhancement works is likely to be very limited, restricting benefits to instream habitat.

**Photo 28** Wide, shallow channel with hard edging within the village. Bedrock is only a few inches under the surface gravel here, so the opportunity for creating varied depths through channel narrowing and bed scour is limited.

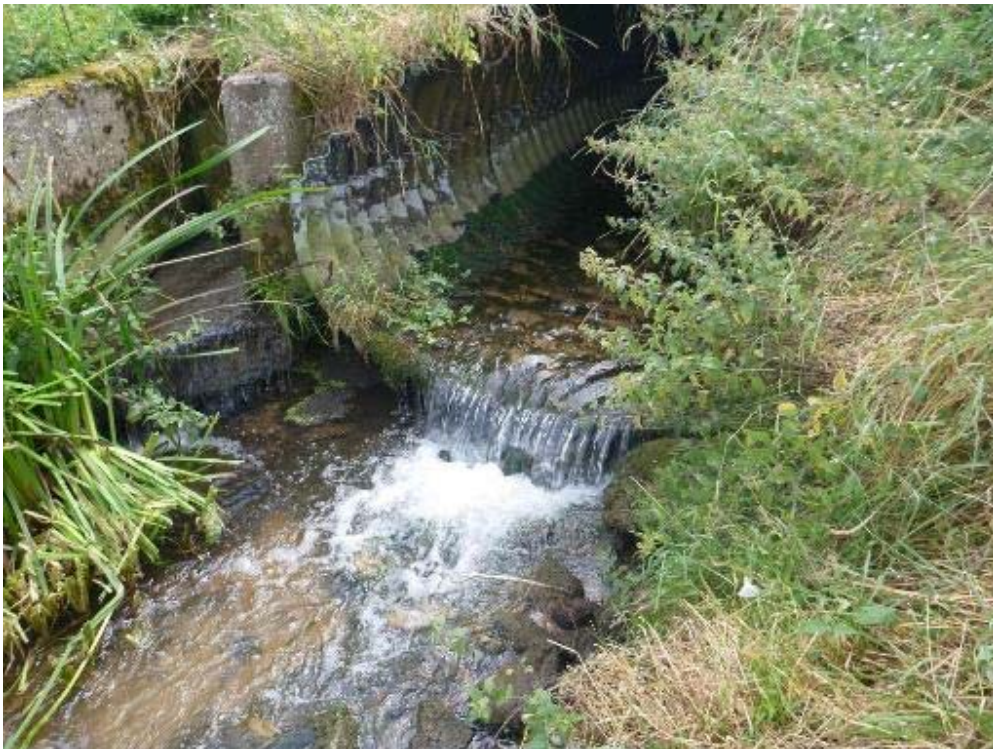
This section of the brook, from Heighington downstream, is designated main river and maintained by the Environment Agency (EA) which includes mowing of the banks and cutting of in-stream vegetation. The latter was ongoing at the time of the visit, with emergent vegetation being cut near the Witham confluence (Photo 36). A culvert under Cowpaddle Lane is slightly perched which would impede fish movements.

**Photo 35 Perched culvert under Cowpaddle Lane bridge**

Where culverts have become perched and a drop between upstream and downstream river bed and water levels has occurred, this can impede free movement of fish and natural sediment transport. To rectify this, the culvert could be replaced with a larger diameter structure (larger pipe or box culvert, Photo 42) set well below bed level. Alternatively, the river bed downstream of the culvert can be raised by introducing stone/gravel to raise downstream water levels (Figures 2 – 3). On the lower reaches of the Branston (Sandhill) Beck towards the Witham, the culvert (Photo 35) could be modified in one of these ways.
