Advisory Visit

Bunnadober River, Co. Mayo, Eire

16th December, 2008

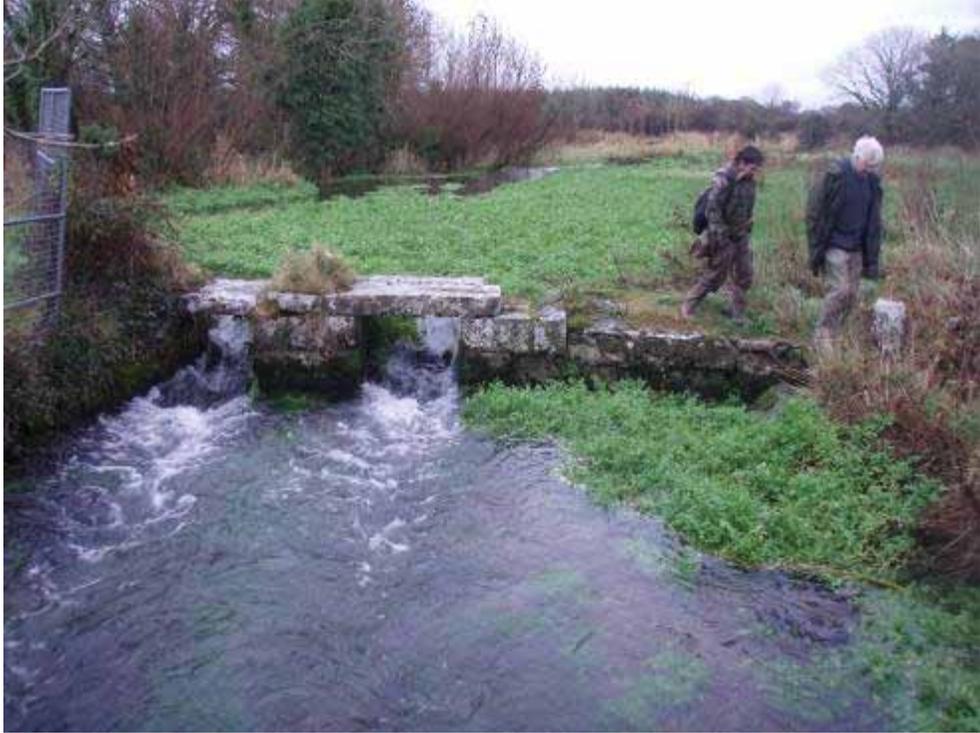
Upstream of the mill is the former mill pond where water would have been impounded to power the mill. Since the mill fell into disuse, the river has reverted to its natural width through the encroachment of marginal vegetation (Photo 1).

Photo 1 Former mill pond, now with open sluices. During the operation of the mill, boards would have been placed in the sluices, and the overspill is where the people are walking. The mill is to the left of the picture.

- Ensure that any plans for the restoration of the mill take account of fish habitat, and restoration work already undertaken. Issues to consider include the backwater effect of restoring the mill pond and sluices; the loss of flow over the restored gravels below the mill if the mill race was reopened; and attraction flows and entrainment/passage of migrating fish (adult and juvenile).

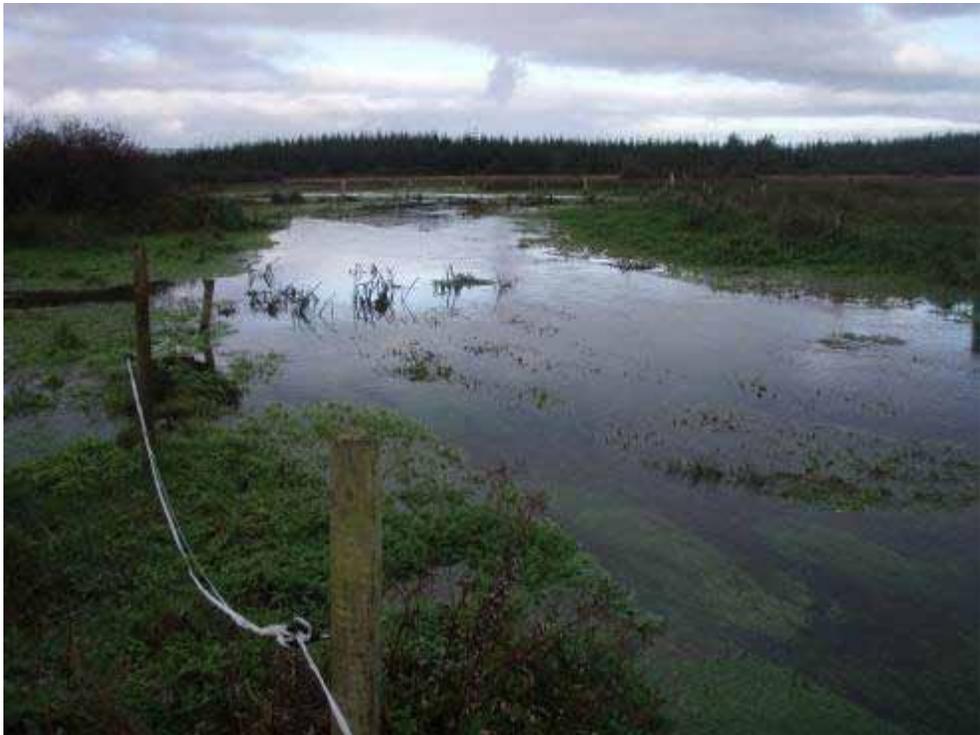
The upper river just below the source is wide and shallow, running through a wet, undrained floodplain (Photos 2 and 3). A typical flora of calcareous areas is present with starwort *Callitriche* sp., mare's-tail *Hippuris vulgaris*, fool's water cress *Apium nodiflorum*, lesser water parsnip *Berula erecta*, and water cress *Rorippa* sp. present. There are also stands of rushes, sedges and grasses. It is not clear whether the channel is naturally wide and diffuse, or whether this is the result of man's activities in the past. There is a stone side to the channel on sections of the left bank, possibly an extension upstream of the works to construct the mill pool.

Photo 2 Upper river just below the source – wide and shallow

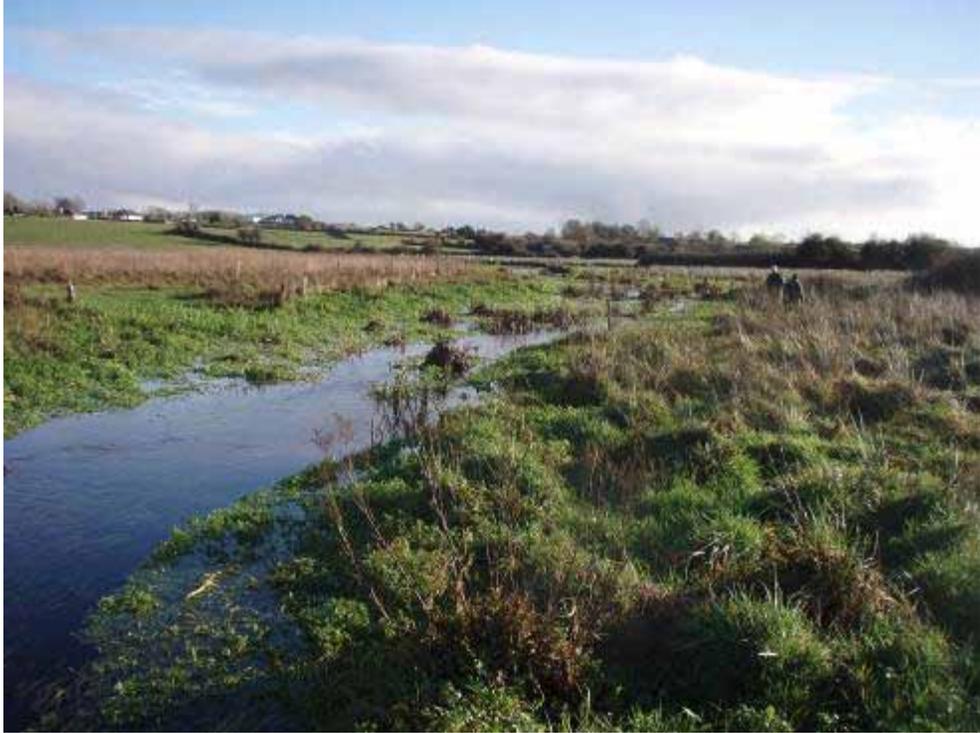
Photo 3 Upper river

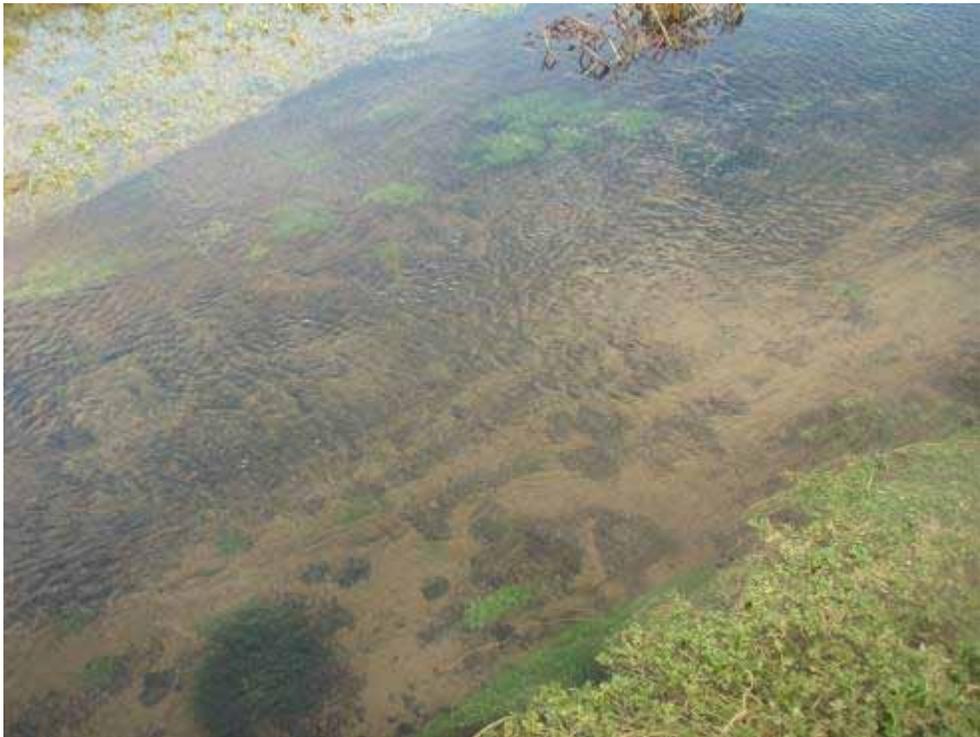
The habitat upstream of the mill is excellent for juvenile trout, but unfortunately there is little, if any, spawning habitat. The bed substrate is uniformly fine sediment because of the wide channel and the associated low water velocities. There are one or two short sections where the river occupies a more defined channel (for example alongside the conifer plantation); here the bed substrate comprises coarser gravels which are the right size for trout spawning, but poorly sorted.

Photo 4 Fine sediments in the upper river

Above the mill, it would be possible to create localised areas of increased water velocity by channel narrowing and introduce gravel in these areas. Probably the easiest way of doing this would be by creating mid-channel islands as described in the *Wild Trout Survival Guide*. A relatively small area of spawning habitat in this section could be of great benefit, as the juvenile trout habitat is excellent. Care should be taken to ensure any works on the section of river above the mill are sympathetic to any conservation interests, and appropriate advice should be sought before any works are carried out.

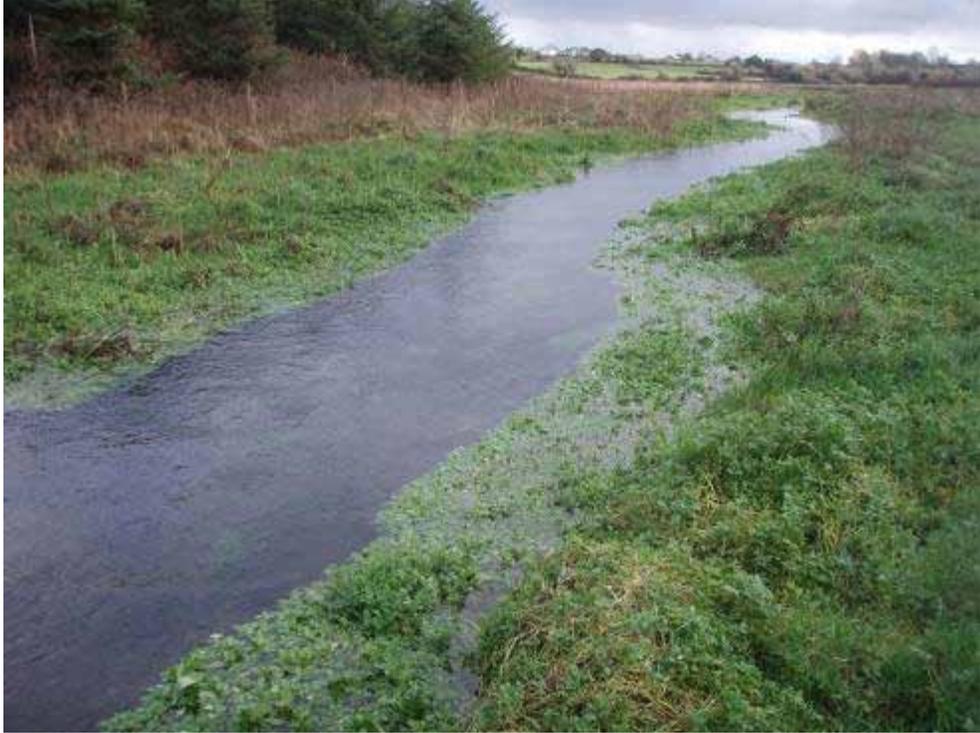
Photo 5 A more defined channel in the upper river (alongside conifer plantation)...

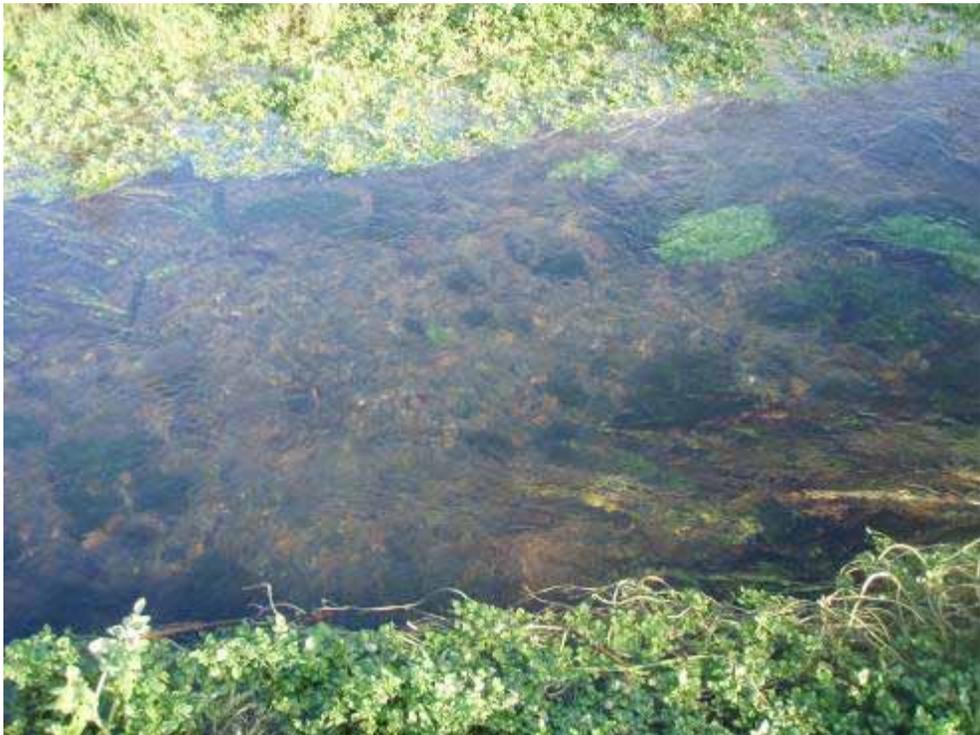
Photo 6 ...and coarser sediments in the faster flow (although still poorly sorted).

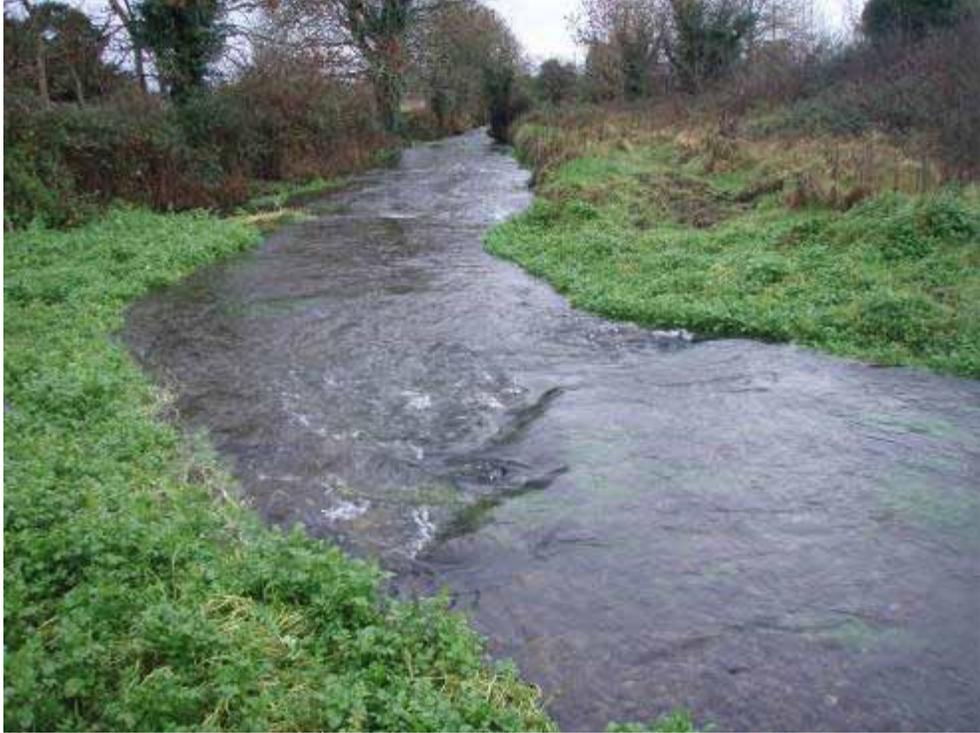
Downstream of the mill, there are a series of low weirs in the channel creating a stepped effect, and then the channel enters a straight section between stone walls, with a relatively steep gradient. Between the low weirs there is a good gravel substrate which is suitable for trout spawning. It is likely that this has been introduced as a spawning habitat improvement. The steeper, straight channel may also have had boulders deliberately placed to create flow variation and retain pockets of gravel for spawning. There is also some good juvenile trout habitat in this section in the form of soft, vegetated margins and cobbles and boulders in the channel.

Photo 7 Downstream of the mill: low weirs, good gravel and vegetated margins. Probably the result of a fishery habitat improvement project.

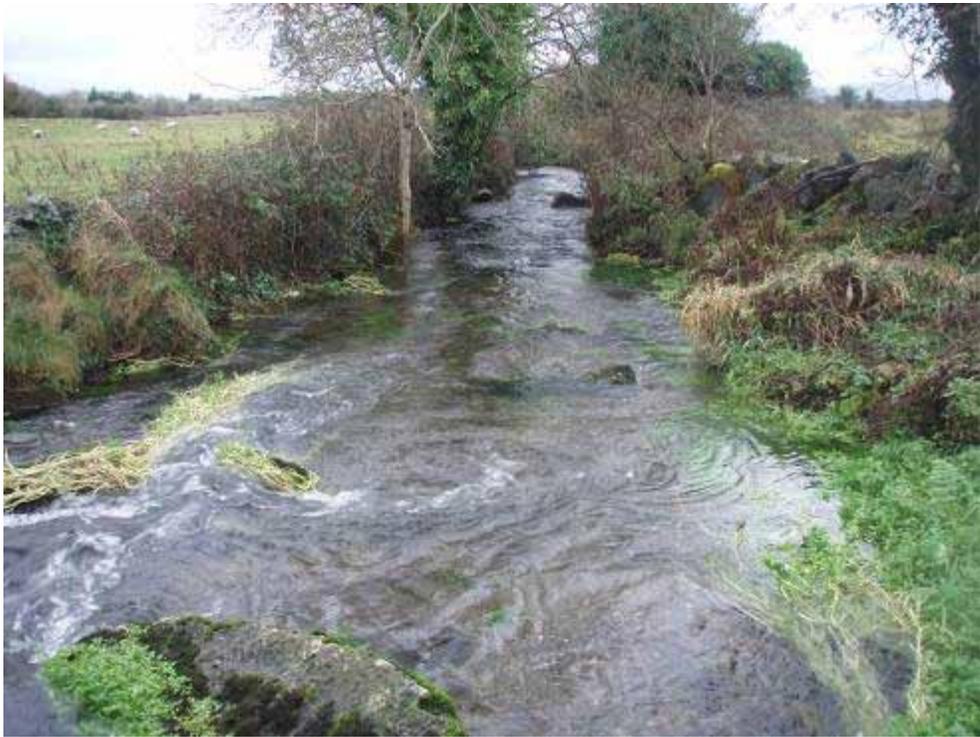
Photo 8 The lower section of the straight steep channel, showing boulders (placed?) and pockets of gravel

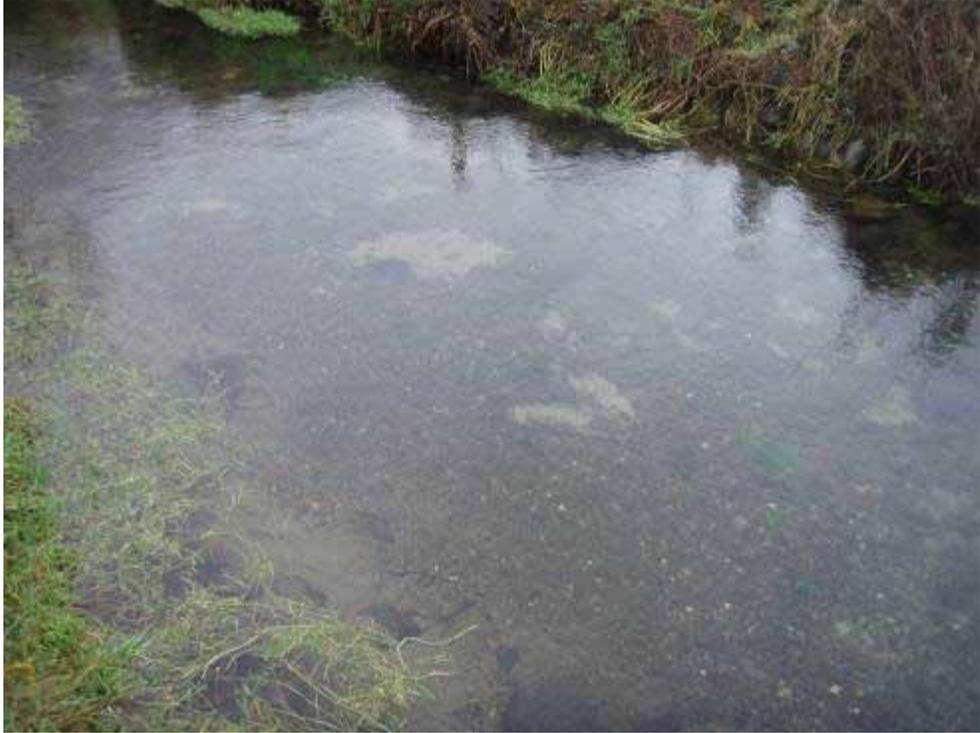
Downstream of the steep, straight, walled channel, the river changes in character as the gradient of the channel levels out. The channel is wider and the bed substrate is marl overlain with a thin layer of fine gravel (Photo 9). There was evidence of the removal of some marginal vegetation here; this is apparently a common practice in late summer/early autumn on the limestone tributaries of the large loughs to prevent total encroachment and facilitate access for spawning trout.

Photo 9 Fine gravel overlaying marl

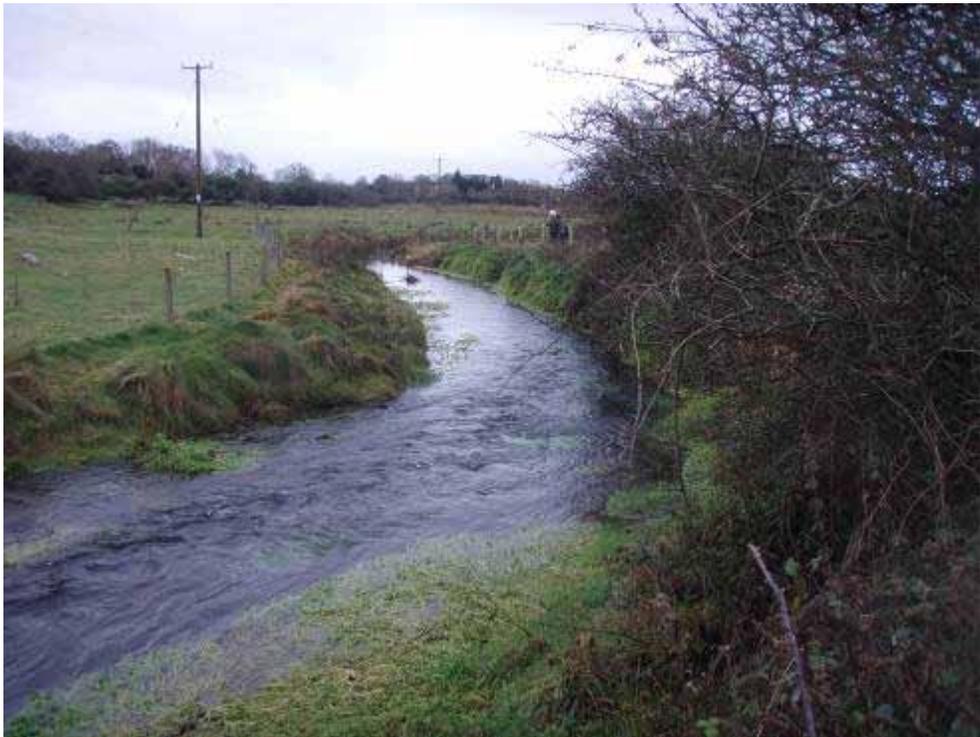
The channel retains some gradient and a reasonable flow velocity (Photo 10) with progress downstream to an outcrop of limestone bedrock across the channel which forms a cascade and a deep scour pool. Beyond this point the channel is very low gradient, overwide and has been dredged for land drainage (Photo 11); the channel is full of emergent vegetation (Photo 12).

Photo 10 Area of higher bed level and higher water velocity

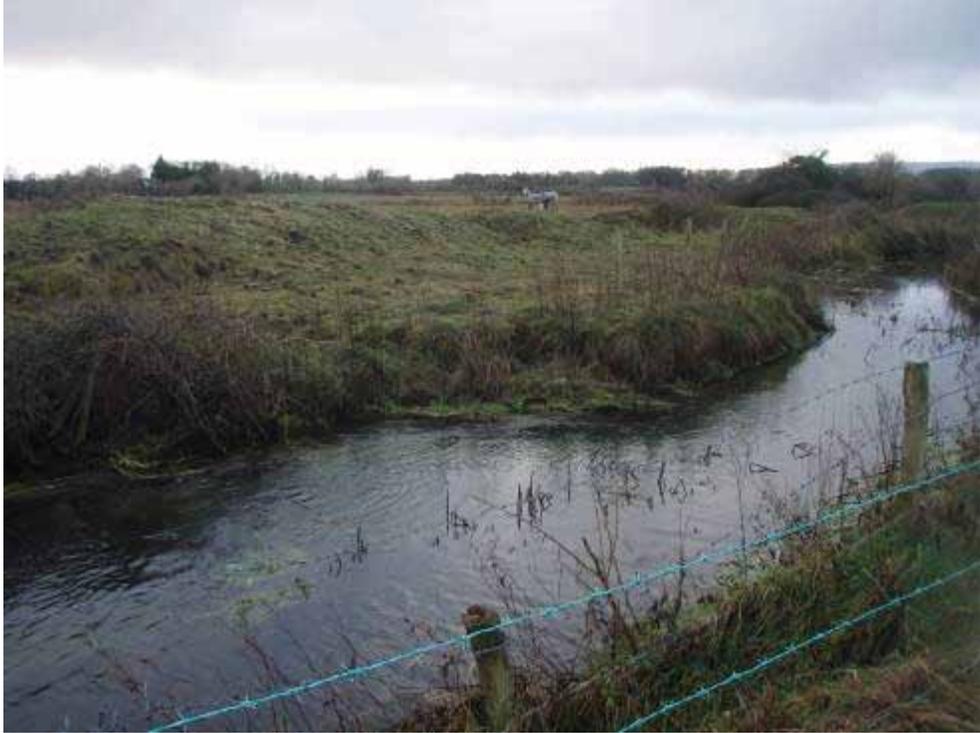
There is a new fence on the right bank which is protecting the river margin from cattle grazing. The left bank has an old fence in a poor state of repair. Spoil heaps from previous dredging can be seen on the left bank downstream of the ditch confluence which prevented further progress.

Photo 11 Dredging spoil piles on the far bank; new fence in the foreground.

Techniques for channel narrowing are described in the *Wild Trout Survival Guide* (supplied) and the creation of a two-stage channel within the current bank line is probably the best option here. There is ample material in the dredged spoil heaps for using as backfill.

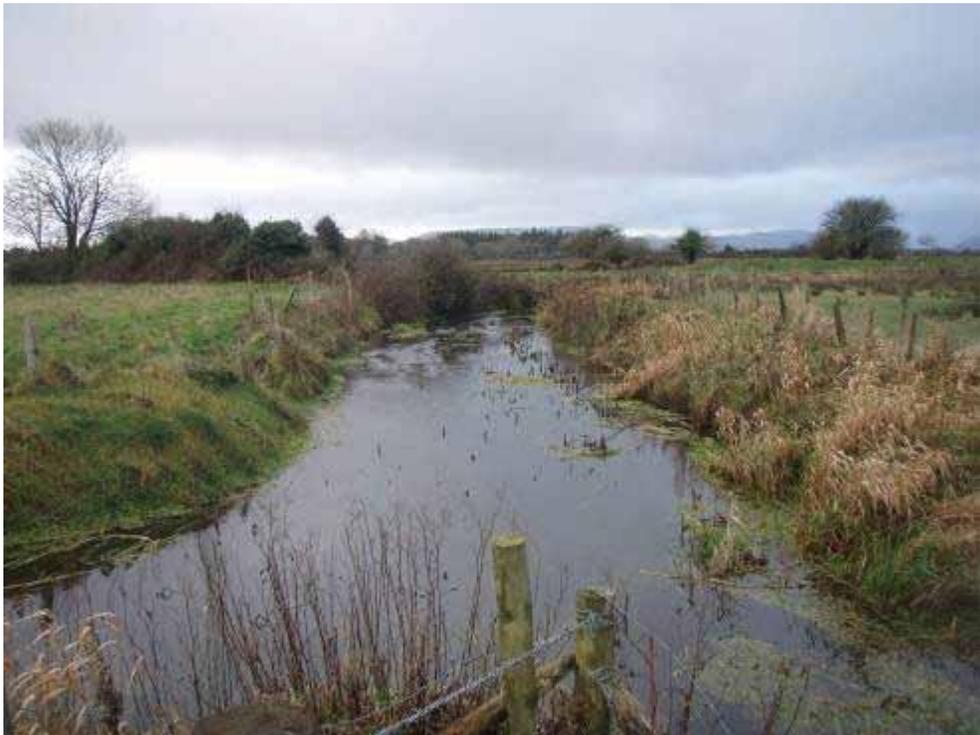
Overall the habitat for trout on the lower section of the river is poor. There is no spawning habitat and the wide, slow, weed-choked channel is not good habitat for juvenile or adult trout. The amount of emergent vegetation in the channel could be a barrier to adult trout running up from the lough to spawn; this visit was in December when much had died back, yet there was still a considerable amount present. There was little evidence of spawning activity on the gravels near the mill, which contrasted markedly with some small tributaries of Lough Corrib which were visited subsequently (see below). This suggests that there are few trout currently using the Bunnadober for spawning.

Photo 12 Low gradient, lower river – wide, slow-flowing and with emergent vegetation across the whole channel. The hills in the distance are on the far (west) side of Lough Mask.

A more short term approach to improving access on the lower river would be controlling the emergent weed growth mechanically or with the herbicide glyphosate. Again, consultation with the relevant authorities is required.

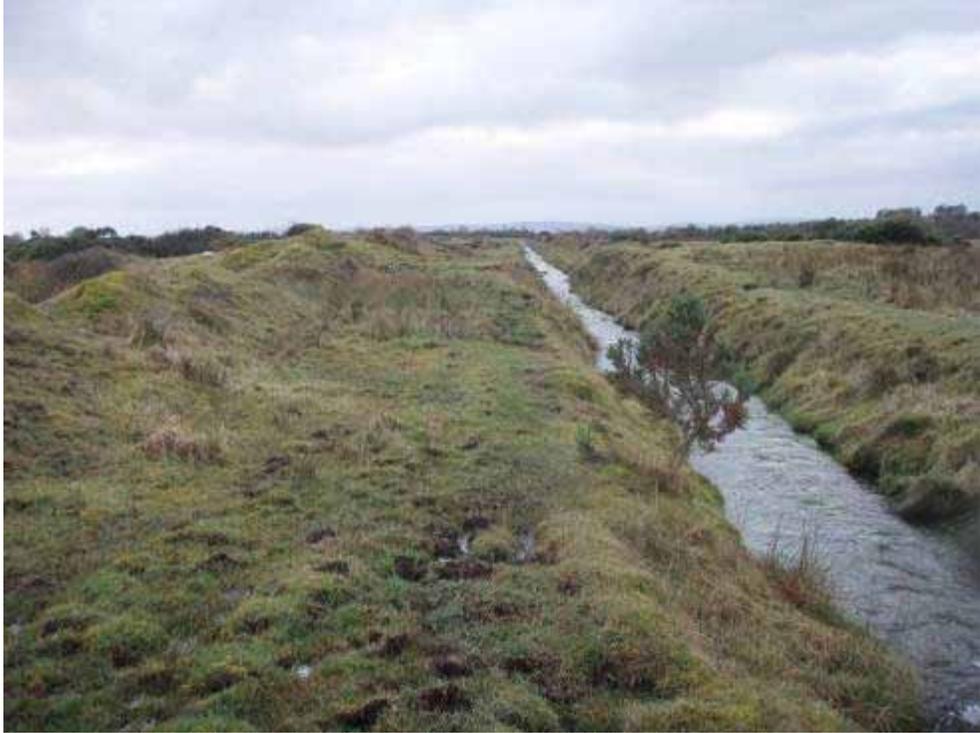
Photo 13 Ballynulty Stream – straightened and dredged (spoil heaps on LHB); the subject of a habitat improvement project

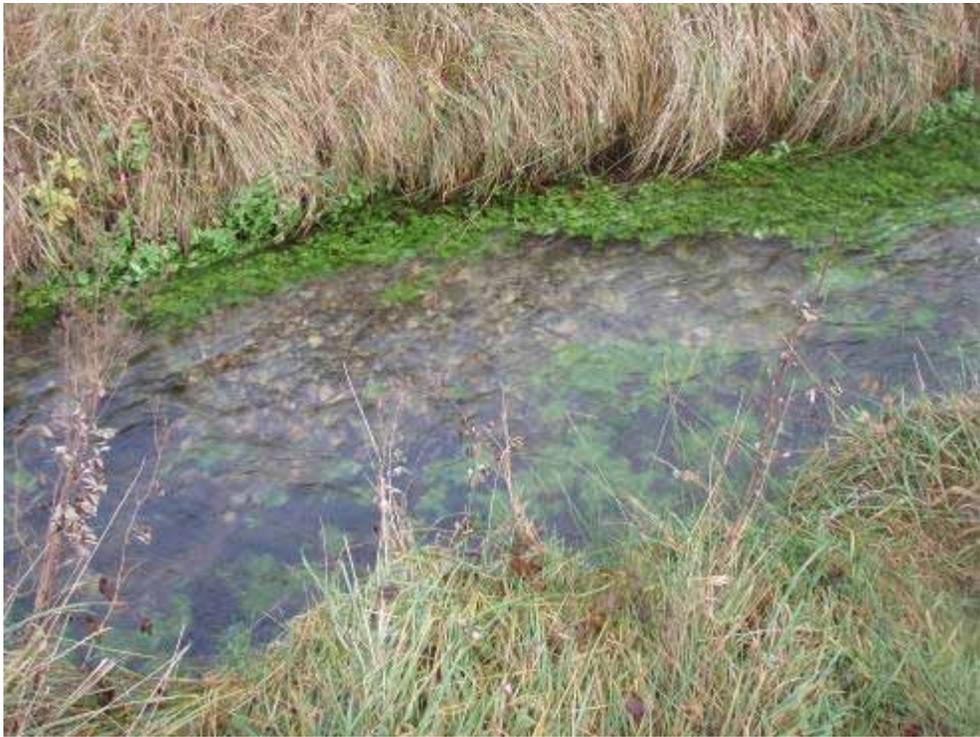
Photo 14 A large trout redd on introduced gravel in the Ballynulty Stream

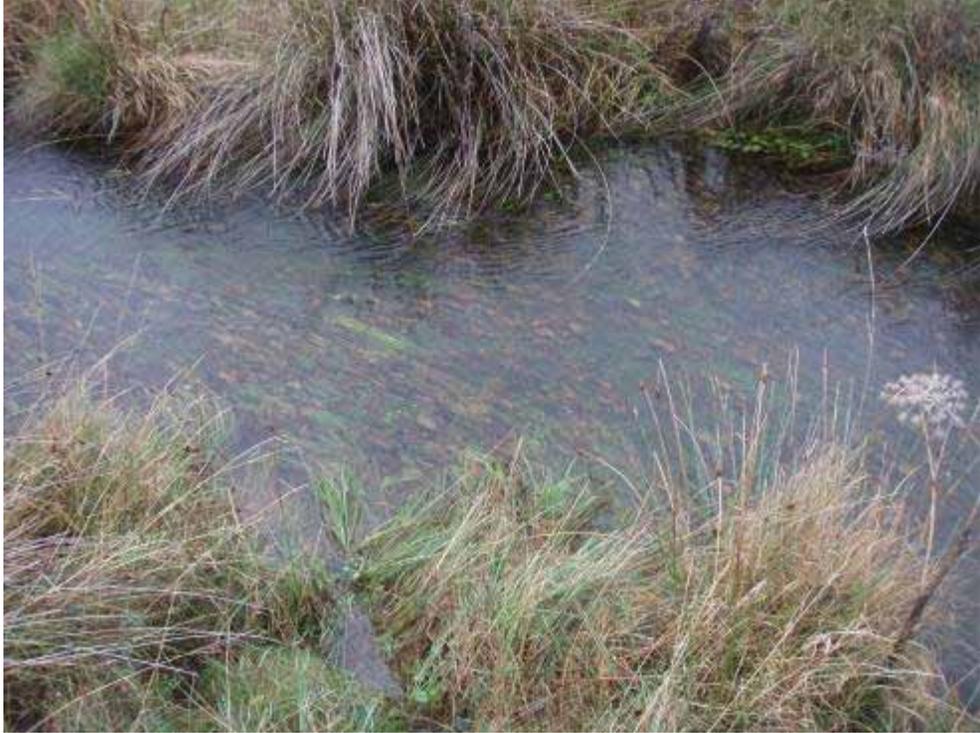
Photo 15 The bed of the Ballycurran Stream in an un-restored section – note the weed cover

Plenty of trout spawning activity had occurred in both streams, and redds were clearly evident throughout the improved sections. On the Ballycurran Stream it was interesting to see the contrast between the restored and un-restored sections; the latter were slow-flowing with a bed covered in vegetation comprised of species favouring slow flows (e.g. broad-leaved pondweed *Potamogeton natans*). There was no spawning activity in the un-restored sections, although these may provide valuable cover for fry and parr and help to hold up water levels in summer.

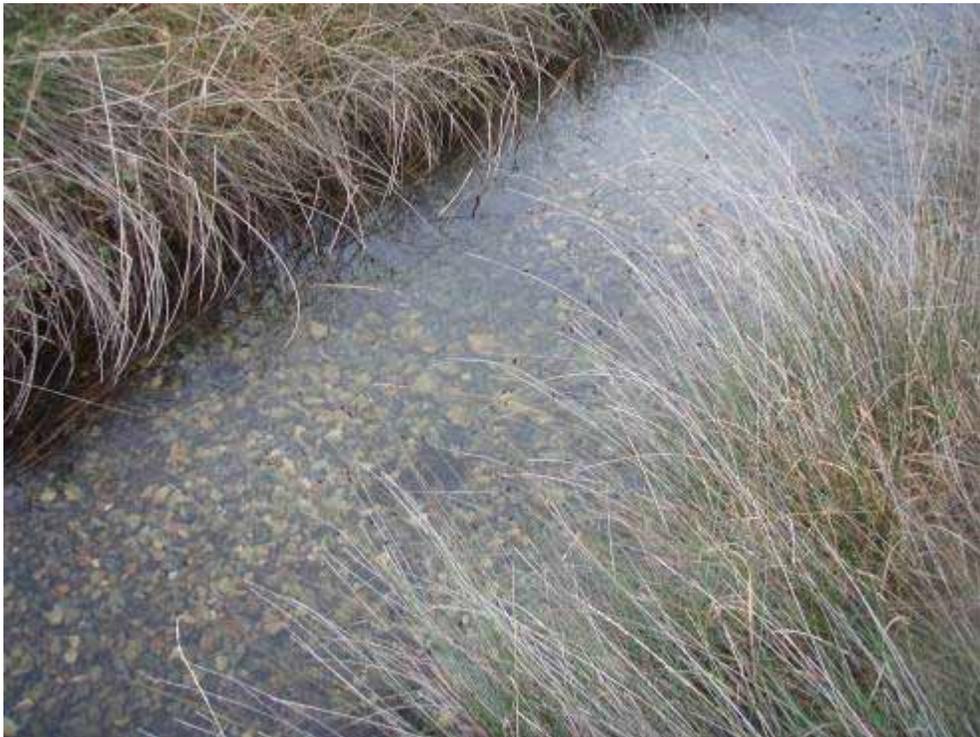
Photo 16 Introduced gravel on the Ballycurran Stream, with evident trout spawning activity
