By Brook, Ford to Slaughterford, Wiltshire

An Advisory Visit by the Wild Trout Trust August 2016

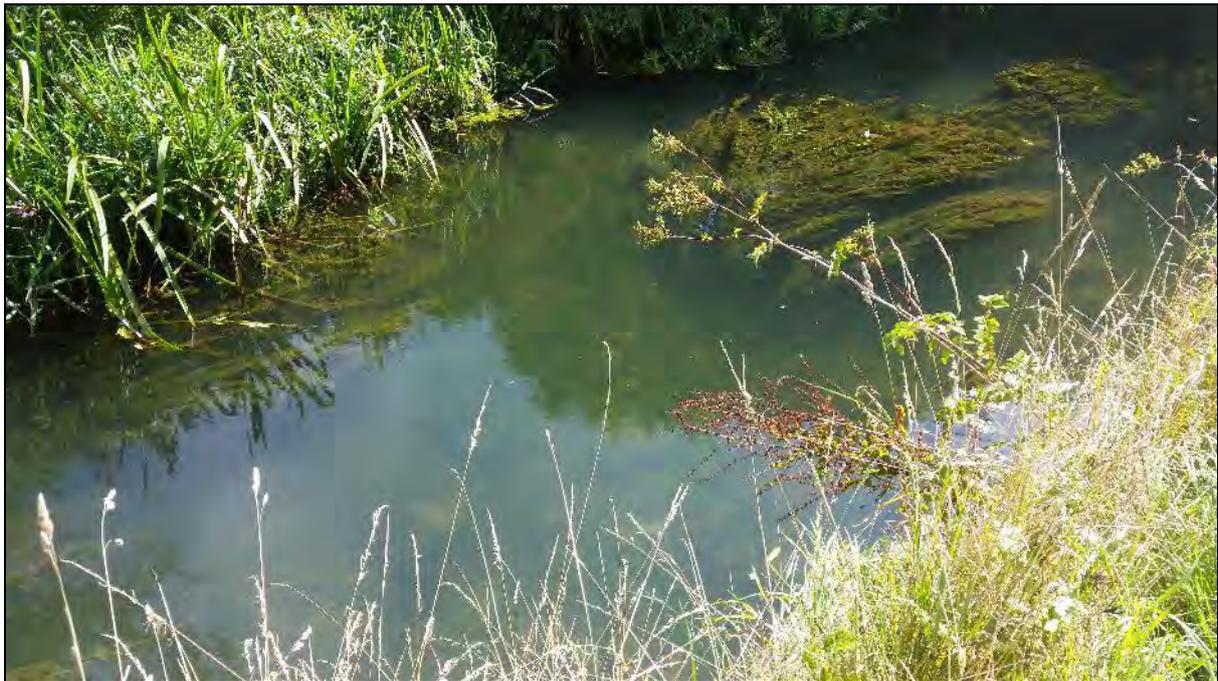
bed. As observed in the 2009 visit, the brook was experiencing a significant algal bloom which coated the bed and much of the submerged weeds (Figure 2).

Figure 2: Algae covers the bed and some of the submerged weeds

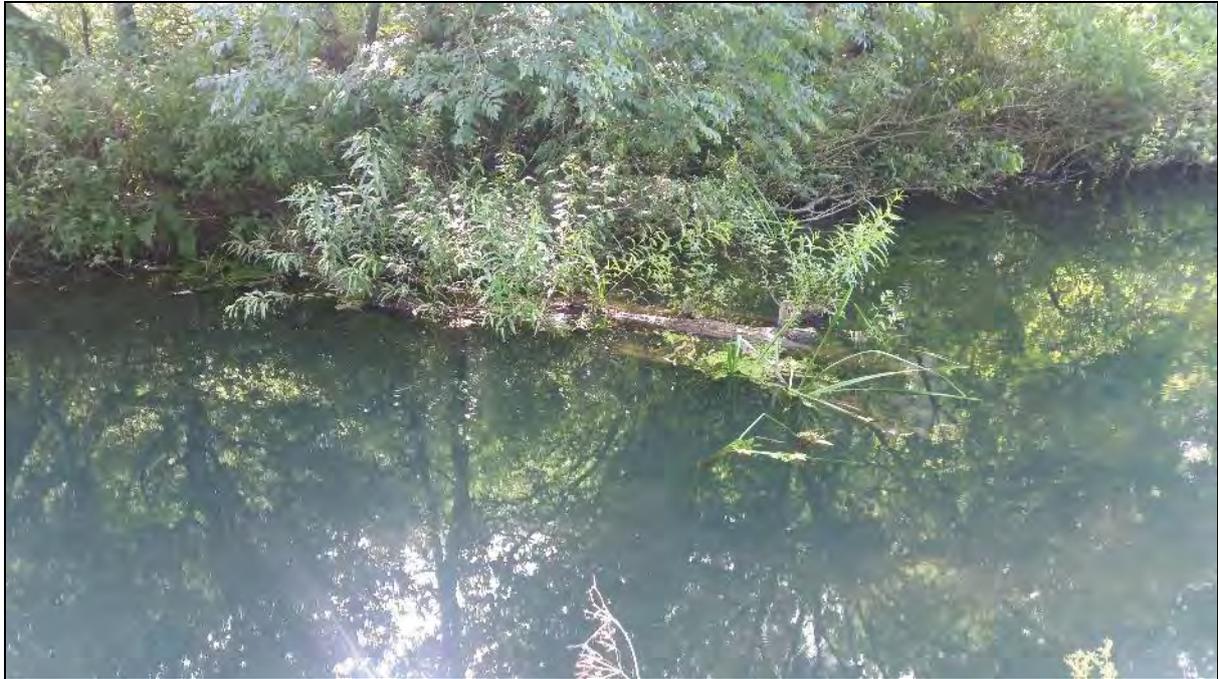
A few woody habitat features have been installed which are providing some additional cover habitat and probably provide some good lies for adult fish (Figure 5). However, the low energy flows, which characterise the brook throughout the vast majority of the year, significantly limit the ability of such

Figure 5: Woody habitat features provide additional lies but provide limited flow deflection in impounded flows

features to function as flow deflectors (limiting their influence on the morphology of the channel). It may be worthwhile introducing some additional woody habitat features in positions and orientations that will maximise their potential to deflect flow and influence habitat beyond their immediate location. However, even the most pronounced of features will have a limited effect whilst the brook remains impounded.

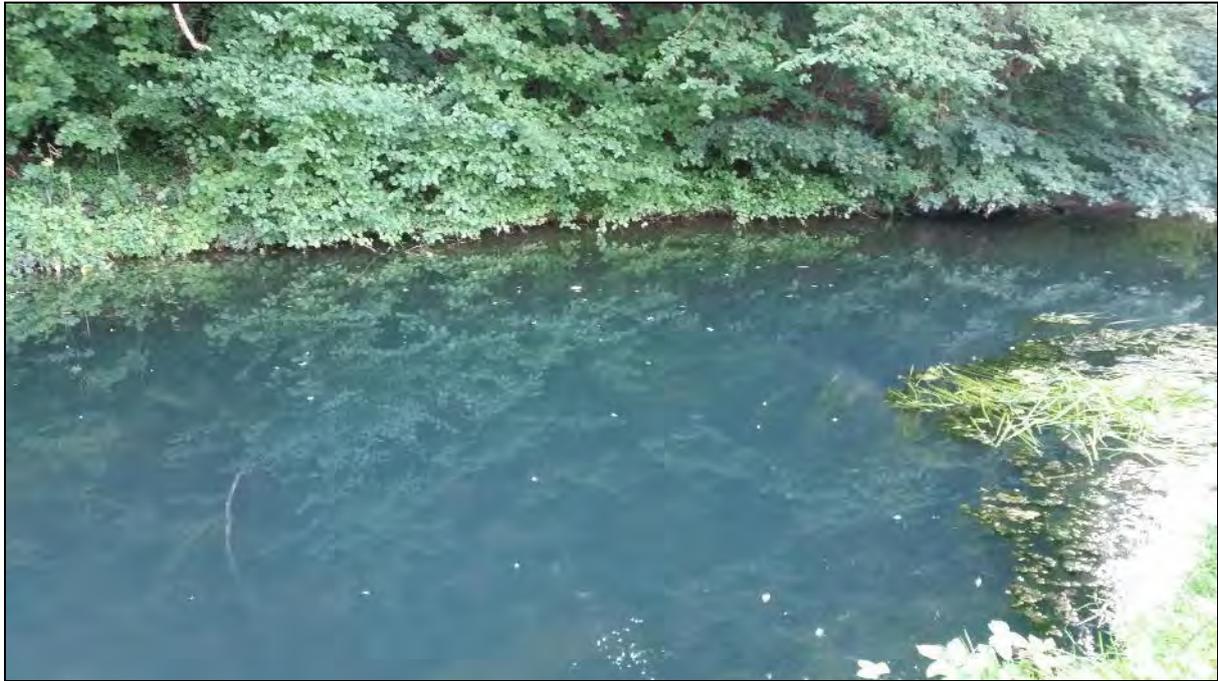
The sluggishness of flow through the reach is further compounded by the channel being significantly over-wide and deep for the mean discharge of water the brook carries (Figure 6). The presence of pondweeds (Figure 7 - species not identified), that would normally be found in stillwater or extremely slow-flowing waterbodies, highlights the extent to which the brook has diverged from its natural state. It is advisable to check if the pondweed is an alien invasive such as Canadian pondweed (*Elodea Canadensis*) or Curly waterweed (*Lagarosiphon major*) and eradicating if required.

Figure 6: The overwide channel further compounds the sluggishness of flows and uniformity of habitat

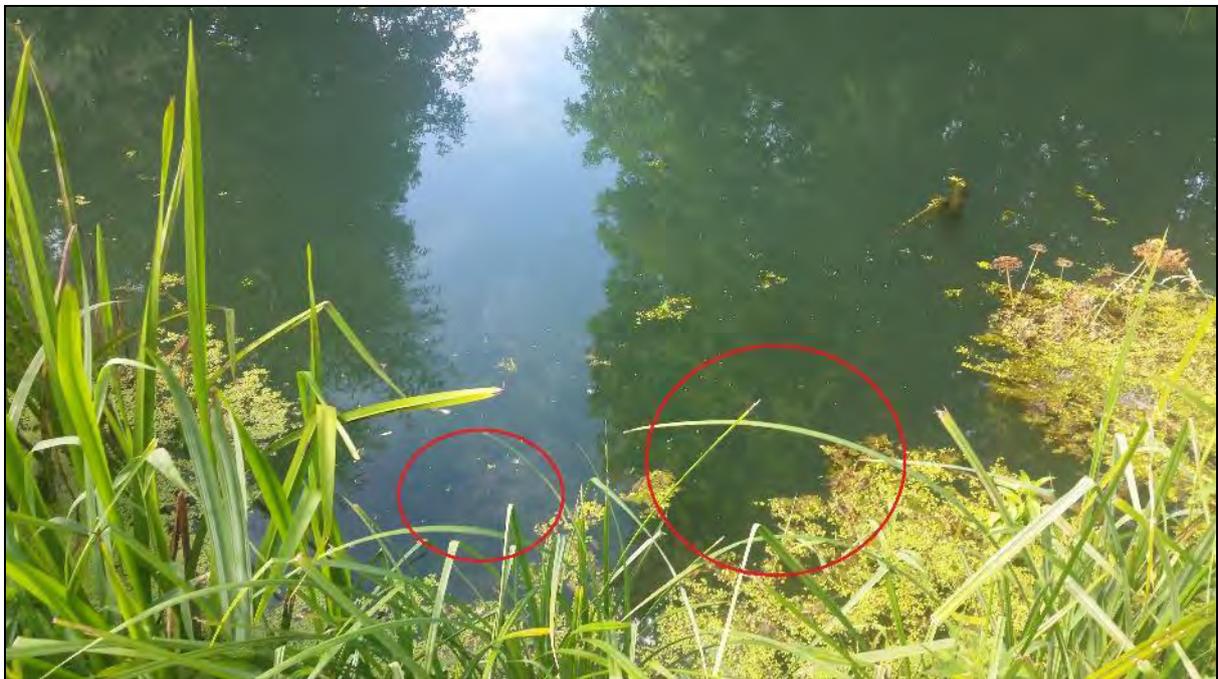
Figure 7: Partially obscured by the reflection of bankside trees, pondweed (circled in red) is indicative of extremely slow flows

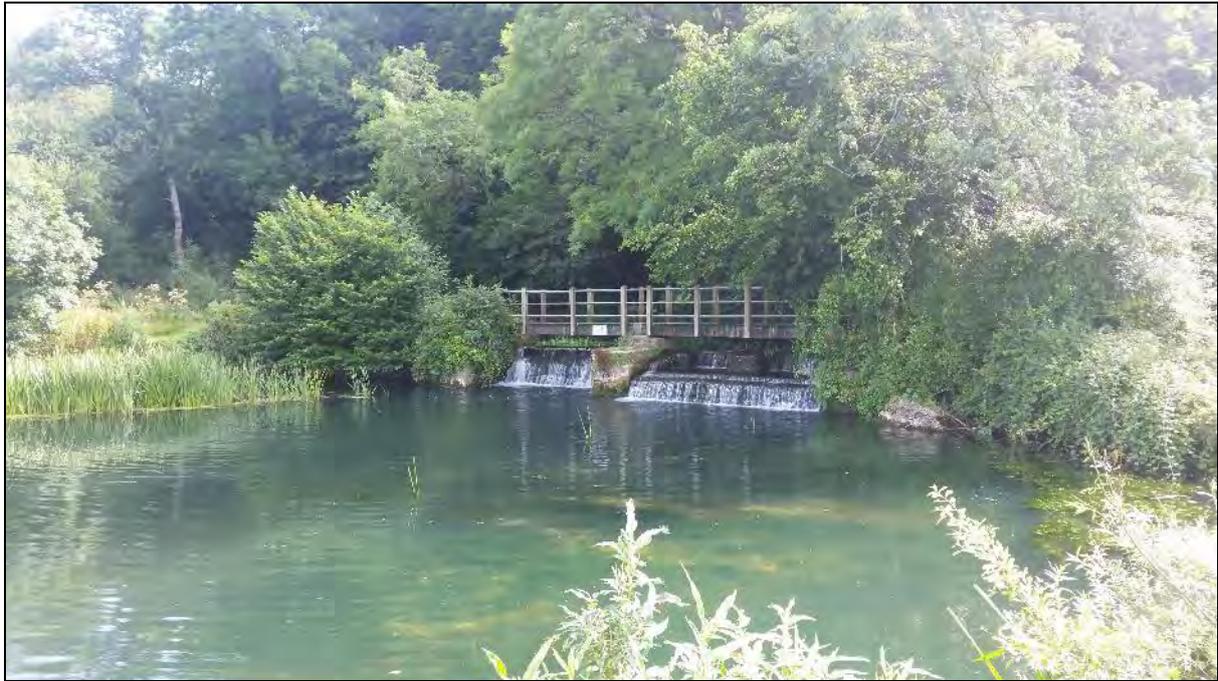
At NGR ST 83805 74520, a large weir impounds the river and presents as a complete barrier to fish passage (Figure 8). This structure is severely reducing habitat quality upstream (as illustrated Figure 9) as well as having other impacts on the river downstream (as illustrated Figure 10).

Figure 8: An upstream view of the uppermost impoundment

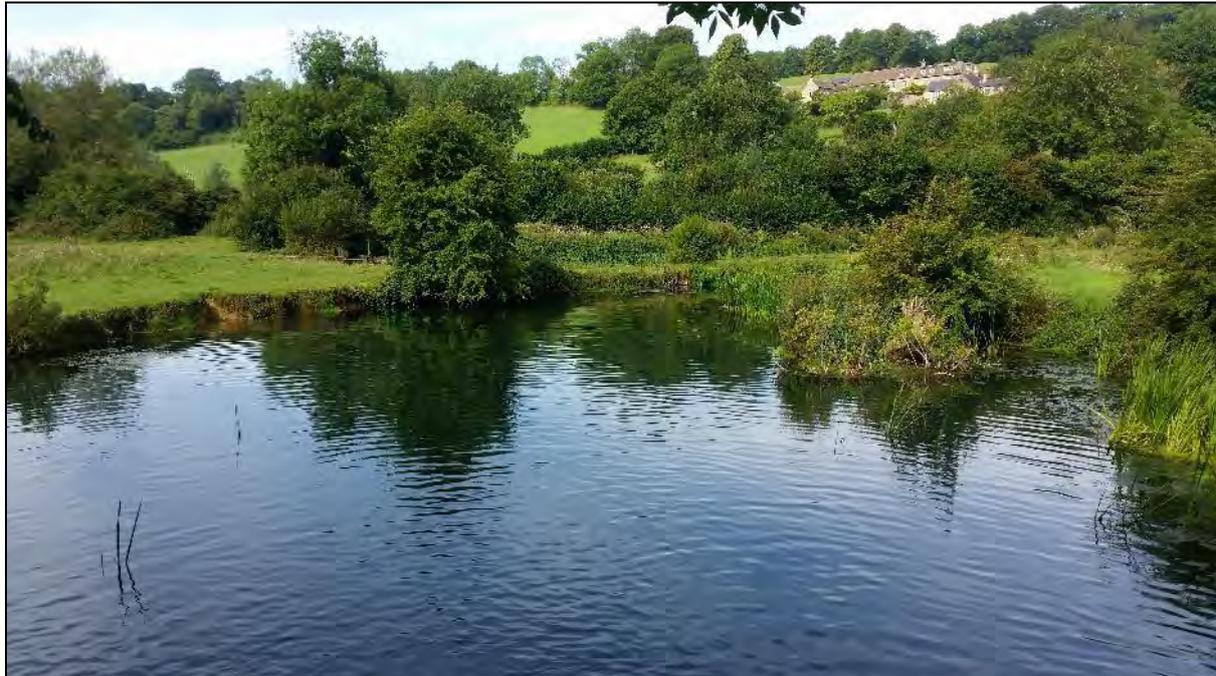
Below the weir the river abruptly widens (Figure 11). There are probably several factors contributing to the rate of bank erosion at this location. Dogs and grazing livestock have accelerated the rate of erosion but the interruption of natural sediment transport caused by the weir, along with eddying flows around the pool, are probably significant factors. A cursory inspection of the riverbed highlighted a general lack of any stony substrate (Figure 12).

Figure 11: The widened channel below the uppermost impoundment

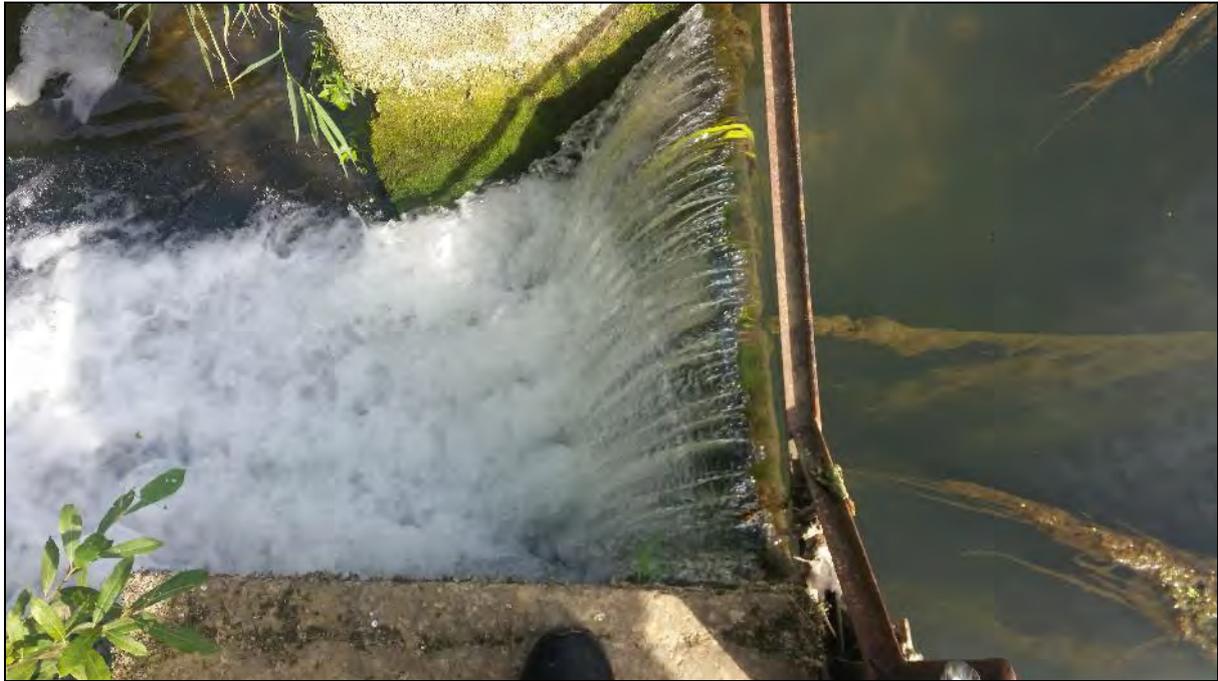
Figure 13:

A short distance downstream, a sluice forms another impoundment and barrier to fish passage (Figure 13). Whilst the deeper water created by impounding the river may be considered by some to provide good holding water for larger, stocked trout, the slow flows may also be altering the behaviour of trout and impacting on the quality of angling. Adult trout in naturally free-flowing rivers often seek out lies where they can hold up on the edge a fast run of water **(sometimes referred to as a 'feeding lane')** and **take passing prey from the surface or mid-water**. In sluggish flows, the lack of distinct feeding lanes is likely to impact on trout feeding behaviour, so that they cruise, looking for food and feed more opportunistically. Dry fly fishing for cruising fish is a difficult undertaking and very few anglers enjoy much success in such circumstances. Furthermore, slow-flowing water is also warmed more quickly by the sun (especially if the riverbed is covered in dark silt); warmer water retains less dissolved oxygen and this can reduce trout activity, making them less inclined to take a fly. Temperatures above 20 degrees C will put trout under severe stress and can sometimes prove fatal. As well as degrading habitat quality, impassable impoundments prevent trout from accessing potential spawning habitat upstream. They also prevent sections of river from naturally repopulating following pollution incidents or other fish kill events.

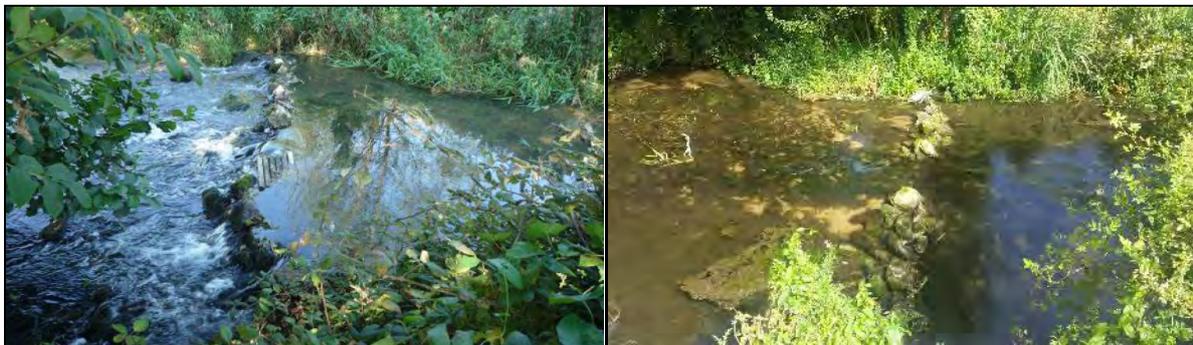
Downstream of the sluice the river is more free-flowing. It was encouraging to see that a small weir identified in the 2009 advisory report had been modified as recommended (Figure 14).

Figure 14: Left: The small weir in 2009. Right: The weir with centre third removed 2016

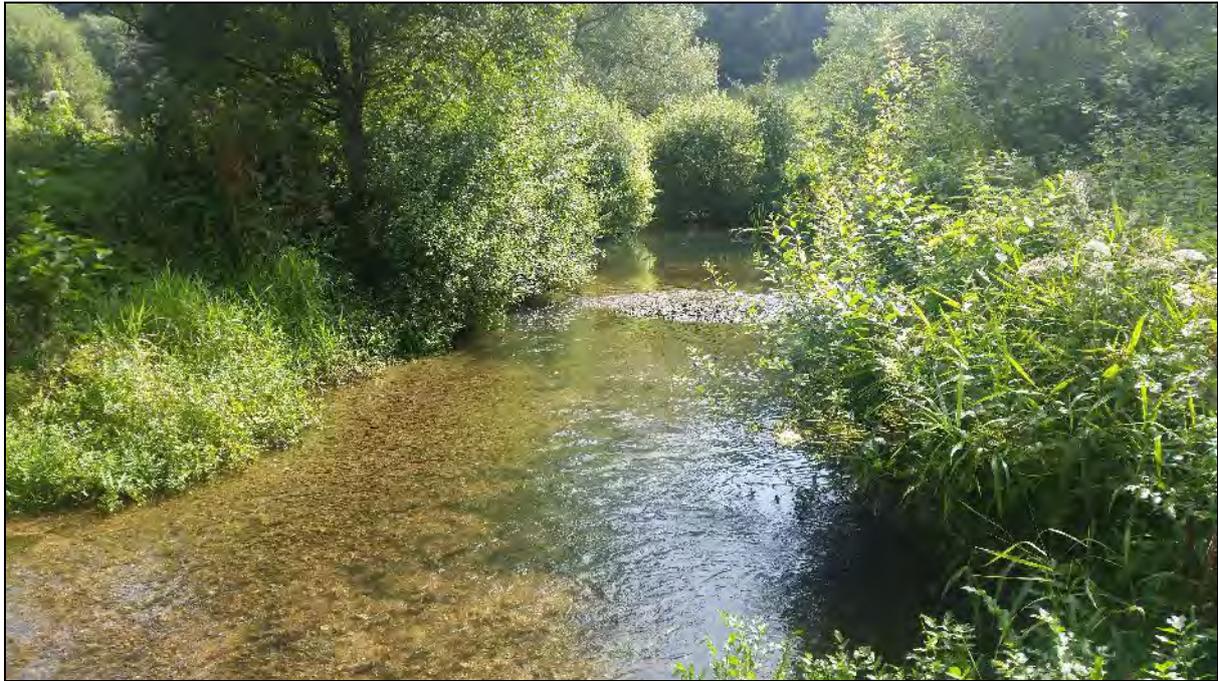
Figure 20: A shallow riffle would benefit from some simple flow deflecting woody habitat features

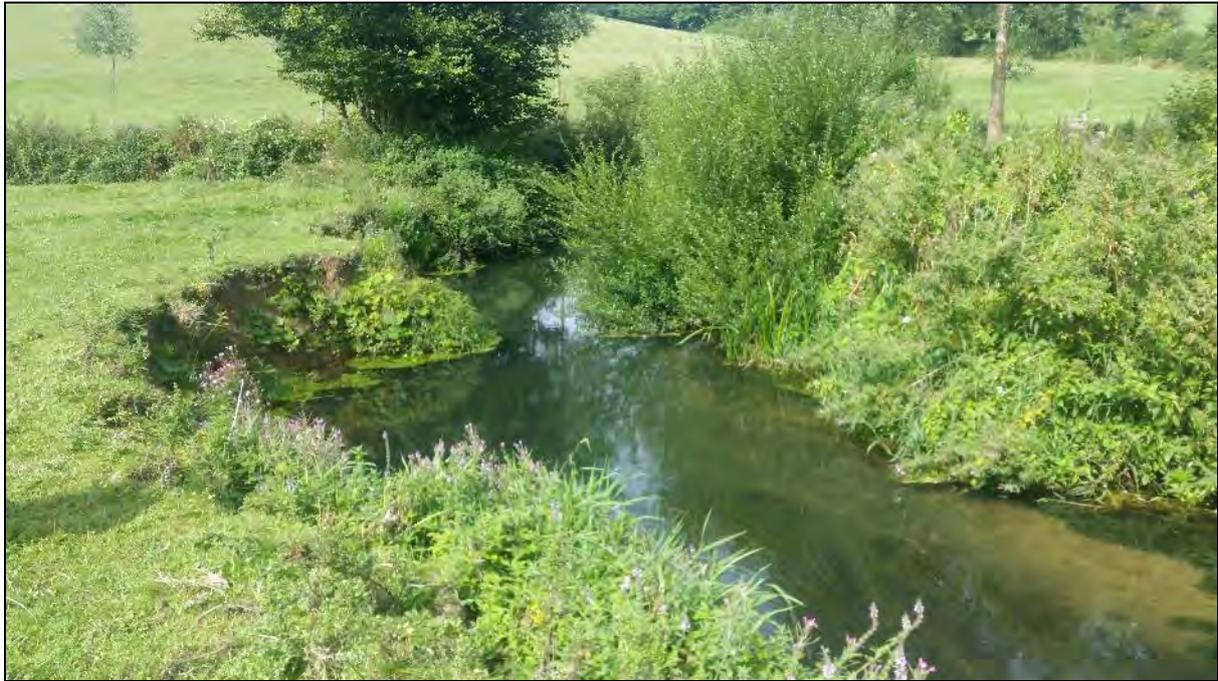
In the next field downstream, the brook deepens and flows slow (Figure 22). Intensive grazing has denuded the upper bank of root structure and accelerated bank erosion. Reduced bank stability and increased soil compaction will significantly increase the volume of fine sediment entering the brook at this location. After a short distance the bed rises up into a shallow glide (Figure 23). Although the brook is relatively shallow at this location, flow is nonetheless influenced (slowed) by another impoundment downstream.

Figure 22: Flow slows down again and becomes laminar

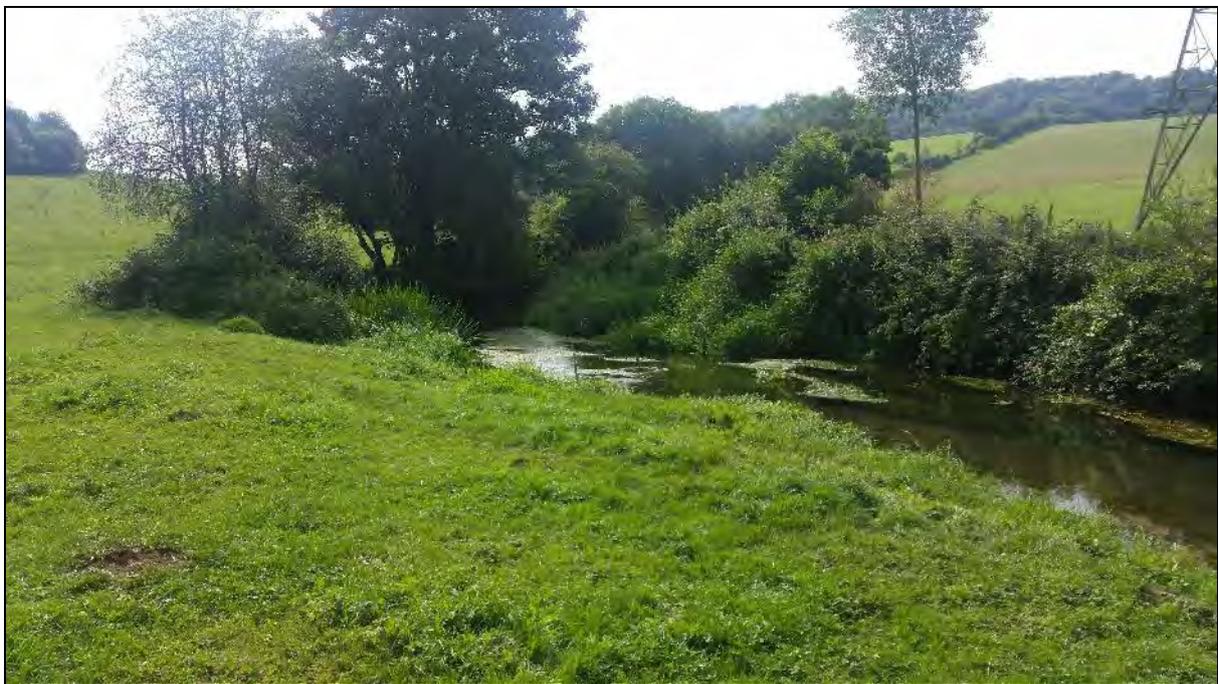
Figure 23: A shallow glide provides some variation in depth but flow is slowed by an impoundment

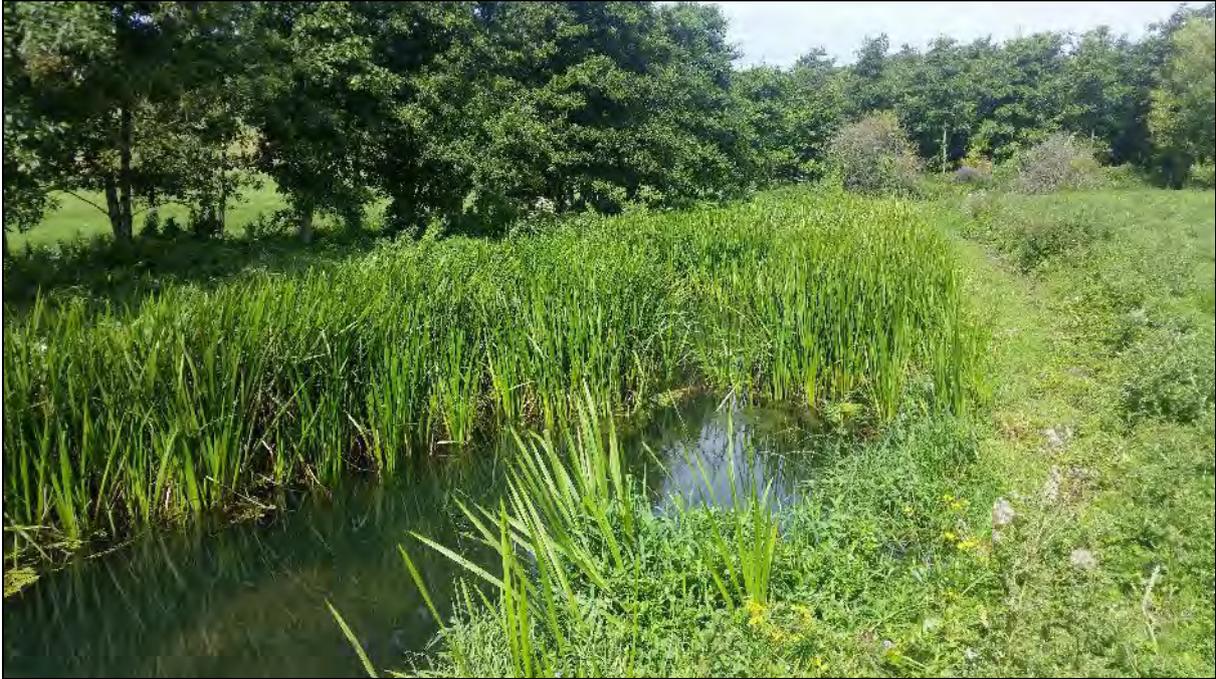
Through the downstream half of the field, the character of the brook changes dramatically: it becomes canalised in an artificially straight and uniformly deep channel and flow is extremely slow and laminar. The slow flows, uniform habitat and total lack of tree cover has resulted in bur reed (*Sparganium erectum*) encroaching across the channel. In a natural river, marginal plant species are only able to encroach as far as flow, depth and light conditions will allow. However, in impounded and uniform channels there can be very little difference between the conditions at the river margins and the centre of the stream. A lack of any shade from bankside trees further compounds the problem resulting in a

channel that will require a substantial amount of expensive annual maintenance to remain functional.

Figure 24: The straightened and impounded channel is lacking tree cover. Perfect conditions for uncontrolled marginal encroachment.

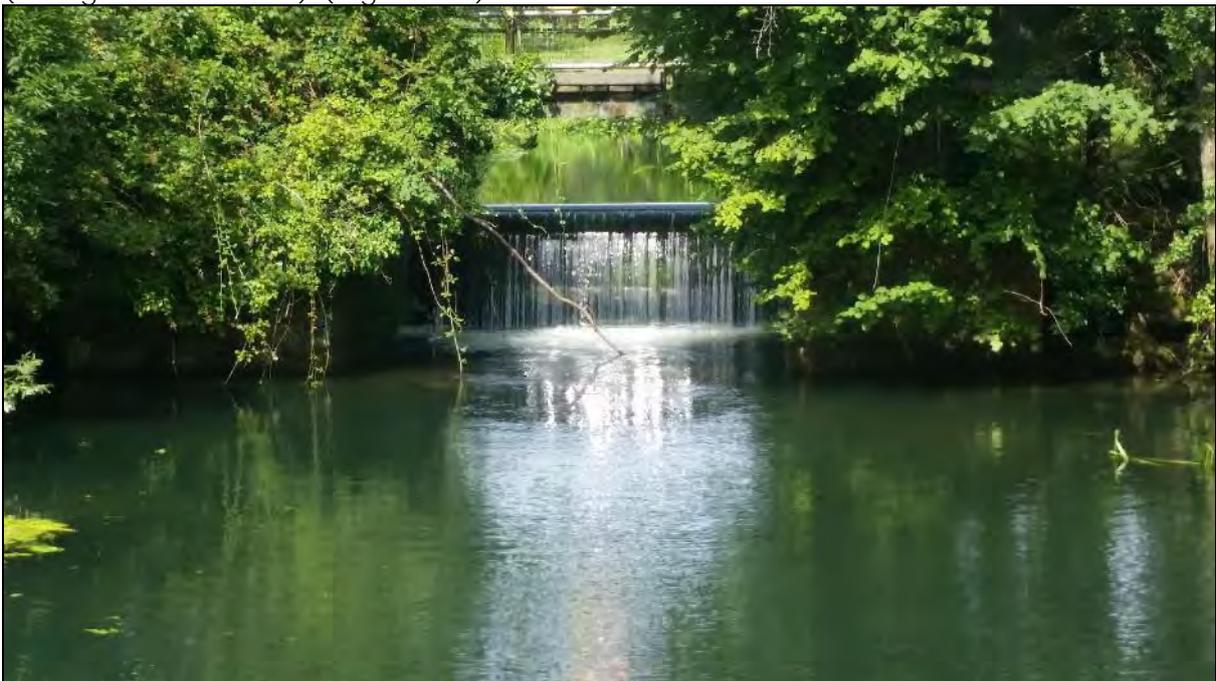
The poor conditions observed in the brook are due to both the artificial shape and form of the channel itself and also to the fact that flows are so heavily impounded. The structure impounding the flow is a redundant and non-functional (permanently closed) sluice gate owned by the Environment Agency (Slaughterford Gate) (Figure 25).

Figure 25: Slaughterford Gate seriously degrades habitat quality upstream and is a complete barrier to fish passage.

1. Continue to work with the Environment Agency, BART and other stakeholders to develop solutions to eliminate (or reduce as far as possible) impoundments and barriers to fish passage.

impoundment/fish passage solution in the short term could reduce the likelihood of funding a more effective solution in the medium term. As Slaughterford Gate is presently an Environment Agency owned asset, every effort should be made to ensure that the best possible solution is delivered. Once a project to improve fish passage has been delivered at the structure, it may not necessarily be a priority to fund any further improvements for some time. Similarly, if the ownership of the structure changes before an optimal solution has been delivered, the handover of responsibility may also reduce its priority.

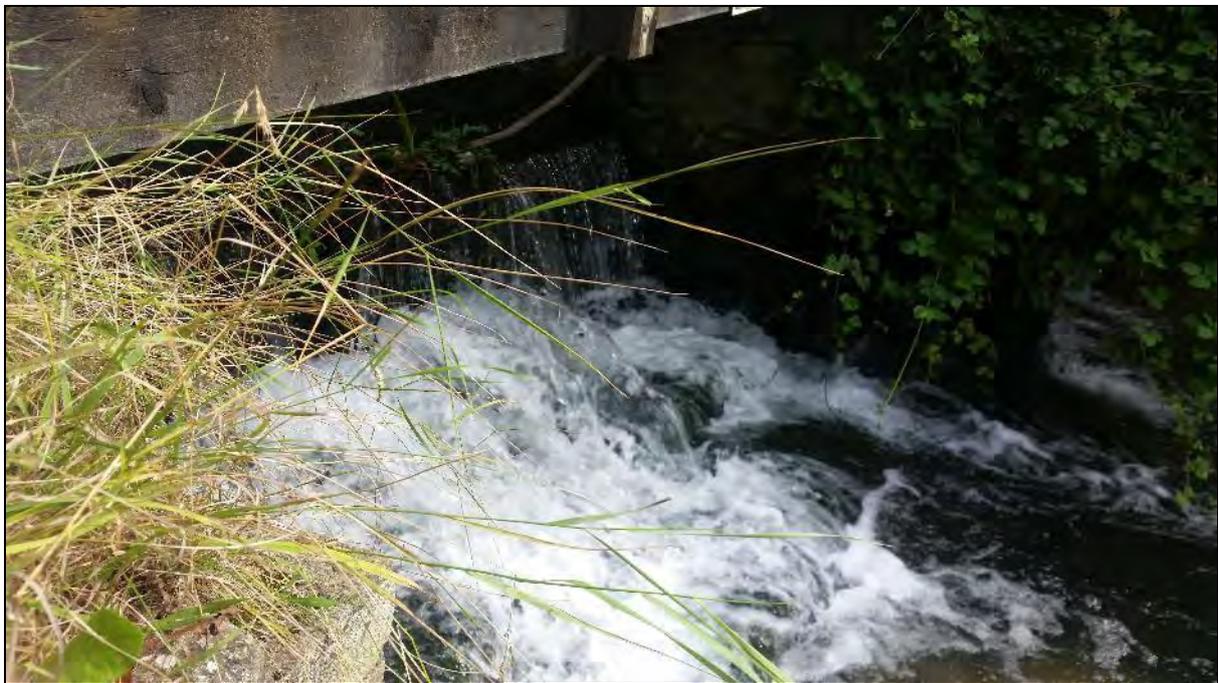
Downstream the river is briefly free-flowing before once again becoming impounded by another structure near the old rag mill (Figure 26). As outlined in the 2009 report this structure is in a state of disrepair and at risk of collapse (evidenced by water piping through the brickwork). This is a potential health and safety concern as a footbridge for a public footpath is situated on the structure. Lowering the water level upstream by removing the stoplog from the weir would help but ideally the structure should be removed and replaced with a clear-span footbridge.

Figure 26: Another impoundment further fragments habitat and the wild trout population.

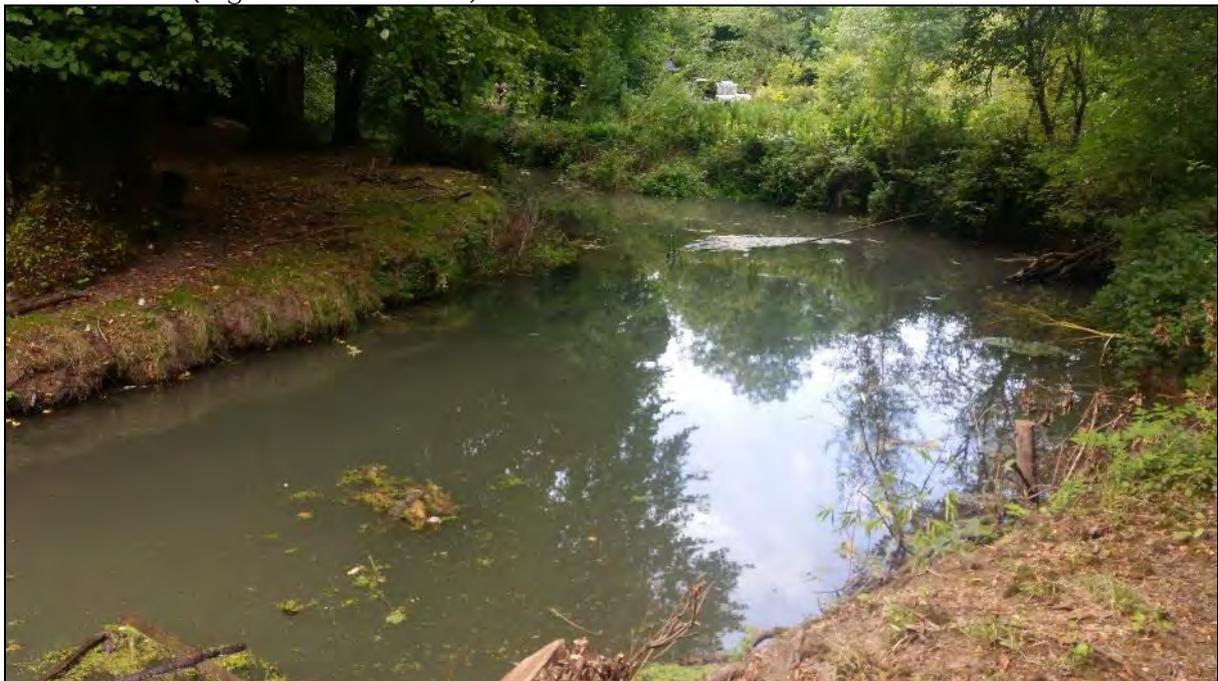
Continuing downstream, the floodplain narrows and becomes more densely wooded. Flows once again become sluggish but in this case not due to the impounding effects of a weir or sluice but to the channel being, in many places, significantly over-wide (Figures 28 and 19). In places the riverbanks have been poached by livestock and this has almost-certainly contributed to the widening of the channel (Figures 29 and 30).

Figure 28: Overwide and over-shaded, habitat becomes uniform through the wooded reach.

4. Through the wooded reach below Rag Mill, consider opening up sections of tree canopy and introducing flow deflection and cover by hinging or felling trees into the channel and securing with sweet-chestnut stakes (Figures 35 and 36). These features are the best means of safely reproducing the fallen tree habitat that trout (along with countless other fish and freshwater invertebrates) have evolved to utilise.

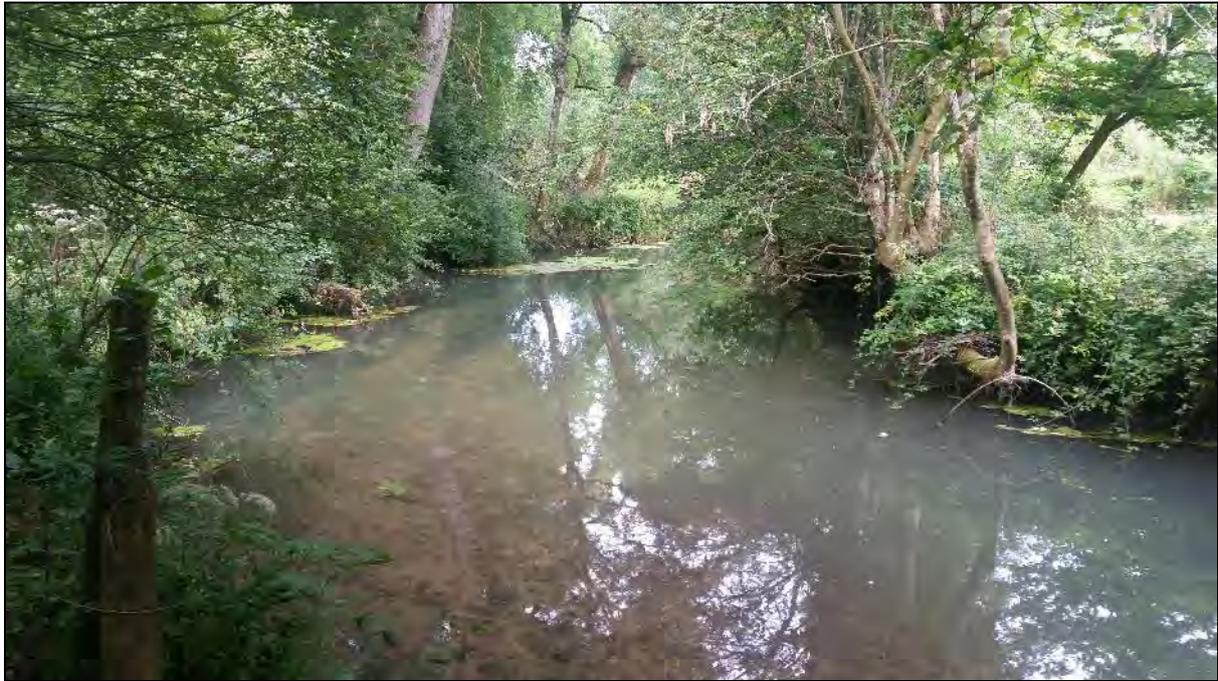
Figure 29: The over-wide channel causes slow, laminar flows. Note the reflection on the flat water surface.

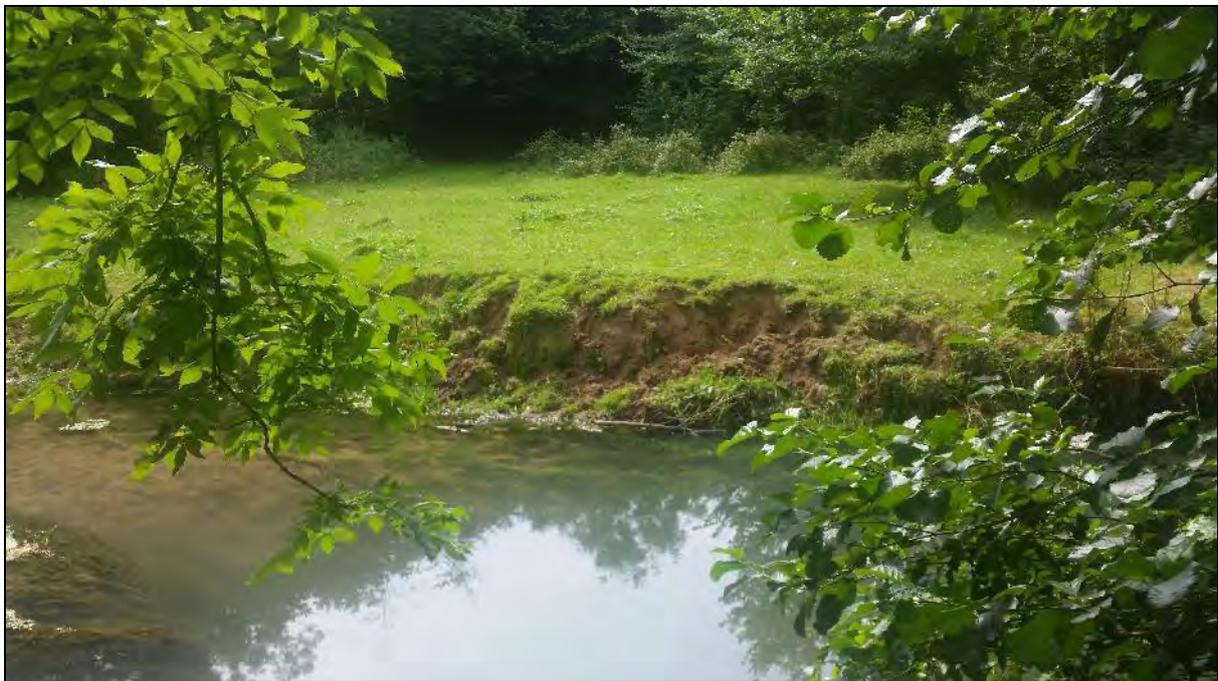
Figure 30: Bank poaching is eroding the banks and contributing to the widening of the channel.

2. Continue to engage with land owners/tenant farmers with regards to protecting the river margins from grazing livestock. Even relatively short sections of temporary electric fencing could heavily poached sections recover, improve biodiversity and reduce the input of fine sediment.
3. In the un-impounded reaches (hopefully one day to include the whole of the water visited), install some simple log flow deflectors to amplify the existing natural processes scouring small pools and runs (Figures 32 and 33). Also consider introducing some marginal brushwood structures alongside potential spawning sites to provide refuge habitat for juvenile trout (Figure 34).

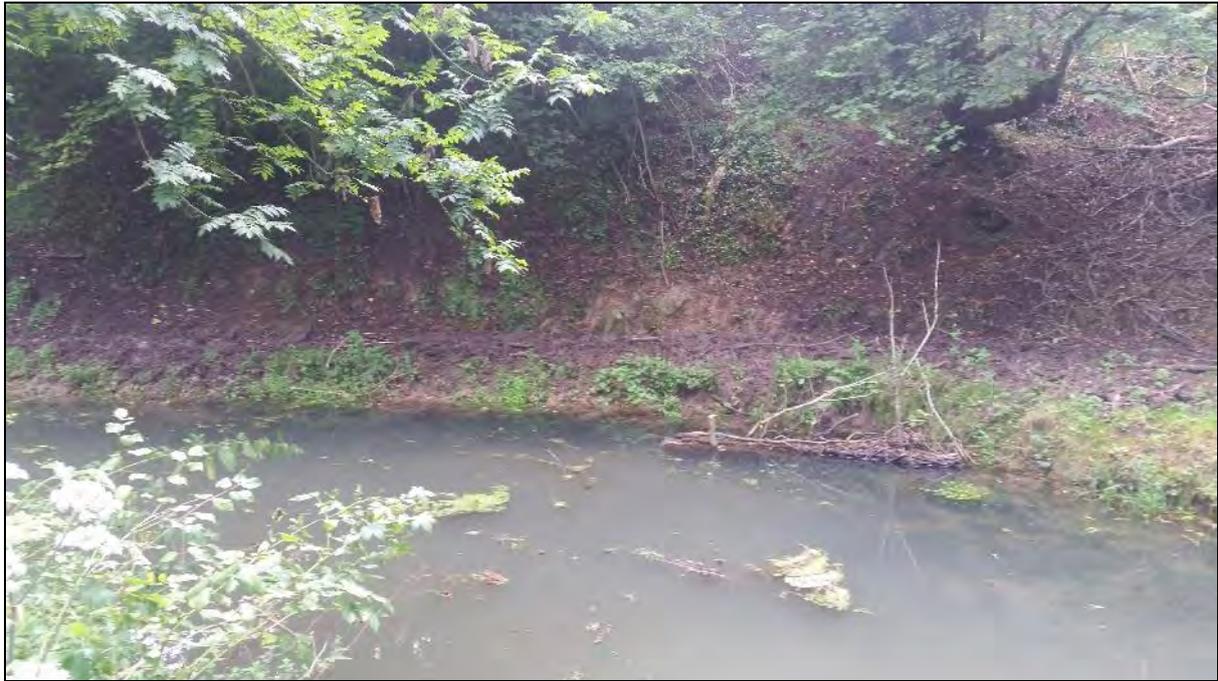
Figure 31: Bank poaching is often more acute under heavy shade where banks struggle to re-vegetate.
