Advisory Visit

Catlow Gill, River Aire, Carleton Village Residents

July 2017

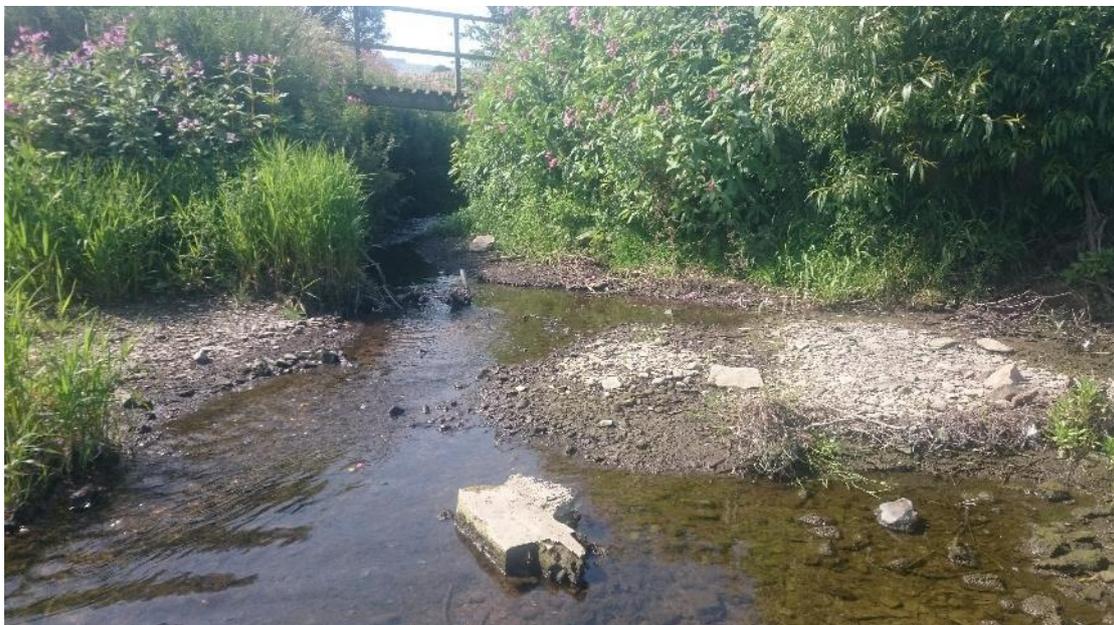
Catlow Gill (hereafter, the beck) has a confluence with the River Aire at SD 97057 50555, and appears to maintain a shallow but reasonably accessible mouth (Fig 2). The very lowest sections will always be a zone of deposition as spate flows down the beck typically hit the more substantial flows in the main river and lose their velocity causing fine sediment to drop out. The confluence was formerly well protected u/s by a large crack willow which was heavily coppiced earlier in 2017 by Northern Power. Although the stumps are sprouting again, the beneficial cover provided by substantial low trailing branches will take many years to regenerate, and the deposition of sediments around the mouth will probably change substantially over the coming winters, so it is worth monitoring change at this location. It is also worth making a concerted effort to keep this area free from Himalayan balsam. This invasive non-native species tends to outcompete native vegetation and develops a monoculture before dying back to leave banks bare during the winter, and hence more susceptible to erosion. Fish are more likely to pass across shallower water into the tributary if they feel safe and protected by low cover over or into the water provided by native plant species, especially important at spawning time for trout when balsam is dying back.

Fig 2. The confluence of Catlow Gill with the River Aire (SD 97057 50555) is crossed by a footbridge, popular with dog-walkers as well as anglers. Note stands of Himalayan balsam here. Immediately u/s, the culvert beneath Heslaker Lane retains a natural substrate throughout and is not a major issue for fish passage.

Himalayan balsam was the only invasive plant identified during the walkover, and that was at the confluence with the mainstem Aire suggesting that the beck itself is not a source as yet. It will be

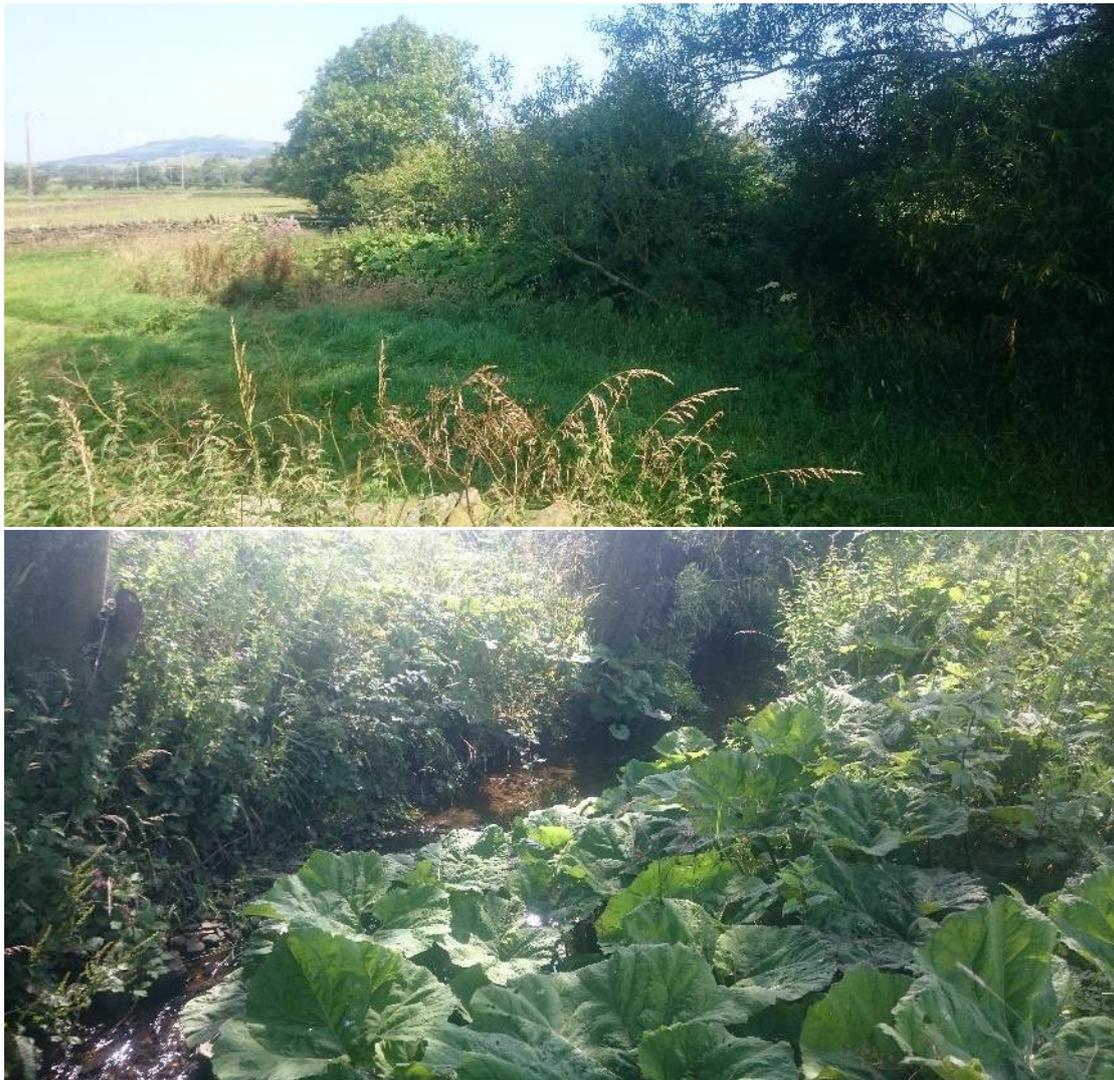
Fig 3. The lowest sections of the beck run close to Heslaker Lane but there is an excellent riparian buffer strip of mature trees and mixed herbage on the RB. The LB is also reasonably well buffered by native herb species on the top of flood bunding.

The riparian cover also provides shade to keep the water cool (something sorely lacking on the mainstem Aire), and introduces an element of hydraulic roughness - under higher flows, the water has to flow around and through the vegetation, thereby slowing the flow and trapping debris.

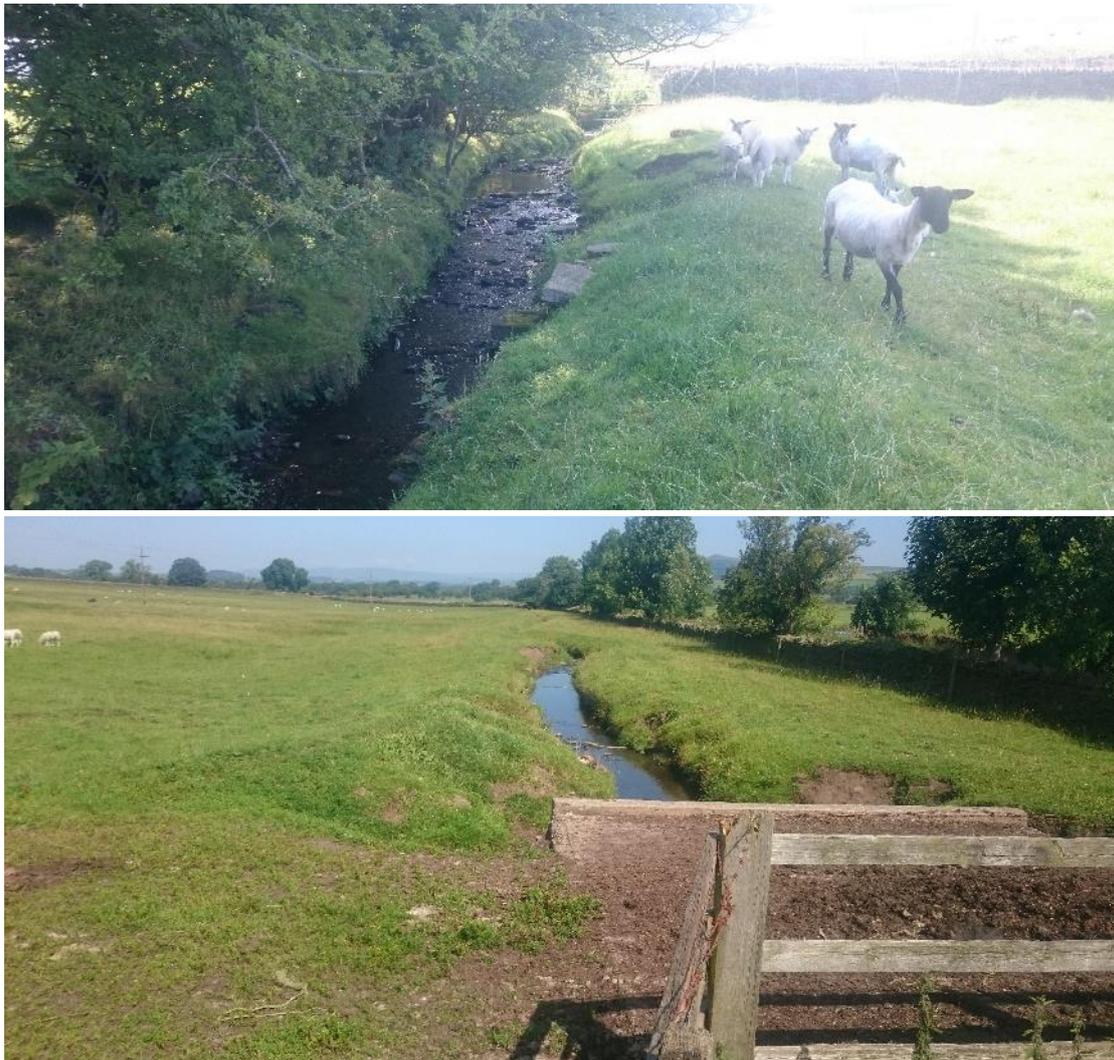
Fig 4. Further u/s, as the beck deviates away from the Heslaker Lane boundary, and unfettered livestock access becomes an issue, there is a distinct lack of riparian cover. Note the 'perching' of the beck caused by flood bunds / dredging.

Unfortunately, this riparian fringe rapidly disappears due to the attentions of both cattle and sheep in the fields u/s. Indeed, where the beck deviates from the walled boundary of Heslaker Lane, the banks are bald, a monoculture of grazed short-sward grasses (Fig 4). Such an exposed section leaves fish vulnerable to predation and may actually contribute to the fragmentation of populations as they are less likely to traverse the distance except at night or under higher flows. This section would benefit from some livestock exclusion fencing to allow riparian regeneration, limiting stock to a drinking bay or offline solution – see Recommendations.

Within the fields that have been subject to prolonged livestock access, the bank vegetation has been reduced to a short sward monoculture of grass. Excluding the stock from the bank while retaining a couple of formalised access points for drinking could provide numerous benefits to both the livestock (safer, formalised access; limiting disease or parasite transmission; grazing of herbage 'through' fence), and beck ecology and bank stability (more diverse vegetation providing multiple ecosystem services). Simply excluding livestock will allow a naturally diverse array of plants to recolonise rapidly.

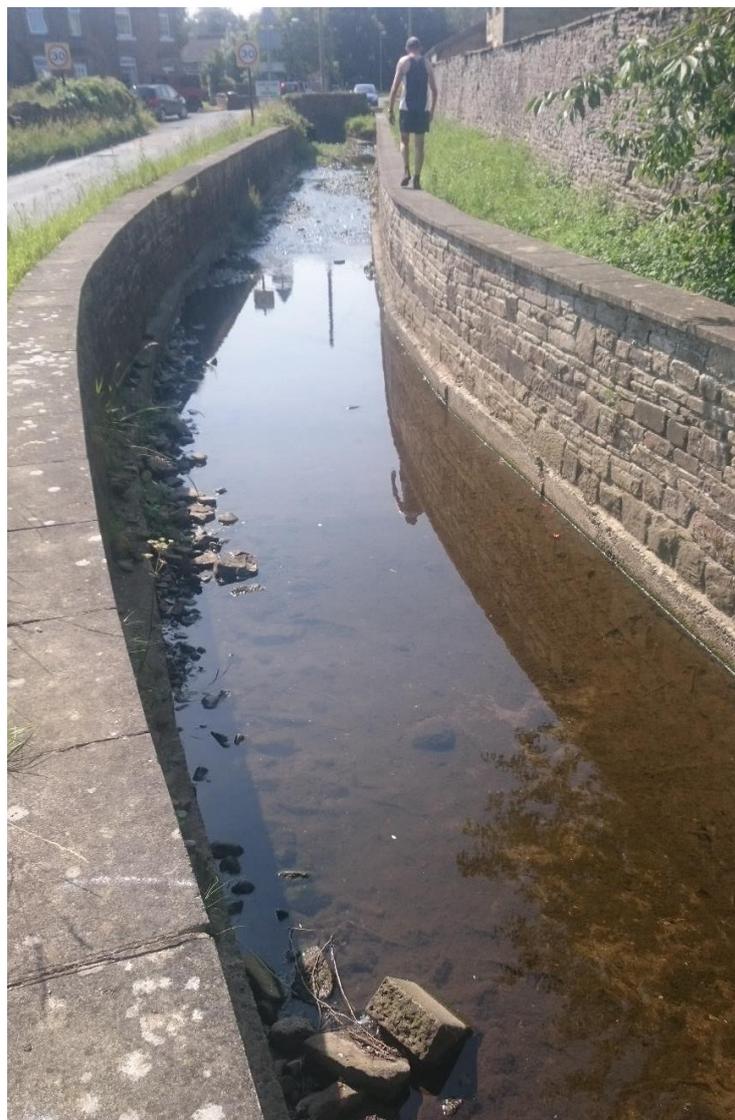
On the outskirts of the village, the channel is formalised into a box-shaped, walled cross-section (Fig 5). It is over-capacity for the majority of flows experienced during the year and, especially as it is located just below a pinch-point on the system (the second Heslaker Lane culvert), acts as a gravel trap. It is believed that Craven Council

organised for the removal of a considerable volume of accumulated sediment in August 2016. While there remains some natural substrate in the channel, it is still effectively an unsorted 'cake-mix' retaining a flat bottomed topography and hence, devoid of features for trout. If this is an ongoing requirement, then following removal, the remaining substrate could be sculpted more sensitively to encourage a more sinuous, narrower and hence deeper route through the section. The beck has re-established a narrow meandering channel where it has the energy to do so at the u/s end (see Fig 5, next to the runner) but as the energy dissipates, its ability to move and sort substrate is lost towards the d/s end (Fig 5, foreground)

Fig 5. Looking u/s at the first walled section parallel to Heslaker Lane as it enters the Carleton-in-Craven. This is the site of recent gravel extraction.

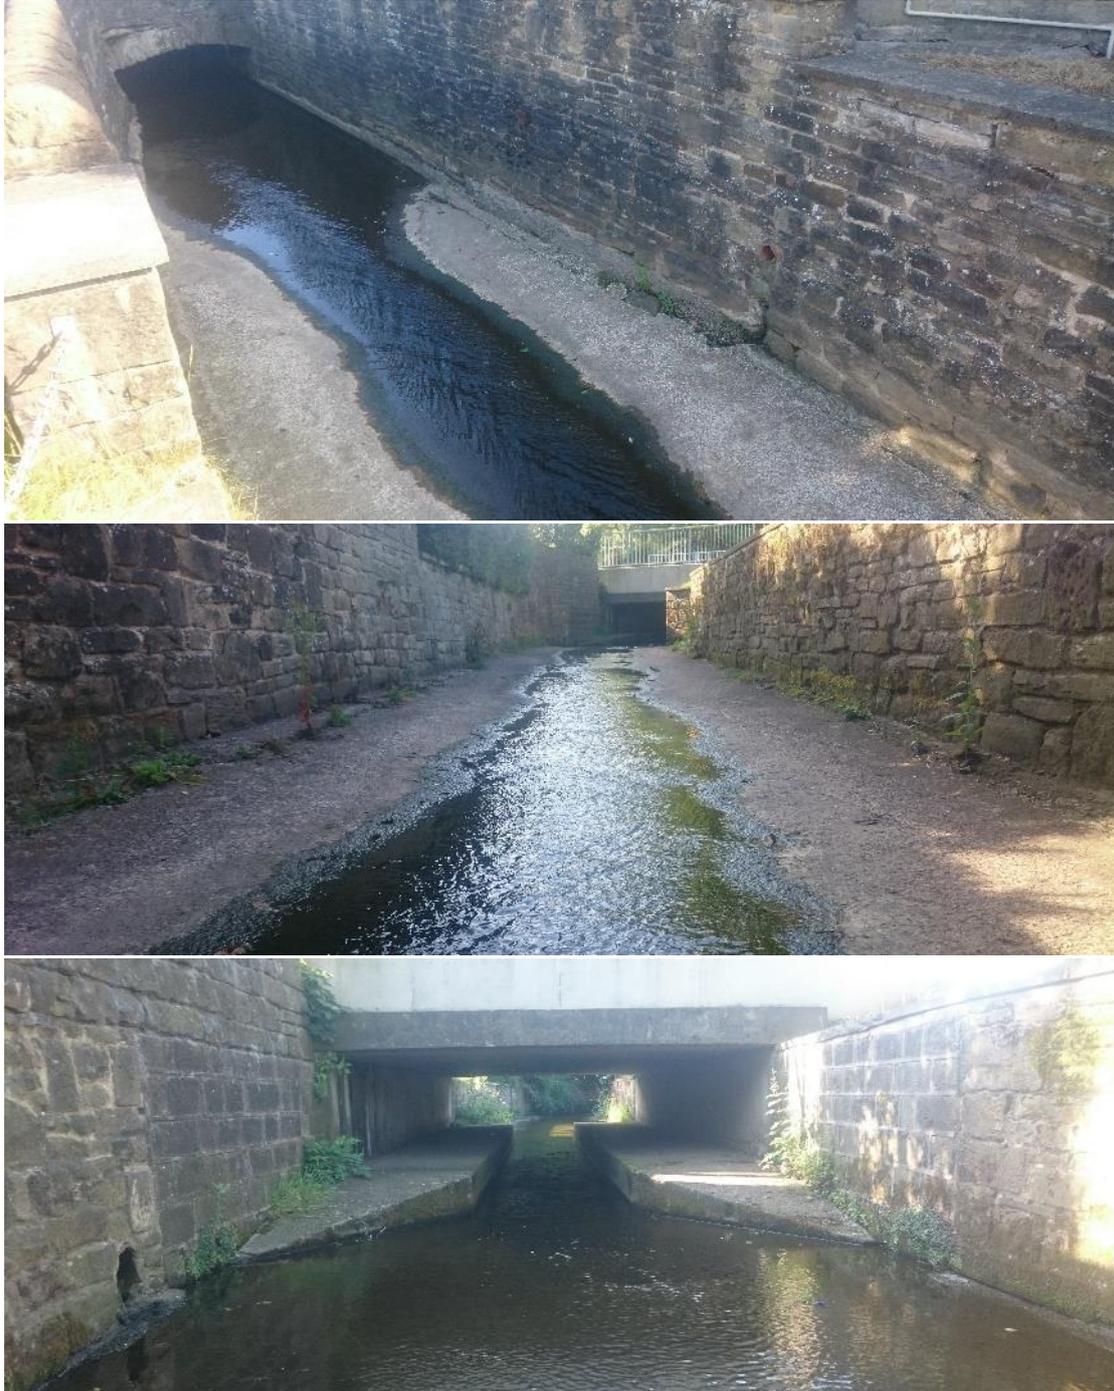
The second culvert under Heslaker Lane (Fig 6) is older than the first, and now inadequate in terms of aperture to cope with very high flows; holes in the LB wall originally installed to divert flooding from the lane into the beck now allow the beck to escape into the road. There is

sufficient depth of water through the culvert, but then the beck is routed along ~90m of low gradient concrete channel (Fig 6; lower panels). A two-stage channel has been created under the Leys Close bridge, presumably to keep a focal flow through the centre and prevent build-up of sediment or debris at the bridge pinch-point.

Fig 6. Upper panel: immediately u/s of second Heslaker Lane culvert, the aperture of which appears under capacity for peak flows. There is adequate depth of water through the culvert for fish to move through. Mid panel: smooth concrete and walled culvert of very shallow gradient, devoid of features. Lower panel: more recent culvert modification beneath Leys Close bridge is designed with a two-stage channel.

The shallow, mostly laminar flow along the concrete channel is a major issue for fish passage but due to the low gradient, one that can

The extent of concrete channel that does not retain any natural bed substrate and hence presents a shallow, relatively laminar skim of water is considerable, but because of its shallow gradient, is not insurmountable. Fixing a series of alternating u/s deflectors of $\sim 1\text{m}$ in length and $0.1\text{-}0.2\text{m}$ in height along the length of the open concrete channel would retain a greater depth of water throughout the reach for fish to swim in and create slack water refugia for fish to rest in. These do not increase flood risk as under spate conditions, the water simply passes over the top, and the u/s angle ensures that when each deflector is over-topped, the water (leaving it at a perpendicular angle) is directed toward the middle of the channel and hence, not causing erosion at the sides – see Fig 15. The major restriction to peak flow capacity in the system is the aperture of the culvert under Heslaker Lane in Fig 6 (upper panel).

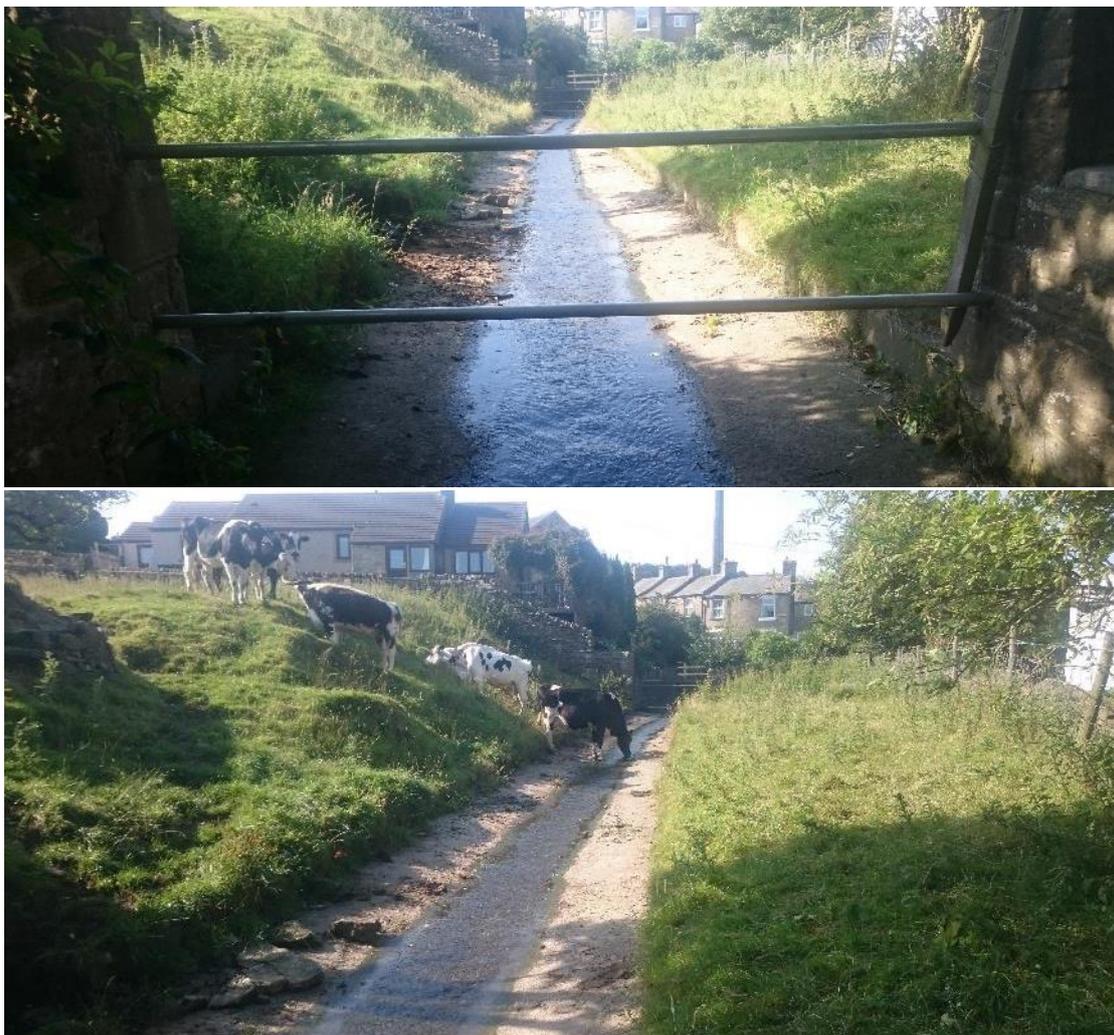
The concrete channel continues through metal bars and a small paddock before entering the more developed area (Fig 7). Cattle graze the field and have complete access to the channel. Due to the steep nature of the RB, this seems to be quite hazardous and a real health risk as several cattle were observed to slide awkwardly as they entered to drink. Restricting access to only the most d/s end (next to the metal bars) for drinking, and fencing off the remainder of the steep RB would reduce sediment ingress and promote better riparian growth along the edge of the channel where it is only walled by $\sim 0.2\text{m}$ as opposed to $>1\text{m}$.

Fig 7. Continuation of the concrete channel through a field to the north of Church Street. Cattle have access to the full length, $\sim 50\text{m}$. Note small parcel of land on the LB (right side of image) which could be protected from grazing or modified for flood storage.

Indeed, if livestock was excluded, the low lying area on the LB (Fig 7) could be formalised as a flood storage area which might help alleviate problems at the bridge culvert d/s (Fig 6; upper panel). The aperture currently housing the metal bars is bounded by substantial walls which would restrict high spate flows, thereby backing-up water over the low-lying LB. By skimming off the soil to just above the level of the current channel wall, there is a conservatively estimated 125m³ capacity for flood water (assuming a 0.5m depth), probably more.

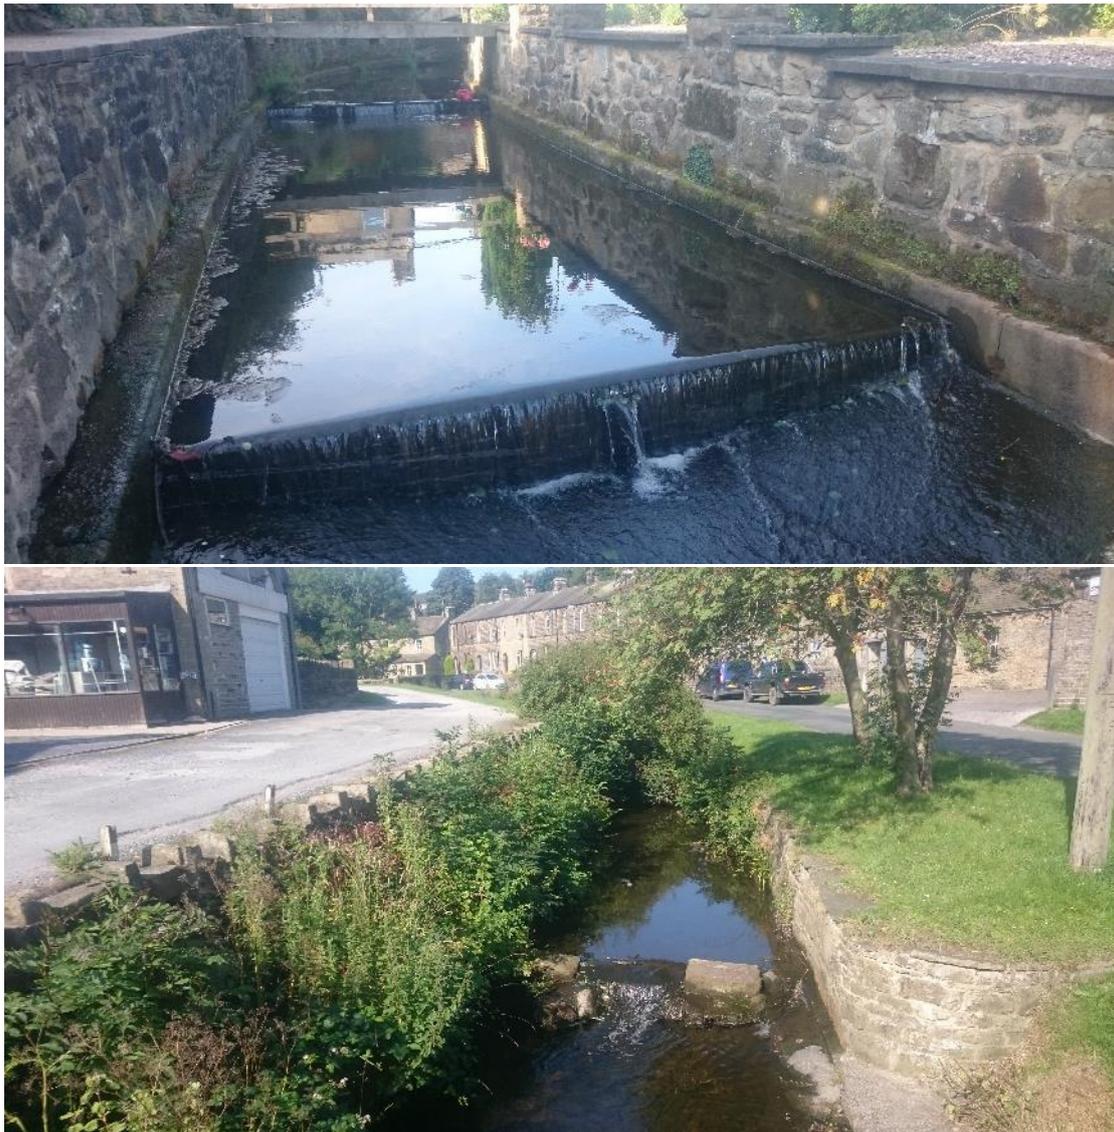
Fig 8. Upper panel: a series of wooden board step weirs installed by the householder, which severely hamper fish passage. Lower panel: redundant weir causing erosion and hampering fish passage immediately u/s of Church Street bridge.

The first of two ornamental wooden weirs is installed u/s from the paddock (Fig 8; upper panel). There are wide-ranging, less appreciated environmental issues with weirs aside from fish passage - see a WTT video outlining key impacts, here:

On a completely artificial, concrete channel (such as here), they do introduce some much required depth of water but are a poor substitute for natural pool habitat. Unfortunately, the concrete apron below the first of these also means that there is insufficient water depth for fish to approach, let alone jump from. The impounded reach above is devoid of features and a perfect spot for predators to pick off trout as they move through, and plus will only fill up with sediment over time. Removal is the best option but would require the installation of artificial baffles throughout the reach to create depth of water again. Another option to explore would be to notch each weir crest to provide a focus under low-flow conditions, and especially for fish moving downstream. There would be a further requirement to install some pre-barrage structure below the first weir to increase the depth. All of these options will require engagement with the owner of the structures.

Immediately u/s of Church Street bridge, there is another weir which was allegedly built to trap sediment and prevent it moving d/s to block the bridges (Fig 8; lower panel). It has performed that function historically to almost the level of the crest of the weir and now it has no further capacity to do so; sediment is currently transported over the top and it is, therefore, redundant. It serves only to impede fish passage, and eddies in the pool d/s are causing erosion to the channel walls. In the u/s impounded section, the sediment has been deposited in a uniform layer leading to a flat topography devoid of features, and if it were not for a substantial overhanging bush covering the entire width of the channel, it is highly unlikely any trout would remain here. Here, complete or partial removal should be considered.

Notching of the two ornamental wooden weirs would probably provide the simplest solution. Cutting a 0.6-0.8m wide and 0.1m deep notch into the crest will focus flow, especially under summer flow conditions, thereby providing a target for fish moving in either direction. Under high flows, the weir behaves exactly the same as it currently does. A pre-barrage is required for below the first wooden weir as there is no plunge pool on the concrete channel for fish to leap from; paired deflectors (i.e. directly opposite each other with a narrow aperture between) at the head of the series of alternating offset structures (outlined above; Fig 15) will probably suffice.

The stone and concrete weir (Fig 8) could be fully removed and if broken into large blocks, these could be arranged in the channel, partly to slow the transfer of accumulated sediment and partly to provide some much needed physical variability in between the channel walls. Each of the buried stone weirs should be treated in the same manner, the blocks rearranged to allow free transport of sediment and movement of fish, or removed and used elsewhere to better effect (see below).

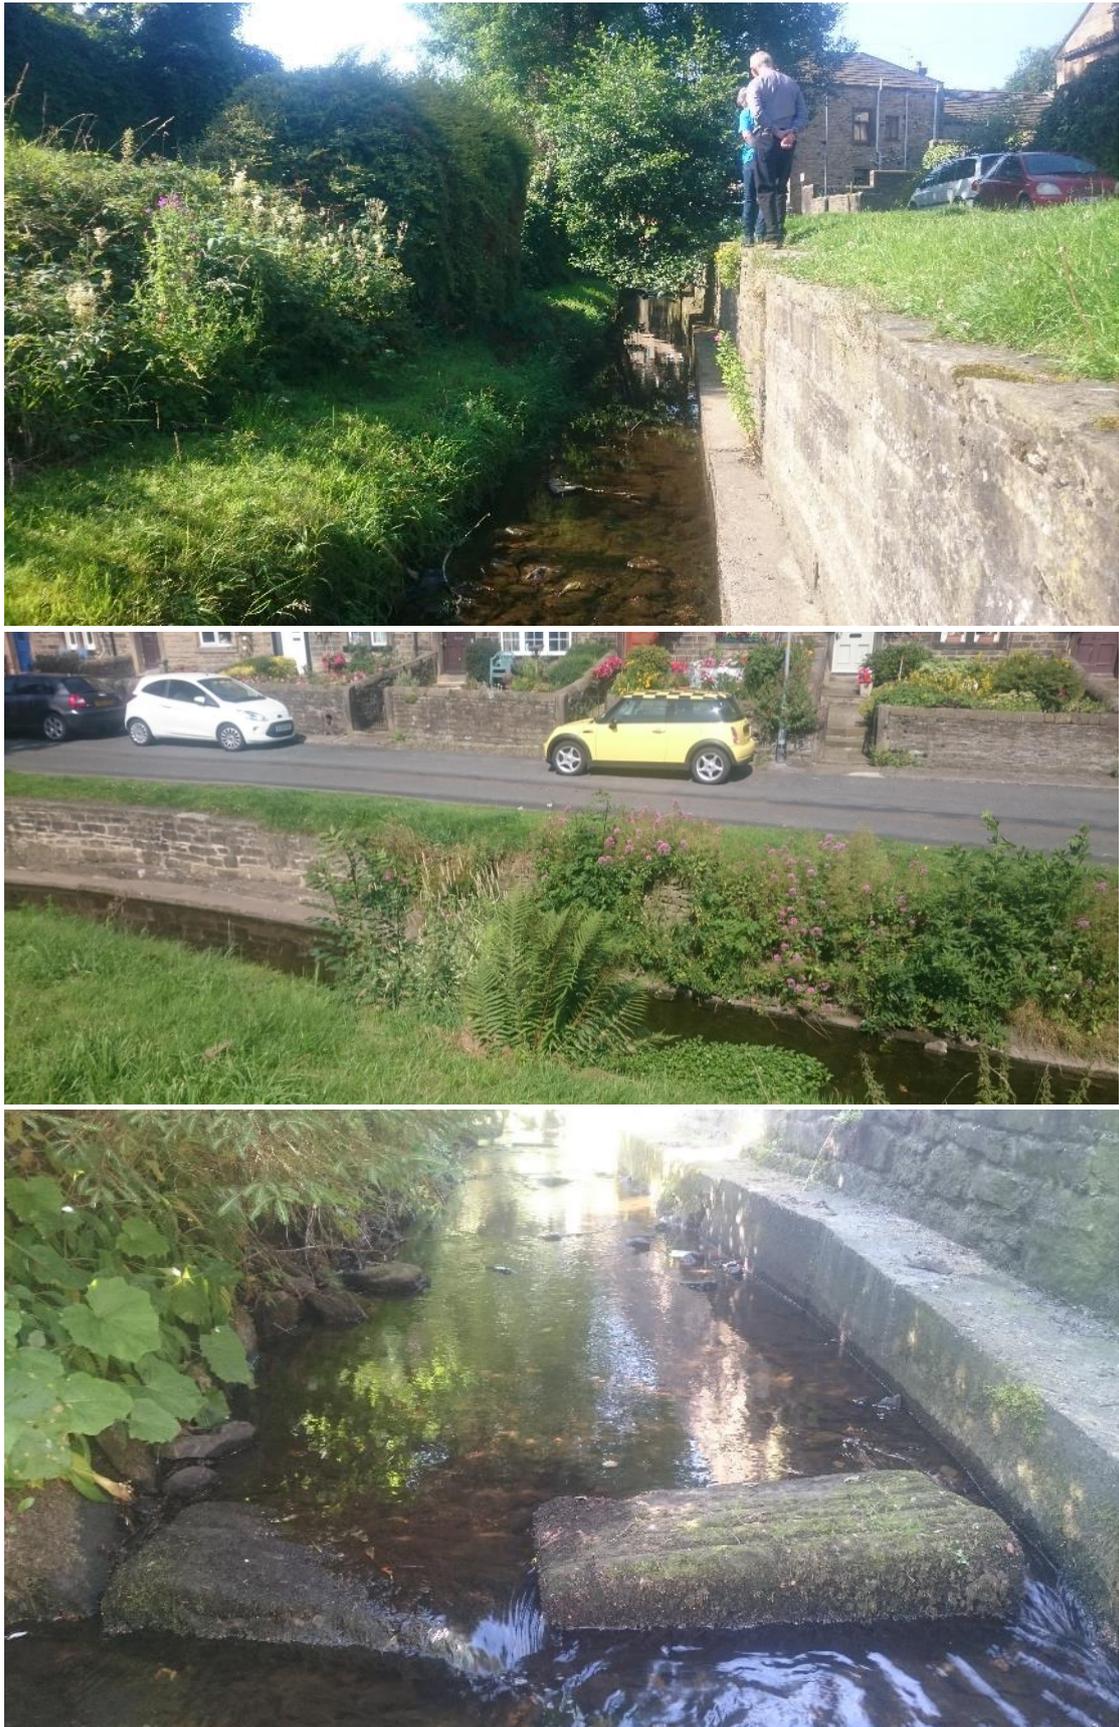
The channel is constrained by gently sweeping walls between Brook View and Beck Side residential roads (Fig 9). The riparian zone is assumed to be variously controlled by private landowners or the Parish Council. The LB is heavily protected as it forms the outside of the bend. Currently, it is mostly mown grass at the wall top with only the occasional tree. At the lower end, there is better cover afforded by native plants; a welcome splash of colour in the village, and a valuable resource for pollinating insects. This should be encouraged. The RB on the inside of the bend has more natural plant cover, some of which reaches over and trails into the water. At various points, large stone blocks have been introduced, formerly as sediment trap weirs and now used as stepping stones. Again, their original function is redundant, and they should be relocated to generate channel sinuosity or pinch points.

Fig 9. The beck between Brook View and Beck Side. While both banks are walled, the LB (on the outside of the sweeping bend) is protected by a concrete step-toe. The RB is better vegetated, but note close mowing on both banks. There are a number of stepping-stone structures which hamper sediment transport more than fish passage

Within the village, especially between Brook View and Beck Side, there are lengths of bank edge and wall top where the grass has been mowed and maintained as a lawn. The negative impacts are similar to that of grazing by livestock (lack of cover, diversity, loss of bank resilience, etc). Ideally, the bank edges should be left unmanaged, or could be positively managed to encourage native flowering plants to form a swathe of colour in the centre of the village; an attractive focal point. It will also encourage and support insects such as butterflies and bees that are suffering serious population declines in many areas.

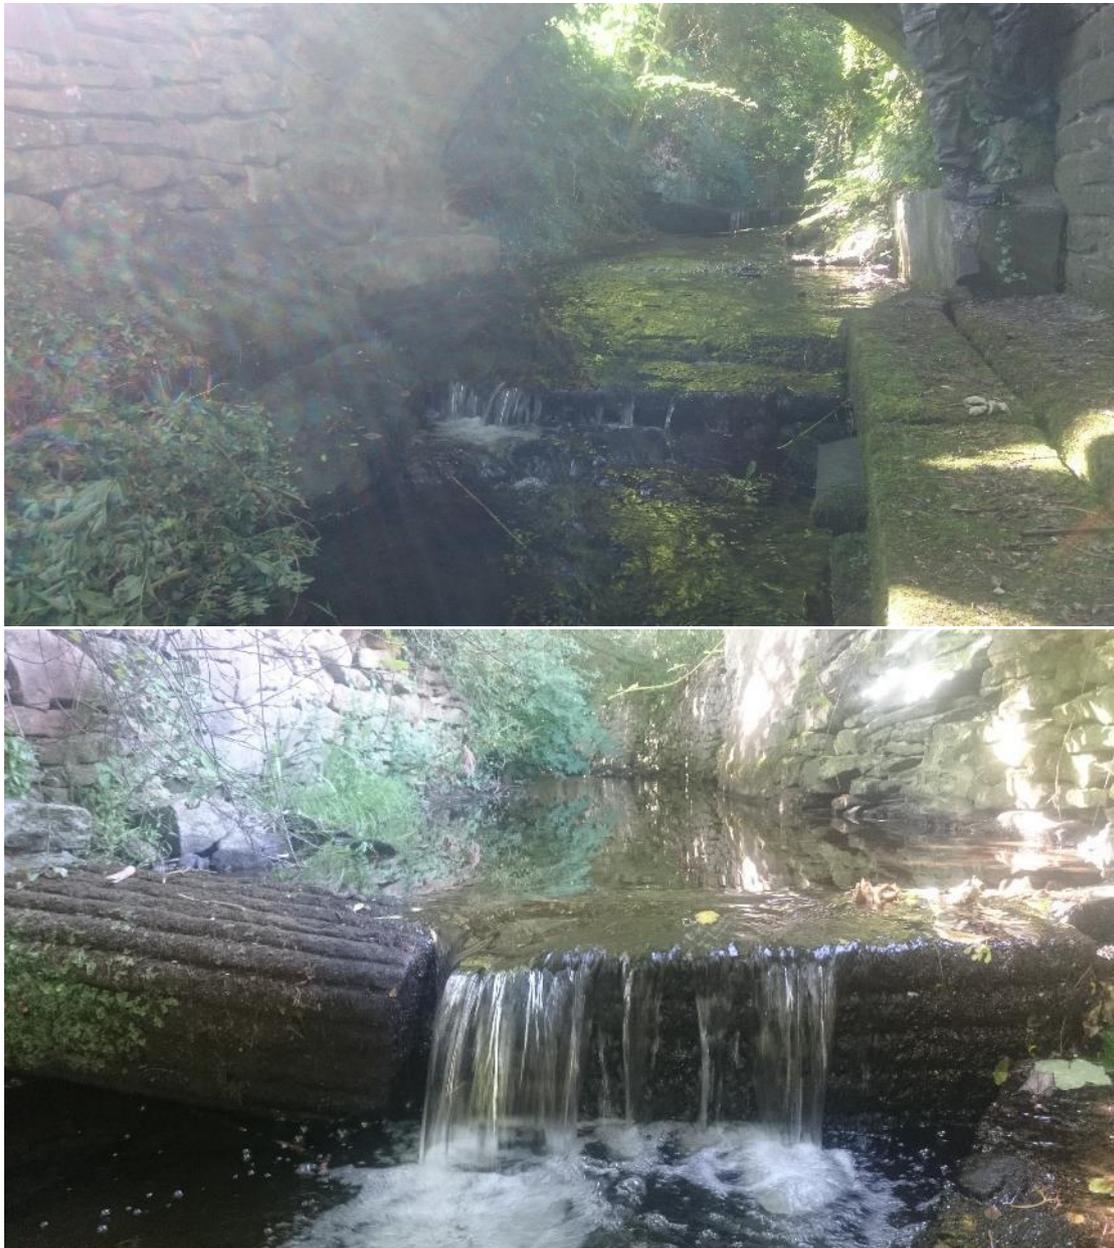
An old stone footbridge spans the beck between Brook View and Beck Side. The combined effect of the bridge footings and the weir immediately u/s effectively starving the beck of substrate d/s has led to the creation of a scour pool and a substantial head-loss (i.e. step in water level) across the structure.

Fig 10. The footings of the footbridge between Brook View and BeckSide have caused substantial erosion downstream. Coupled with a redundant step weir immediately u/s inhibiting supply of sediment, they pose a significant fish passage issue.

As noted in the habitat assessment, bridge footings and aprons typically have a step and plunge pool below them caused by accelerated flow and subsequent increased erosion, coupled with a reduced supply of substrate from upstream. Often the simplest way to address the step issue is to effectively drown it out by increasing the d/s water level with some sort of pre-barrage. In the case of the two bridges, some of the large block stones currently in place as defunct step weirs (lower down the beck) could be arranged at the tail of the existing plunge pools, with a focal notch to sufficiently raise the water level but not create further issues for fish passage.

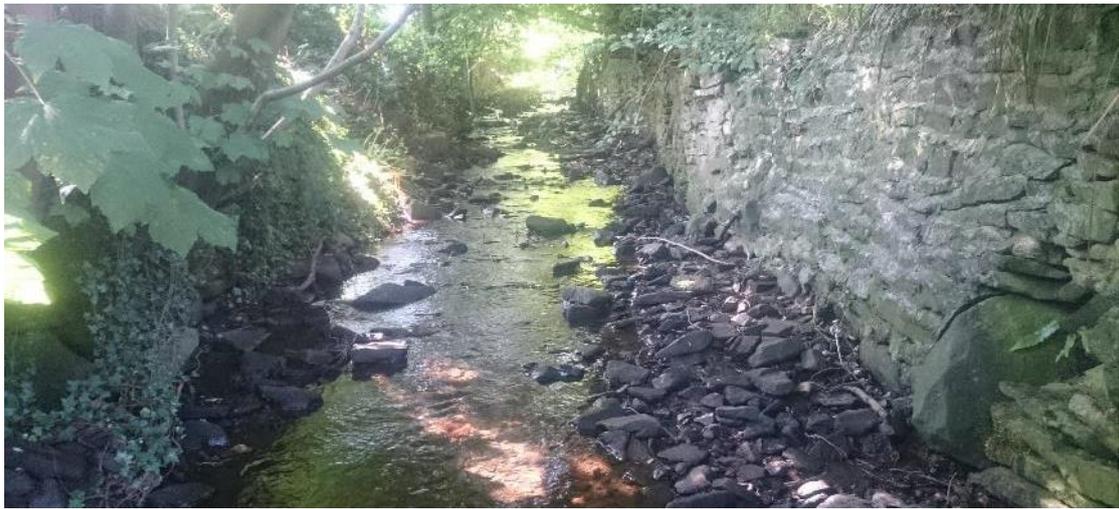
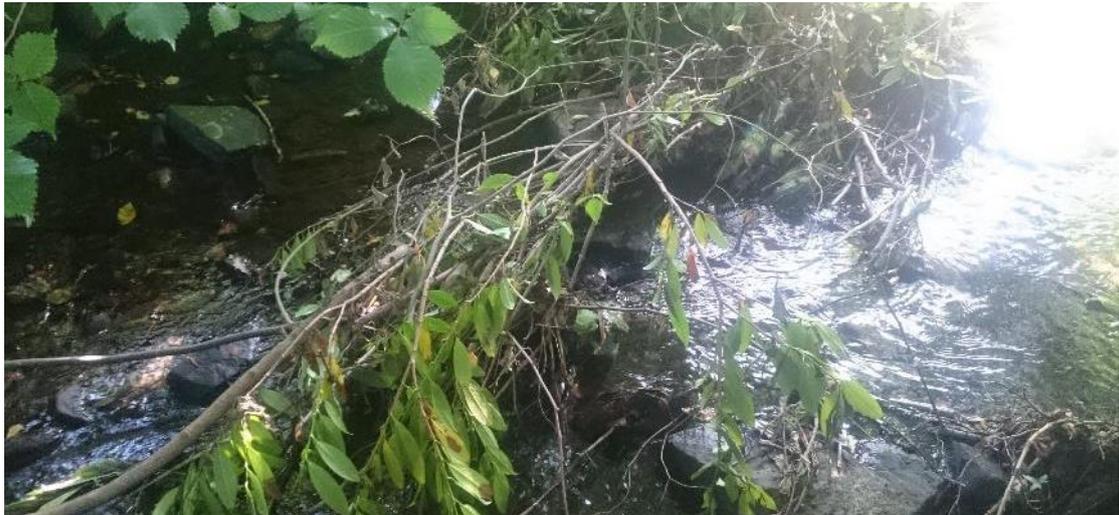
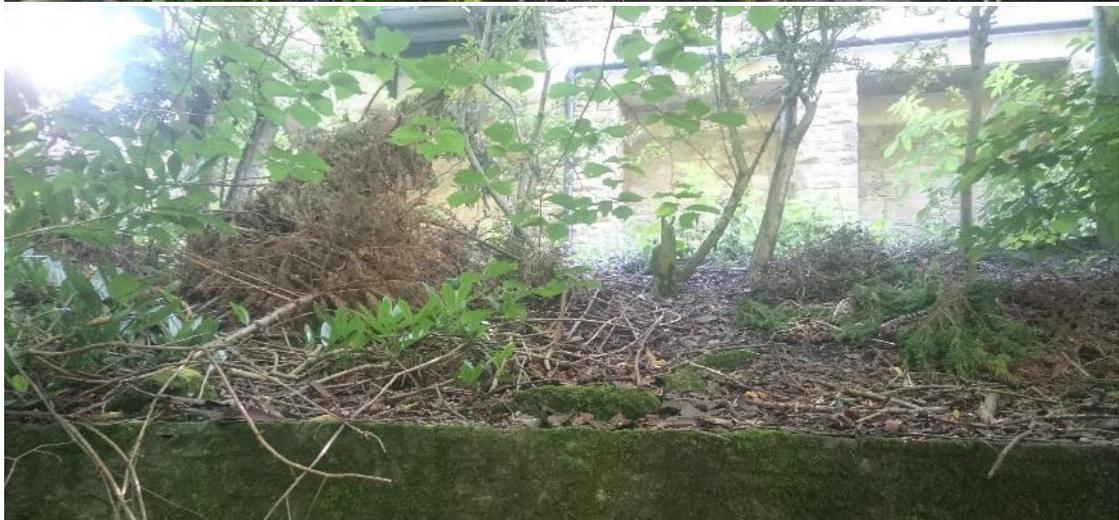
Above the footbridge, the beck has created its own more natural narrow channel with some slight meandering even within the confines of the walls; this could be encouraged and emphasised with some rearrangement of larger boulders. A small patch of native woodland on the LB provides some welcome cover from low branches and trailing ivy. The RB is heavily shaded by the close proximity of the mill buildings, now converted into flats, and some large mature trees;

there is little understory. A narrow riparian strip on the bank wall tops is managed by various properties, some more sensitively than others. Runoff across the rough Brook View track and over bare bank-top soil is likely to introduce excess fine sediment which will clog the gaps between gravels and reduce their quality as spawning habitat for fish, and as living and feeding areas for many invertebrates. Unfortunately, there was also disappointing evidence of dumping of garden waste onto the banks (where it will maintain bare earth and leach nutrient-rich liquor into the channel) and directly into the channel itself (of a size which could block or contribute to blockage of the bridges below). Plus, such cuttings are one of the routes by which invasive plants end up along river ecosystems. Engagement is key in such situations.

Fig 11. Upper panel: u/s of the footbridge (in Fig 10), the beck has created a more natural channel morphology via deposits of larger sediment to the sides, despite still being bound by walls. Unfortunately, some riparian owners are treating the beck as a disposal system for their garden waste (lower panels).

It is worth engaging with those residents who are using the beck to dispose of their garden waste, to highlight how the beck is a central feature to the village, how planned improvements elsewhere on the beck will be to the wider benefit of the village residents, and the potential negatives (causing blockage, pollution, introducing invasive species) resulting from their actions.

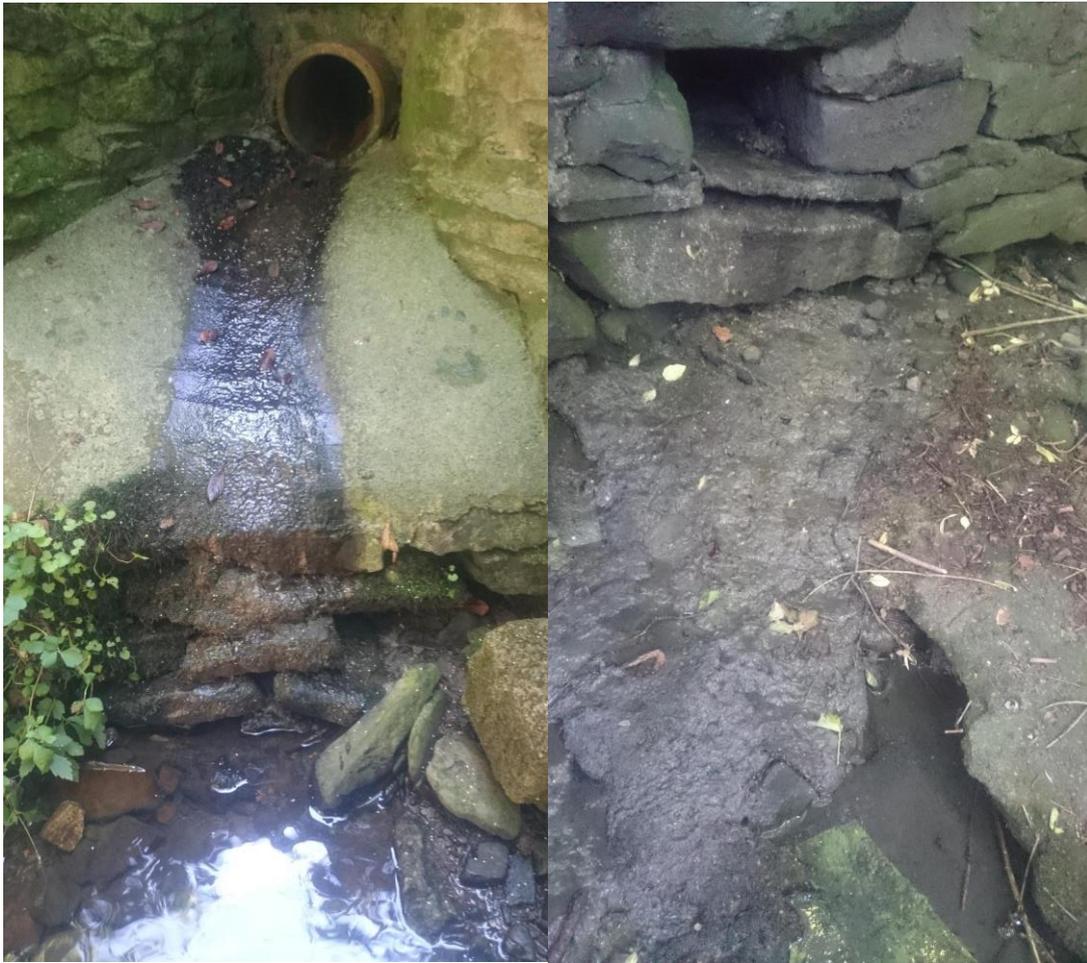
A large pool has formed d/s of the West Road bridge, for exactly the same reasons as noted for the footbridge. The culvert apron beneath the bridge is degrading and quite pock-marked in places with some variation in depth of water. The step onto the apron would require addressing (as before) with a pre-barrage to effectively drown out the height differential. Associated with the bridge infrastructure were two pipes, both discharging water of dubious origin (Fig 12).

Fig 12. Two pipes at the West Road bridge with dubious discharges (despite relatively low flow conditions) point to misconnections in the sewerage-drainage system.

Diffuse pollution from soil ingress where livestock is trampling the banks should be addressed by the measures suggested above. The two point sources identified in Fig 12 should be monitored and any instances of discoloured or foul-smelling water reported immediately to the Environment Agency Incident Hotline (0800 807060).

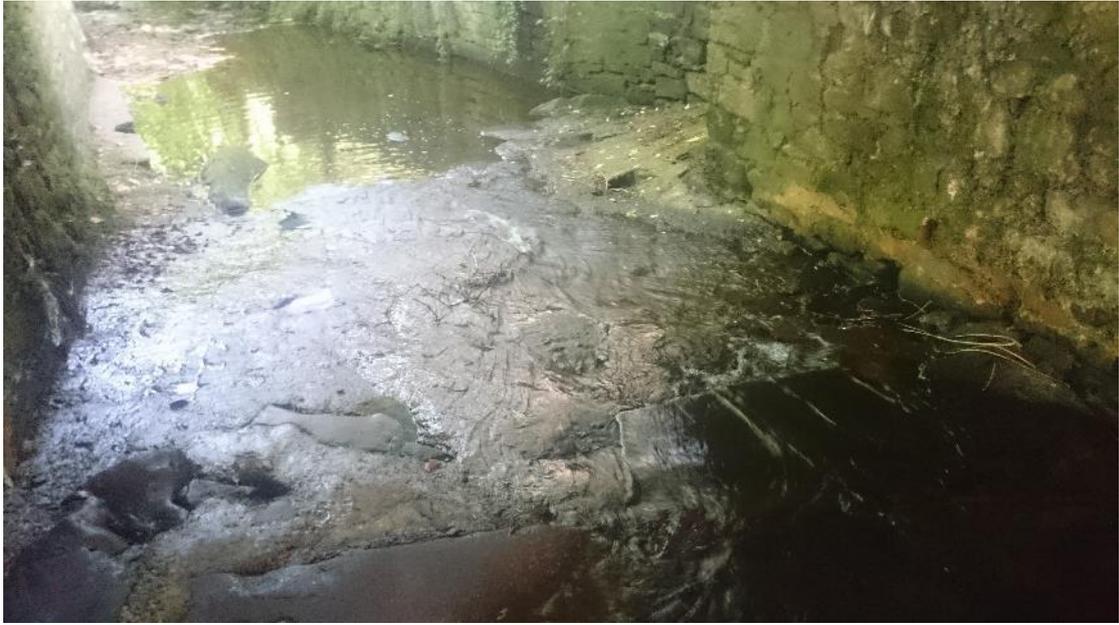
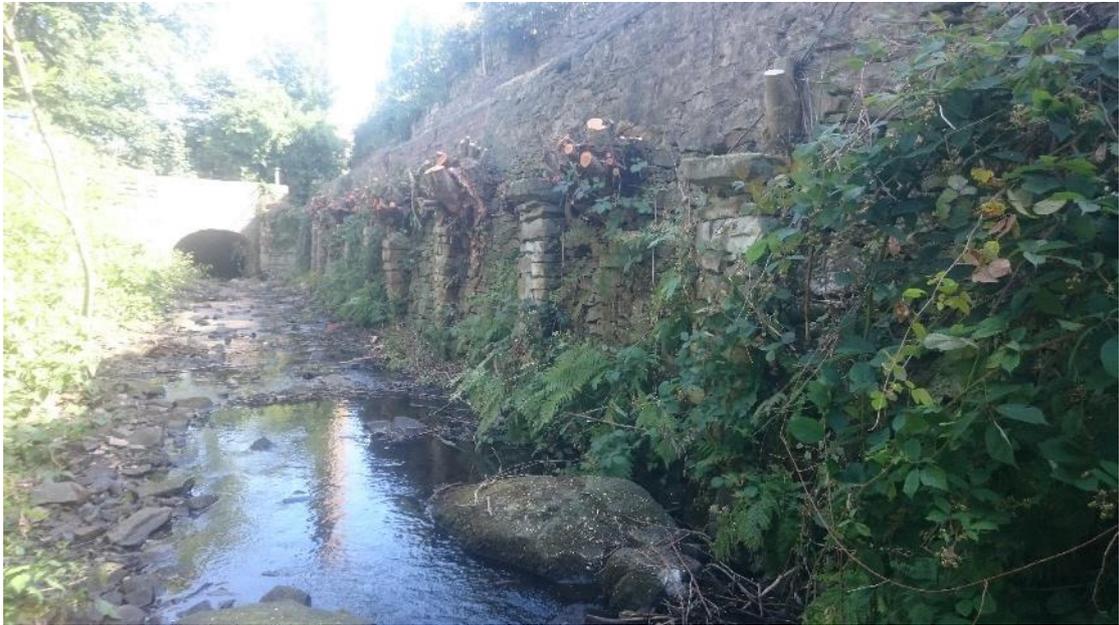
The walling of the channel continues for ~50m u/s of the West Road bridge, but the width of the artificial channel is very much over capacity to the extent that the wetted channel at the typical summer flow (observed) is ~30% (Fig 13). As a consequence, the sediment deposited and now effectively forming the LB has been consolidated by encroaching vegetation. This will probably extend as some reasonably mature trees growing through walling at ~3-4m above the beck bed on the RB have been coppiced, presumably to prevent any damage to that wall. Hence, there will be more light to the developing understory on the LB.

Fig 13. Upper panel: West Road bridge culvert is eroding badly and presents a challenge to fish passage on the d/s apron. Through the bridge culvert itself, there is sufficient water depth and some natural deposition of sediment. Lower panel: looking d/s to the West Road bridge, trees have recently been coppiced to protect the wall, which might actually promote more beneficial understory herbage and bushes at beck level. Note the more natural bed sediment structure around larger boulders.

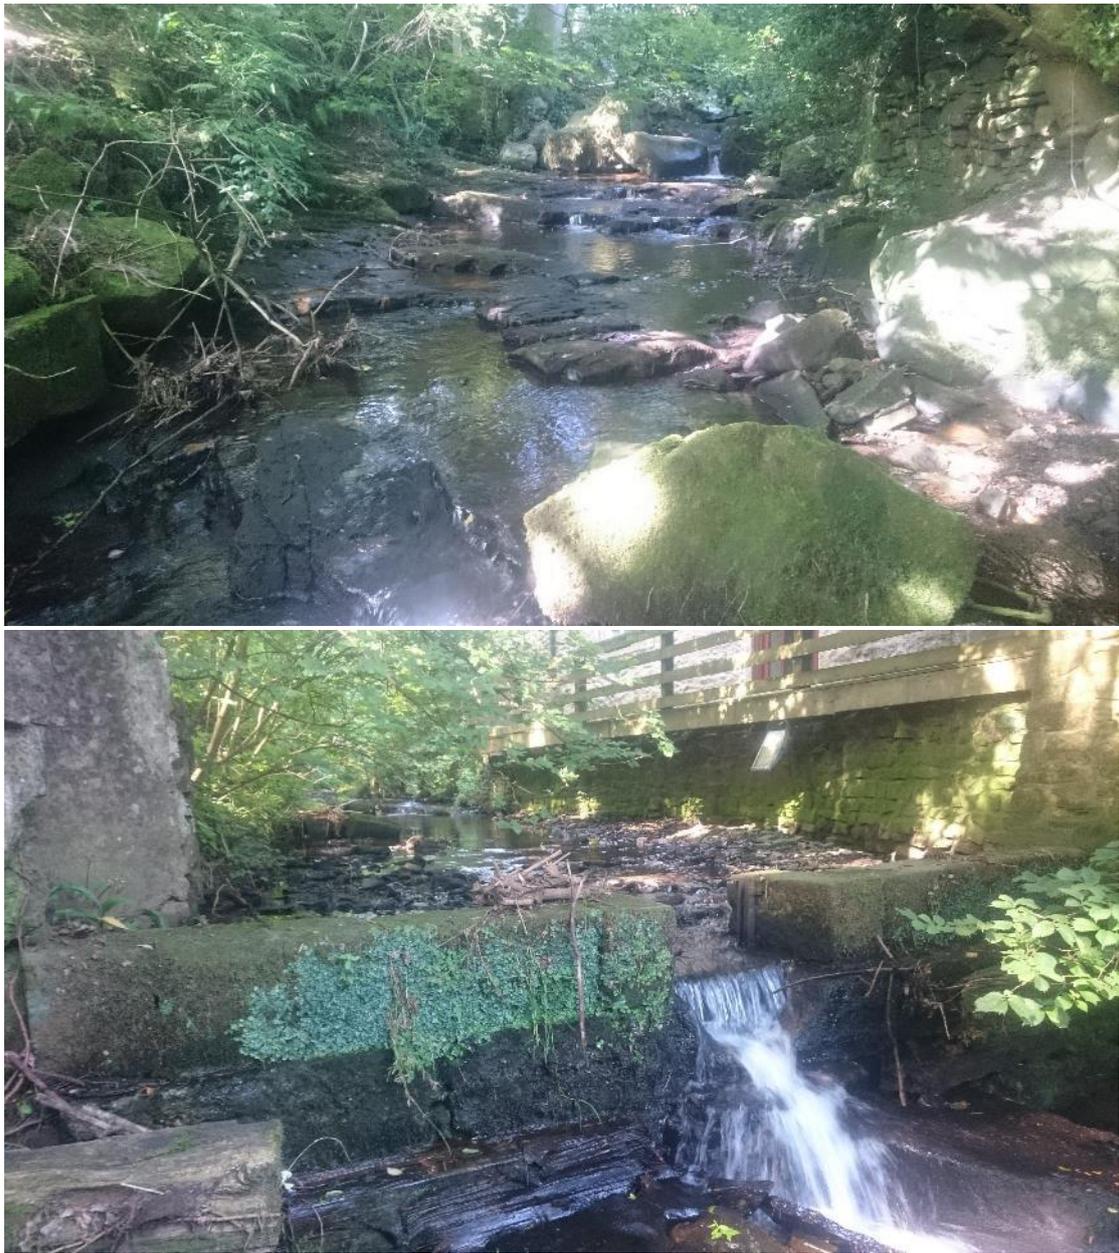
An increasing gradient associated with the underlying geology and narrow valley, and the presence of more, large boulders, has created a series of pools and cascades in the final section (Fig 14). A natural bedrock waterfall probably forms the upstream limit to fish passage, ~100m further. The RB supports excellent natural deciduous woodland which introduces woody debris and leaf litter, as well as providing shade and low cover. Hence, the habitat for trout at the 'top' of Catlow Gill is very good quality.

Fig 14. More natural pool and cascade channel structure through a short wooded section up to a natural barrier of bedrock, now modified, at SD 97095 49527.
