Advisory Visit

River Ceiriog, Brynkinalt Estate, Chirk

August 2016

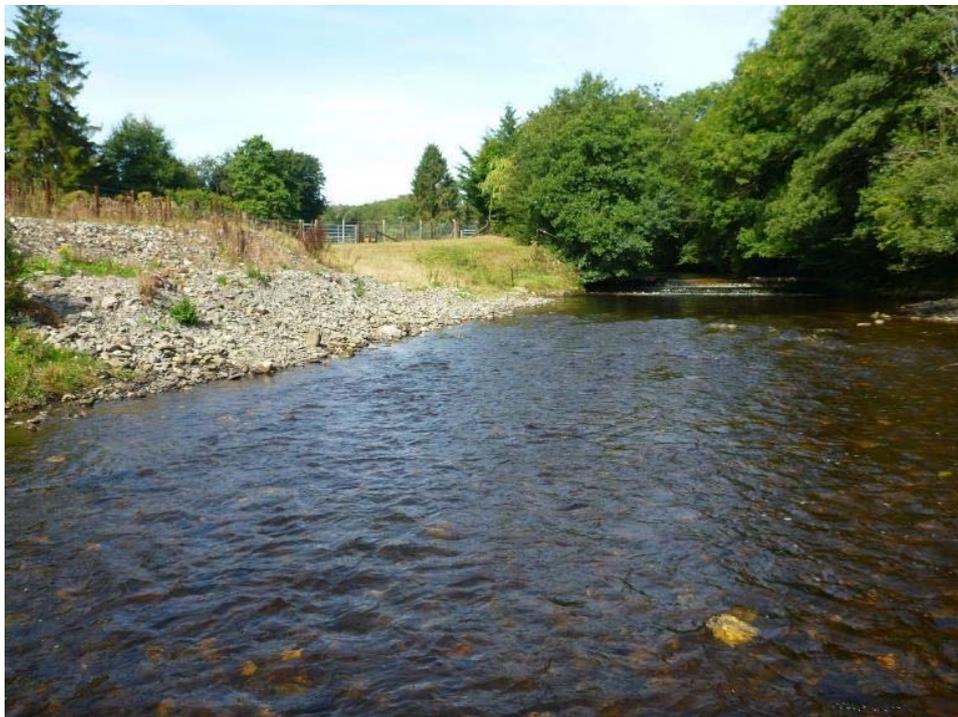
The flow gauging weir marks the upstream extent of the water inspected on this visit. Being a steep, rain-fed river, the Ceiriog actively transports its bedload of gravel and cobbles. The gauging weir is a trap for this sediment

and regular maintenance is carried out by NRW to clear the accumulated gravels from upstream; these were deposited in-channel downstream of the weir, but at the request of the Estate have recently been deposited on the bank. This was because an Irish ford (pipe crossing) used for forestry access a short distance downstream was prone to blocking with sediment. The ford has since been destroyed by floods and access for forestry machinery has yet to be re-established. If a ford is rebuilt, it is important to set the bed below the existing river bed level, at the natural slope of the river channel, to allow active sediment transport over the structure; this will avoid the issue of material being trapped upstream or the structure becoming perched.

Photo 1 Gauging weir with gravels removed from upstream and deposited on the bank downstream. Ideally these should be re-introduced to the river channel, as per previous practice.

Reintroduction of the gravels to the river channel is good practice from a fishery/biodiversity perspective, because it reduces the disruption of the natural sediment transport process caused by the presence of the weir. Maintaining natural sediment transport within a system also reduces the extent of unwanted bed and bank scour that can occur when a channel is starved of sediment. Natural sediment dynamics support the habitats favoured by salmon, trout, lampreys, bullhead, water crowfoot, etc. Any future crossing points should not interrupt sediment transport.

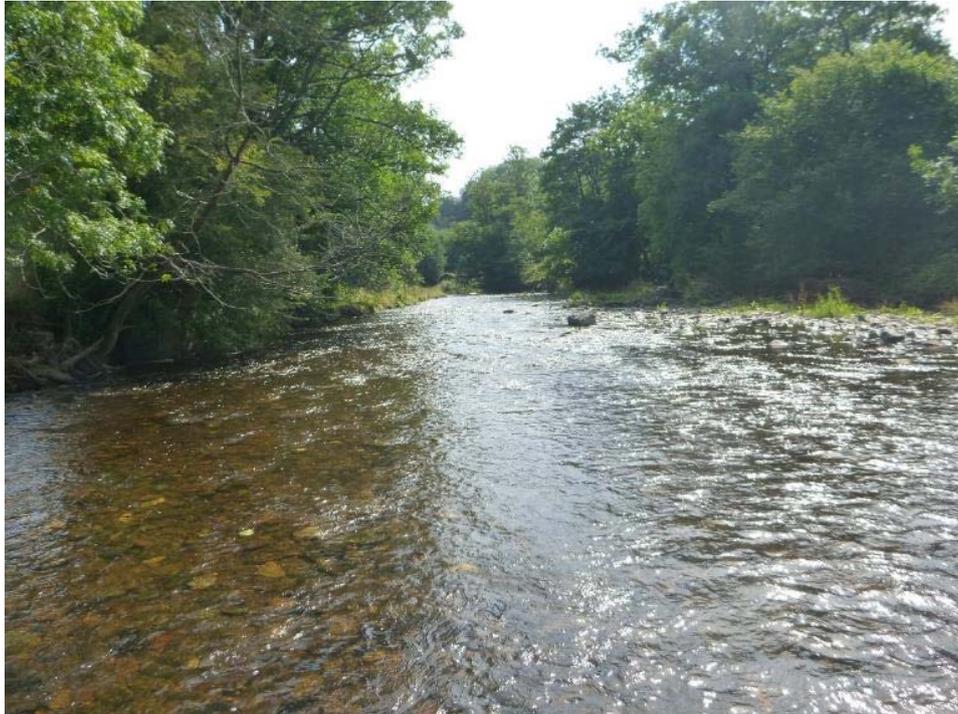
Much of the in-stream habitat downstream of the weir is fast and shallow (ankle – calf depth) with the river bed dominated by cobbles and large gravel (Photo 2).

Photo 2 Fast, shallow, gravel/cobble dominated reach.

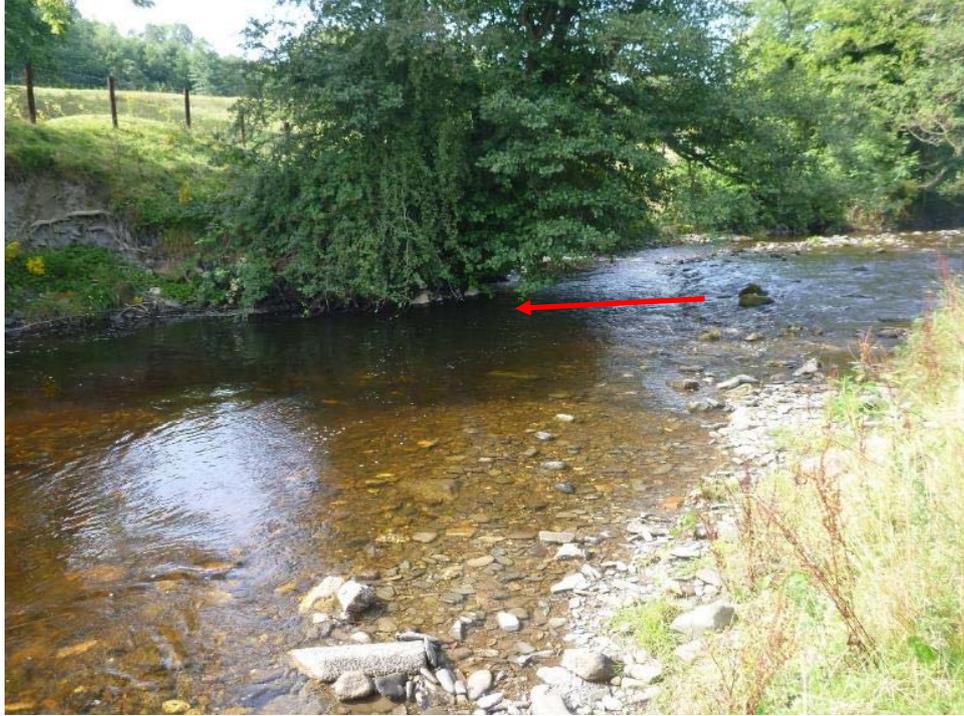
Photo 3 Current deflected against a resilient bank produces deeper water habitat.

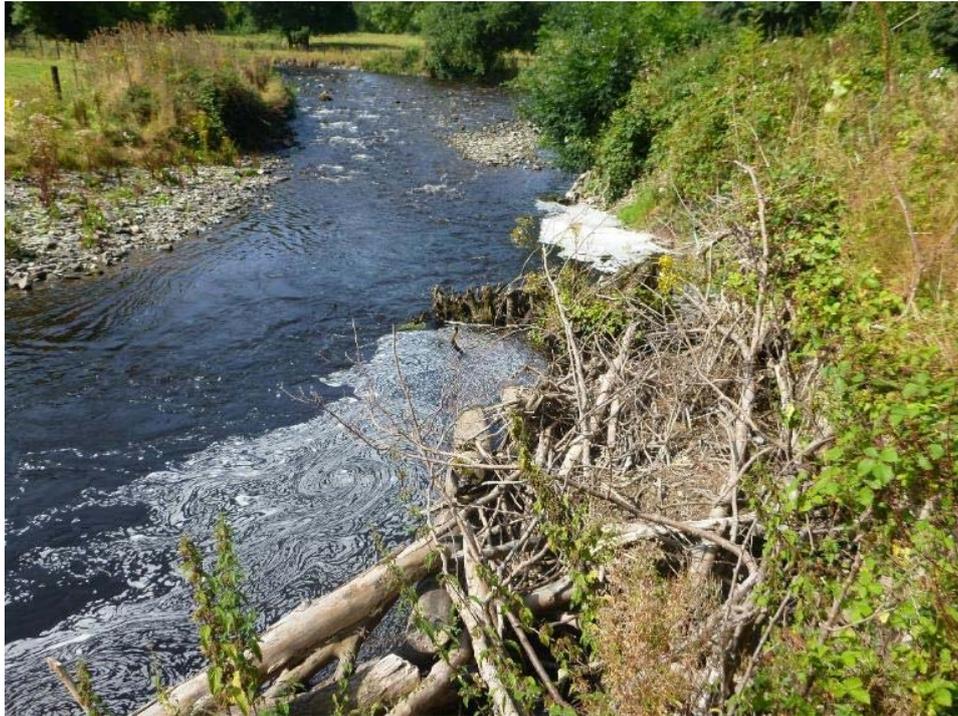
Inspection of the 1872 1:2500 scale OS map (www.old-maps.co.uk) shows there was a weir present in the approximate location of Photo 4, with a sluice and offtake channel on the left bank. No clear evidence of the weir remains but the offtake channel is still visible on current maps and led to a pump (hydraulic ram?) in the vicinity of the present viaduct and onwards across present field numbers 2343 and 6063, feeding into ponds and re-joining the river at Lady's Bridge.

Photo 4 A scour pool on a bend combined with large woody material provides excellent adult fish habitat.

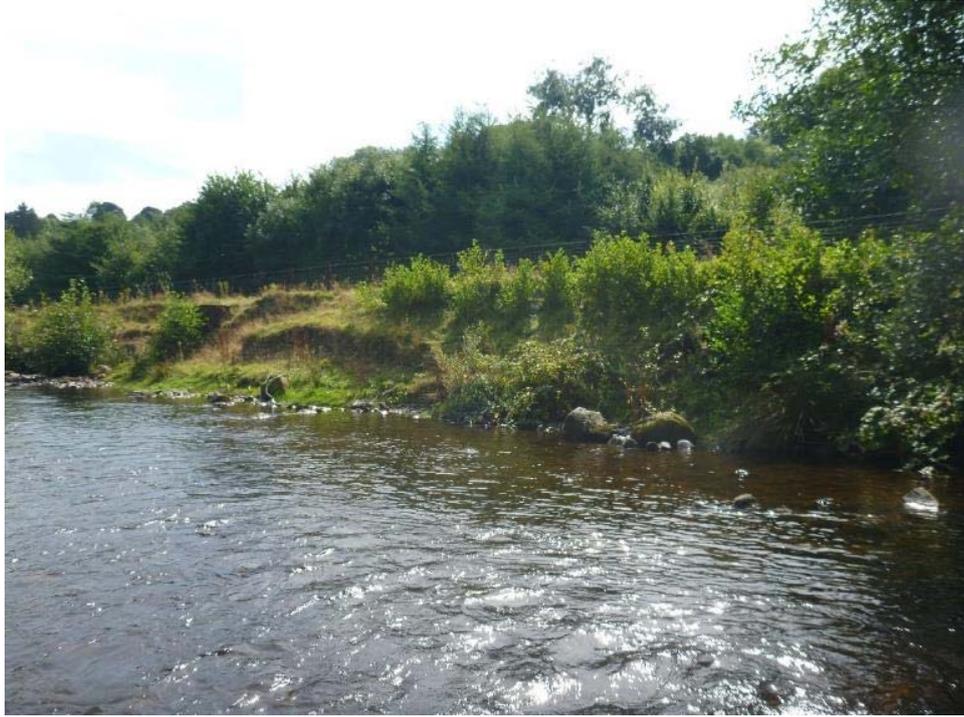
There are some positive signs that the fencing in this location is working and having an impact on the form of the river channel. Photos 5 and 6 show areas on the right and left banks respectively where reduced grazing pressure is allowing self-seeded trees to establish and where marginal gravel shoals are colonising with vegetation, stabilising and narrowing the river channel.

Photo 5 Self-seeded alders establishing in the absence of grazing.

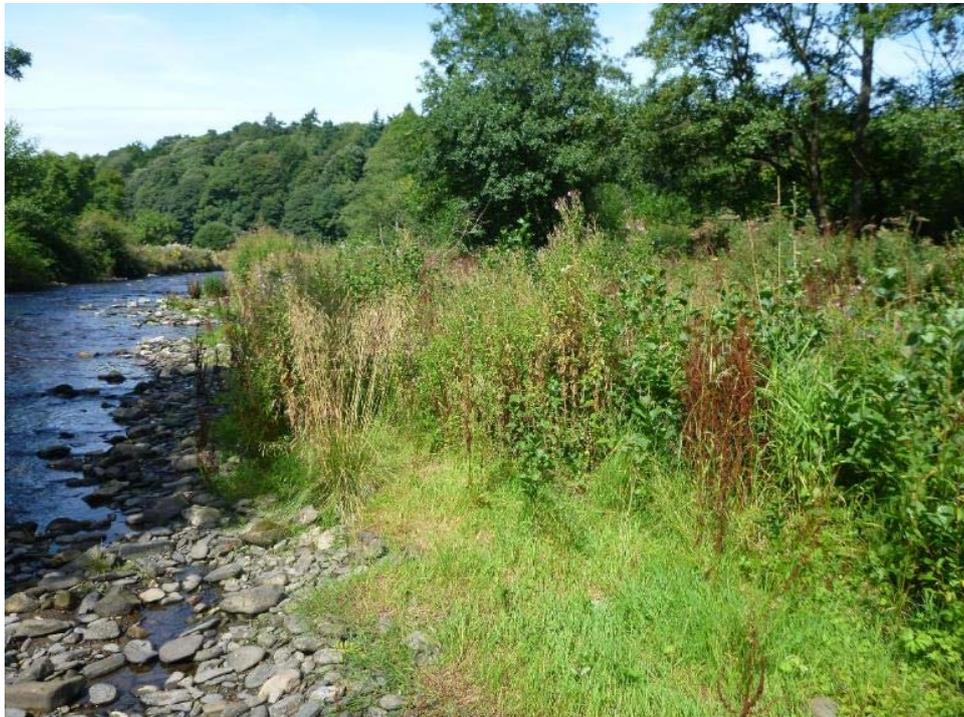
Photo 6 Herbaceous vegetation and tree seedlings consolidate a gravel bar, narrowing and eventually deepening the river channel.

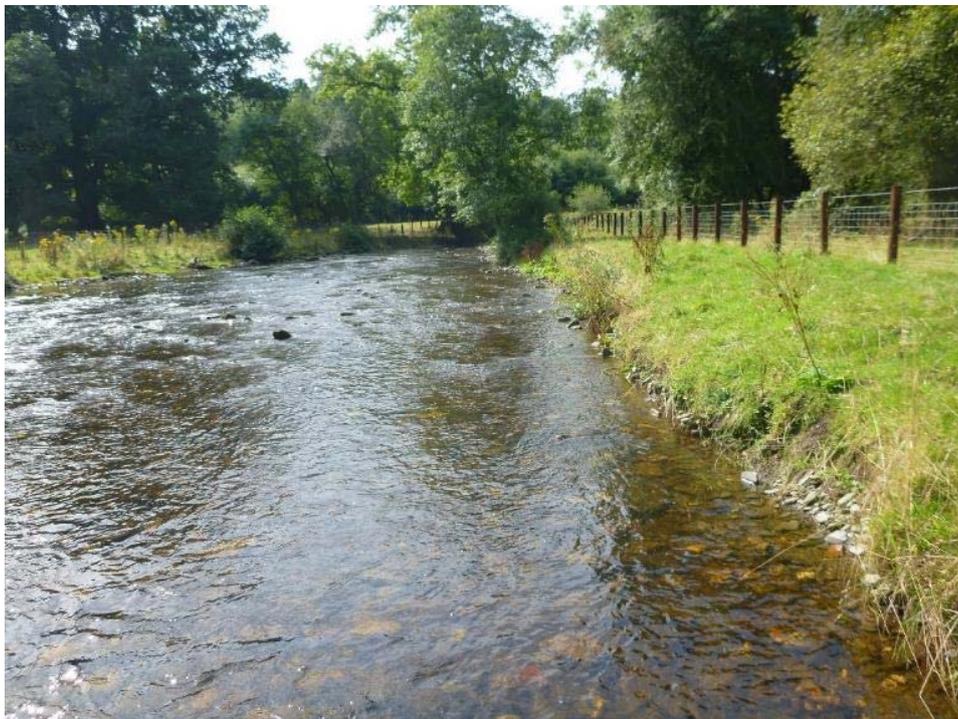
Unfortunately, in other areas the fence is not proving as effective and grazing is evidently taking place on the river side. It appears stock are getting through the water gate barrier at the crossing/drinking point as reflected in the bankside vegetation upstream and downstream of this point (Photos 7 – 9). The shallow nature of the river here means that once behind the fence, stock can access long lengths and both banks, negating the benefit of the fence. The crossing point is gated, so if alternative watering arrangements could be made, stock could be excluded from the river.

Photo 7 Upstream of the cattle drink/crossing, the banks are evidently being grazed.

- Maintain and improve the stock fencing to prevent grazing of the river banks. The recovery of natural vegetation along the banks will

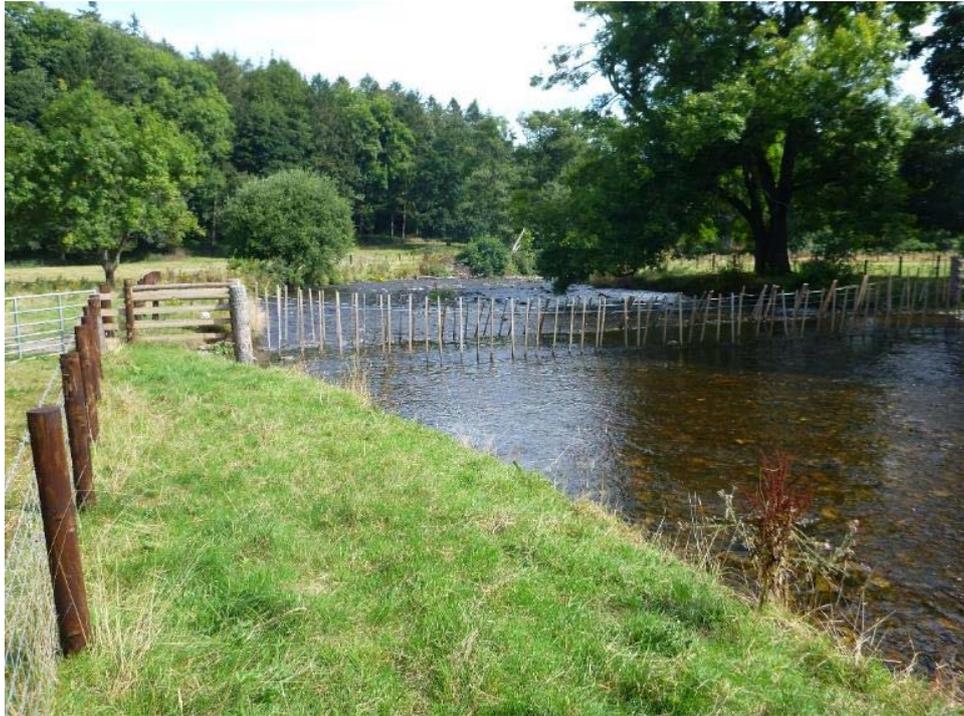
Photo 8 Cattle drink/crossing with ineffective water gate

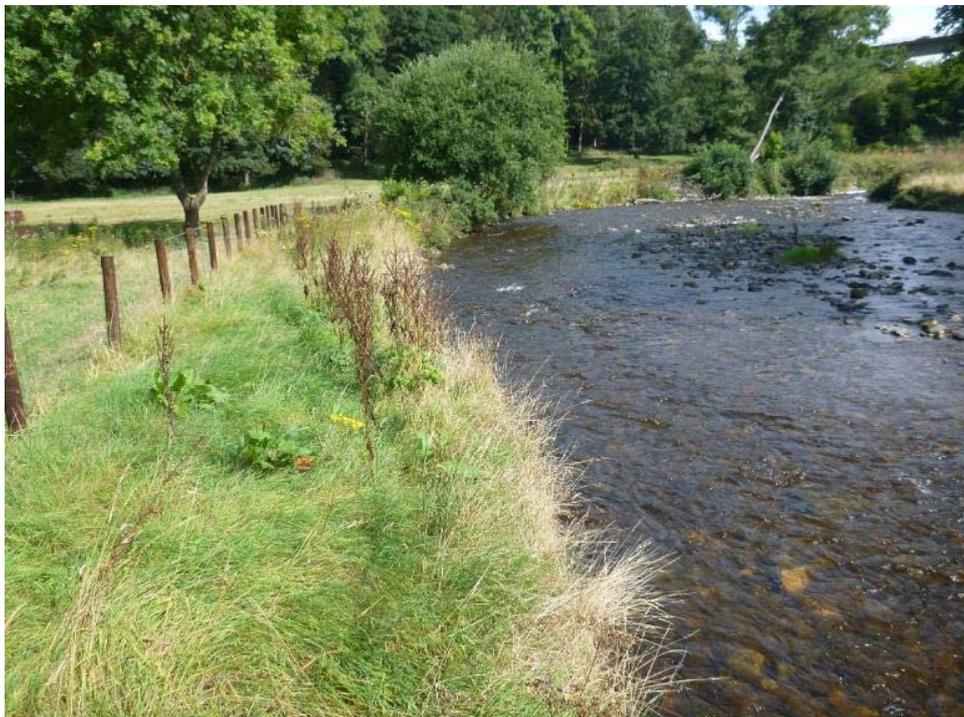
Photo 9 Downstream of the cattle drink/crossing – less grazing pressure, better bankside habitat. If stock can be excluded, planting some willow whips here (with a view to laying them in the margins in future) is recommended.

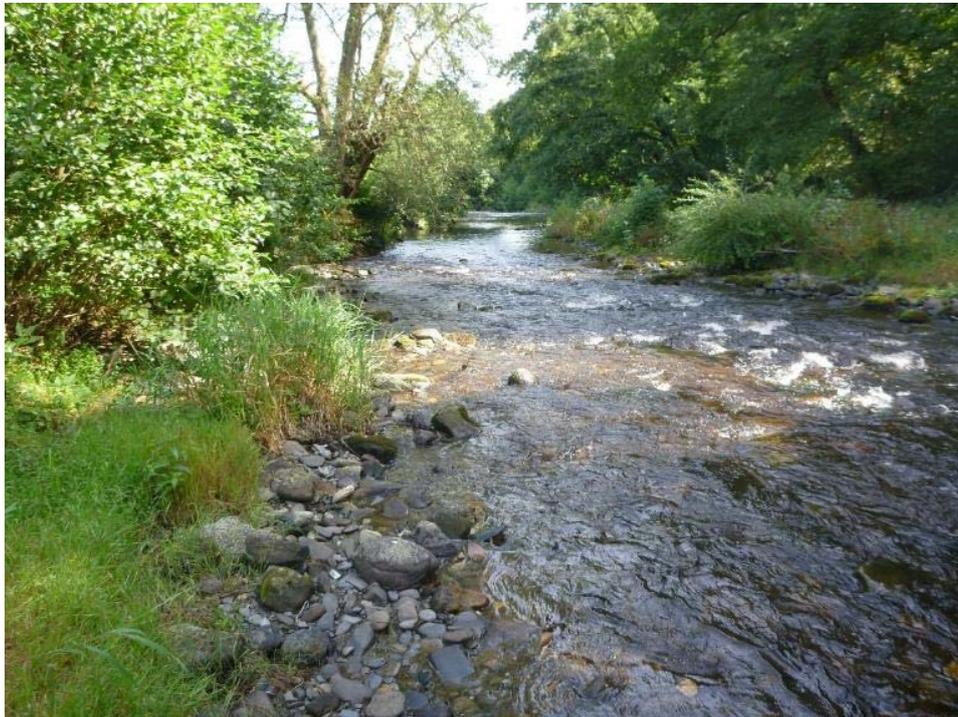
Photo 10 Excellent riparian habitat contributing to bank stabilisation and natural channel narrowing.

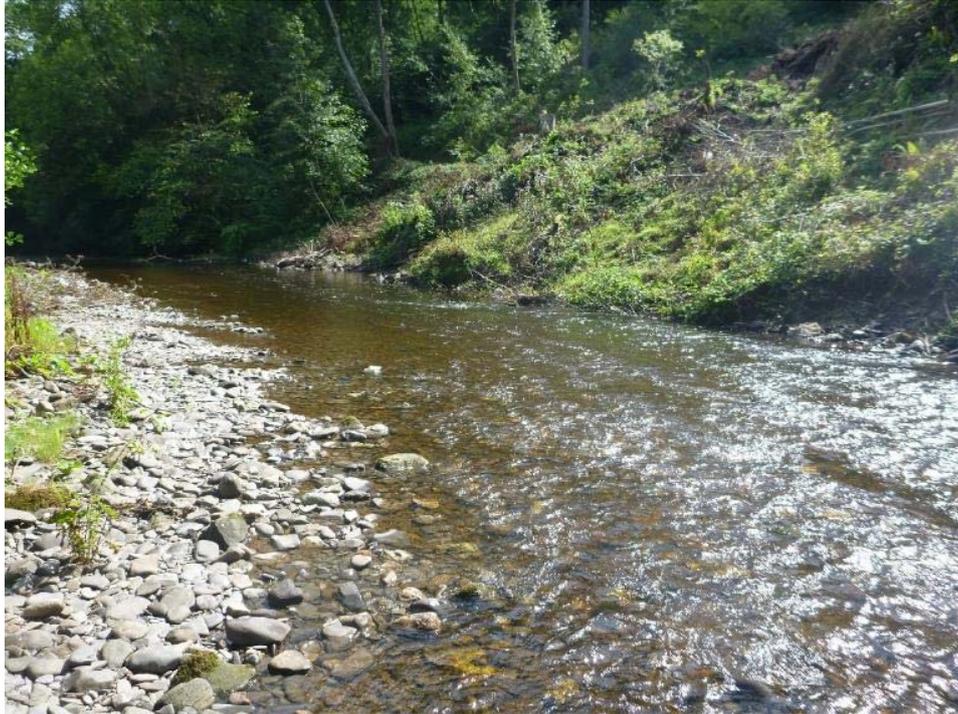
A short section of the right bank has recently been cleared of trees and the timber extracted via the left bank. This area coincides with a deeper glide and it would be useful to re-establish some low cover along the right bank to encourage fish to hold in the deeper water.

Photo 11 Valuable deeper water habitat that would benefit from additional low and trailing cover.

- Provide some low cover over the water along the length of river on the right bank downstream of the viaduct which has been recently cleared of trees (Photo 11). Tree kickers (see below) could be attached to suitable anchor points on the bank (e.g. tree stumps) and in the longer term, regrowth of trees on the bank from coppiced stools can be hinged into the margins.

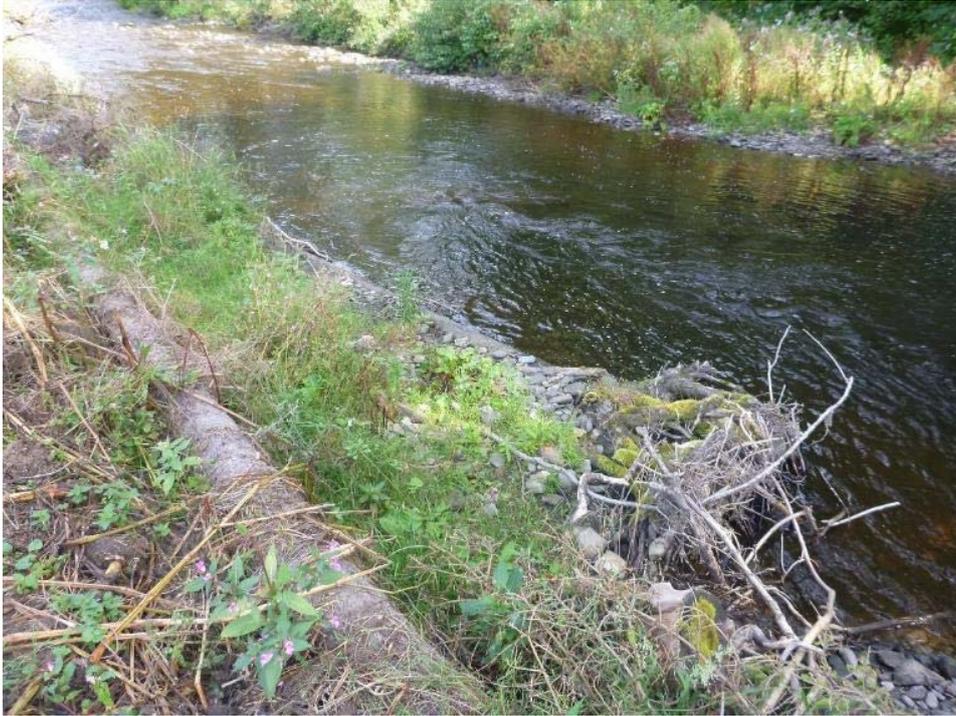
good marginal habitat and helping to narrow and deepen the channel, complementing one of the few deep pools present in this section (Photos 12, 13). The cleared area has been re-planted with conifers; broadleaved trees would be better immediately alongside the watercourse, providing deeper bank stabilising root systems and a more diverse invertebrate fauna.

Photo 12 Tree trunks laid along the bank have helped to narrow and deepen the channel.

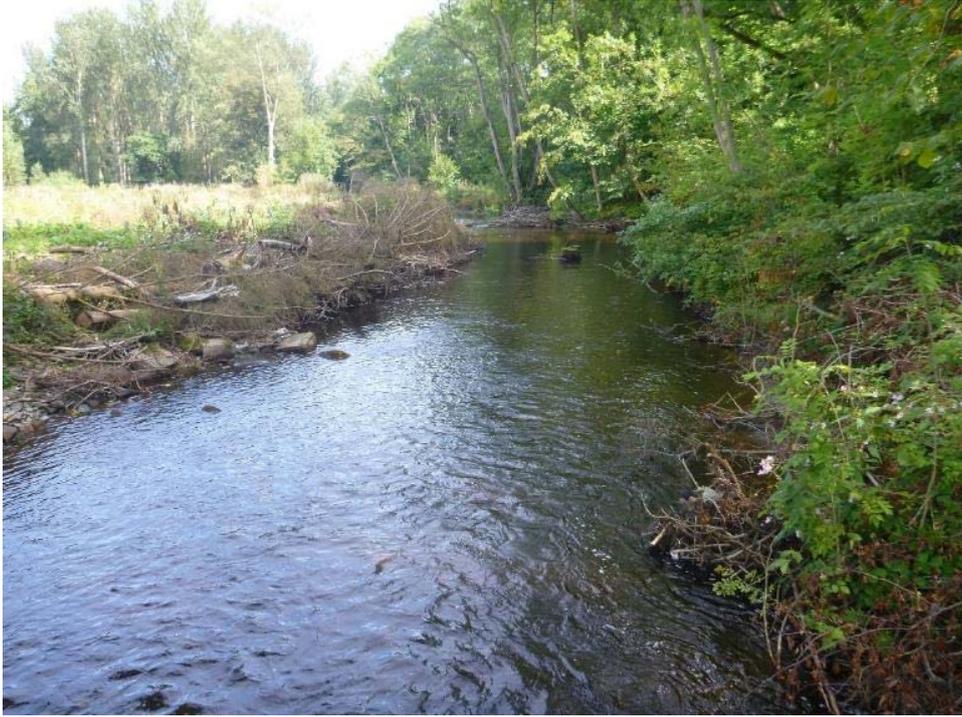
Photo 13 Coarse woody material laid along the bankside provides good cover for juvenile salmonids.

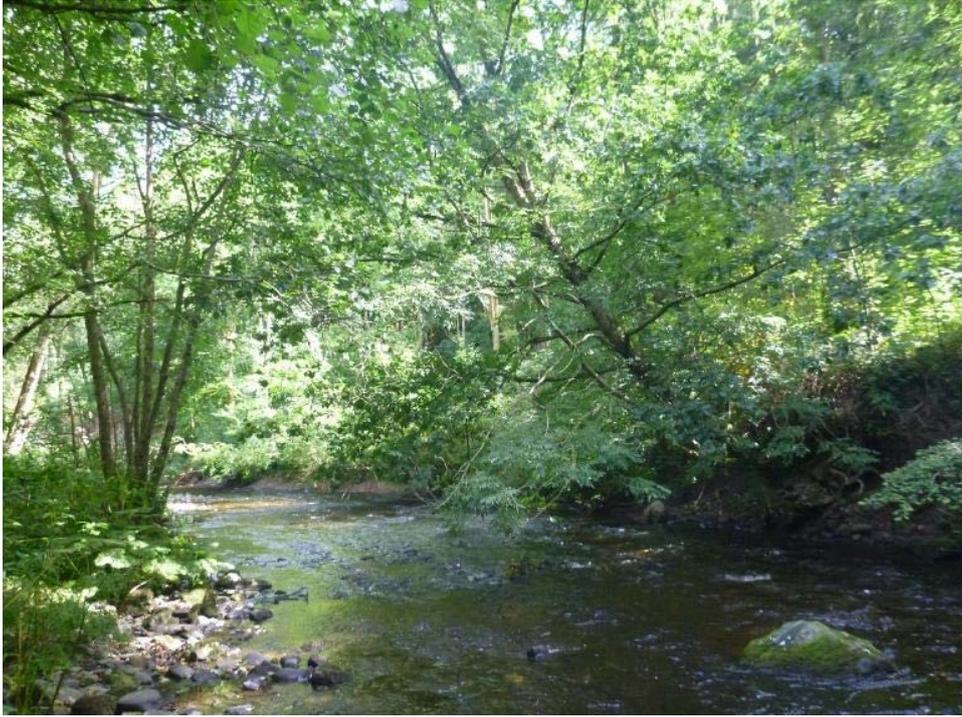
Further down this section towards Lady's Bridge, the fast, shallow nature of the river continues with no pool habitat. There are a number of bankside trees which lend themselves to being positioned in the river channel to promote scour and hopefully increase depth variation.

Photo 14 Trees close to the watercourse could be felled and fixed in position to encourage scour and depth variation.

- The reach of river between the viaduct and Lady's Bridge could have some tree kickers installed. These are whole trees felled into the watercourse and attached securely to their stumps with steel cable. They are generally swept parallel to the bank in high water events. Their presence changes flow patterns and creates localised scour and deposition and hence depth variation. The viaduct to Lady's Bridge is a particularly straight section which would benefit from some variation. Downstream of Lady's Bridge is similar, but the river bed there is largely comprised of bedrock so would not scour.

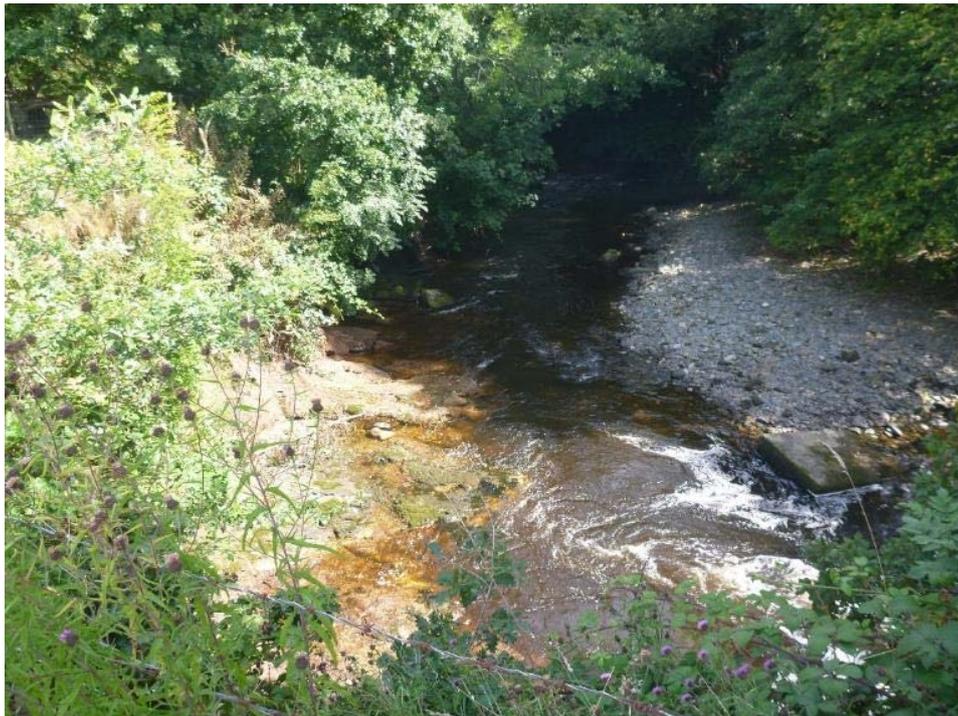
The river makes a sharp right turn at the downstream end of field 7086 and there is a pool here bordered by bedrock on the left bank and a gravel point bar on the right bank (Photo 15). The 1872 map shows this was the site of a weir with a sluice on the left bank sending water along a leat to Pont-y-blew, possibly for water power for the forge there. There are no remains of the weir, although the leat is still evident on the left bank.

Photo 15 Site of former weir

The reach downstream of the former weir site (field number 8893) is heavily shaded by trees and largely a shallow glide. This area would benefit from tree hinging.

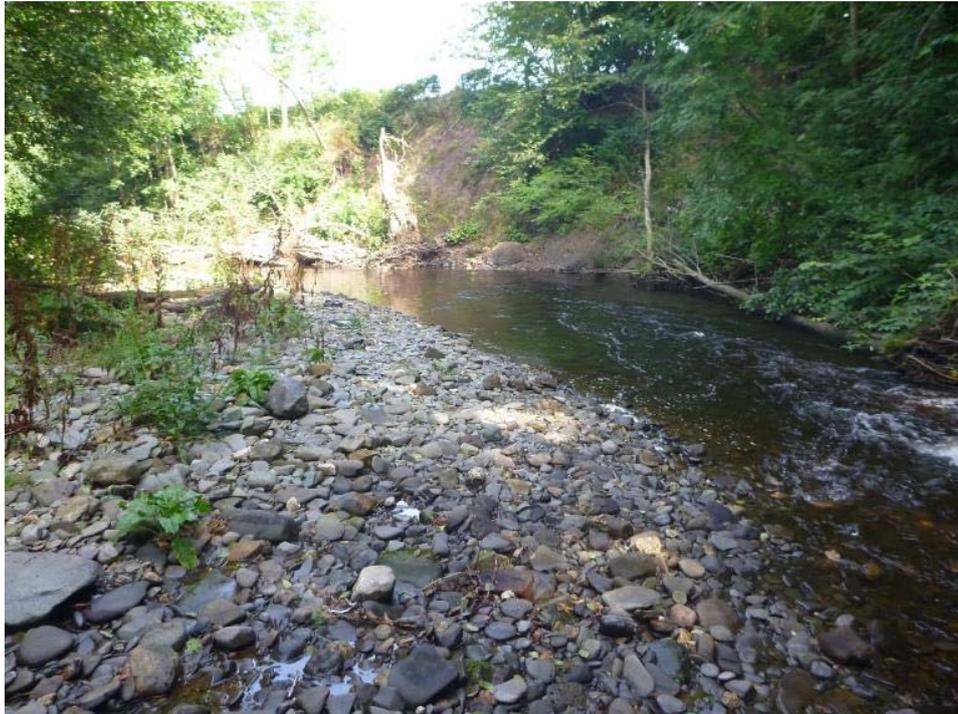
Photo 16 Deep pool habitat found on the outside of a bend – good for adult fish.

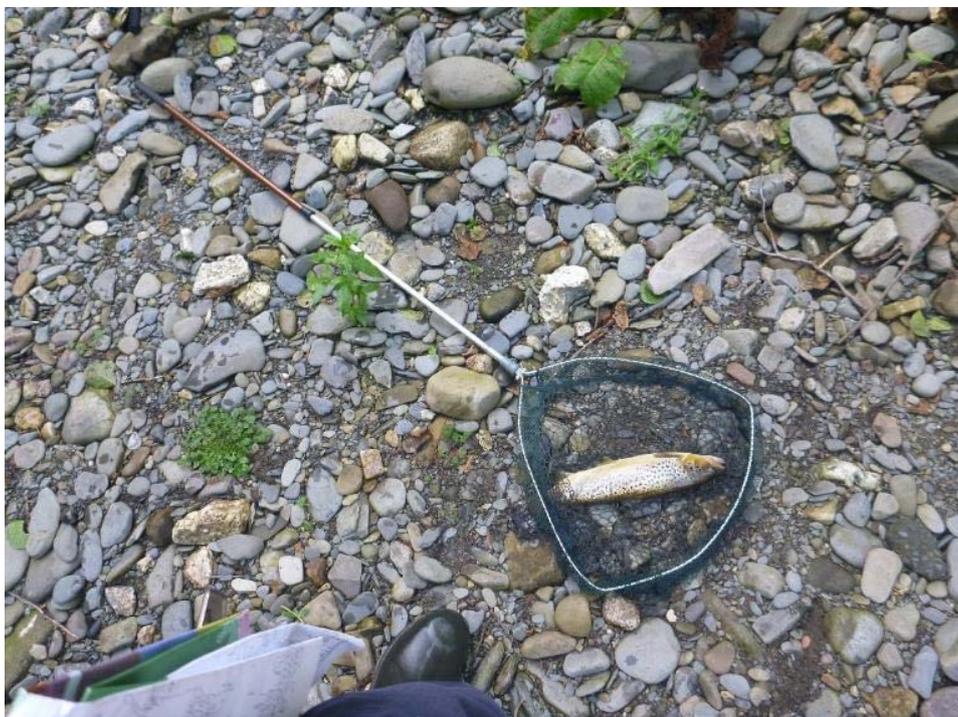
Photo 17 A trout from the above pool found in a poacher's net!

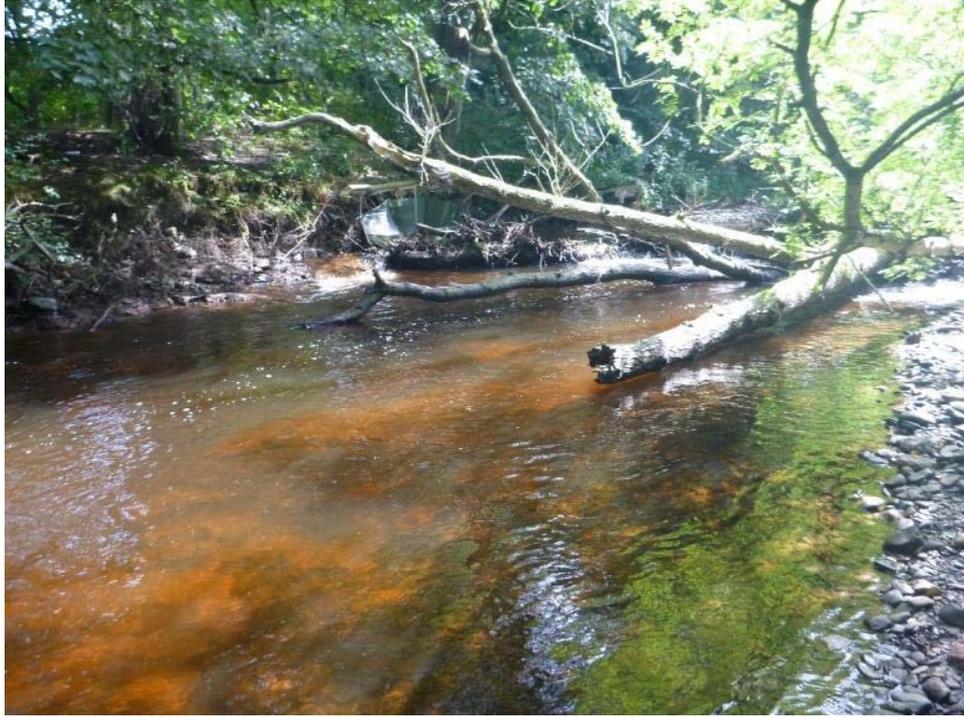
Photo 18 Stable large woody material often creates depth by promoting bed scour.

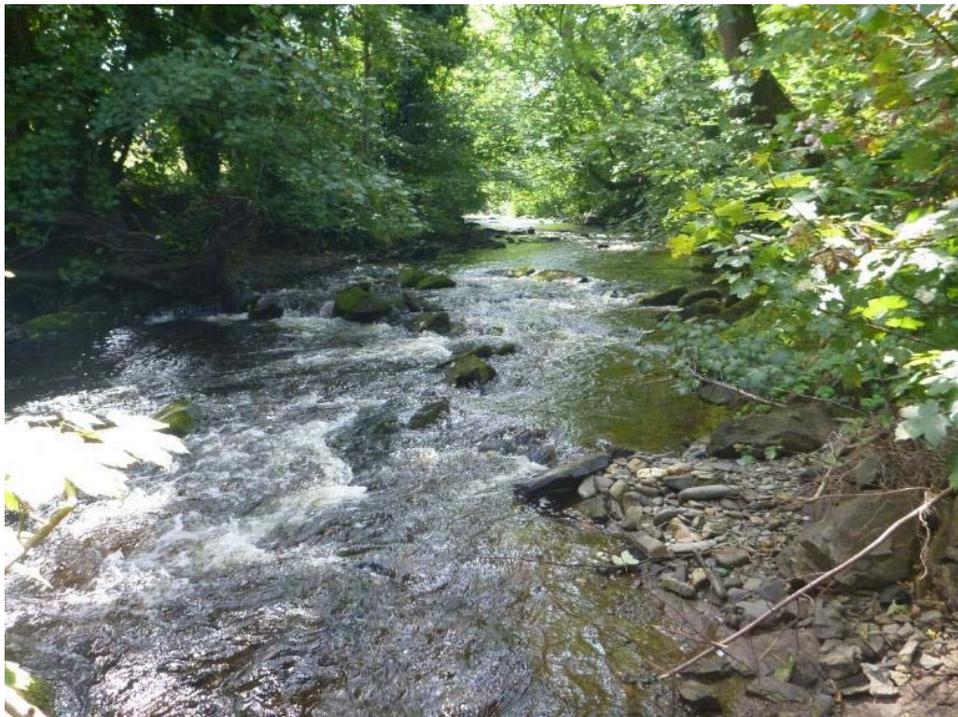
Downstream of the road bridge, the gradient of the river increases and the in-stream habitat becomes a series of cascades and large boulders (Photo 19) before returning to riffle and glides. The banks are tree lined with previously coppiced sycamore present on the left bank which would lend itself to hinging into the river margins.

Photo 19 Steeper channel section of cascade and boulder habitat.

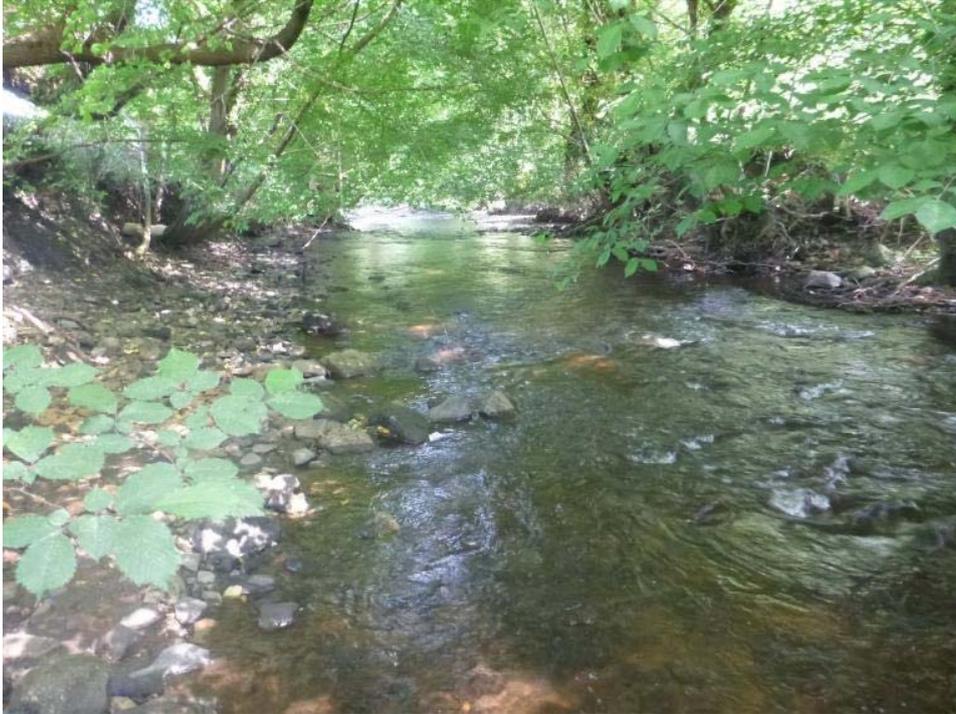
Past the chapel towards the forge, the river is heavily shaded with coppiced hazel and sheep are present here. The combination of shade and grazing means the banks are very bare, contributing to widening and shallowing of the river channel (Photo 20). Selective coppicing to reduce shade and restriction of grazing adjacent to the river would greatly improve riparian habitat.

Photo 20 Bare banks due to sheep grazing and shading.

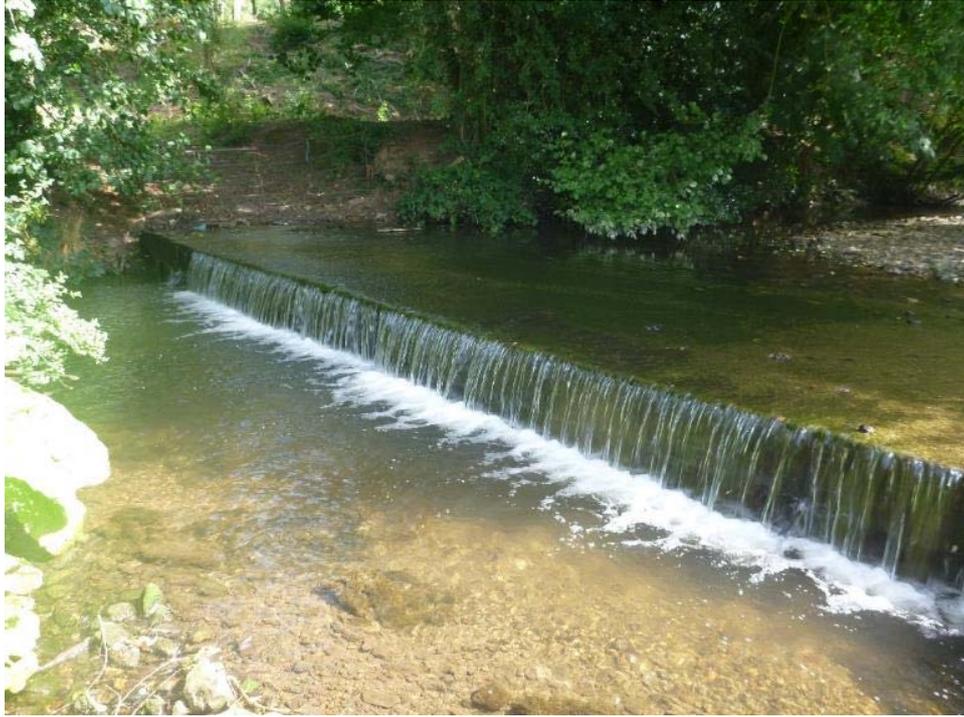
The Morlas Brook joins the river from the right bank opposite the forge. This tributary is designated as “good” by the Environment Agency under the last two assessment cycles for the Water Framework Directive, with “good” score for fish and “high” for invertebrates. It is potentially a valuable spawning tributary for trout, sea-trout, salmon and possibly lampreys. Unfortunately, a short distance above the confluence is a concrete ford which is an impediment to free fish passage, particularly at low flows (Photo 21).

Photo 21 Concrete ford on the Morlas Brook, an impediment to fish passage.

- The ford/weir on the Morlas Brook should be modified to improve opportunities for fish passage. River crossings have the potential to impede fish passage and sediment transport and comprehensive guidance can be found here <https://www.sepa.org.uk/media/151036/wat-sg-25.pdf> . This should

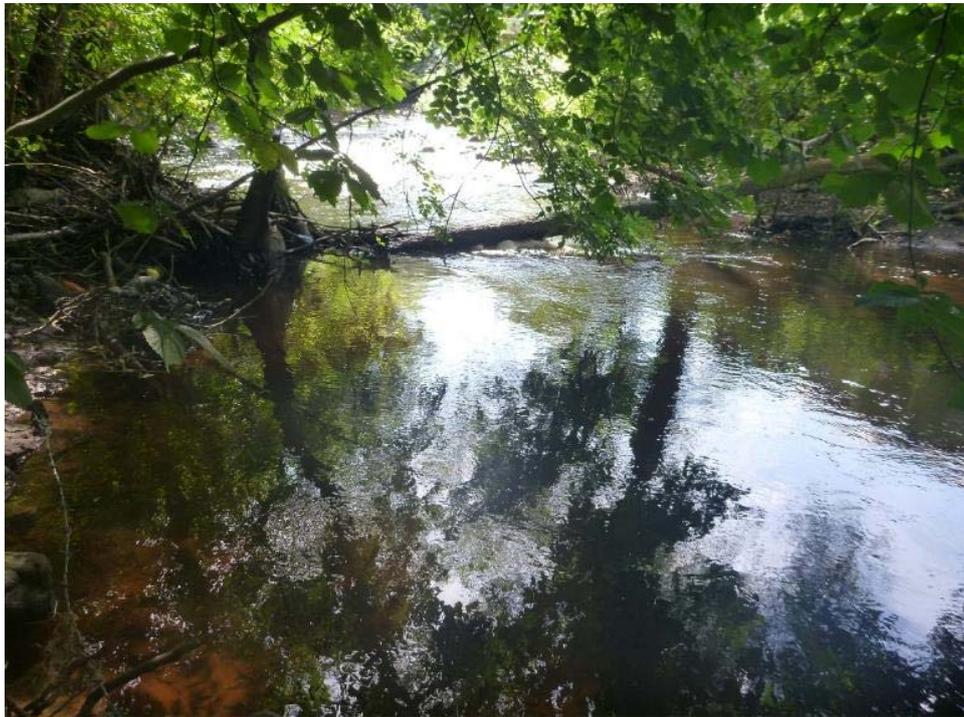
Photo 22 A deeper pool associated with undershot scour beneath the fallen tree.

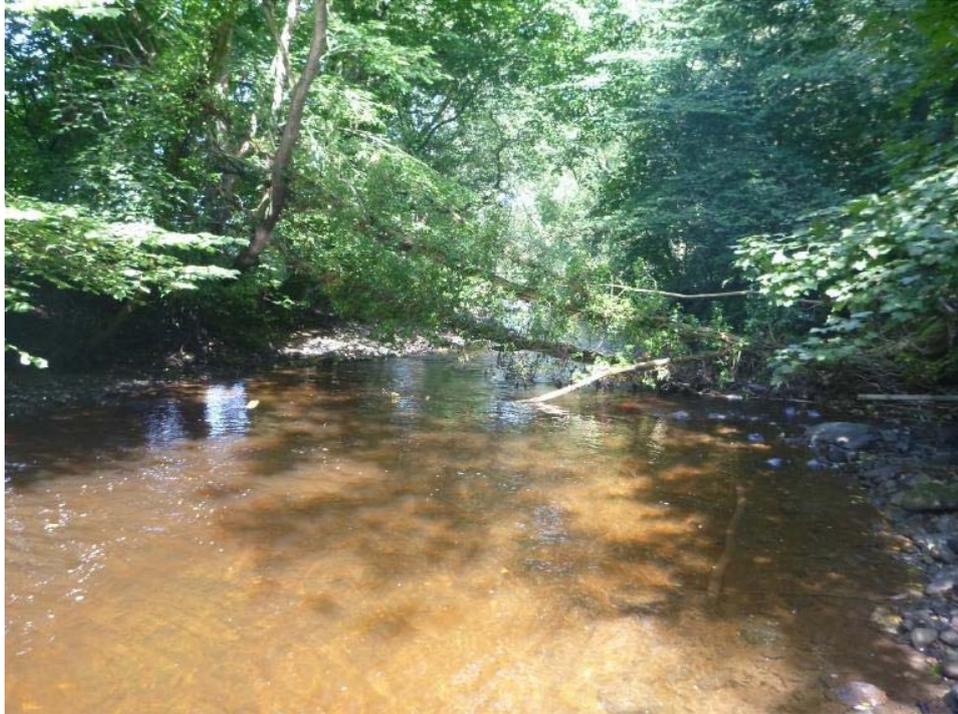
Photo 23 Deeper pool area associated with fallen trees.

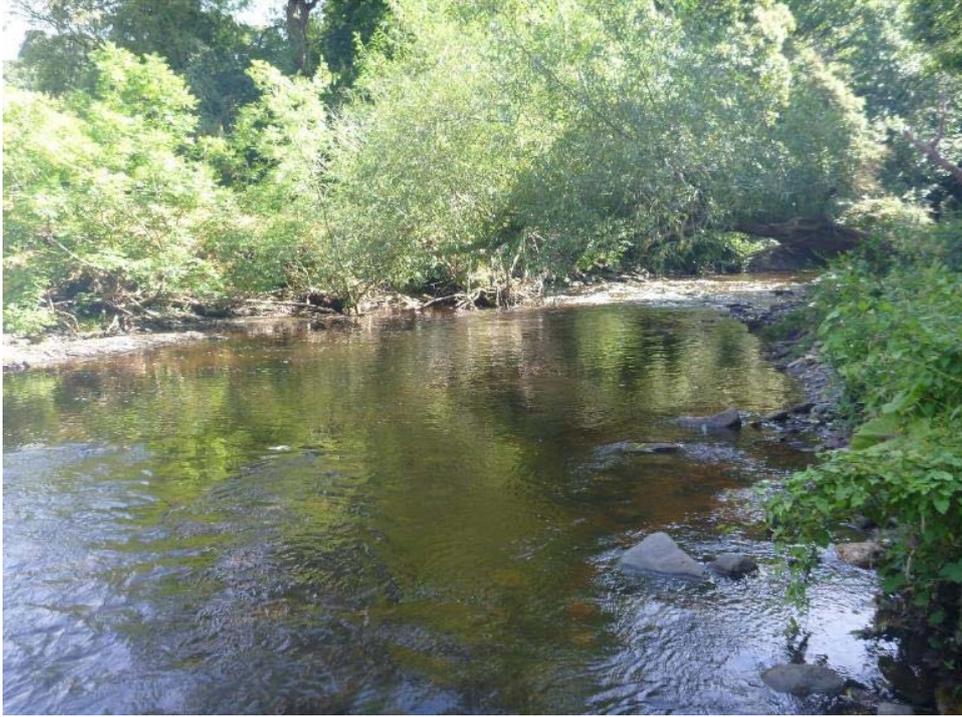
Photo 24 Good pool habitat with excellent woody cover along the far bank, below Forge Farm.

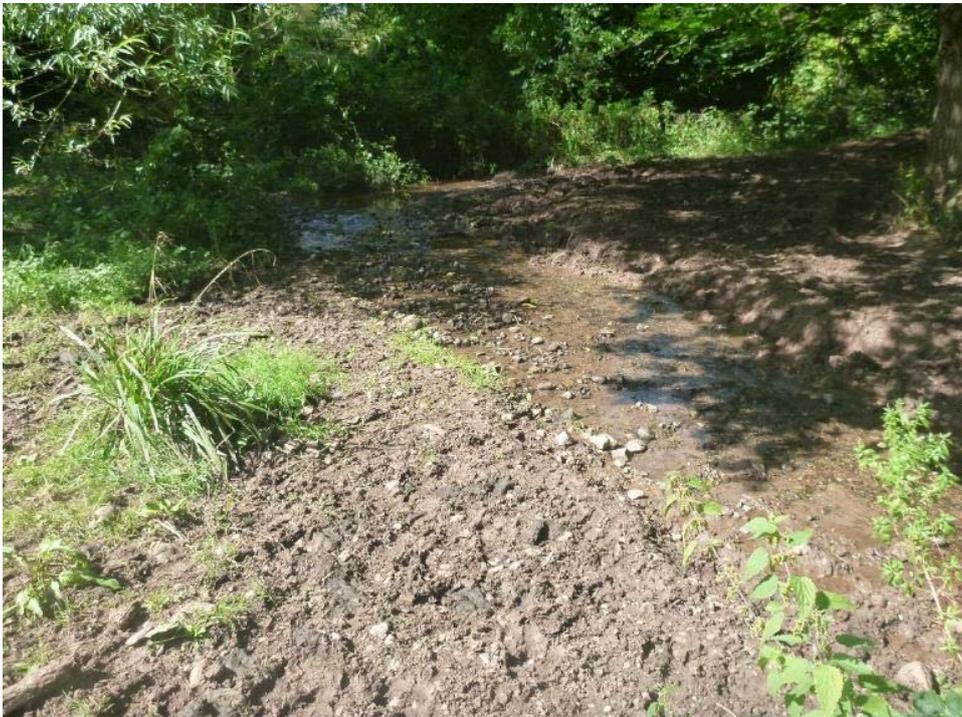
At Riverside Cottage on the left bank, a small stream (Bolas's Dingle) enters the river. There is heavy livestock trampling of the stream in the field below the cottage, an undesirable fine sediment input to the river (Photo 25).

Photo 25 Livestock trampling causing a fine sediment input via Bolas's Dingle.

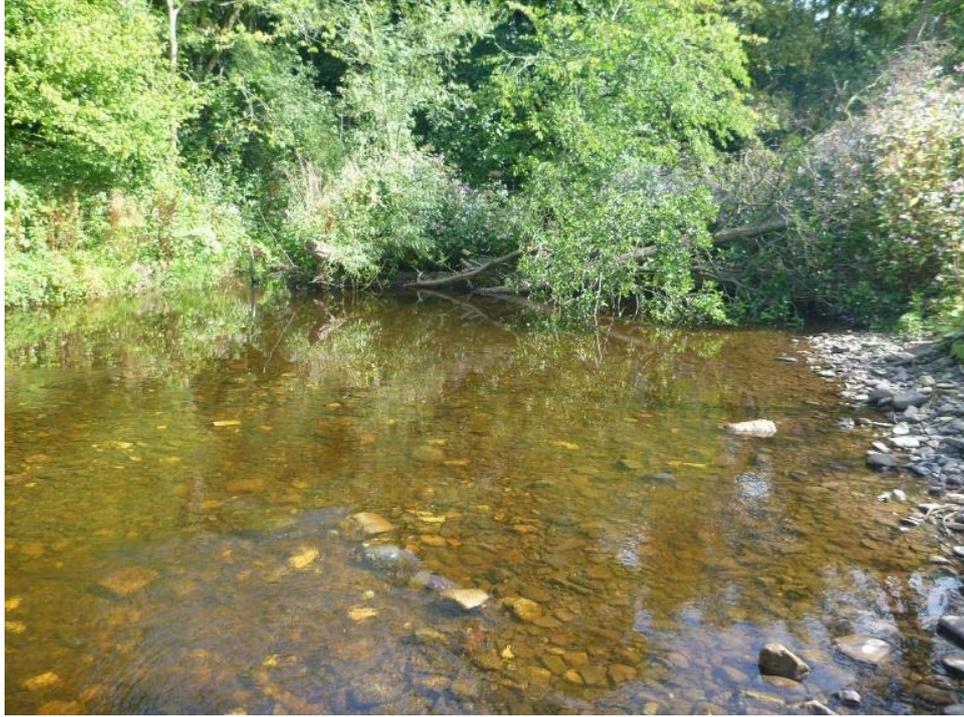
Photo 26 Large woody material in the river has created undershot scour and a deep pool, plus thrown up clean, sorted gravel downstream – both good habitats for adult fish and spawning respectively.

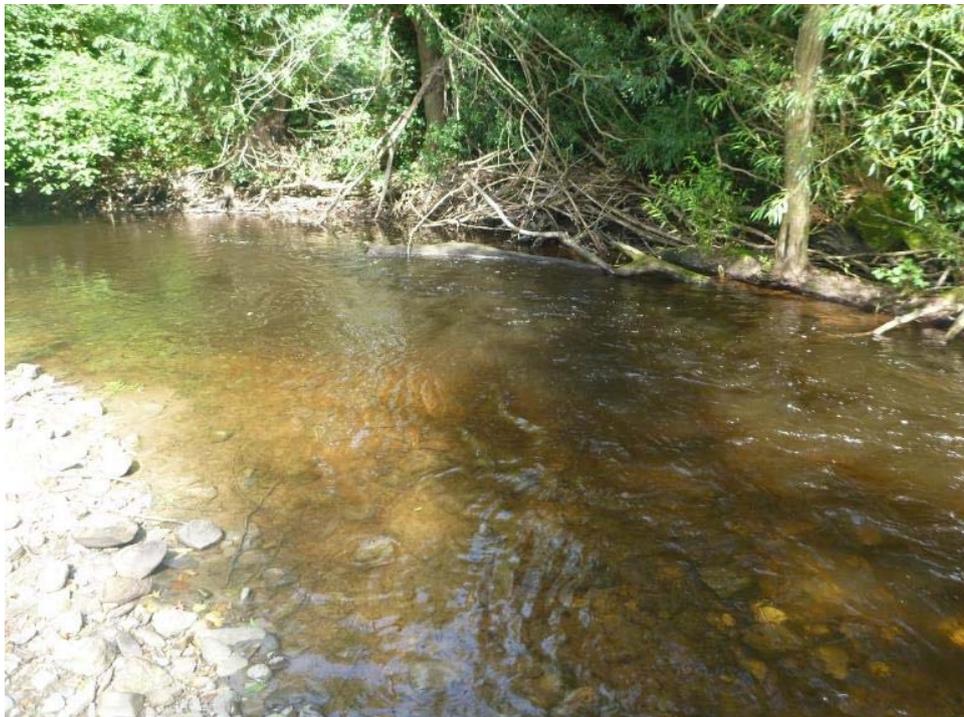
Photo 27 One of numerous examples of deeper pool habitat with good cover, upstream of Pont Llygodyn.

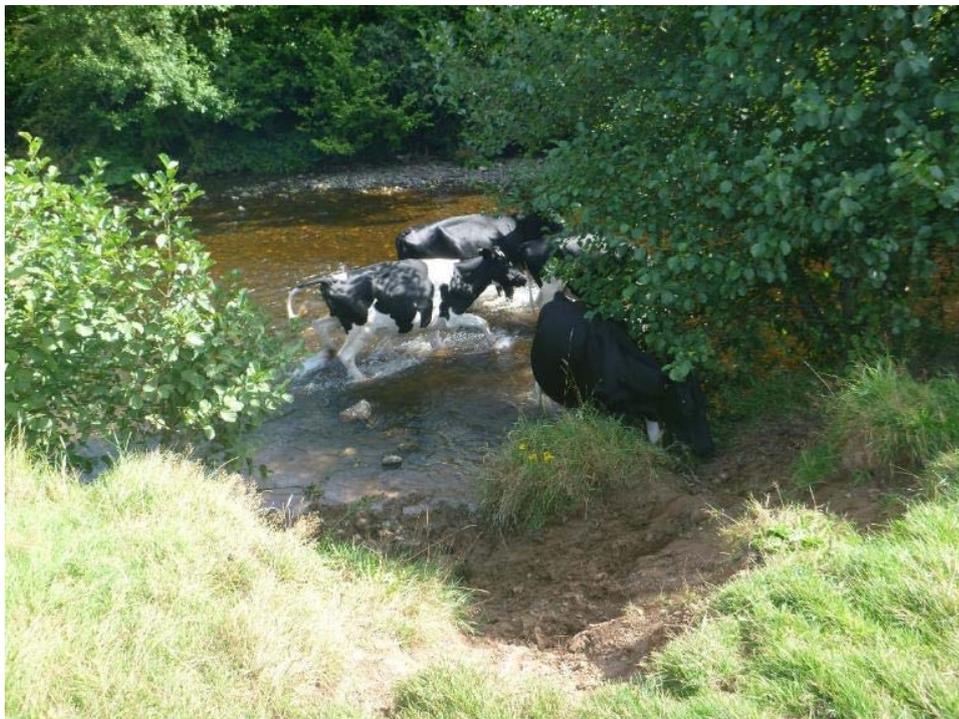
Downstream of the bridge the left bank is unfenced, grazed pasture and cattle are creating access points to the river (Photo 28). The left bank vegetation is currently good, with trees, bushes and tall vegetation present, but this could change over time with continued stock access.

Photo 28 Cattle with free access to the river.

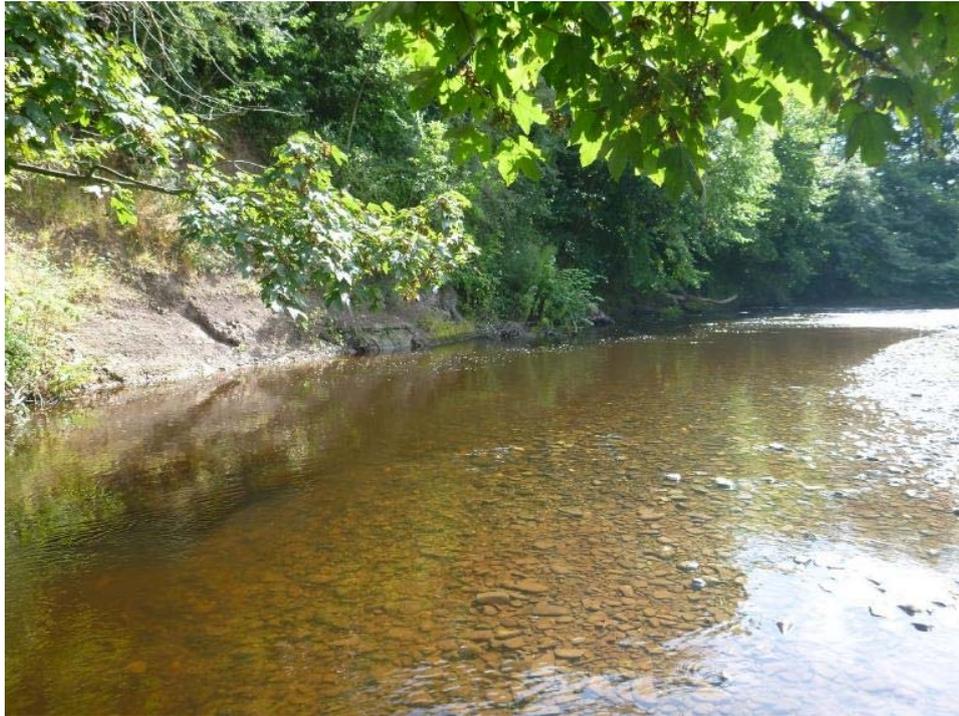
There are some good holding pools on the outside of bends here, downstream towards the Dee confluence (Photo 29).

Photo 29 Deep pools on the outside of bends towards the Dee confluence.
