**ADVISORY VISIT TO THE RIVER CEIRIOG,
WALES,
UNDERTAKEN BY VAUGHAN LEWIS,
WINDRUSH AEC LTD, ON BEHALF OF CEIRIOG
FLY FISHING CLUB
MAY 2008**

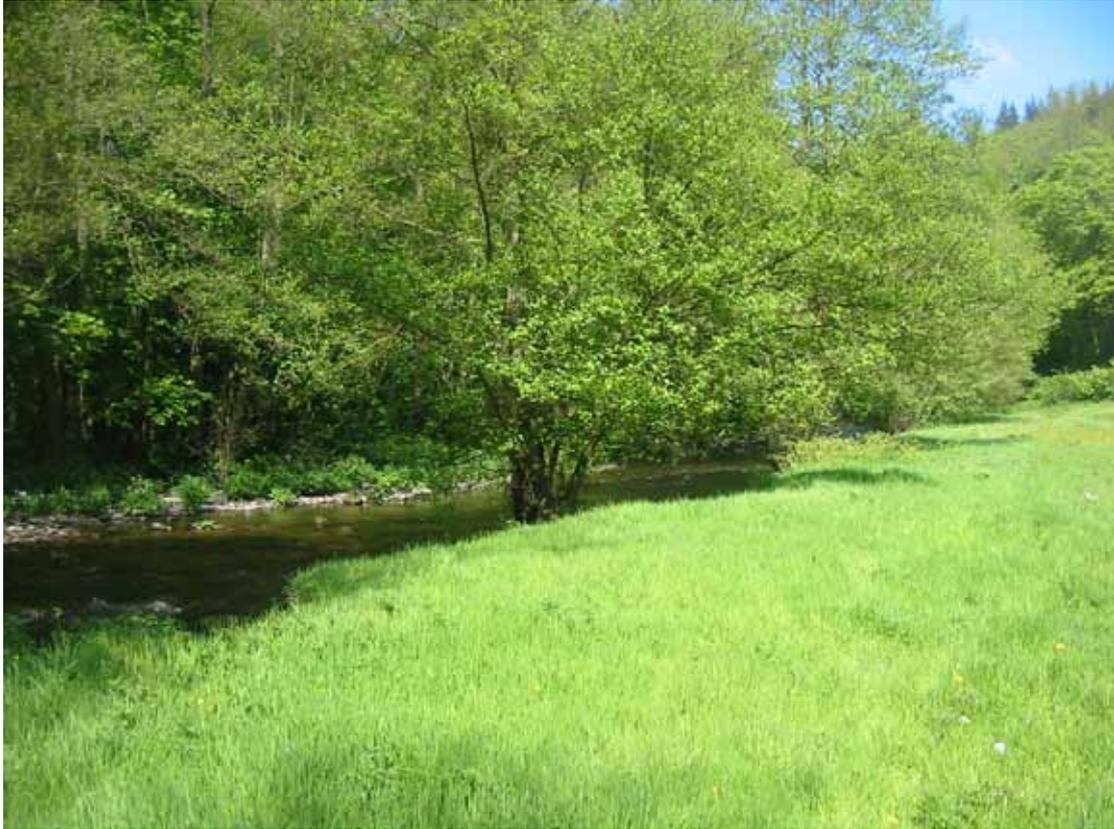
Typical reach of the middle river

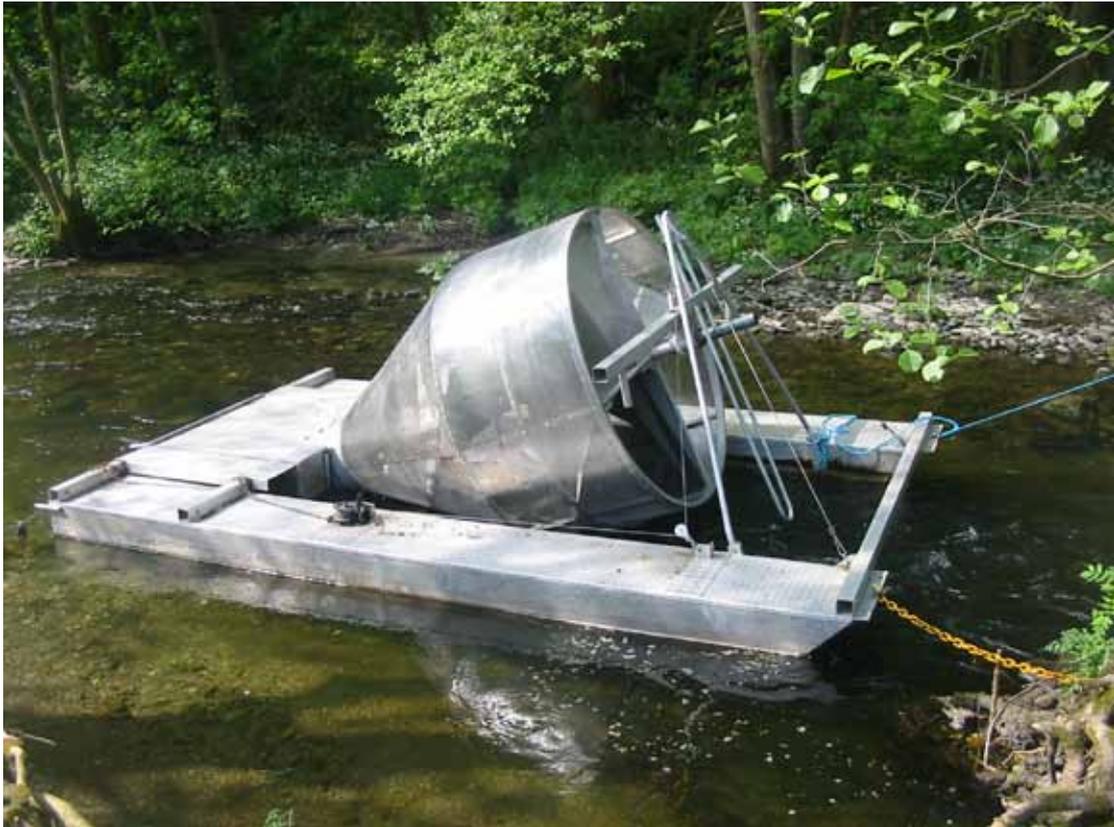
Rotary screw smolt trap

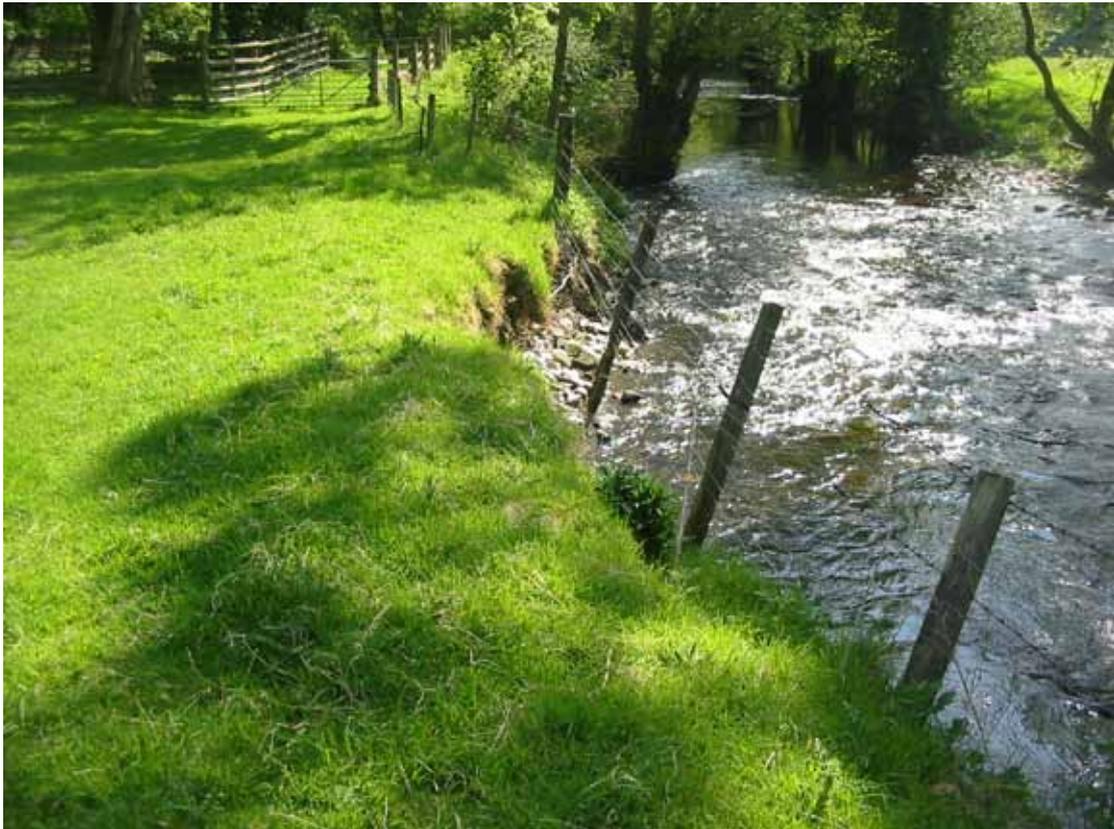
- The integrity of some of the fencing along the river had been lost, partly due to erosion of the bank, and partly due to sheep being able to force their way through sections of the fence. It is recommended that any fencing erected in the future is made sheep proof, and that it is erected at least 5m from the bank top in order to allow the development of a wide, well-vegetated buffer strip.

Bank erosion as a result of fencing being erected too close to the bank top

Fencing should ideally be erected along all reaches subject to significant grazing pressure from stock.

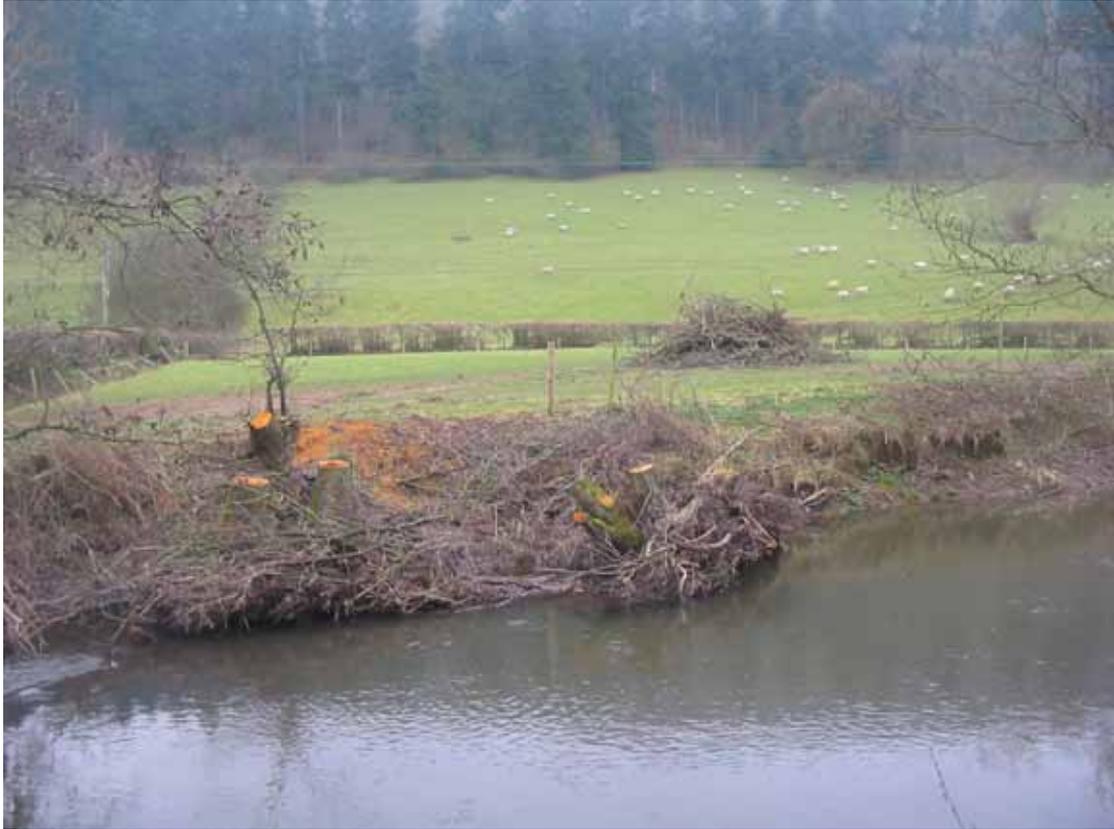
Recent coppicing

- Further tree cutting should be considered along the heavily wooded sections of the fishery. By instigating a well-planned programme of rotational coppicing, shading of the channel can be reduced, thus encouraging the growth of valuable marginal vegetation. Care must be taken to avoid excessive coppicing as this can lead to over-warming of the water, to the detriment of fish. The aim should be to produce dappled shade over the channel, with between 40% and 60% shading. The reach above Castle Mill Bridge was an example showing the desired mix of shading and light. Selected trees should be clearly marked before cutting. A period of around 5-7 years should be

maintained between successive coppicing. If a significant cut of timber is proposed, it may be necessary to obtain a felling licence from the Forestry Commission.

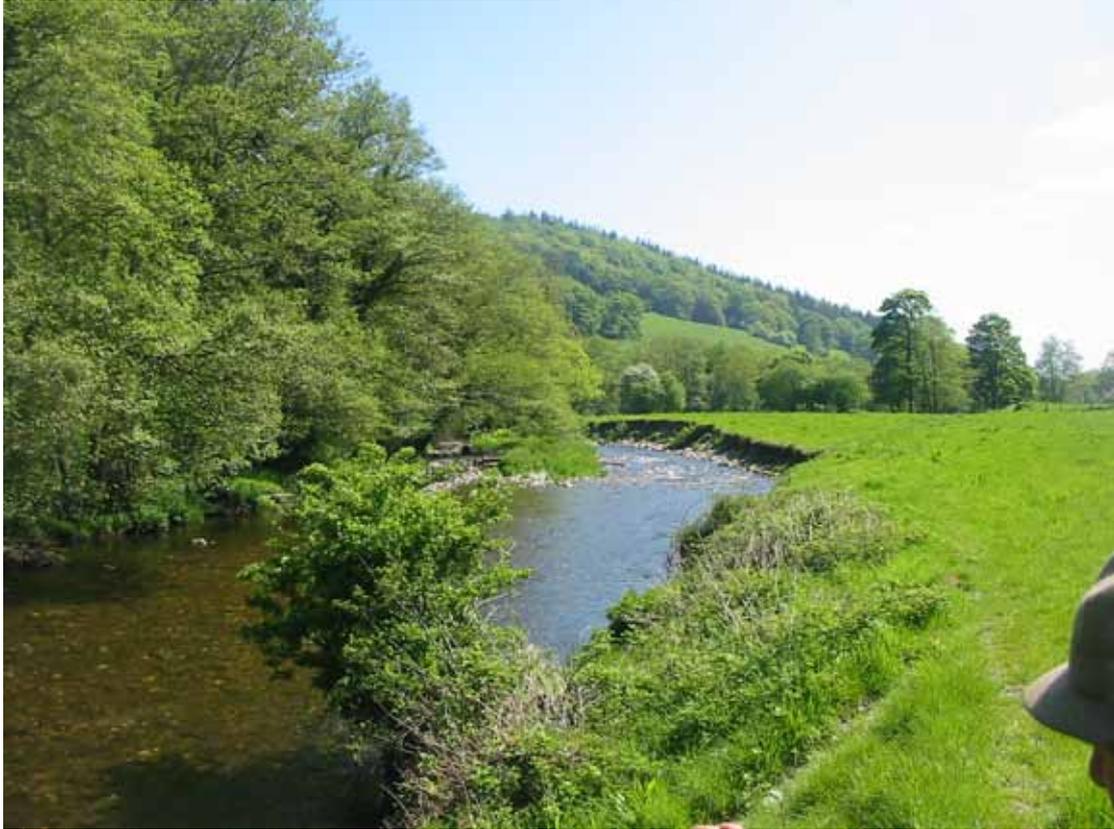
From the Chippings to the Broken Bridge, the channel was rather overwide with limited instream feature following the severe flood in 2000. This had lowered the bed on the RB of the fishery by some 0.75m, taking the main flow away from its original LB path and along the RB. As a consequence, this was steep and very unstable with a significant damaging erosion taking place each year.

Realigned and badly eroded section of river upstream of The Chippings. Note that the channel along the RB is some 0.75m lower than the LB, with the former RB now effectively an island in the centre of the river

- The overwide section of river upstream of the Chippings could be addressed by cutting down between 5-10 alder trunks on the LB and winching them across to the RB, where they would be installed in a line facing upstream at around 30⁰ upstream. This would tend to push the flow away from the RB into the middle of the channel, protecting the RB from excessive erosion. In conjunction with a temporary (electric) or permanent (post and wire) fence to protect the bank from stock erosion, this would, overtime, reduce erosion and allow the riverbanks to recover, eventually narrowing the river.
