Little Avon, Charfield, South Gloucestershire

An Advisory Visit by the Wild Trout Trust February 2016

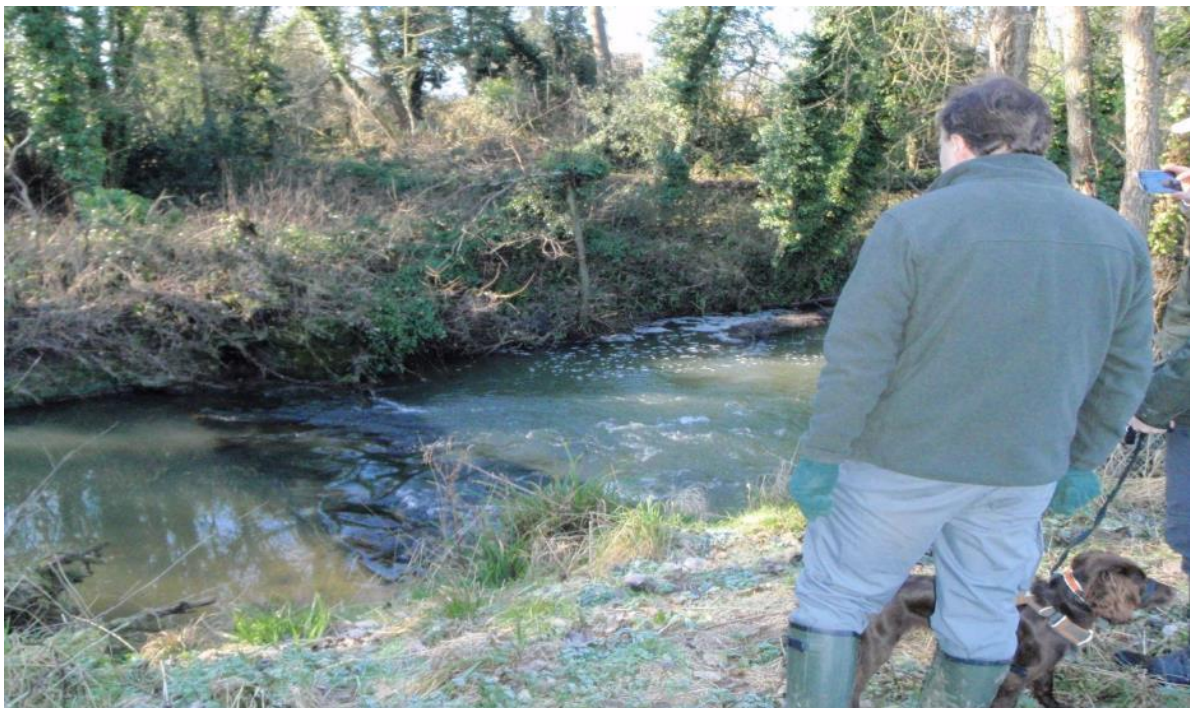
Photo 1: Remains of defunct weir on beat 1; note the base stones are intact allowing fish passage over the top

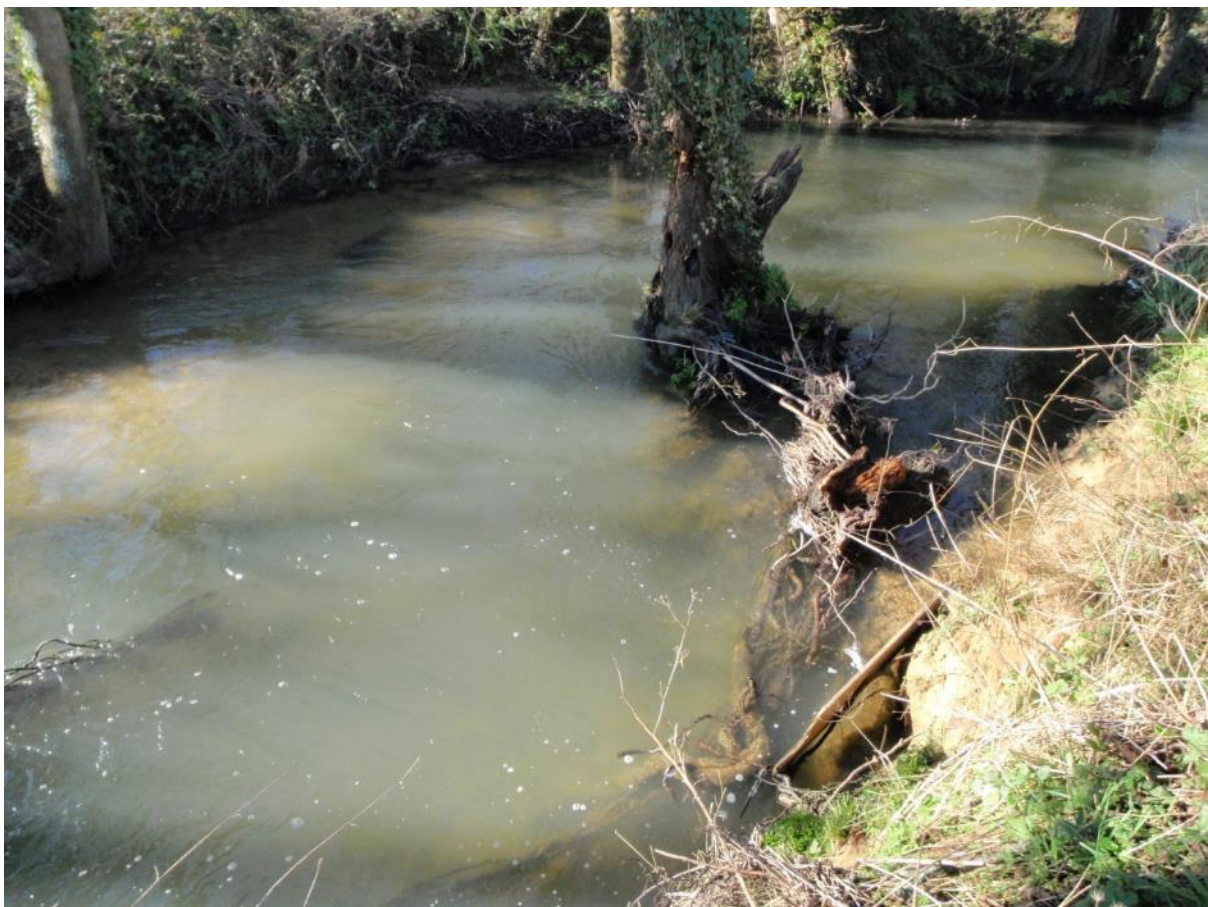
Although limited to certain stretches, there is some woody debris present in the channel over the survey reach (see photo 2.). Woody debris is a naturally occurring component in most rivers. Bank side trees, limbs or branches that fall or are washed into the river play an important role in natural river processes,

Photo 2: An example of naturally occurring LWD on the lower beat

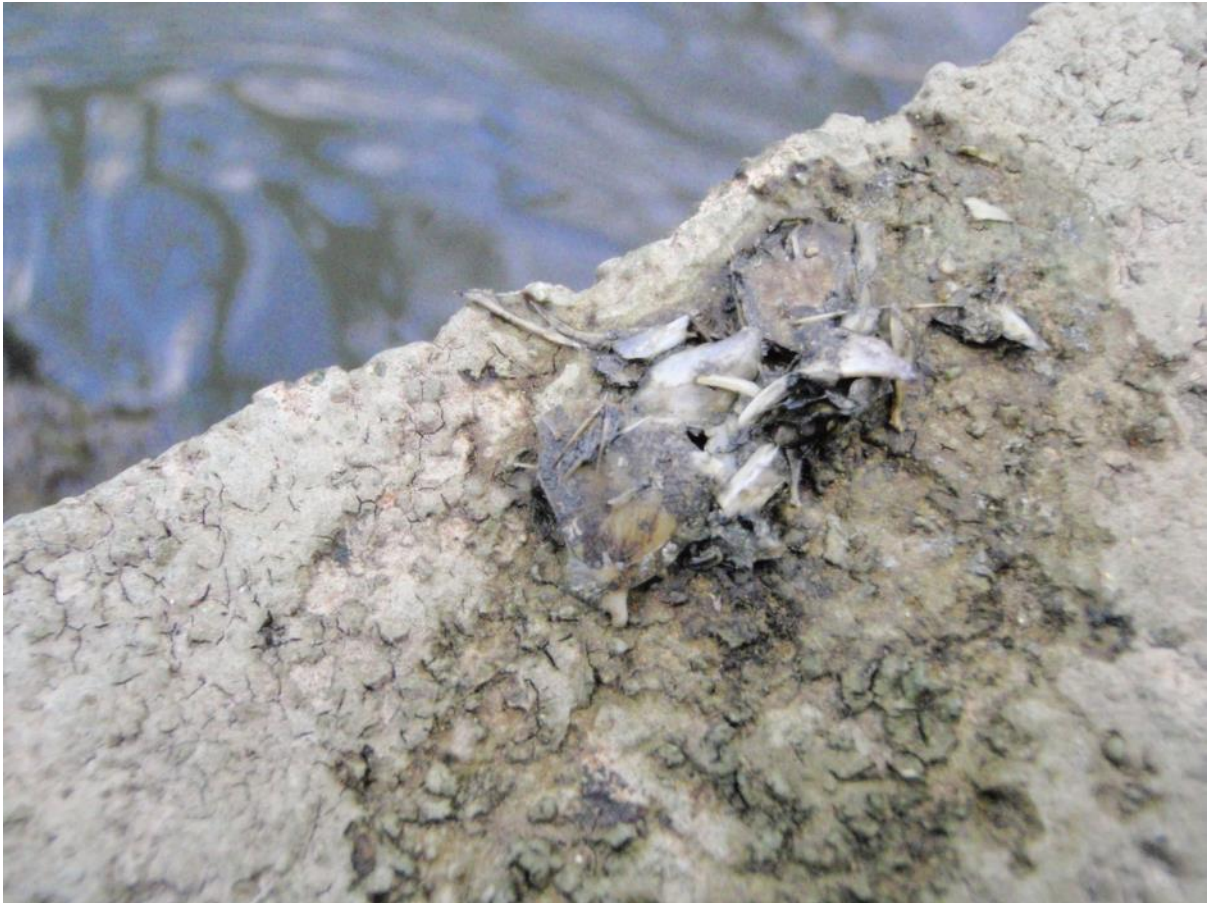
Photo 3: otter spraint on the Ozleworth brook

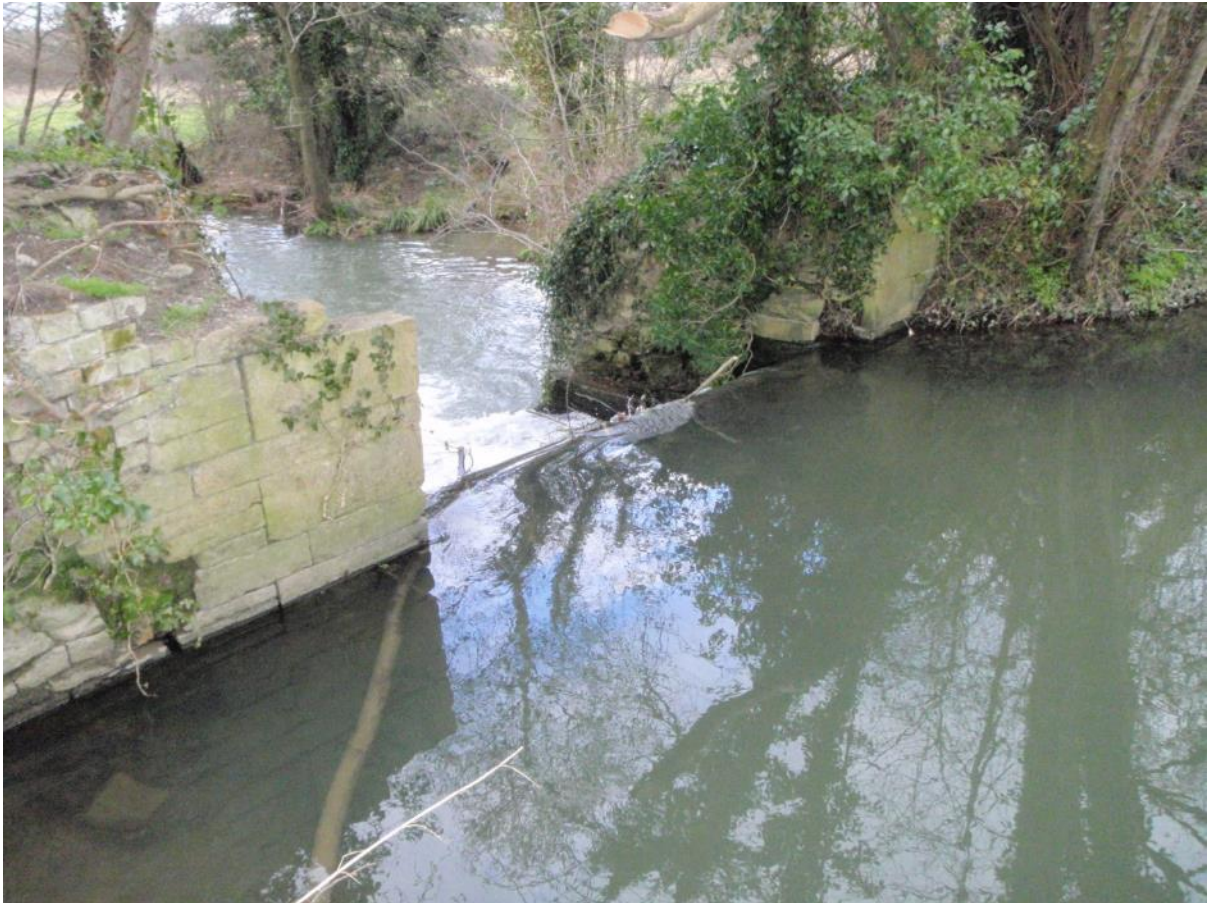
The flow conditions above the weir are slow and sluggish and the surface of the water is laminar or 'flat' with no apparent complexity in flow types. The lack of gravel riffles (raised areas of loose gravel accumulation) and the largely uniform depth continue until the influence of the impoundment is lost some 100m upstream. The impounding effect means that sediment drops out of suspension upstream of the weir, smothering and compacting the natural gravel bed by filling in the interstices between individual stones, limiting habitat availability and discouraging oxygenation, crucial for the larval or nymphal stage of mayflies (*Ephemeroptera*), caddisflies (*Trichoptera*) and stoneflies (*Plecoptera*). The homogenous, canal-like conditions are a clear indication of the negative effect that the impoundment is having on the rivers habitat.

The weir is constructed of concrete with stone block sides. A number of wooden sleepers act as boards that maintain the river level upstream. The river spills several feet over the top of the sleepers on to a solid apron (most likely to be blocks of stone or concrete) and drops a further foot on to the river bed below. It is likely to have been constructed for use by the woollen milling industry in the early 1800's. The weir currently serves no useful purpose and unfortunately, because of its height (some 4ft), allows no fish passage upstream. Several pipes can be seen to the side of the weir on the LB and these appear to allow overflow into the pool below when the river is in flood. It is possible that with careful planning and some investigation, this impoundment could be removed and made passable for fish and these options will be discussed in the recommendations section (4).

Photo 4: Weir on beat 6 (Ozleworth Brook); note deep slow, sluggish conditions above. The weir's height makes it completely impassable to fish.

This is the largest and most significant impoundment on the fishery and currently does not allow any fish passage. Removal of this weir is likely to improve connectivity for brown trout and grayling populations between the Ozleworth Brook and the Little River Avon. There are a number of techniques available to overcome this problem but because of the potential scale of the project, it is recommended that the CAA consults the expert opinion of the local Environment Agency office before any decisions are made.

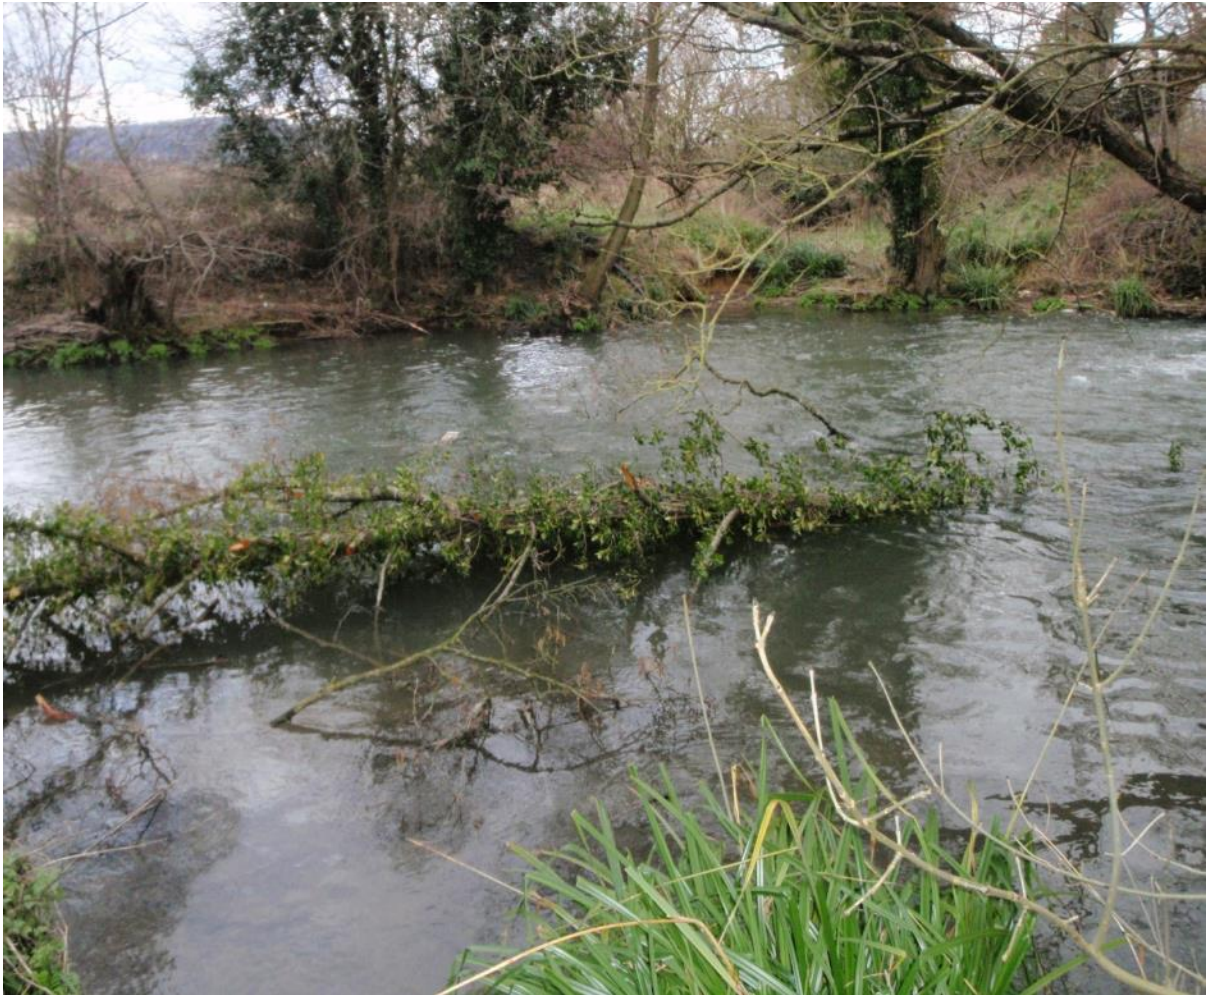
Photo 5: Beat 6 weir pool on Ozleworth Brook: Note the naturally fallen tree providing excellent fish refuge in the foreground

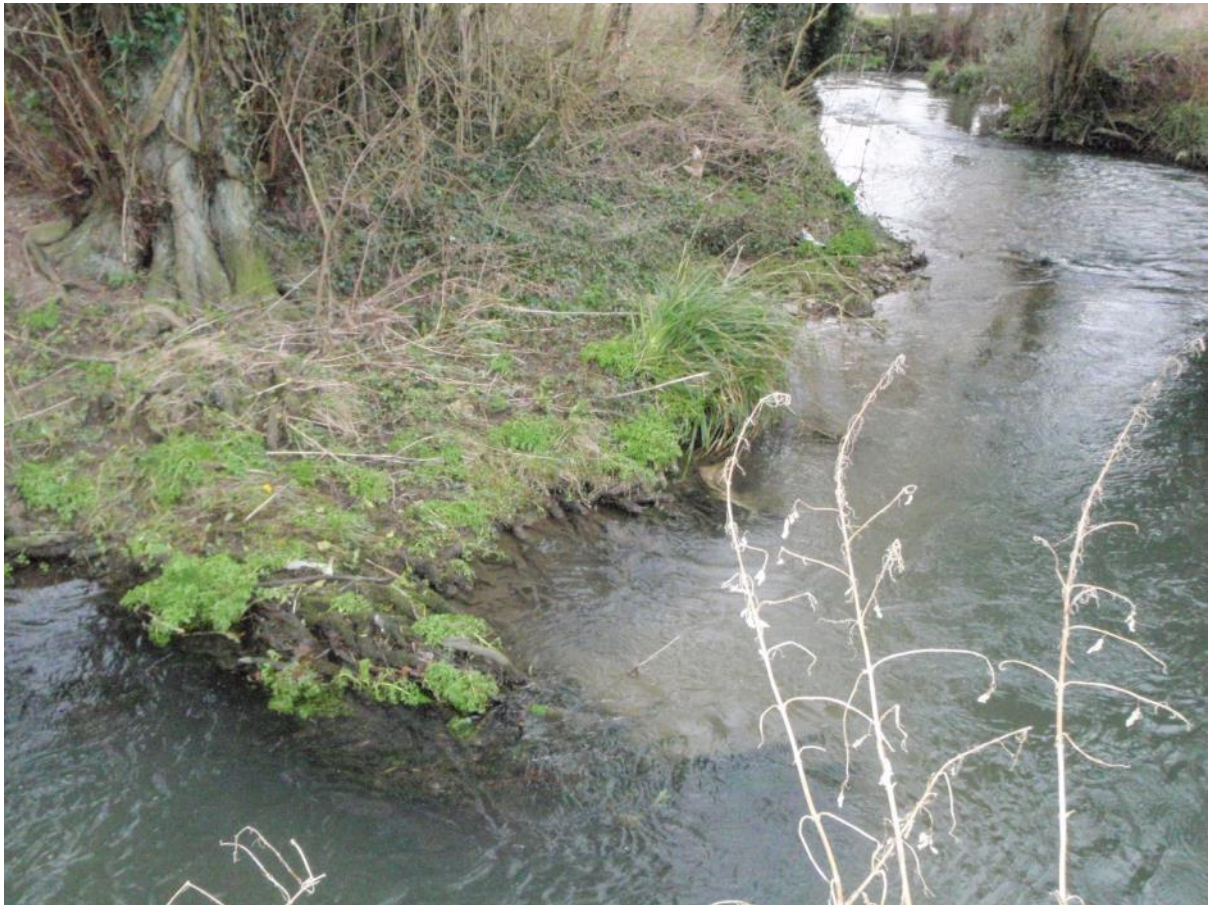
Photo 6: Large alder root system affecting flow pattern midstream; note the slower depositional zone immediately downstream

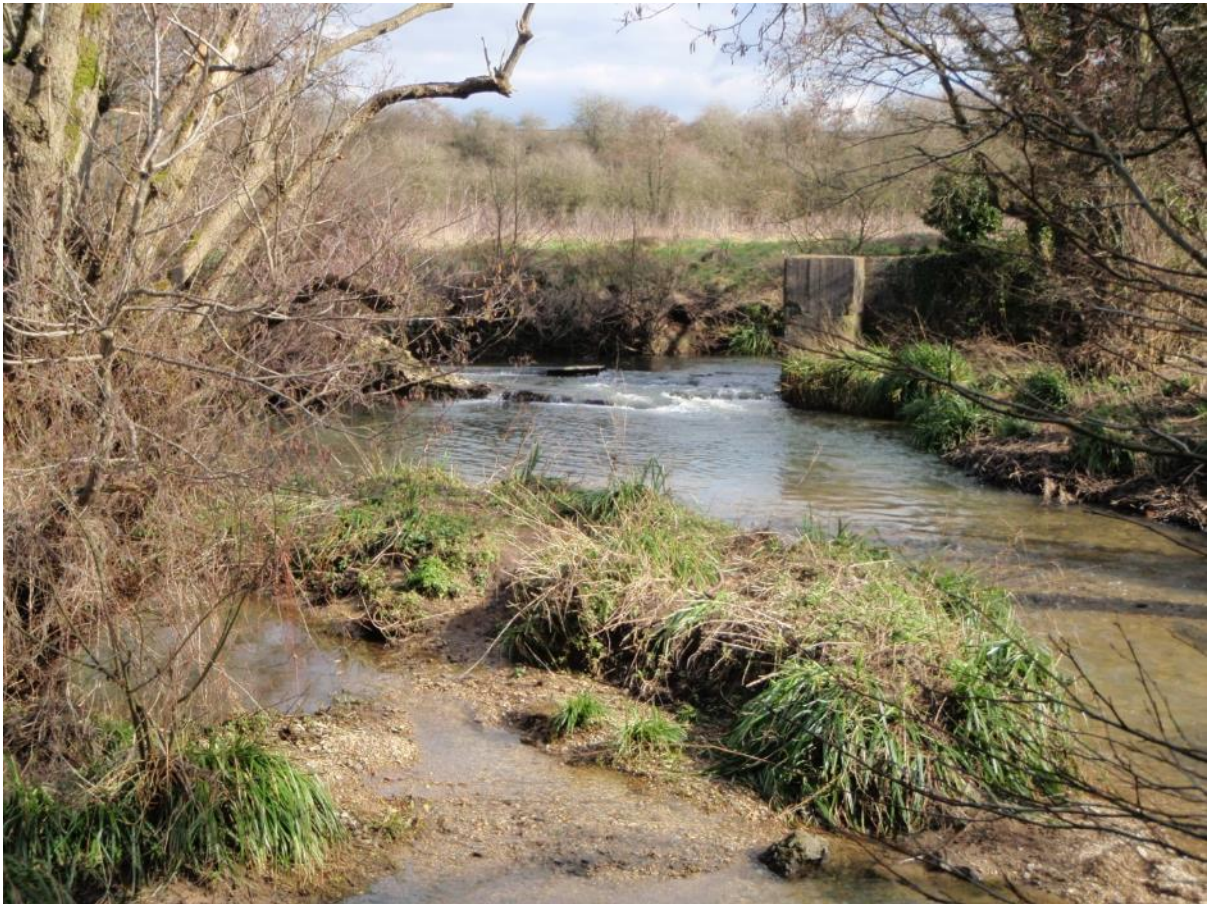
A mid channel island has formed below the weir splitting the channel in two and creating an important backwater area on the RB suitable for juvenile brown trout. The channel running along the LB has good velocity and a relatively shallow depth as it leaves the weir pool which contains a mixture of well sorted gravels that may provide favourable spawning habitat for adult brown trout.

Photo 7: Remains of old structure on beat 3; note the back water area(left) and clean well sorted gravels (right)

The remaining base of the weir currently allows fish passage over the top and adds some beneficial morphology to the channel in the immediate area. The weir base is useful to some degree as its partial interruption to the main flow creates a complex pattern of flow immediately downstream with some interesting results, not least a middle channel island which adds to habitat complexity. However, during low summer flows, the remaining weir base could act as a barrier to fish, particularly to juvenile salmonids and bullheads (*Cottus gobio*). Therefore, some minor adjustments could be made in the central part of the channel using petrol or hydraulic powered 'road breaker'. A team of two to four people with a road breaker, sledge hammers and iron bars, could break out one or two sections in the central part of the channel to allow fish passage. The arising material could be

deposited downstream in a riffle area and would contribute to channel roughness, creating some more diverse flow conditions.

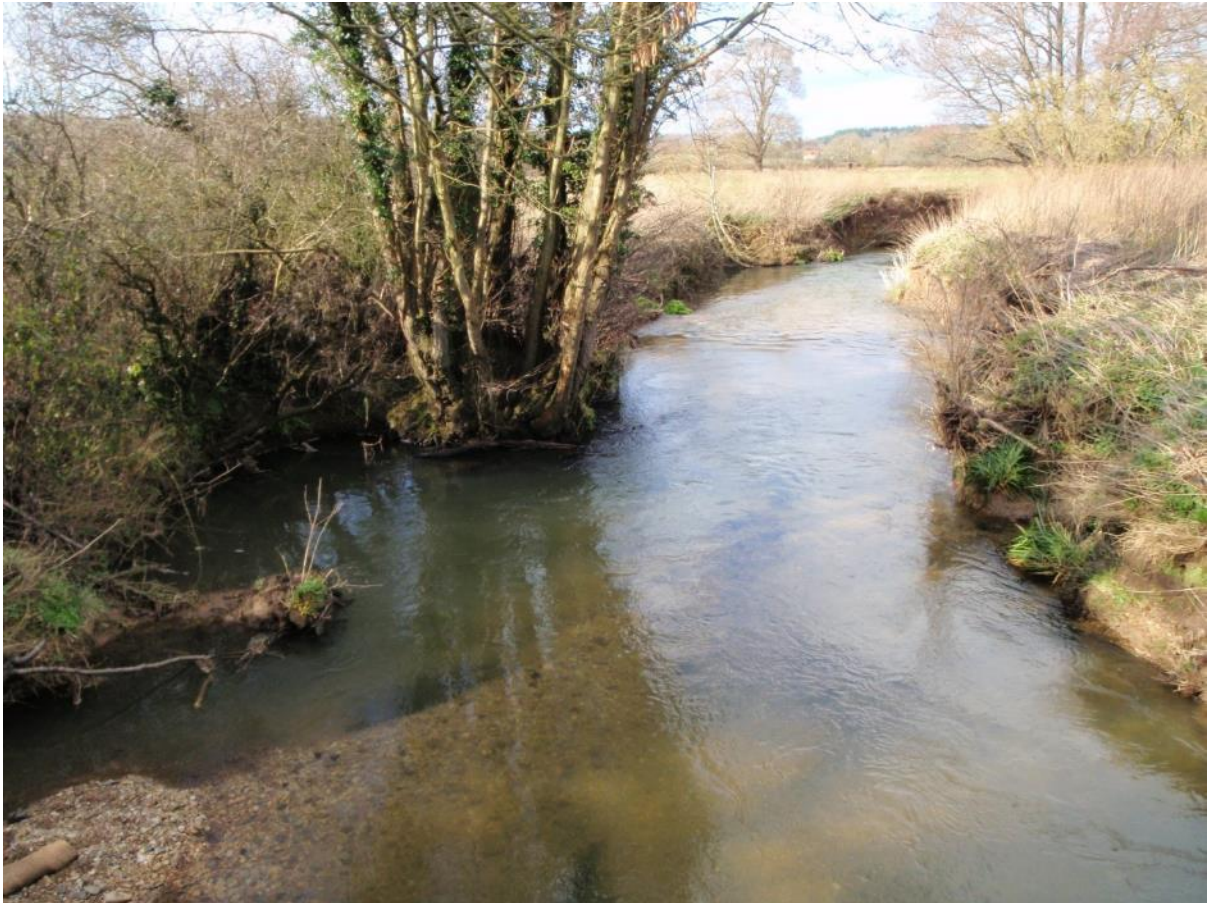
As the river flows underneath an aluminium bridge and into a sharp bend on the LB, the entrainment of alluvial gravels from the outside bend has created several gravel bars. The undulating bed in this area affects the channel roughness, forming a series of complex flow patterns. A stand of alders has been partially eroded leaving a backwater area with excellent overhead tree cover and an under-scoured root ball. This particular area is a good example of mesohabitat (pool, riffle, glide) that increases the physical heterogeneity of the river channel making it suitable for a range of fish and invertebrate species.

Photo 8: Bend below aluminium bridge; note the backwater area with overhanging cover and rootball (left) and clean well sorted gravels and complex flow patterns (foreground)

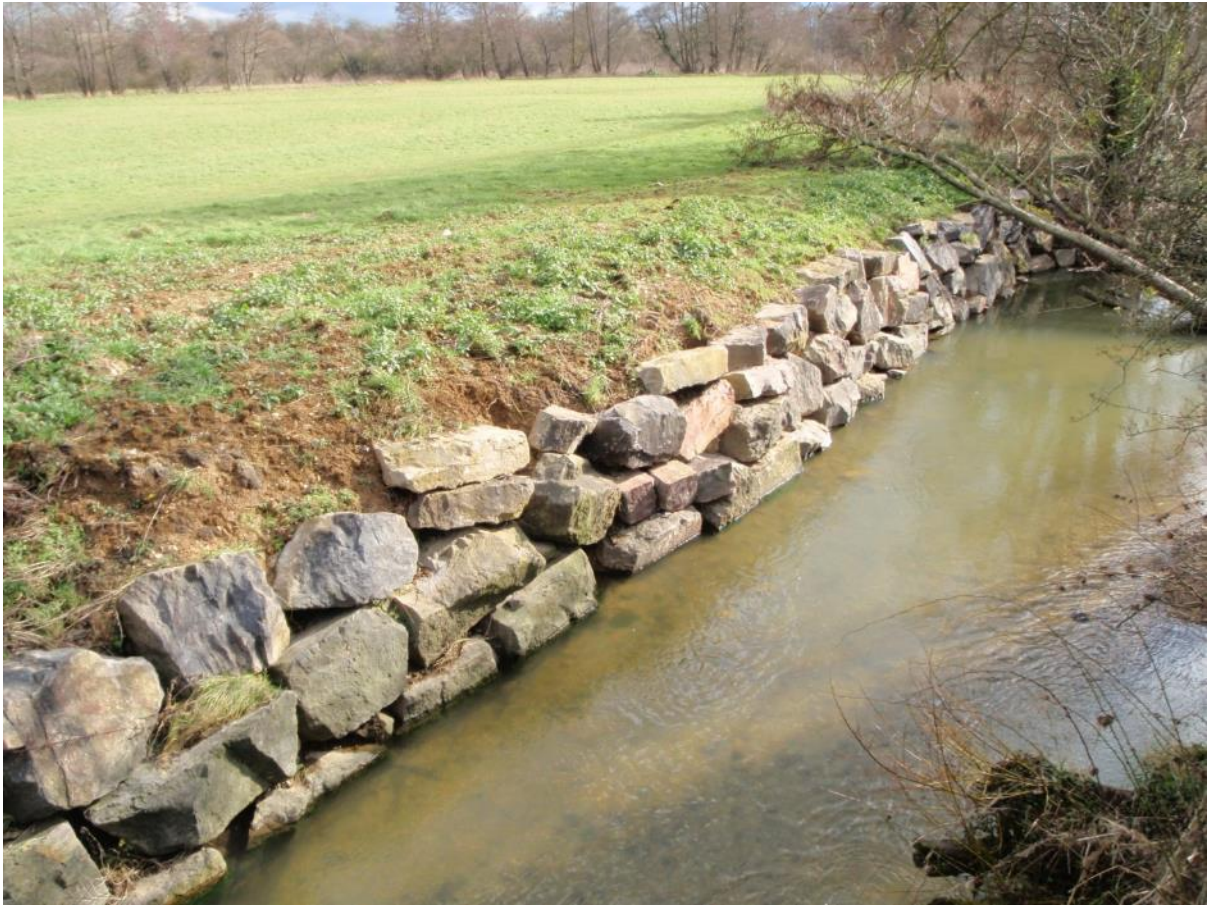
Downstream from the aluminium bridge the river flows under a recently replaced concrete bridge. The original bridge and part of the RB was lost during spate conditions and the bank has been repaired with large limestone blocks to prevent erosion. The limestone blocks have been stacked vertically and although the gaps between the stones offer some habitat availability for plants and terrestrial mammals, the habitat for fish and invertebrates is limited. The vertical face of the large stones provides little opportunity for a marginal zone to form. Opportunities for enhancement will be discussed in the recommendation section.

Photo 9: Limestone block repair; the sheer vertical face presents problems for marginal and emergent plants to colonise.

In several areas on the CAA fishery the estate has worked with a local contractor to prevent erosion using large limestone blocks. Whilst more ecologically beneficial than other engineered solutions. The vertical piling of blocks to protect the banks could be adjusted to provide a more natural solution that is more erosion resistant and able to support a wider range of biodiversity, whilst also creating complex instream habitat for fish and invertebrates.

The limestone blocks could be stepped back at an angle of 45 degrees. The first stone should ideally be placed directly into the

channel (ideally the top of the stone should be at water level height) with the next stone resting on the back edge of the first stone, staggering the heights and gradually working backward in a slope (rather than a vertical face) towards the top of the bank. The gaps between the large stones can then be filled with smaller angular rocks or flint gravels mixed with soil won from bank excavation to form the sloping bank. Once the gaps between the rocks are filled, a mixture of native marginal plants or willow whips can be used to stabilize and consolidate the structure. Installation of fencing at the top of the sloping bank, with a buffer strip of 3m between the fencing and the top of the structure are recommended in order to limit the grazing of marginal plants and poaching of the bank by livestock.

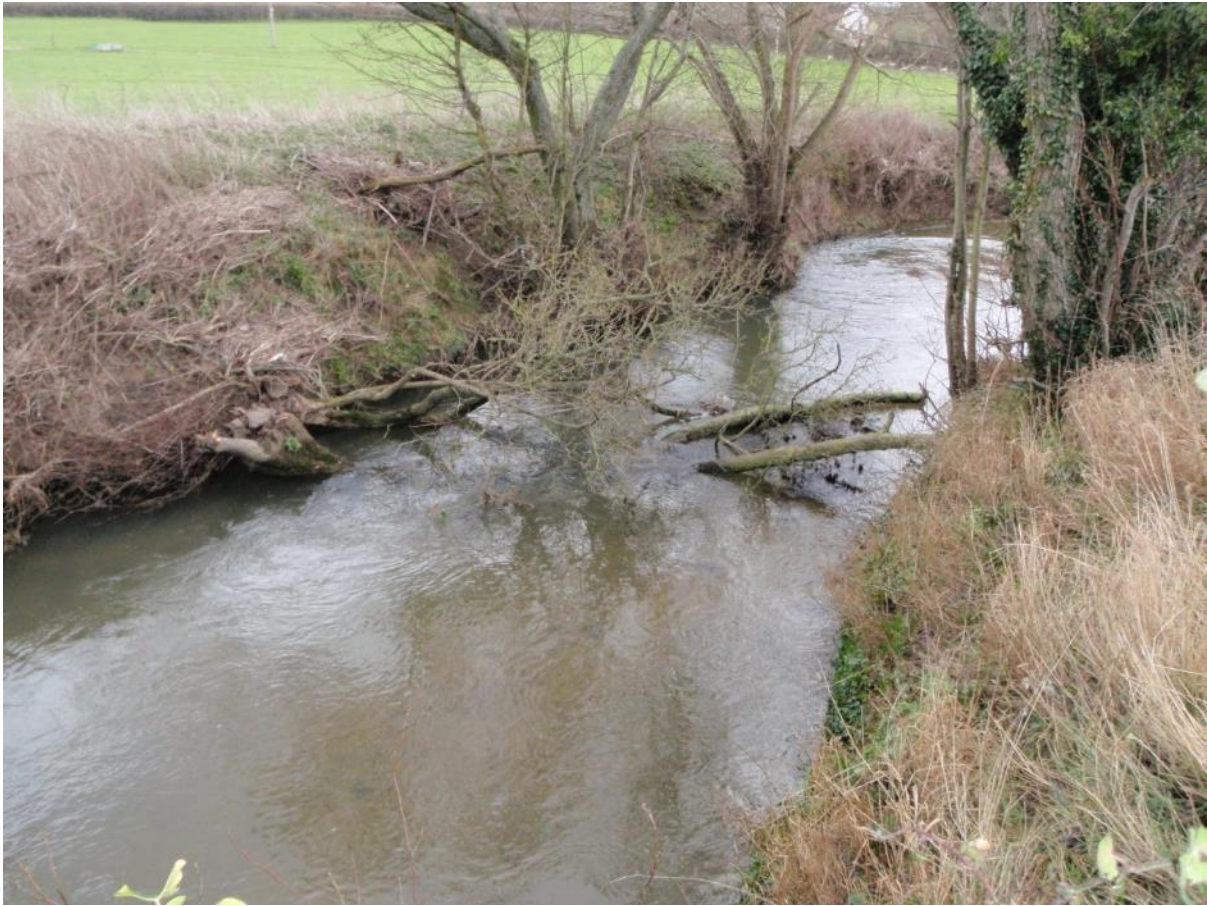
Beat 2 starts from the concrete bridge where the overall habitat improves significantly without the influence of any impoundment for some 500m. The channel is significantly narrower and as such the velocity increases creating excellent pool, riffle and glide sequences. There are a number of opportunities to pin or fix LWD that has already fallen into the channel along this reach.

Photo 10: LWD has fallen naturally into the channel; this presents an ideal opportunity for pinning into the river bed along the RB (top of picture)

- Utilise woody material that has already fallen into the channel by pinning it into the bed using chestnut posts and heavy gauge galvanised wire.
- Use large boughs or branches from on-going tree works and pin into channel to create scouring and sorting of gravels and provide cover and refuge for all life cycles of salmonids.

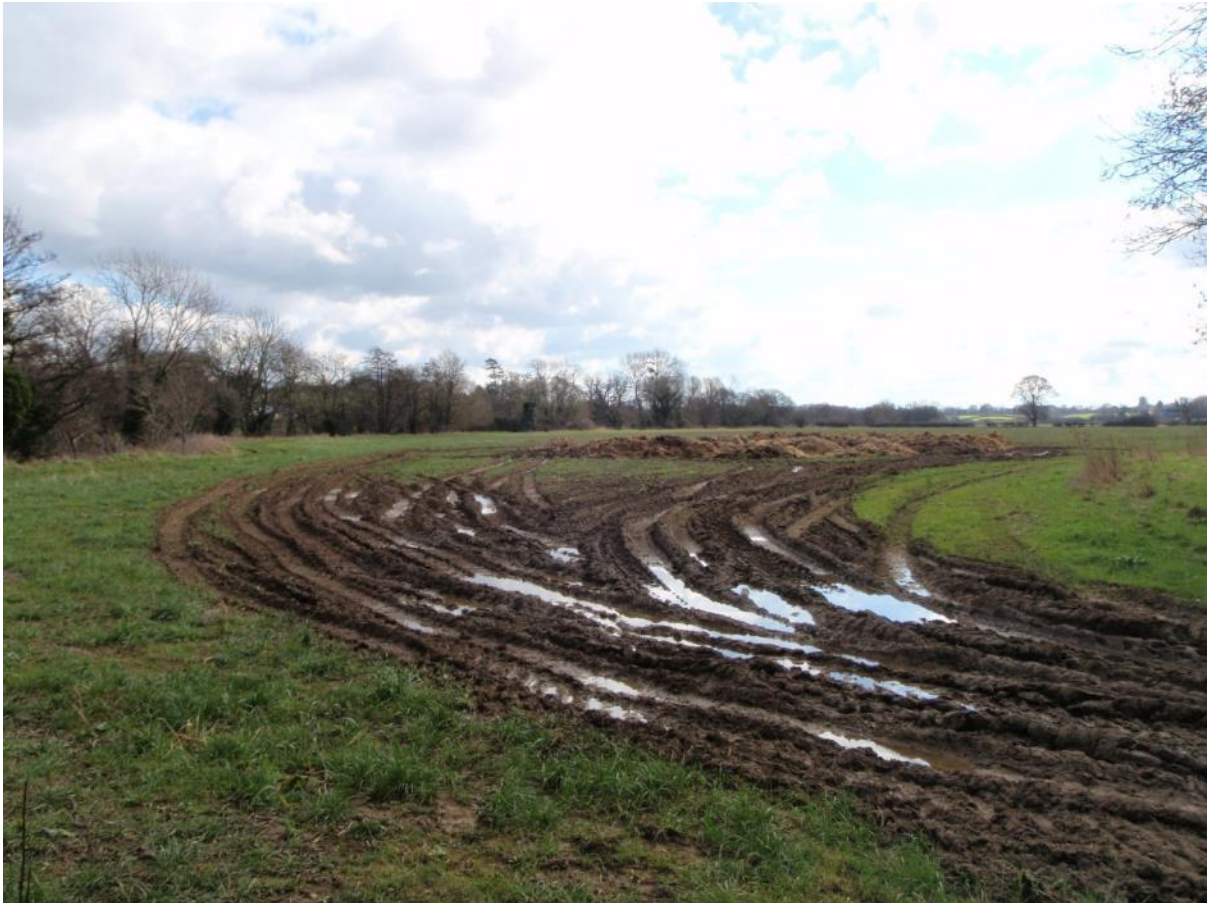
Half way along beat 2 the river reaches a sharp bend and meets a muddy track leading over a small stone bridge. A small feeder stream flows through plastic pipes underneath the stone bridge, entering the main channel at the bend. During the survey a large pile of manure was observed in close proximity to river bank and track. This is an example of bad farming practice. The dumping of manure close to a feeder stream and track has the potential to introduce ammonia to the water-course, which is directly toxic to fish, invertebrates and many other species. There is also a risk of sediment entering the channel from the track and this should be addressed in the short-term.

Photo 11: Beat 2. Manure piled next to main river (left of picture) and feeder stream (right of picture, just out of sight)

It is recommended that the club discusses this issue with the land owner. Moving manure well away from the river banks would reduce the risk of enrichment from manure and sedimentation from the track. Leaving a wider buffer strip around the feeder stream and main channel would reduce the probability of sediment loading and enrichment during wet periods. There is potential to build a vegetated catch pit at the feeder stream outlet at this point to reduce sediment loading. Appropriate design and costs for construction and on-going maintenance would need to be carefully considered if this were to be implemented.

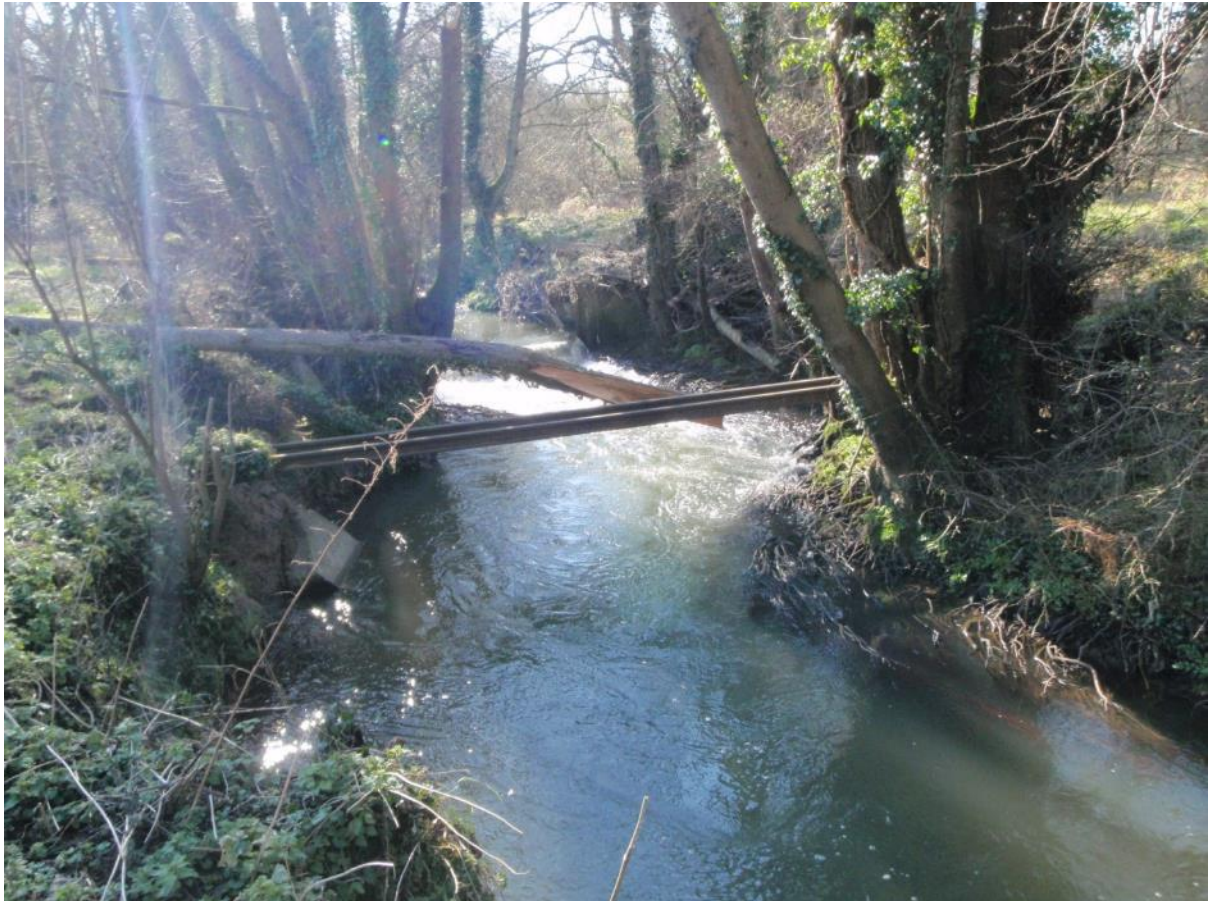
The second impoundment is an active sheet metal weir situated at the bottom of the fishery and currently presents a barrier to fish passage. There is potential for lifting of the sheet metal, effectively removing the impoundment. However, this would need to be discussed with the land owner and the local EA as its removal could drop the water level upstream. Remediation measures may be required upstream if the weir is removed completely.

The weir base left intact upstream should also be taken into consideration if the lower sheet metal weir is removed, as it could become more of an impoundment with a drop in water level. This could be addressed by creating natural 'pinch points' situated at the current weir positions that retain water levels upstream. There are signs of bank erosion below the sheet metal weir and it is likely that under high flows, turbulence is significantly increased in this area. This is exacerbated by the large root-balls of several alder trees which constrict the flow

'throttling' the channel and increasing bed and lateral erosion. It is likely that removal of the weir would reduce this throttling effect and slow the rate of erosion. This could be done in conjunction with some coppicing work to let light penetrate the immediate area, improving marginal plant growth and encouraging bank stabilization.

Photo 12: Lower weir on beat 1; note the lateral bank erosion on the left of picture

The lower weir on beat 1 currently presents a significant barrier to fish passage. Although only a foot in height, it creates slow and sluggish conditions upstream, interrupting the natural gradient of the river and the migration of bedload and gravel downstream. There is potential for it to be passable to fish during high flows, but during low flows it presents a significant barrier for fish moving up or downstream. There is good potential for the sheet metal weir to be removed by attaching chains to a large excavator and pulling the sheet metal free of the weir sides. This would need to be discussed with the local Environment Agency office and should not be attempted without prior investigation.
