Advisory Visit

Cherry Hinton Brook, Cambridge

18th July 2017

1.0 Introduction

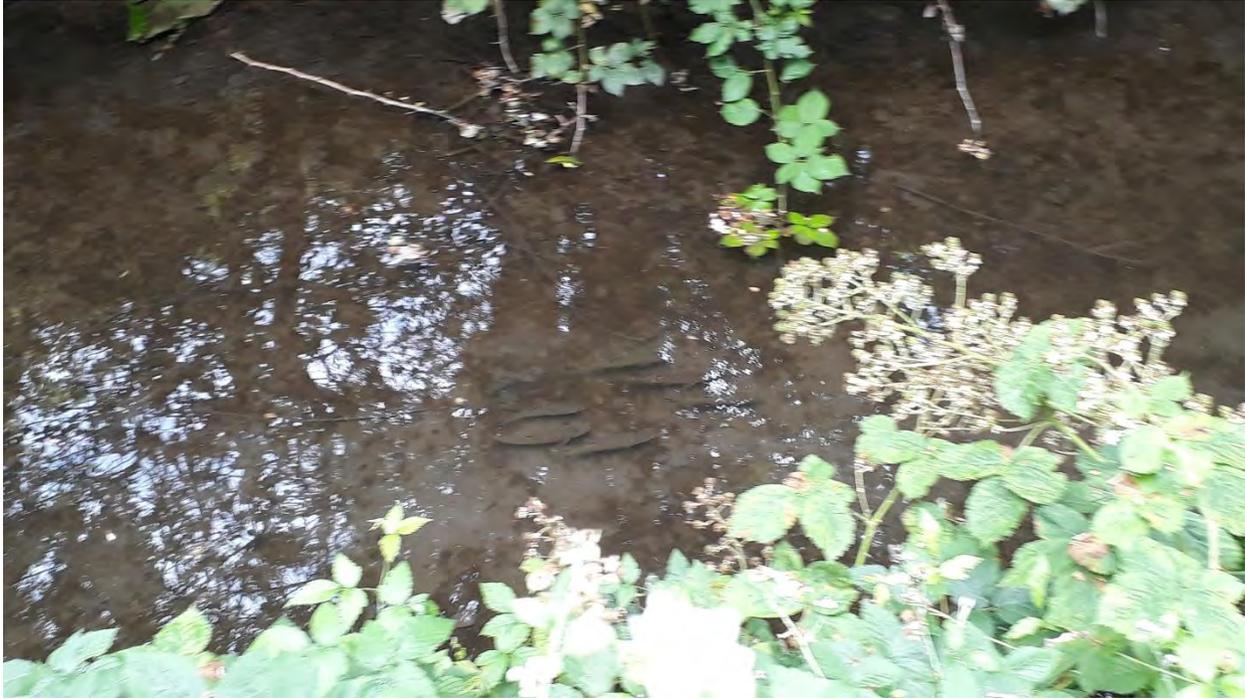
Picture 1 – a shoal of dace and small chub observed at Coldham’s Common. These fish are believed to have been introduced to the brook as they would not typically be found in slow silty reaches. It is doubtful that this species could breed in the brook.

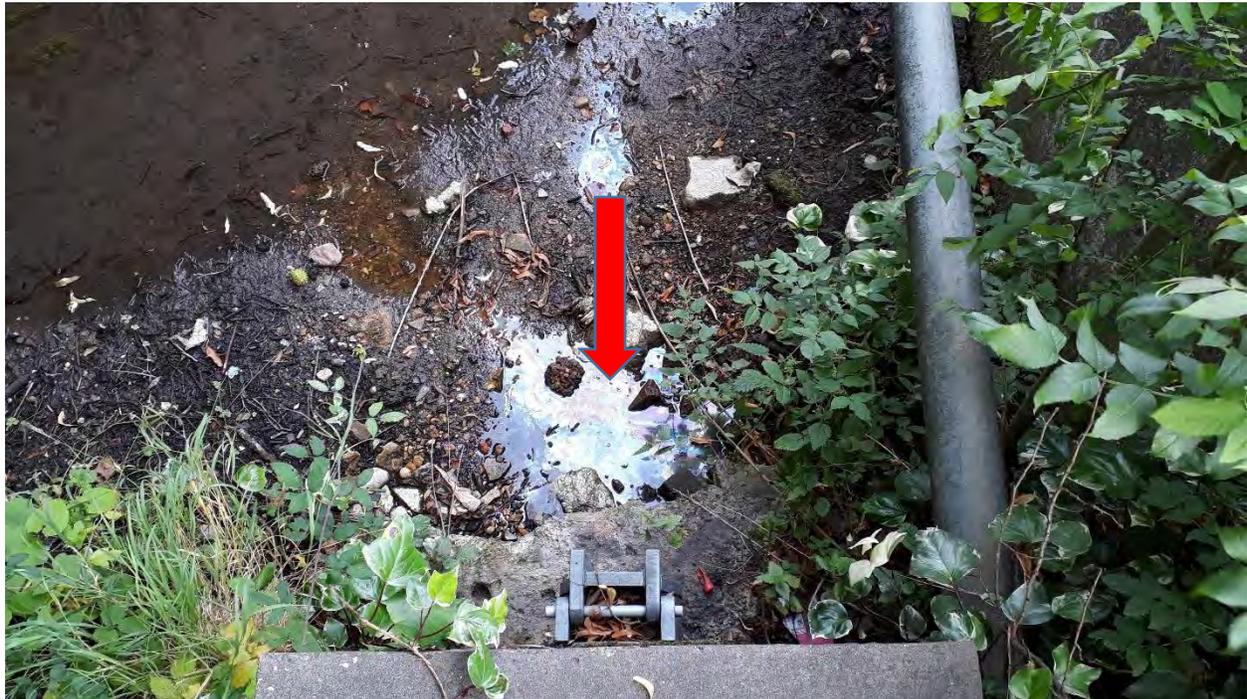
Picture 2 – oil residue (red arrow) present immediately below a surface water outfall (at the downstream end of the Sainsbury’s car park but not necessarily emerging from their site).

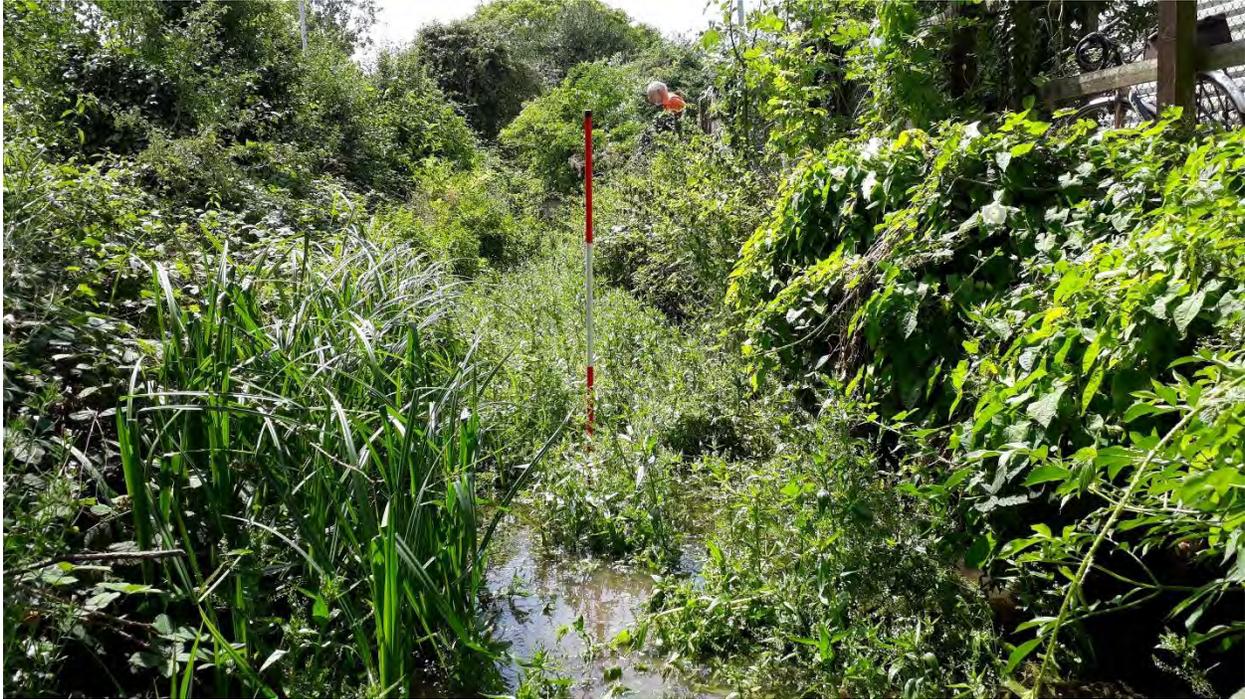
Picture 3 – lush emergent vegetation providing excellent cover for water voles in the reach from Sainsbury's towards Burnside.

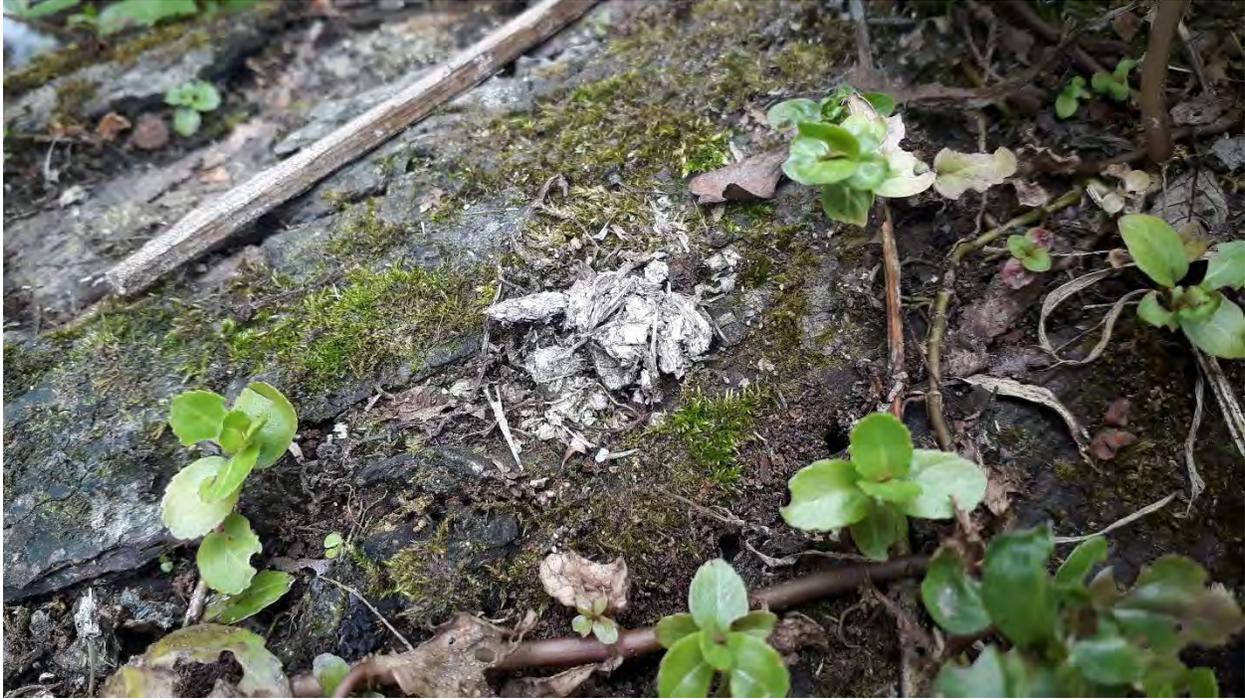
Picture 4 – an old otter spraint found on the log that is immediately upstream of the bridge that leads the public footpath into Coldham’s Common.

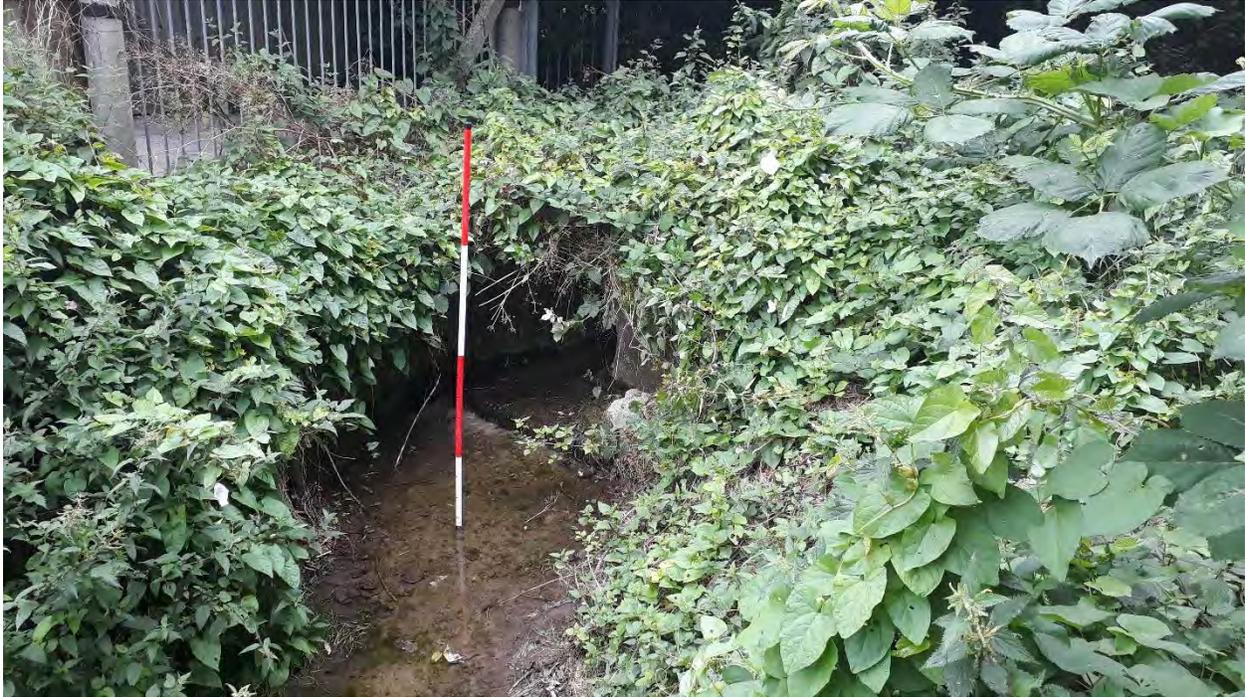
Picture 5 – flow in the Cherry Hinton Brook reducing at Galfrid Close.

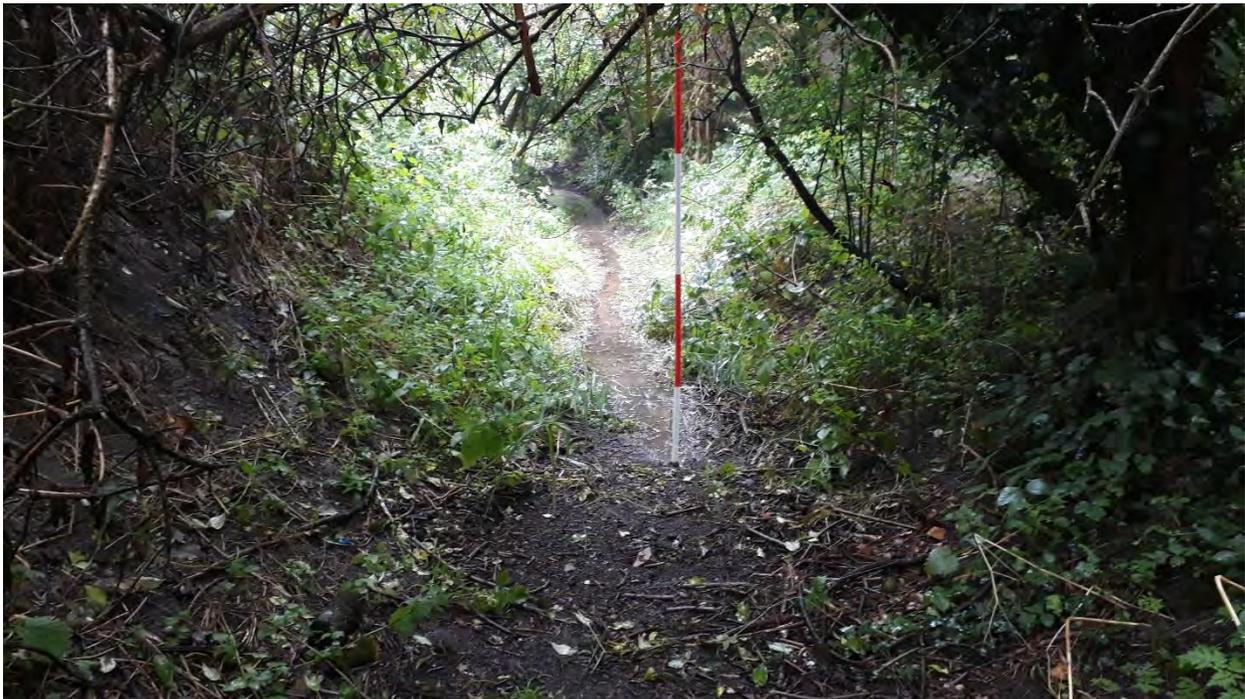
Picture 6 – the Cherry Hinton Brook finally dries in the vicinity of Whitehill Close.

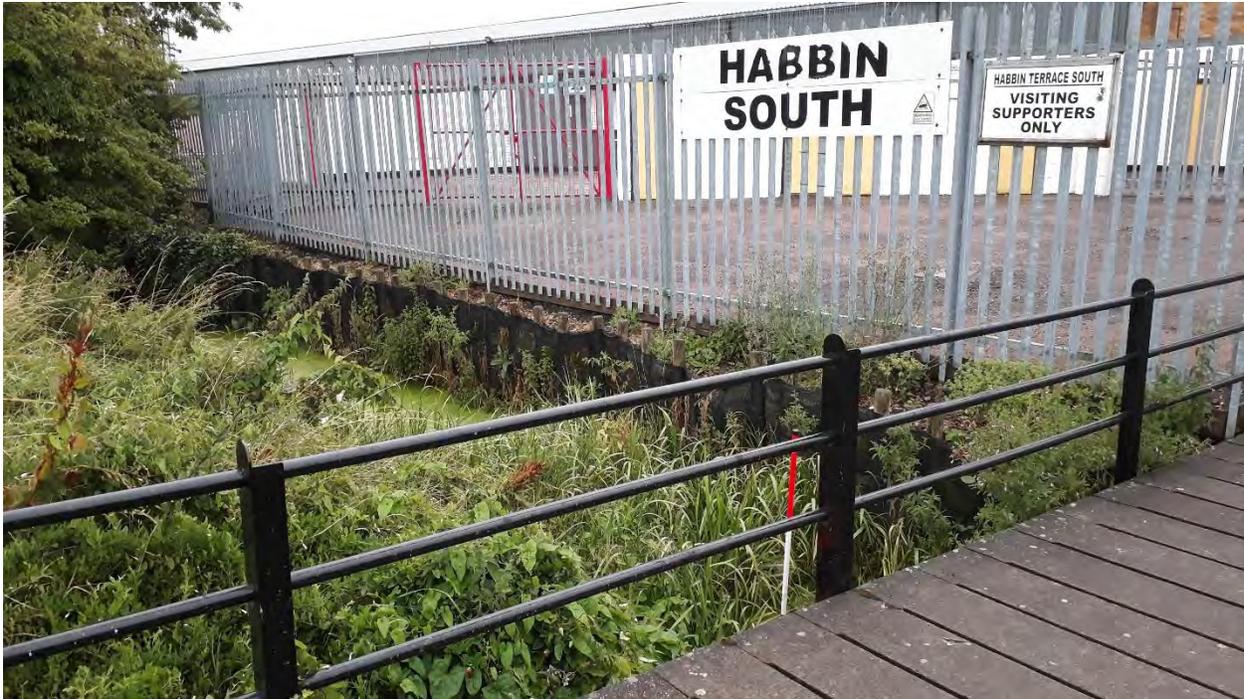
Picture 7 – the Brook’s channel holds water again near to the football stadium but is more akin to a ditch rather than a small chalk river.

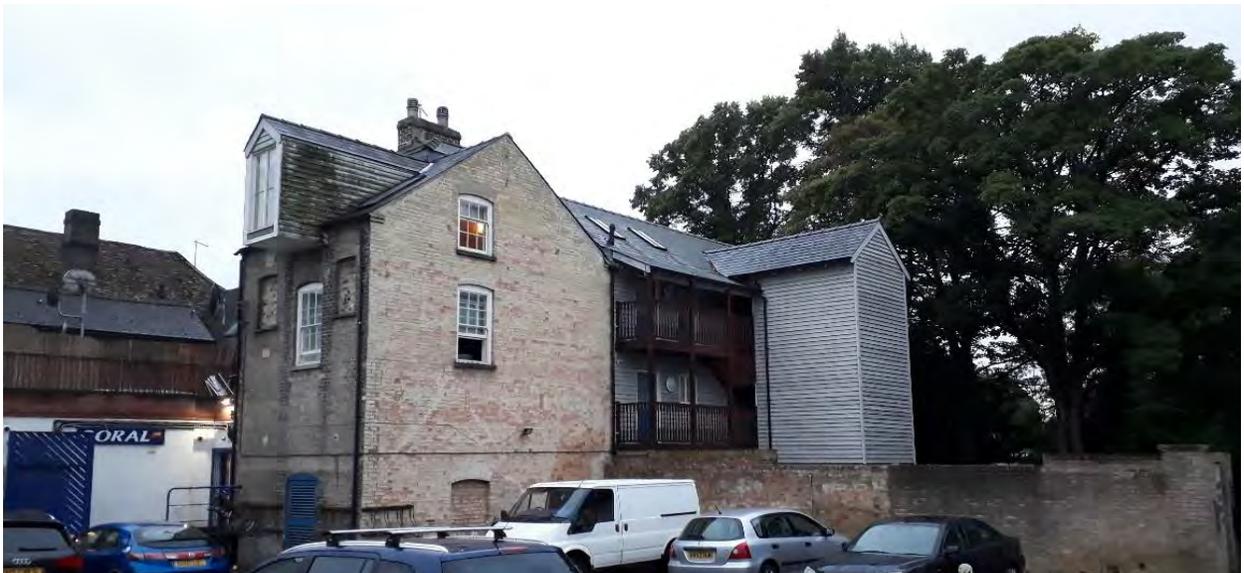
Picture 8 - a former mill building seen from Ditton Close suggesting that the Cherry Hinton Brook once carried enough water to power a mill.

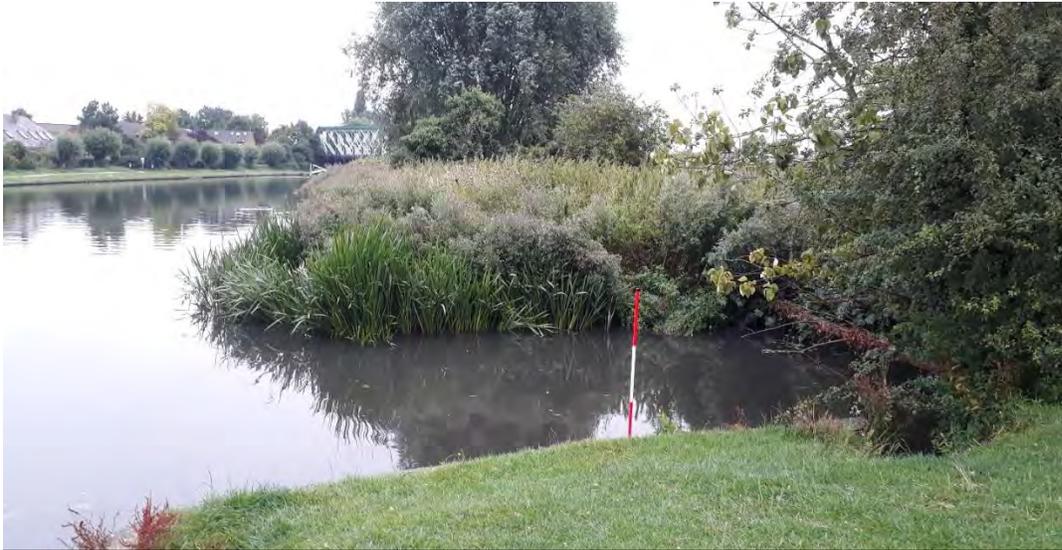
Picture 9 – the confluence of the Coldham's Brook with the River Cam

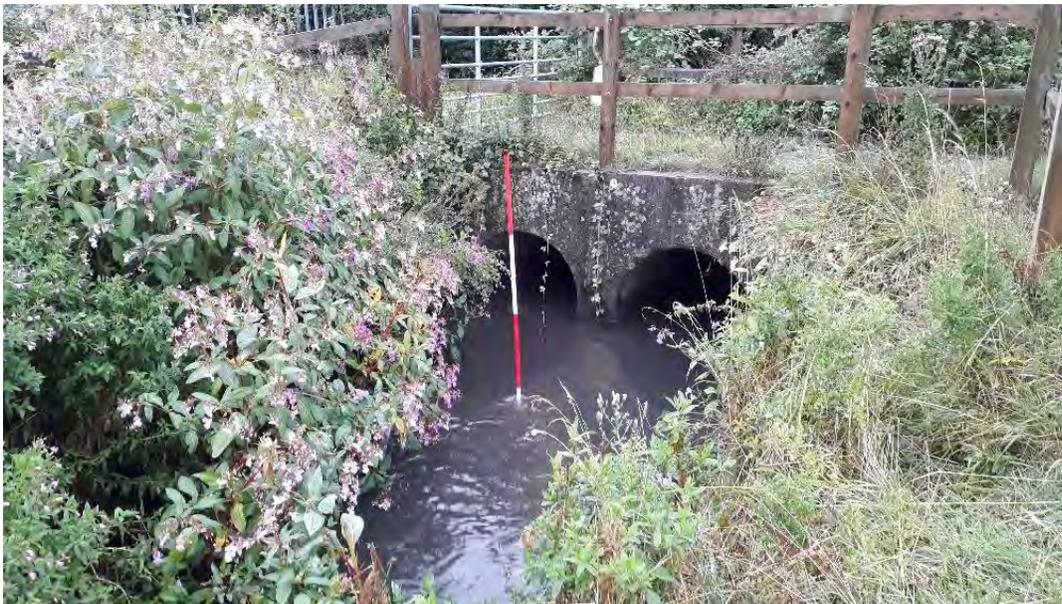
Picture 10 – good flow was evident over a shallow gravel bed on the Coldham's Brook. Note the invasive Himalayan balsam plant.

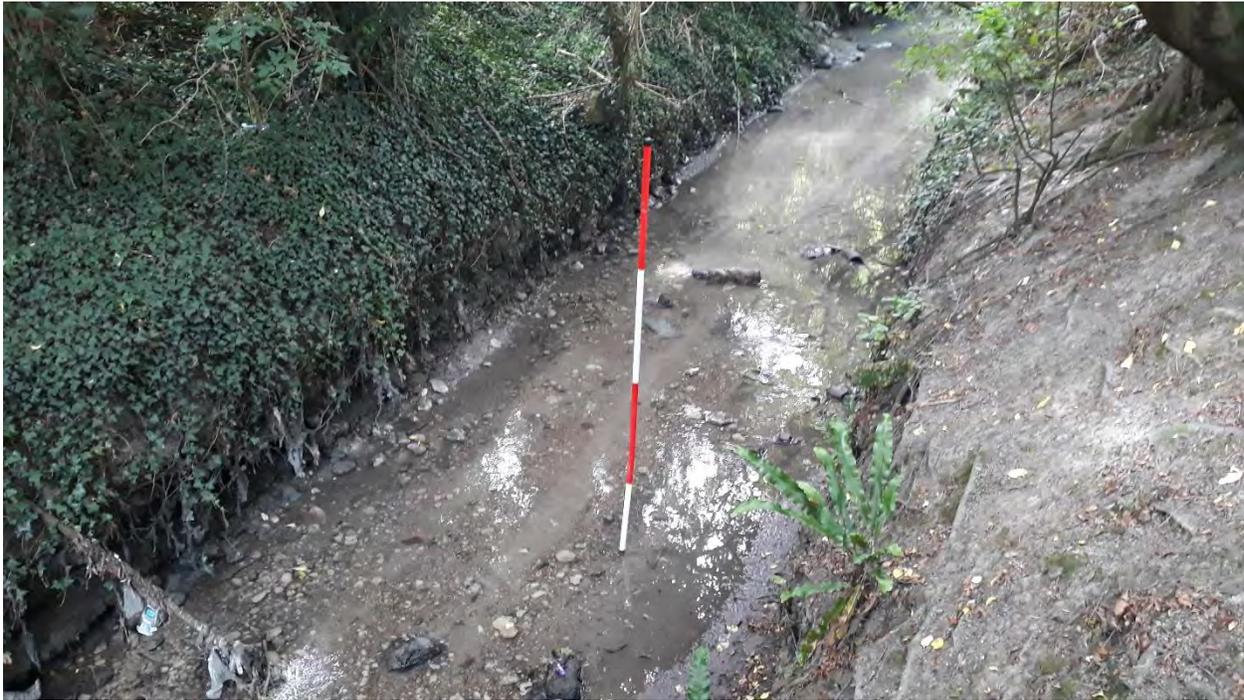
Picture 11 – note the deeply cut channel of the Coldham's Brook near to its emergence from beneath east Cambridge. The channel has been cut down into the chalk strata with chalk nodules and small flinty gravels present. A stone loach was observed.

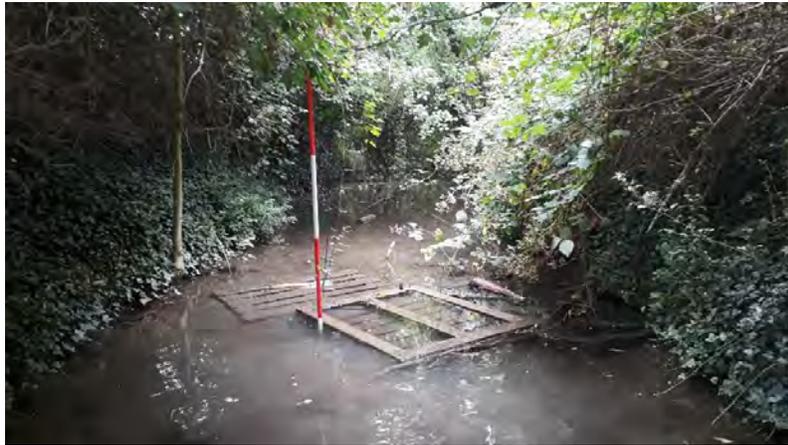
Picture 12 – the Cherry Hinton Brook is almost totally shaded where the public footpath enters Coldham’s Common.

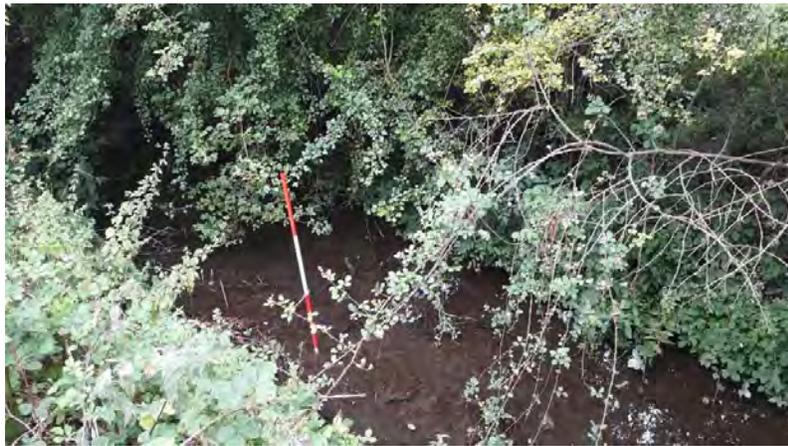
Picture 13 – the Cherry Hinton Brook is partially shaded but suffering from excessive siltation within Coldham’s Common as it approaches Galfrid Close (where it becomes open it is then entirely choked by reeds).

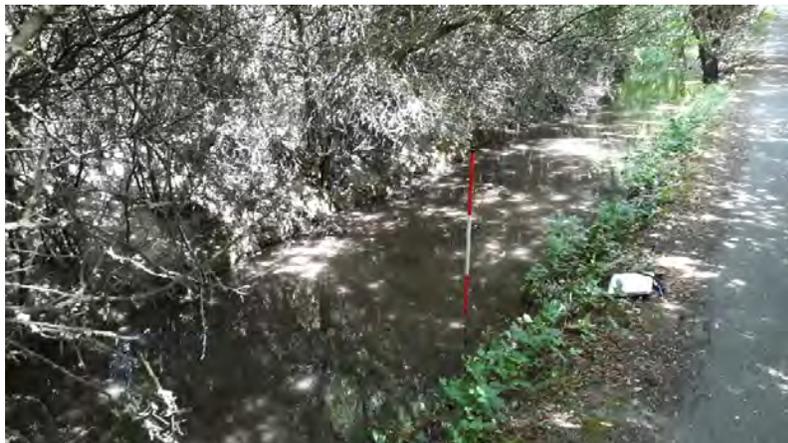
Picture 14 – Cherry Hinton Brook along Snakey Path, no vegetation is present on the bank beneath the black thorns. Allowing light to reach the channel would bring benefits to the brook.

A basic tree-shade survey should be undertaken to identify reaches of the channel that might benefit from increased light penetration. Tree management in urban areas can be a sensitive issue and full liaison with **Cambridge City Council, and possibly local residents' groups, would be** needed. The tree-shade survey may even identify some reaches that could benefit from further tree planting. For example, willows may be beneficial for their quick growth and ability to consolidate marginal silt. The planting of new willow trees may enable a future stock of pollard willows to be grown (which are very typical of the Cambridge landscape).

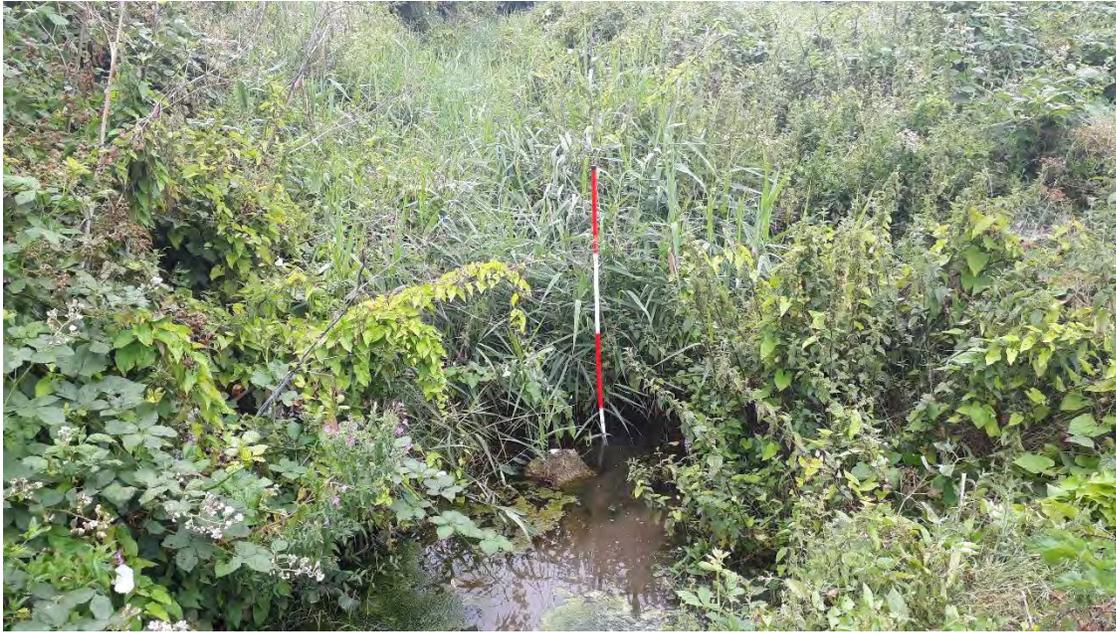
Picture 15 – the channel of the brook is choked by common reed in Coldham's Common.

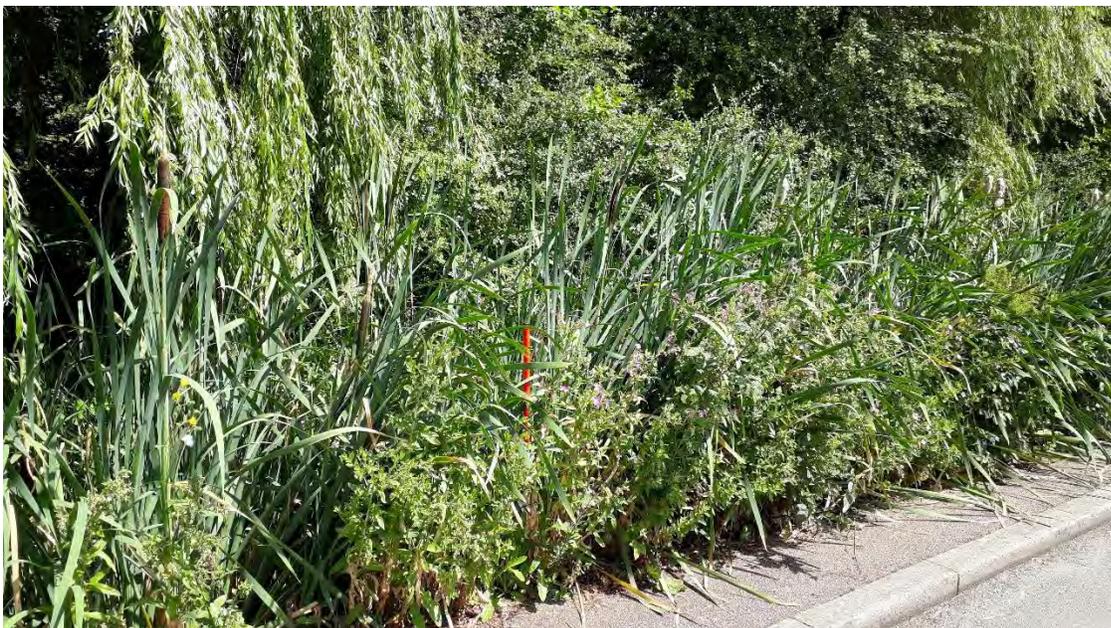
Picture 16 – the channel of the brook is partially choked with reedmace at Burnside.

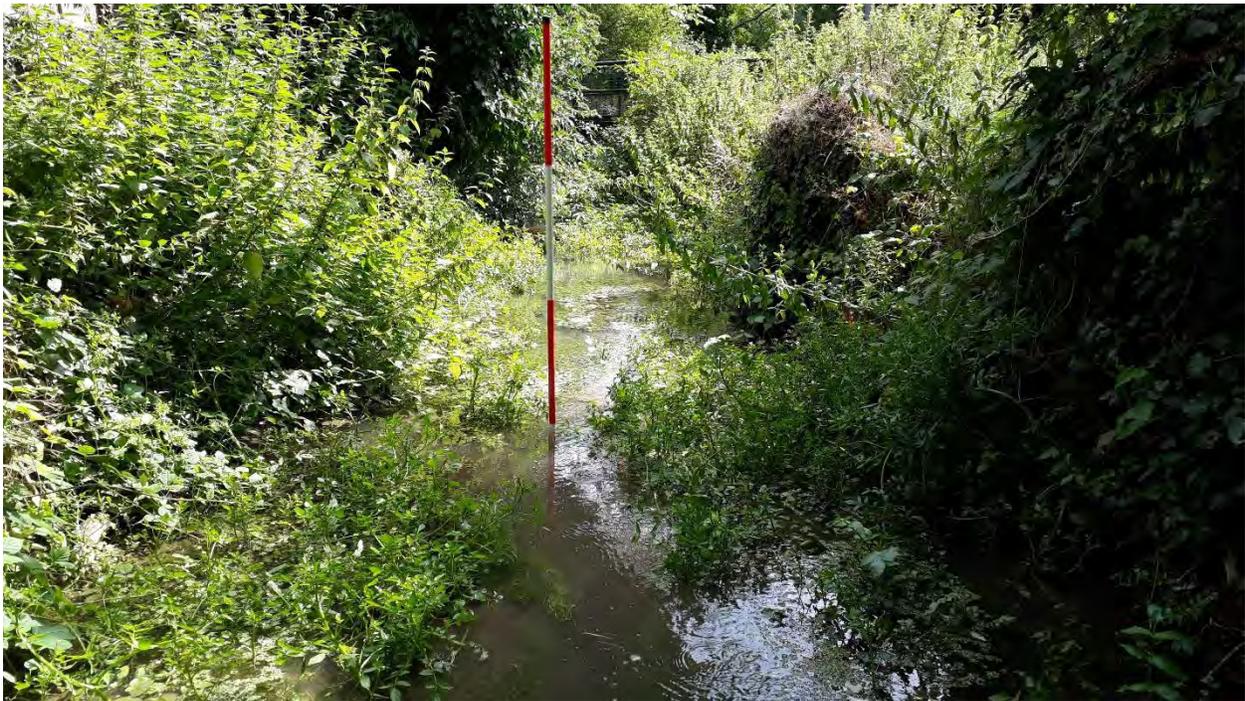
Picture 17 – the brook nearer to Cherry Hinton exhibits some shallow and faster moving areas. These reaches would be a suitable to undertake hand weed cutting within.

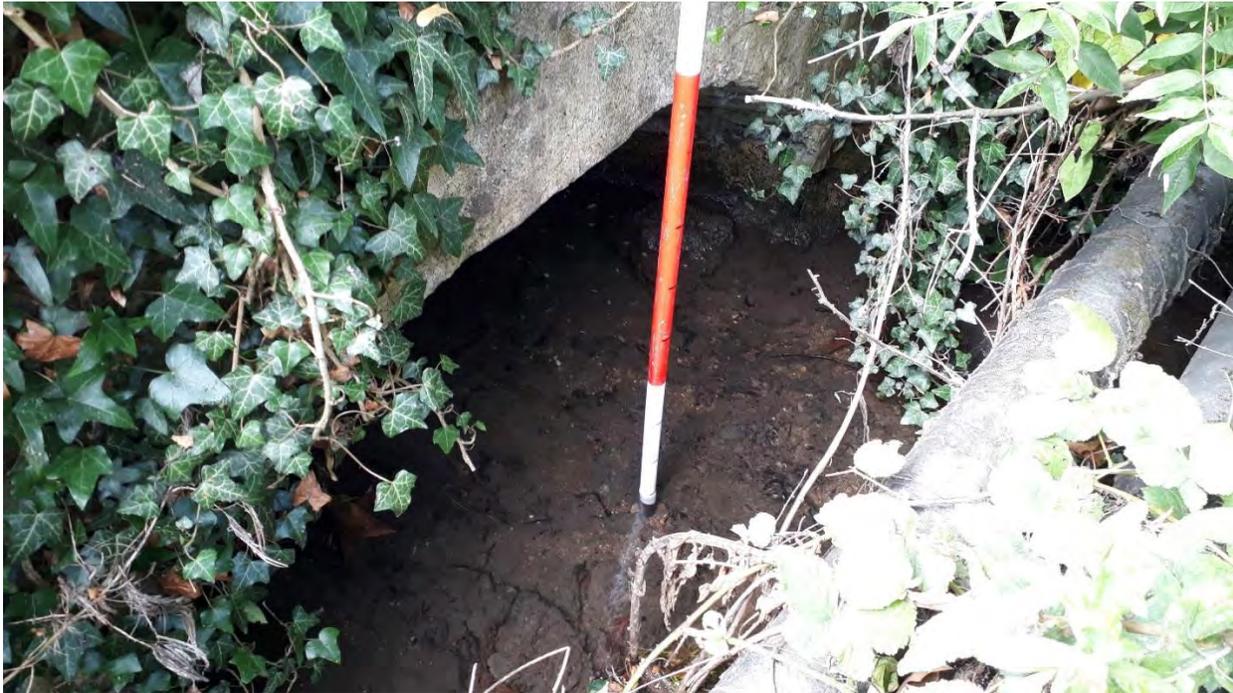
Picture 18 – note the firm gravel bed beneath the original road culvert in the vicinity of Sainsbury's. This observation is important as it shows that the brook did once have a gravel bed (at least in places).

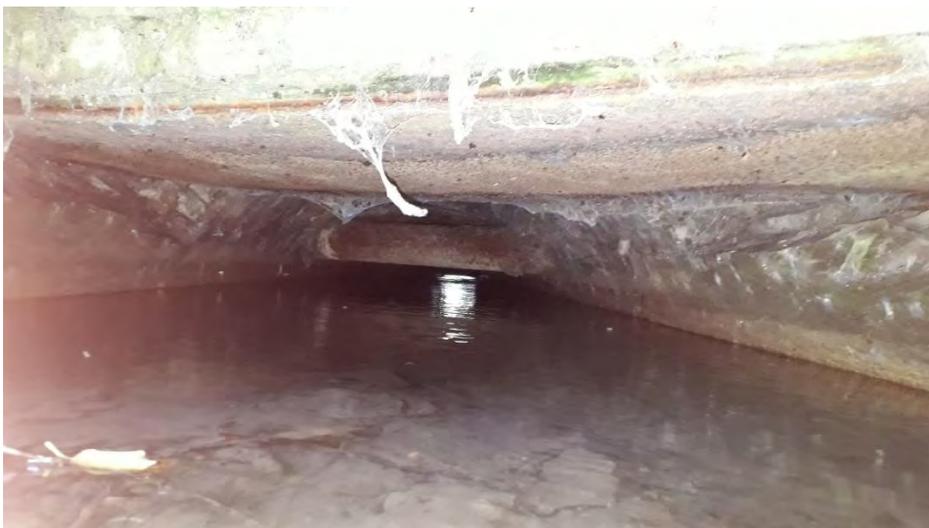
Picture 19 – note the extremely low head-room beneath the Sainsbury's culvert. Features such as this represent significant obstructions to flow. Furthermore, the presence of bridges with low-head clearance is typical on chalk rivers not prone to high flows.

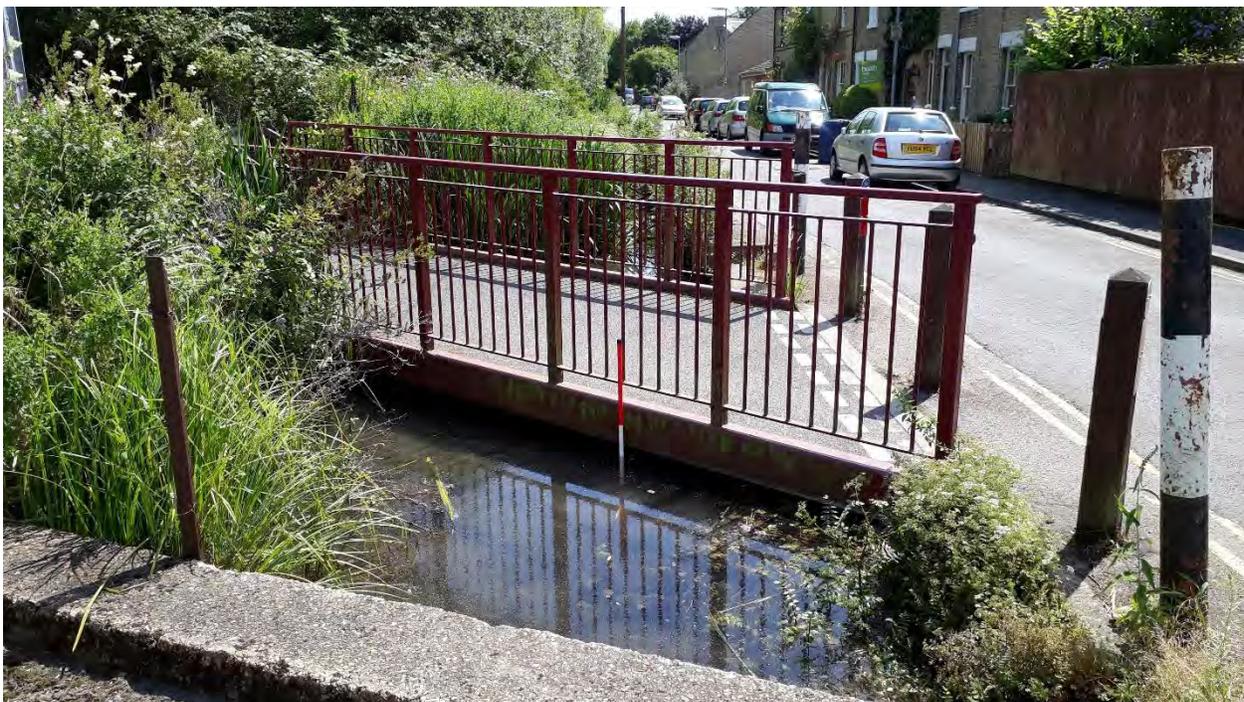
A number of culverts cause impoundments to flow. The most notable was that at Burnside (picture 20) where the channel has been deepened to flow beneath it but has consequently silted up resulting in a channel depth of over 1.3m but with only ~0.3m of open water.

Picture 20 – note the depth beneath the level bridge at Burnside. Digging the channel deeper would not help move flows along this reach.

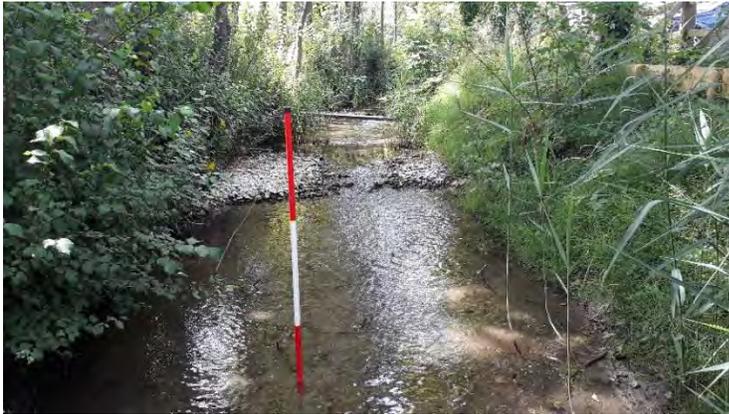
Picture 21 – view of A-wing flow deflectors adjacent to the Sainsbury's car park. Note that this reach has gradient and a fall between the structures can be observed.

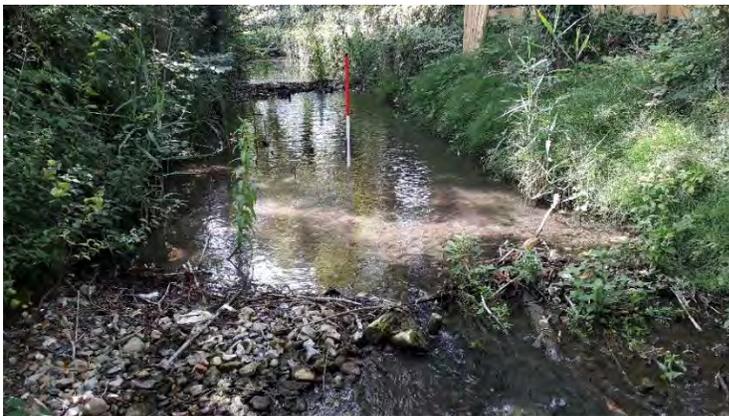
Picture 22 – note the large sized gravel used to backfill the deflectors. The grade of stone is allowing a significant proportion of the flow to move through the deflectors rather than over them. This is reducing the deflectors' effectiveness and actually dissipating some of the flow.

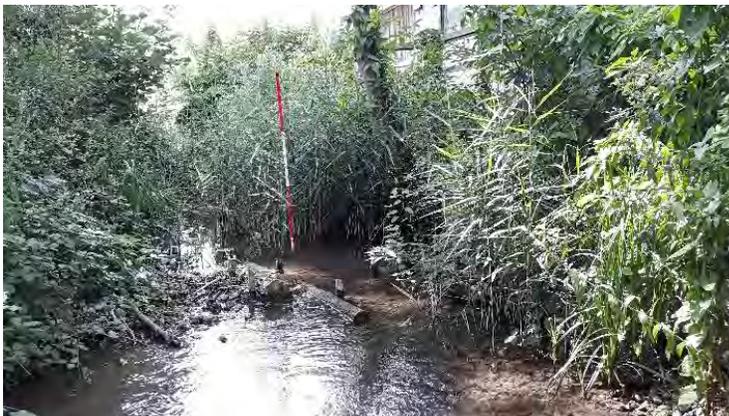
Picture 23 – note the depth of ~0.4m upstream of the deflector and the dense stand of reed which will only benefit further from such impoundments.

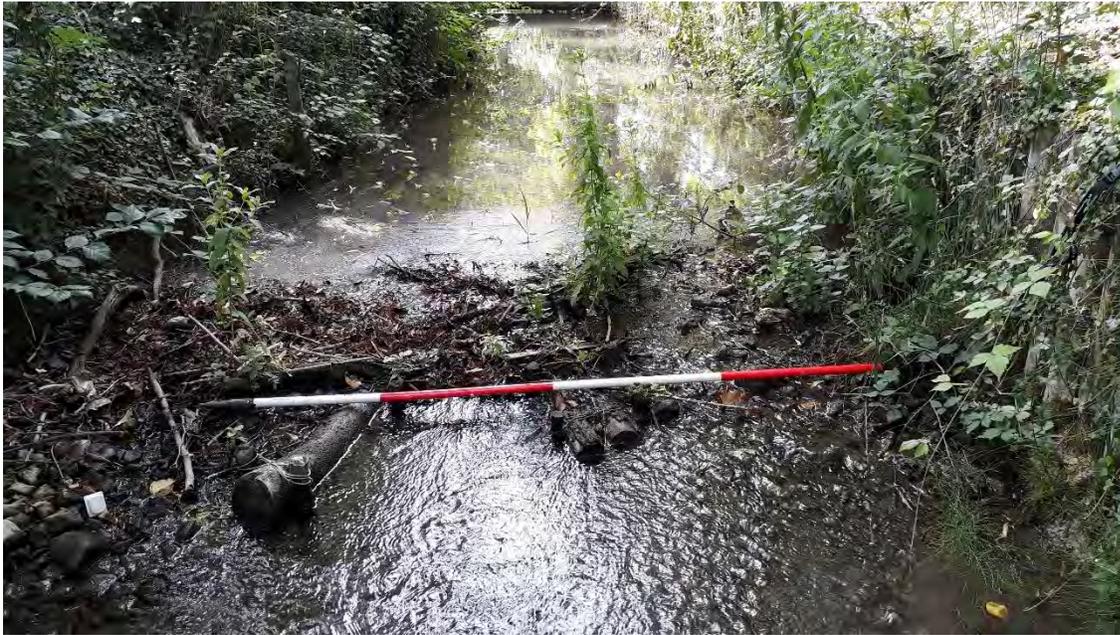
Picture 24 – flow deflector with debris against it causing water to be pushed through the stones. This type of feature would act as a barrier to fish movement.

Whilst the work to date is commended, it is strongly urged that a review of the deflectors be undertaken (with the author) to identify how they could be adjusted to create more ecologically and geomorphologically beneficial flow conditions. This could be as simple as adjusting the form of deflectors by redistributing gravel or adding some smaller particles to increase their water-tightness (preventing the flow of water through the gravel and pushing it over it). The main objective would be to ensure that no structure impounds the flow.

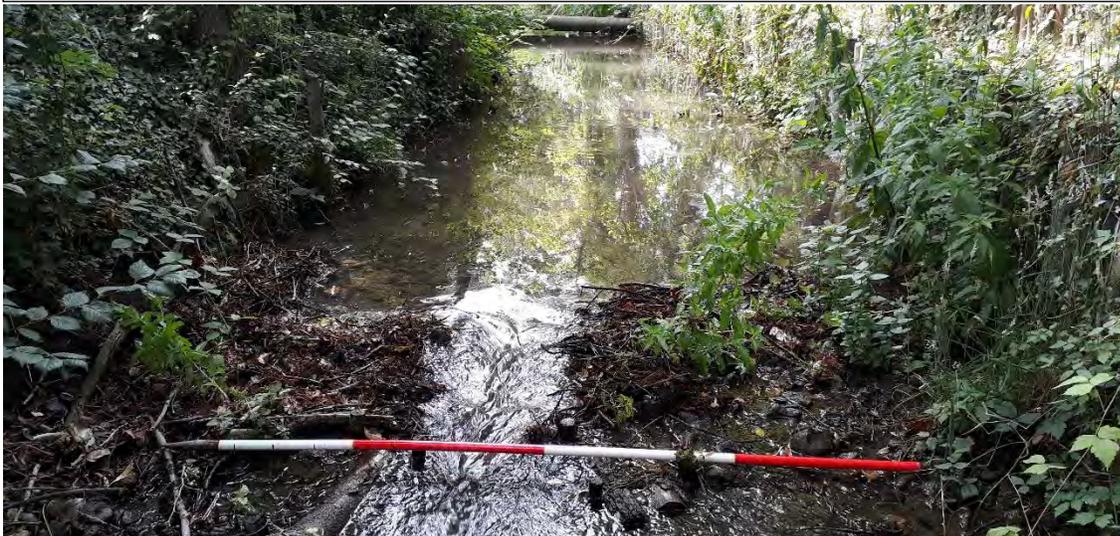
Picture 25 – with a little adjustment of the debris the brook's flow can be centred back in the channel where it can energise the pool. Simple maintenance of such structures is needed.

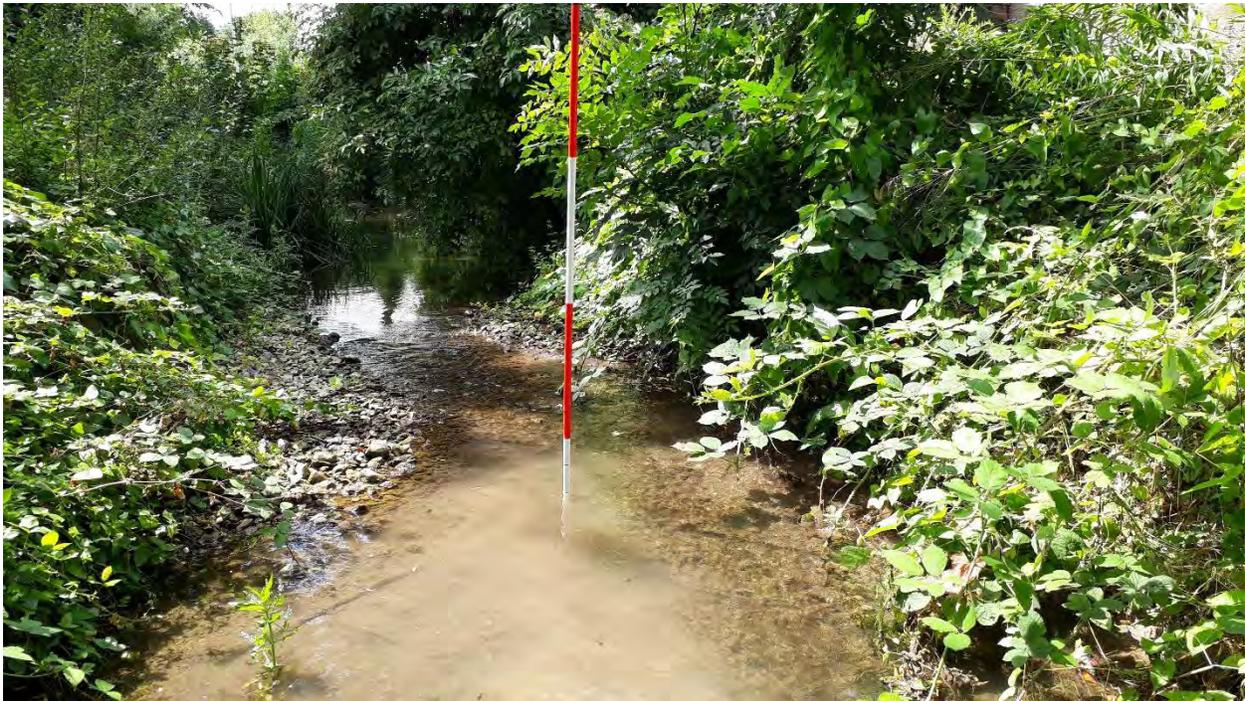
One deflector in particular had encouraged development of a long gravel run (picture 26). Consequently this feature demonstrates how bed raising using gravel could be more advantageous to the brook overall in so far that it would still provide local areas of scour, provide ecologically important riffles and would increase the ability of the brook to transfer fine sediment along its channel.

Picture 26 – note how the placement of gravel upon the bed over a distance of ~5m has shown how more extensive bed raising could bring about restoration of the brook.

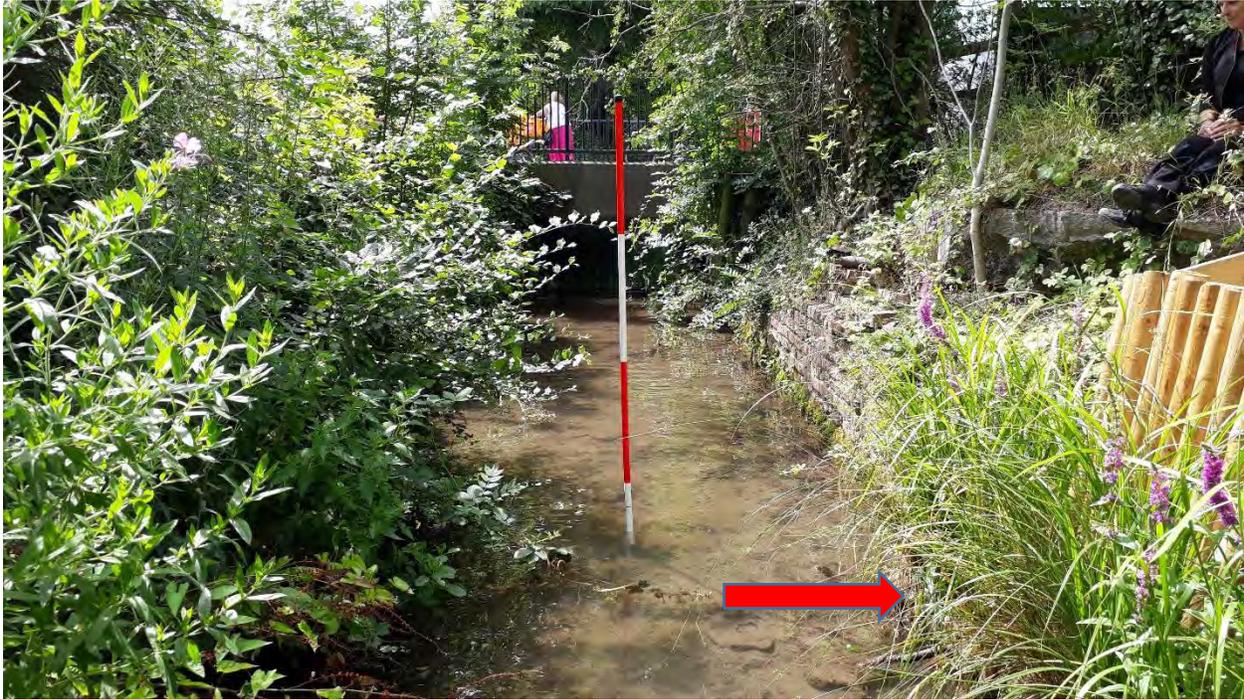
Picture 27 – note how the use of pre-planted coir rolls (shown by arrow) has delivered effective and attractive screening of the hard wood and stone revetments (when undertaken in areas with adequate sunlight).

With regard to the continued use of pre-planted coir rolls, it would be advisable to observe their effectiveness and to decide if, and how, they could be used in the future. They are expensive and similar effects can often be achieved with locally sourced natural materials.

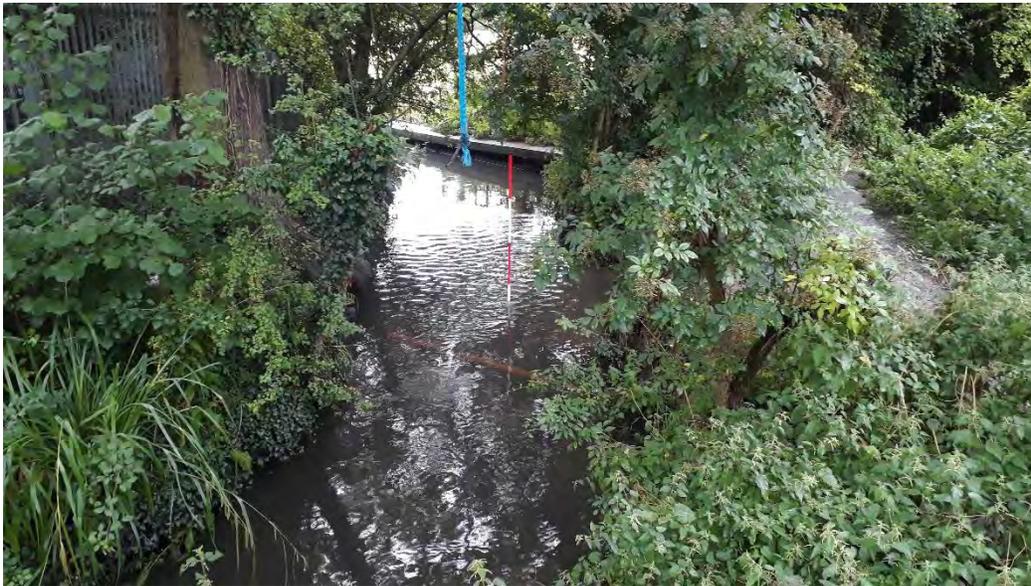
Picture 28 – the lower reaches of the Coldham's Brook exhibit relatively swift flows, a gravel bed and an attractive balance of tree cover and more open areas. Trout are more likely to be present within this reach than elsewhere within this watercourse.

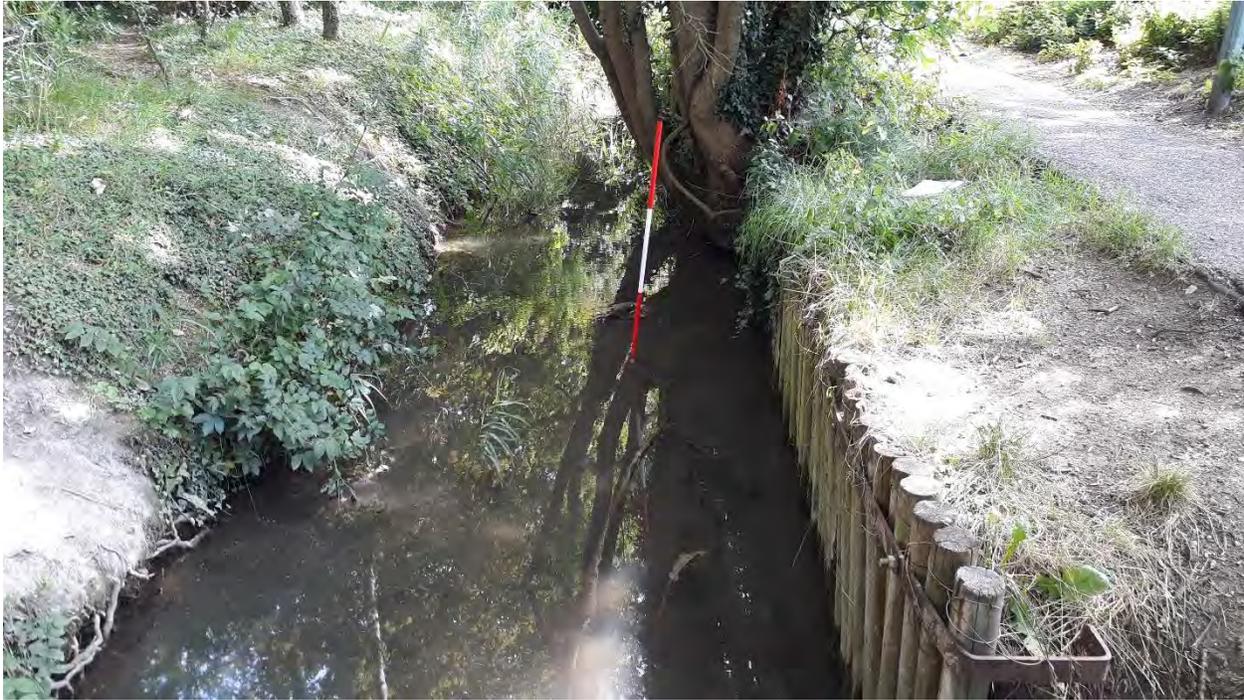
Picture 29 – the effect of shade caused by the tree is evident by the lack of vegetation beneath it.

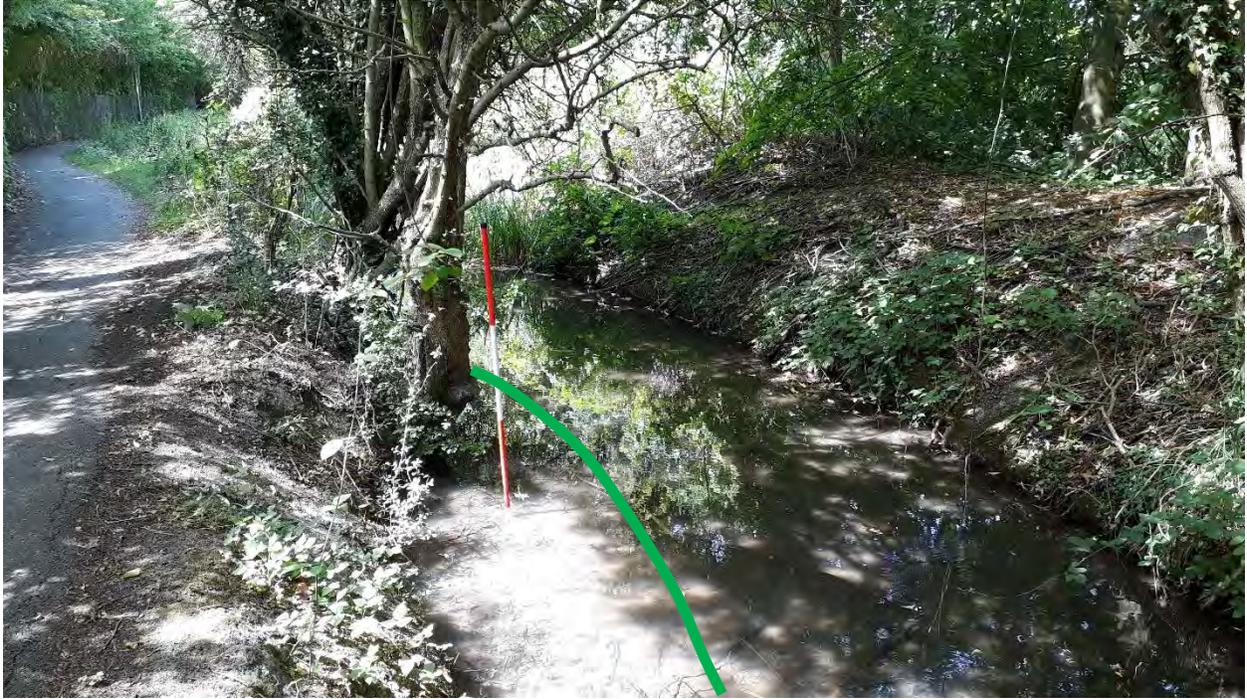
Picture 30 – the slight meander could be enhanced further through the use of a brushwood ledge (shown by green line).

An alternative to the use of pre-planted coir rolls would be to create brushwood margins. These features can be deployed where the channel exhibits sinuosity thereby using the features to speed up flows on the outside of meanders to encourage sediment transfer and deposition. If the sediment is not mobilised then a team of volunteers with buckets can be used to hand-lift silt from the bed and to place it on the newly created margin. The margin can then be planted with translocated plants or stock especially brought in for the brook. (However, a sustainable solution to silt management should be sought rather than depend upon volunteer effort).
