Advisory Visit

Cherry Hinton Brook, Cambridge

18th July 2017

1.0 Introduction

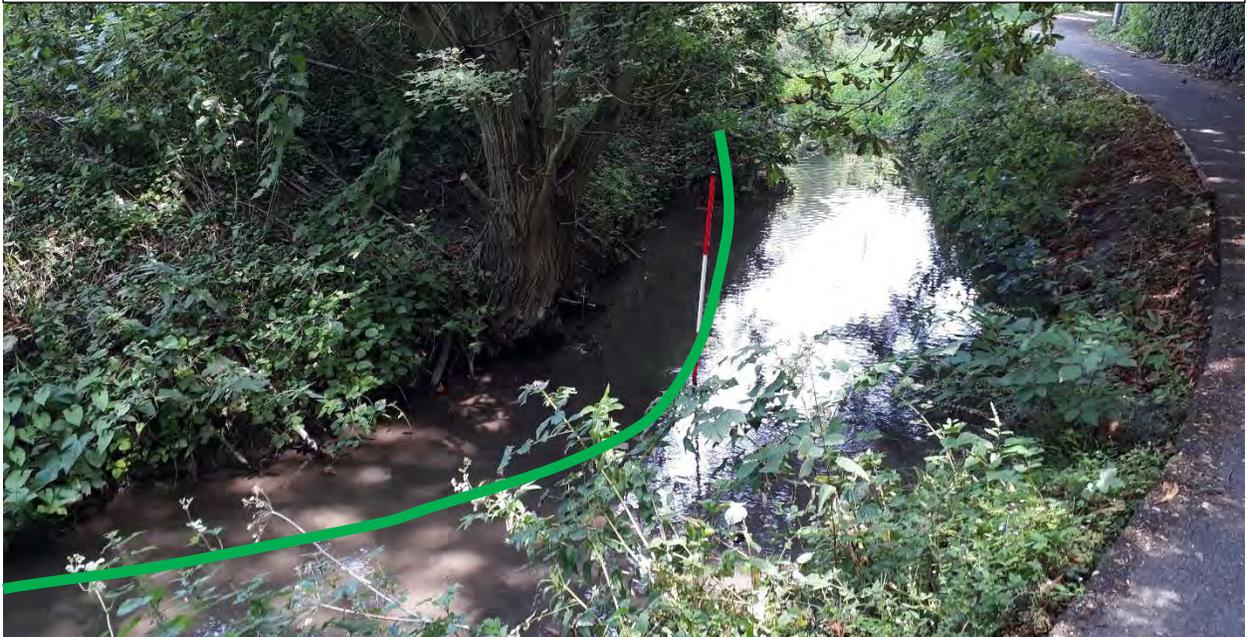
Picture 31 – the slight meander could be enhanced further through the use of a brushwood ledge (shown by green line).

An alternative to the use of pre-planted coir rolls would be to create brushwood margins. These features can be deployed where the channel exhibits sinuosity thereby using the features to speed up flows on the outside of meanders to encourage sediment transfer and deposition. If the sediment is not mobilised then a team of volunteers with buckets can be used to hand-lift silt from the bed and to place it on the newly created margin. The margin can then be planted with translocated plants or stock especially brought in for the brook. (However, a sustainable solution to silt management should be sought rather than depend upon volunteer effort).

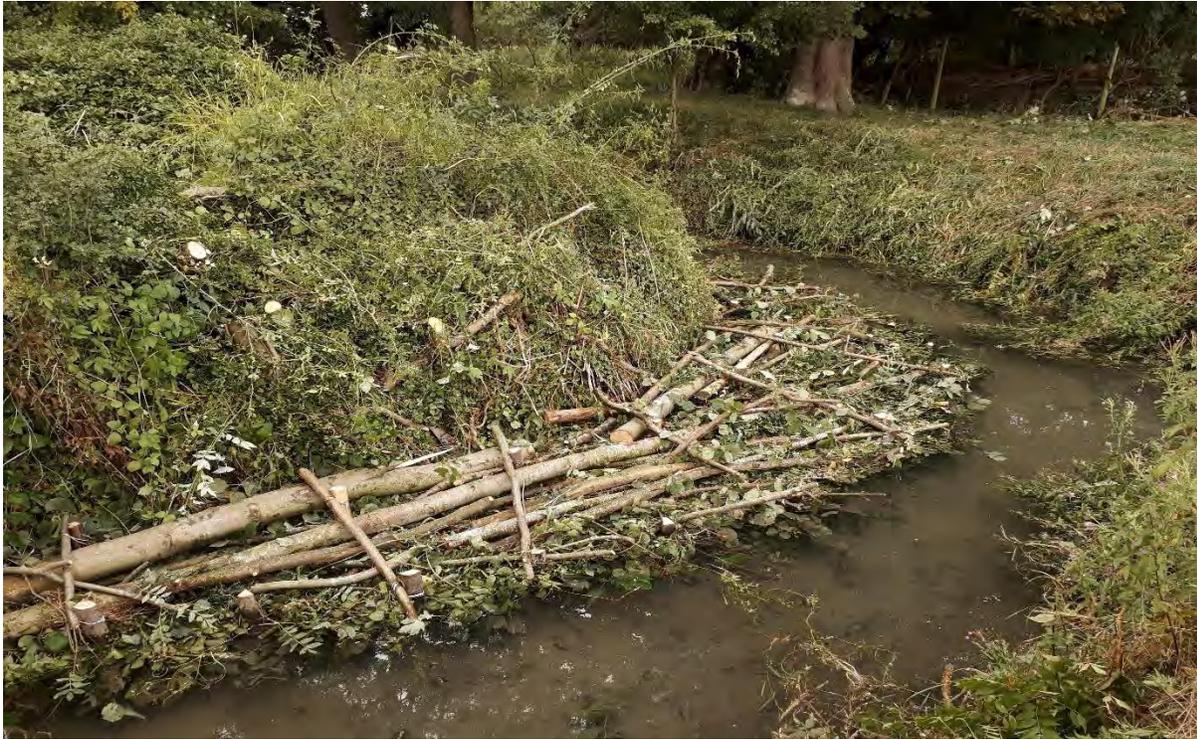
Picture 32 – a brushwood ledge created to enhance a meander on the Hoffer Brook, similar structures could be used on the Cherry Hinton Brook.

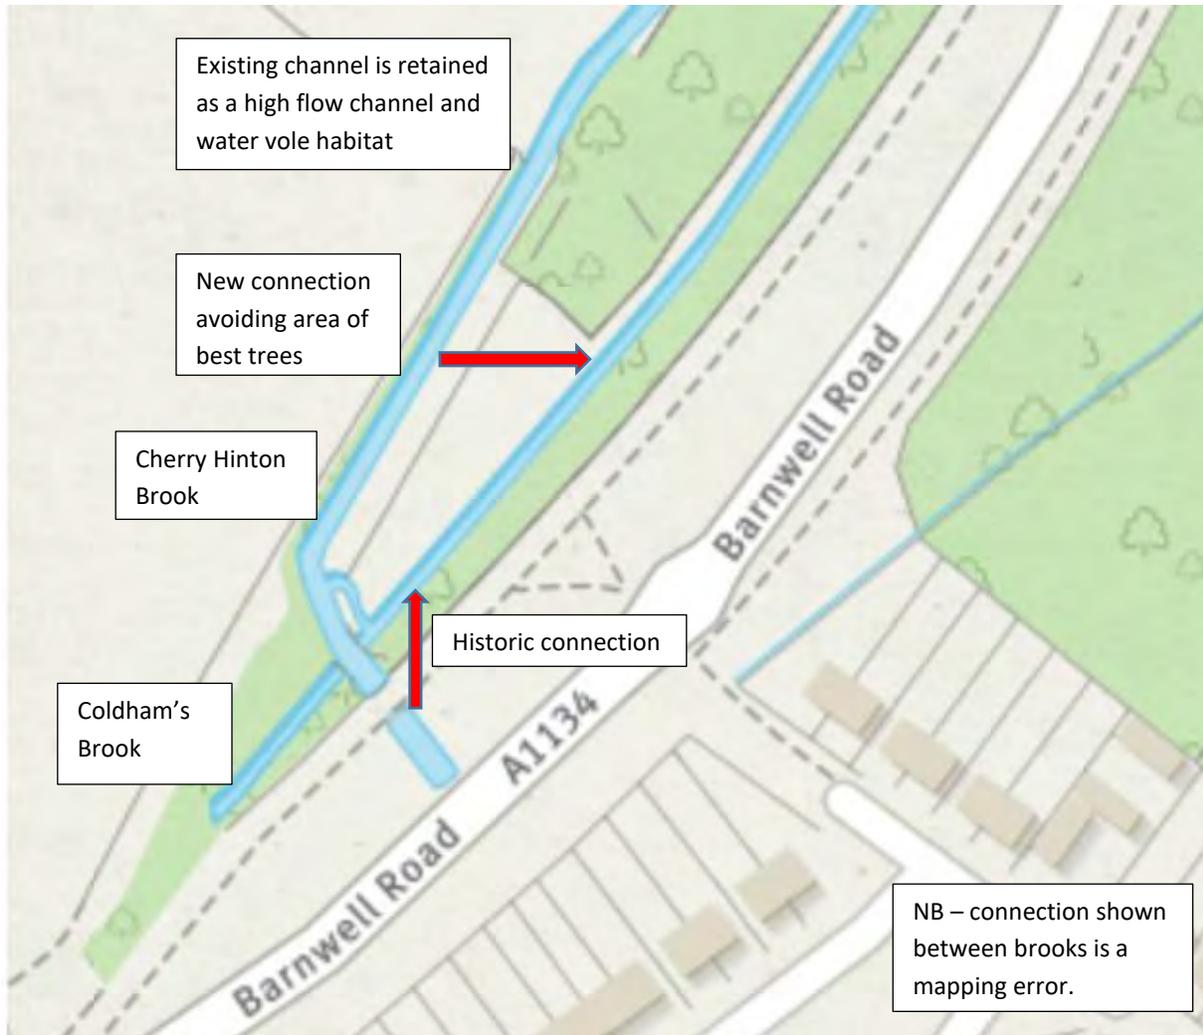
Map 4 – general location of where a connection between the Cherry Hinton Brook and Coldham's Brook could be made.

The logical step is to consider where a connection between the brooks could be made. It is proposed that, subject to legal permissions, flow

investigations and land ownership issues, a connection of the brooks within **the Coldham's Common could be made**. The connection within the Common could take the form of a naturalistic channel that would enable a wide range of fish species to move up it (similar in concept to the fish pass channels at **Byron's Pool and Lammas Land**, Cambridge, but in this case high energy scour protection would not be needed to the same extent).

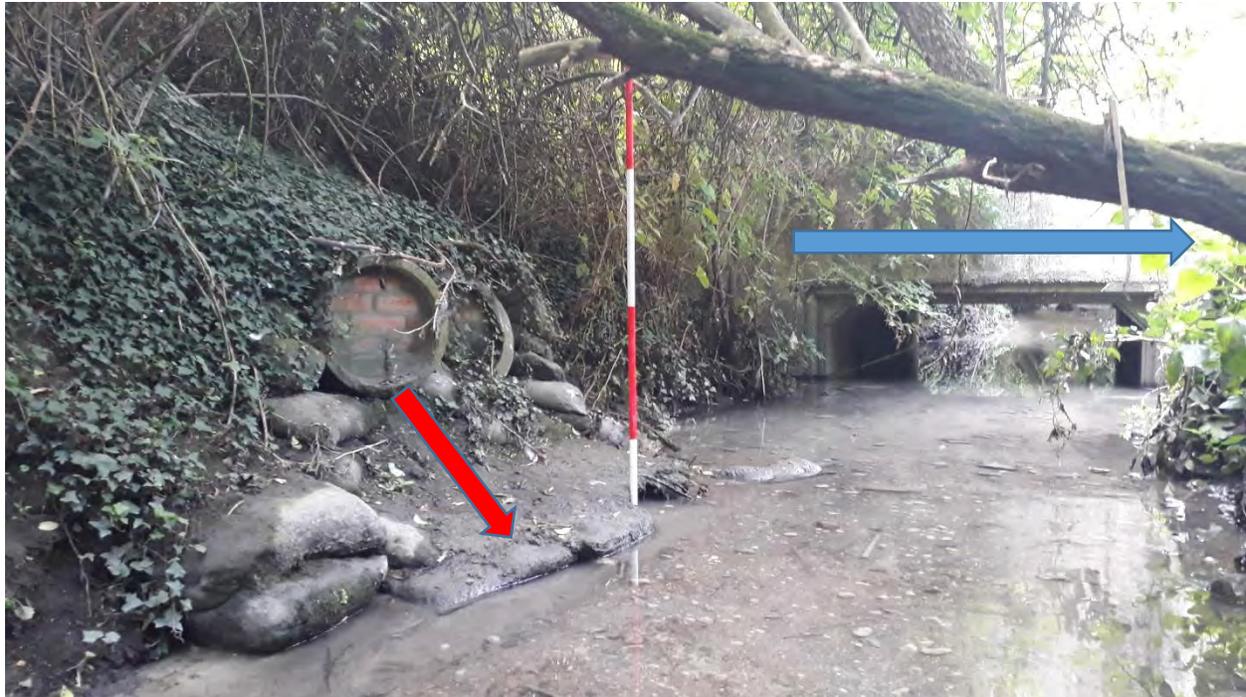
It should be noted that during **investigation of the Coldham's Brook** near to its first crossing by the Cherry Hinton Brook there appeared to be a former connection. Two 600mm concrete pipes emerged at an angle to the brook,

which together with bed armouring, suggested that flow had at some point in the recent past been directed from the Cherry Hinton Brook down into **Coldham's Brook**. These pipes are now bricked-up. Enquiry should be made with the Council's drainage team to see if this historic connection is known.

Picture 33 – note the blocked outfall to the Coldham's Brook (red arrow) believed to have been from the Cherry Hinton Brook. The Cherry Hinton Brook now flows over the Coldham's Brook (blue arrow).
