Crow Brook, Telford: Advisory Visit

Report and Proposal by Paul Gaskell of the Wild Trout Trust – Following a Site Visit on 13/11/2015

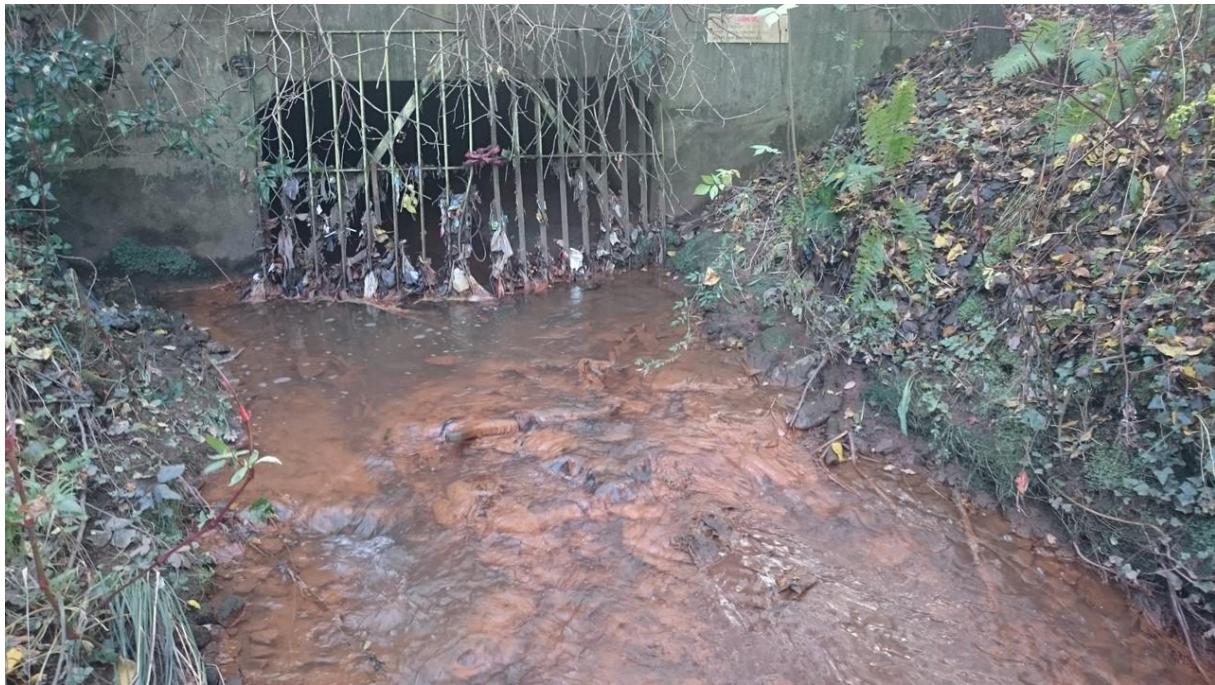
The upstream limit of visited locations was at SJ 68214 12987 where the Crow Brook flows out of a culvert (Fig. 1). The ochre that coats the full width of the river bed is readily visible. Conversations on the day indicate that there is an upstream "serpentine" section that was designed to provide treatment for the ochreous water (via settling out of insoluble ochre and associated sediment). That facility is currently in need of maintenance and no longer providing protection against ochre inputs to the downstream watercourse.

Figure 1: Ochre precipitate (Iron III oxide) coating the channel bed at the upstream limit of the visited reach at SJ 68214 12987.

In order to make morphological improvements meaningful, it would be necessary to tackle the upstream water quality issues. As a first priority, the reinstatement of functional treatment for mine-water is essential.

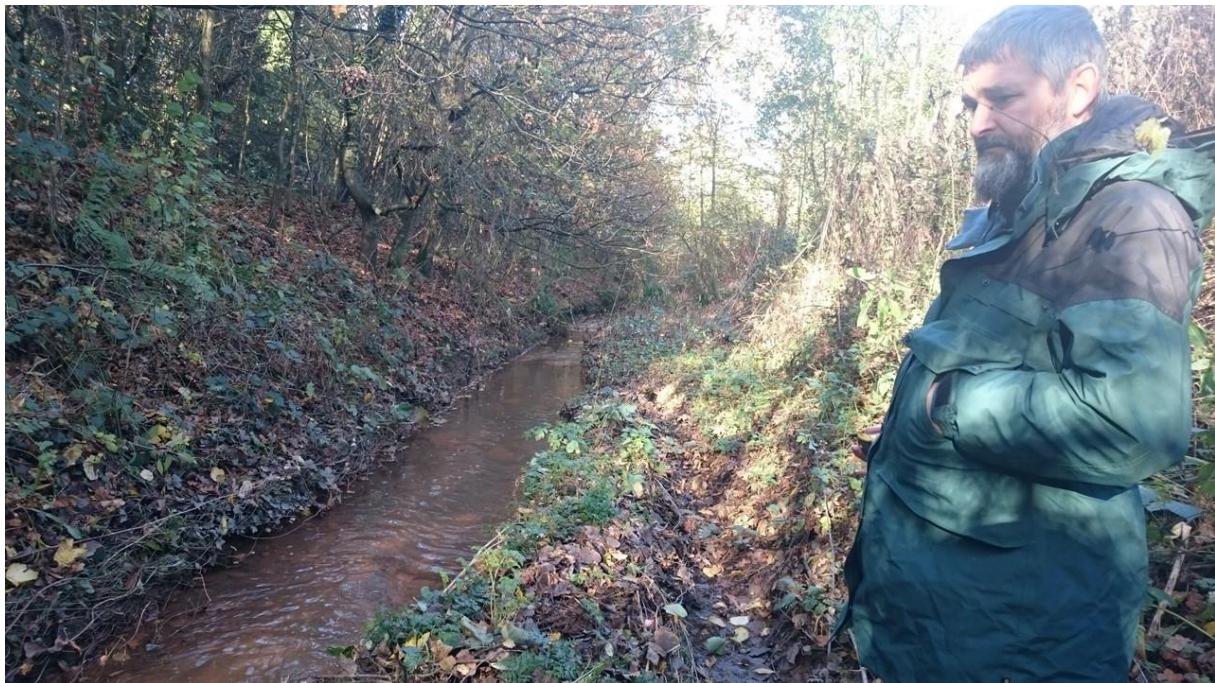
The LHB is steep at this location (Fig. 2) but there is a relatively wide and level bank top on the RHB. This flat RHB is much lower (and closer to the normal water level) than the LHB. Consequently, it would be relatively easy to cut into that flat bank in order to produce a more meandering planform than the current, extremely straight path of the brook. The potential for suitable plant machinery to gain access appears relatively straightforward at this location. The road is close by and, if necessary, some felling of saplings should allow access for a small machine and bucket.

Figure 2: Relatively steep LHB and low-lying/level RHB. Shot taken facing downstream from the culvert (Fig.1). There is scope for increasing the channel length of the brook via encouraging a more meandering planform.

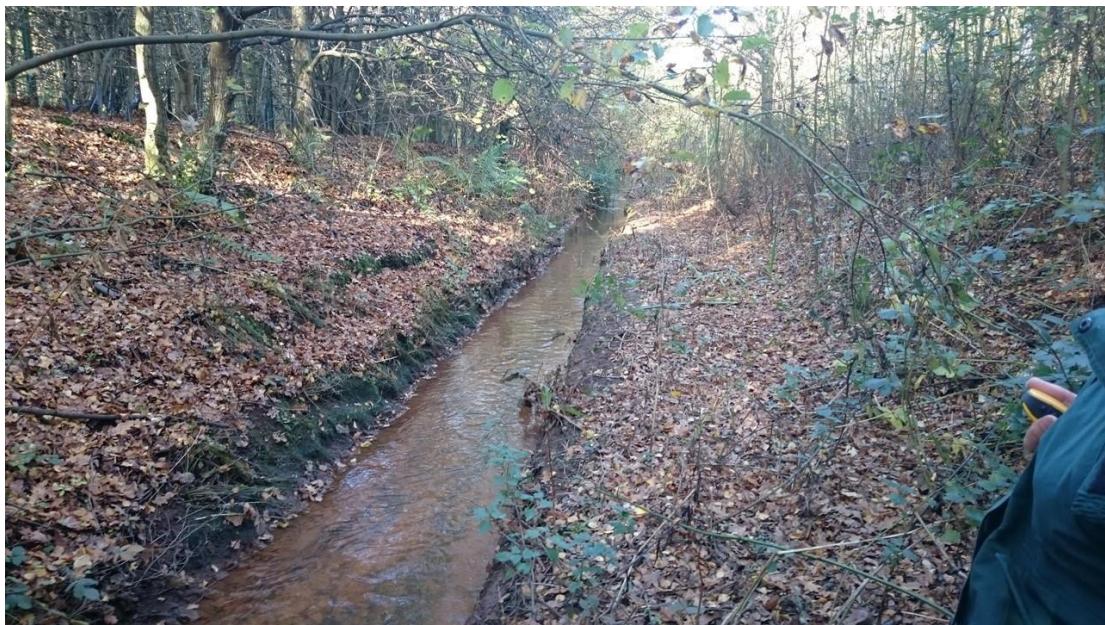
At SJ 68200 13051, there is a typical example of the opportunities on this reach to establish some minor canopy management in order to stagger the age/height structure of the (established) surrounding woodland (Fig. 3). Increased variation in the light/shade regime would benefit some of the existing understory fern and sedge tussocks. However, for full benefit, some (volunteer group) management of the low-level Himalayan balsam infestation and some other dominant vegetation (principally brambles) is desirable.

Figure 3: Uniform canopy height and shade regime with little understory diversity (note ochre coating the soft/sandy stream-bed).

The ruler-straight planform is also evident in Figure 3 (as is the blanket coverage of ochre on the stream-bed). It may be possible to use a combination of excavation by mini-digger and installation of woody material to create a more meandering channel (see Section 3 “Recommendations”).

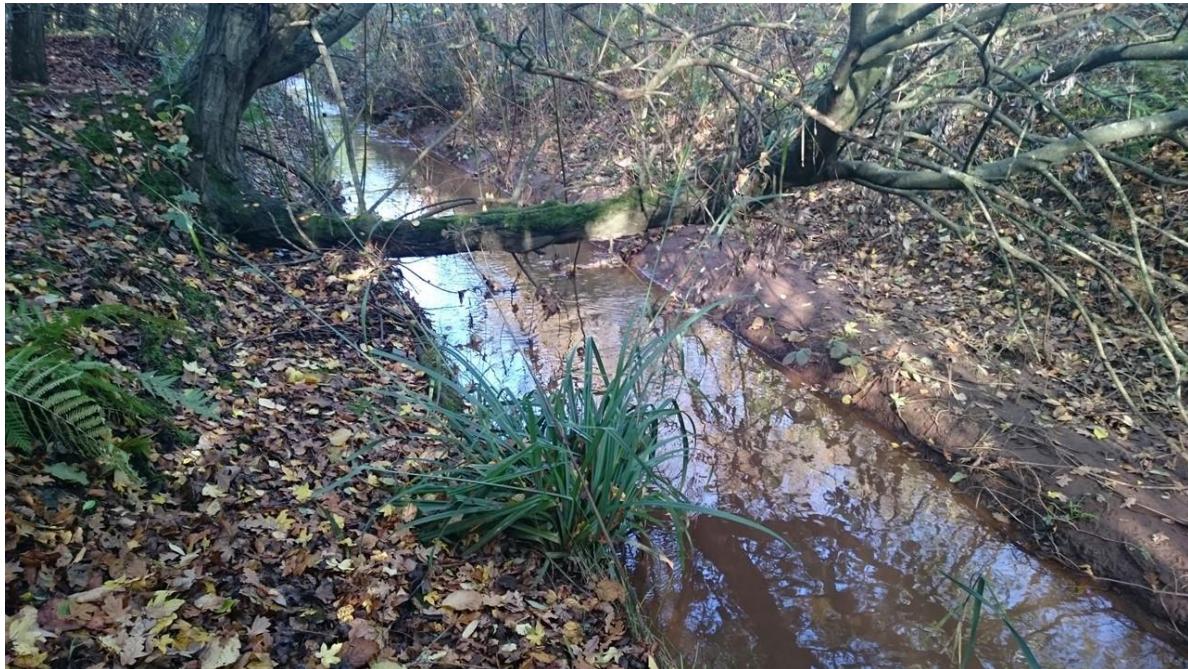
A naturally-occurring fallen tree (Fig. 4) provides an example of how woody material of suitable dimensions improves the ecological value of the channel structure. However, it must be stressed that the current status of this channel is best categorised as a severely degraded drainage channel. The combination of a perfectly linear planform, copious ochreous sludge and (even if the banks were allowed to engage in natural erosion processes) the available substrate is likely to be dominated by sand and silt. In combination, this yields very poor prospects for thriving and diverse aquatic communities.

Figure 4: Tree spanning the brook above the normal bank level at SJ 68193 13087. Additional aquatic habitat benefits are associated with stable woody material that is partially (or wholly) below the waterline. Tree limbs like this can be partially cut and then hinged into the channel in the same manner as hedge-laying.

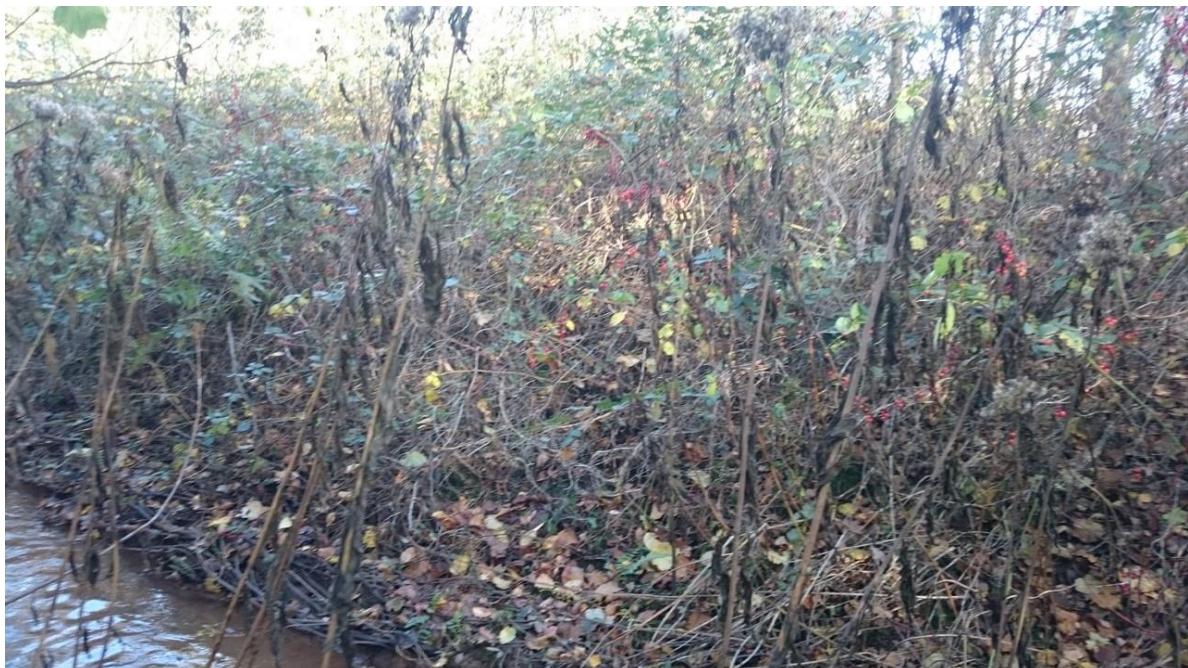
There was an example of bramble patch that could be reduced/controlled by volunteer groups to promote a more diverse understory just downstream (Fig. 5). Note that control over Himalayan balsam would be required in order to prevent the newly cleared patch being rapidly colonised by that invasive species.

Figure 5: Dense brambles on the RHB approximately 5 metres downstream from area pictured in Fig. 4

As well as creating a more varied tree canopy, the bramble control would make it possible to undertake some seeding with locally-appropriate species.

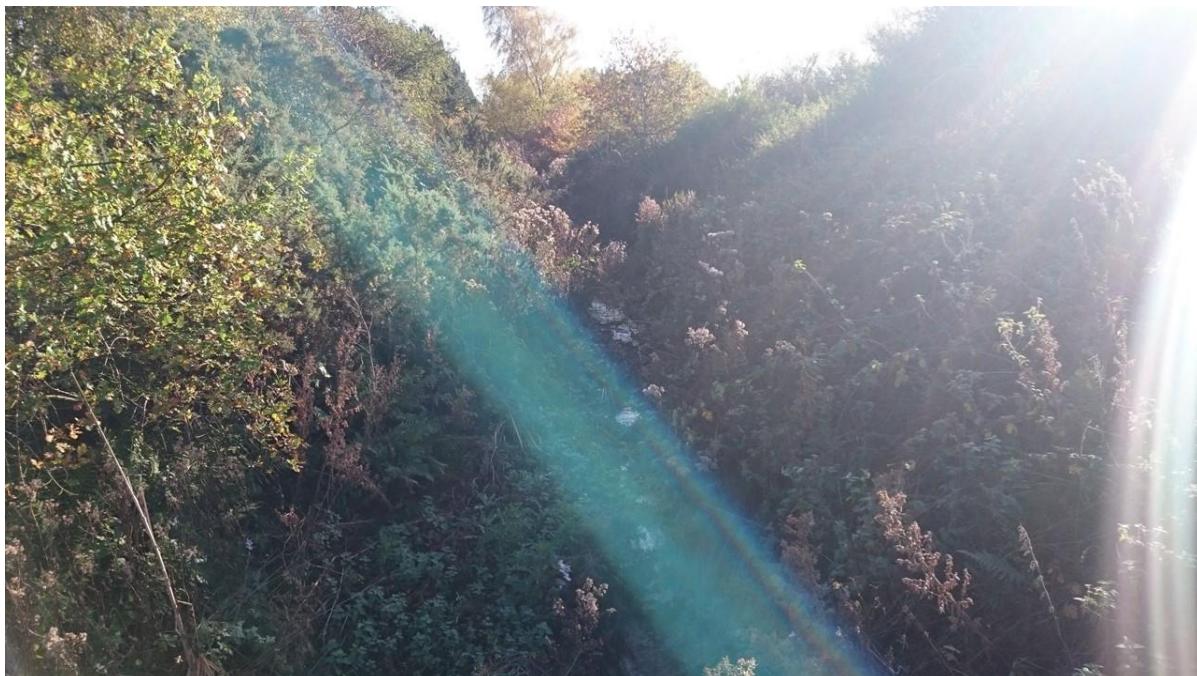
In order to compare dimensions and channel characteristics in this reach to a natural/non-armoured section of the brook, we examined the brook on the downstream side of the culverted section under the road at SJ 68058 13337 (which was the downstream limit (Fig. 6) of the reach where the investigation of the feasibility of initial works are requested by the E.A.).

Figure 6: Looking directly upstream from the road at the downstream limit of the straightened section at SJ 68058 13337

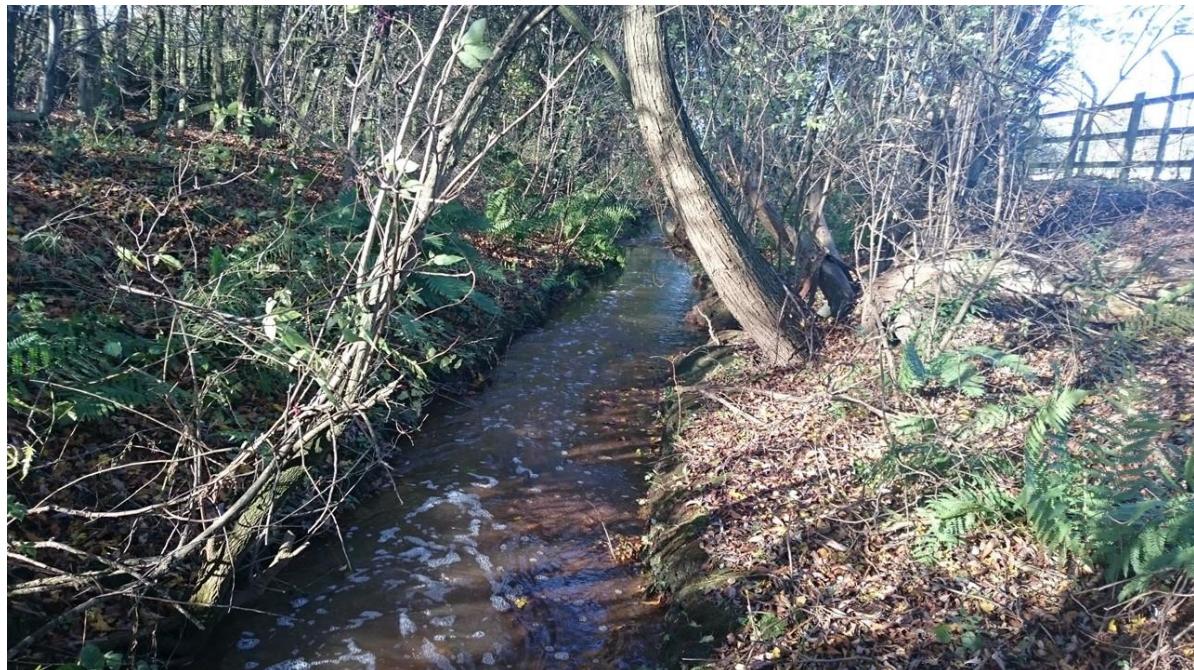
armouring. Instead, the straight channel seems to be maintained largely by the increased bank resistance afforded by tree root systems that may have been planted to line the brook (Fig. 7).

Figure 7: Although still fairly straight, there is some more deviation from a totally linear path where the brook is less formally confined by heavy engineering of the channel. Habitat quality is, consequently a little better in this section pictured at SJ 68017 13447

If landowners were amenable, it may even be possible to increase the amount of meandering by modifying the LHB along this section (section 3 "Recommendations").

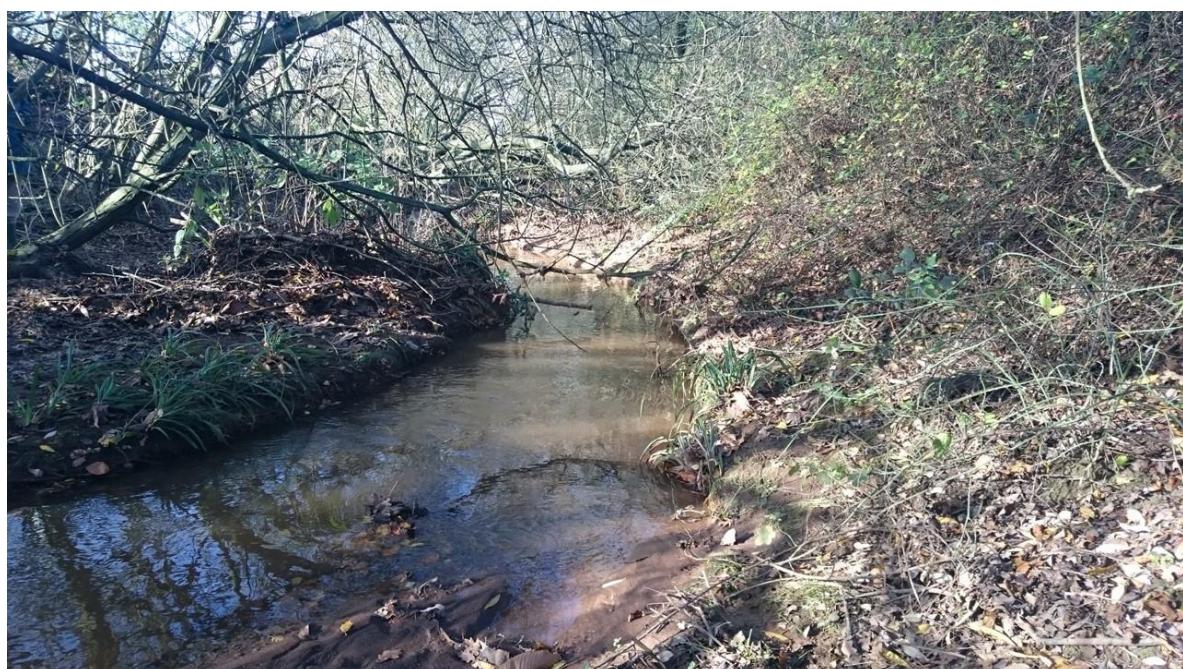
As an example of the natural propensities of the Brook, there is a naturally-occurring meander (Fig. 8) at SJ67852 13589.

Figure 8: Natural meander at SJ67852 13589 – note the sandy/silty nature of the watercourse.

Despite the sandy nature of the riverbank material, the watercourse does not display worrying levels of incision (cutting downwards) or lateral erosion in the absence of heavily armoured banks and channel bed. The presence of root structures of varying depths (including tree roots) tends to help to stabilise those processes of erosion and deposition.

Consequently, it appears that allowing a greater degree of natural erosion and deposition to produce a more meandering planform of the brook would be an appropriate and achievable goal. This could be coupled with actively digging out certain sections in order to kick-start this process. Further details are given in the next section.

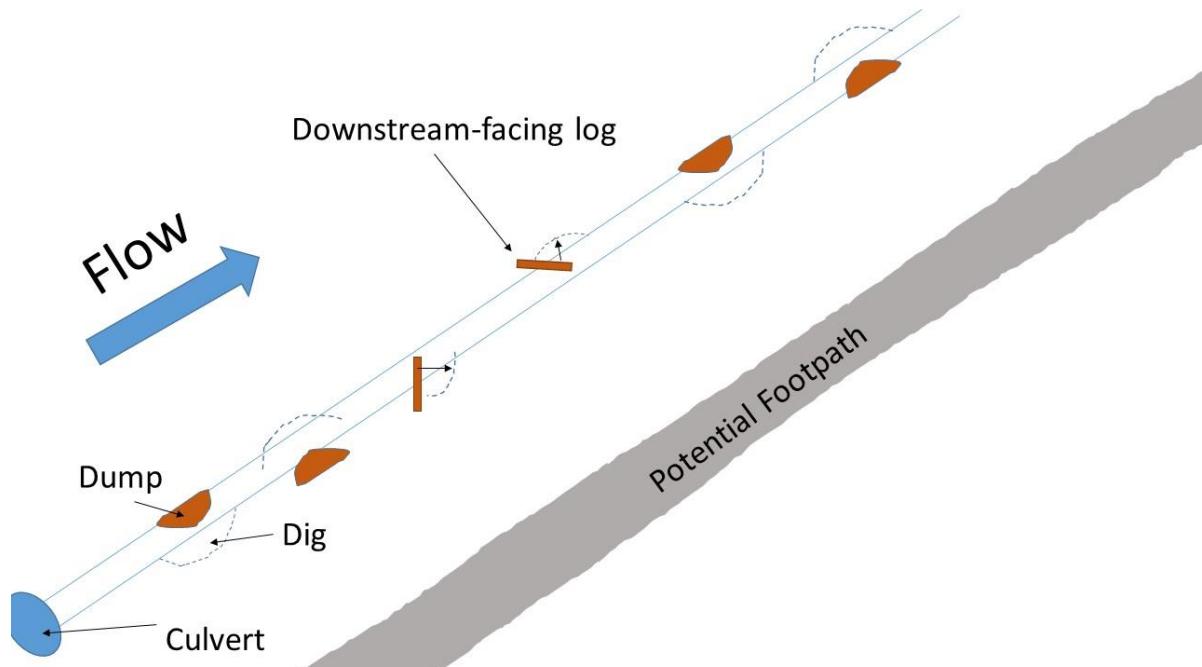
Figure 9: Re-meandering measures - "Dig and Dump" and using log deflectors positioned so as to erode the bank adjacent to the downstream face of each log

- Cutting back dense patches of brambles.
- Potential supportive seeding/planting of native river corridor woodland plants.
- Fixing logs/tree trunks to the stream bed (including laying of suitable bankside species e.g. willow, hazel, elm and hawthorn) so as to actively promote bank erosion and generate meandering planform of the brook (Fig. 9).

- Using “dig and dump” techniques to pull back the bank toe on the RHB – and repositioning the excavated material on the opposite bank to produce a berm and instant re-meandering (Fig. 9).

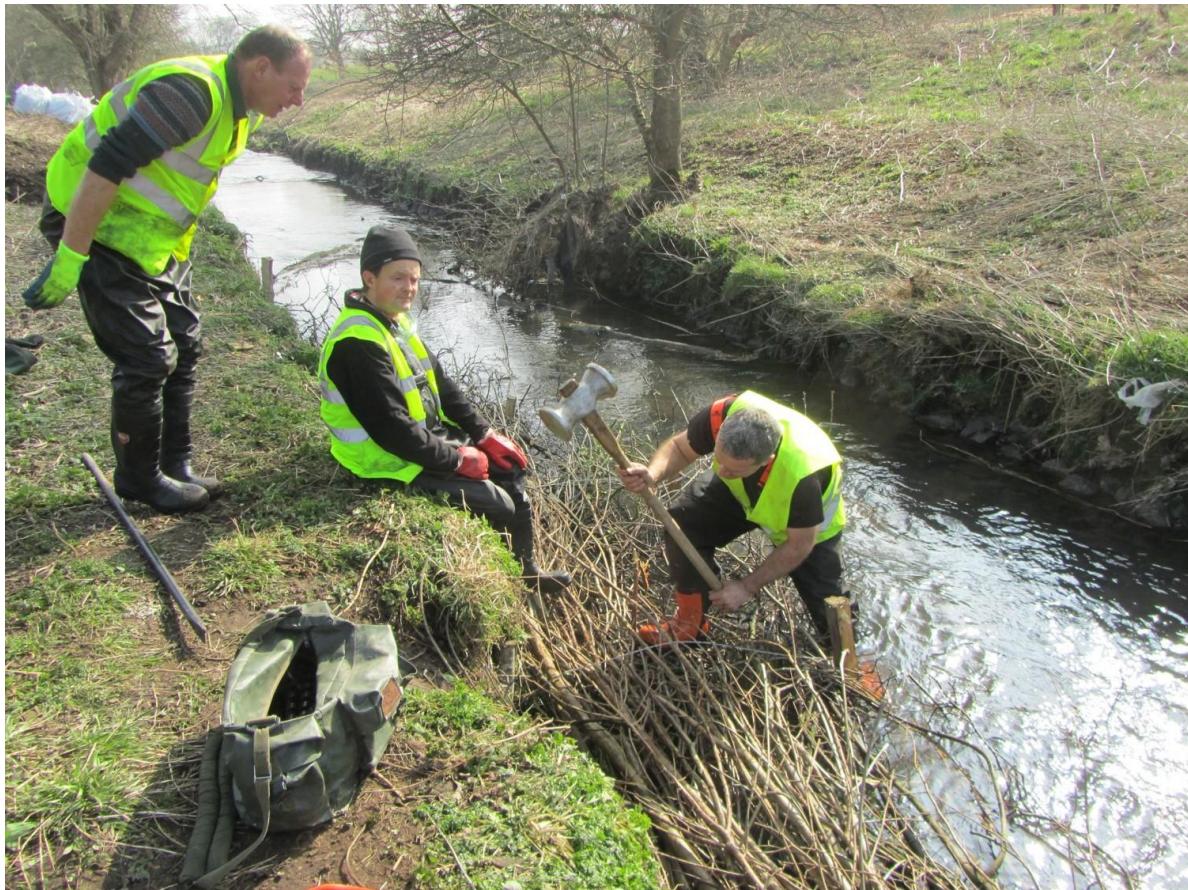
Figure 10: Berms created from back-fill from dig and dump can be stabilised by brash, stakes and fencing wire.

- Berms could be stabilised using brush arising from coppicing work with material secured using stakes (Figs. 9 and 10).
