Habitat Advisory visit to the River
Dikler, Lower Swell, Gloucestershire
Undertaken on behalf of the Wild Trout
Trust, Vaughan Lewis, Windrush AEC
Ltd
June 2012

1.0 Introduction

2.0 Habitat assessment

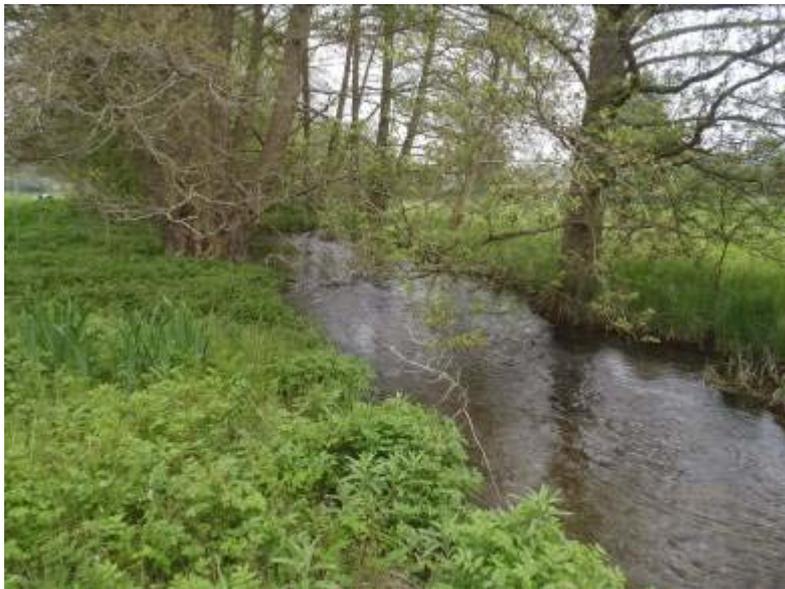
Typical section of the upper river showing tree cover and well-fenced margins

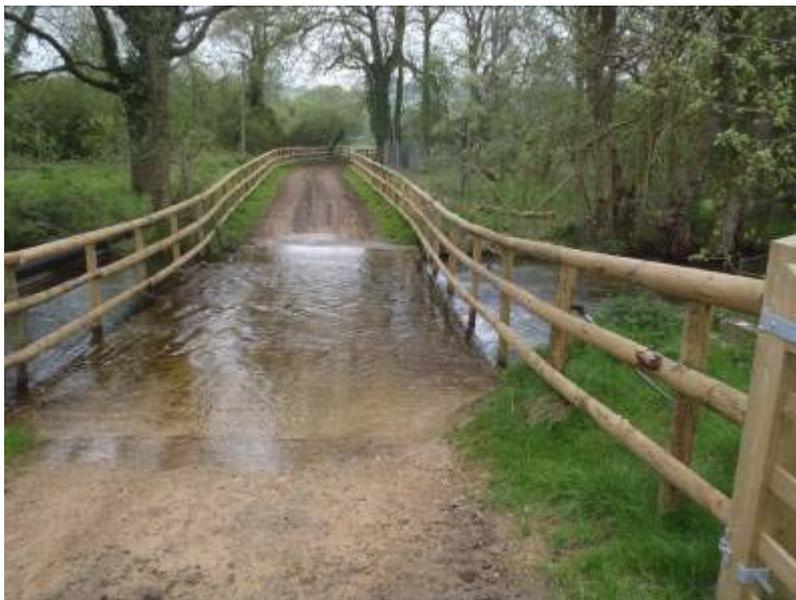
Towards the upper end of the fishery, there were two significant obstructions to fish migration. The first was a concrete ford. The level at which this had been installed means that only a very shallow flow of water passes across the ford, effectively preventing fish migration except during very high flows. The inclusion of small submerged culverts within the concrete slab was meant to improve fish passage. However, they are undersized, with a high flow velocity and will not be readily used by trout or other fish species.

Concrete ford preventing fish migration

- Addressing the presence of the three obstructions to fish passage is important. Without this work, the fish populations in the river will remain fragmented. The obstruction caused by the concrete ford can be overcome (subject to the structural stability of the ford) by cutting a central notch in the structure, some 0.5m wide and 300mm deep. The gap will allow fish passage at all flows. Safe passage of vehicles can then be created by spanning the gap with suitably sized steel or wooden bearers.

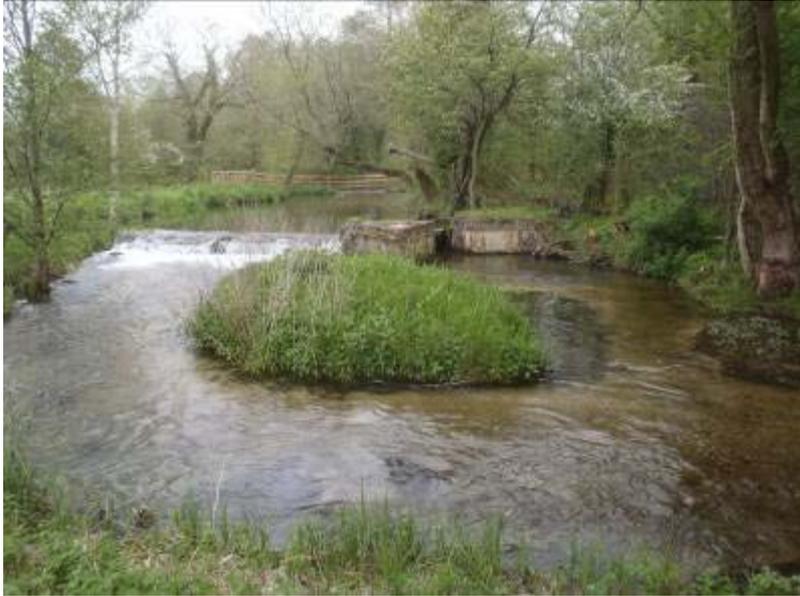
The second obstruction to passage was a weir forming a natural swimming pool at what appears to be the site of a former pumphouse.

‘Swimming pool’ weir with former pumphouse on right of picture

The swimming pool has become heavily silted, with the water only a few centimetres deep upstream of the weir. The new owner has expressed a desire to renovate the feature by de-silting the channel upstream of the weir. Downstream of the swimming pool, the instream habitat remained excellent, with extensive beds of water crowfoot growing over gravel dominated shallows. However, the channel was overly incised, due to past dredging. Evidence of the dredging was provided by the raised levees particularly on the RB. These reduced hydrological connectivity between the river and its flood plain. Excavation of the levees showed that they contained a high proportion of gravel and cobble, originally from the riverbed.

- The ideal solution to migration across the 'Swimming Pool' weir would be to remove it totally. However, if there is a requirement to retain the structure, then a simple pre-barrage should be installed, raising the water by around 300mm. This should be adequate to allow fish to move across both the pre-barrage and 'Swimming Pool' weir.

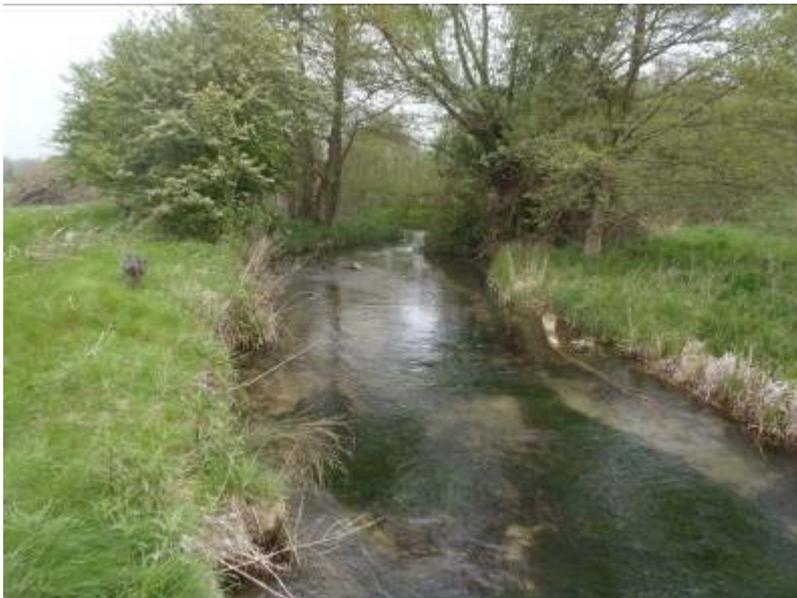
Excellent instream habitat with water crowfoot. Note elevated true RB (left of picture) due to deposited dredgings

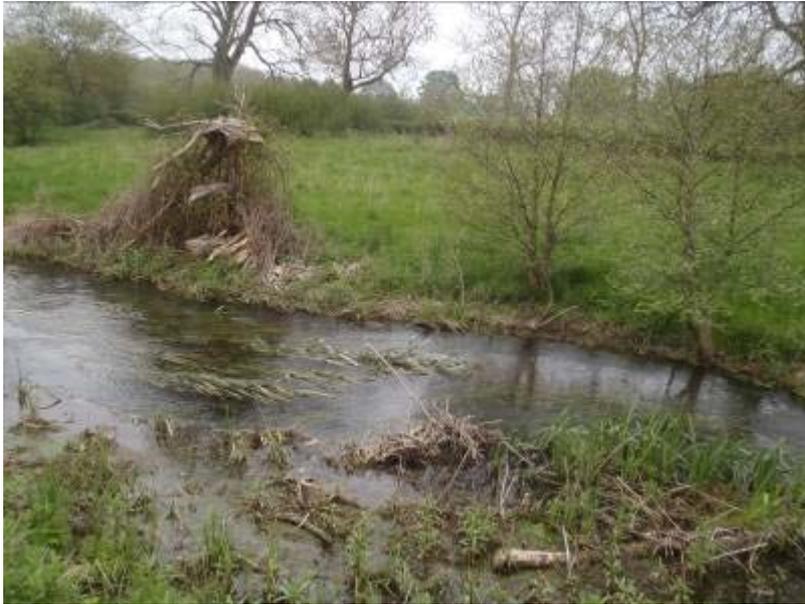
Further downstream, the gradient of the river decreased as the influence of the Hyde Mill impoundment became more obvious. The silt burden in the channel became deeper, with an increased growth of emergent vegetation across the channel.

Channel upstream of Hyde Mill

Hyde Mill itself presented a total barrier to migrating fish, effectively isolating fish populations upstream and downstream of the mill.

- The impoundment at Hyde Mill could most easily be addressed by using an existing channel as a bypass as discussed on site. This would involve either constructing a ‘rock ramp’ easement below the sluice connecting the main river and bypass channel above Hyde Mill, or modifying the culvert that connect the two channels near to this location. Some more detailed design work would be necessary before deciding on which option to pursue. It may be possible to help fund some of the work involved with addressing all 3 obstructions using money from the DEFRA funded Catchment Restoration Fund which would come via the local Cotswold Rivers Trust (contact Trevor Cramphorn at <http://cotswoldsrivetrust.org/>)

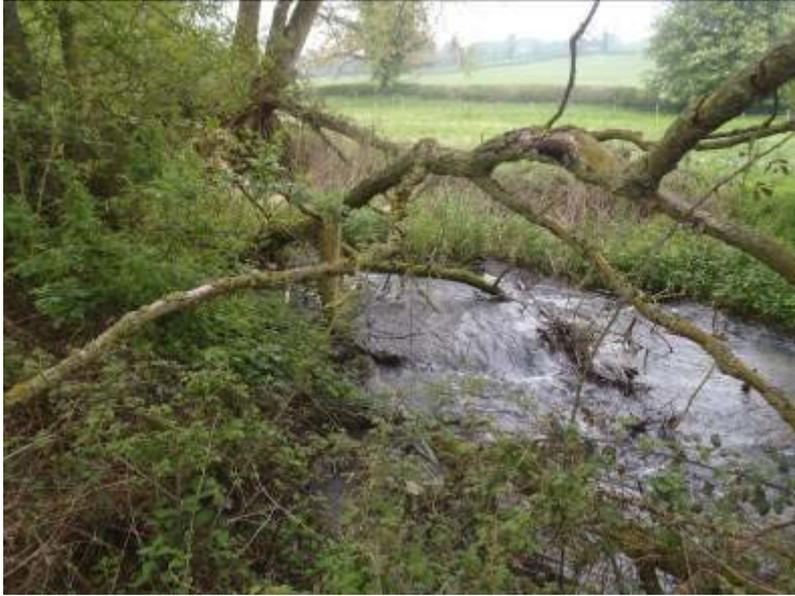
Existing LWD. Note scour and cover created

- Some coppicing work has already been carried out by the river. It would be useful to continue this along the whole length of the fishery. Care should be taken not to remove too much shade. An ideal mix is probably a 60:40 split, in favour of shaded channel. Try and stagger the coppicing so that there are trees at all stages re-growth, with cutting carried out over say 5 years. Timber arising from the coppicing can usefully be used to introduce LWD to the channel. Best practice is to try and 'hinge' and fix timber in place. Alternatively, fix in places using wooden stakes and wire (see pictures below).

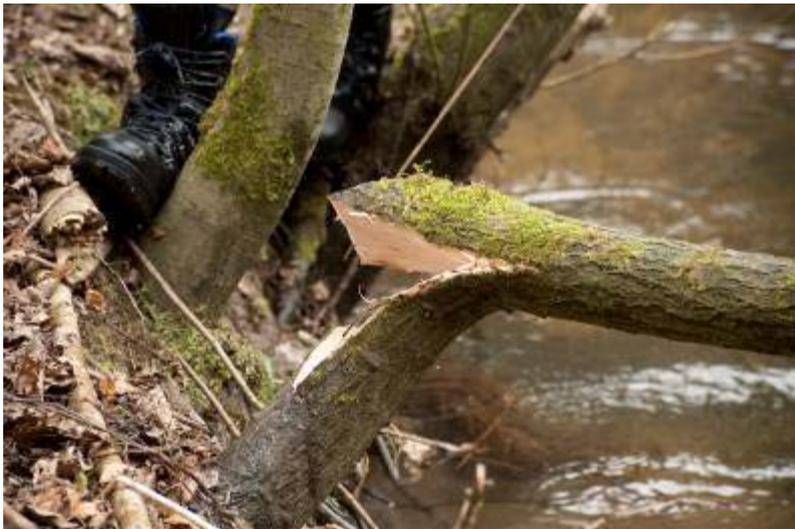
Cut and hinged timber

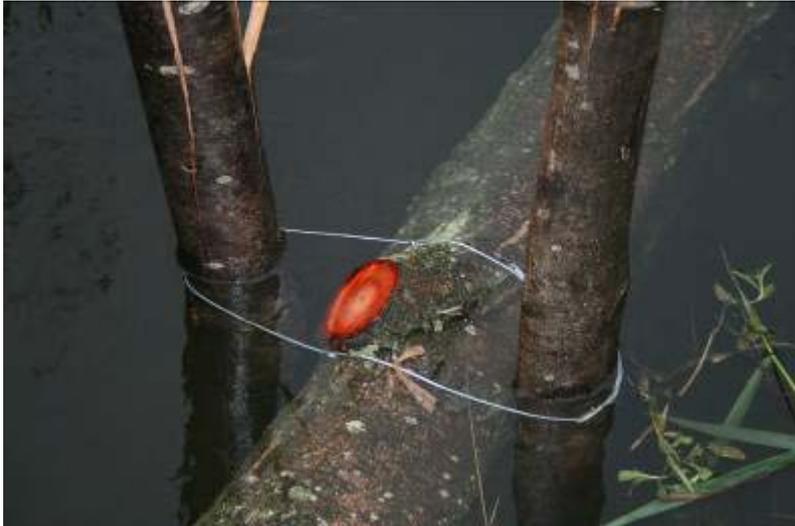
Additional post and wire fixing

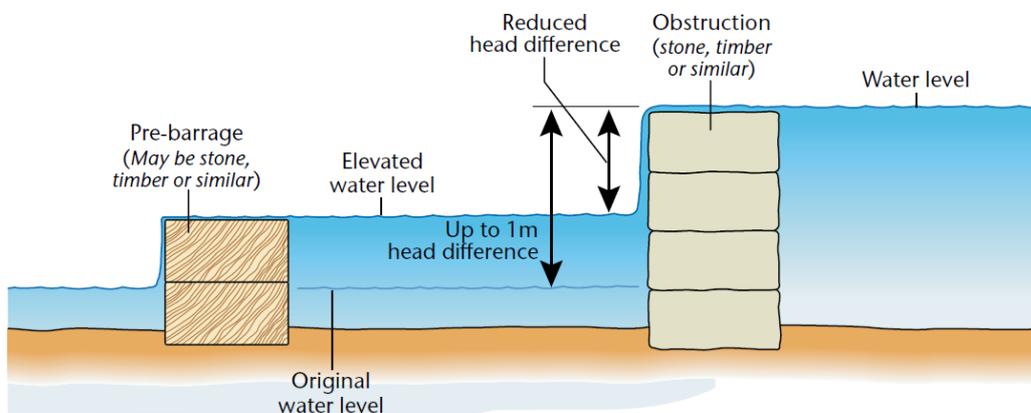
Pre-barrage installed below a weir

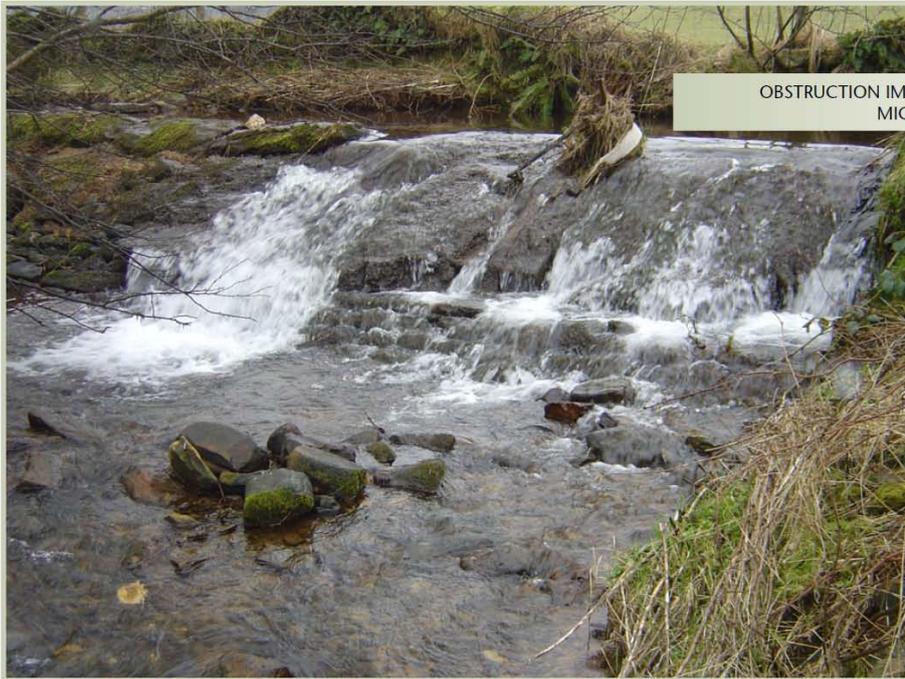
OBSTRUCTION IMPASSABLE TO
MIGRATING FISH

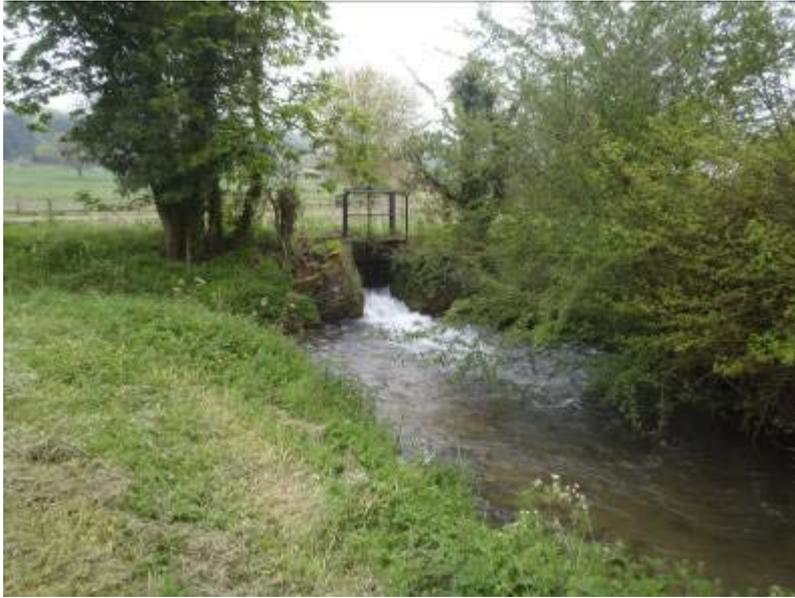
Bypass channel and sluice. Rock ramp could be used to create passage through the sluice

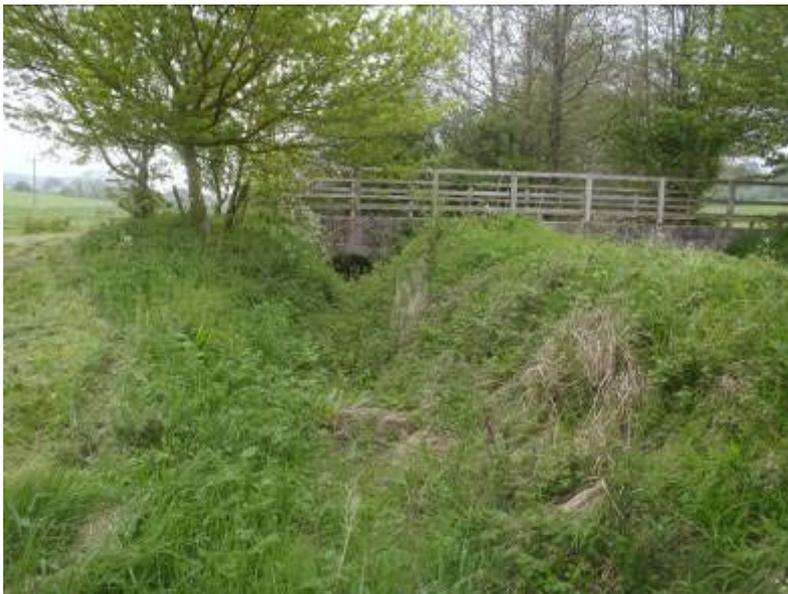
**Culvert that connects RB of bypass stream to main river u/s of Hyde Mill.
Another potential bypass route**
