Advisory Visit

River Dove

May 2018

This report is the output of a site visit undertaken by Tim Jacklin of the Wild Trout Trust to the Derbyshire County Angling Club (DCAC) section of the River Dove, Crowdecote, Derbyshire on 1st May, 2018. Comments in this report are based on observations on the day of the site visit and discussions with members of the DCAC committee.

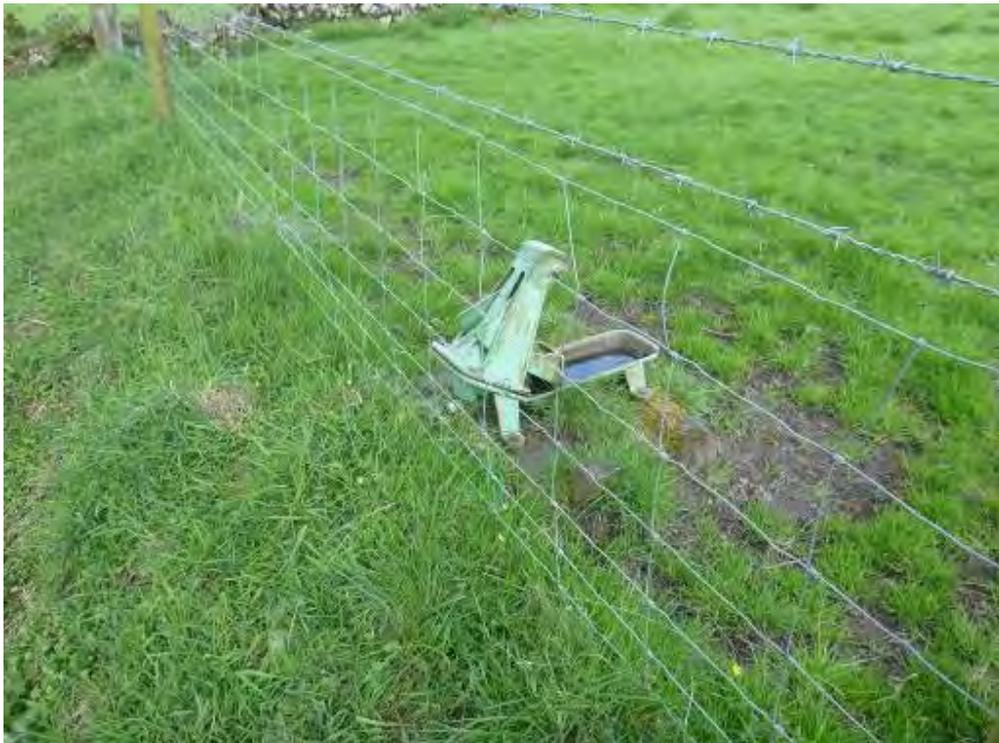
The DCAC bank (LB) is fenced off from livestock with a wide buffer strip between the river and agricultural land (Photo 1). The fencing was erected about ten years ago by Trent Rivers Trust (in combination with the development of the Peak Angling Passport scheme) and has allowed excellent riparian habitat to develop. The fence is probably the most important asset in

Photo 1 Stockproof fencing is one of the most important assets of the fishery and should be maintained as a priority. The pasture pump drinkers appear to be redundant and maybe could be re-deployed elsewhere.

maintaining good habitat on the fishery and priority should be given to its maintenance and keeping it stockproof. The ongoing replacement of rotten posts and sections of wire is far less of a financial burden than replacement of the entire fence. The opposite bank (RB) is mostly fenced off, with one or two exceptions (see section 3.2); liaison with the landowner and fishing interests of that bank is recommended to limit stock access to the river as far as possible.

- Maintain the existing fencing along the river and keep it stockproof. This is the single most important factor in maintaining good habitat on this fishery.
- Liaise with the landowner and fishing interests on the opposite bank (RB) to improve and extend the fencing there, in particular, the area highlighted in Photo 22. The ideal solution would be complete exclusion of livestock and provision of an alternative watering source. It may be possible to utilise pasture pumps, depending upon the requirements of the livestock. If complete exclusion is not possible, a livestock watering point similar to Photo 27 could be created here if the RB was fenced.

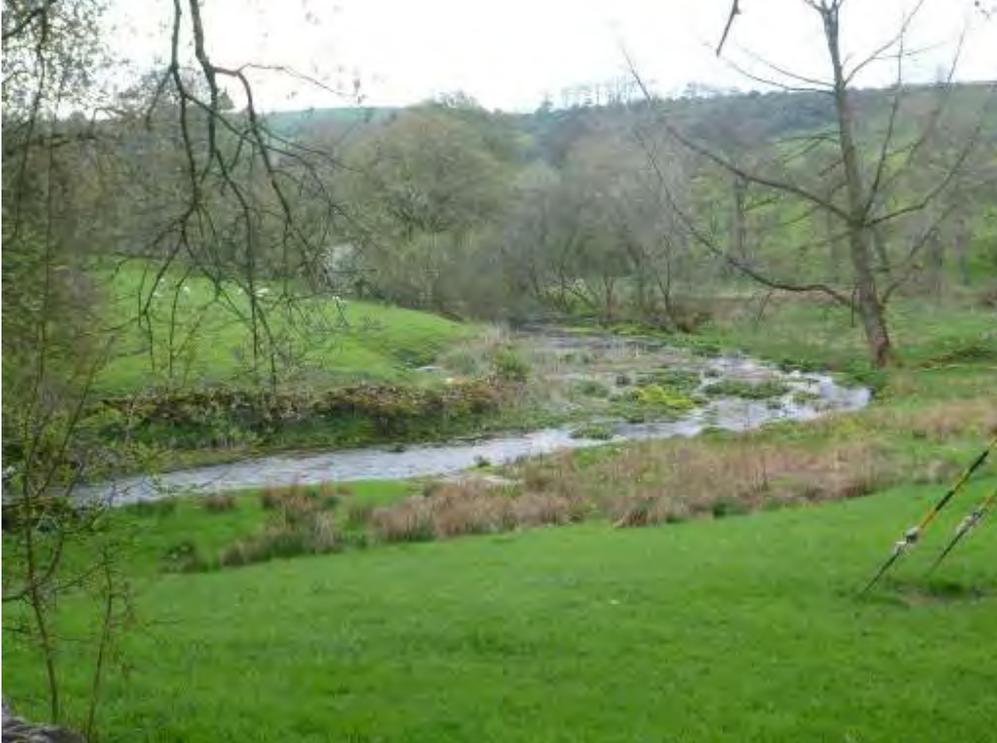
At the downstream end of the fishery, a spring source enters the river from the right bank (Photo 2); these features are common on the upper Dove, emanating from the limestone geology on the Derbyshire bank (LB). The flows vary depending upon recent past rainfall, but the springs provide a valuable supplement to the base flow of the river. Just downstream of the spring confluence, the small sewage treatment works serving Crowdecote discharges to the river (Photo 3). This works is relatively modern and there are no

Photo 2 Spring source from the limestone geology of the Derbyshire bank; flowing strongly following a wet winter/early spring.

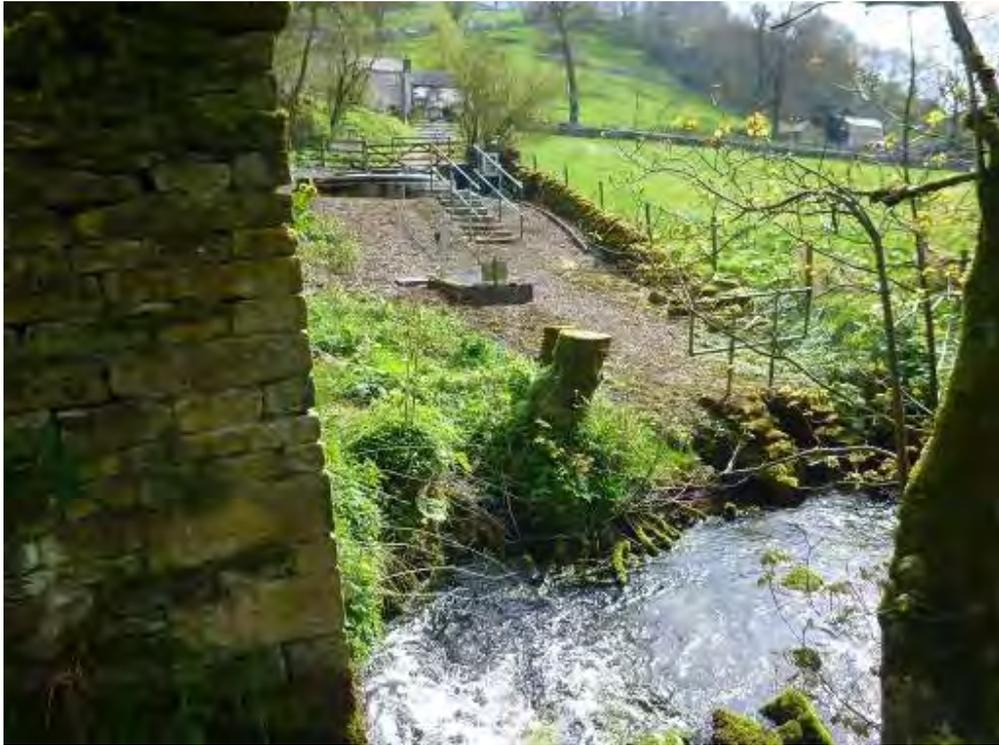
Photo 3 Sewage treatment works.

reported problems with the discharge; regular visual inspection is recommended to ensure this continues to be the case.

- Continue to keep a watching brief on water quality using the Anglers' Riverfly Monitoring Initiative (Riverfly Partnership). Keep an eye on the sewage works discharge for visual signs of pollution (e.g. sewage fungus).

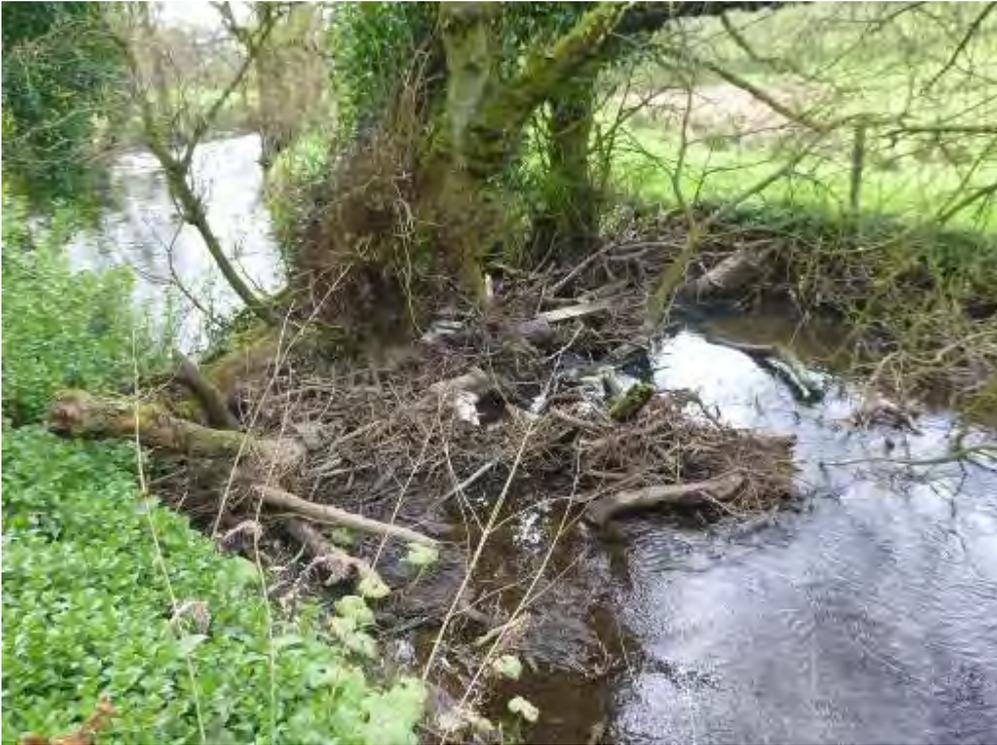
Despite the absence of the mill and weir, the straight reach immediately upstream (for circa 100m) shows evidence of regularly fluctuating water levels caused by water backing up; a "tide line" of about 18 inches of bare bank is visible above the water line (Photo 5). This is being caused by a substantial debris dam downstream of the old weir location (Photo 4).

The impounding effect the debris dam is having is preventing the reach upstream from reaching its full habitat potential, by reducing scour/erosion and promoting the deposition of fine sediment. There is also a substantial head difference across the debris dam (c. 0.7m) which could be a barrier to fish migration. For these reasons, it is recommended that the debris dam is carefully removed. As described during the site visit, this should be done in stages, with key supporting elements within the dam cut and/or removed with the aim of the river naturally shifting the structure during high flows.

Photo 4 Substantial debris dam near the downstream end of the fishery.

Complete removal in one go is **not** recommended as this will release substantial amounts of accumulated fine sediment from upstream. Please note that this recommendation is an exception to the general rule of retaining woody material in the river to provide fish cover and refuge, as described in 3.1 above.

- Remove the large debris dam at the downstream end of the fishery, doing so in stages over a period of 1 -2 years. Weaken the dam by removing key supporting pieces and allow the river to gradually break through and move accumulated fine sediment during high water events.

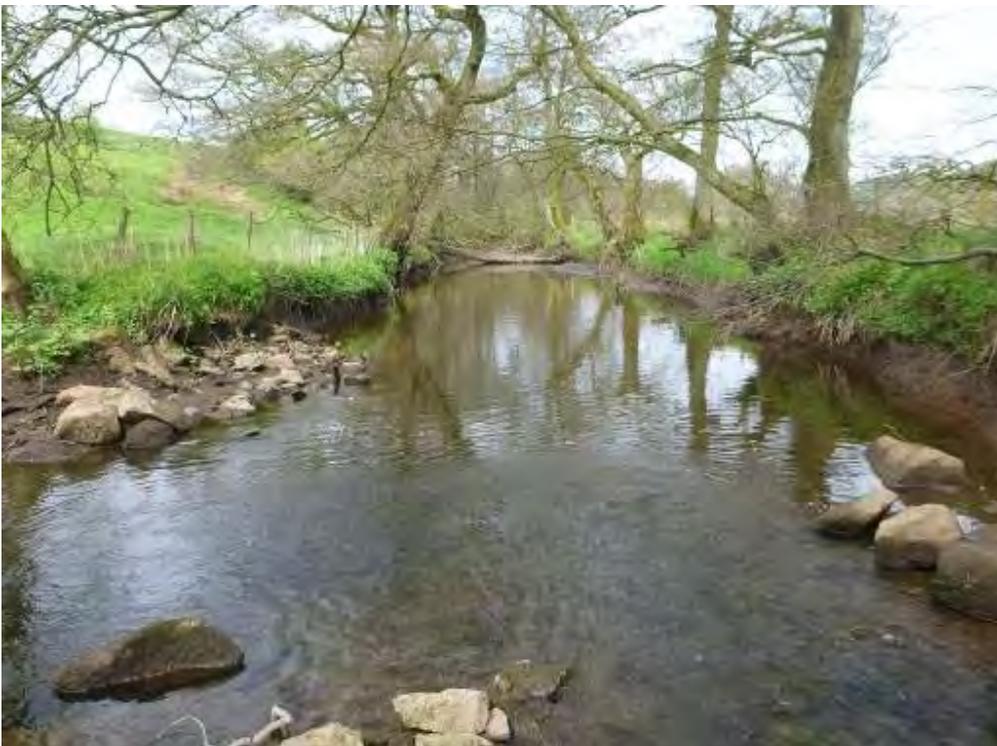
Photo 5 Reach upstream of the debris dam with remains of corn mill weir in the foreground.

Introduce more structure to the straight channel section upstream (Photos 5 & 6) in the form of brushwood mattress (Photo 28) and tree kickers (Photo 30).

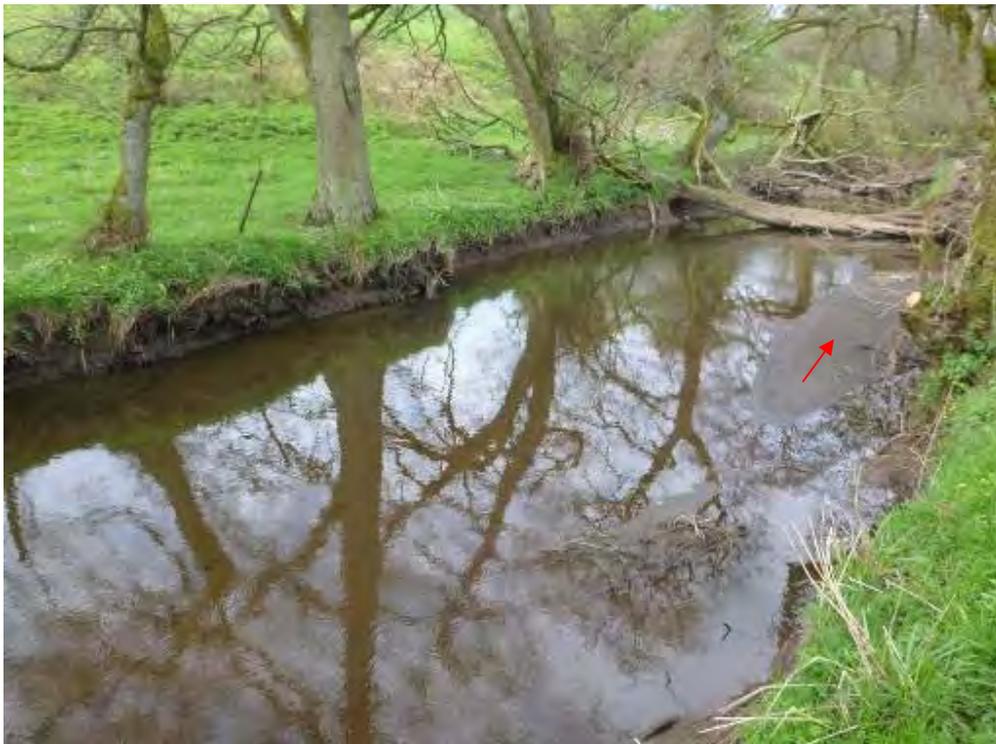
The straight section upstream of the old weir is wide and shallow with accumulations of fine sediment and shale gravel caused by the impounding effect of the debris dam. There are several fallen trees almost spanning the channel which should be left in place as they will create areas of scour and depth once the effects of the debris dam removal downstream start to be seen (Photo 6). There is scope for increasing the amount of cover in this section by introducing woody material to pinch the wider sections of channel; if stakes can be driven into the bed here, some of the material removed from the debris dam could be used to create a brushwood mattress. Tree kicker structures anchored to bankside trees could also be used (see recommendations for techniques).

Photo 6 Wide shallow reach upstream of old corn mill weir, with accumulations of finer sediment (arrow). Leave woody material in situ and observe the effects of the removal of the downstream debris dam. Then consider introducing more structure (brushwood mattress / tree kickers).

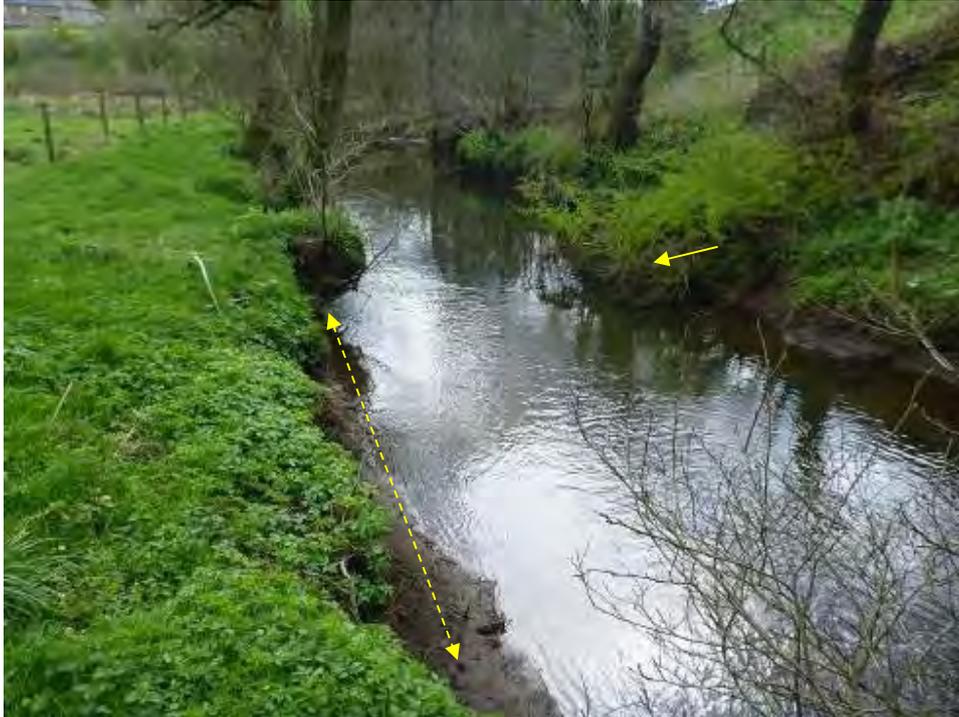
Photo 7 Good overhead cover provided by the hawthorn bush overhanging the far bank (solid arrow). This type of feature should be preserved and encouraged. There is scope for better cover on the near bank (dashed arrow) and planting of willow whips/stakes could be tried here, with a view to hinging them over into the water in the future.

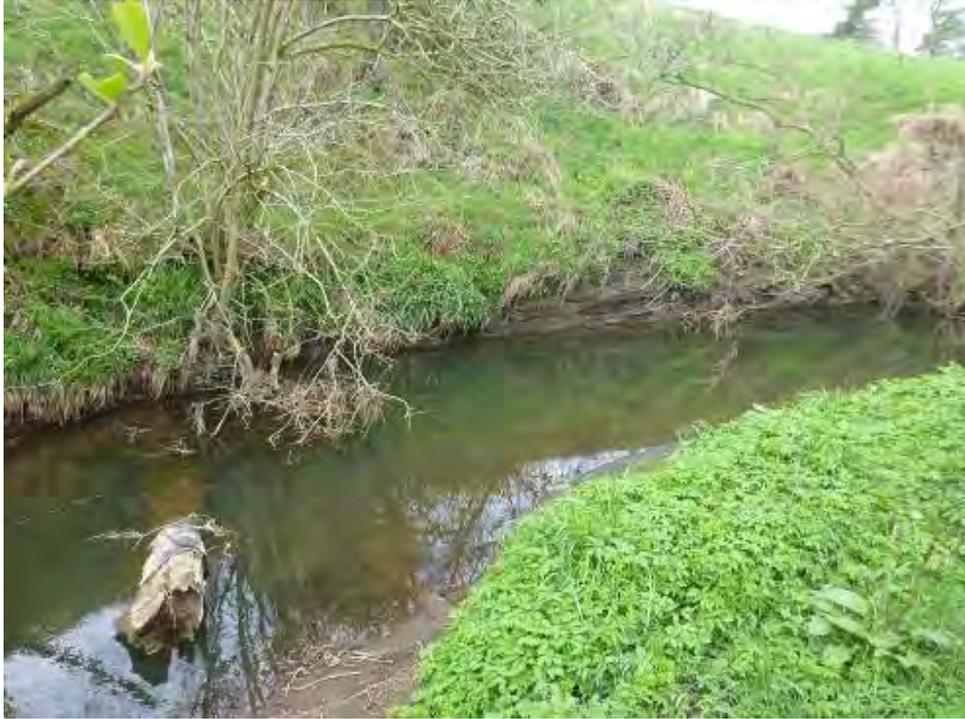
Photo 8 Good habitat likely to hold fish. The depth provided by the scour against the steep far bank is complemented by the in-stream structure and overhanging branches.

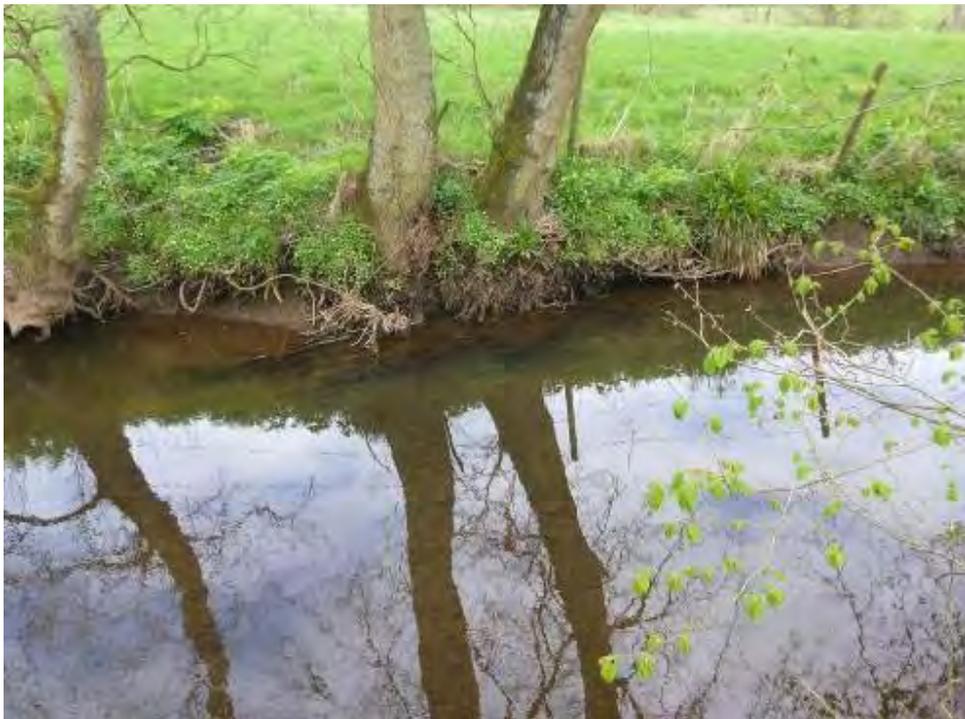
Photo 9 Submerged tree roots provide excellent cover for holding trout. In shallower areas, they can make the difference between a trout being present or absent.

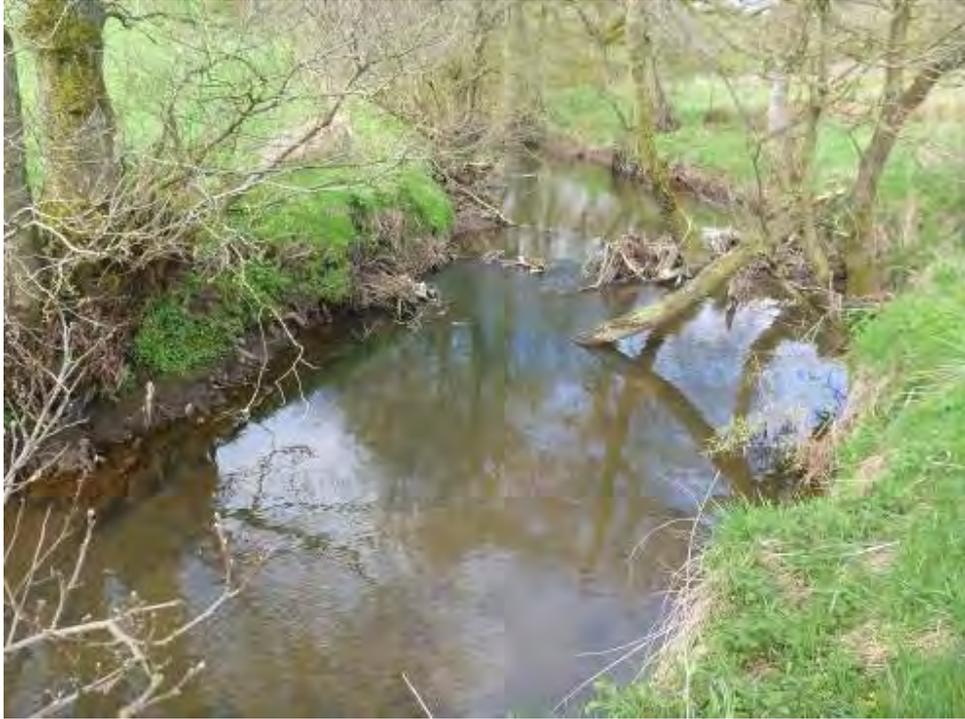
Photo 10 Large woody material in the river channel. A trout was observed in the shallower water in the foreground here, which sought refuge in the structure/deeper scour upstream when disturbed. This illustrates the point in section 3.1 regarding the importance of retaining resting/refuge lies from which fish will venture into “catchable” positions when feeding.

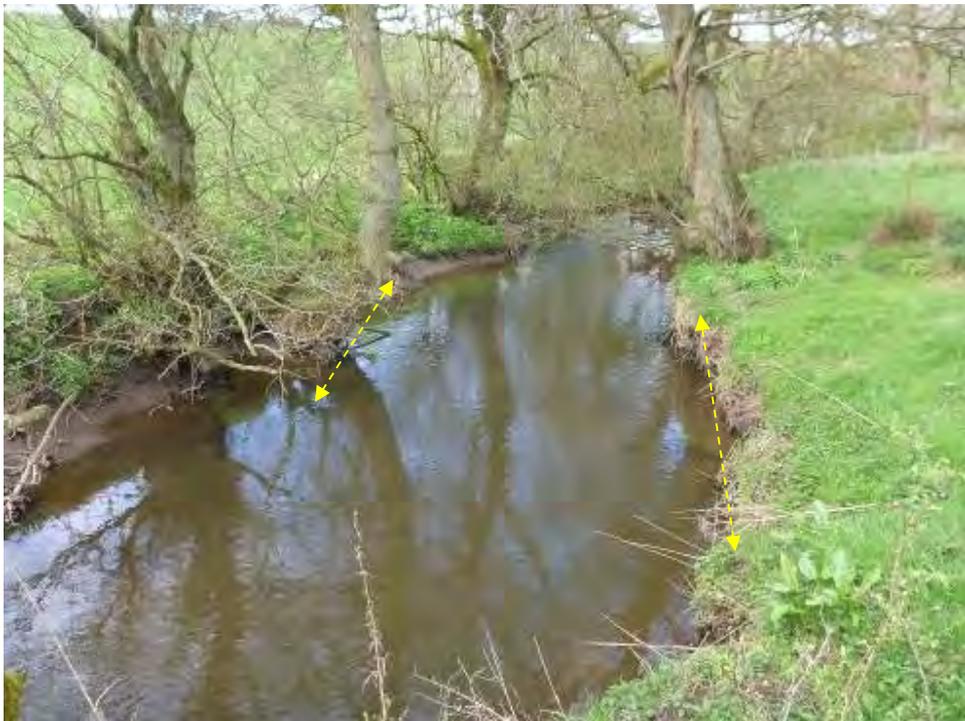
Photo 11 A pool/glide area which has sufficient depth to hold a fish, but needs better cover. Attaching a tree kicker (far bank) and planting willow (near bank) are options here.

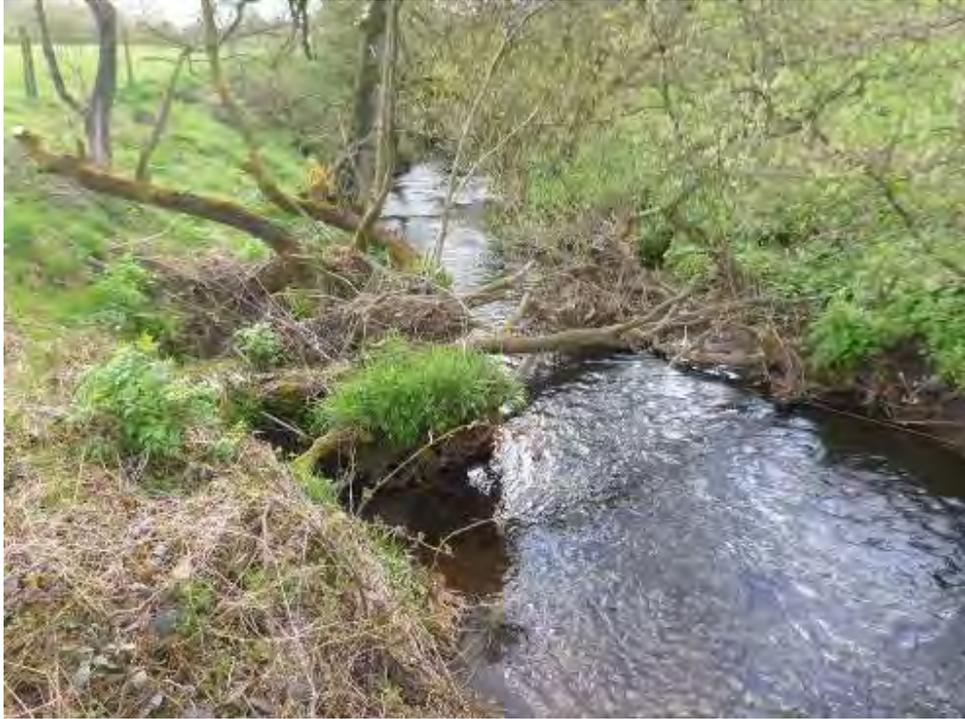
Photo 12 Large woody material in a narrower section of channel. Again, this is a feature which provides a sanctuary for fish from which they will venture out to feed, and should be retained.

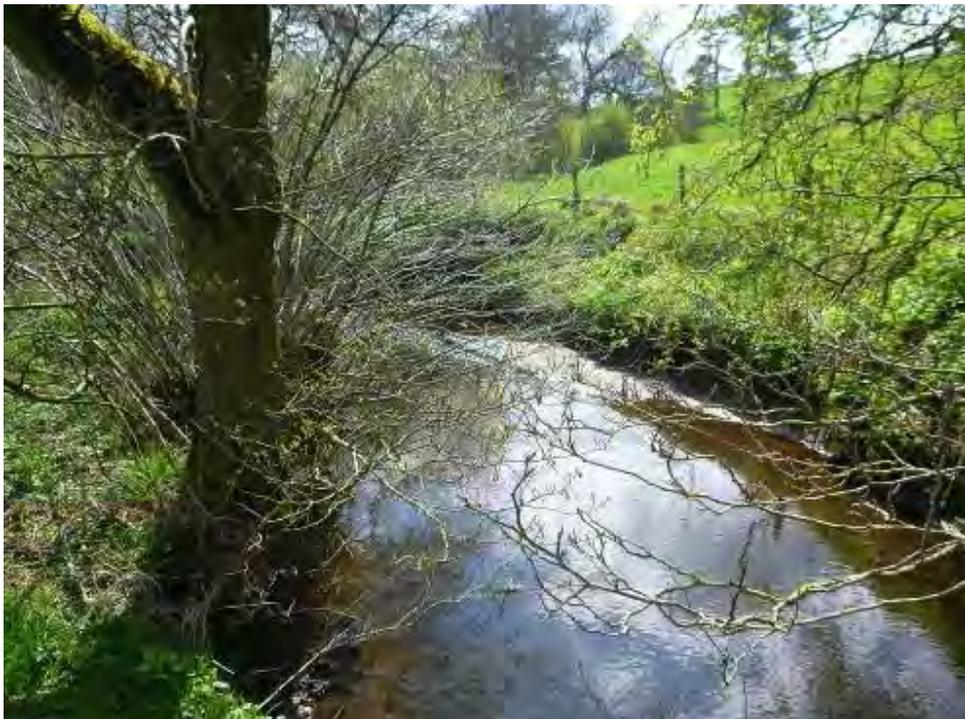
Photo 13 Coppice re-growth (left of picture) is ideal for partially cutting and laying into the channel (like hedge laying), to provide instant cover.

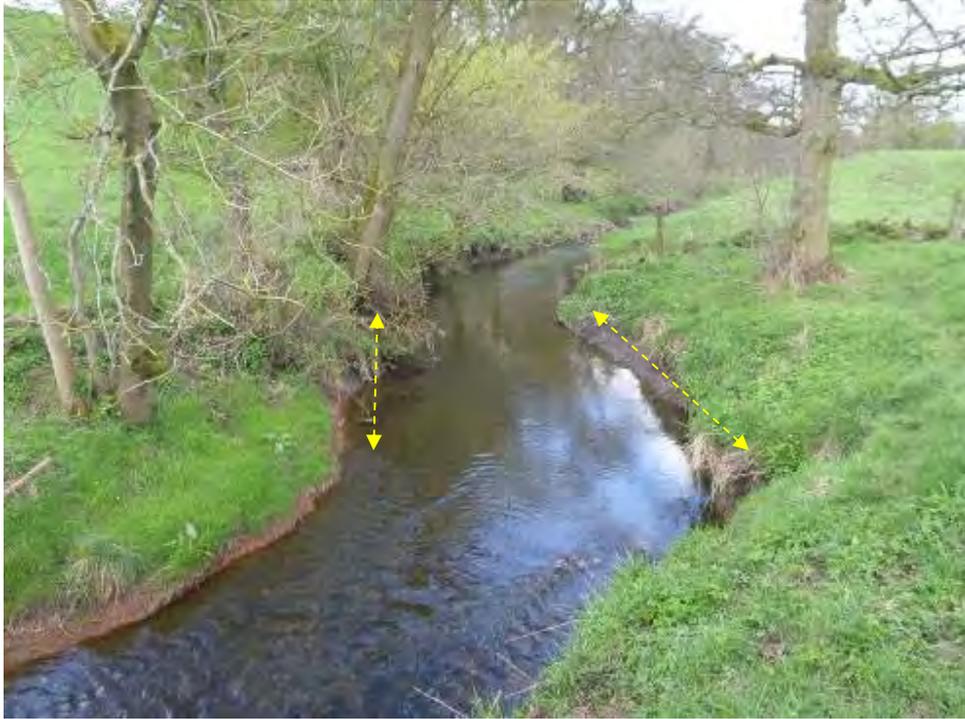
Photo 14 Another area with scope for increasing the amount of cover to improve fish holding potential: tree kicker on the far bank and bush/tree planting on the near bank.

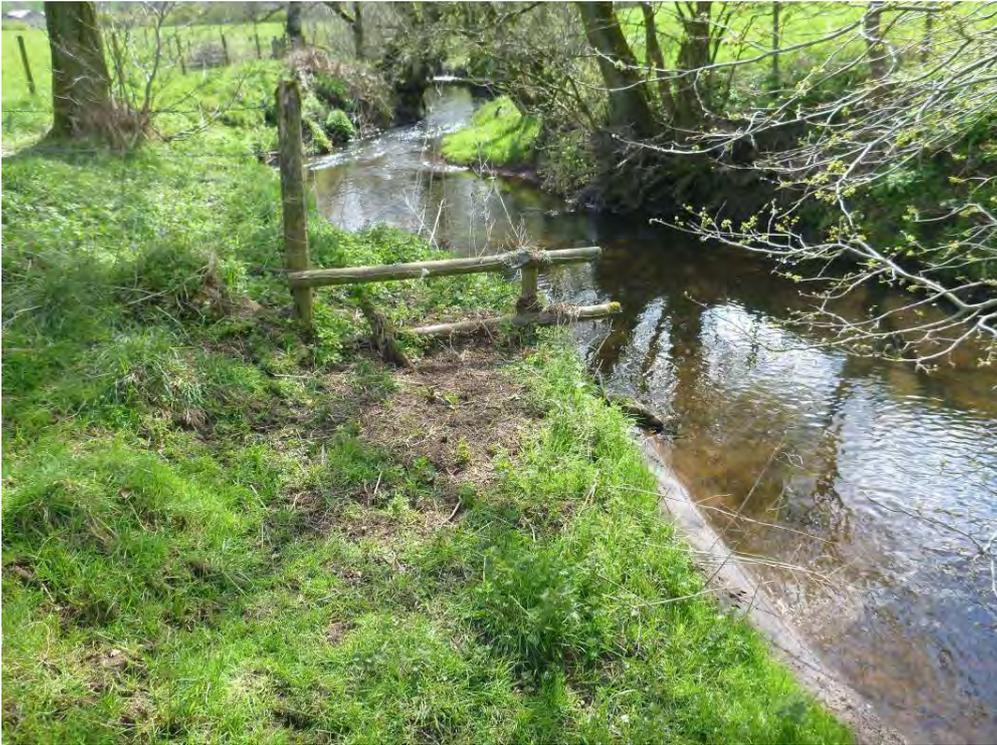
In the middle section of the fishery, there is a field on the LB which is not fenced. The end of the downstream fencing is bounded by a low, step-over section (Photo 15) – this should be monitored to ensure it does not provide an access point for livestock into the fenced area.

Photo 15 Make sure the low point at the end of the riparian fencing here does not provide livestock access into the fenced area.

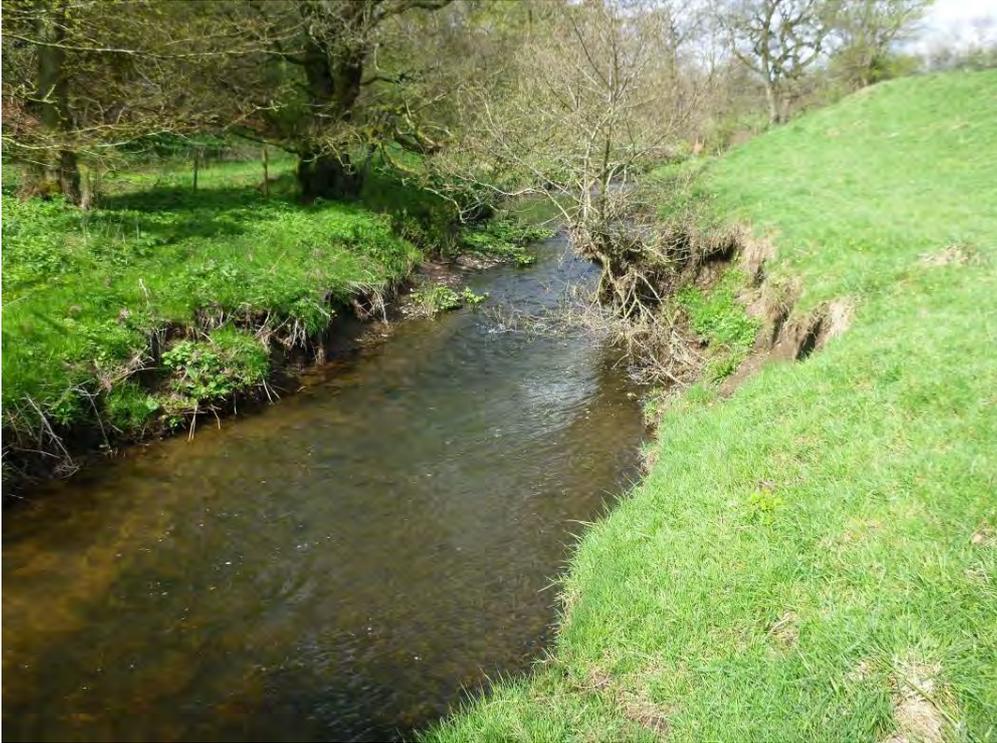
In the unfenced section, the effect of grazing on the bankside vegetation is evident. Whilst the grazing is relatively light, it limits the development of taller herbage and prevents tree succession, so there are far fewer younger trees coming through compared to the fenced section. This limits the amount of cover available in the channel from overhanging vegetation, bushes and fallen trees, hence reducing the potential for holding fish. (Photos 16 - 17).

Photo 16 The unfenced LB section of the fishery (right of shot) has fewer trees and hence less cover and poorer bank stability.

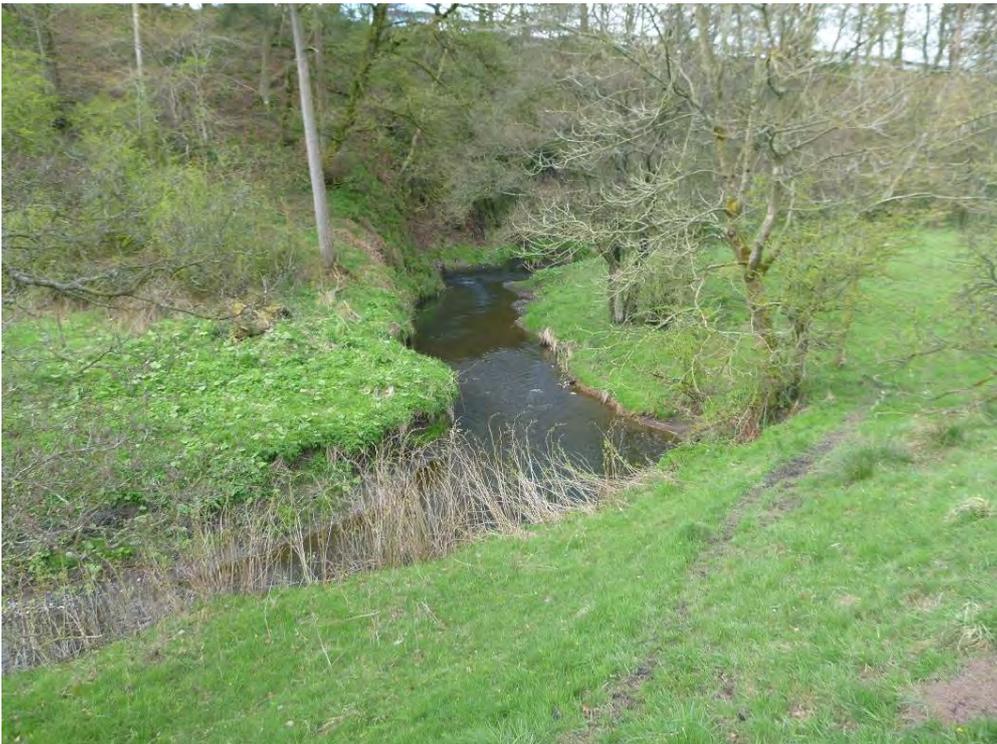
Photo 17 As above, a wider view shows the lack of trees (and tree succession) immediately adjacent to the river. The lesser bank stability leads to a wider, shallower channel with less cover and less potential for holding fish.

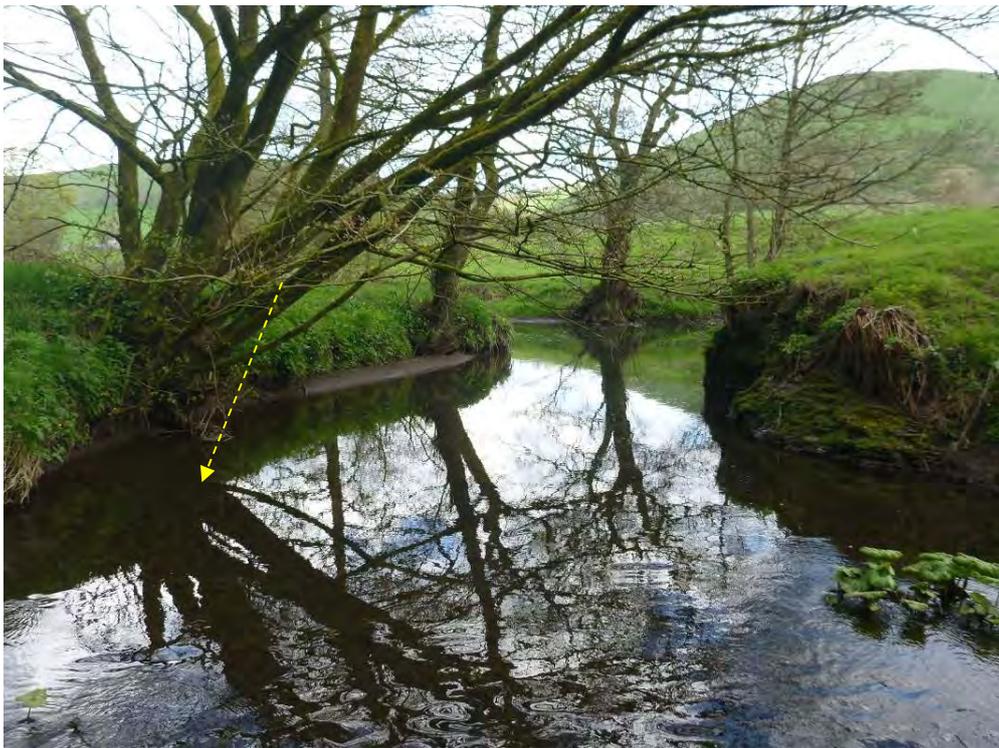
With progress upstream, there is a large pool associated with a meander which provides good adult trout habitat. Hinging some of the overhanging branches here to trail into the margins would provide additional fish holding features (Photo 18). Immediately upstream of this pool, there is a fallen tree across a riffle; this is providing good cover and refuge habitat for juvenile trout and is not obstructing an area that would be fished, so should be left in place (Photo 19). Goosanders are common on the upper Dove, so any dense cover that can be utilised by smaller fish is valuable in reducing predation pressure.

Photo 18 Large pool on a meander. Hinging some of the overhanging branches into the water here will enhance the fish-holding features.

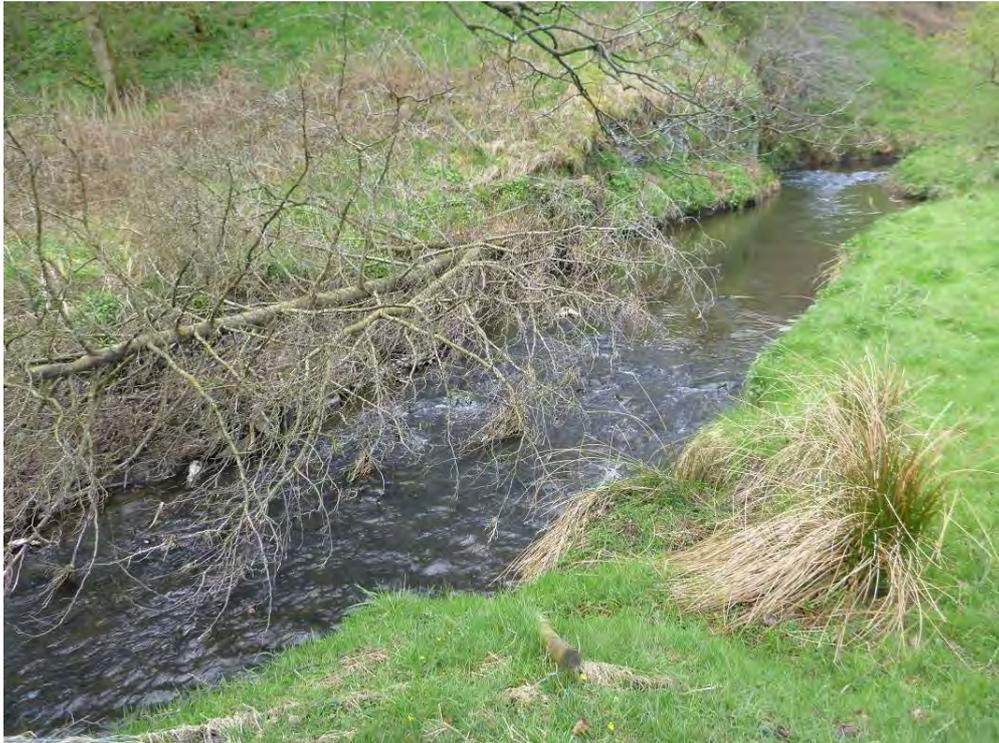
Photo 19 Fallen tree across a riffle – leave in situ as a refuge for juvenile trout.

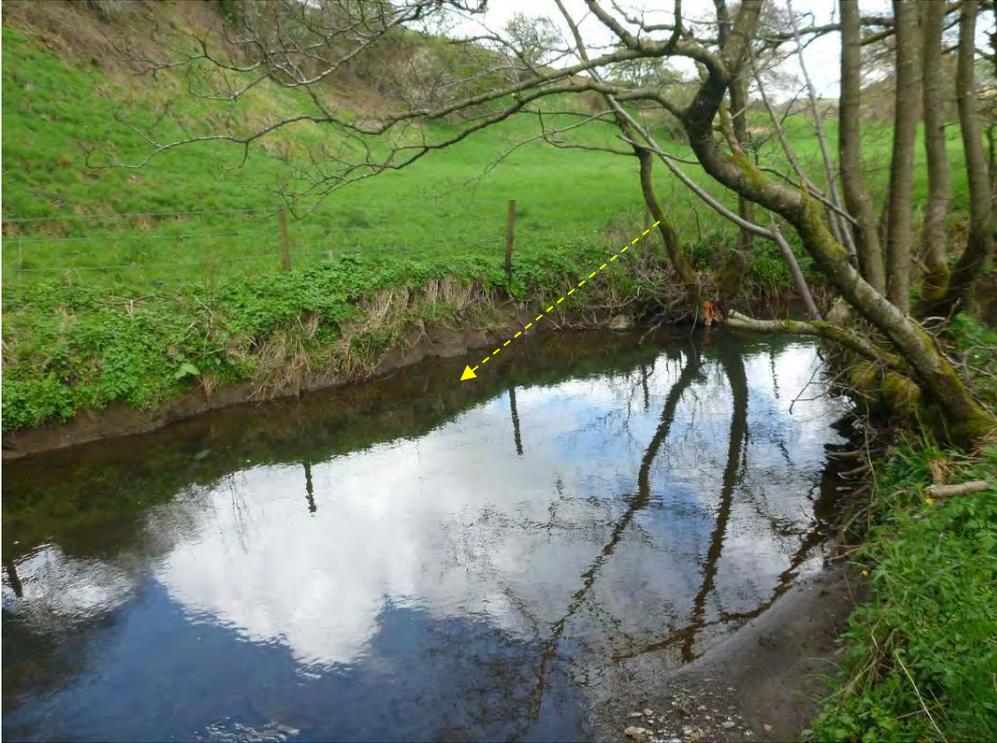
Further upstream, the LB fencing resumes and bankside habitat improves. There is some fencing on the opposite bank, although ideally it should be located further away from the river's edge to allow tree succession and/or planting (Photos 20 - 21). There is a gap in the opposite bank (RB) fencing for the length of one field where there is evidently stock access for watering. The livestock are also crossing the river here and grazing the LB; a second fence on the LB (in addition to the Passport Scheme fence) prevents livestock access within the wider buffer strip, but is not protecting the immediate bankside habitat (Photo 22). Ideally, an alternative water source should be provided and the RB fenced off, or a drinking area created along with fencing which prevents livestock from crossing the river. Liaison with the RB landowner and fishing interests is recommended.

Photo 20 Right bank habitat would benefit from the fence being set back. Willow could be planted here to provide better cover on that bank. Hinge the tree (arrow) into the margins.

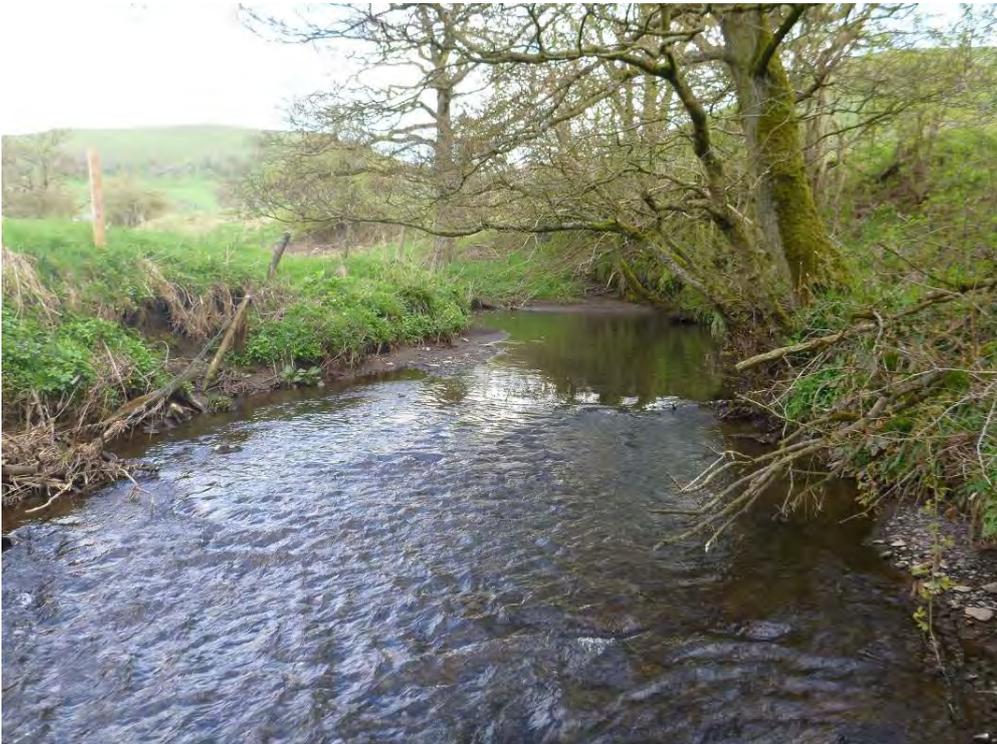
Photo 21 Better bankside vegetation resumes in the fenced area (LB, right of shot).

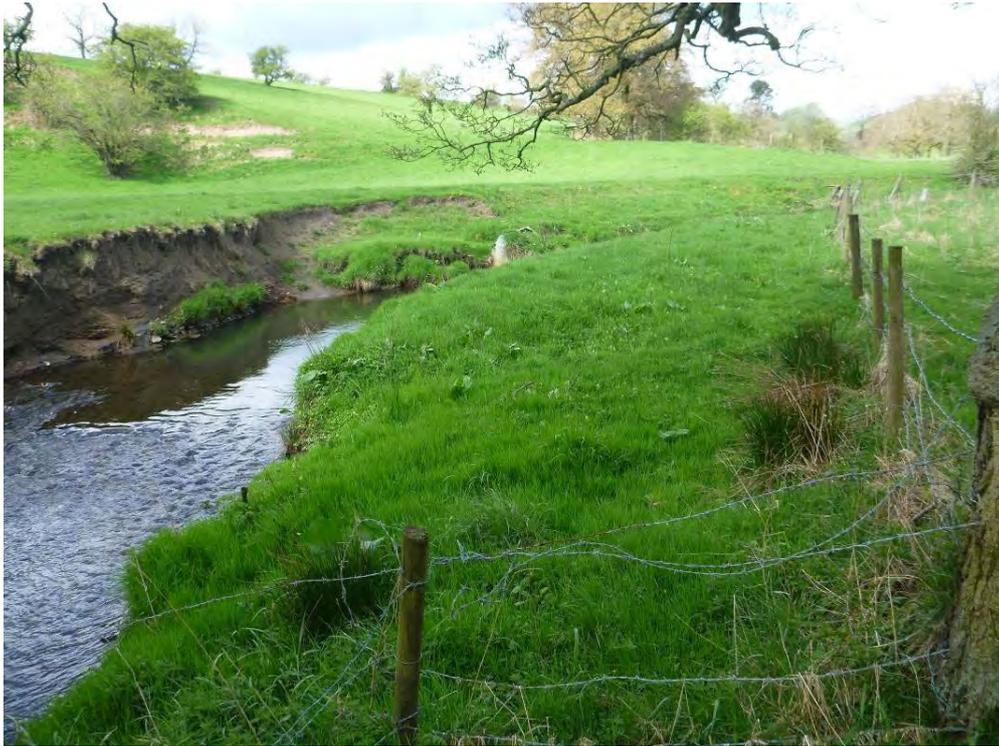
Photo 22 The unfenced section of the RB (far bank). Livestock are crossing the river and impacting upon bankside habitat quality on both banks. The fence visible in the picture prevents access into the buffer strip which is fenced off further back from the river (out of shot, right of picture). RB fencing and a proper cattle drink would greatly benefit this area.

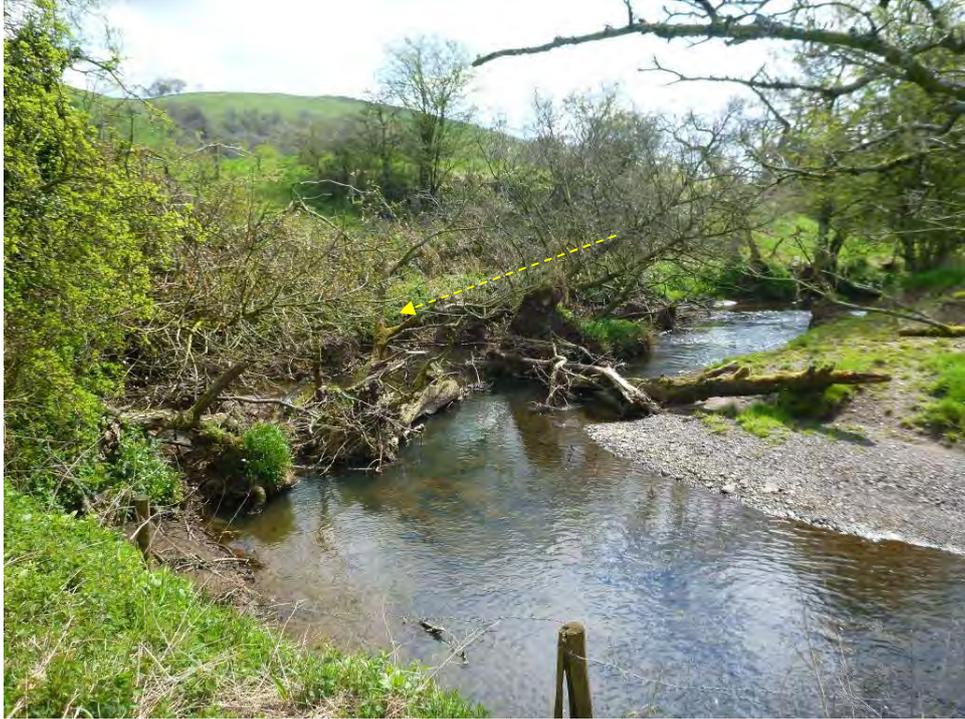
At the upstream extent of the section in Photo 22, there is an accumulation of woody material where several alder trees have collapsed into the river from the steep LB (Photo 23). This is providing some valuable in-stream structure, but could be enhanced and made more accessible for angling by removing some of the higher level branches and wedging them at the back (bank) side of the structure.

Photo 23 Retain the woody material in channel, but cut some of the higher branches and wedge behind the structure.

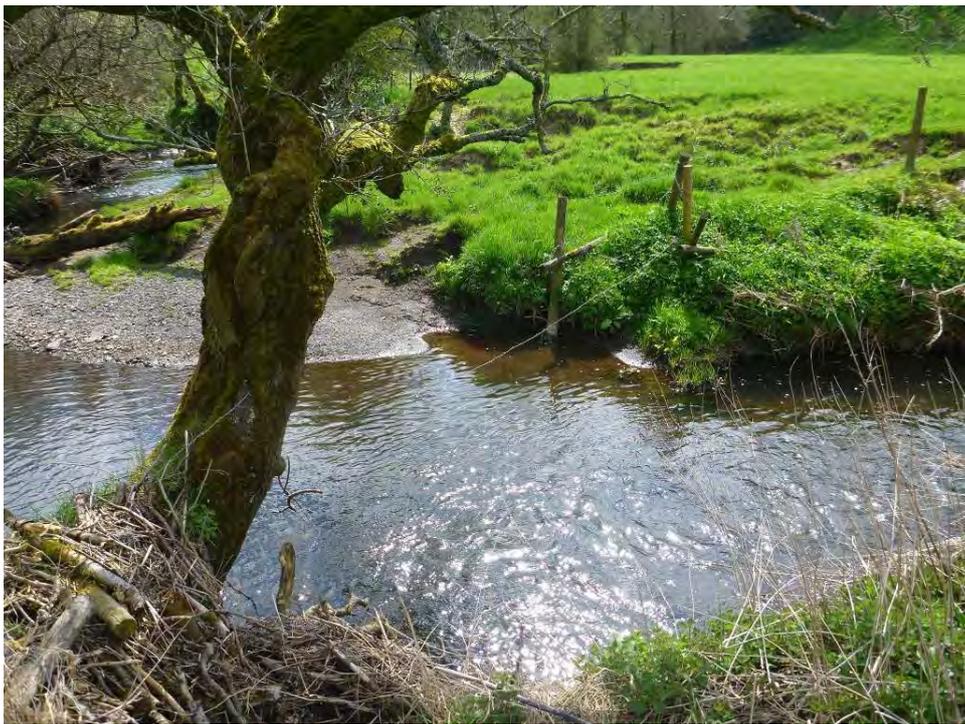
On the RB opposite the woody material, the bank is low with a gravel point bar (Photo 24). This could provide an area for controlled livestock watering from the RB by installing waist-high, cross-channel barriers (such as telegraph poles) to delineate an area between bankside fencing (see recommendations). The use of the redundant pasture pumps noted above could also be explored.

Photo 24 The low RB could be an area where a livestock drinking point is created in conjunction with fencing. Drinking points still have an impact on the river (concentrated bank damage, faecal inputs) and require regular maintenance, so complete livestock exclusion and an alternative means of watering is the ideal solution.

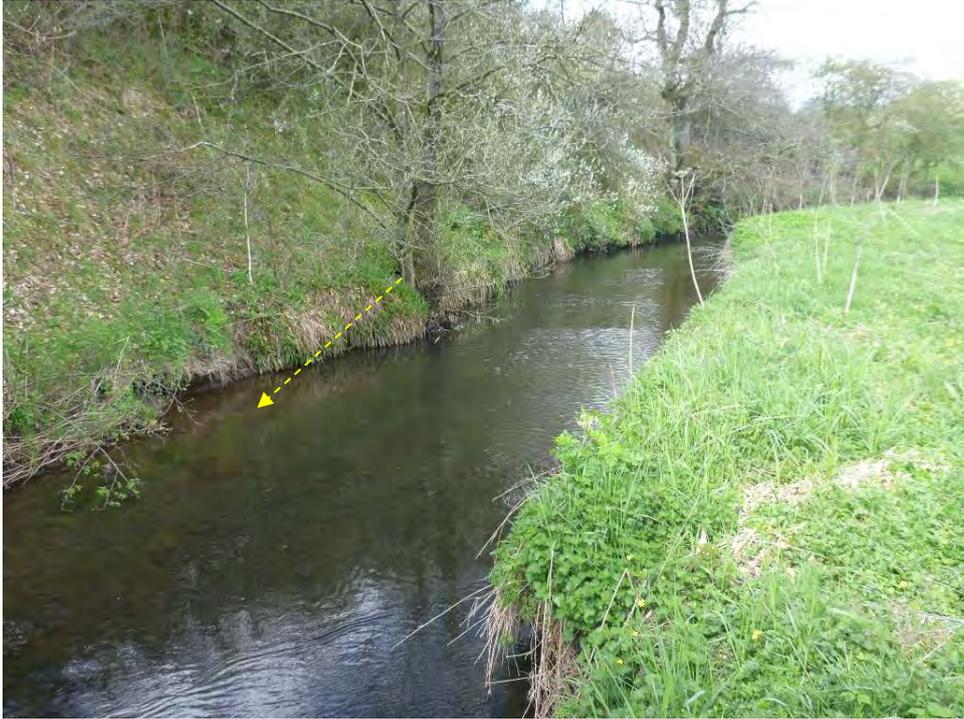
Further upstream towards the upstream boundary, there are opportunities to improve cover and fish-holding potential along areas of glide habitat (Photos 25 & 26).

Photo 25 Fix tree kicker structure and/or hinge trees on far bank to improve cover.

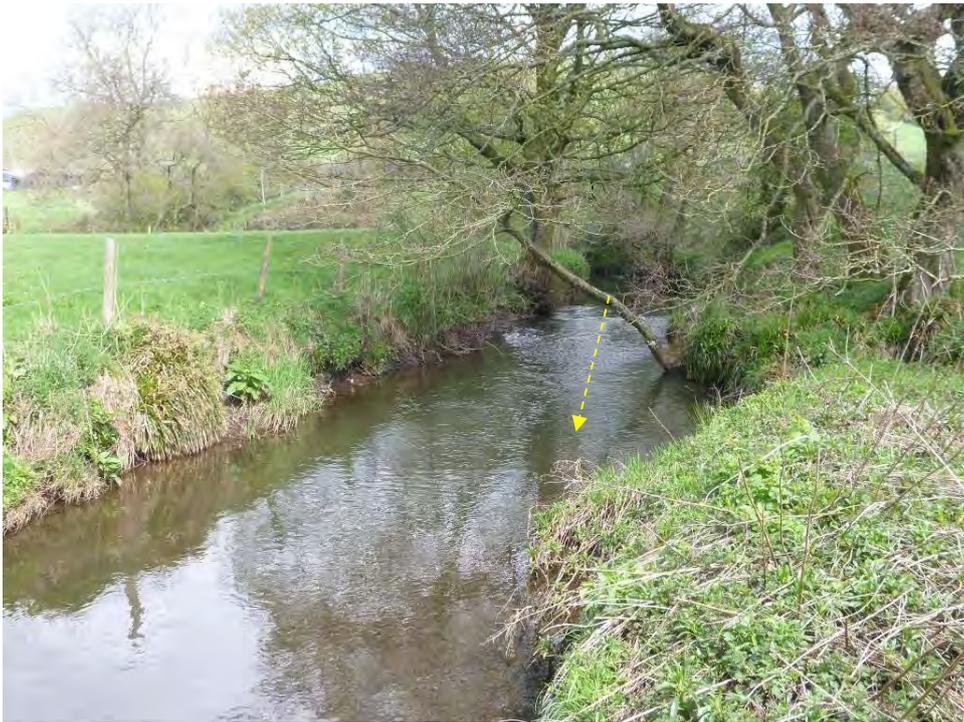
Photo 26 Hinge tree into the river.
