**ADVISORY VISIT TO THE OKEOVER FISHERY
RIVER DOVE, DERBYSHIRE,
UNDERTAKEN BY VAUGHAN LEWIS,
WINDRUSH AEC LTD, ON BEHALF OF
OKEOVER FLY FISHING CLUB
APRIL 2008**

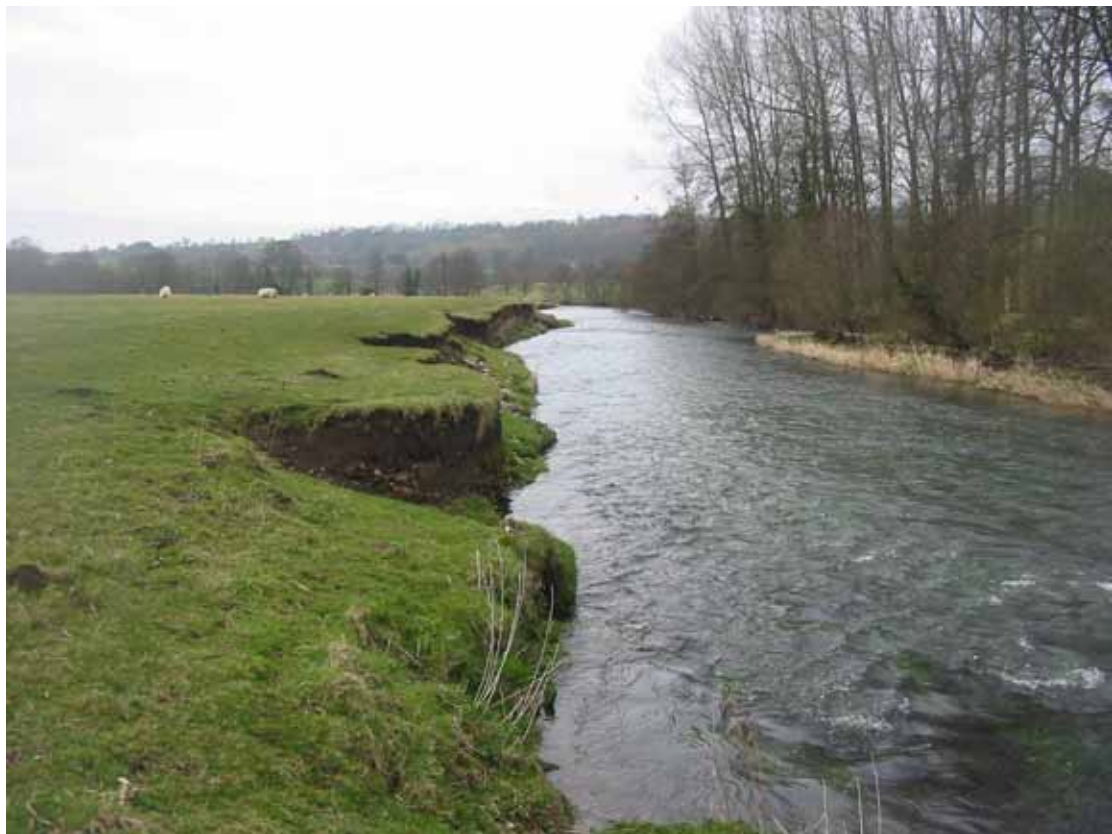
Downstream of Okeover Mill, an increasing number of beef cattle had been allowed to graze the LB of the river. This had resulted in some localised sections of excessive erosion, particularly in the vicinity of a colony of nesting sand martins. As a consequence, there was a concern that the erosion might lead to loss of nests and/or nesting sites. In contrast, the RB of the river was fenced, with a well-developed fringe of trees, dominated by alder *Alnus glutinosa*.

Excessive erosion of bank containing sand martin colony

- In sections where increased pressure from agricultural stock has caused excessive bank erosion, stock proof fencing should be erected. Ideally, an ungrazed buffer of 10m should be created between the new fence line and the existing bank. This will both allow the development of coarse grasses and emergent vegetation that will slow down the rate of erosion, and will optimise detention of fine sediment from surface run-off. If it is not possible to create a 10m buffer strip, then the maximum practical width should be protected.

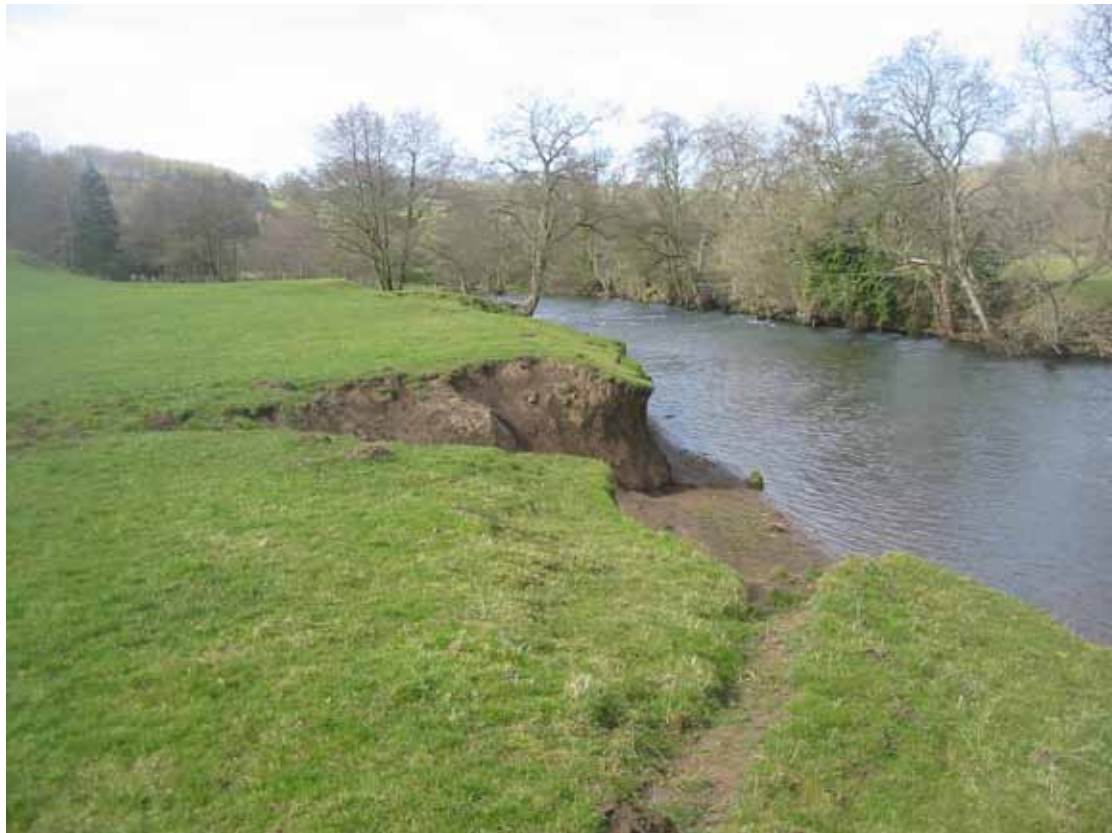
The land on the RB above the weir had been placed into the Countryside Stewardship scheme, creating a valuable wetland resource. As part of the scheme the riverbank had been fenced to prevent damage by agricultural stock. Further upstream, the river was not fenced, allowing access to the banks for stock. As a consequence, there was some localised overgrazing and associated erosion.

Overgrazing and erosion of banks in the upper reaches of the fishery

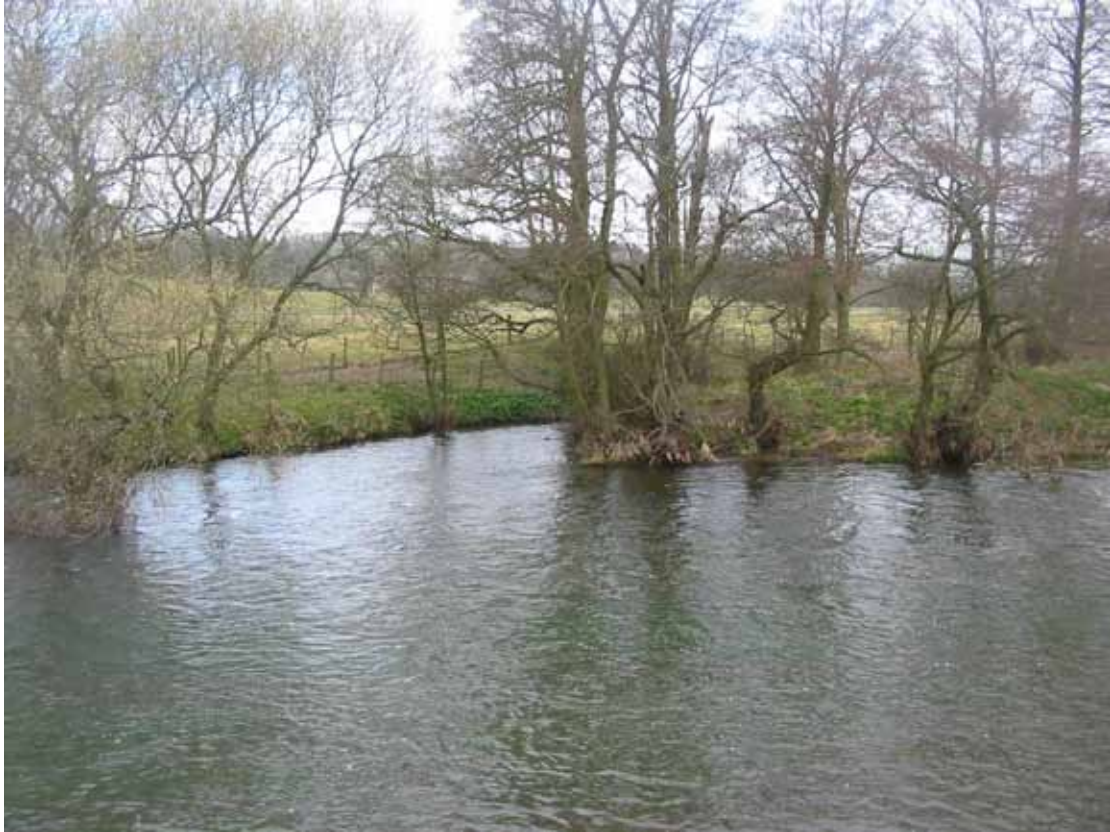
Confluence of the Millstream and main river downstream on Okeover Mill

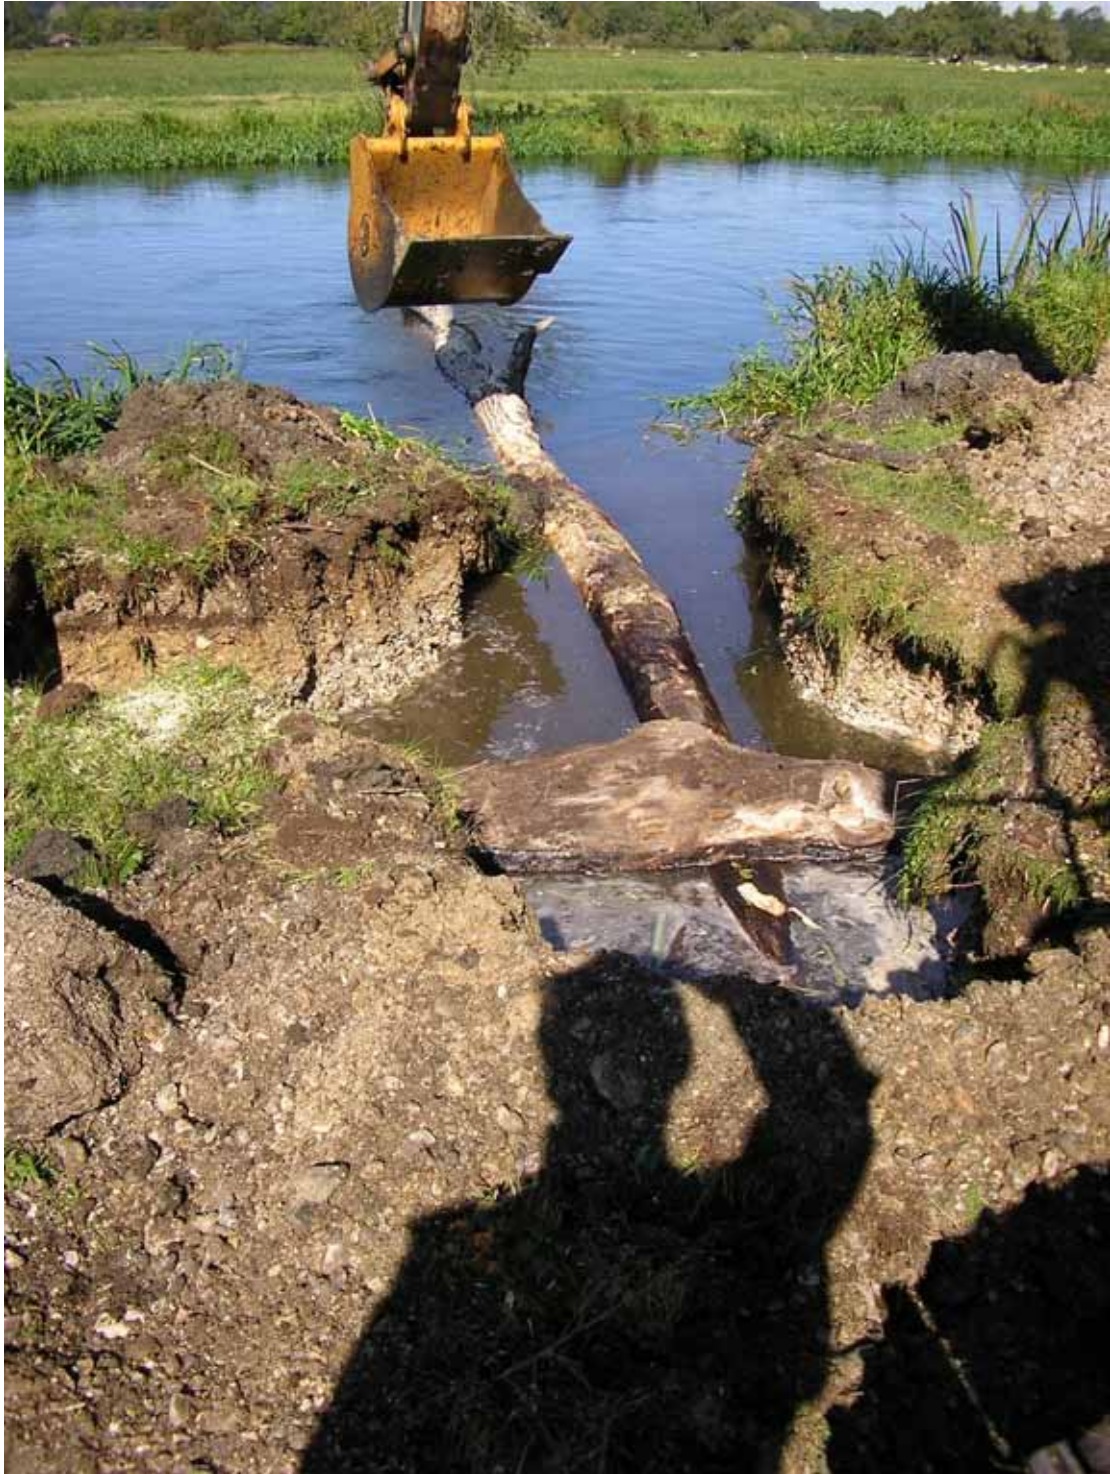
LWD with 'T' bar of wood attached and lowered into pre-dug slot. Slot is then backfilled to reinstate bank and create a firm fixing.

Larger trees can be held in place using the 'T' bar technique. The photograph below should be self-explanatory. This technique can be undertaken using smaller 'T' bar anchors buried in the ground if no access is available for mechanical plant.
